# Insurance Institute for Highway Safety Crashworthiness Evaluation

## Crash Test Report 2003 Infiniti Q45 (CEF0302)

**Vehicle identification number:** JNKBF01A03M100660  
**Body style:** Large 4-door sedan  
**Engine/transmission:** Longitudinal 4.5-liter V8, 5-speed automatic, rear-wheel drive

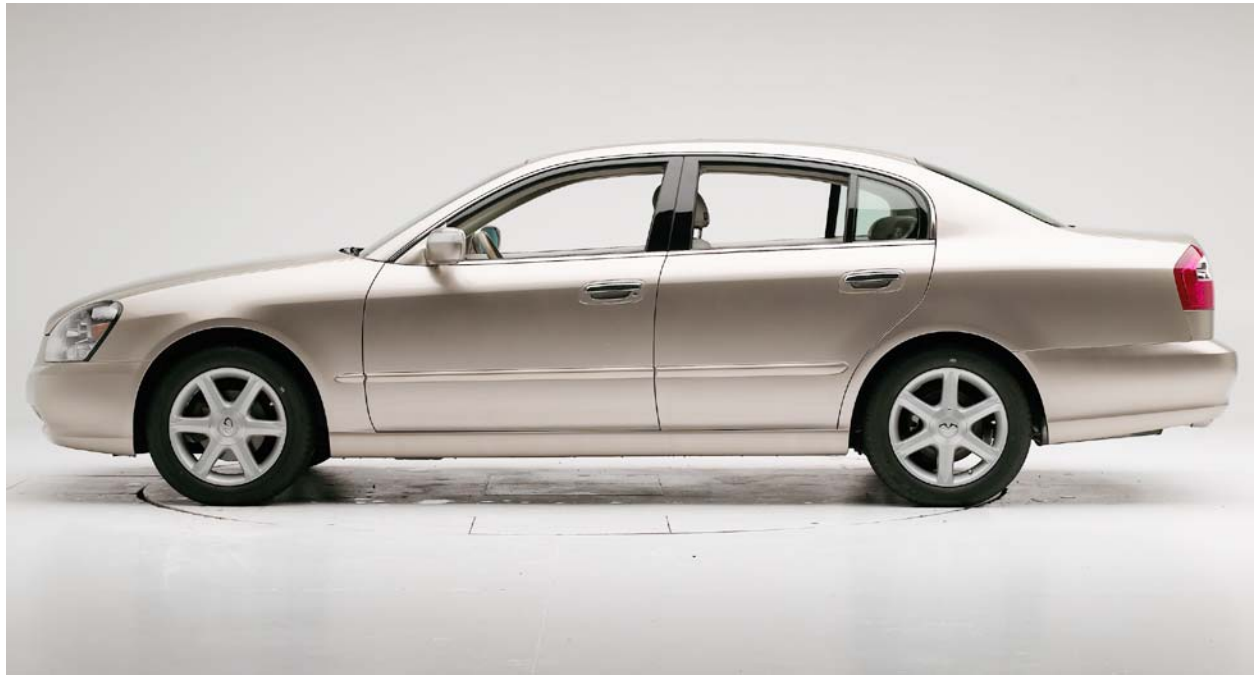
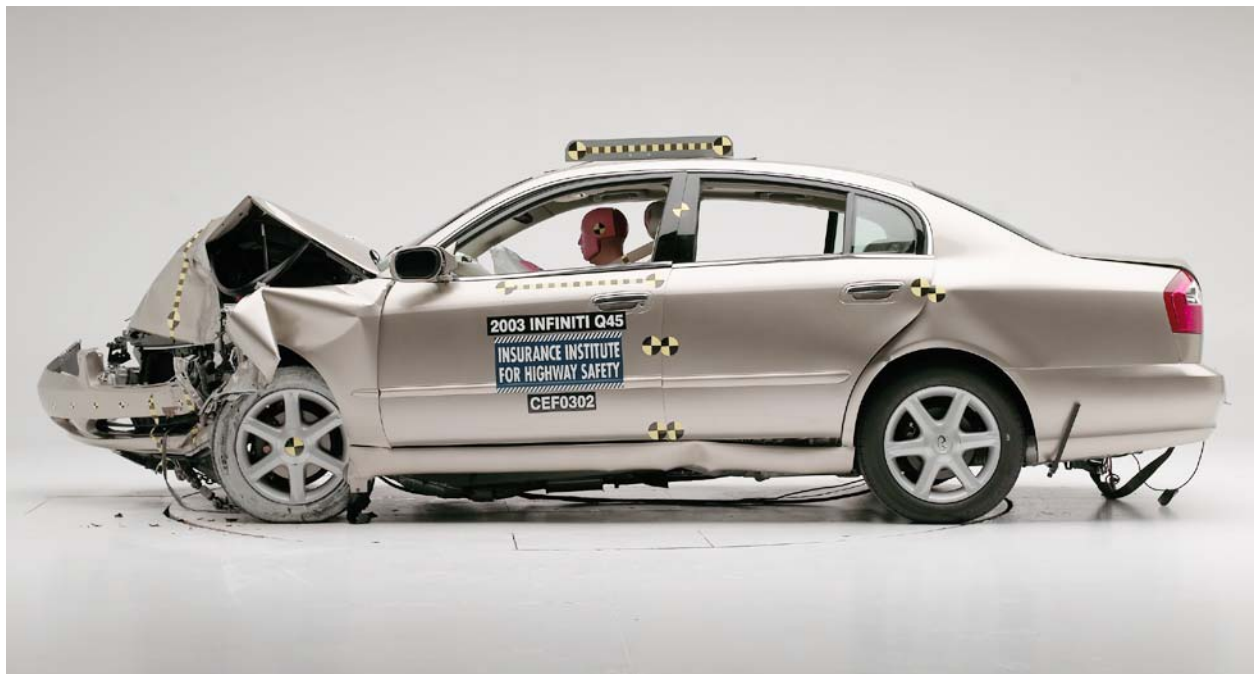
**Figure 1**  
**Precrash and Postcrash Side Views — 2003 Infiniti Q45**

A 2003 Infiniti Q45 was crash tested on January 16, 2003 into a fixed deformable barrier at 39.8 mi/h (64.1 km/h) and a 40 percent overlap on the driver side. A Hybrid III 50th percentile male dummy was positioned in the driver seat with the lap/shoulder belt fastened.

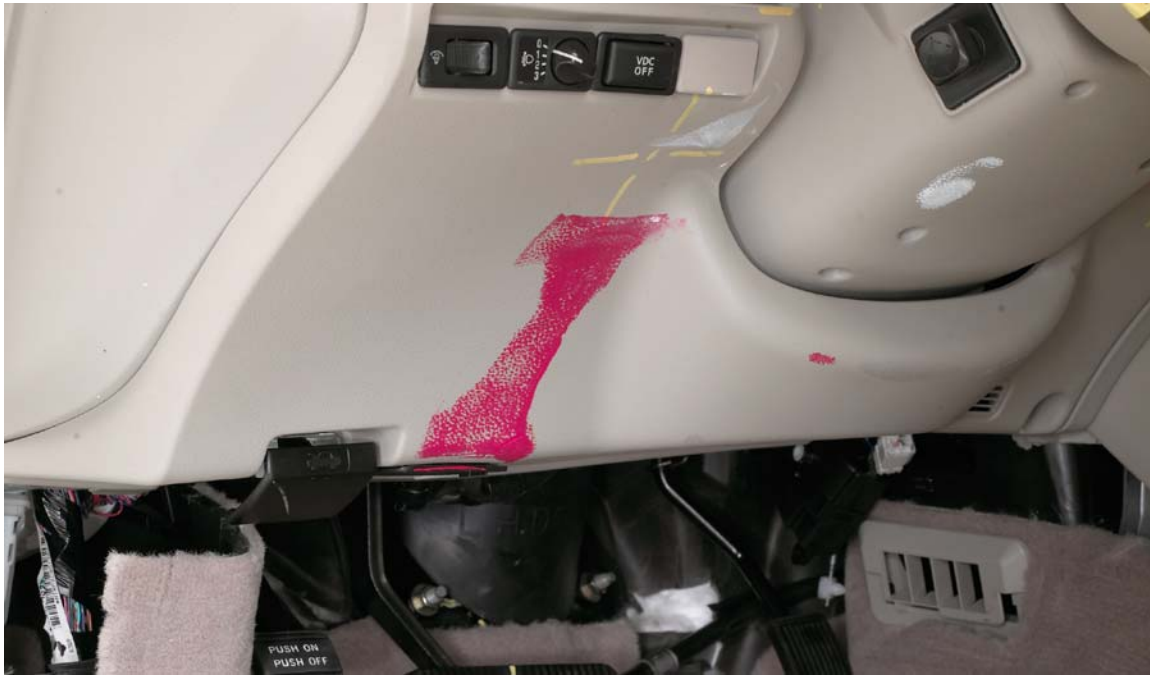
**Figure 4**  
**Dummy Left Knee/Shin Contacts, Postcrash — 2003 Infiniti Q45**

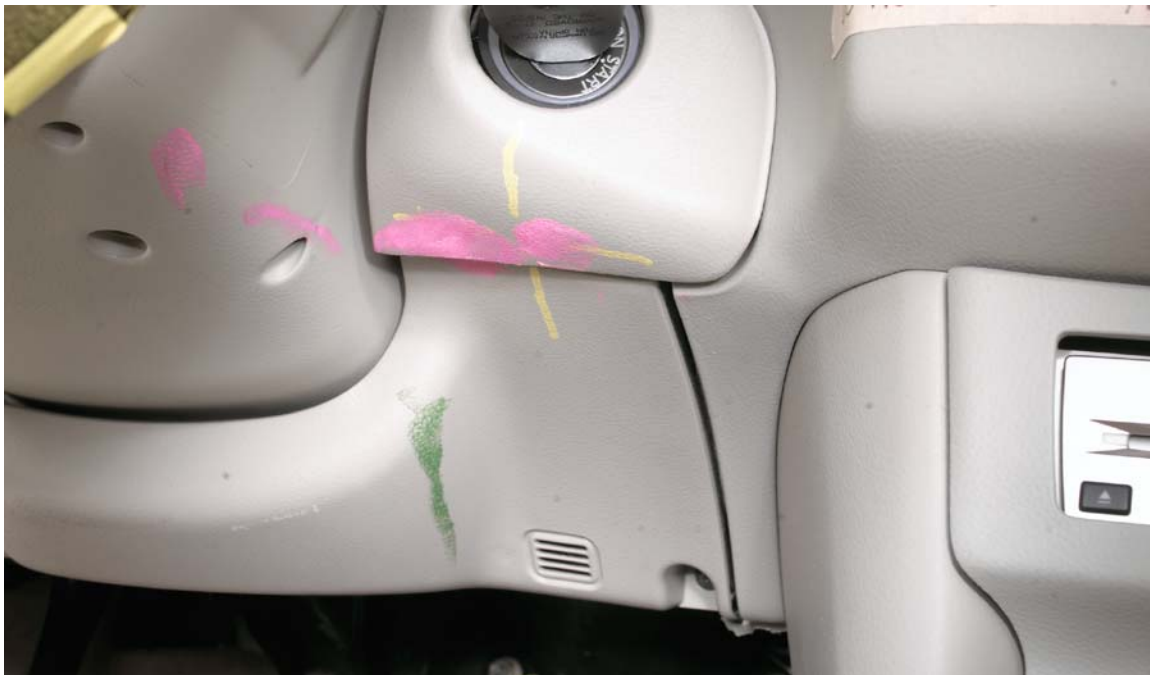
**Figure 5**  
**Dummy Right Knee/Shin Contacts, Postcrash — 2003 Infiniti Q45**

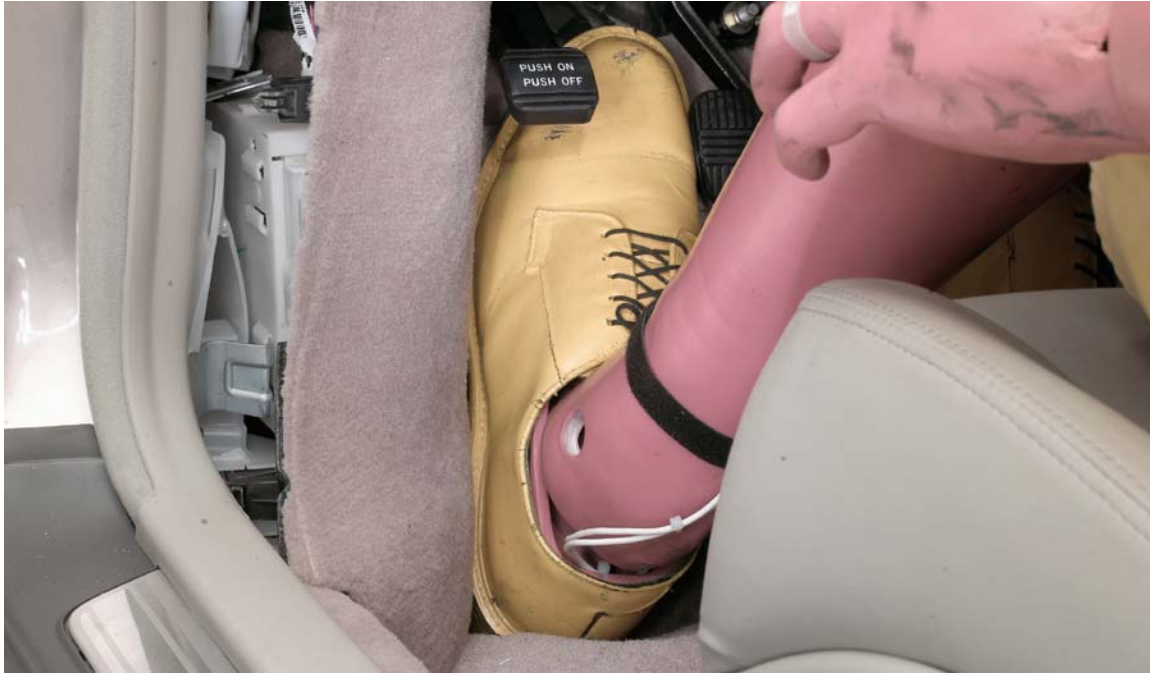
**Figure 6**  
**Dummy Feet Positions, Postcrash — 2003 Infiniti Q45**
