REPORT NUMBER: 214-CAL-03-06

**SAFETY COMPLIANCE TESTING FOR FMVSS 214
SIDE IMPACT PROTECTION
INDICANT**

MITSUBISHI MOTORS CORPORATION
2003 MITSUBISHI OUTLANDER
MPV

VERIDIAN ENGINEERING TEST NUMBER: 8675-F214-06

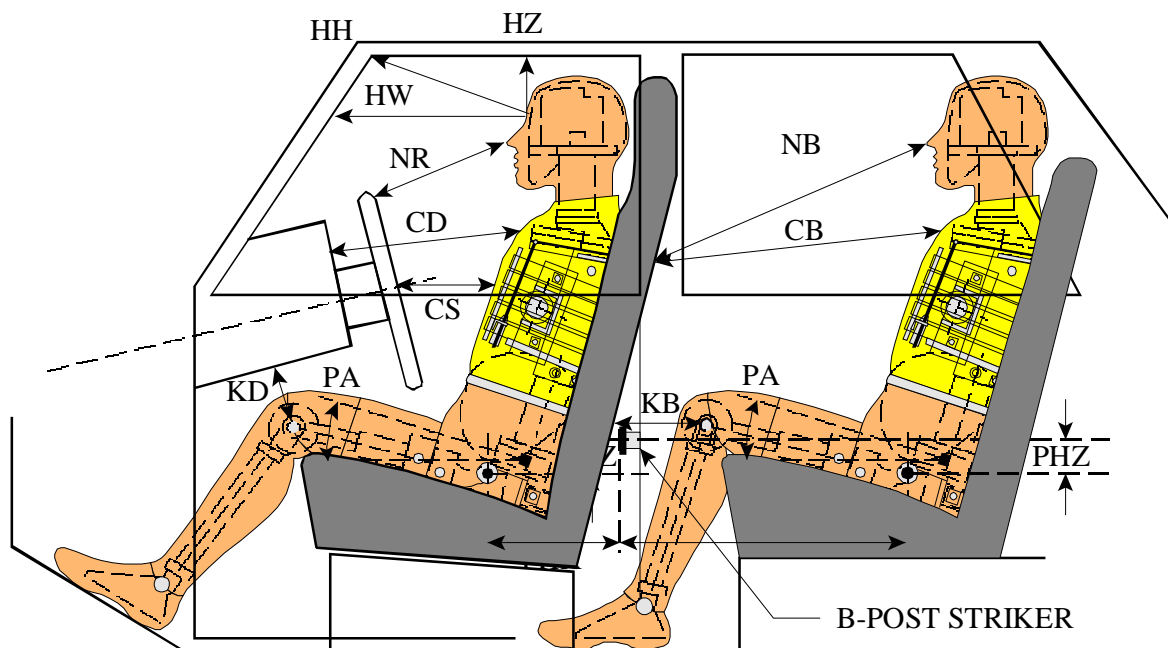
DATA SHEET 7

SID H3 LONGITUDINAL CLEARANCE DIMENSIONS

DRIVER ID# 015	LEFT REAR PASS. ID# 016
HH	388	N/A
HW	602	N/A
HZ	162	192
NR/NB	389	591
CD/CB	546	556
CS	260	N/A
KDL(KDA°)/KBL(KBA°)	162 / (27 °)	245 / (20 °)
KDR(KBA°)/KBR(KBA°)	152 / (27 °)	245 / (20 °)
PA°	24.8°	23.6°
PHX	215	219
PHZ	171	248

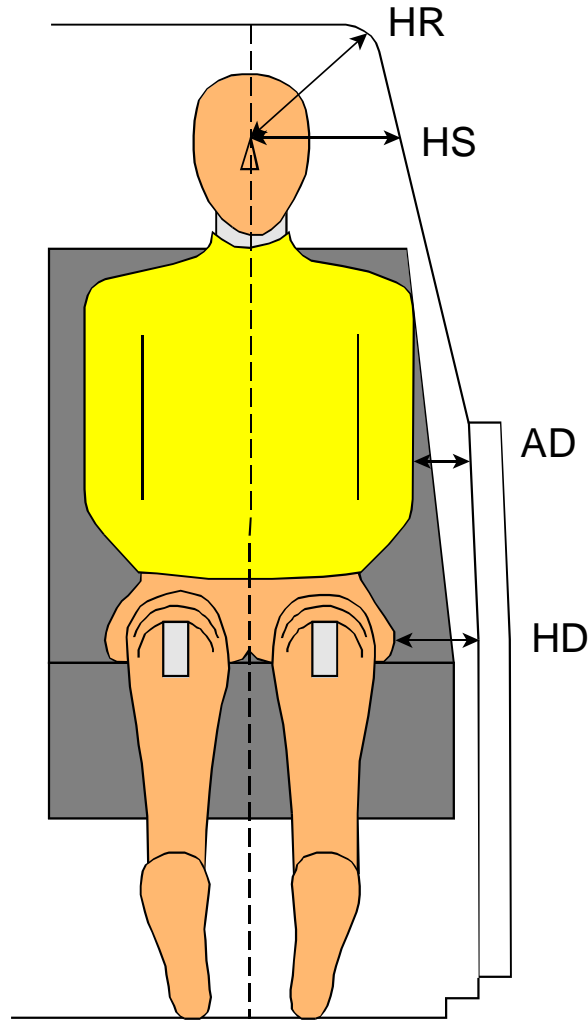
DATA SHEET 8

SID H3 LATERAL CLEARANCE DIMENSIONS

DRIVER ID # 015		LEFT REAR PASS. ID # 016	
HR	195		202	
HS	311		317	
AD*	LOWER: 116	UPPER: 113	LOWER: 103	UPPER: 95
HD	166		146

* Lower measurement is taken laterally at the center of the lower rib accelerometer height from the SID H3 arm segment to the closest part of the vehicle side.
 Upper measurement is taken laterally at the center of the upper rib accelerometer height from the SID H3 arm segment to the closest part of the vehicle side.

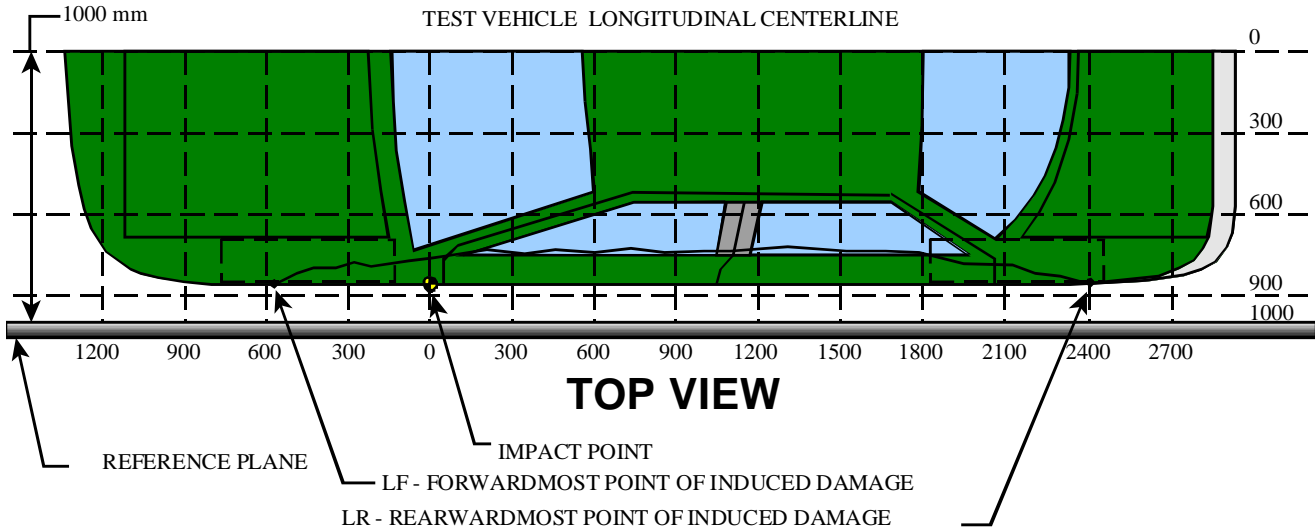
DATA SHEET 11

VEHICLE DAMAGE PROFILE DISTANCES

MEASUREMENT CONVENTIONS:
 Forward of the impact point (towards front of vehicle) is considered negative (—).
 Rearward of the impact point (toward rearend of vehicle) is considered positive (+).

DPD MEASUREMENTS	POST TEST (mm)	PRETEST (mm)	STATIC CRUSH (mm)
1 (LR = 2850 mm)	236	231	5
2 2160	181	137	44
3 1470	418	149	269
4 780	388	146	242
5 90	276	154	122
6 (LF = -600 mm)	157	154	3

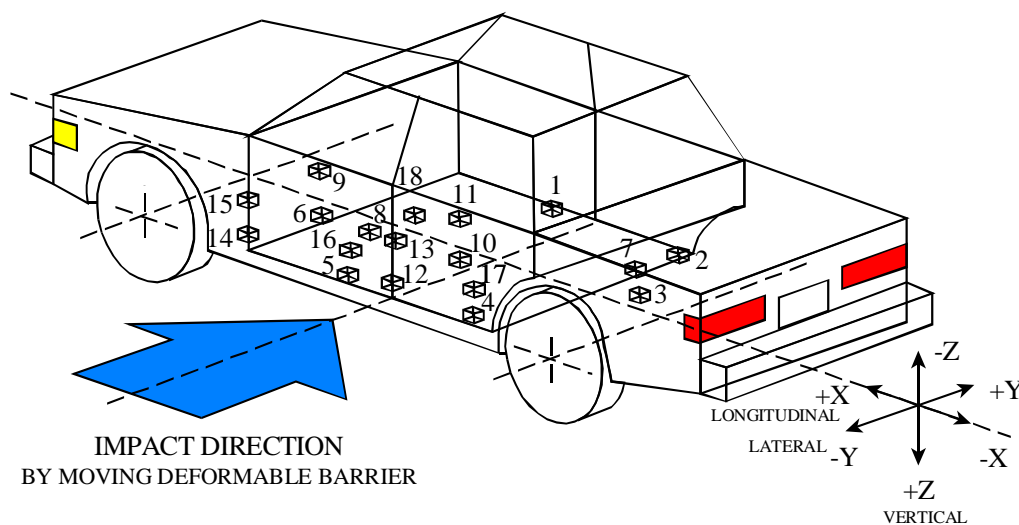
DATA SHEET 13

TEST VEHICLE ACCELEROMETER LOCATIONS AND DATA SUMMARY

| 1-Right Side Sill @ Front Seat | 10-Midrear of Left Rear Door |
| 2-Right Side Sill @ Rear Seat | 11-Left Rear Door Upper Centerline |
| 3-Rear Floorpan Above Axle | 12-Left Lower B-Pillar |
| 4-Left Side Sill @ Rear Seat | 13-Left Middle B-Pillar |
| 5-Left Side Sill @ Front Seat | 14-Left Lower A-Pillar |
| 6-Left Front Door on Centerline | 15-Left Middle A-Pillar |
| 7-Right Rear Occupant Compartment | 16-Front Seat Track |
| 8-Midrear of Left Front Door | 17-Rear Seat Track |
| 9-Left Front Door Upper Centerline | 18-Vehicle CG |

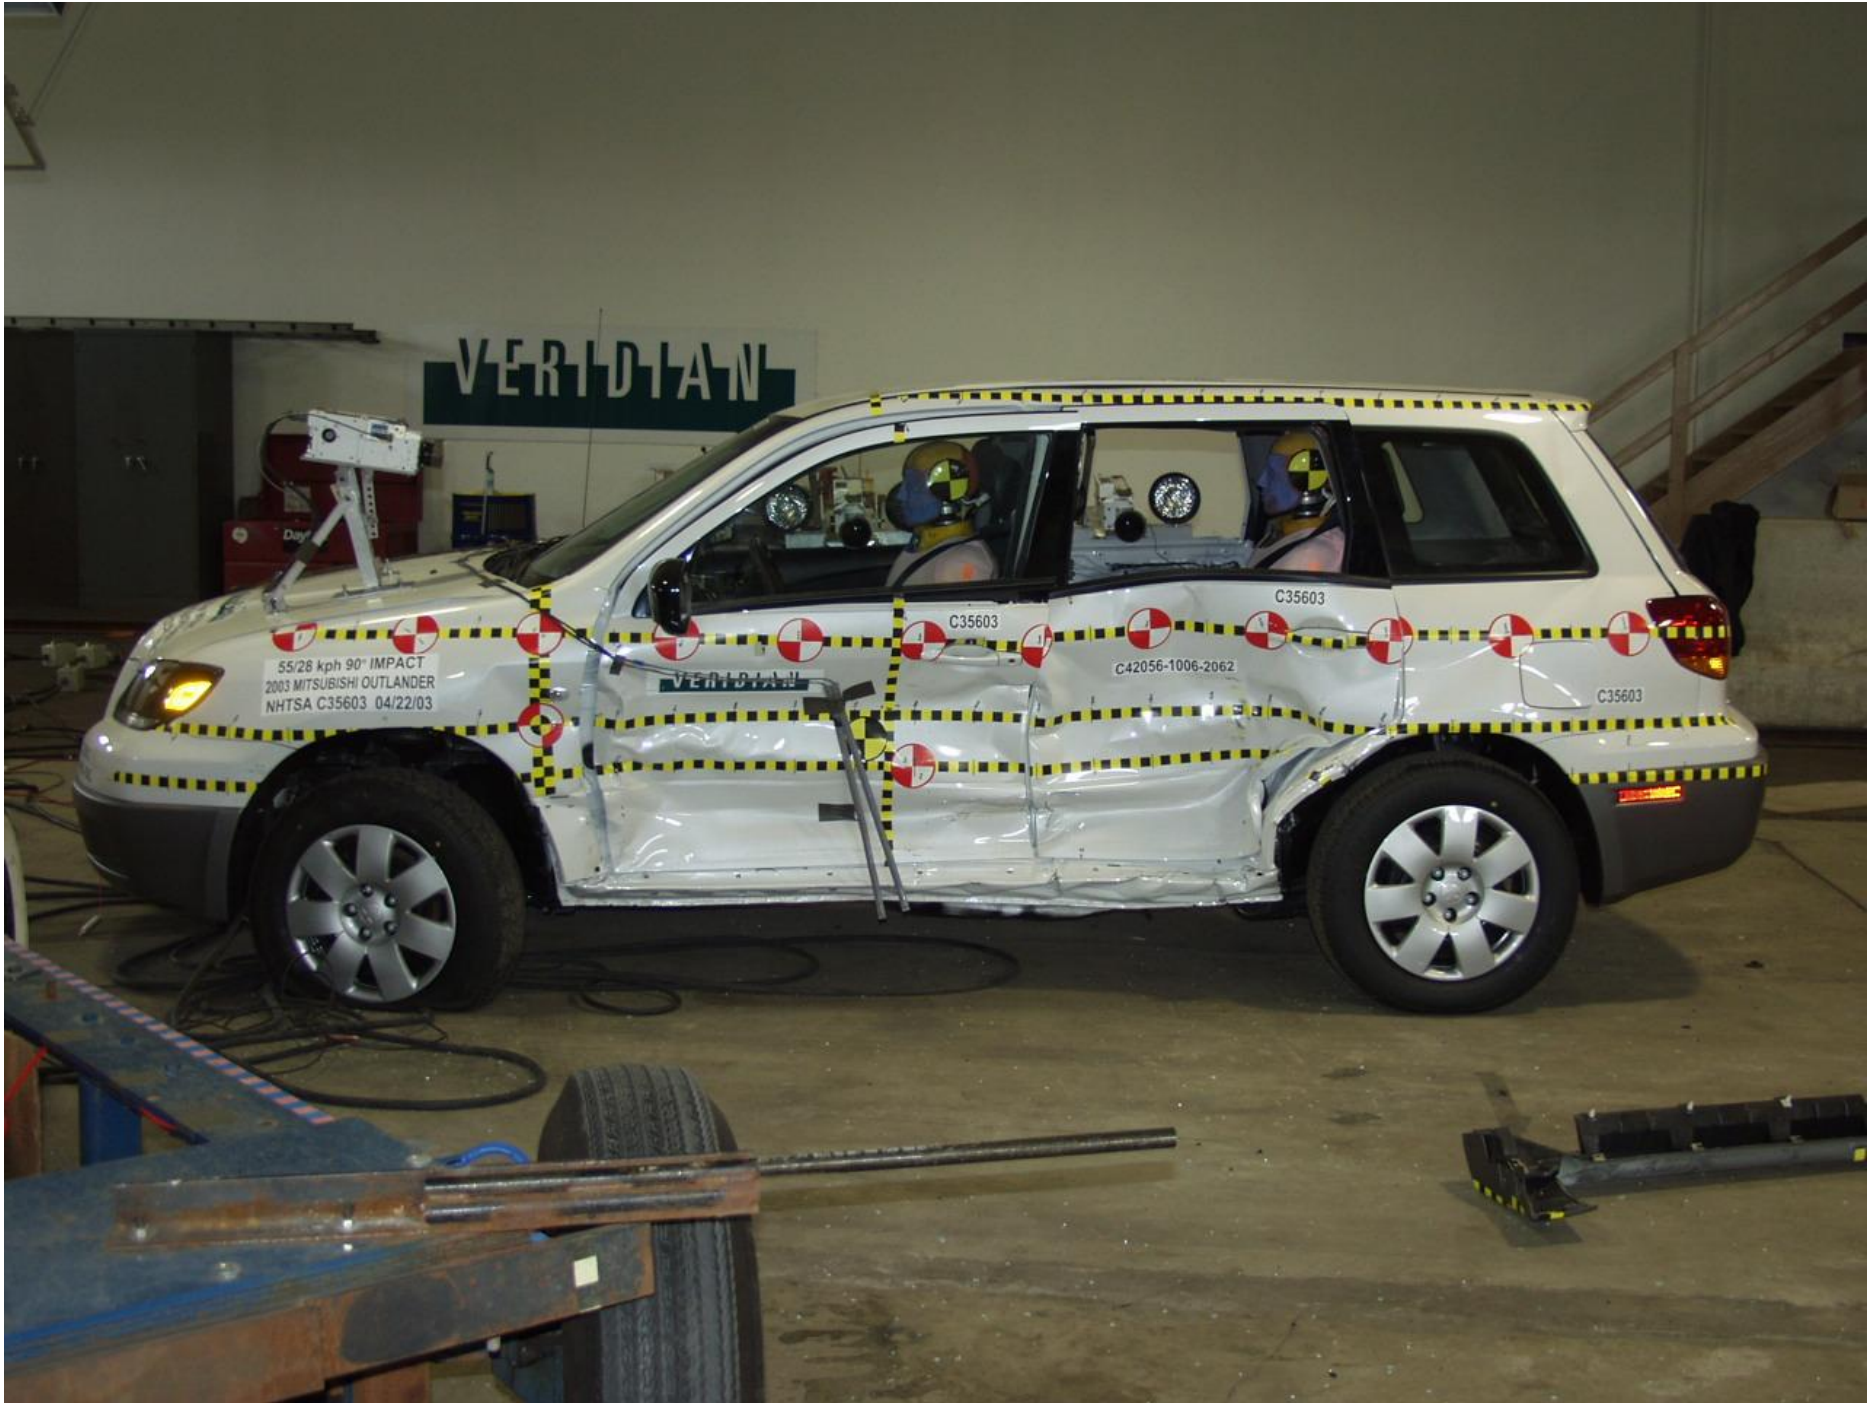
Figure A-6 POST-TEST IMPACTED SIDE VIEW OF TEST VEHICLE

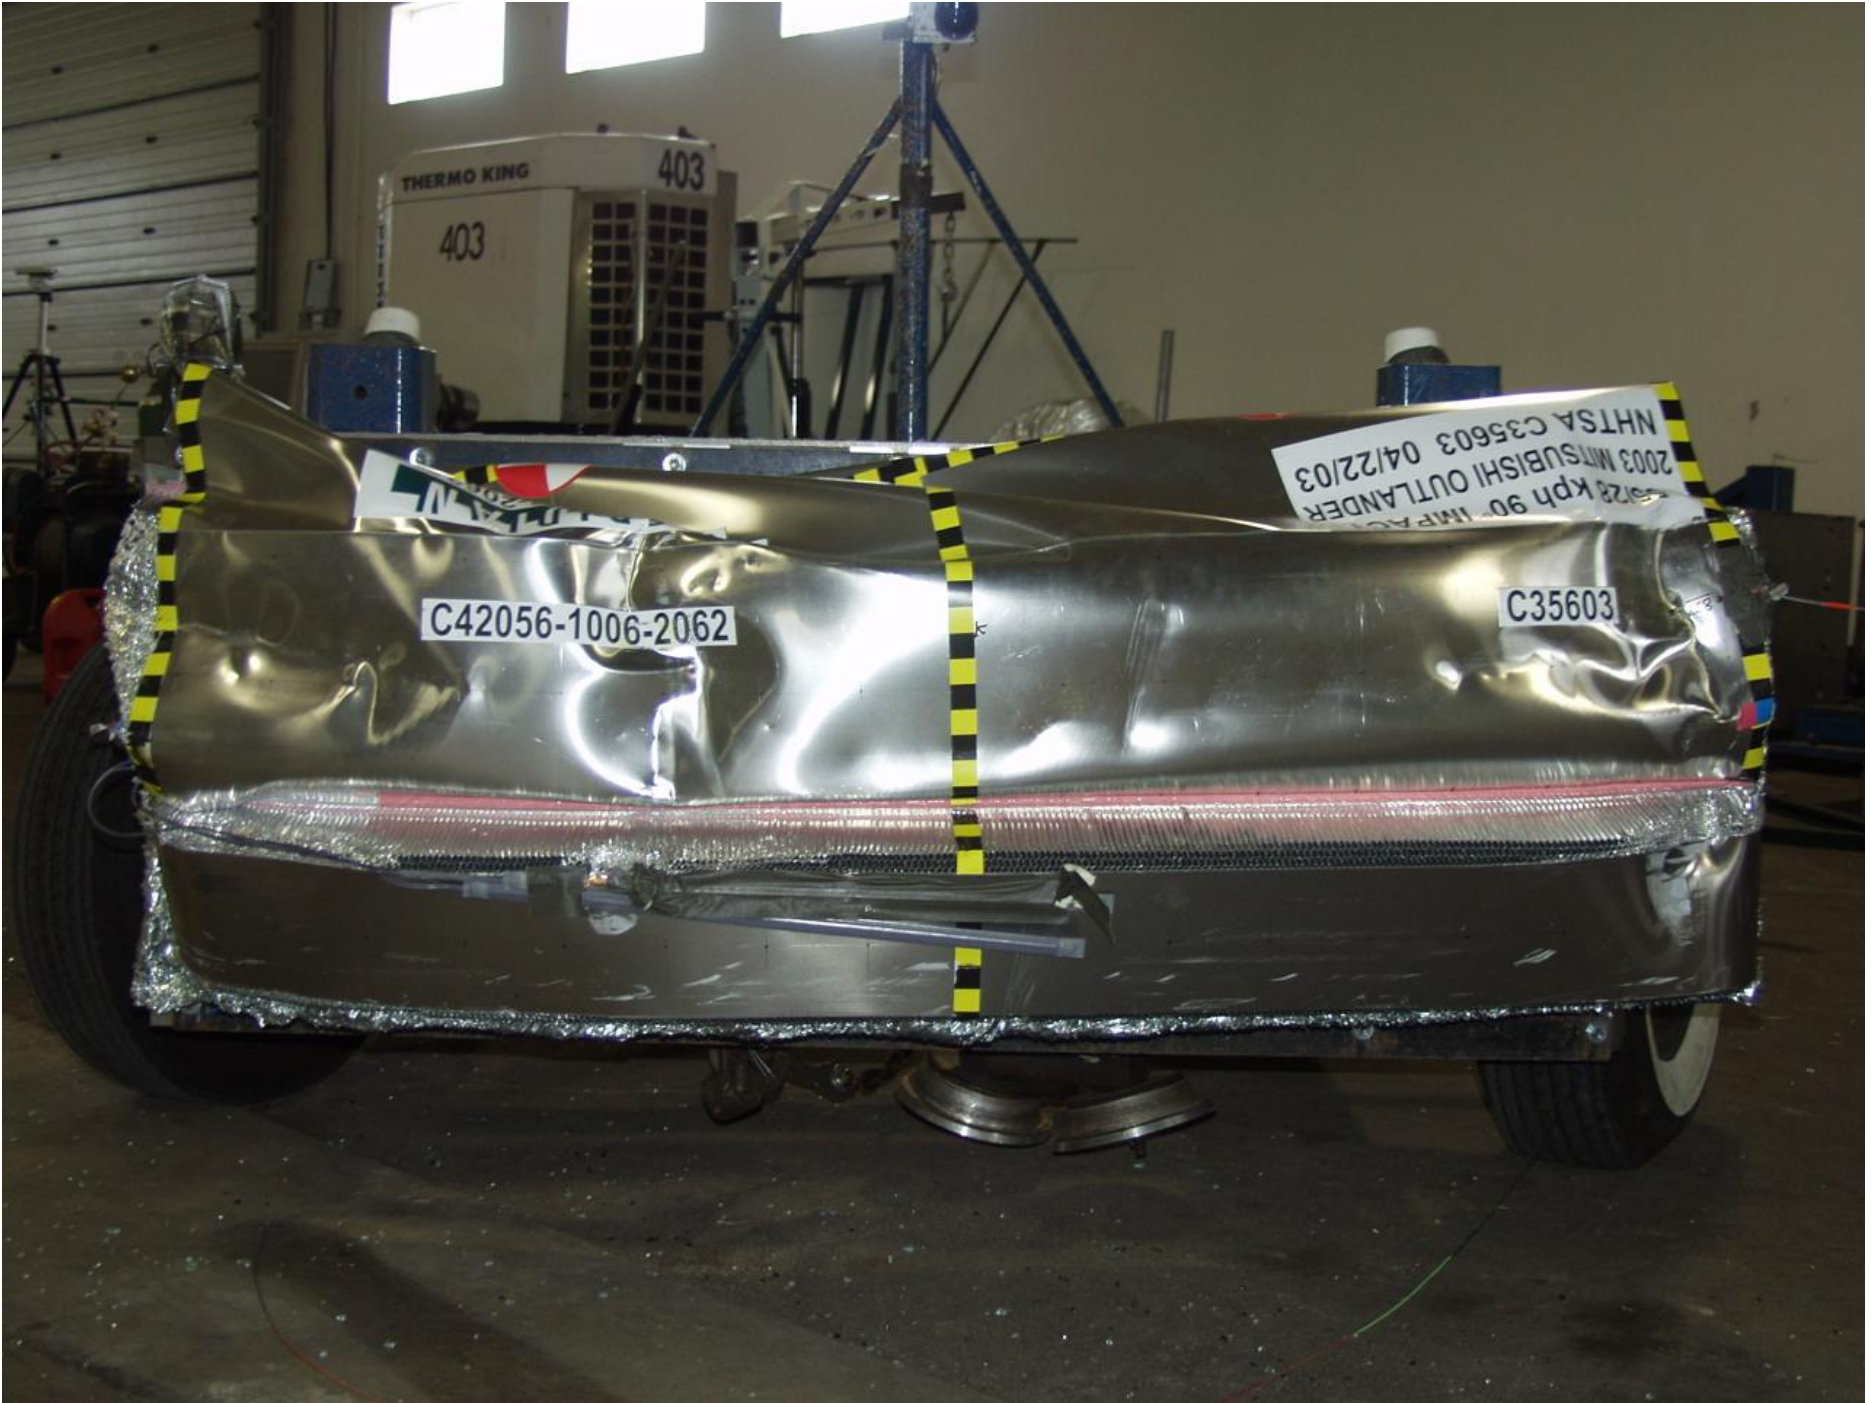
Figure A-16 POST-TEST FRONTAL VIEW OF IMPACTOR FACE

1. Row A at Center of Bumper Level	=	<u>209</u>	millimeters
2. Row B at Top of Bumper Level	=	<u>168</u>	millimeters
3. Row C at Mid Level	=	<u>139</u>	millimeters
4. Row D at Top of Stack Level	=	<u>179</u>	millimeters

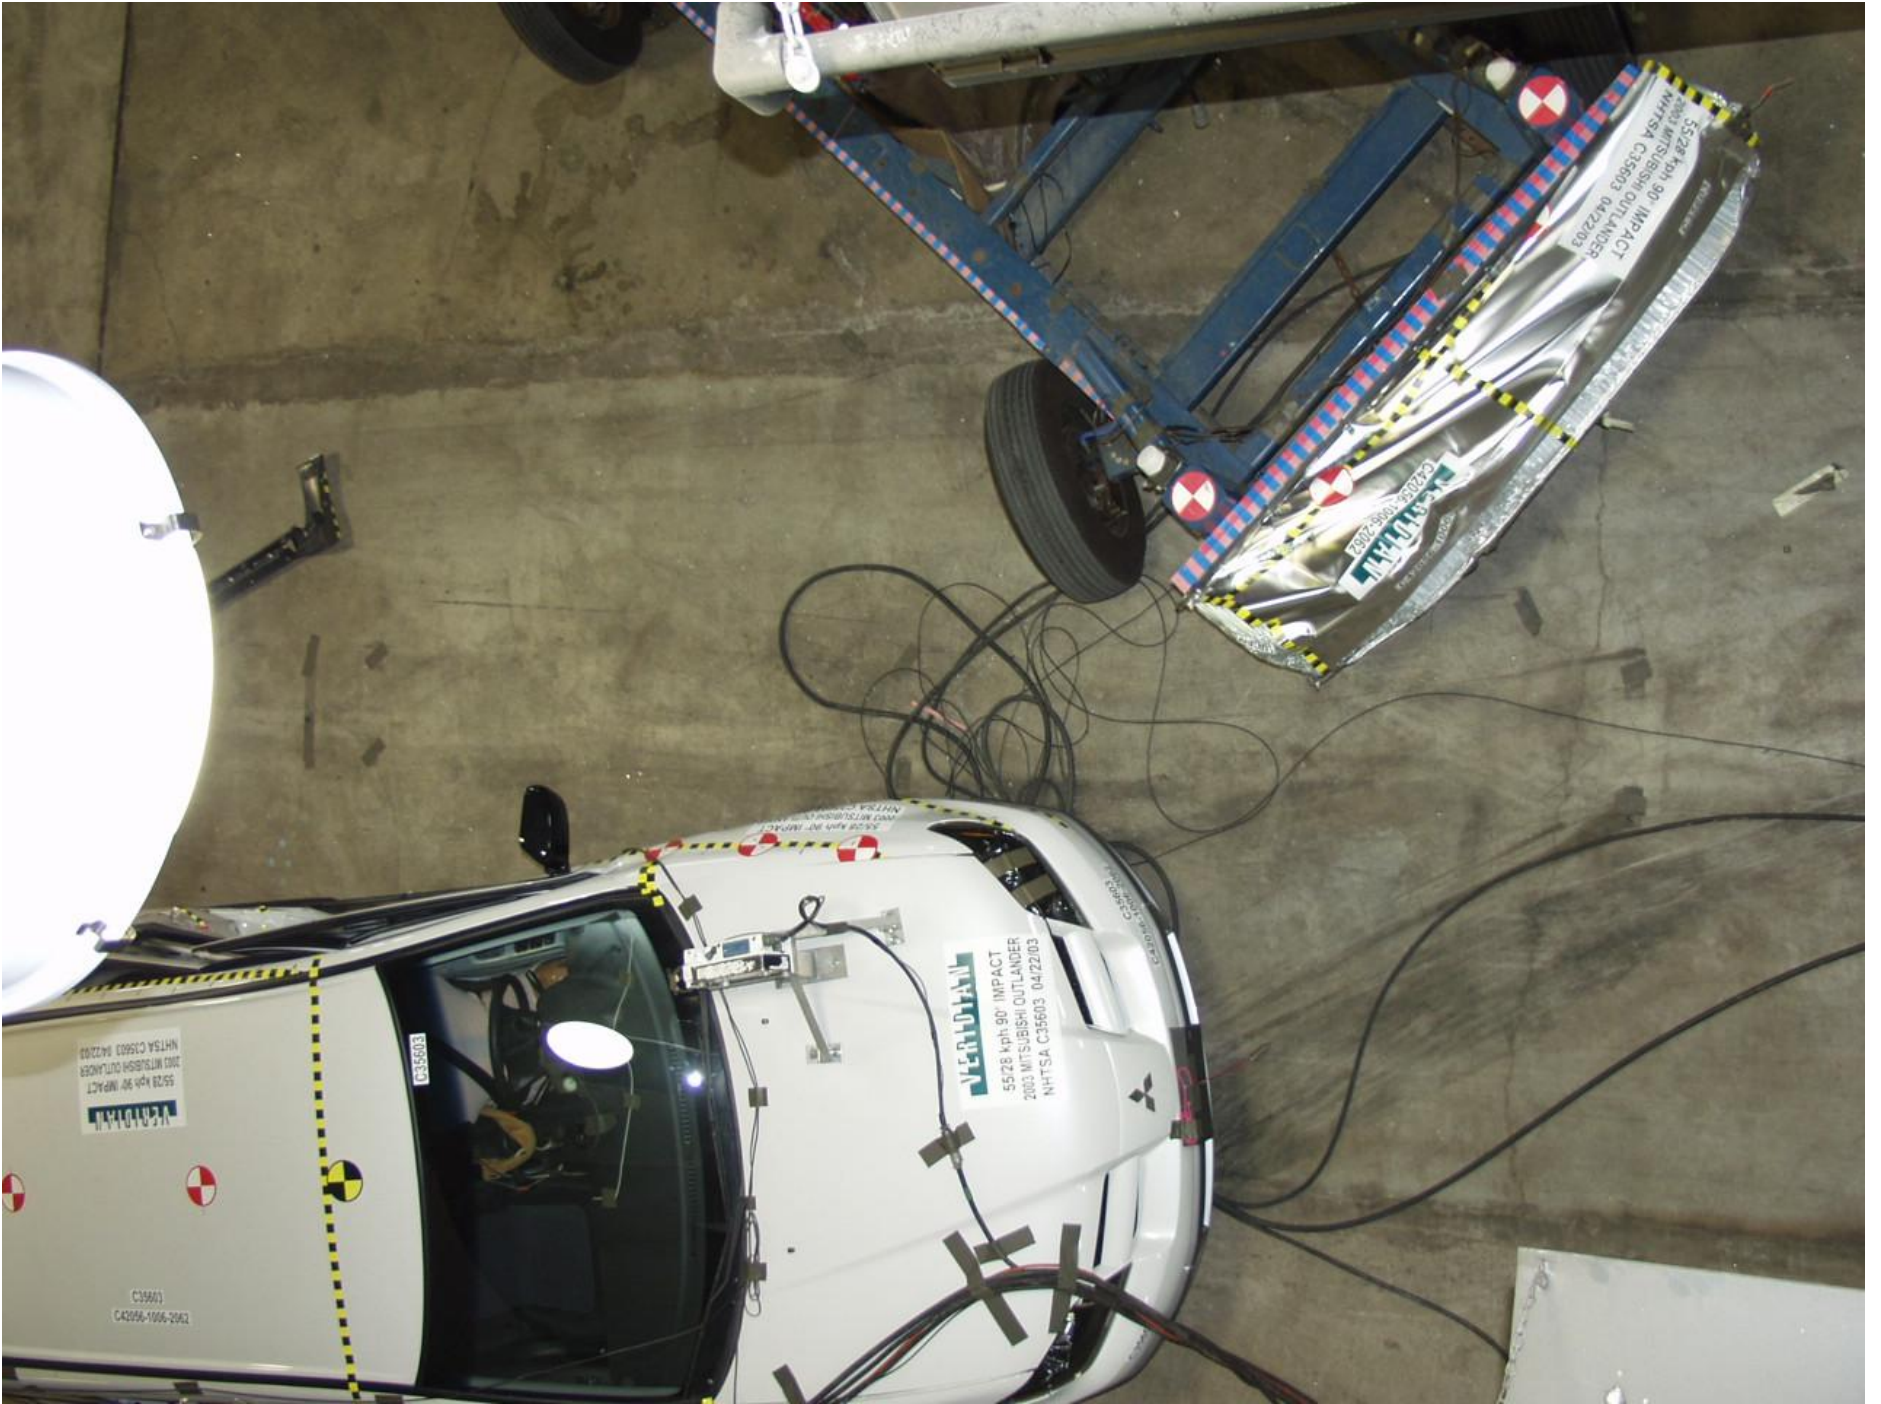
Figure A-24 POST-TEST OVERHEAD VIEW OF MDB AND VEHICLE
