REPORT NUMBER: 8717-01

**NEW CAR ASSESSMENT PROGRAM  
SIDE IMPACT TEST**

BAYERISCHE MOTORENWERKE AG  
2003 BMW Z4  
2-DOOR CONVERTIBLE

**FINAL REPORT**

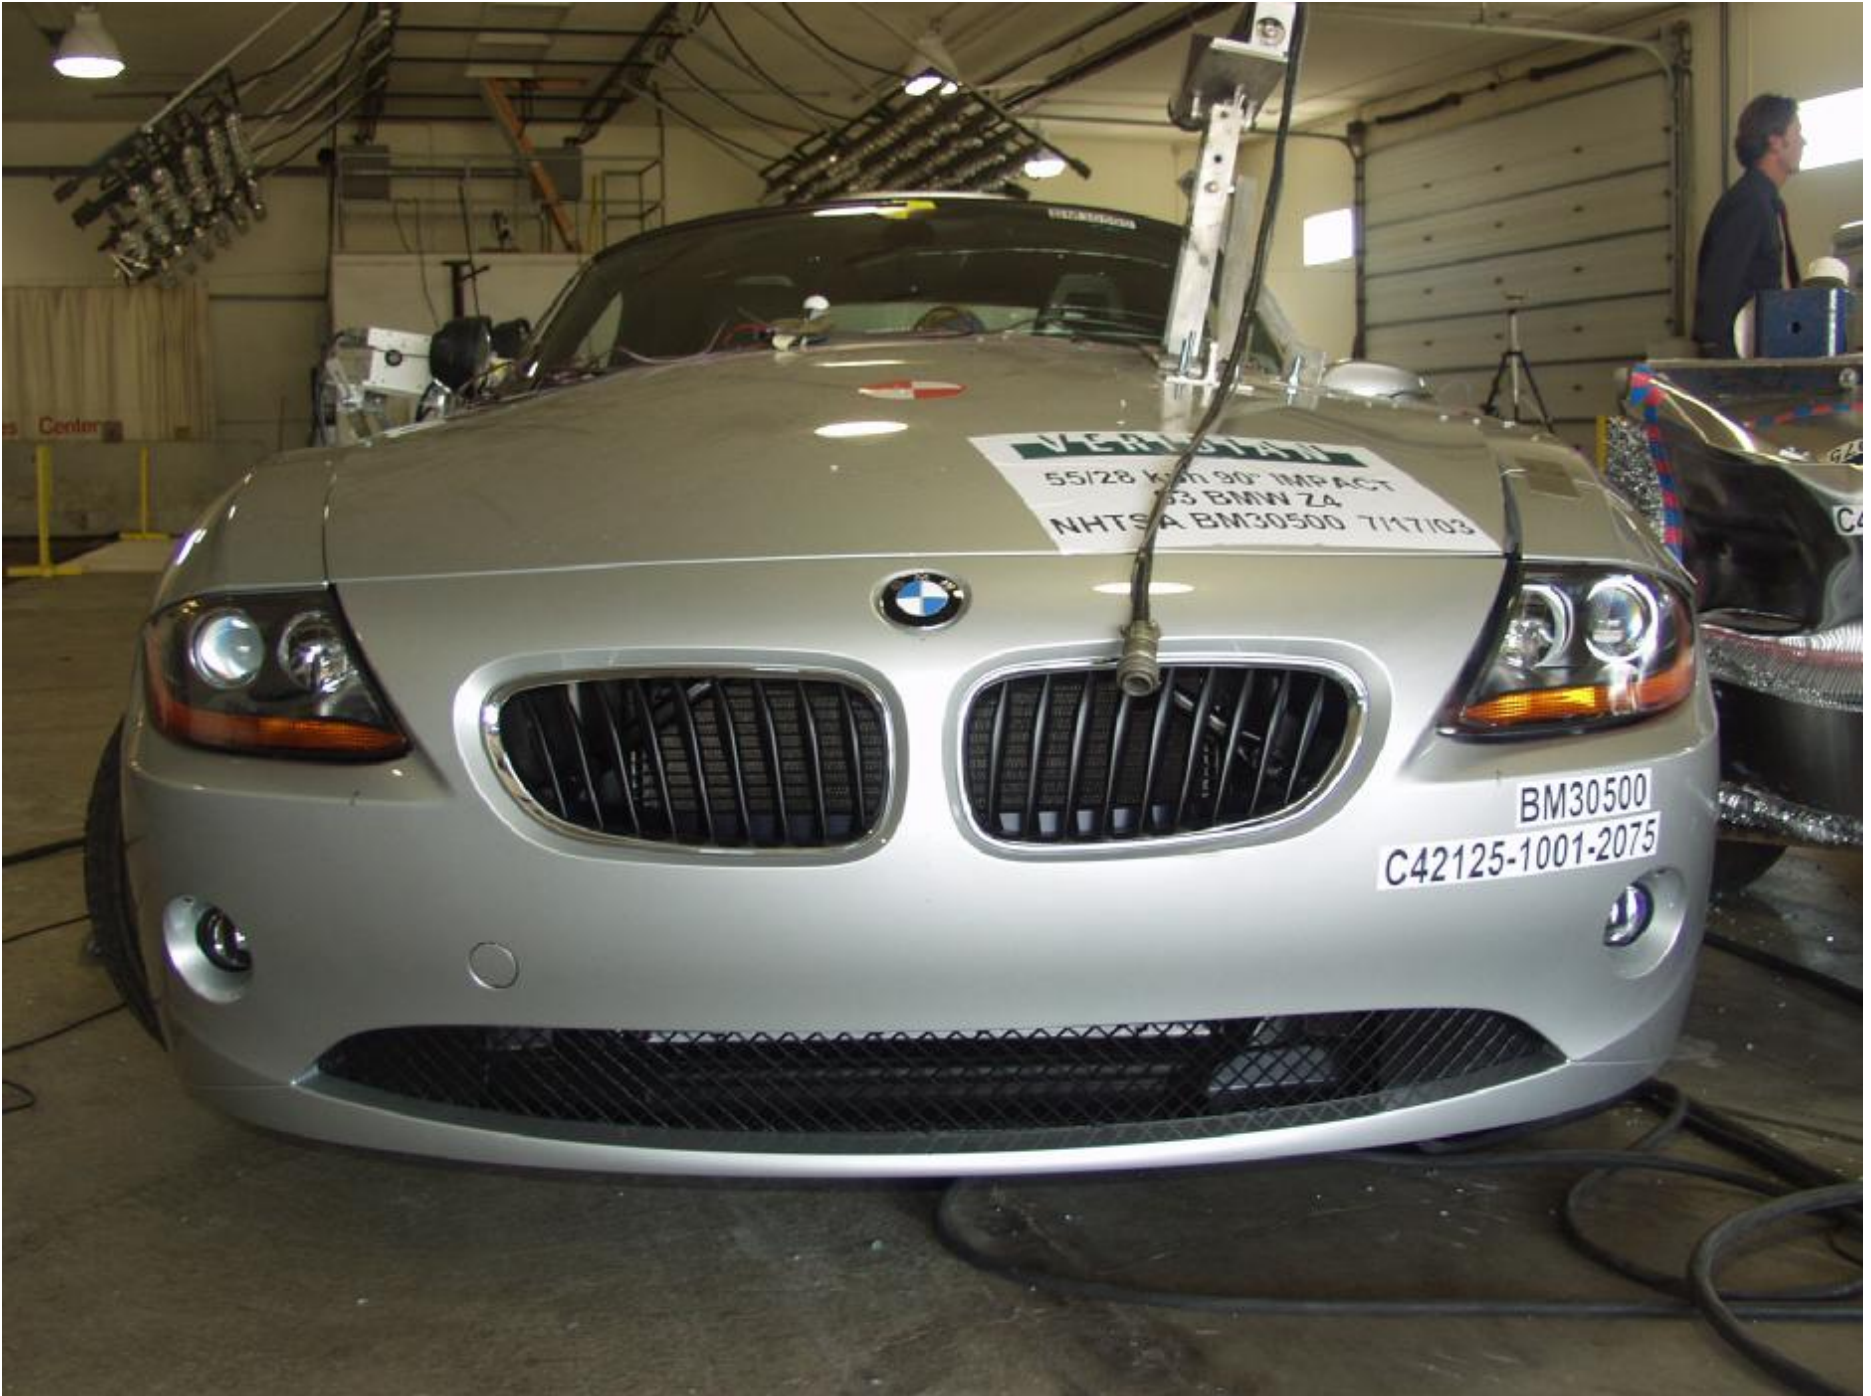
Figure A-2 POST-TEST FRONTAL VIEW OF TEST VEHICLE

CRITICAL AREAS OF PERFORMANCE	
Pillar Performance	No visible tears or separations
Sill Separation	None
Windshield Damage	Windshield cracked at the driver side lower edge
Window Damage	Left door window shattered at impact
Other Notable Effects	None

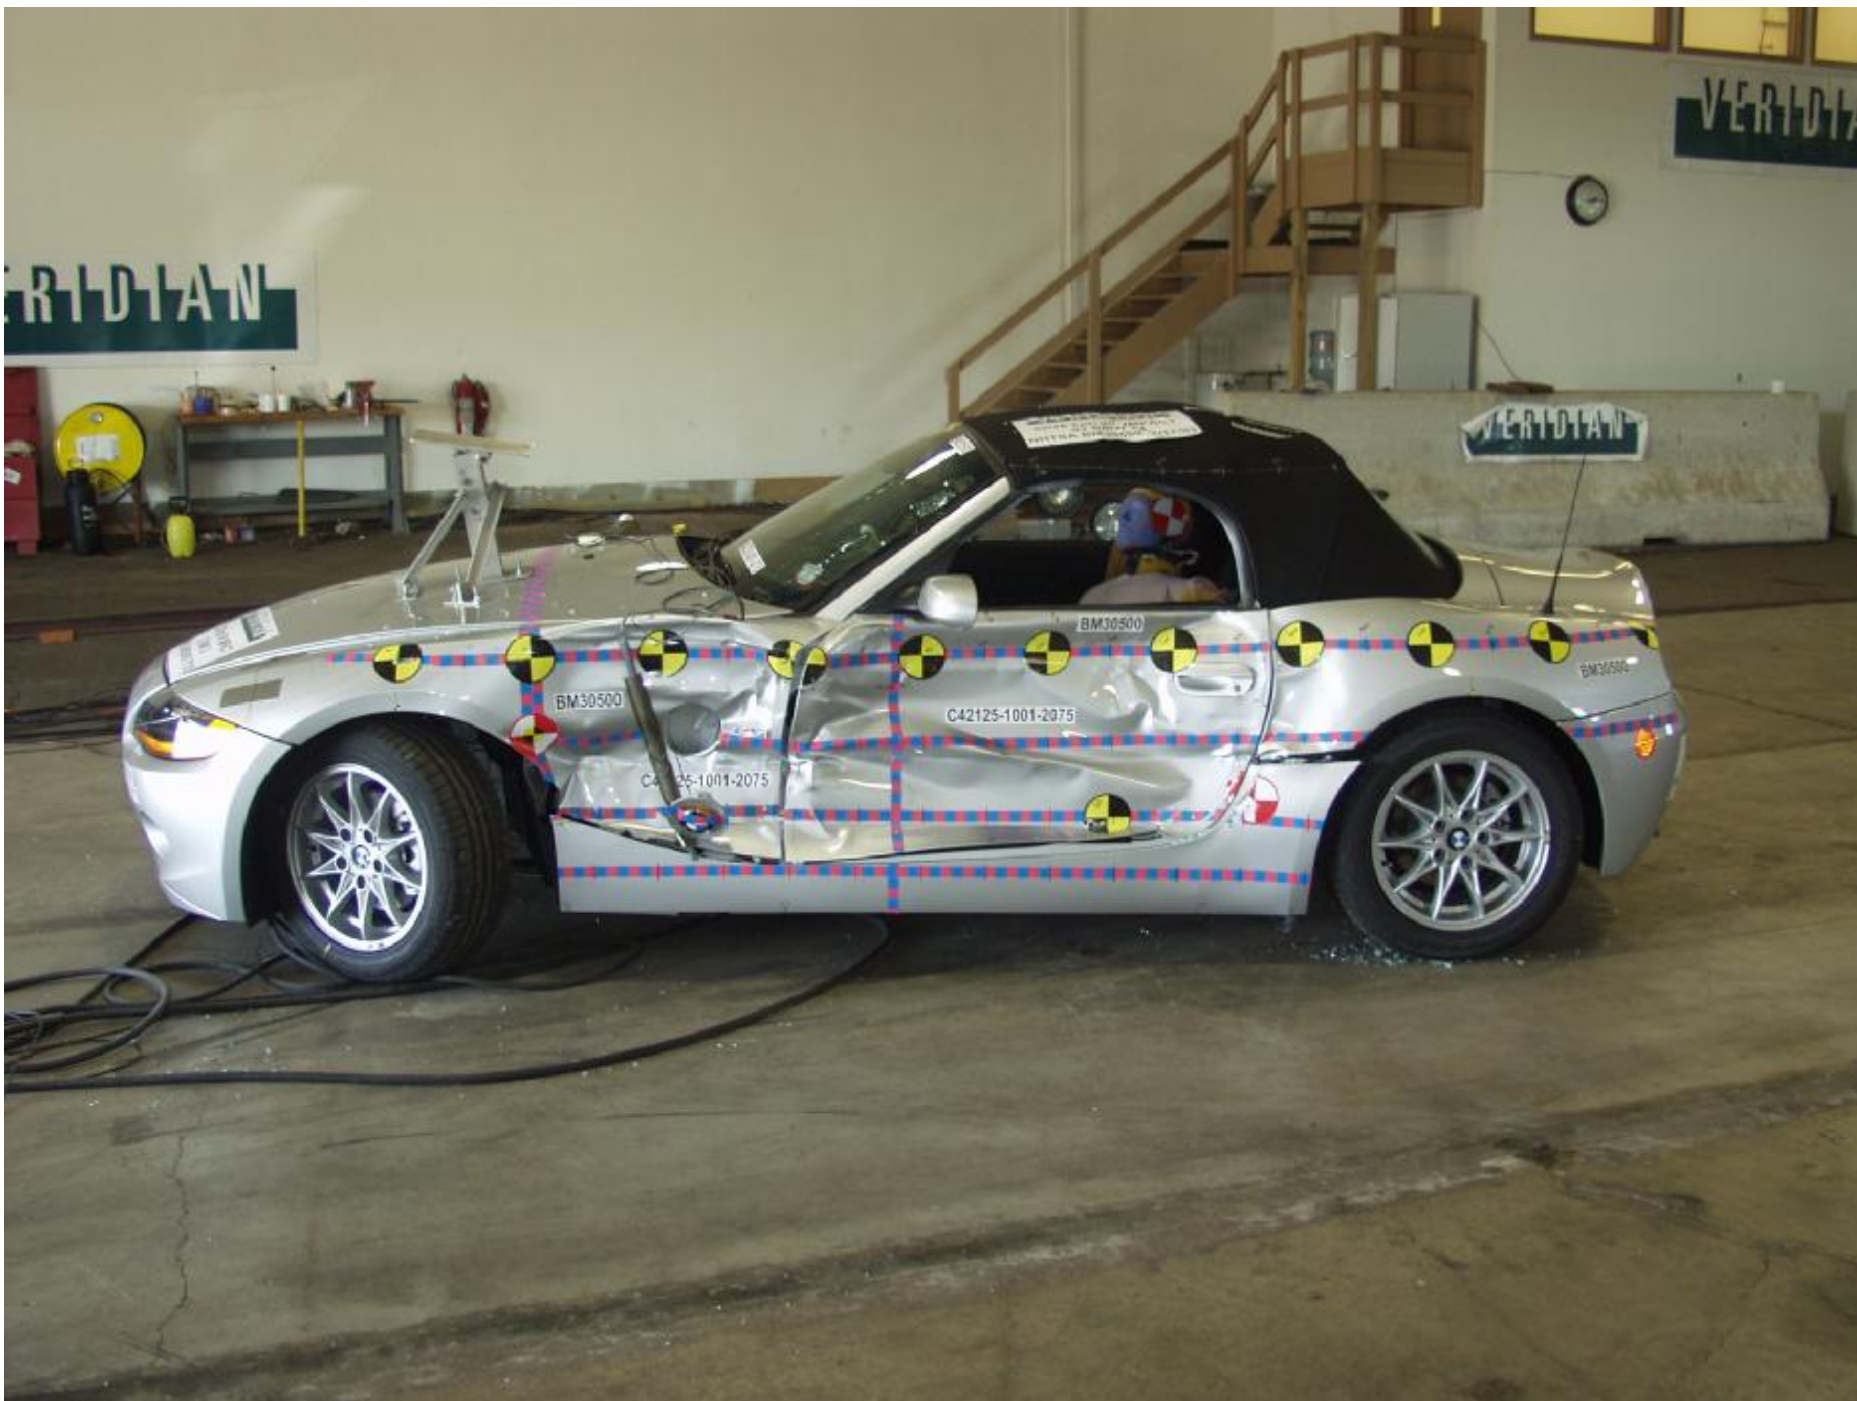
Figure A-6 POST-TEST IMPACTED SIDE VIEW OF TEST VEHICLE

1. LEVEL 1 ( 234 mm above ground) = 40 millimeters

2. LEVEL 2 ( 366 mm above ground) = 139 millimeters

3. LEVEL 3 ( 551 mm above ground) = 197 millimeters

4. LEVEL 4 ( 760 mm above ground) = 165 millimeters

5. LEVEL 5 ( 1141 mm above ground) = 32 millimeters

Maximum Post-Test Intrusion = 197 millimeters

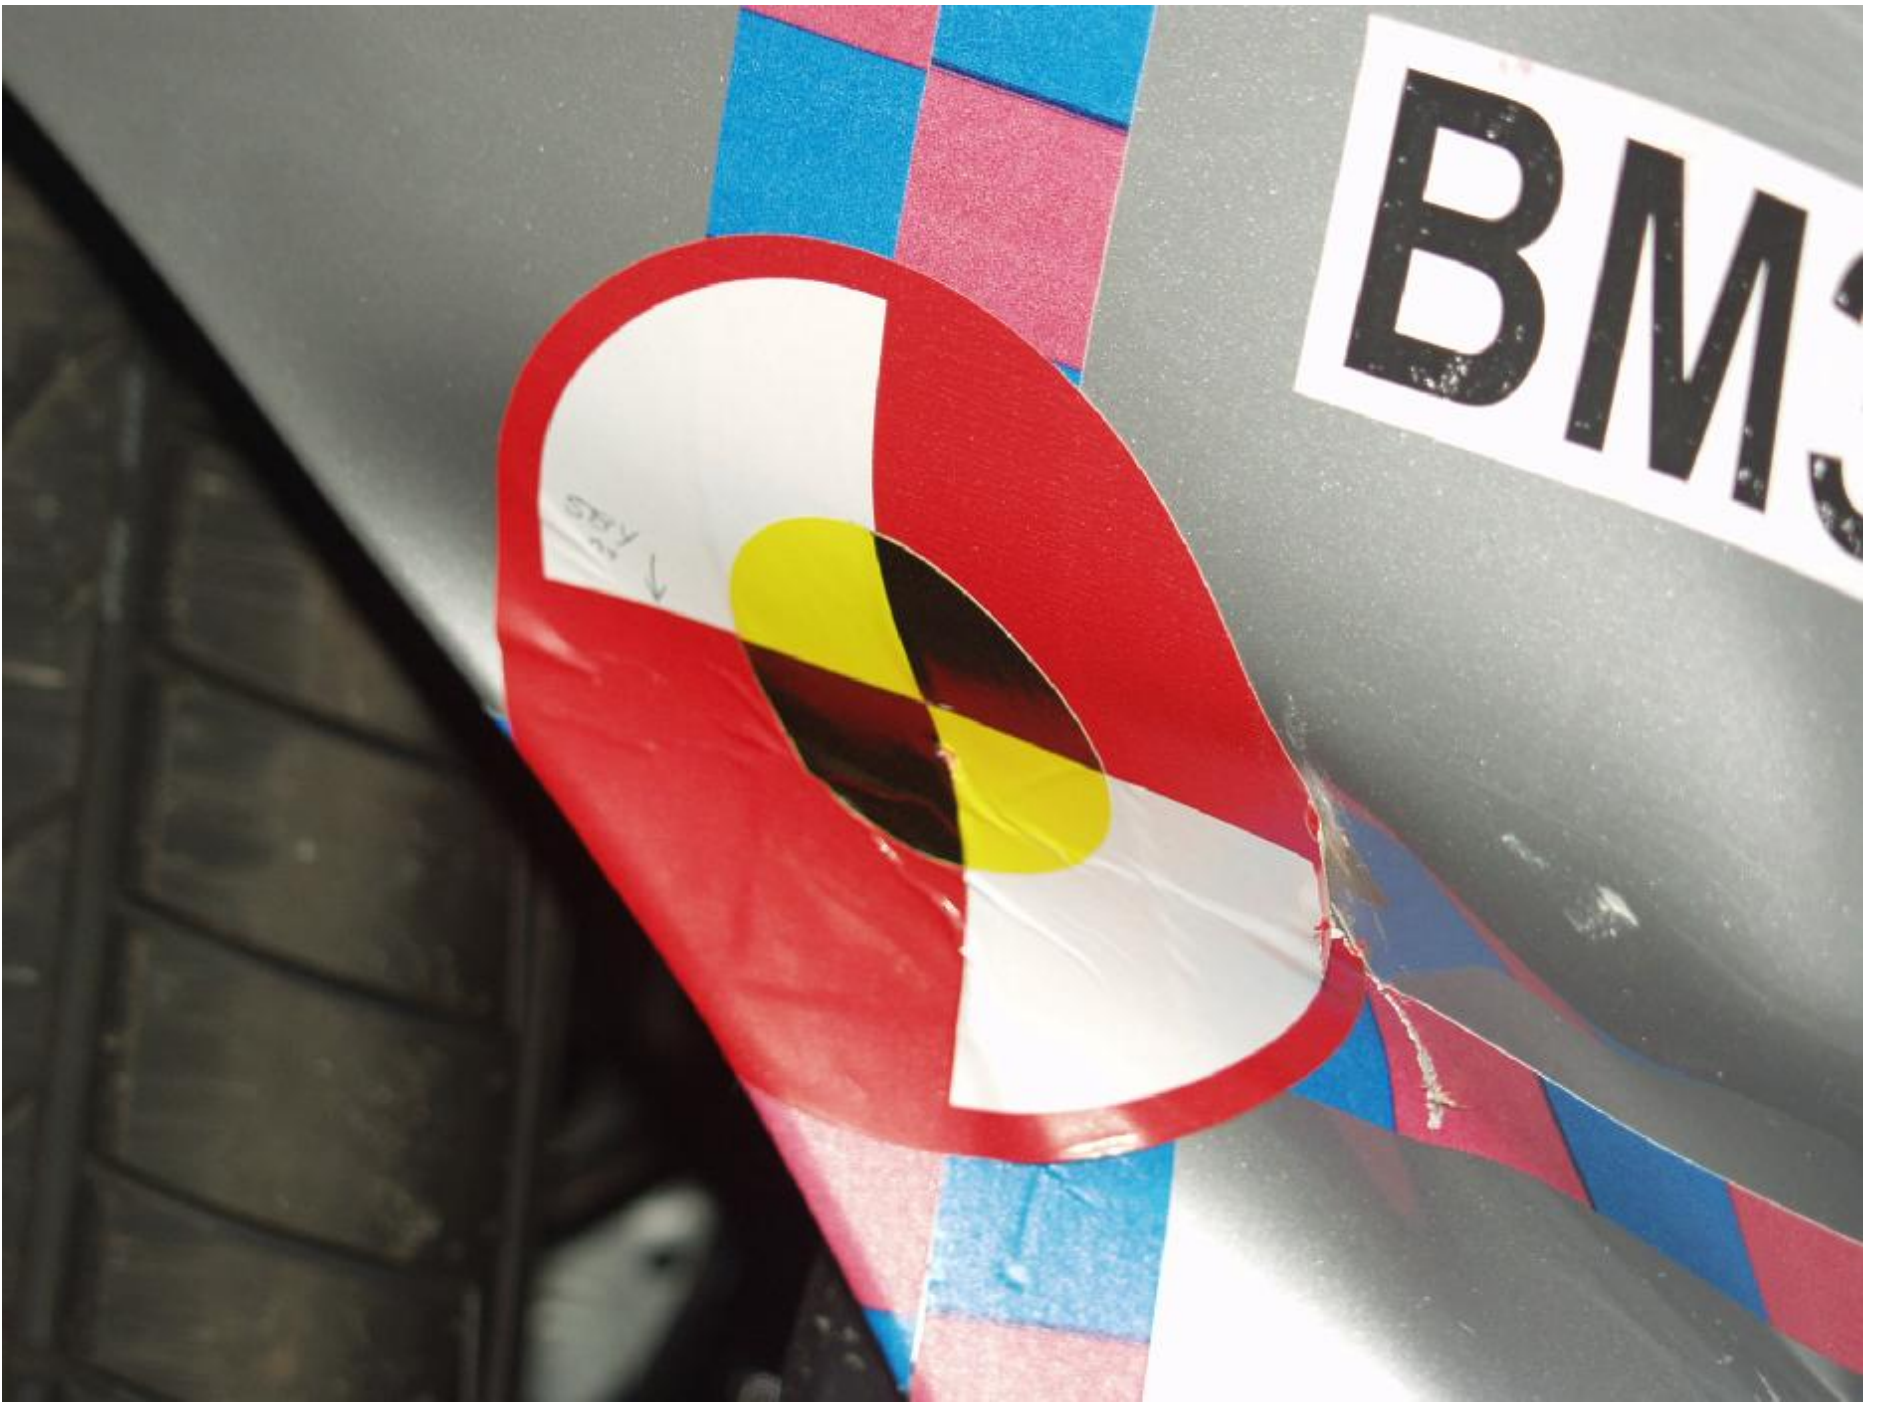
Figure A-39 POST-TEST CLOSE-UP VIEW OF IMPACT POINT TARGET

Actual Impact Point is 0 mm rearward of nominal impact ref. line (Lateral)

Actual Impact Point is 7 mm below nominal impact point (Vertical)

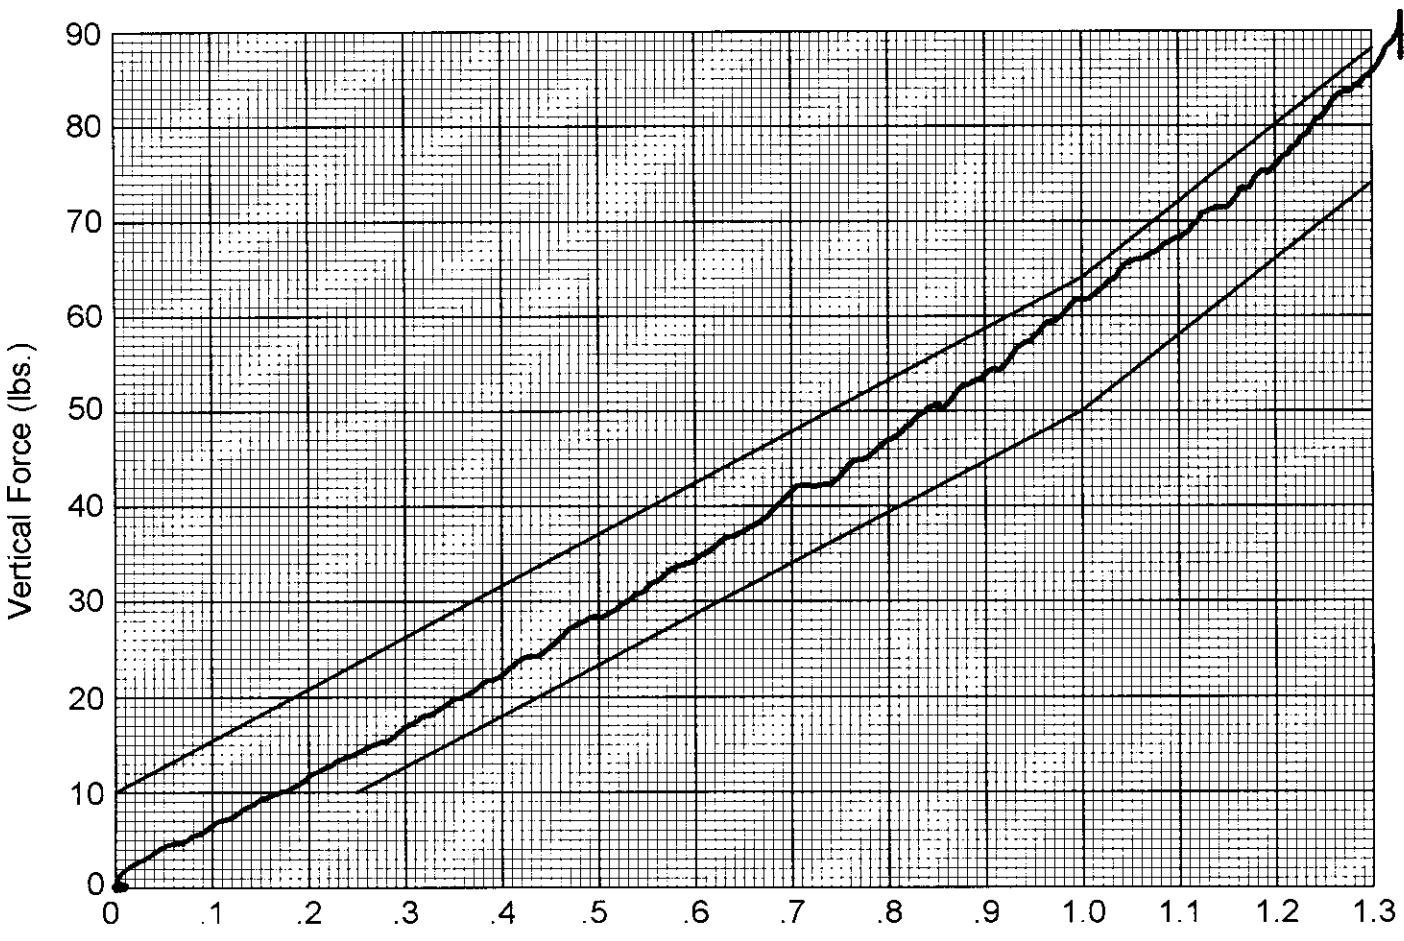
Hybrid II  
Abdomen Static Press

TEST PARAMETER	SPECIFICATION	TEST RESULTS
TEMPERATURE (°C)	18.9 - 25.5	21.1
RELATIVE HUMIDITY (%)	10 - 70	29
FORCE @ 13 mm (N)	104 - 162	125
FORCE @ 19 mm (N)	163 - 221	191
FORCE @ 25 mm (N)	222 - 280	276
FORCE @ 33 mm (N)	325 - 391	347

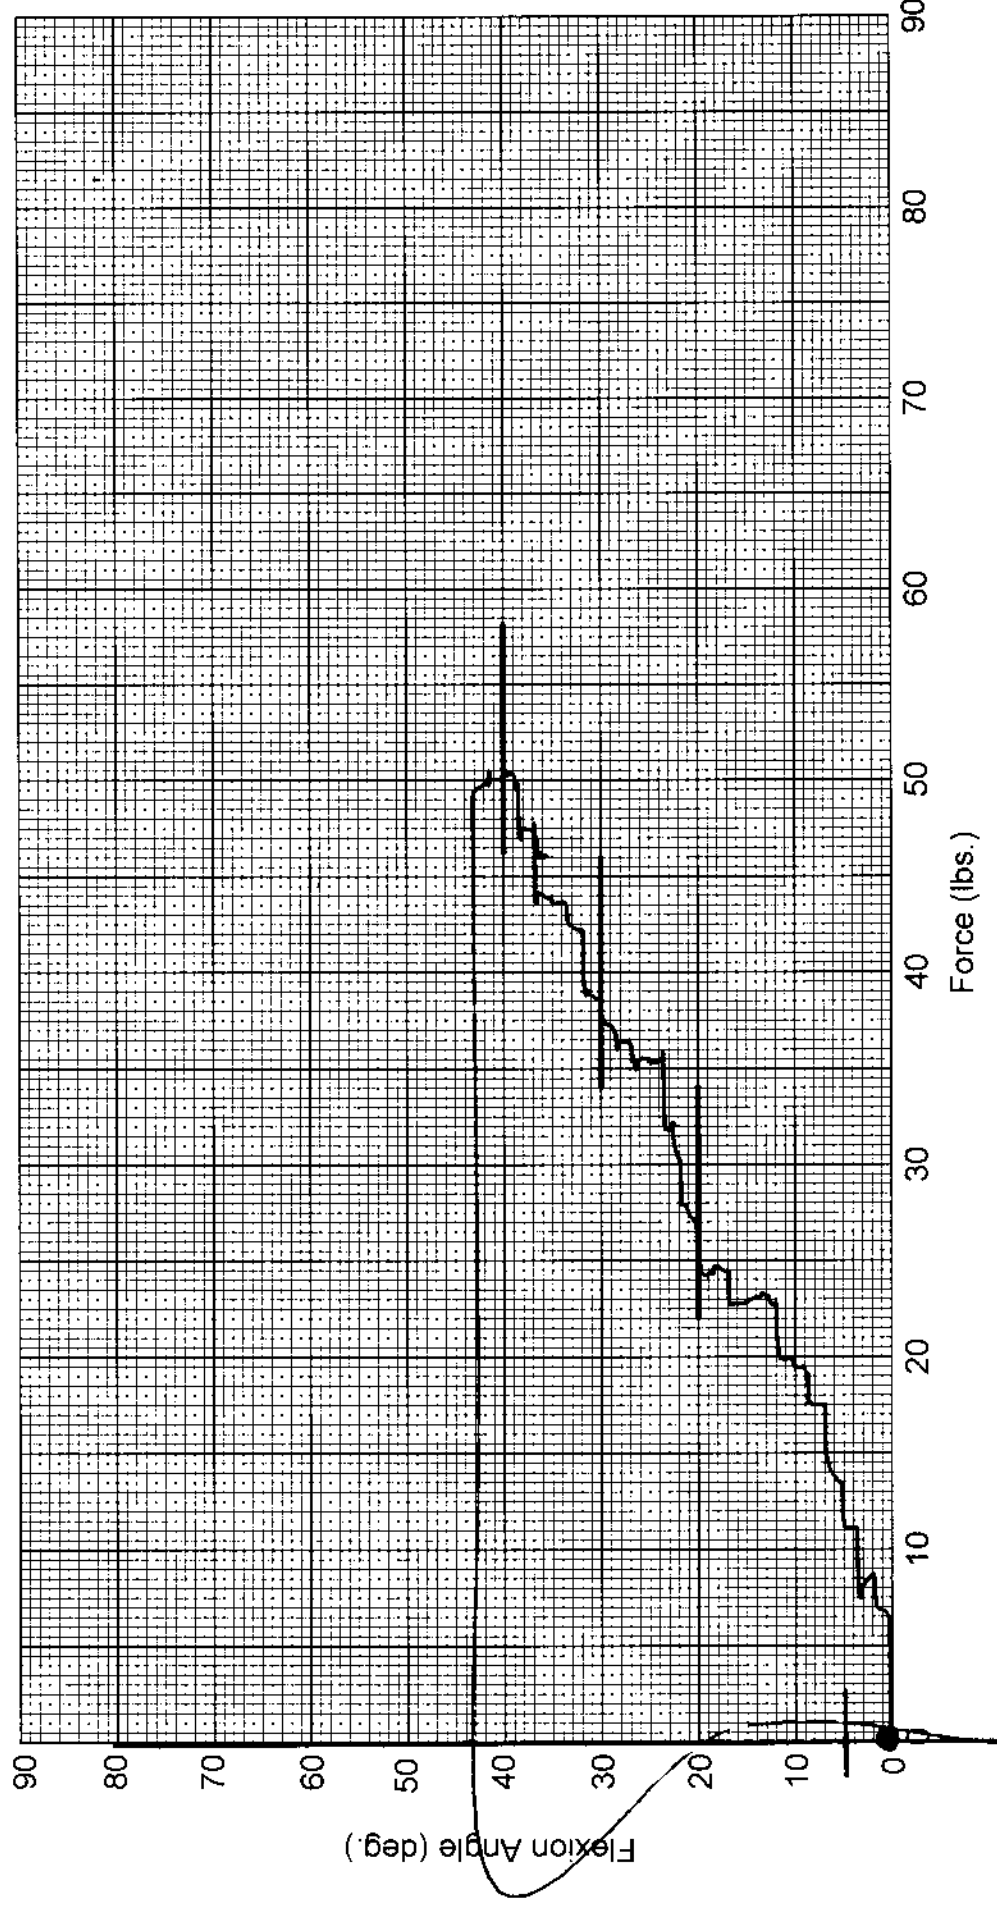
Hybrid II Lumbar Spine Flexion Test

TEST PARAMETER	SPECIFICATION	TEST RESULTS
TEMPERATURE (°C)	18.9 - 25.5	21.1
RELATIVE HUMIDITY (%)	10 - 70	29
FORCE @ 0° (N)	0 - 26.7	26
FORCE @ 20° (N)	97.8 - 151.2	111
FORCE @ 30° (N)	151.2 - 204.6	138
FORCE @ 40° (N)	204.6 - 258	222
RETURN ANGLE	12° max.	5

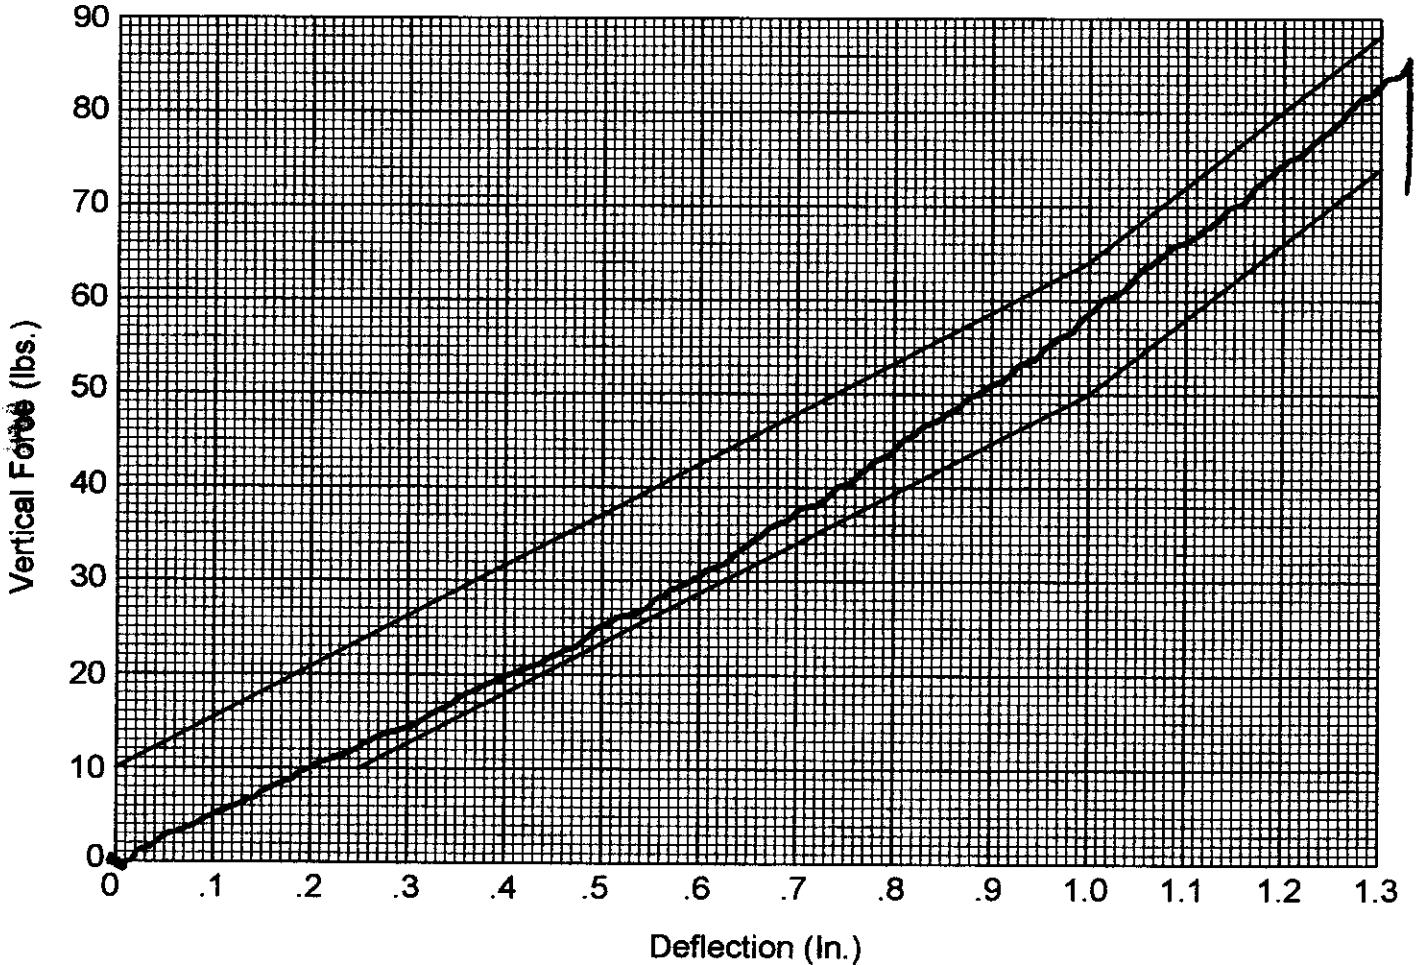
**Hybrid II  
Abdomen Static Press**

TEST PARAMETER	SPECIFICATION	TEST RESULTS
TEMPERATURE (°C)	18.9 - 25.5	21.1
RELATIVE HUMIDITY (%)	10 - 70	48
FORCE @ 13 mm (N)	104 - 162	111.2
FORCE @ 19 mm (N)	163 - 221	182.4
FORCE @ 25 mm (N)	222 - 280	262.4
FORCE @ 33 mm (N)	325 - 391	351.4

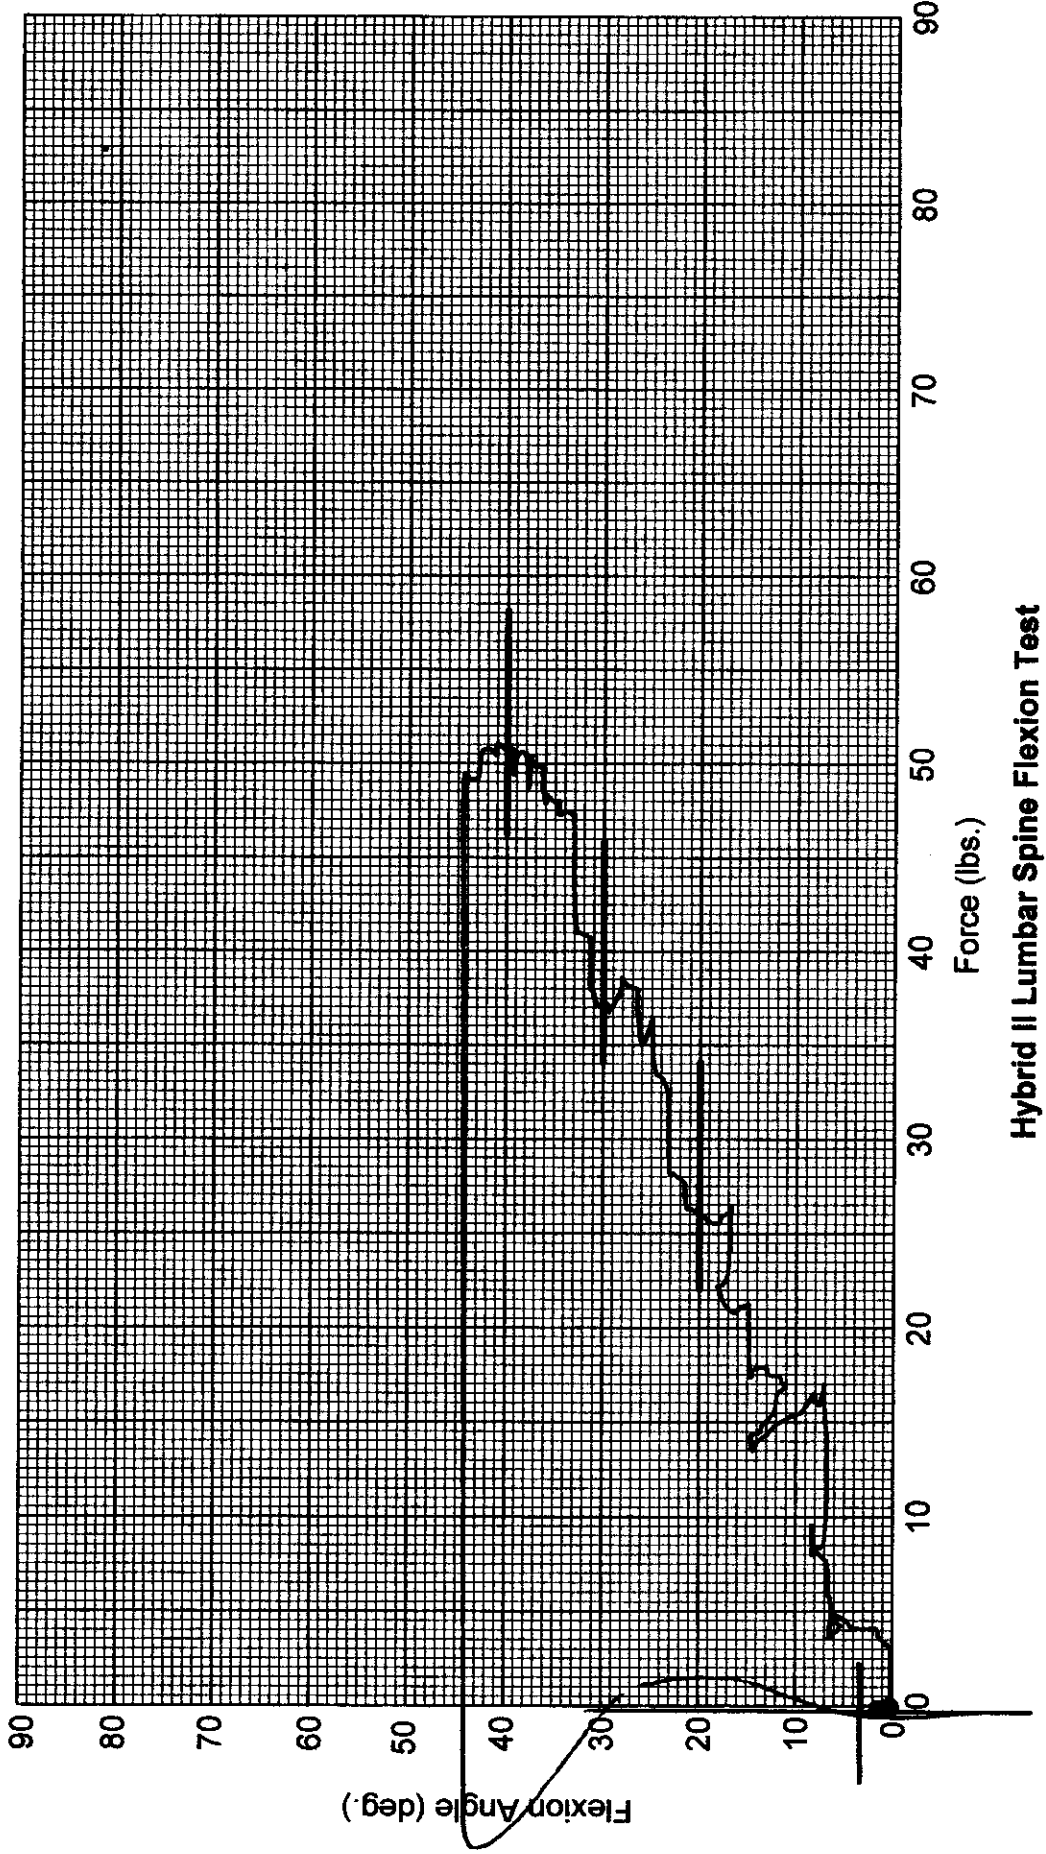
Hybrid II Lumbar Spine Flexion Test

TEST PARAMETER	SPECIFICATION	TEST RESULTS
TEMPERATURE (°C)	18.9 - 25.5	21.1
RELATIVE HUMIDITY (%)	10 - 70	48
FORCE @ 0° (N)	0 - 26.7	17.8
FORCE @ 20° (N)	97.8 - 151.2	115.7
FORCE @ 30° (N)	151.2 - 204.6	164.6
FORCE @ 40° (N)	204.6 - 258	226.9
RETURN ANGLE	12° max.	4
