Report Number: 214-TRC-03-011

Safety Compliance Testing For FMVSS 214

Side Impact Protection

2004 Mitsubishi Endeavor SUV

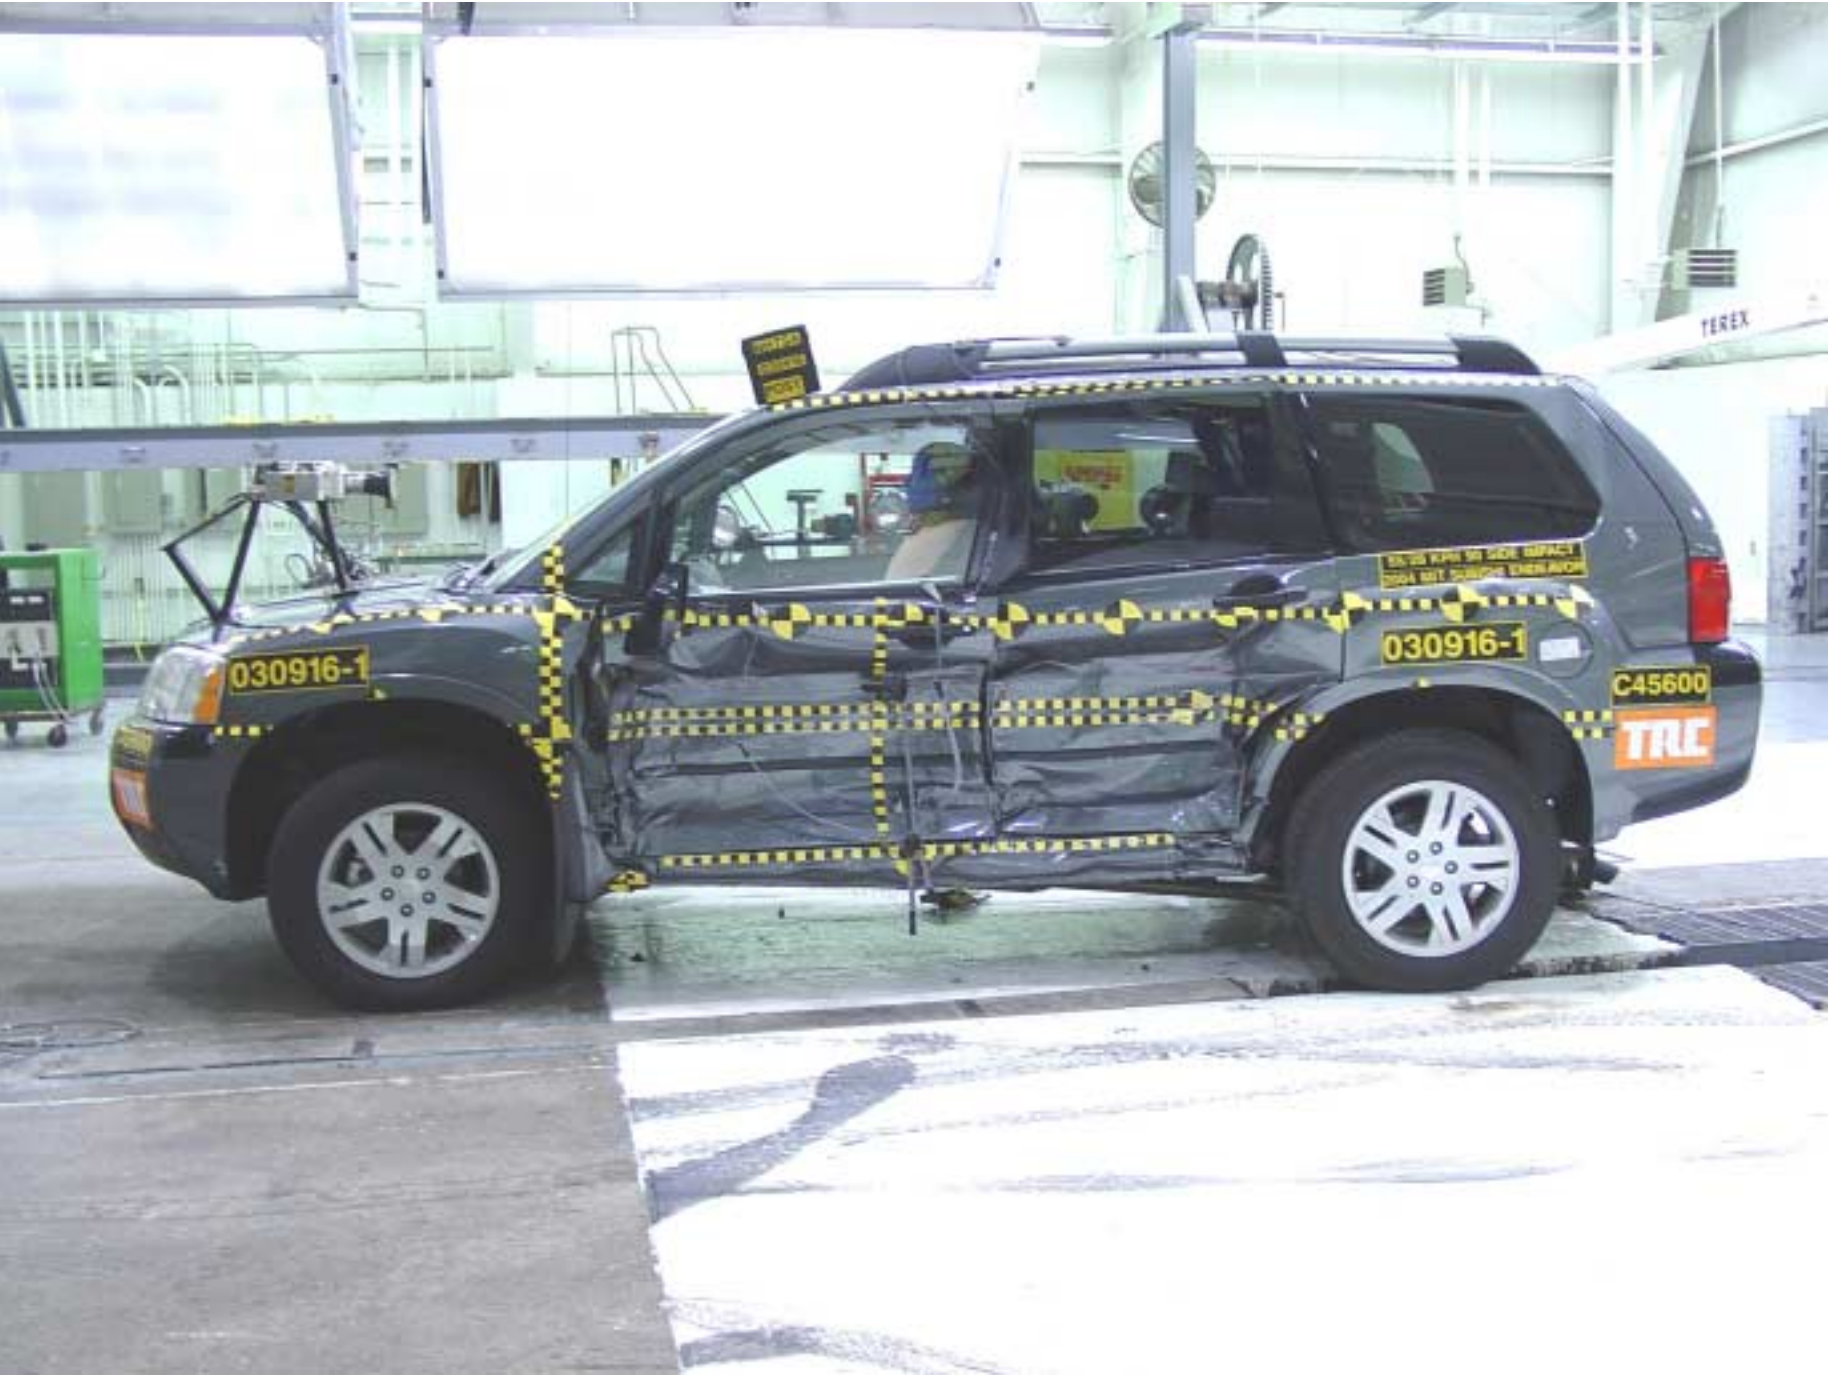
Figure A-4 Post-Test Impacted Side View of Test Vehicle

Full length of induced damage was 0 to 2400 mm.

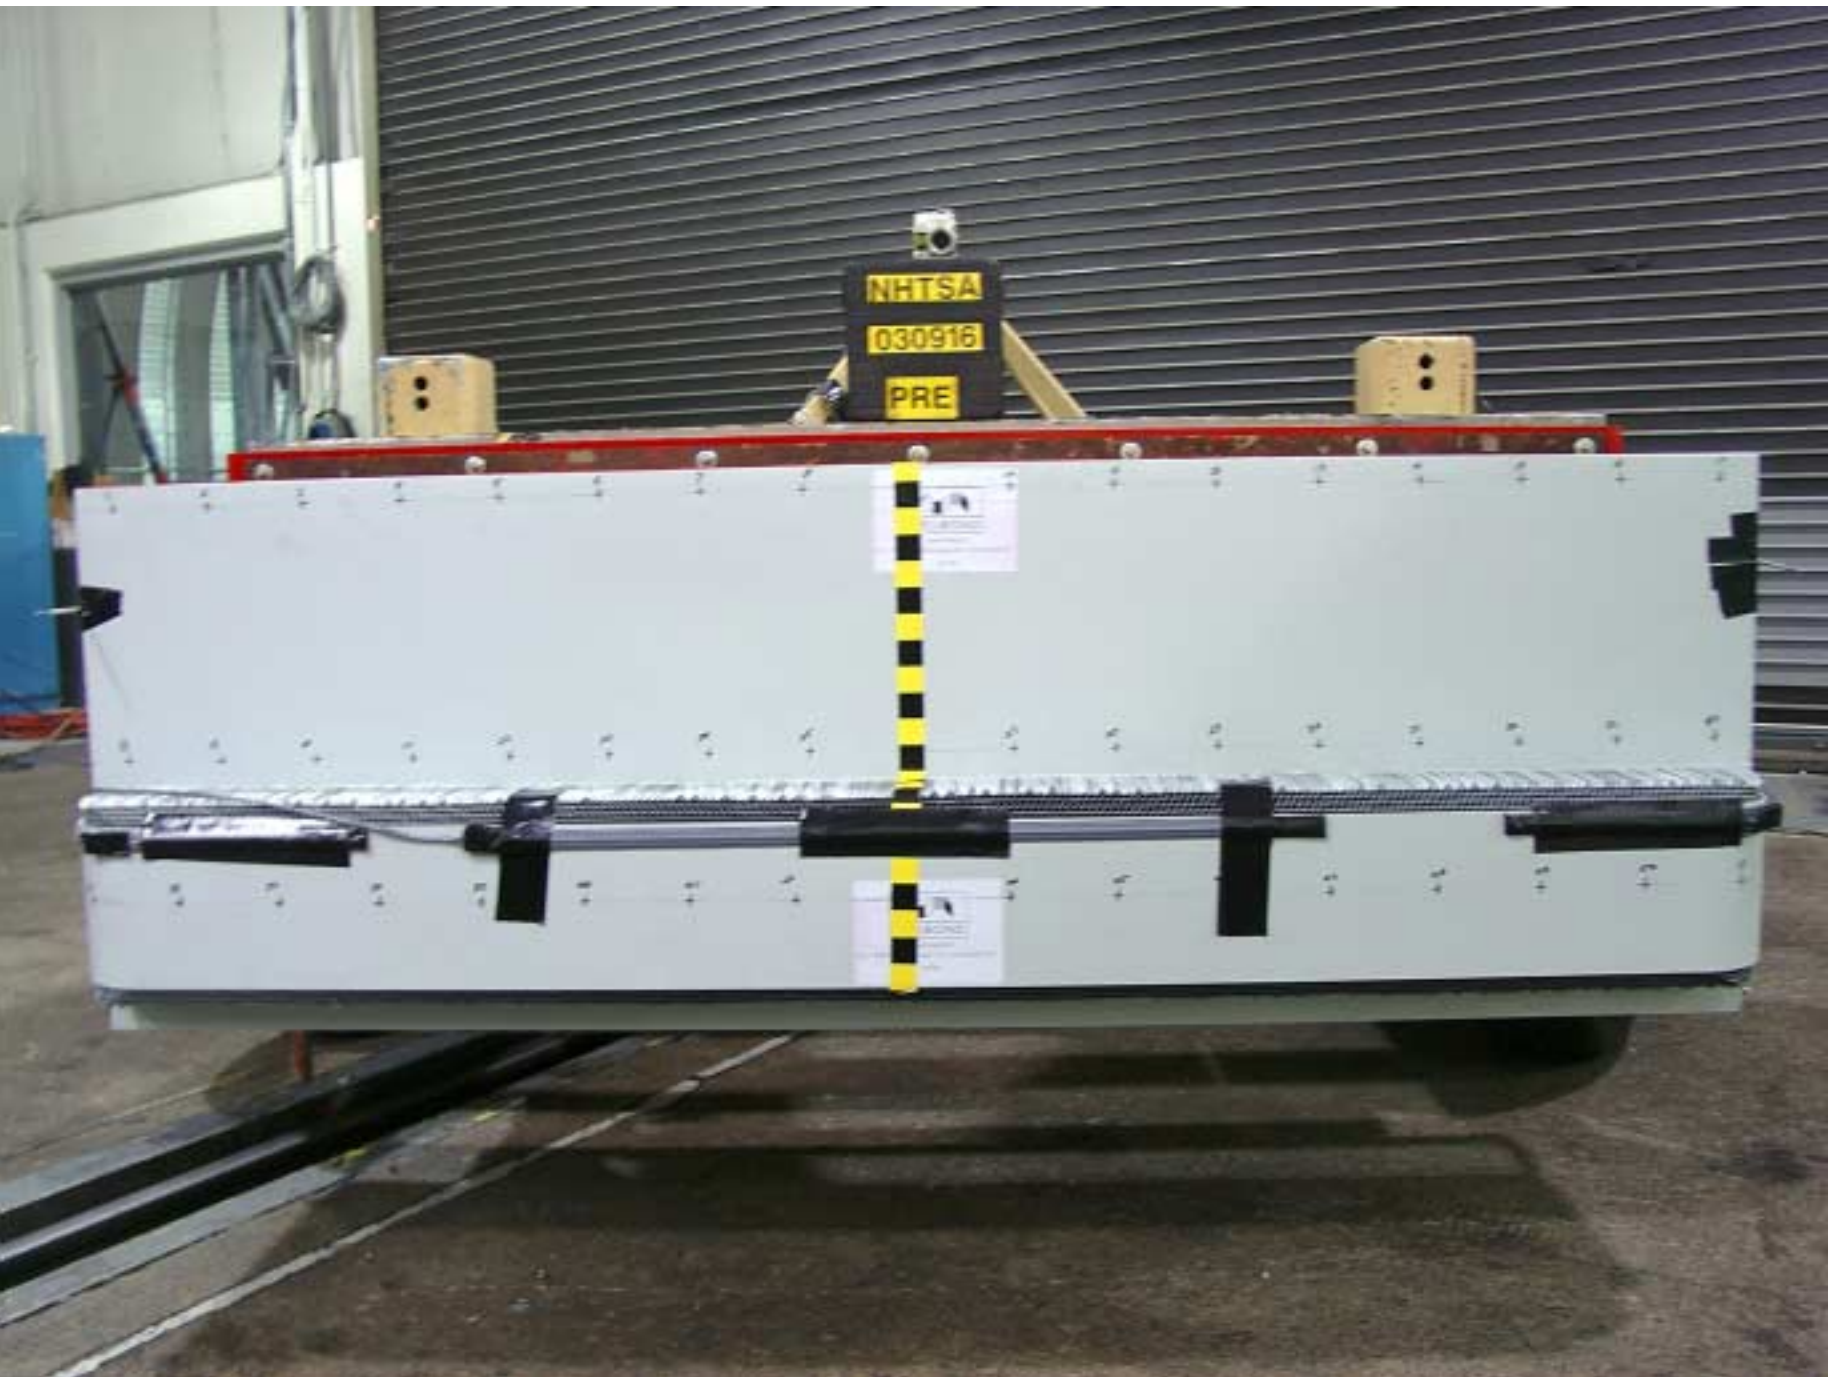
Figure A-17 Pre-Test View of MDB Showing Contact Switches in Place

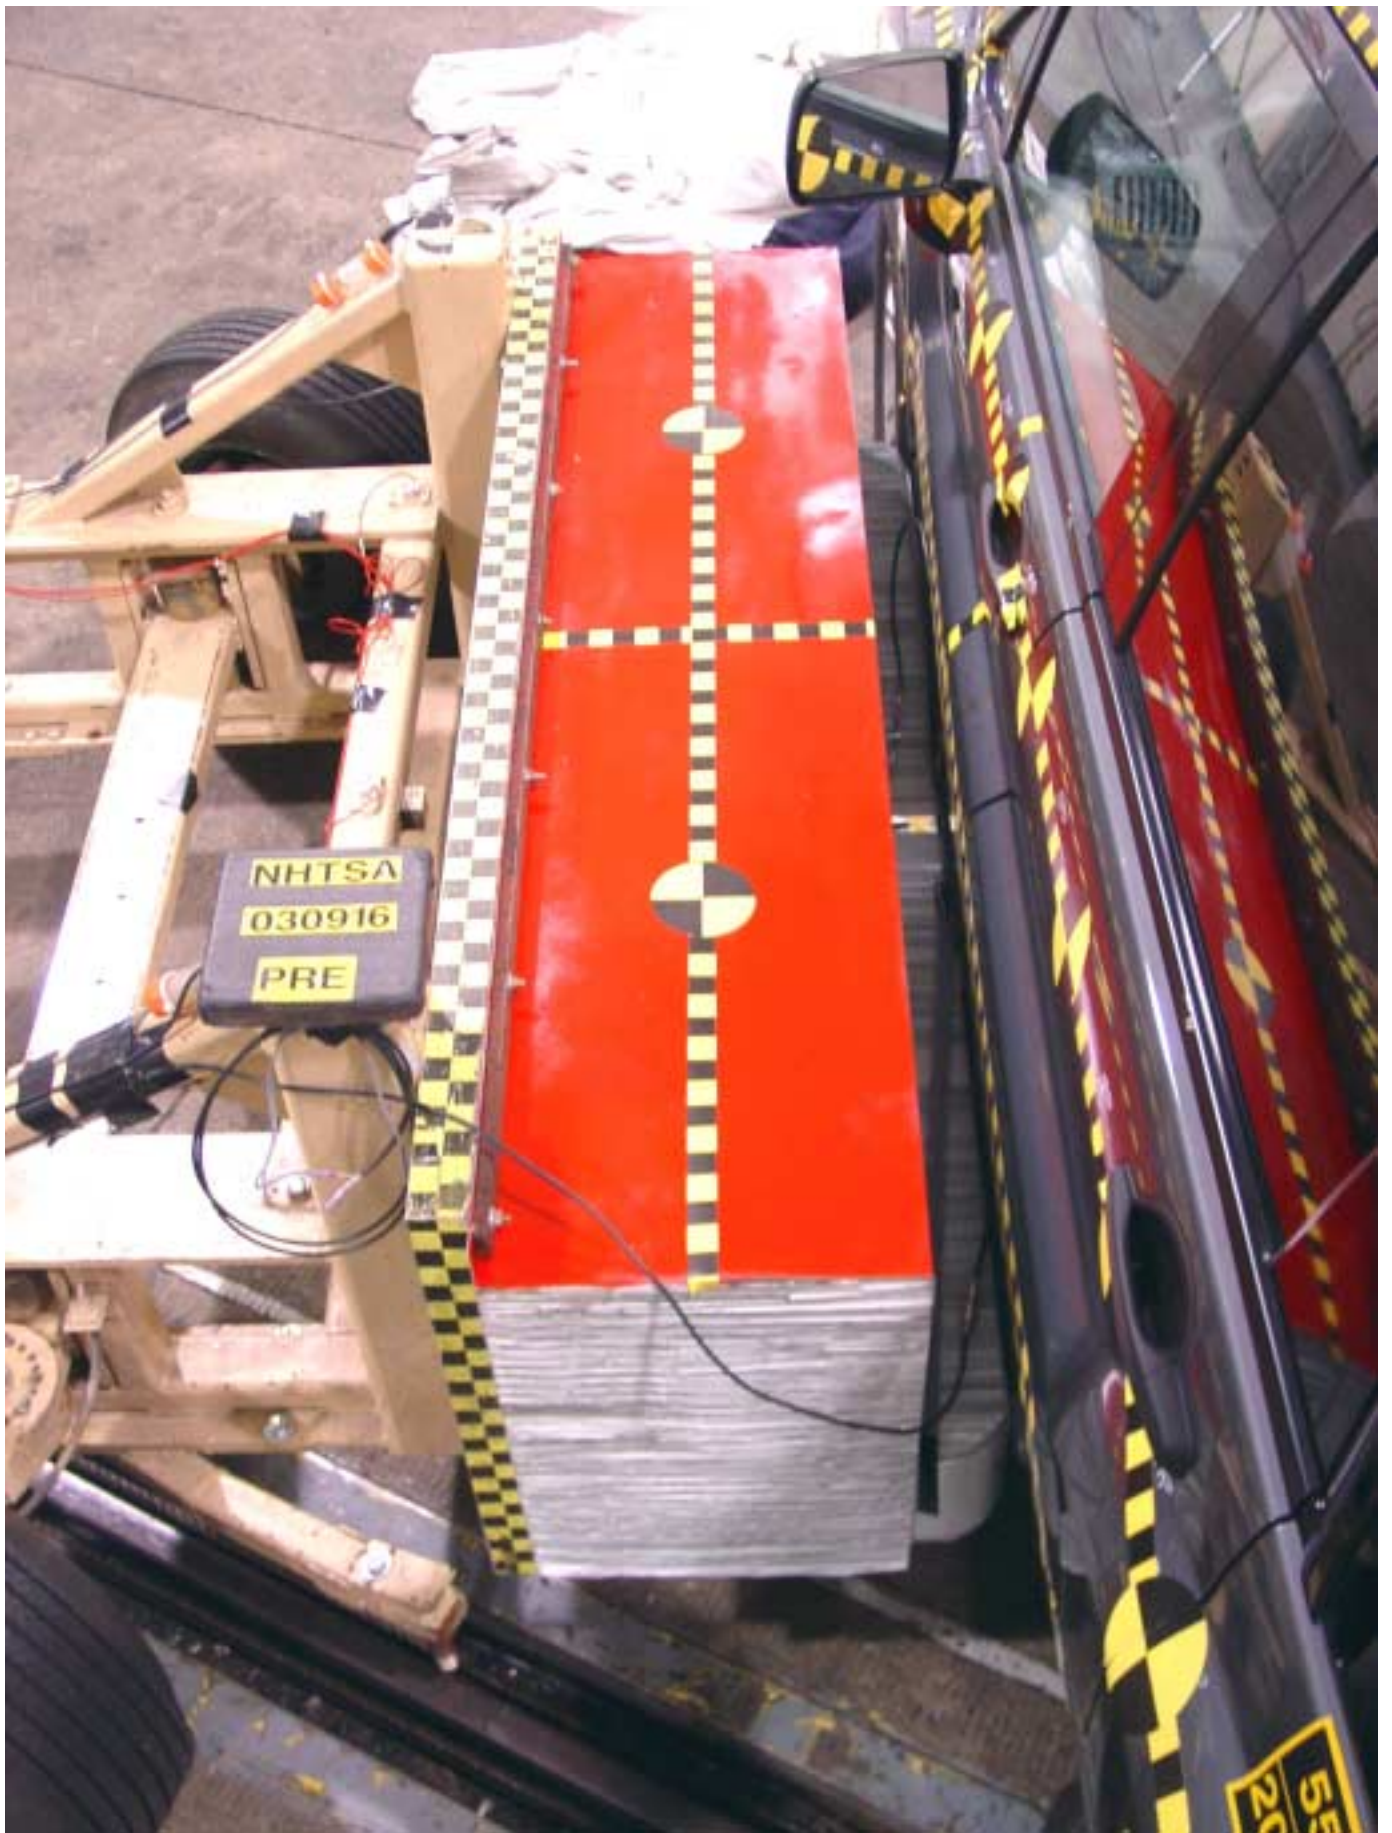
Figure A-18 Pre-Test Overhead View of MDB Aligned with Vehicle

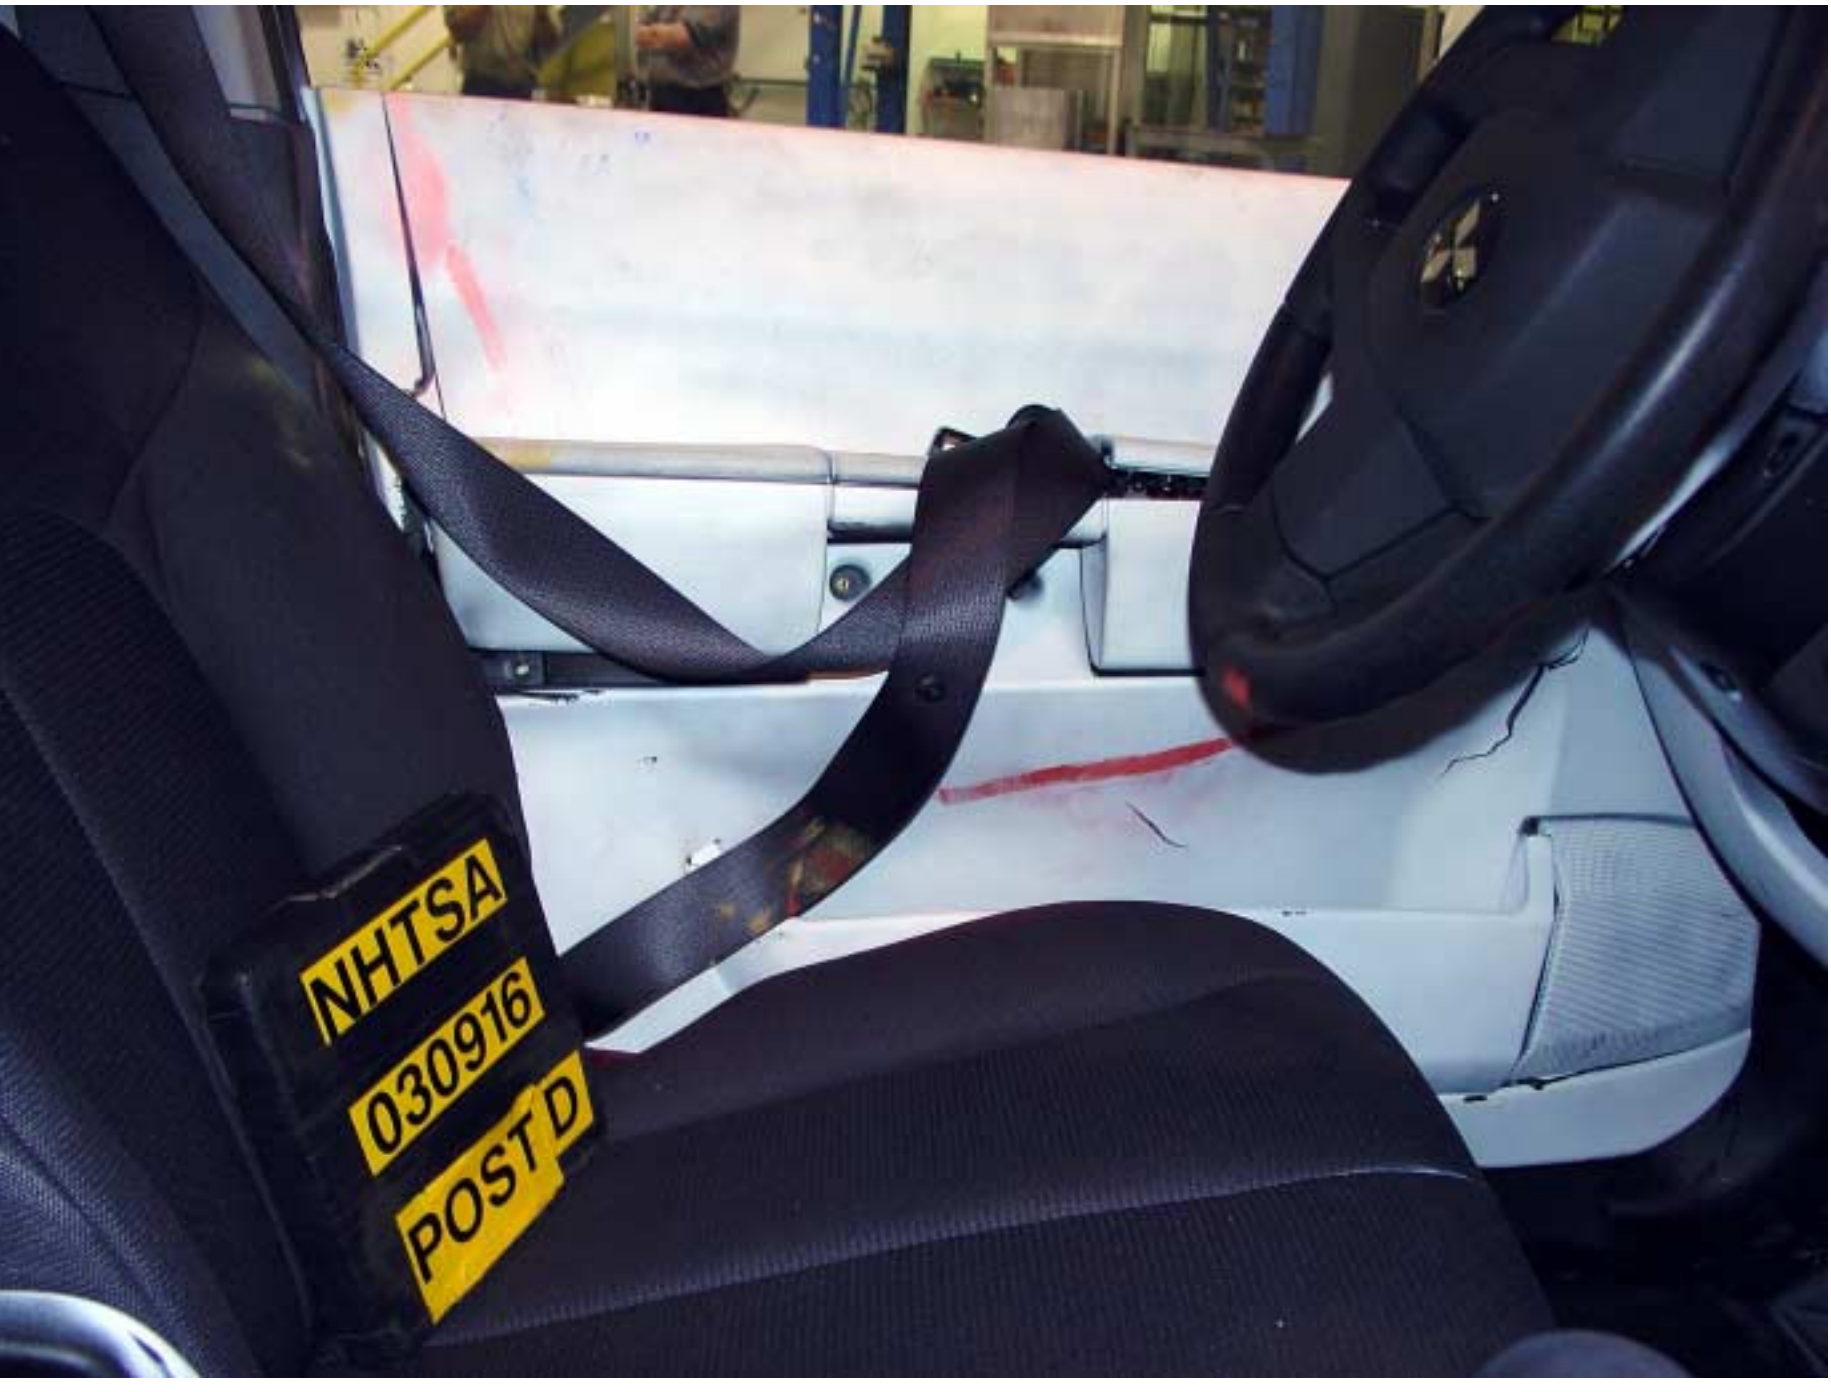
Figure A-35 Post-Test Interior of Front Door Showing SID HIII Impact Locations

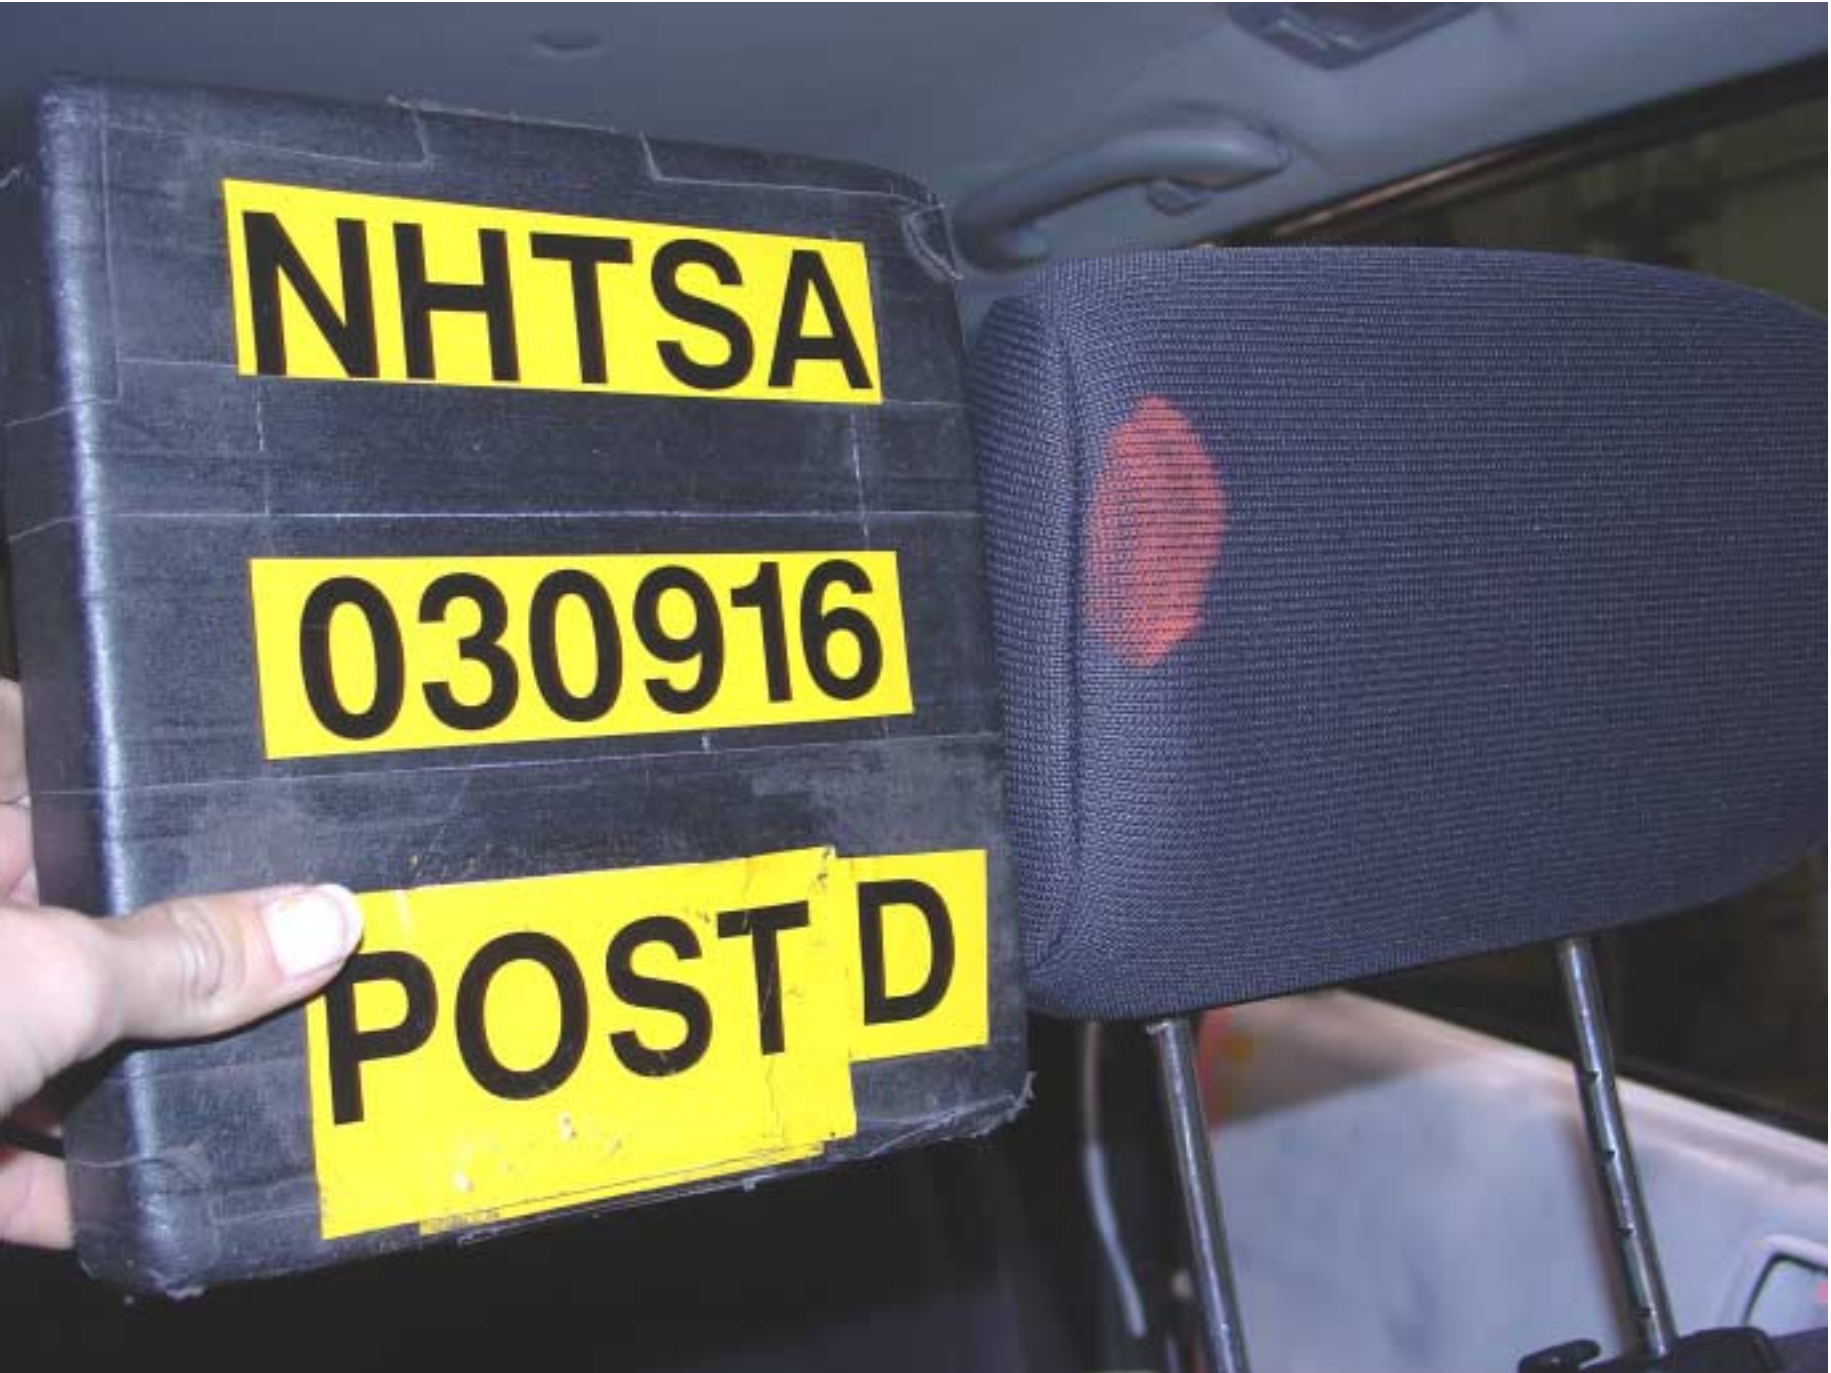
Figure A-36 Post-Test Front SID HIII Contact - View 1

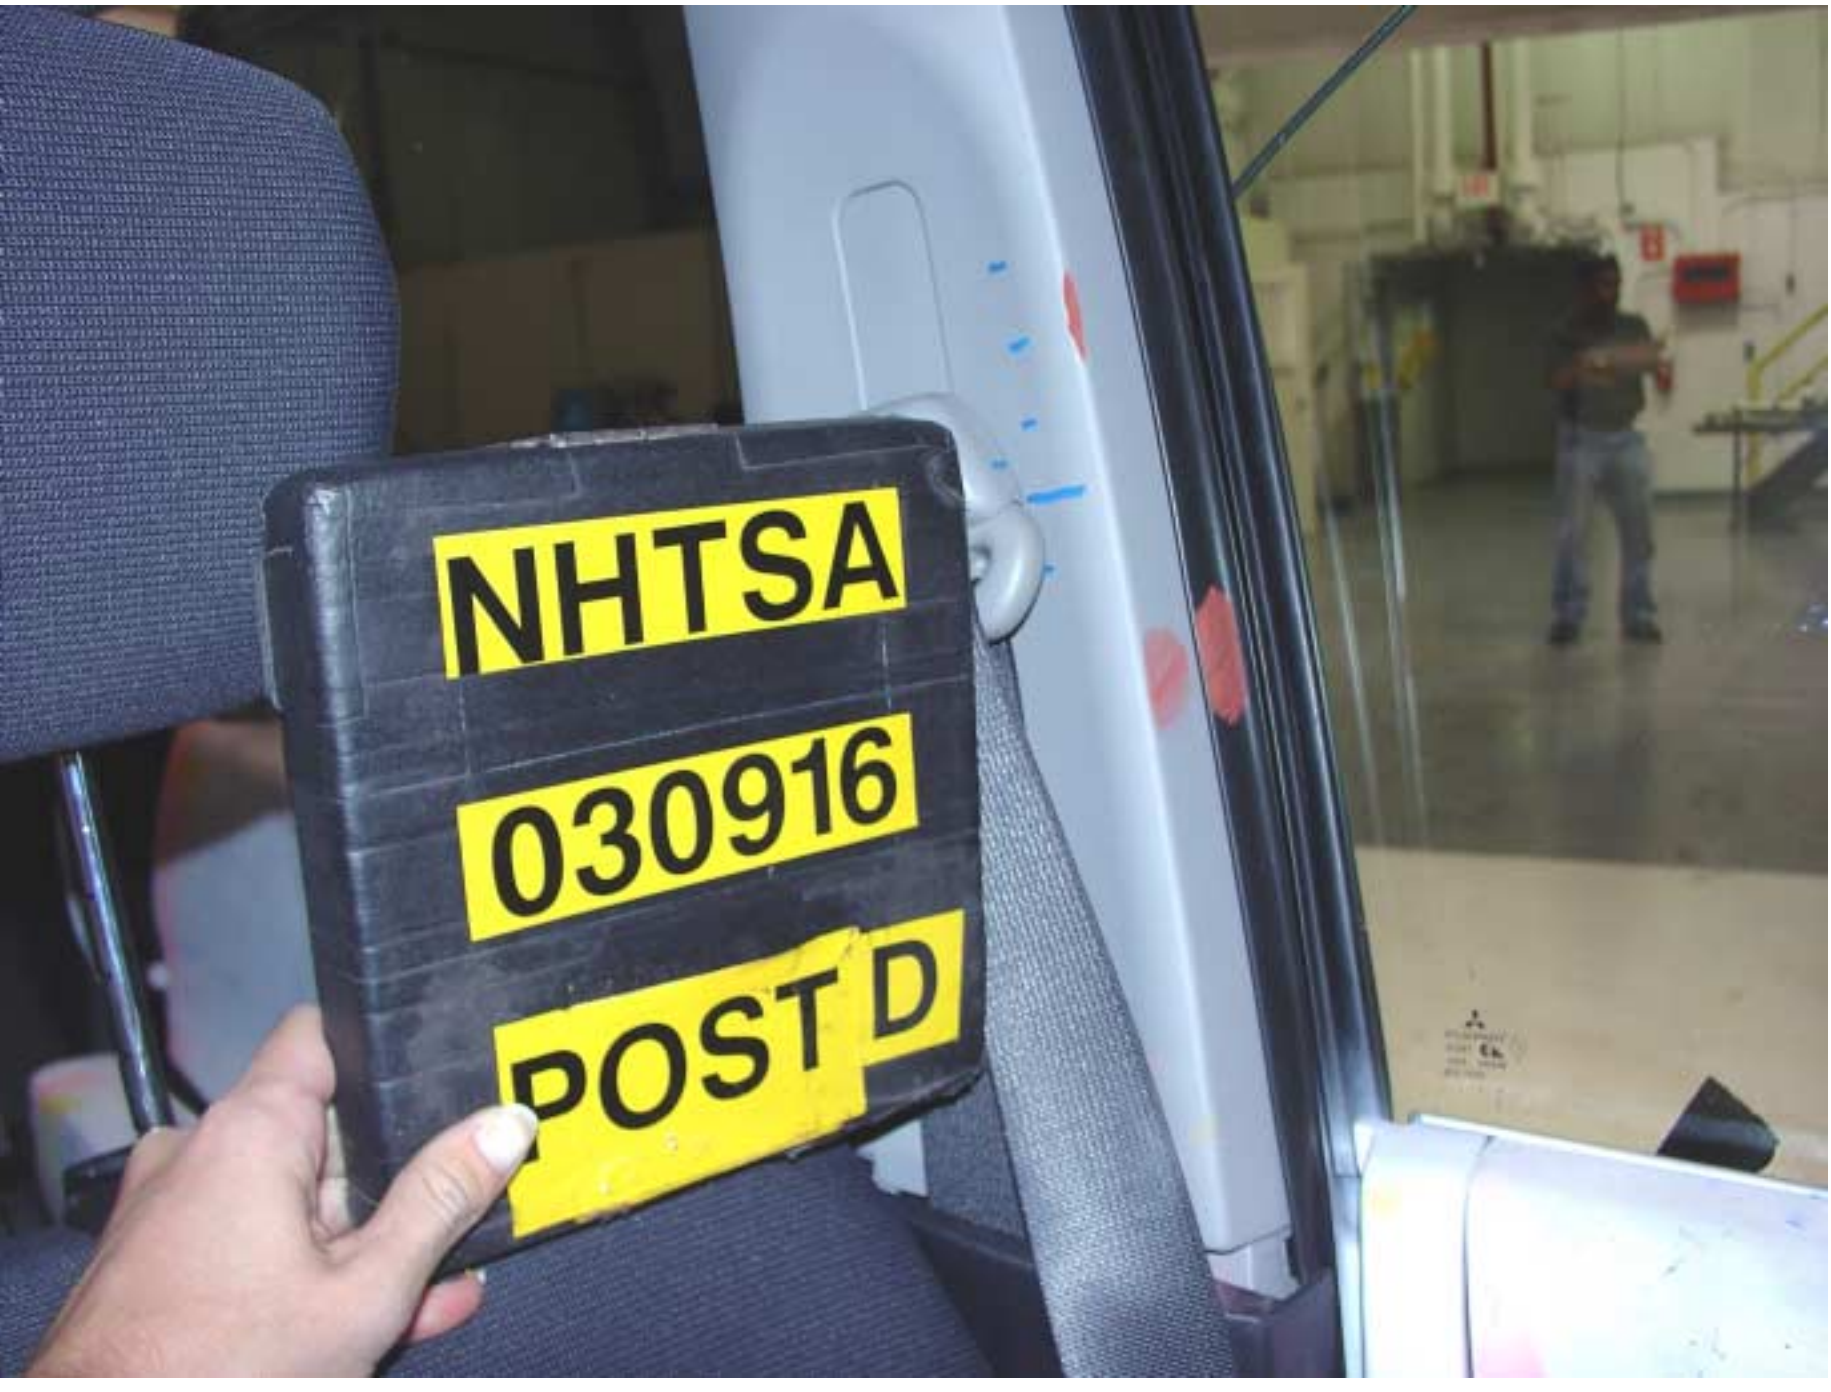
Figure A-37 Post-Test Front SID HIII Contact - View 2

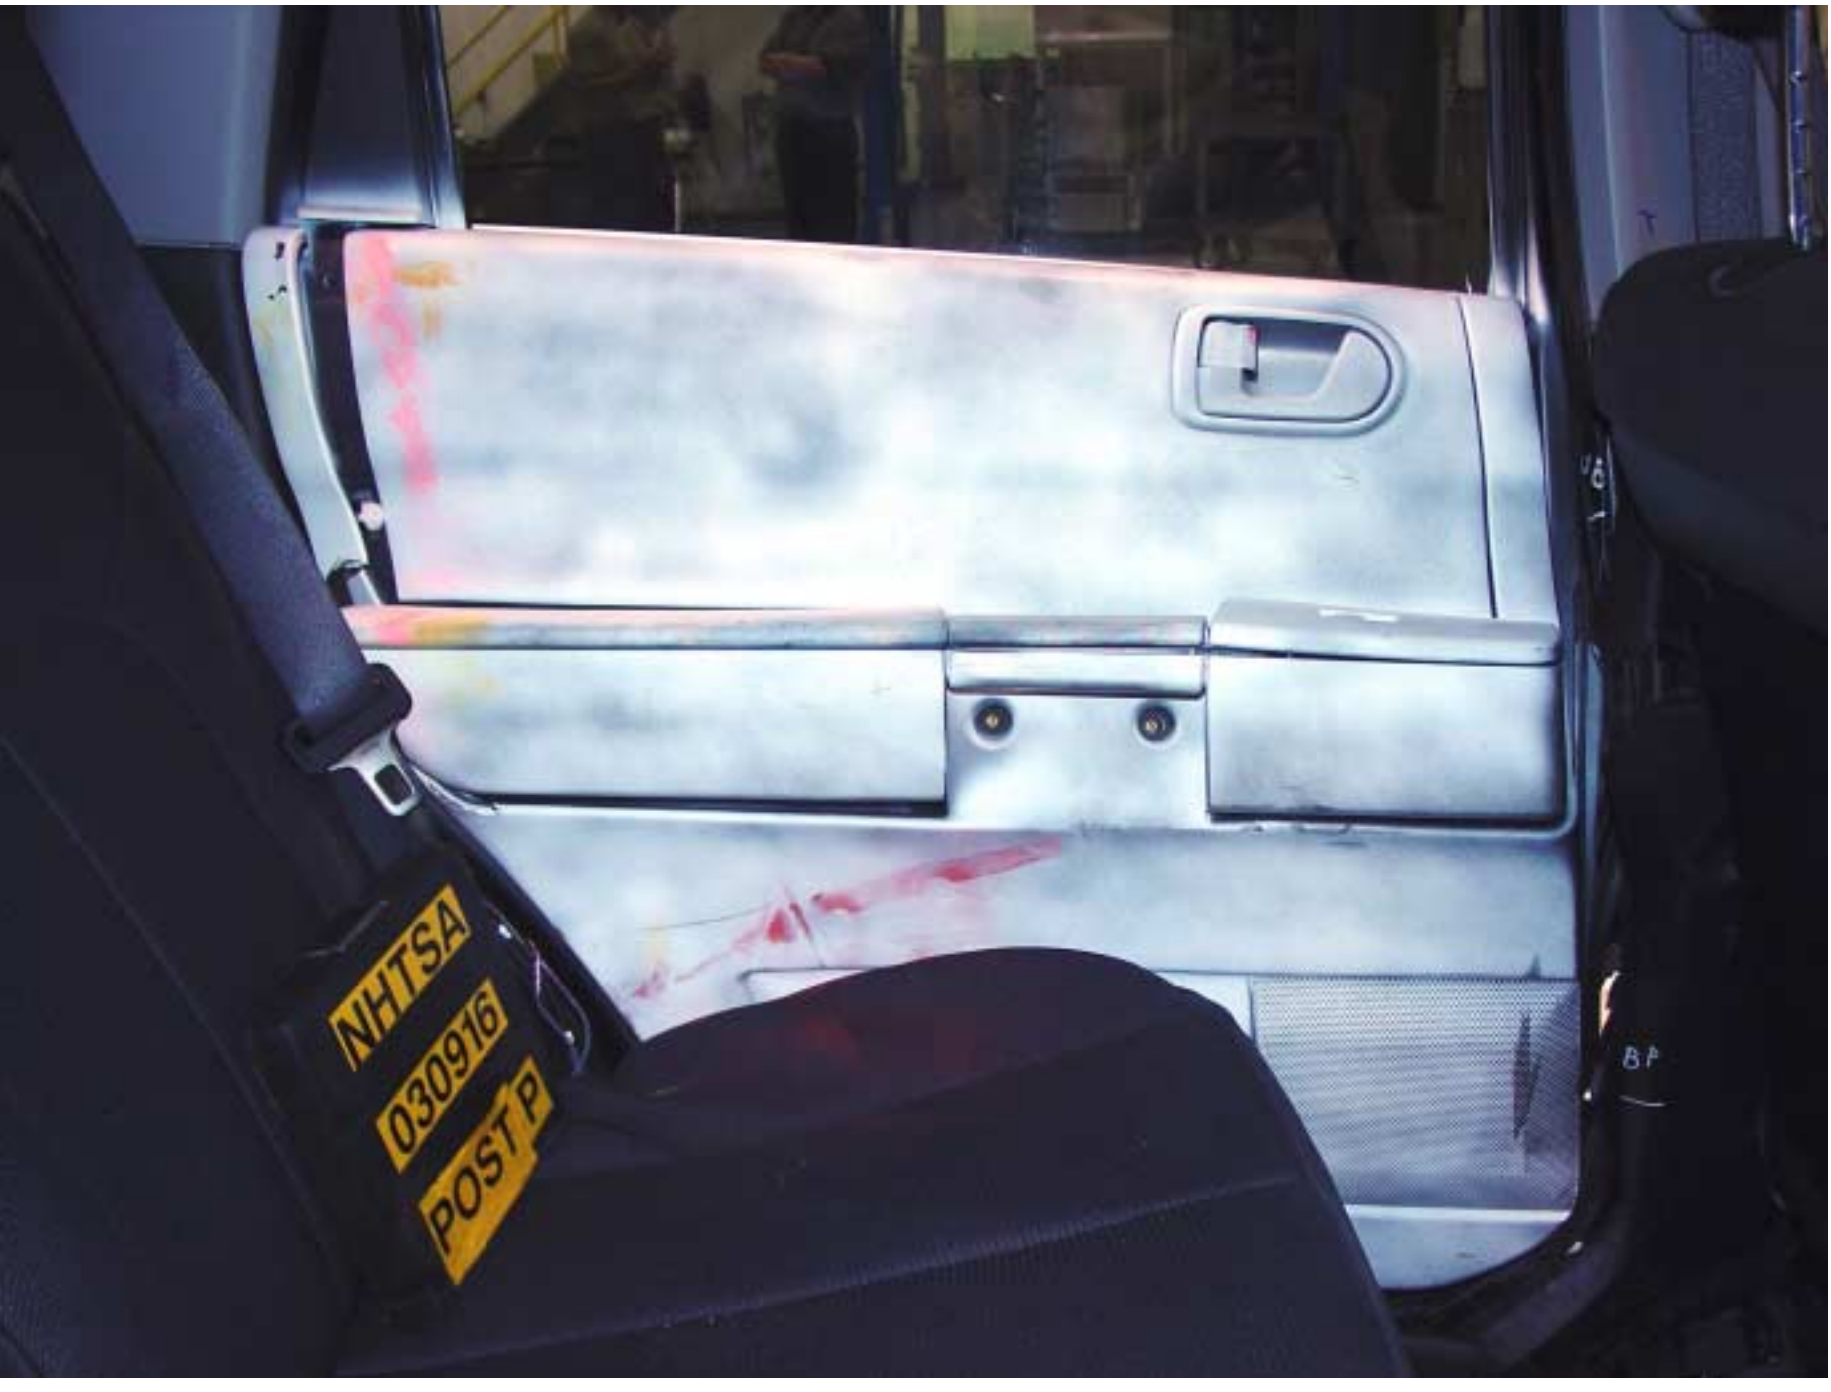
Figure A-39 Post-Test Interior of Rear Panel Showing SID HMMI Impact Locations

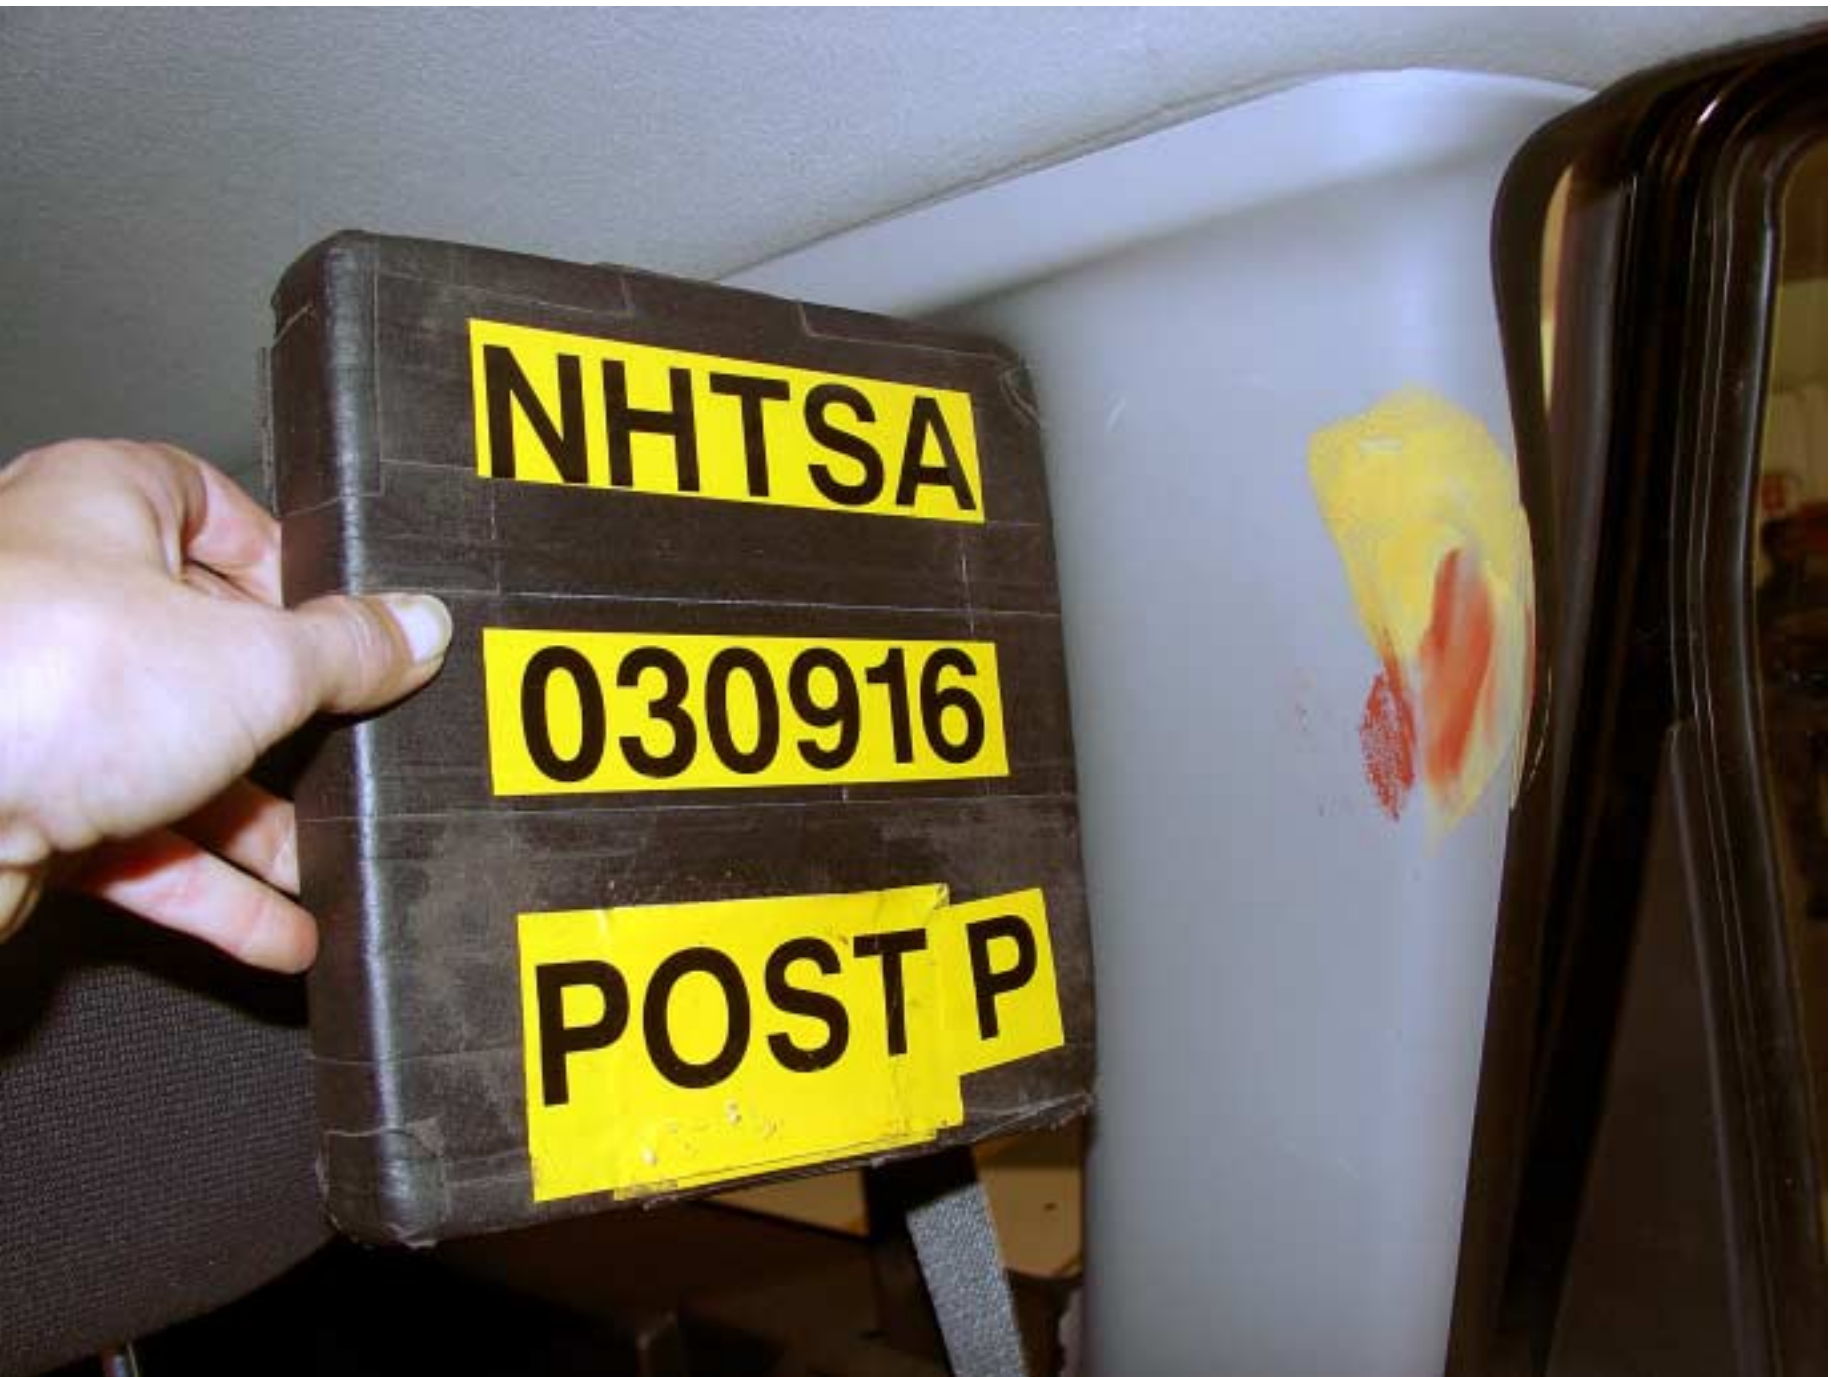
Figure A-40 Post-Test Rear SID HMI Contact View
A-43

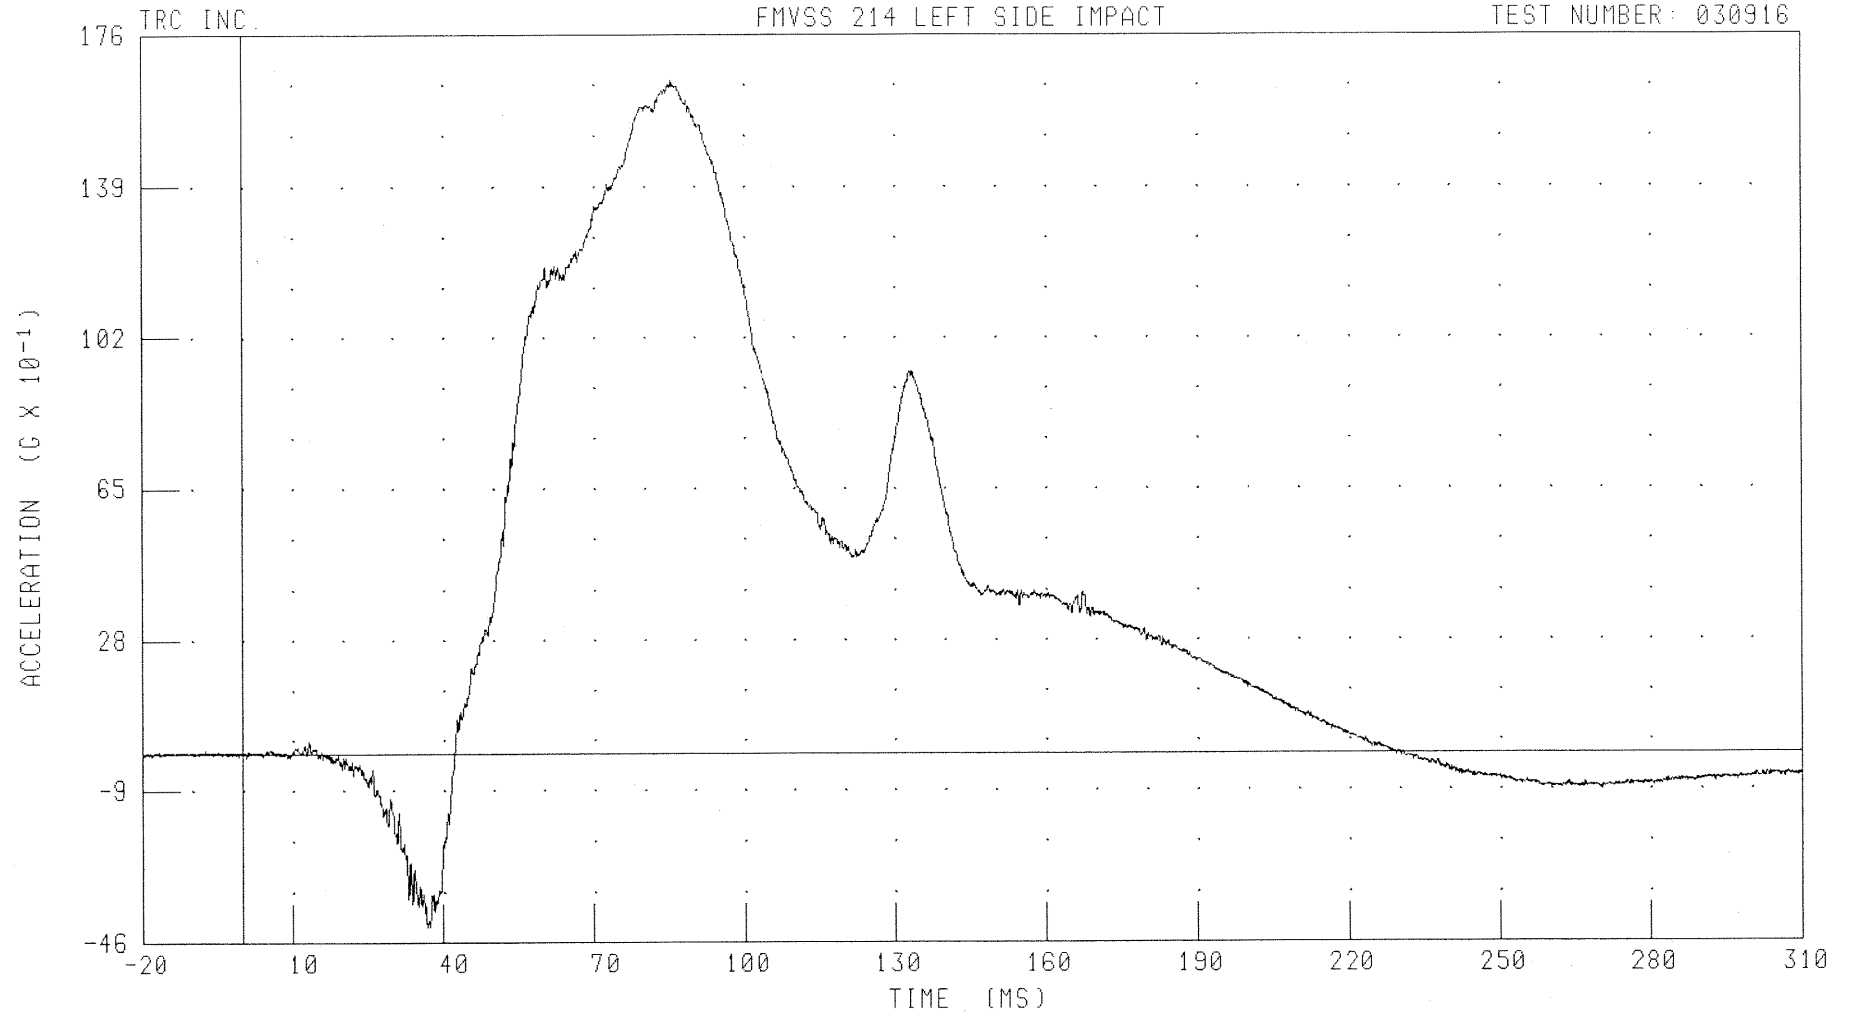
CHANNEL: HEDYR1 FILTER: CH. CLASS 1000

PEAK DATA: 16.48 G @ 85.44 MS; -4.22 G @ 36.80 MS
