Report Number: 214-TRC-03-011

Safety Compliance Testing For FMVSS 214

Side Impact Protection

2004 Mitsubishi Endeavor SUV

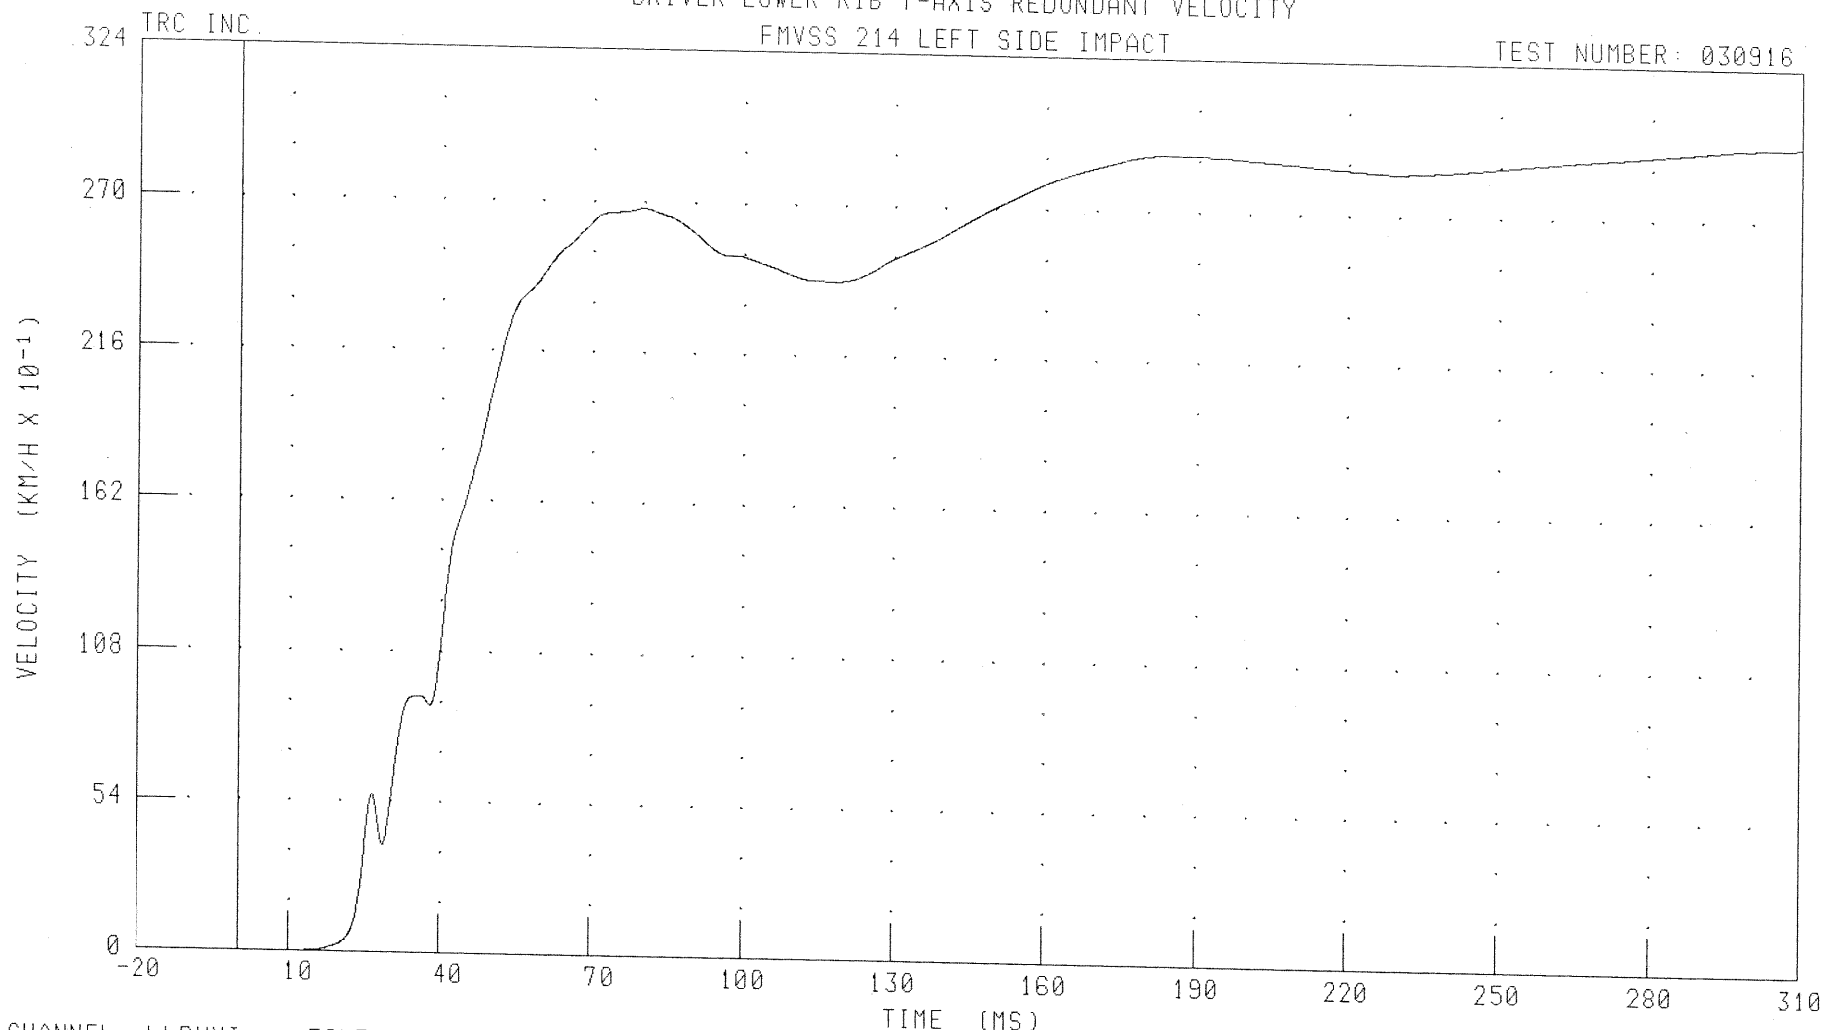
CHANNEL: LLRYVI FILTER: CH. CLASS 180

PEAK DATA: 29.60 KM/H @ 310.00 MS; 0.00 KM/H @ 1.44 MS

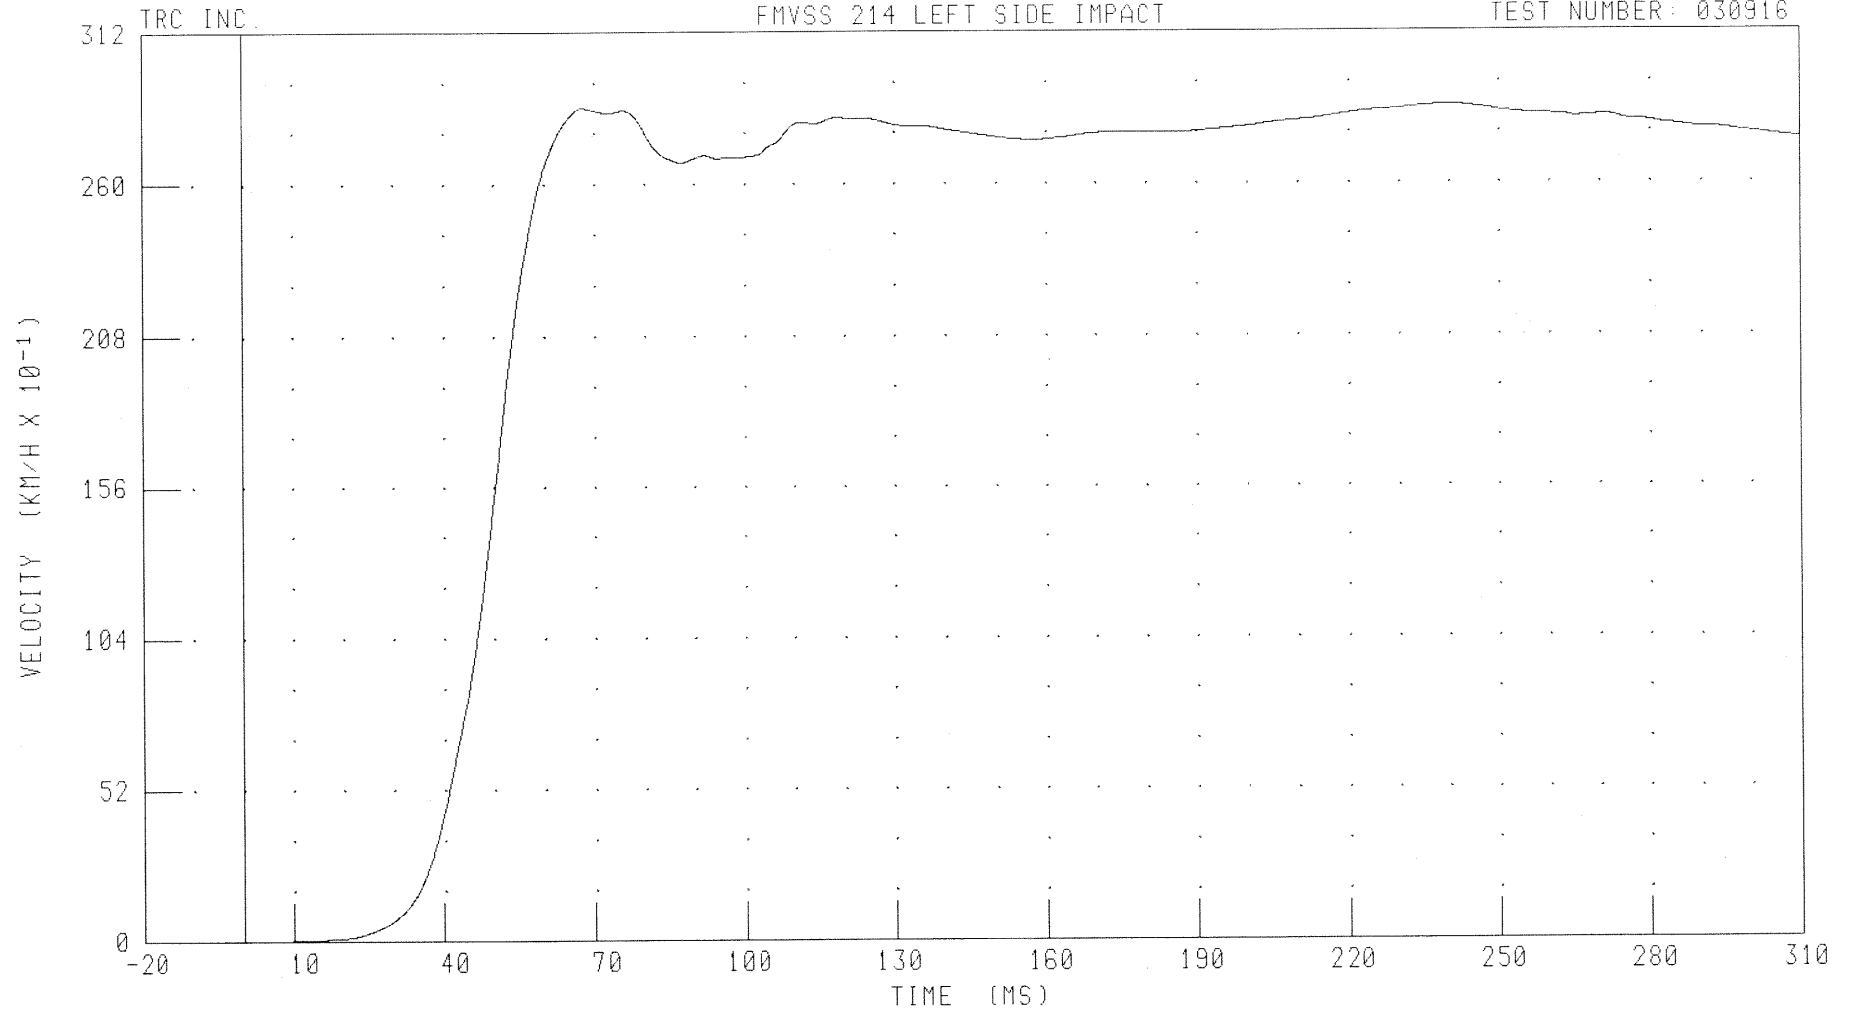
CHANNEL: T12YVJ FILTER: CH. CLASS 180

PEAK DATA: 286.66 KM/H @ 240.32 MS; 0.00 KM/H @ 0.00 MS

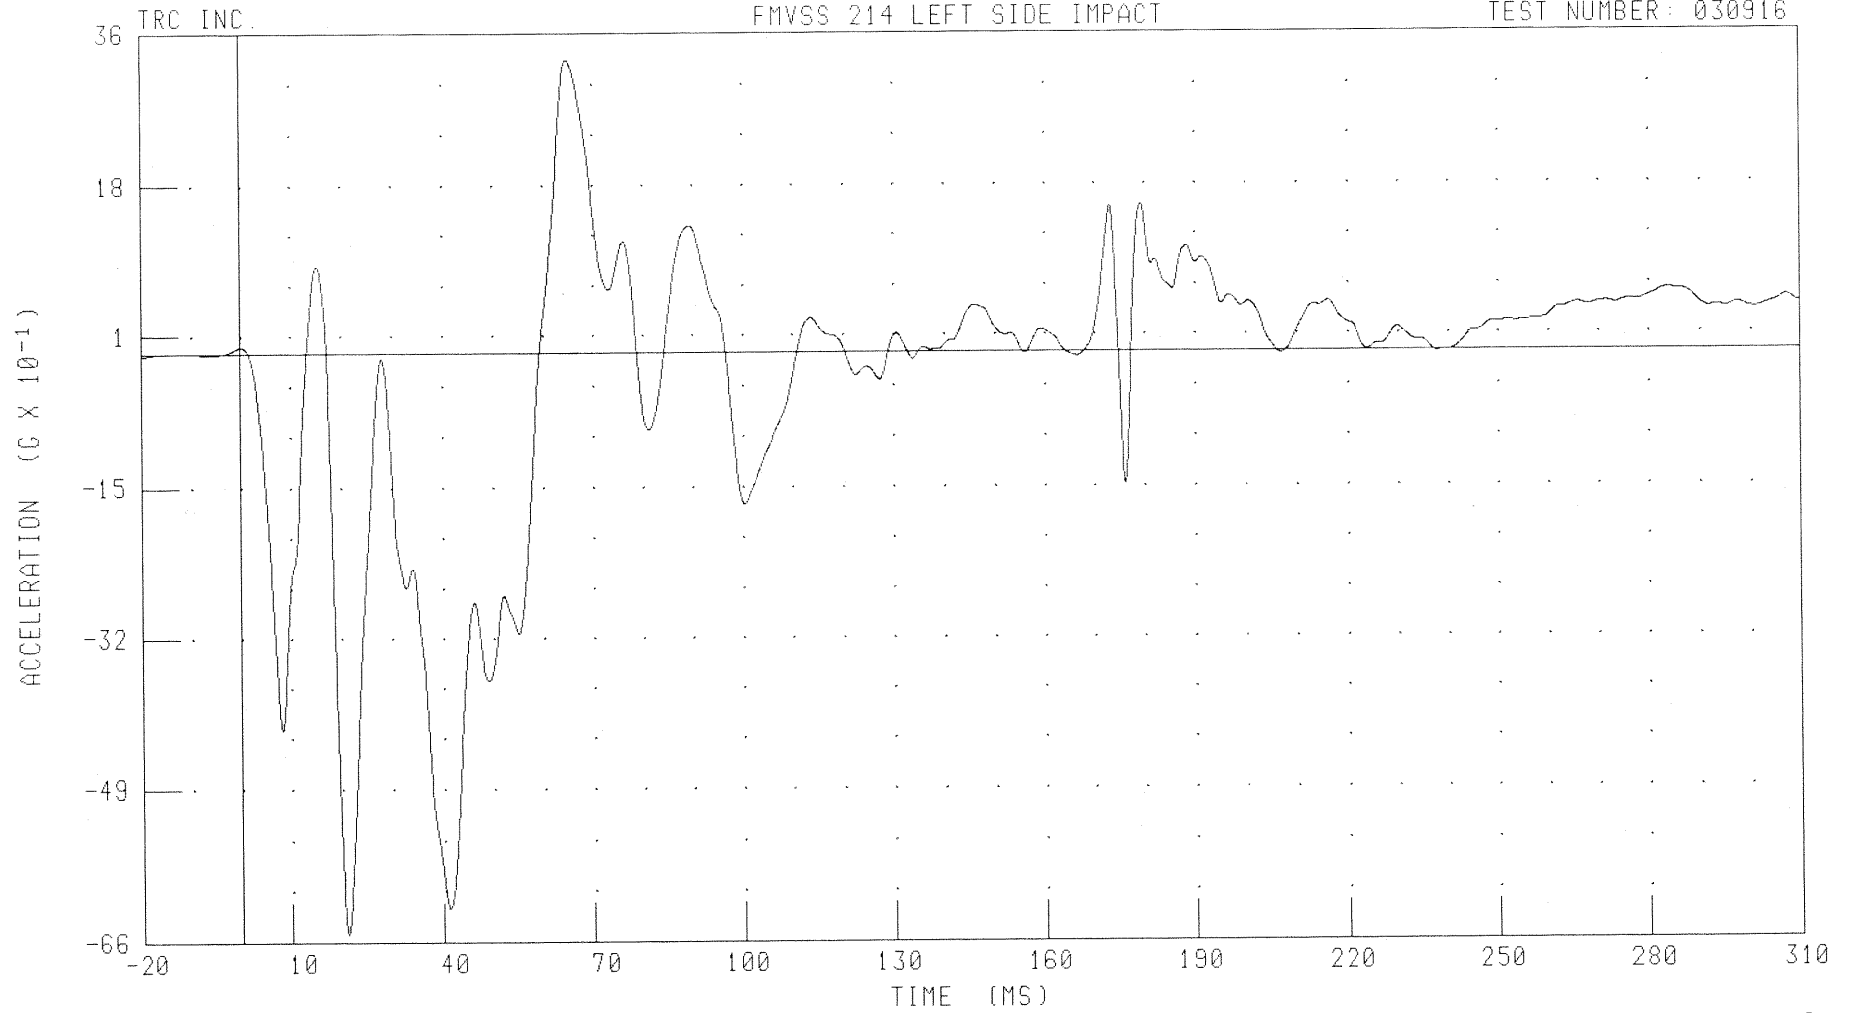
CHANNEL: RDKXG1 FILTER: CH. CLASS 60

PEAK DATA: 3.30 G @ 65.04 MS; -6.51 G @ 21.12 MS

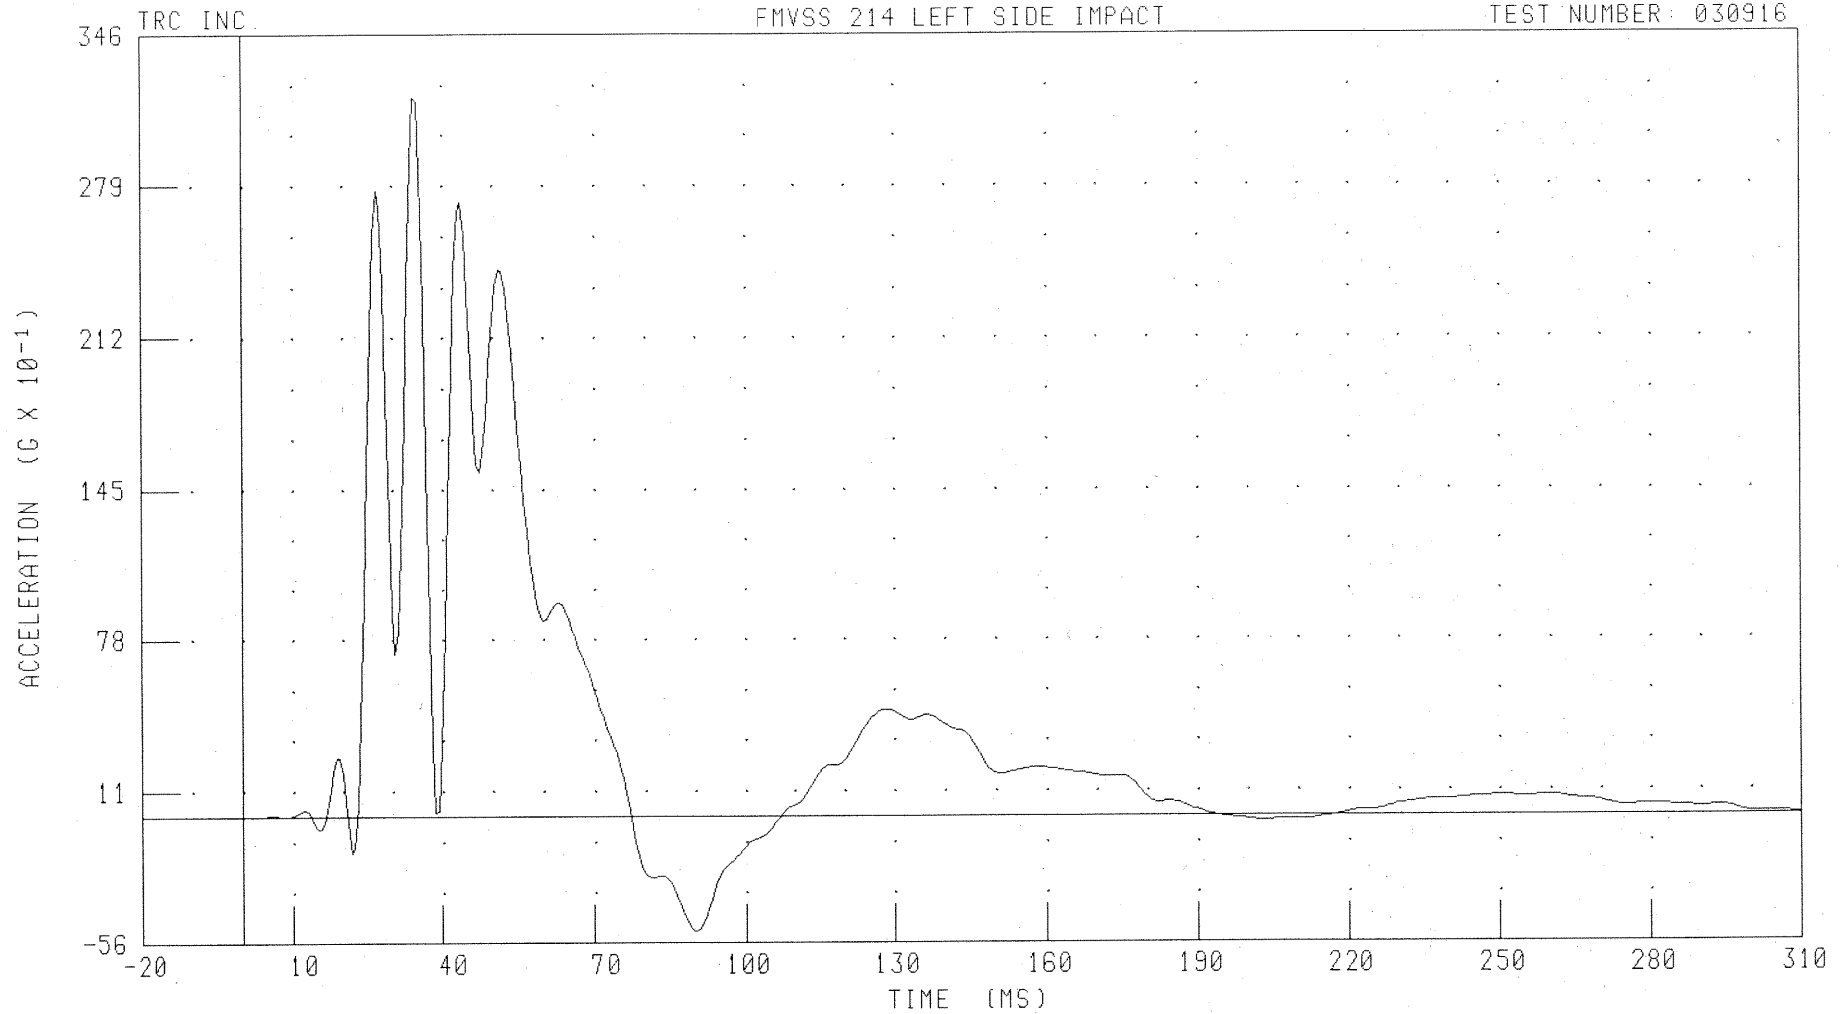
CHANNEL: LURYG1 FILTER: FIR 100

PEAK DATA: 31.81 G @ 34.38 MS; -5.11 G @ 90.00 MS

<table><tr> <th></th> <th style="text-align: center;"><u>Front SID HIII</u></th> <th></th> <th style="text-align: center;"><u>Rear SID HIII</u></th> <th></th> </tr><tr> <td>Left Upper Rib Acceleration:</td> <td style="text-align: center;"><u>31.8</u></td> <td>g's</td> <td style="text-align: center;"><u>35.7</u></td> <td>g's</td> </tr></table>

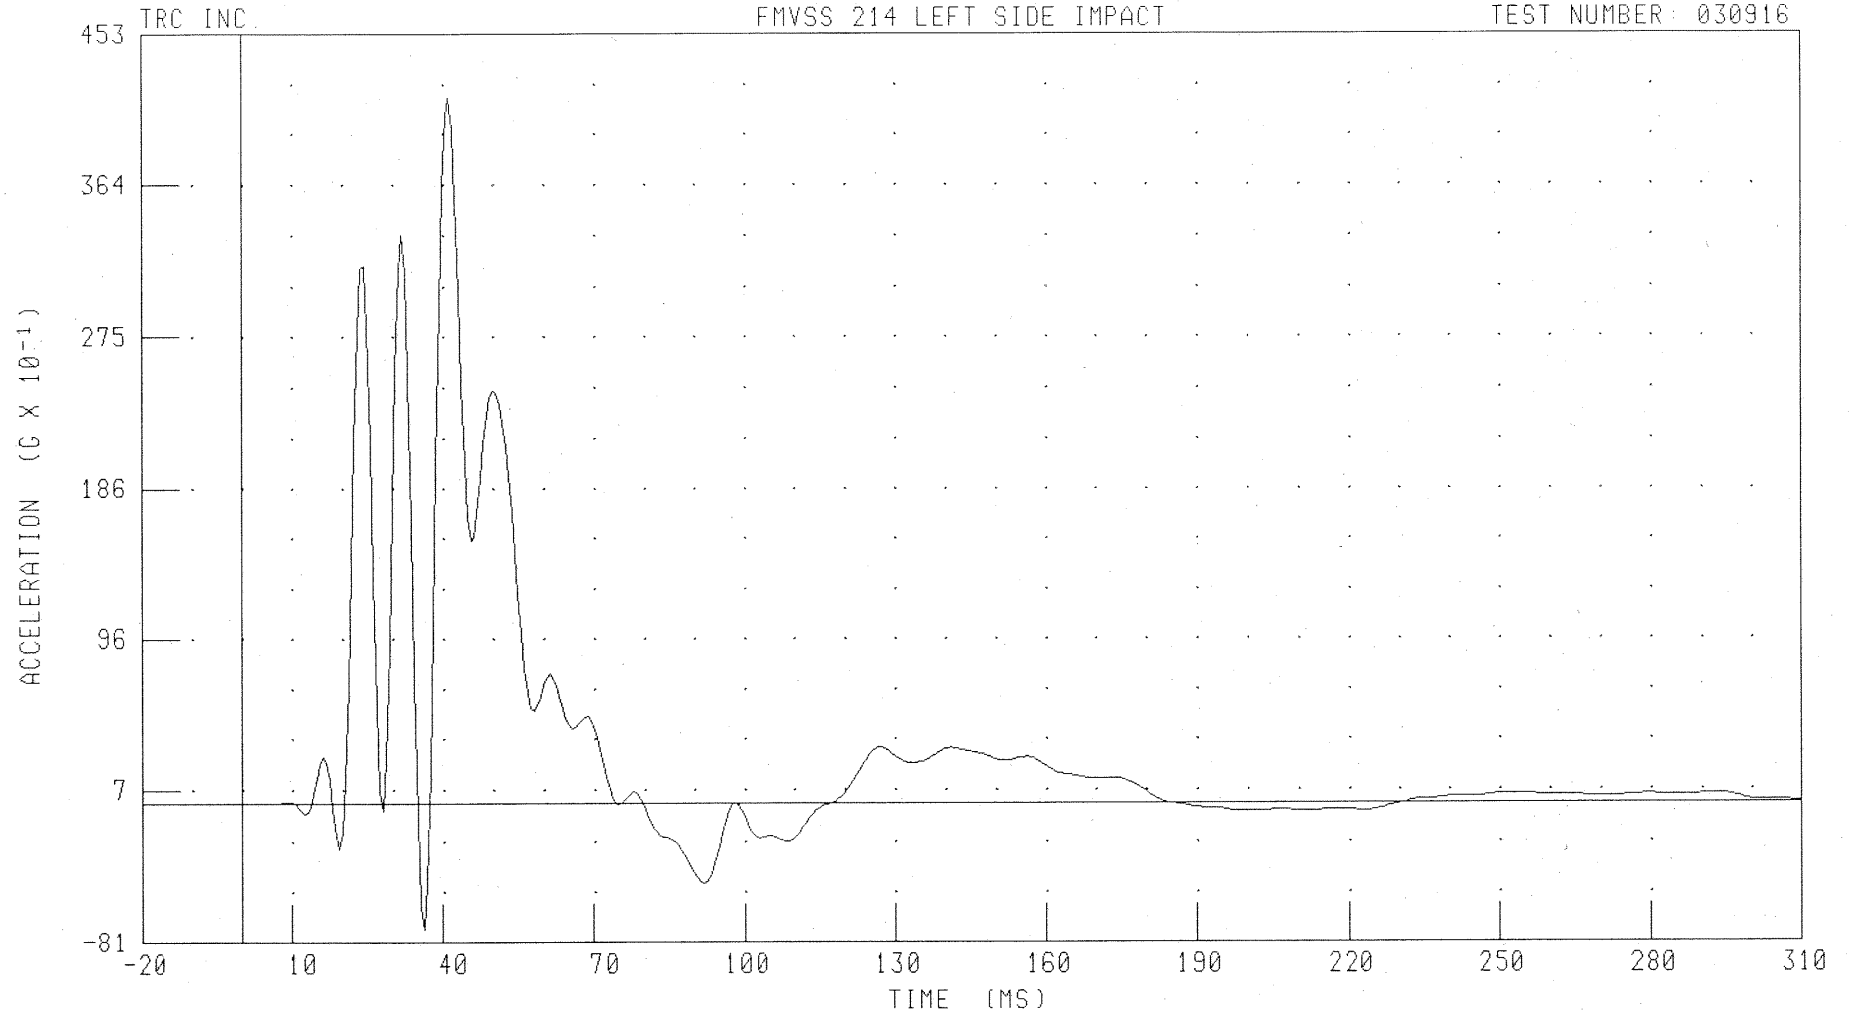
CHANNEL: LLRYG1 FILTER: FIR 100

PEAK DATA: 41.55 G @ 41.25 MS; -7.38 G @ 36.25 MS

<table><tr> <th></th> <th style="text-align: center;"><u>Front SID HIII</u></th> <th></th> <th style="text-align: center;"><u>Rear SID HIII</u></th> <th></th> </tr><tr> <td>Left Lower Rib Acceleration:</td> <td style="text-align: center;"><u>41.6</u></td> <td>g's</td> <td style="text-align: center;"><u>37.5</u></td> <td>g's</td> </tr></table>

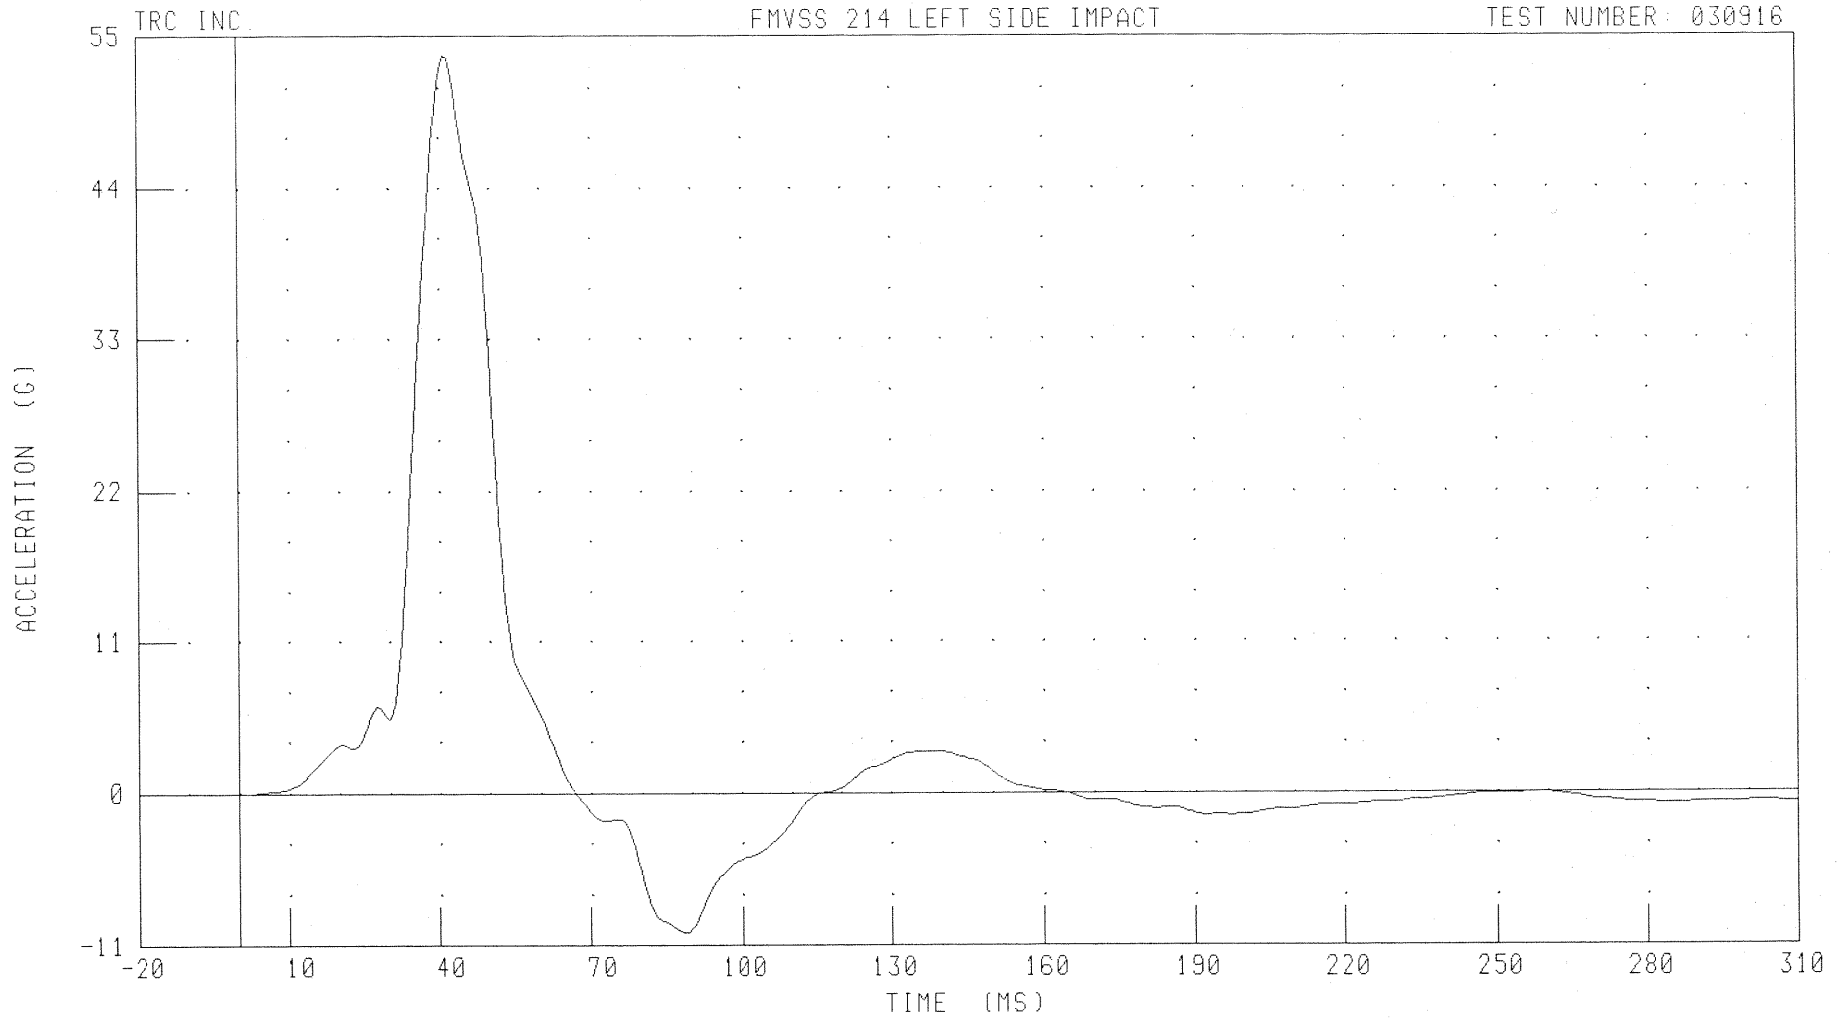
CHANNEL: PEVYG4 FILTER: FIR 100

PEAK DATA: 53.65 G @ 41.25 MS; -10.12 G @ 88.75 MS

<table><tr> <th></th> <th style="text-align: center;"><u>Front SID HIII</u></th> <th></th> <th style="text-align: center;"><u>Rear SID HIII</u></th> <th></th> </tr><tr> <td>Pelvis Acceleration (PEV):</td> <td style="text-align: center;"><u>55.3</u></td> <td>g's</td> <td style="text-align: center;"><u>53.7</u></td> <td>g's</td> </tr></table>

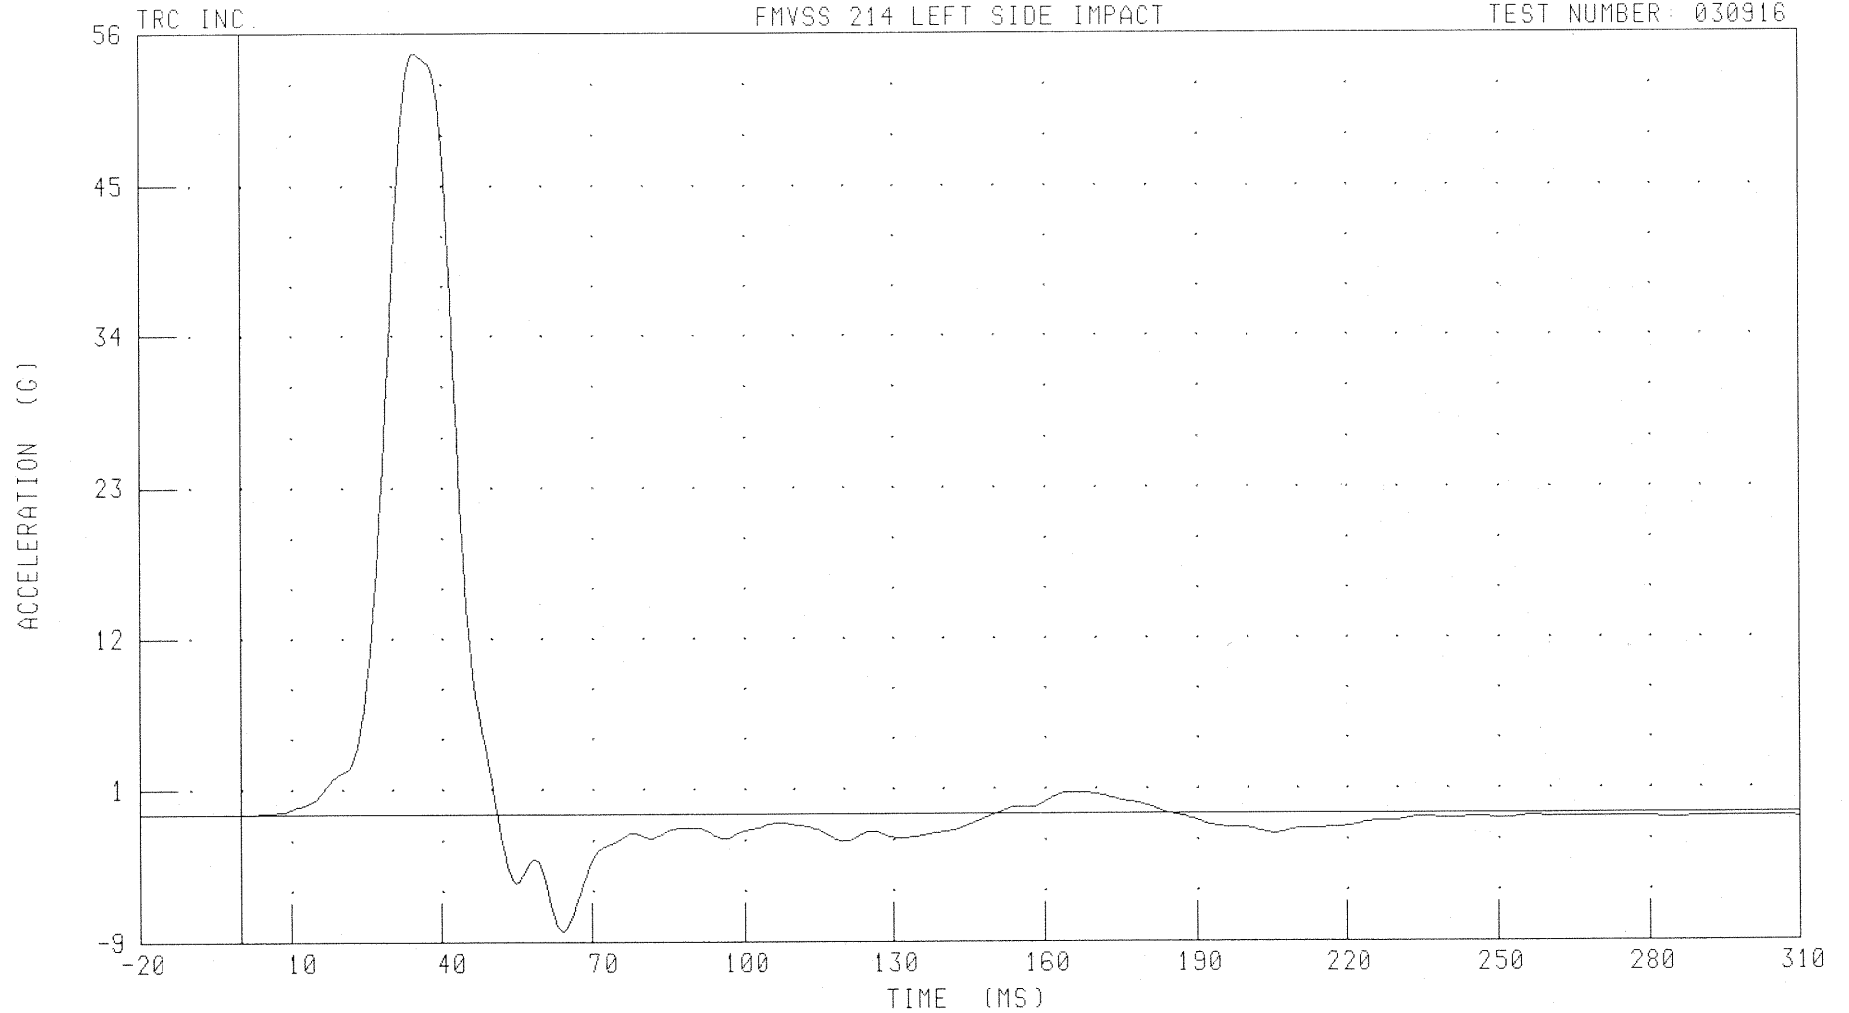
CHANNEL: PEVYR1 FILTER: FIR 100

PEAK DATA: 55.34 G @ 35.00 MS; -8.42 G @ 64.38 MS
