REPORT NUMBER: NCAPSIDE-MGA-2004-001

**NEW CAR ASSESSMENT PROGRAM
SIDE IMPACT TEST**

**Ford Motor Company
2004 Ford Freestar S
NHTSA NUMBER: F40201**

**PREPARED BY:
MGA RESEARCH CORPORATION
5000 WARREN ROAD
BURLINGTON, WI 53105**

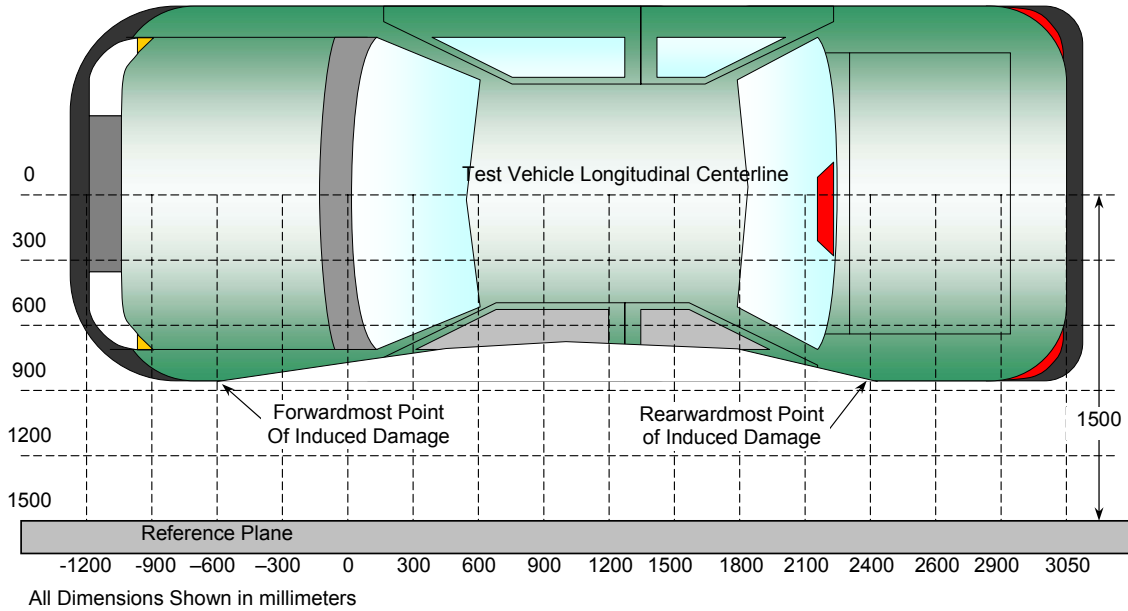
DATA SHEET NO. 13
VEHICLE DAMAGE PROFILE DISTANCES

TOP VIEW

DAMAGE PROFILE DISTANCES

The test vehicle sustained a maximum static crush of 340 mm at level 3, 2100 mm rearward of the left vertical impact point. The driver and passenger SID/HIII's, Serial Nos. 271 and 904 respectively, were calibrated just prior to this test. The SID/HIII's injury criteria are summarized as follows:

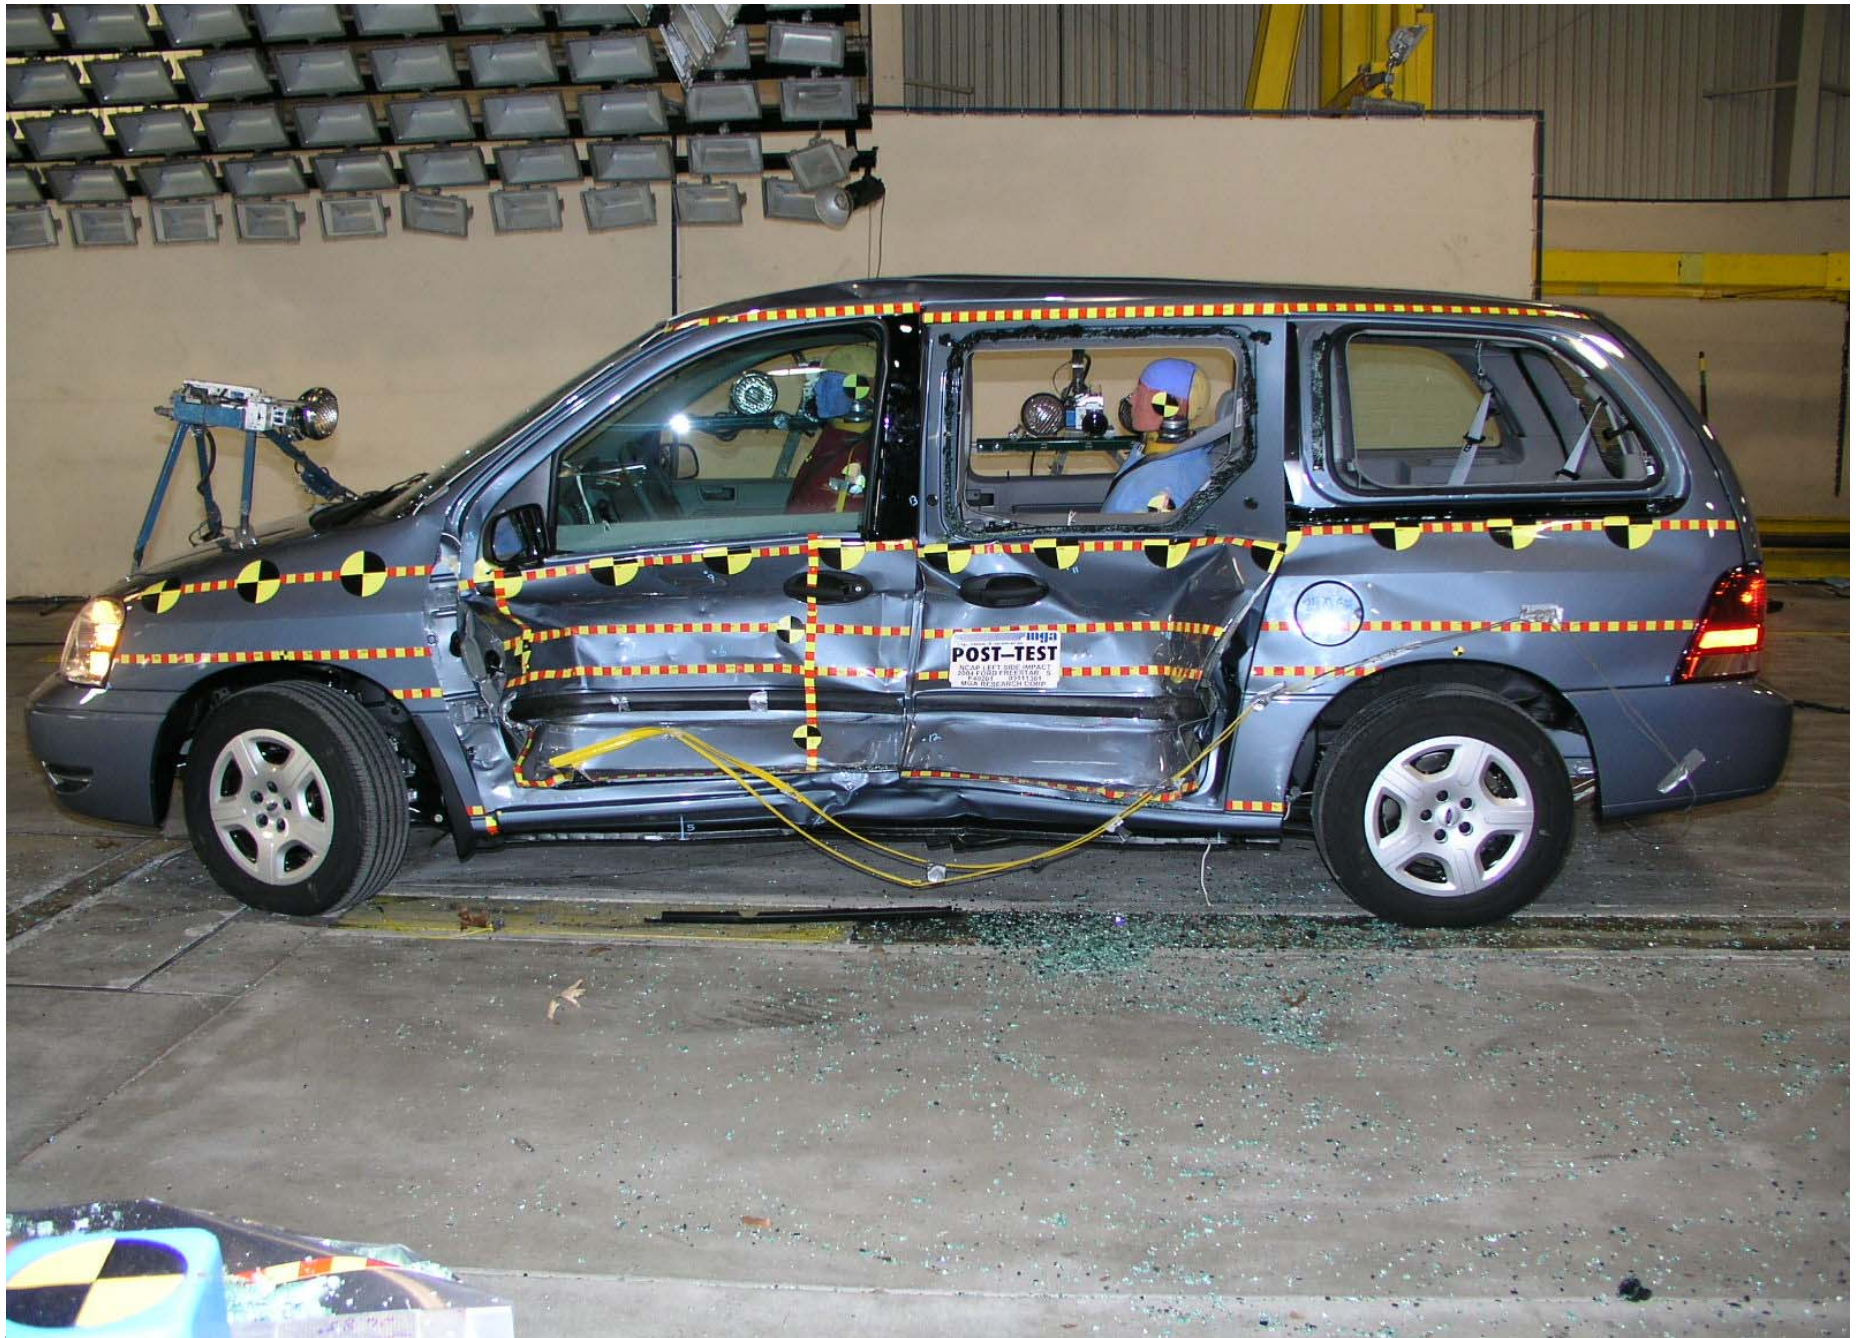
A-8.

Post-Test Left Side View of Test Vehicle

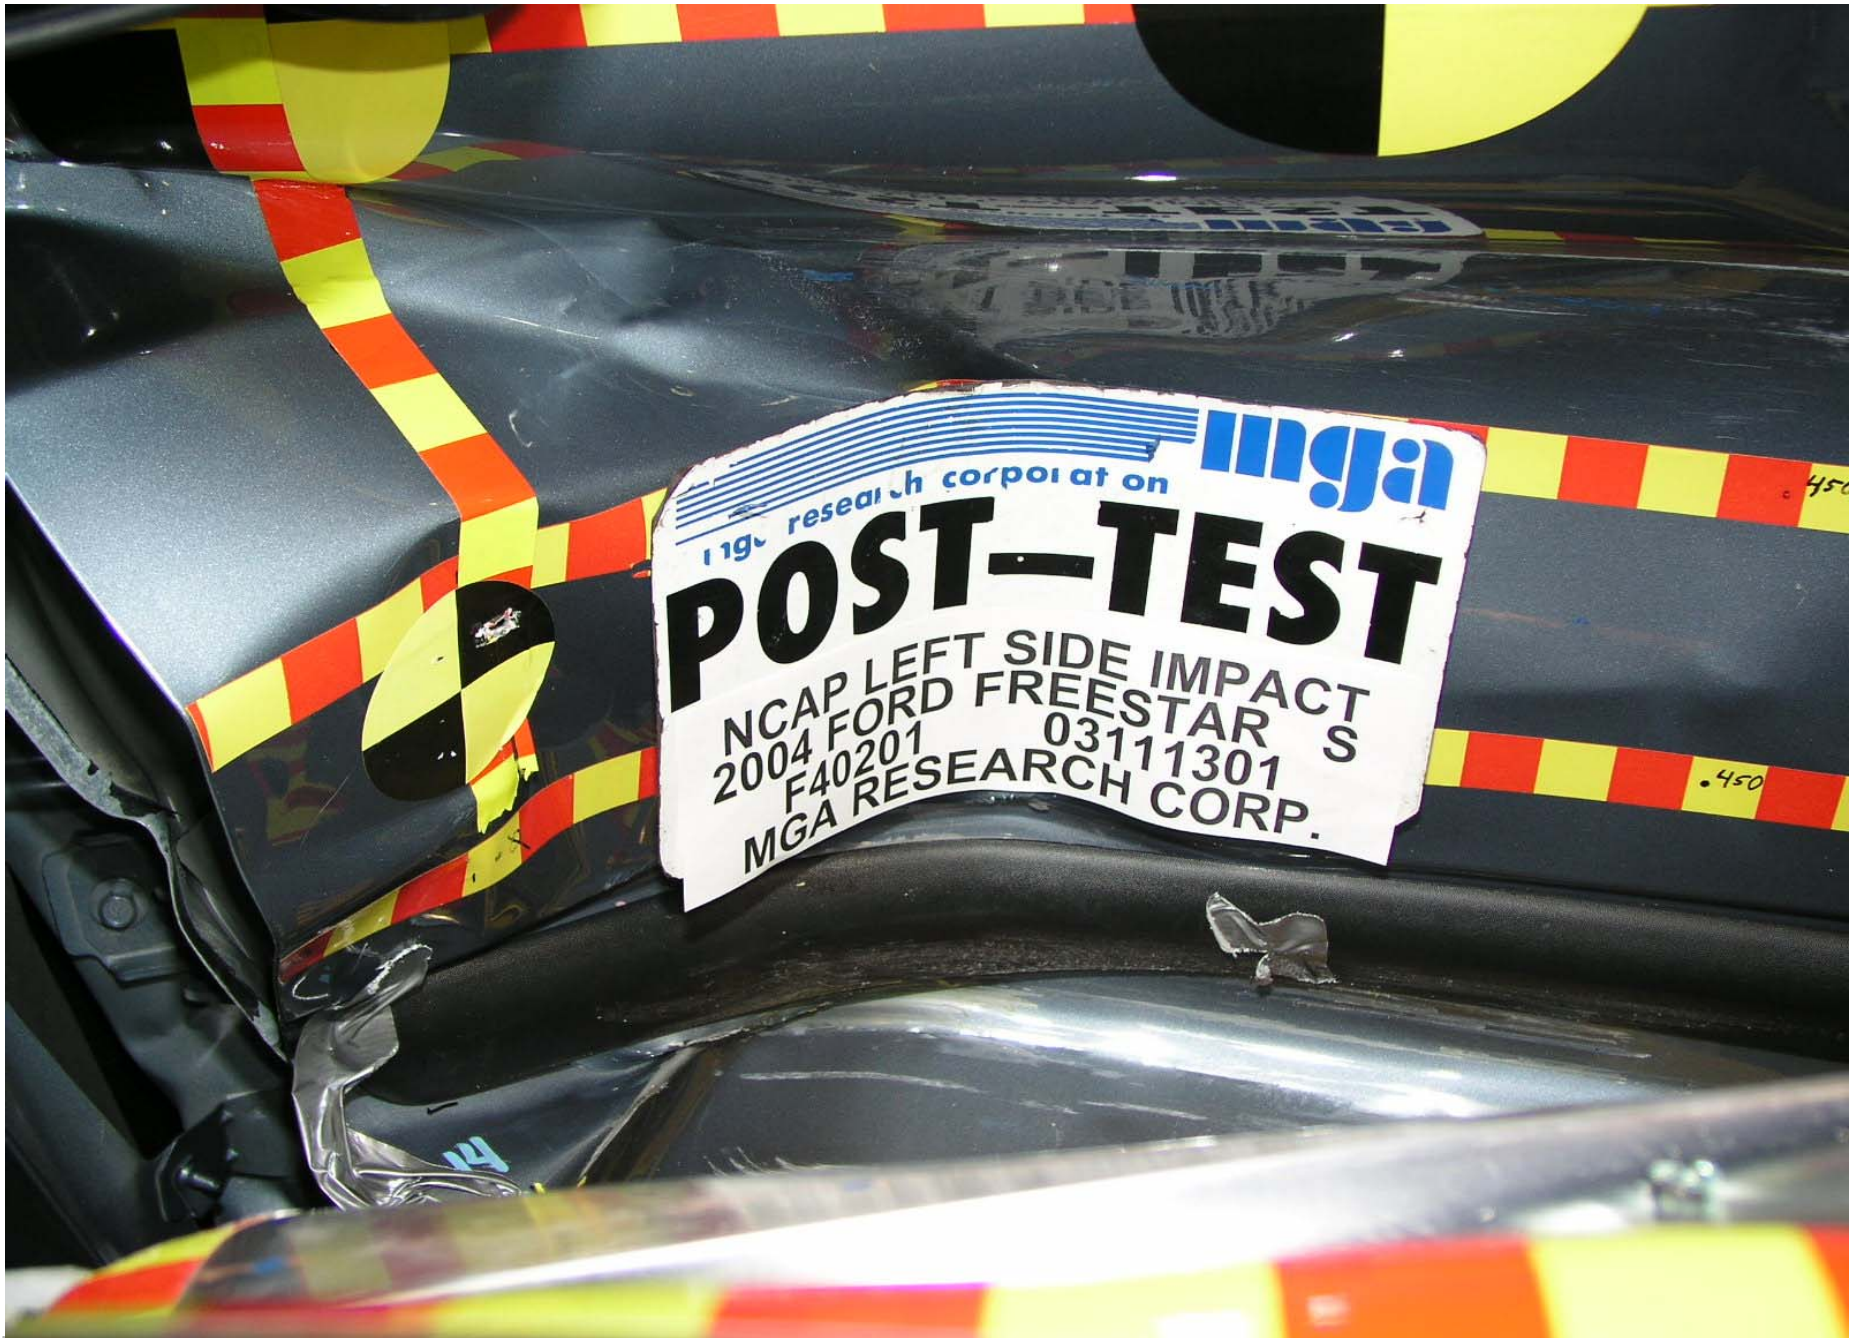
Post-Test Impact Point on Vehicle

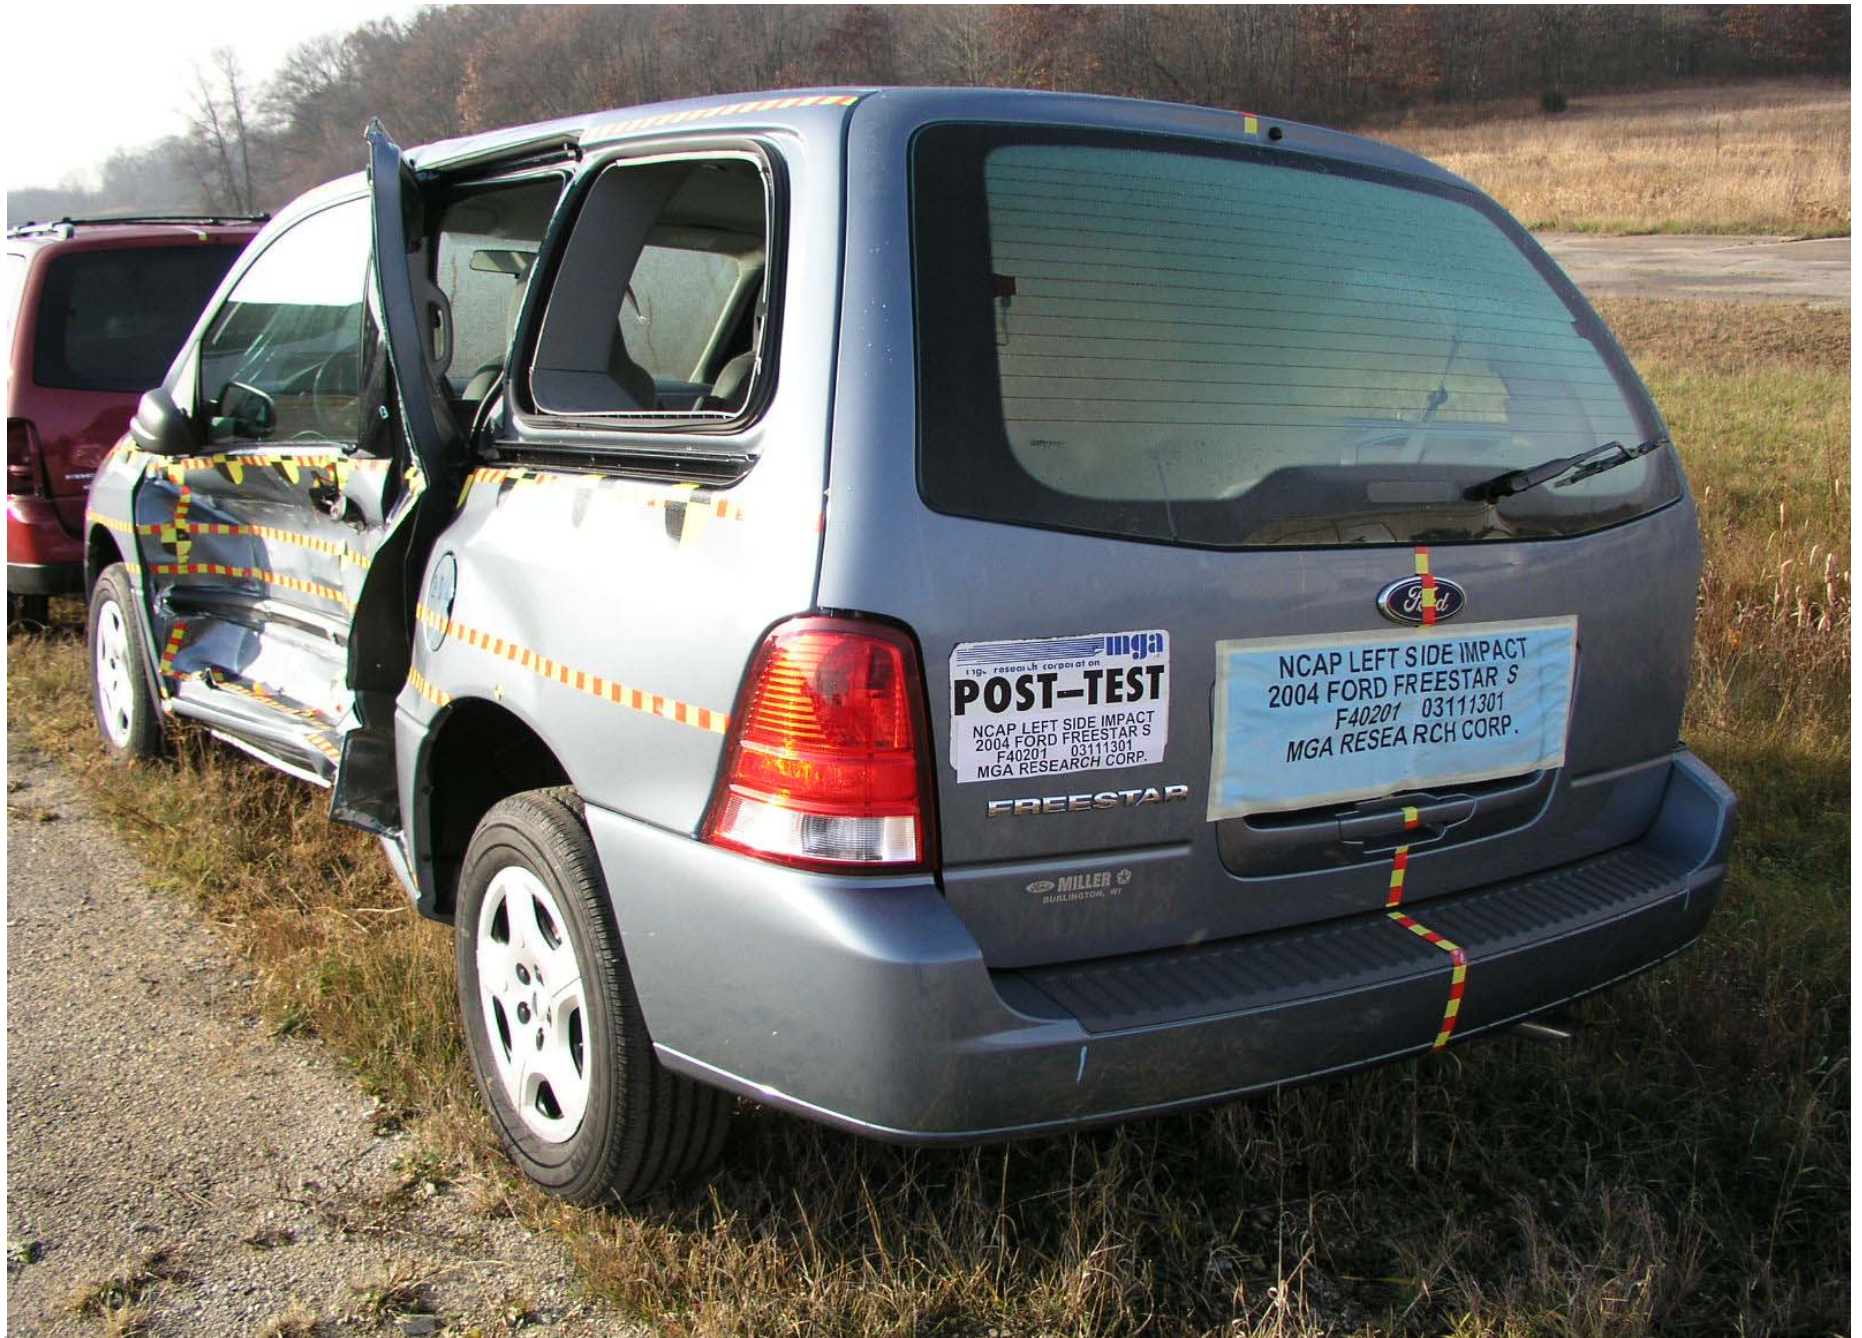
Post-Test Rear ¾ View of Left Side Doors of Test Vehicle

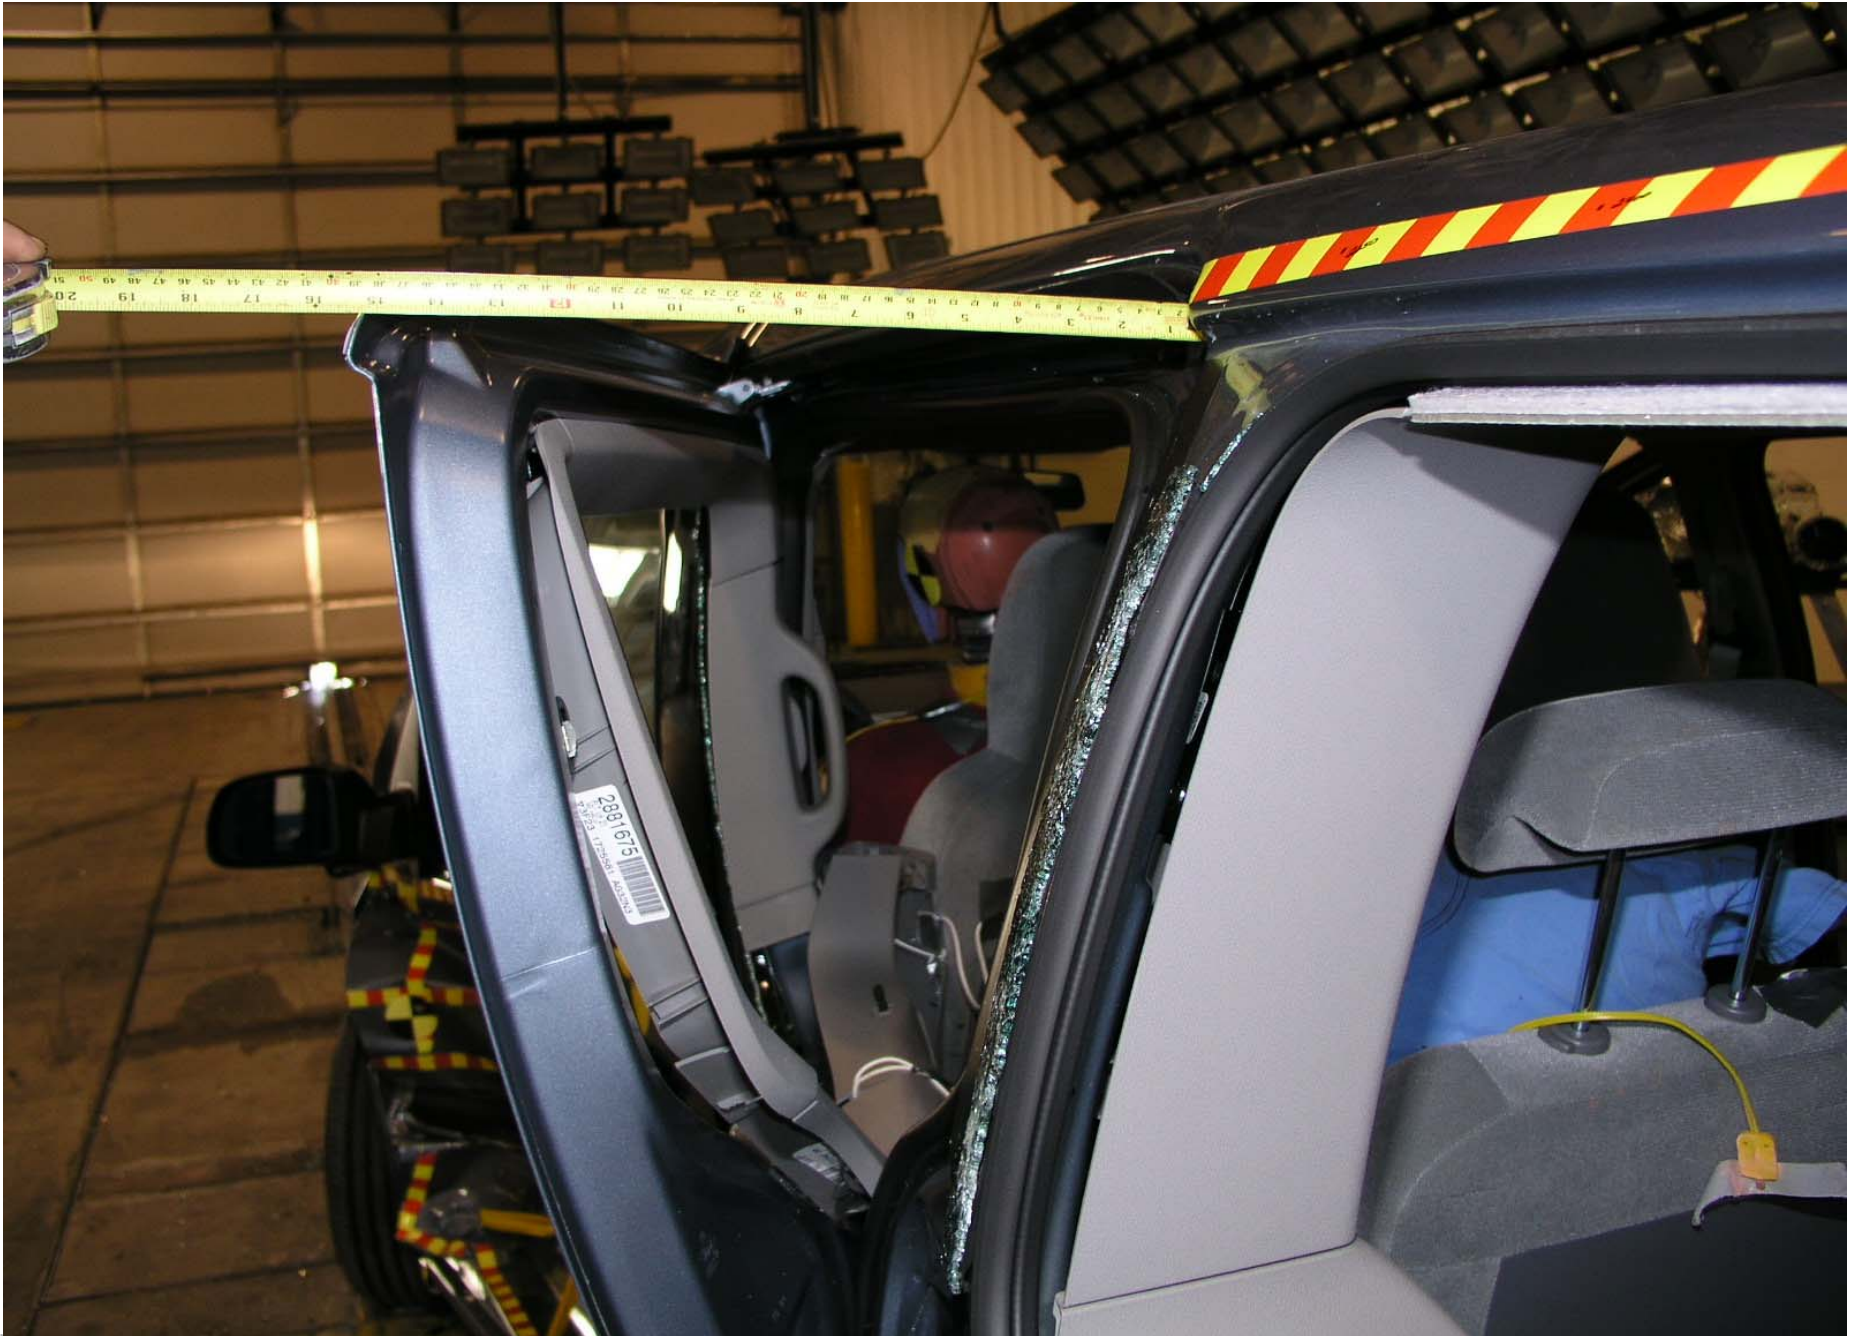
Post-Test Left Rear Door Opening

The left rear sliding door had an opening at the top but remained latched. The opening was approximately 1 foot at the top. See Photos A25, A26, and A27.

Description	Front	Rear
Left Side Door Opening	Door remained closed and latched; Door opened without tools	Remained latched but there was almost a foot opening on the top part of door.
Right Side Door Opening	Door remained closed and latched; Door opened without tools	Door remained closed and latched; Door opened without tools
Seat Movement	0	0
Seat Back Failure	None	None

Critical Areas of Performance	Observations and Conclusions
Pillar Performance	No Separation
Sill Separation	None
Windshield Damage	None
Window Damage	Left Rear and Left Third Seating Row
Other Notable Effects	The left rear sliding door had an opening of about 1 foot.

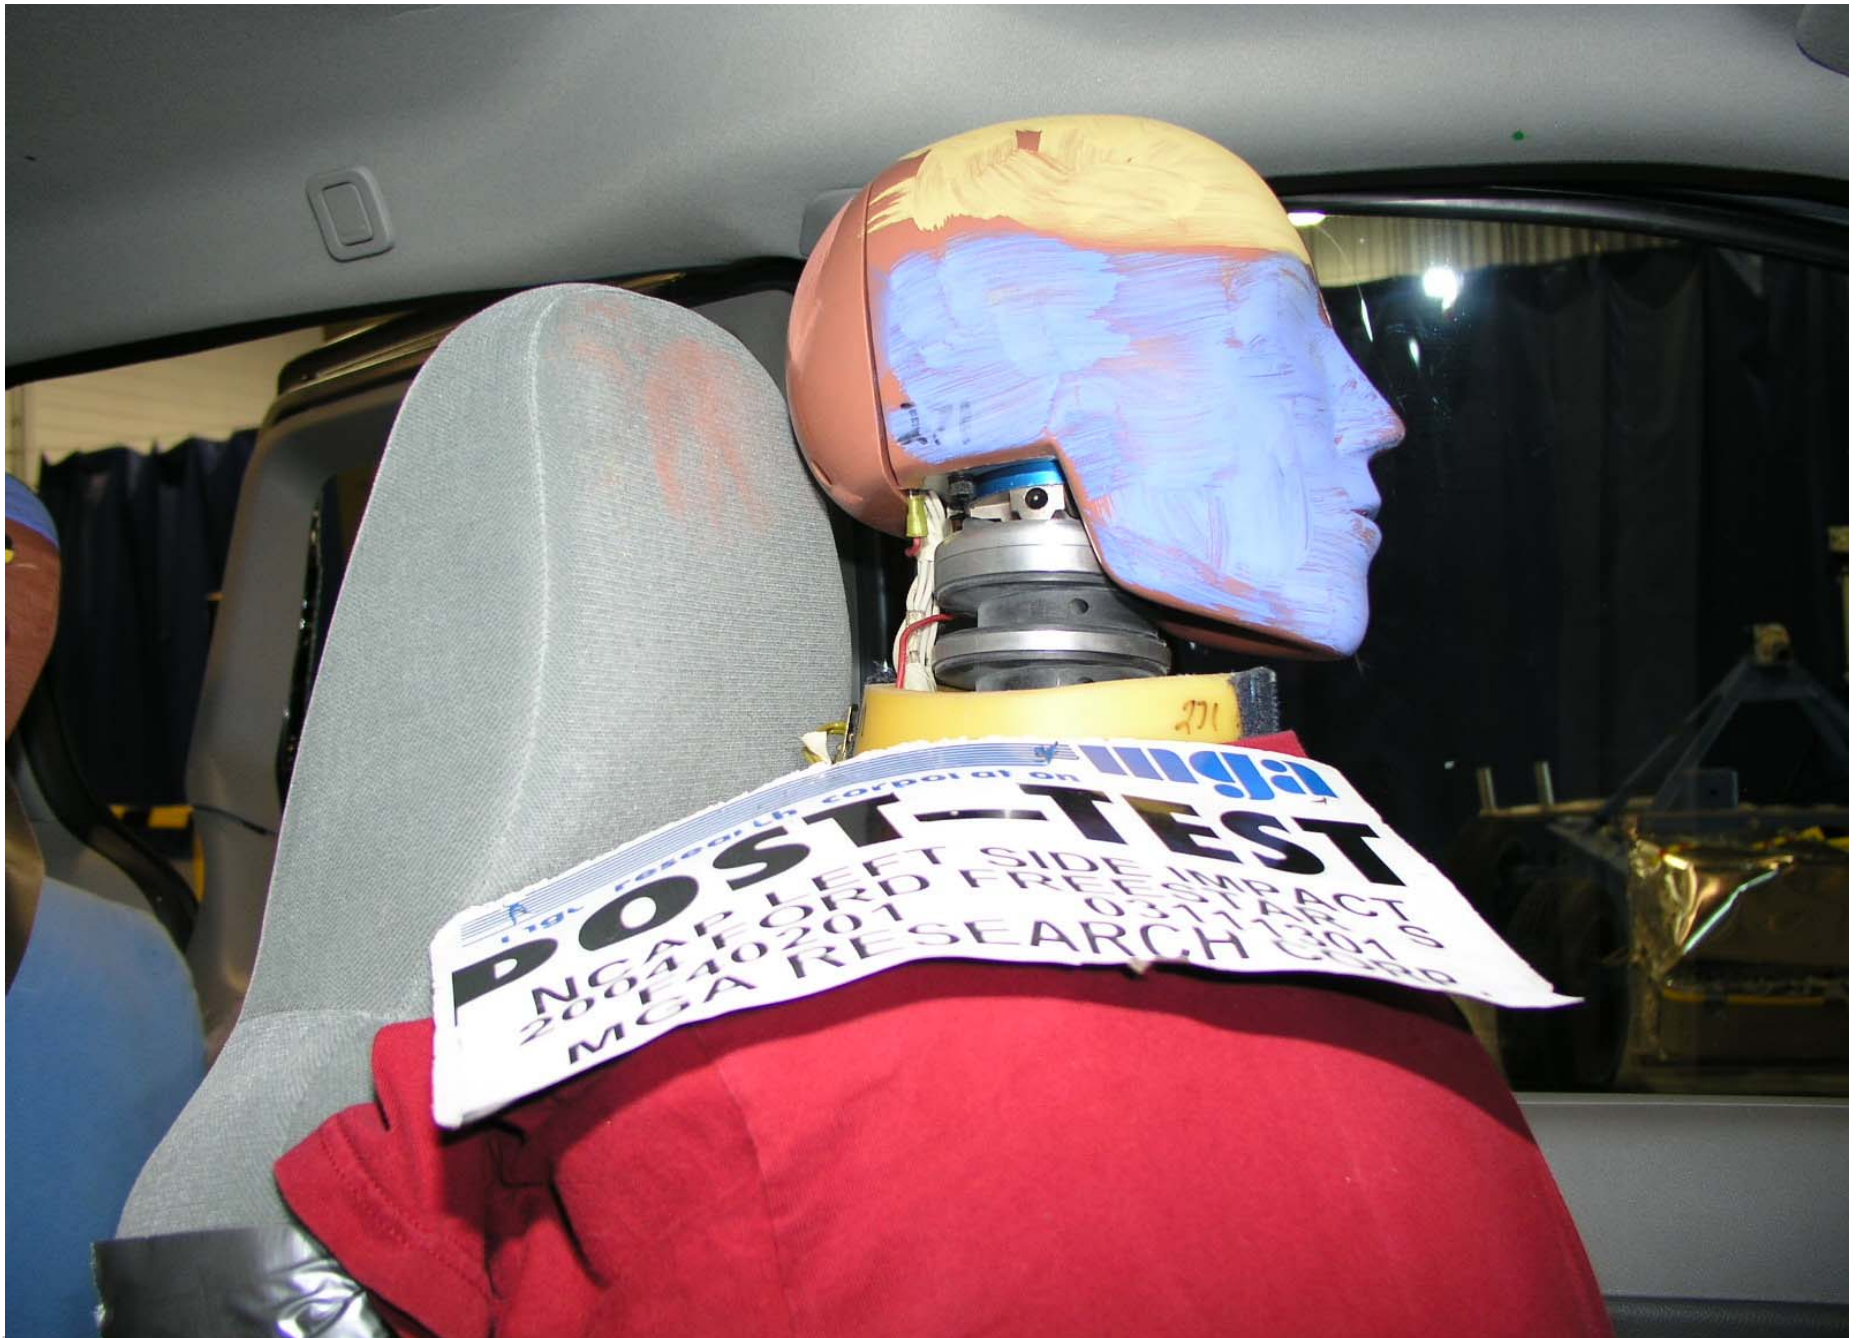
Post-Test Driver Dummy Head Contact
