REPORT NUMBER: 301-CAL-03-01

**SAFETY COMPLIANCE TESTING FOR FMVSS 301  
FUEL SYSTEM INTEGRITY**

VOLVO GOTHENBURG SWEDEN  
2003 VOLVO V70  
STATION WAGON

NHTSA NUMBER: C35900

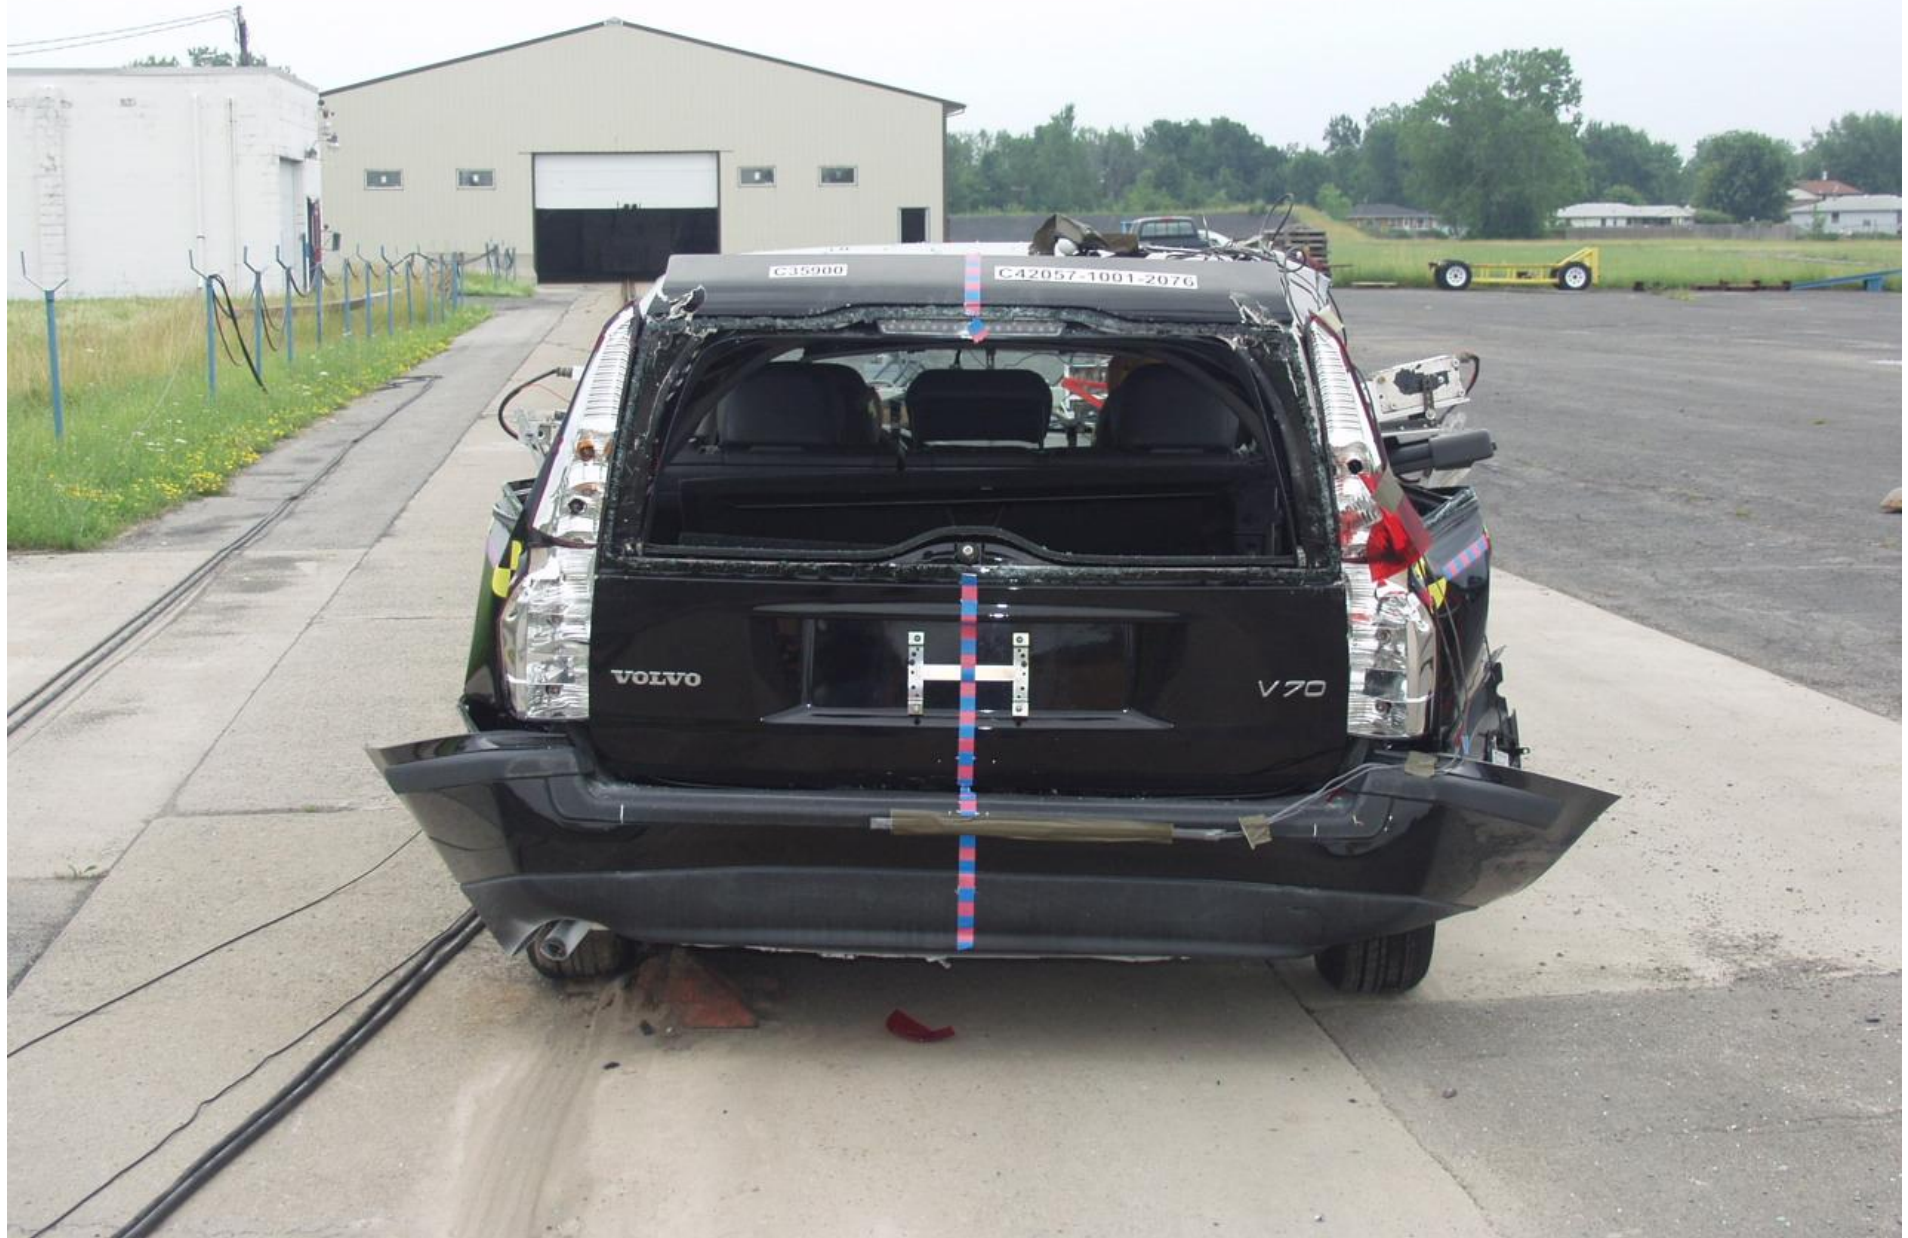
Figure A-8 POST-TEST REAR VIEW

Vehicle Length:  
Pre-Test Left = 4585 ; C/L = 4711 Right = 4586  
Post-Test Left = 4341 ; C/L = 4466 Right = 4362  
Crush Left = 244 ; C/L = 245 Right = 224  
AVERAGE = 238 millimeters
