REPORT NUMBER: 301-CAL-03-05

**SAFETY COMPLIANCE TESTING FOR FMVSS 301
FUEL SYSTEM INTEGRITY**

SATURN CORPORATION
2003 SATURN ION
4-DOOR SEDAN

FINAL REPORT

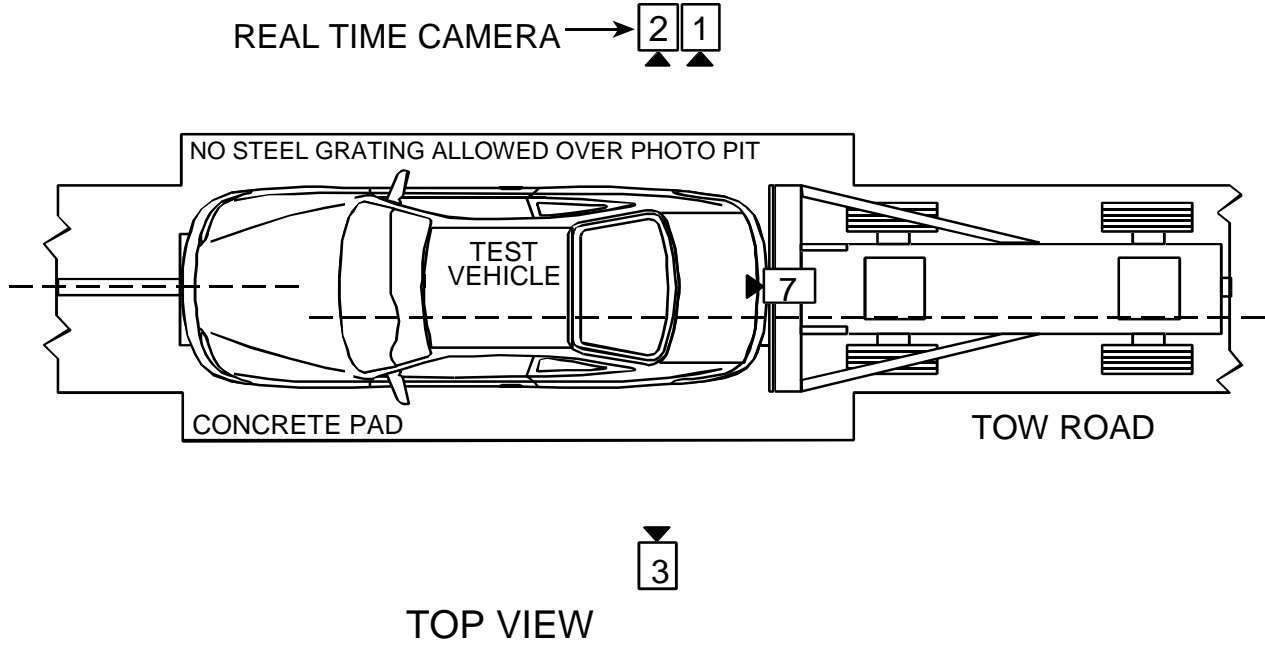
HIGH SPEED CAMERA LOCATIONS

CAMERA NO.	VIEW	CAMERA POSITIONS (mm)*			ANGLE** (degrees)	LENS (mm)	SPEED (fps)
		X	Y	Z			
1	Real-Time Camera	-	-	-	-	-	24
2	Right Side View	15480	1690	1095	-1	35	1000
3	Left Side View	16512	2078	1000	1	35	1000
4	Vehicle Front Underbody View	0	3380	-1956	90	13	995
5	Vehicle Mid-Section Underbody View	0	1938	-1956	90	13	1005
6	Vehicle Rear Underbody View	0	992	-1956	90	13	1030
7	Moving Barrier View	0	0	2515	-105	13	1000
8	Overhead Overall View	-508	0	9804	-90	13	1000
9†	Onboard Driver View	855	2715	970	-6	8	1000
10†	Onboard Passenger View	855	2702	975	-5	8	1000

- * X = film plant to monorail centerline (+ to left of rail)
- Y = film plane to impact location (+ ahead of impact location)
- Z = film plane to ground (+ above ground)
- ** = referenced to horizontal plane

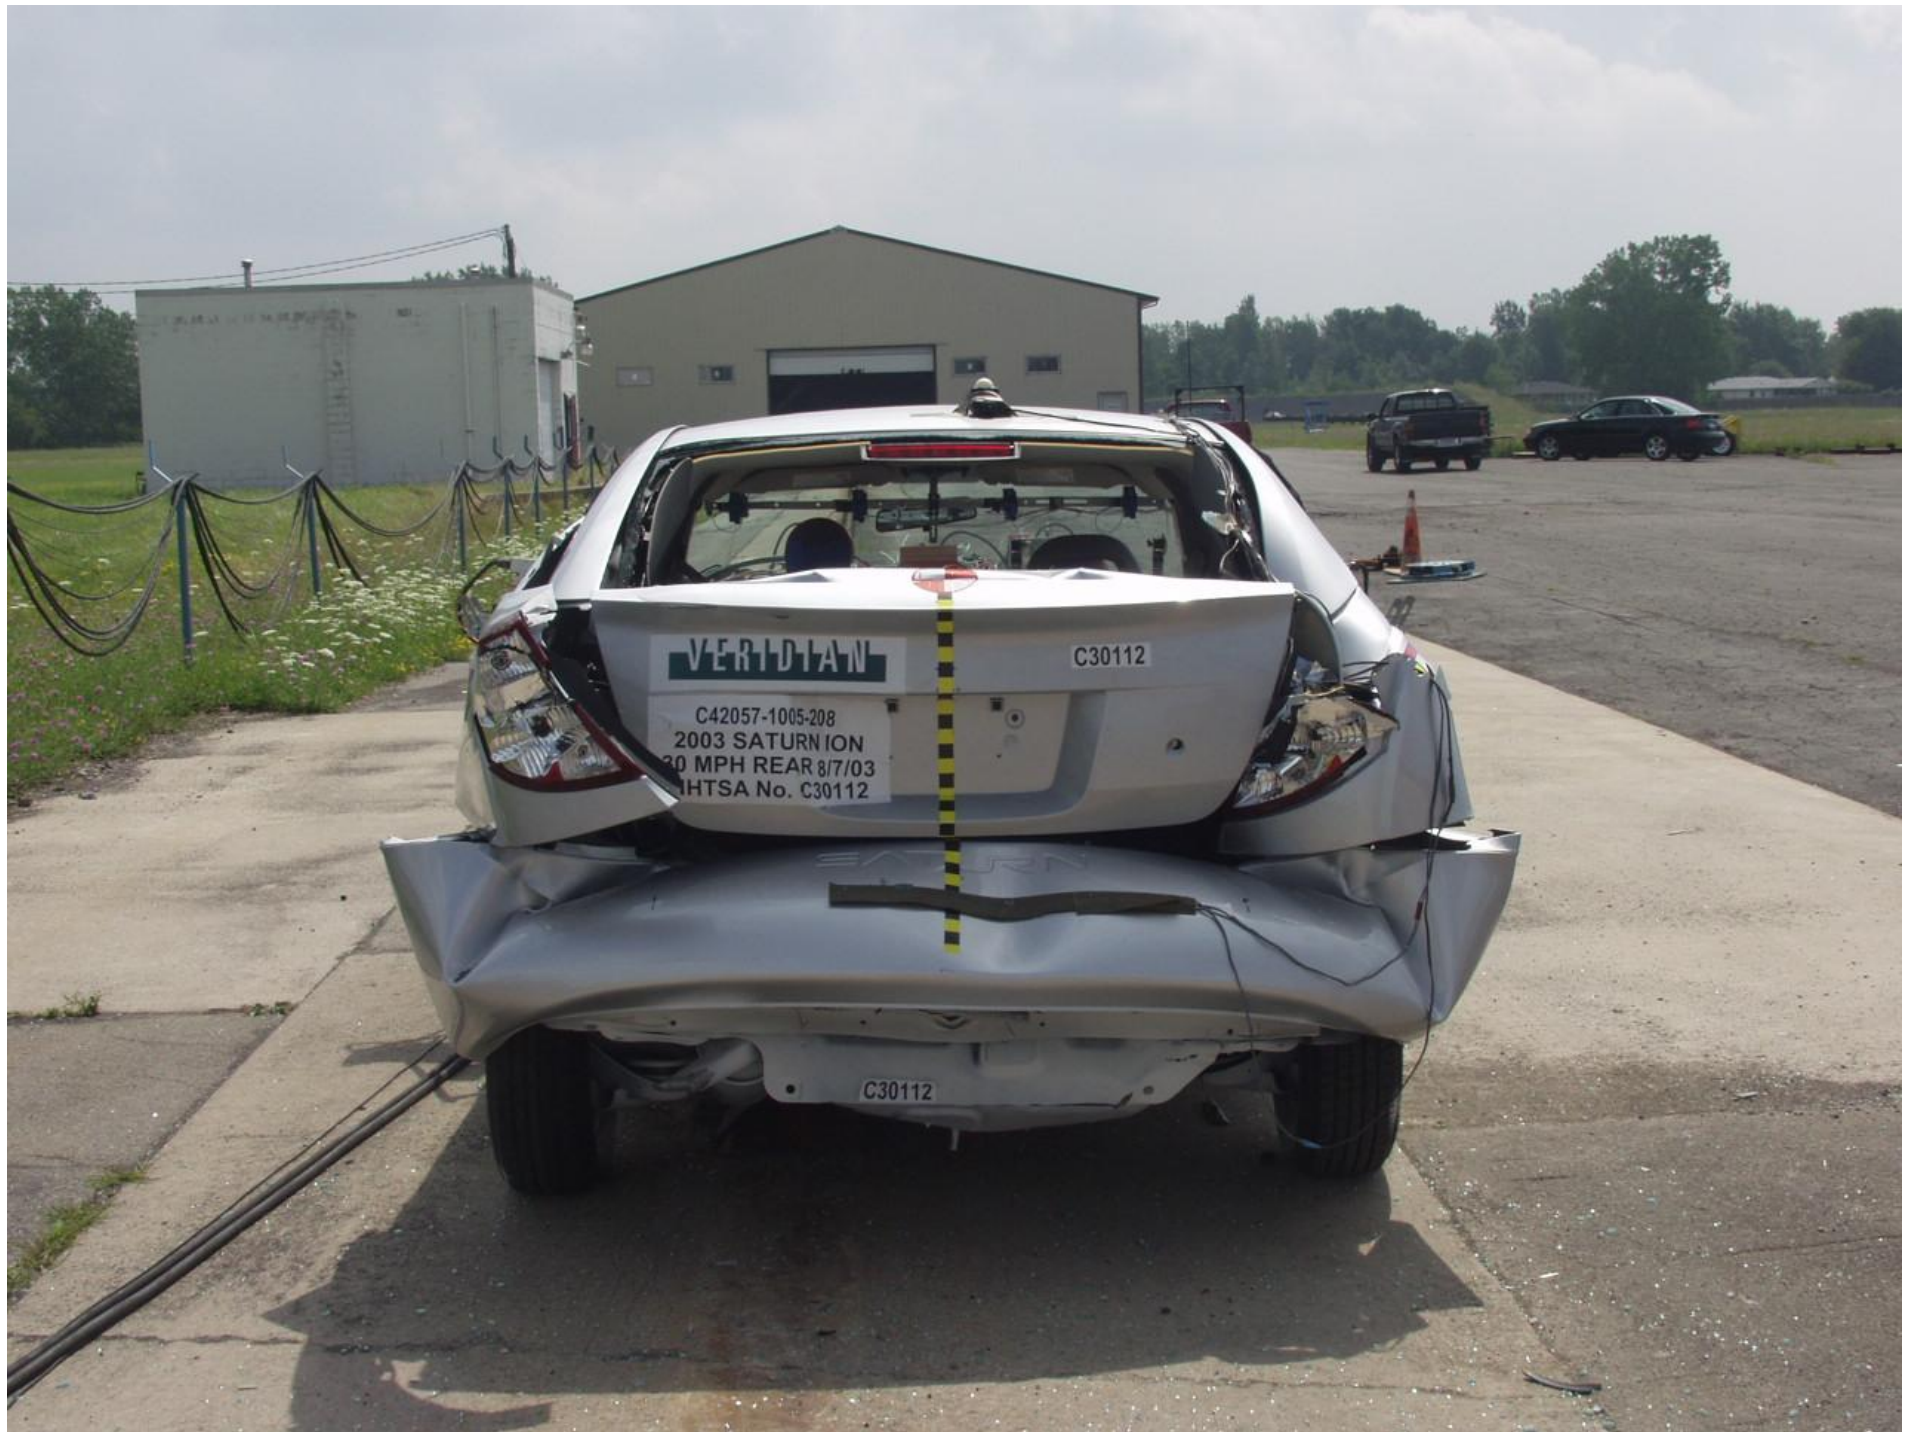
Figure A-8 POST-TEST REAR VIEW

Pre-Test Left = 4523 ; C/L = 4683 Right = 4525
Post-Test Left = 4112 ; C/L = 4212 Right = 4198
Crush Left = 411 ; C/L = 471 Right = 327
AVERAGE = 403 millimeters

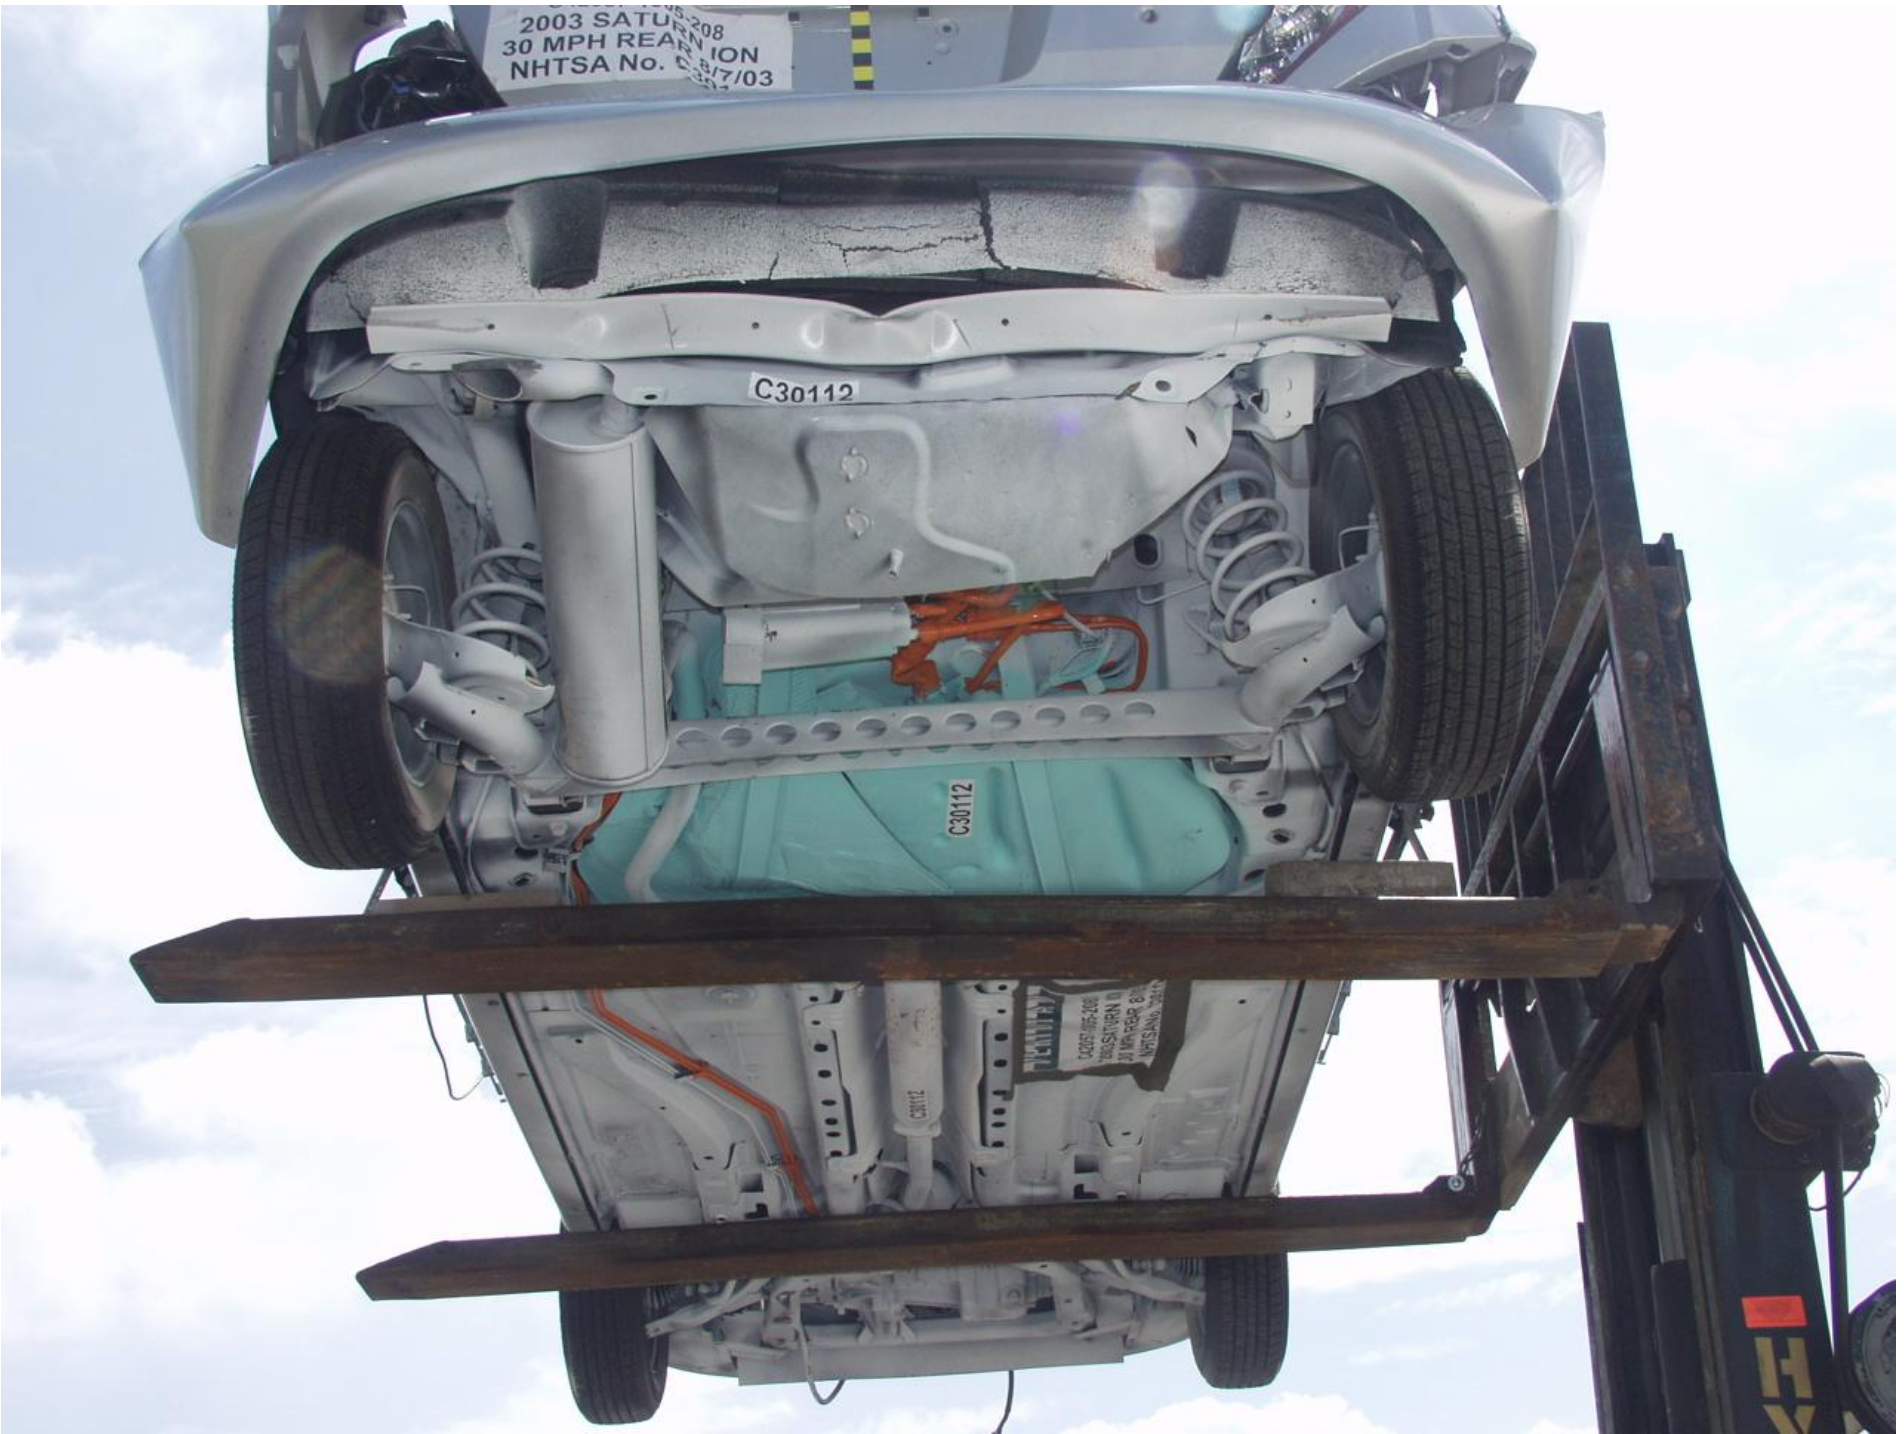
Figure A-16 POST-TEST REAR UNDERBODY VIEW

There was no fuel system fluid spillage following the impact or during any portion of the static rollover test. The average vehicle longitudinal crush was 403 millimeters. The vehicle appeared to comply with all the requirements of FMVSS No. 301 "Fuel System Integrity."

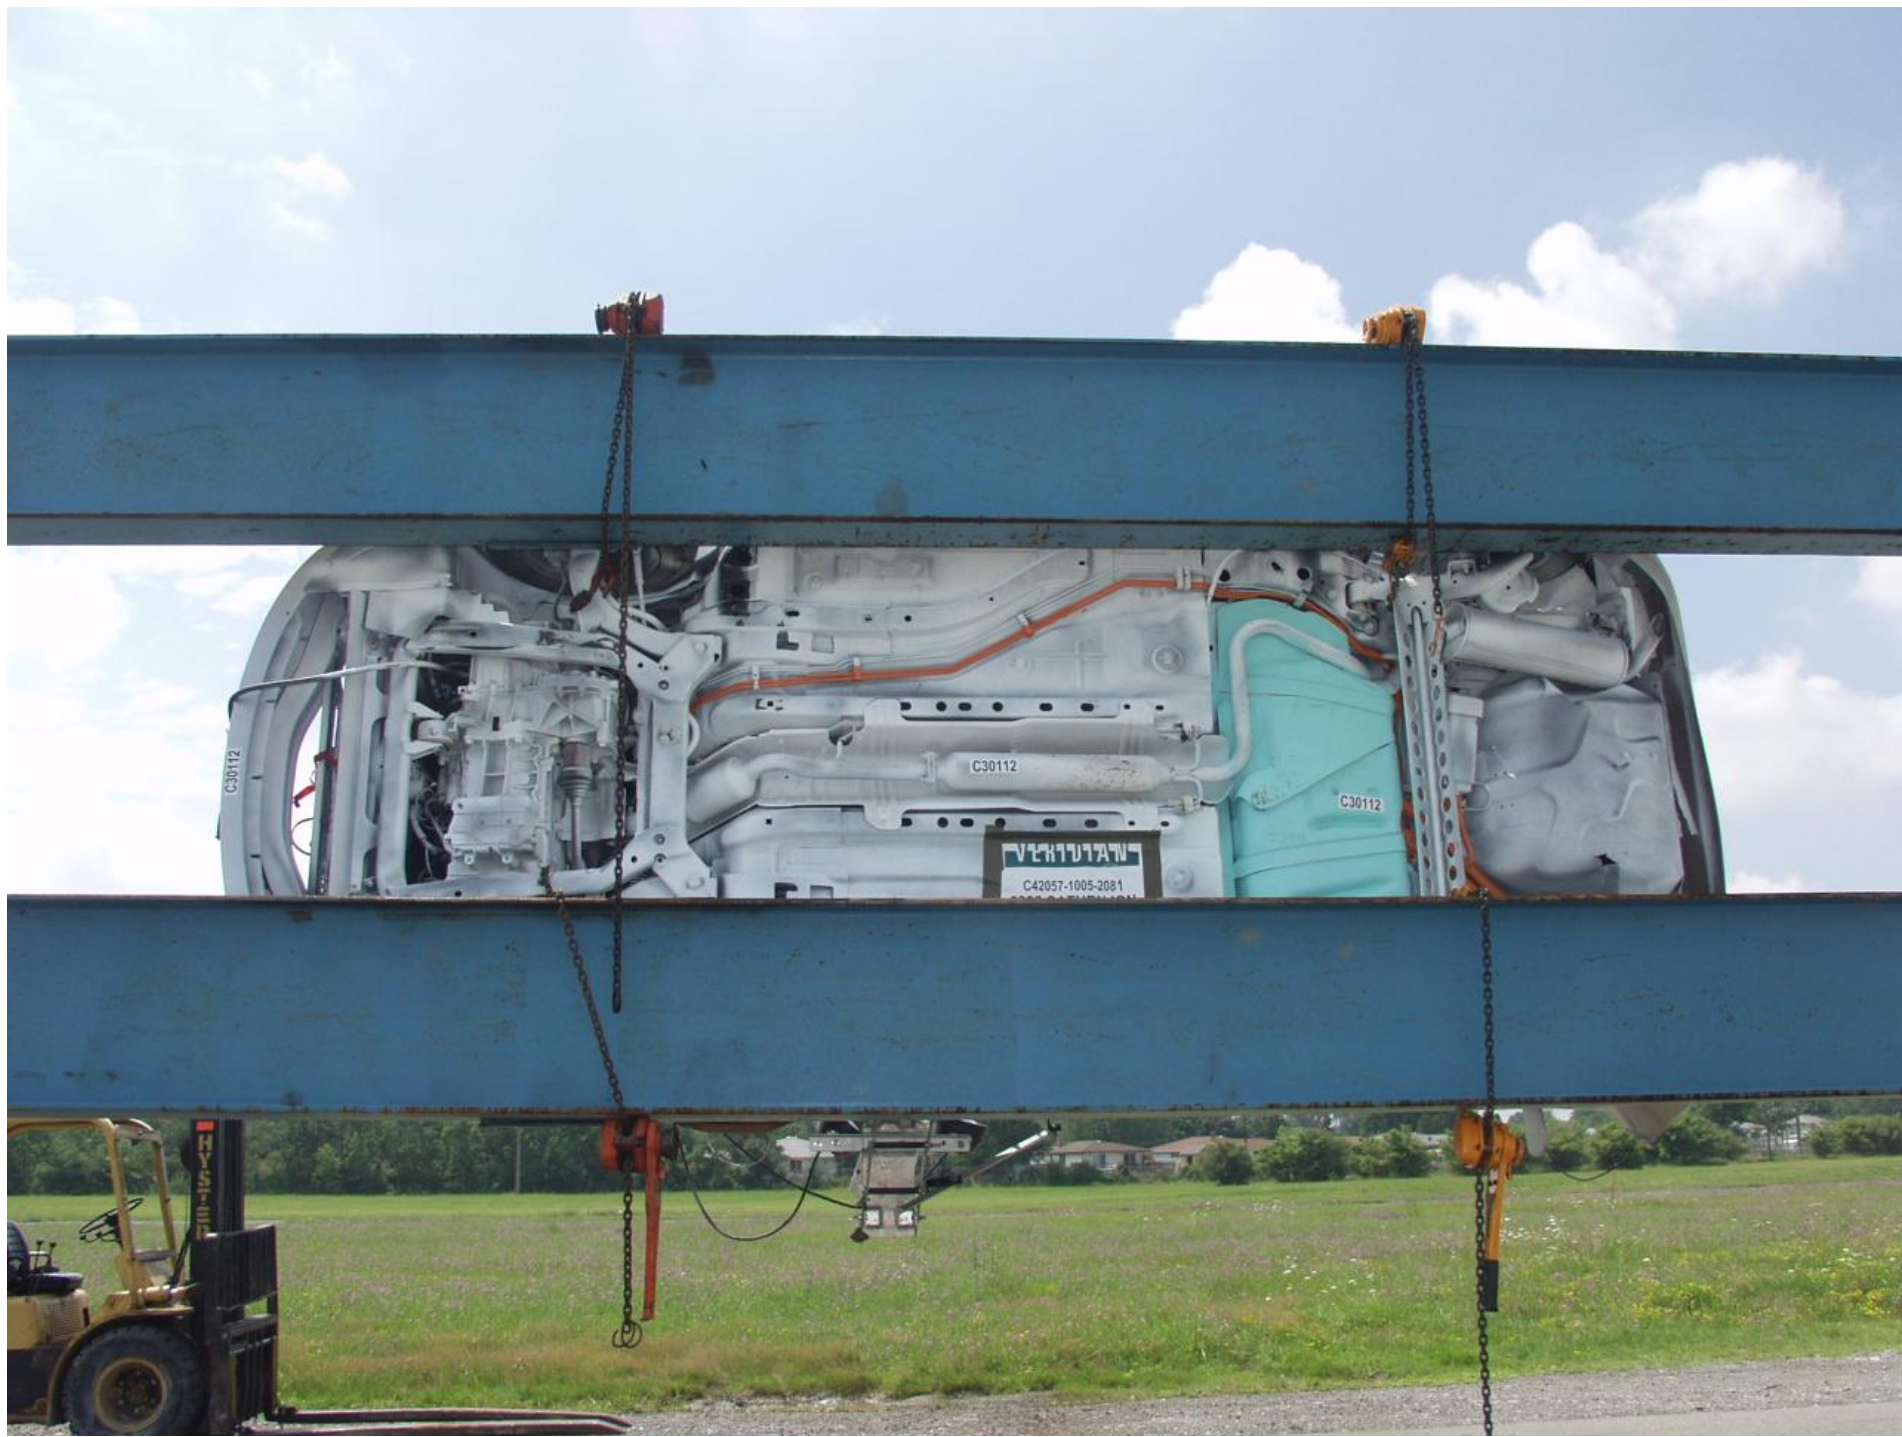
Figure A-19 ROLLOVER 90°

Rollover Stage	Spillage Location
0° - 90°	None
90° - 180°	None
180°-270°	None
270°-360°	None
