**NEW CAR ASSESSMENT PROGRAM  
SIDE IMPACT TEST**

**Hyundai Motor Company  
2004 Hyundai Accent 2 Door  
NHTSA NUMBER: M40508**

**PREPARED BY:  
MGA RESEARCH CORPORATION  
5000 WARREN ROAD  
BURLINGTON, WI 53105**

**FINAL REPORT**

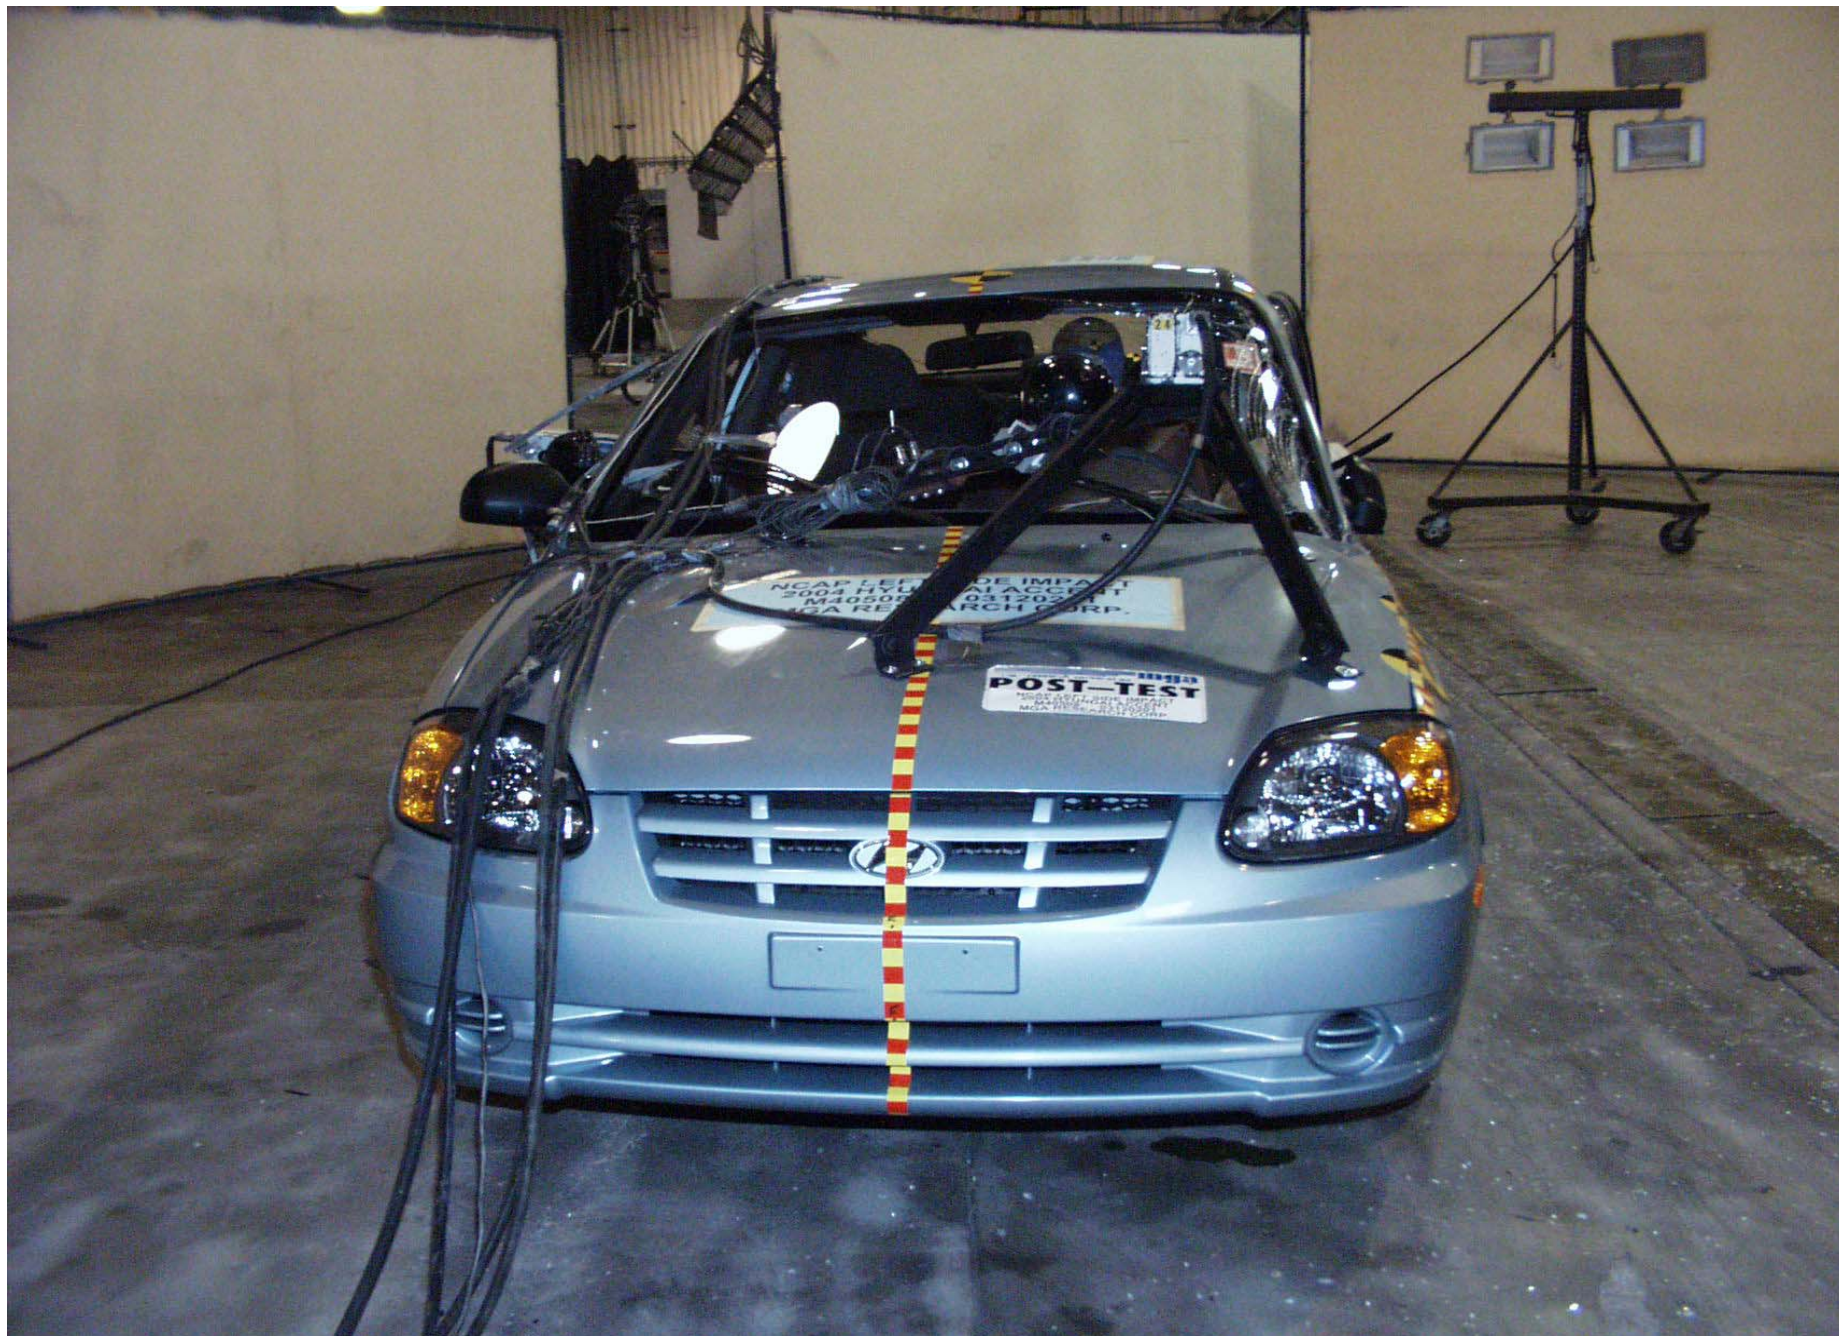
Post-Test Front View of Test Vehicle

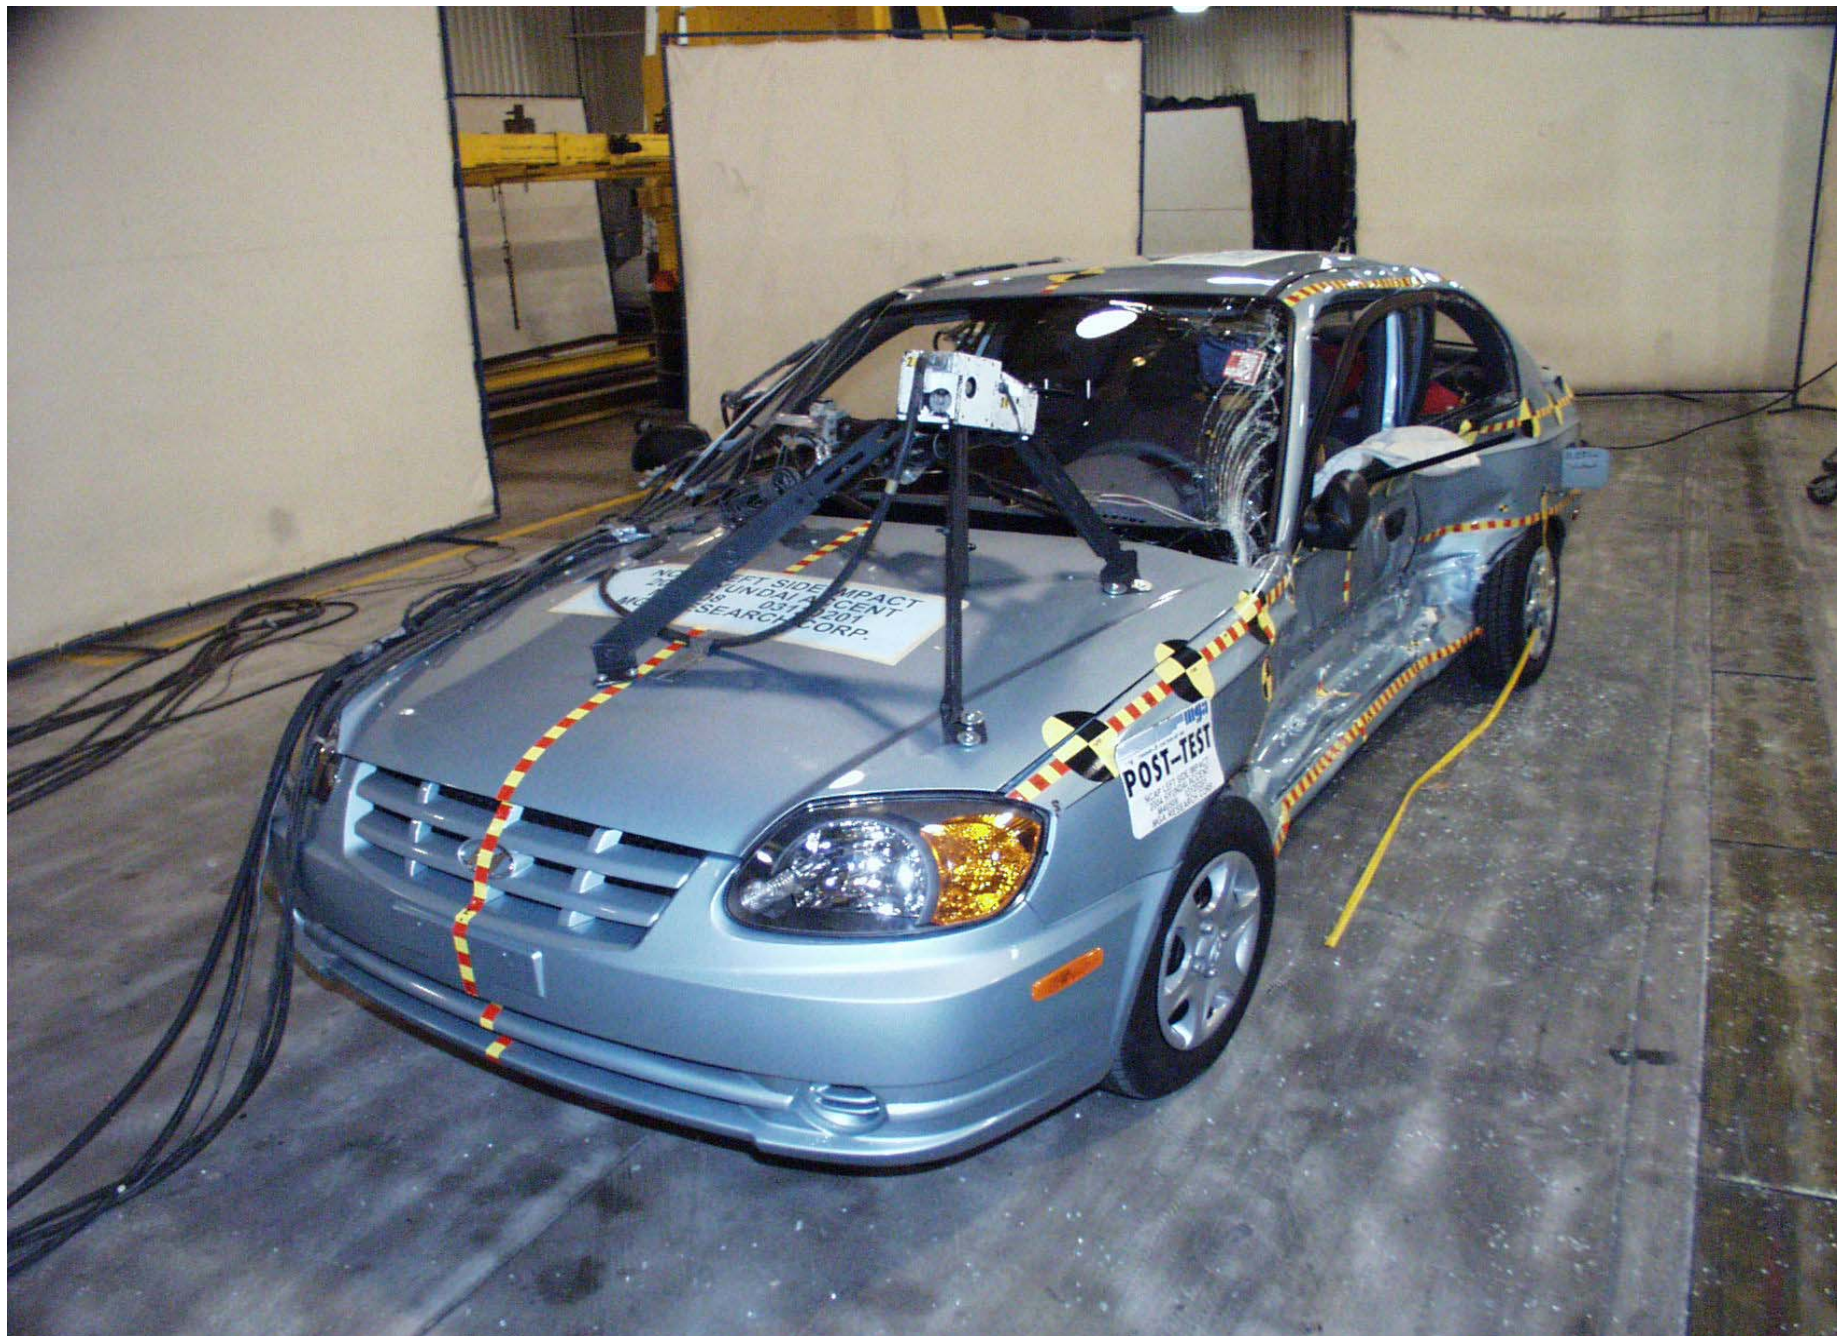
Post-Test Left Front  $\frac{3}{4}$  View of Test Vehicle

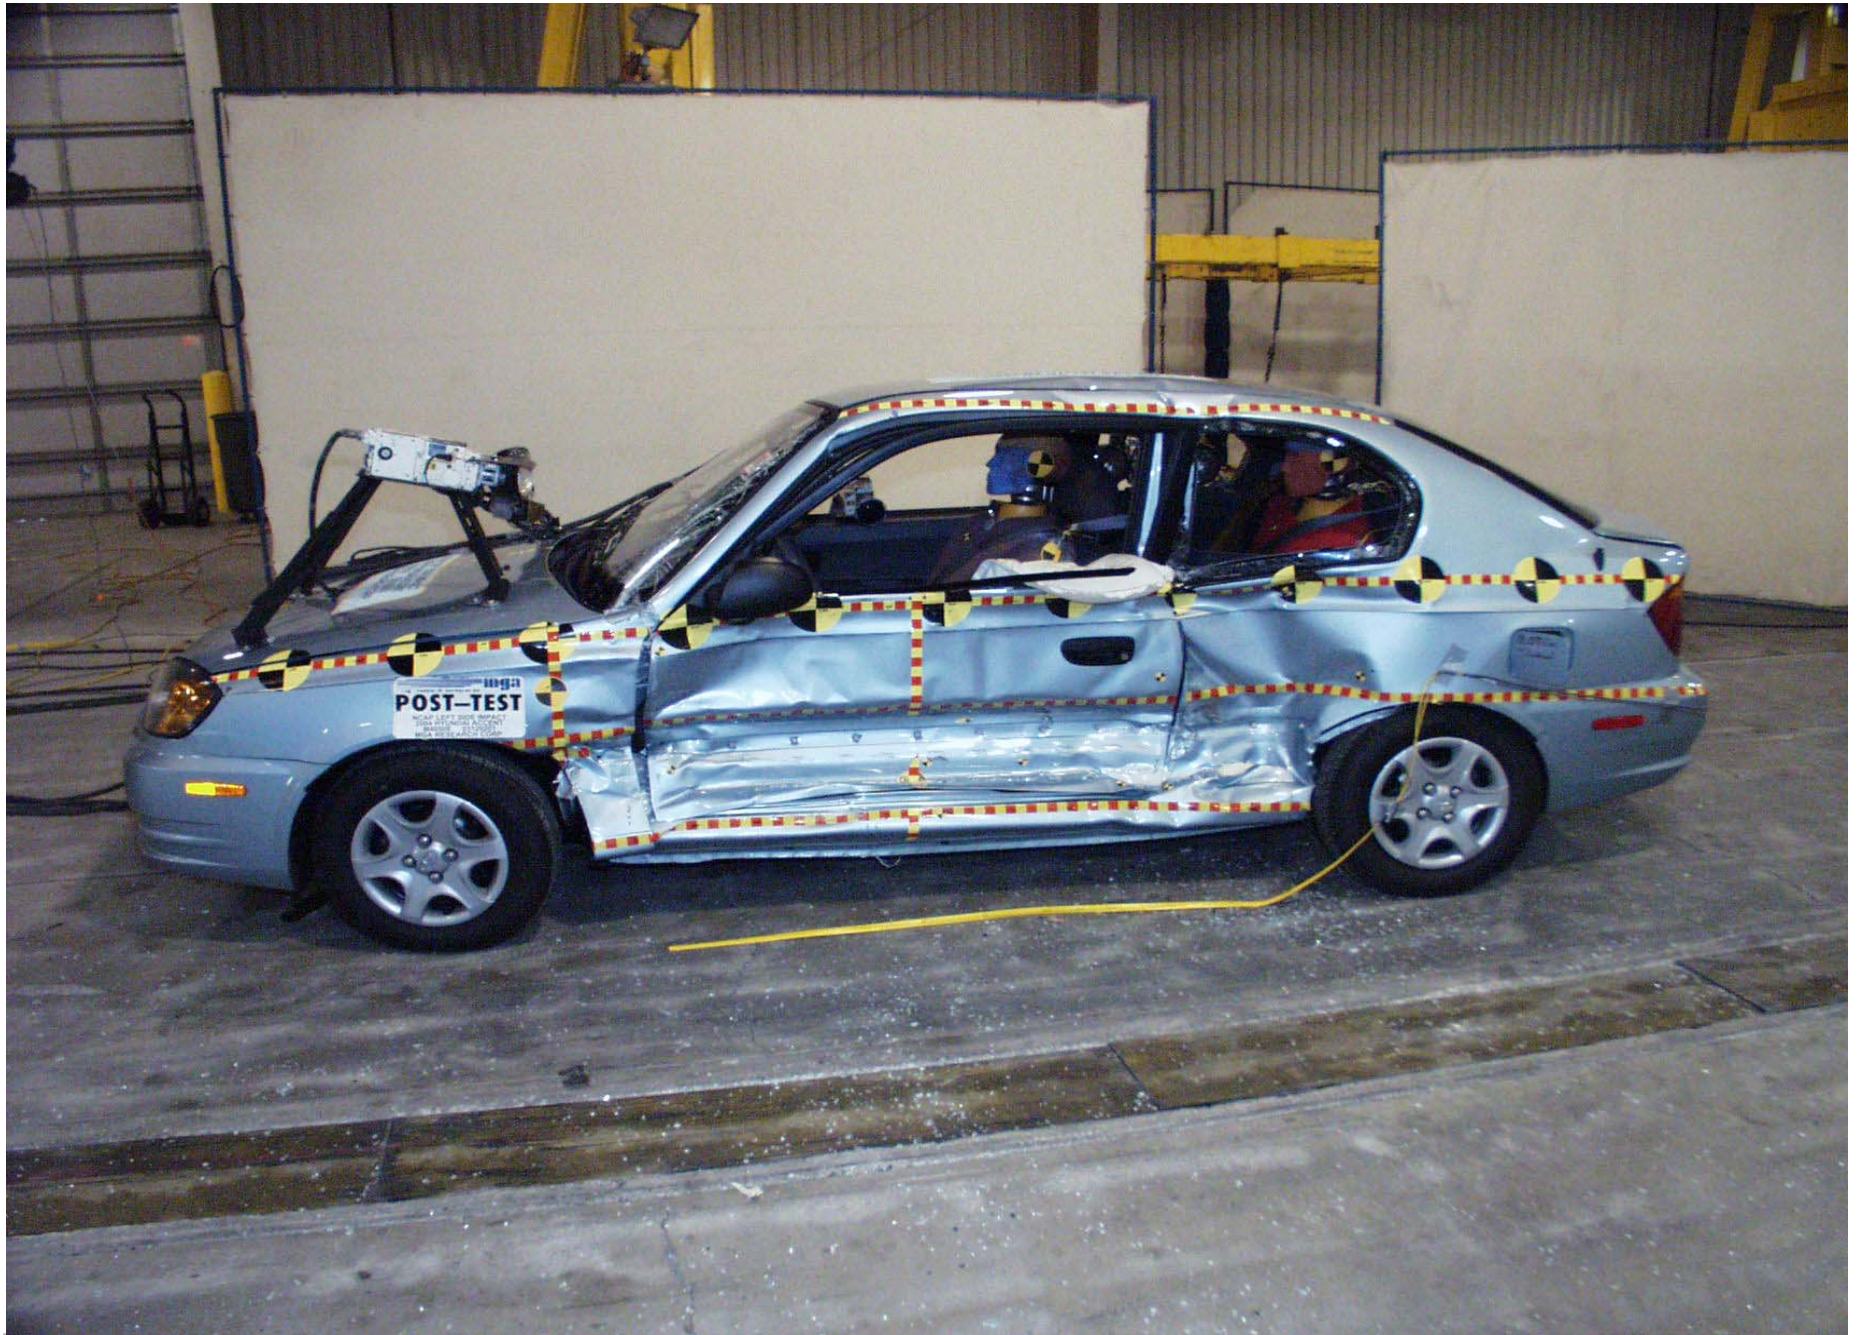
Post-Test Left Side View of Test Vehicle

The test vehicle sustained a maximum static crush of 343 mm at level 2, 1350 mm rearward of the left vertical impact point. The driver and passenger SID/HIII's, Serial Nos. 904 and 271 respectively, were calibrated just prior to this test. The SID/HIII's injury criteria are summarized as follows:

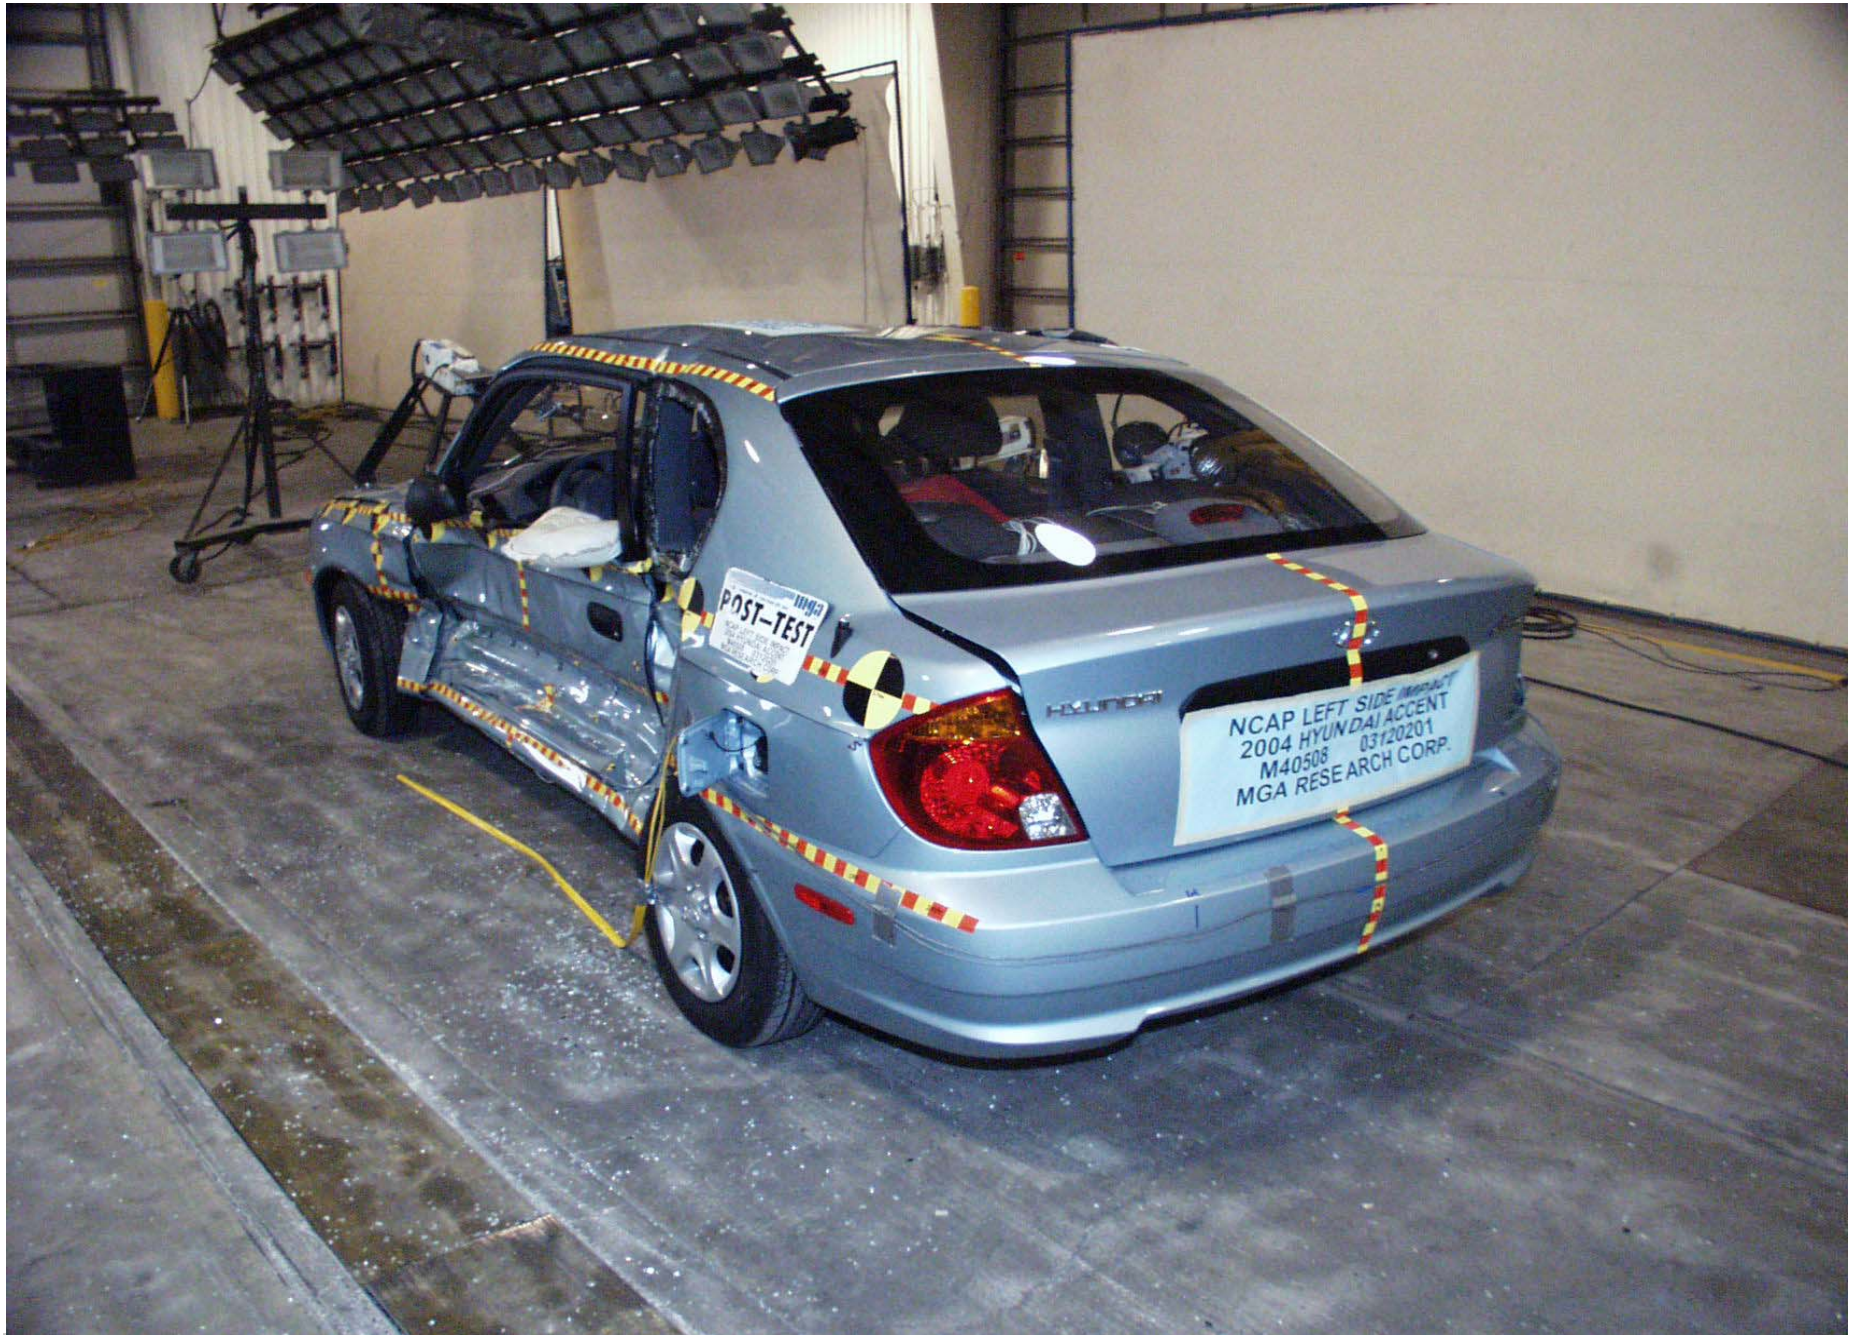
Post-Test Left Rear  $\frac{3}{4}$  View of Test Vehicle

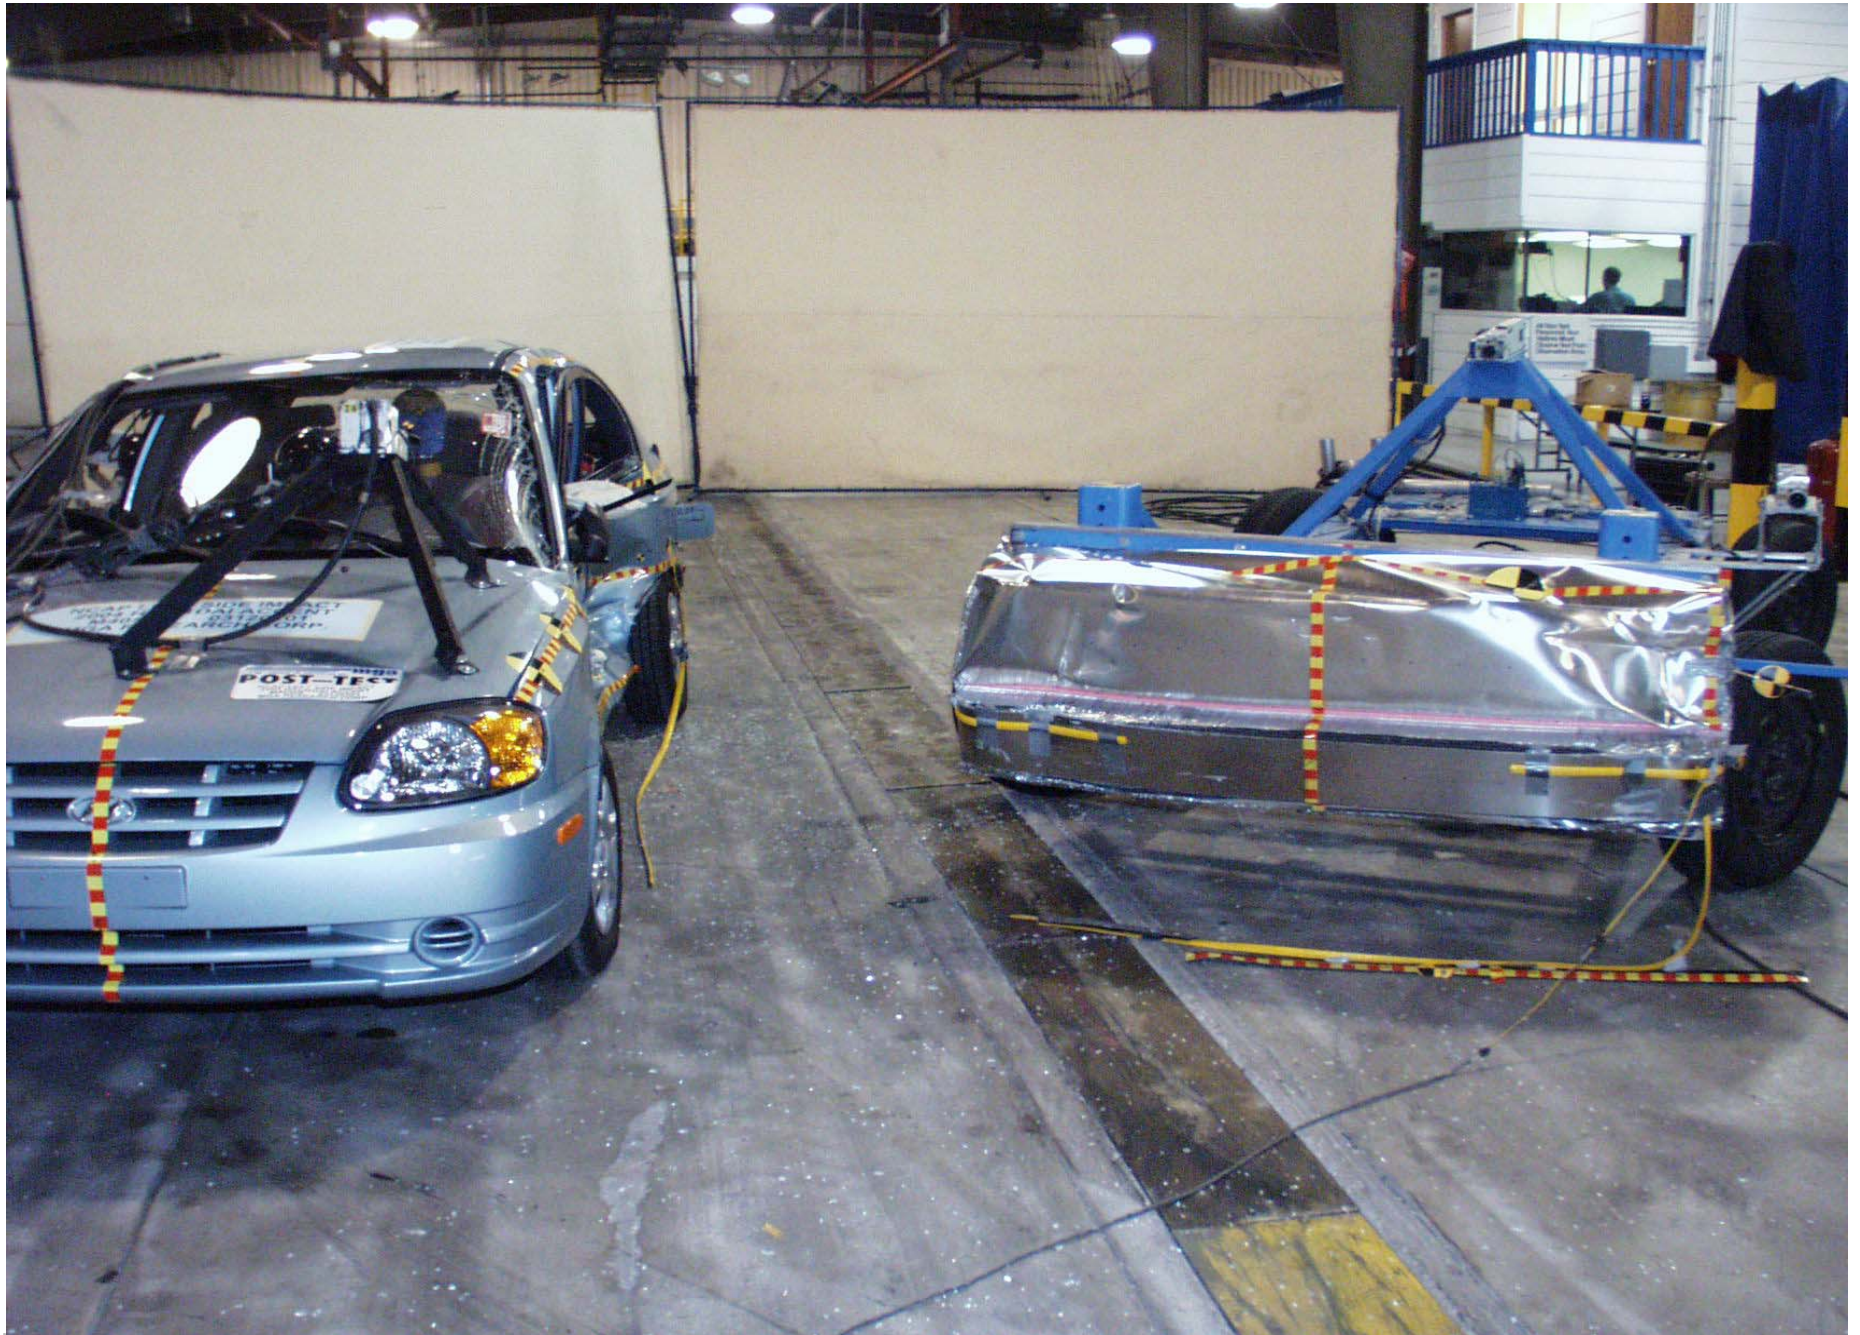
Post-Test MDB and Vehicle (left side)

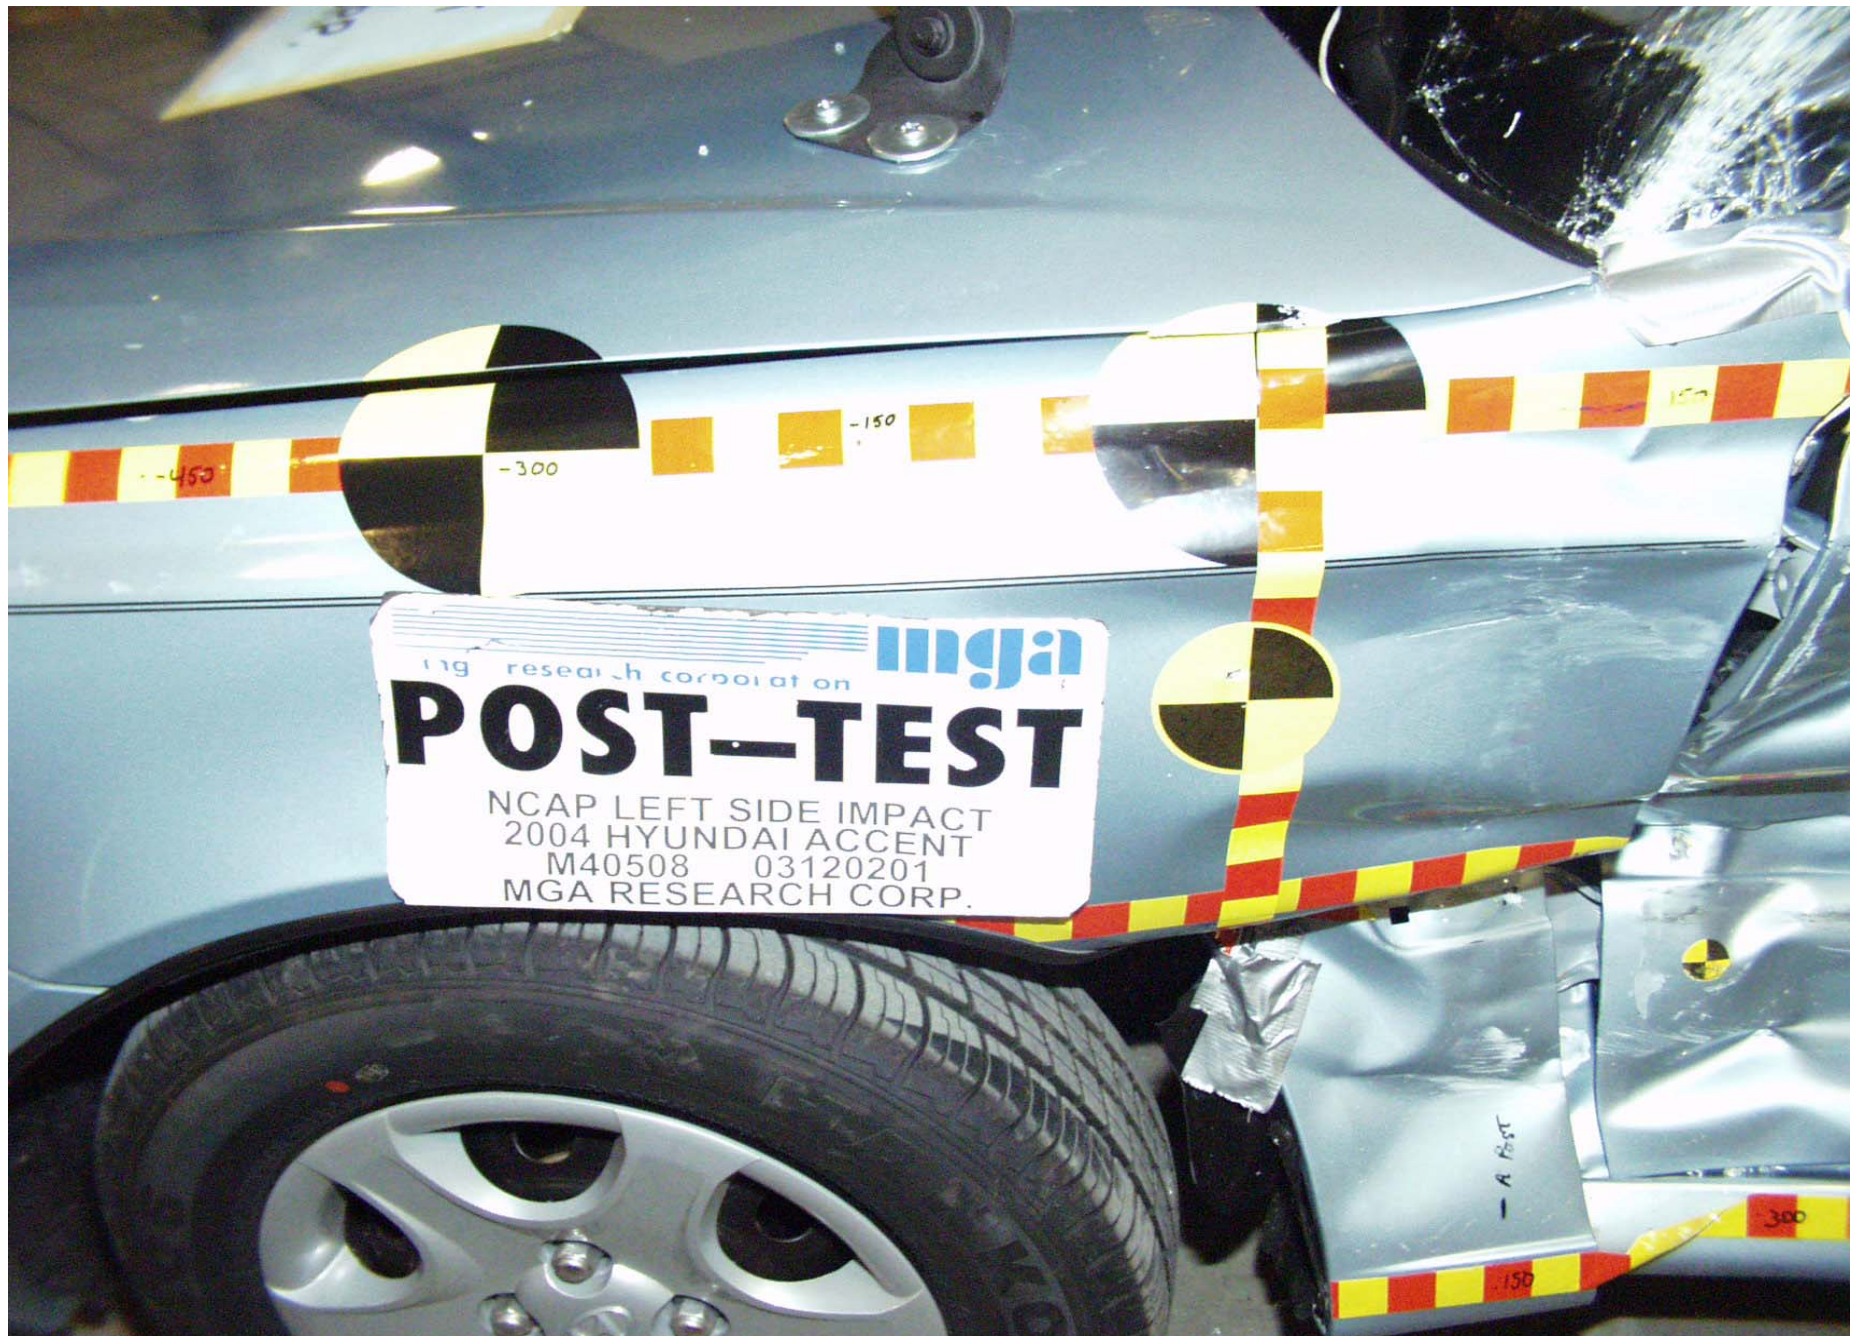
Post-Test Impact Point on Vehicle

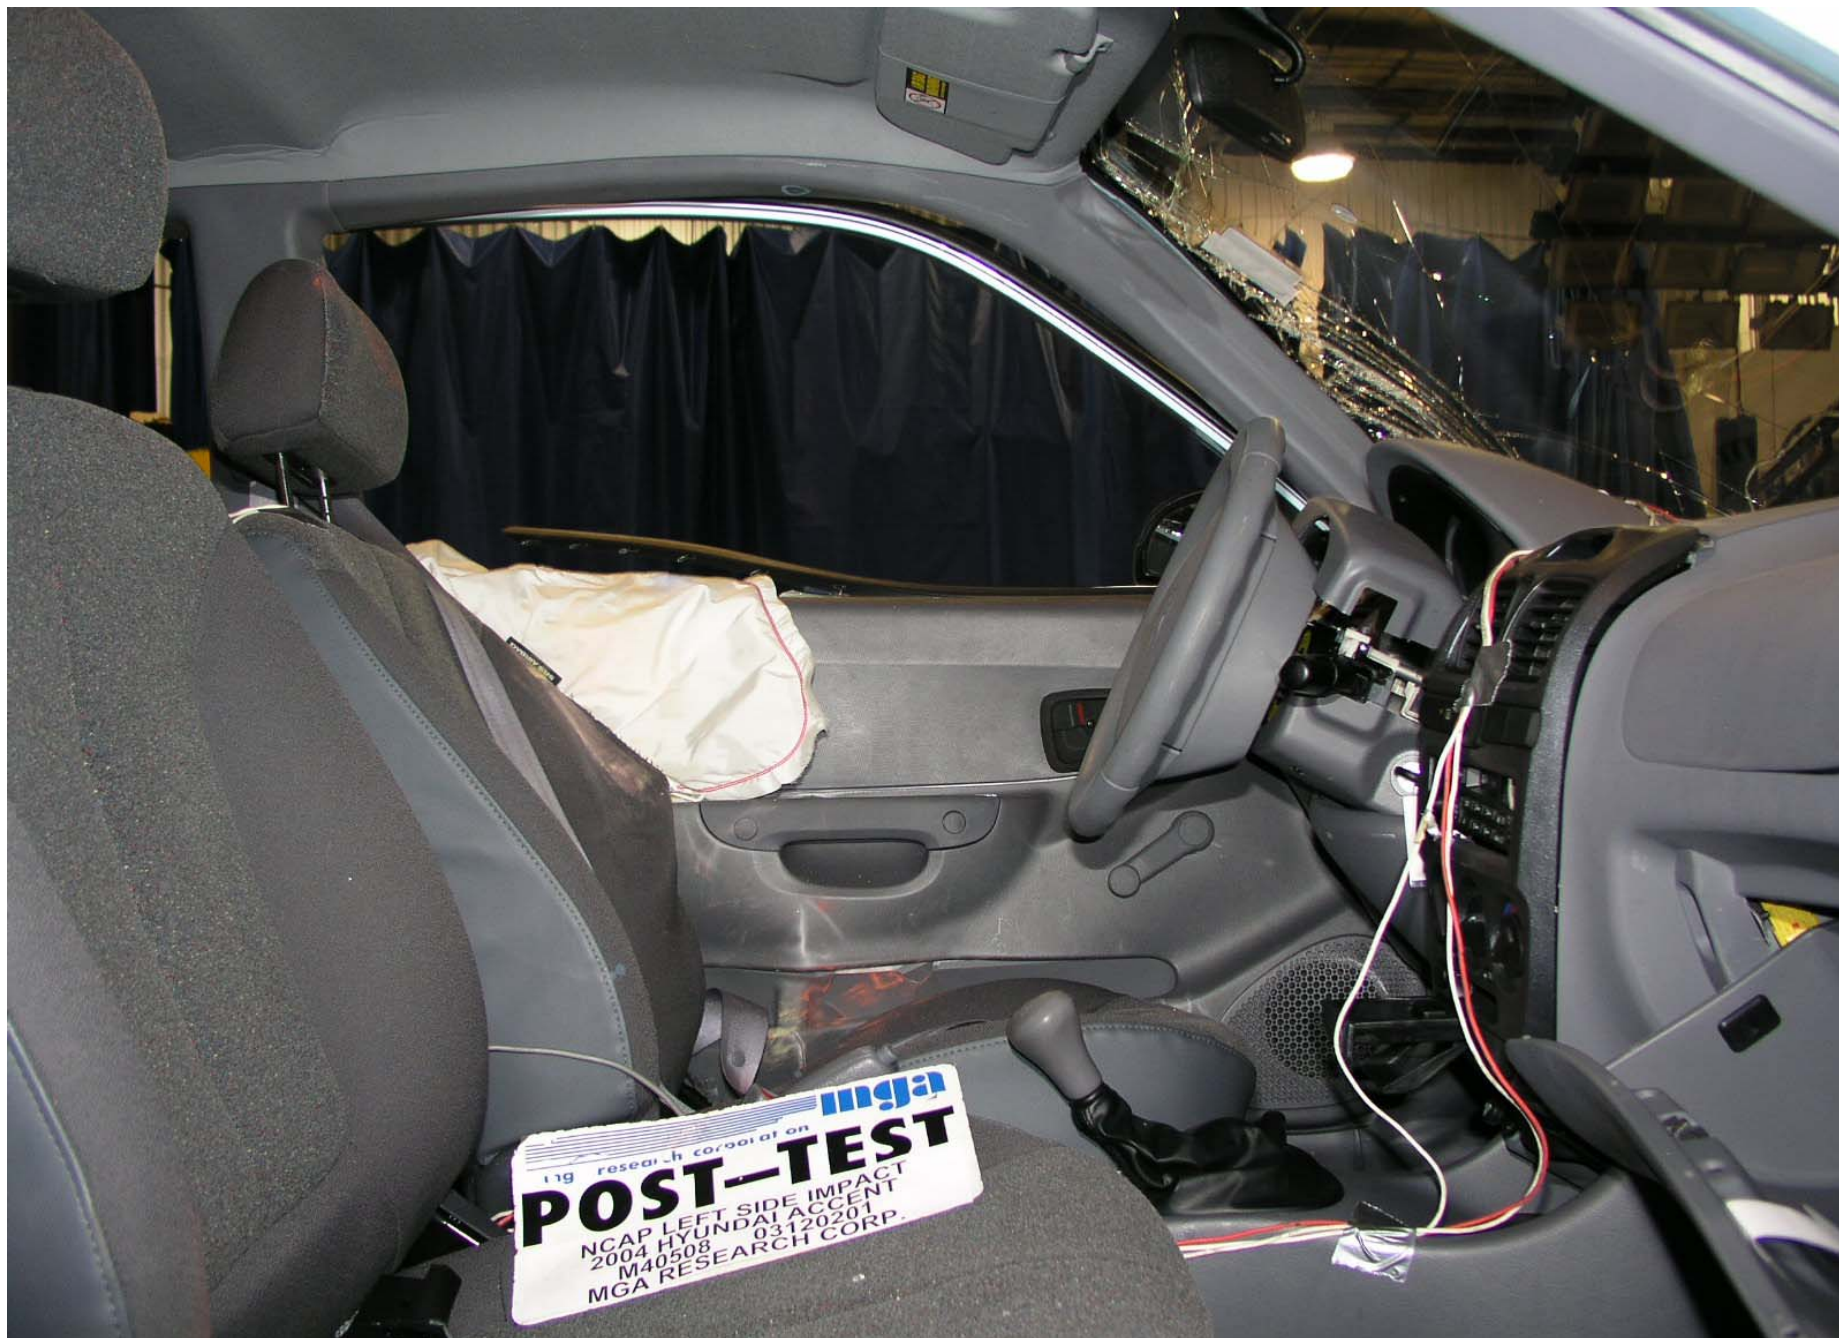
Post-Test Driver Dummy Contact

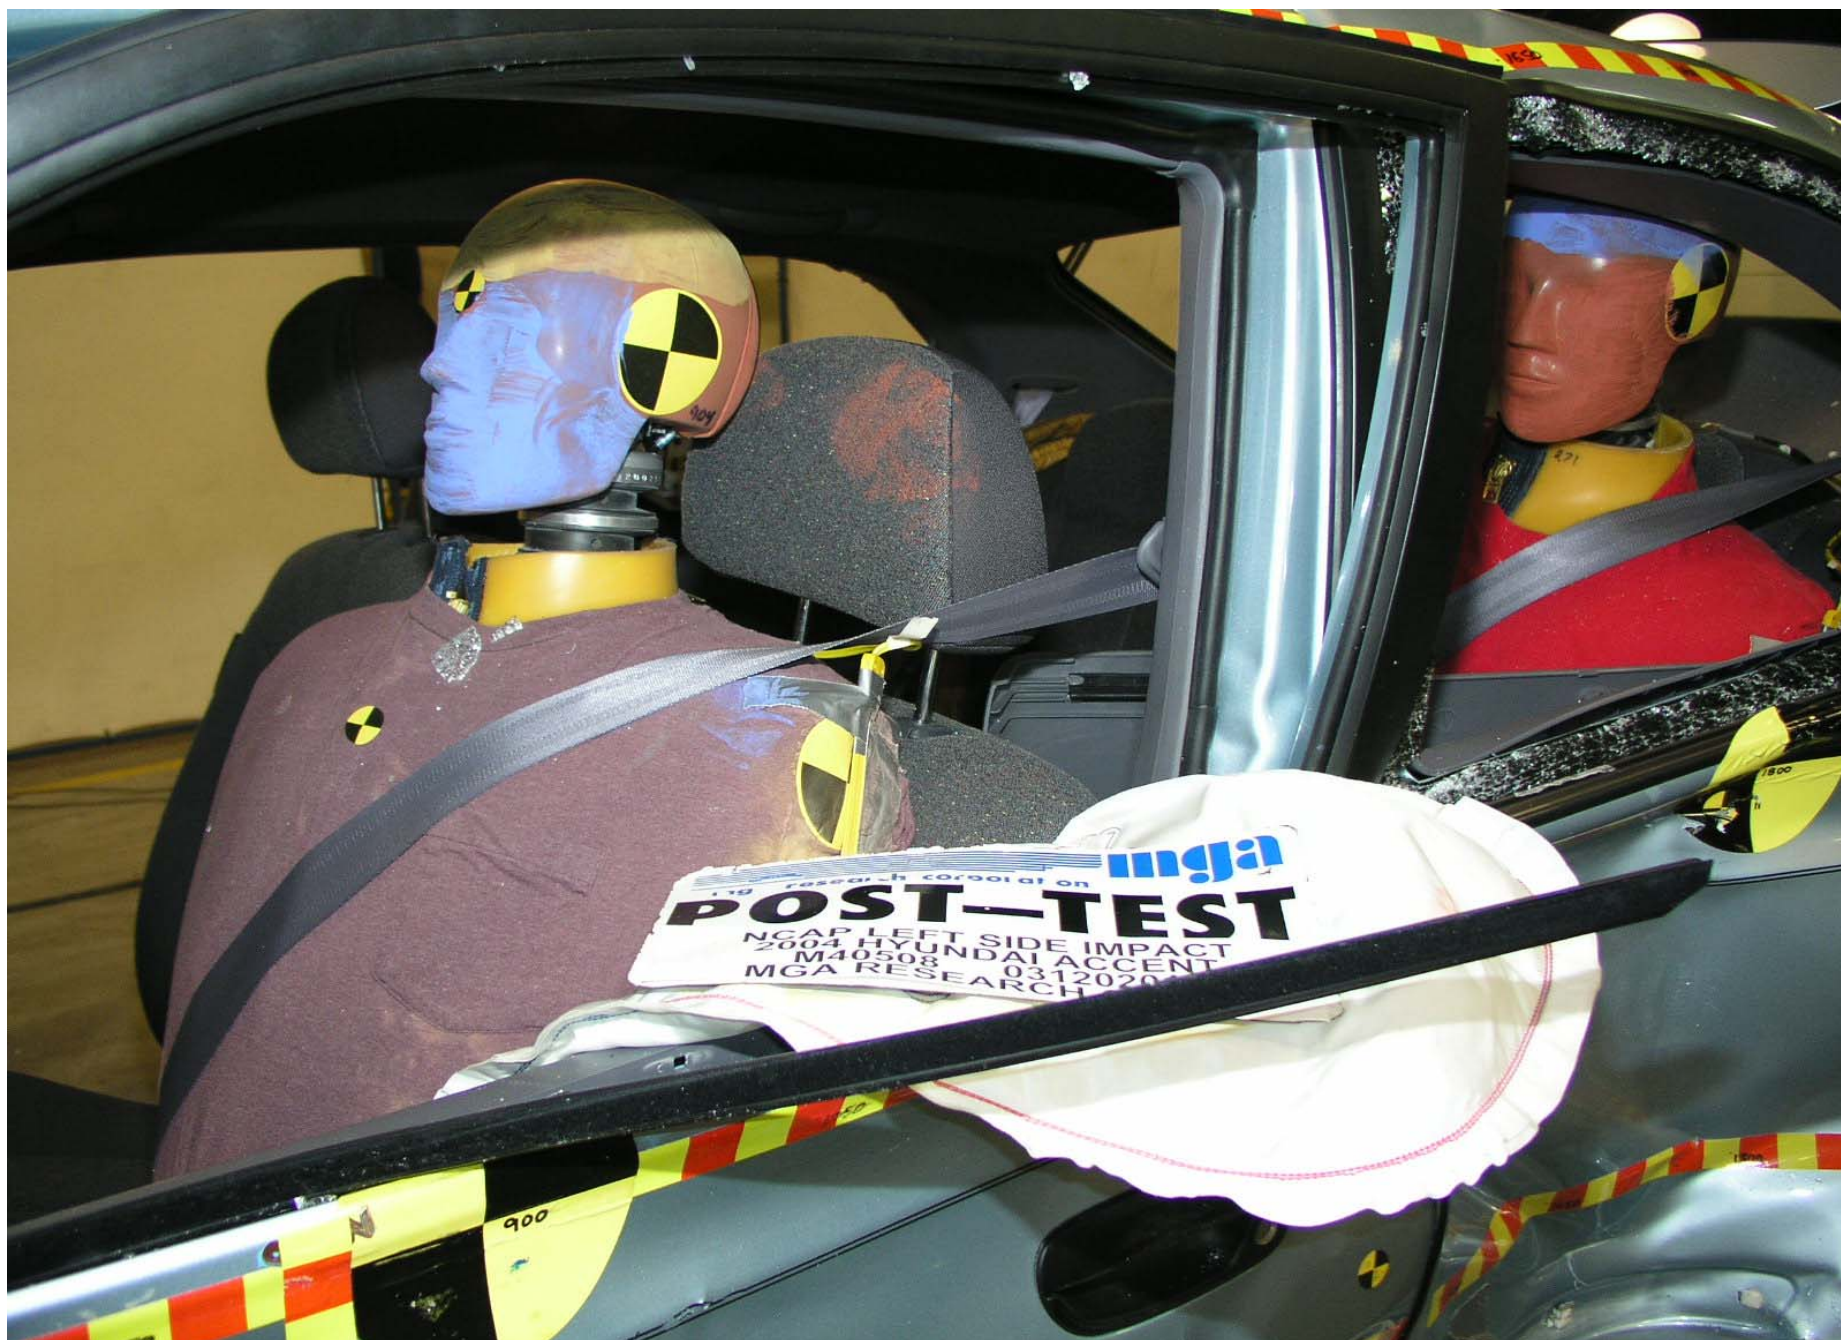
Post-Test Driver Dummy Head Contact

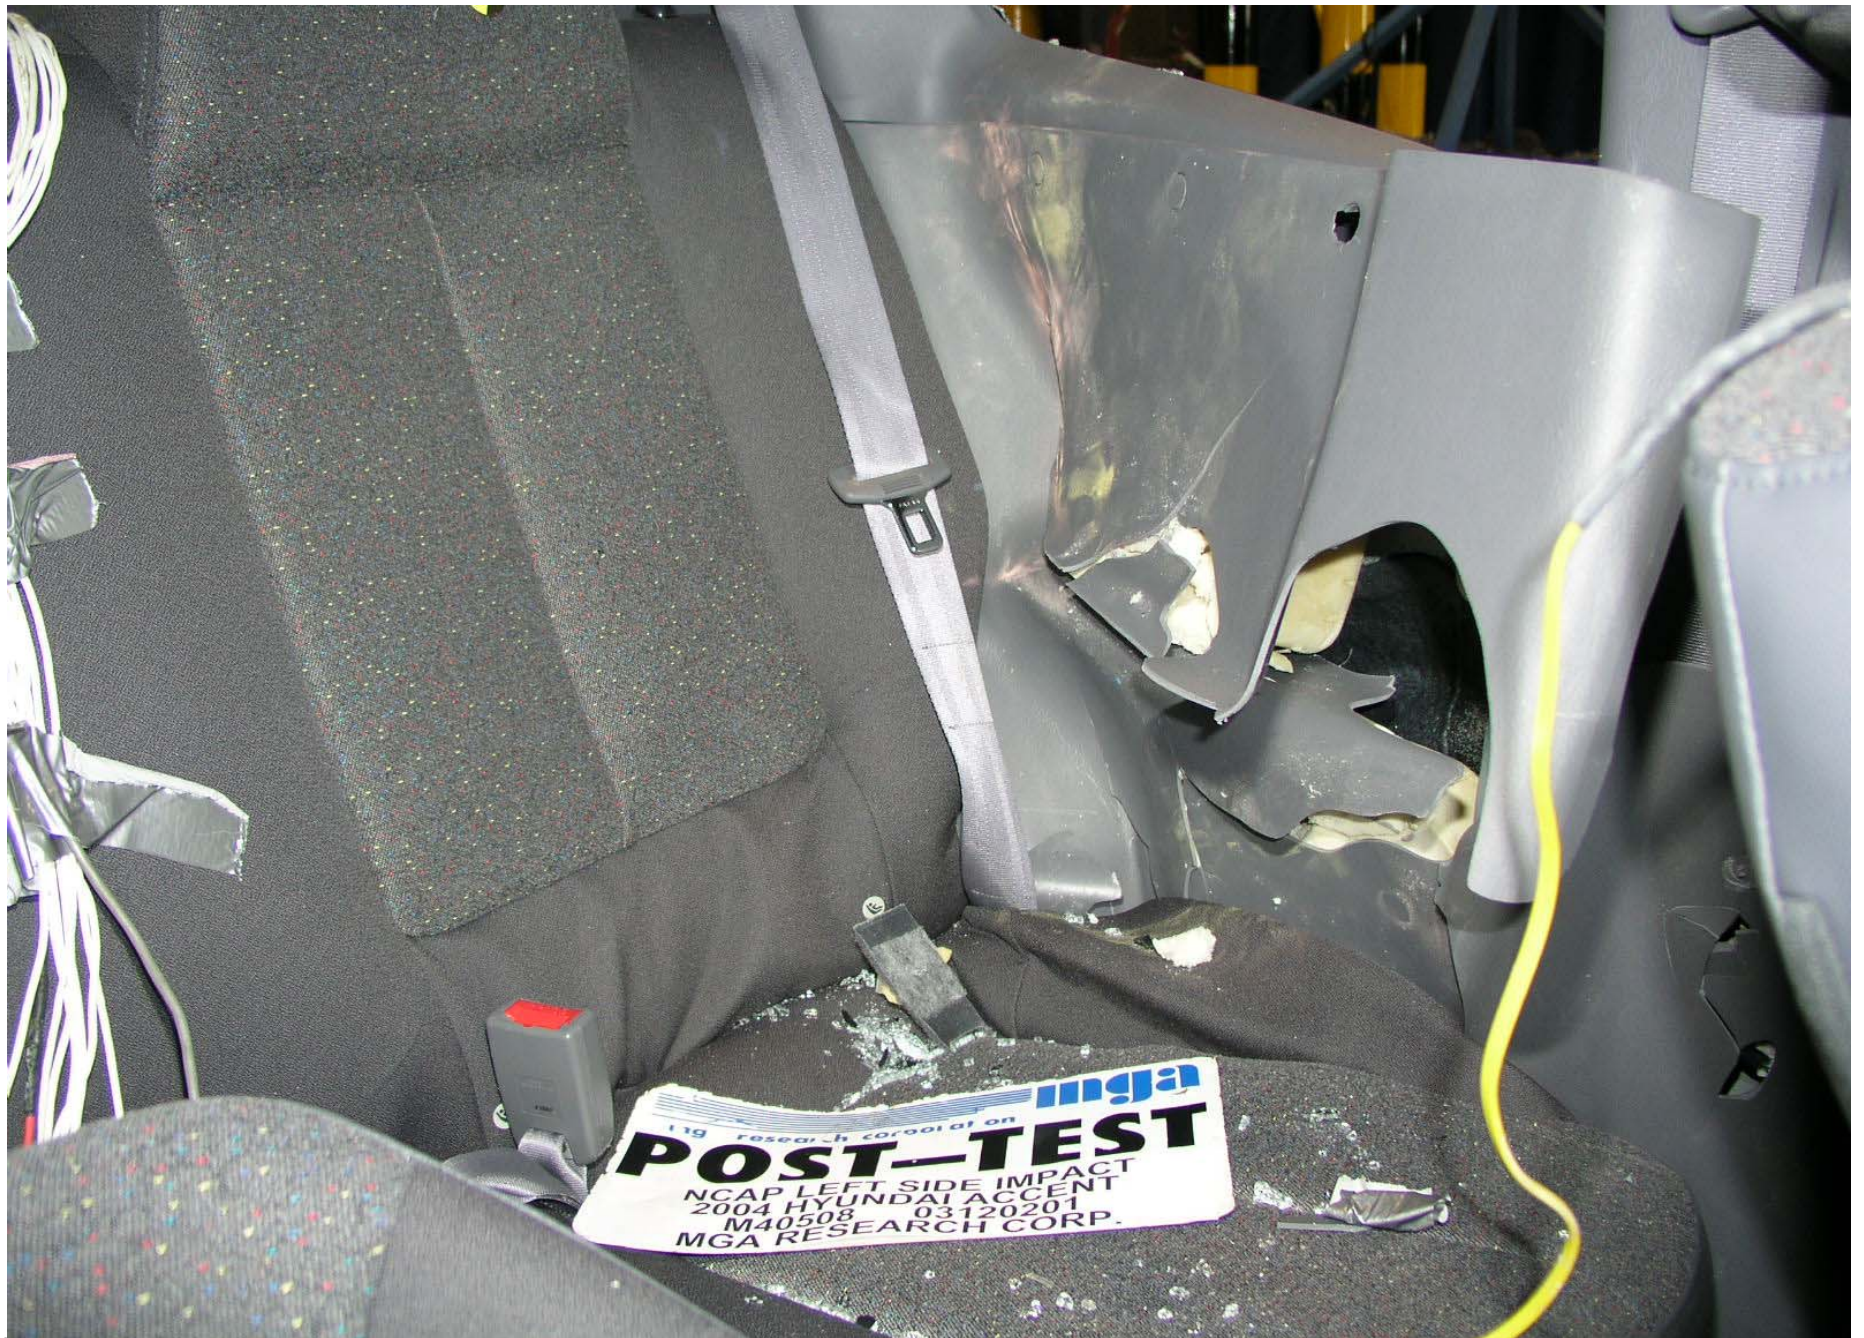
Post-Test Passenger Dummy Contact
