**NEW CAR ASSESSMENT PROGRAM  
SIDE IMPACT TEST**

**Hyundai Motor Company  
2004 Hyundai Accent 2 Door  
NHTSA NUMBER: M40508**

**PREPARED BY:  
MGA RESEARCH CORPORATION  
5000 WARREN ROAD  
BURLINGTON, WI 53105**

**FINAL REPORT**

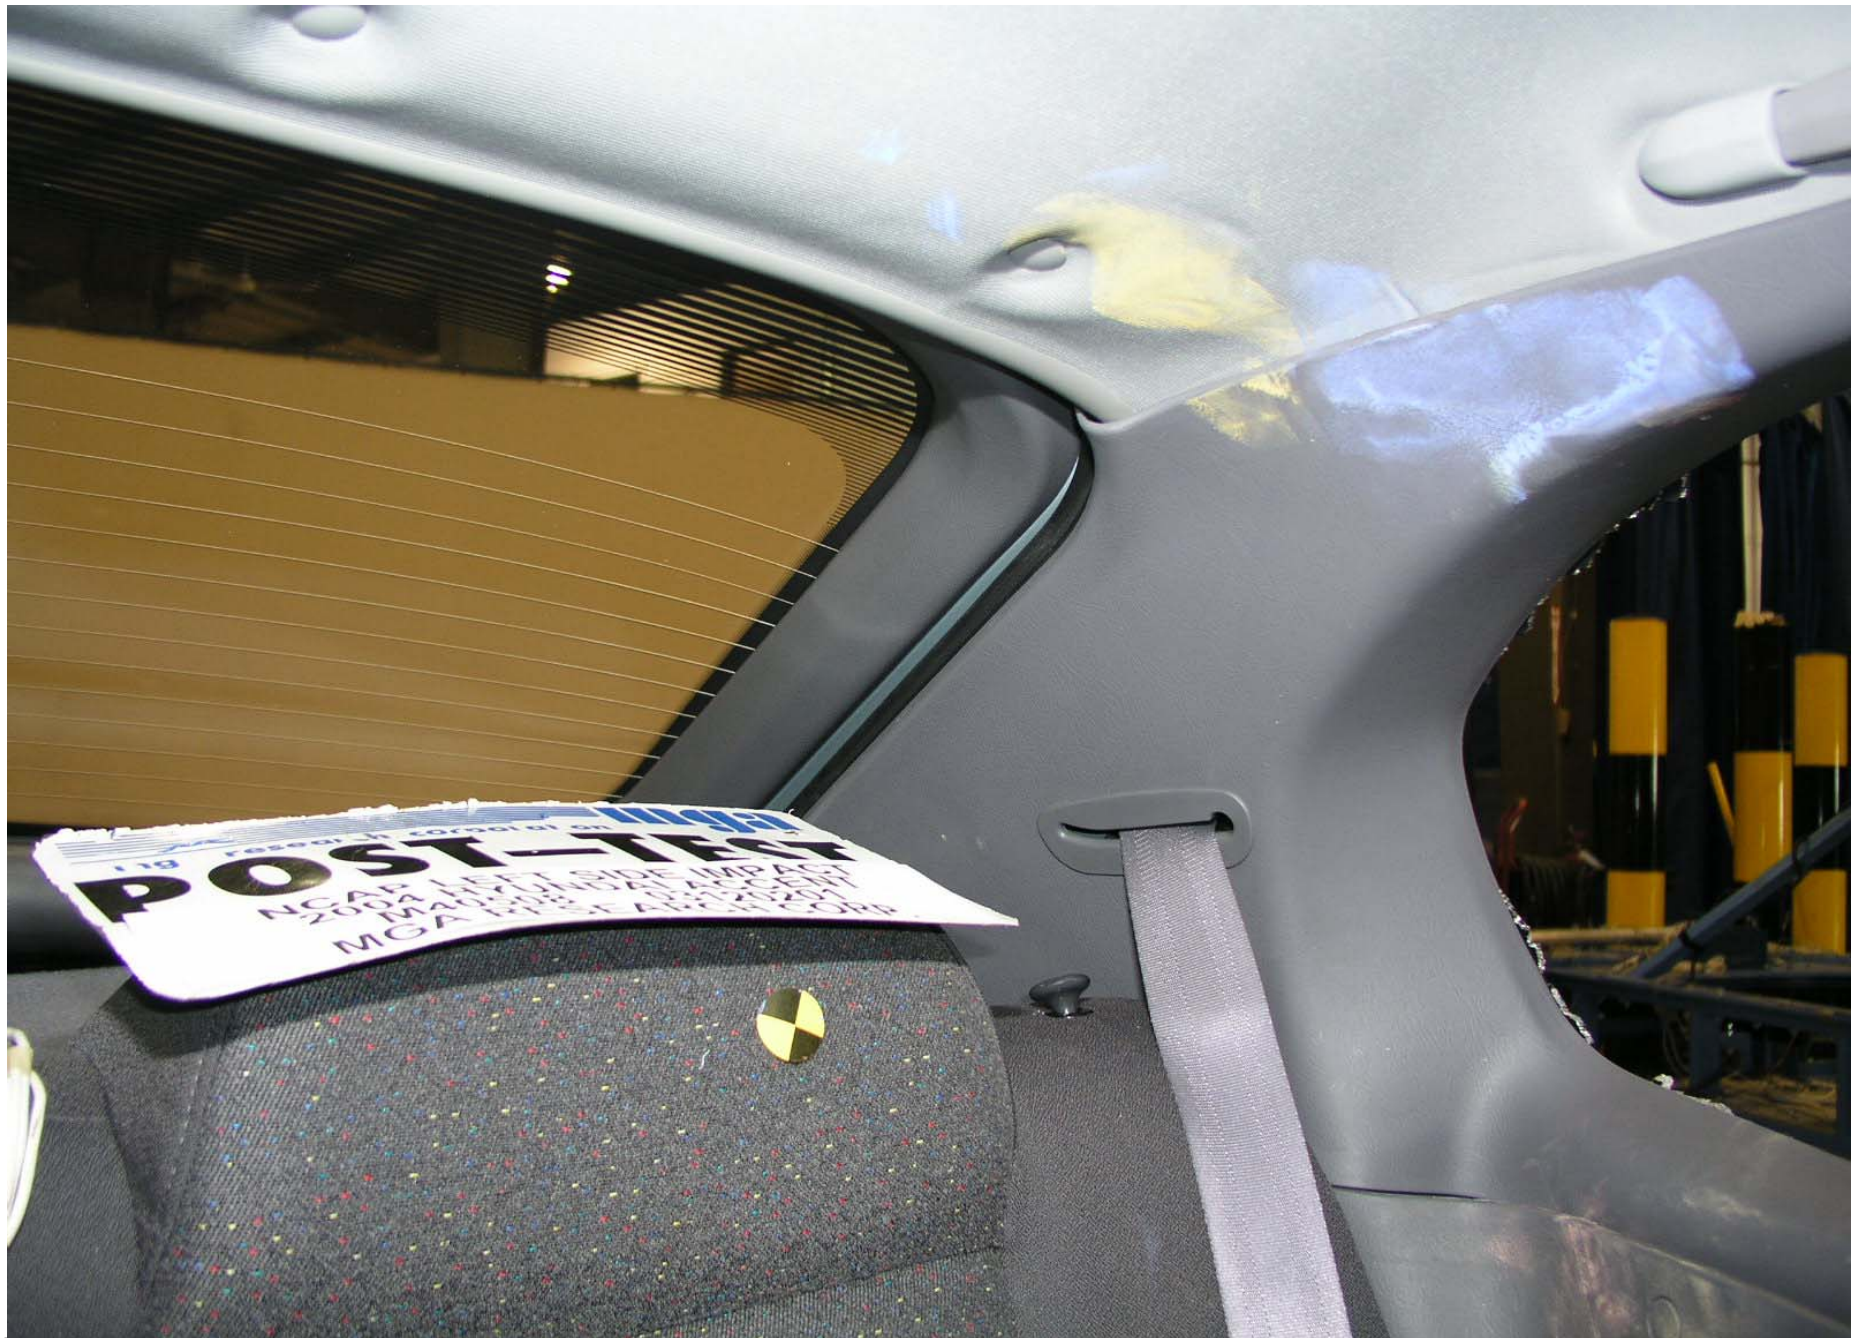
Post-Test Passenger Dummy Head Contact
