**Report Number: NCAP-TRC-03-001**

**New Car Assessment Program**

**“Side Impact Testing”**

**2004 Hyundai Tiburon 2-door**

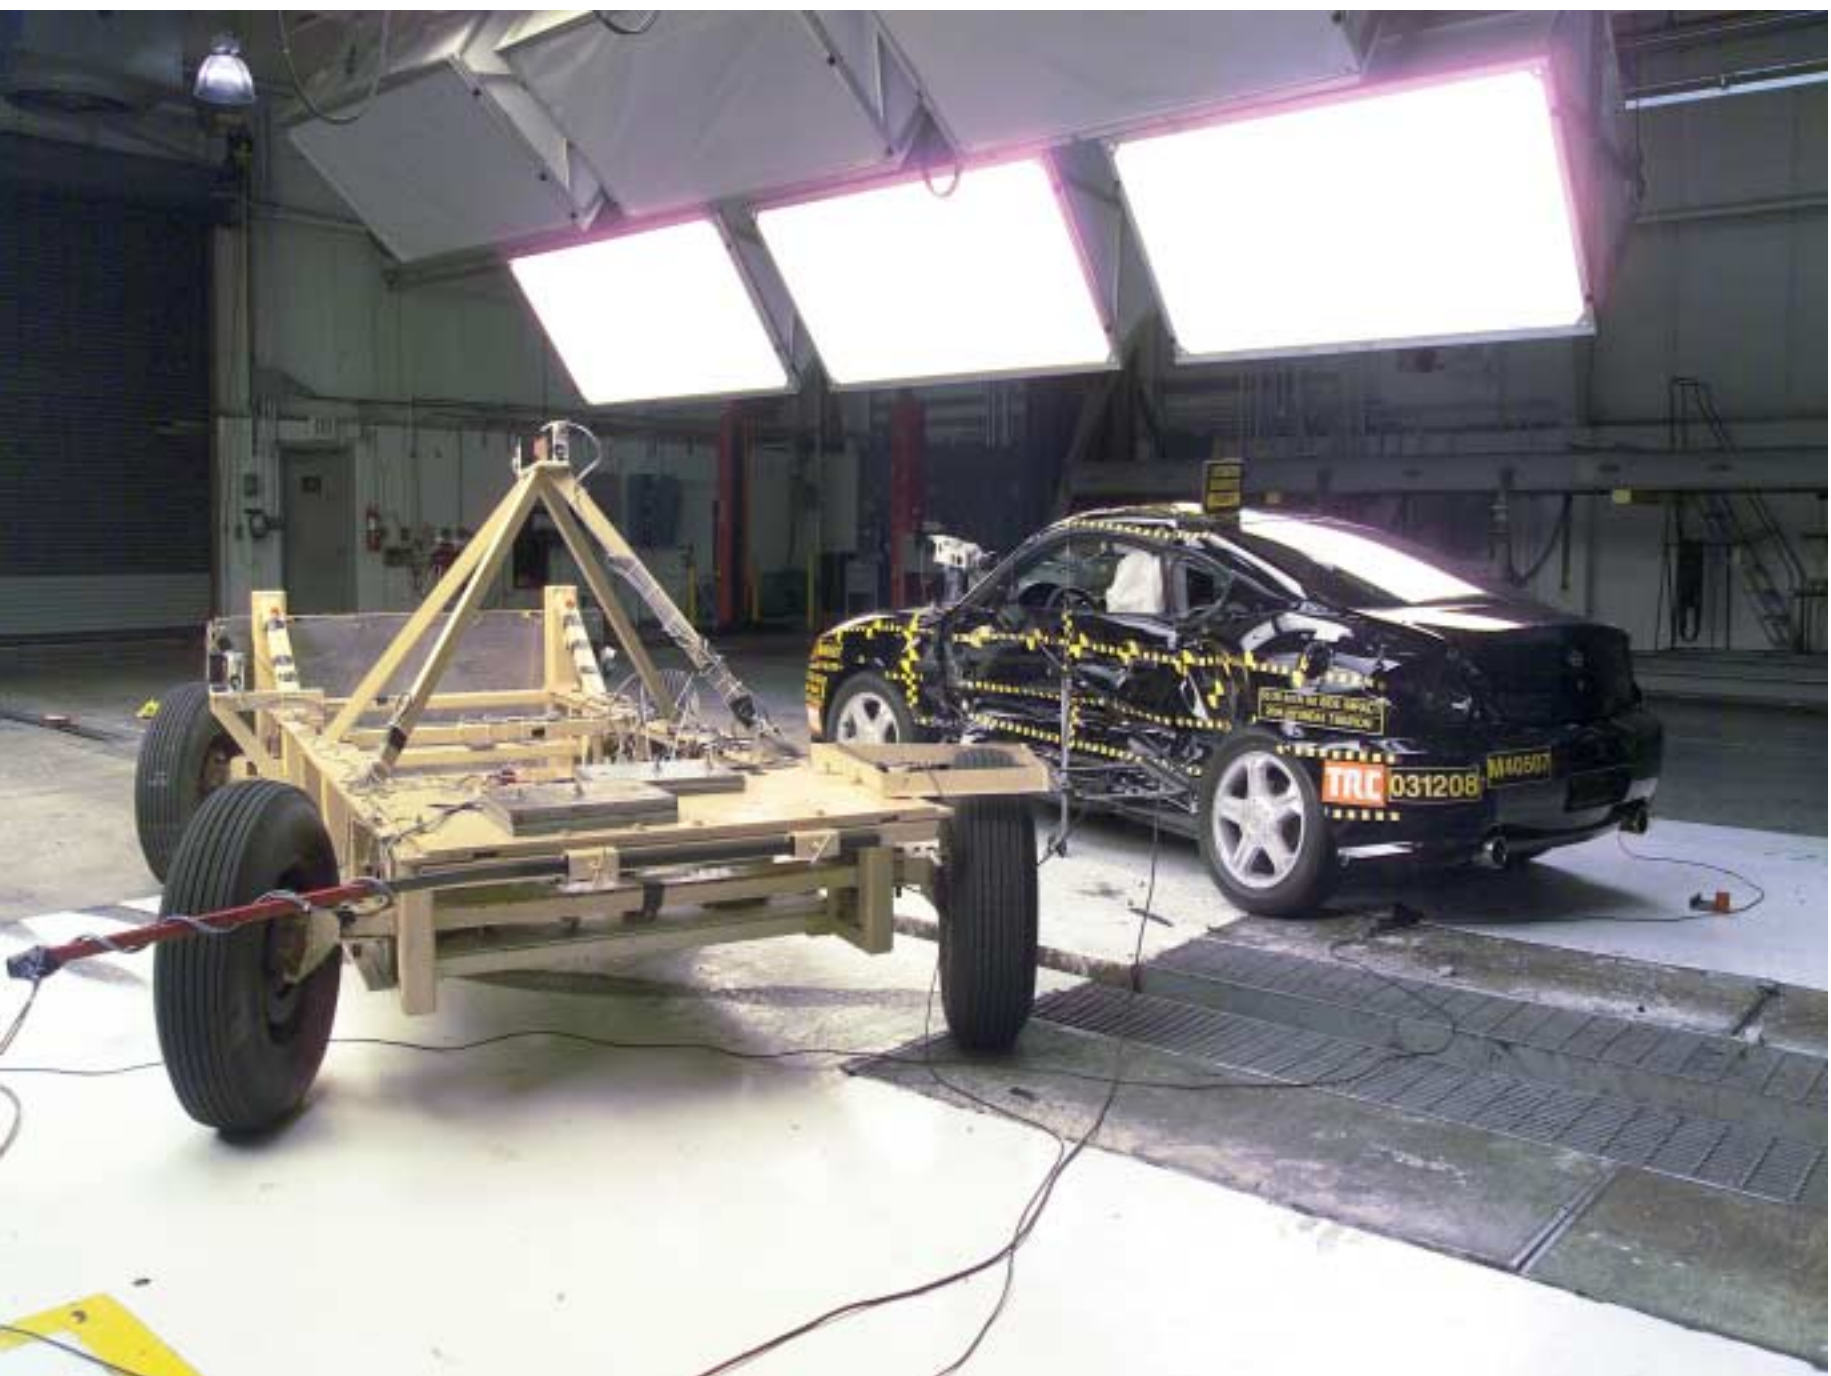
Figure A-4 Post-Test Impact Side View of Test Vehicle

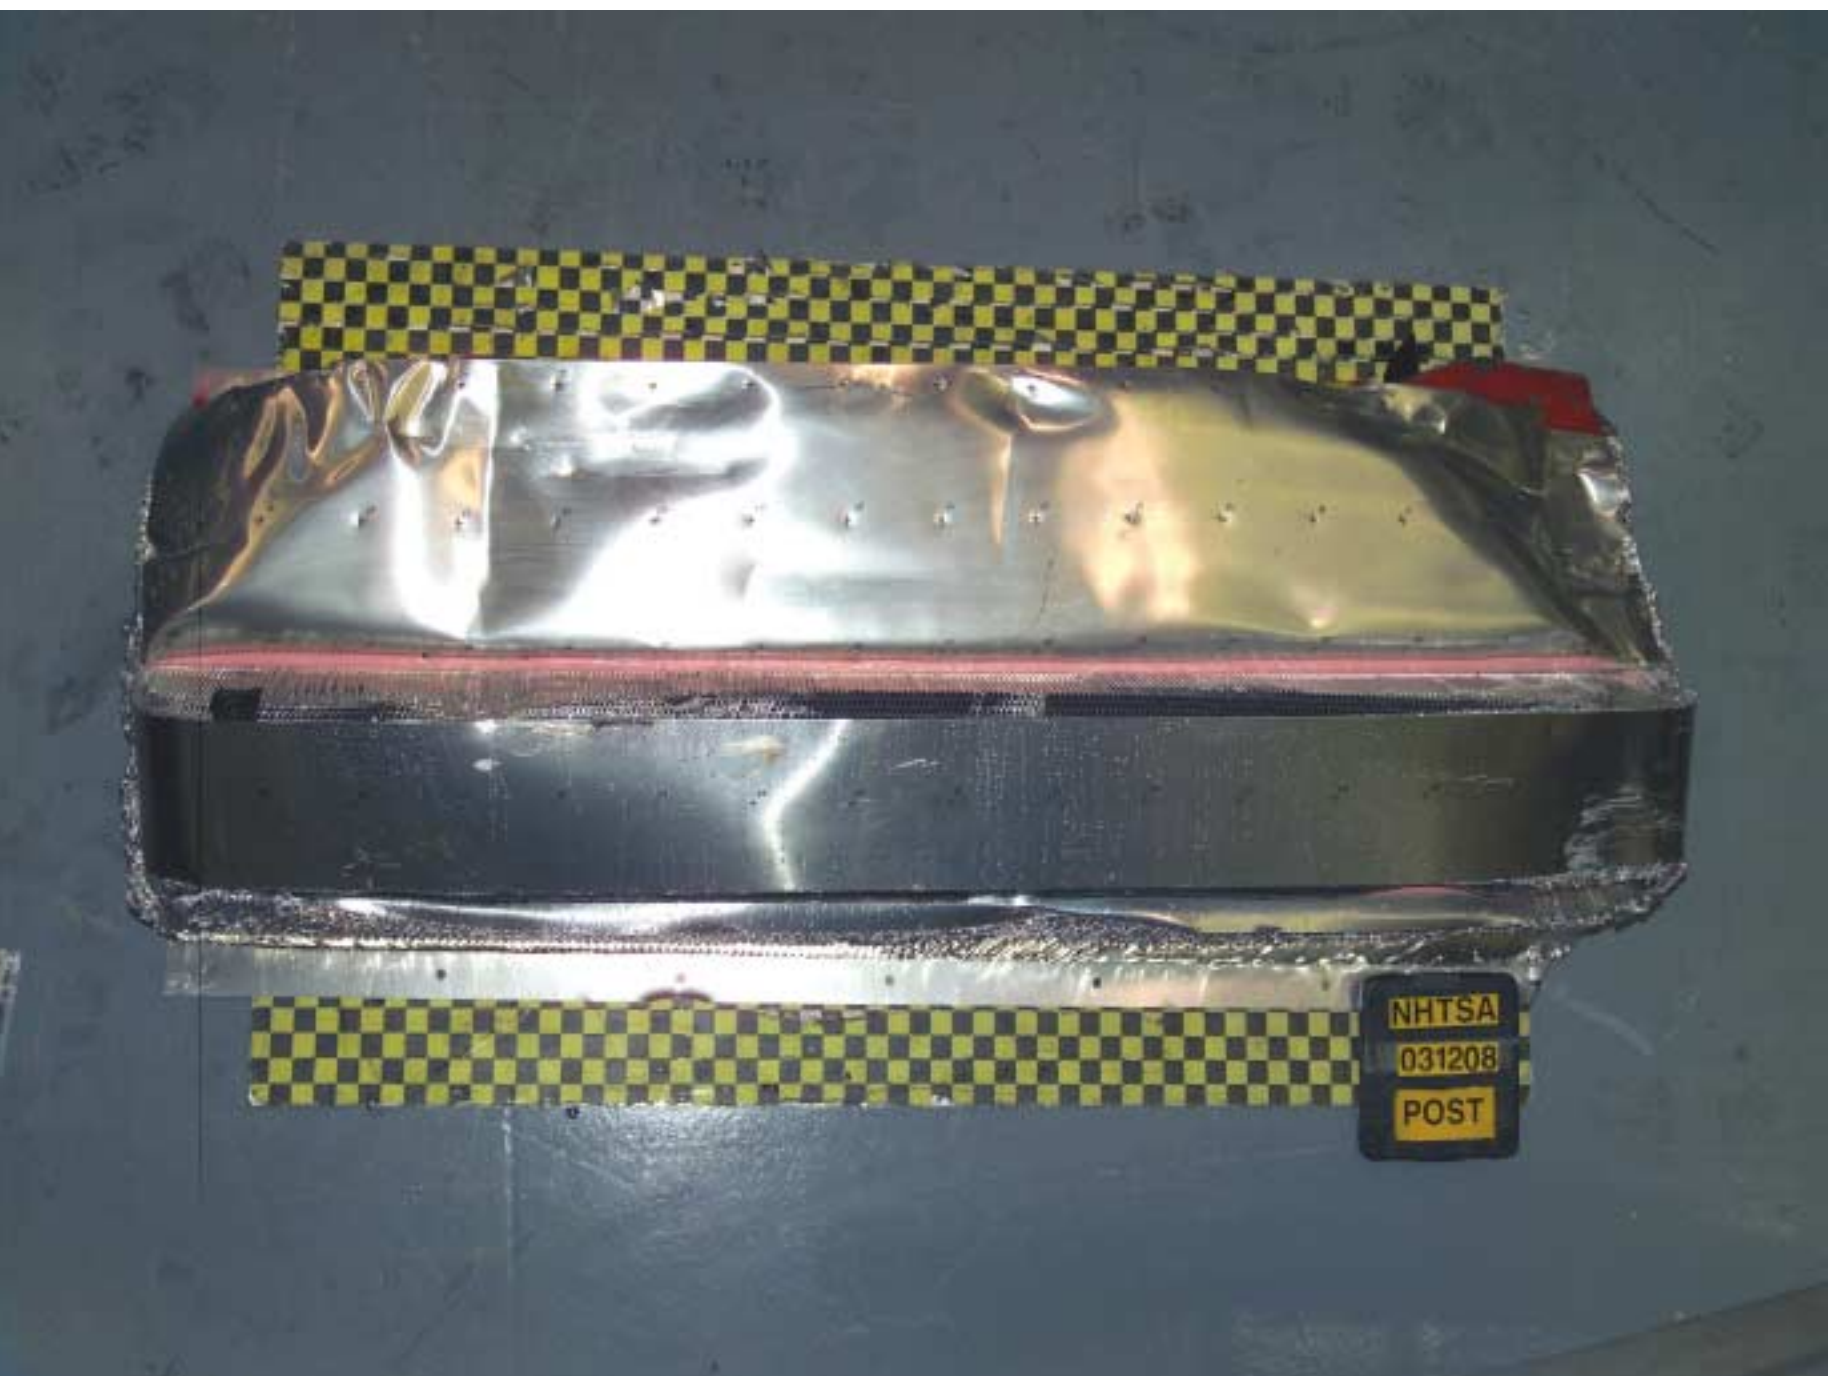
Figure A-10 Post-Test Frontal View of Impactor Face

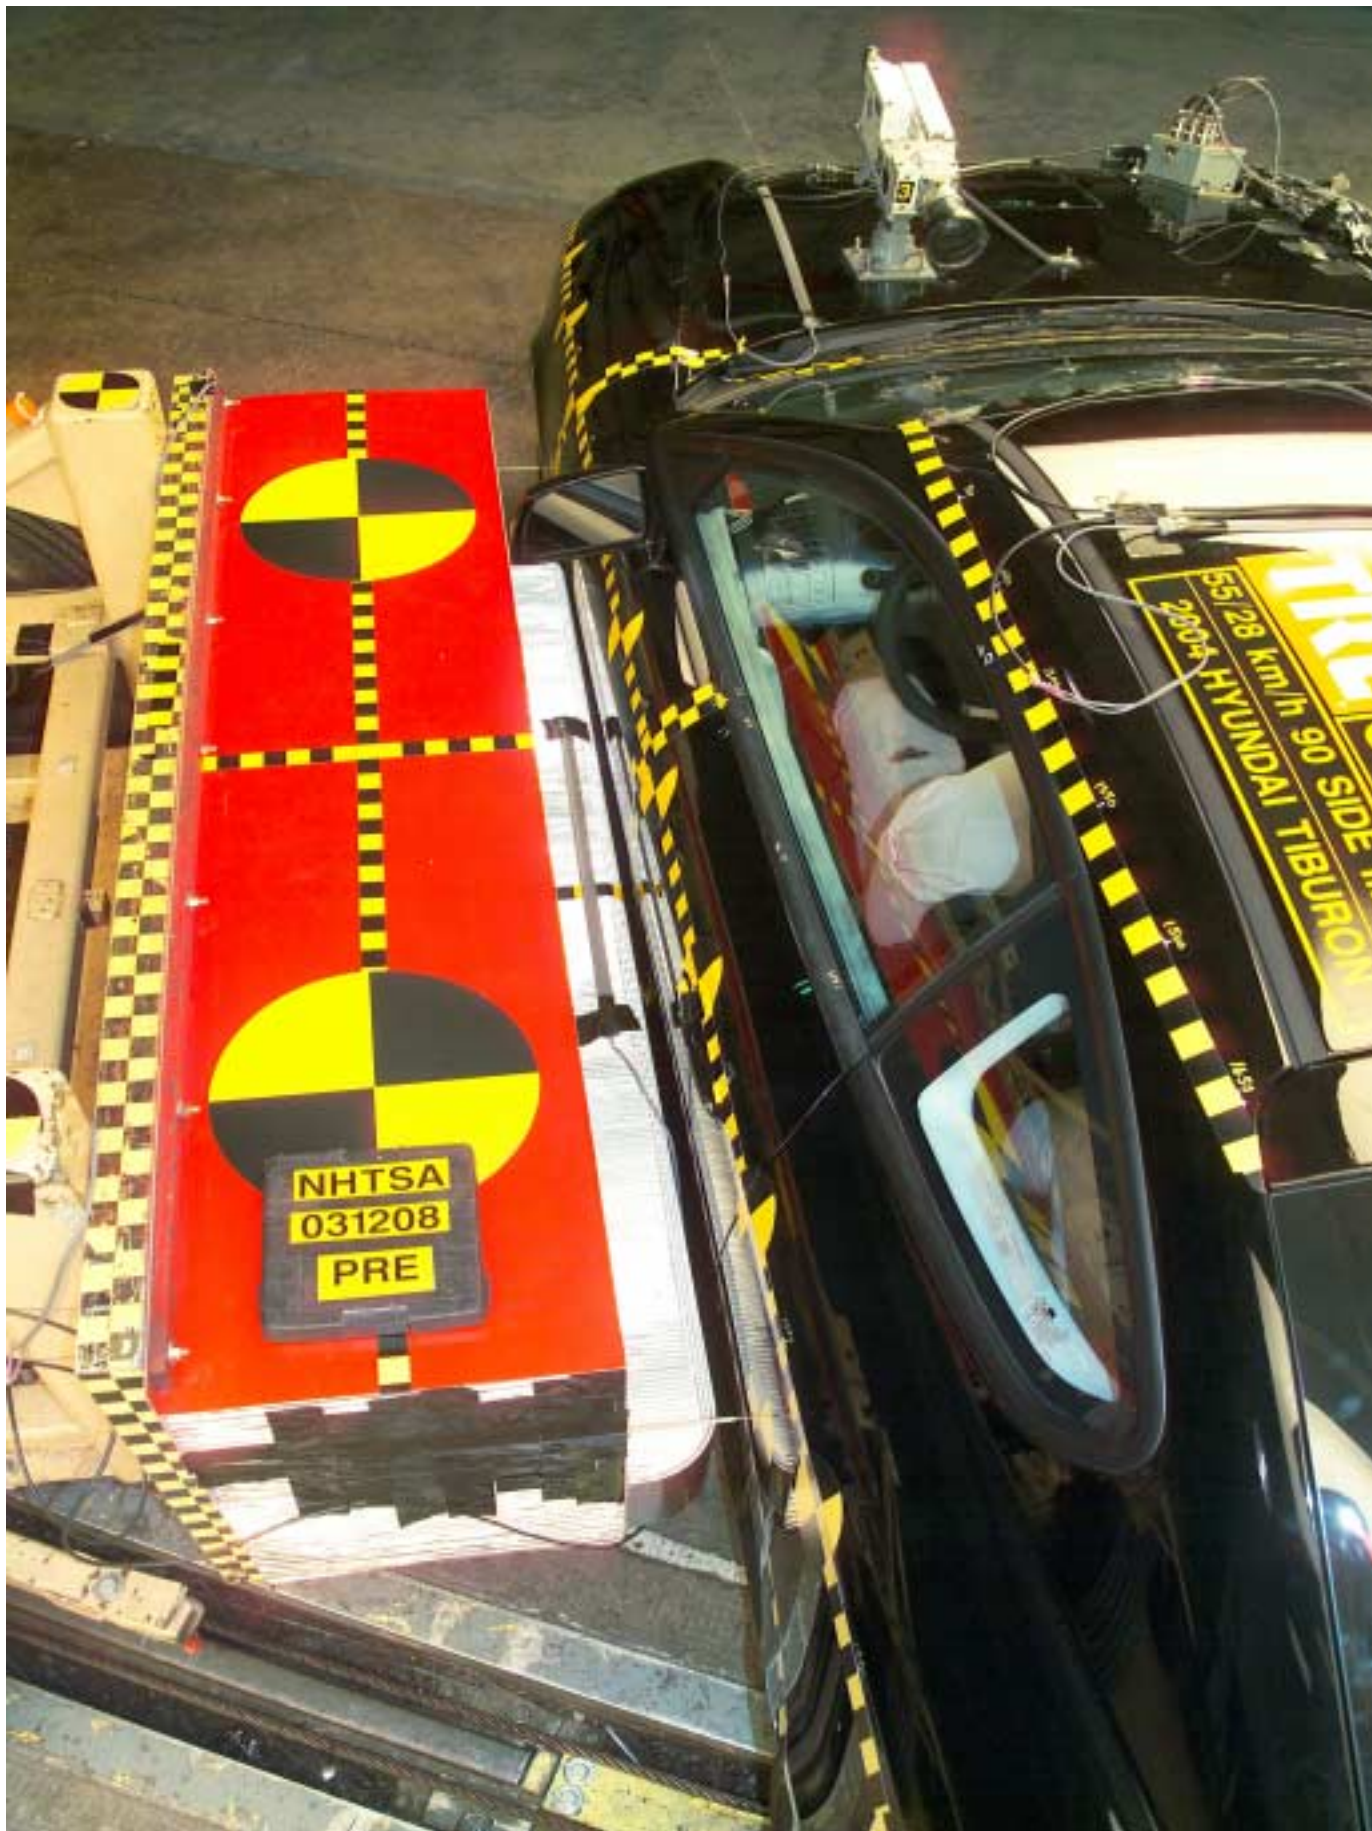
**Figure A-18 Pre-Test Overhead View of MDB Alignment with Vehicle**

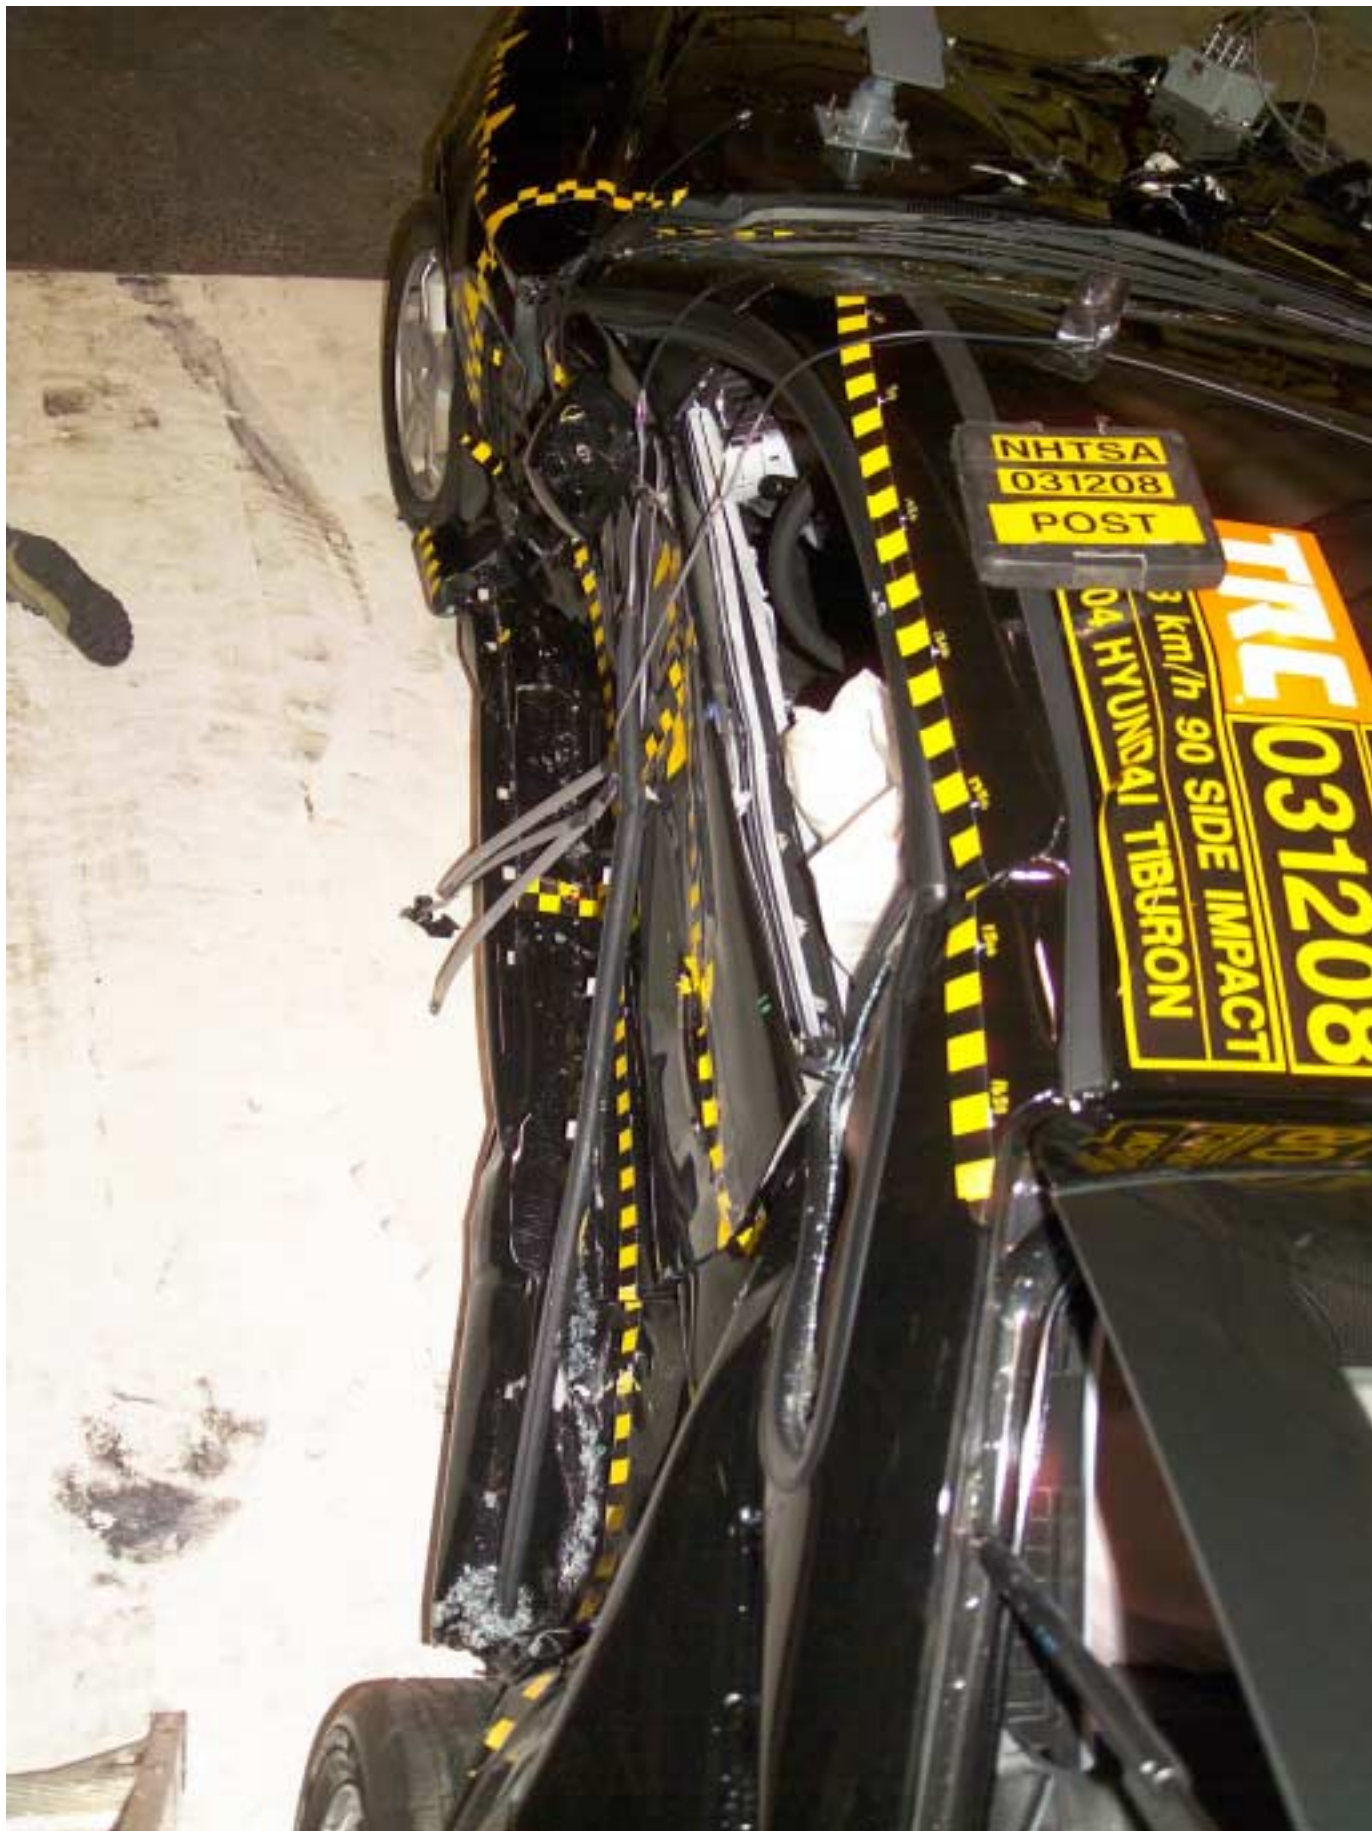
**Figure A-19 Post-Test Overhead View of Vehicle**

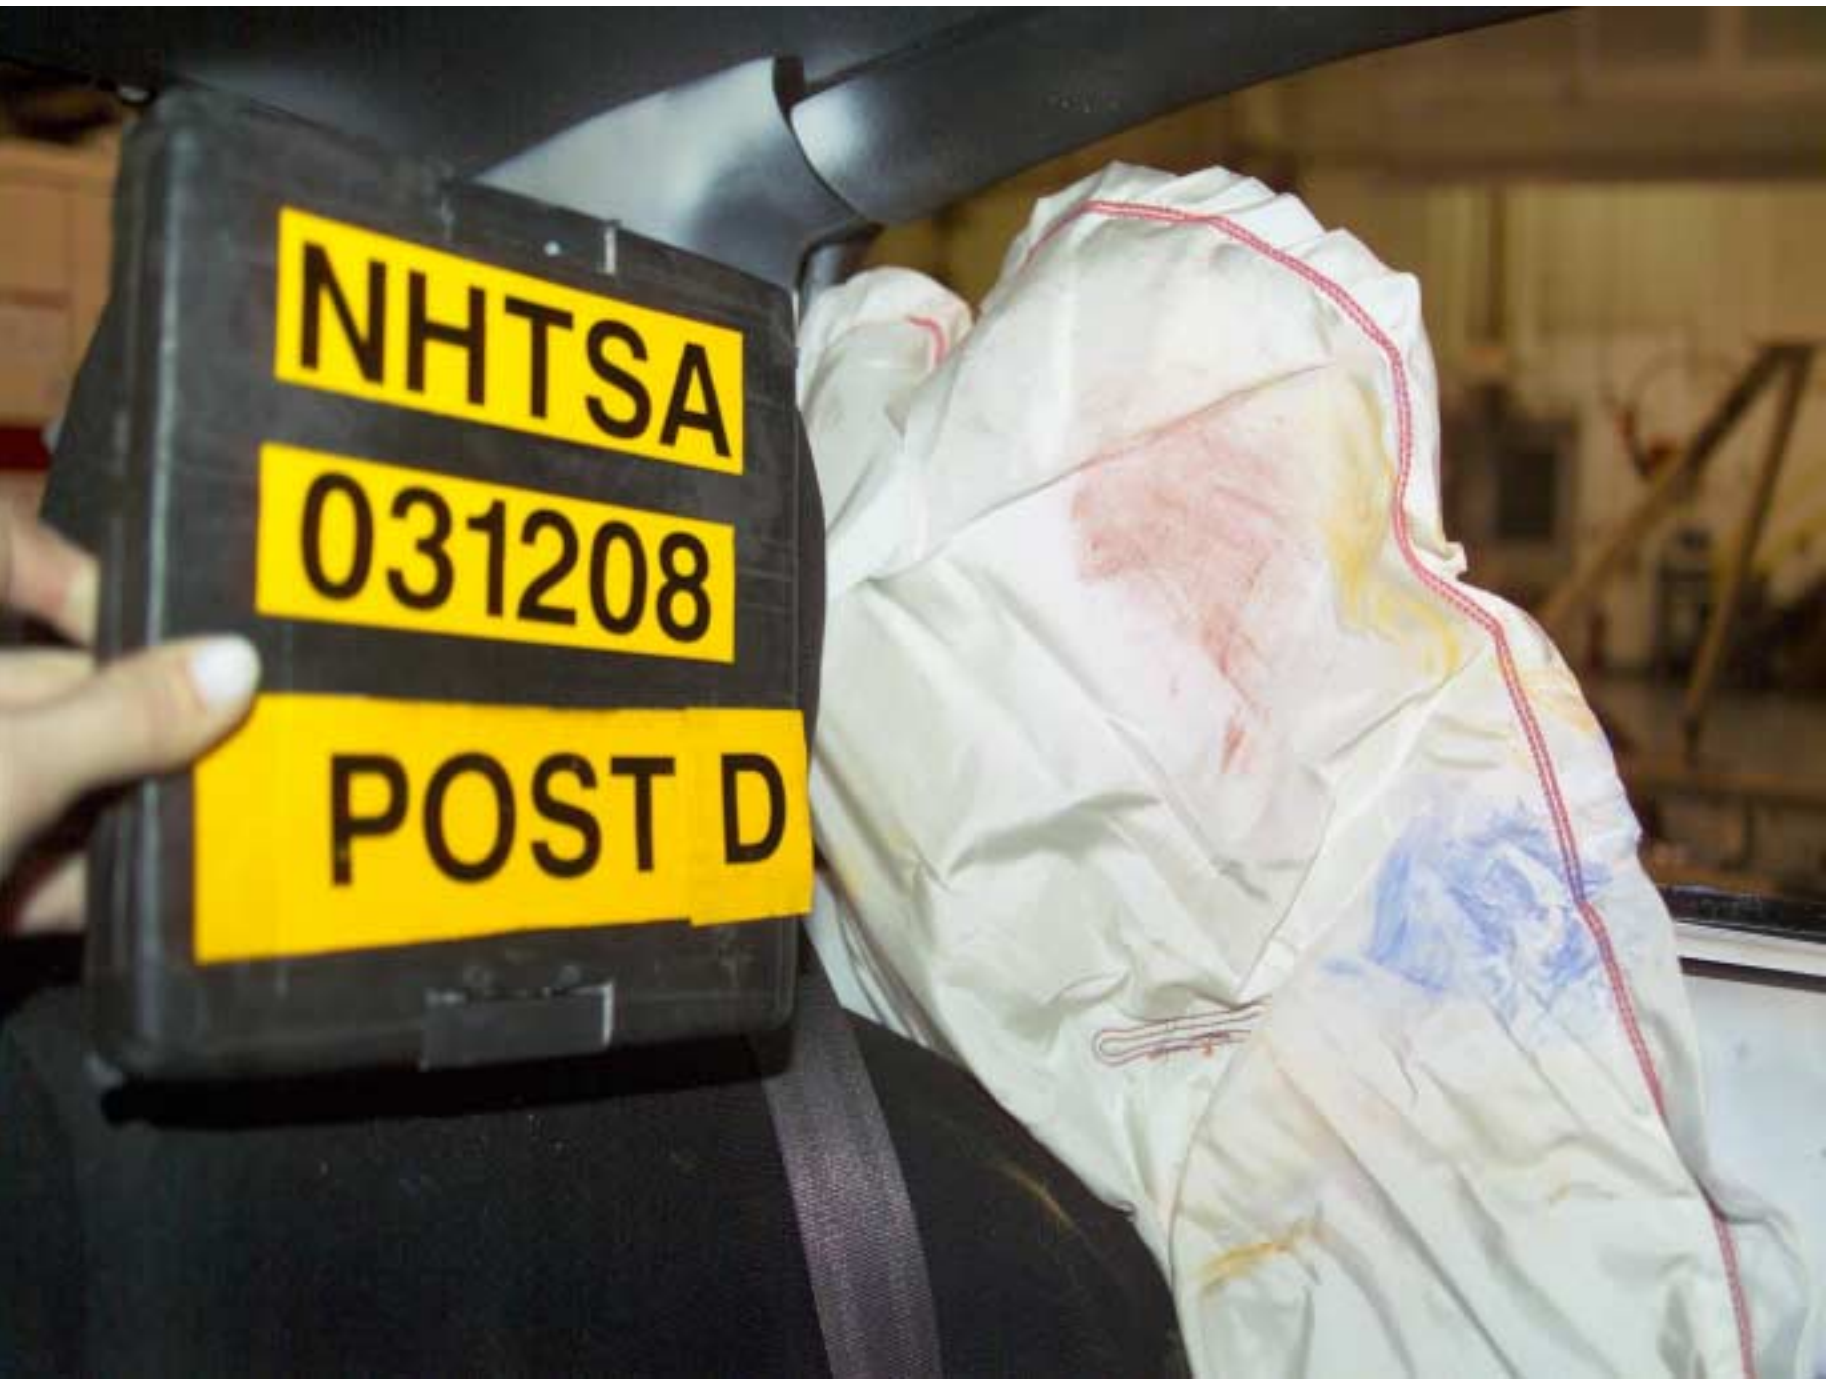
Figure A-29 Post-Test Front SID HIII Contact - View 1

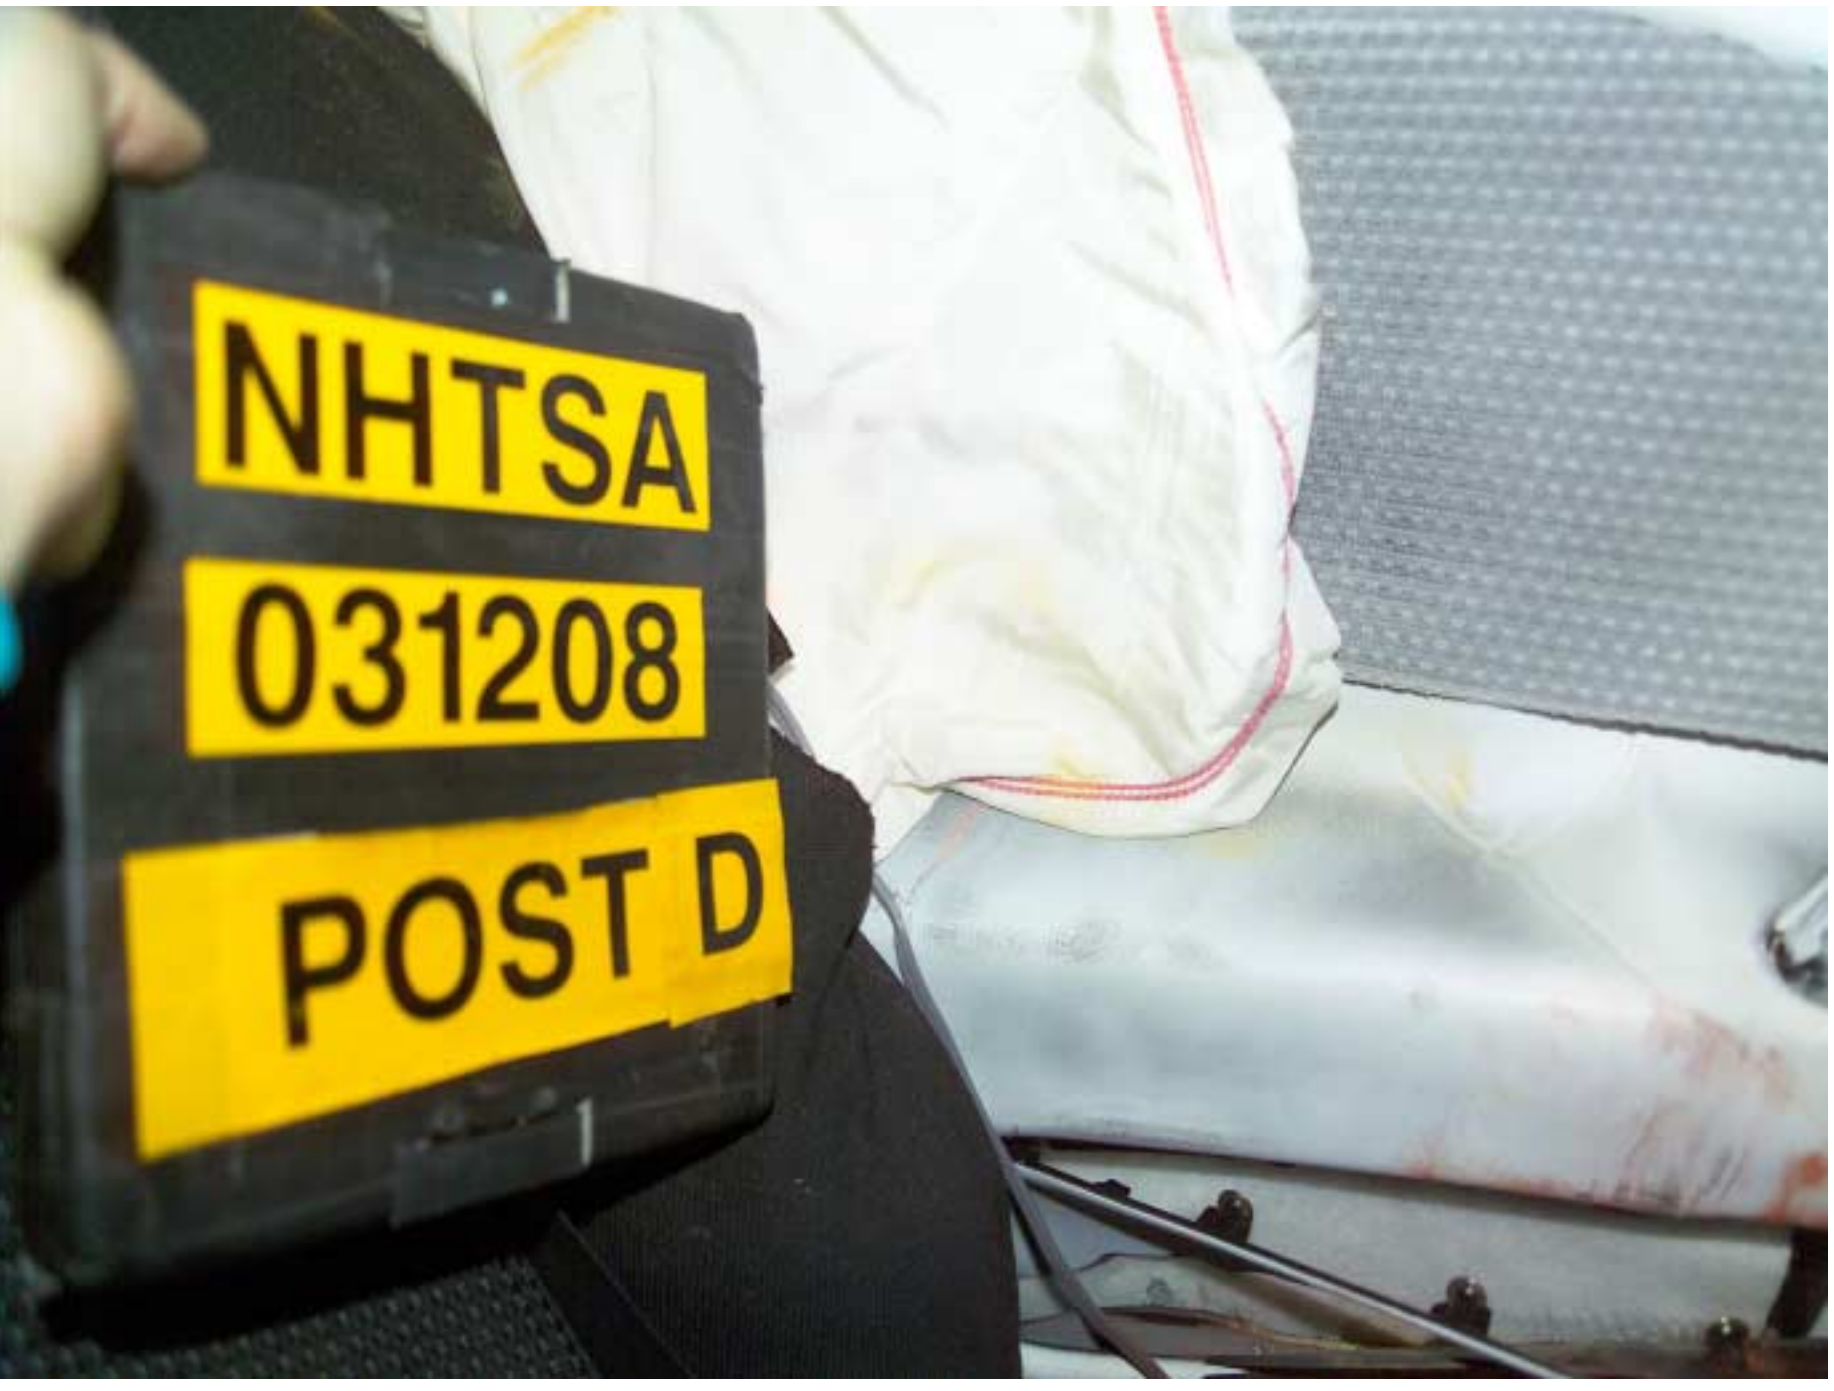
Figure A-30 Post-Test Front SID HIII Contact - View 2

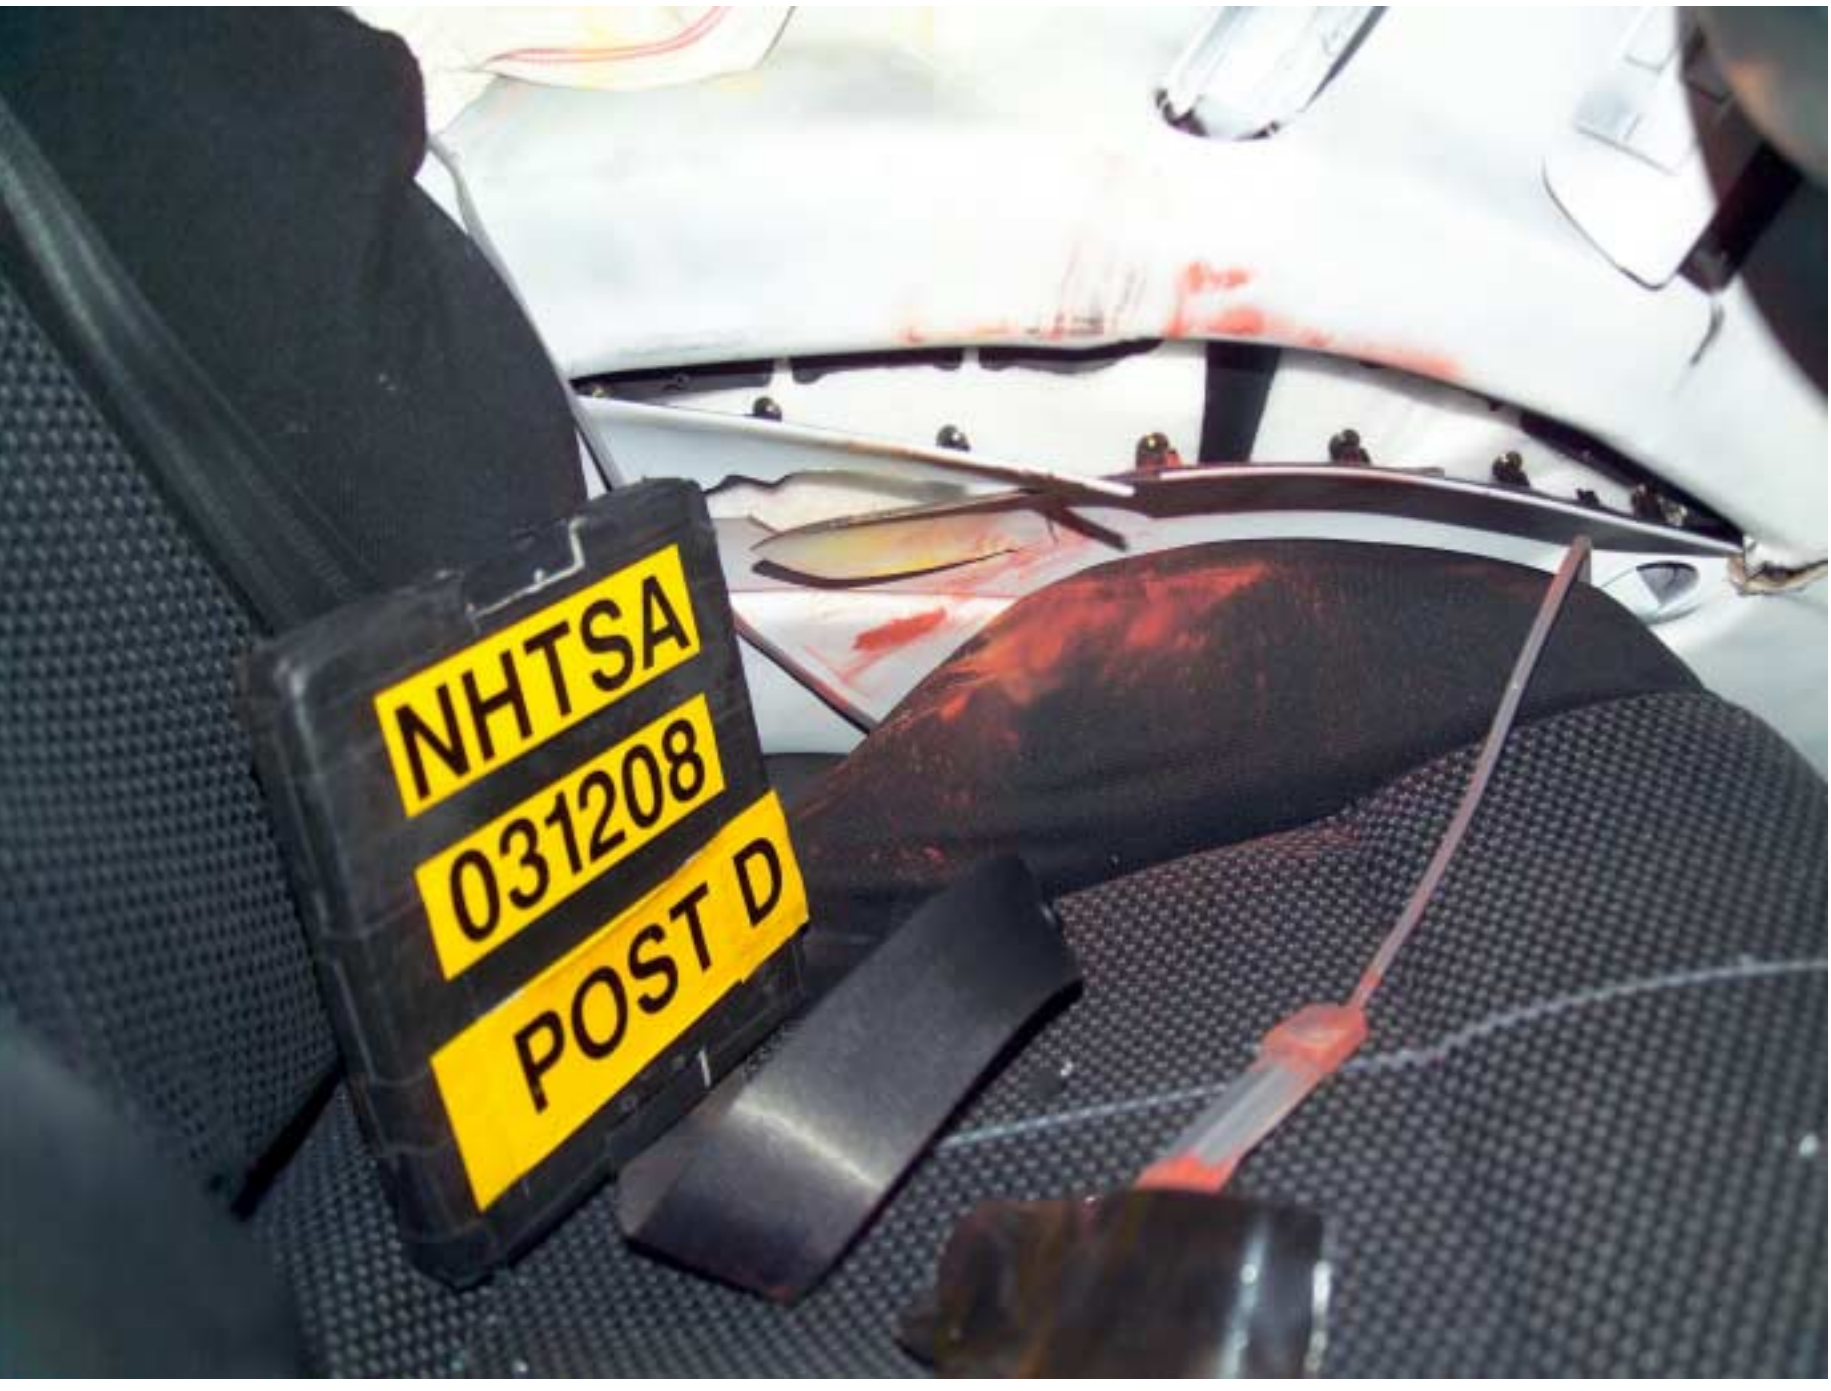
Figure A-31 Post-Test Front SID HIII Contact - View 3

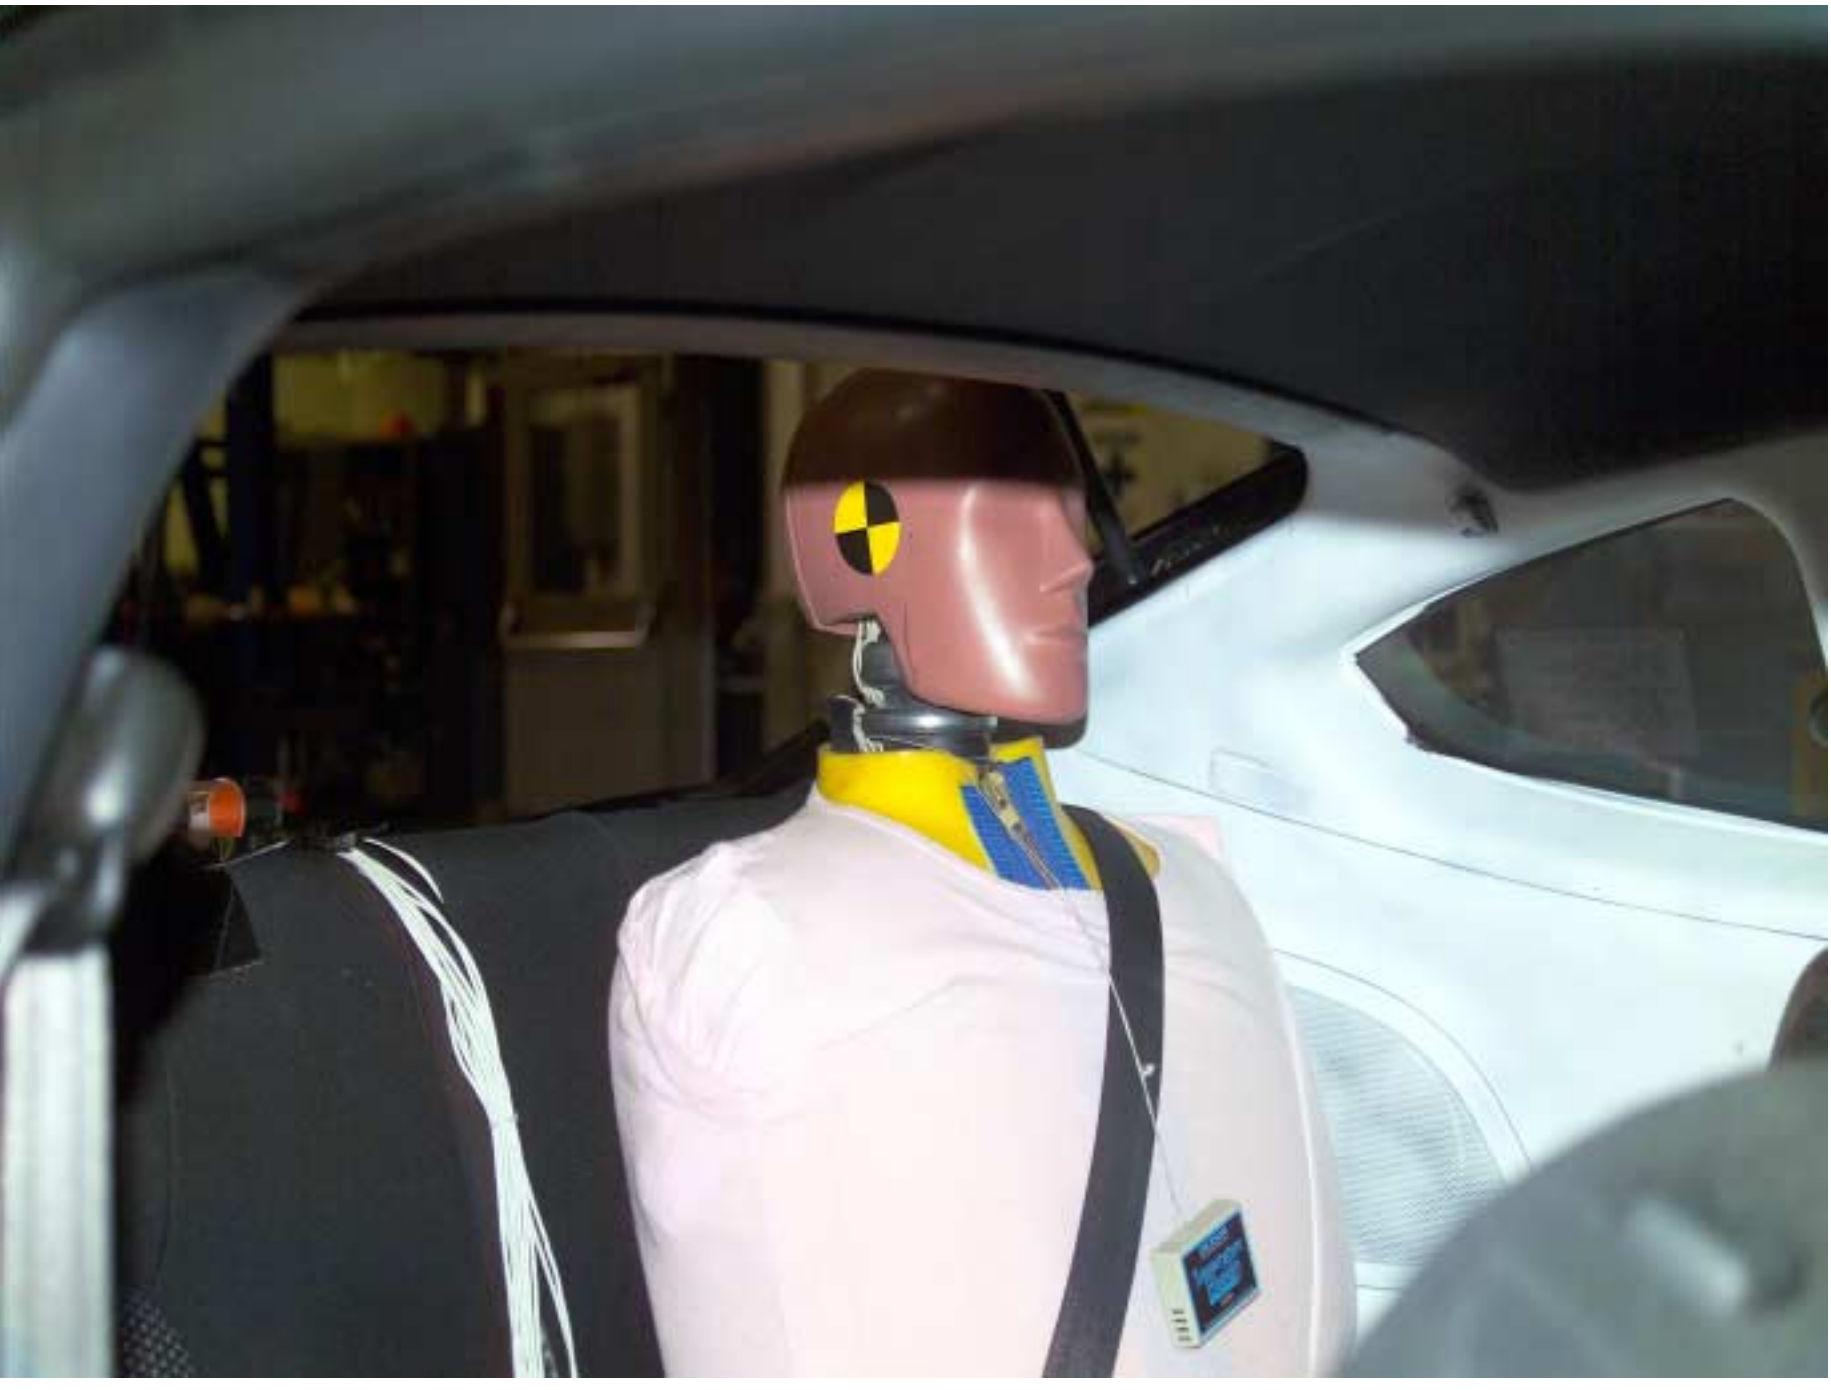
Figure A-32 Post-Test Rear SID HIII Seating Incompatibility - View 1

A second SID HIII was placed in the left rear (Pos. #4) designated seating position as ballast during the test. TRC Inc. was unable to properly seat the dummy for testing due to contact between the dummy's head and the rear vehicle hatch.

The left rear passenger dummy could not be seated properly for the test due to contact between the dummy head and the rear window glass of the vehicle. The dummy was left in the vehicle as ballast and the test was performed with one (1) dummy.

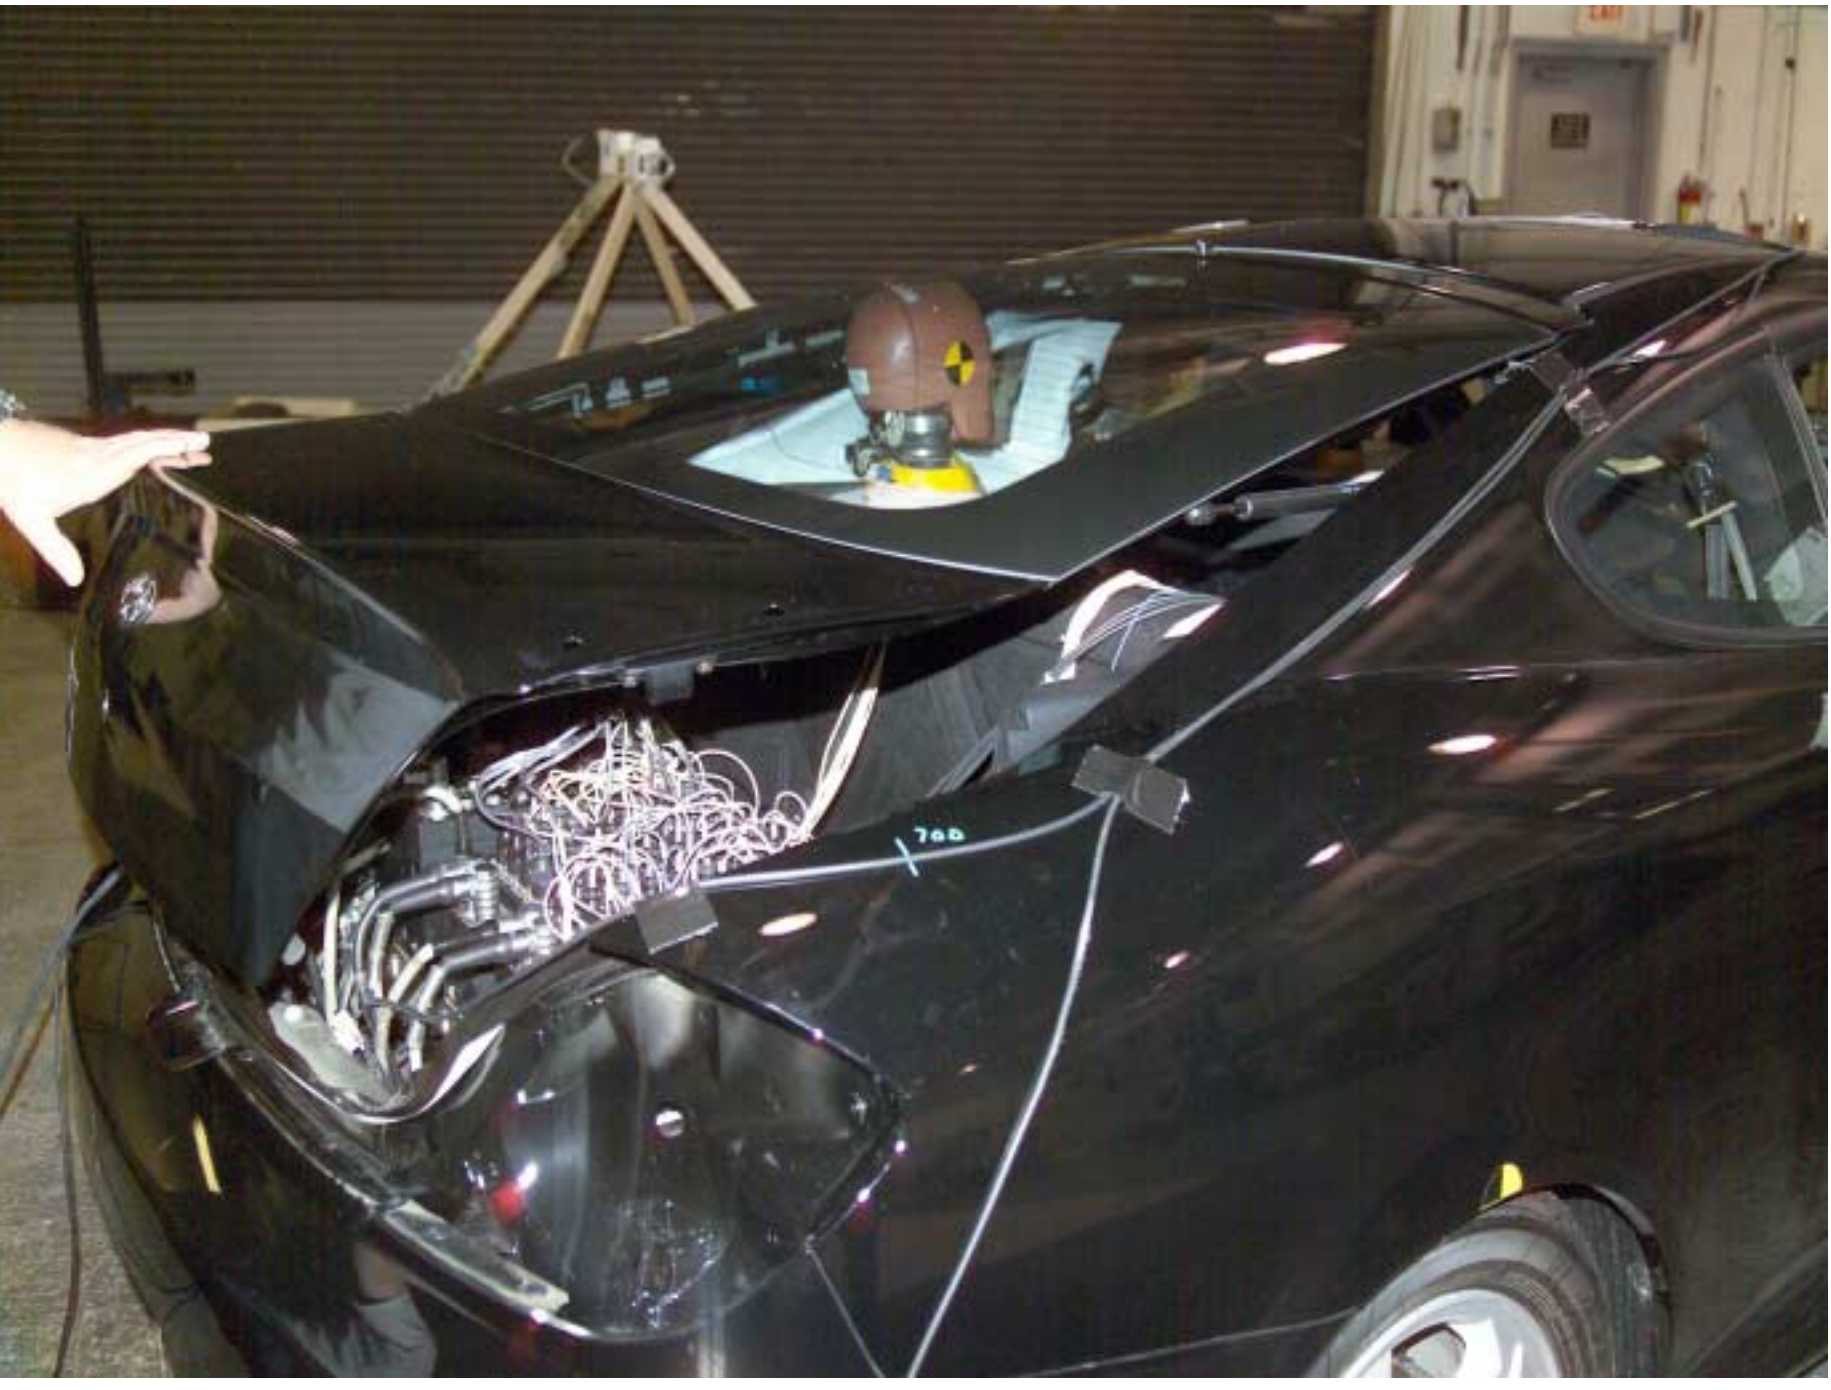
Figure A-34 Post-Test Rear SID HIII Seating Incompatibility - View 3
