**Report Number: NCAP-TRC-03-001**

**New Car Assessment Program**

**“Side Impact Testing”**

**2004 Hyundai Tiburon 2-door**

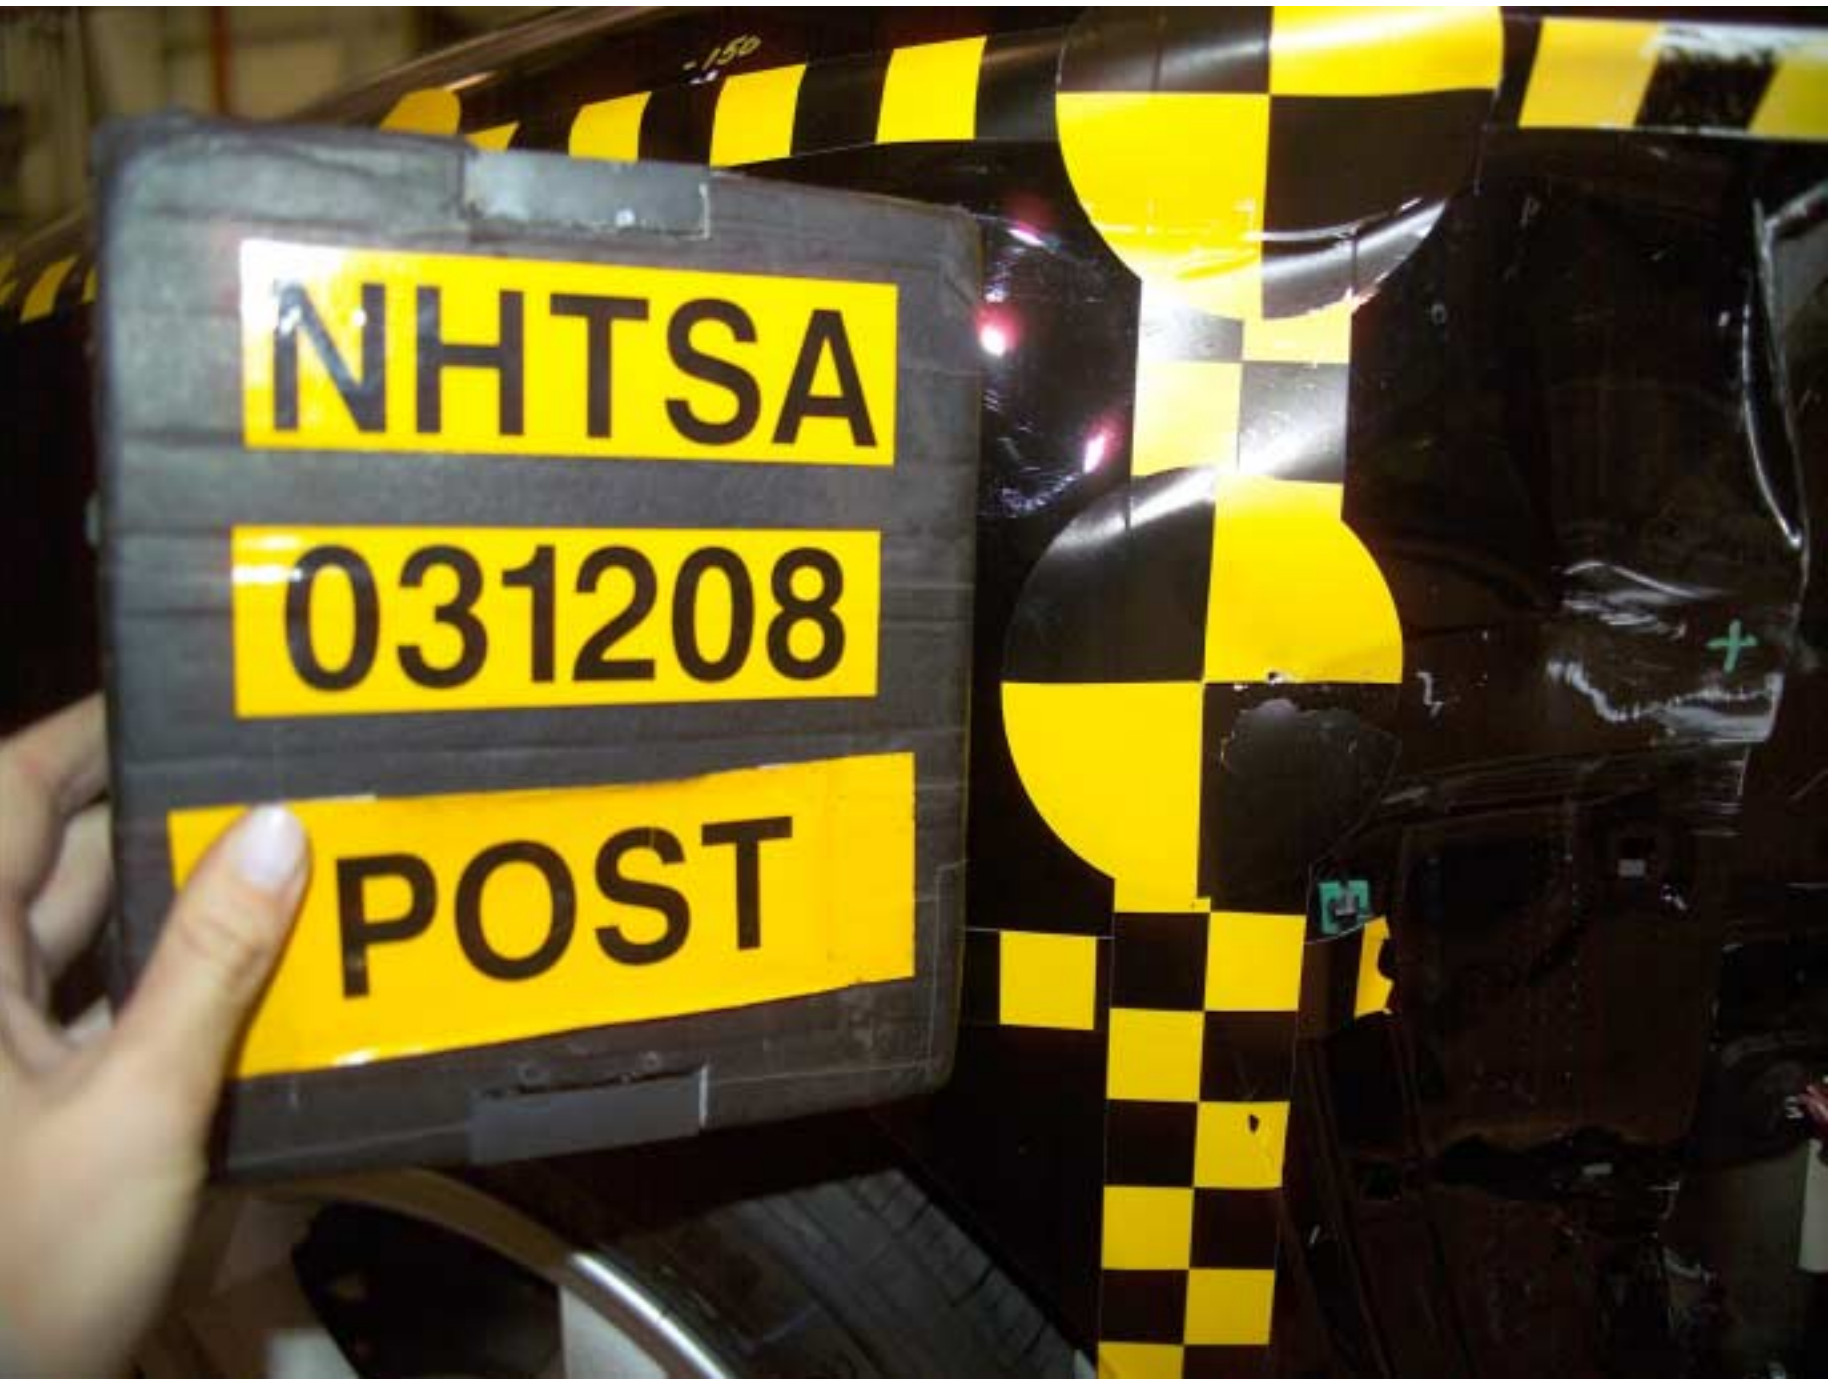
Figure A-36 Post-Test Primary Impact Point View

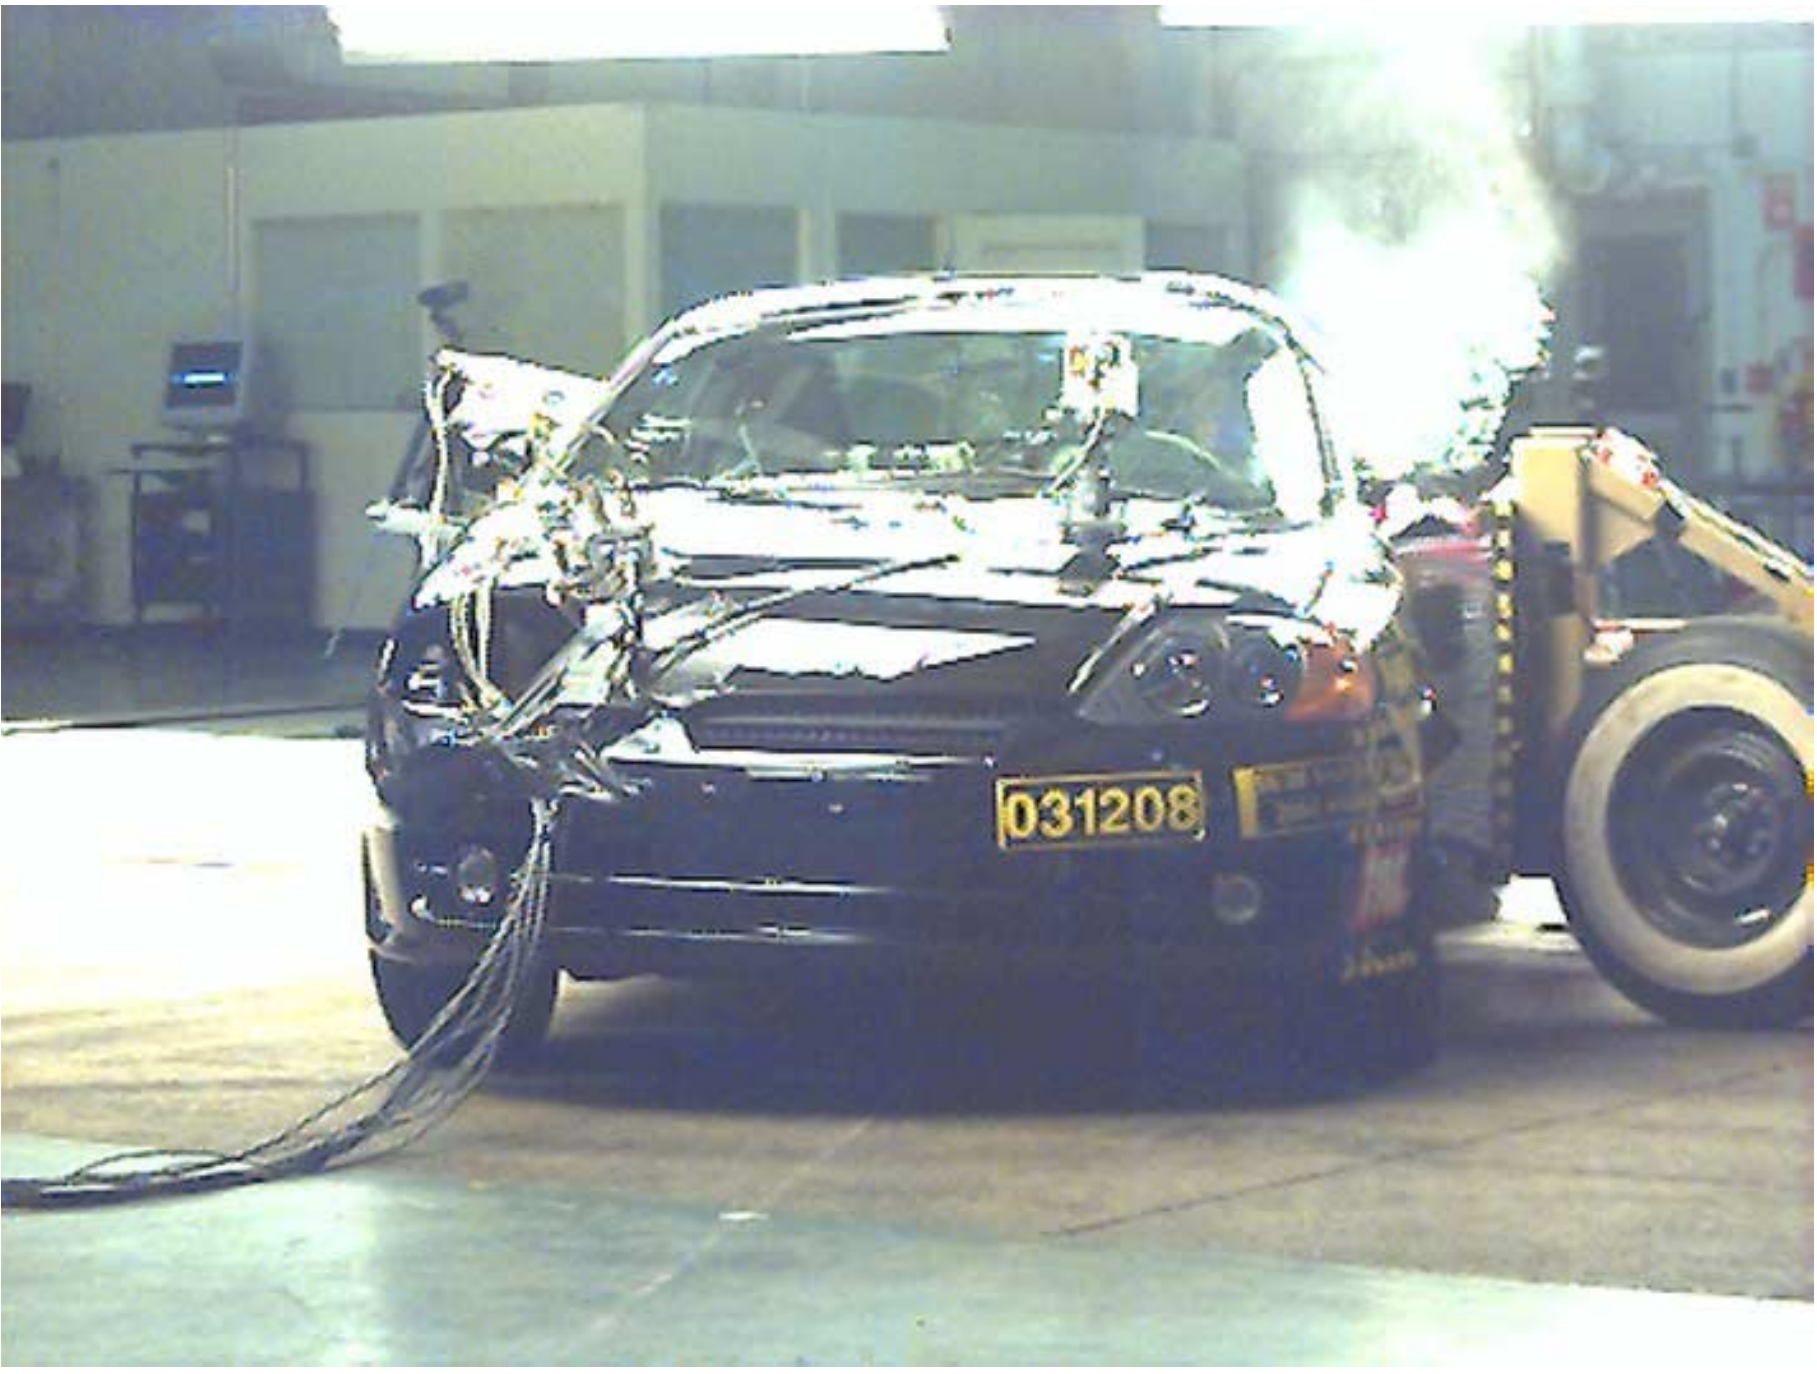
Figure A-41 Impact Event
