**REPORT NUMBER: NCAPSIDE-MGA-2004-003**

**NEW CAR ASSESSMENT PROGRAM  
SIDE IMPACT TEST**

**Honda Motor Company  
2004 Acura TSX 4-Door  
NHTSA NUMBER: M45301**

**PREPARED BY:  
MGA RESEARCH CORPORATION  
5000 WARREN ROAD  
BURLINGTON, WI 53105**

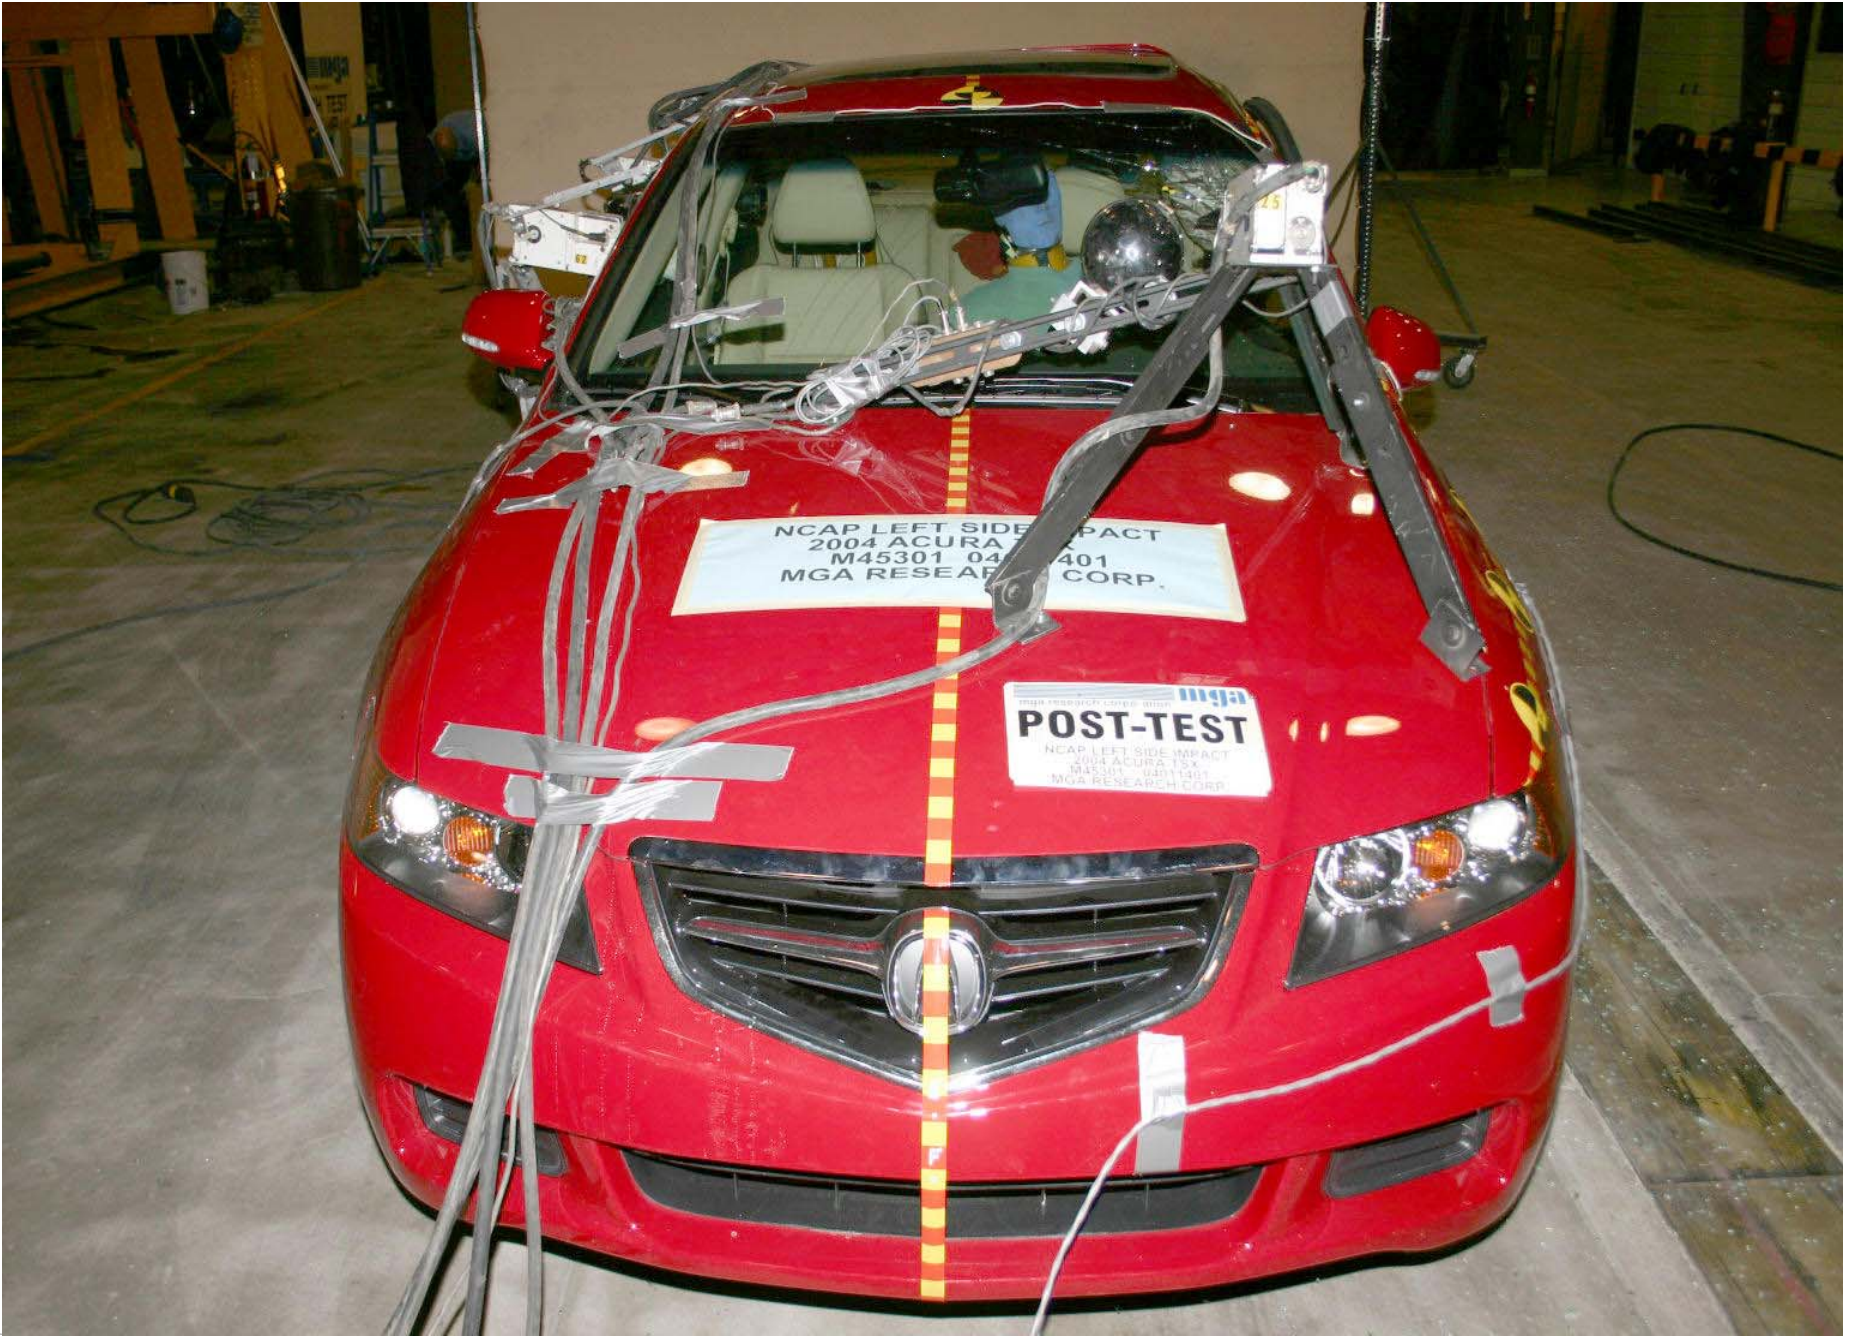
Post-Test Front View of Test Vehicle

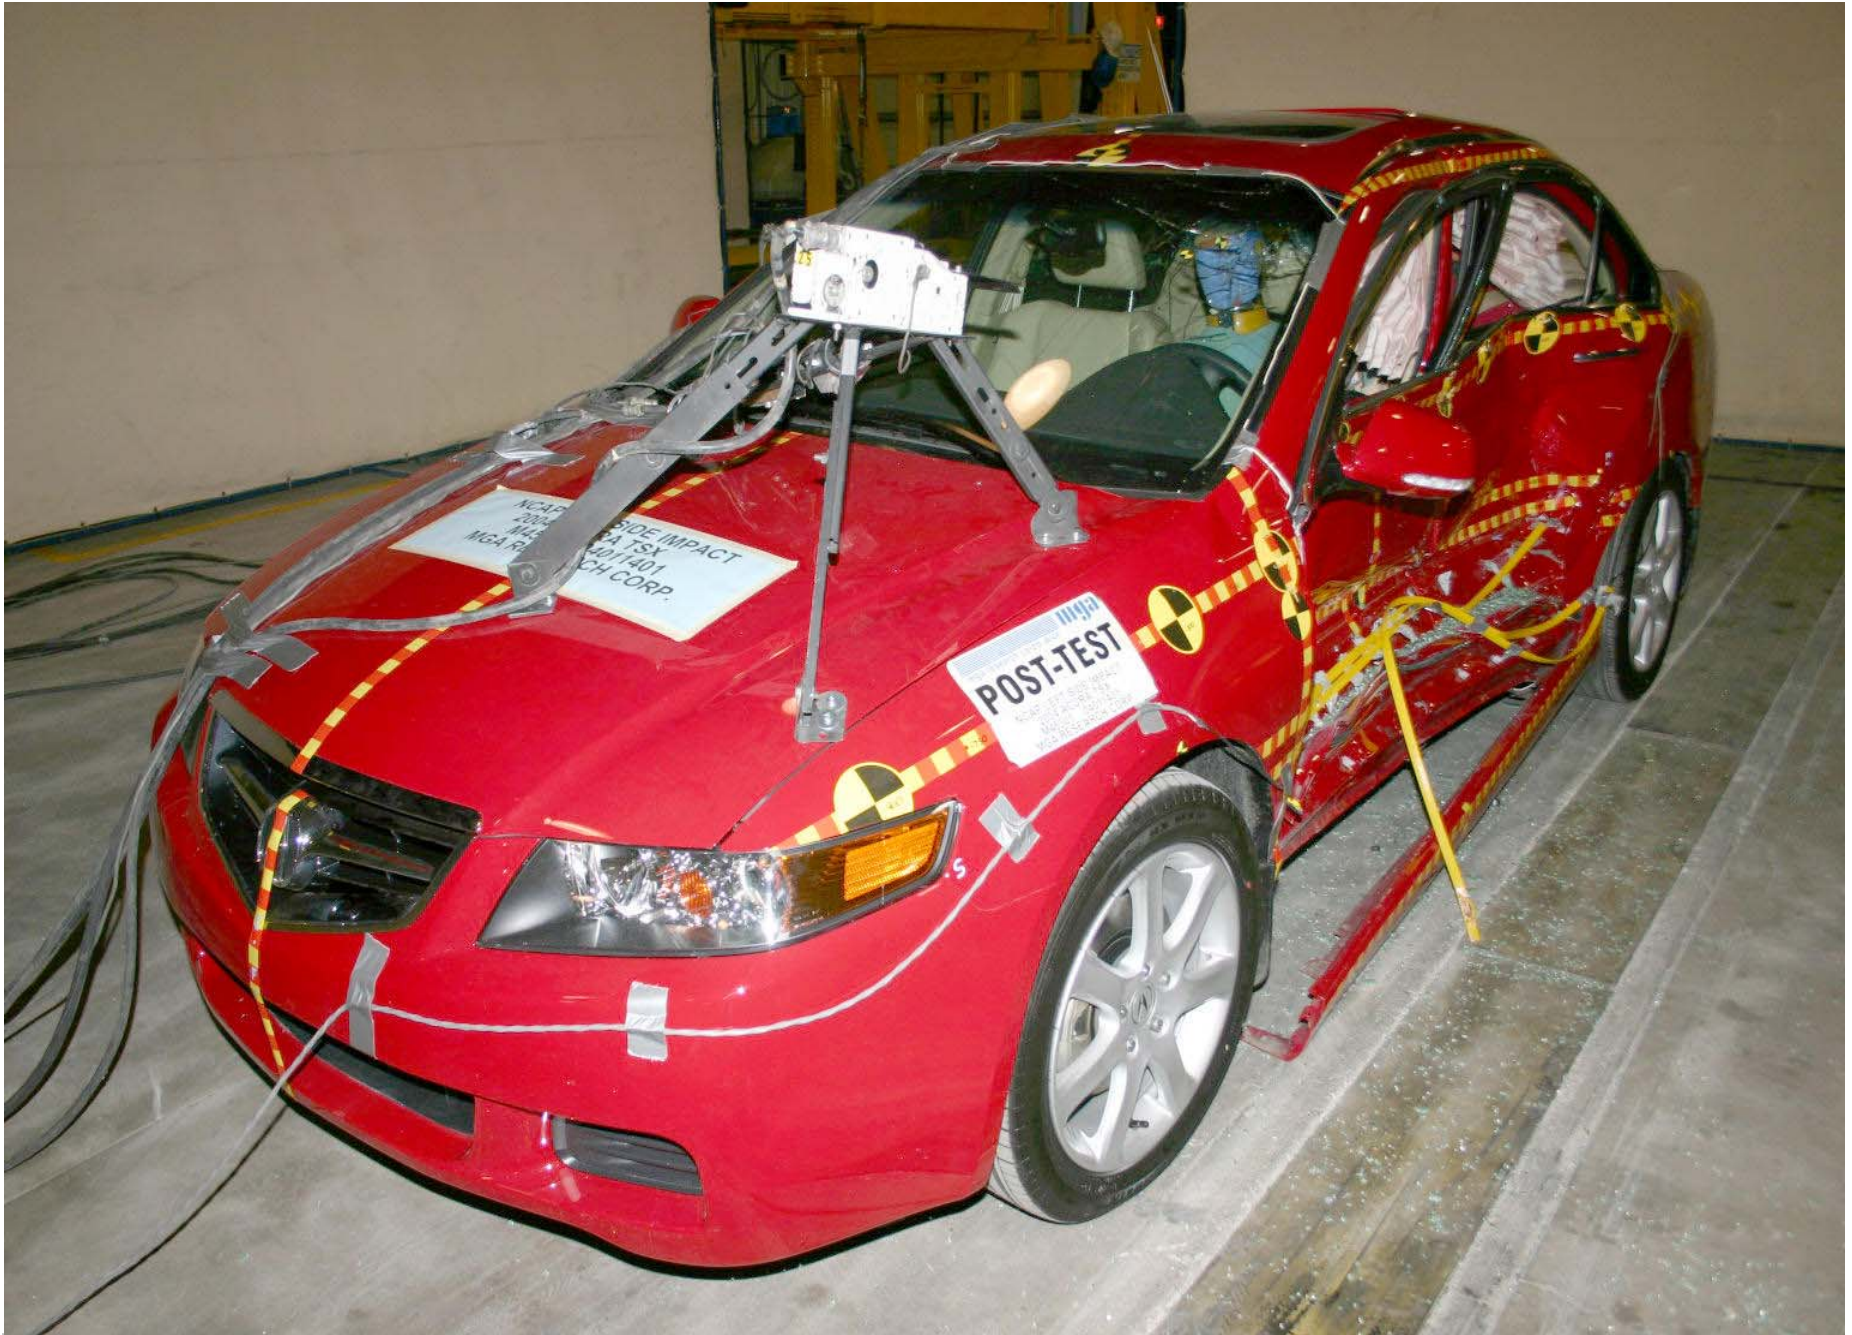
Post-Test Left Front ¾ View of Test Vehicle

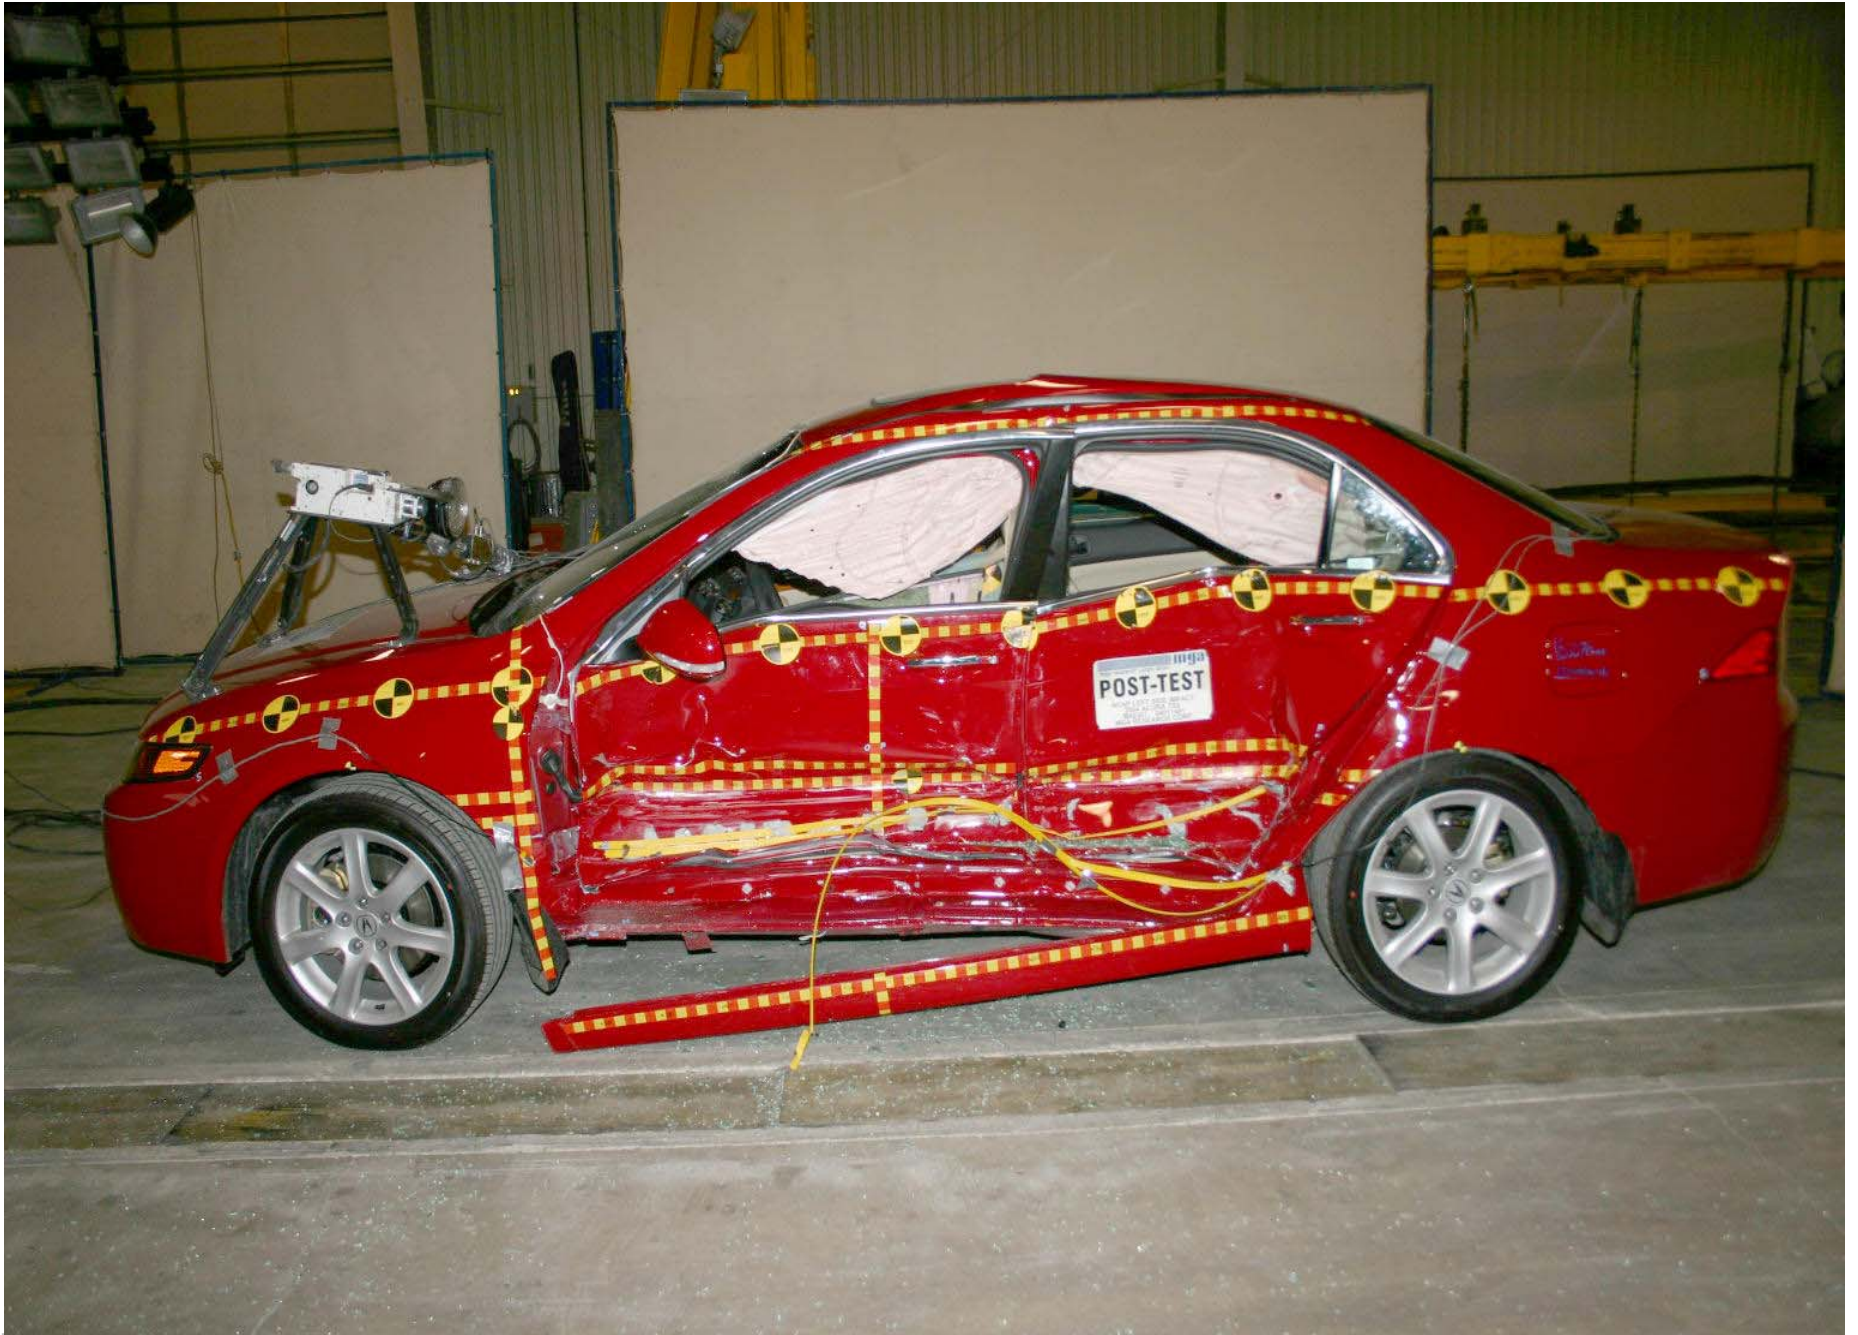
A-10.

Post-Test Left Side View of Test Vehicle

The test vehicle sustained a maximum static crush of 344 mm at level 2, 1200 mm rearward of the left vertical impact point. The driver and passenger SID/HIII's, Serial Nos. 904 and 271 respectively, were calibrated just prior to this test. The SID/HIII's injury criteria are summarized as follows:

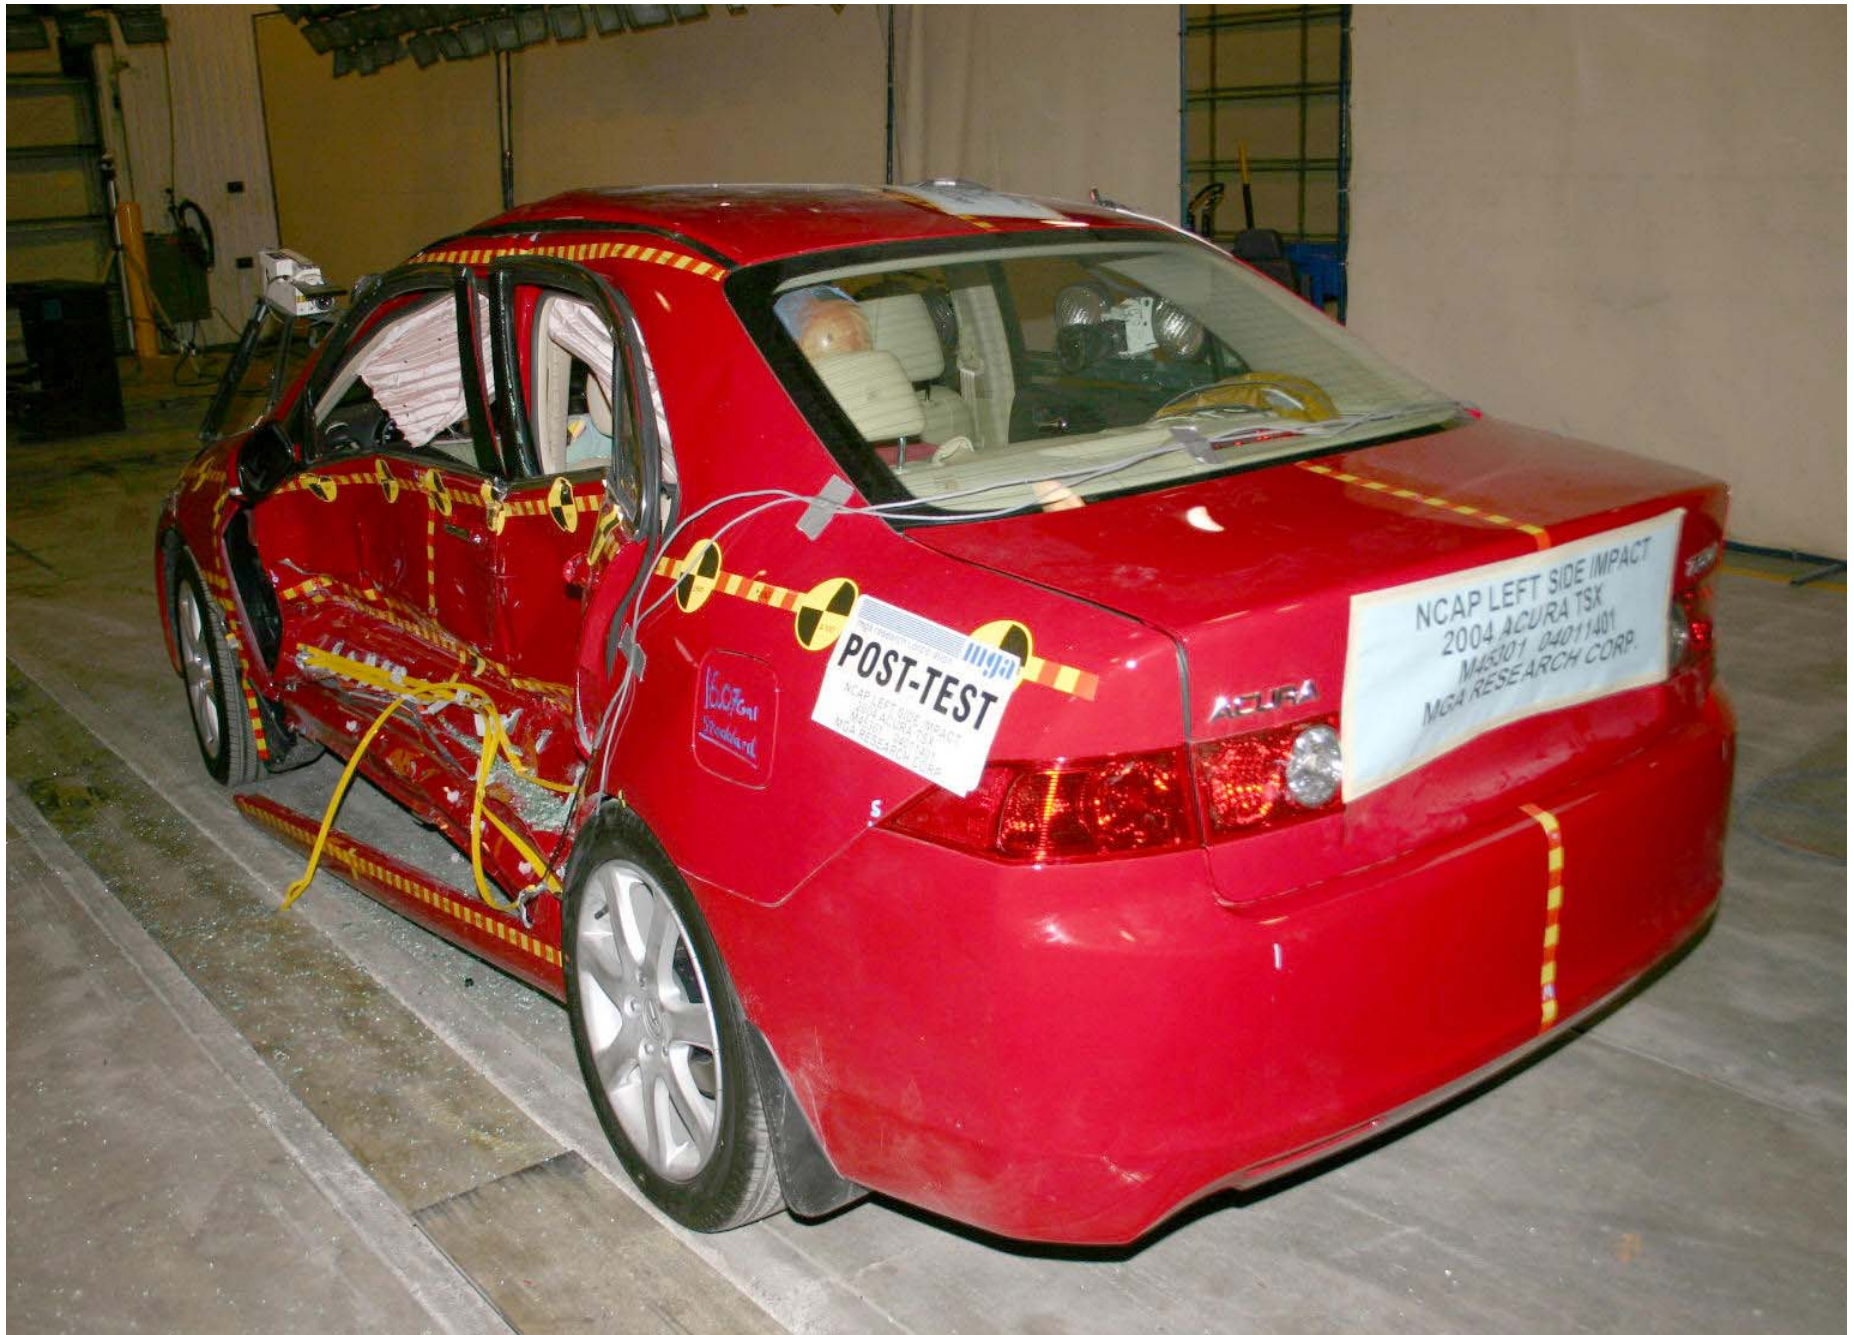
Post-Test Left Rear  $\frac{3}{4}$  View of Test Vehicle

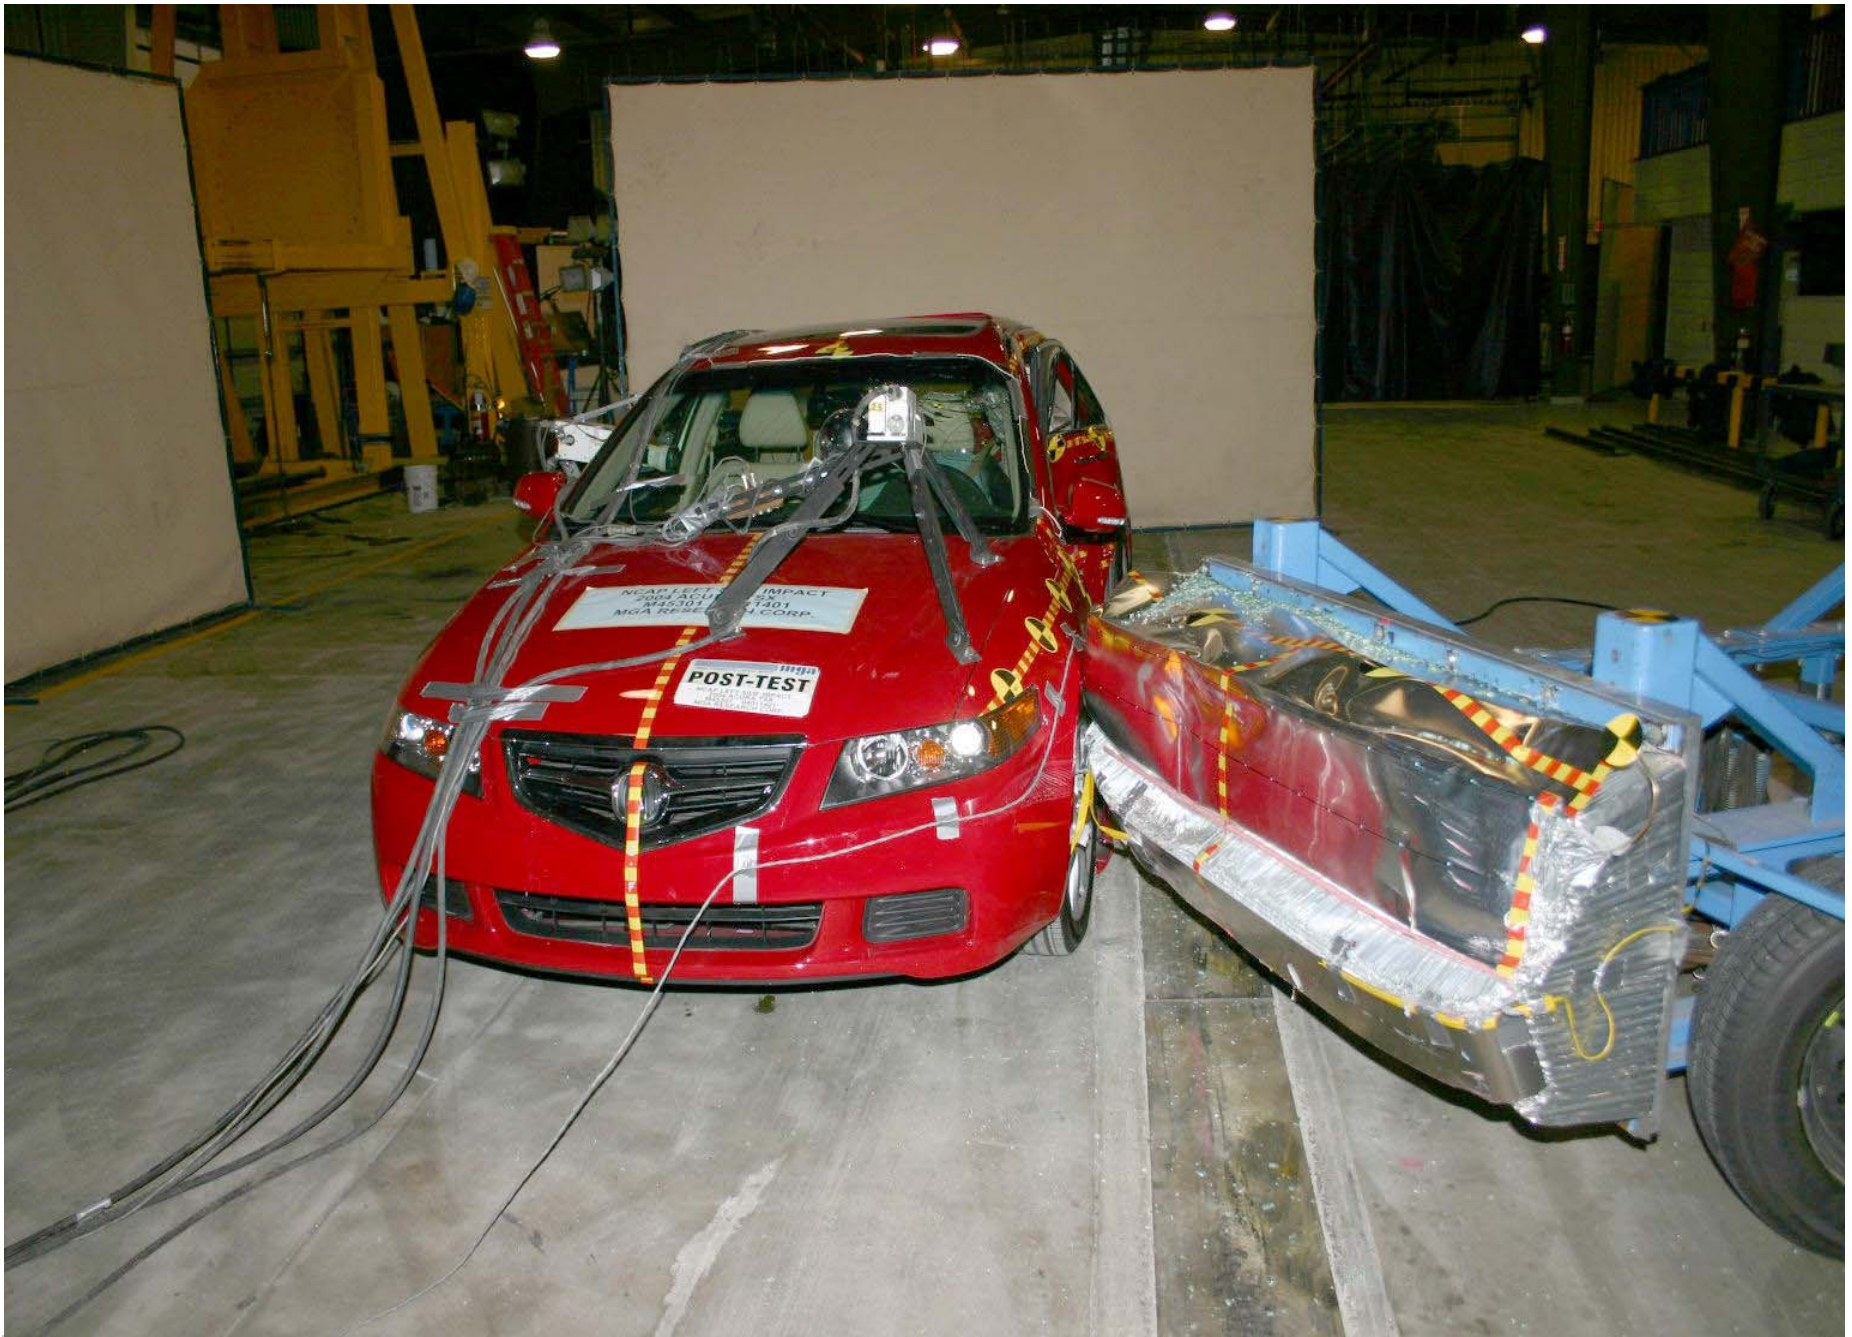
Post-Test MDB (left side) and Vehicle

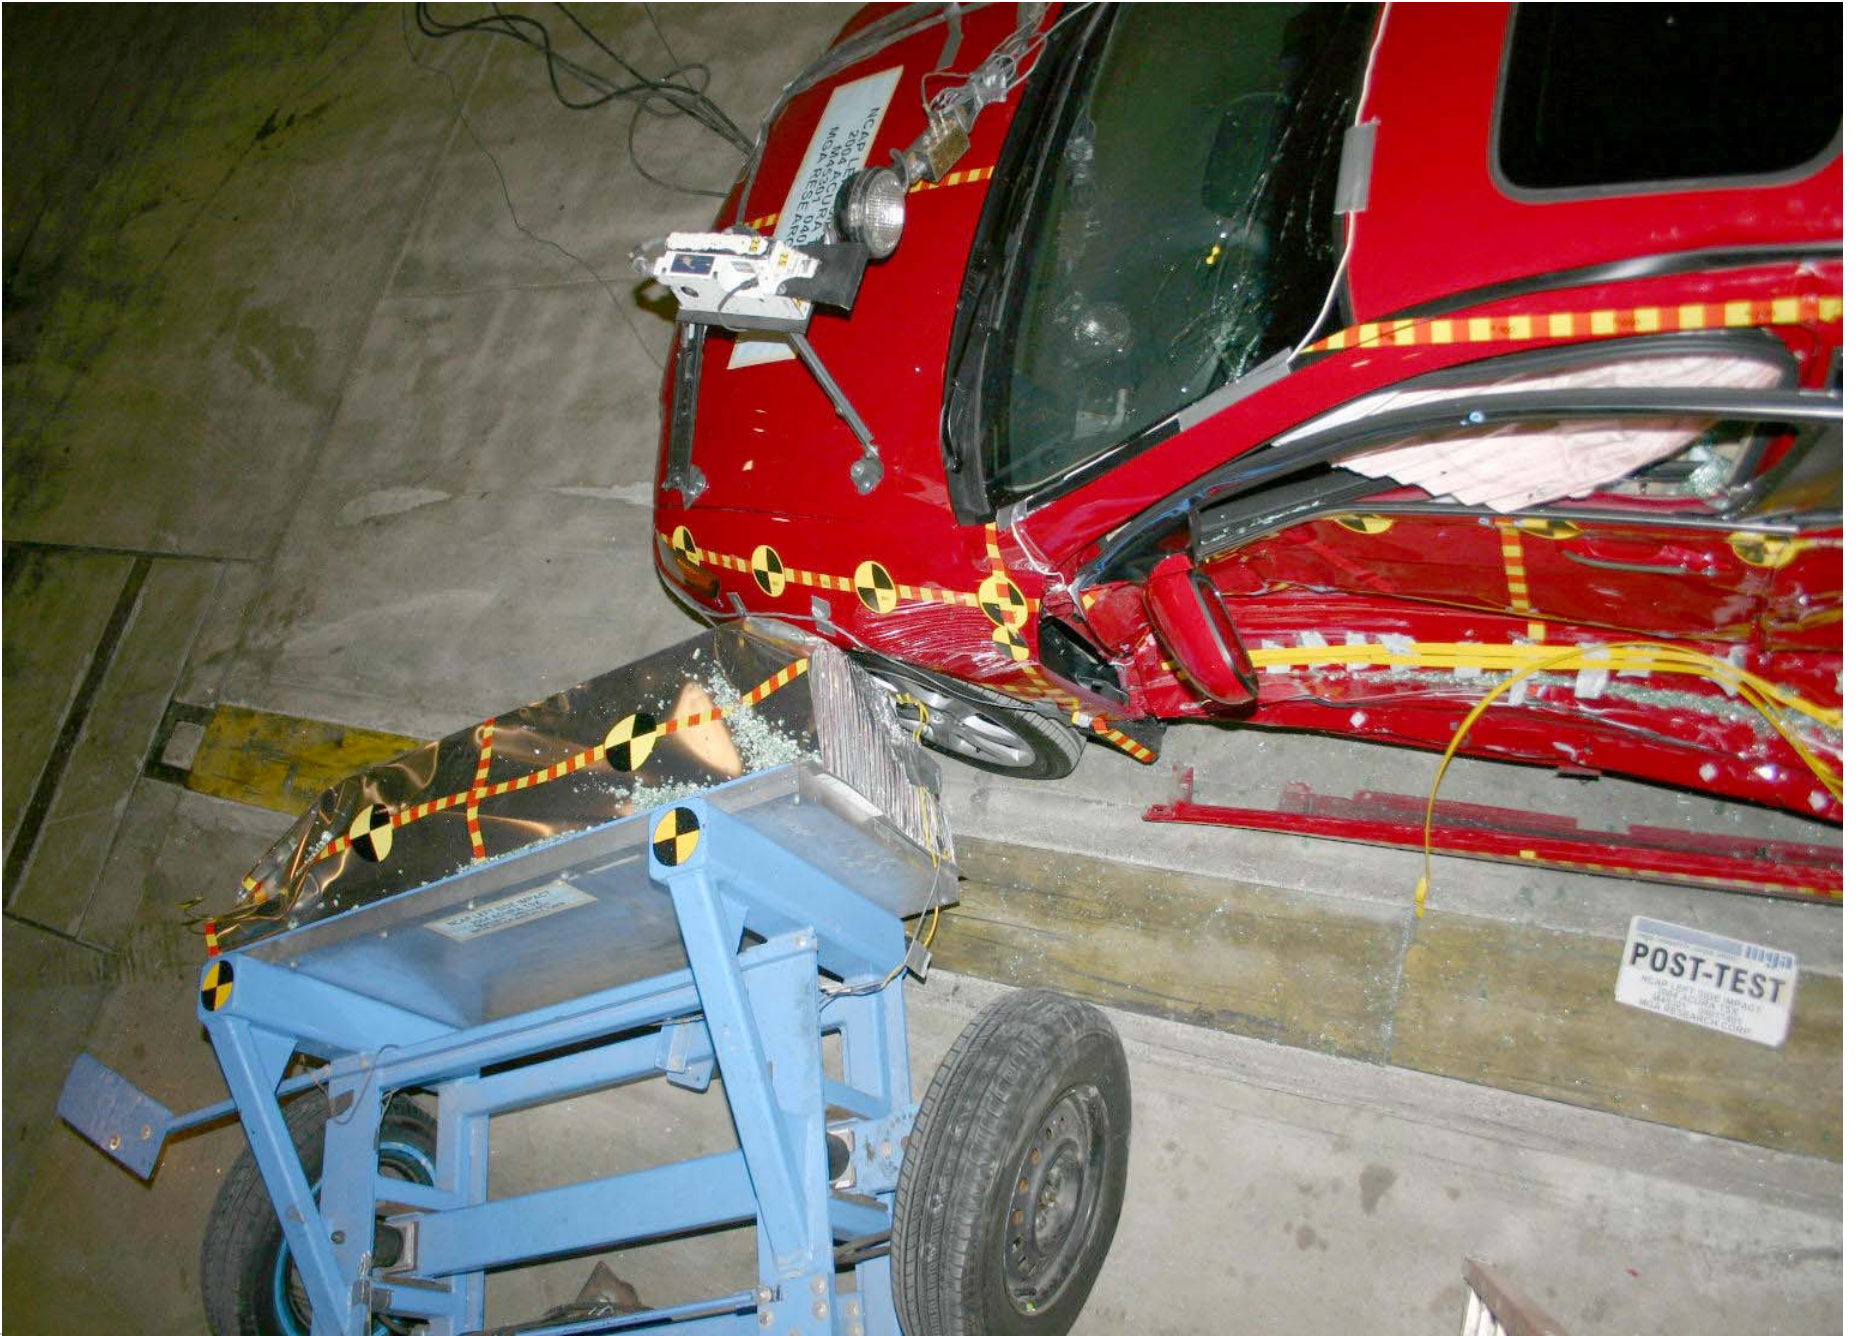
Post-Test MDB and Vehicle Overhead View

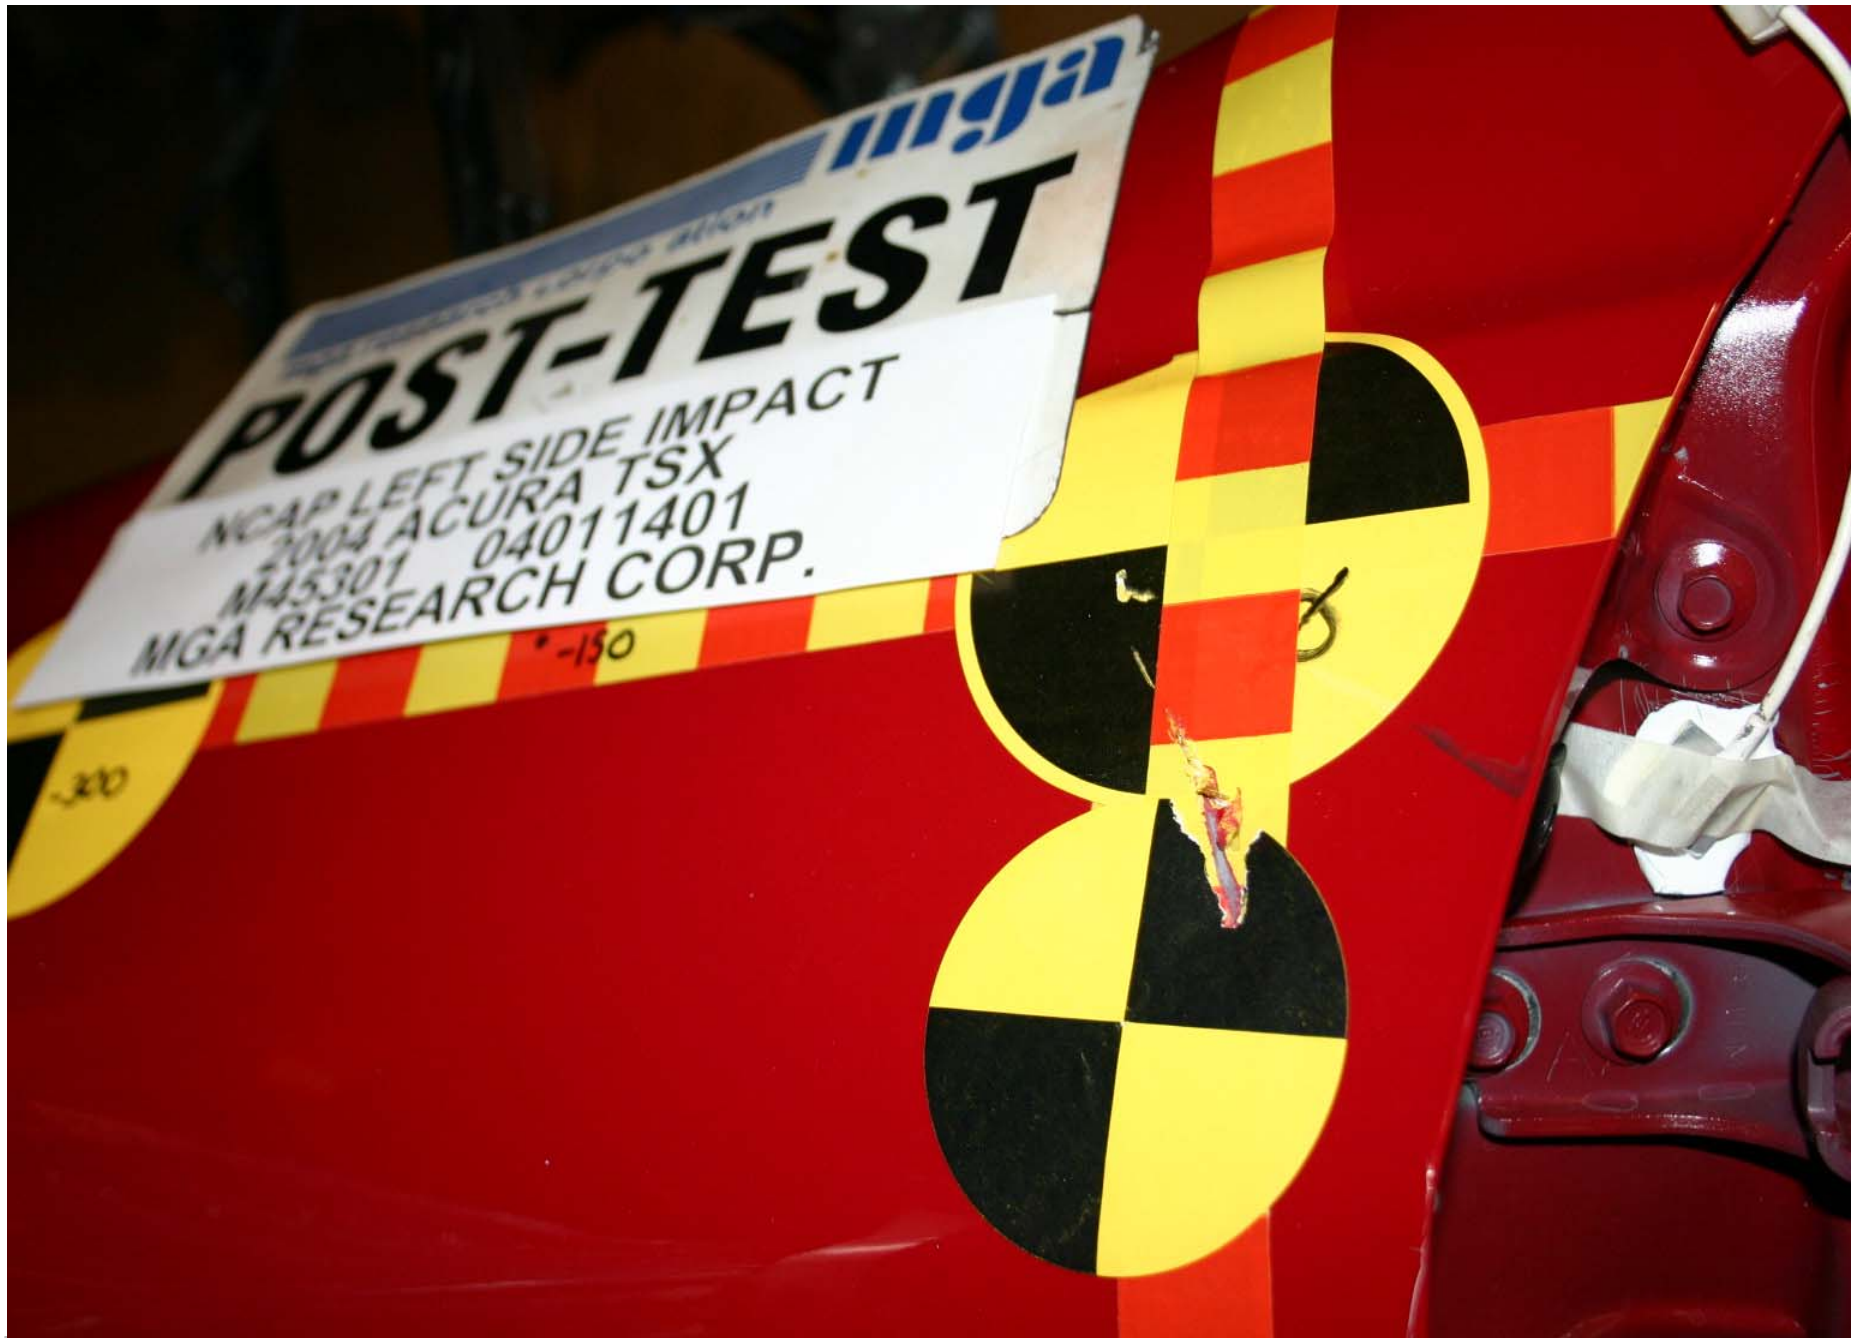
Post-Test Impact Point on Vehicle

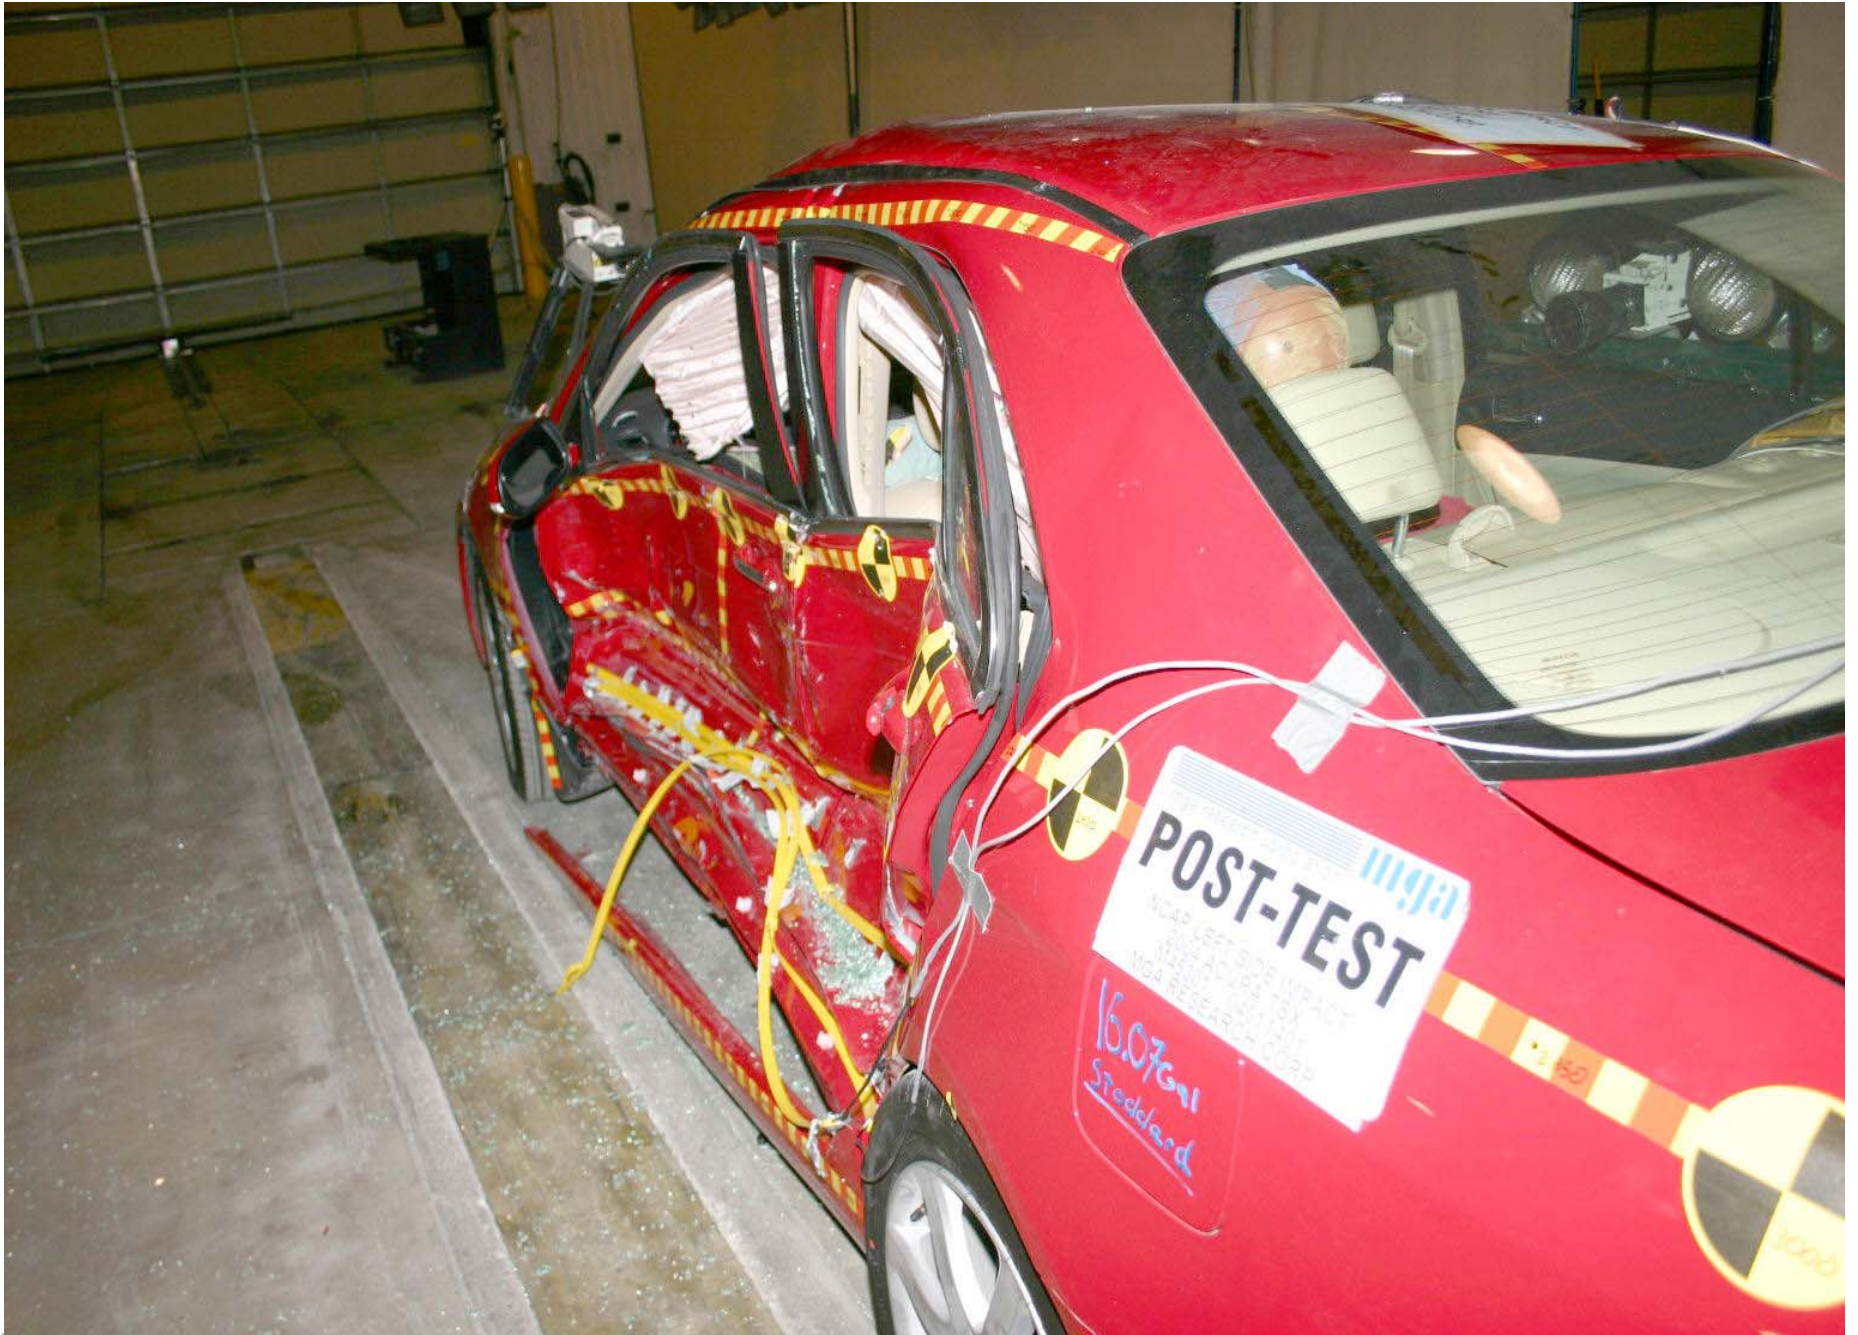
Post-Test Rear 3/4 View of Left Doors of Test Vehicle

Description	Front	Rear
Locked/Unlocked Doors	Doors were unlocked	Doors were unlocked
Left Side Door Opening	Door remained closed and latched	Door remained closed and latched
Right Side Door Opening	Door remained closed and latched; Door opened without tools	Door remained closed and latched; Door opened without tools
Seat Movement	0	0
Seat Back Failure	None	None

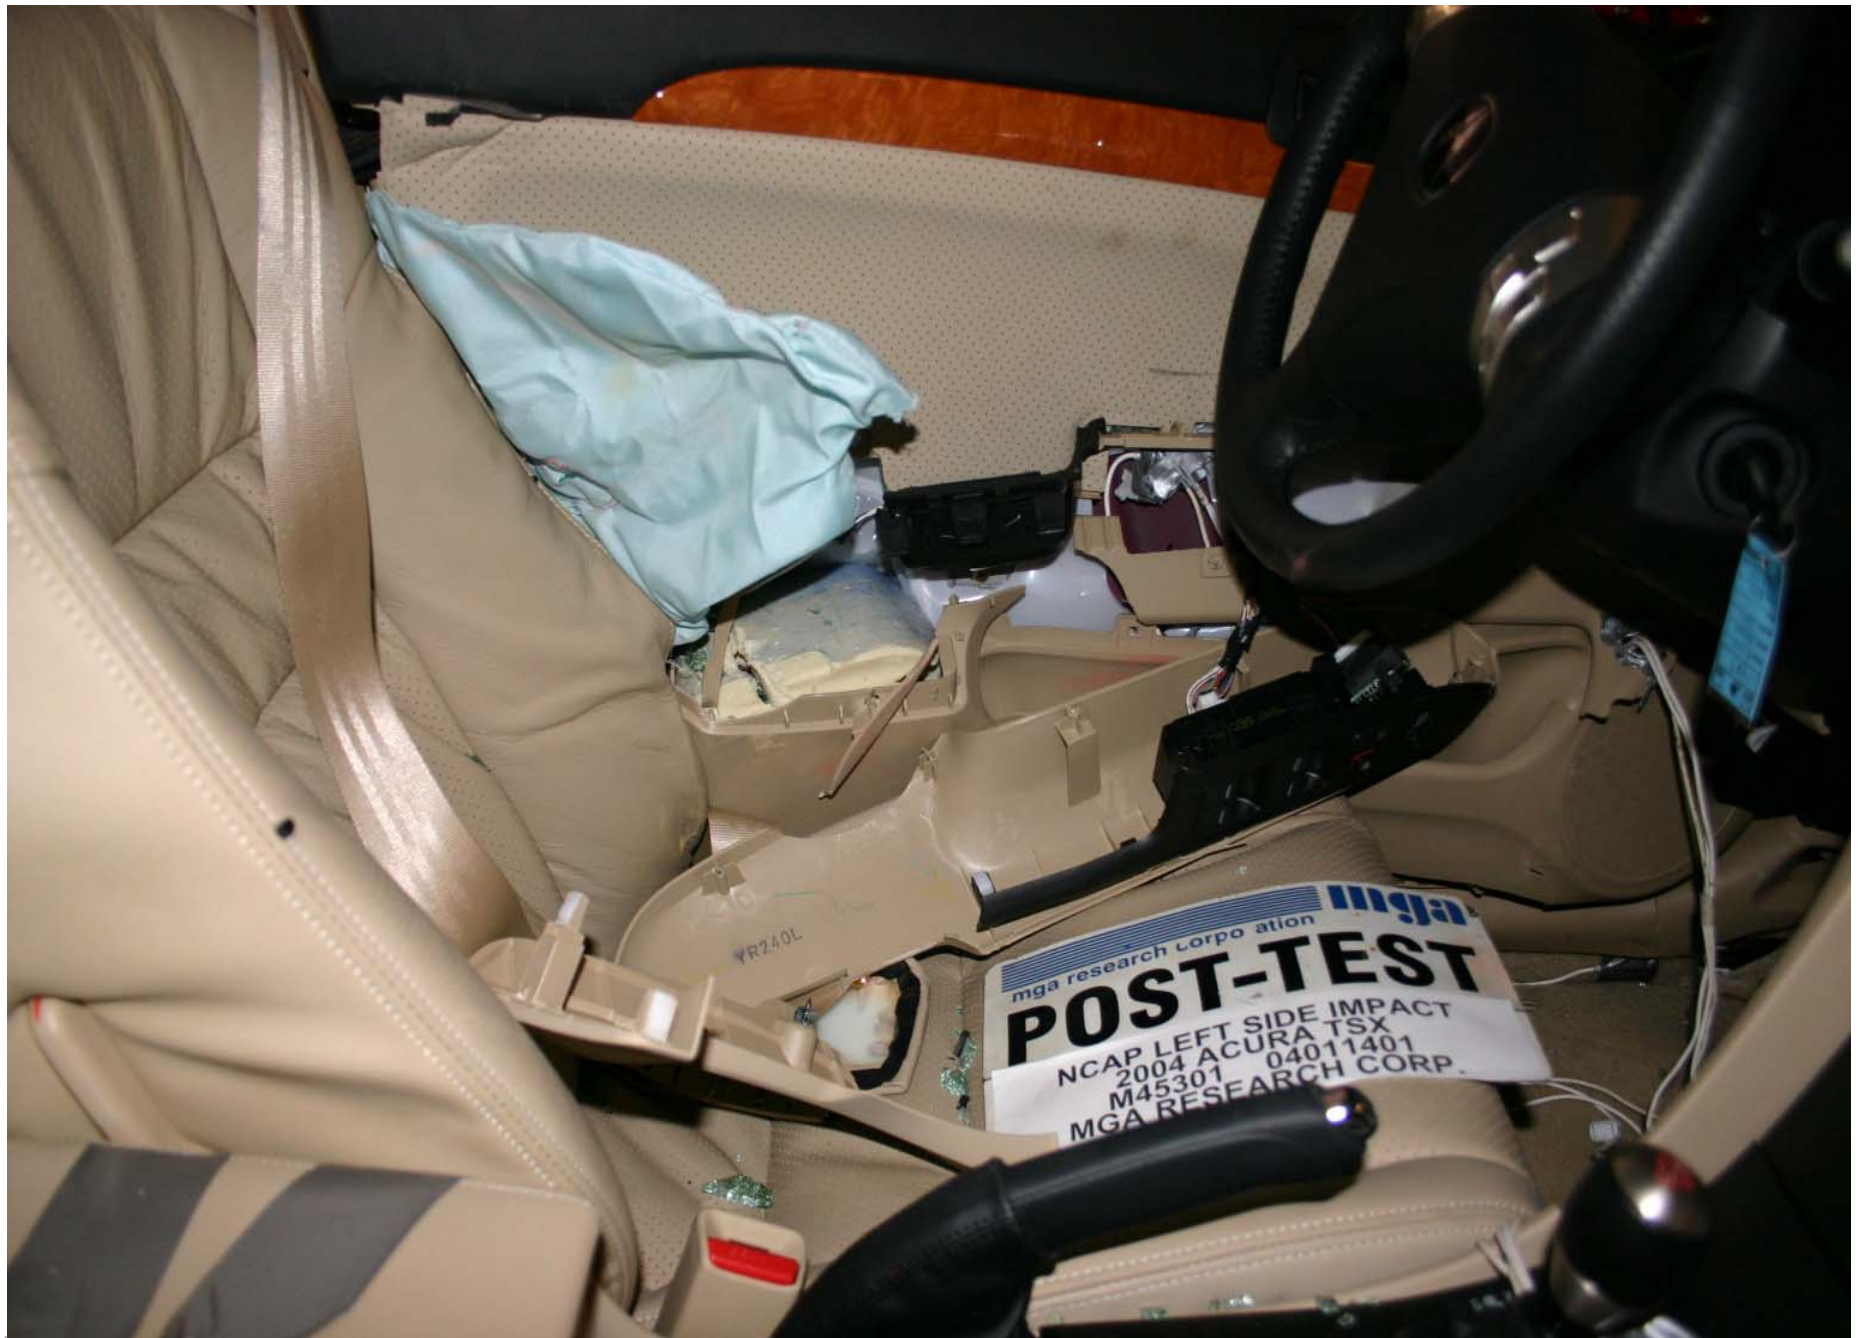
A-36.

Post-Test Driver Dummy Contact
