**REPORT NUMBER: NCAPSIDE-MGA-2004-003**

**NEW CAR ASSESSMENT PROGRAM  
SIDE IMPACT TEST**

**Honda Motor Company  
2004 Acura TSX 4-Door  
NHTSA NUMBER: M45301**

**PREPARED BY:  
MGA RESEARCH CORPORATION  
5000 WARREN ROAD  
BURLINGTON, WI 53105**

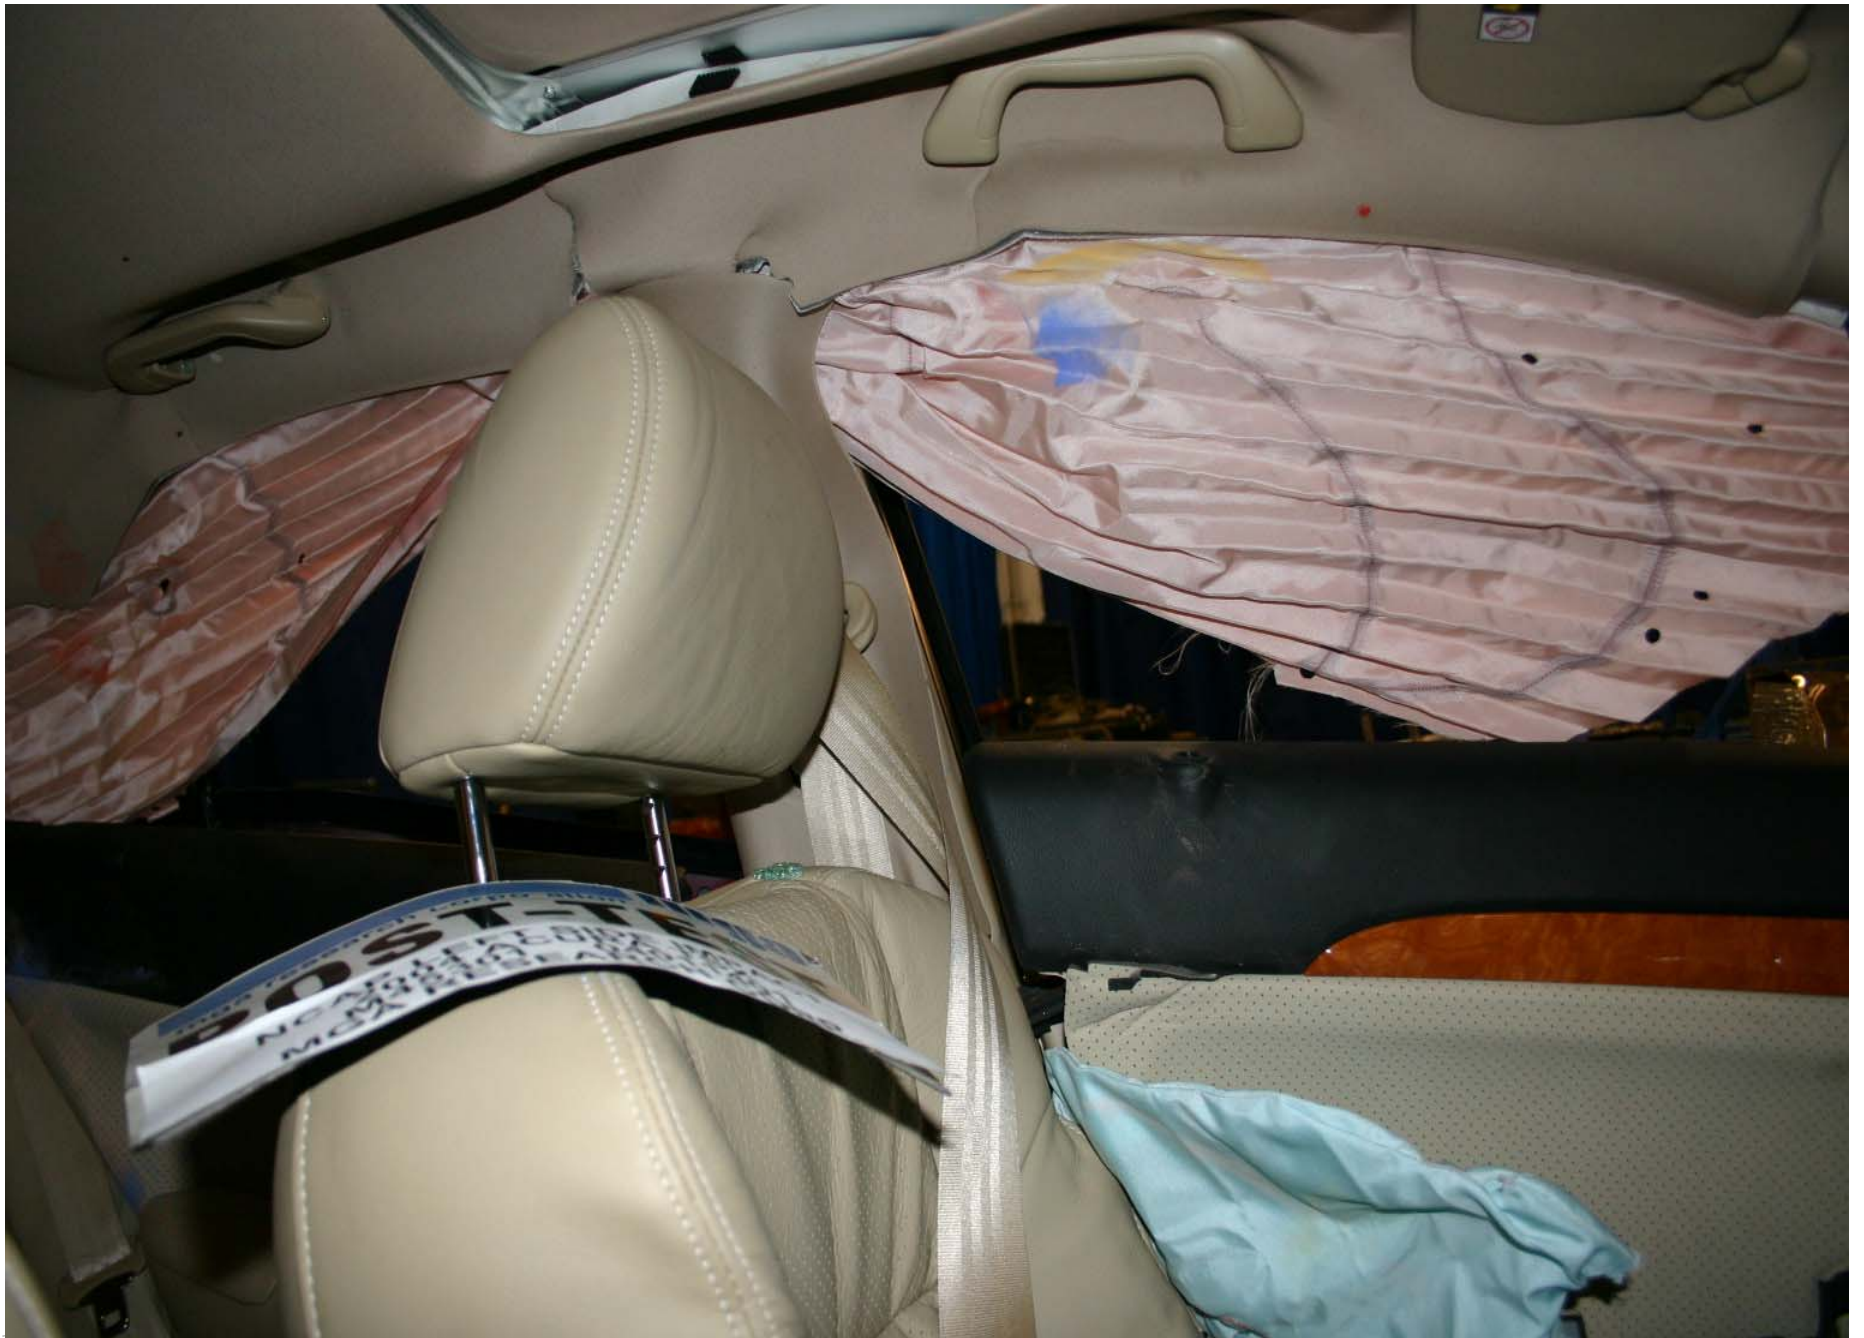
A-37.

Post-Test Driver Dummy Head Contact

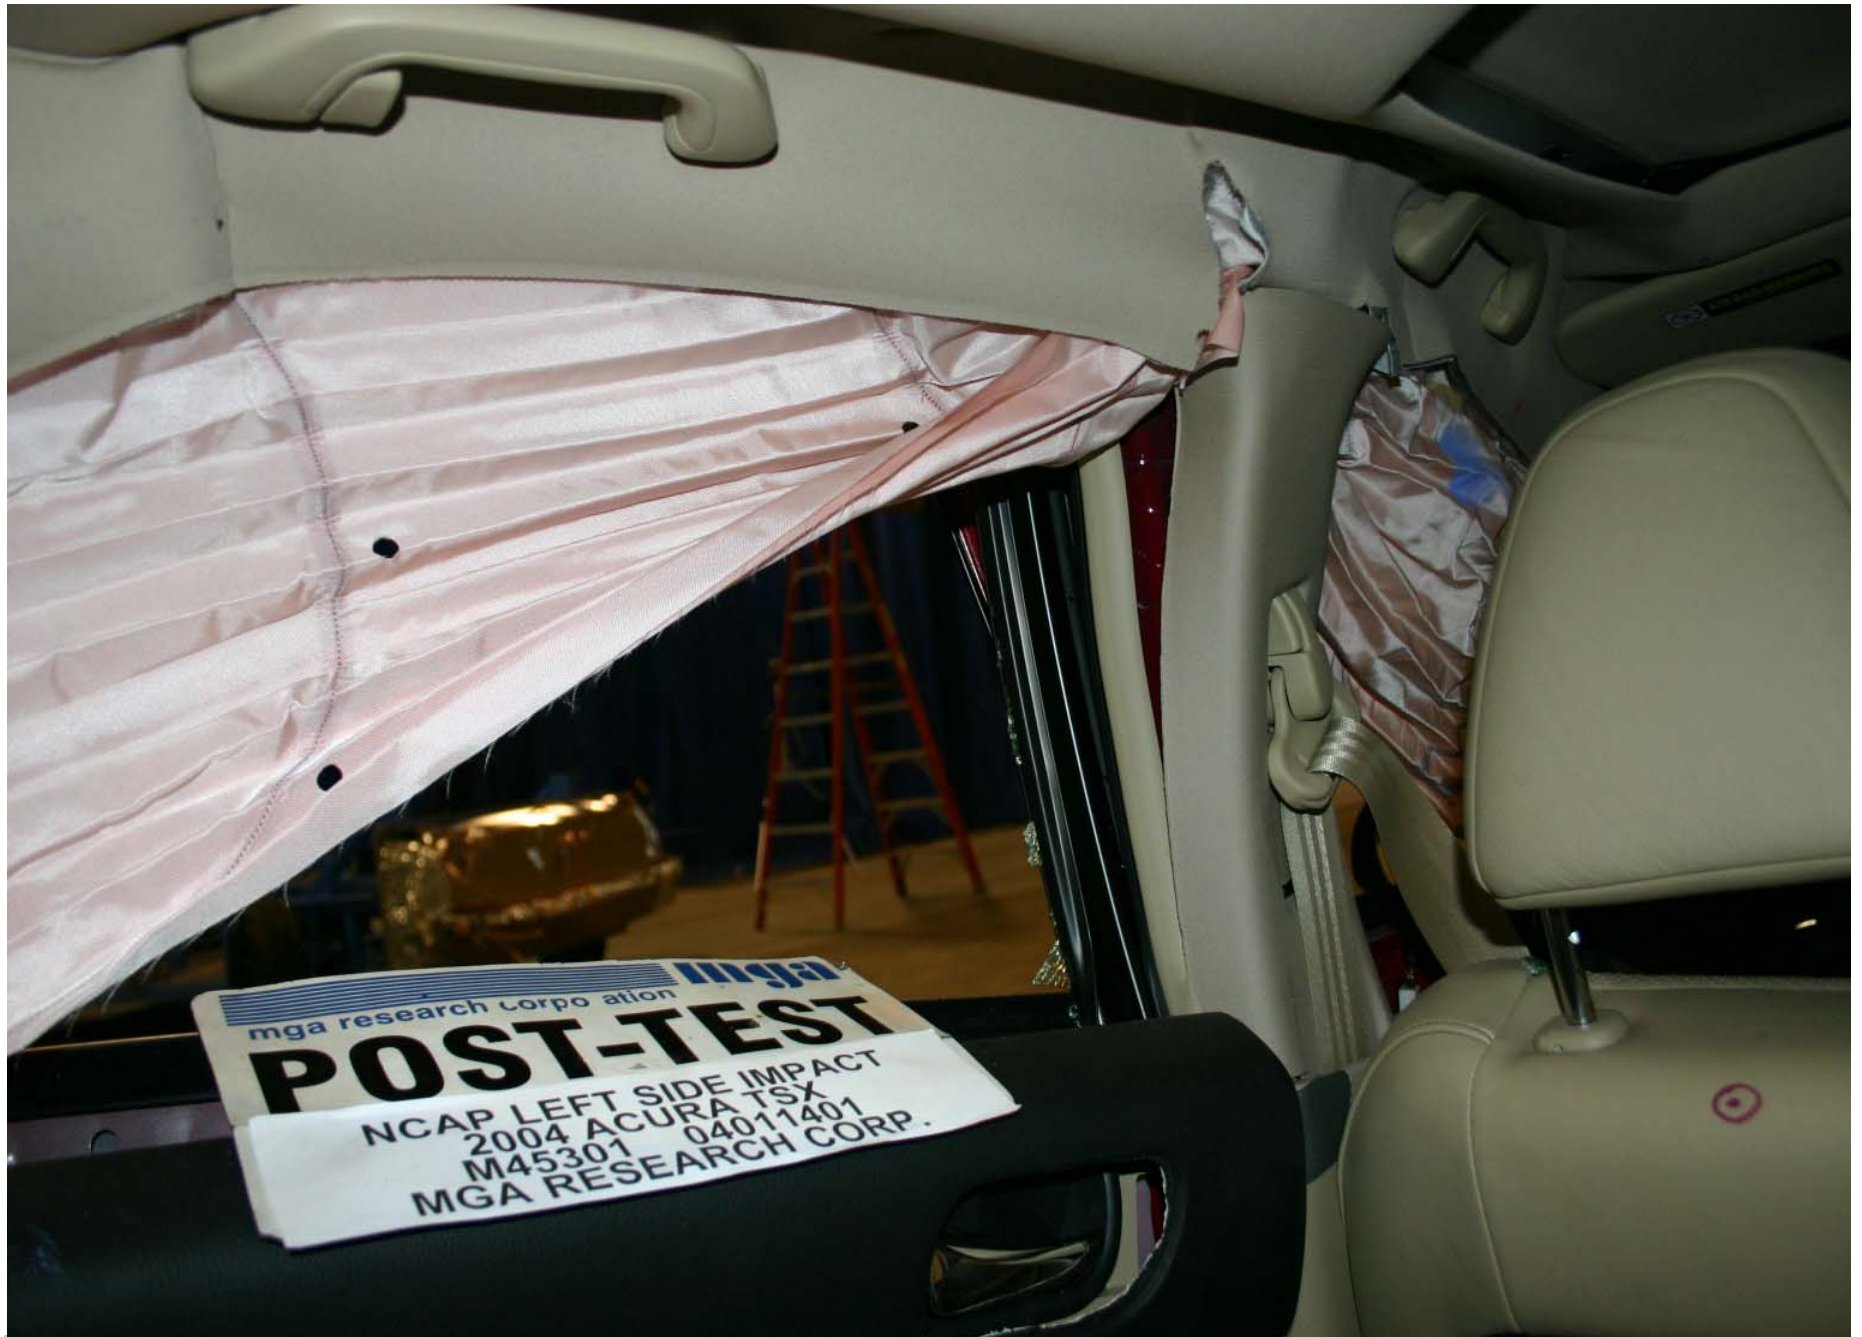
A-47.

Post-Test Passenger Dummy B-Pillar View

Critical Areas of Performance	Observations and Conclusions
Pillar Performance	No Separation
Sill Separation	None
Windshield Damage	Cracked
Window Damage	Left Front and Left Rear
Other Notable Effects	Side airbag failed to properly deploy due to catching on the B-Pillar / Driver's seat back came apart

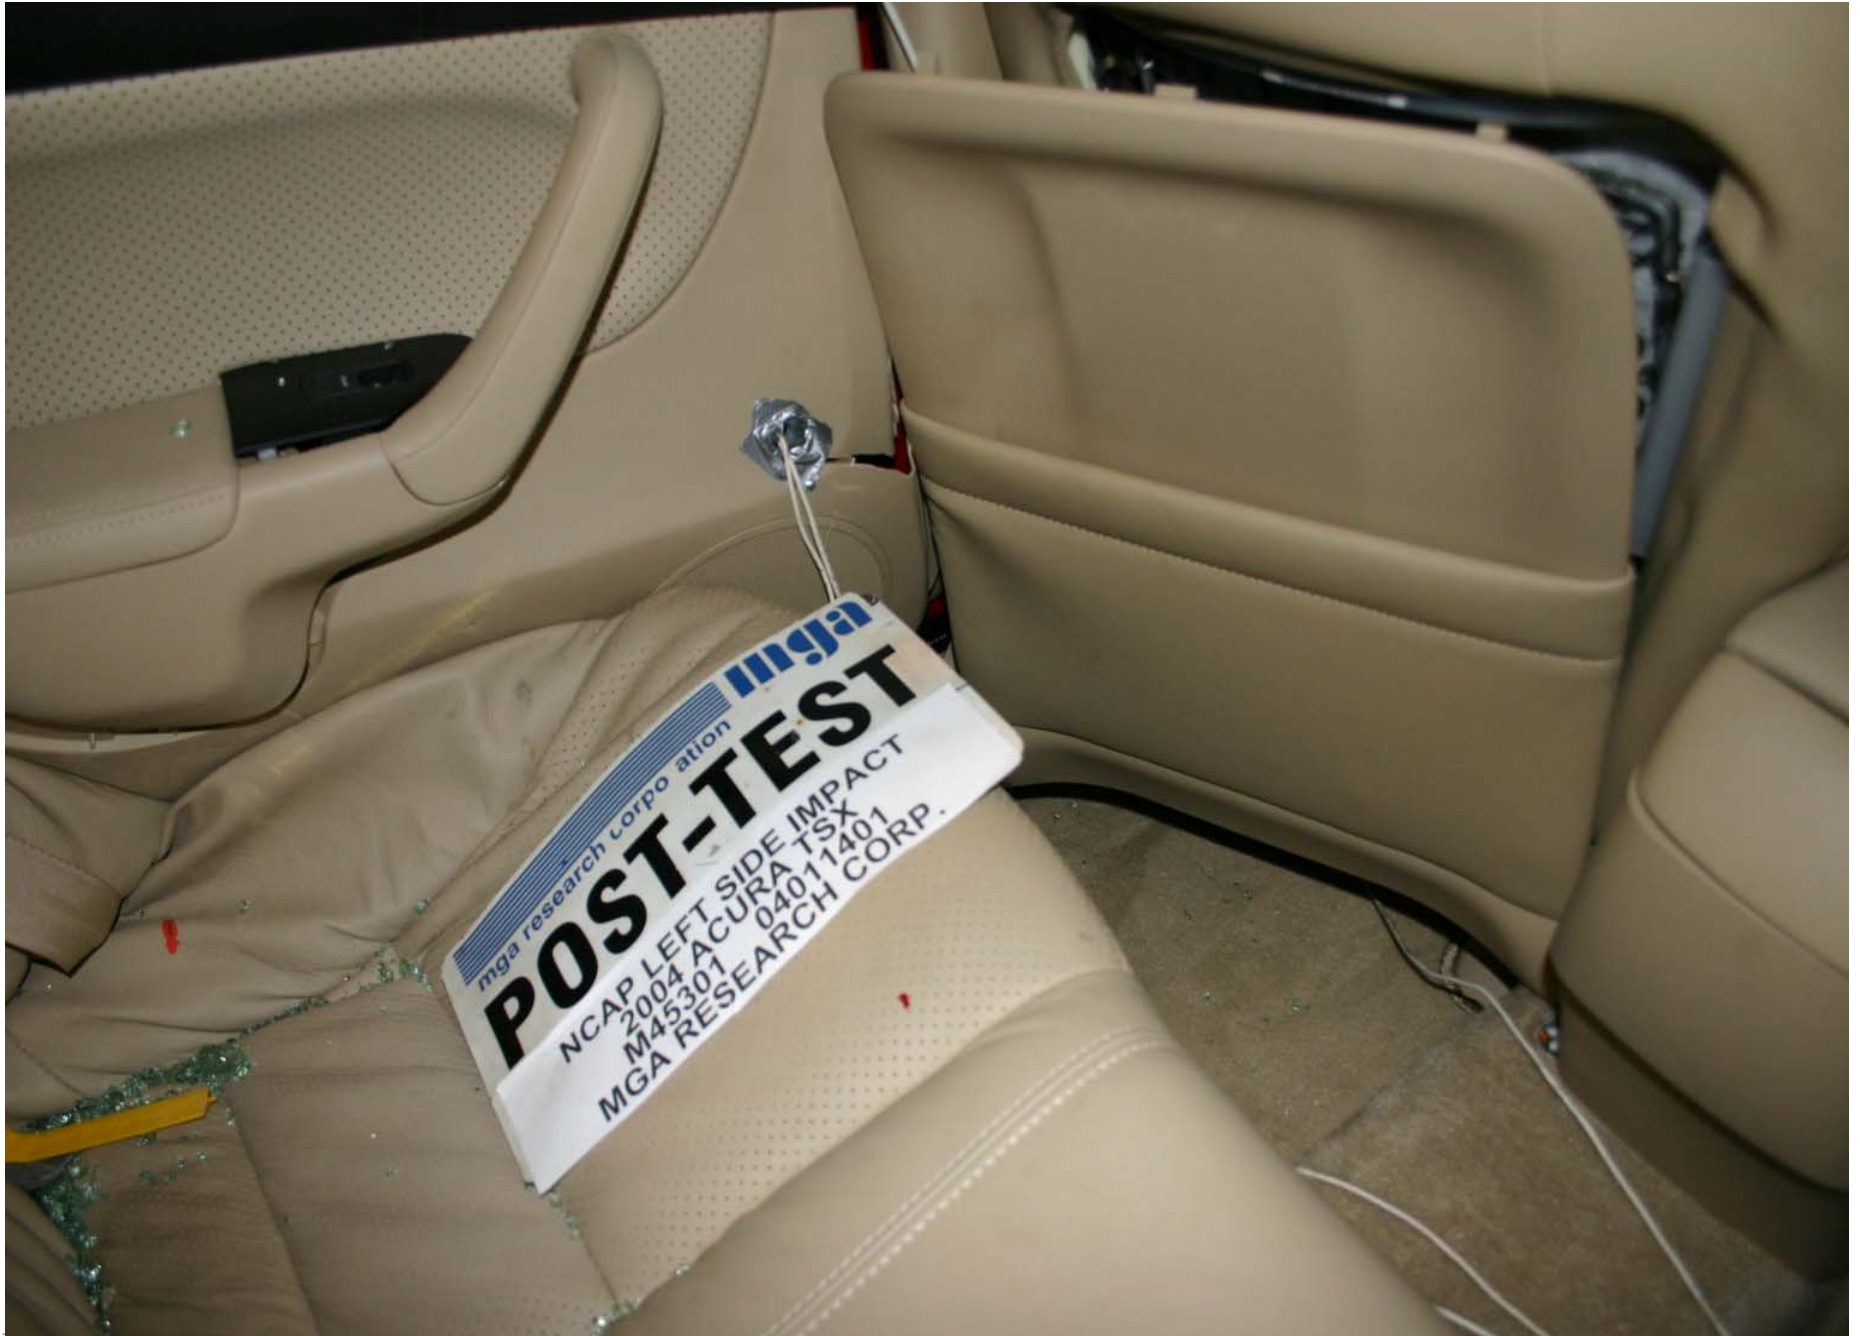
Post-Test Passenger Dummy Seat Back View

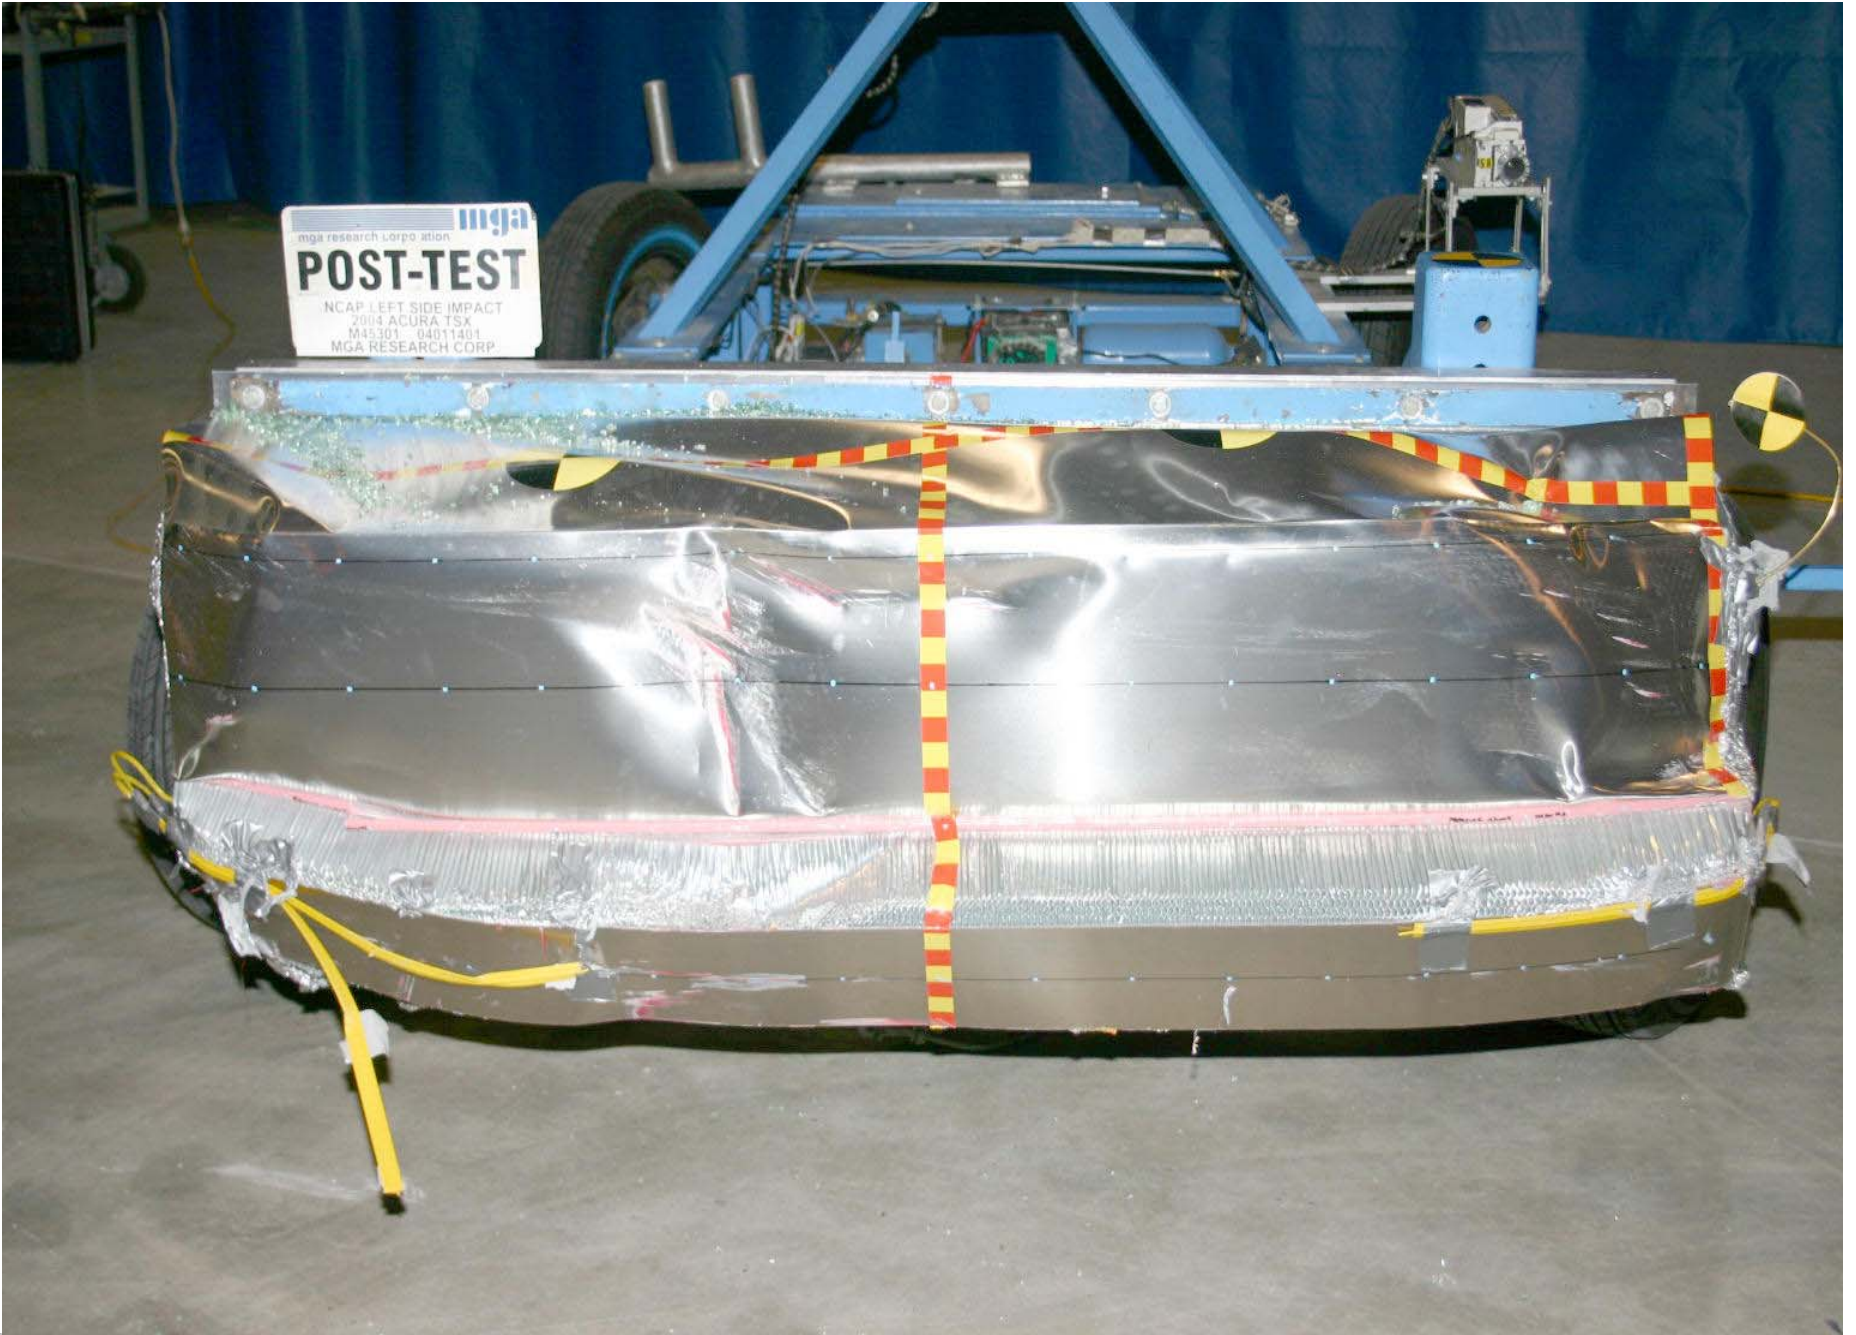
A-50.

Post-Test MDB Front View
