REPORT NO. MCW-DOT-04SN04

**NEW CAR ASSESSMENT PROGRAM  
SIDE IMPACT TESTING**

HONDA MOTOR CORPORATION  
2004 ACURA 3.5RL 4-DOOR SEDAN

FINAL REPORT

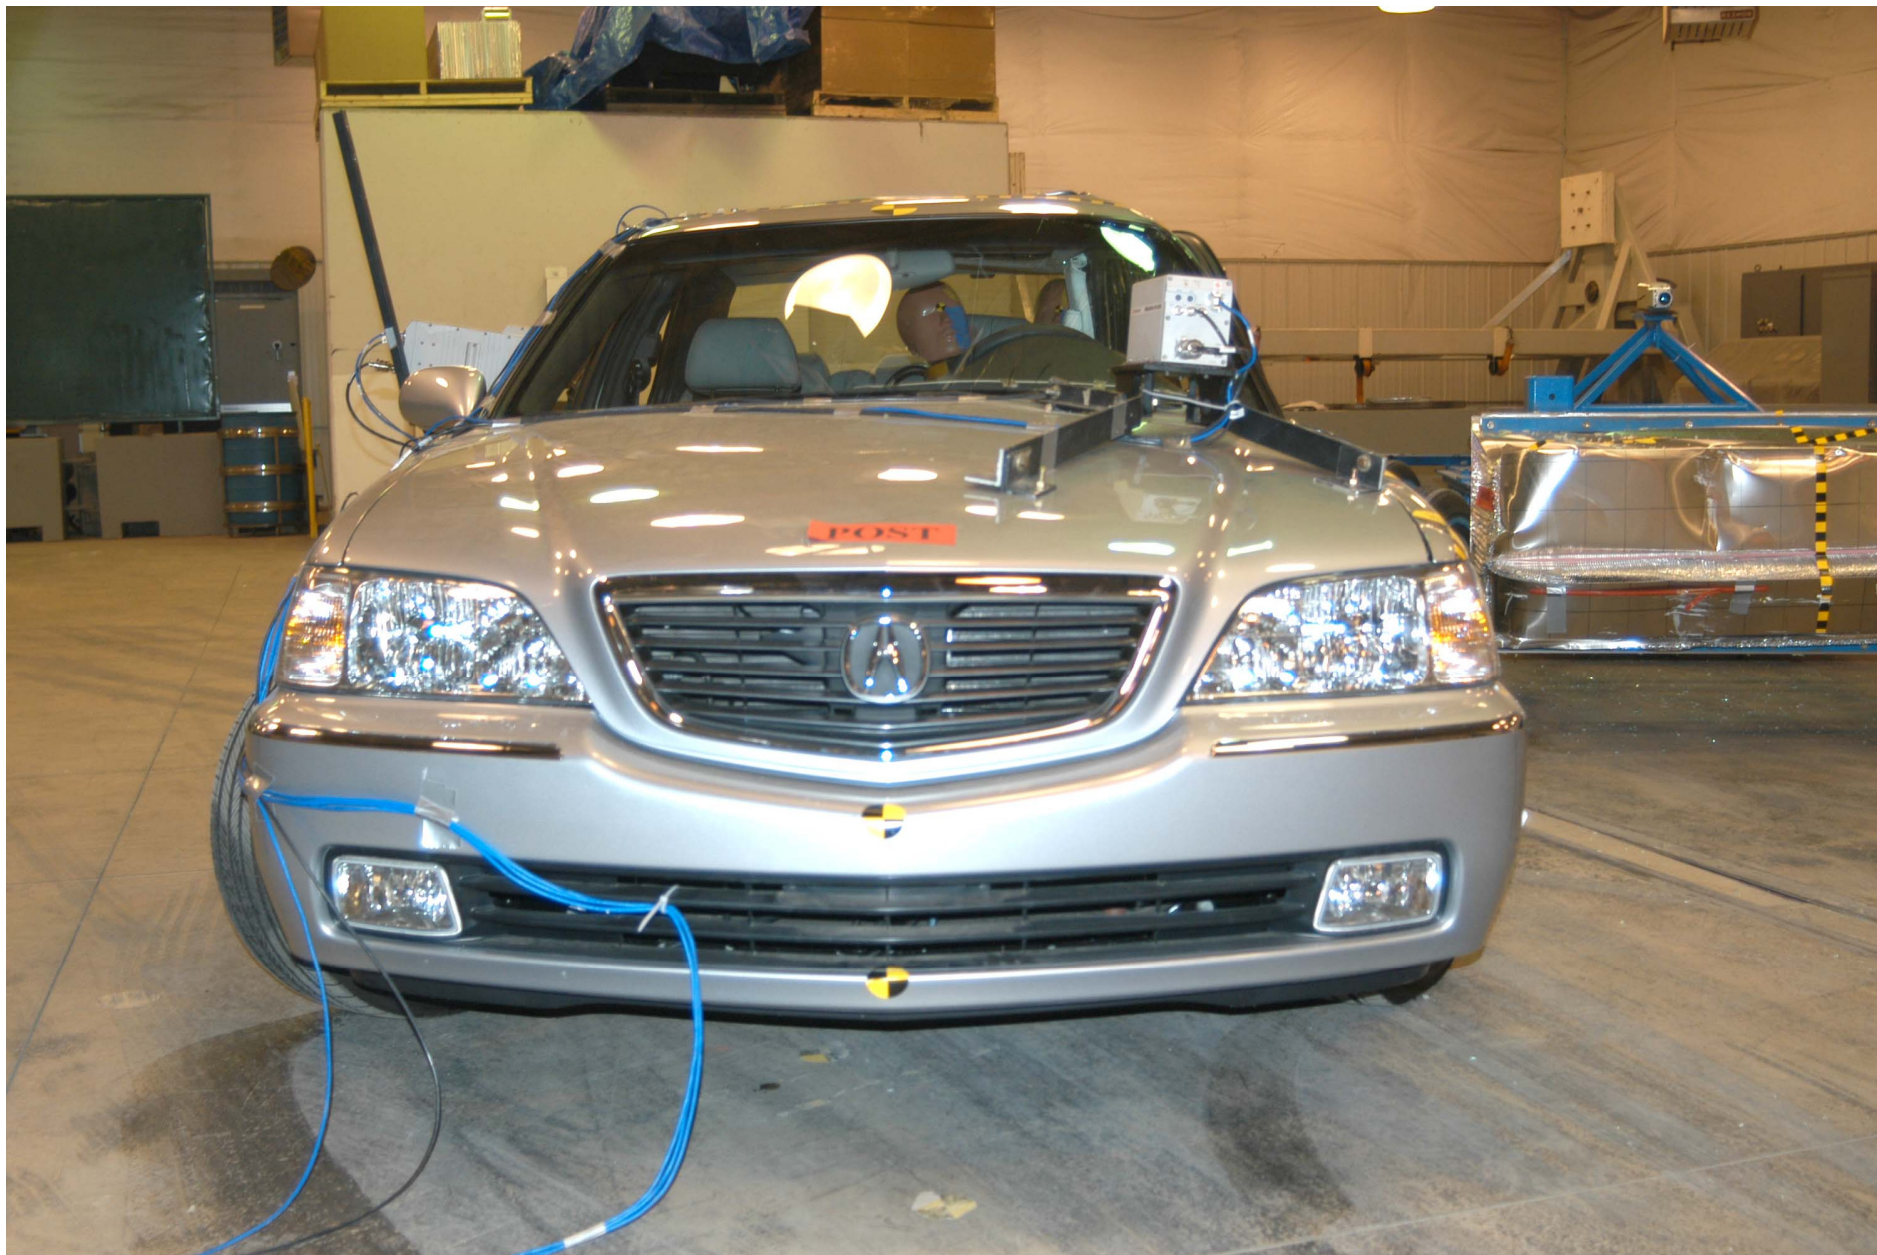
Figure A-2: POST-TEST FRONTAL VIEW OF TEST VEHICLE

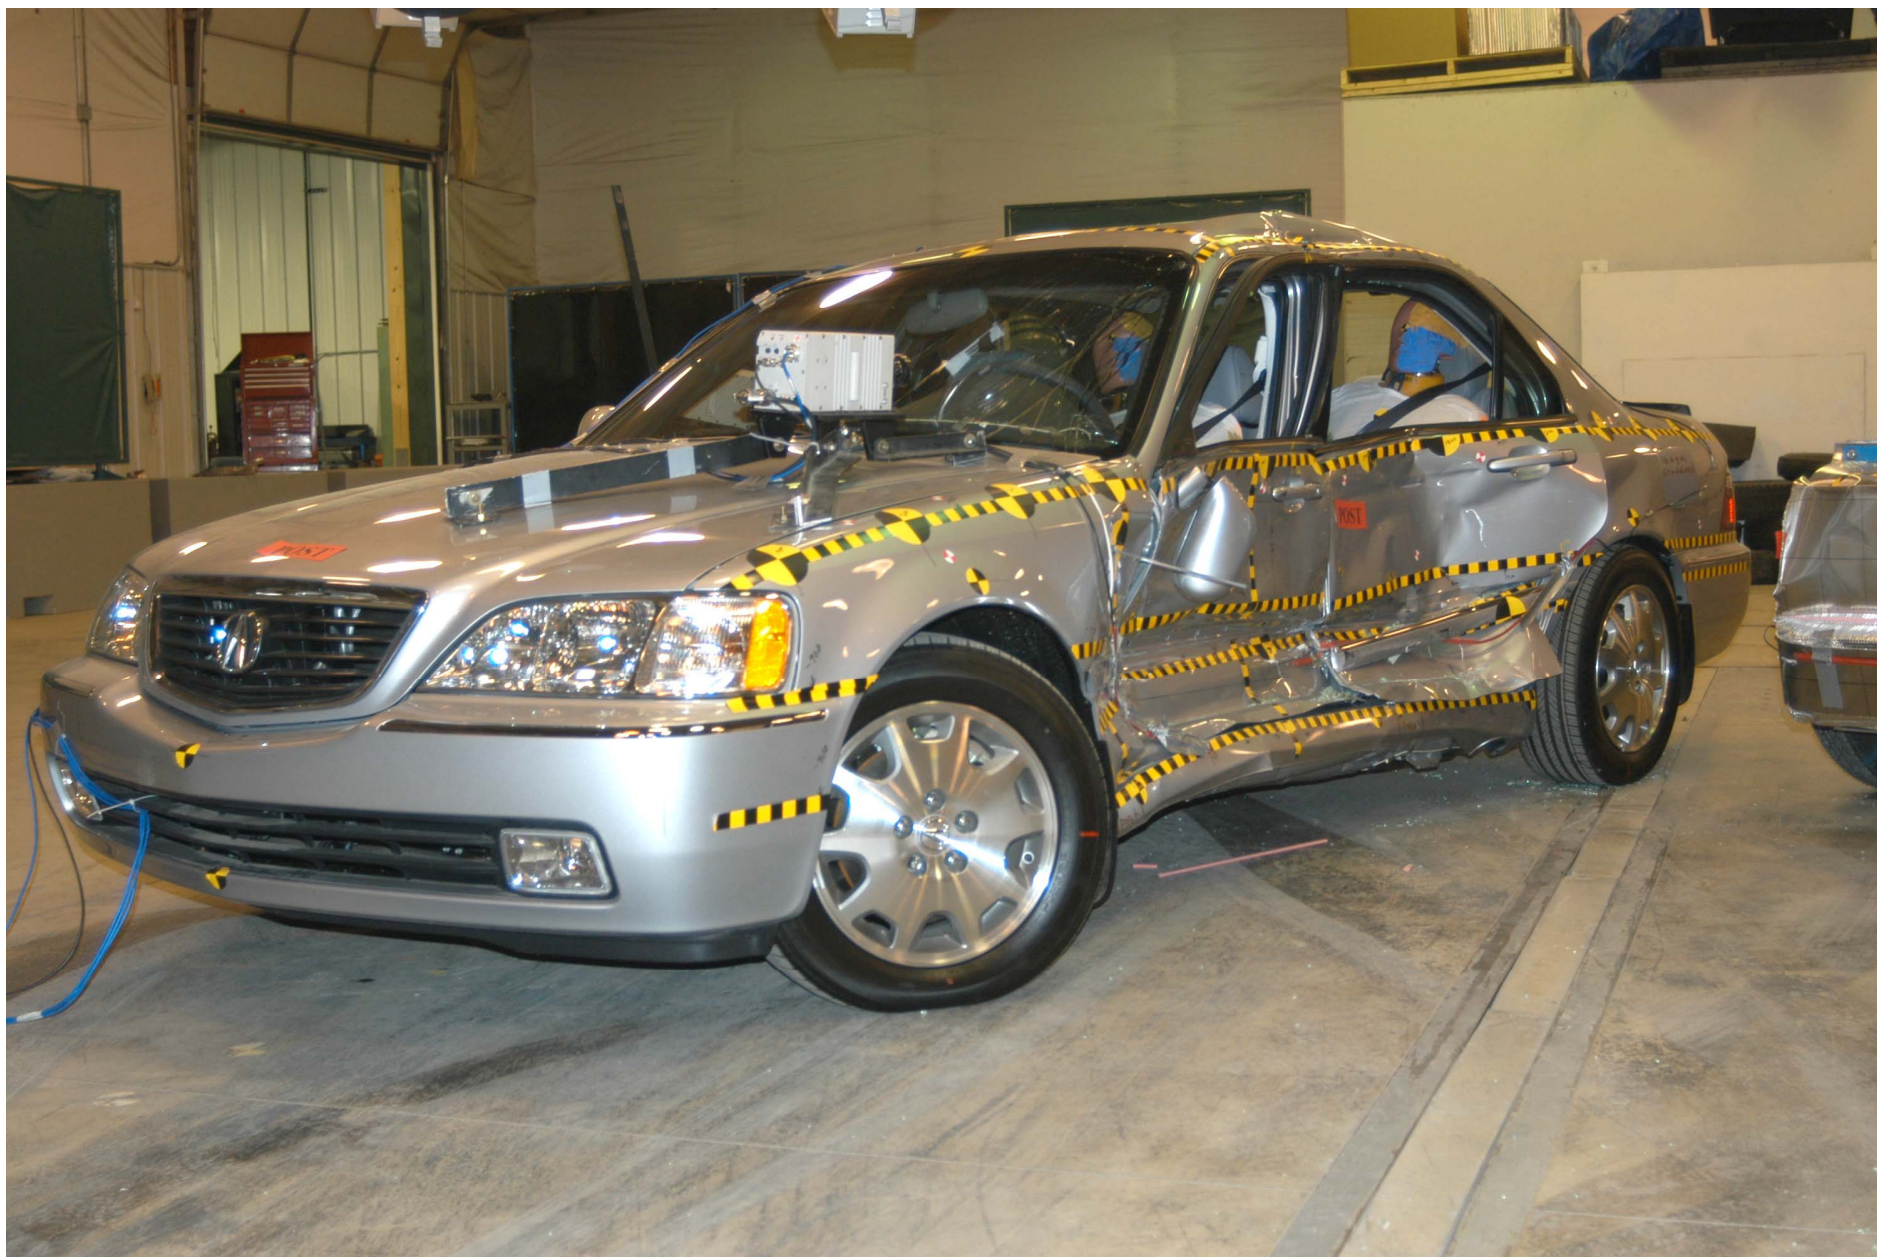
Figure A-4: POST-TEST LEFT FRONT VIEW OF TEST VEHICLE

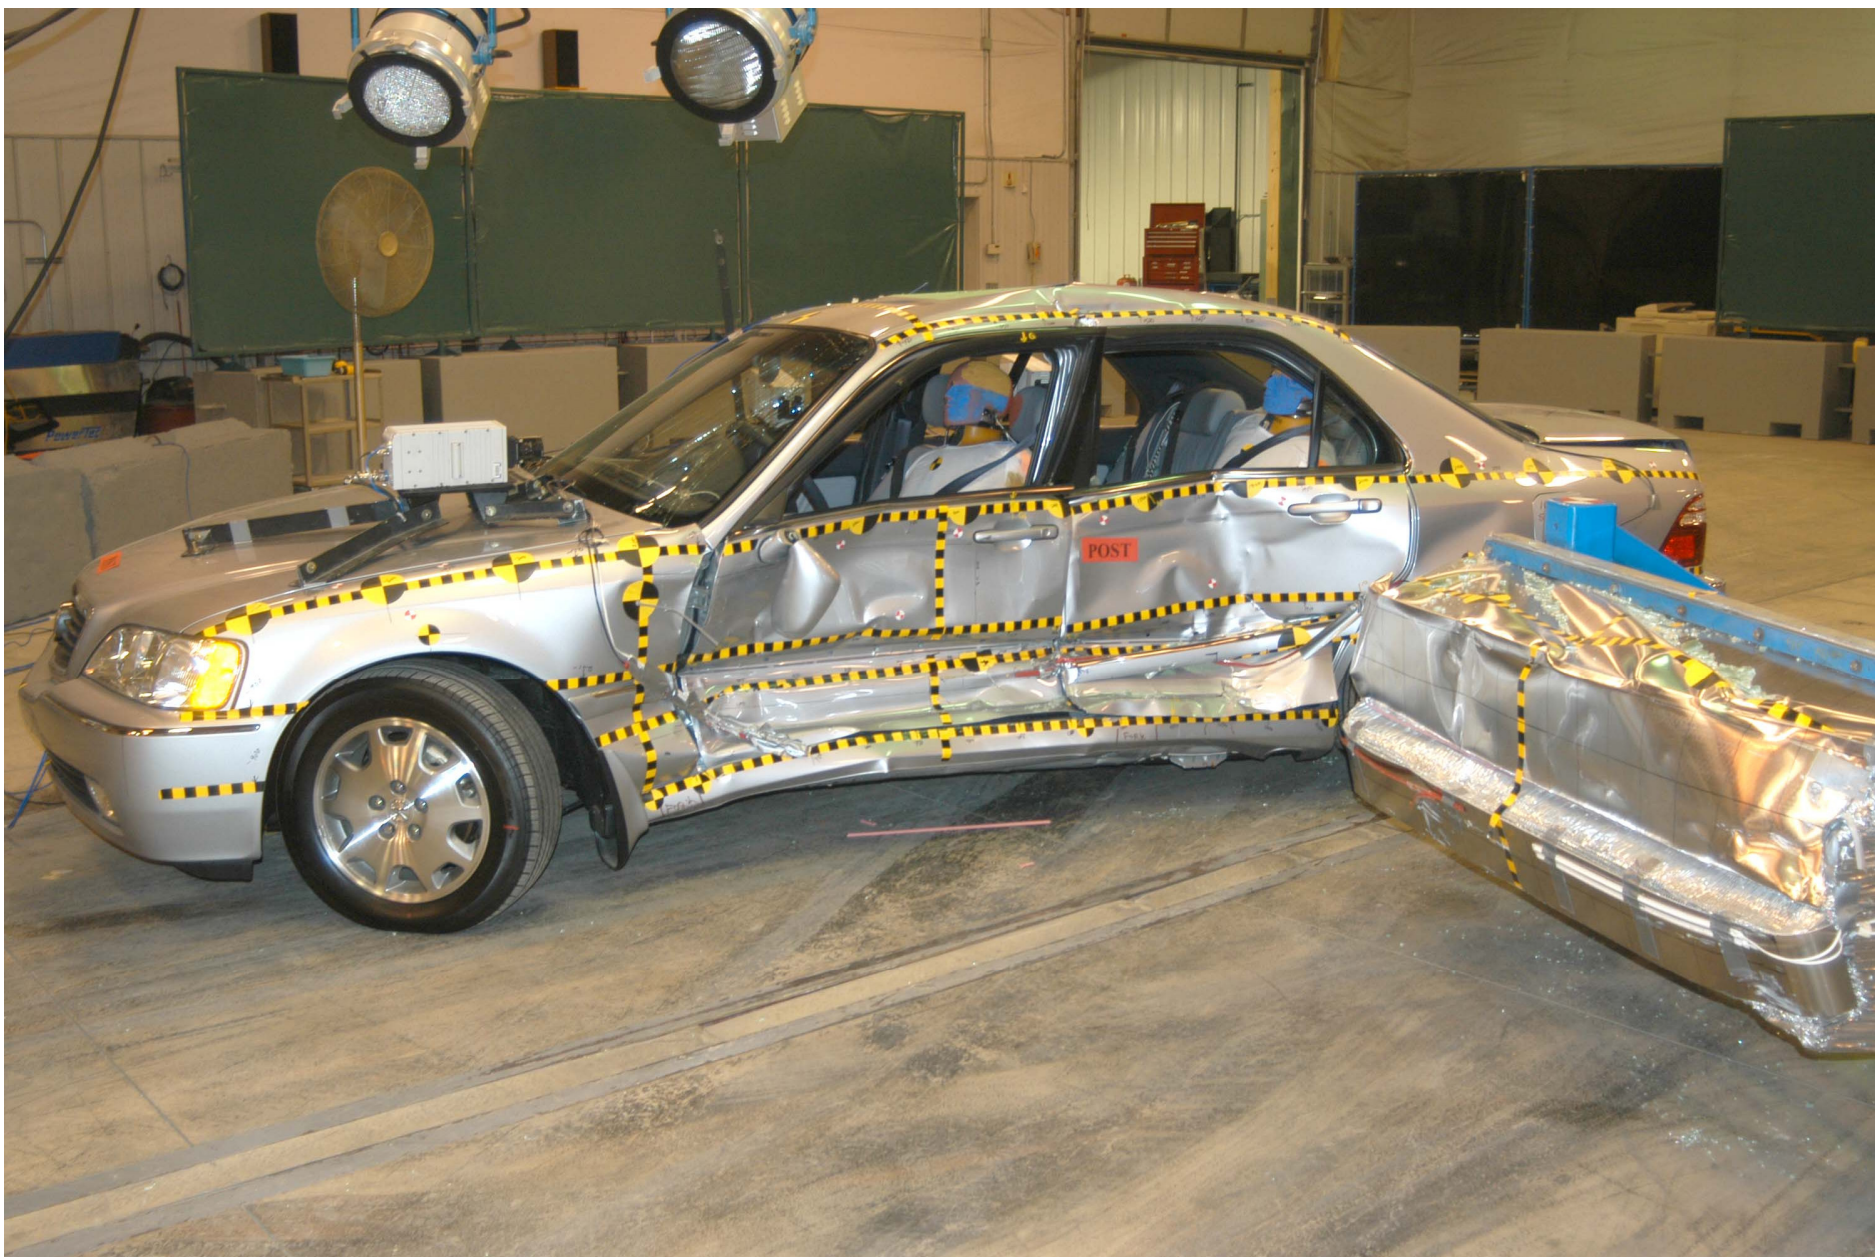
Figure A-6: POST-TEST LEFT SIDE VIEW OF TEST VEHICLE

Maximum Post-Test intrusion at Level 2 is 395 mm

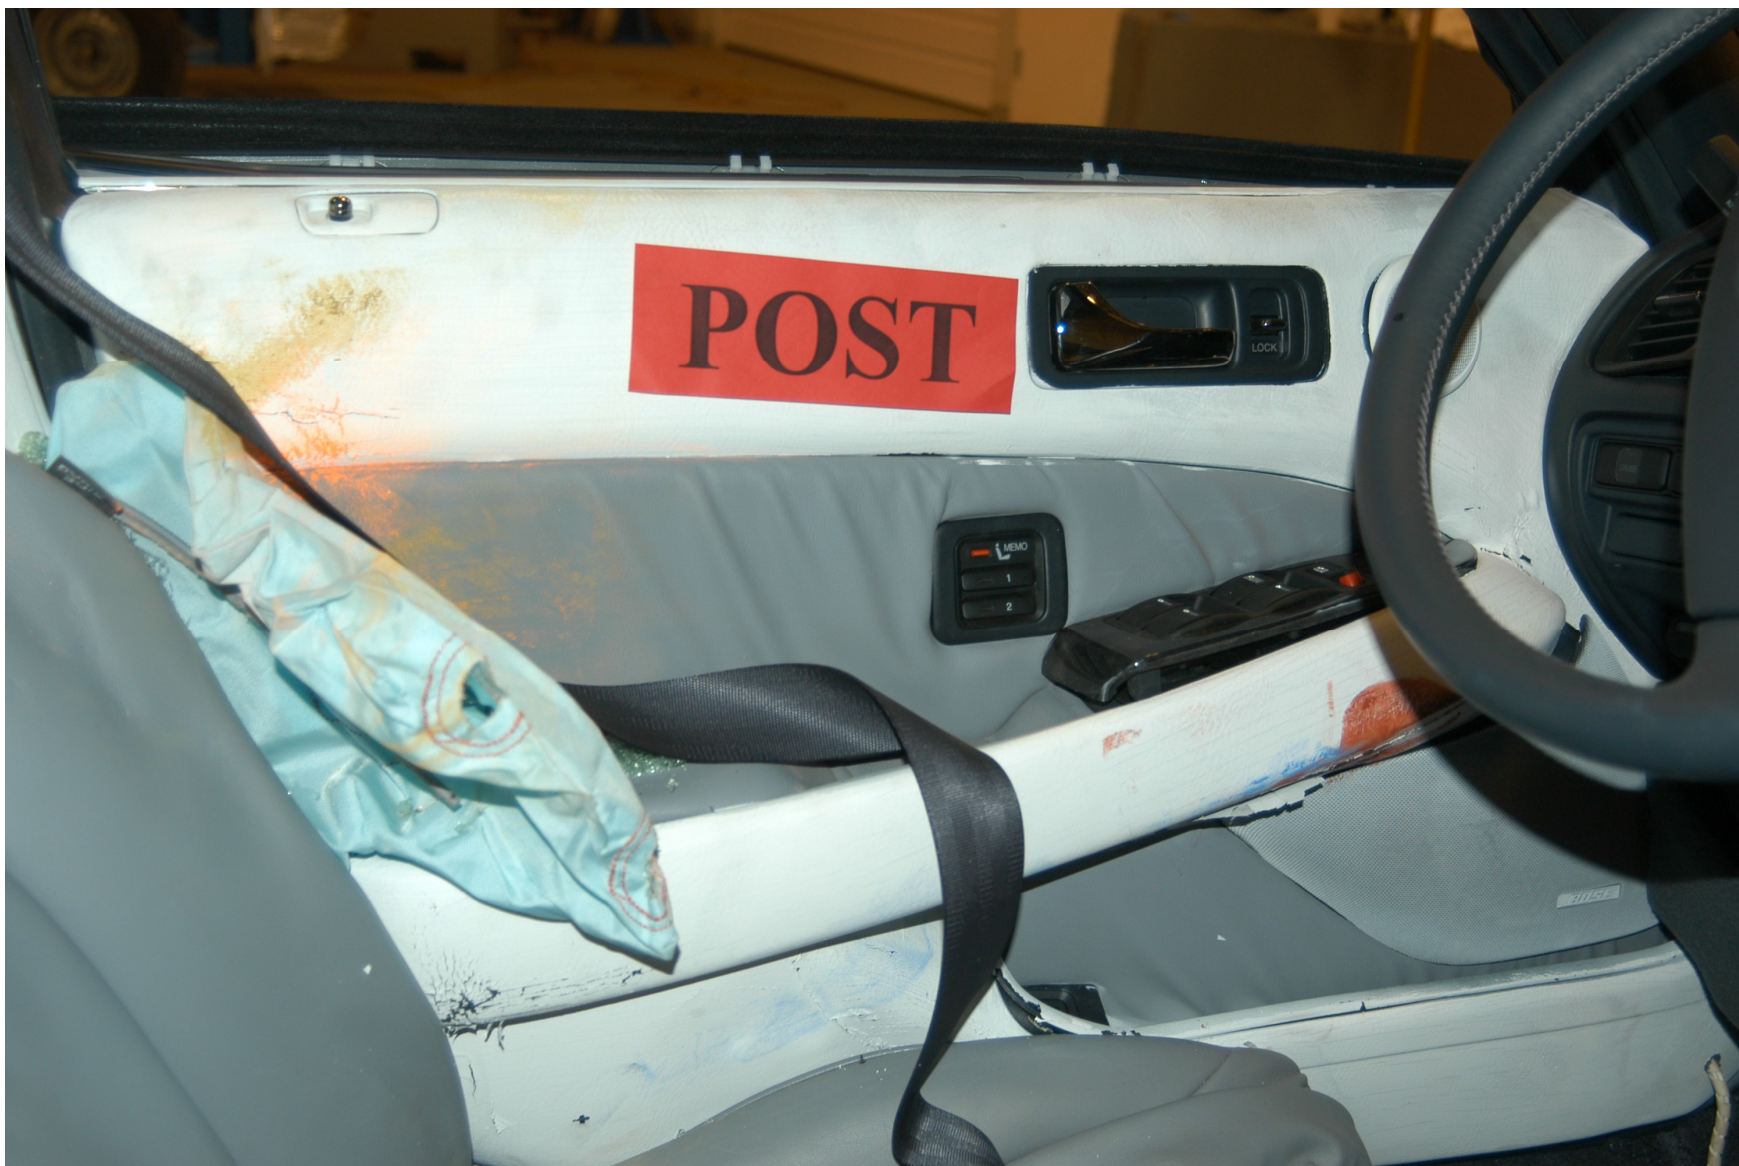
Figure A-26: POST-TEST INTERIOR OF FRONT DOOR SHOWING SID H3 IMPACT LOCATIONS

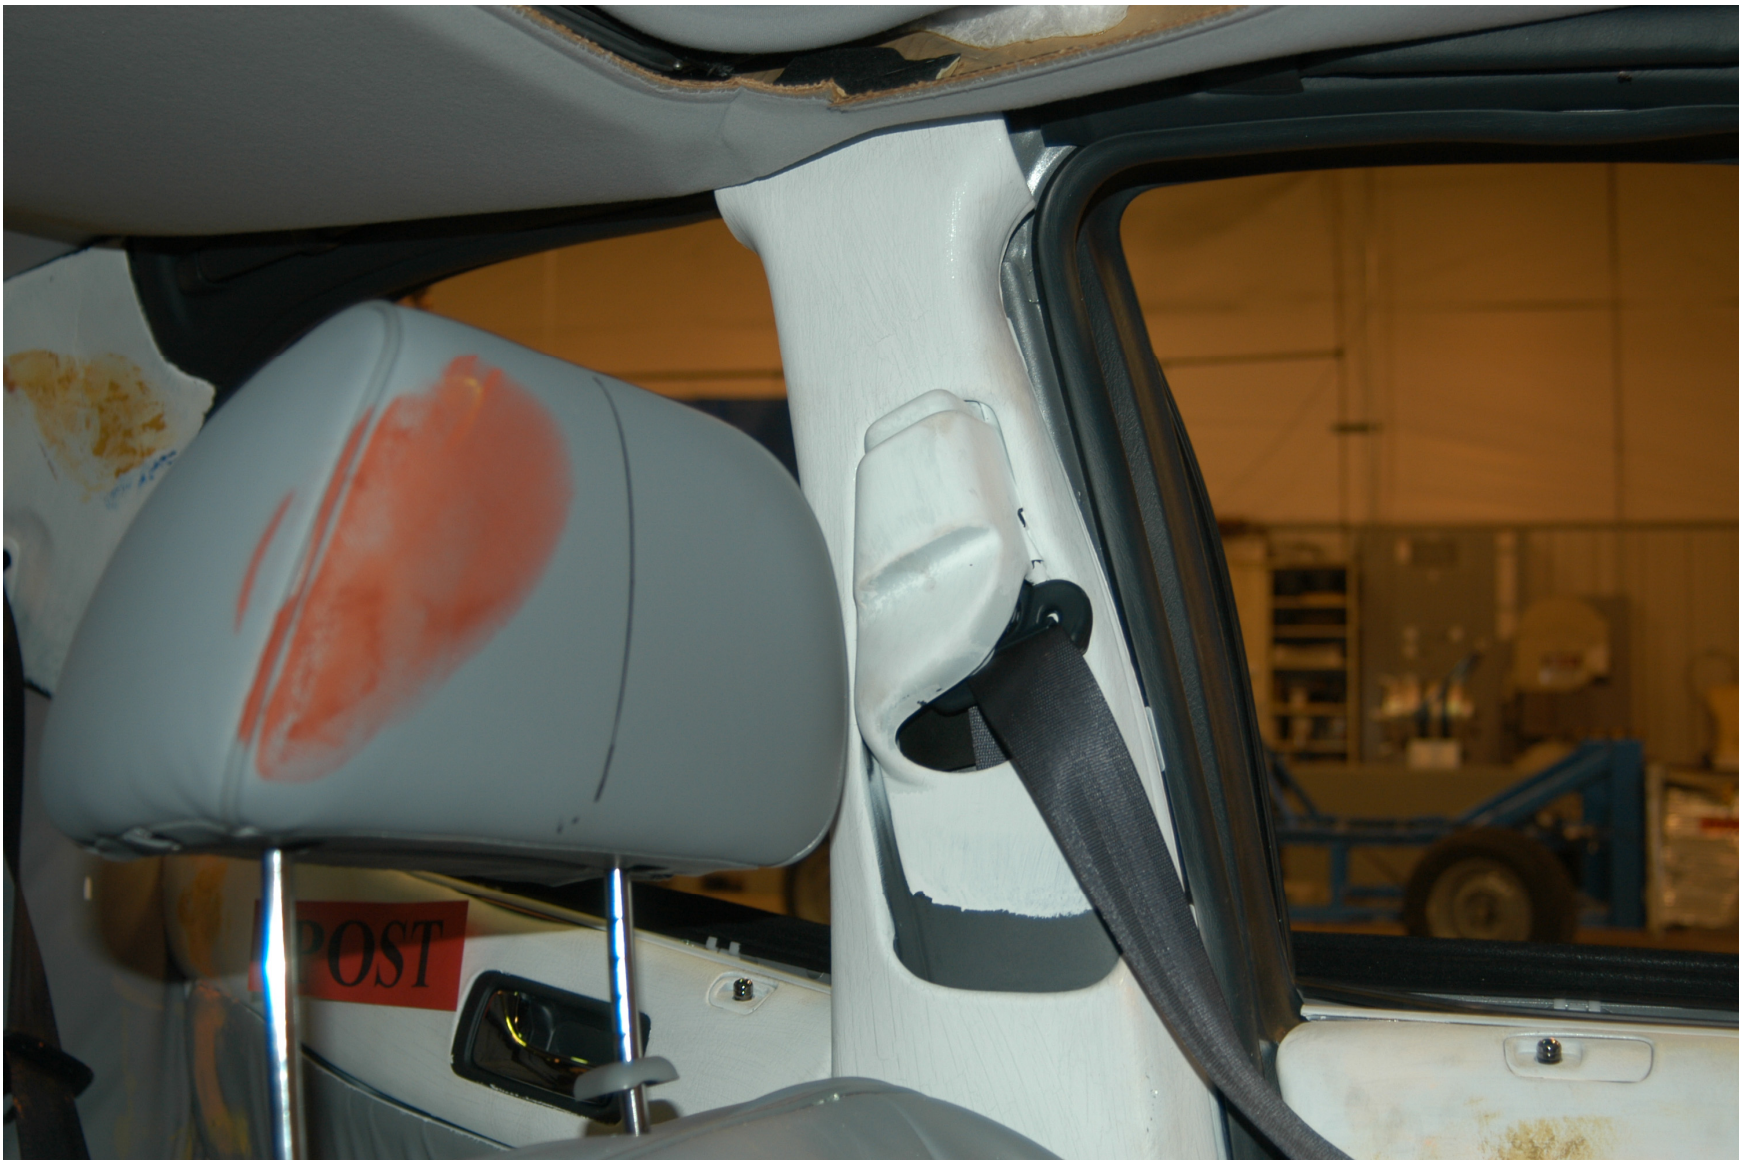
Figure A-27: POST-TEST INTERIOR OF FRONT DOOR SHOWING SID H3 IMPACT LOCATIONS 2

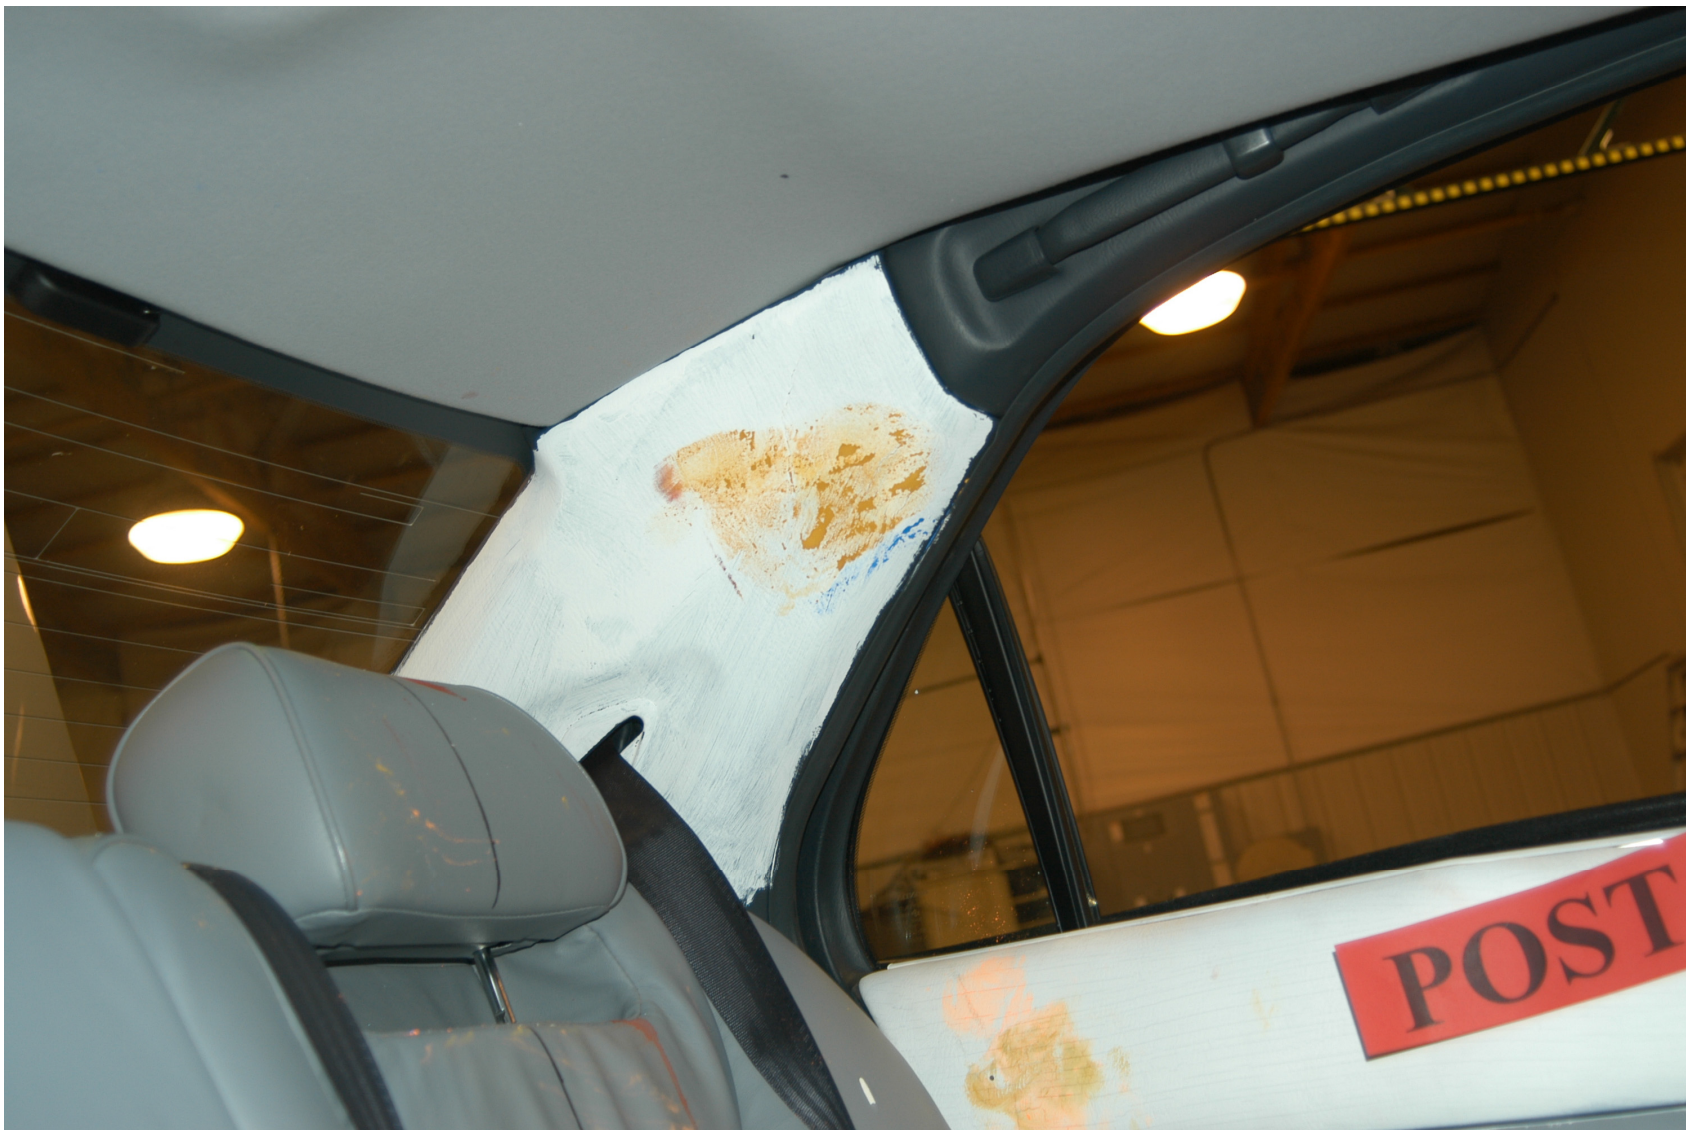
Figure A-30: POST-TEST INTERIOR OF REAR DOOR SHOWING SID H3 IMPACT LOCATIONS 2

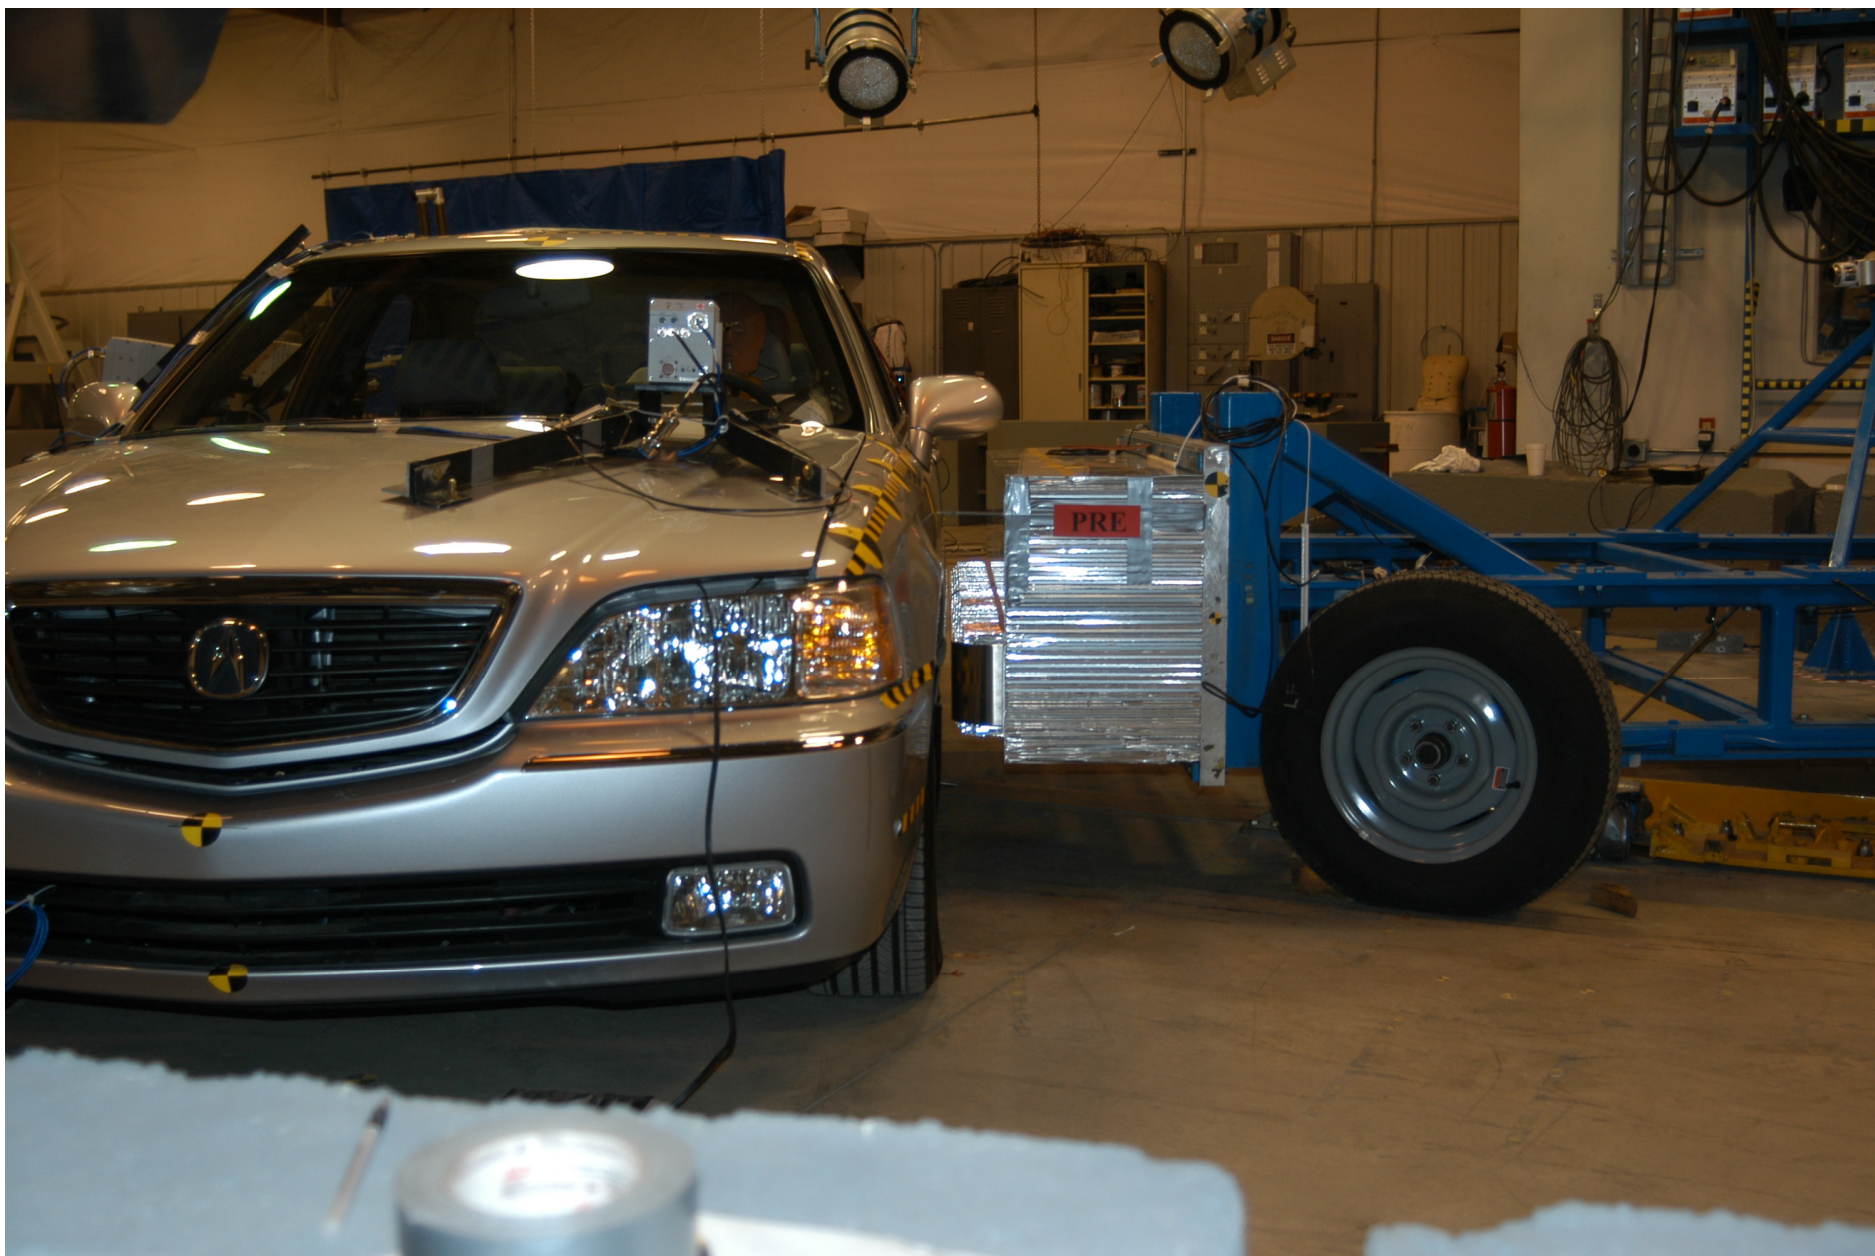
Figure A-31: PRE-TEST LEFT SIDE VIEW OF MDB IN IMPACT POSITION

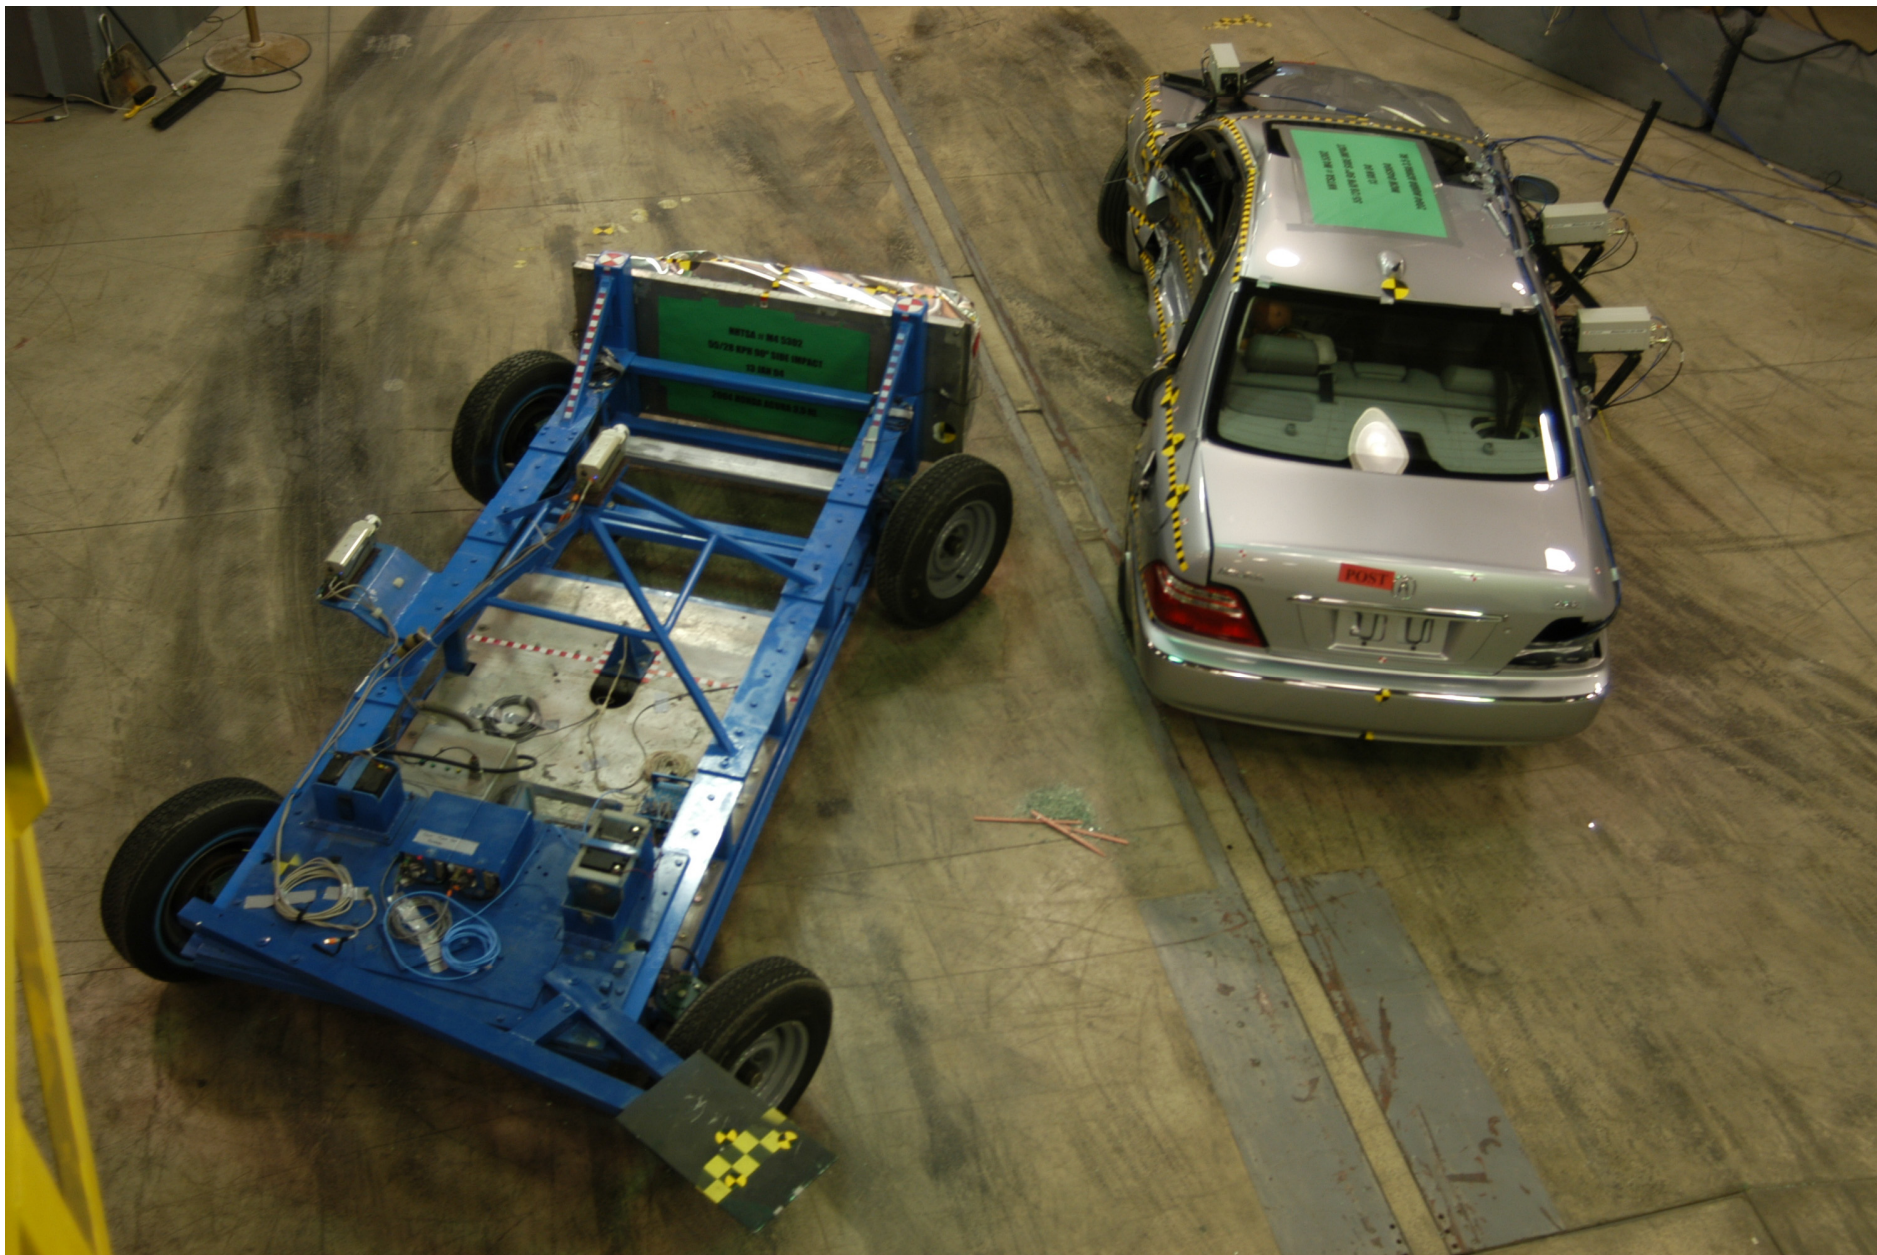
Figure A-36: POST-TEST OVERHEAD VIEW OF MDB

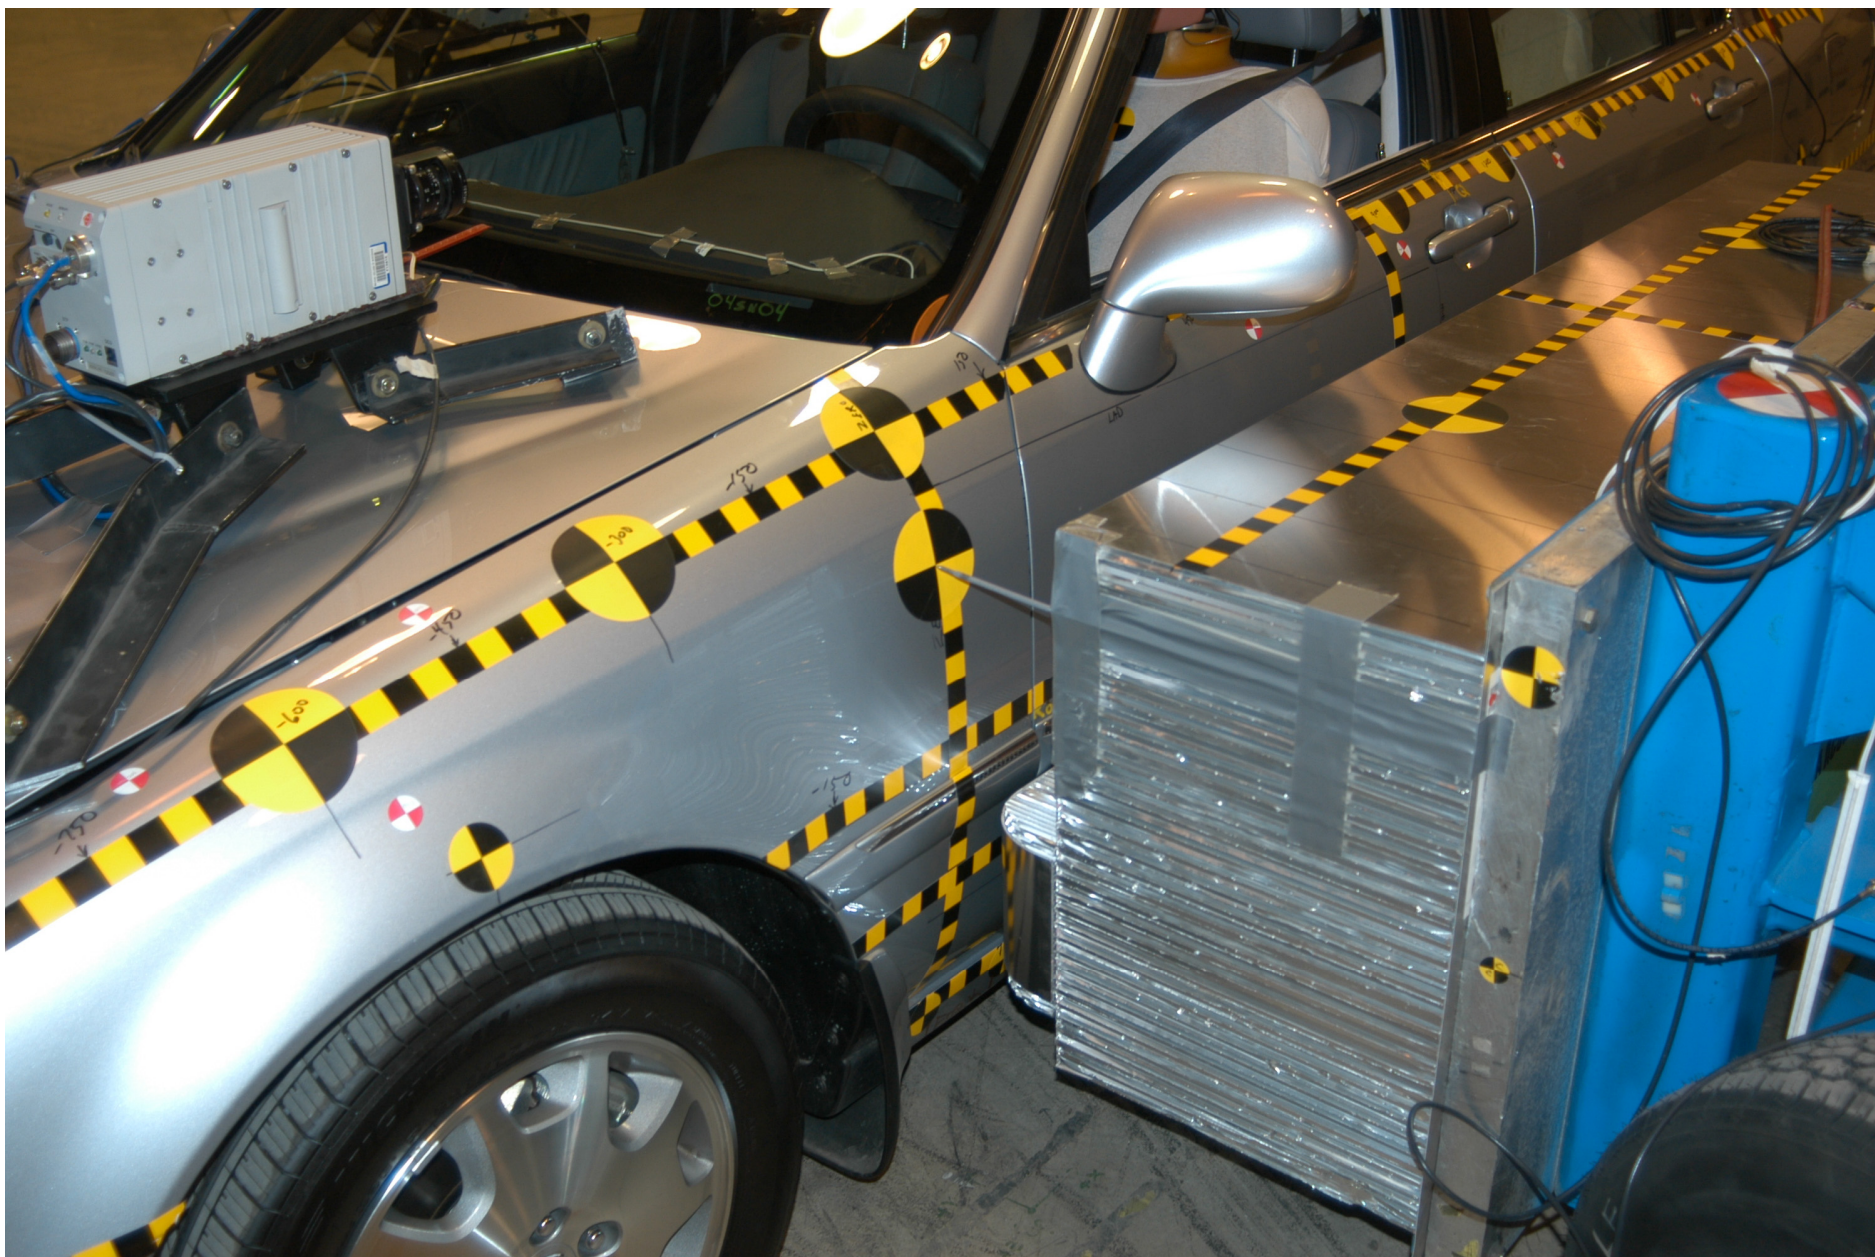
Figure A-37: PRE-TEST CLOSE-UP OF IMPACT POINT TARGET SHOWING WELDING ROD

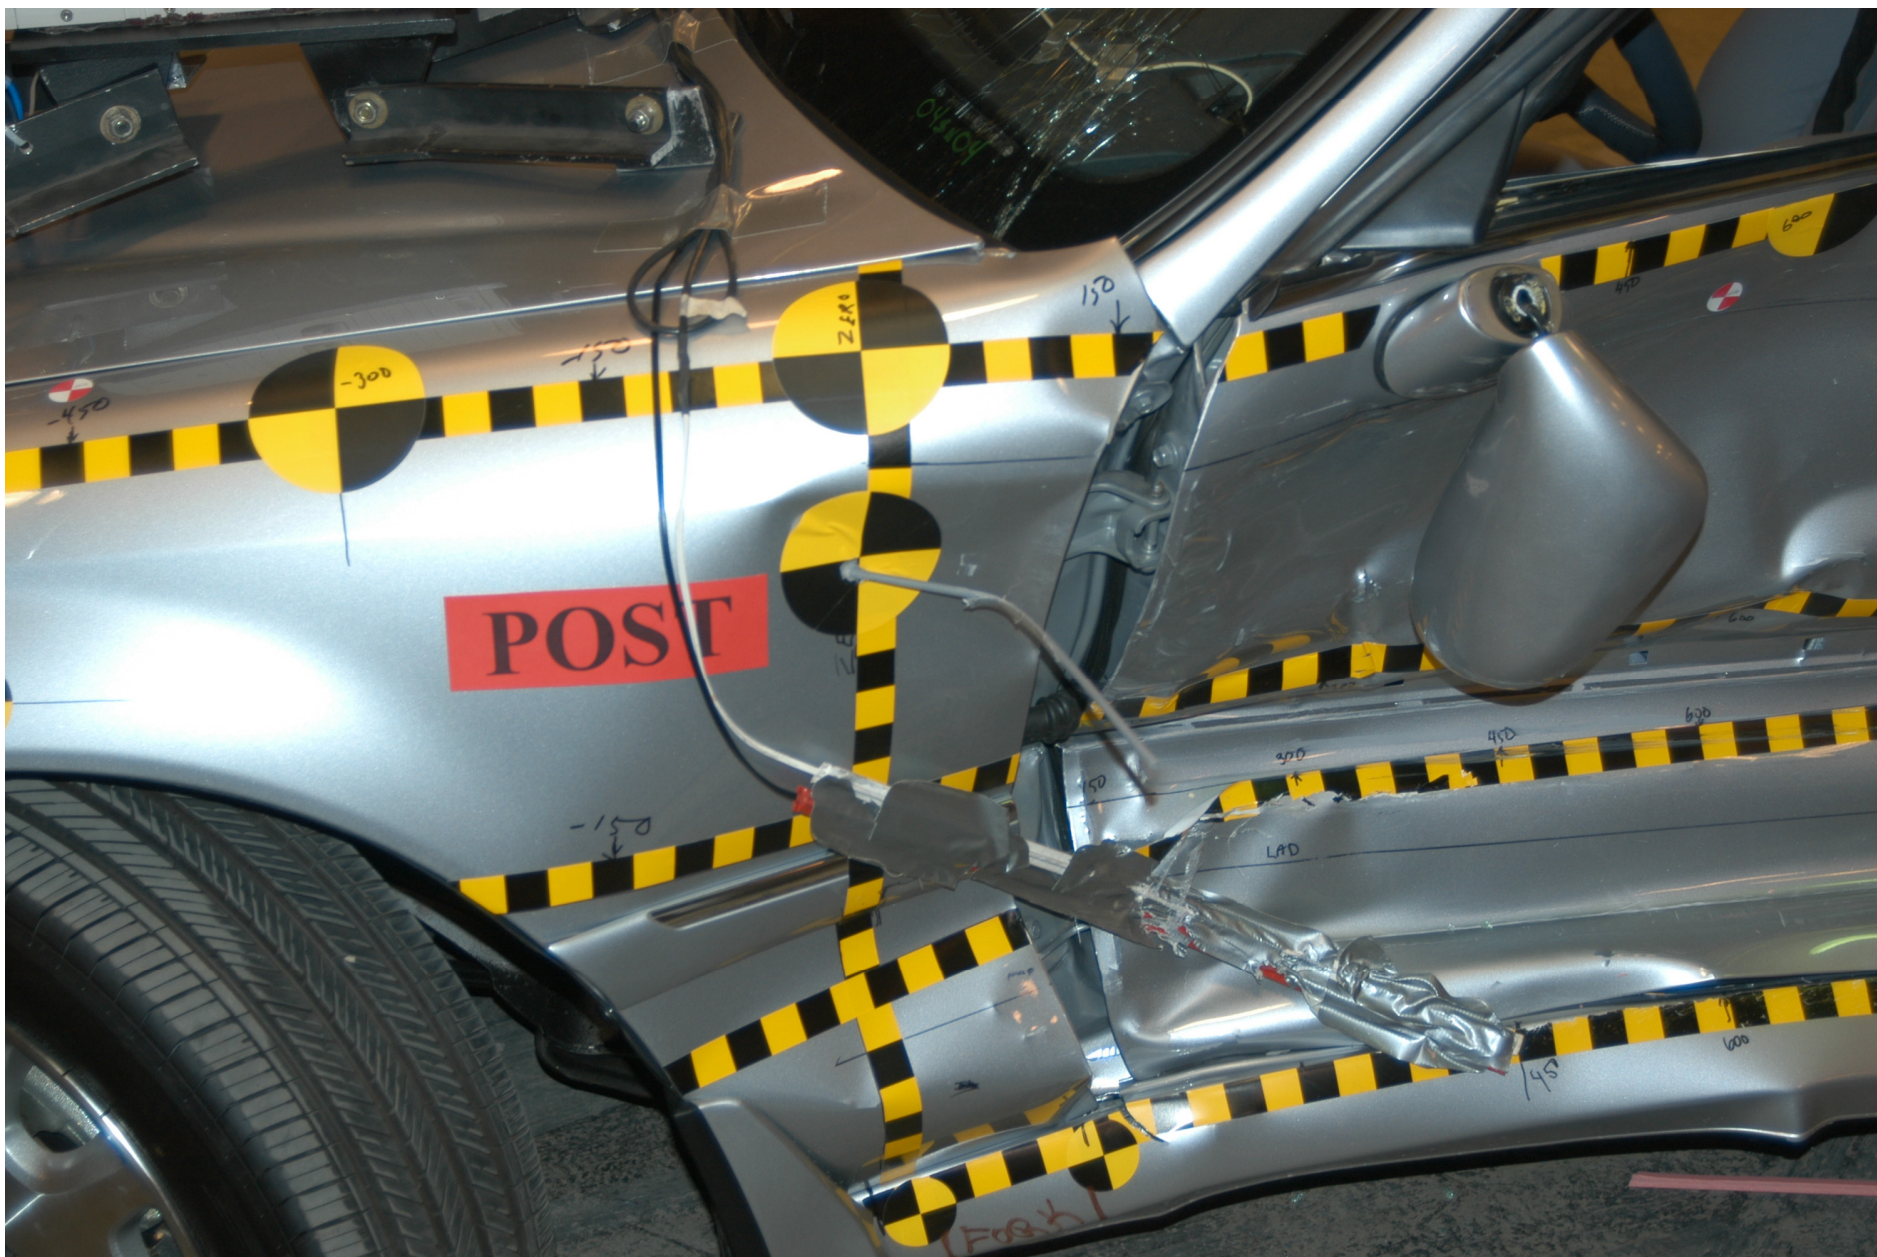
Figure A-38: POST-TEST CLOSE-UP OF IMPACT POINT TARGET

Actual Impact Point is 4 mm forward and 9 mm below nominal impact point
