REPORT NO. MCW-DOT-04SN04

**NEW CAR ASSESSMENT PROGRAM  
SIDE IMPACT TESTING**

HONDA MOTOR CORPORATION  
2004 ACURA 3.5RL 4-DOOR SEDAN

FINAL REPORT

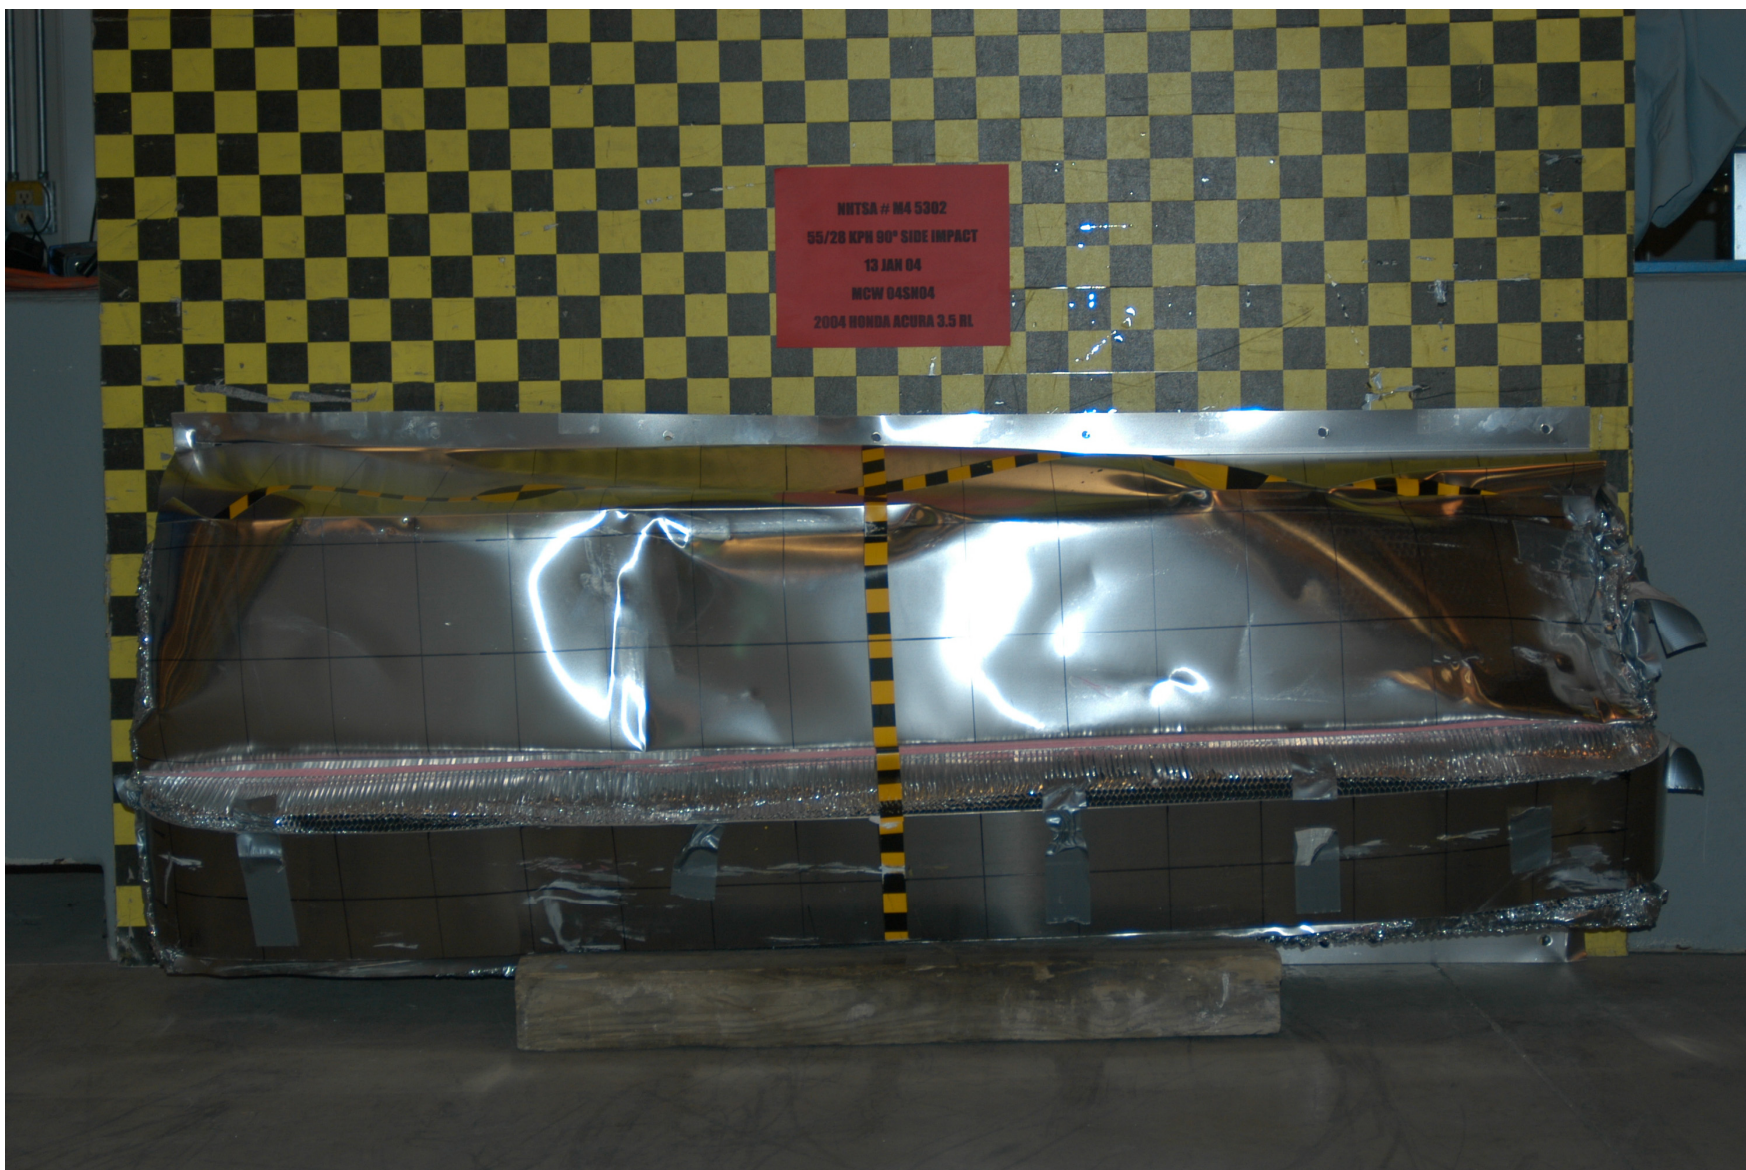
Figure A-48: POST-TEST ALUMINUM BARRIER FRONT
