NEW CAR ASSESSMENT PROGRAM  
SIDE IMPACT TEST

SUZUKI MOTOR COMPANY  
2004 SUZUKI AERIO GX  
4 DOOR SEDAN

NHTSA NUMBER: M40513

FINAL REPORT

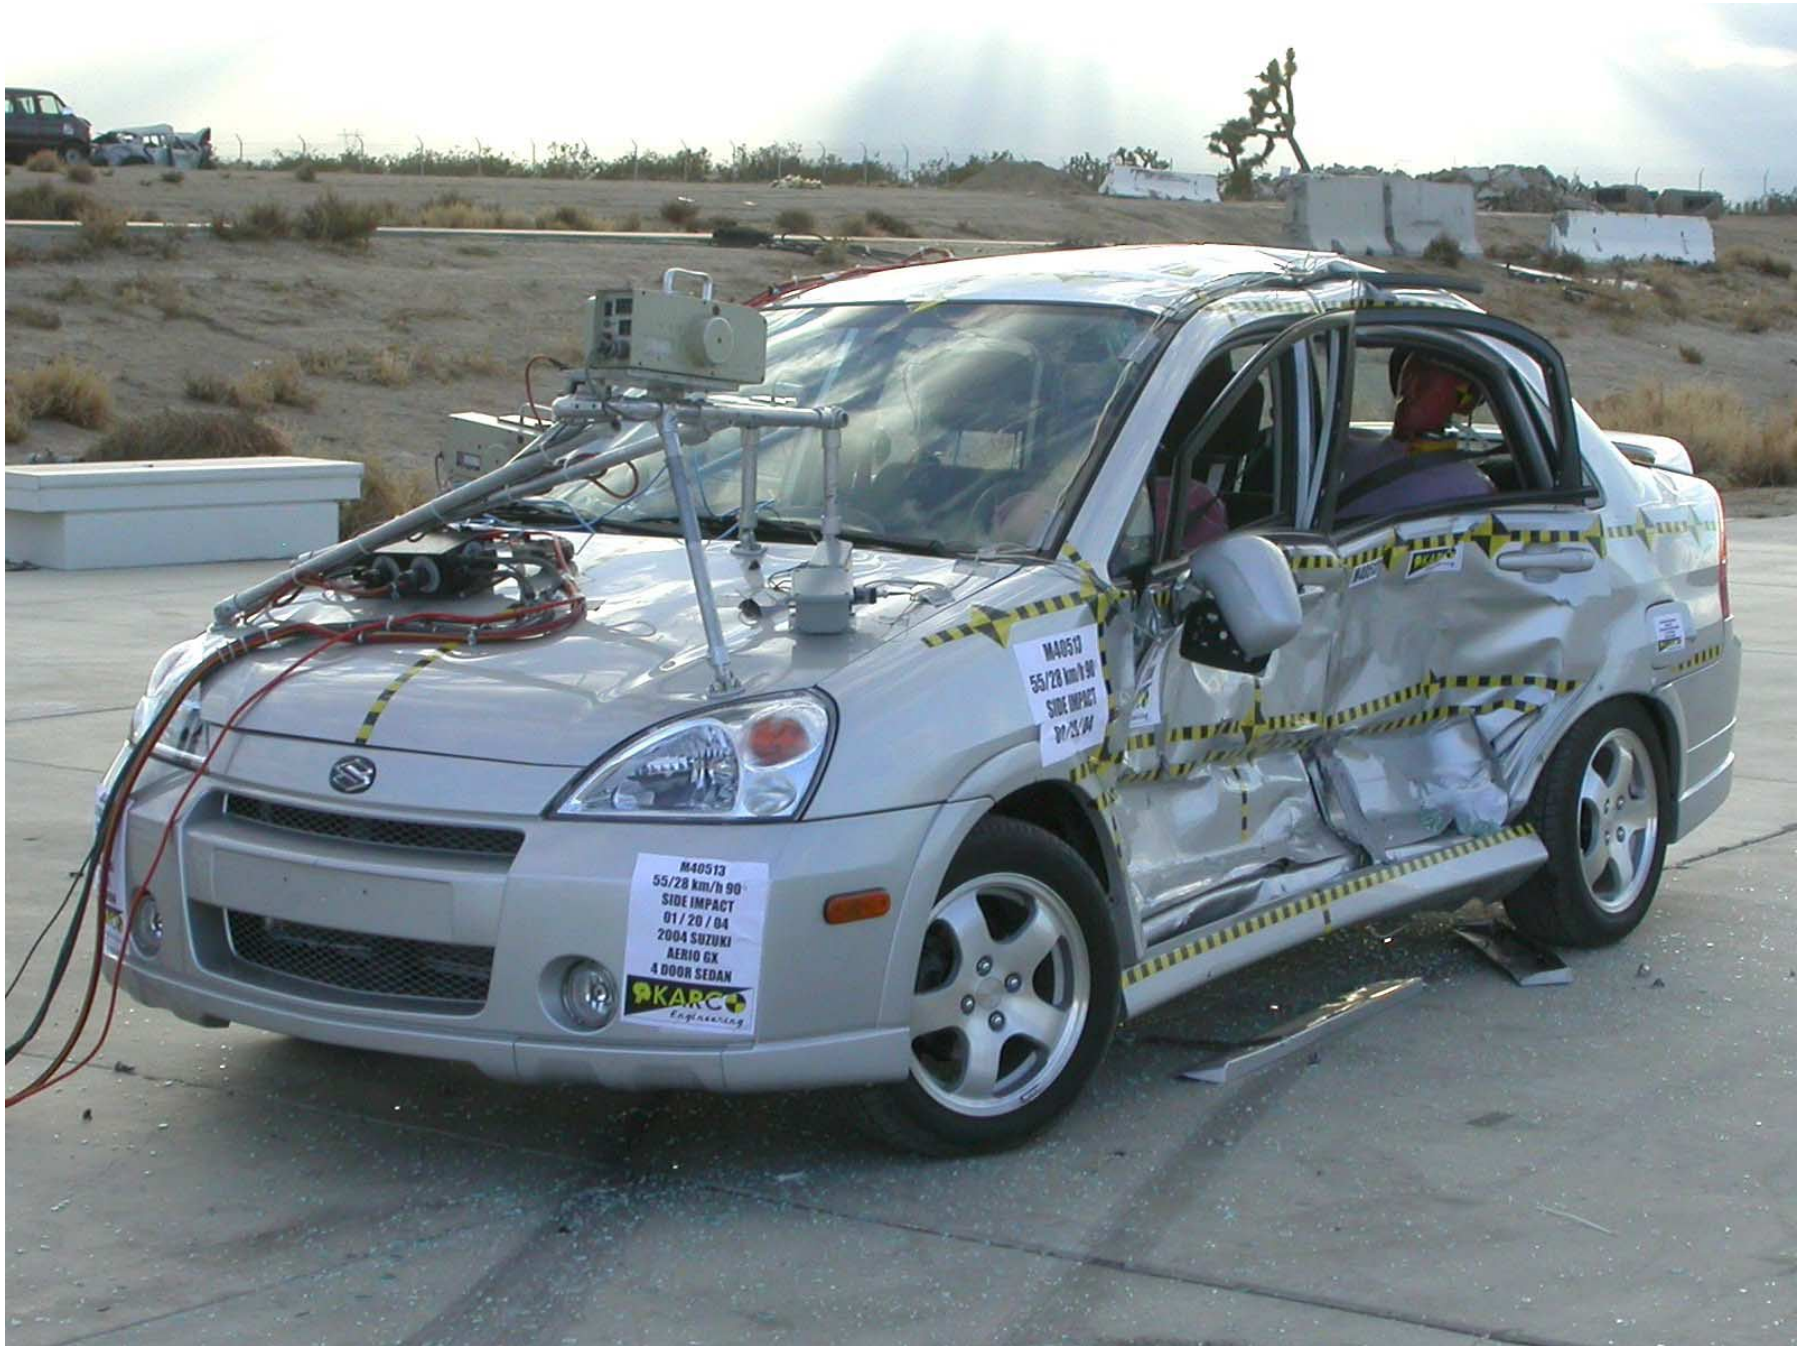
Figure A-8: Left Front ¾ View, Post-Test

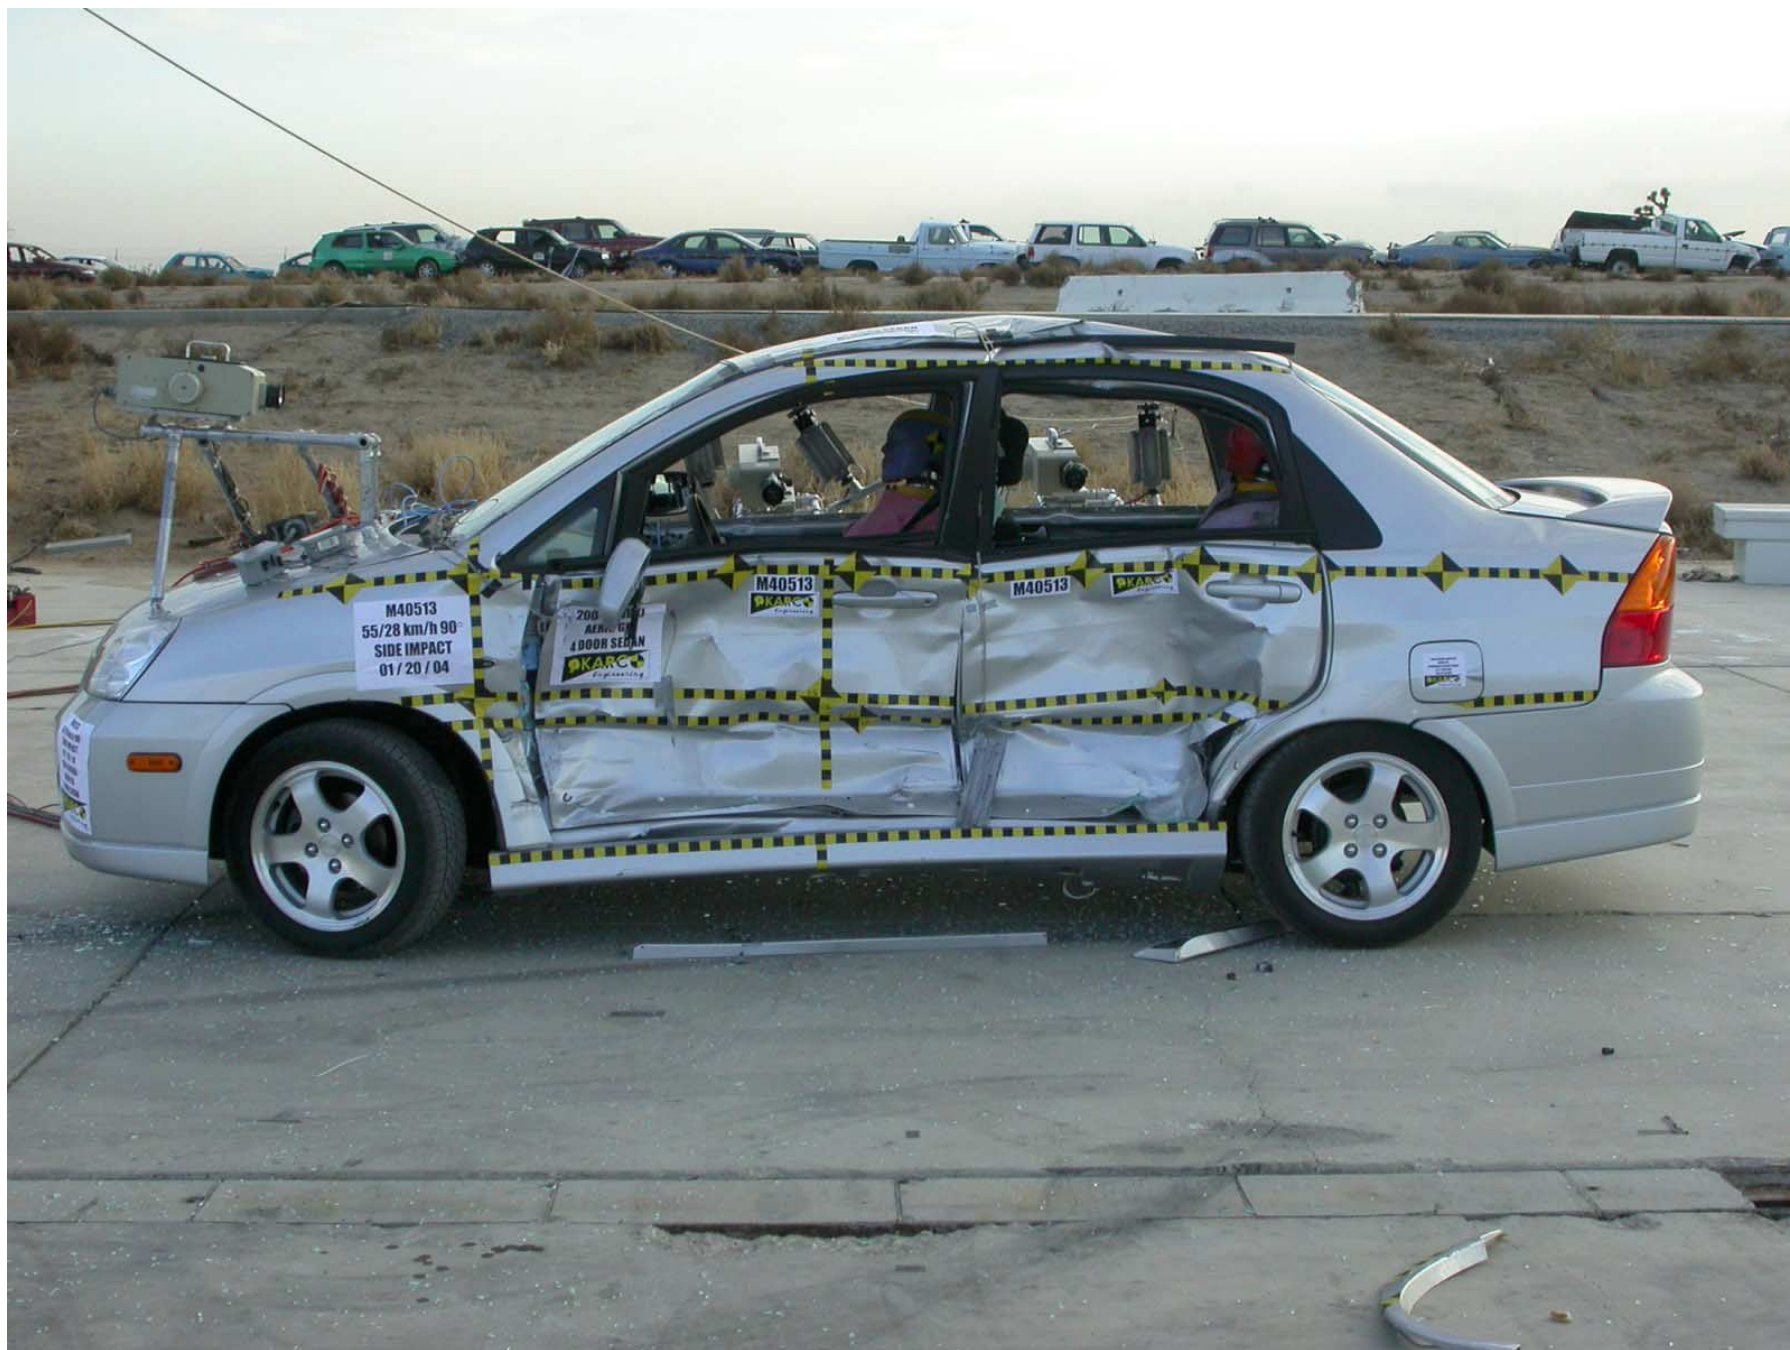
Figure A-10: Left (Impacted) Side View, Post-Test

The test vehicle sustained a maximum static crush of 309 mm at level 2, 1500mm rearward of the left vertical impact point. The driver SID/Hybrid III, Serial No. 274 and the passenger SID/Hybrid III, Serial No. 275 were calibrated just prior to this test. The SID/Hybrid III injury criteria is summarized as follows:

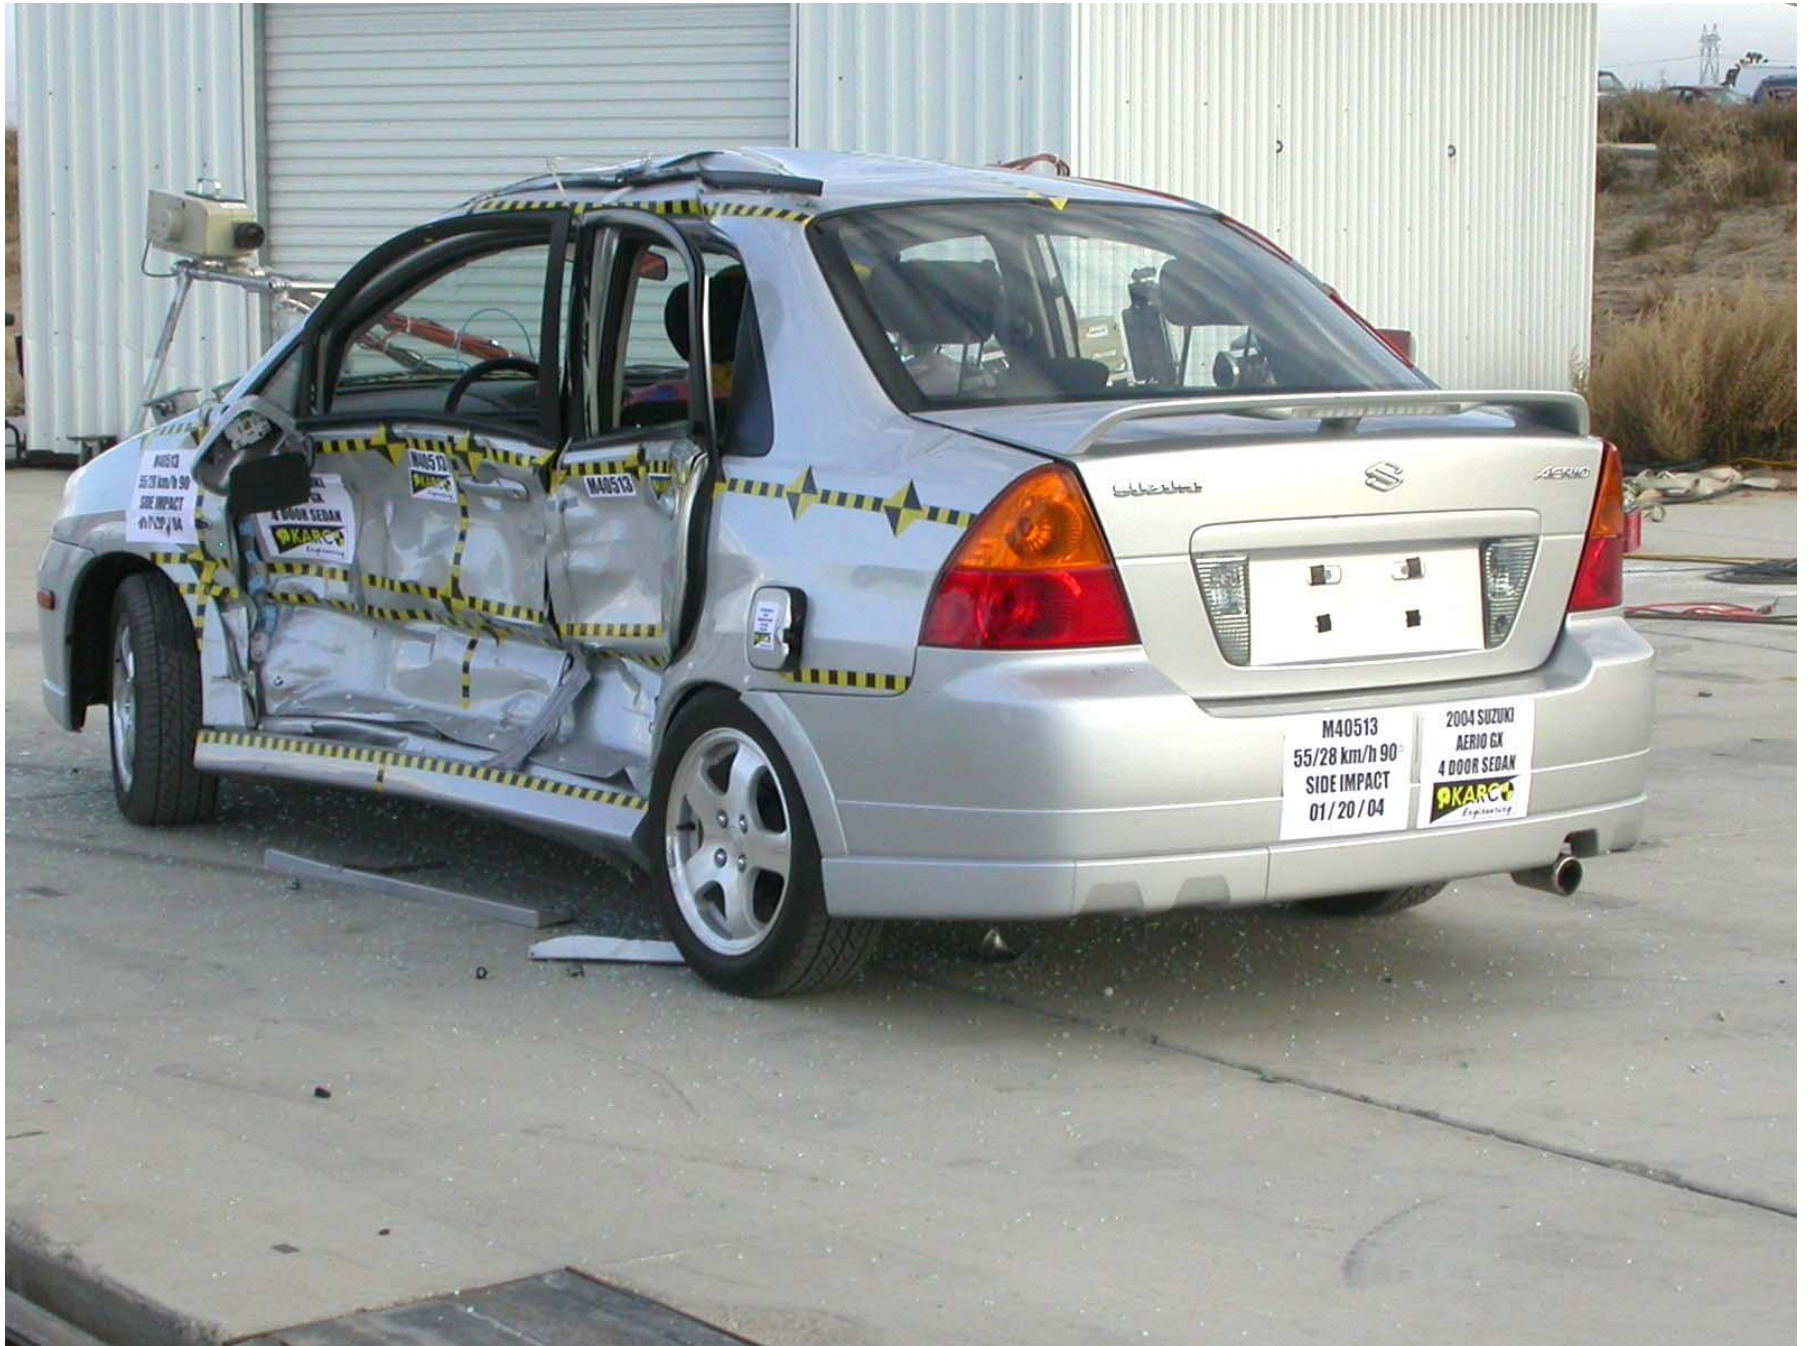
Figure A-12: Left Rear  $\frac{3}{4}$  View, Post-Test

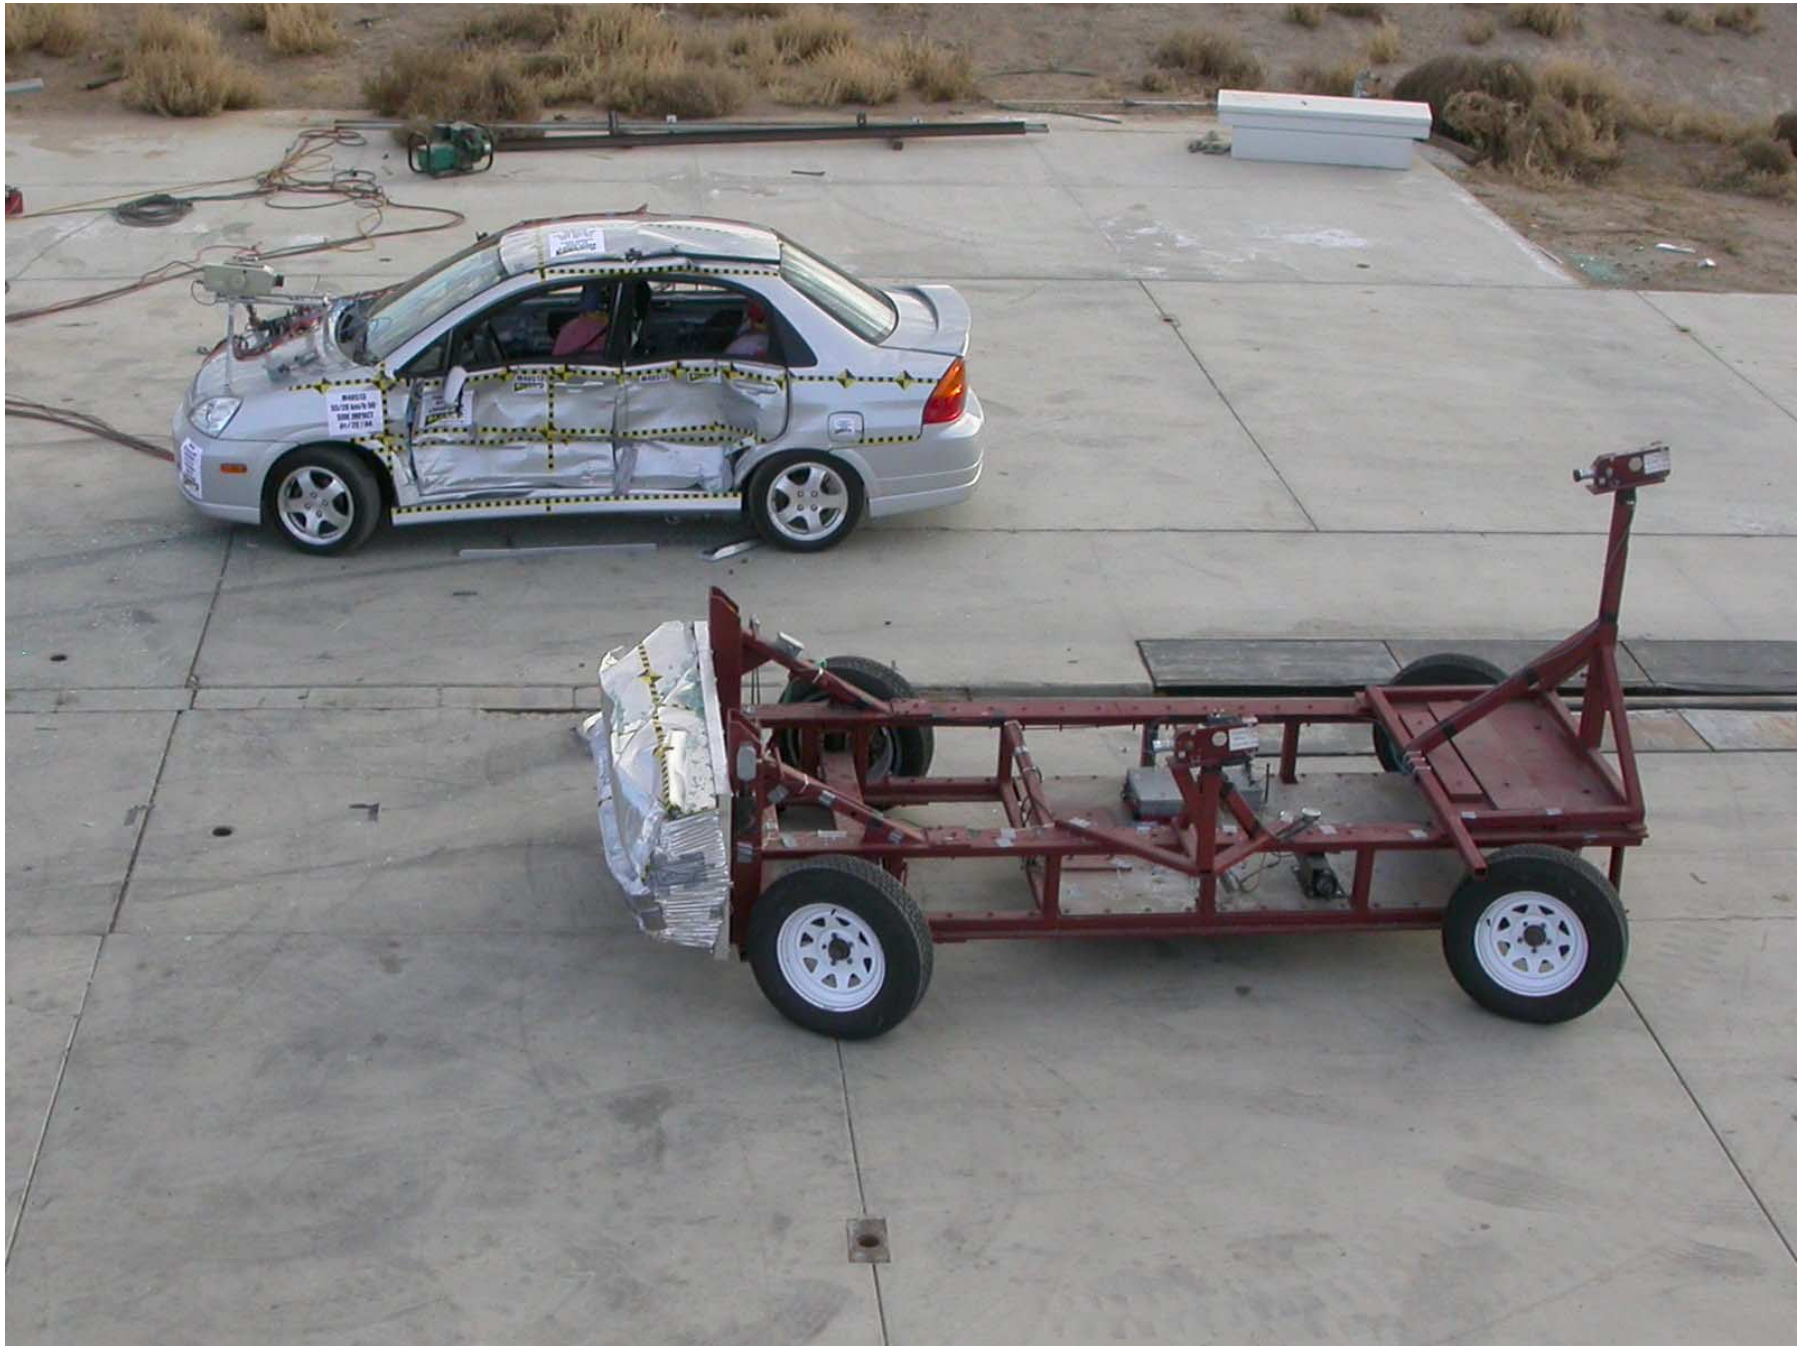
Figure A-22: Overhead Overall View, Post-Test

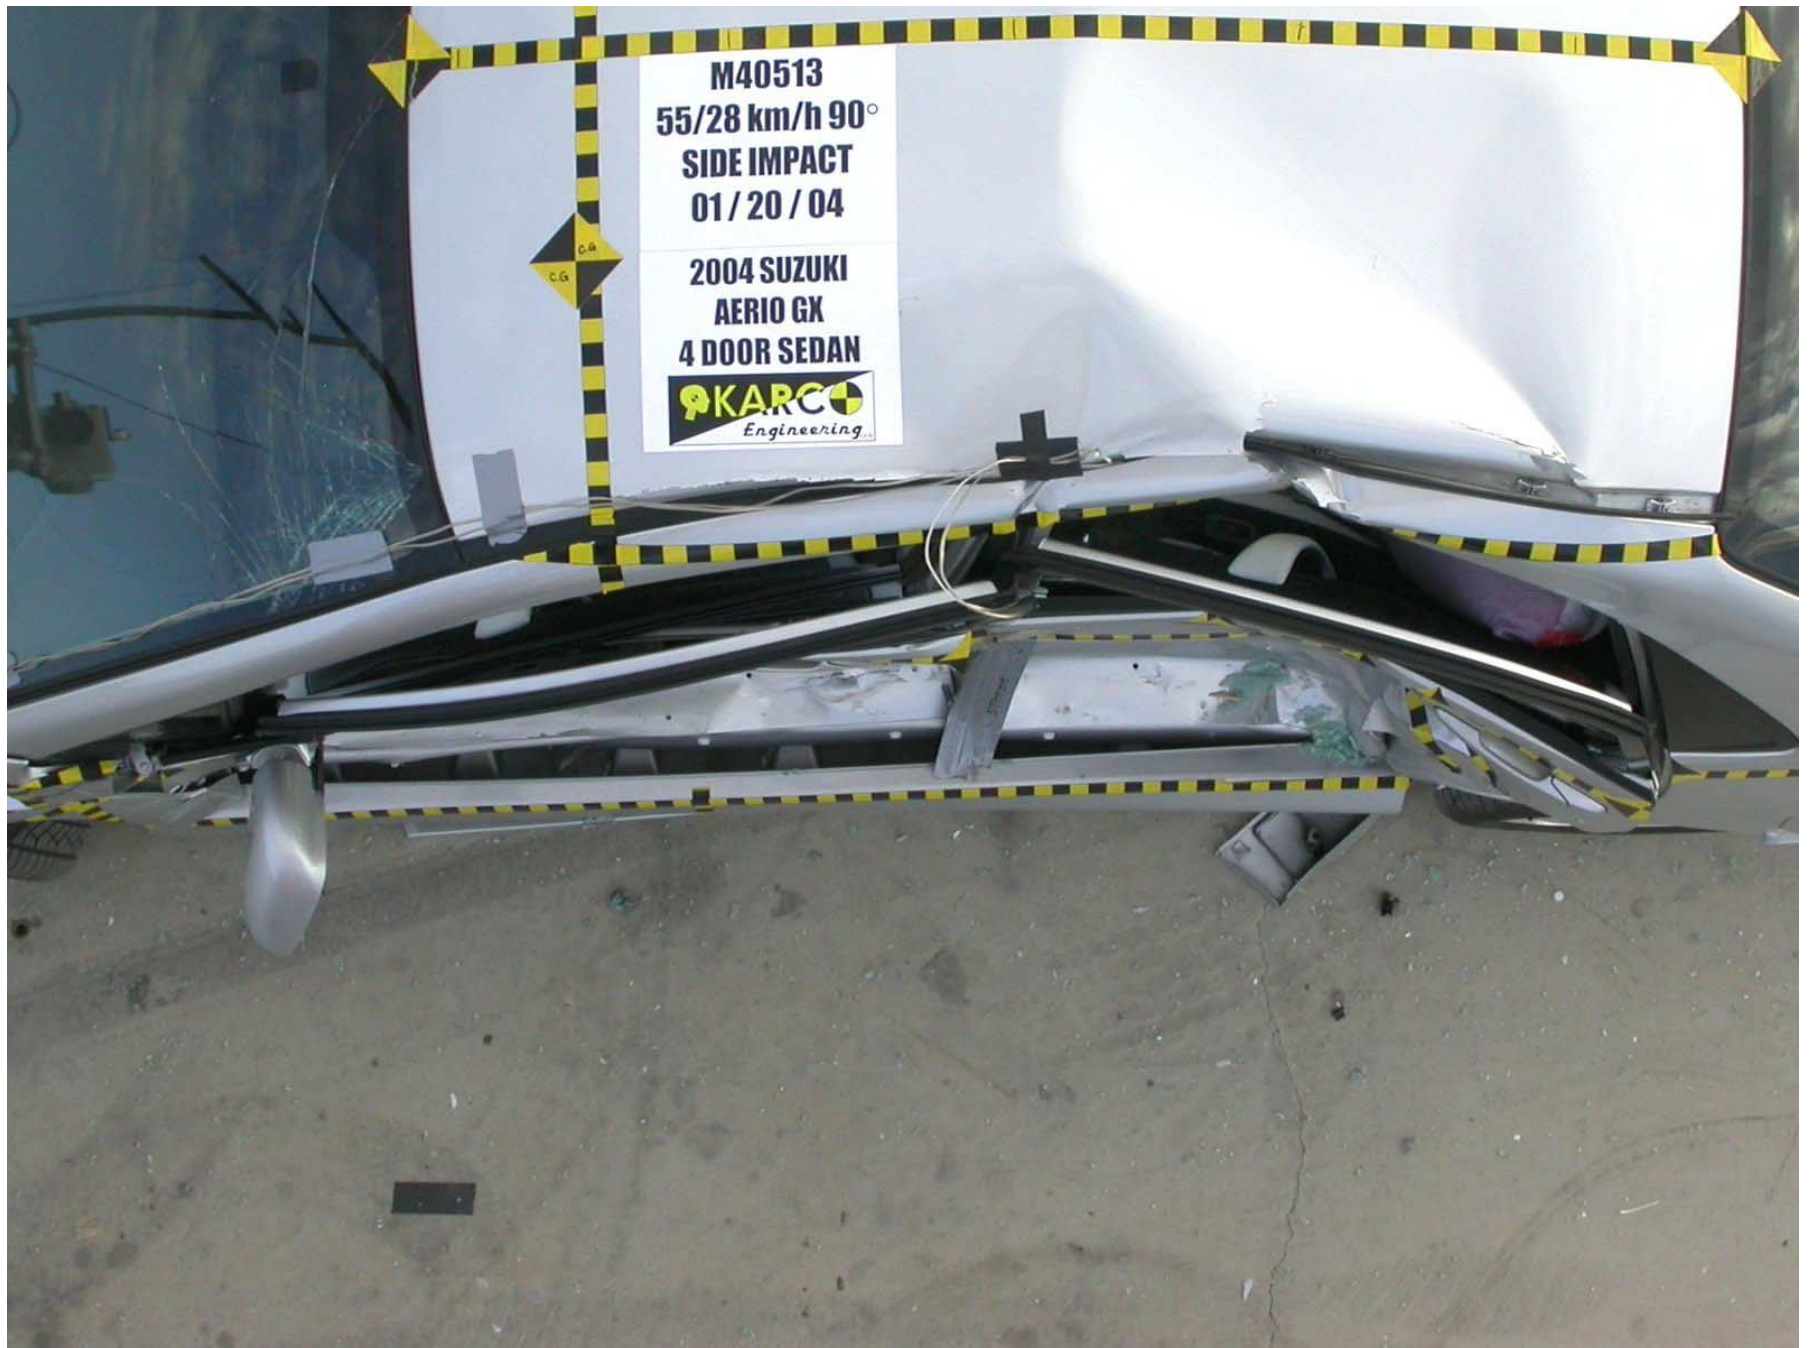
Figure A-24: Overhead Close-up View, Post-Test

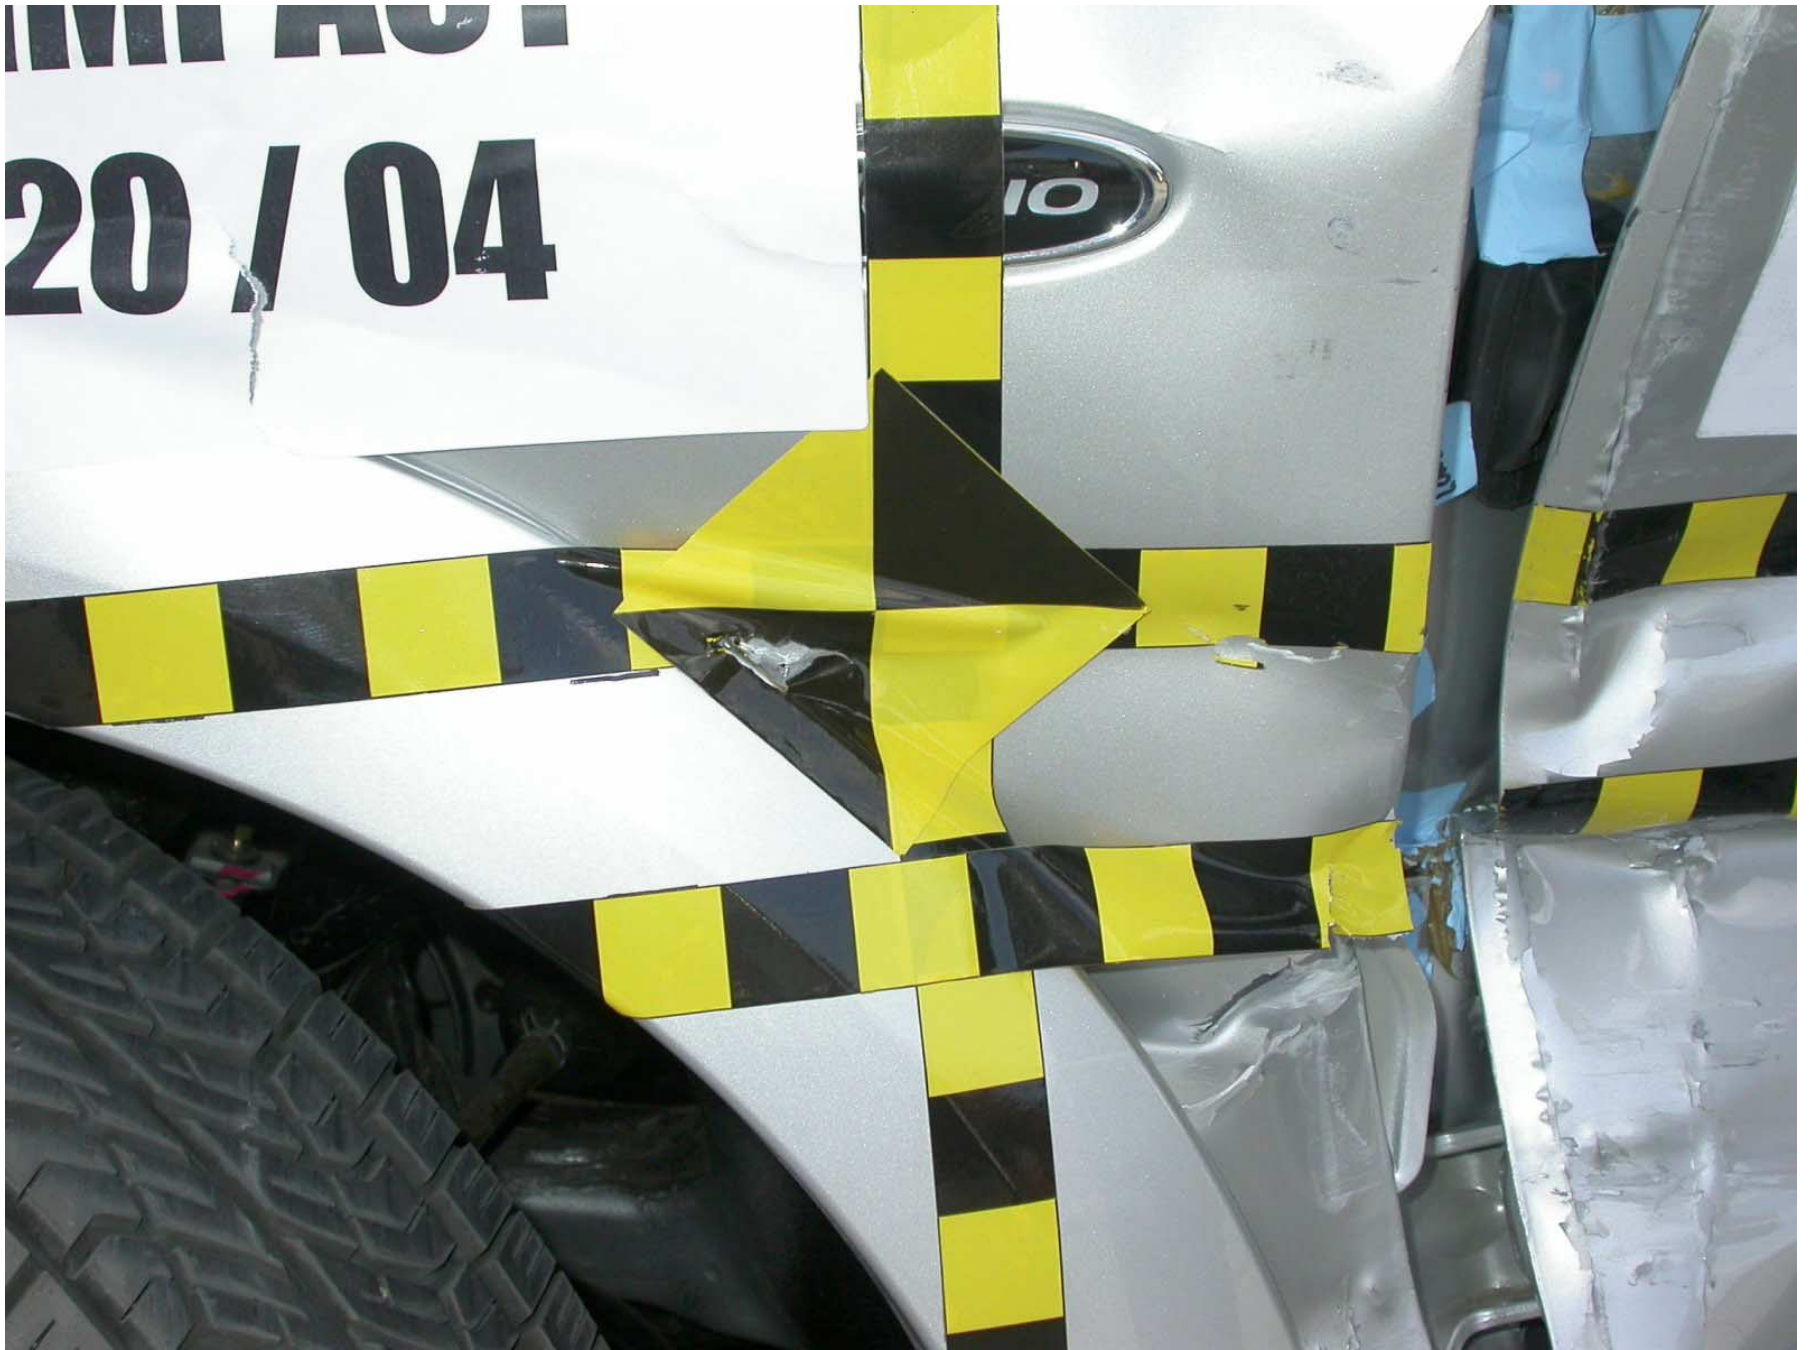
Figure A-26: Impact Point Target, Post-Test

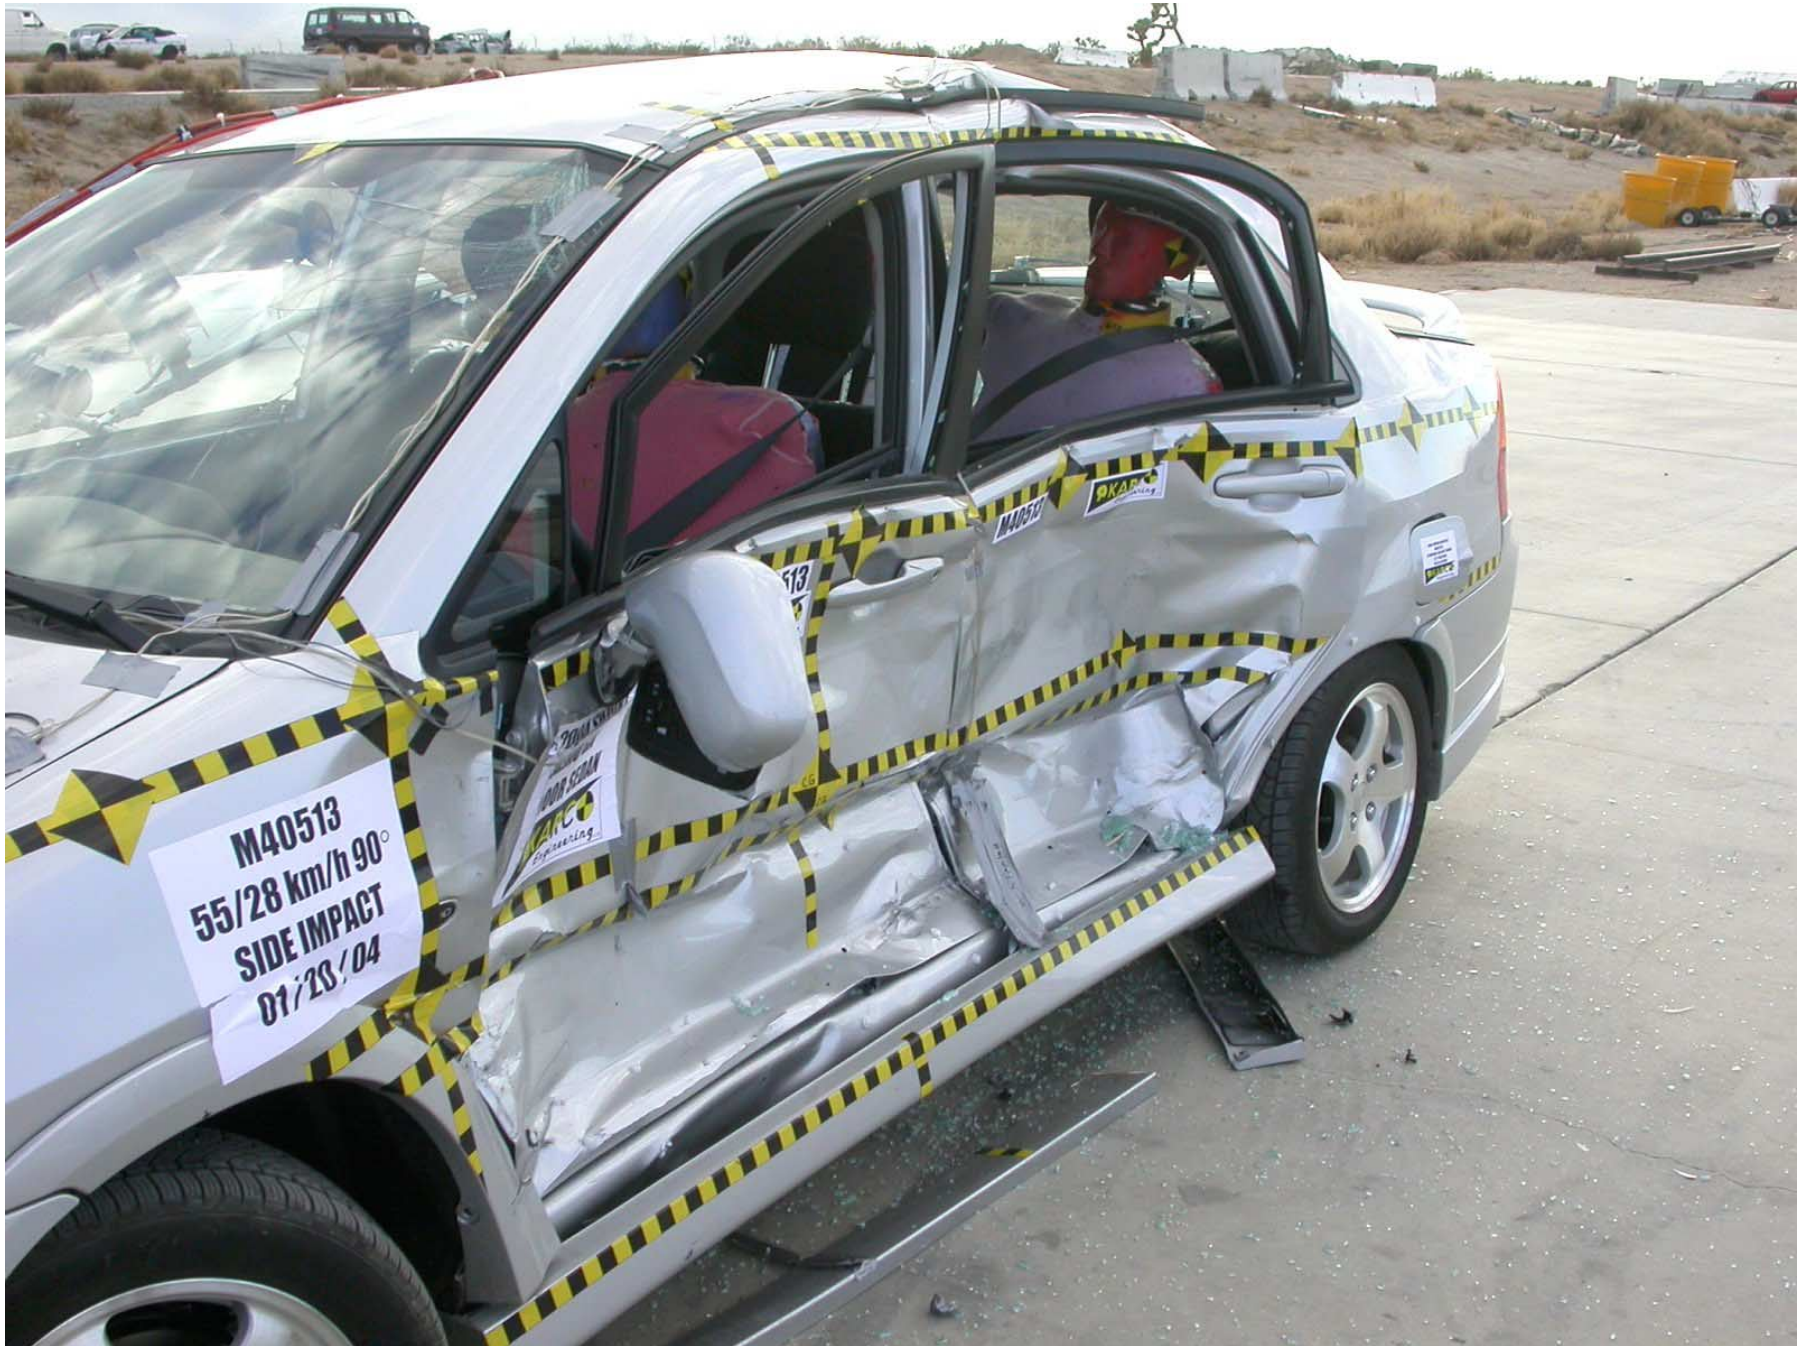
Figure A-28: Front  $\frac{3}{4}$  View of Left Side Doors, Post-Test

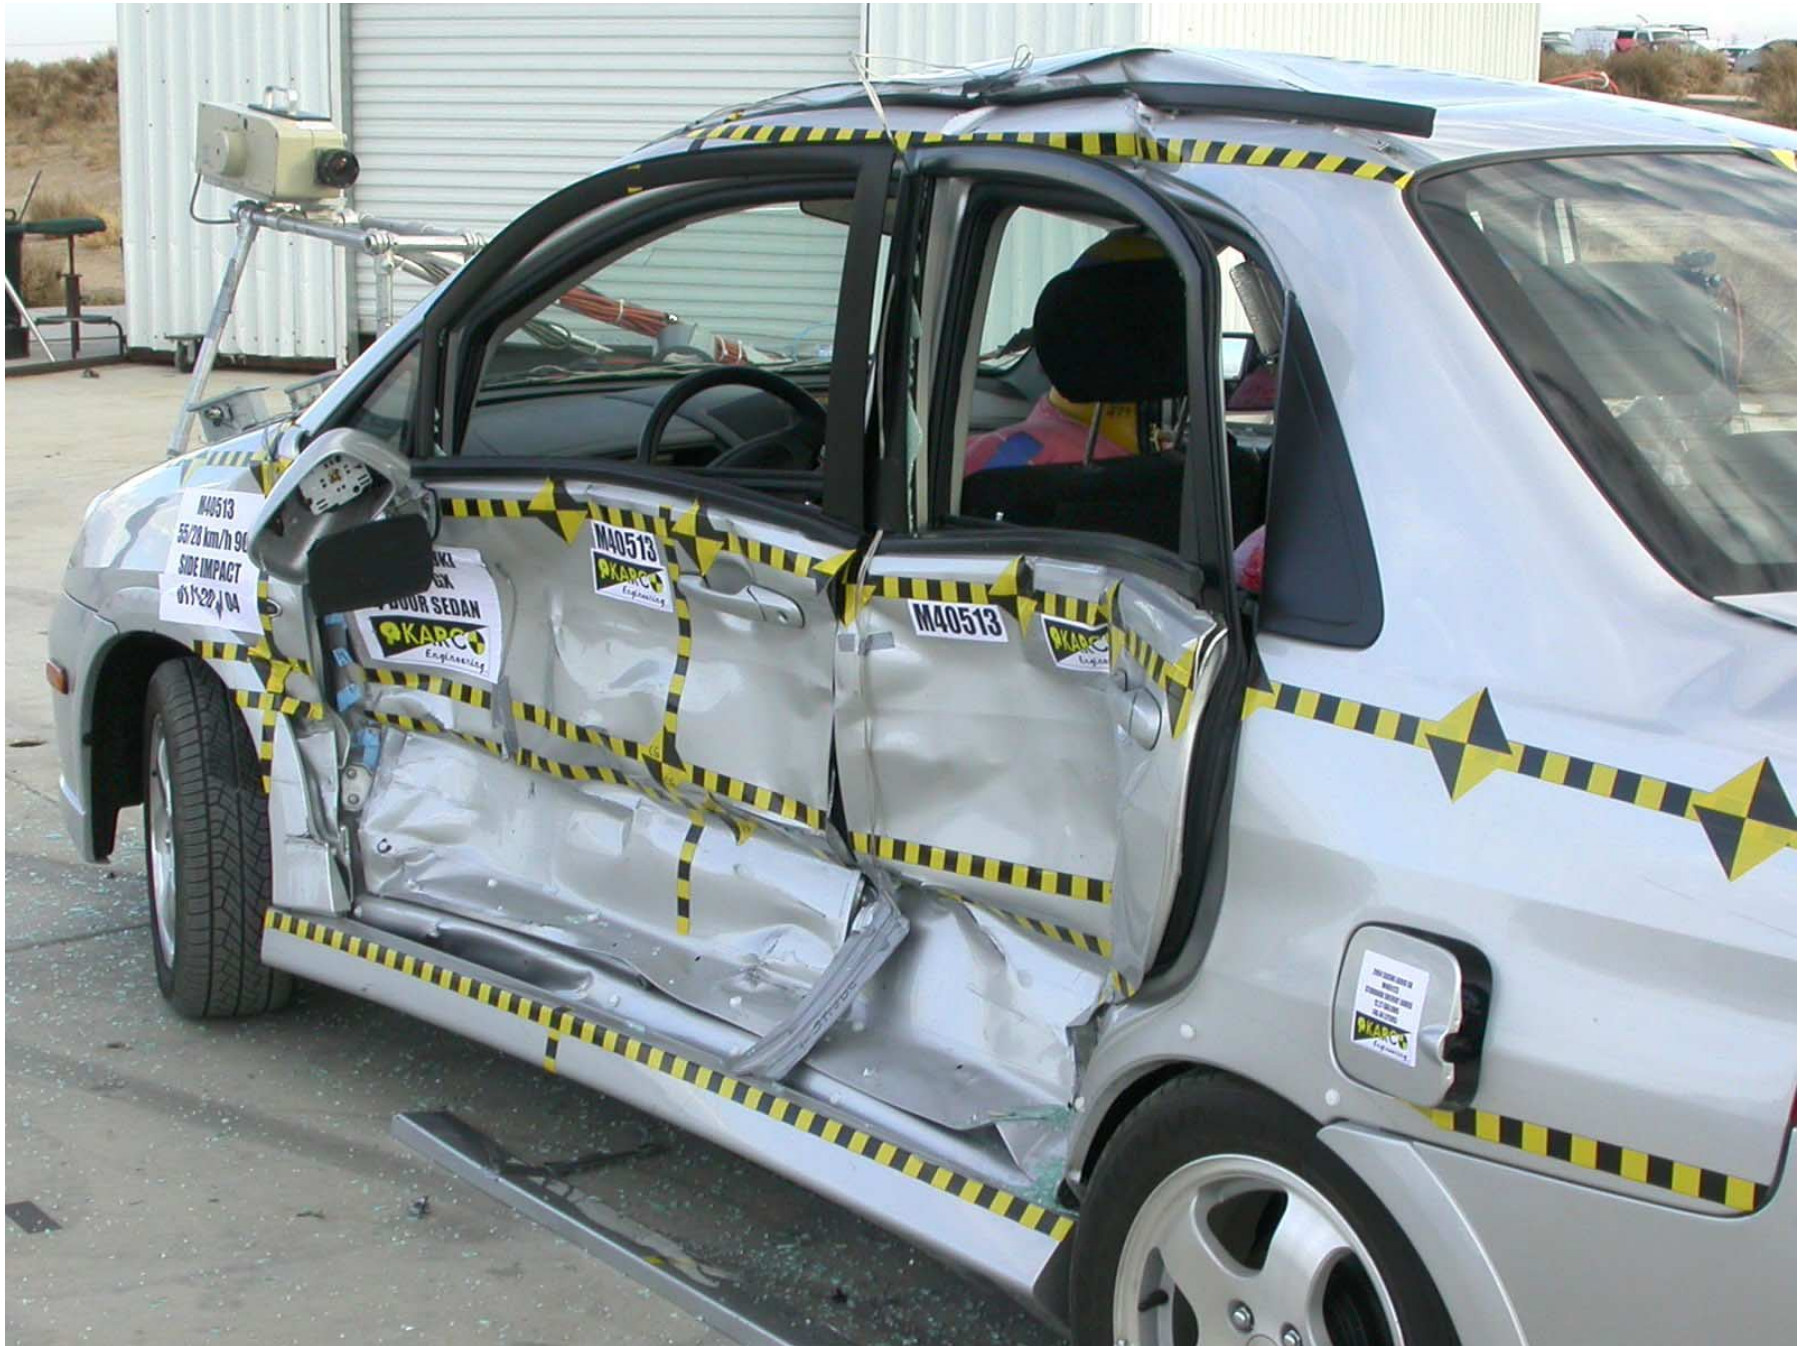
Figure A-30: Rear ¾ View of Left Side Doors, Post-Test

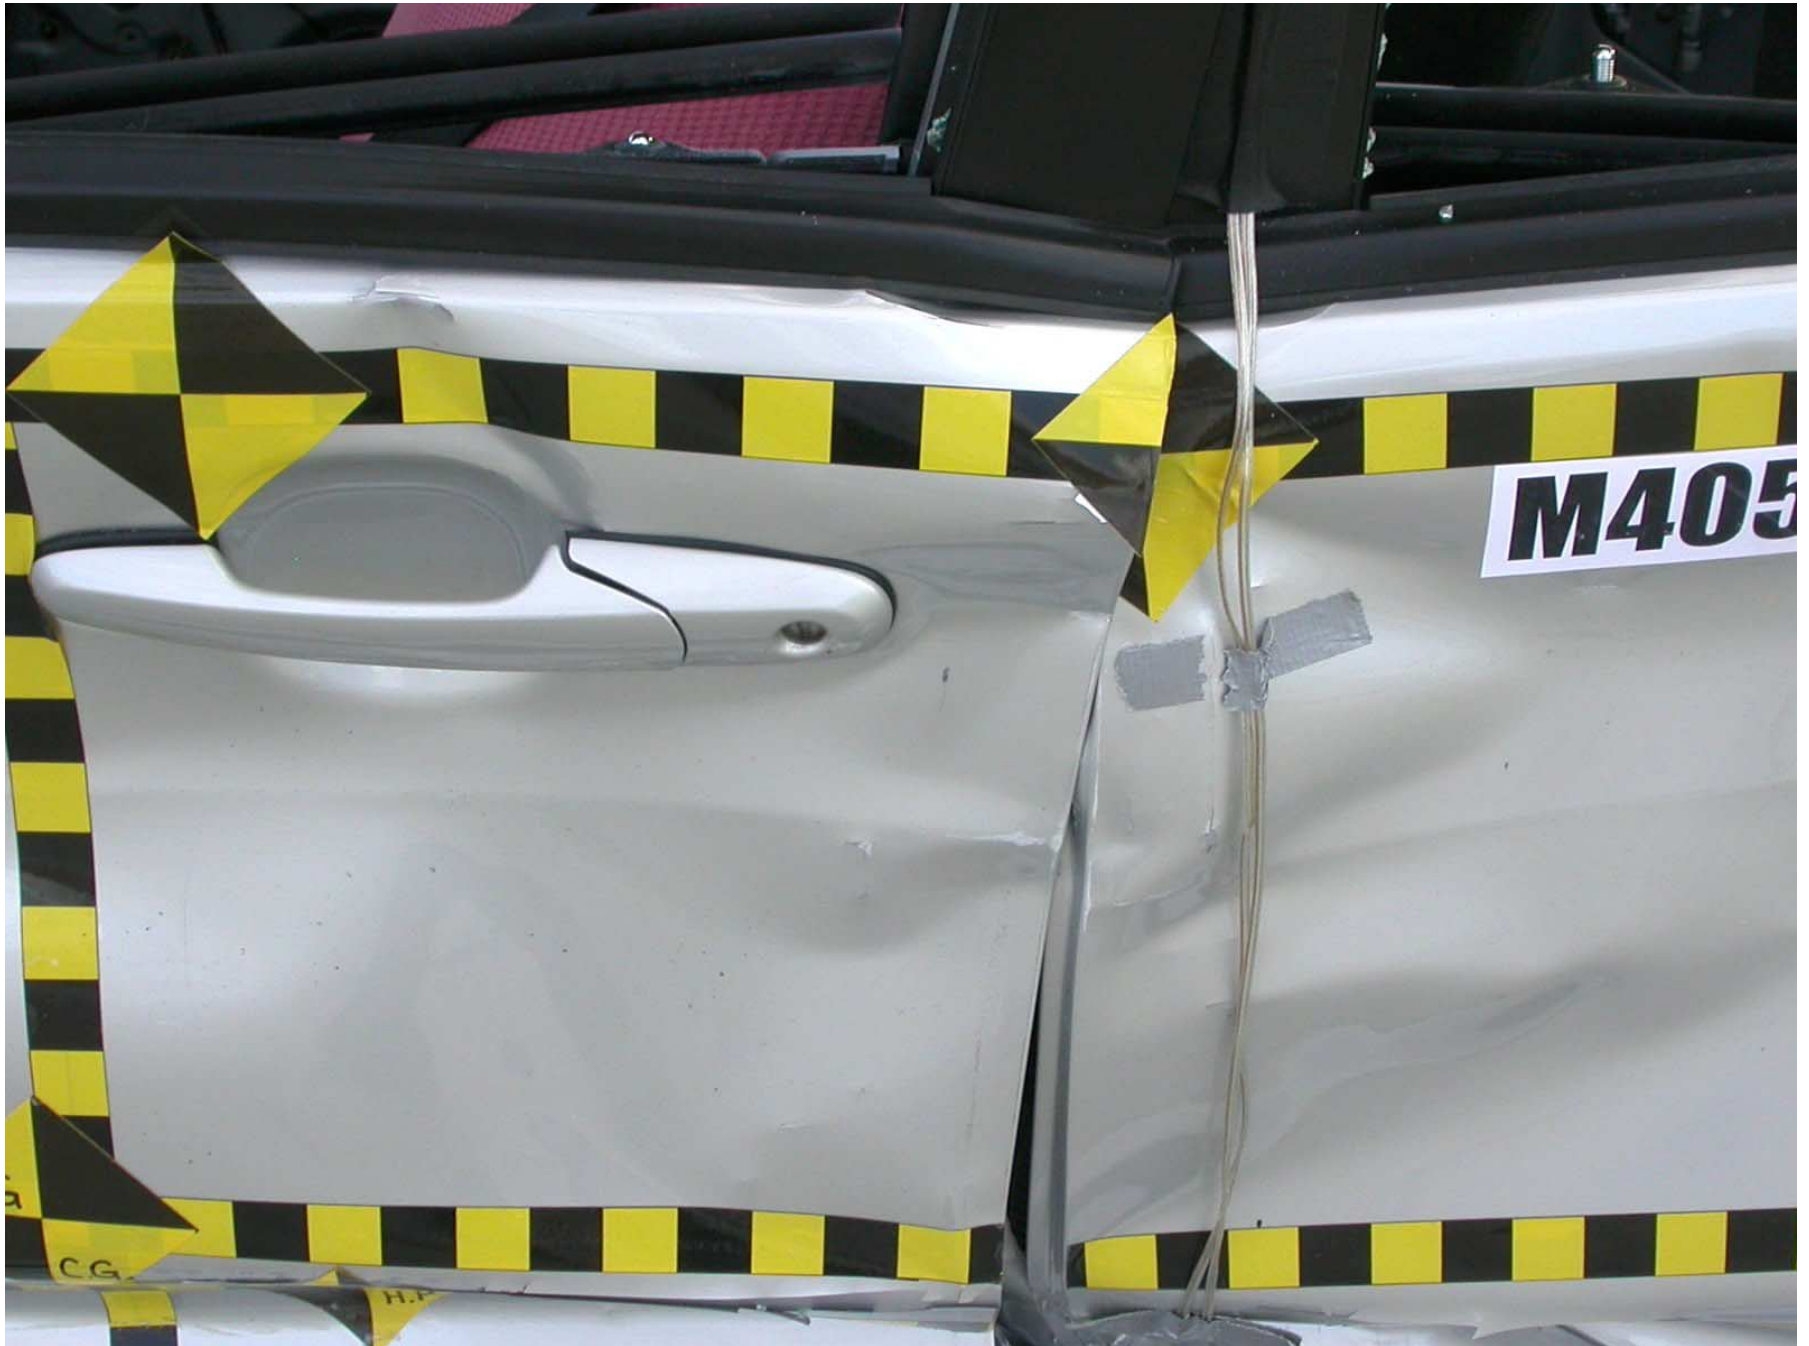
Figure A-32: Left Front Door Closed, Post-Test
