NEW CAR ASSESSMENT PROGRAM  
SIDE IMPACT TEST

SUZUKI MOTOR COMPANY  
2004 SUZUKI AERIO GX  
4 DOOR SEDAN

NHTSA NUMBER: M40513

FINAL REPORT

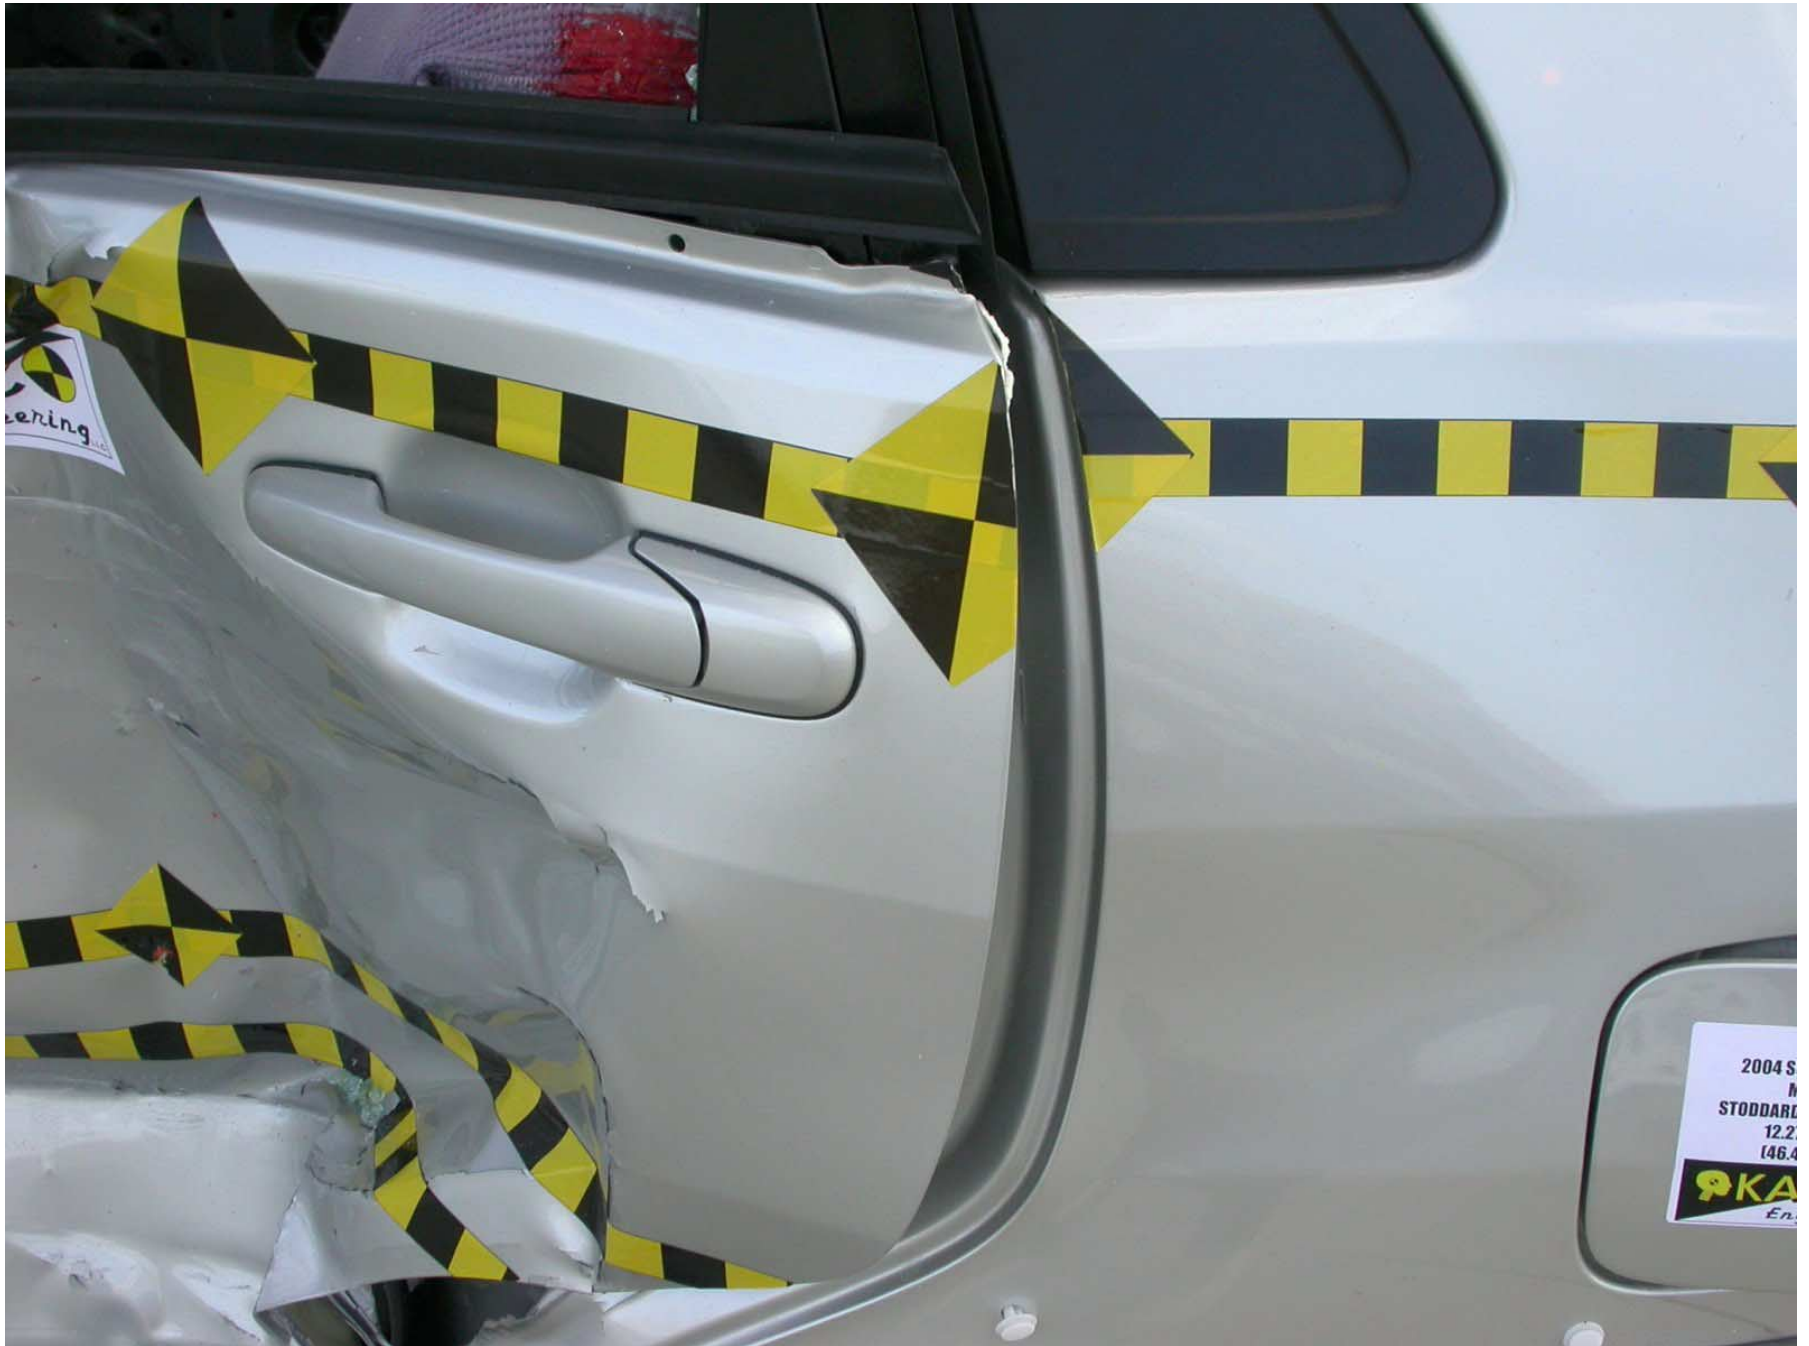
Figure A-34: Left Rear Door Closed, Post-Test

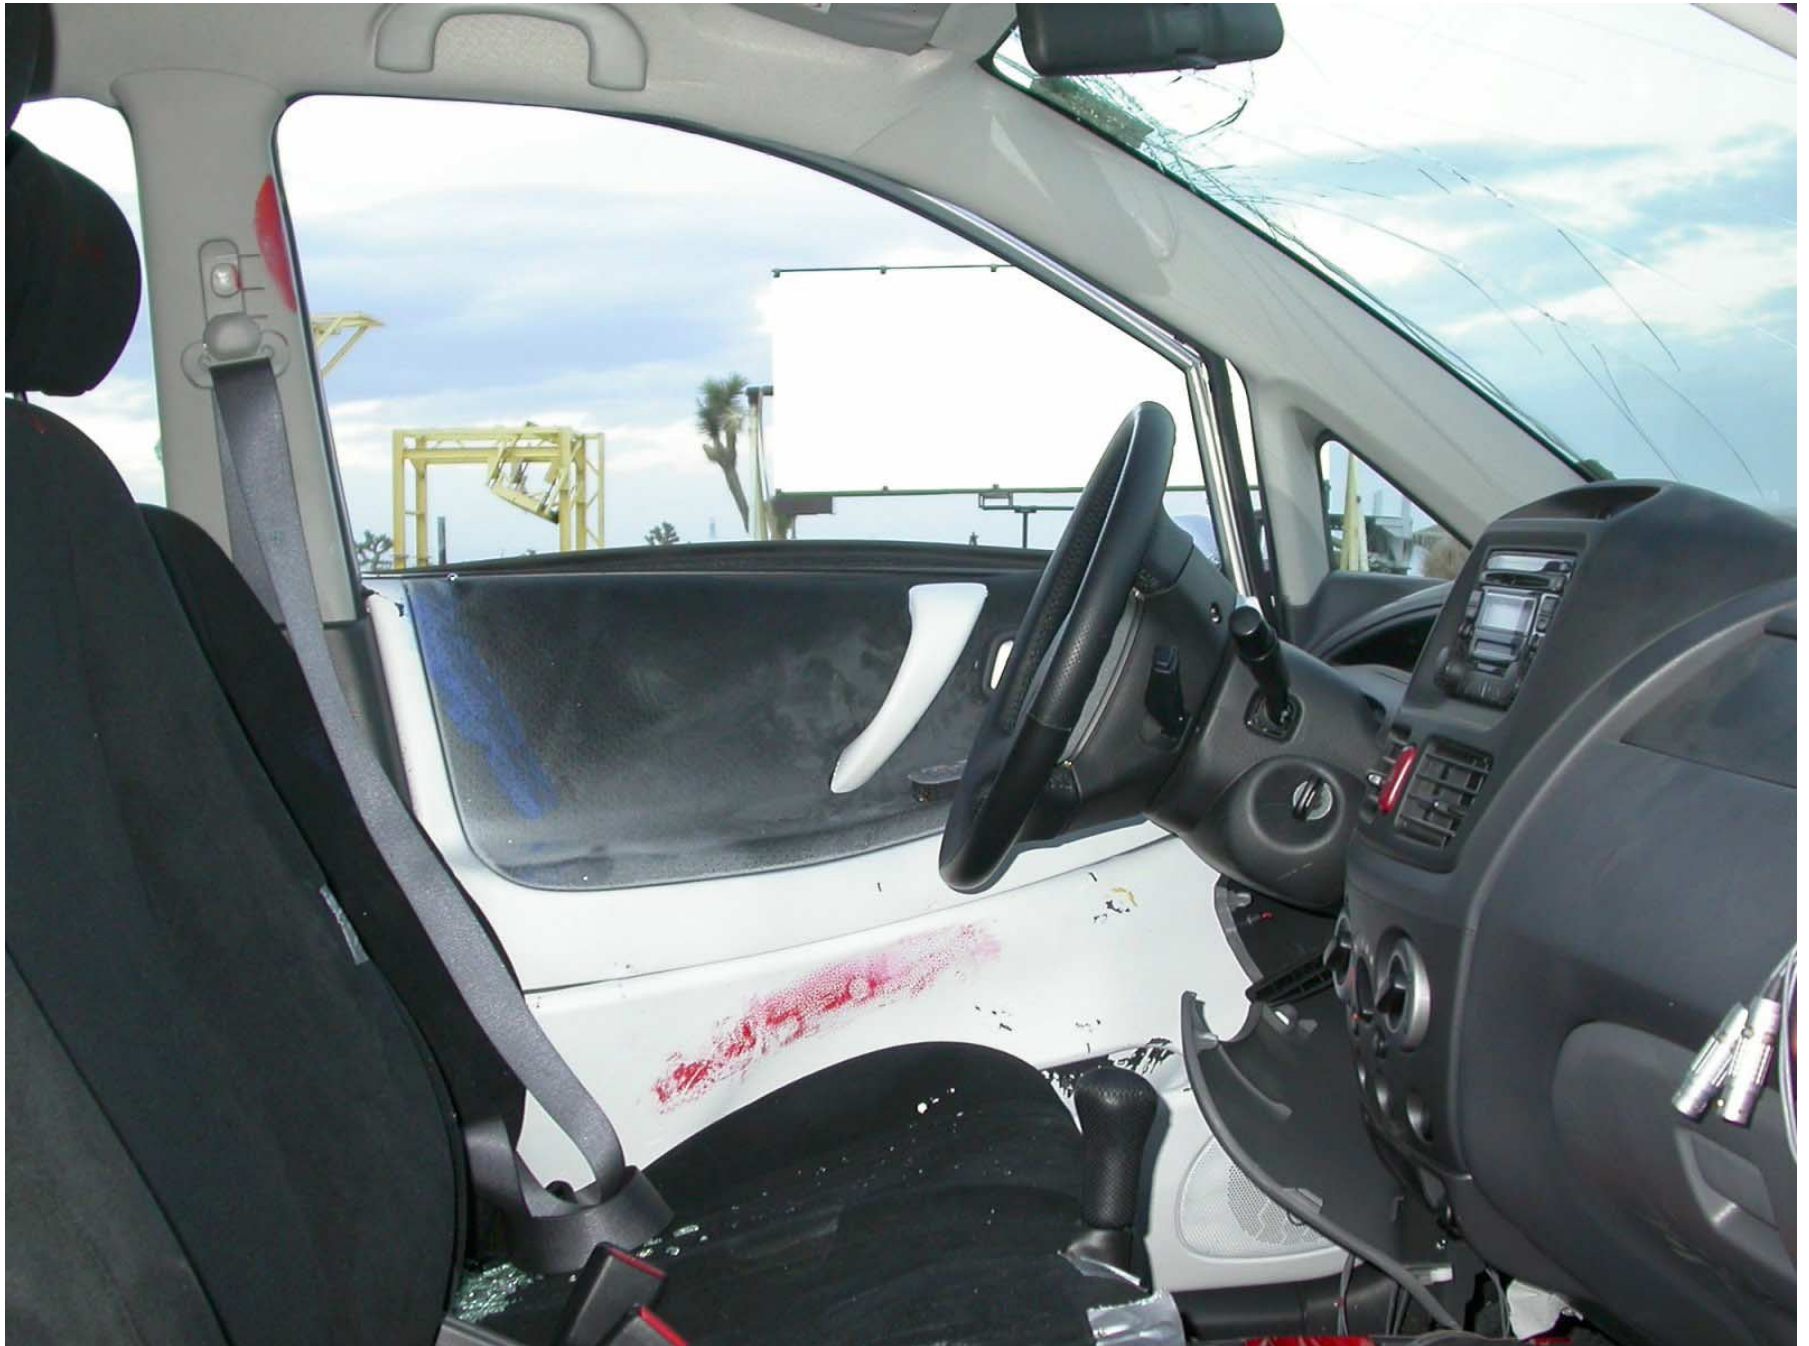
Figure A-43: Driver Dummy Contact Points Inside View, Post-Test

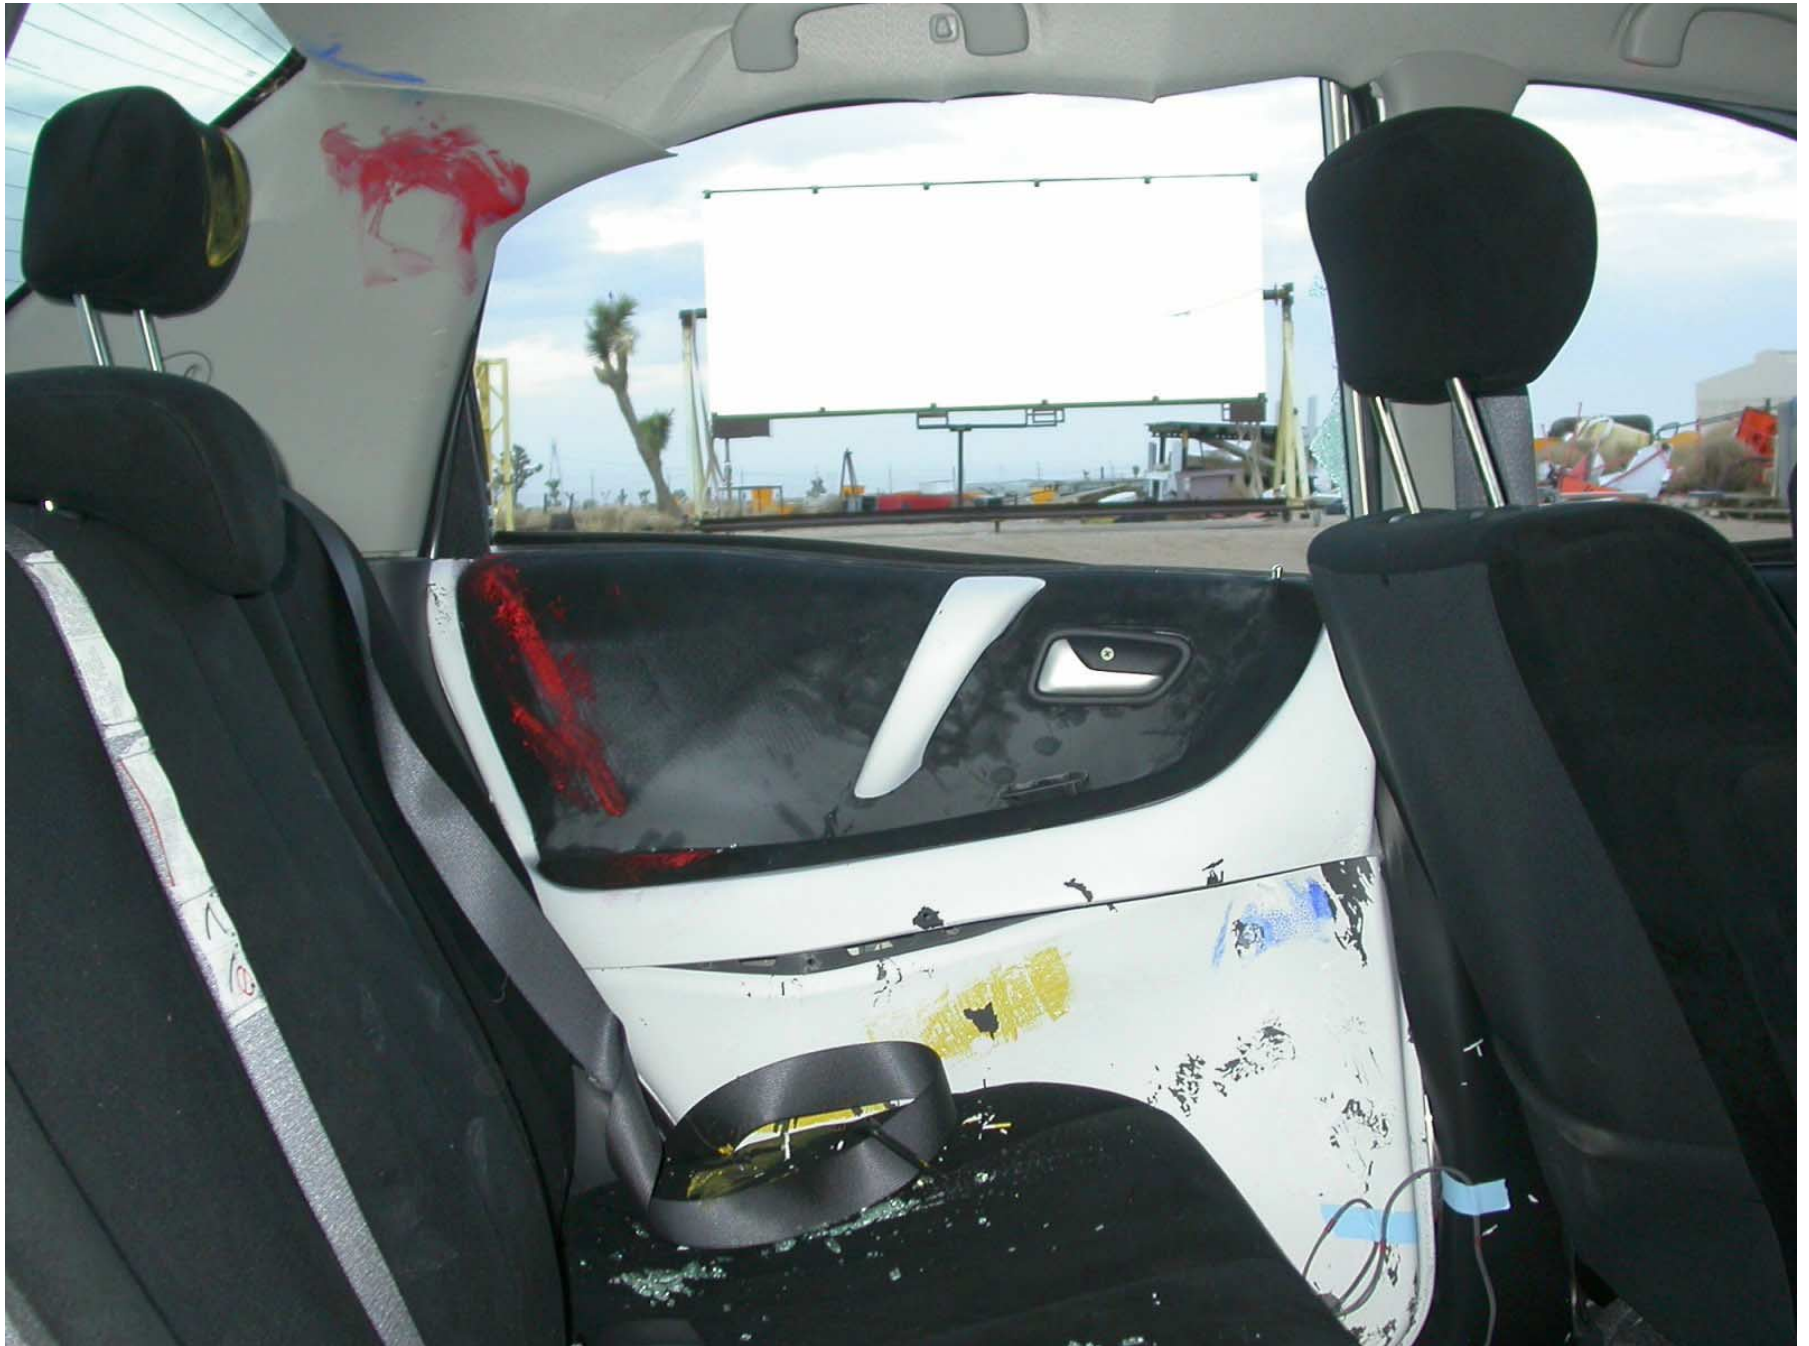
Figure A-52: Passenger Dummy Contact Points Inside View, Post-Test

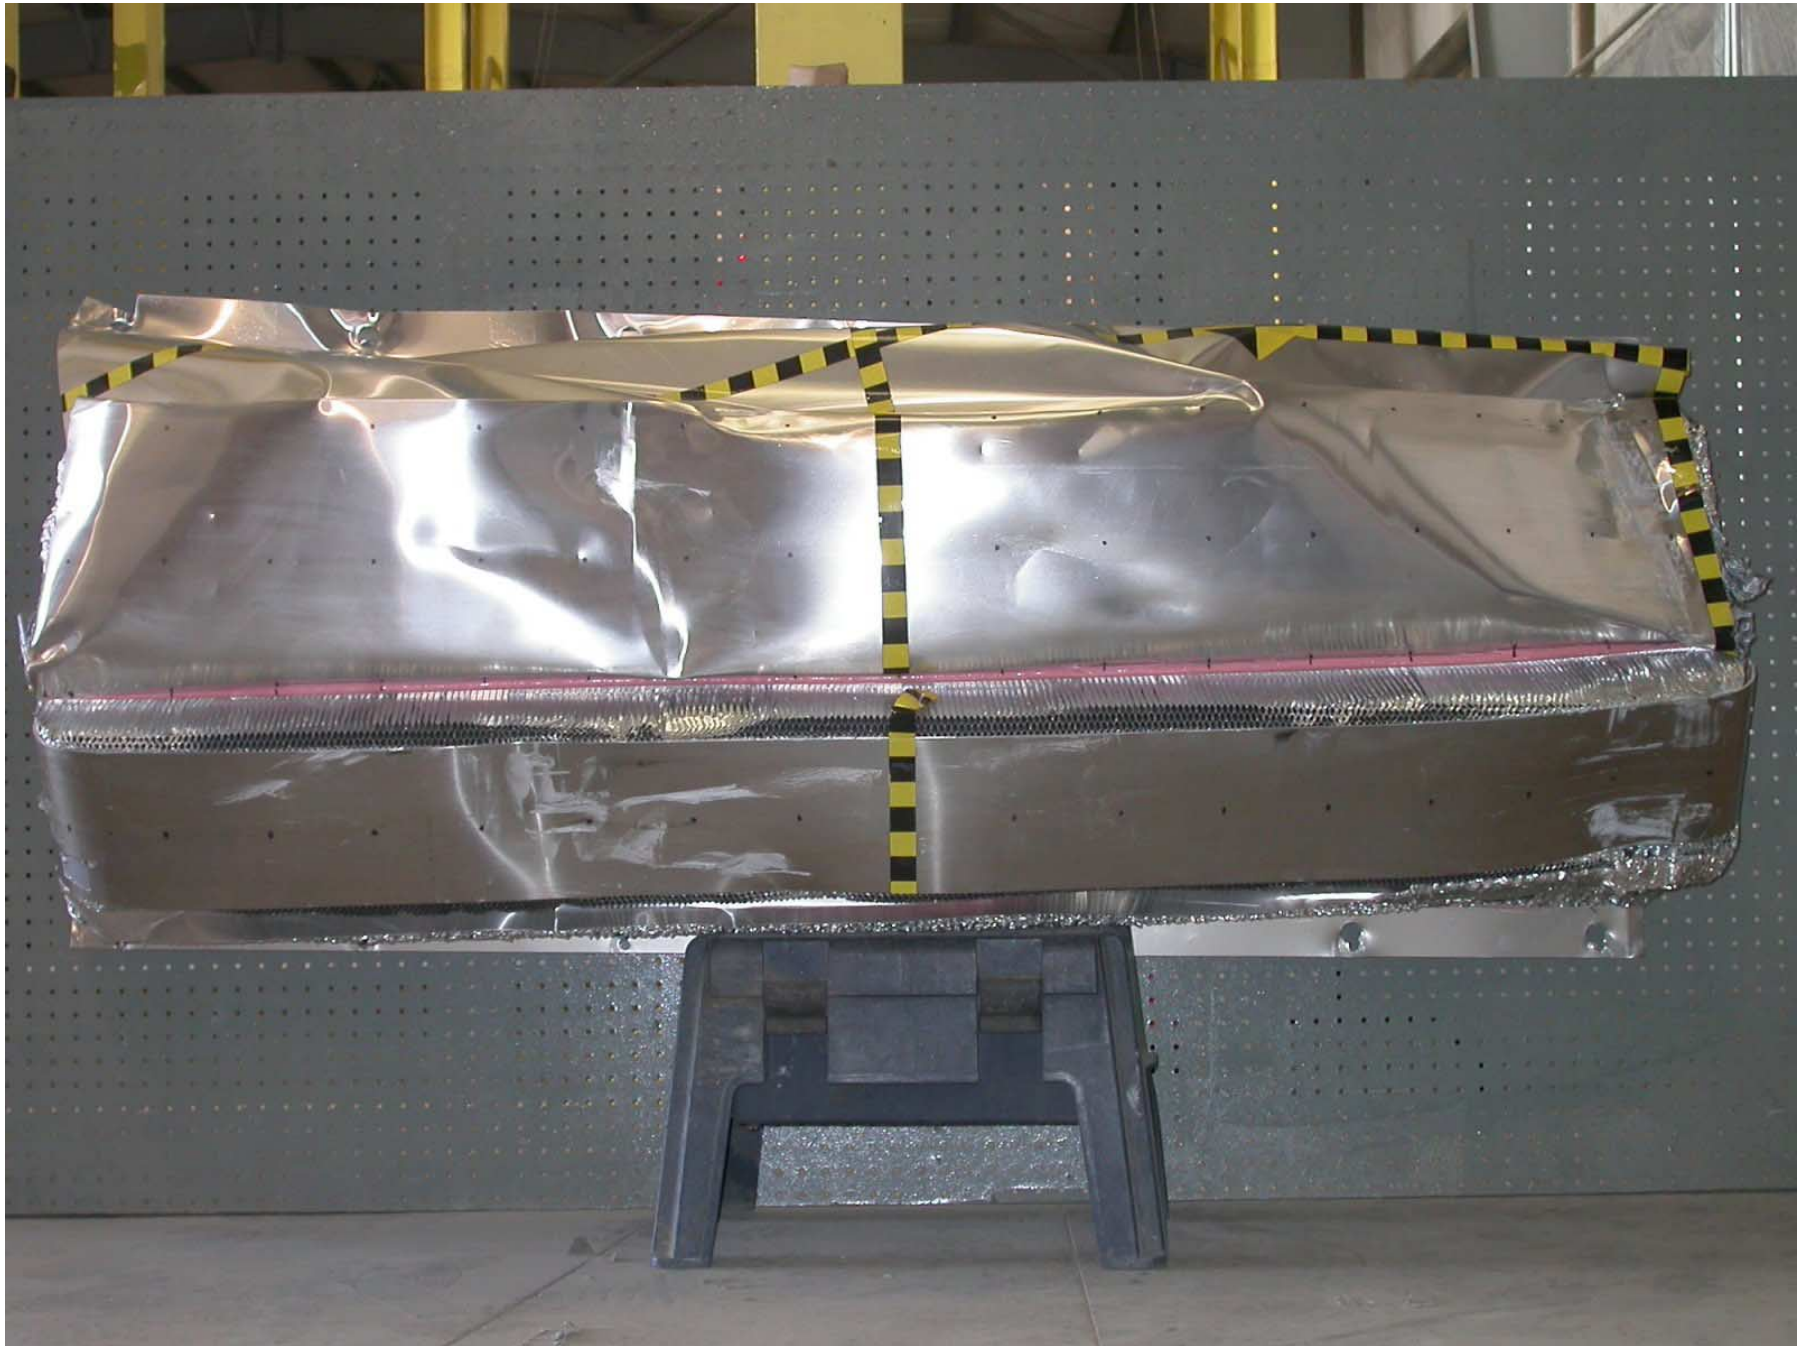
Figure A-54: Front View of Deformable Barrier, Post-Test

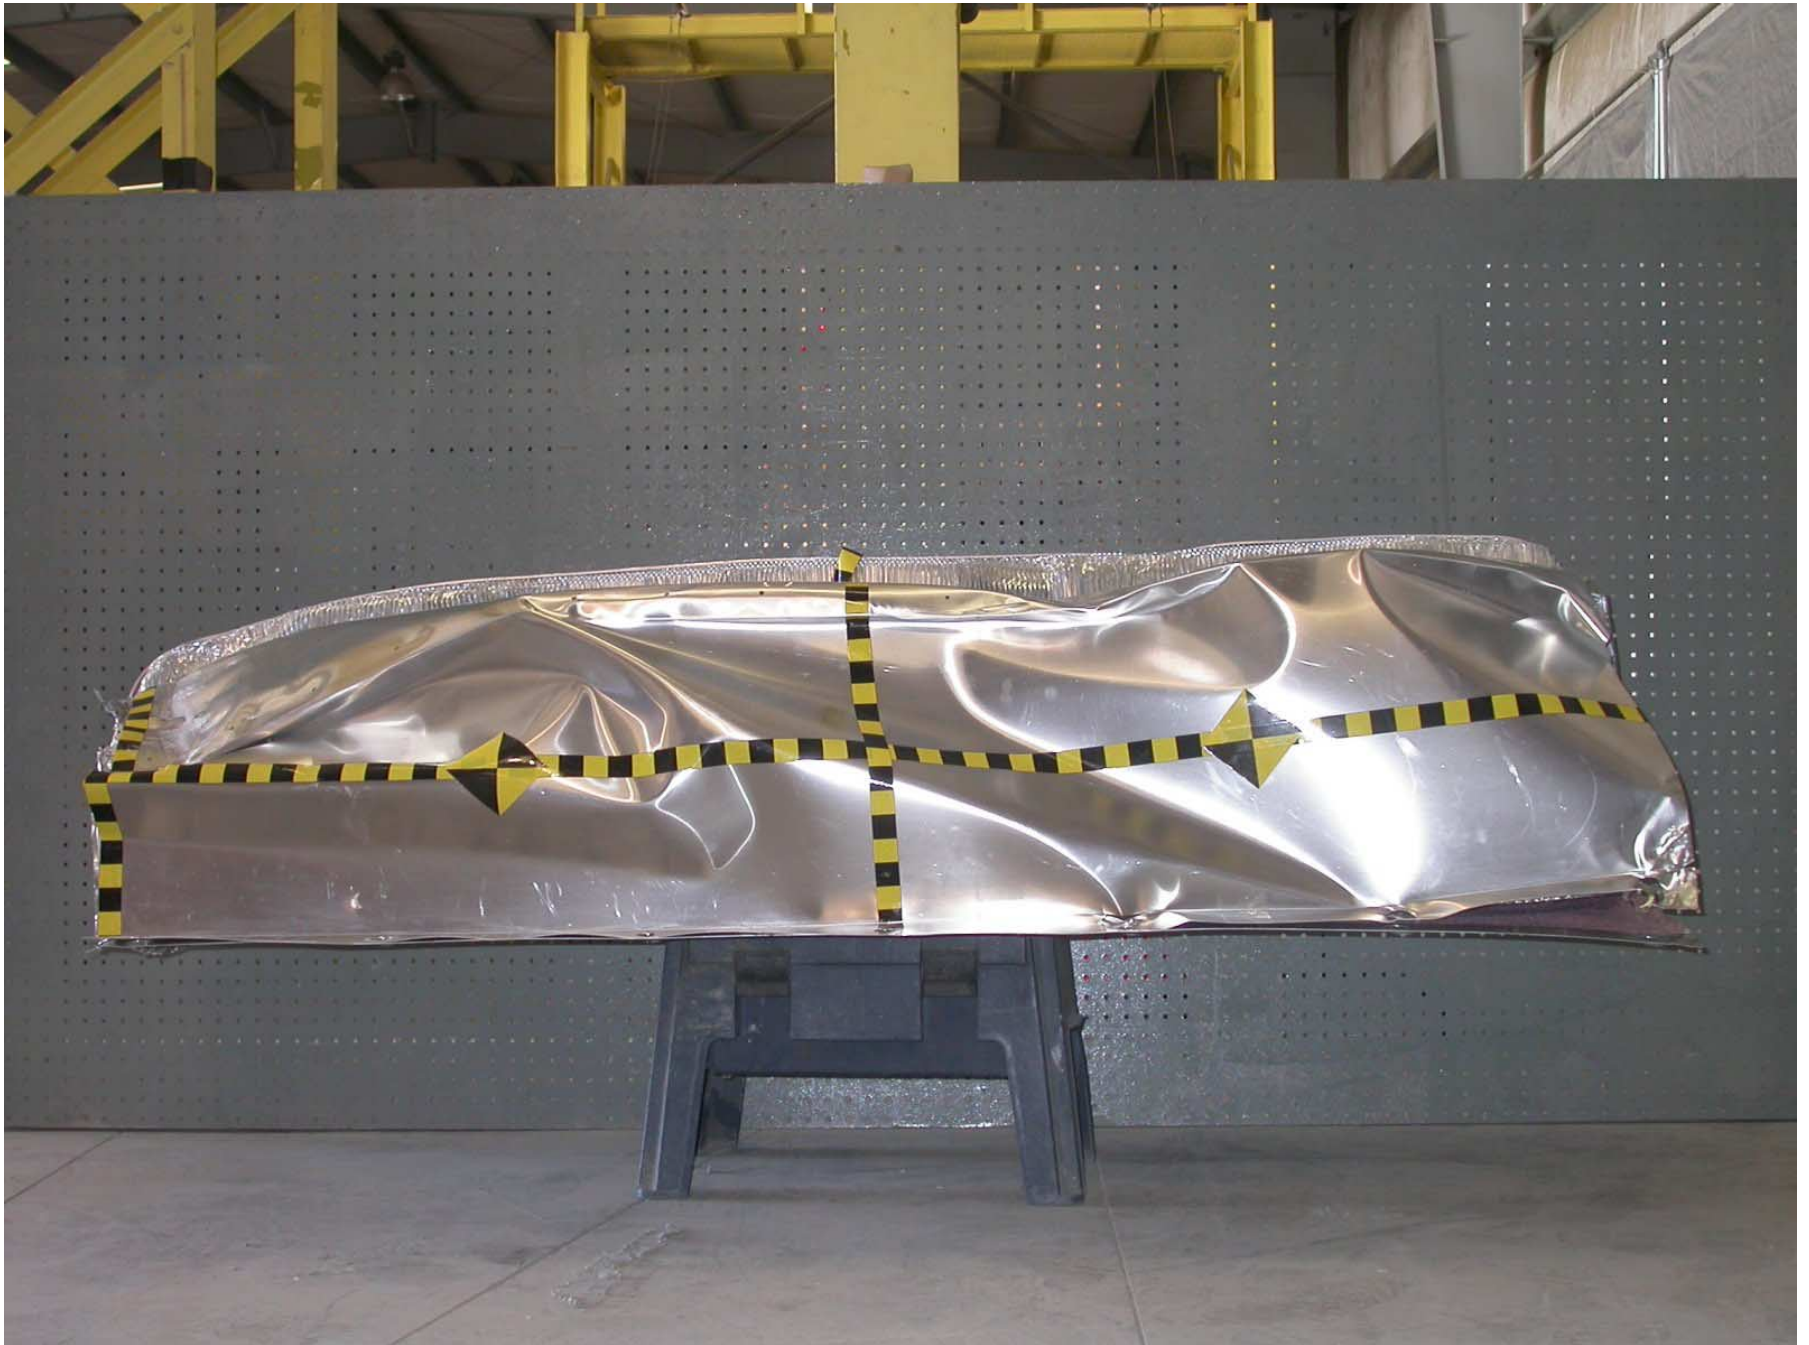
Figure A-56: Top View of Deformable Barrier, Post-Test

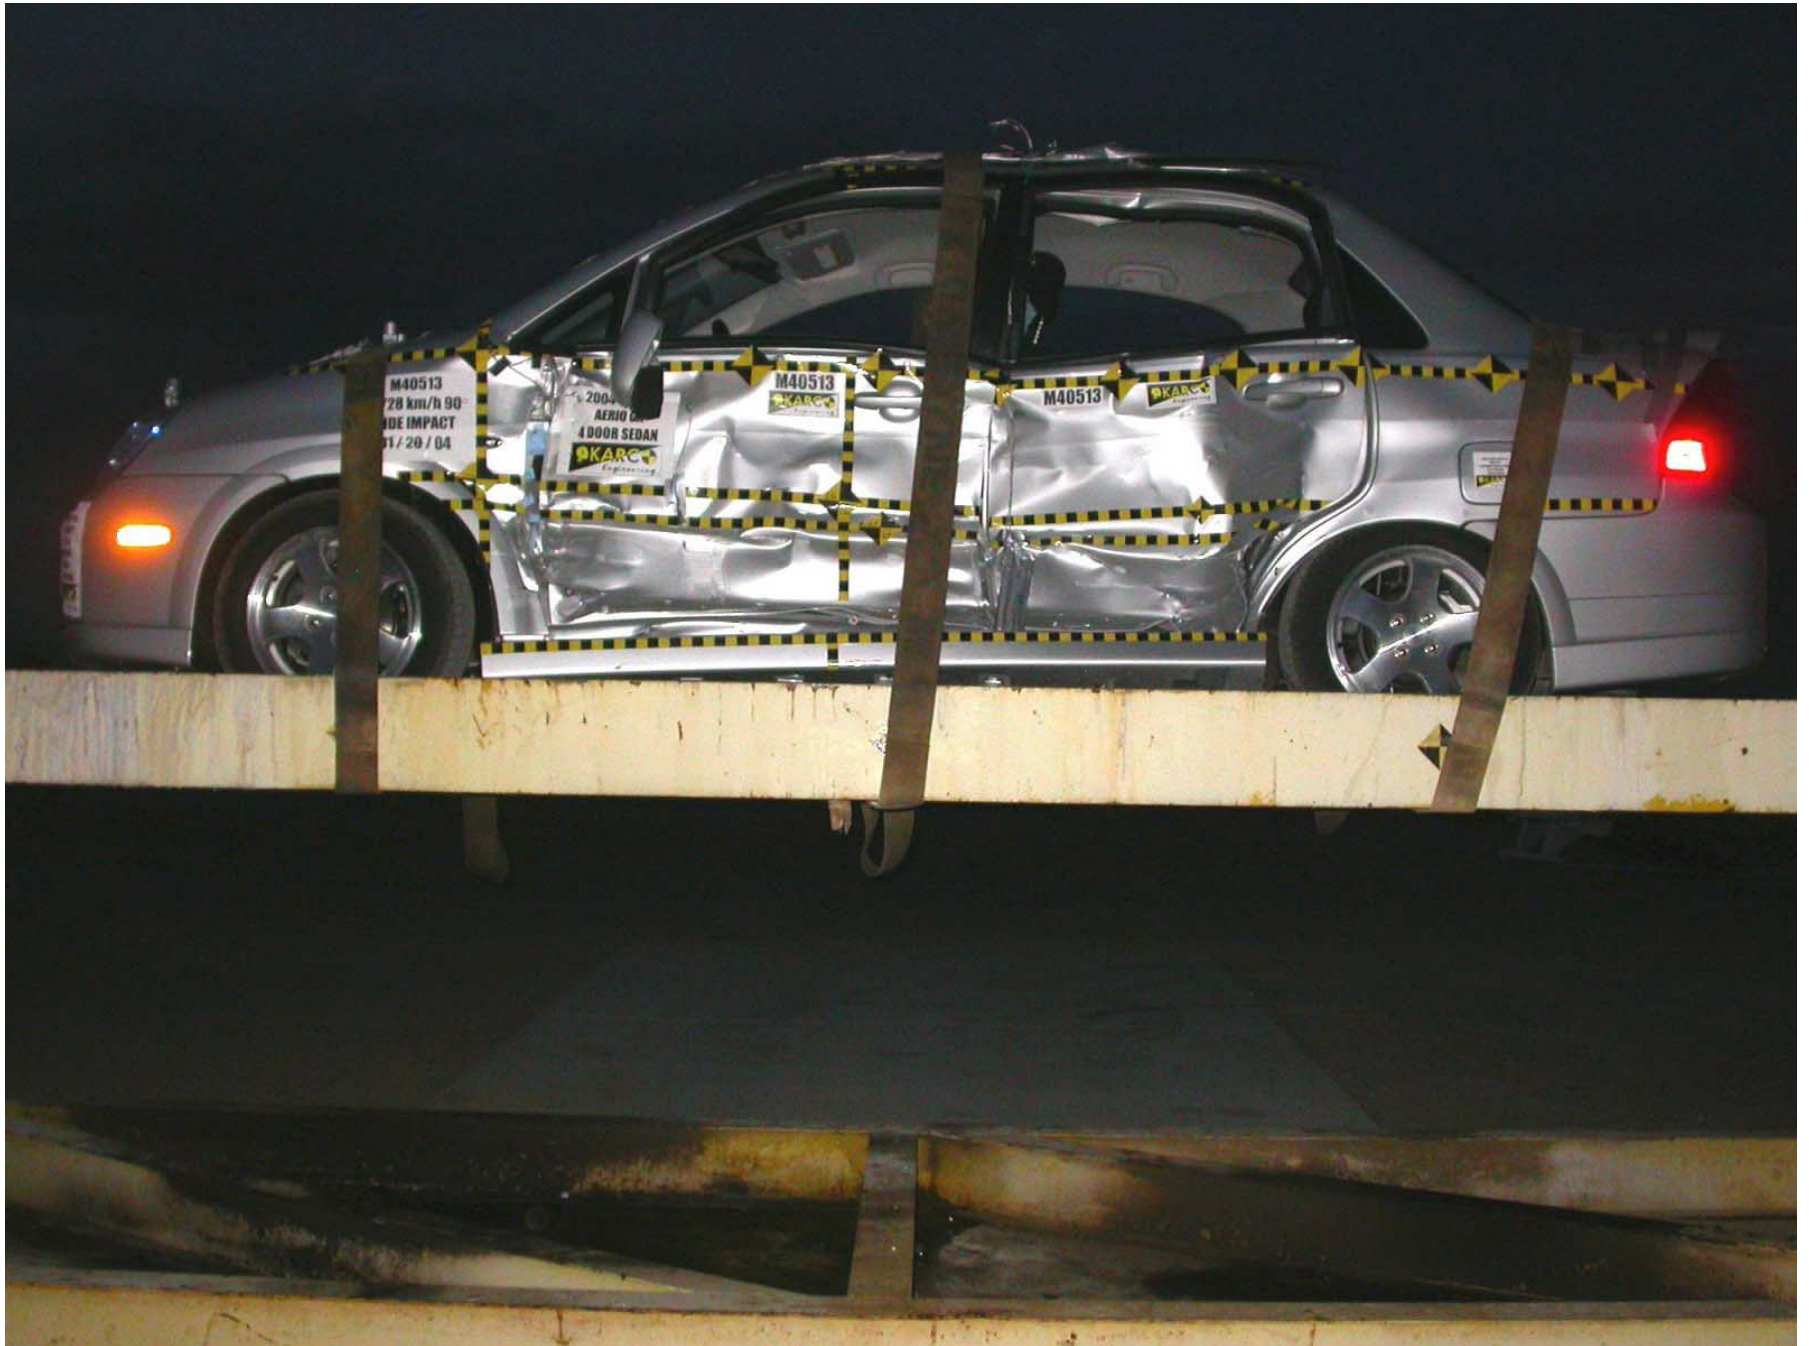
Figure A-61: Vehicle on Rollover Device, 0° View

Figure A-62: Vehicle on Rollover Device, 90° View

Figure A-63: Vehicle on Rollover Device, 180° View

Figure A-64: Vehicle on Rollover Device, 270° View

No solvent leakage occurred during static rollover testing.
