REPORT NUMBER TR-P24003-02-NC

**NEW CAR ASSESSMENT PROGRAM
SIDE IMPACT TEST**

**TOYOTA MOTOR CORPORATION
2004 LEXUS ES 330
4 DOOR SEDAN**

FINAL REPORT

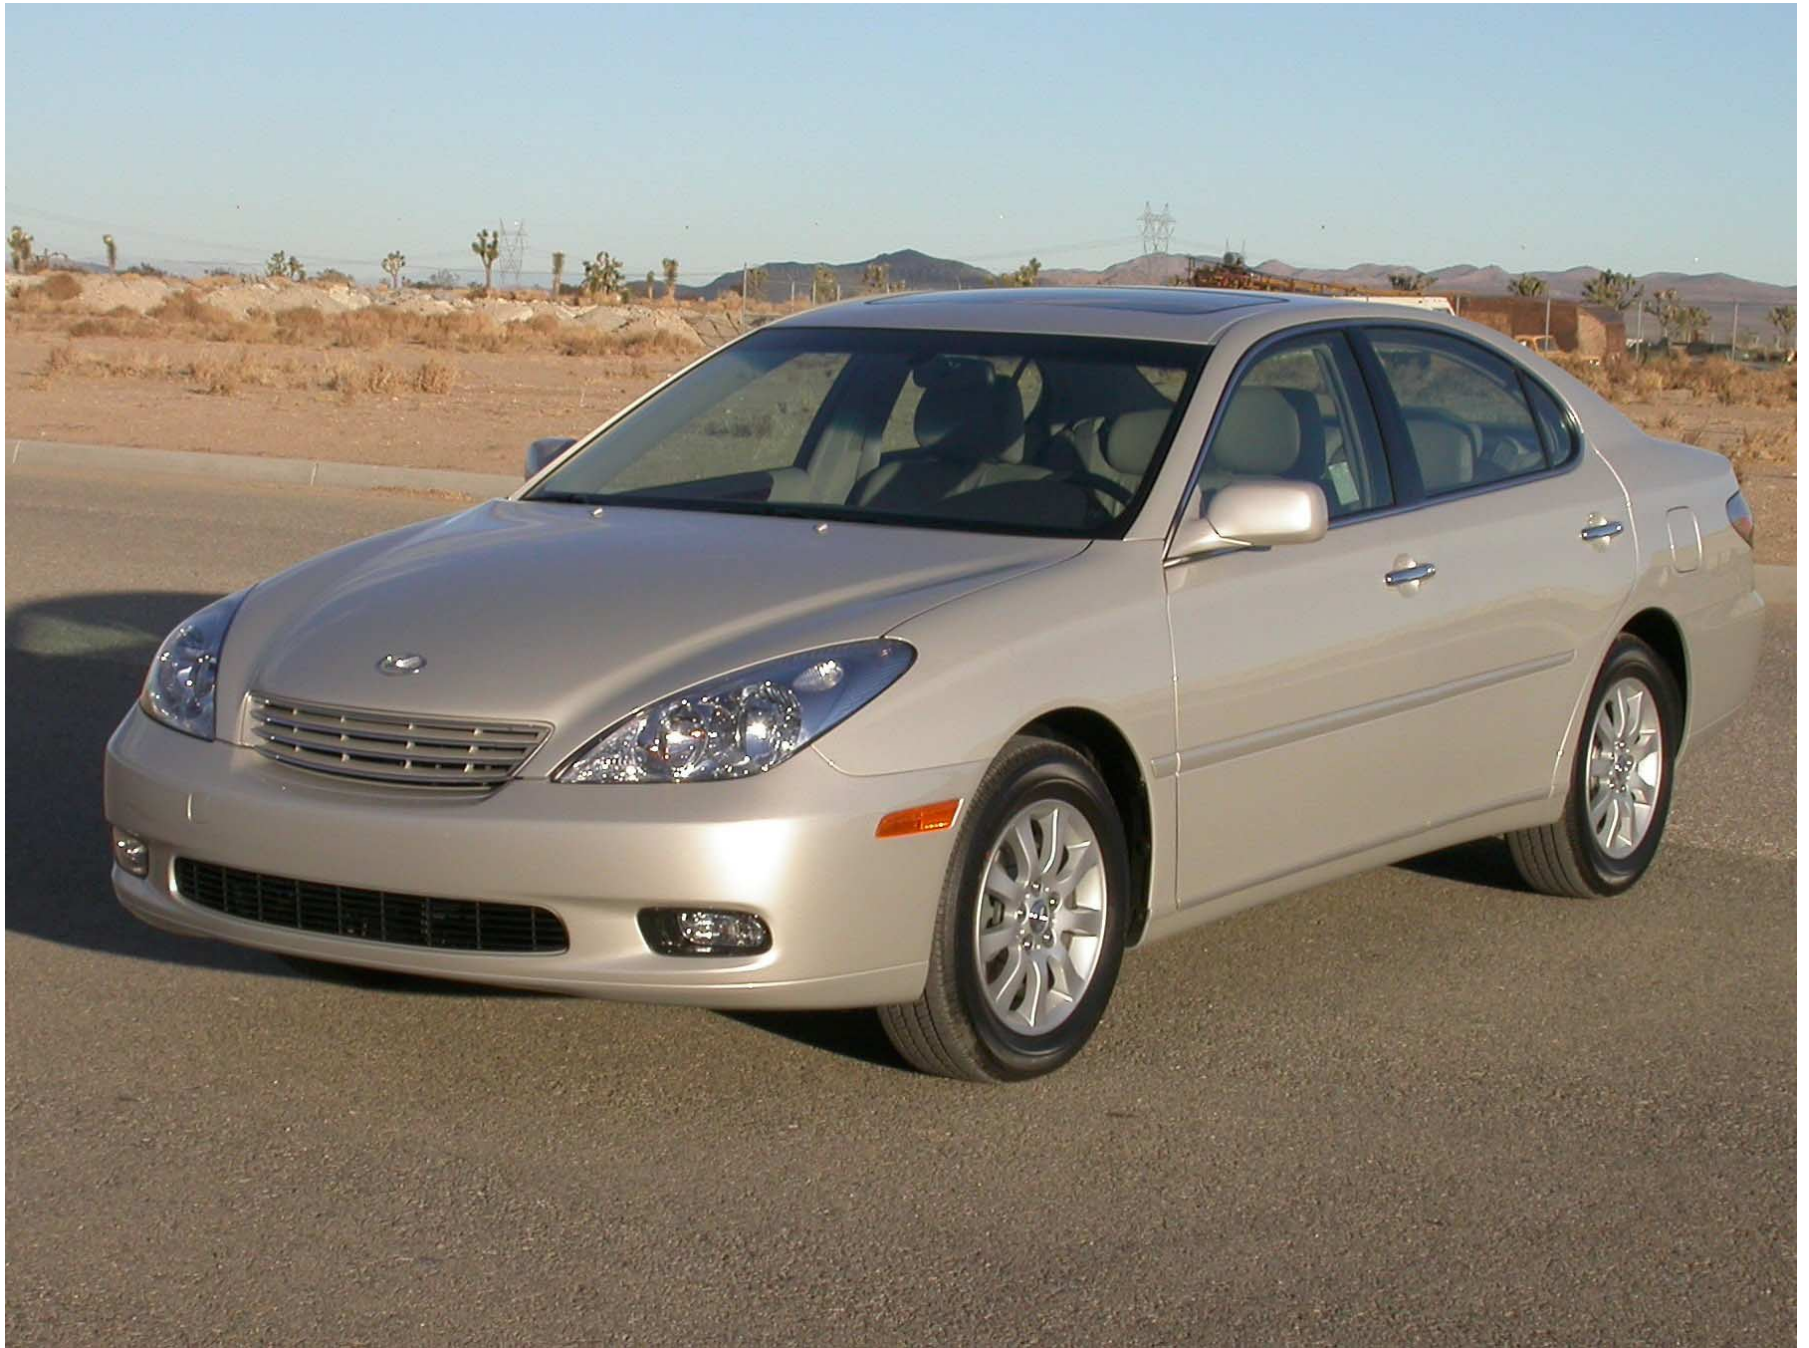
Figure A-1: Left Front, as Received

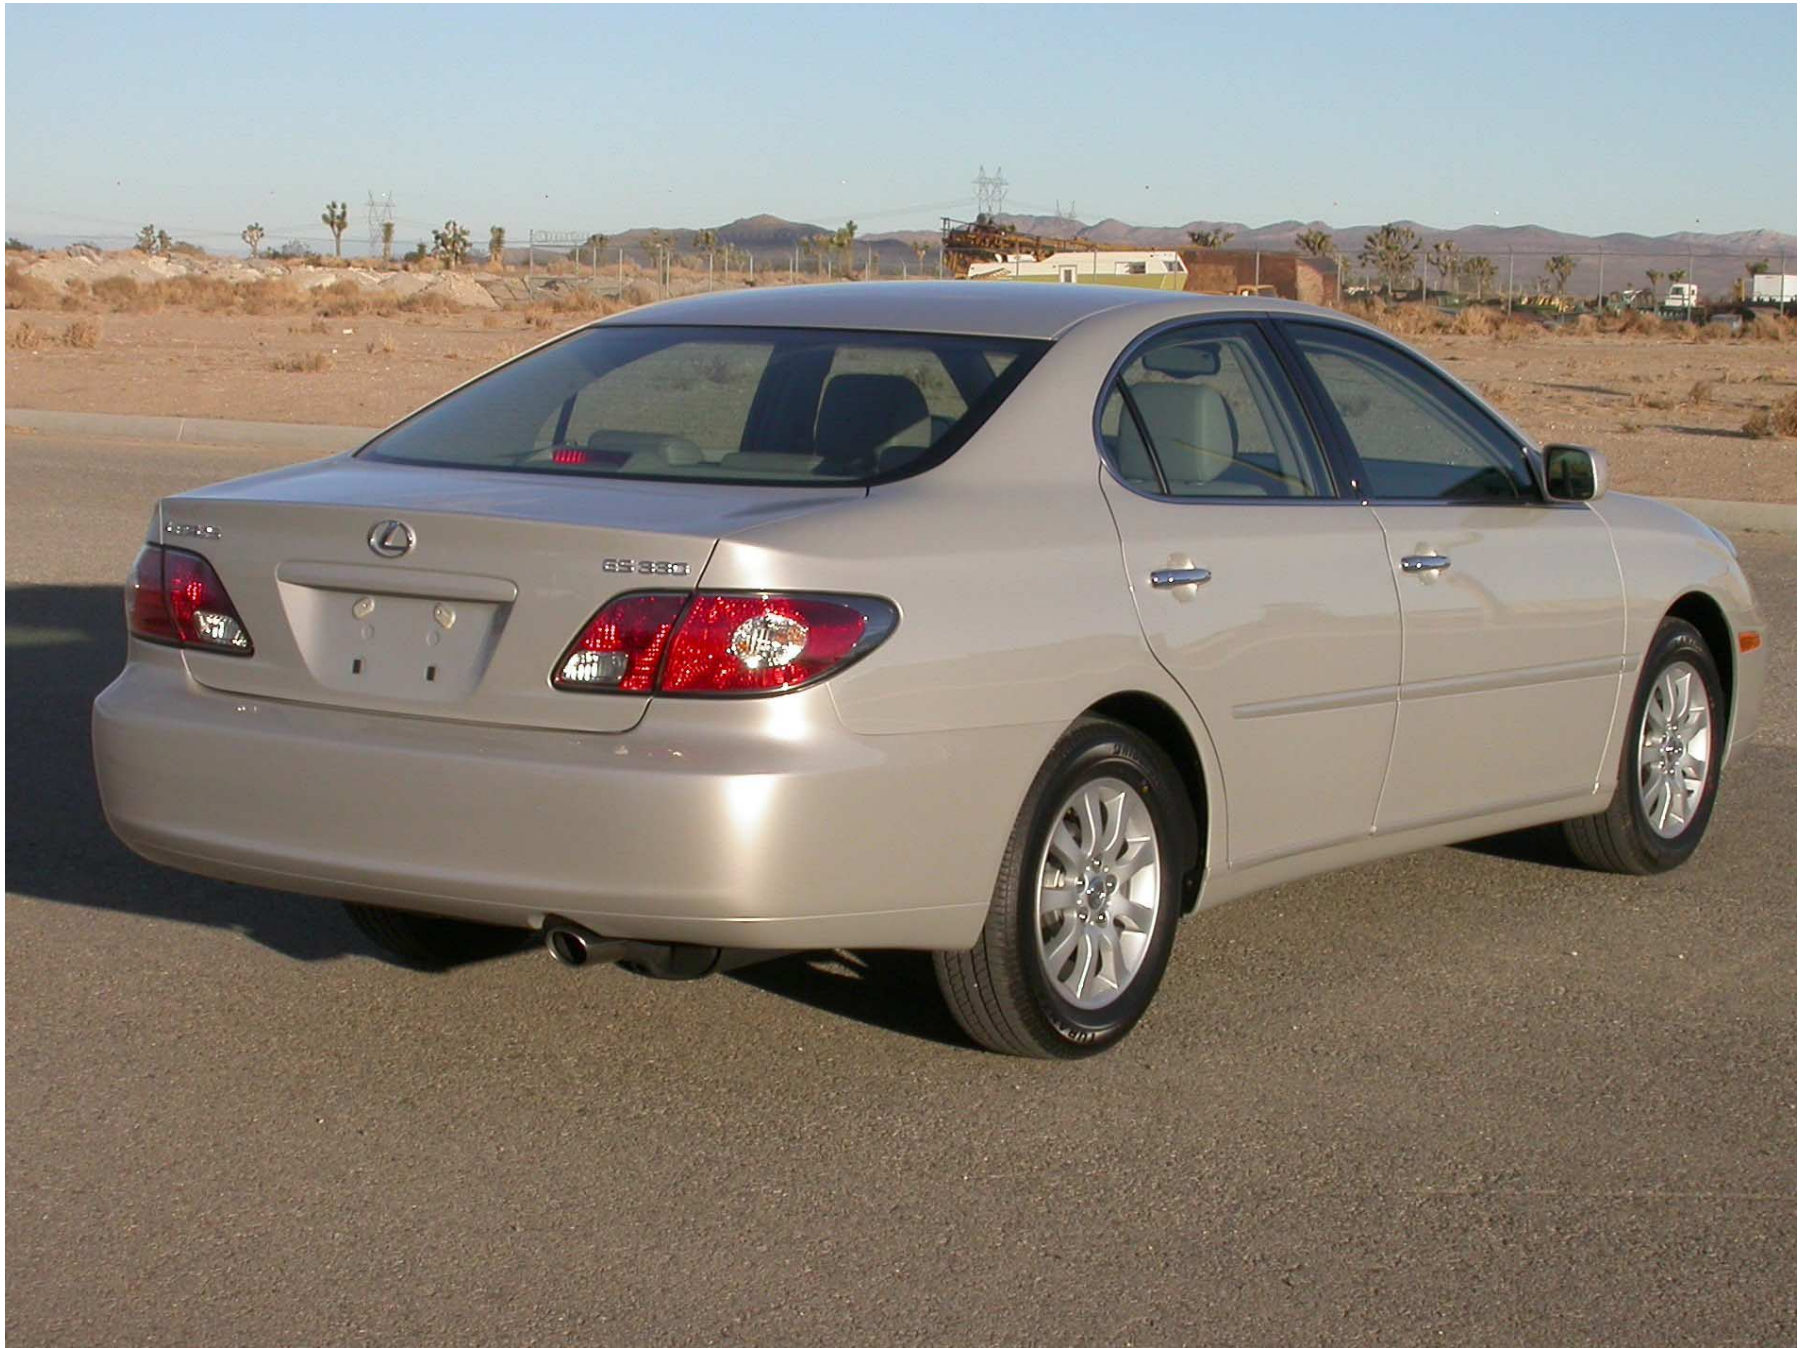
Figure A-2: Right Rear, as Received

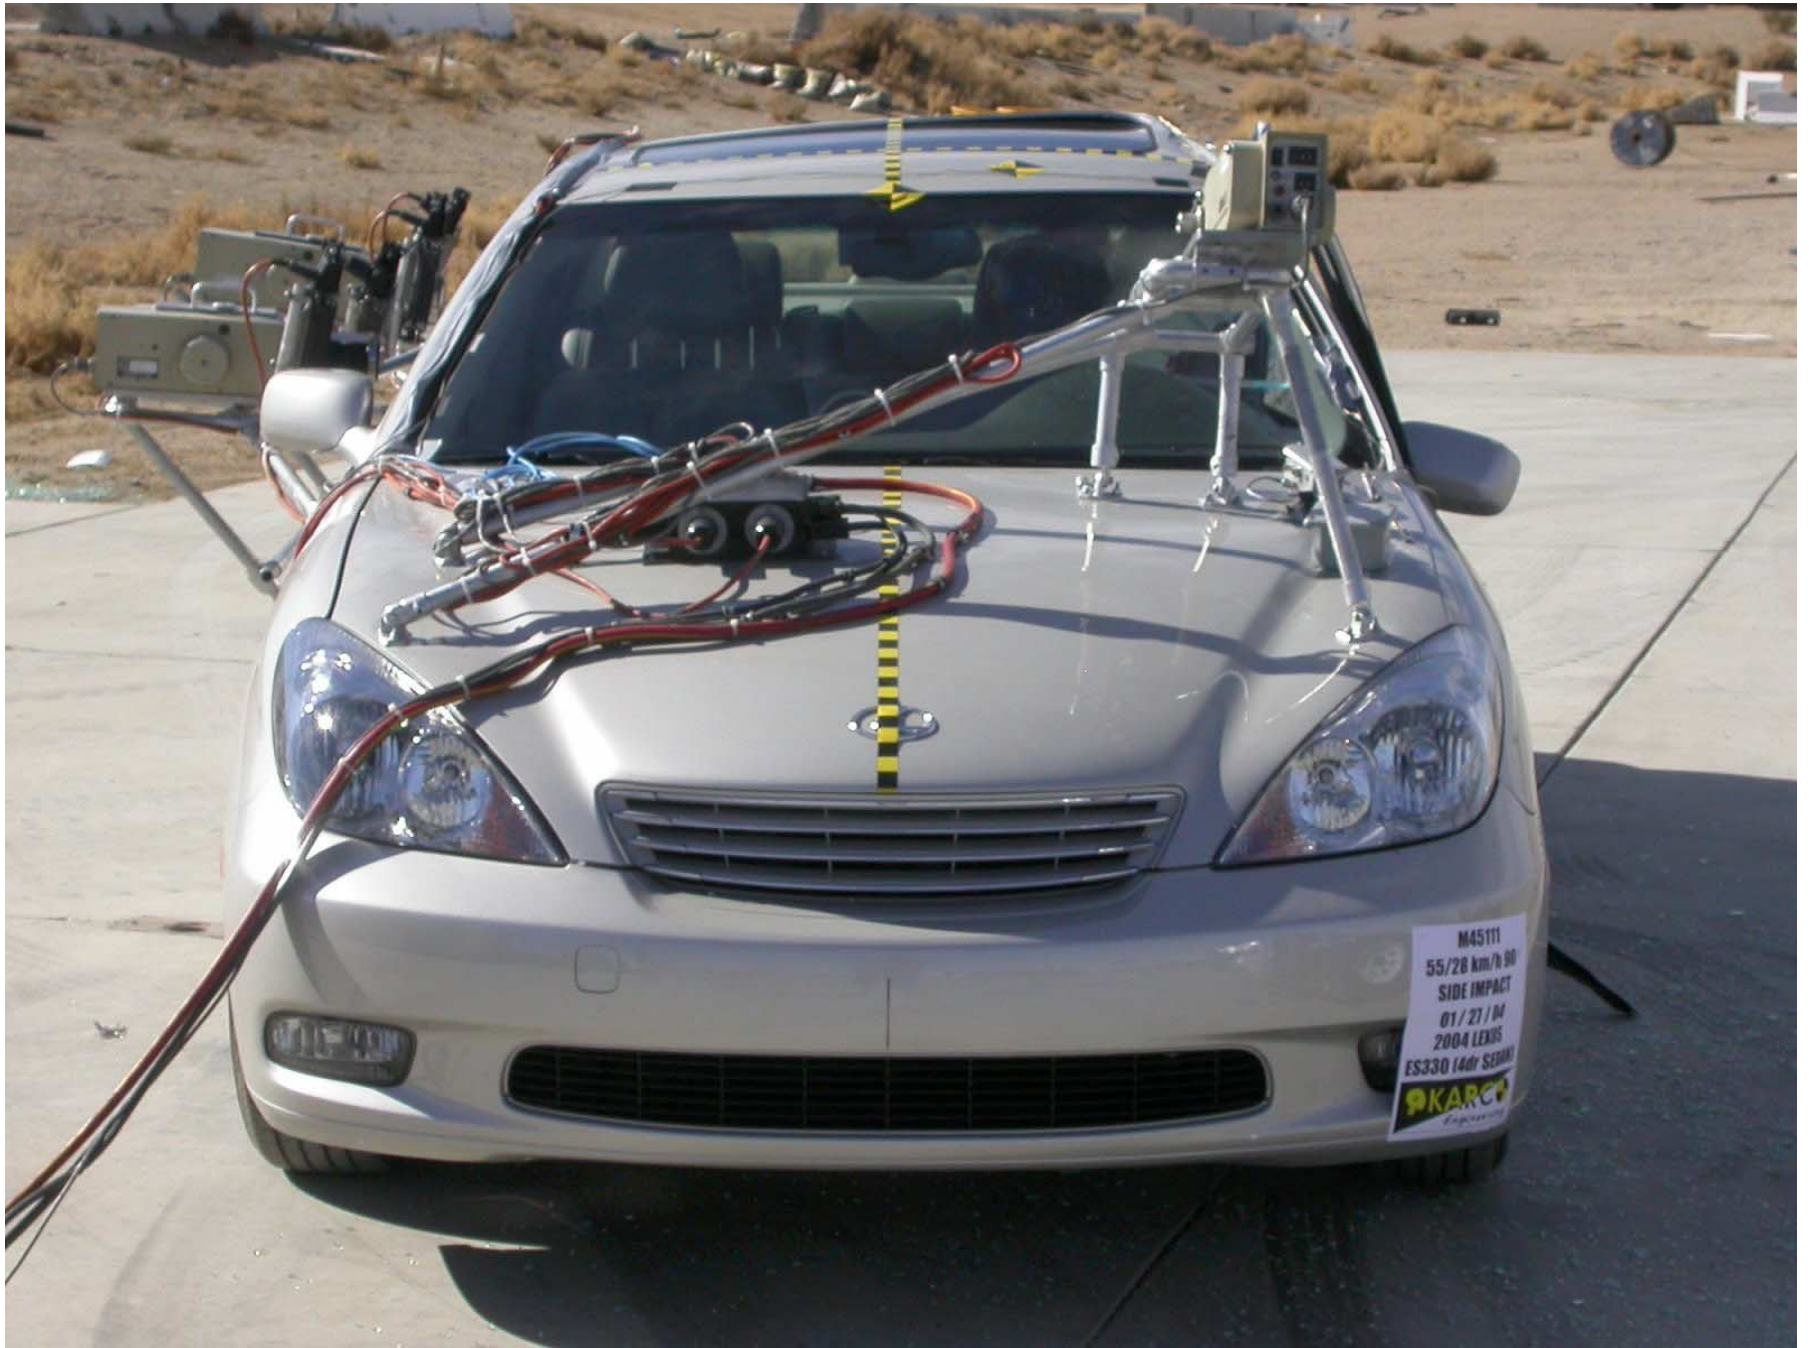
Figure A-6: Front View, Post-Test

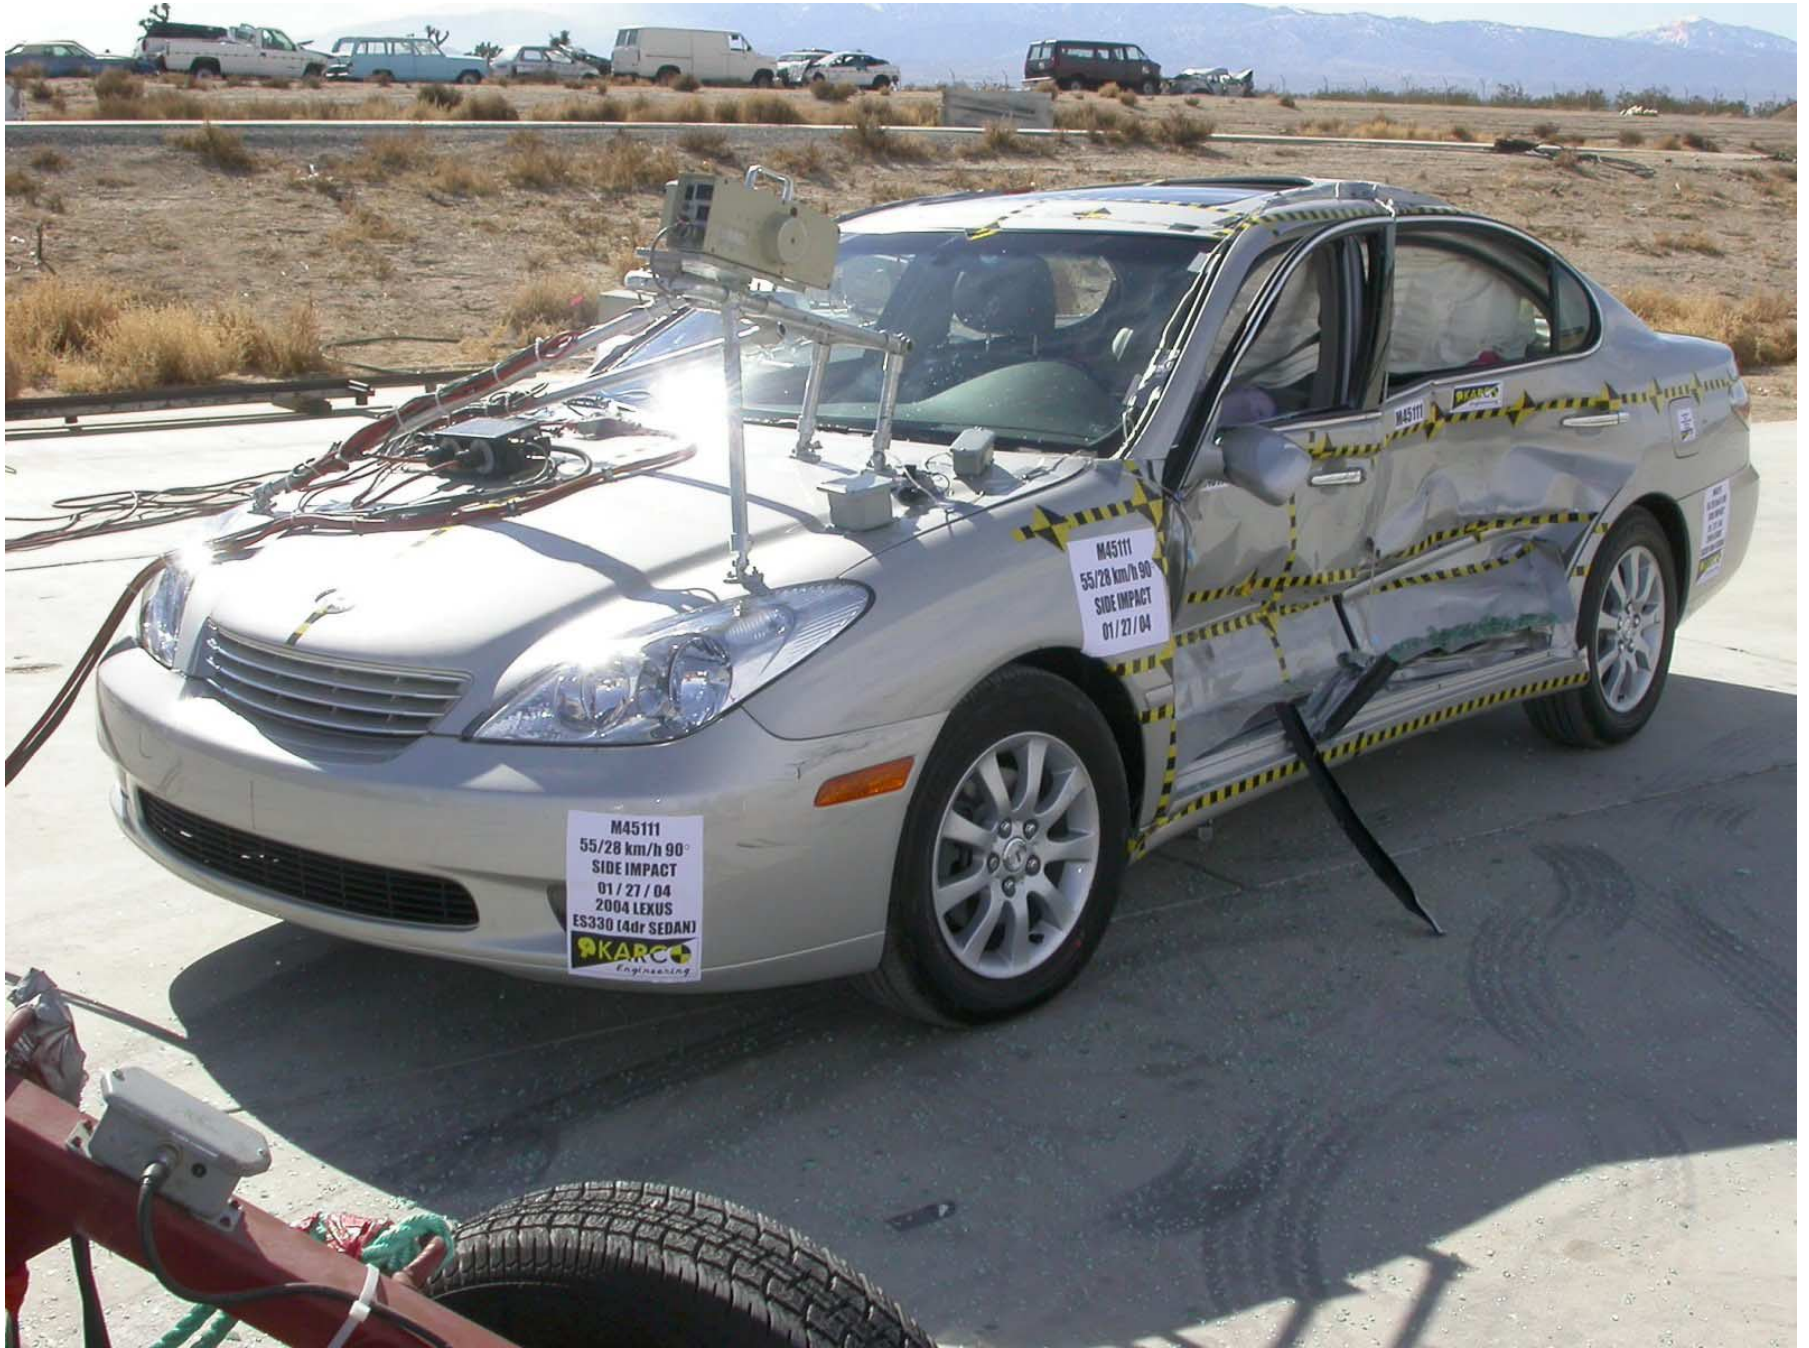
Figure A-8: Left Front ¾ View, Post-Test

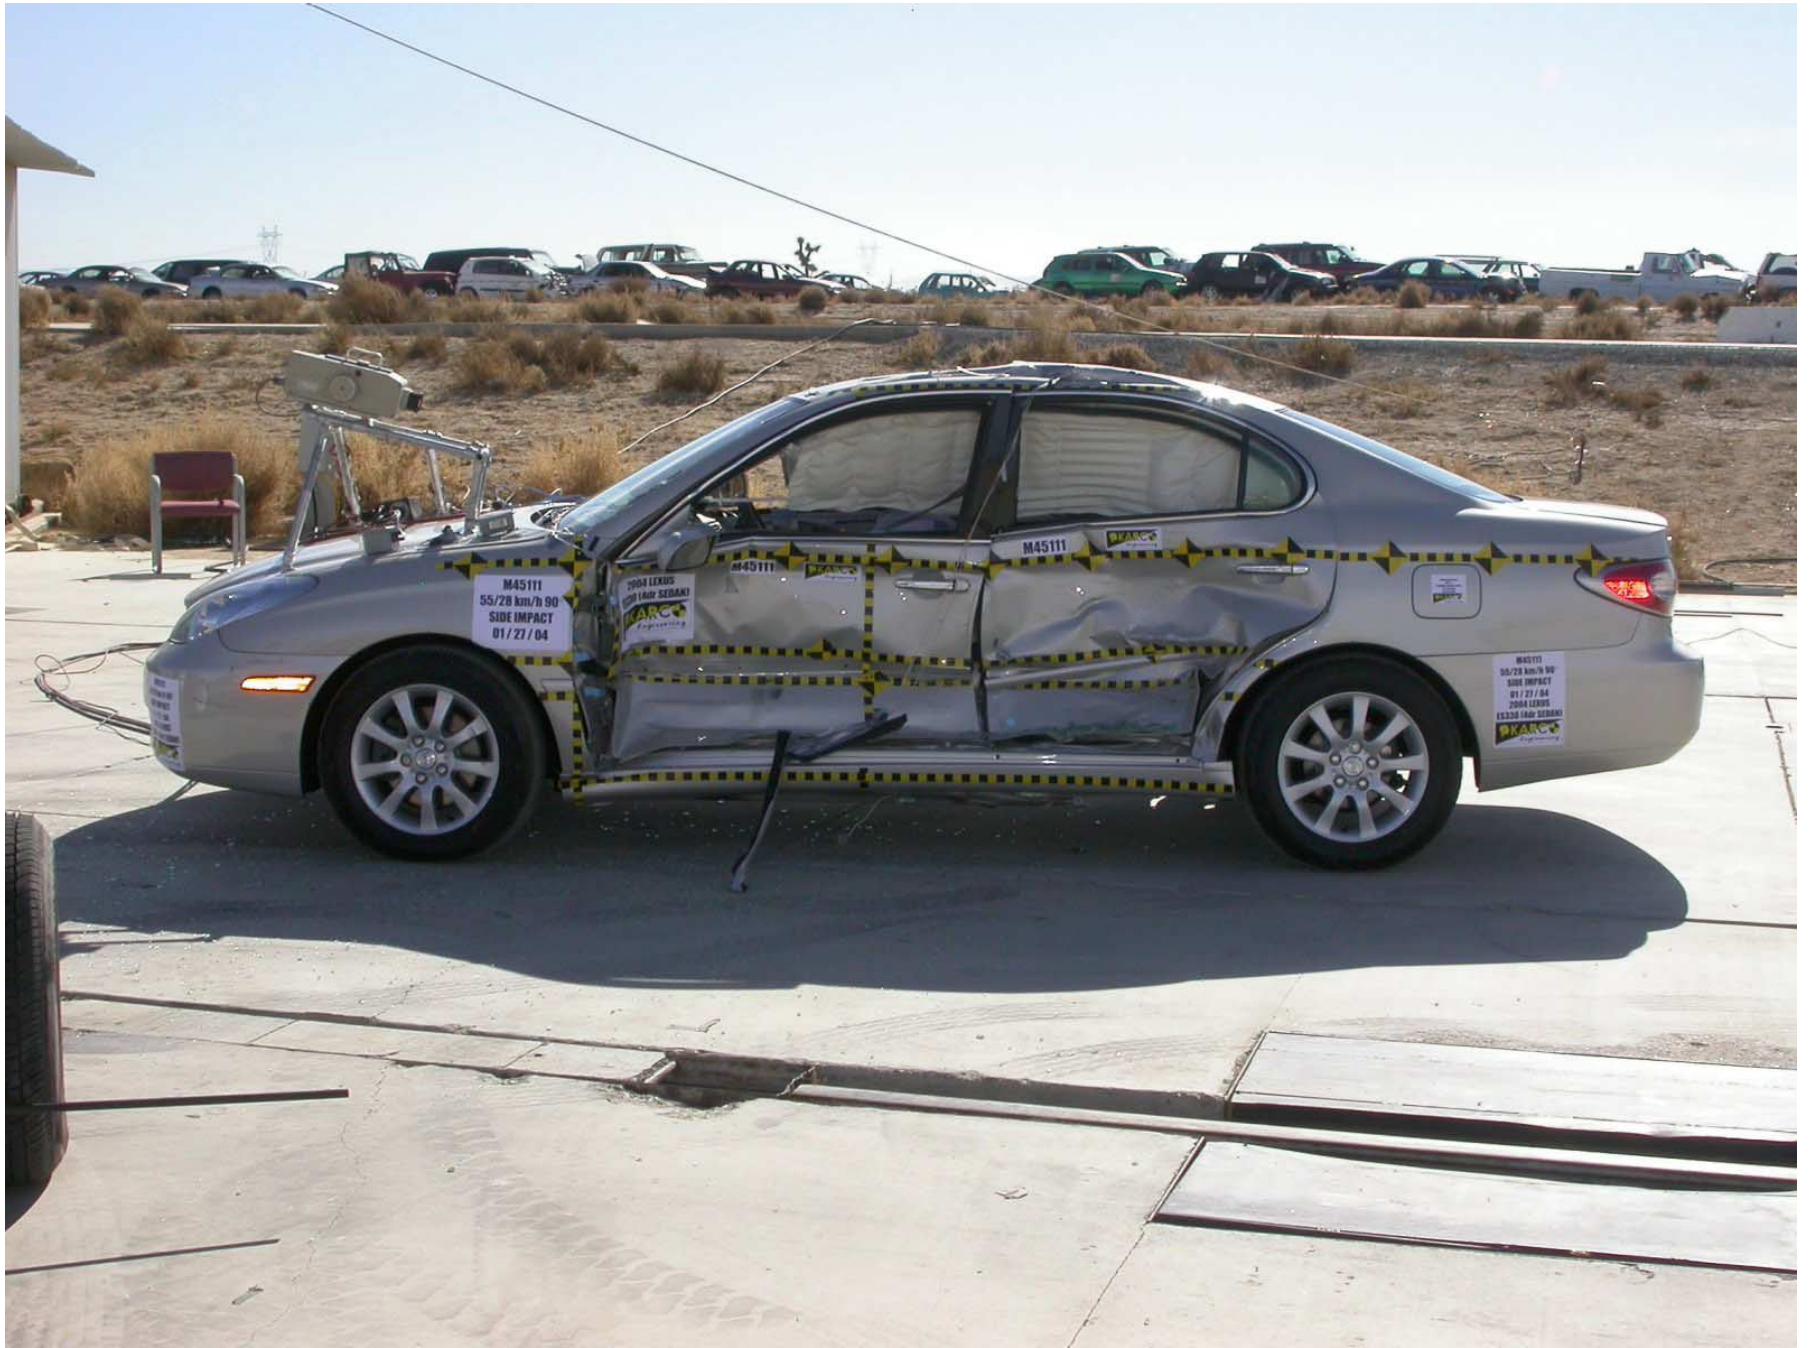
Figure A-10: Left (Impacted) Side View, Post-Test

The test vehicle sustained a maximum static crush of 347 mm at level 2, 1200mm rearward of the left vertical impact point. The driver SID/Hybrid III, Serial No. 275 and the passenger SID/Hybrid III, Serial No. 274 were calibrated just prior to this test. The SID/Hybrid III injury criteria is summarized as follows:

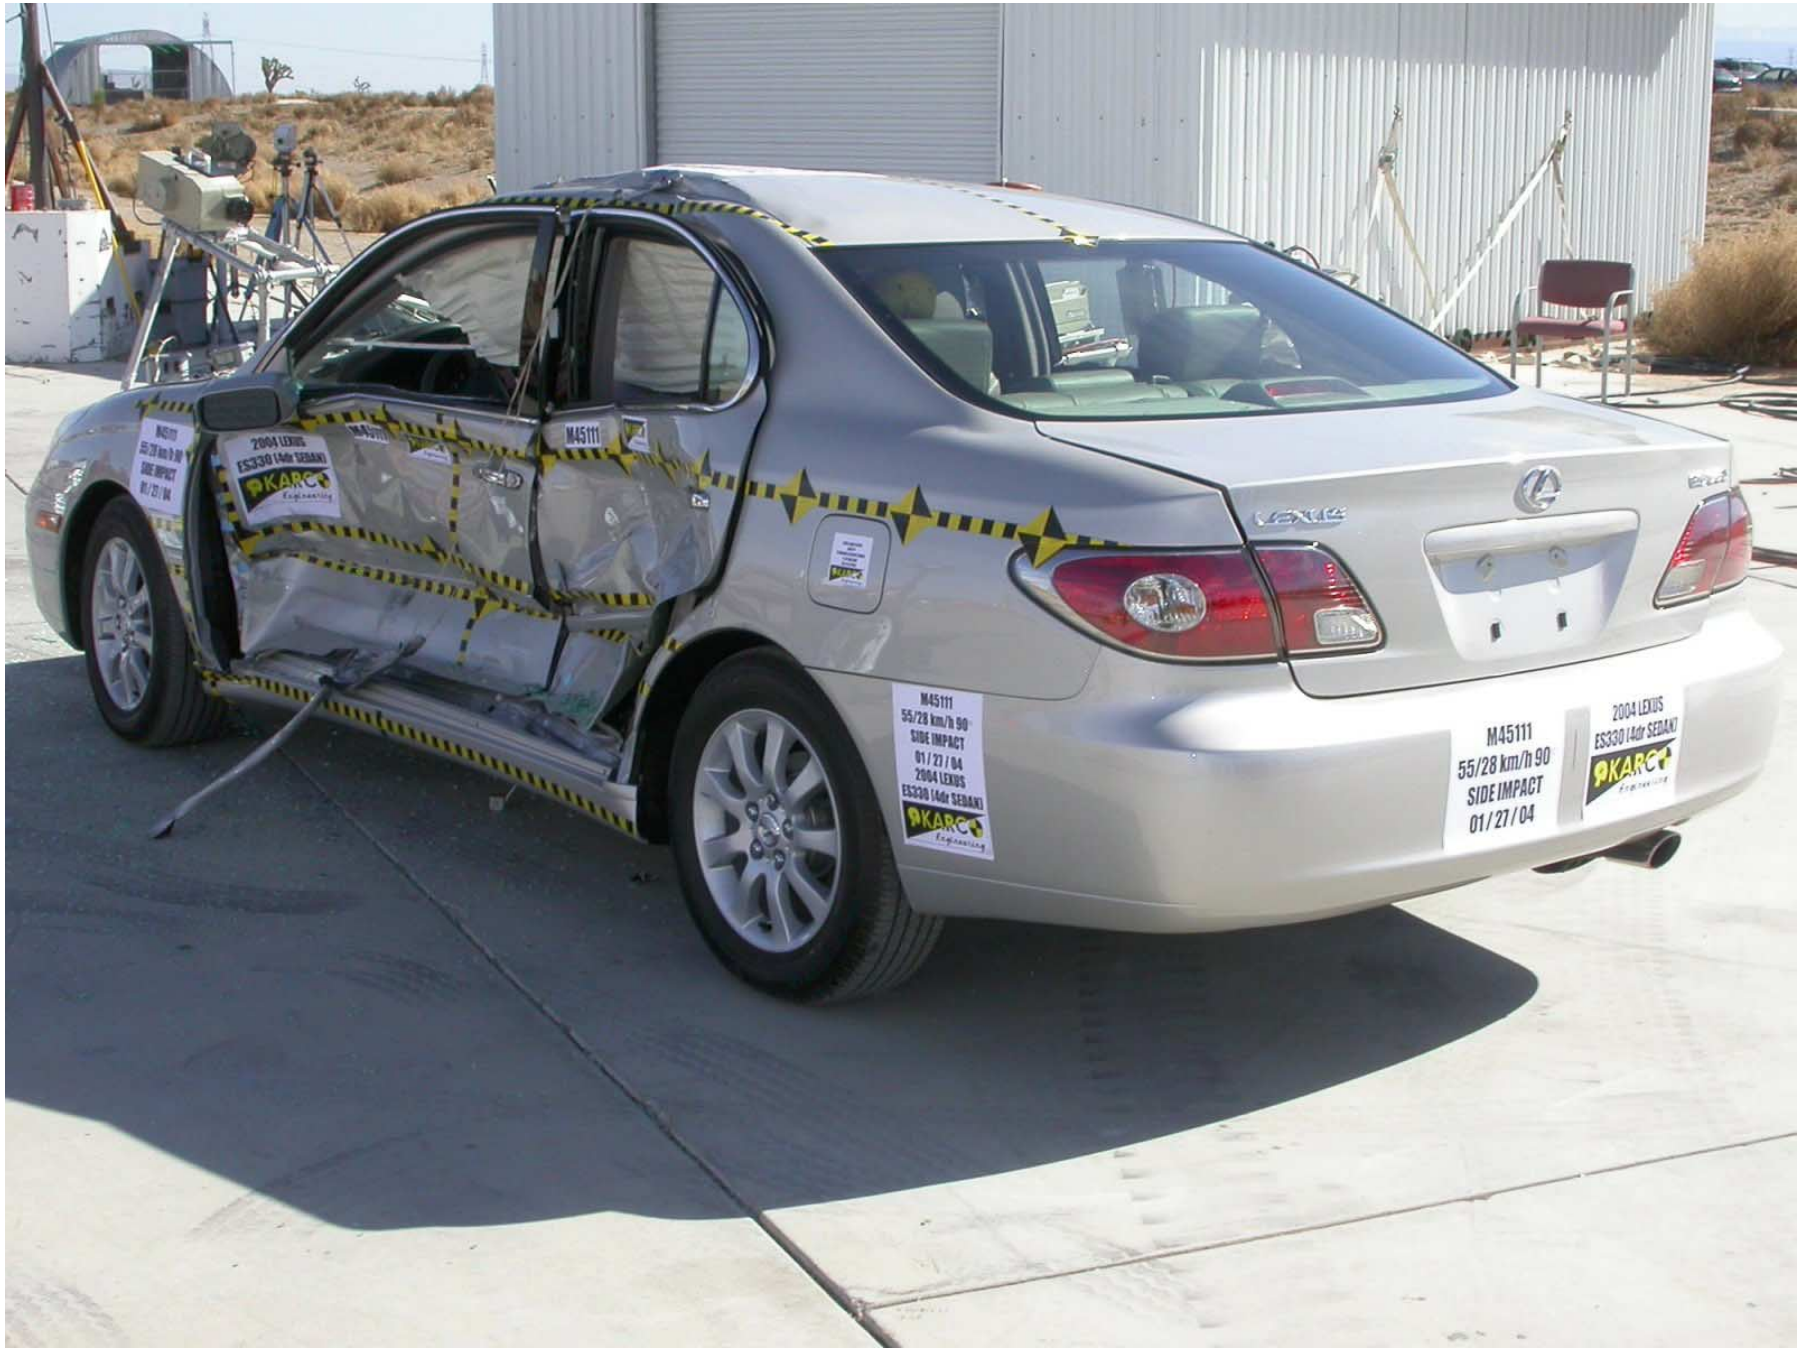
Figure A-12: Left Rear 3/4 View, Post-Test

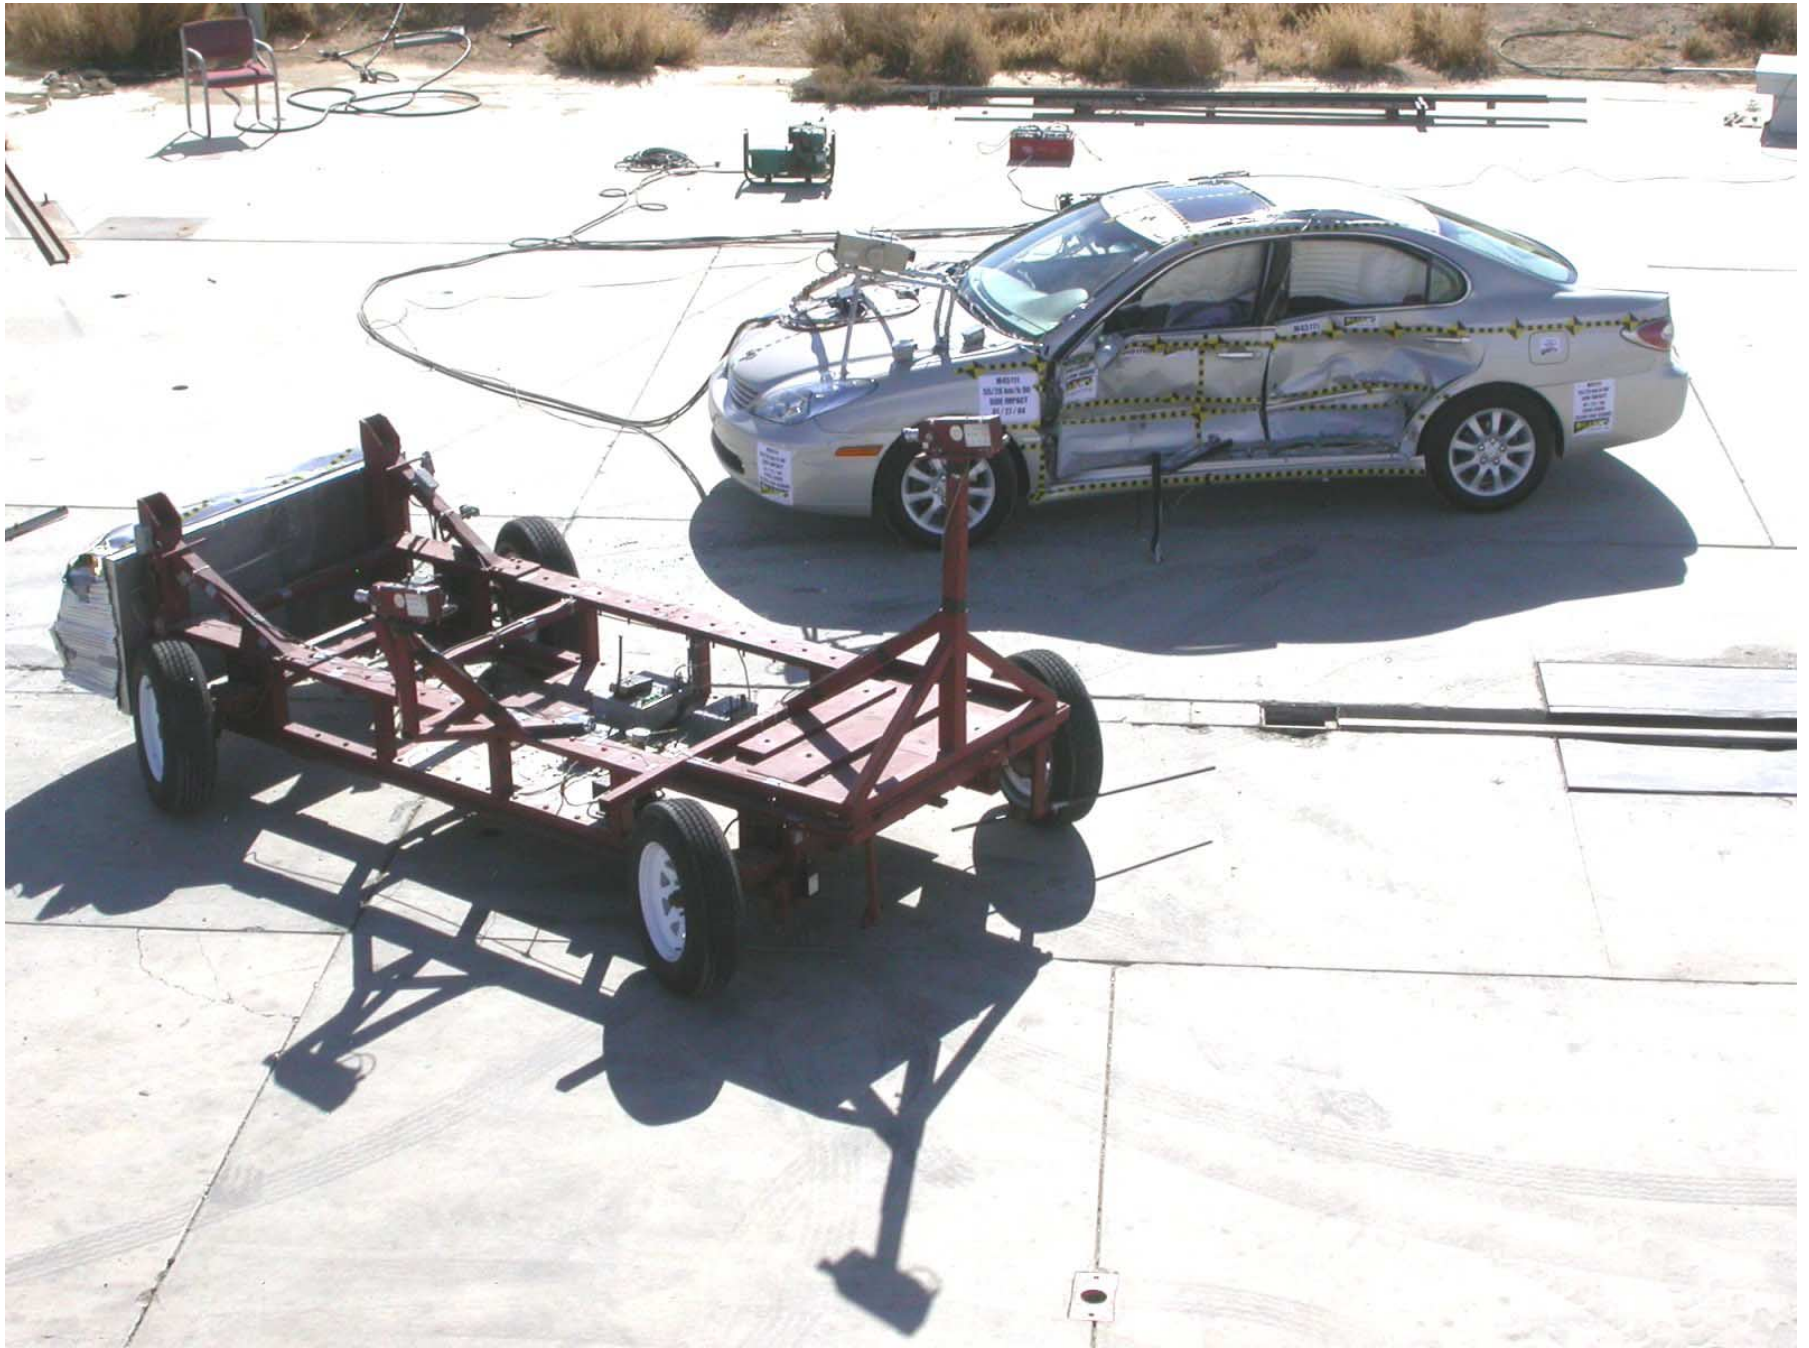
Figure A-22: Overhead Overall View, Post-Test

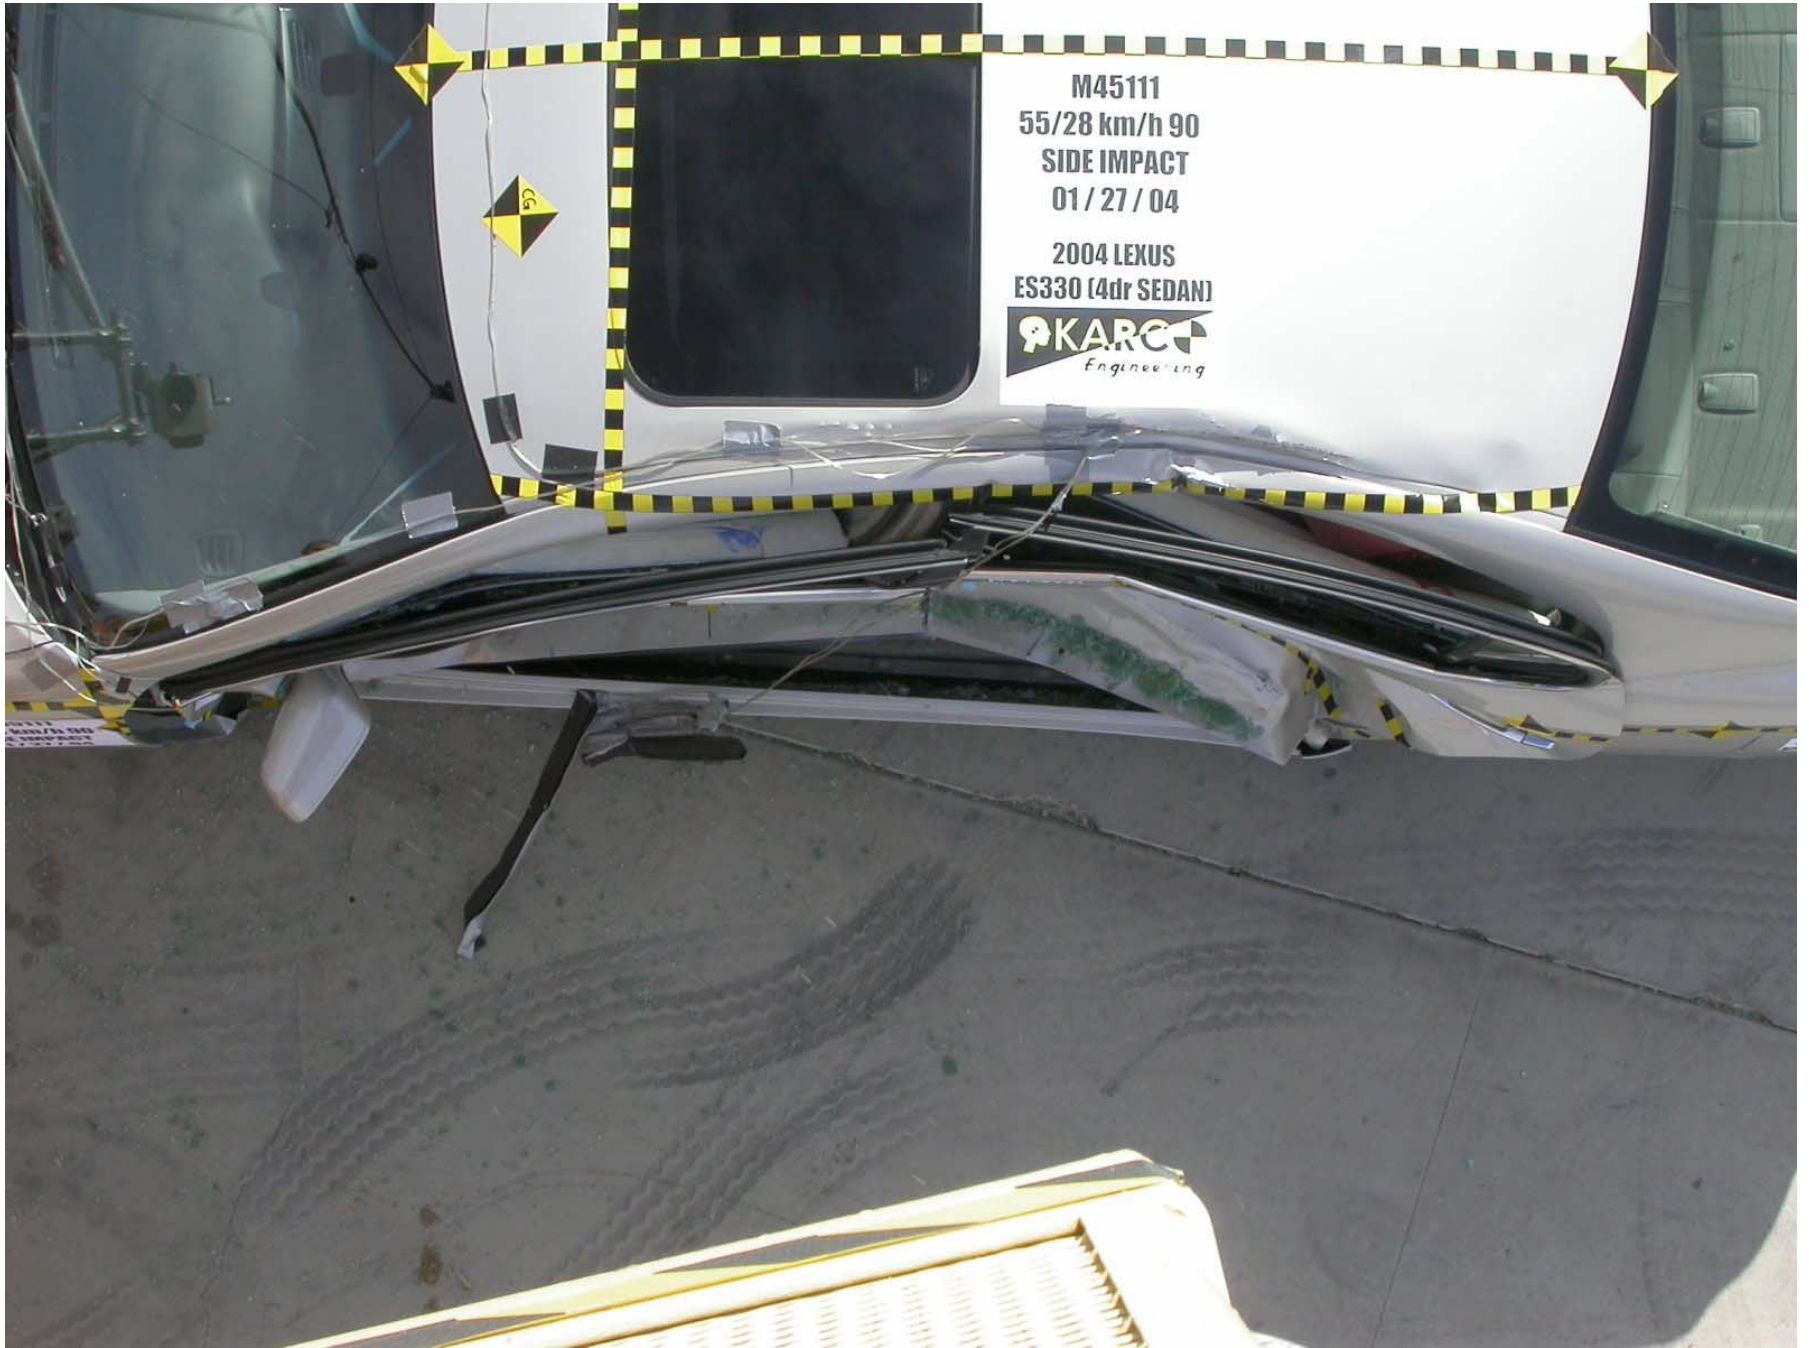
Figure A-24: Overhead Close-up View, Post-Test

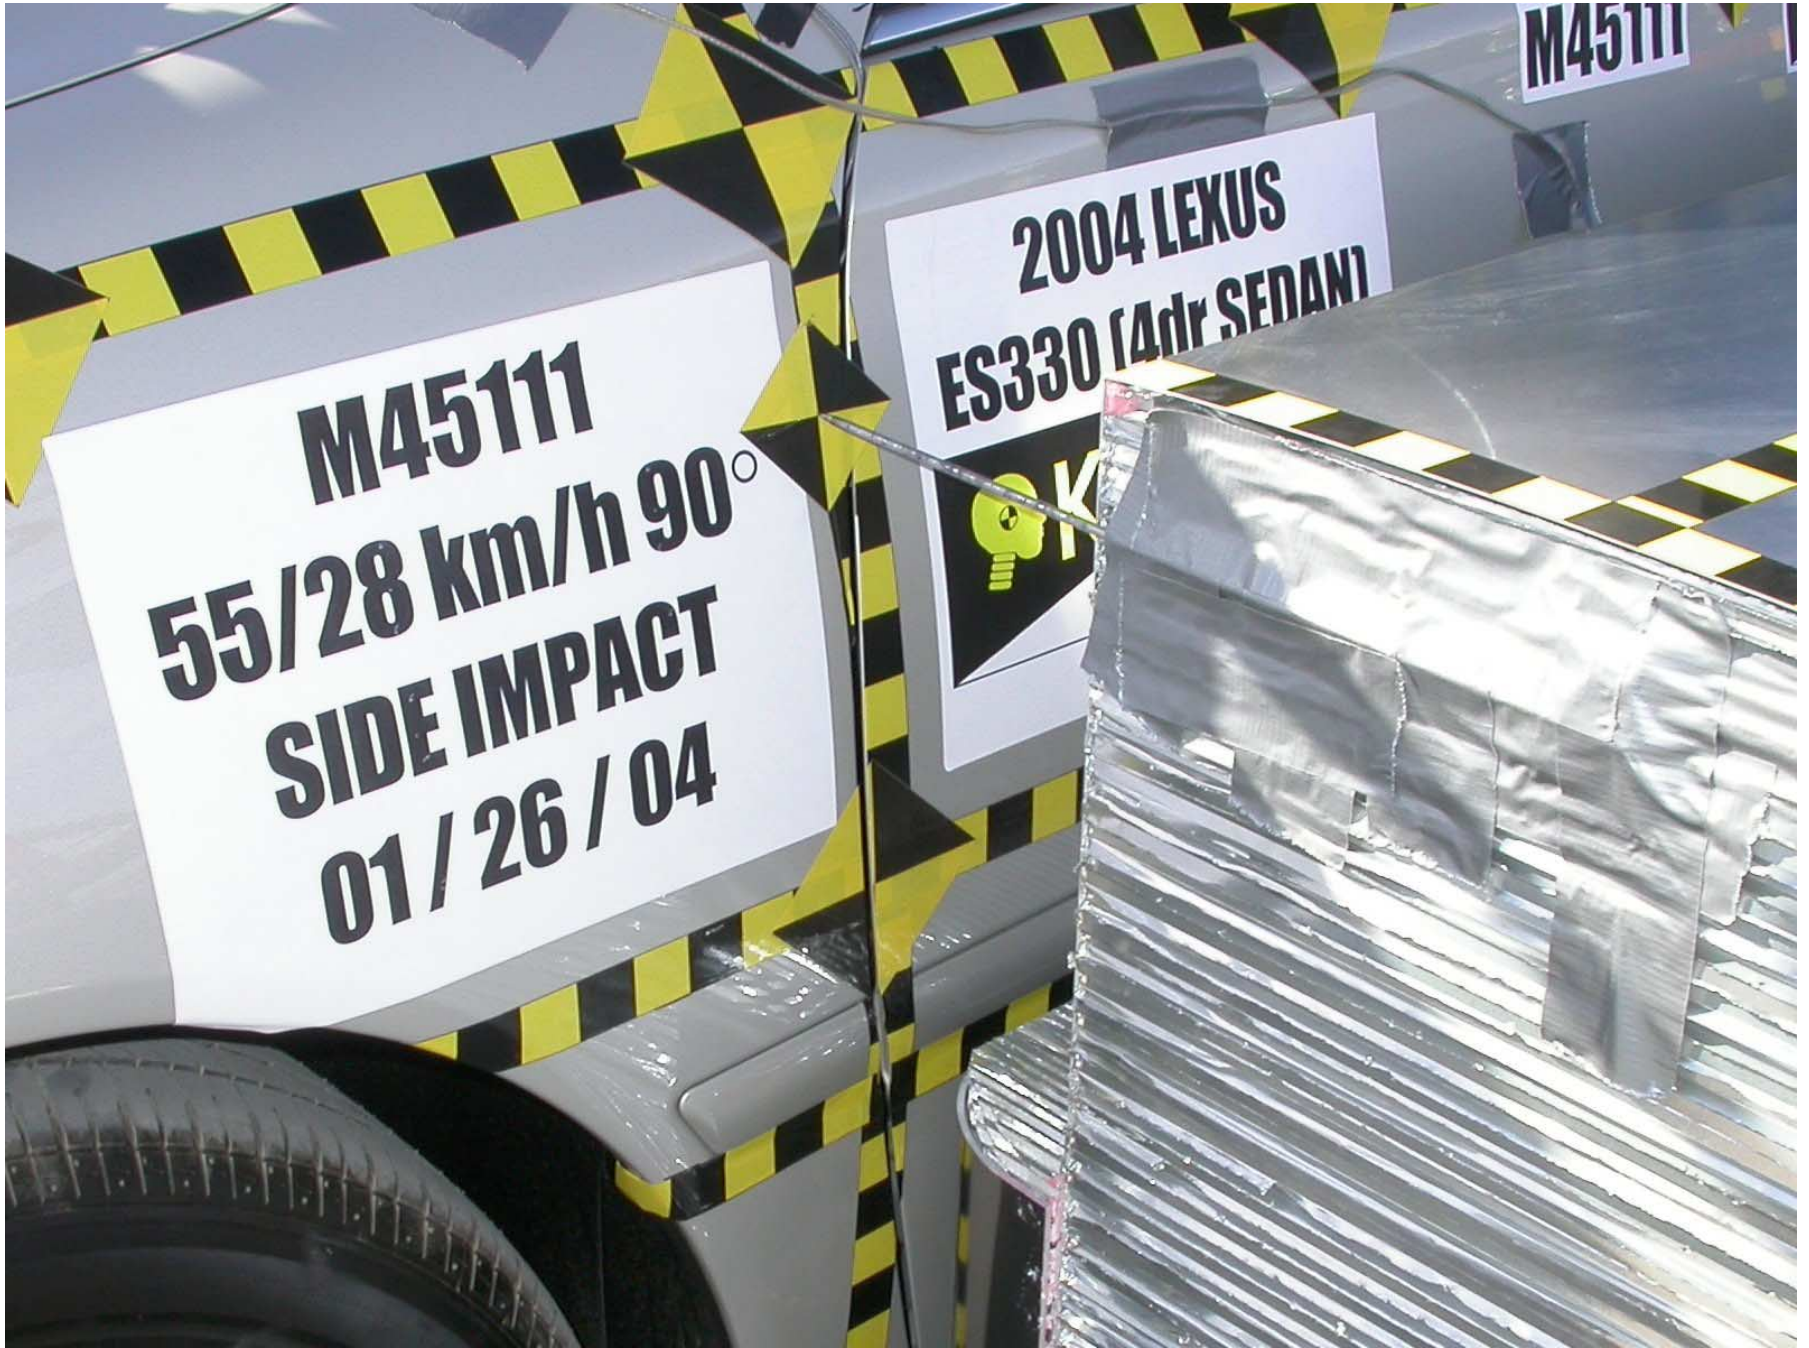
Figure A-25: Impact Point Target Set-up, Pre-Test
