REPORT NUMBER TR-P24003-02-NC

**NEW CAR ASSESSMENT PROGRAM
SIDE IMPACT TEST**

**TOYOTA MOTOR CORPORATION
2004 LEXUS ES 330
4 DOOR SEDAN**

FINAL REPORT

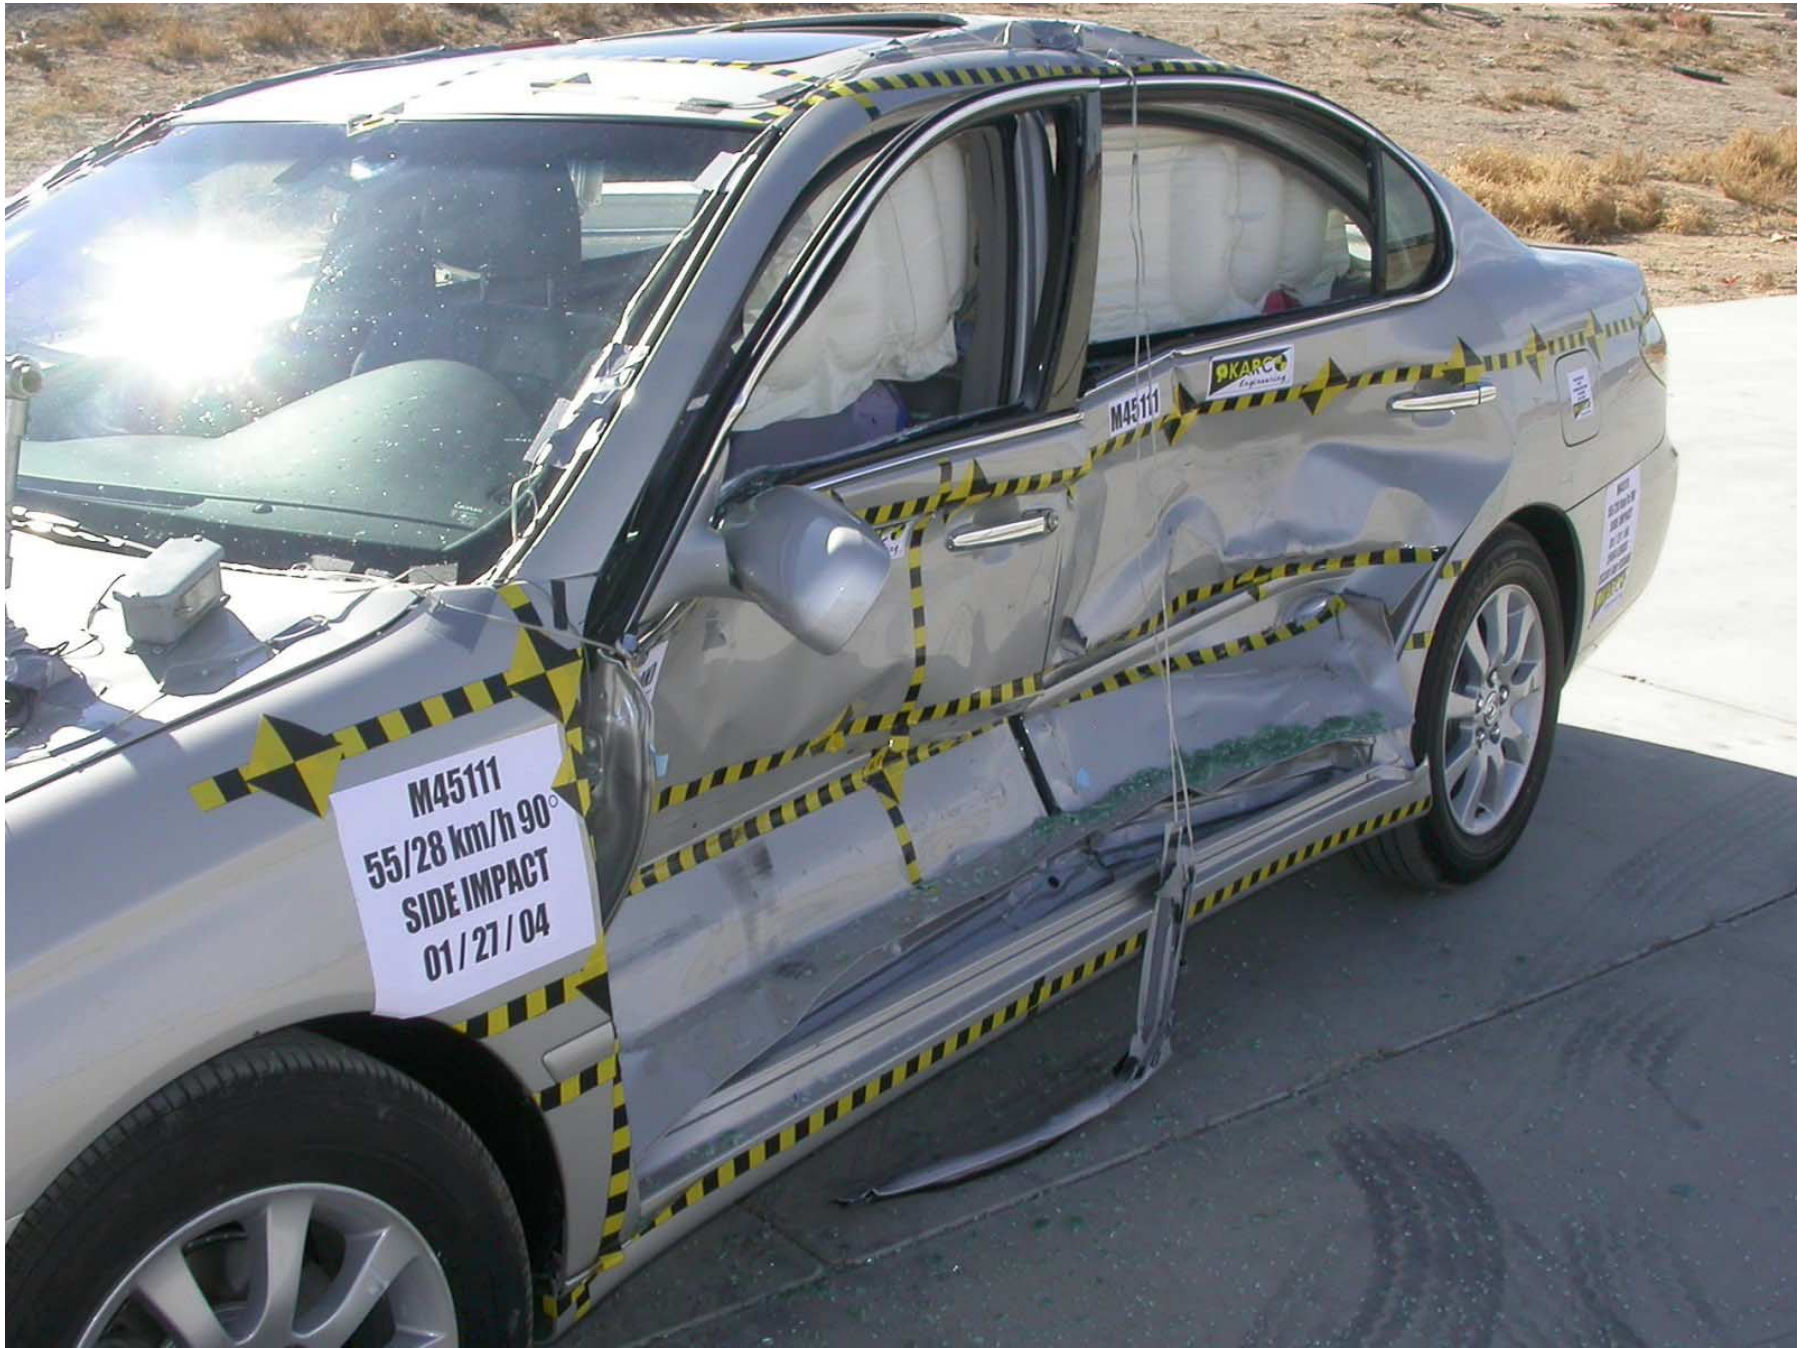
Figure A-28: Front ¾ View of Left Side Doors, Post-Test

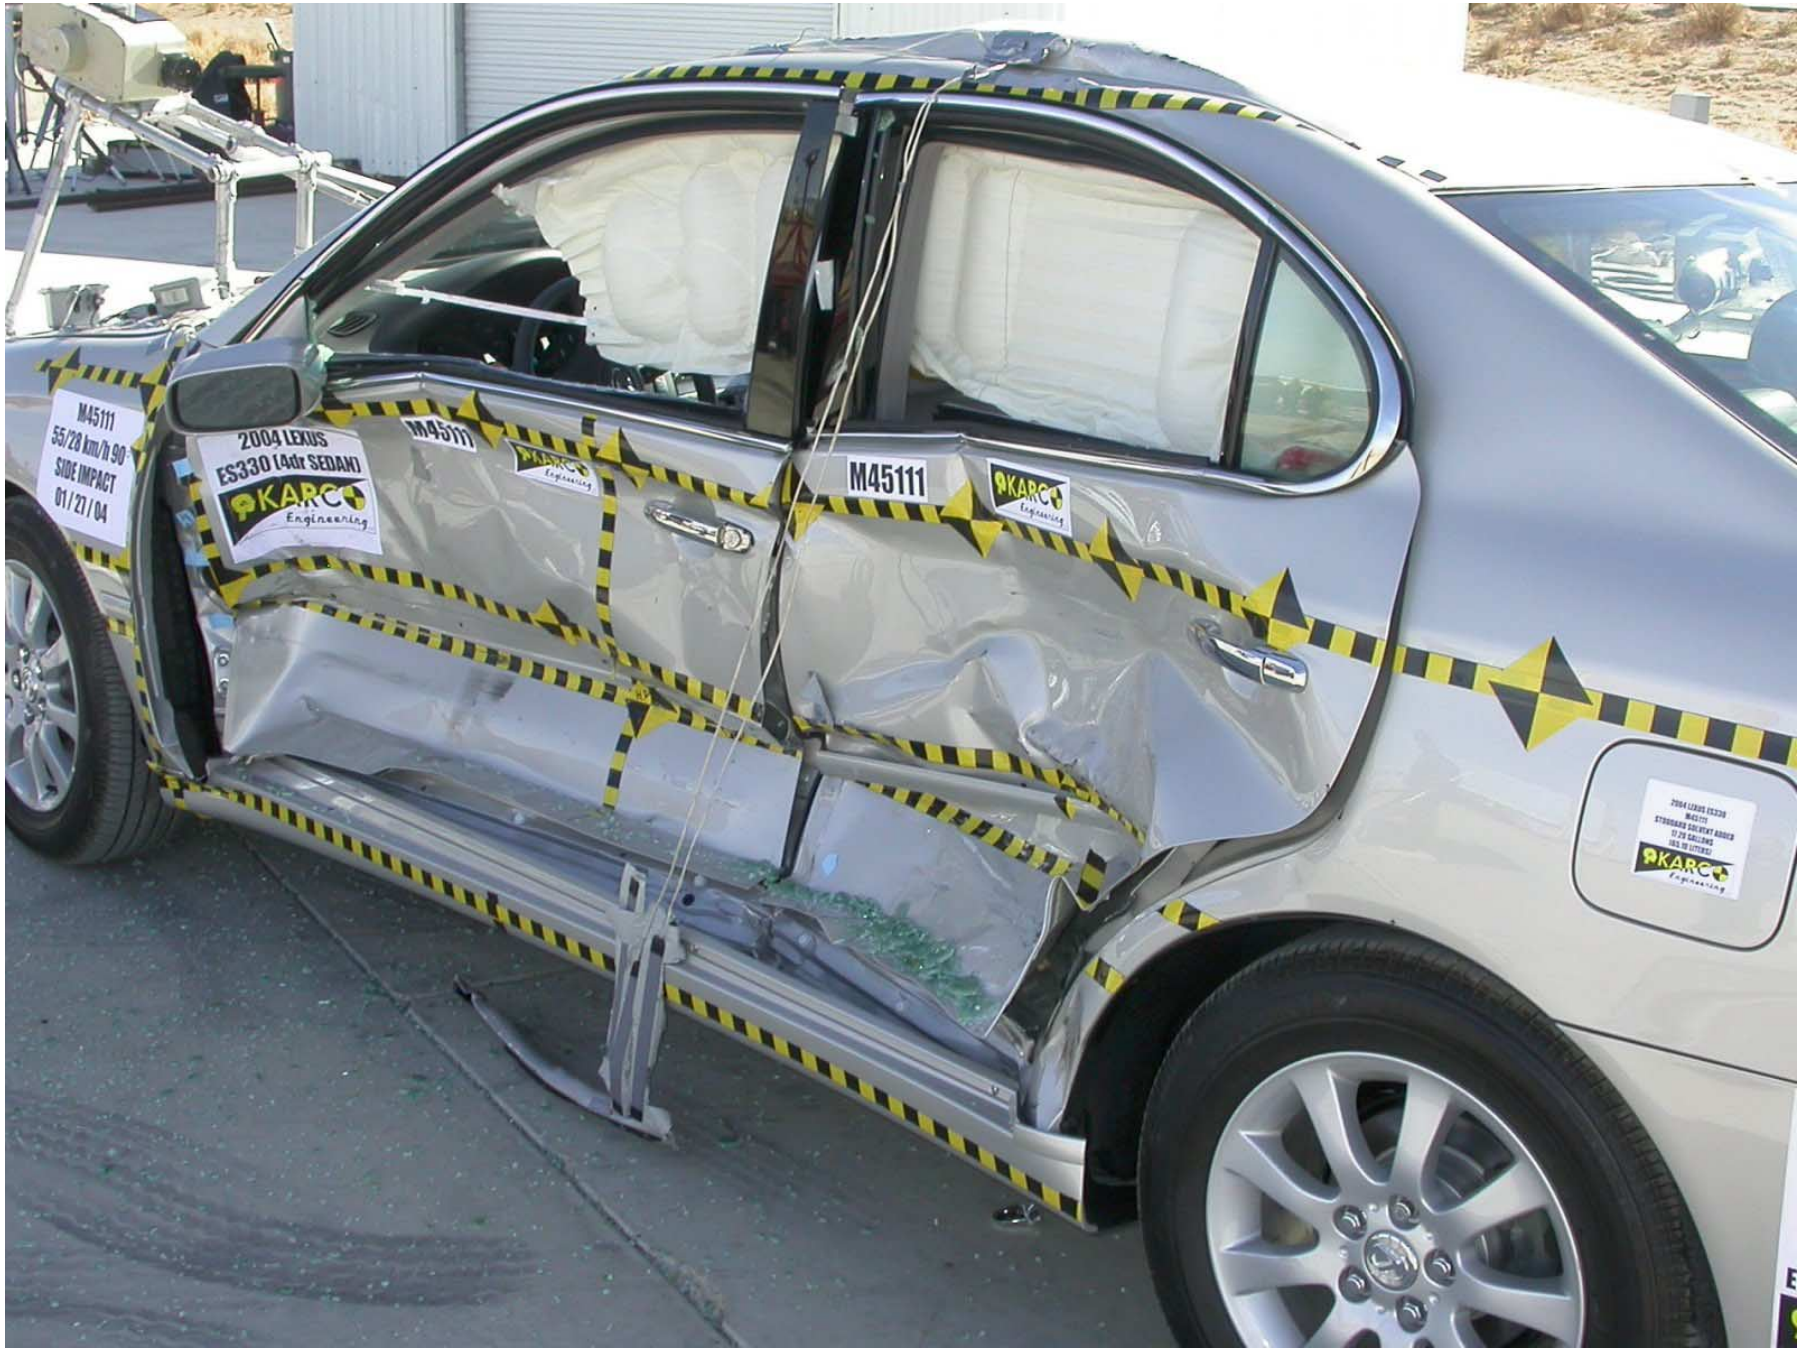
Figure A-30: Rear ¾ View of Left Side Doors, Post-Test

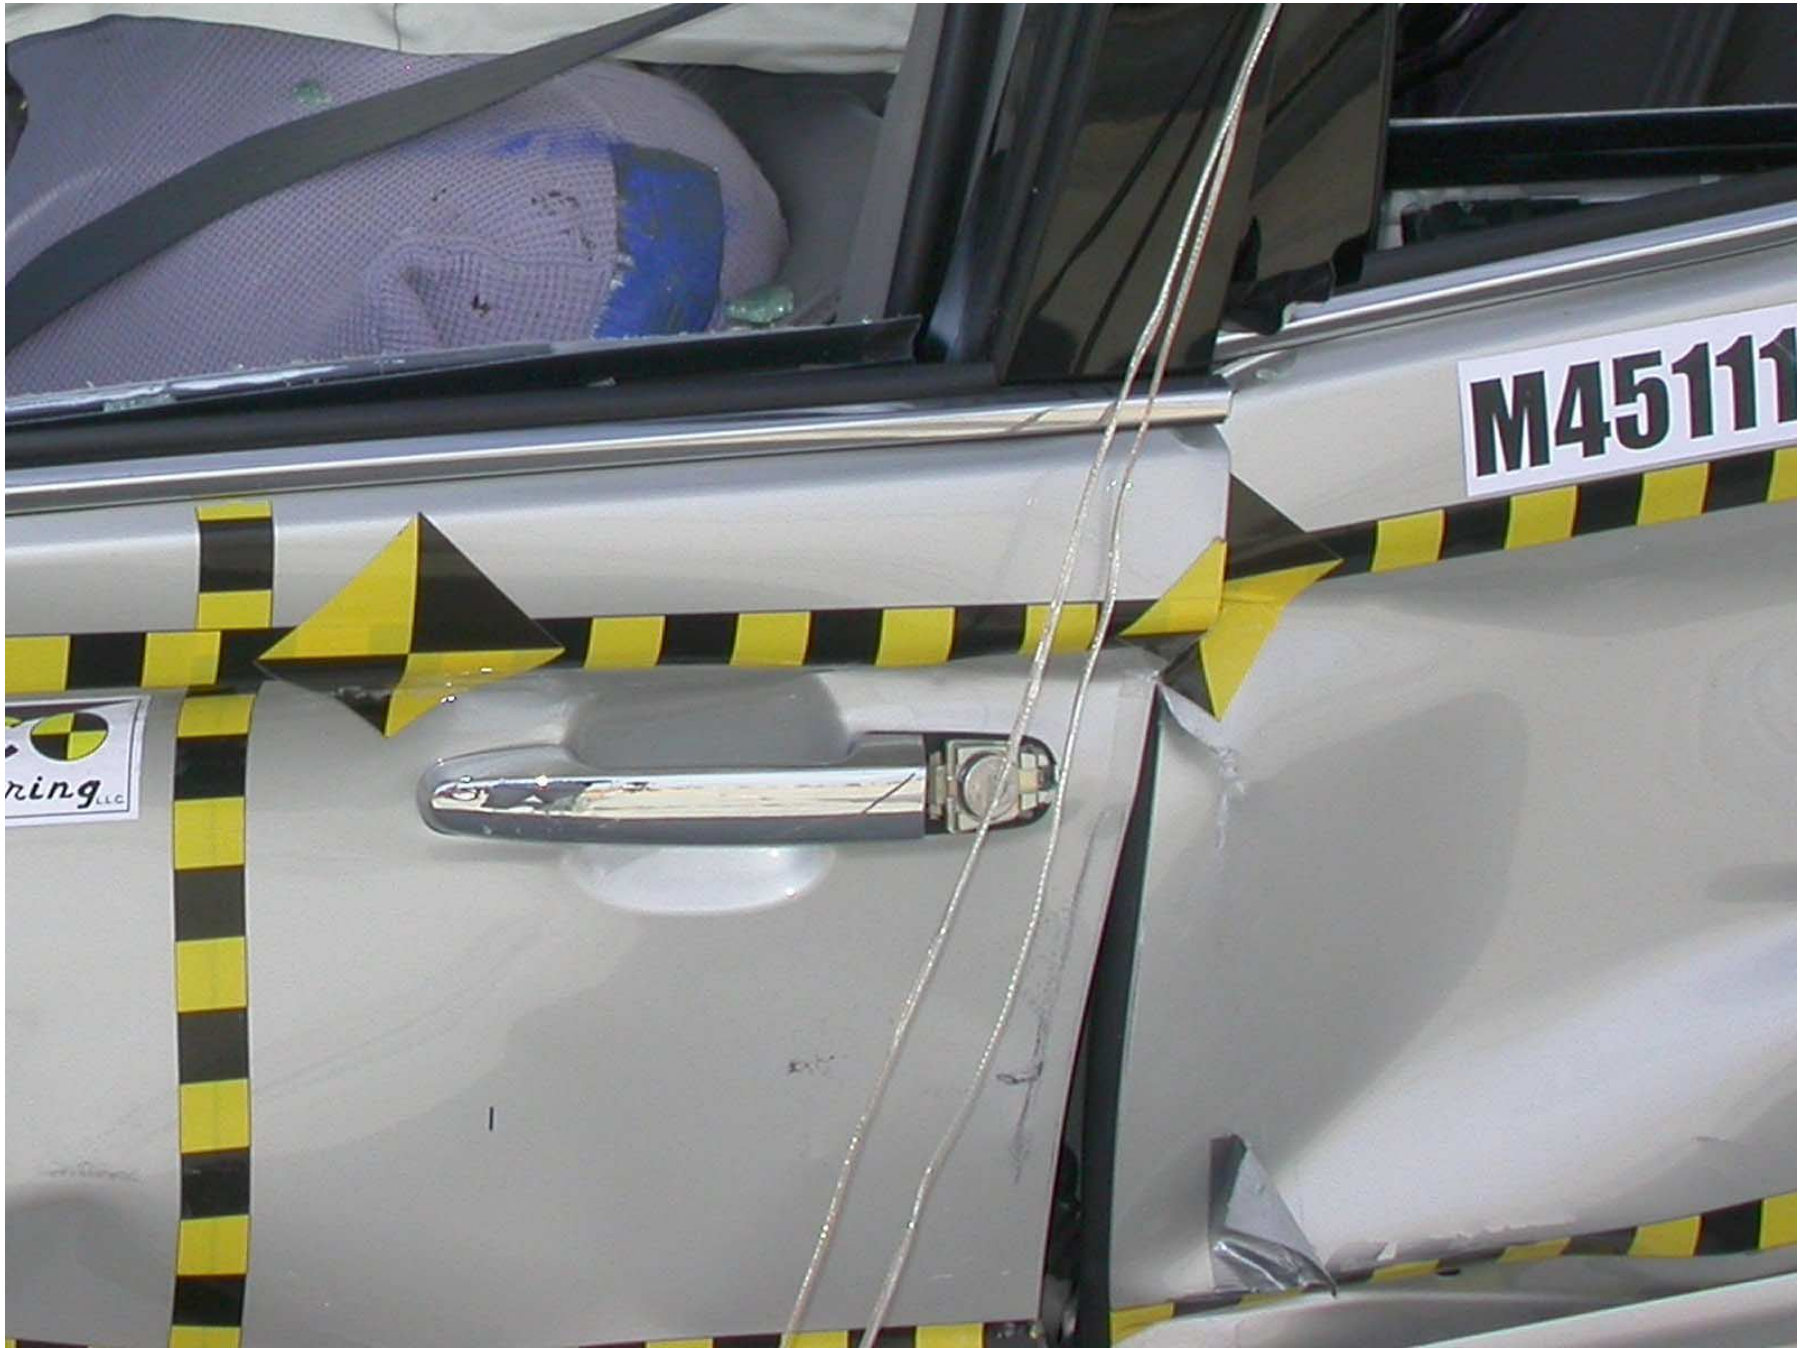
Figure A-32: Left Front Door Closed, Post-Test

Description	Front	Rear
Left Side Door Opening	Remained closed/latched, inoperable	Remained closed/latched, inoperable
Right Side Door Opening	Remained closed/latched, operable	Remained closed/latched, operable
Seat Movement	None	None
Seat Back Failure	None	None

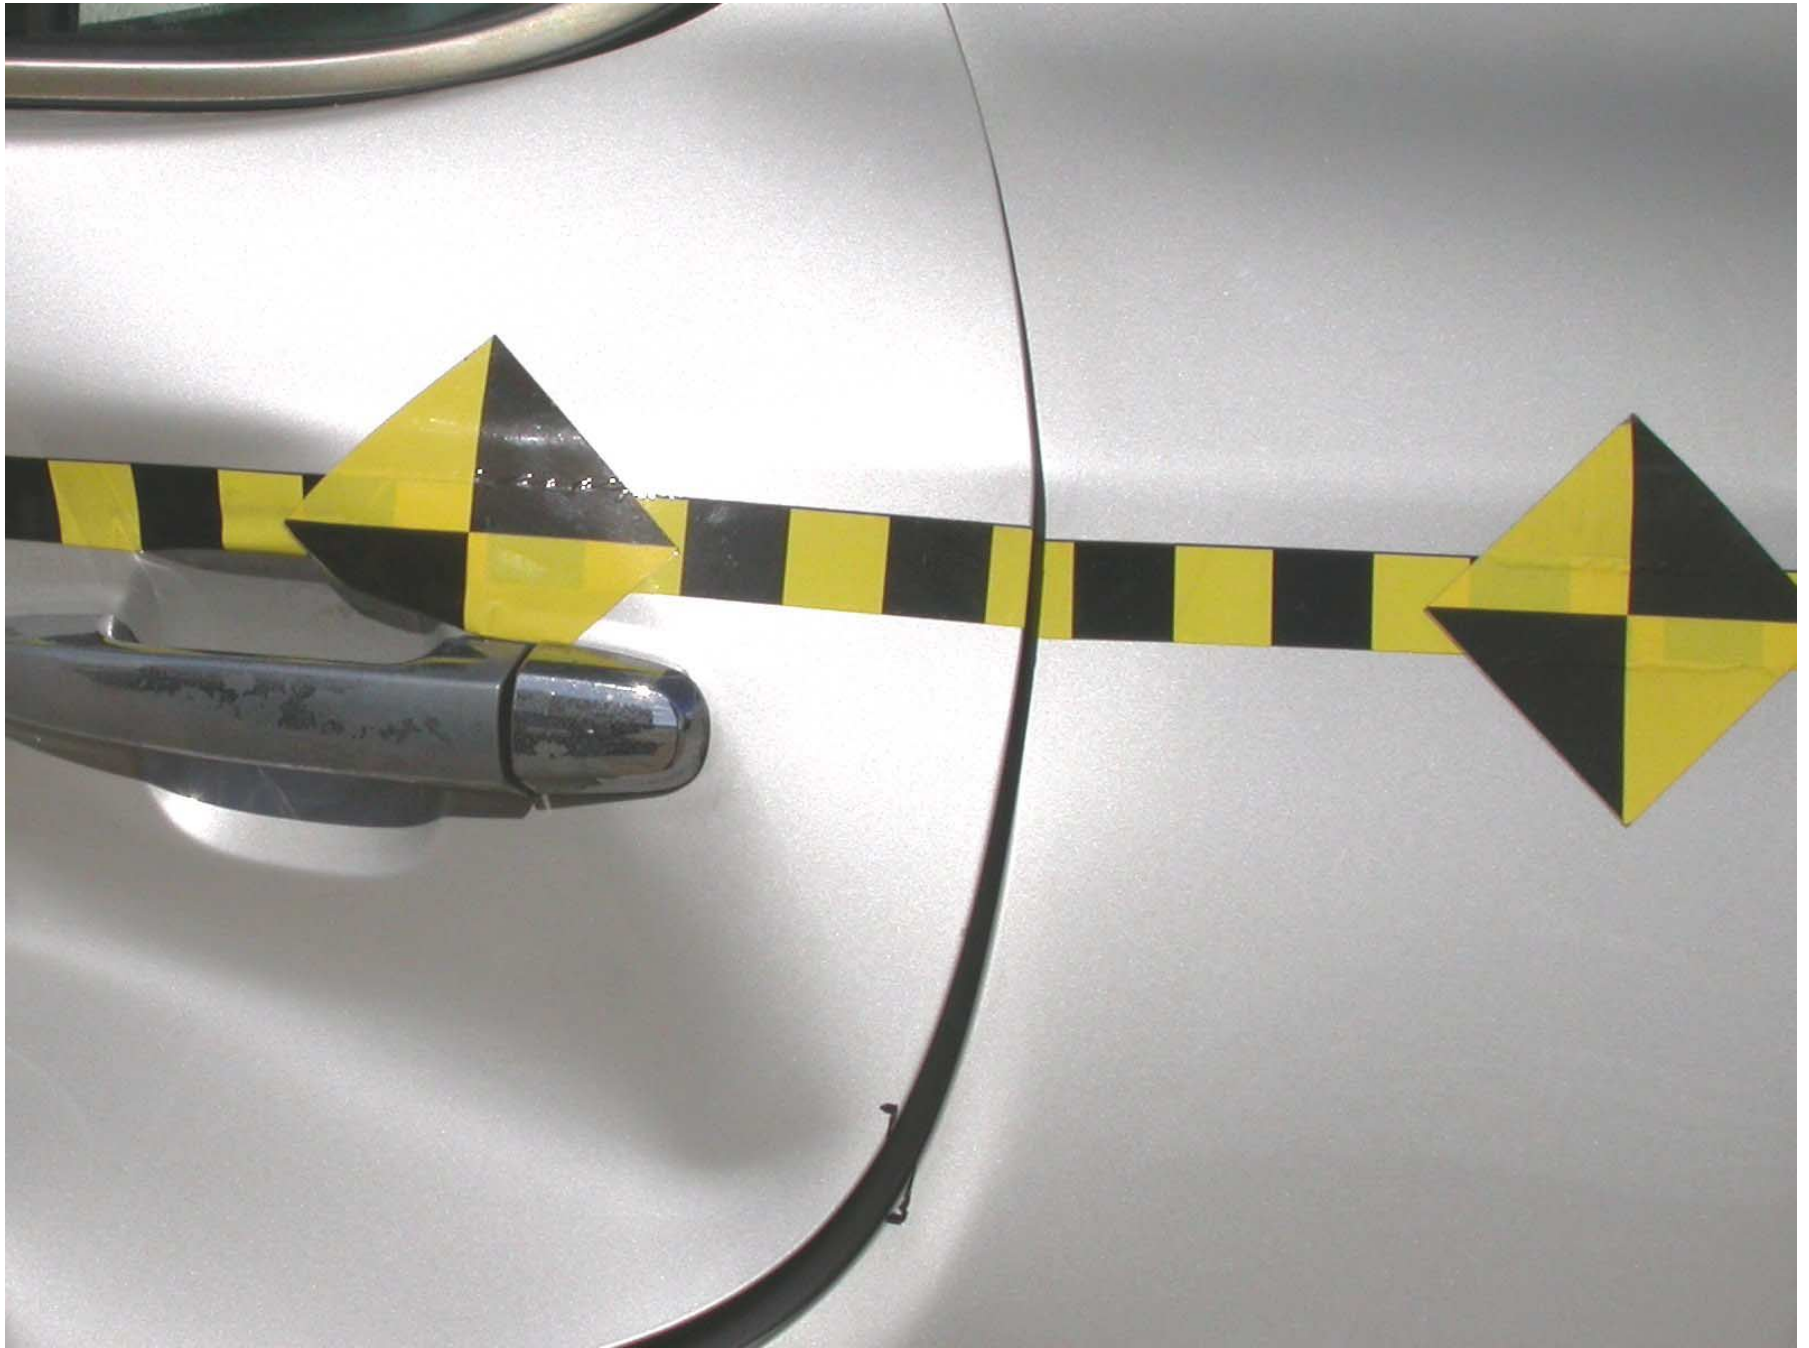
Figure A-34: Left Rear Door Closed, Post-Test

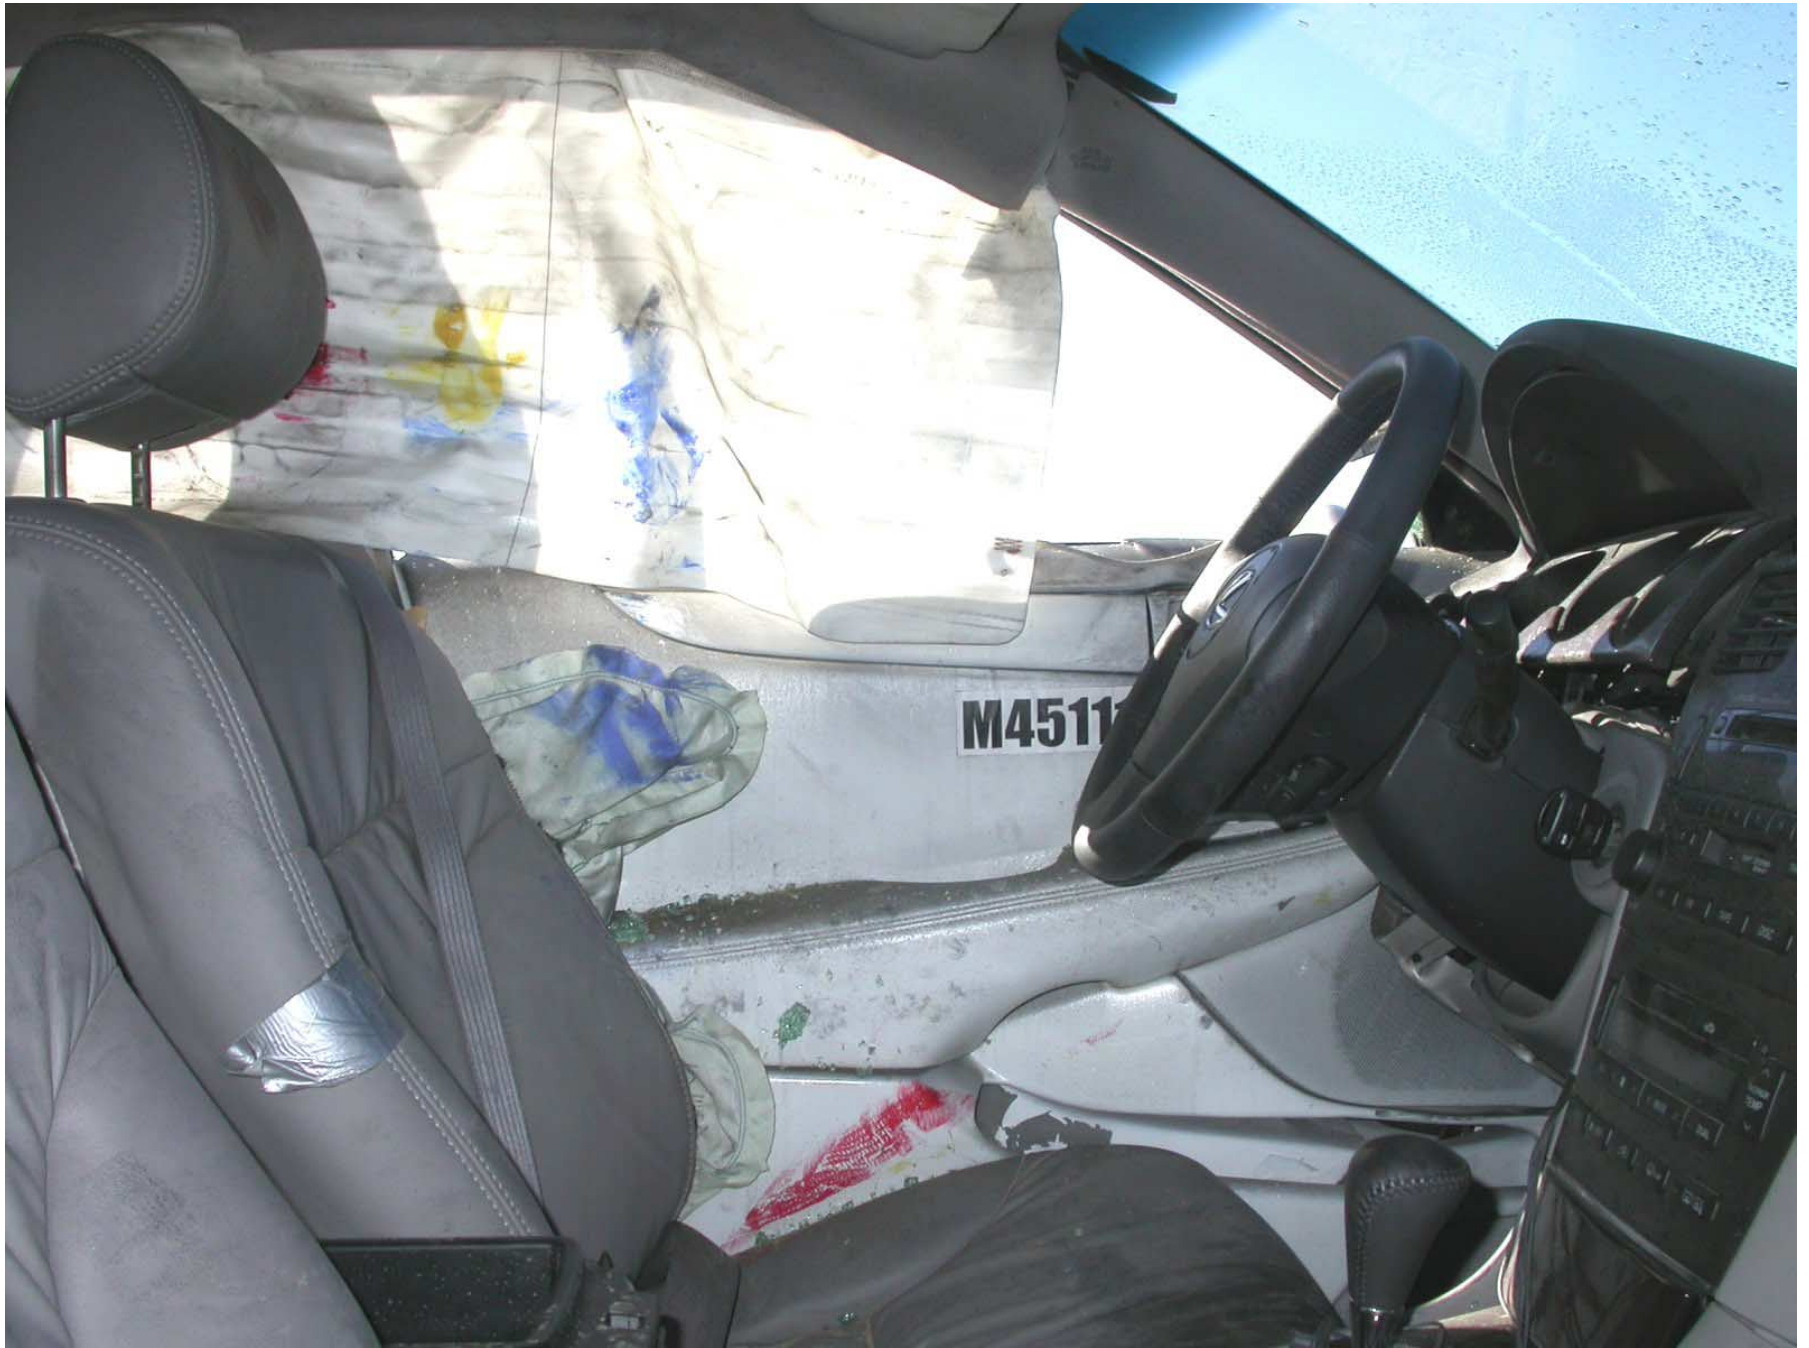
Figure A-43: Driver Dummy Contact Points Inside View, Post-Test (Vehicle Moved)

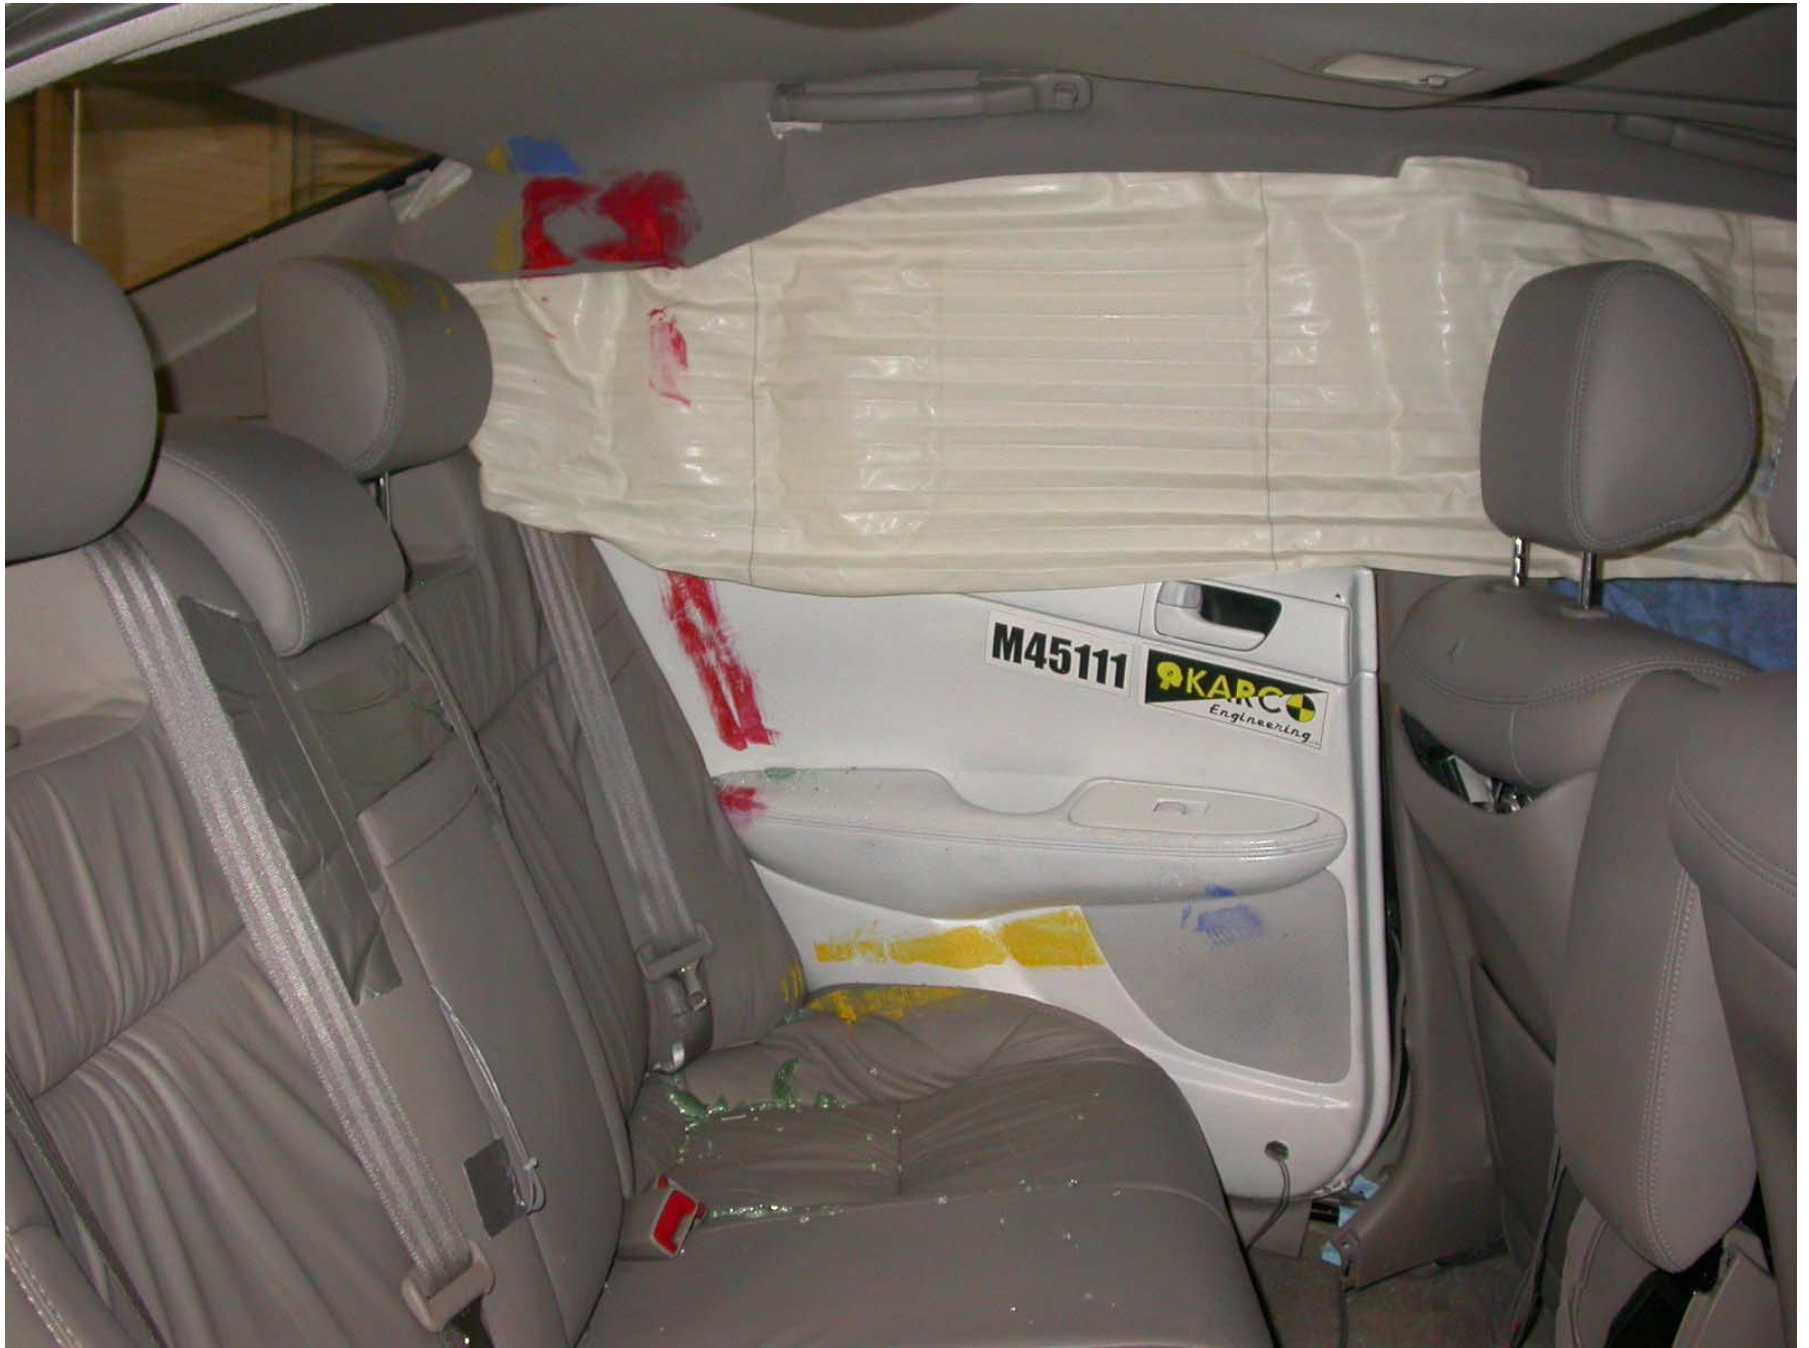
Figure A-52: Passenger Dummy Contact Points Inside View, Post-Test (Vehicle Moved)

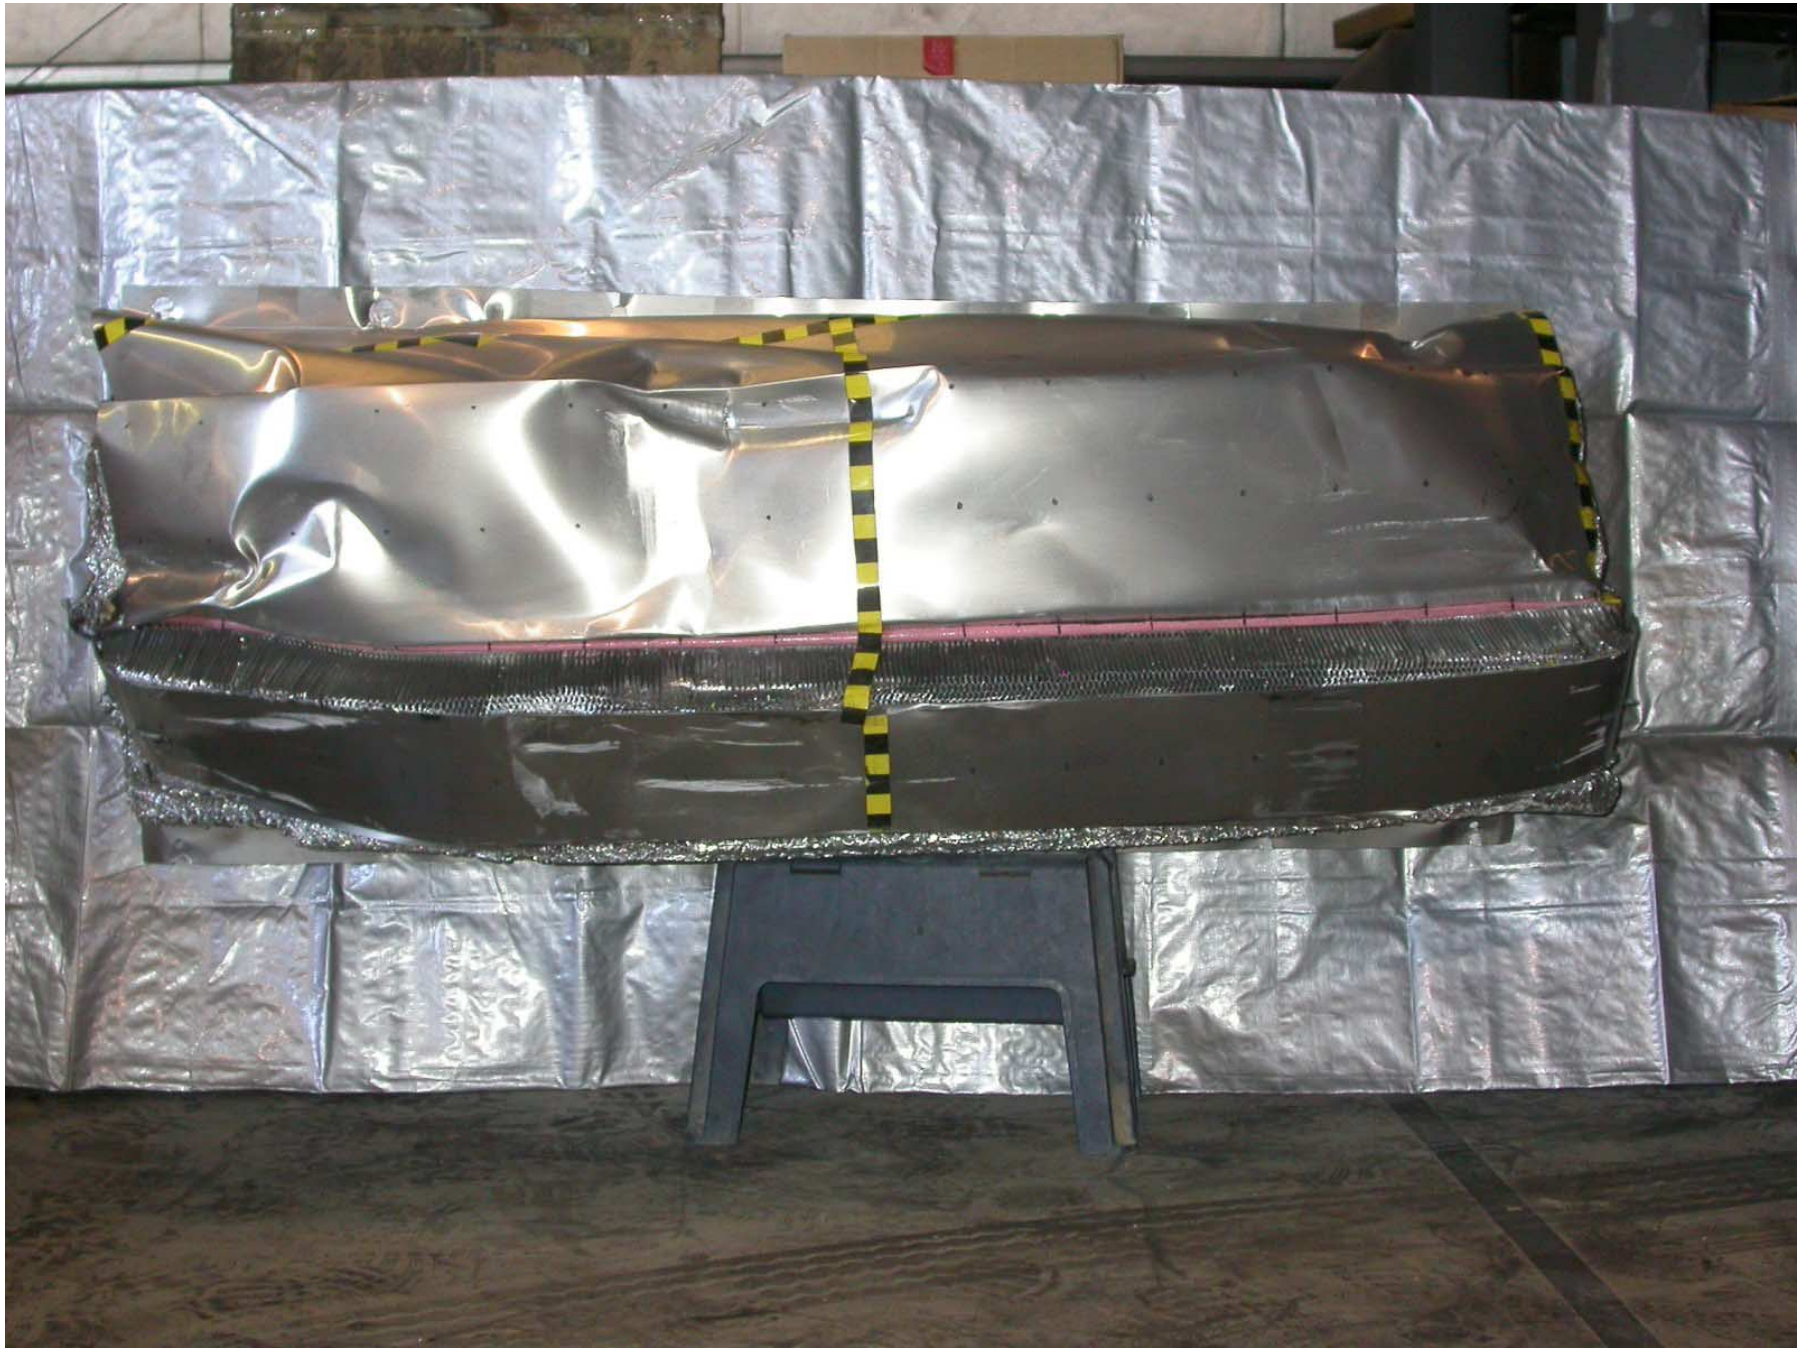
Figure A-54: Front View of Deformable Barrier, Post-Test

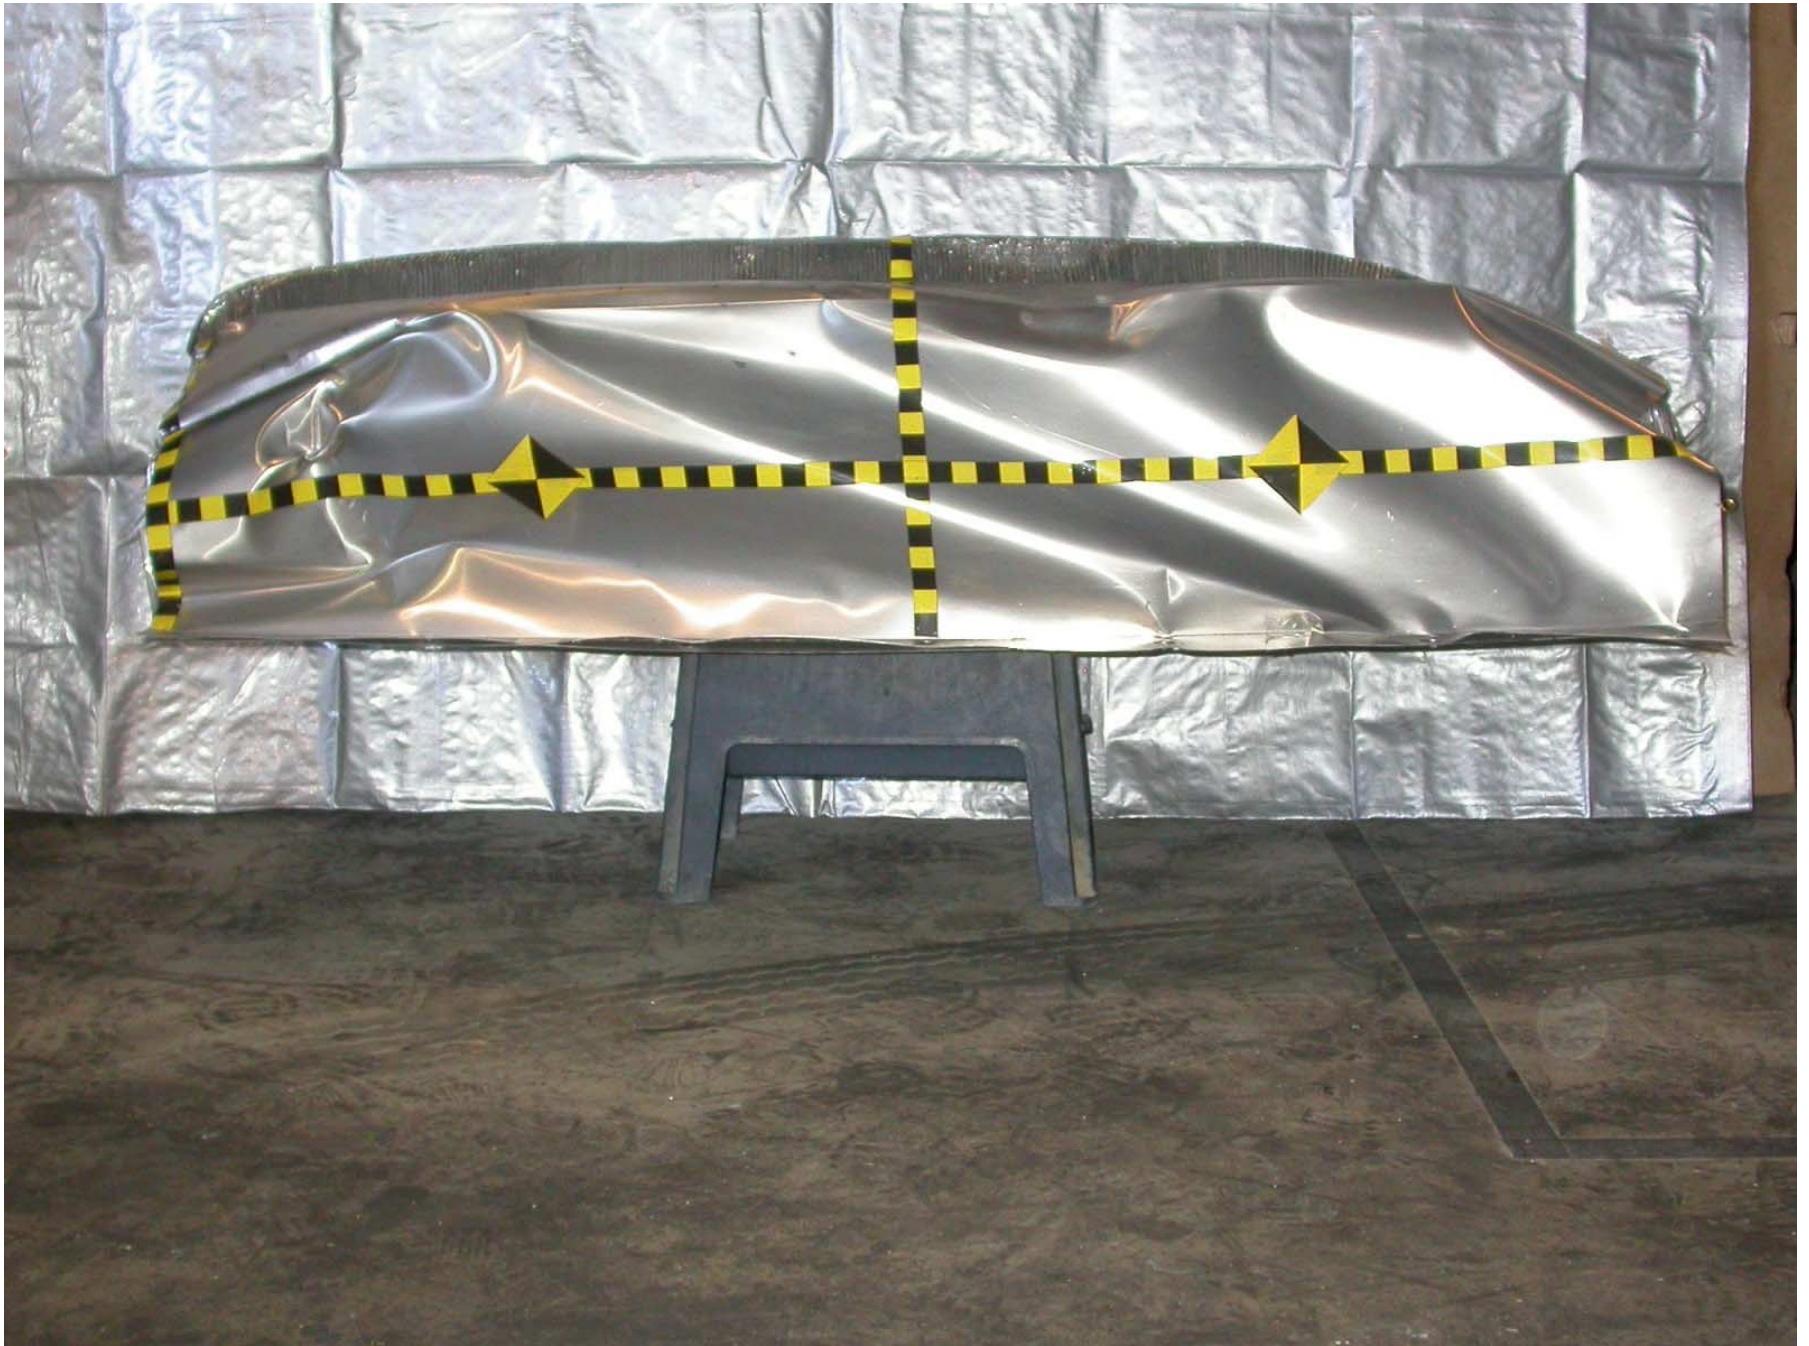
Figure A-56: Top View of Deformable Barrier, Post-Test

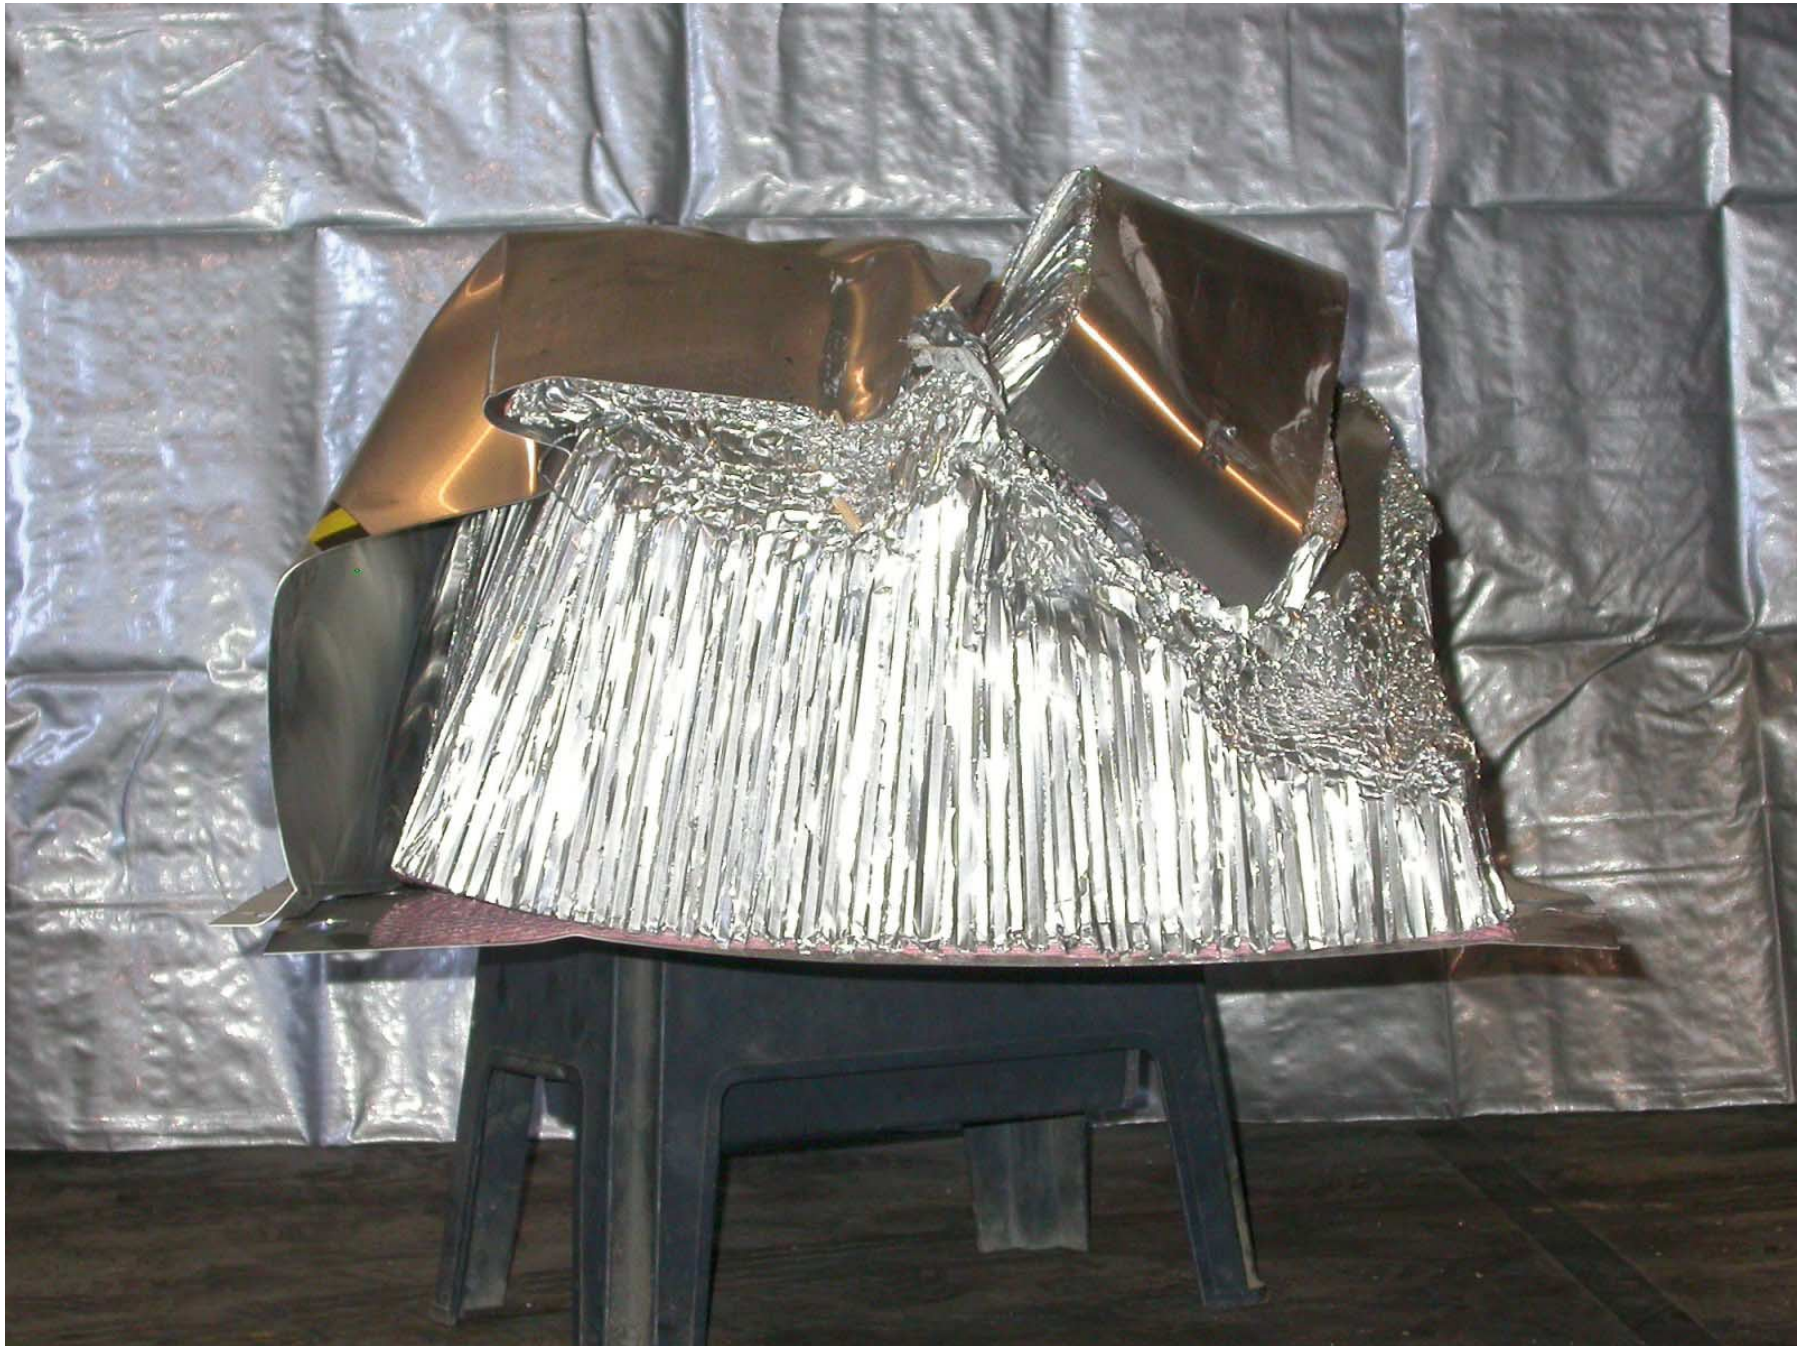
Figure A-58: Right Side View of Deformable Barrier, Post-Test
