REPORT NUMBER TR-P24003-02-NC

**NEW CAR ASSESSMENT PROGRAM
SIDE IMPACT TEST**

**TOYOTA MOTOR CORPORATION
2004 LEXUS ES 330
4 DOOR SEDAN**

FINAL REPORT

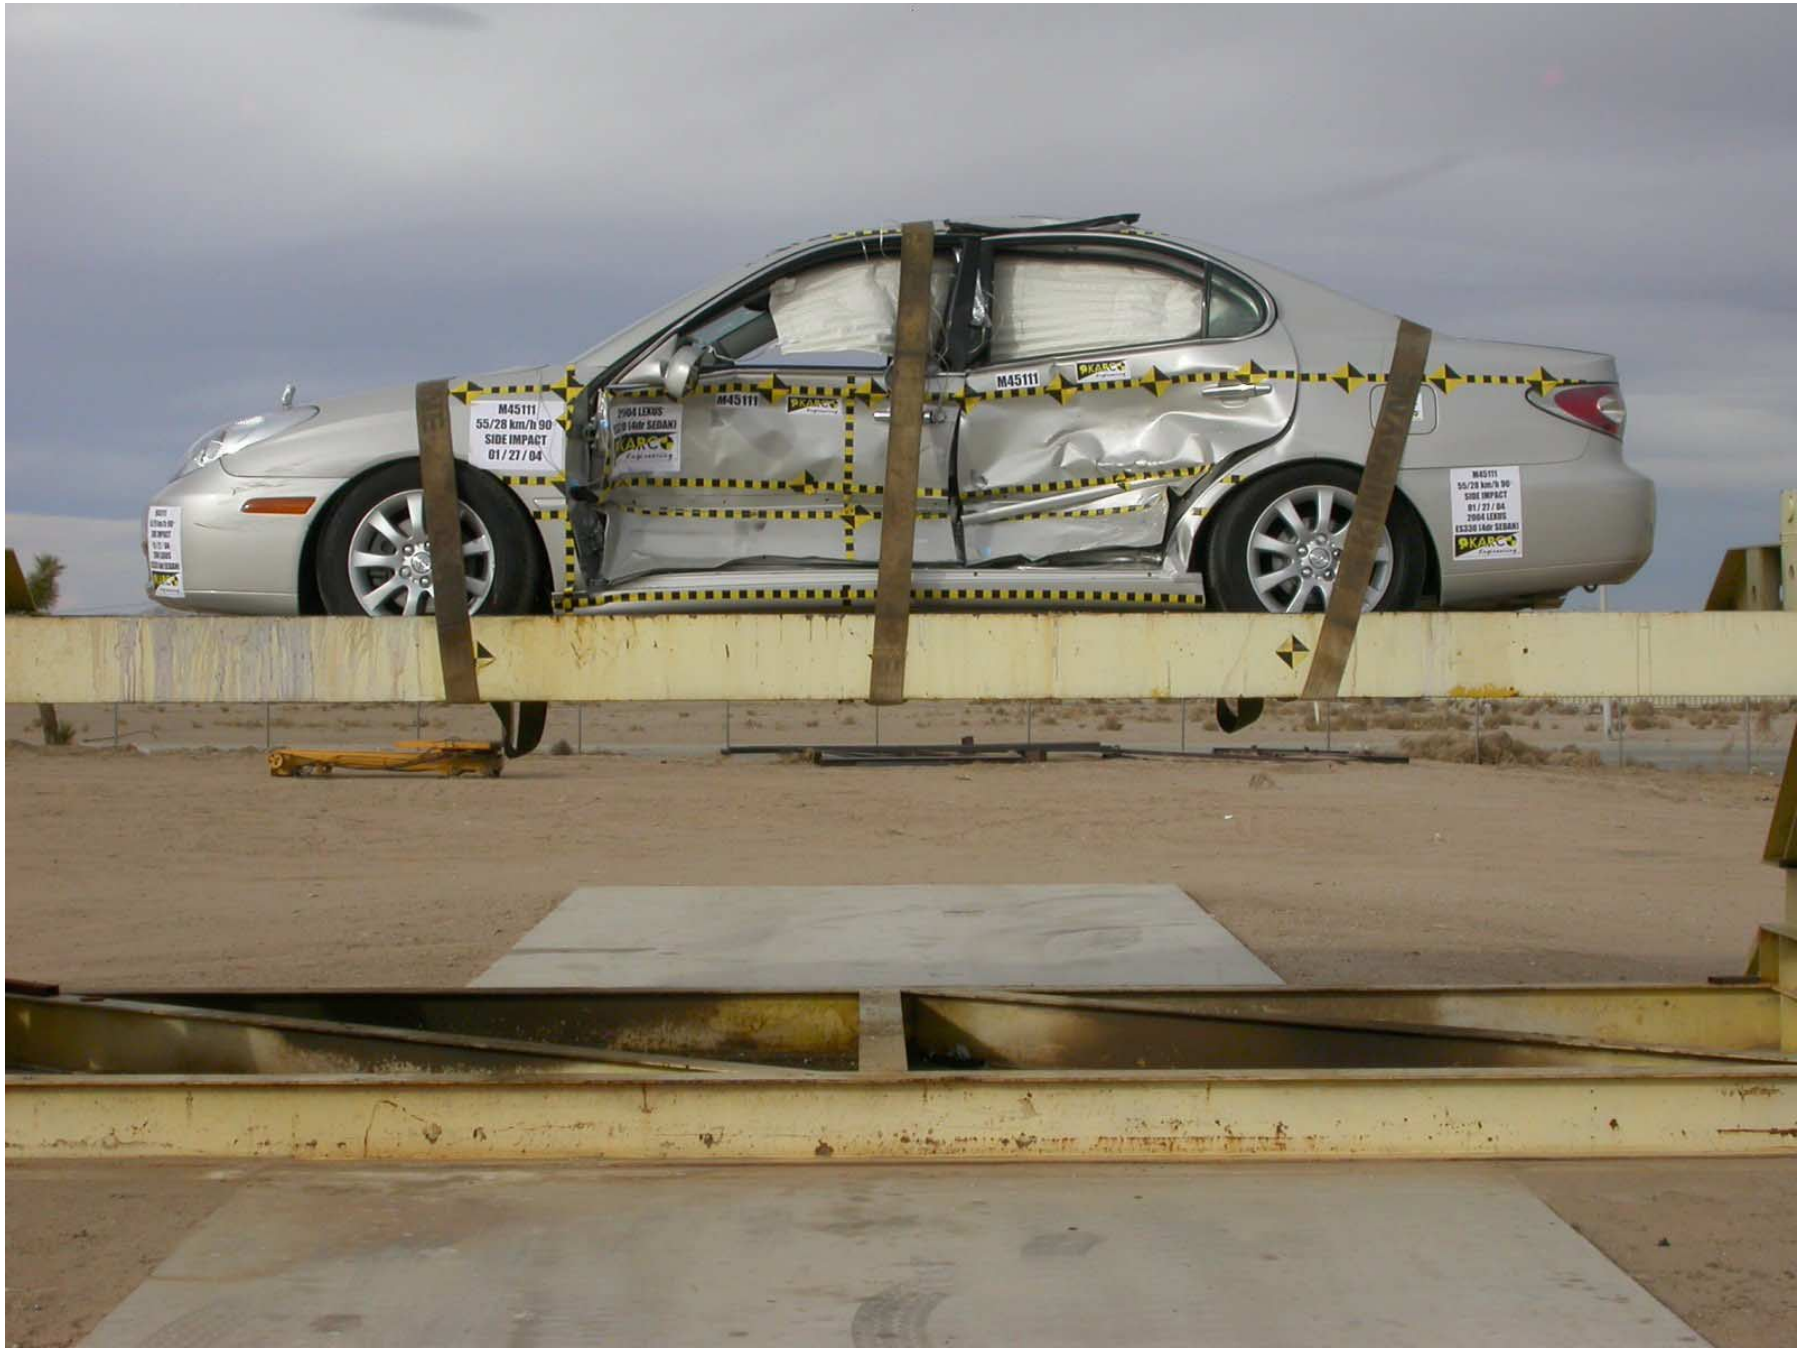
Figure A-61: Vehicle on Rollover Device, 0° View

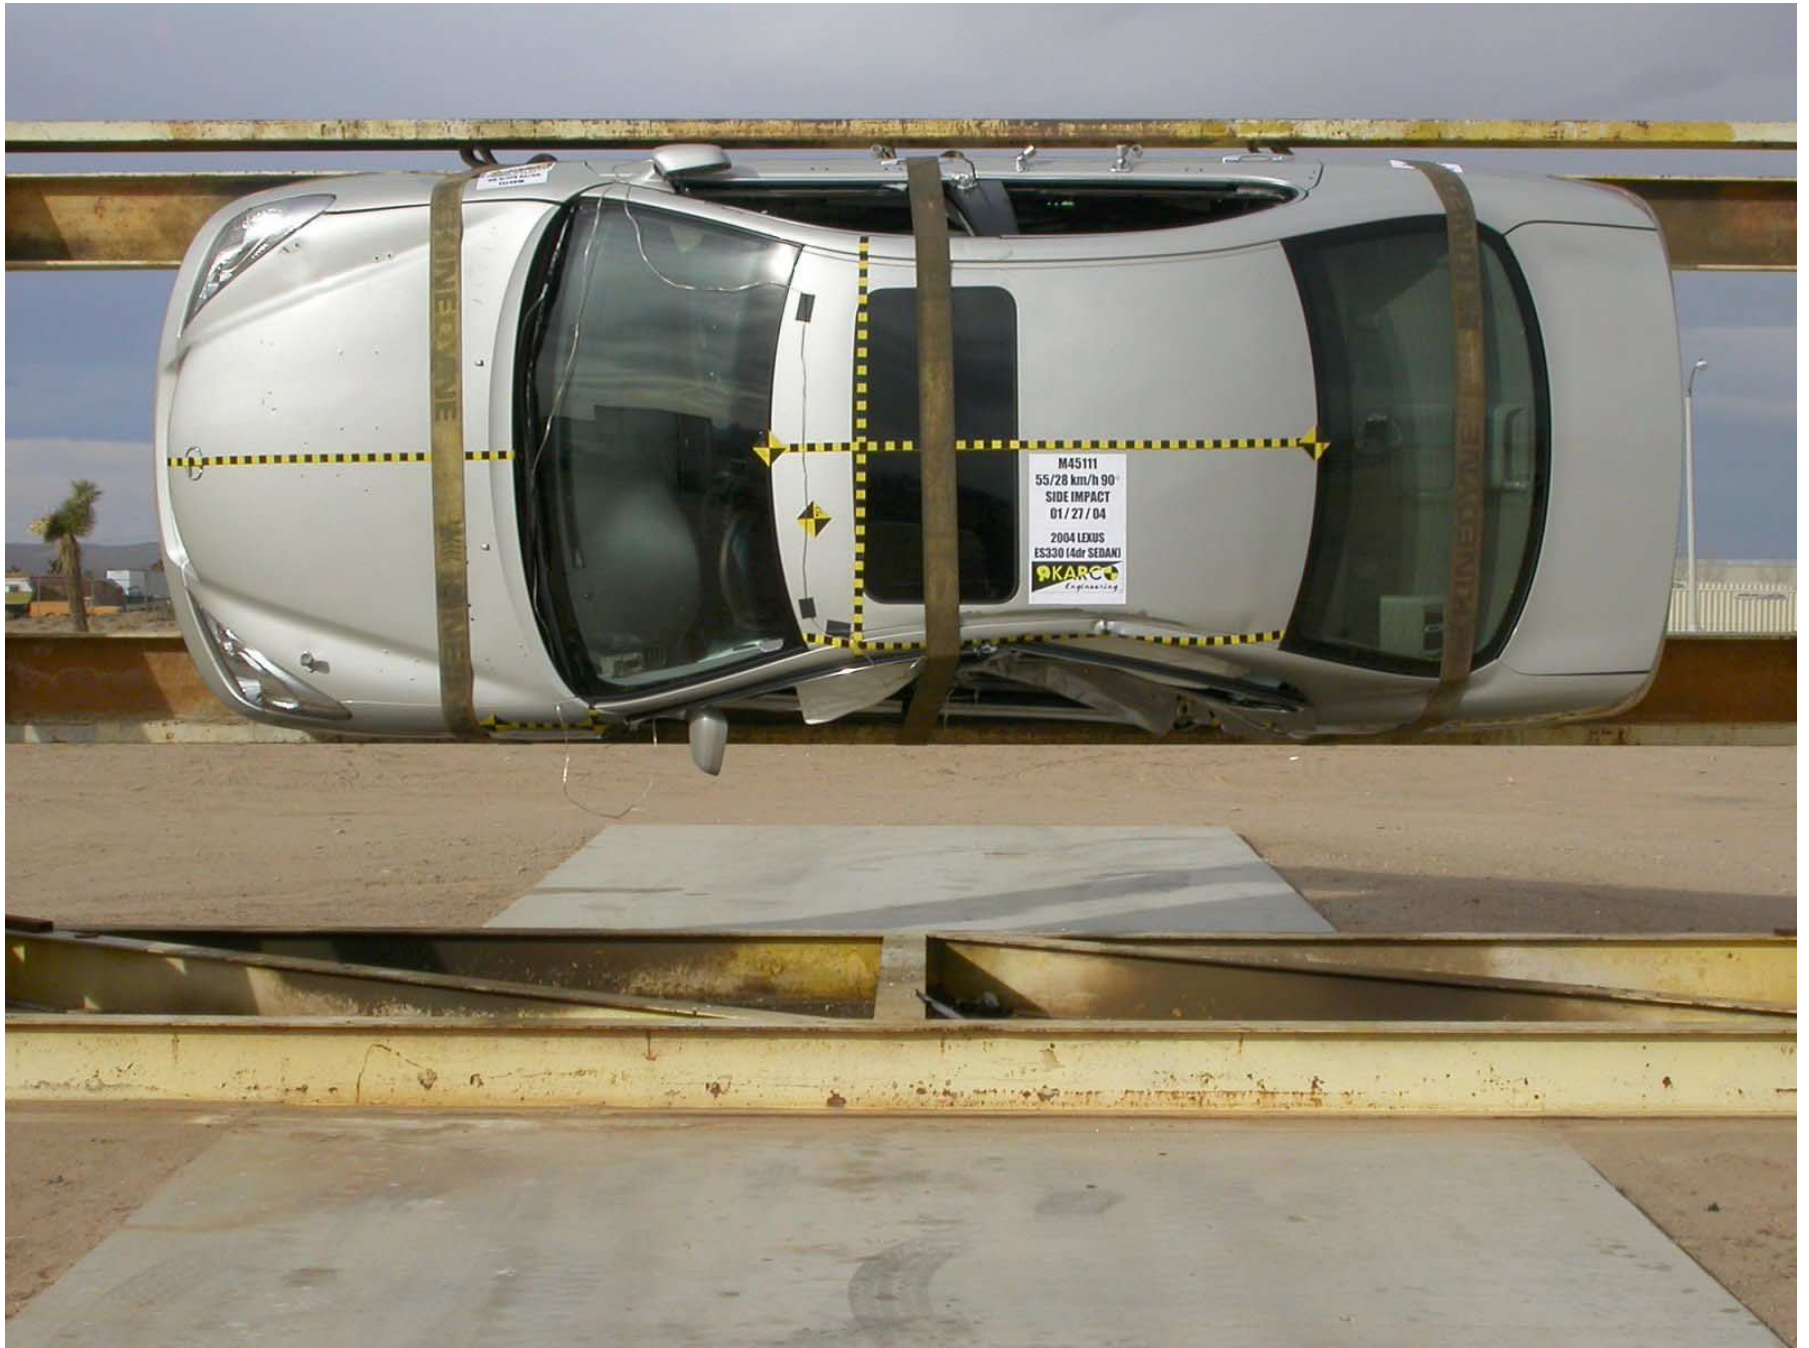
Figure A-62: Vehicle on Rollover Device, 90° View

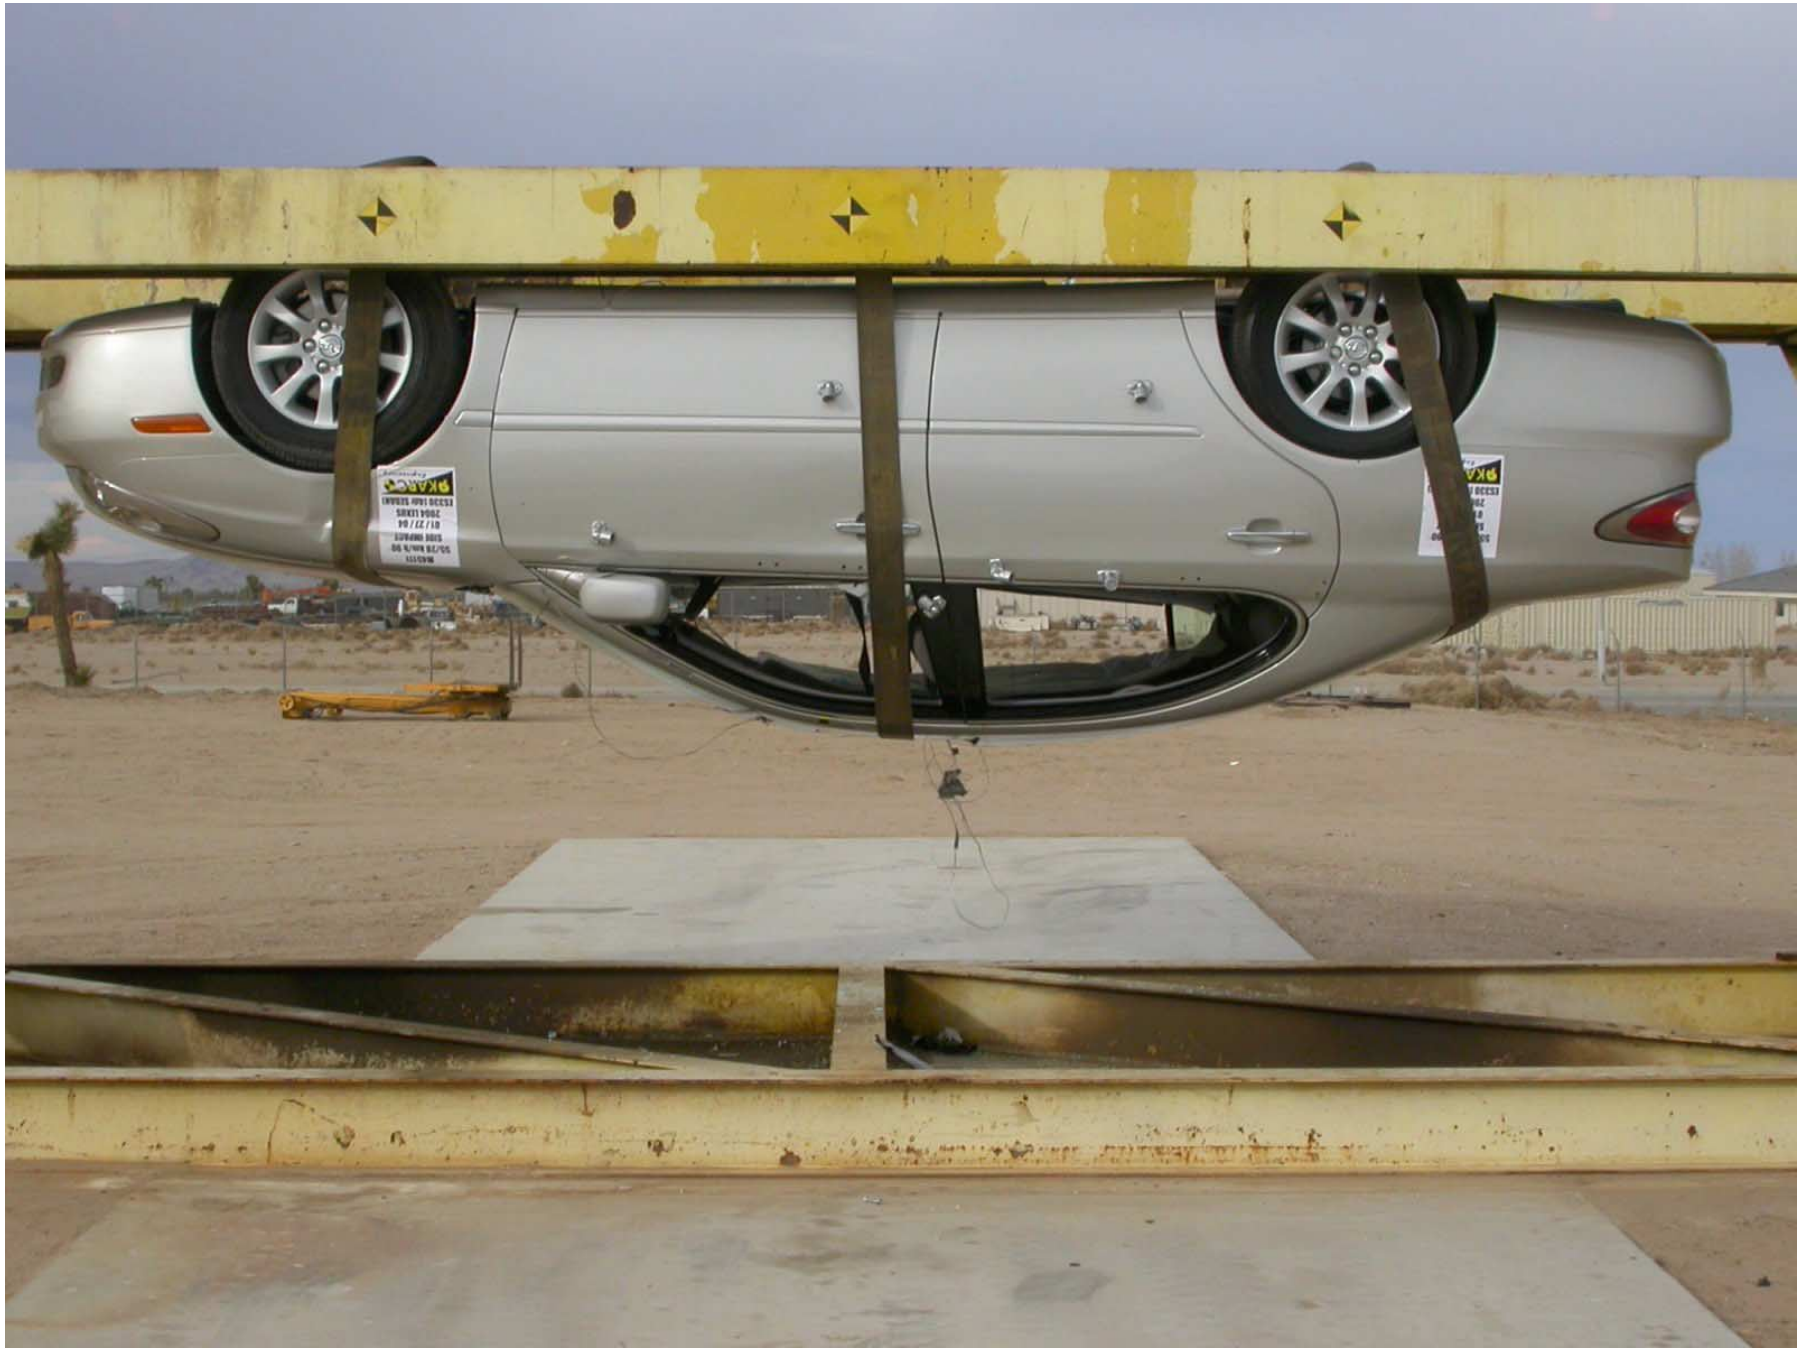
Figure A-63: Vehicle on Rollover Device, 180° View

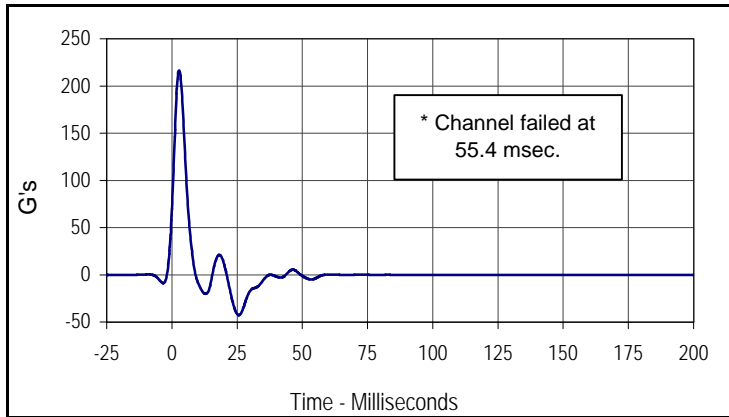
Curve Description			
Vehicle B-Post Lower Y			
CURNO	Type	SAE Class	Units
062	FIL	60	G's
Max	Time	Min	Time
216.6	2.8	-42.8	25.6

* Channel failed at 55.4 msec.
