# Insurance Institute for Highway Safety Crashworthiness Evaluation

## Crash Test Report 2003 Lincoln Town Car (CEF0301)

**Vehicle identification number:** 1LNHM82W23Y602391  
**Body style:** Large 4-door sedan  
**Engine/transmission:** Longitudinal 4.6-liter V8, 4-speed automatic transmission, rear-wheel drive

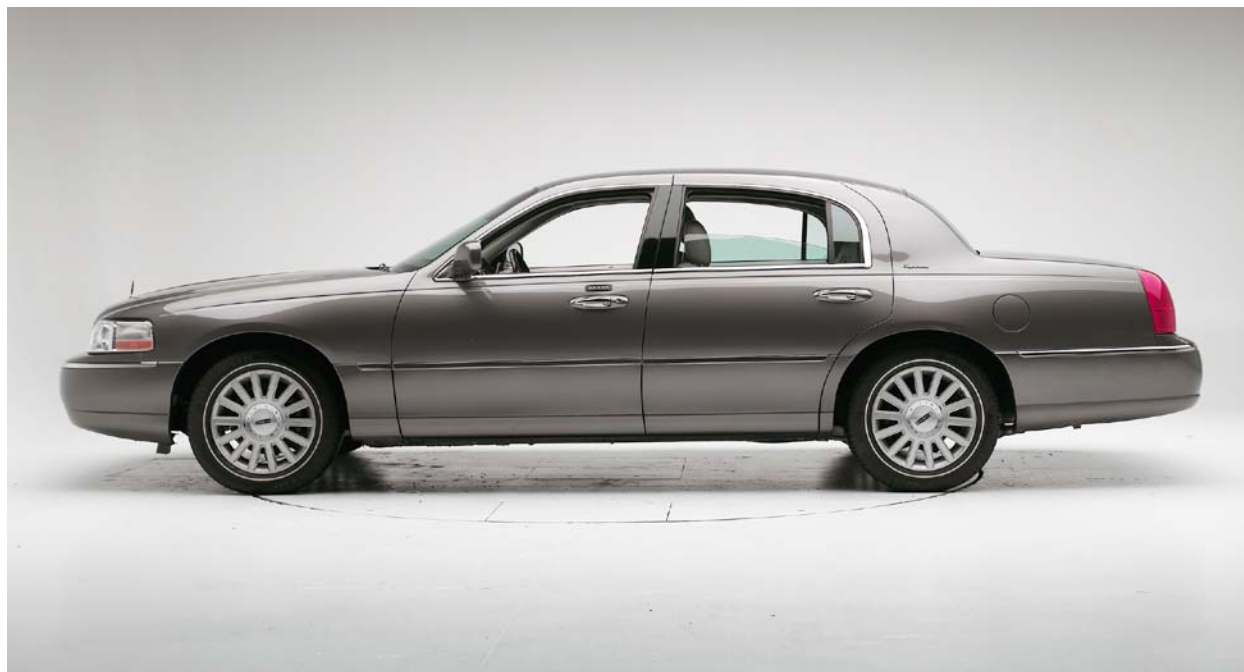
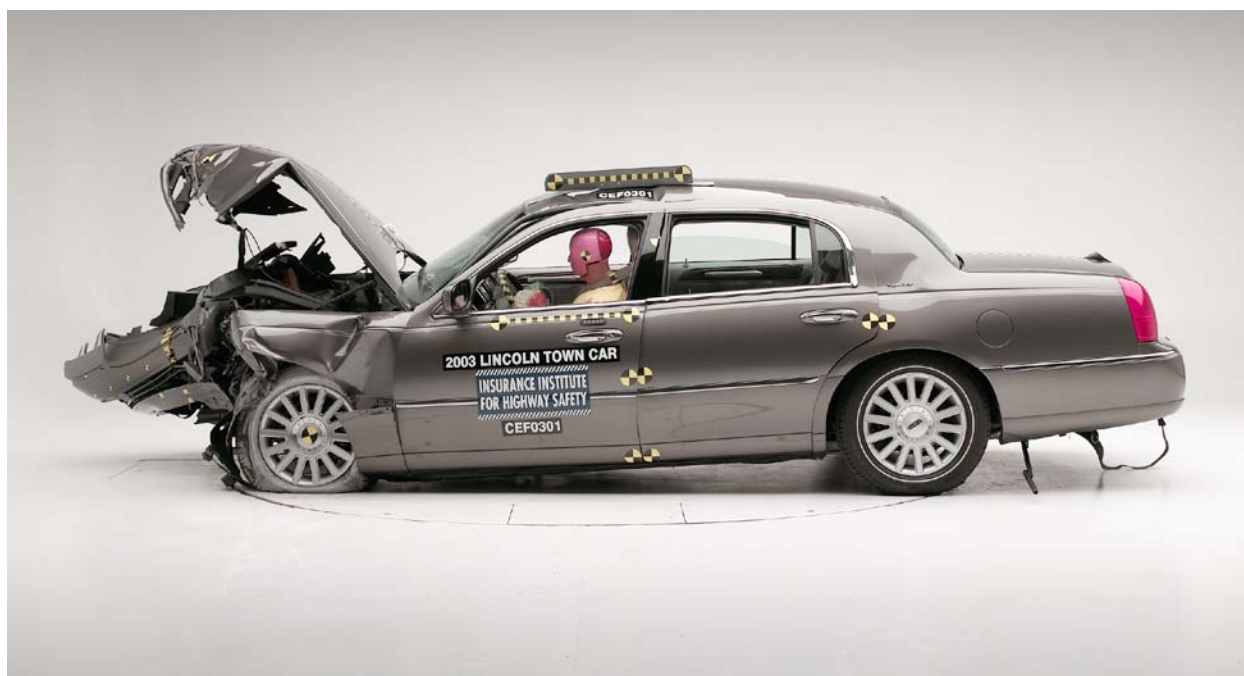
**Figure 1**  
**Precrash and Postcrash Side Views — 2003 Lincoln Town Car**

A 2003 Lincoln Town Car was crash tested on January 9, 2003 into a fixed deformable barrier at 39.8 mi/h (64.1 km/h) and a 40 percent overlap on the driver side. A Hybrid III 50th percentile male dummy was positioned in the driver seat with the lap/shoulder belt fastened.

All doors remained closed during the crash. After the crash, the driver door and left rear door required additional effort but no tools to open. The right front and right rear doors opened with ease. The driver door aperture shortened 4 cm, as measured at the lower edge of the window.

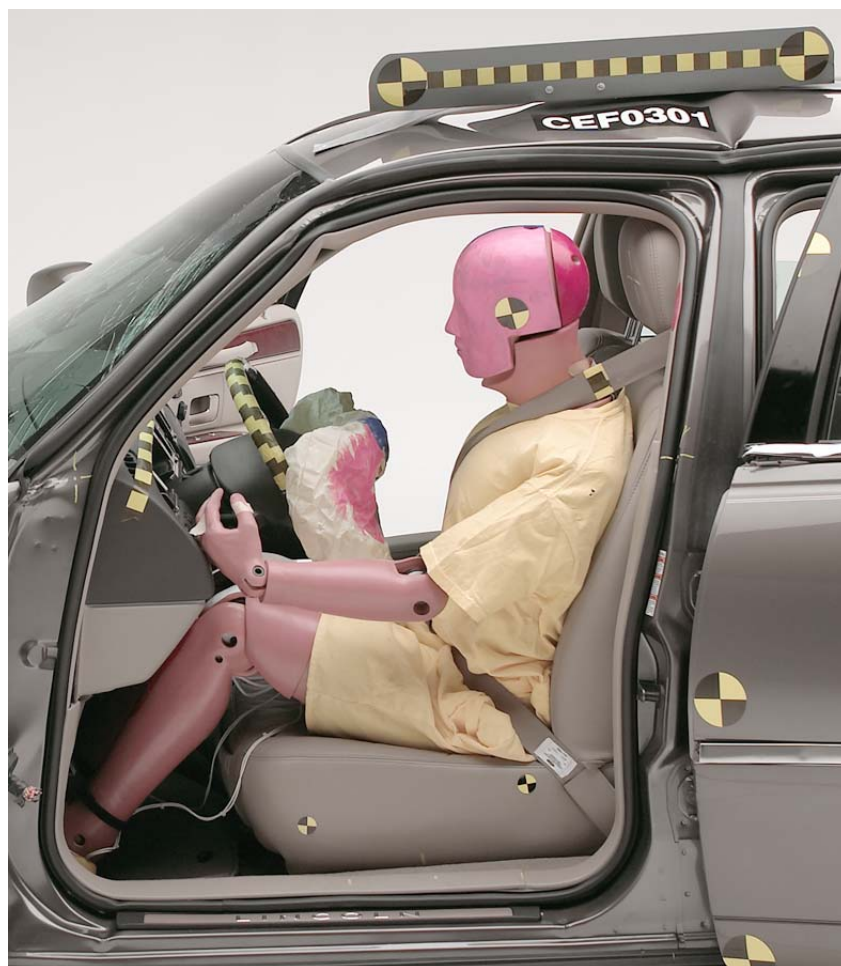
**Figure 3**  
**Dummy and Vehicle Interior, Postcrash — 2003 Lincoln Town Car**

Postcrash examination of the driver seat rails indicated no discernible movement of the seat in its tracks during the crash. Deformation of the floor under the driver seat caused the seat to tip outboard and pitch forward, leaving the head restraint in contact with the B-pillar.

Analysis of the high-speed film taken from camera position E indicated the dummy began to load the airbag at 84 ms, 12 ms after the airbag was fully deployed. Paint transferred from the dummy's face indicated the nose loaded the airbag 11 cm above and 2 cm to the left of its center. When the dummy's head was close to the steering wheel, the resultant head acceleration indicated an increase of 16 g over a duration of 16 ms, beginning at 125 ms. It is possible that this peak resulted from deployment of the second stage of the airbag, which is reported by Ford to deploy about 100 ms after the first stage deploys in a crash of this type, rather than from contact with the steering wheel. After loading the airbag, the dummy's head rebounded, moving outboard and partway past the precrash plane of the side window. The rear of the dummy's head then contacted the B-pillar at 246 ms, according to the head acceleration data. After contacting the B-pillar, the head moved slightly forward and the top right of the head contacted the top edge of the window frame at 297 ms. The dummy then moved inboard and faced forward. Table 2 provides the timing of these events.

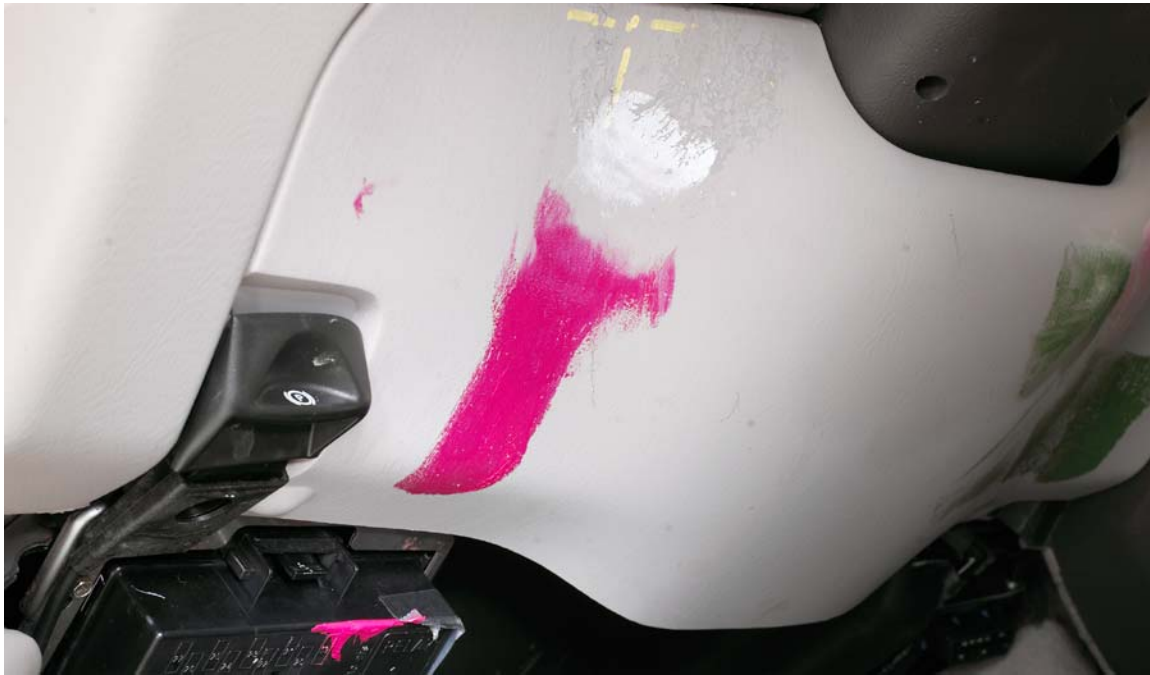
**Figure 4**  
**Dummy Left Knee/Shin Contacts, Postcrash — 2003 Lincoln Town Car**

**Left leg and foot:** The maximum left upper tibia A-P moment was –184 Nm at 74 ms, significantly contributing to the left upper tibia index of 0.91 at 74 ms.

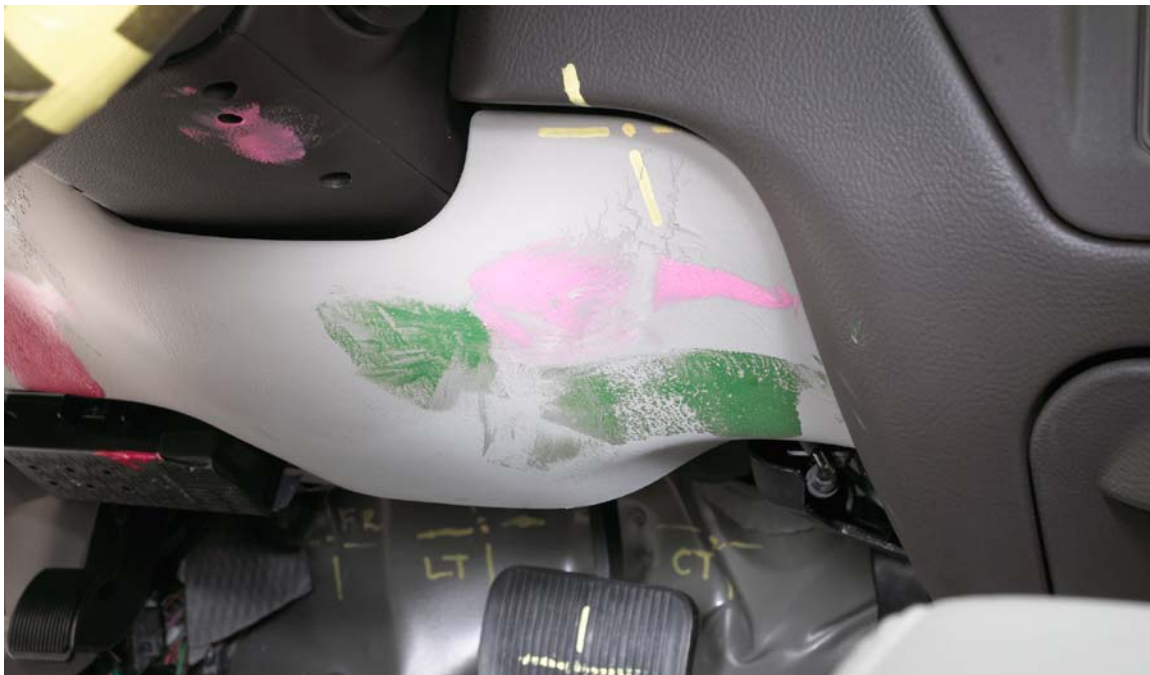
**Figure 5**  
**Dummy Right Knee/Shin Contacts, Postcrash — 2003 Lincoln Town Car**

**Right leg and foot:** None of the injury measures exceeded published threshold values.

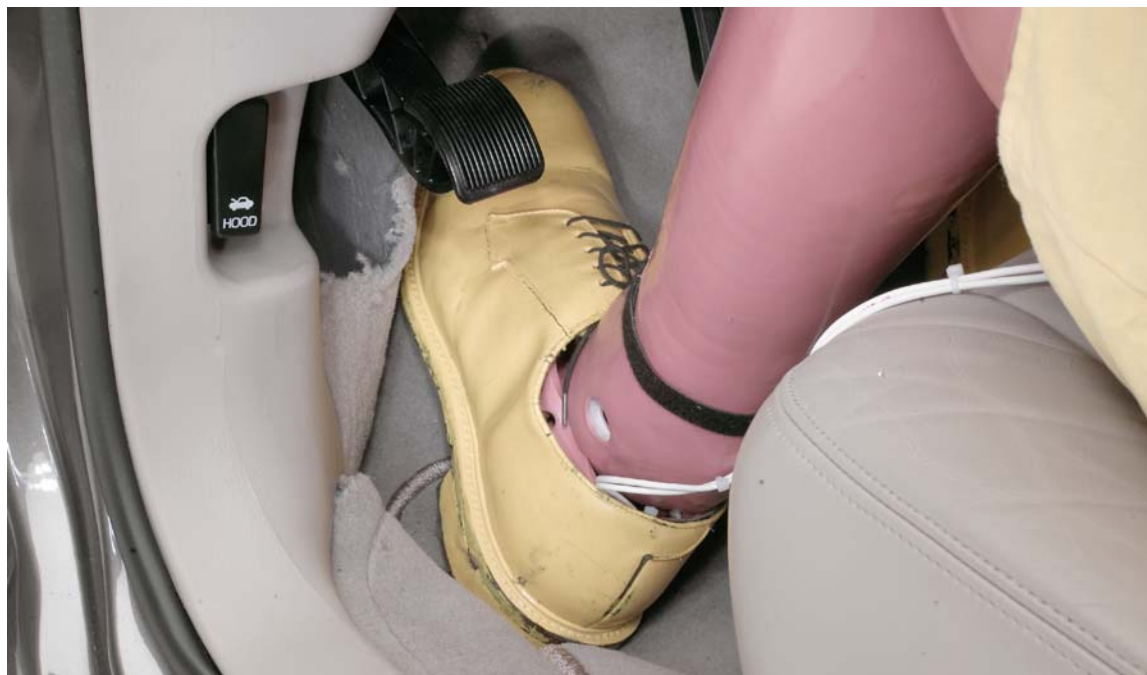
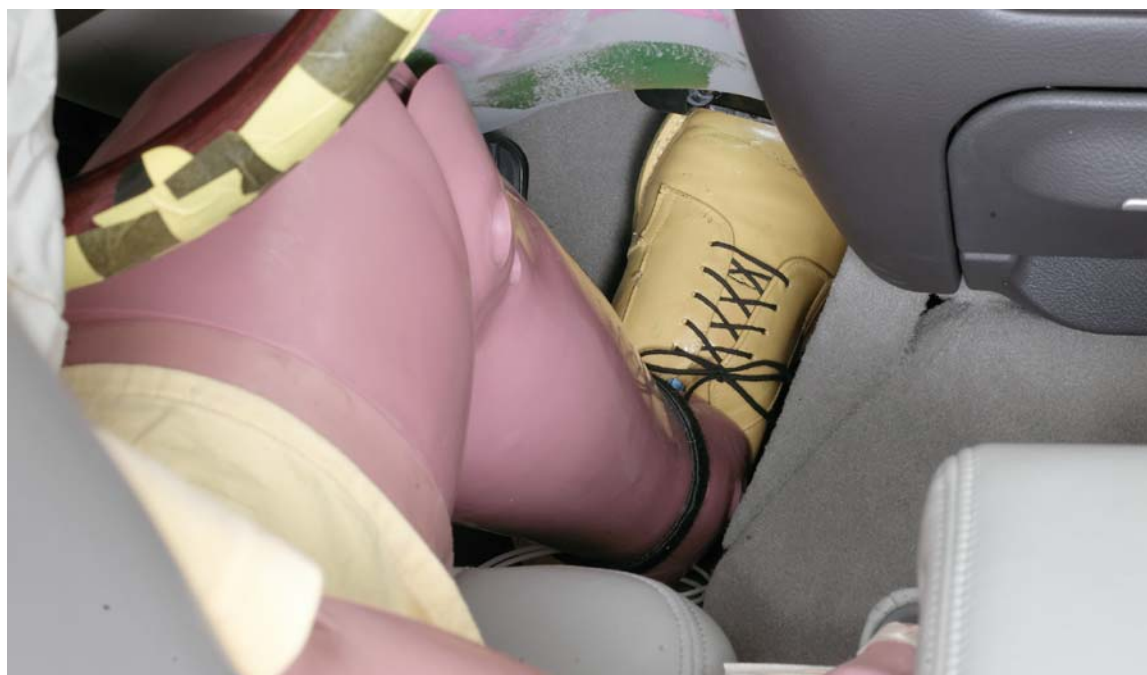
**Figure 6**  
**Dummy Feet Positions, Postcrash — 2003 Lincoln Town Car**

Measures of intrusion taken after the crash indicated the lower instrument panel in front of the dummy moved rearward 1-2 cm. Resultant intrusion in the driver footwell measured 10 cm in the area where a footrest typically would be located and 10-11 cm at other places on the toe pan. All doors remained closed during the crash. After the crash, the driver door and left rear door required slight additional effort but no tools to open. The right front and right rear doors opened with ease. Deformation of the floor under the driver seat caused the seat to tip outboard and pitch forward.
