# Insurance Institute for Highway Safety Crashworthiness Evaluation

## Crash Test Report 2003 Lincoln Town Car (CEF0313)

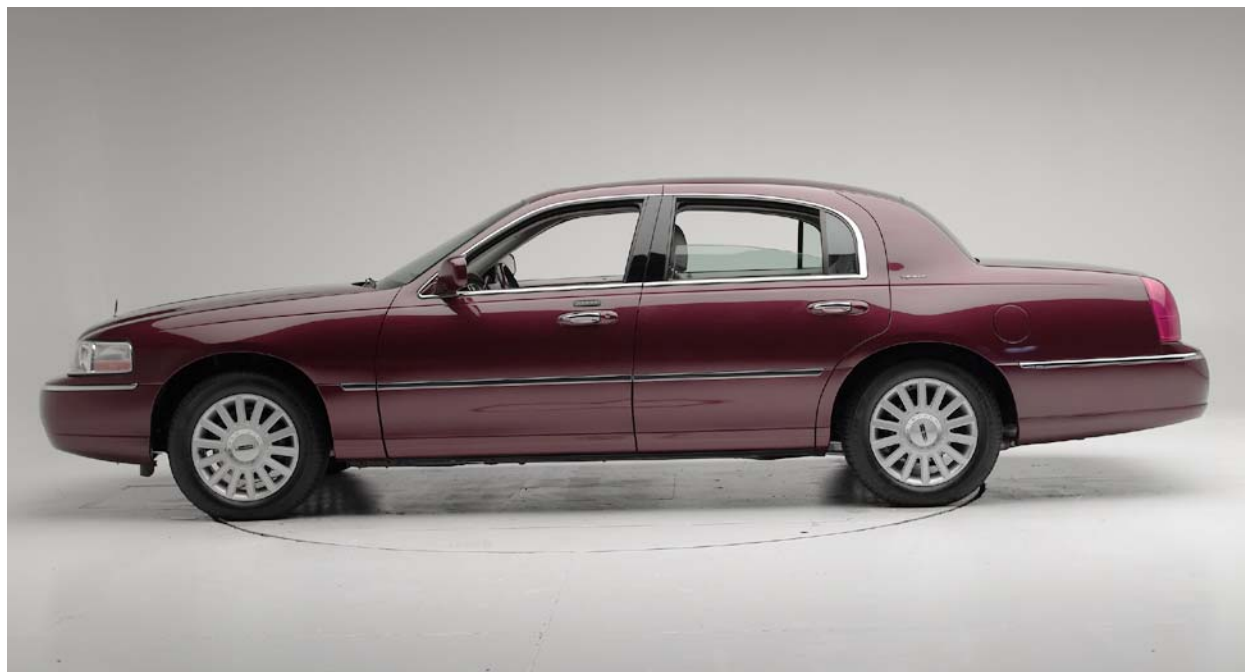
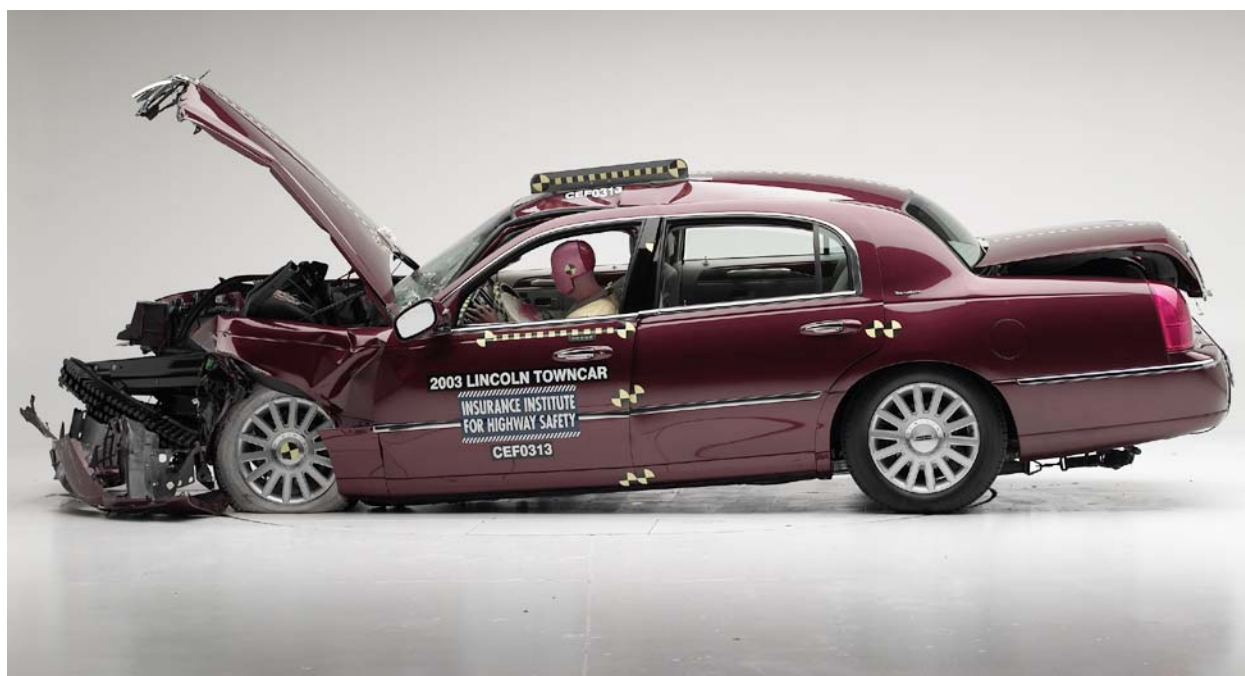
**Figure 1**  
**Preocrash and Postcrash Side Views — 2003 Lincoln Town Car**

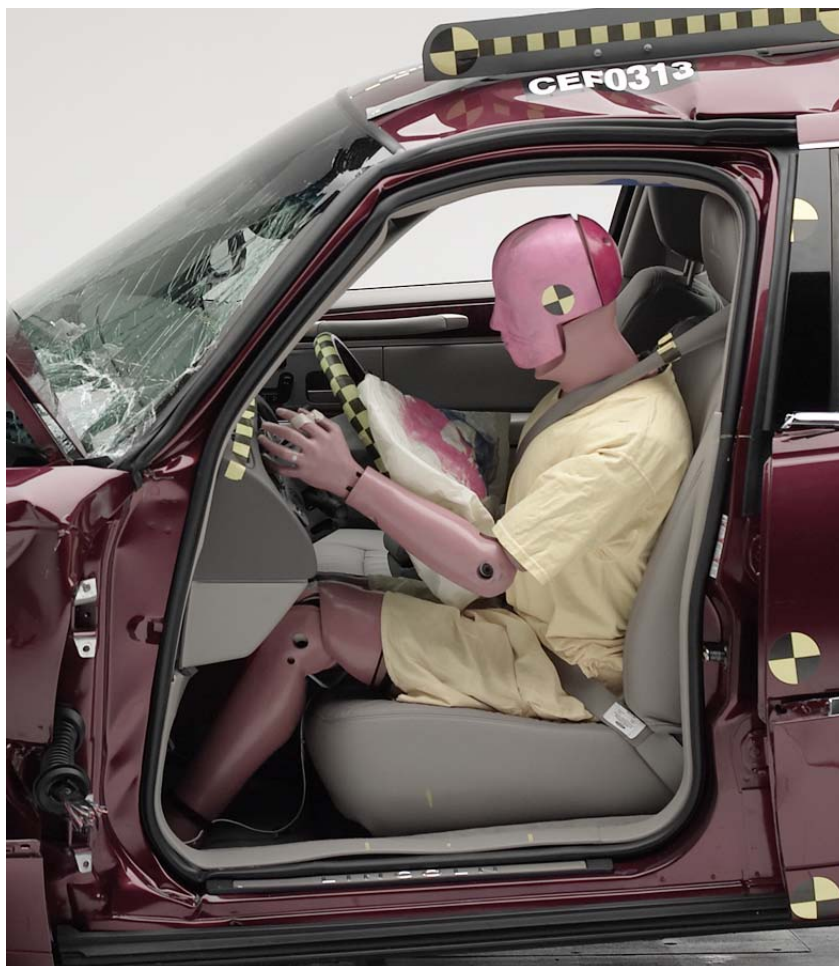
**Figure 3**  
**Dummy and Vehicle Interior, Postcrash — 2003 Lincoln Town Car**

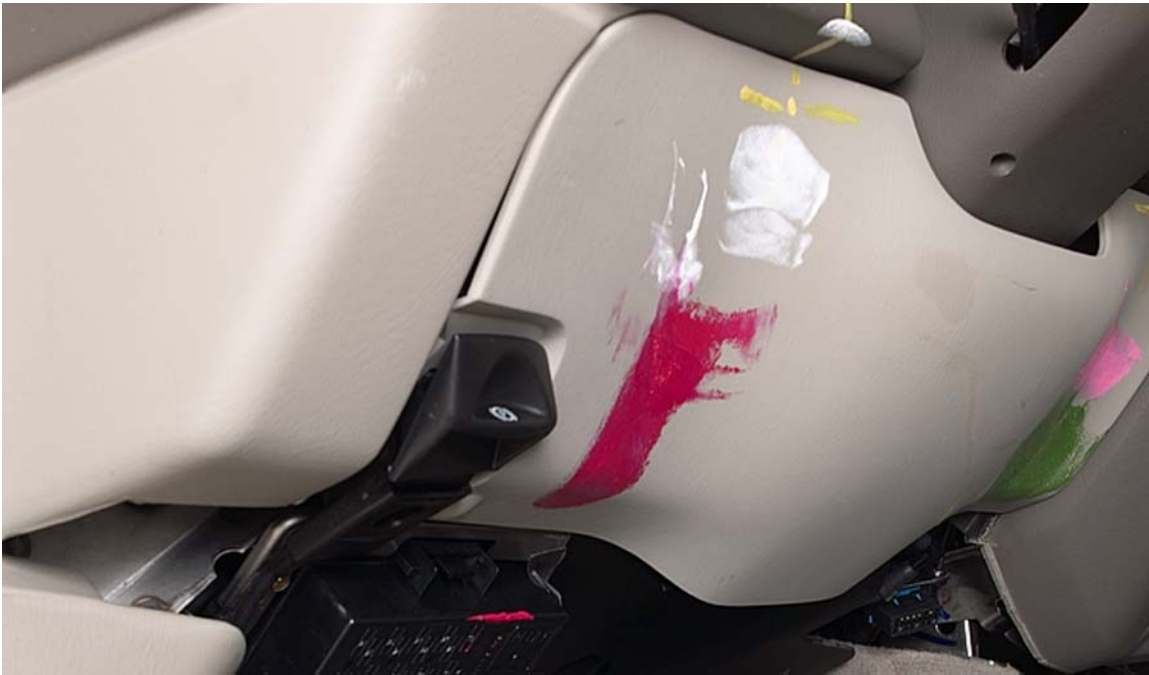
**Figure 4**  
**Dummy Left Knee/Shin Contacts, Postcrash — 2003 Lincoln Town Car**

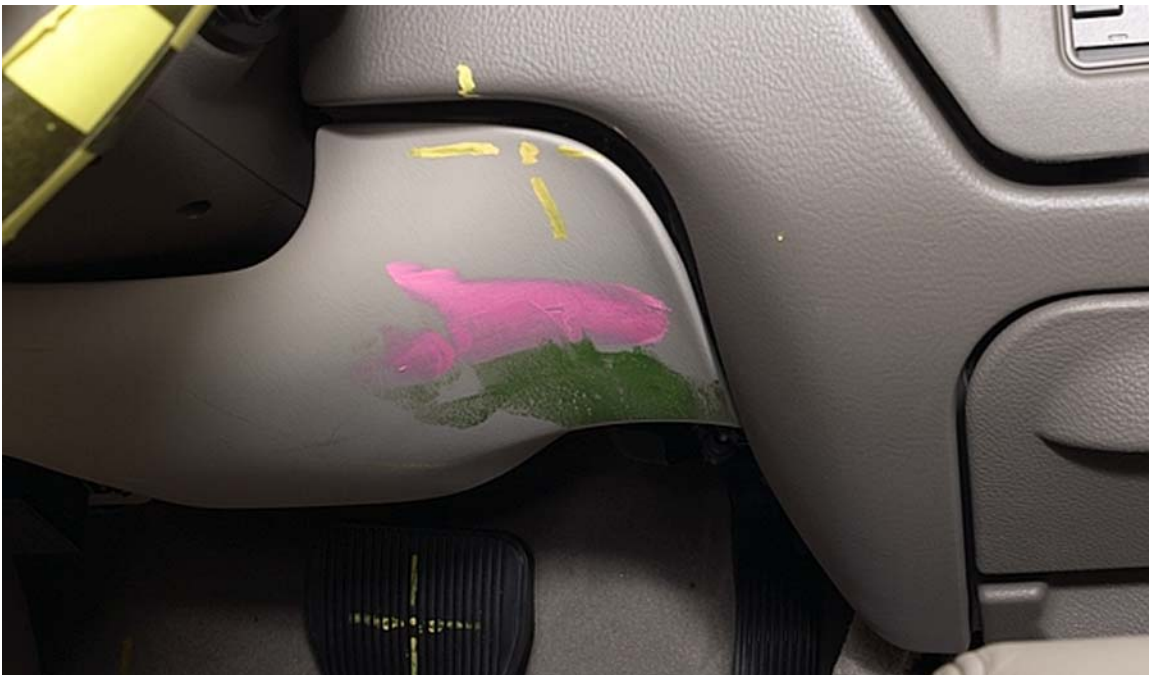
**Figure 5**  
**Dummy Right Knee/Shin Contacts, Postcrash — 2003 Lincoln Town Car**

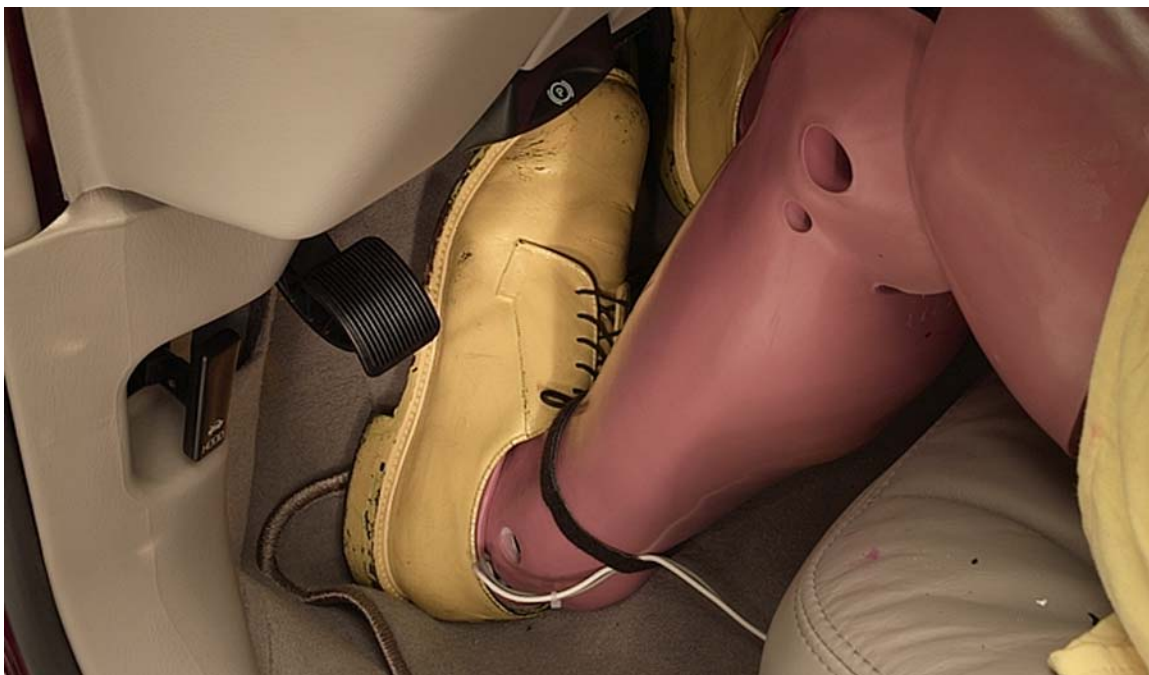
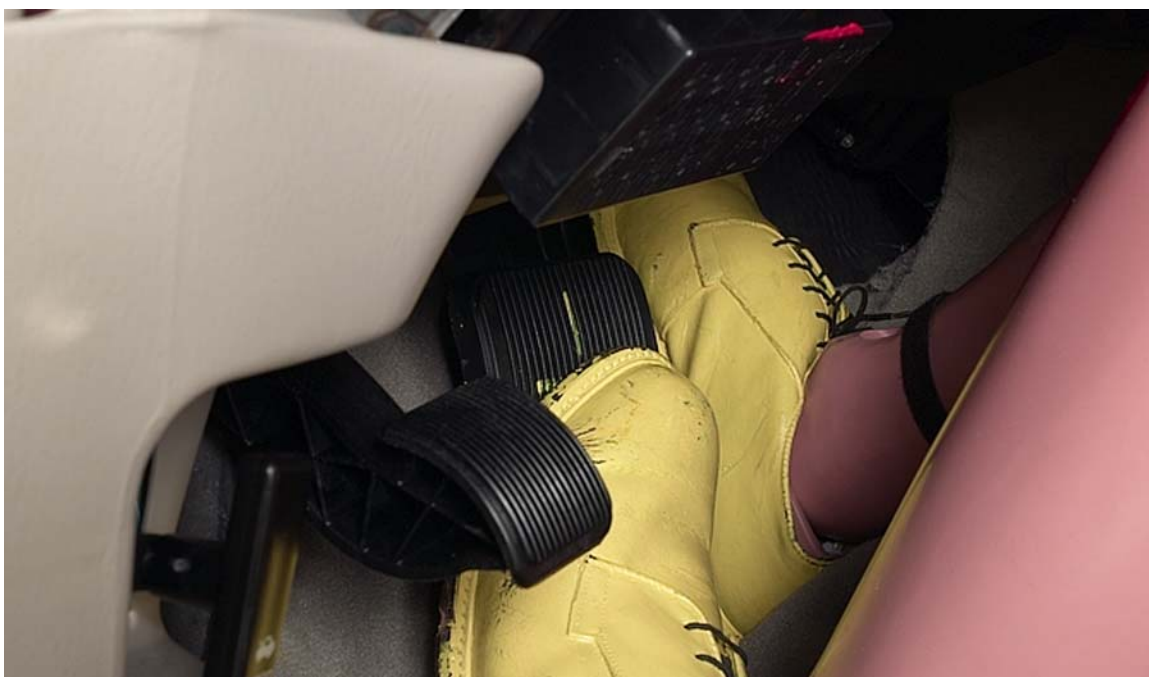
**Figure 6**  
**Dummy Feet Positions, Postcrash — 2003 Lincoln Town Car**
