**Report Number: 214-TRC-03-015**

**Safety Compliance Testing For FMVSS 214**

**Side Impact Protection**

**2004 Mazda 3 4-door**

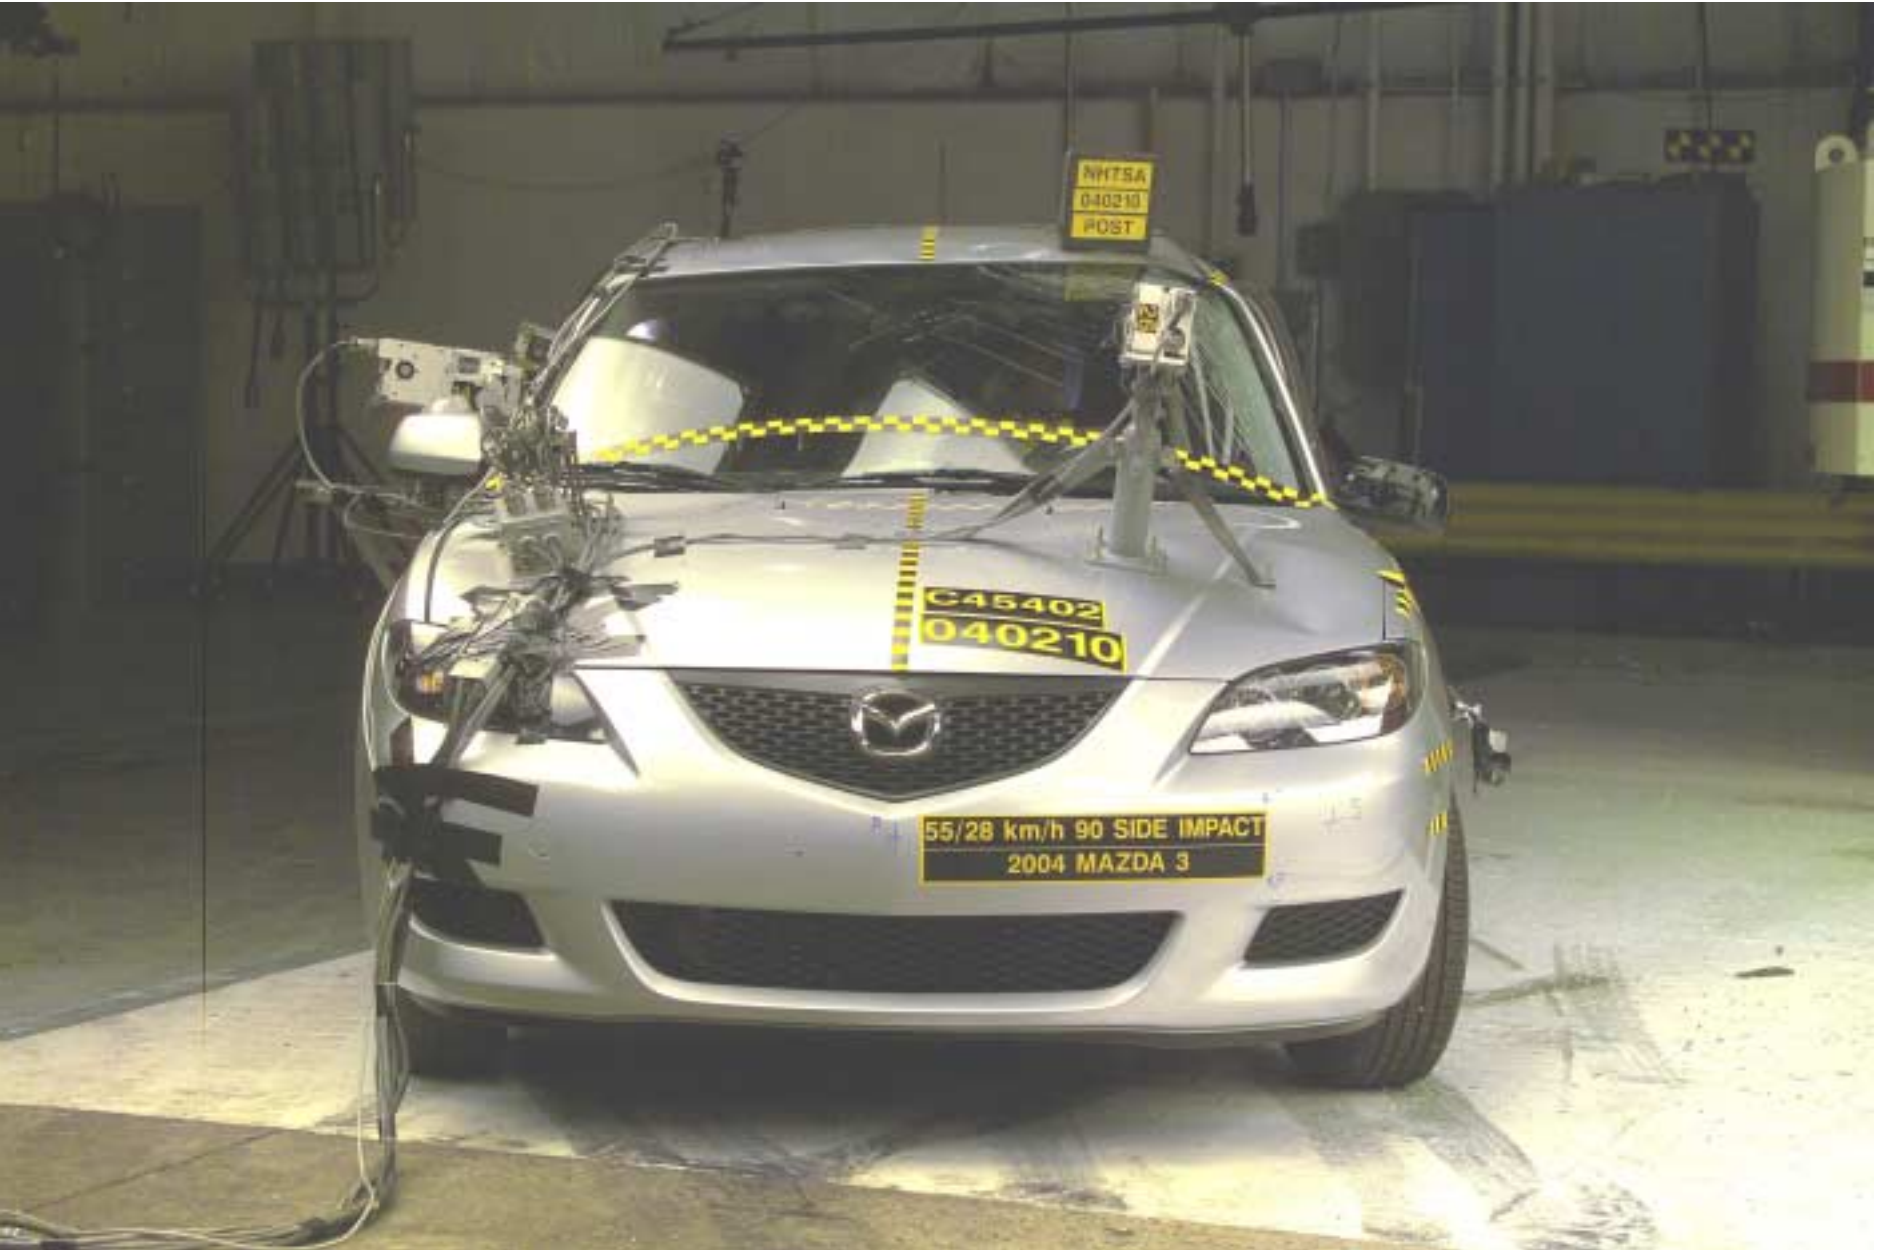
Figure A-2 Post-Test Front View of Test Vehicle  
A-5

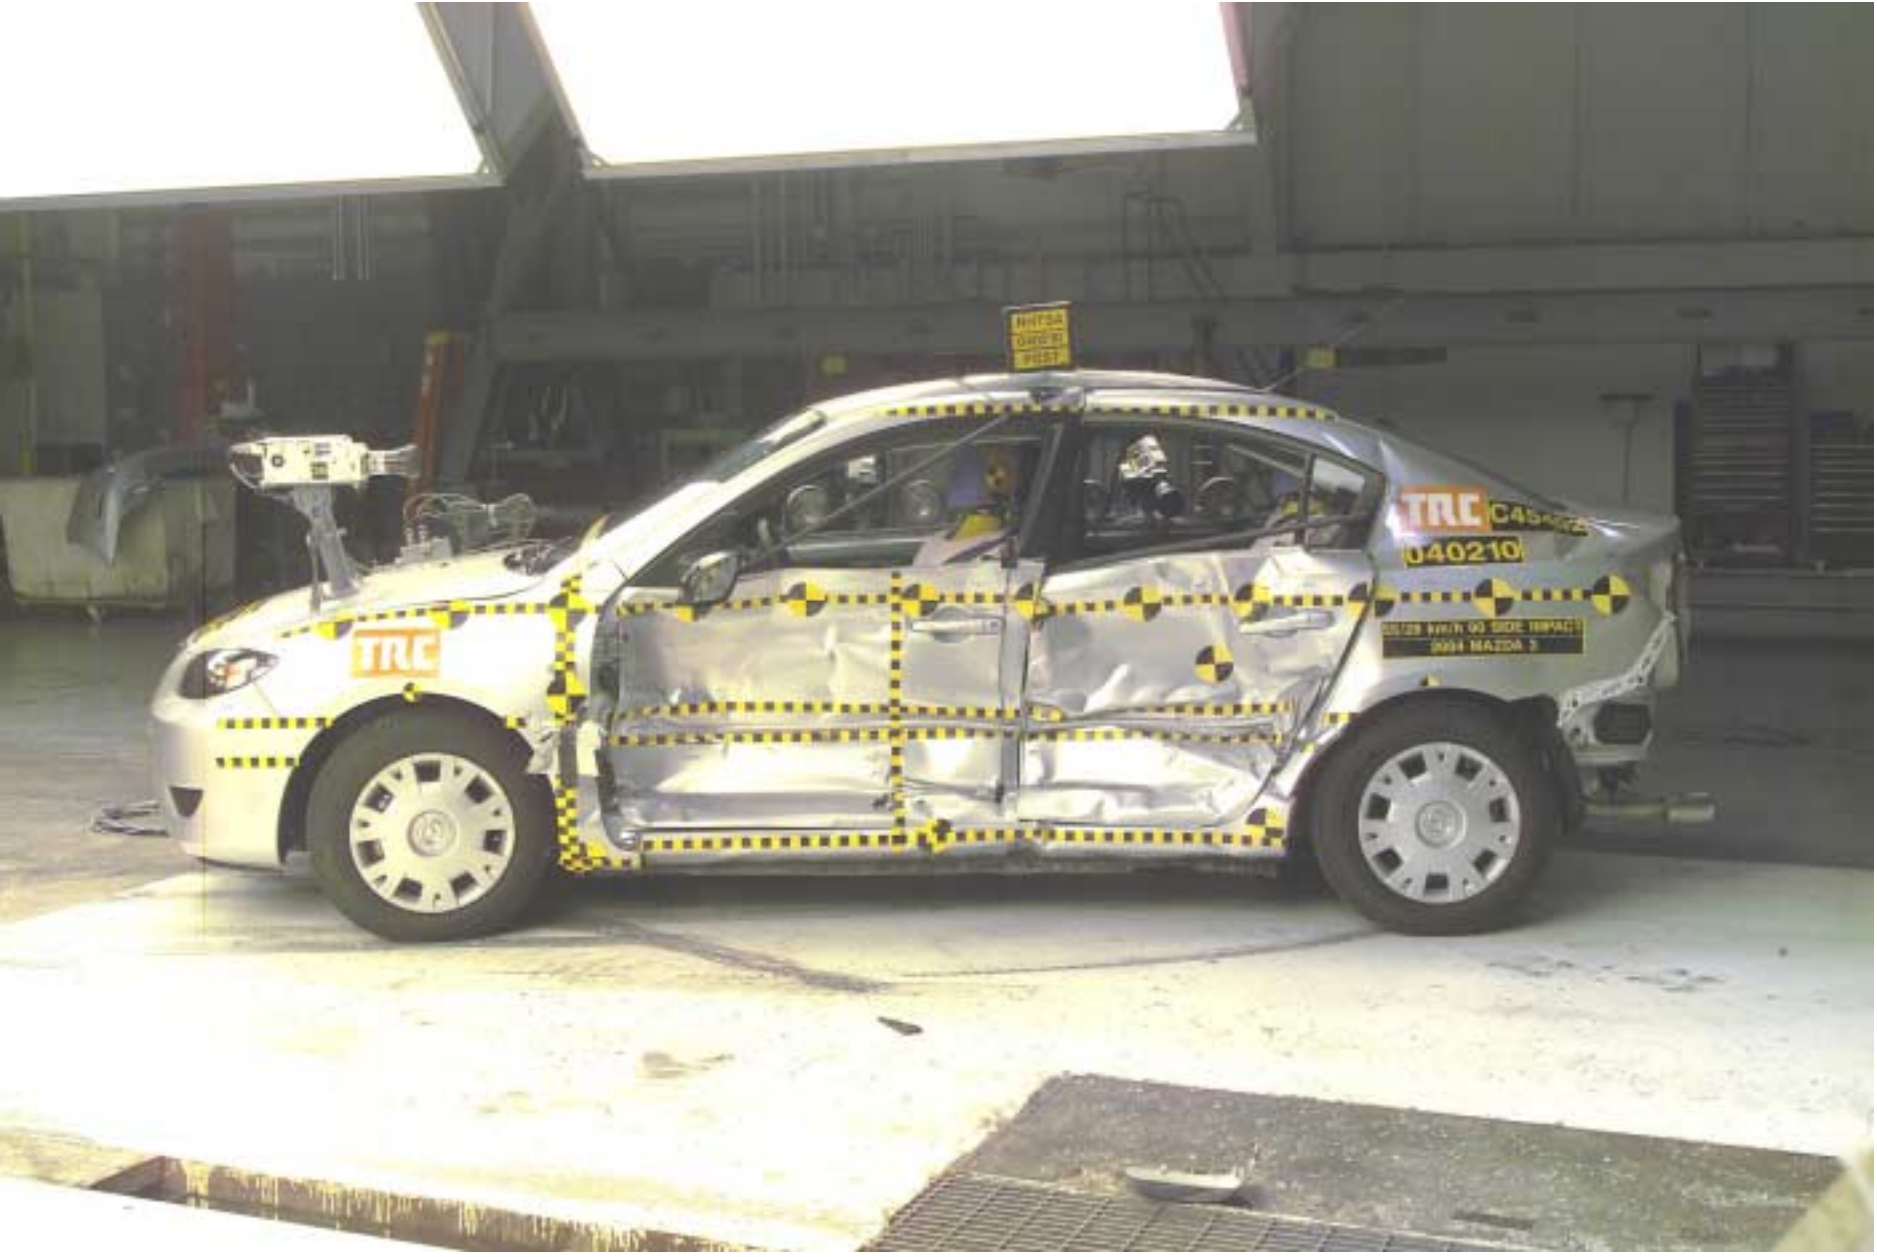
Figure A-4 Post-Test Impacted Side View of Test Vehicle  
A-7

Full length of induced damage was 1950 mm.

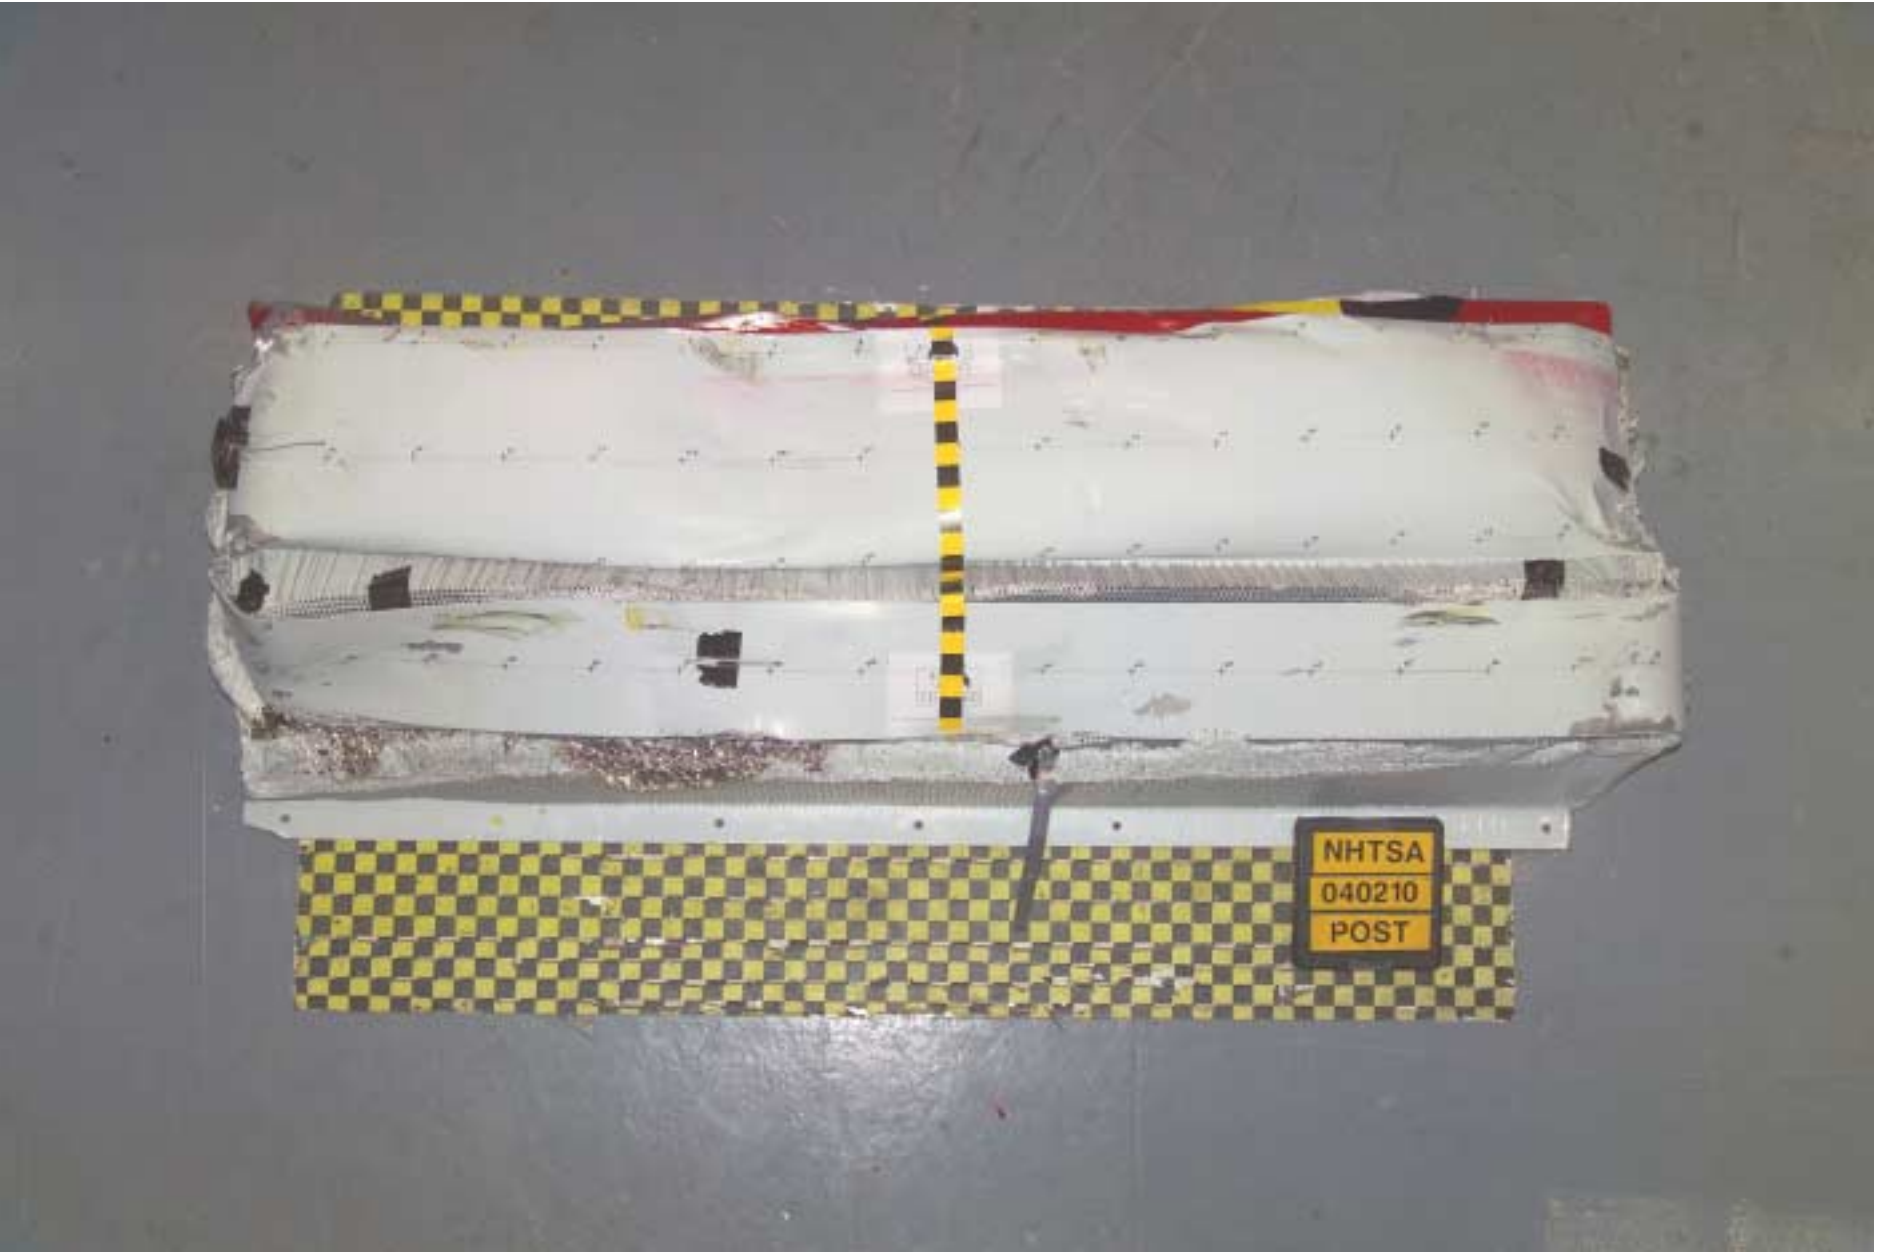
Figure A-8 Post-Test Frontal View of Impactor Face  
A-11

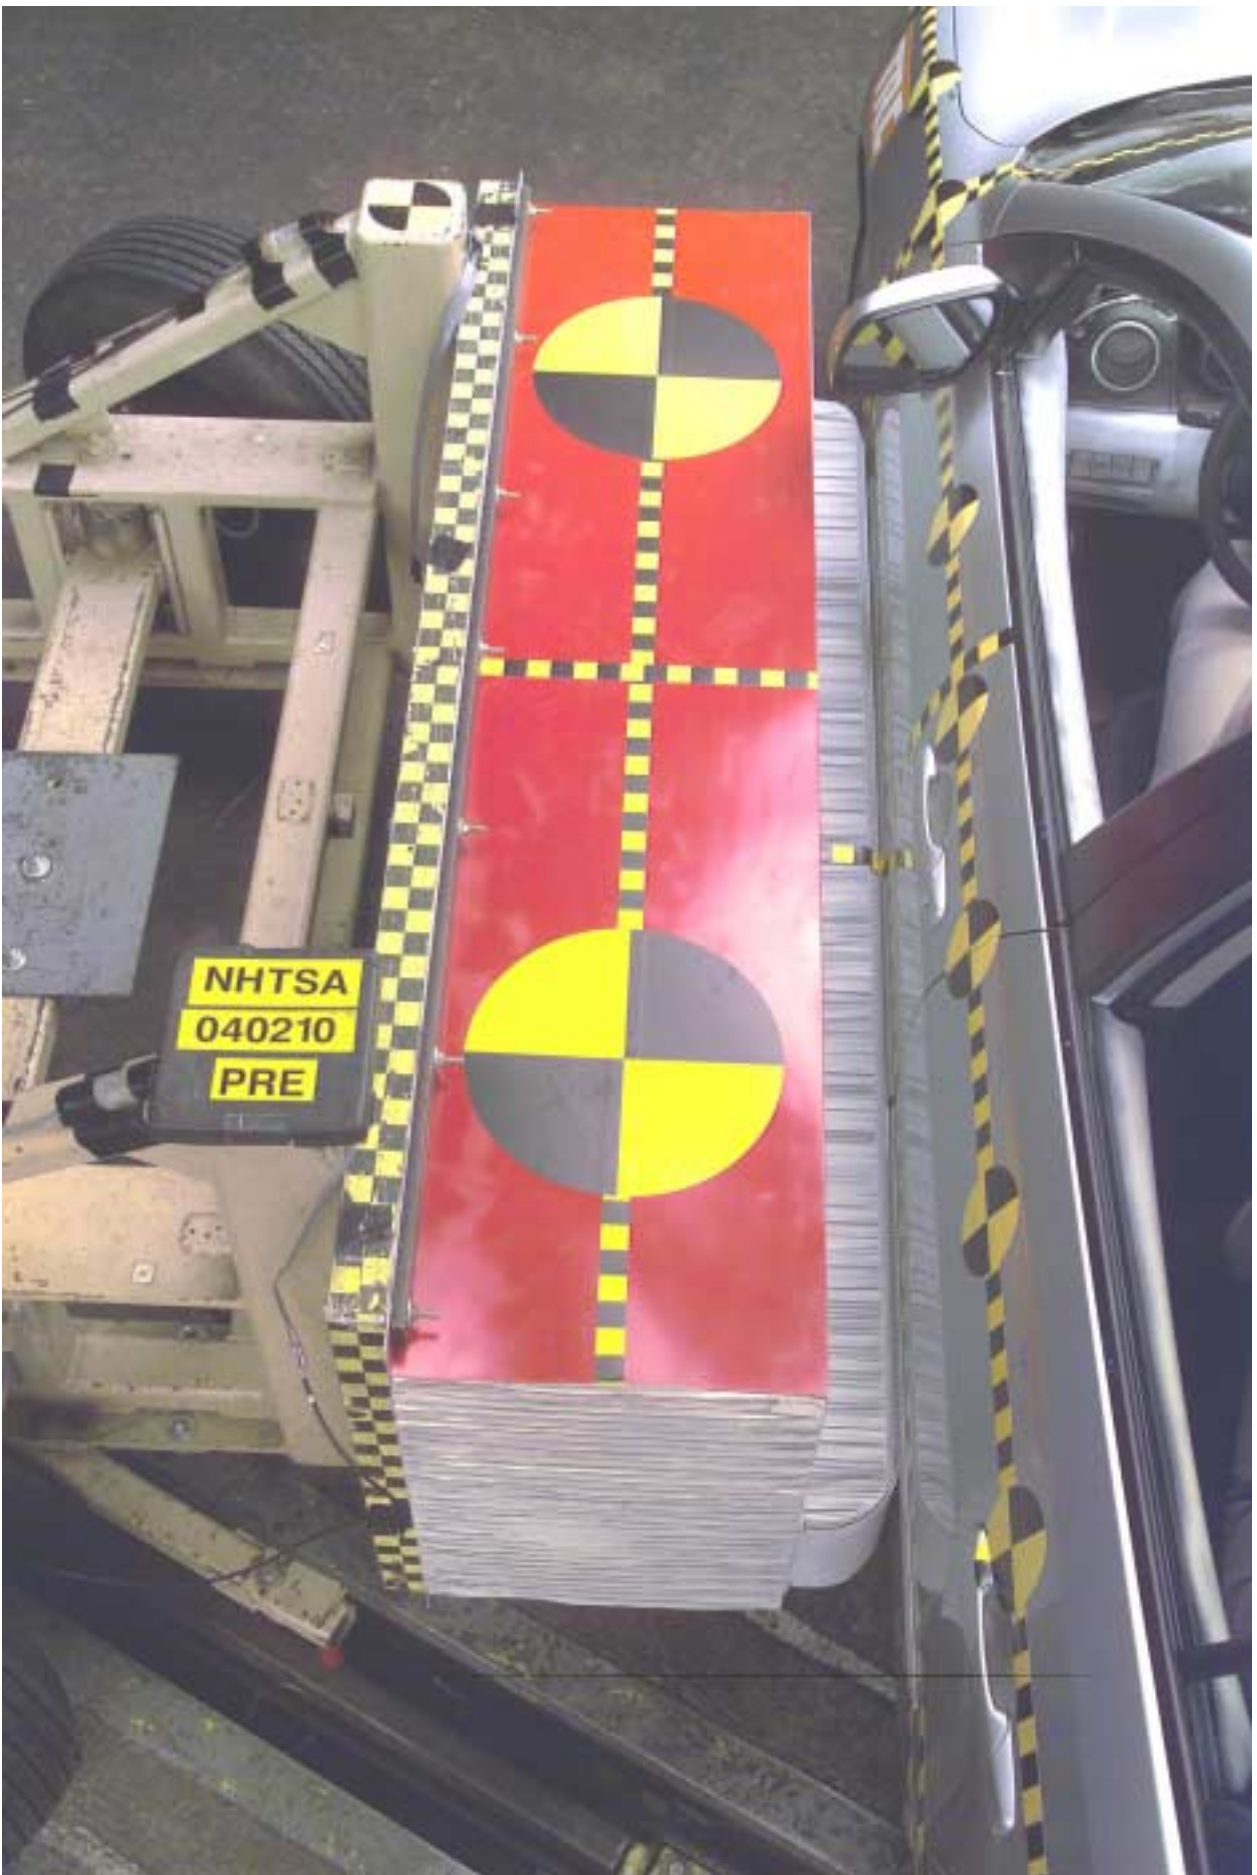
**Figure A-16 Pre-Test Overhead View of MDB Aligned with Vehicle**

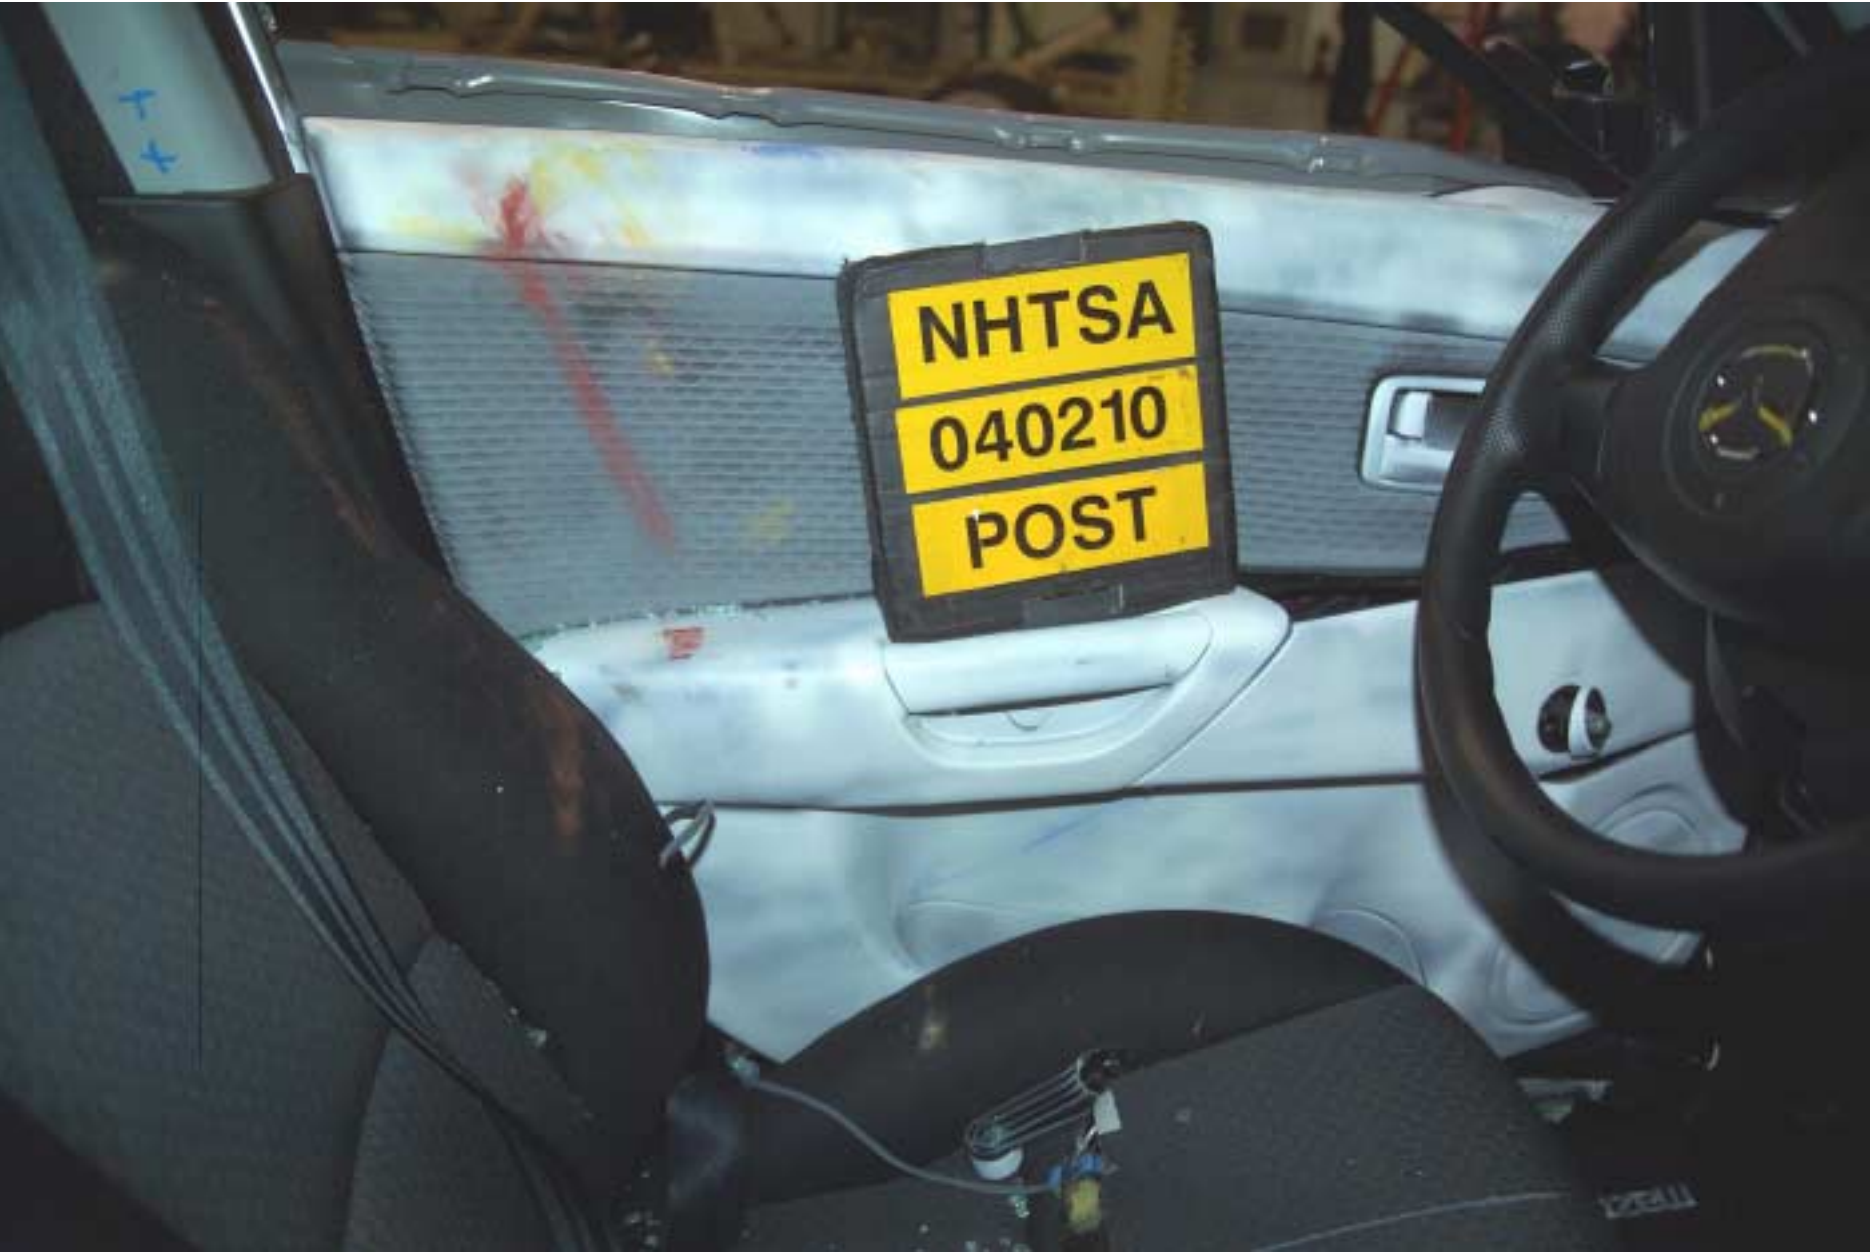
Figure A-29 Post-Test Interior of Front Door Showing SID HIII Impact Locations

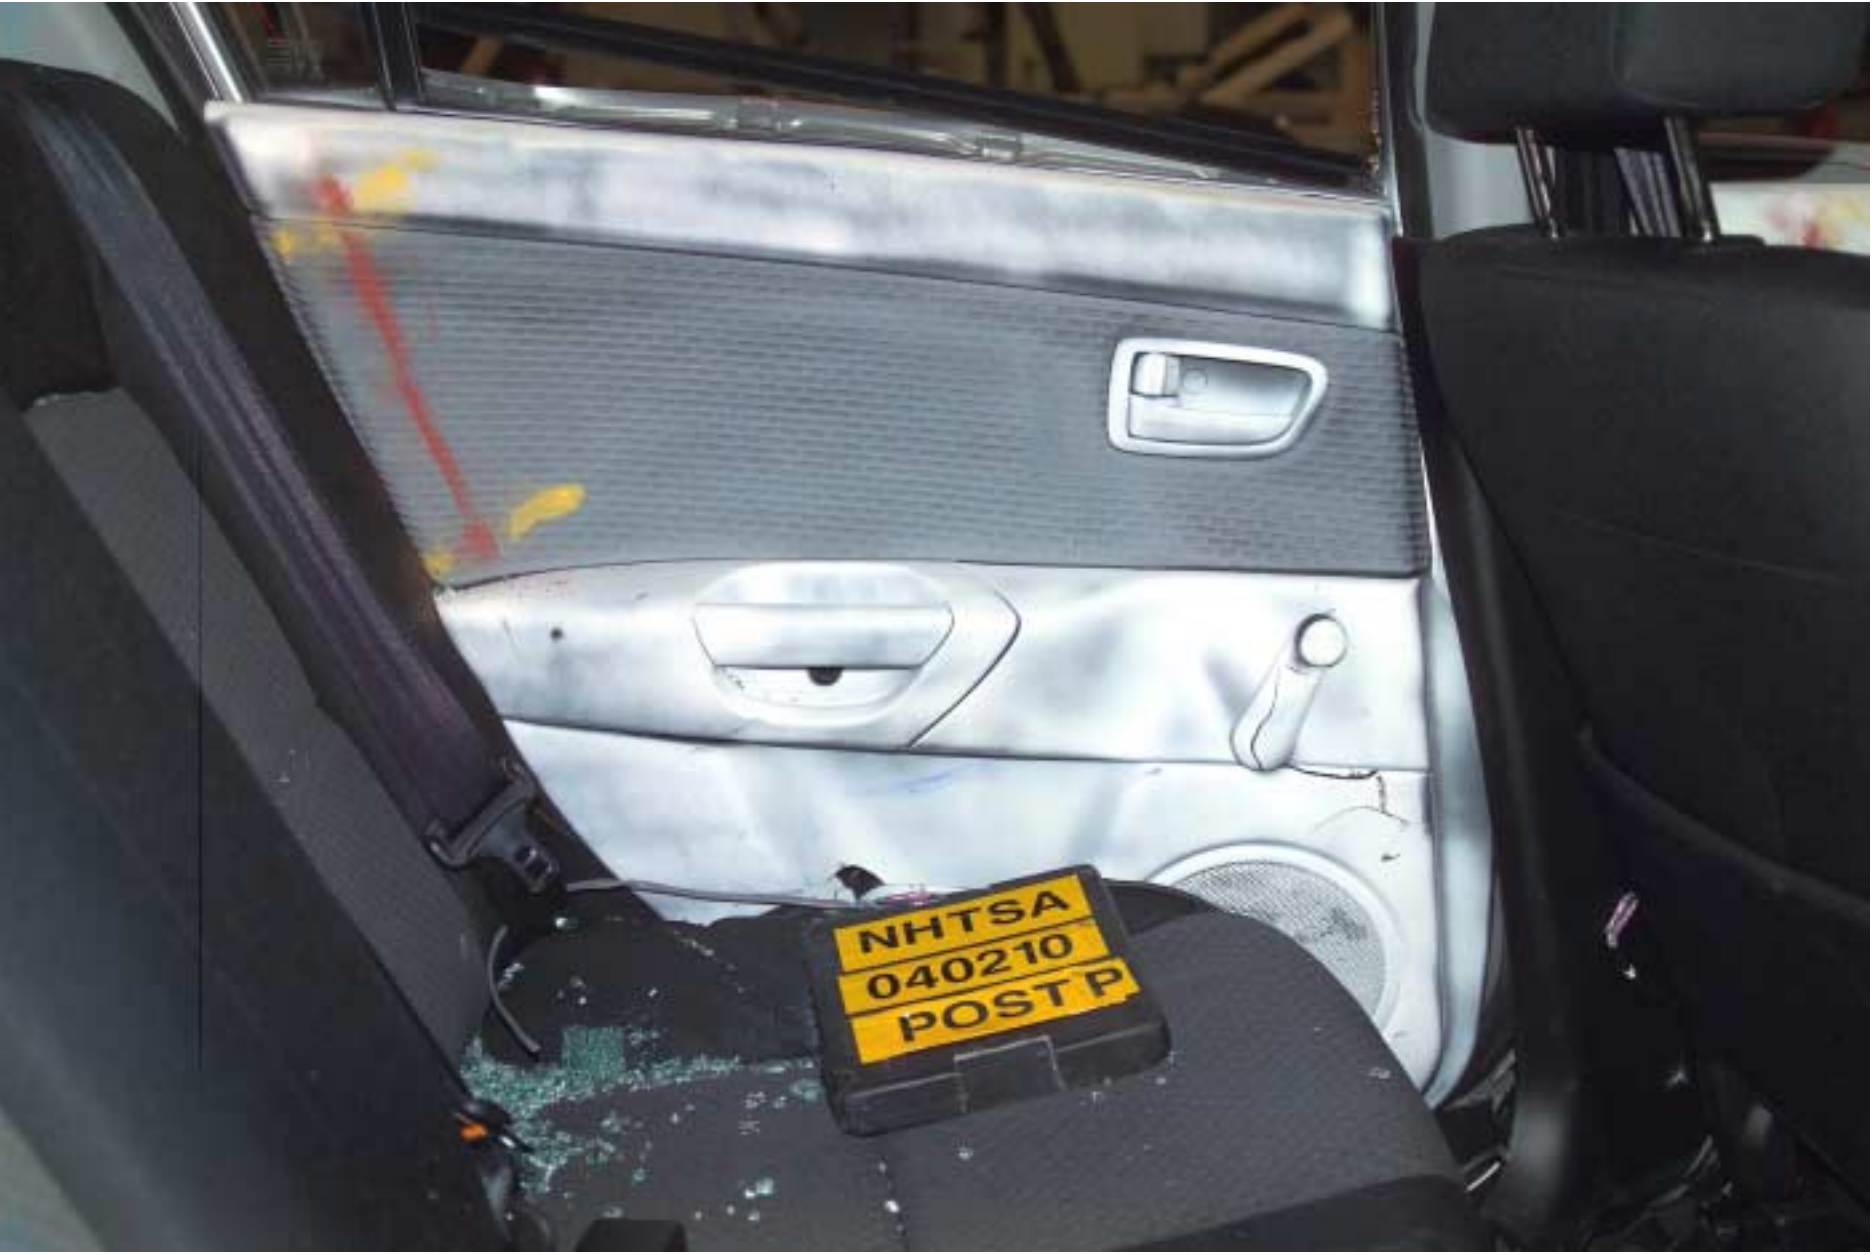
Figure A-32 Post-Test Interior of Rear Panel Showing SID HIII Impact Locations
