**REPORT NUMBER: NCAPSIDE-MGA-2004-004**

**NEW CAR ASSESSMENT PROGRAM  
SIDE IMPACT TEST**

**General Motors Corporation  
2004 Cadillac SRX  
NHTSA NUMBER: M40112**

**PREPARED BY:  
MGA RESEARCH CORPORATION  
5000 WARREN ROAD  
BURLINGTON, WI 53105**

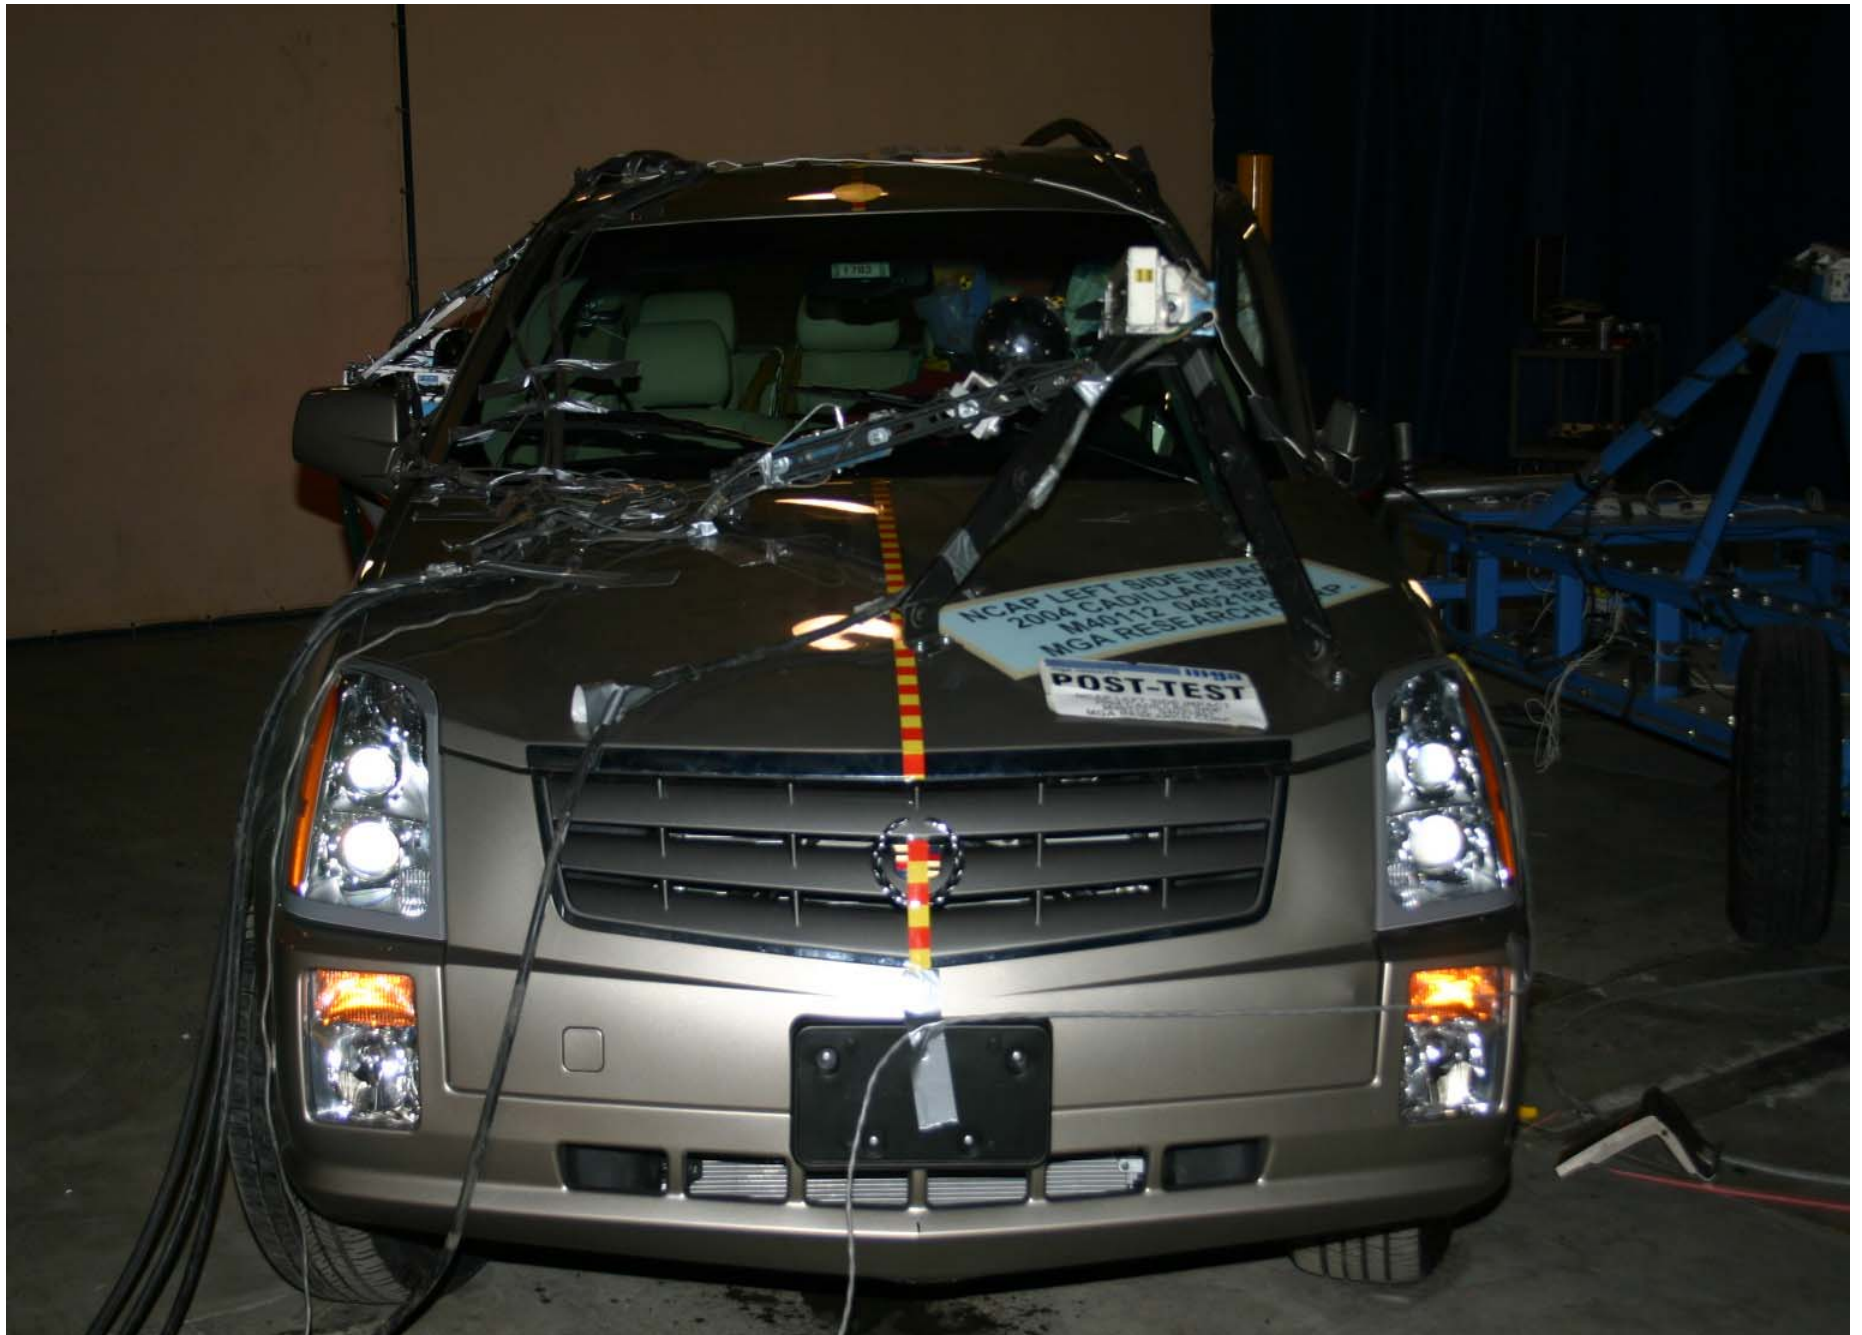
Post-Test Front View of Test Vehicle

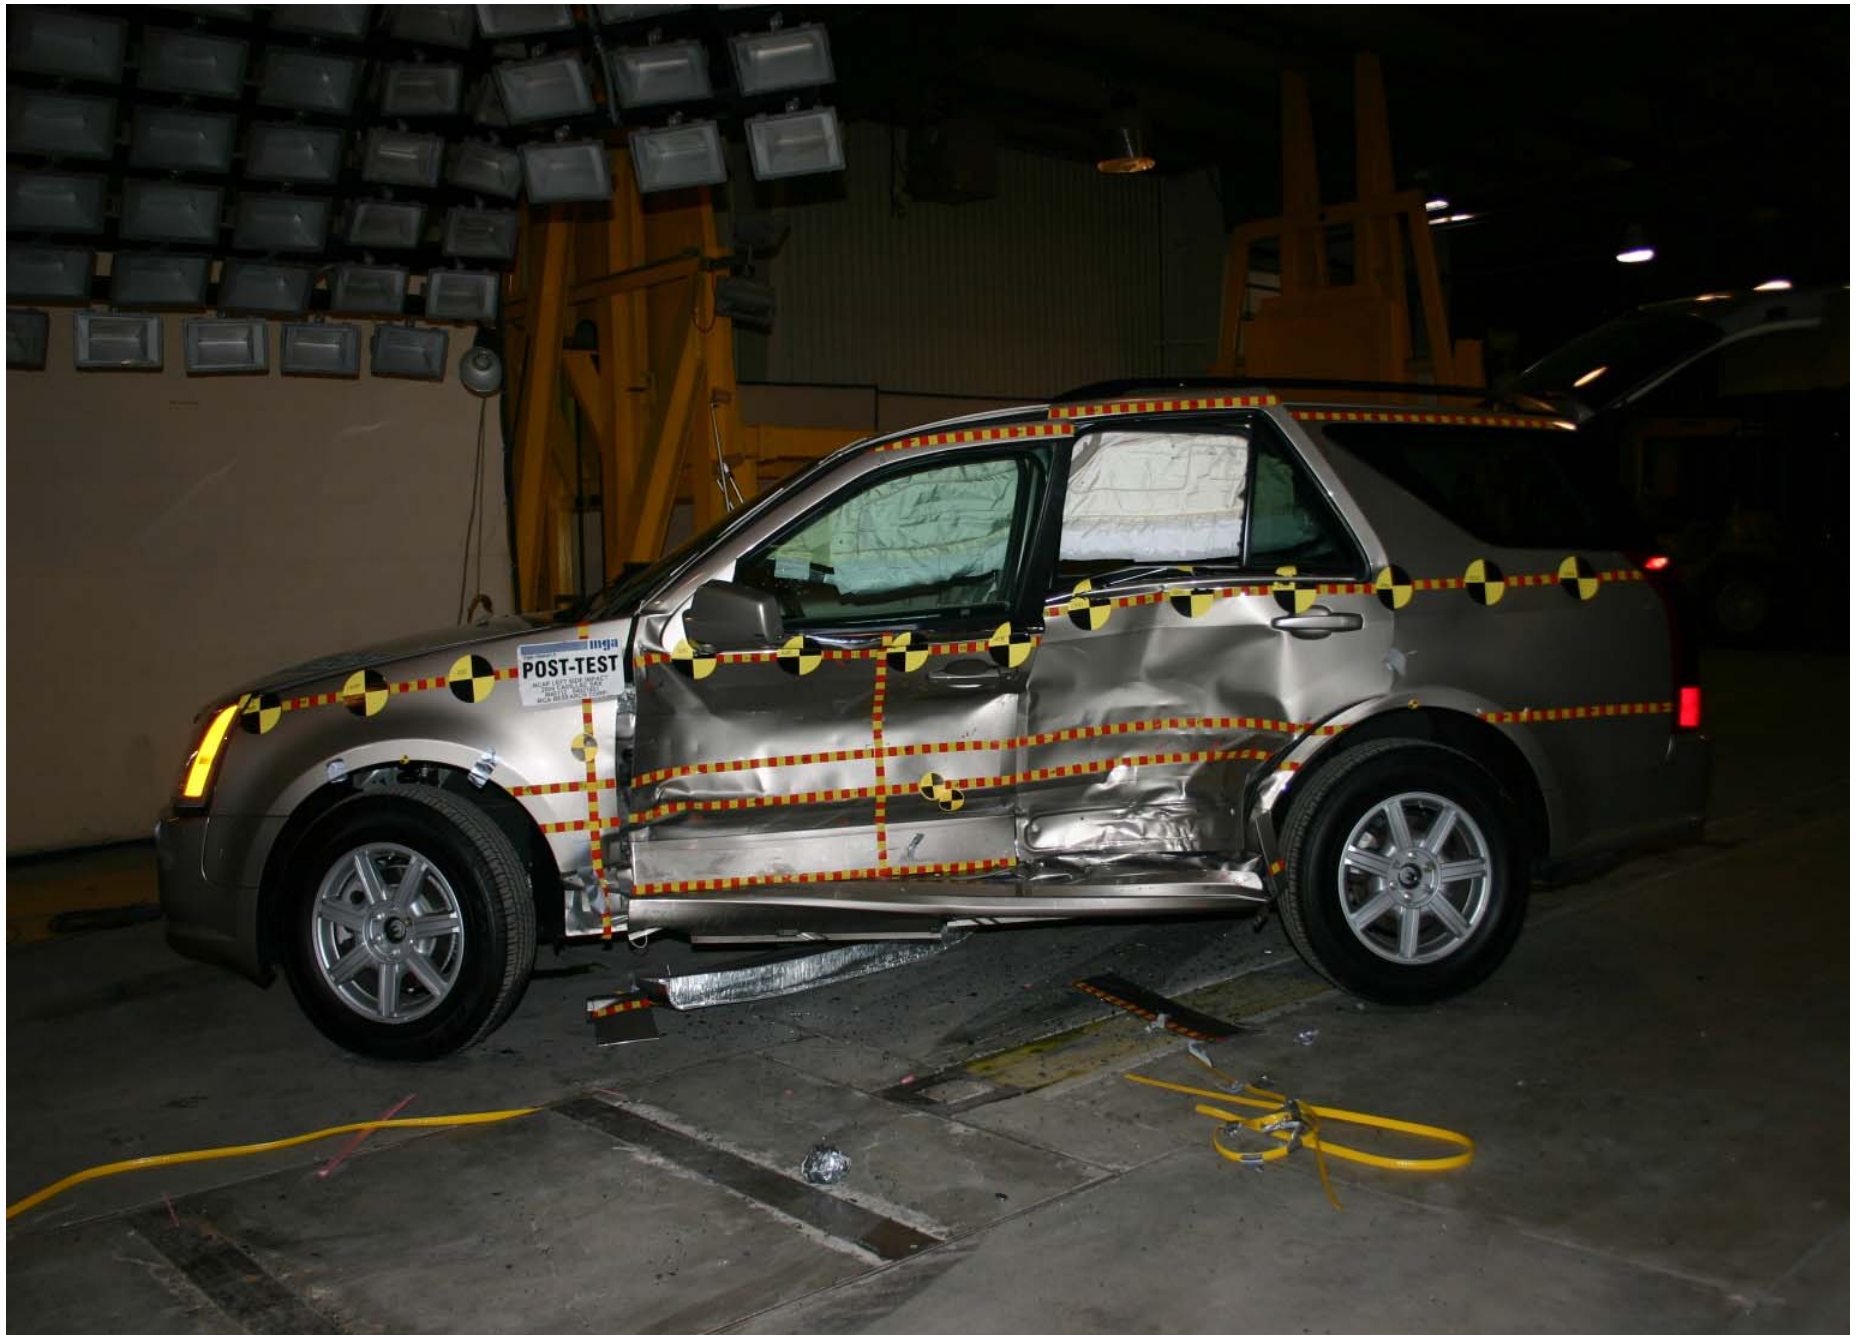
Post-Test Left Side View of Test Vehicle

The test vehicle sustained a maximum static crush of 345 mm at level 1, 1350 mm rearward of the left vertical impact point. The driver and passenger SID/HIIL's, Serial Nos. 271 and 904 respectively, were calibrated just prior to this test. The SID/HIIL's injury criteria are summarized as follows:

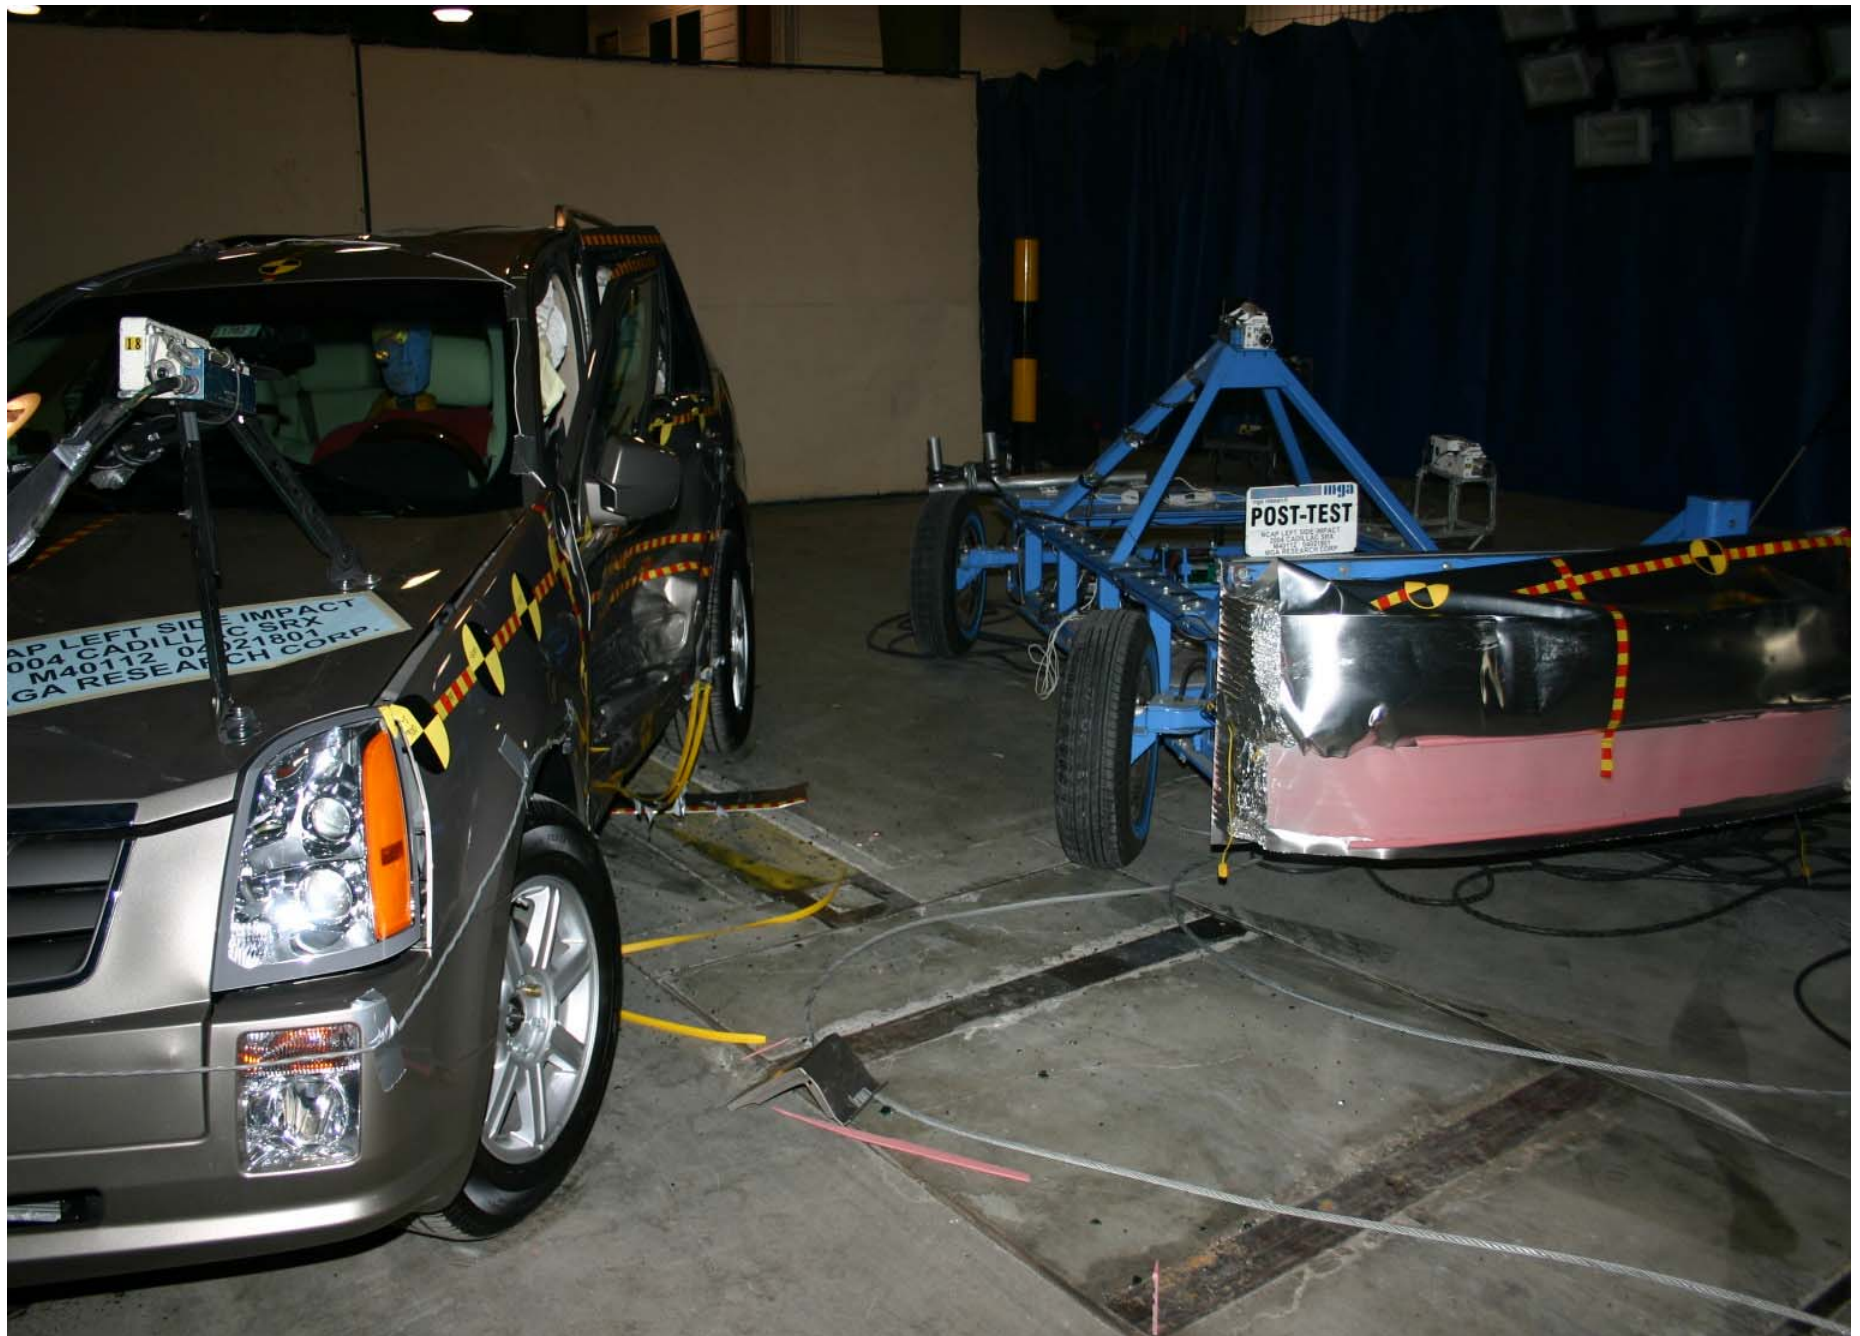
Post-Test MDB and Vehicle (Left Front View)

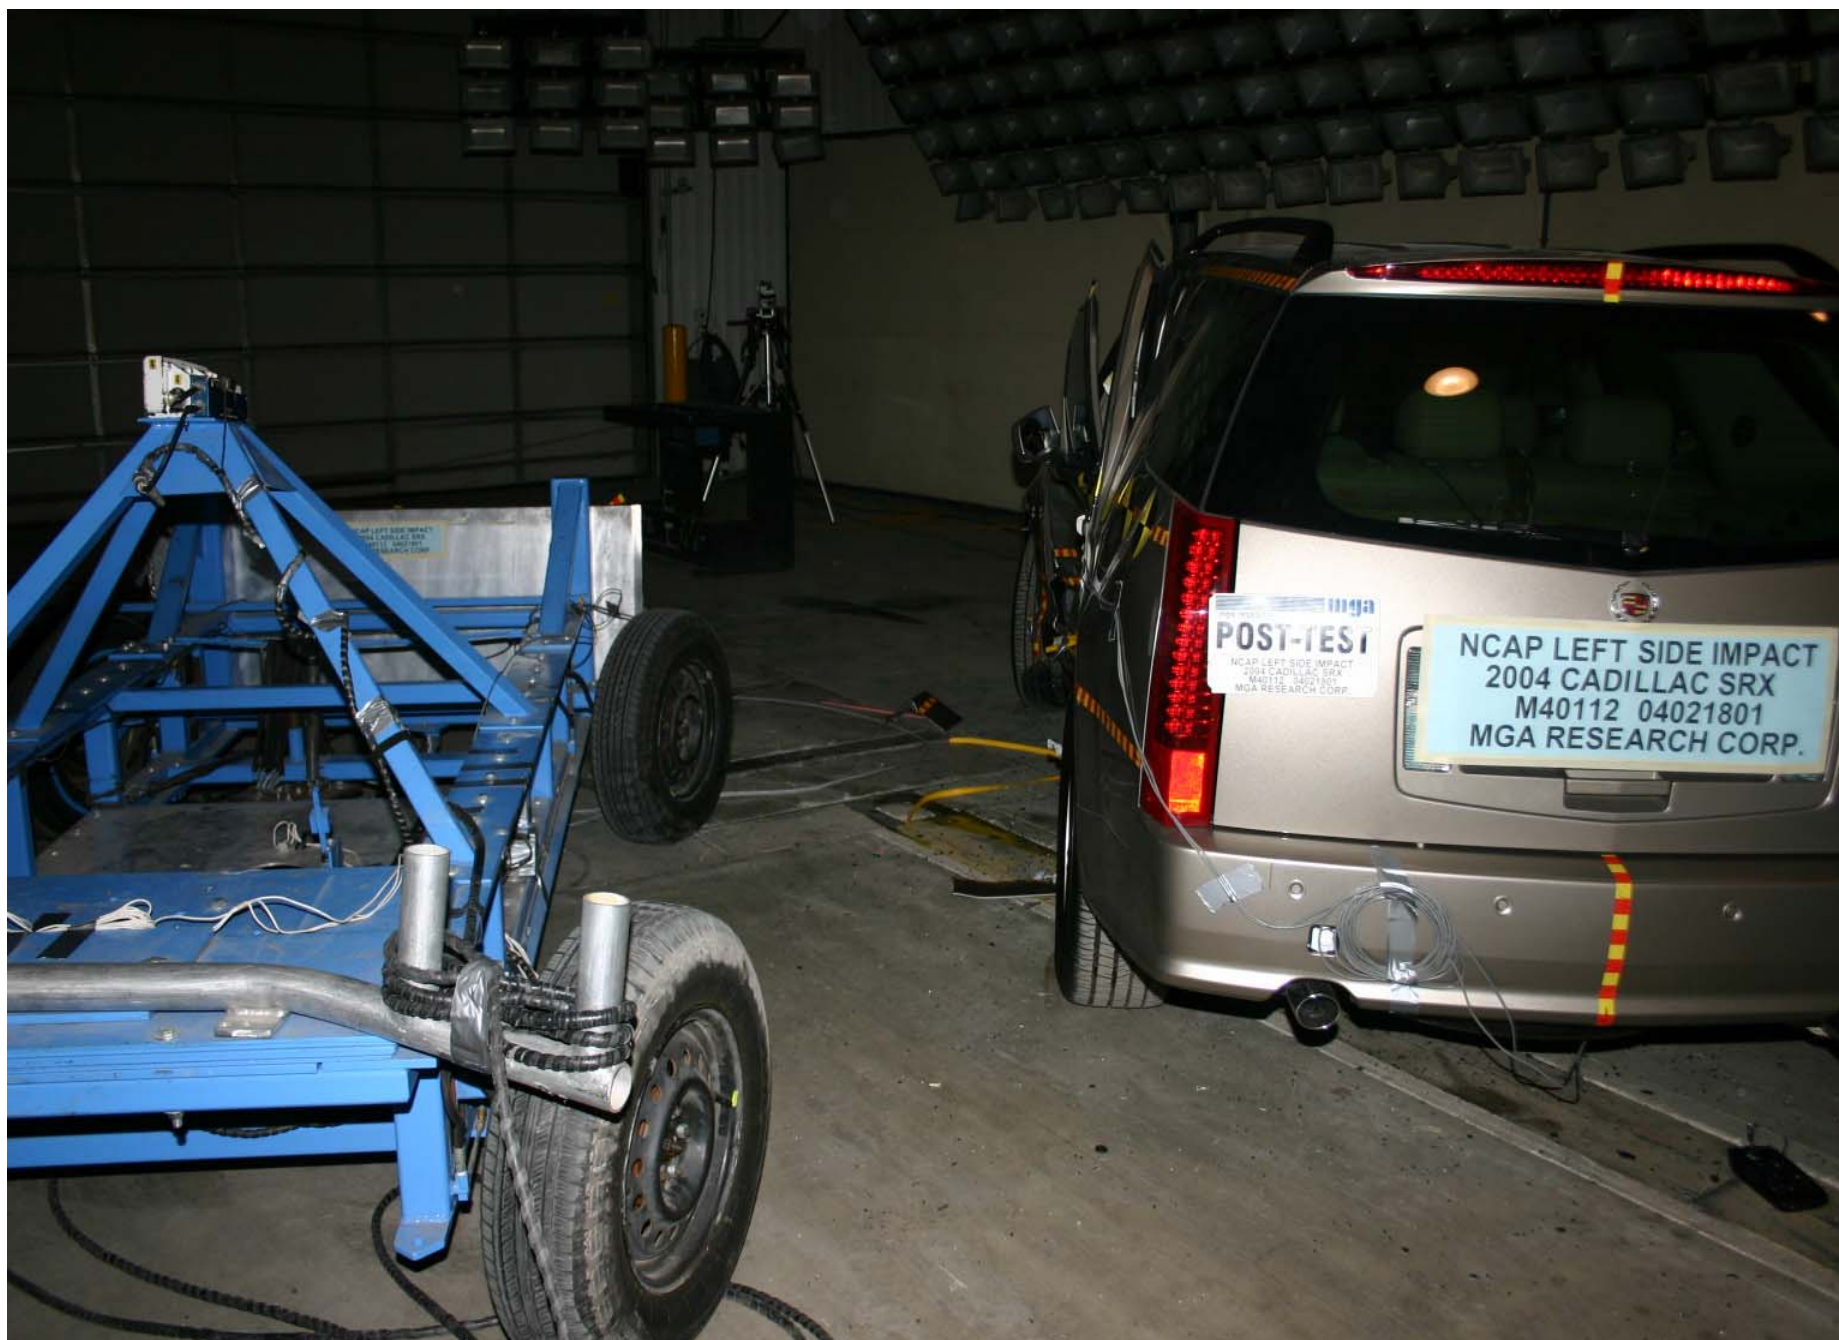
Post-Test MDB and Vehicle (Left Rear View)

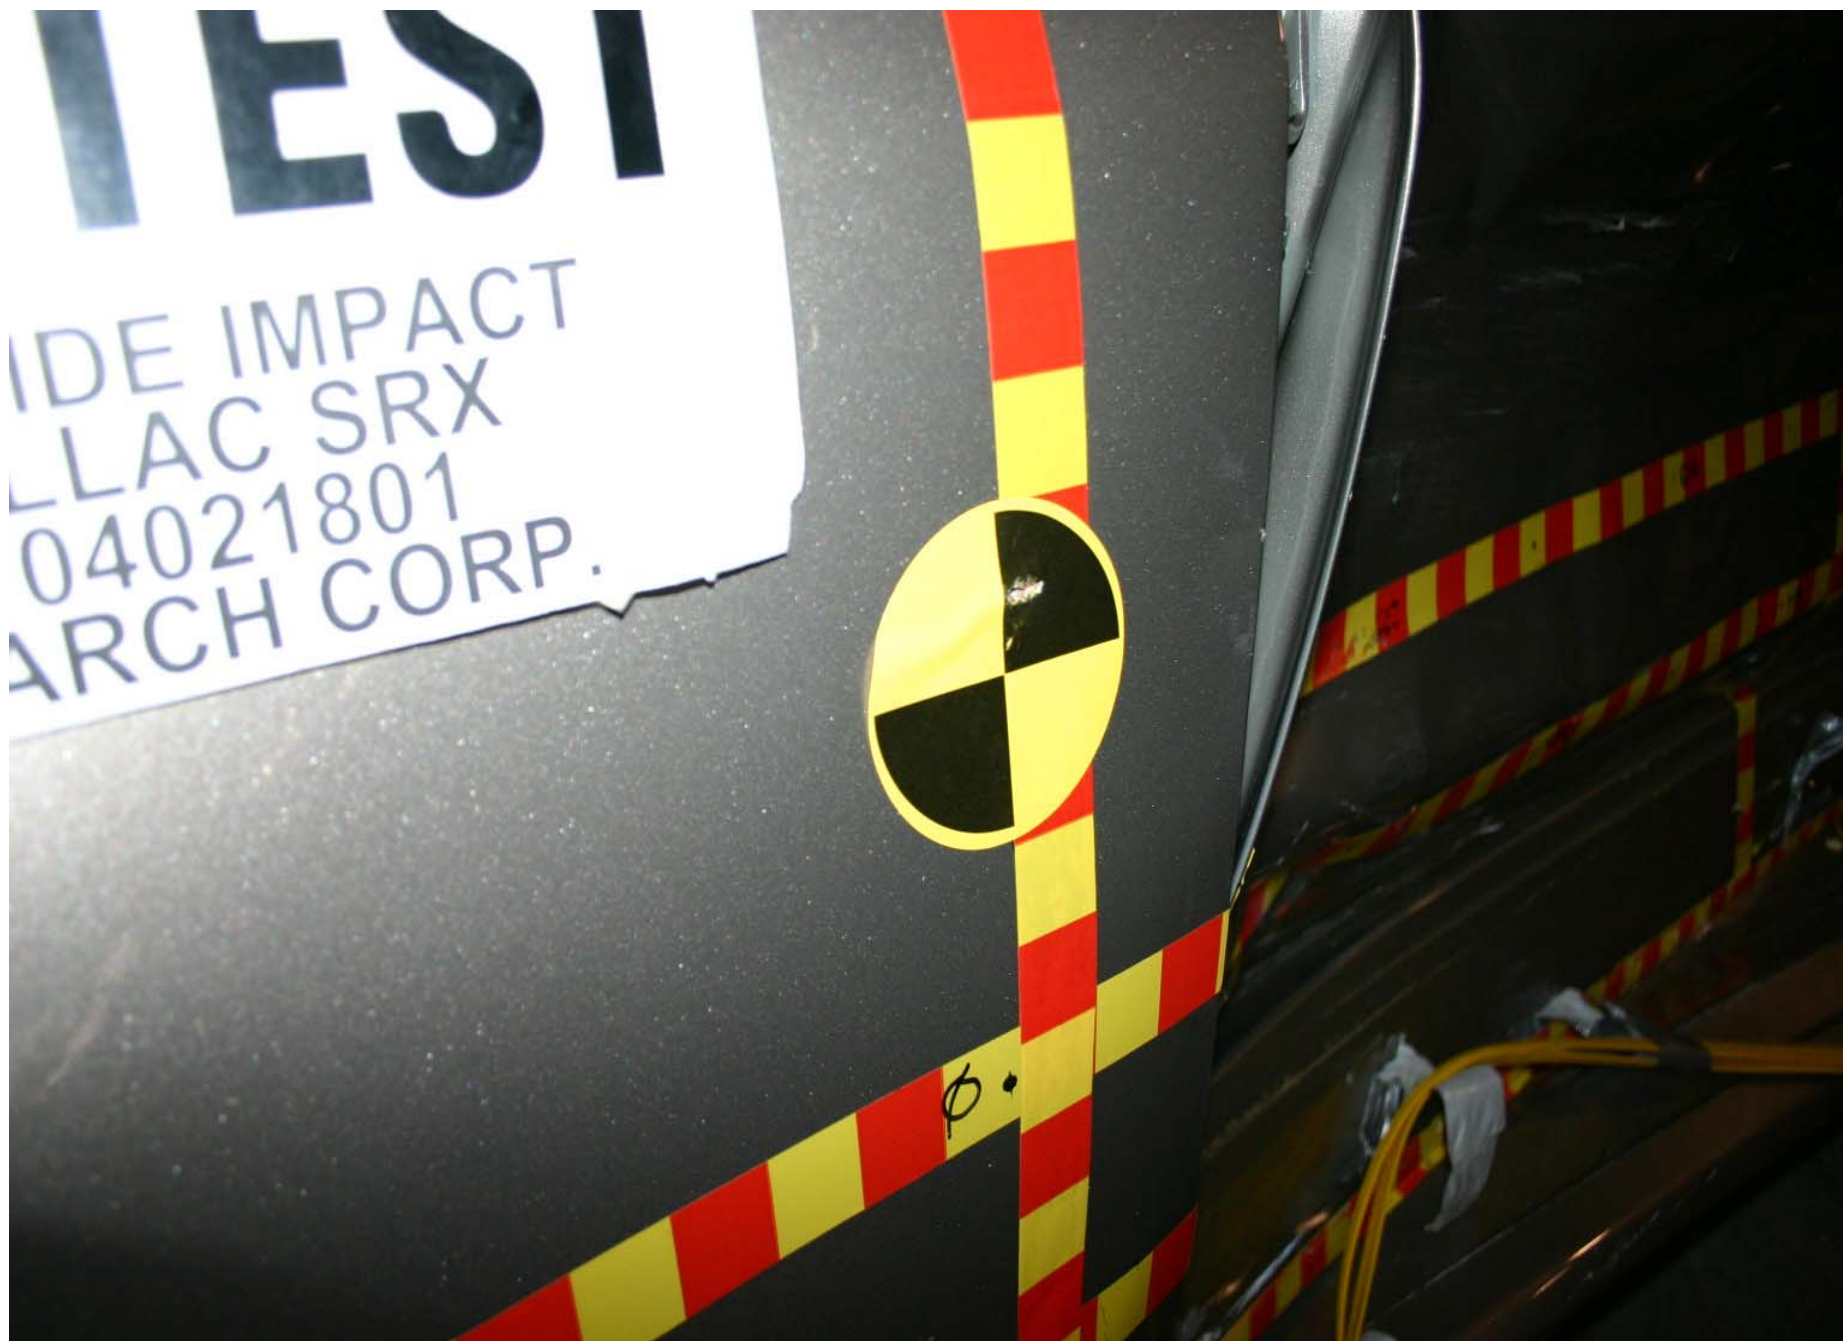
Post-Test Impact Point on Vehicle

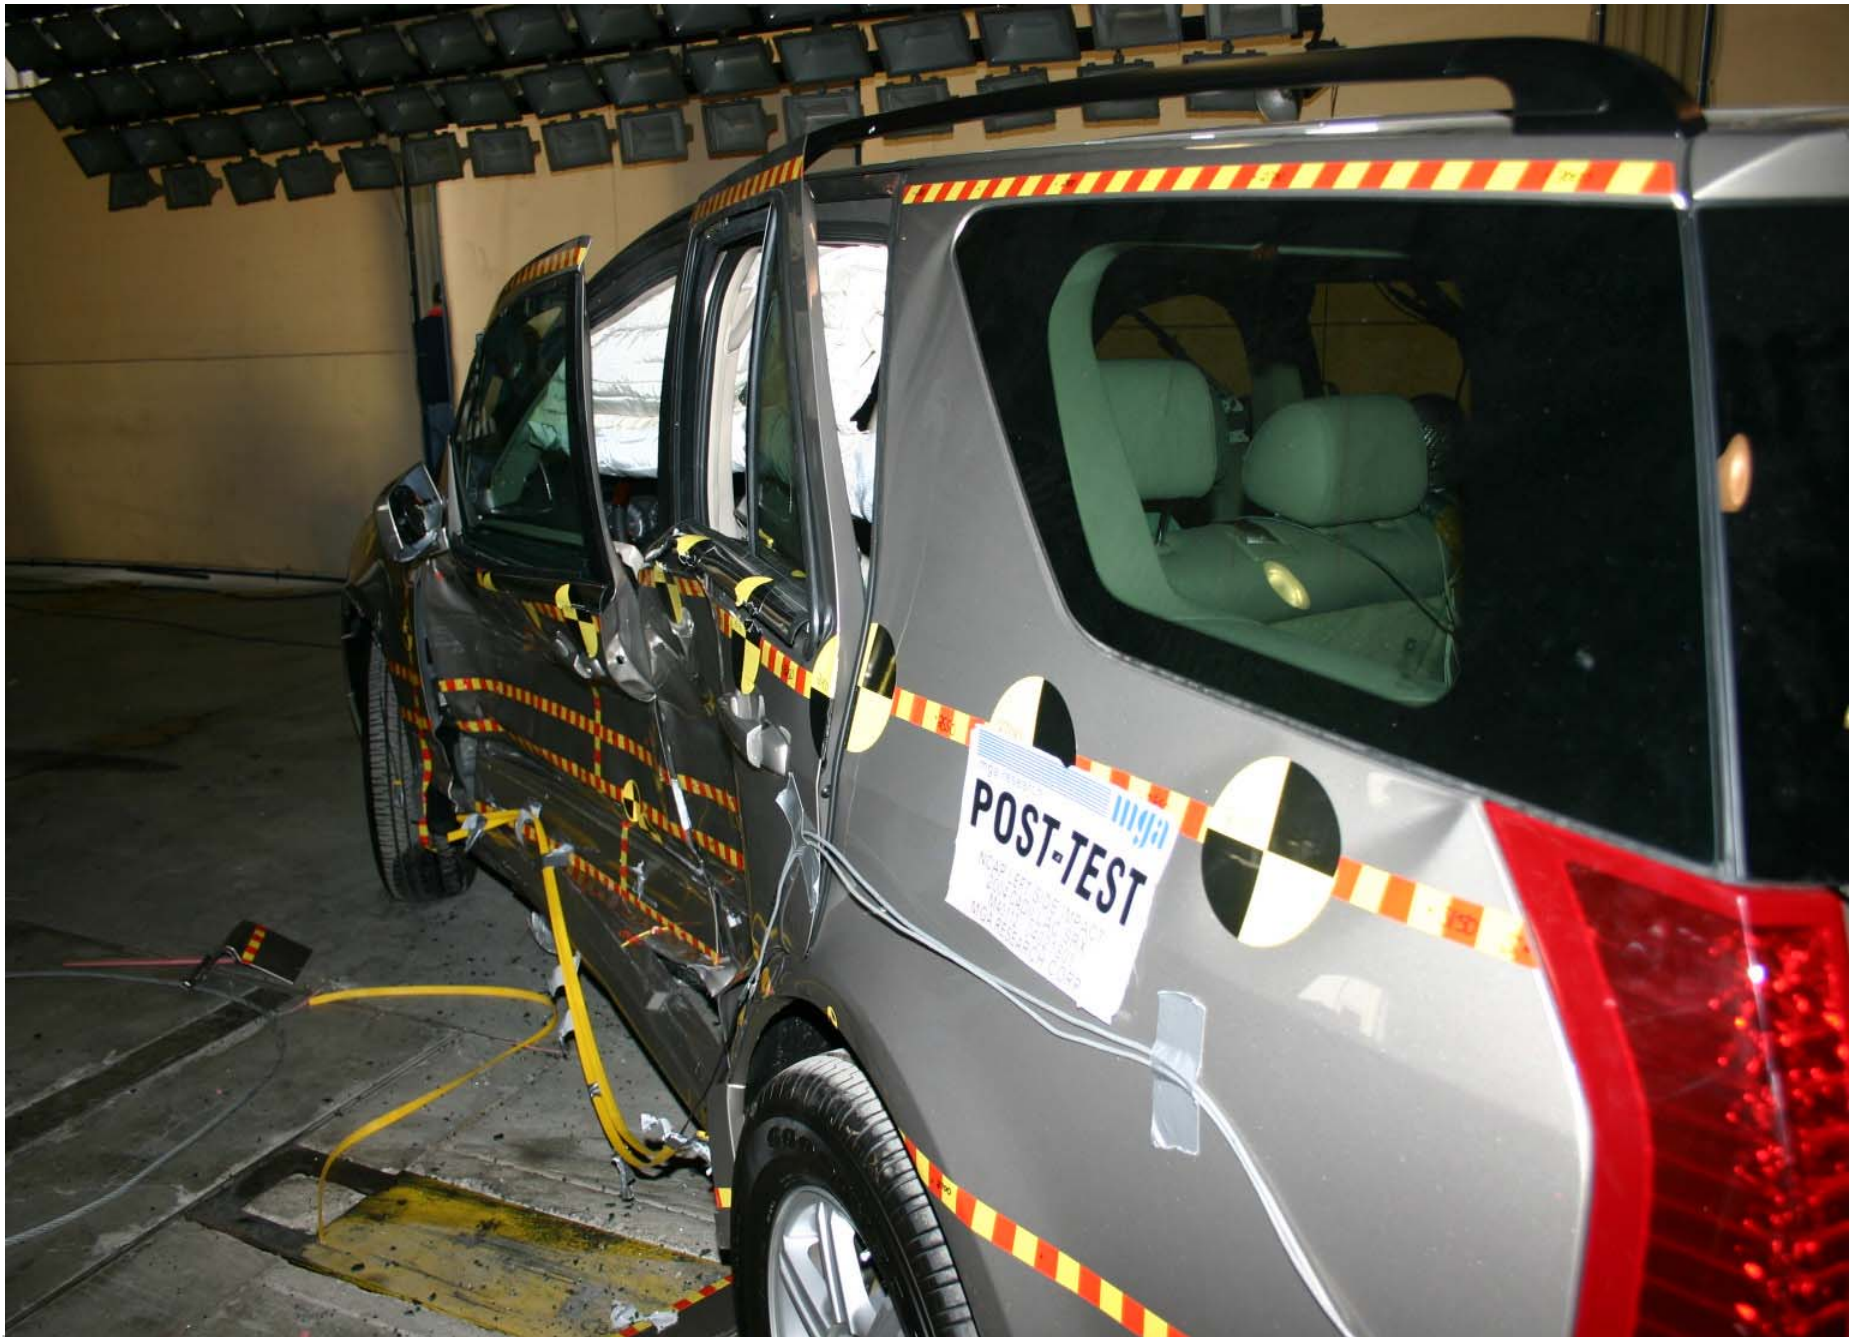
Post-Test Rear  $\frac{3}{4}$  View of Left Doors of Test Vehicle

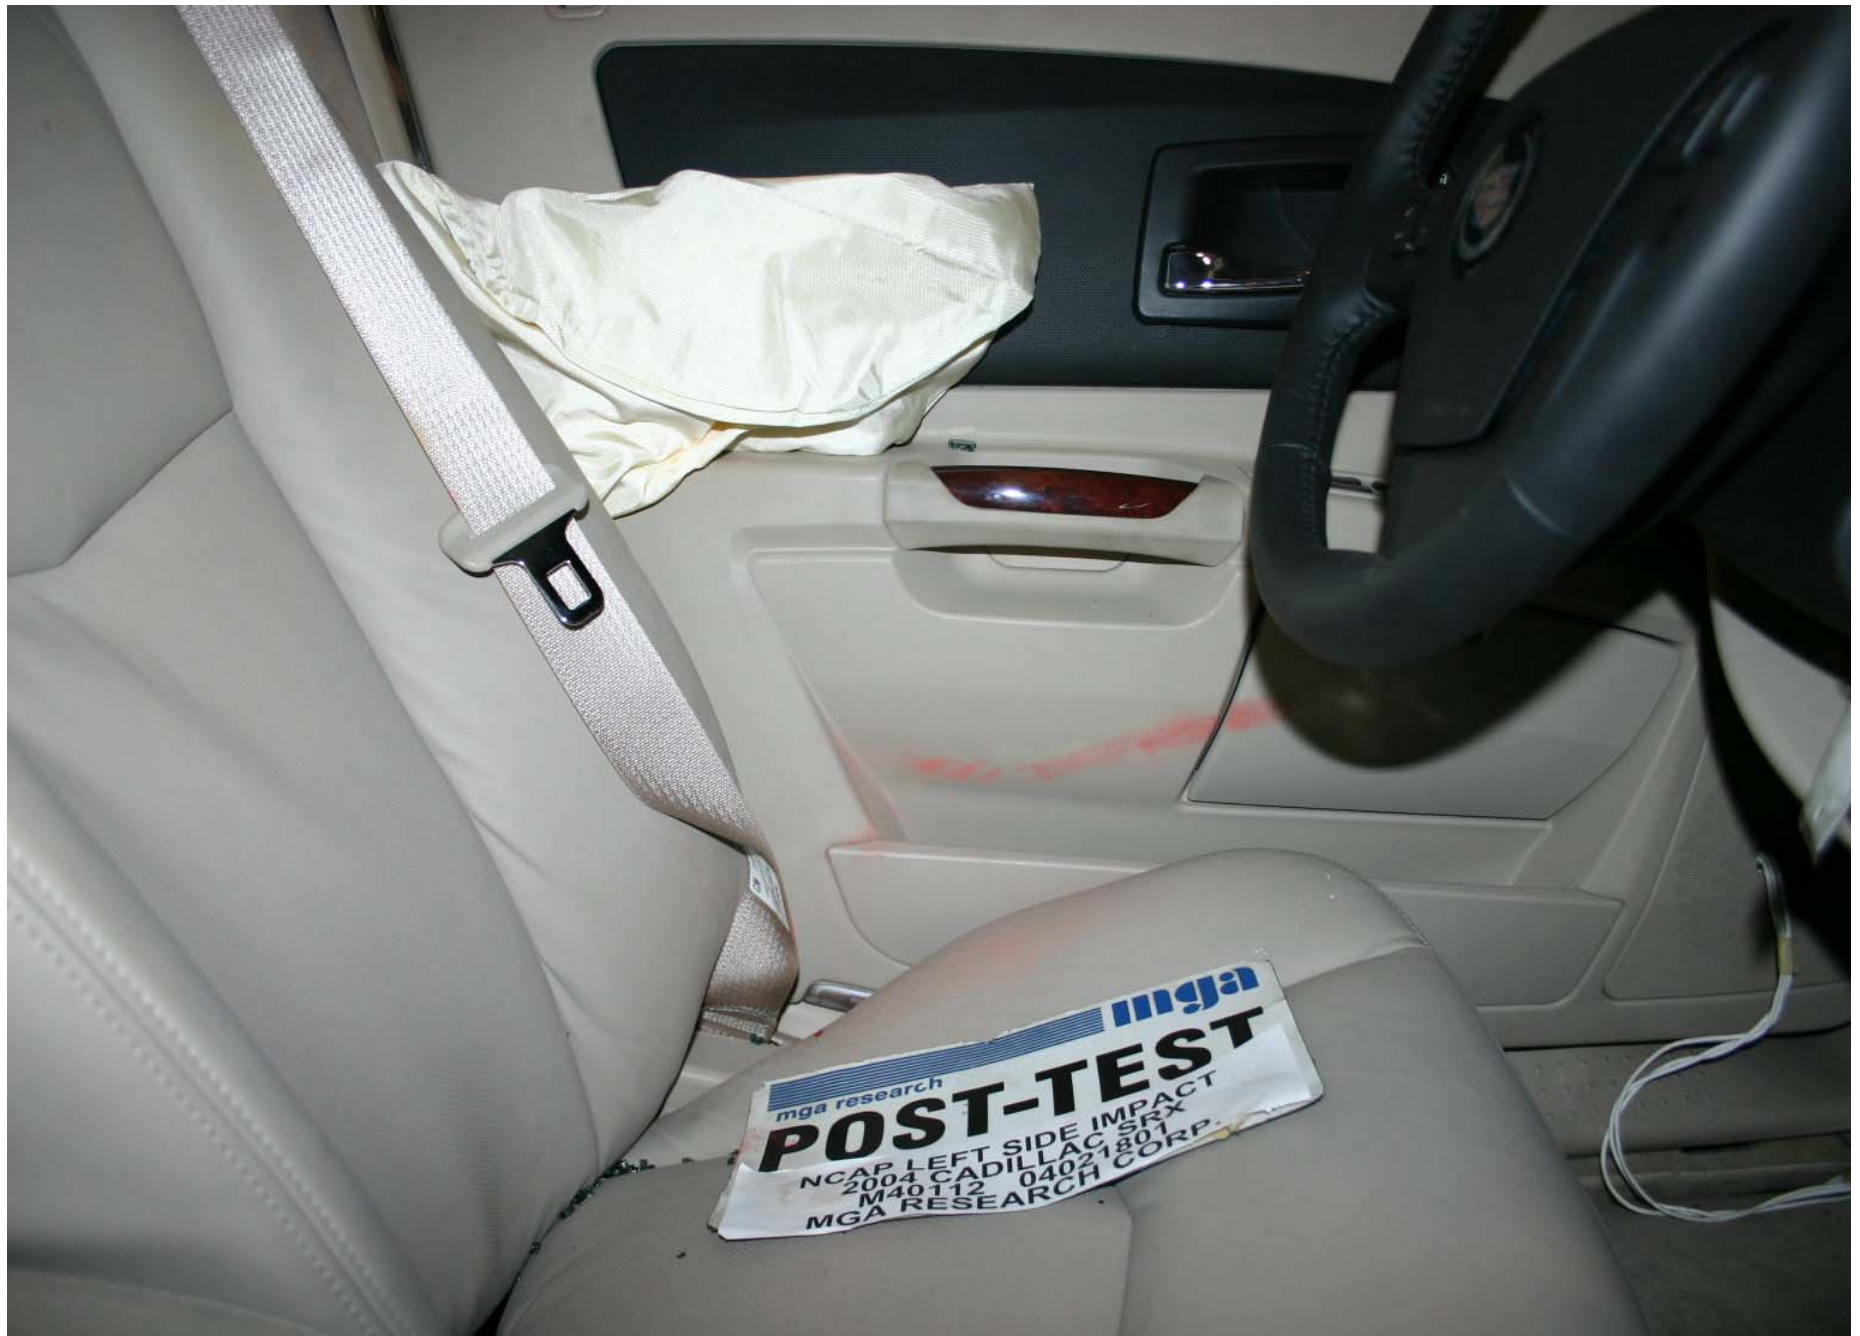
Post-Test Driver Dummy Contact

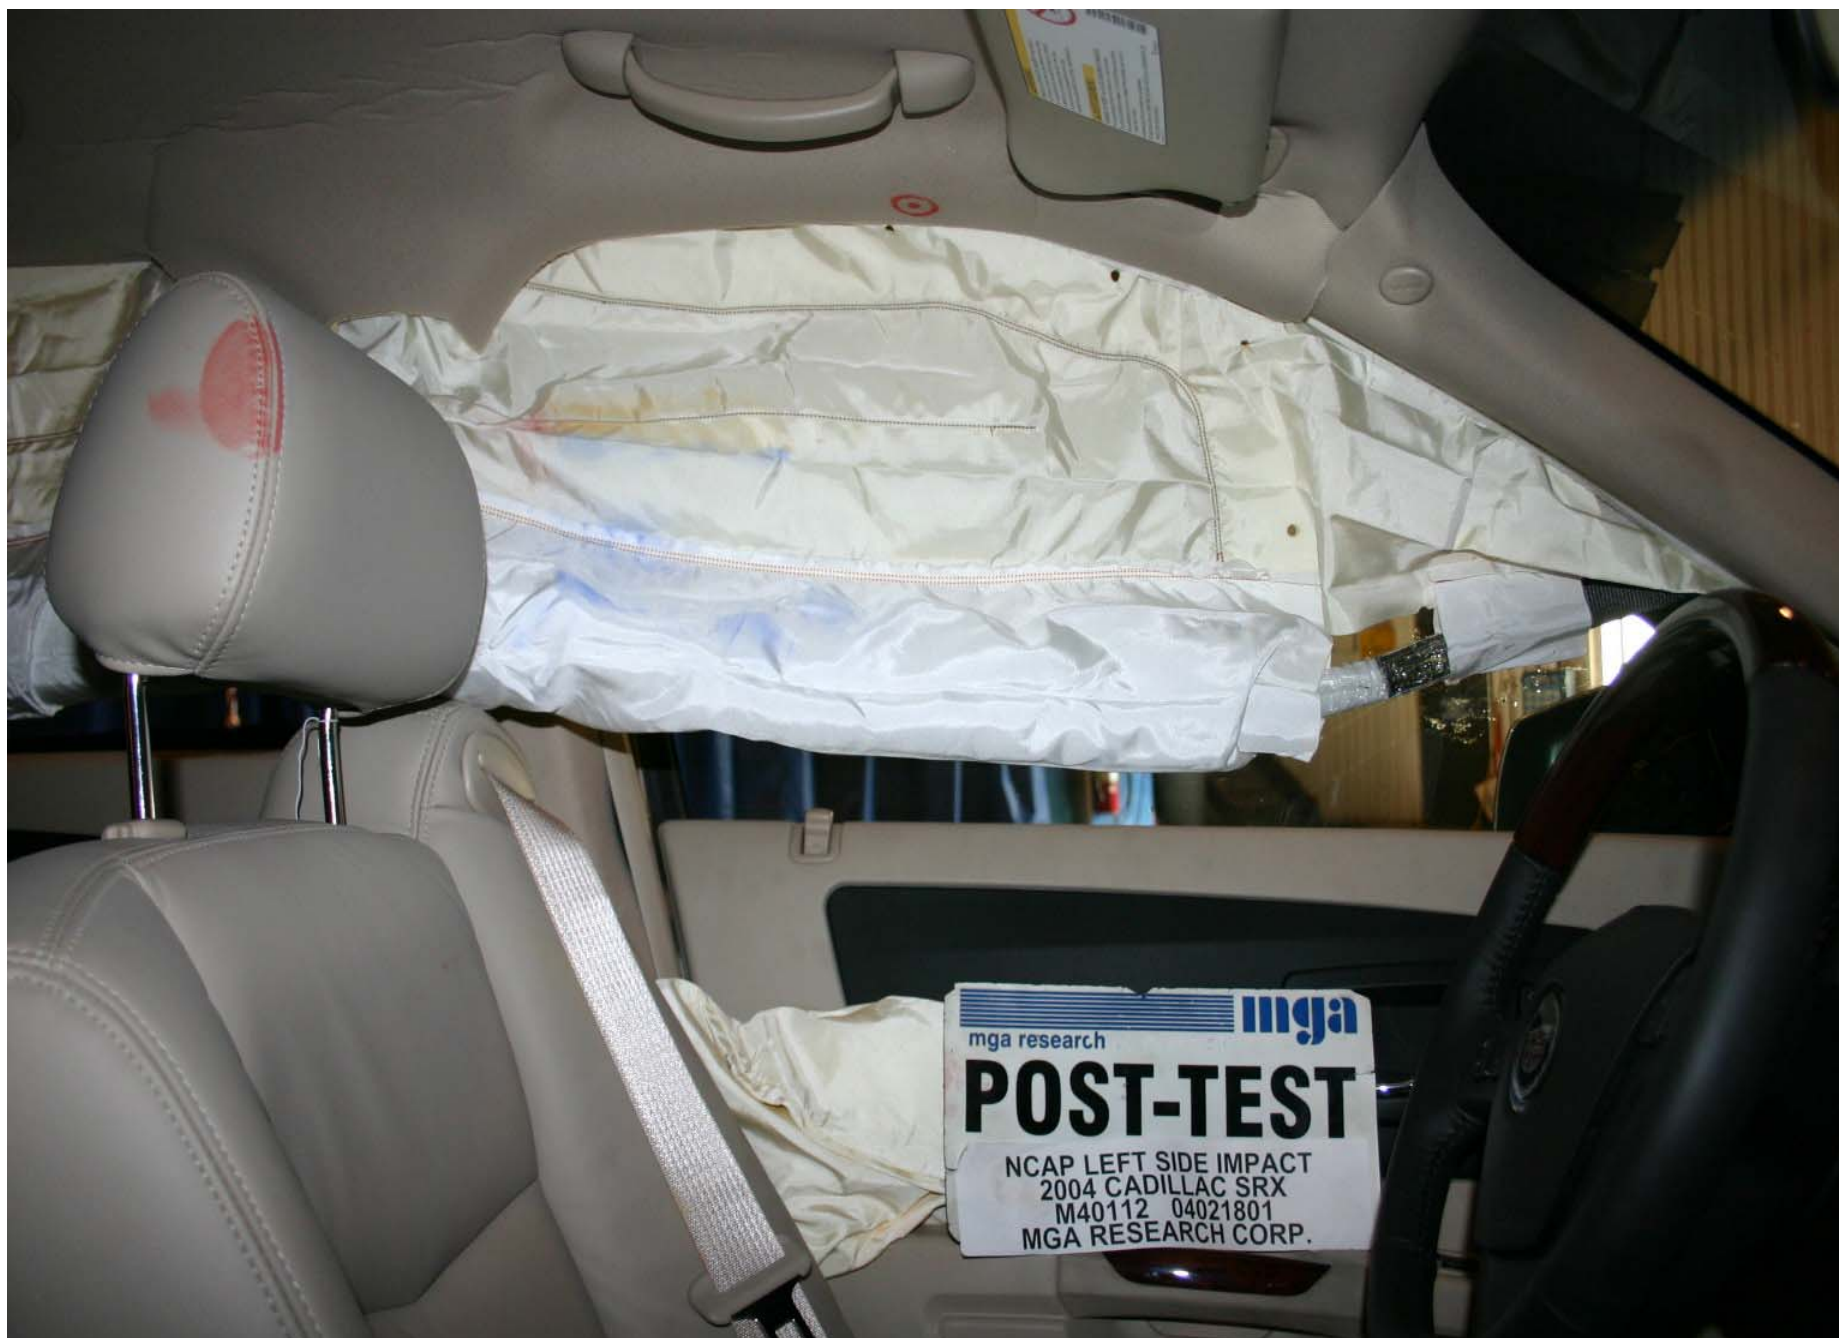
Post-Test Driver Dummy Head Contact

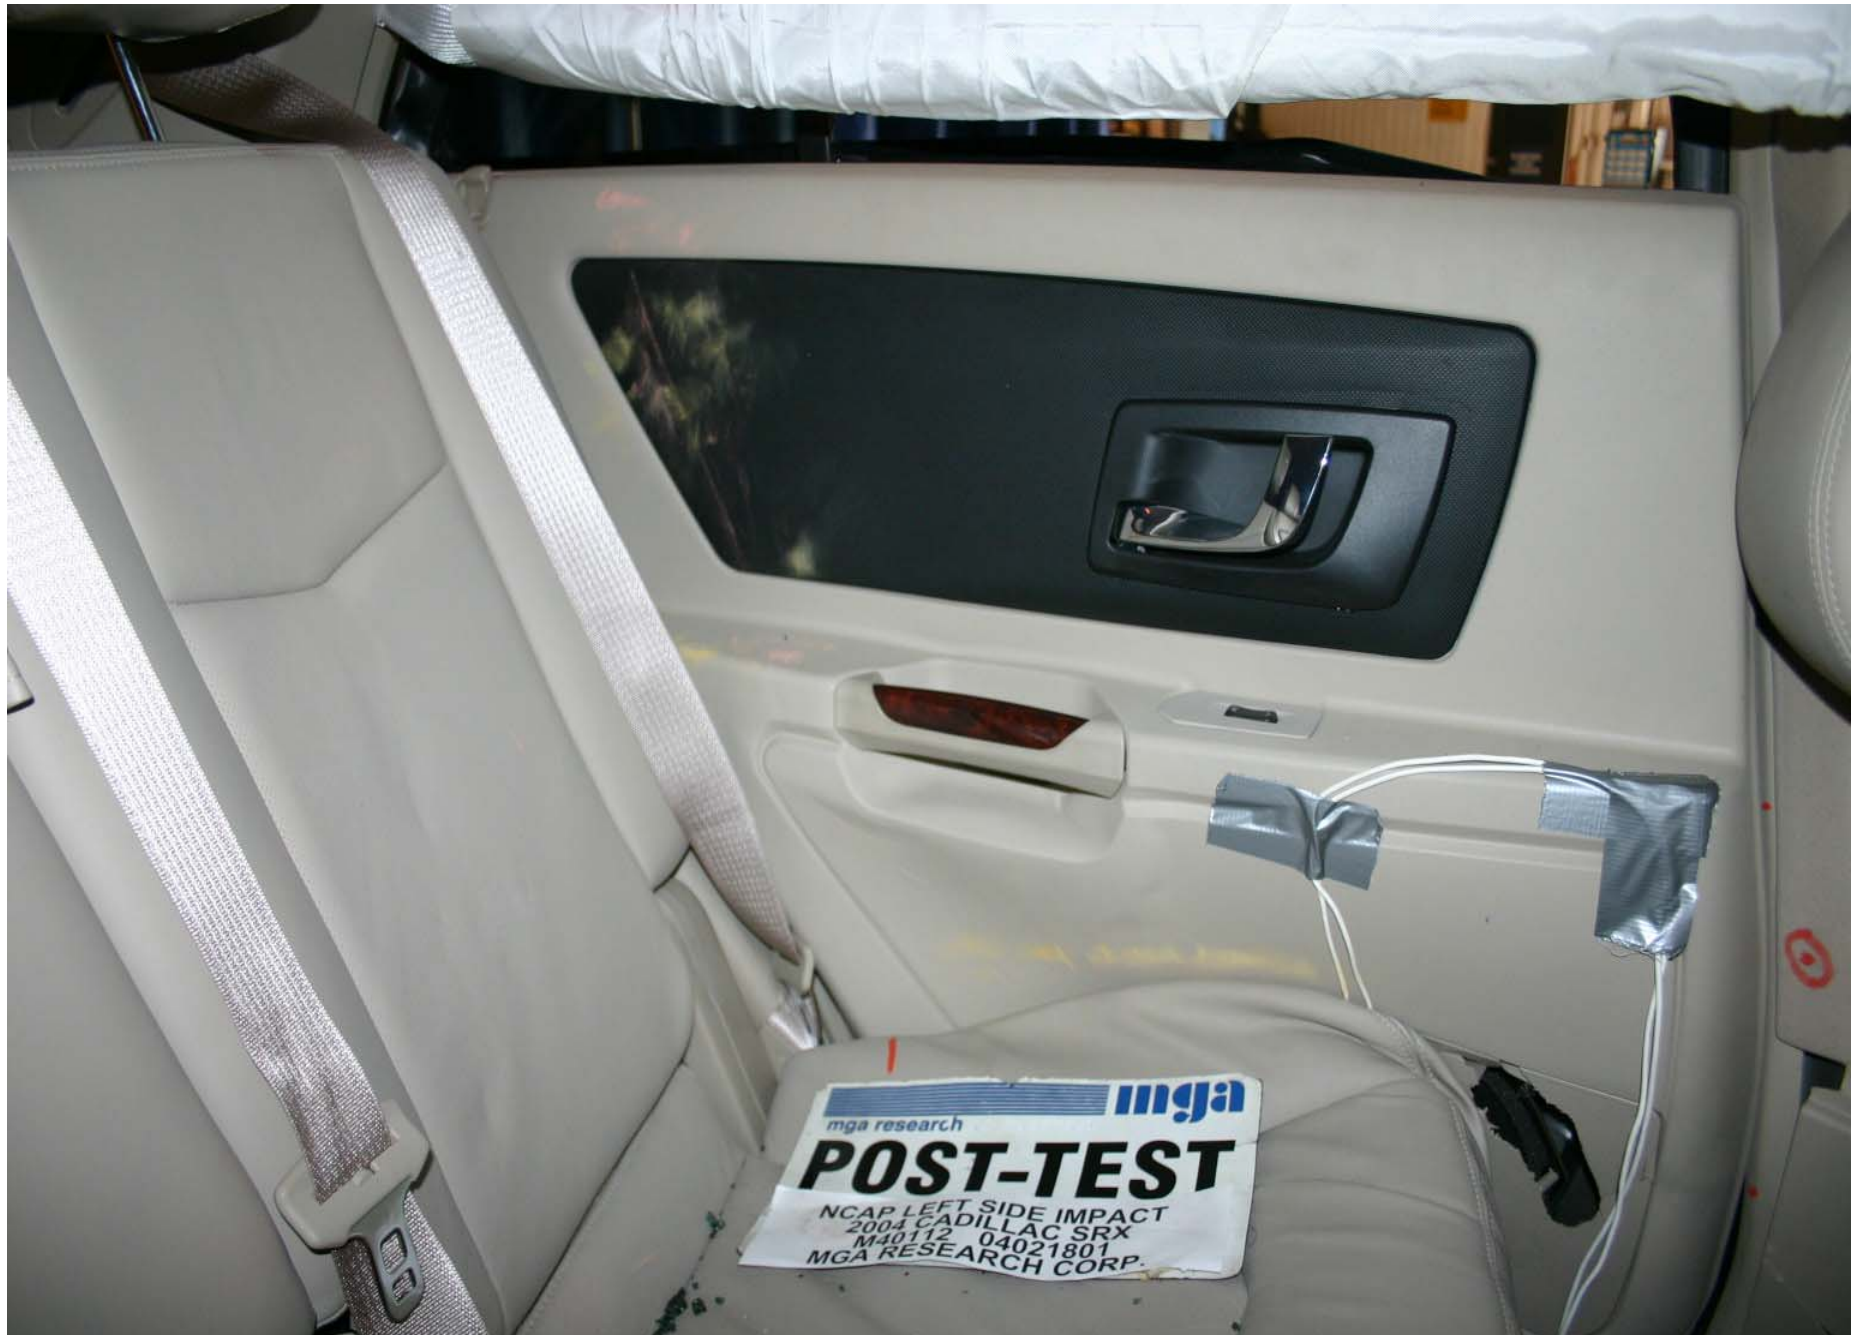
Post-Test Passenger Dummy Contact
