**REPORT NUMBER: NCAPSIDE-MGA-2004-004**

**NEW CAR ASSESSMENT PROGRAM  
SIDE IMPACT TEST**

**General Motors Corporation  
2004 Cadillac SRX  
NHTSA NUMBER: M40112**

**PREPARED BY:  
MGA RESEARCH CORPORATION  
5000 WARREN ROAD  
BURLINGTON, WI 53105**

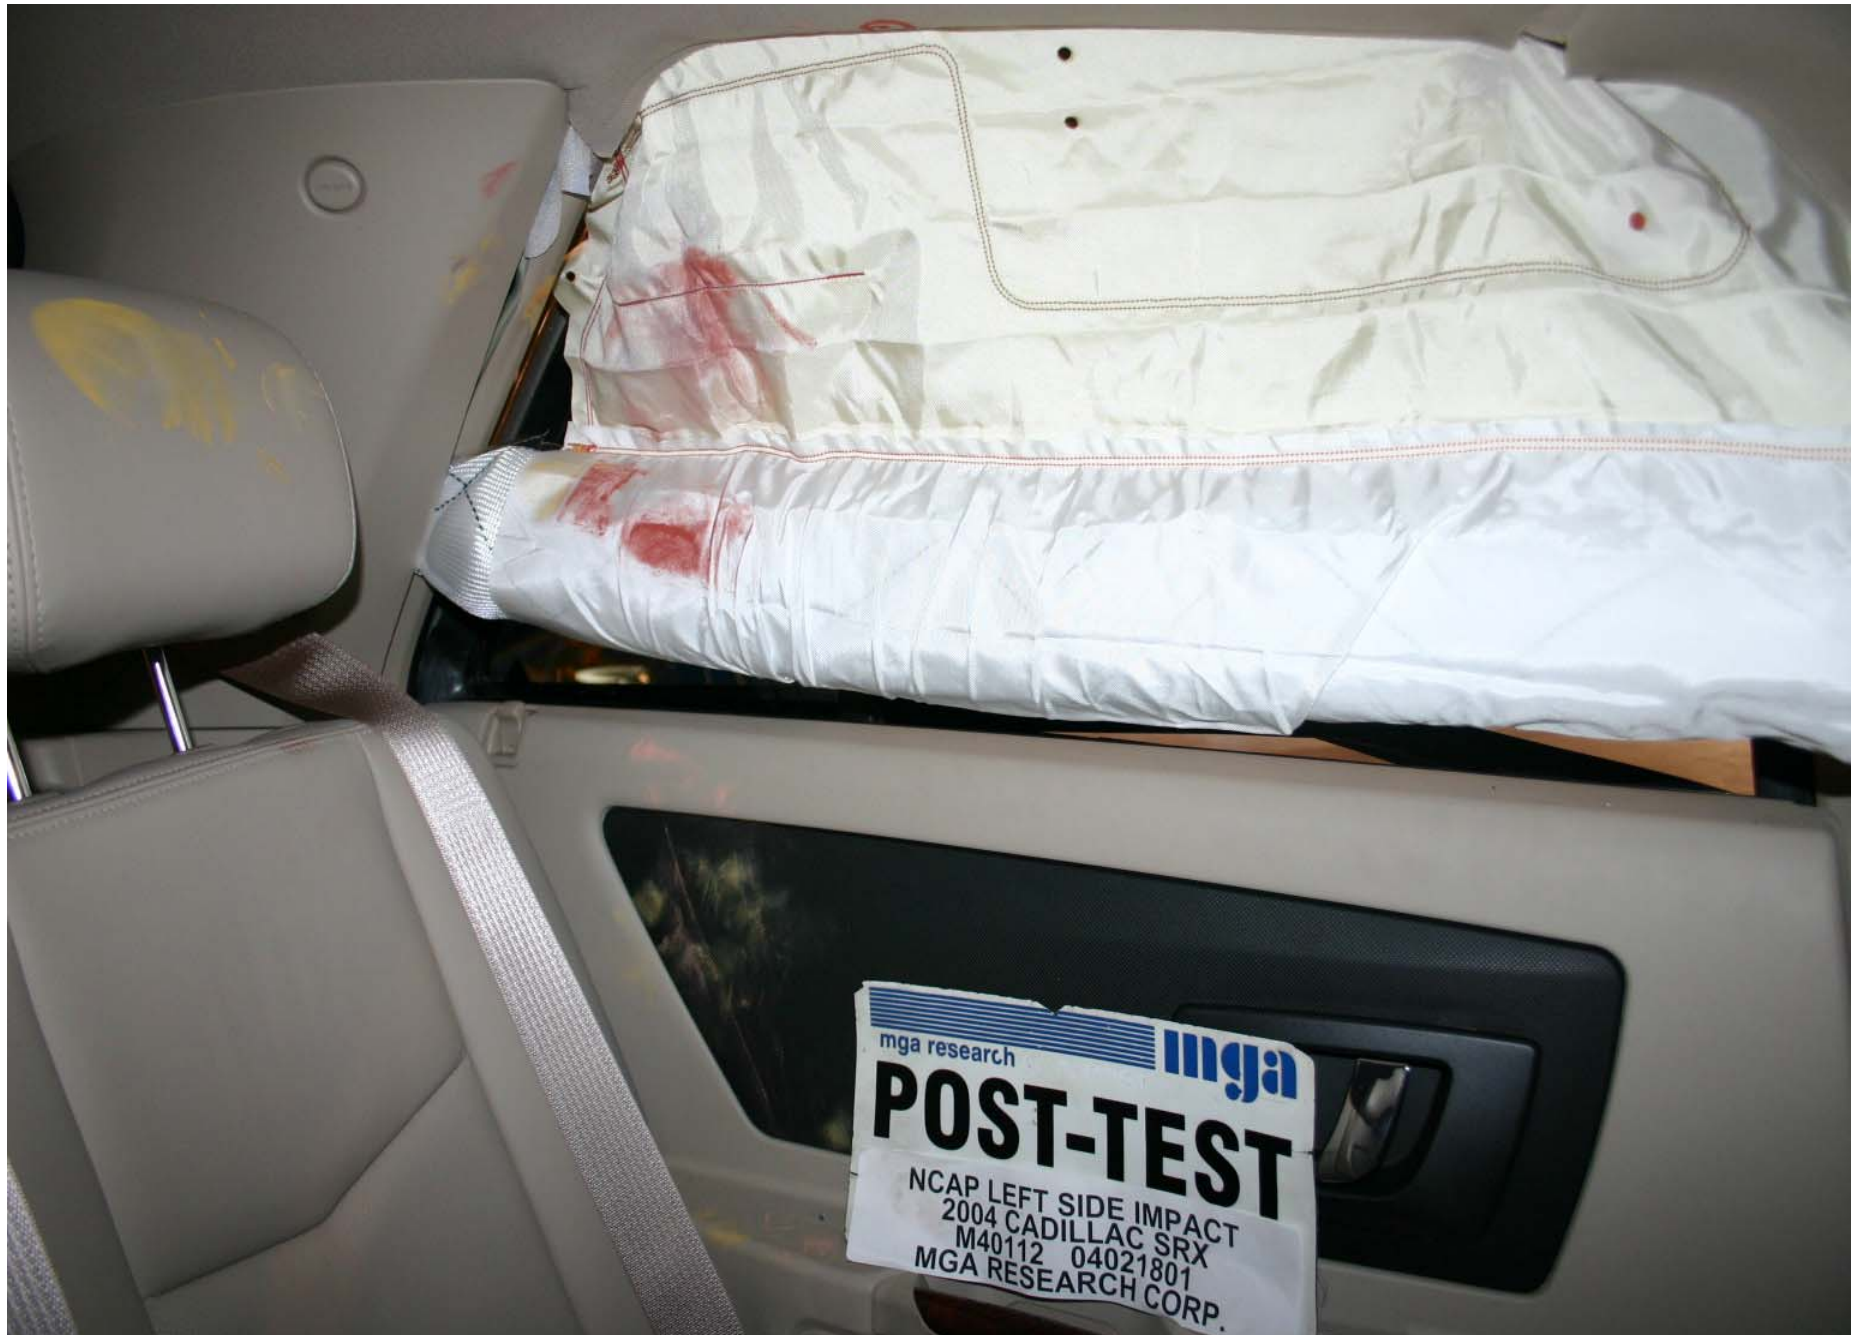
A-44.

Post-Test Passenger Dummy Head Contact

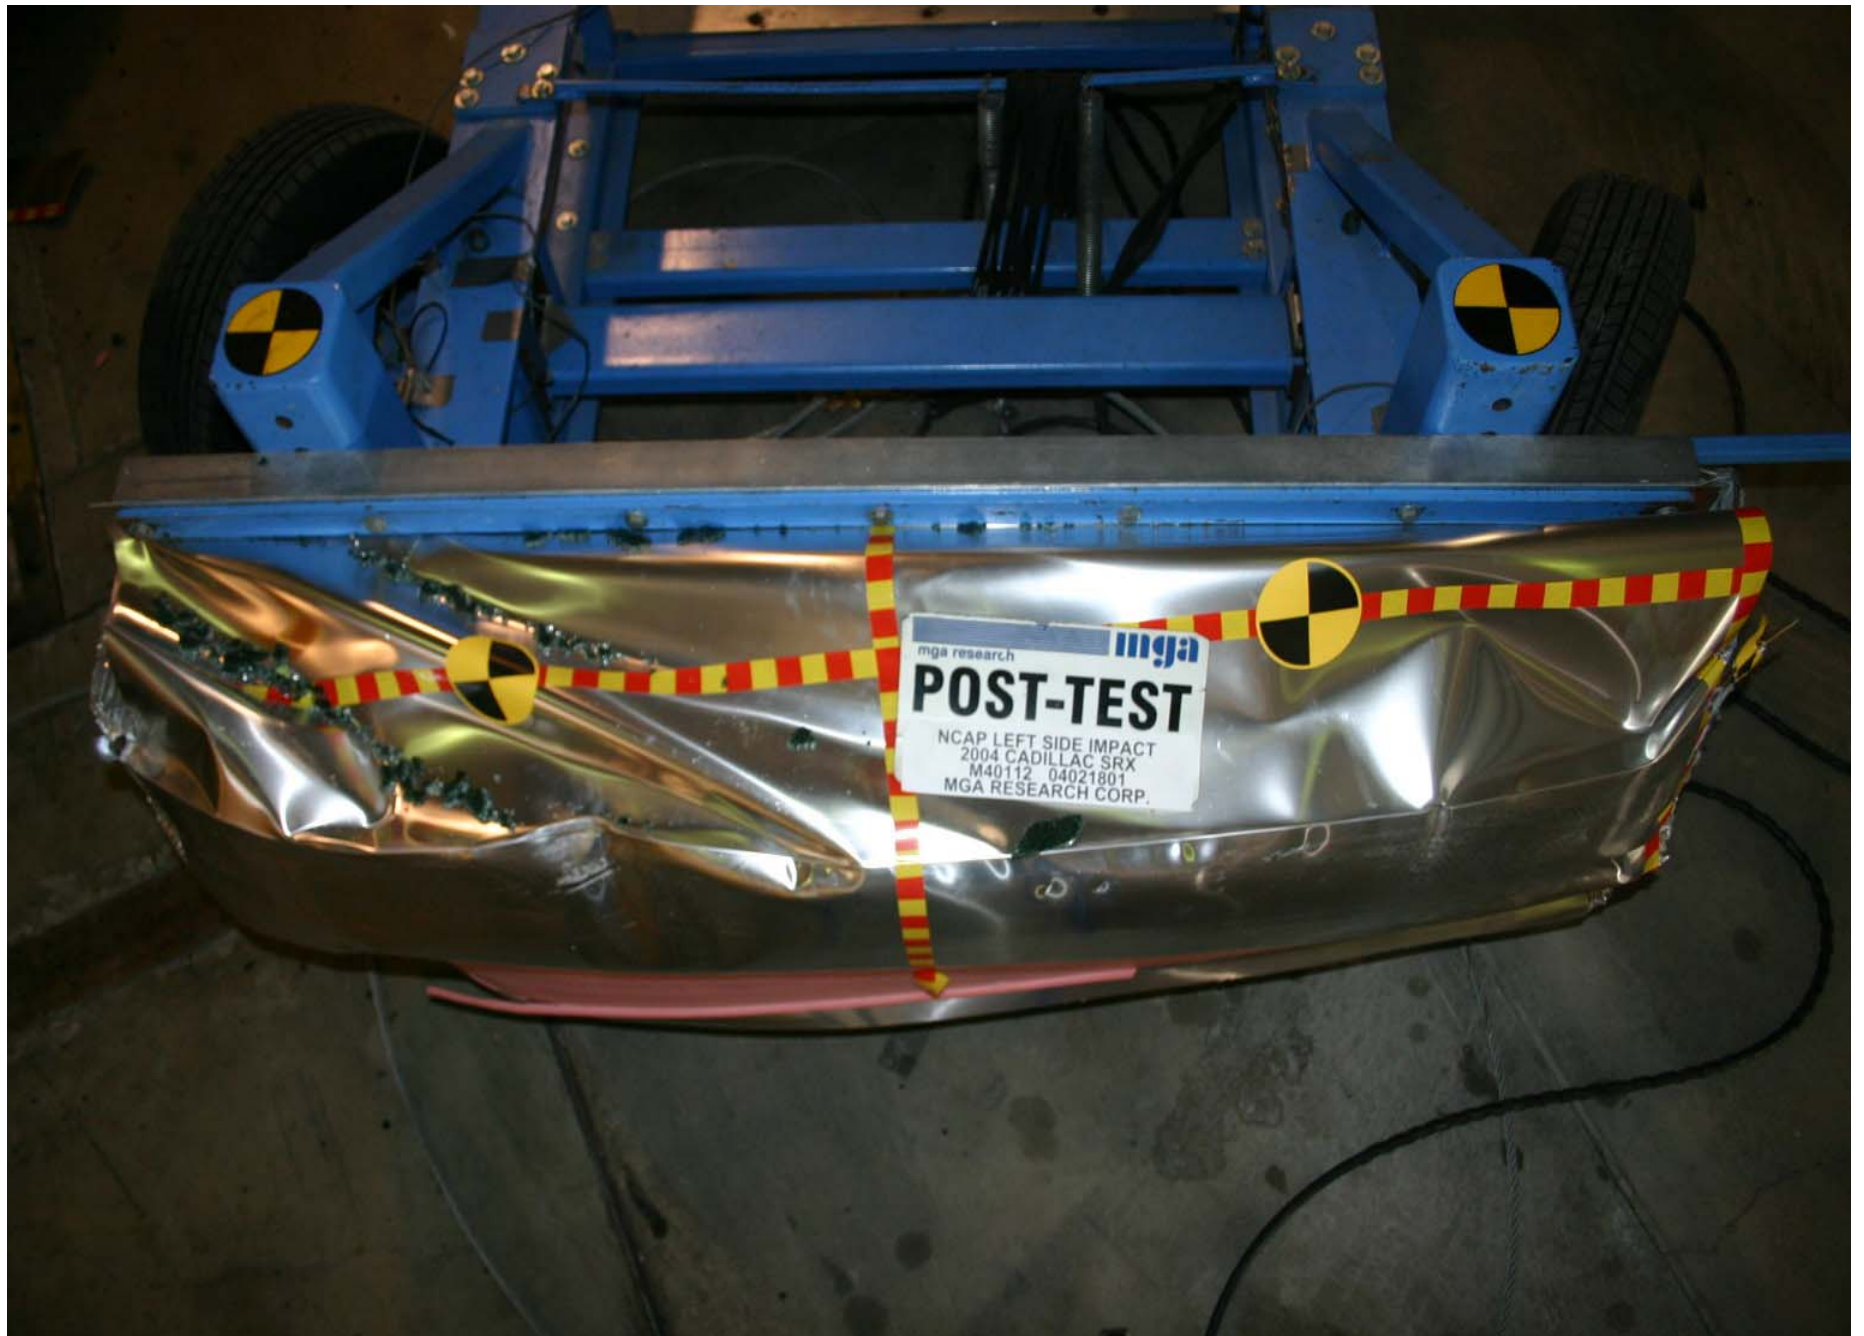
Post-Test MDB Top View

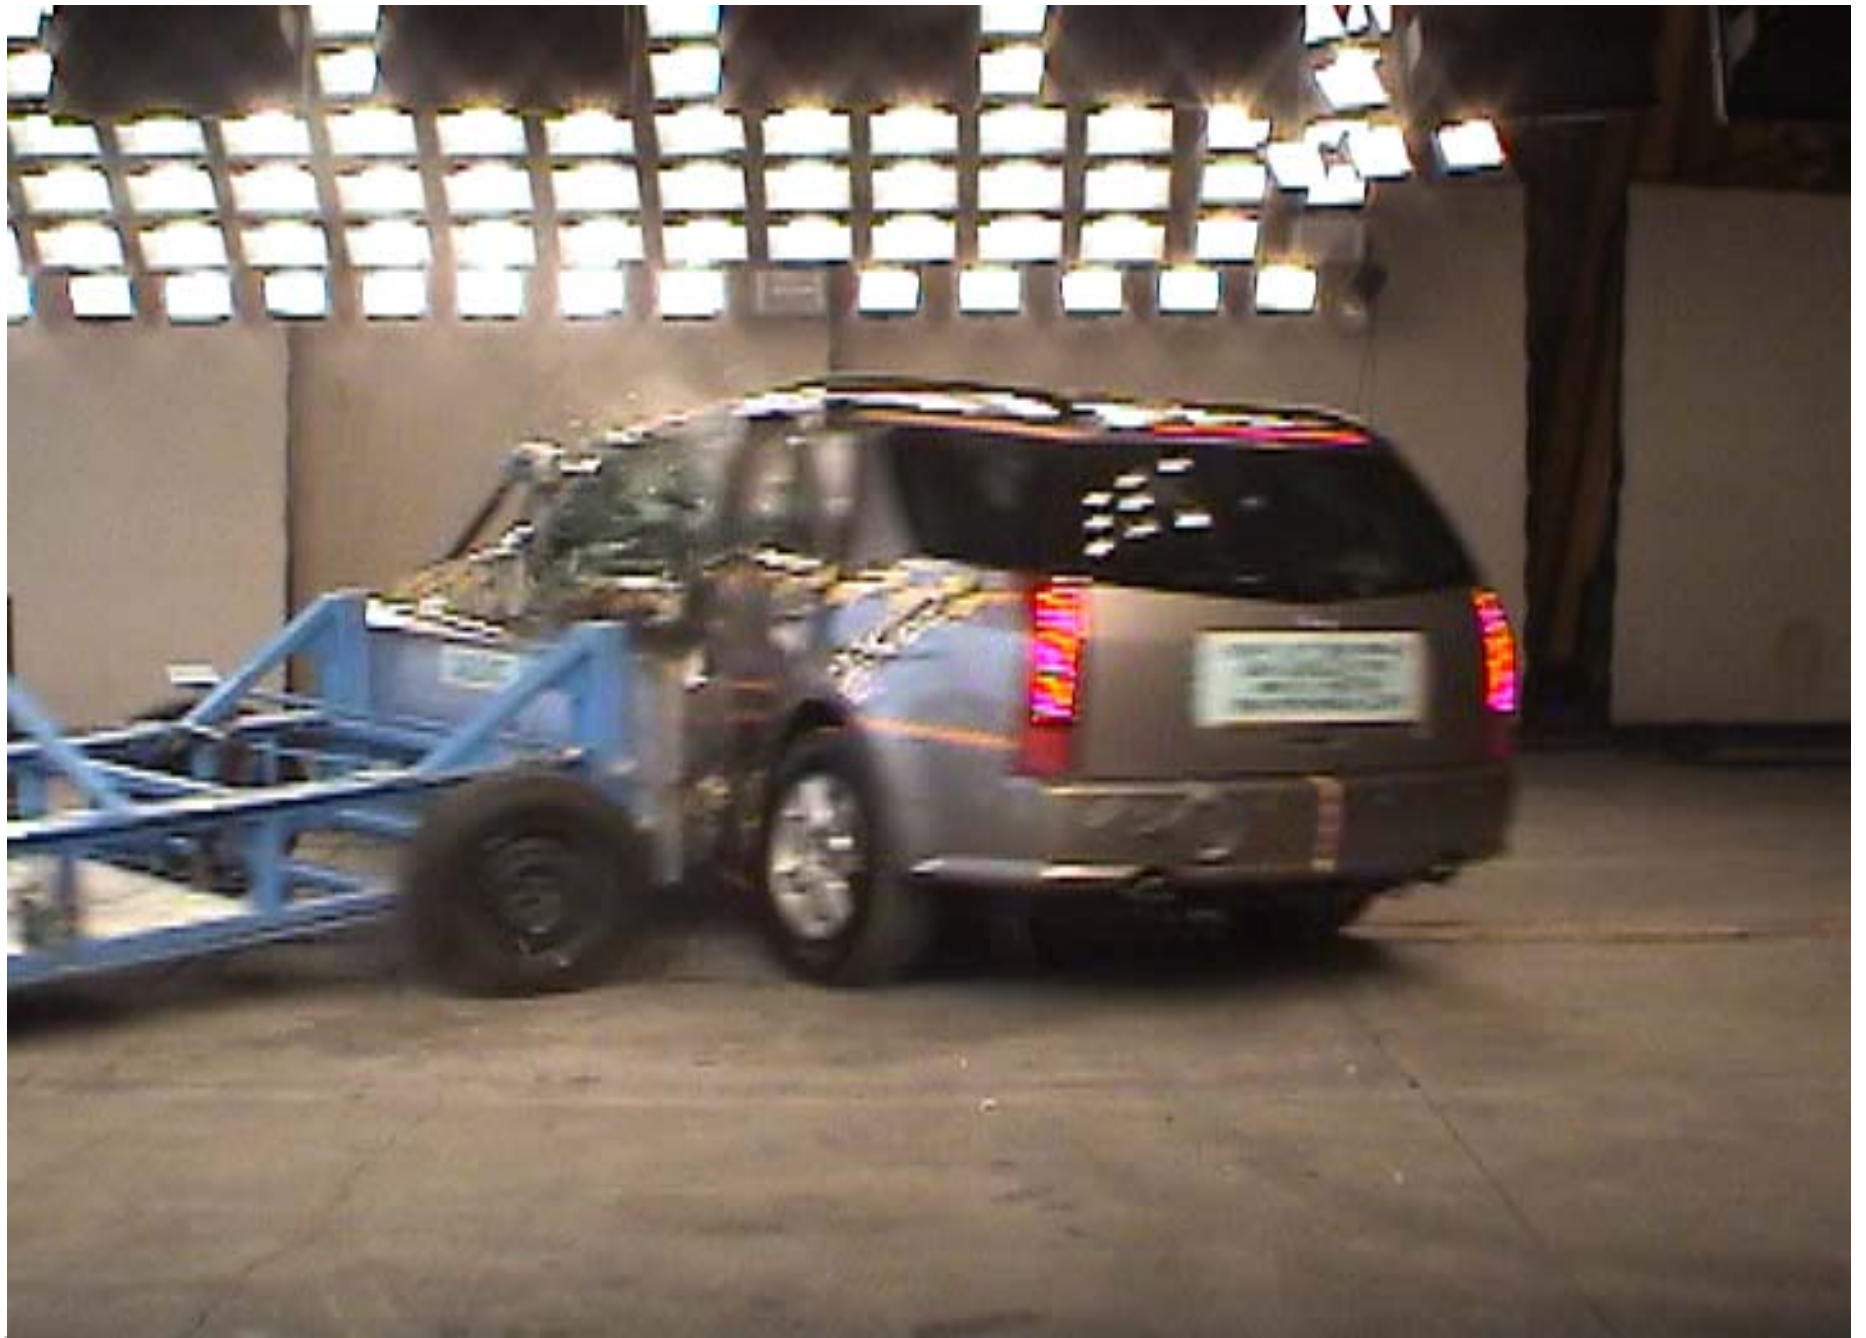
Vehicle Impact

A model year 2004 Cadillac SRX 4 Door was impacted on the left (driver's) side by a Moving Deformable Barrier (MDB) which was moving forward in a 27° crabbed position to the tow road guidance system at a velocity of 62.0 km/h. The specified impact velocity range is from 61.1 to 62.7 km/h. The test (target) vehicle was stationary and positioned 63° to the line of forward motion. The weight of the vehicle as tested was 2314.8 kg and the test weight of the MDB was 1361.2 kg. The test was conducted at MGA Research Corporation in Burlington, Wisconsin, on February 18, 2004.

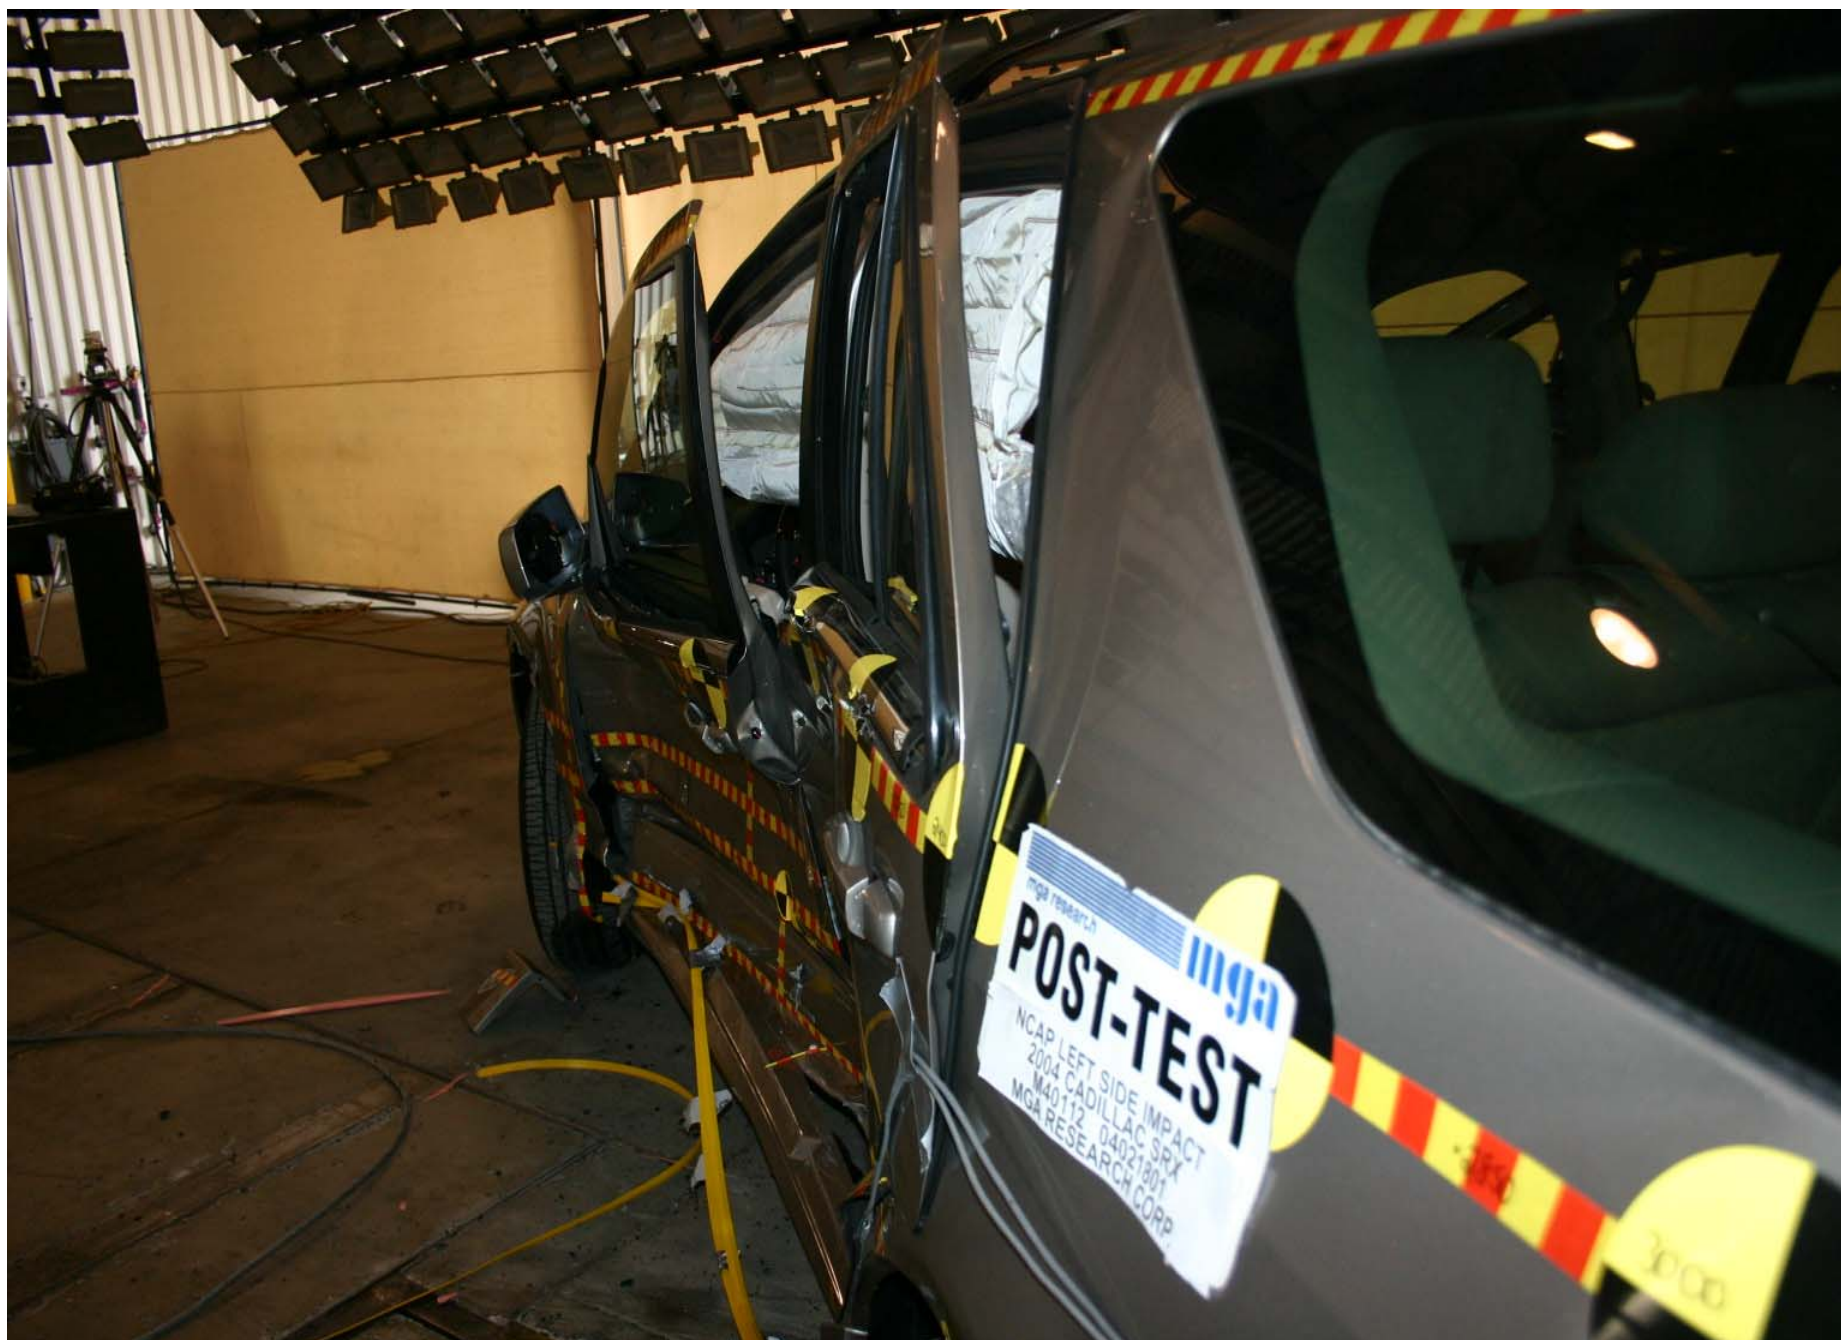
Post-Test Left Rear View of Left Side Doors

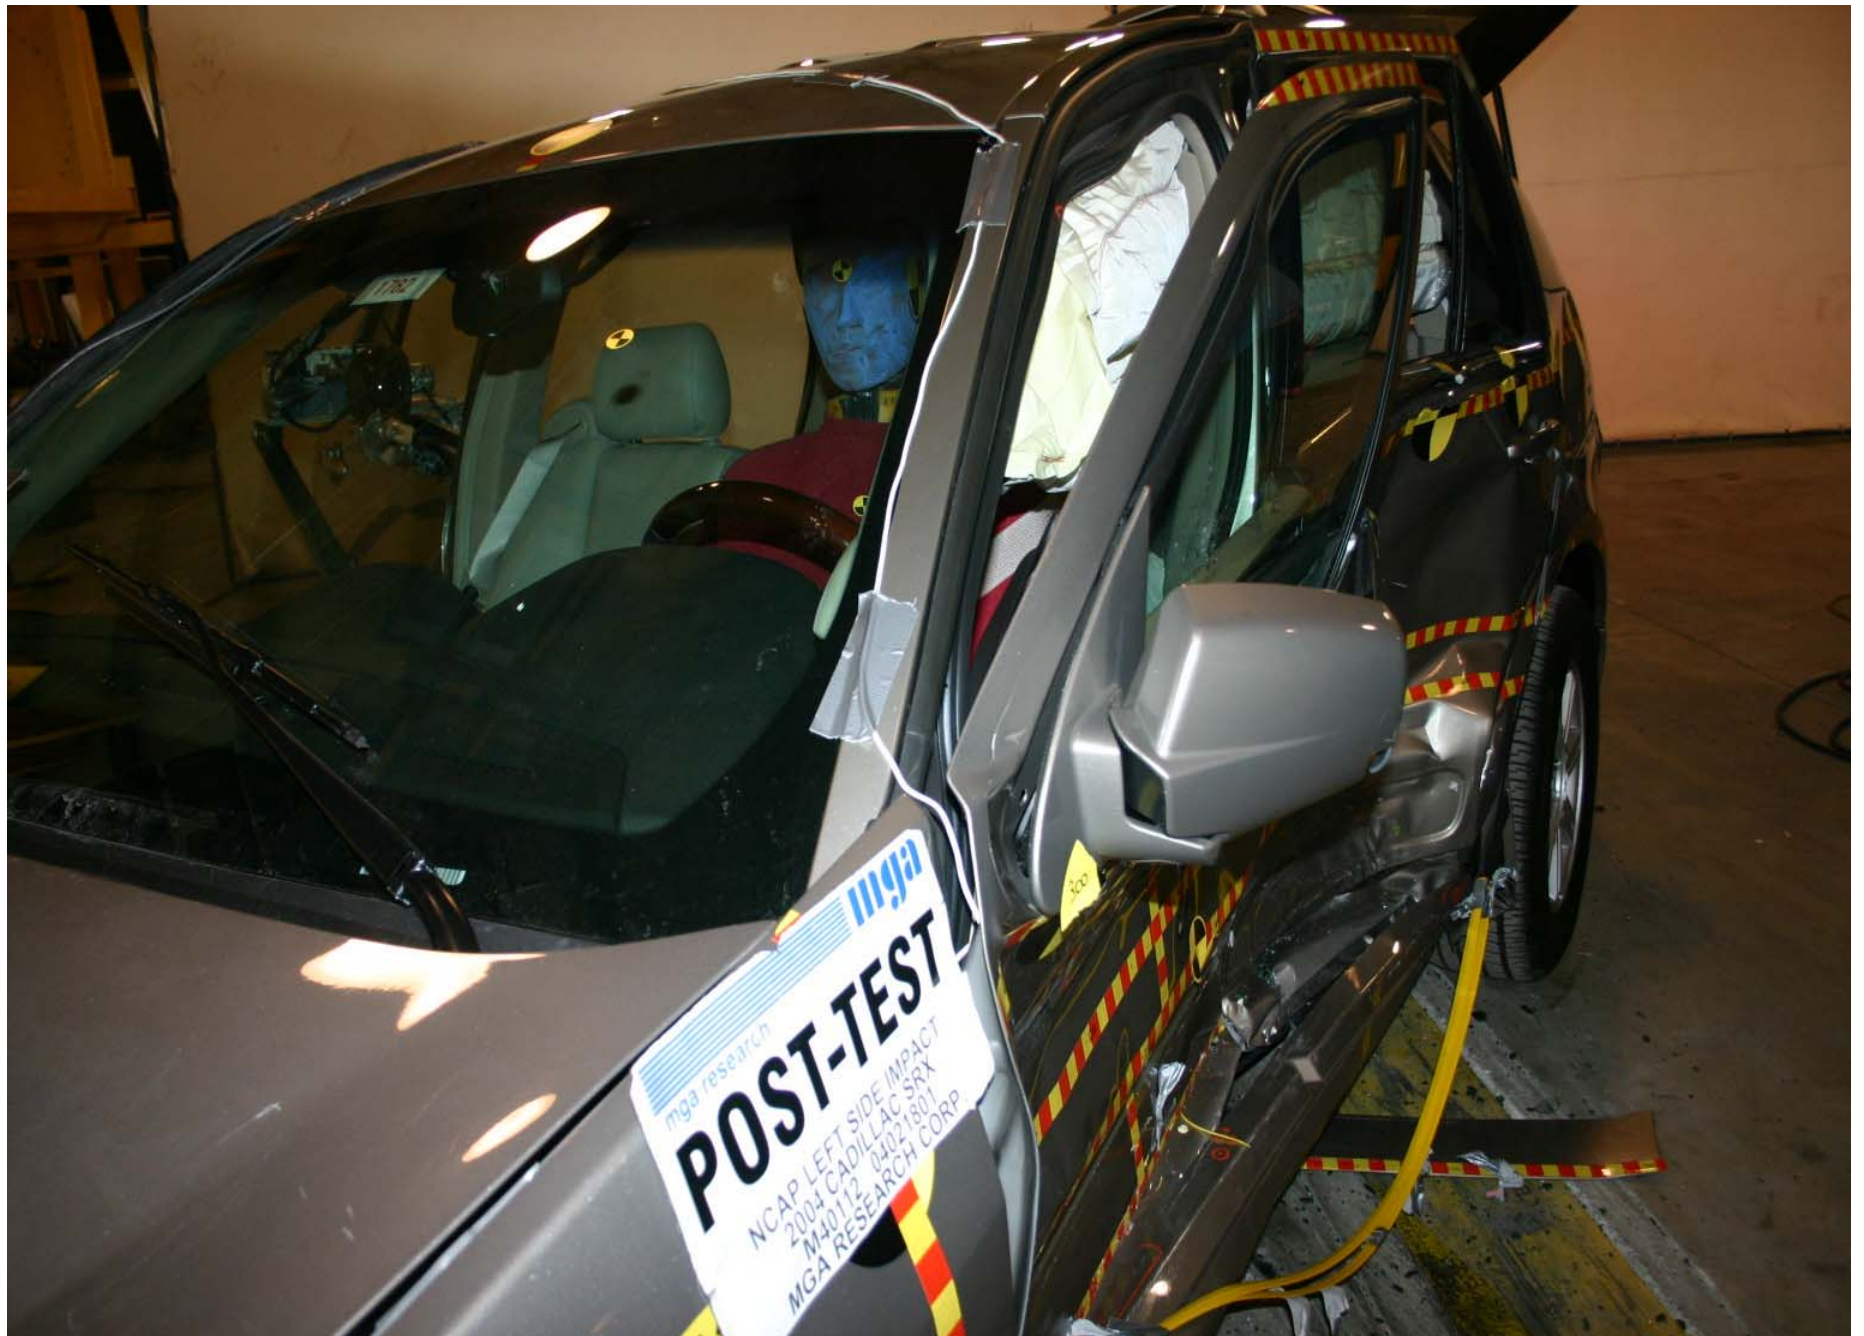
Post-Test Left Front View of Left Side Doors

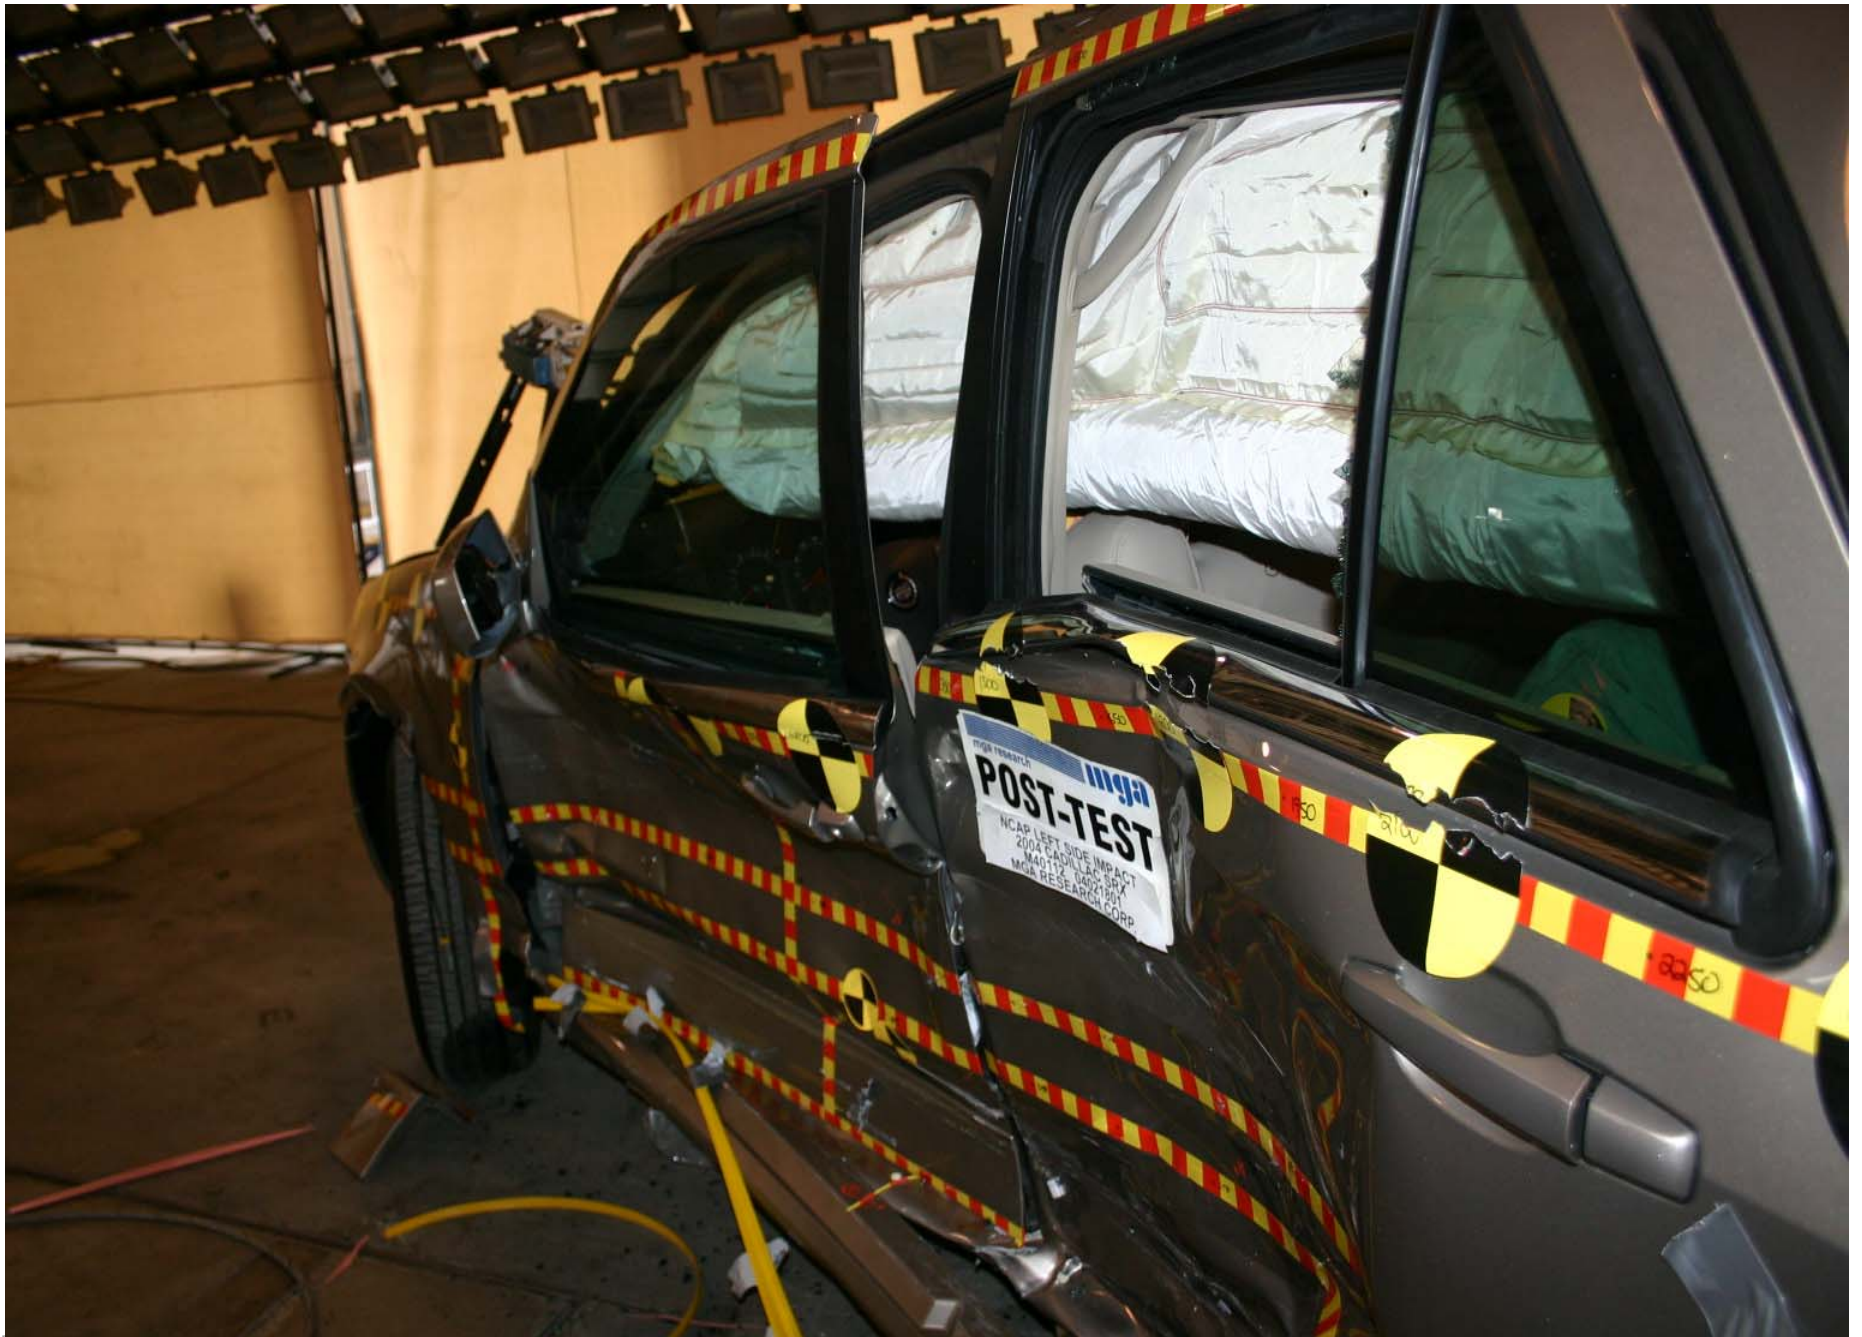
Post-Test  $\frac{3}{4}$  Rear View of Left Side Doors

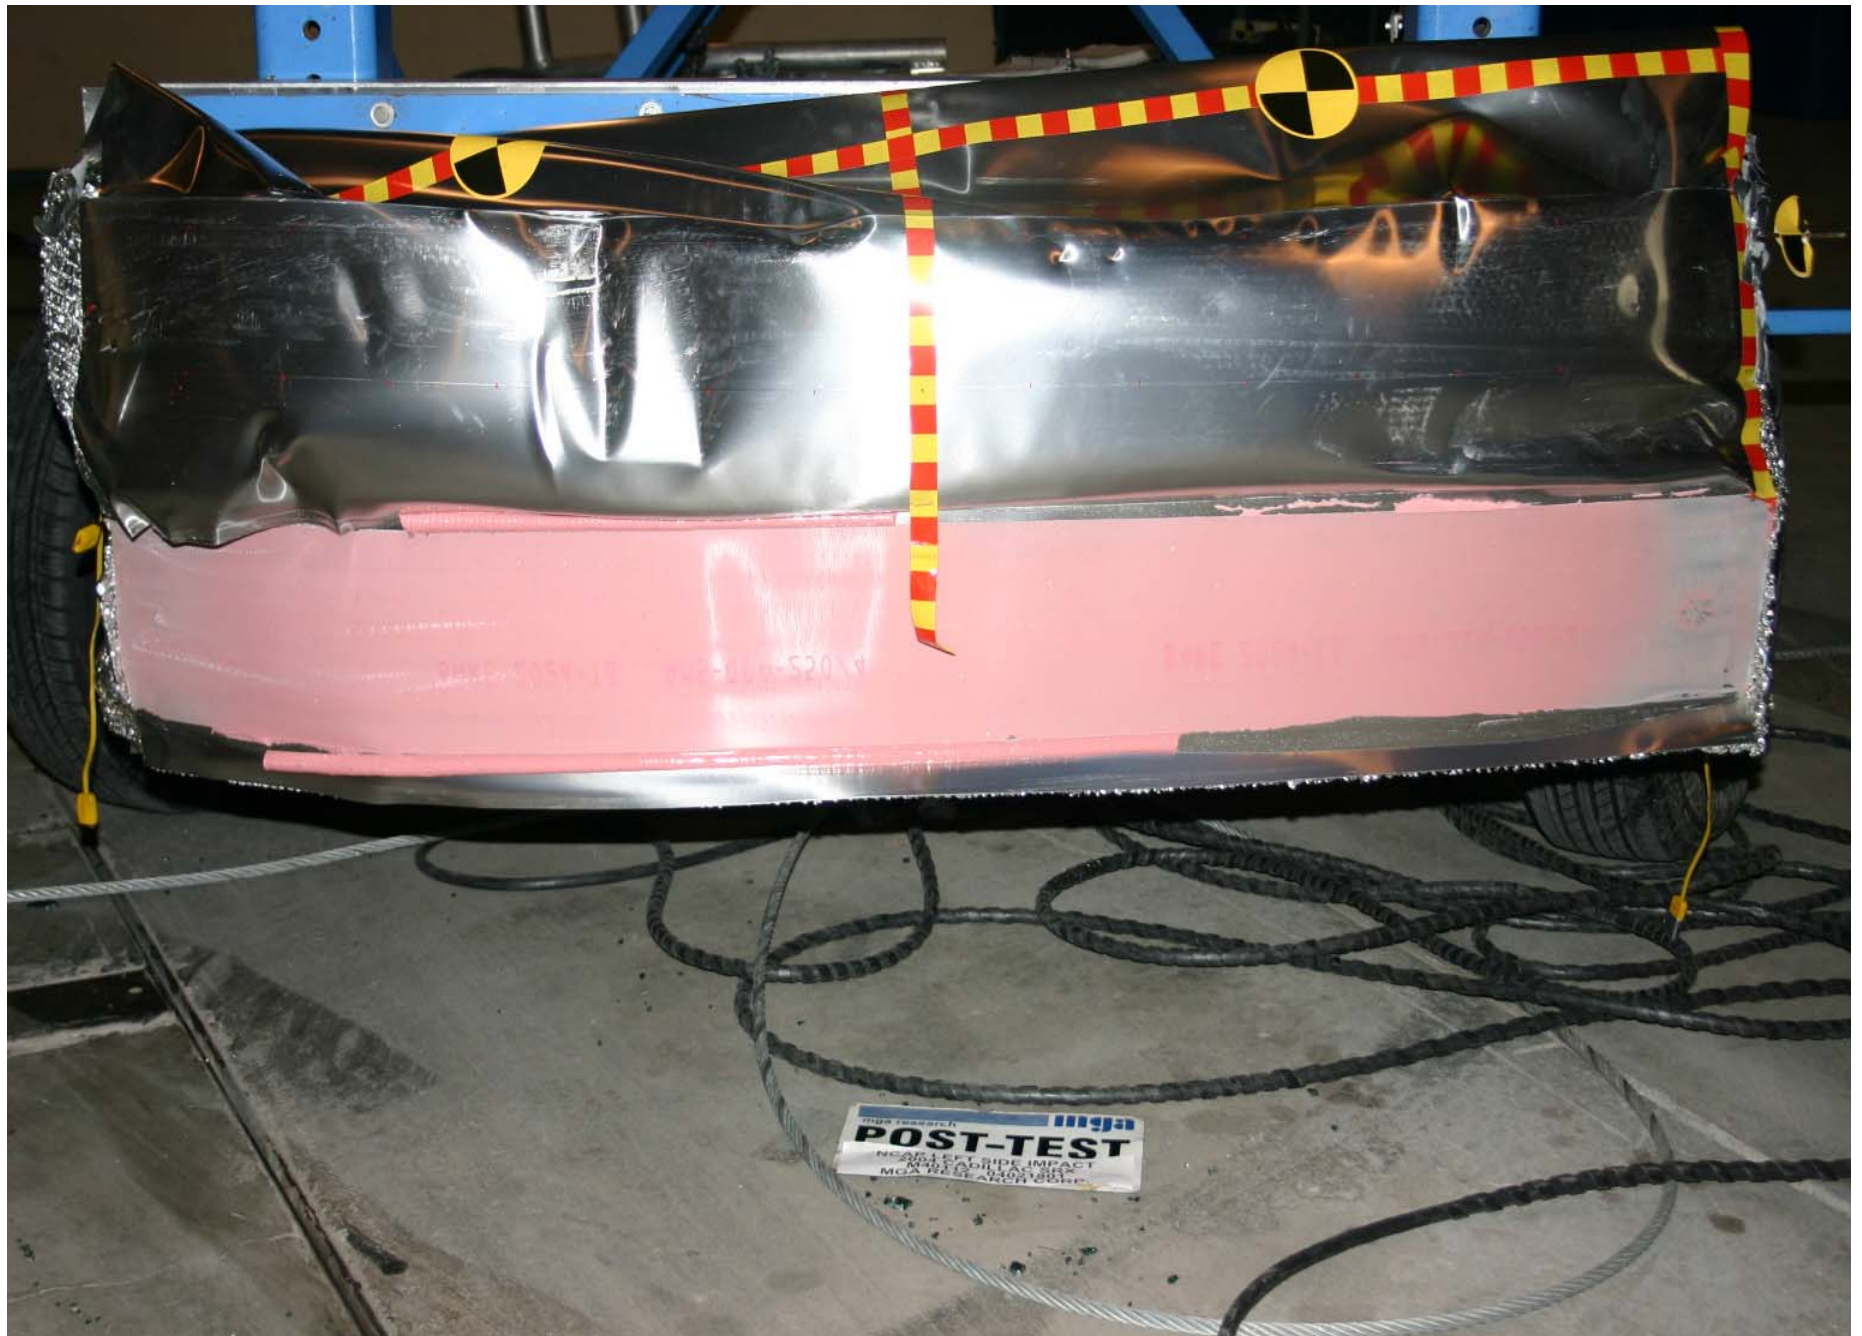
Post-Test MDB with Bumper Missing

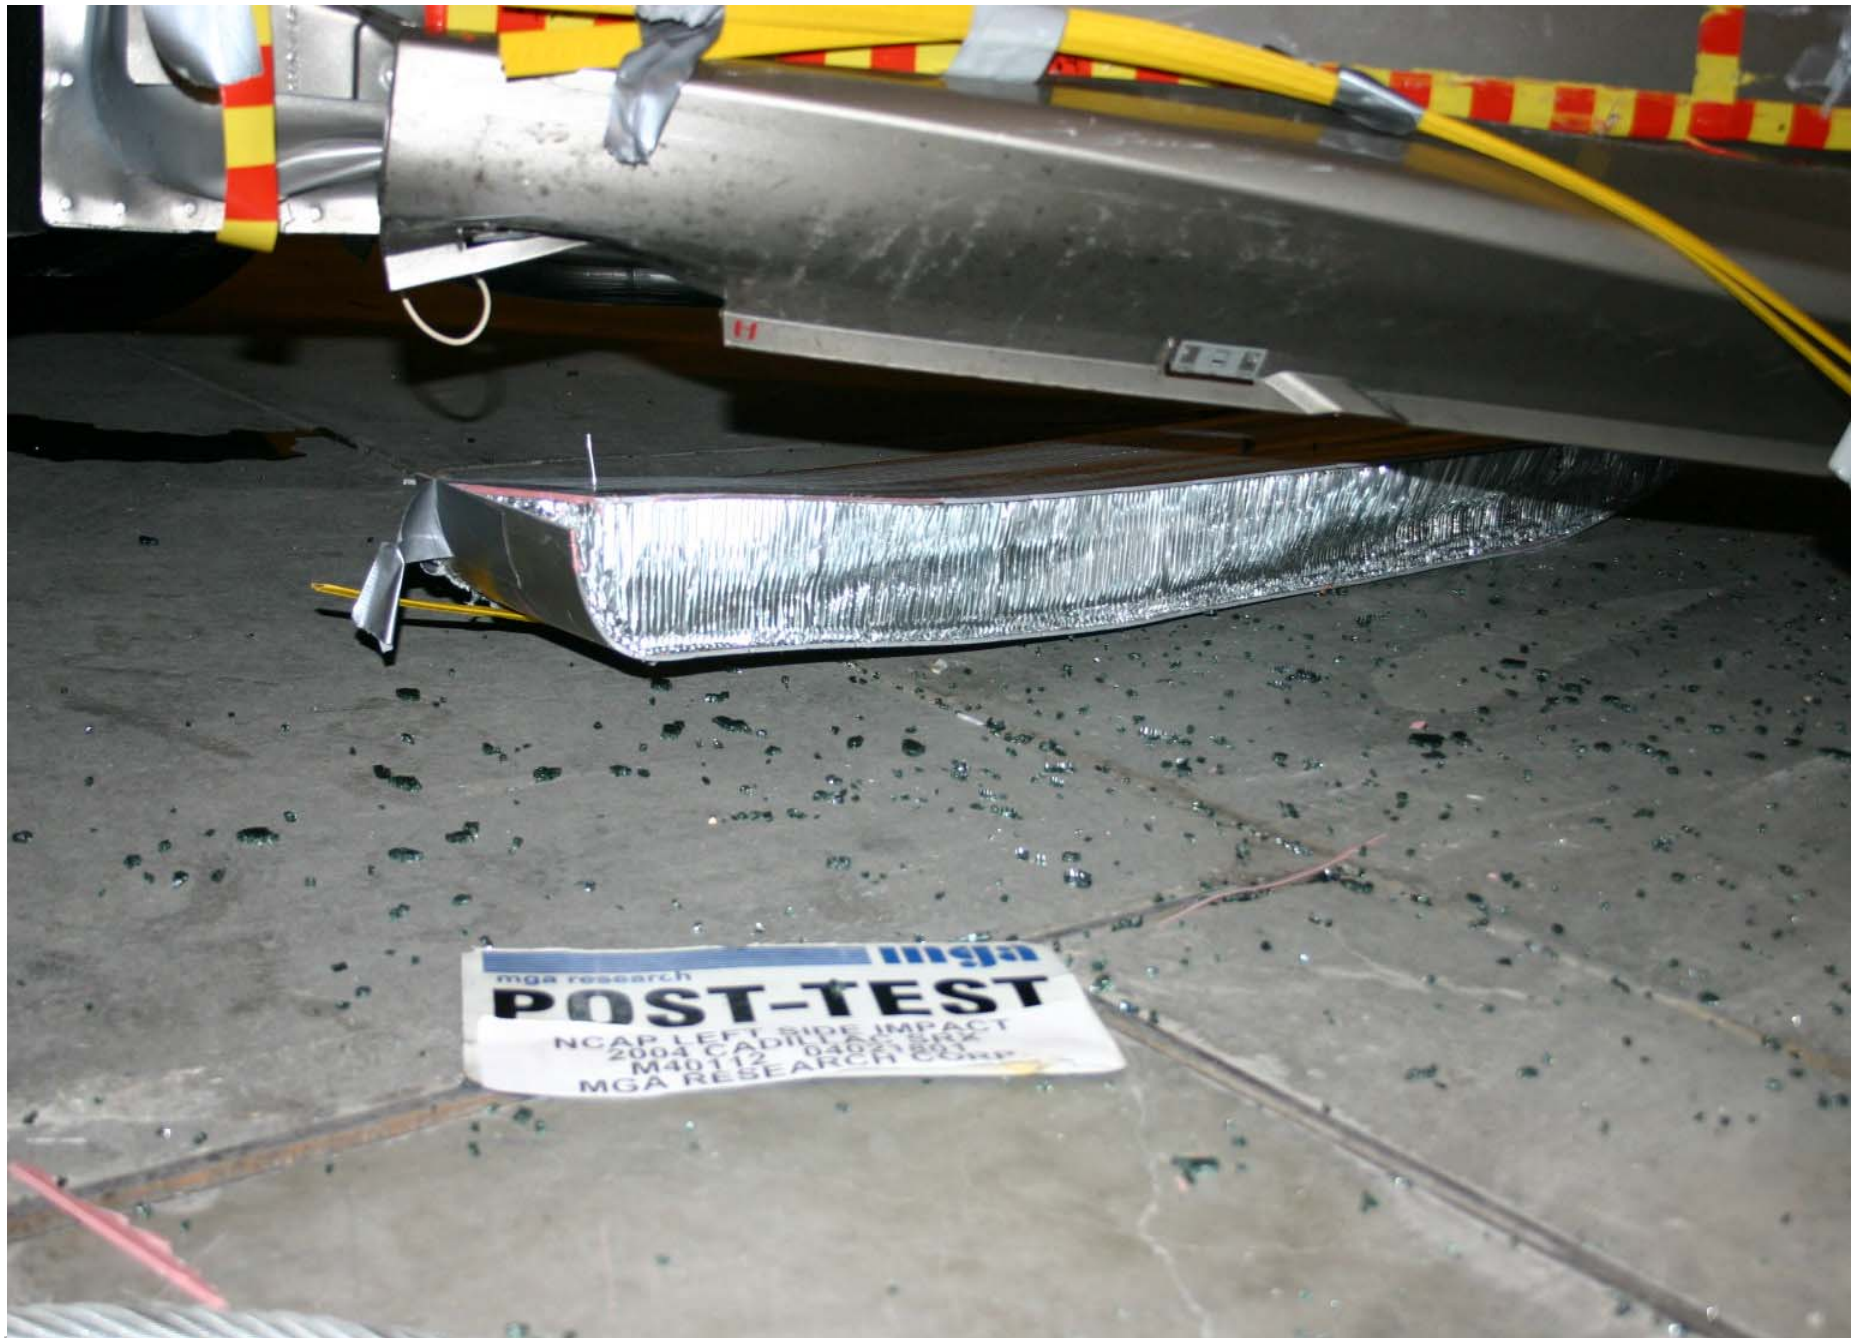
Post-Test MDB Bumper
