**REPORT NUMBER TR-P24003-04-NC**

**NEW CAR ASSESSMENT PROGRAM  
SIDE IMPACT TEST**

**TOYOTA MOTOR CORPORATION  
2004 TOYOTA HIGHLANDER  
SUV**

**NHTSA NUMBER: M45113**

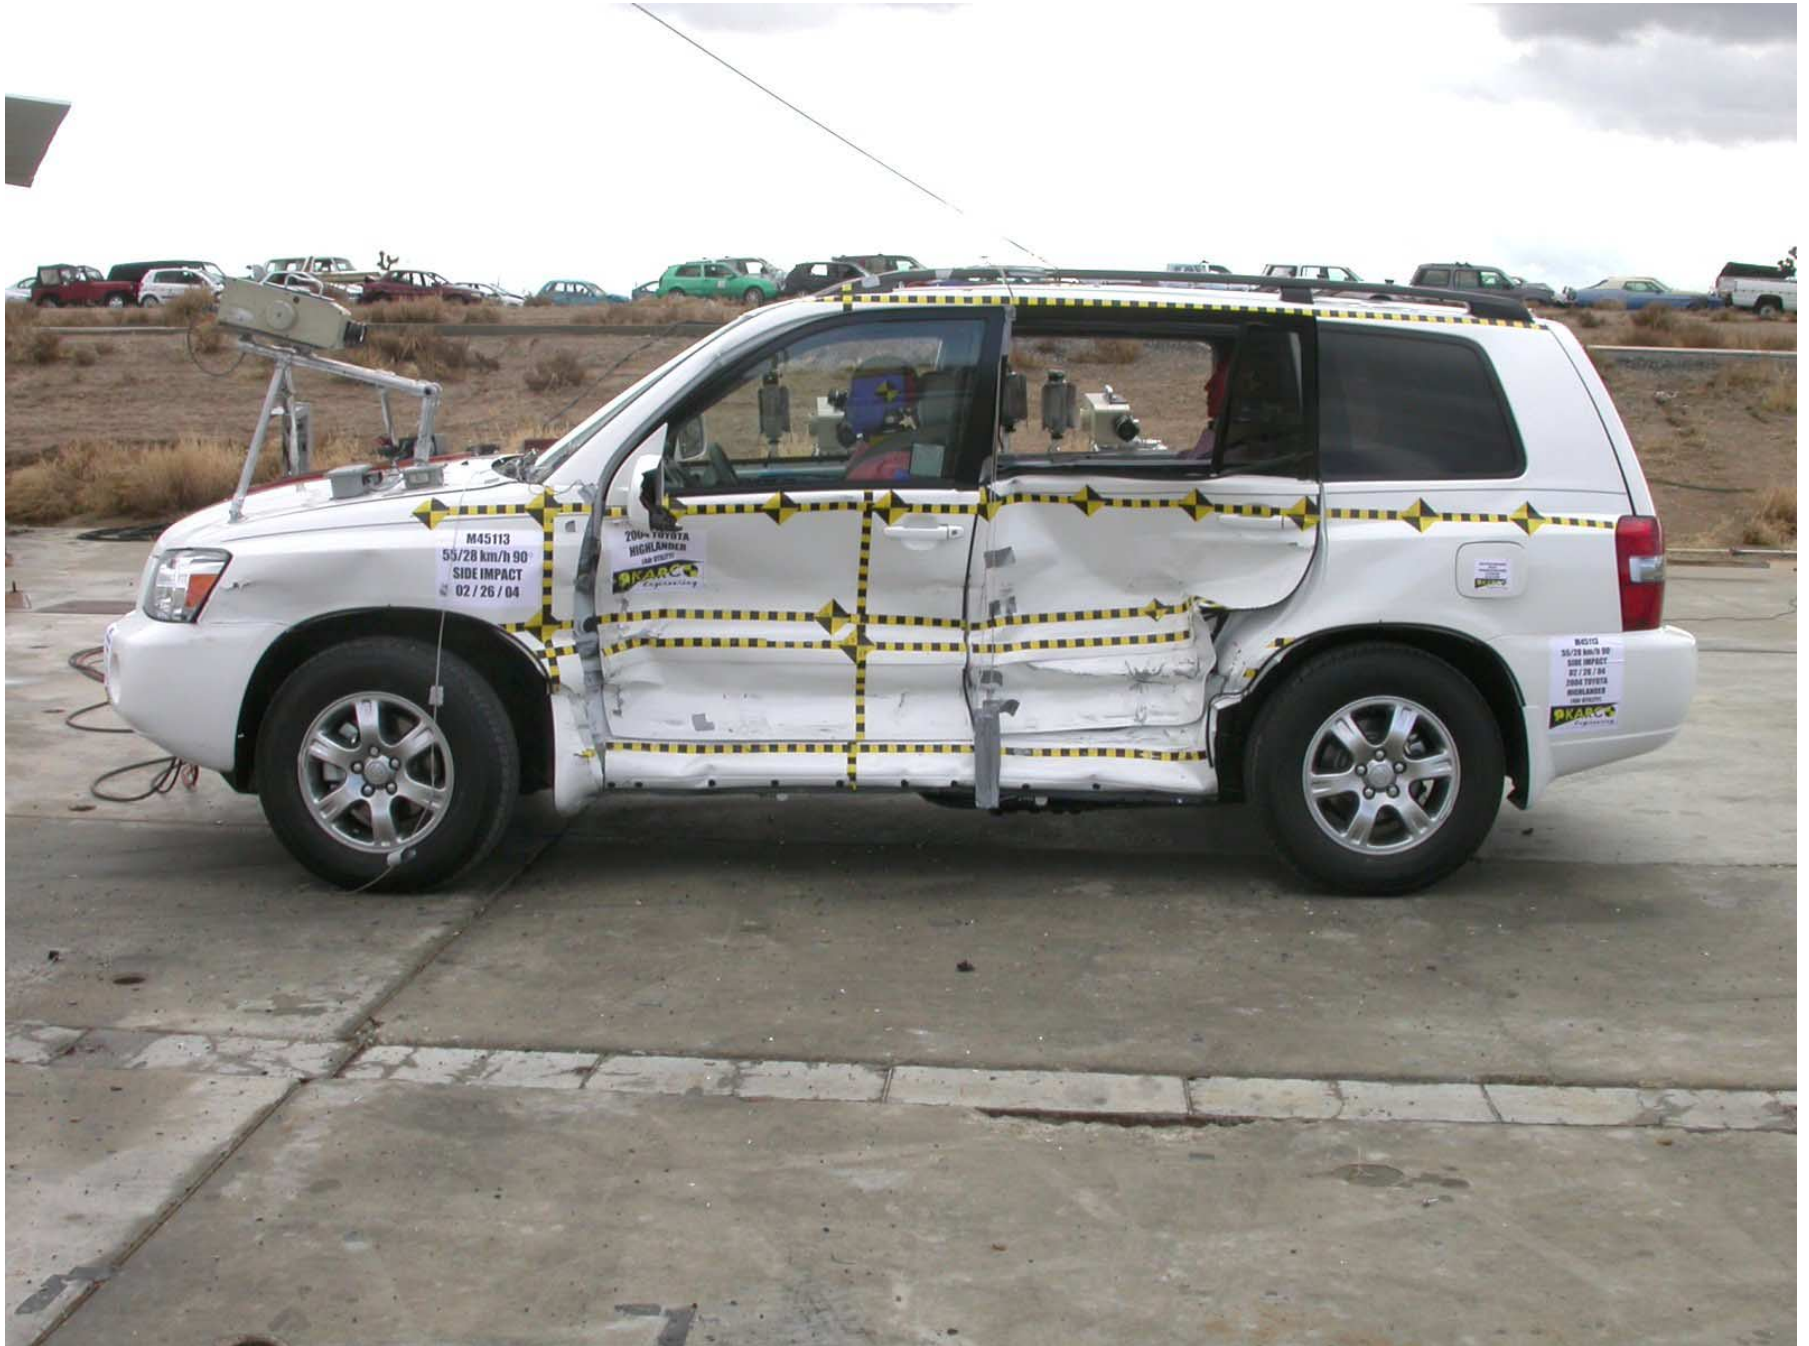
Figure A-10: Left (Impacted) Side View, Post-Test

The test vehicle sustained a maximum static crush of 331 mm at level 3, 1350mm rearward of the left vertical impact point. The driver SID/Hybrid III, Serial No. 274 and the passenger SID/Hybrid III, Serial No. 275 were calibrated just prior to this test. The SID/Hybrid III injury criteria is summarized as follows:

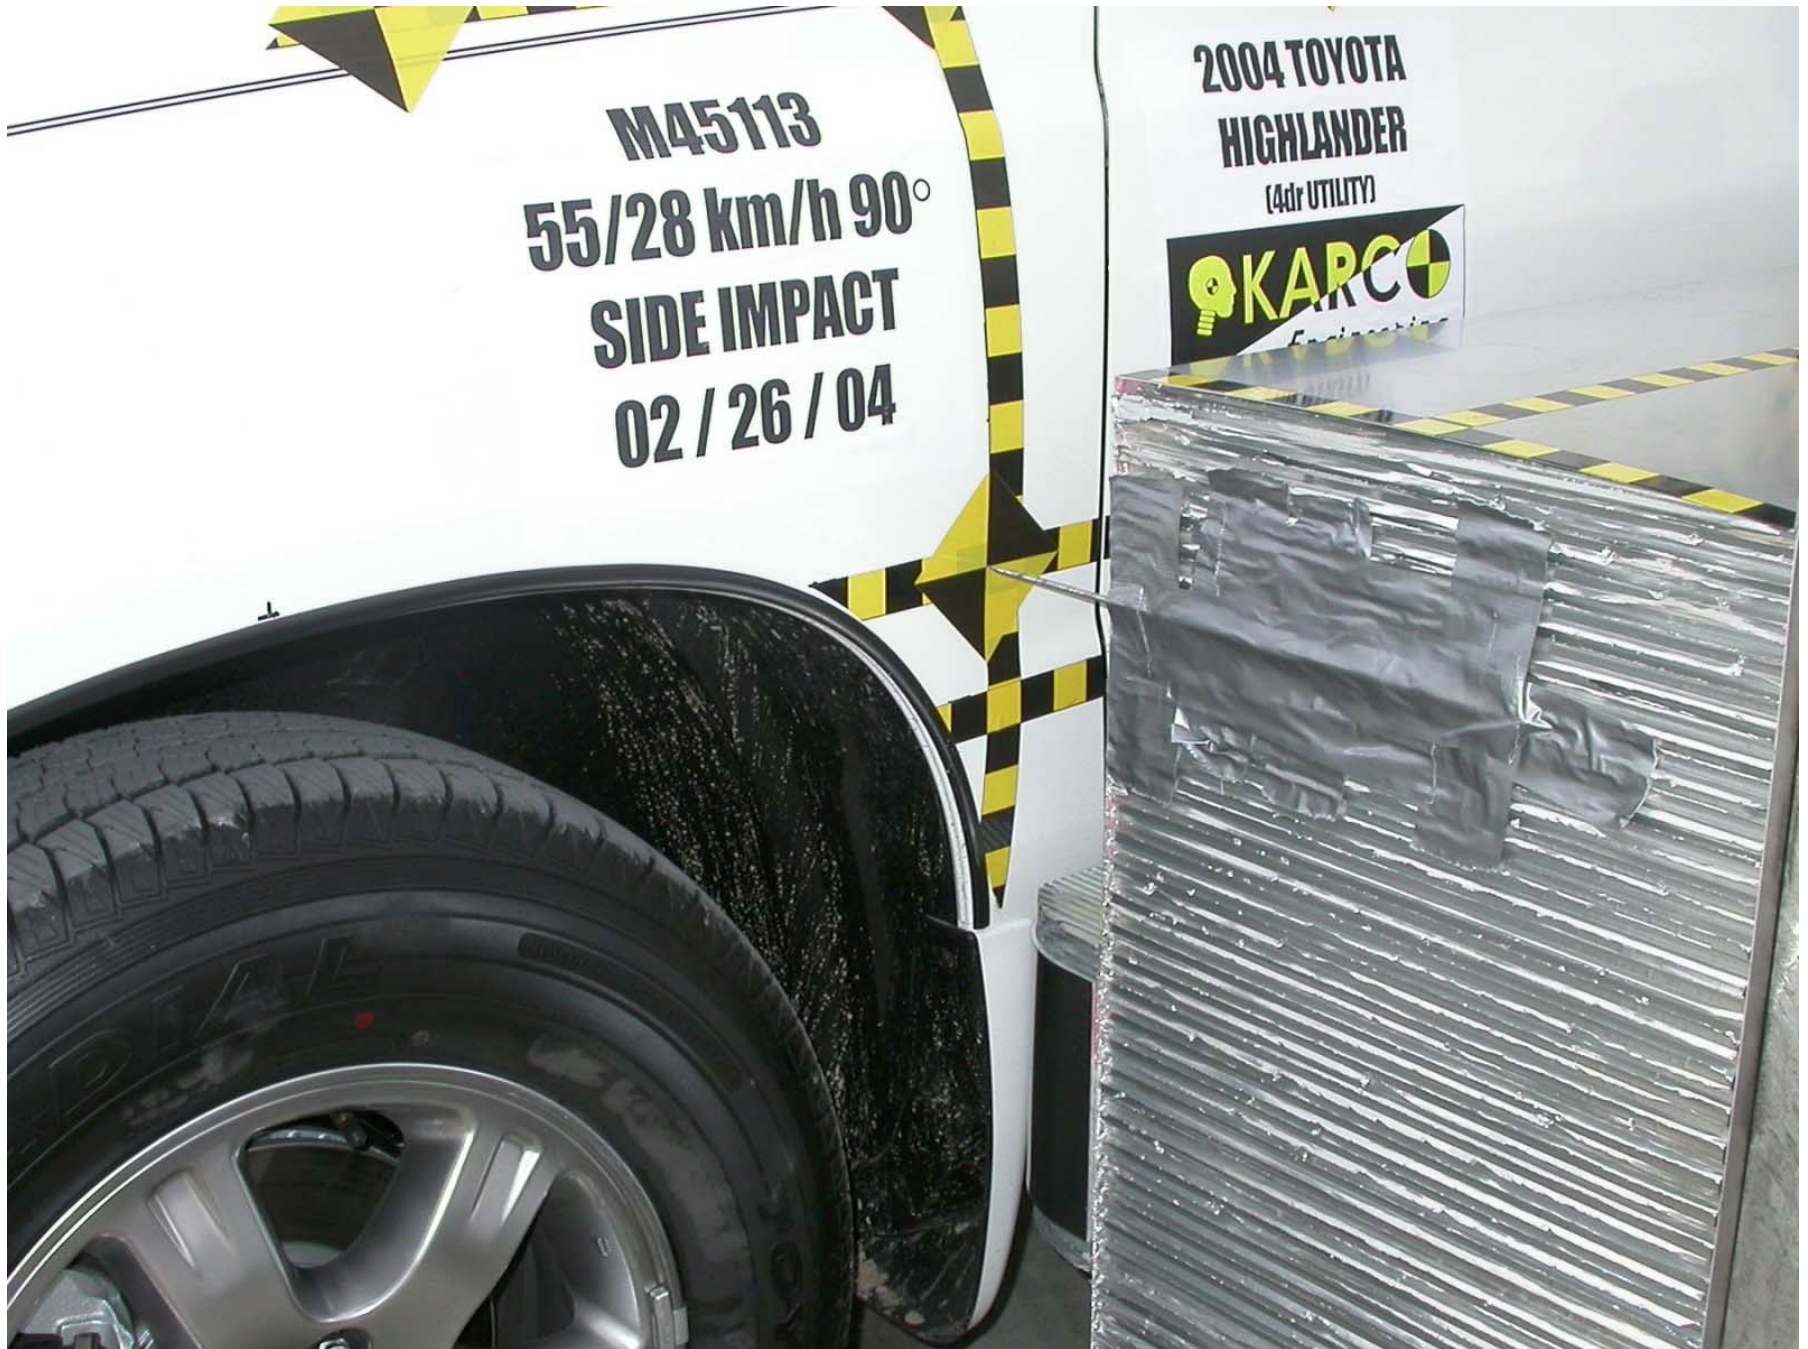
Figure A-25: Impact Point Target Set-up, Pre-Test

| Measurement Description | Units | Value |
|---|---|---|
| Actual Impact Point Aft of Front Axle | mm | 423 |

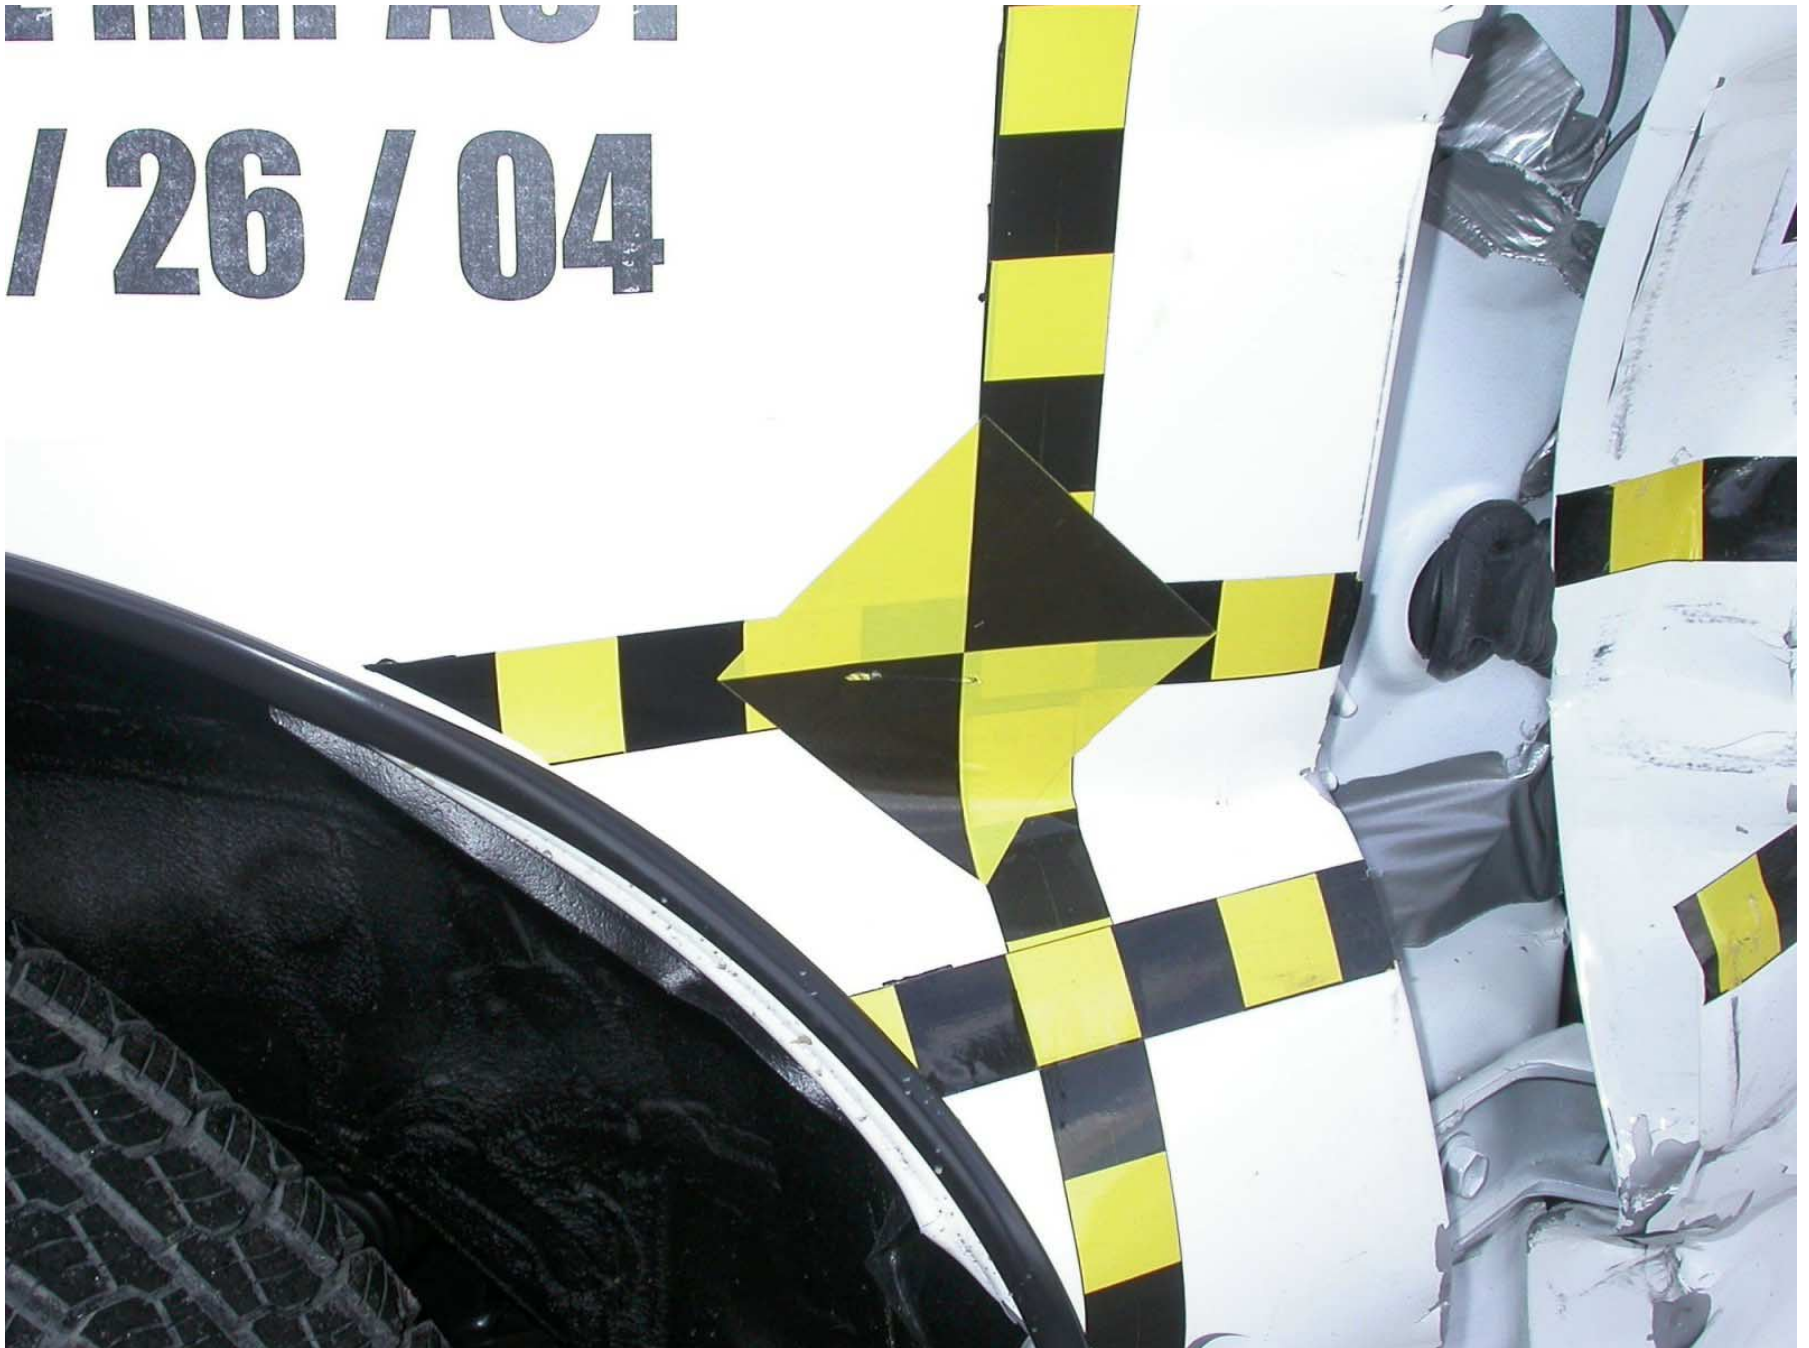
Figure A-26: Impact Point Target, Post-Test

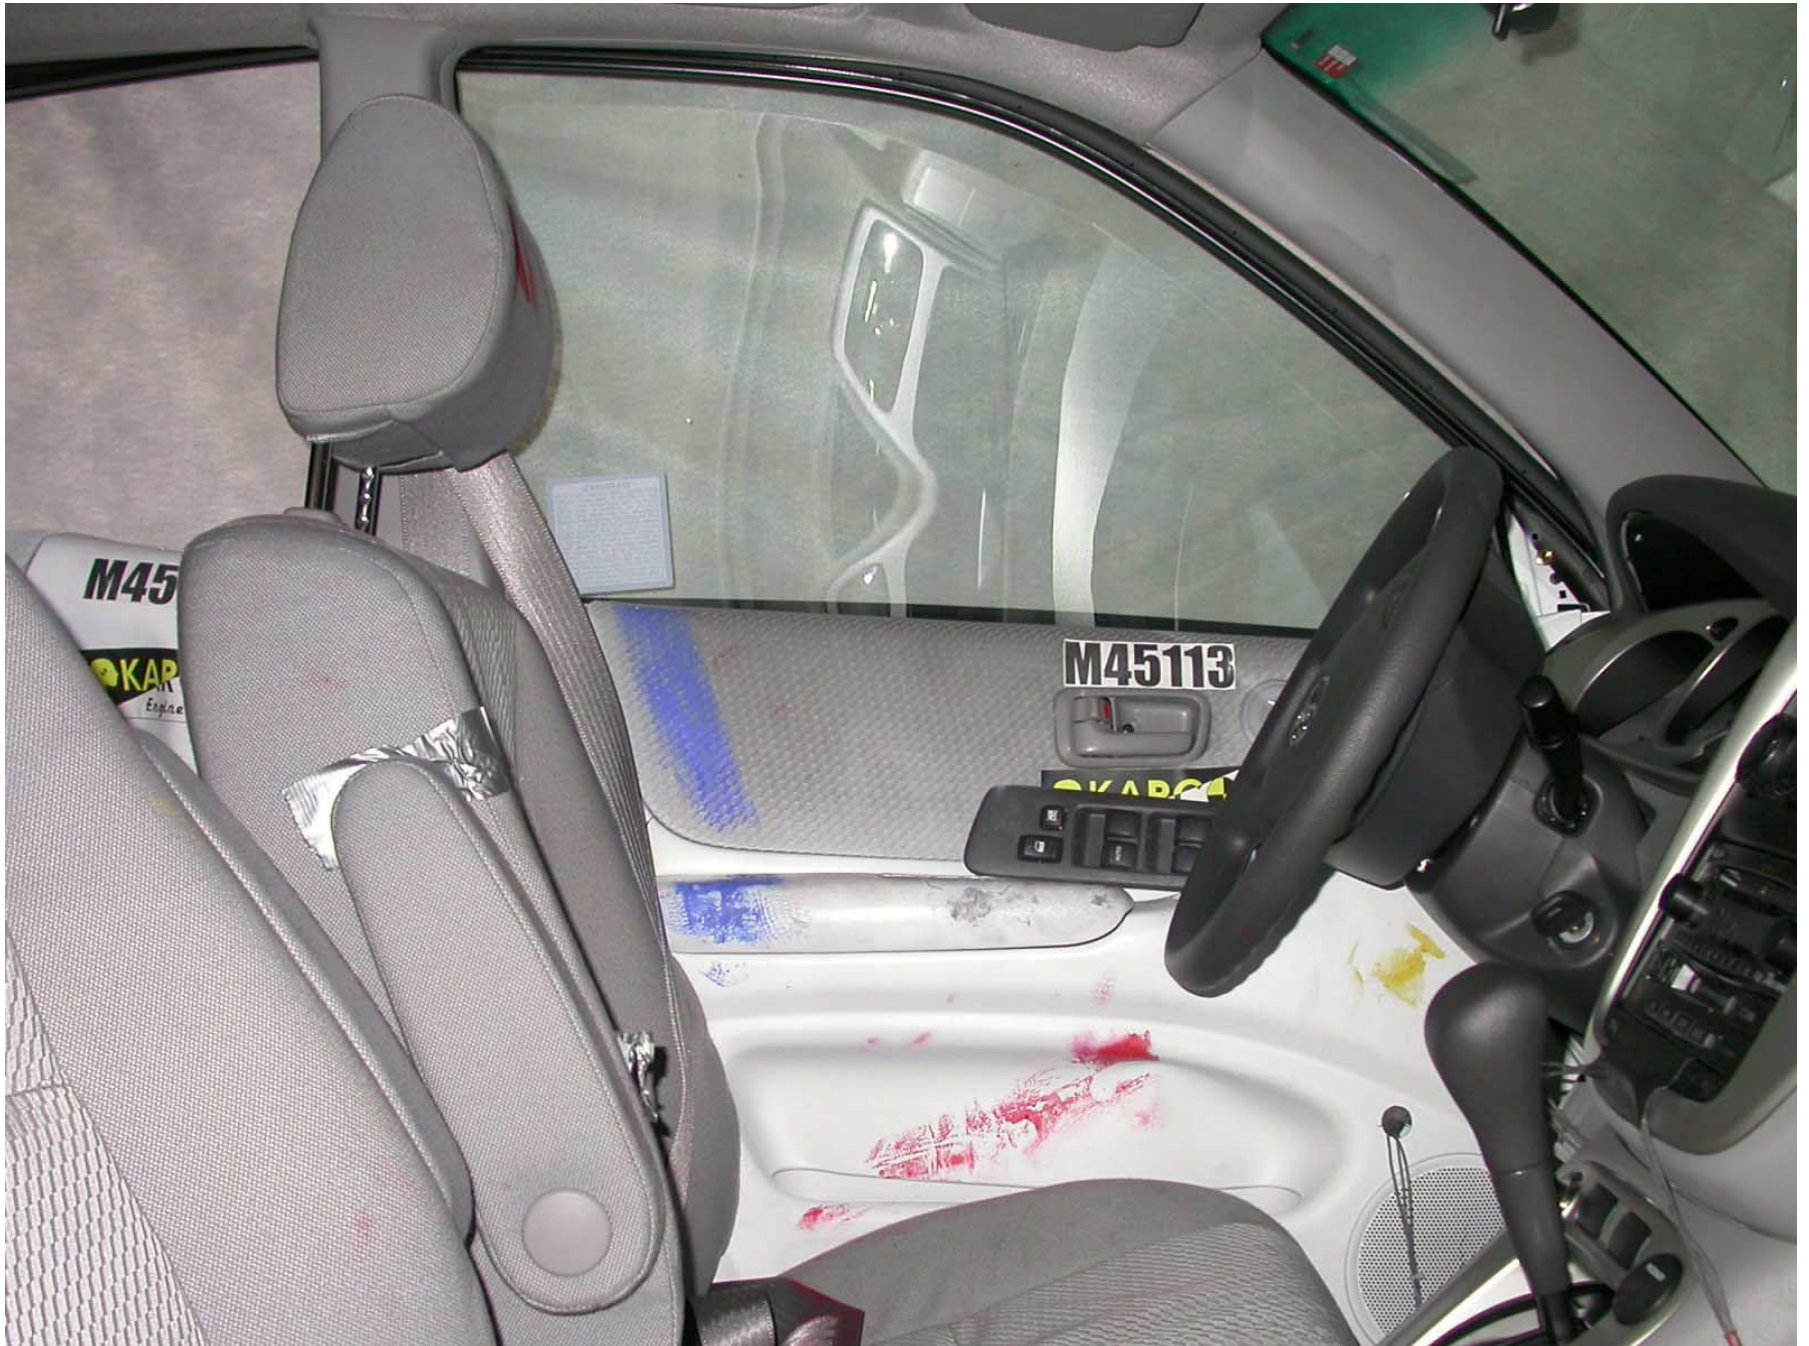
Figure A-43: Driver Dummy Contact Points Inside View, Post-Test

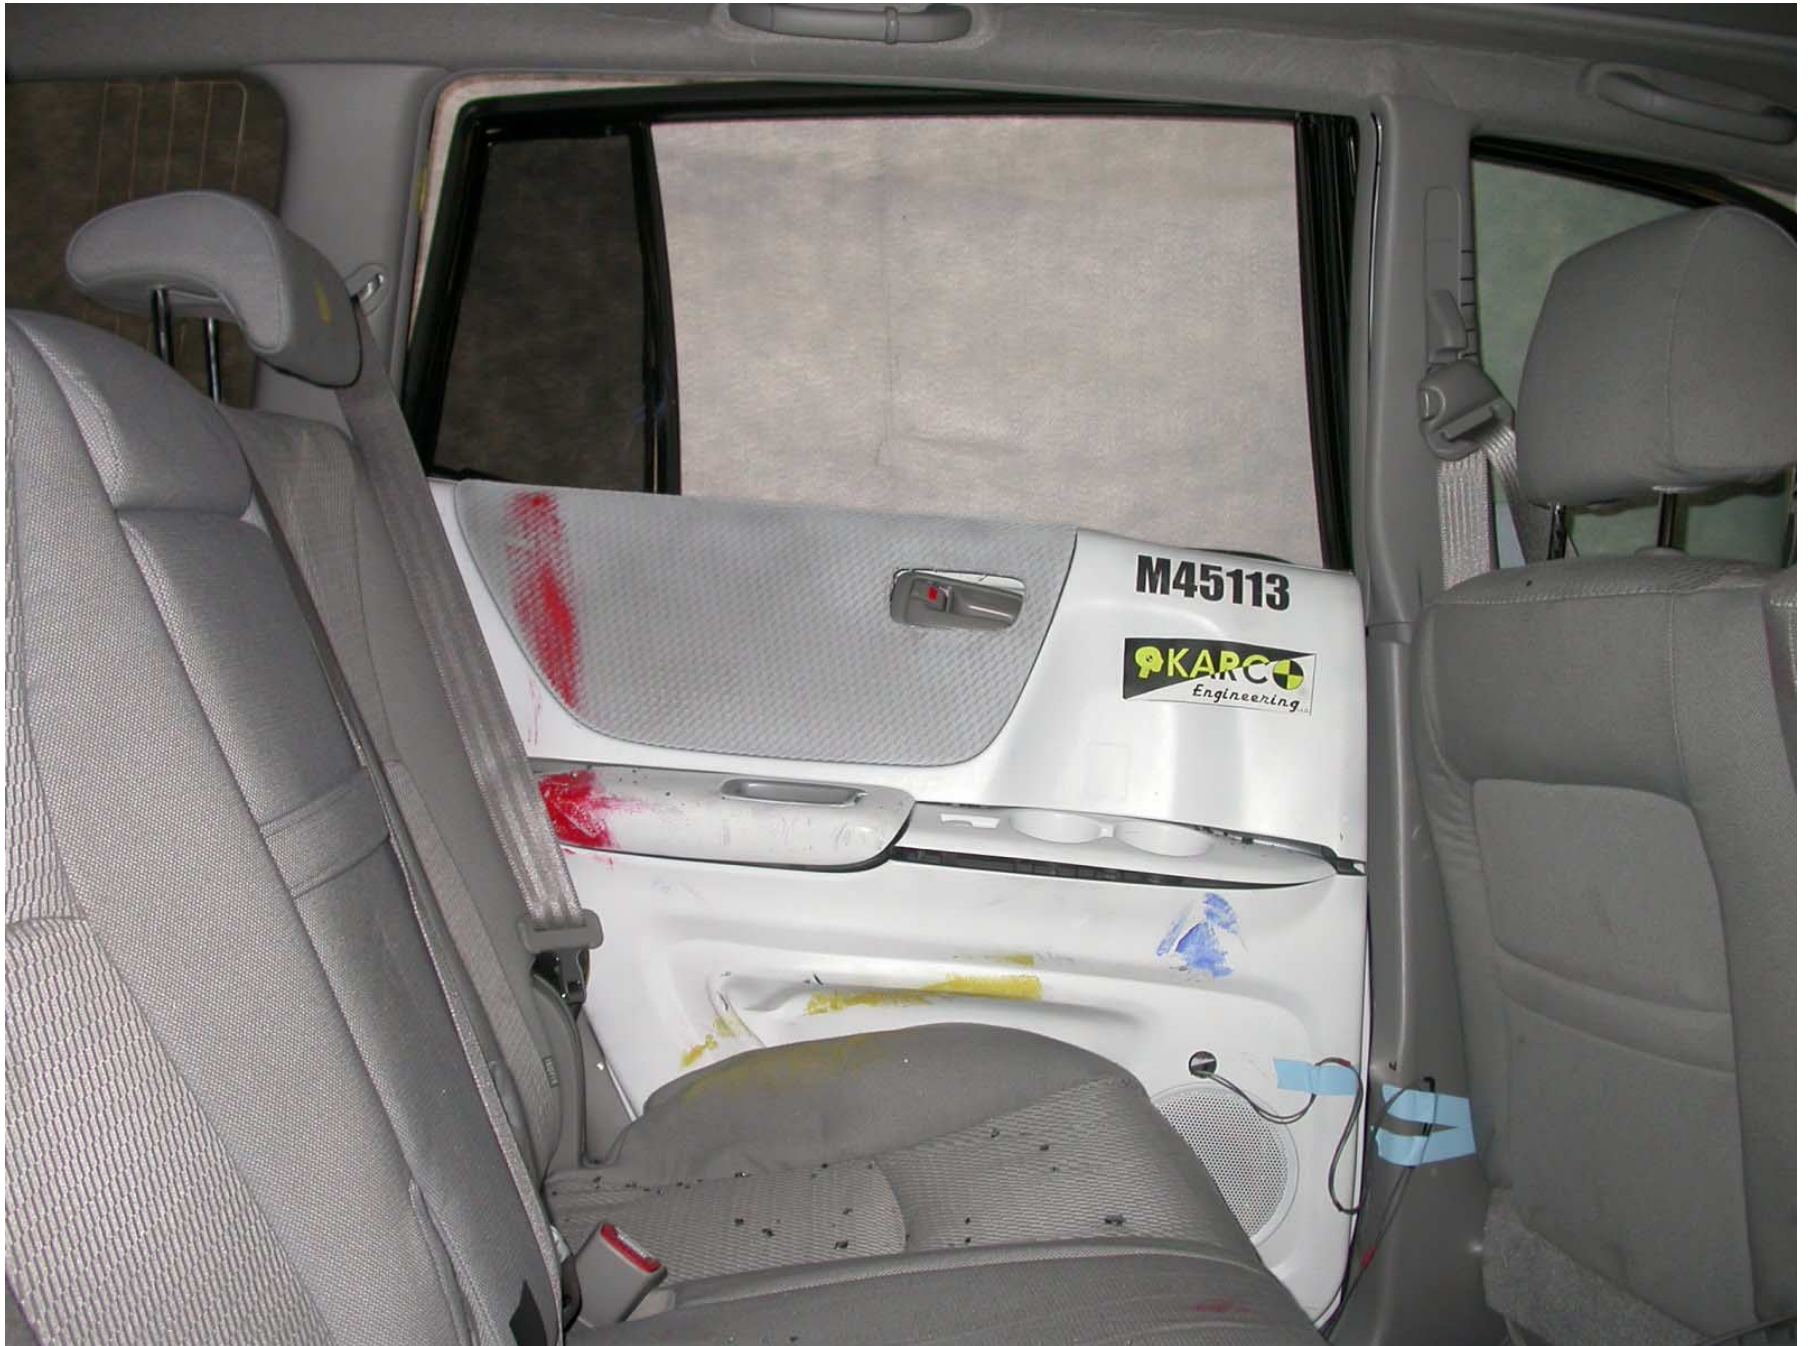
Figure A-52: Passenger Dummy Contact Points Inside View, Post-Test

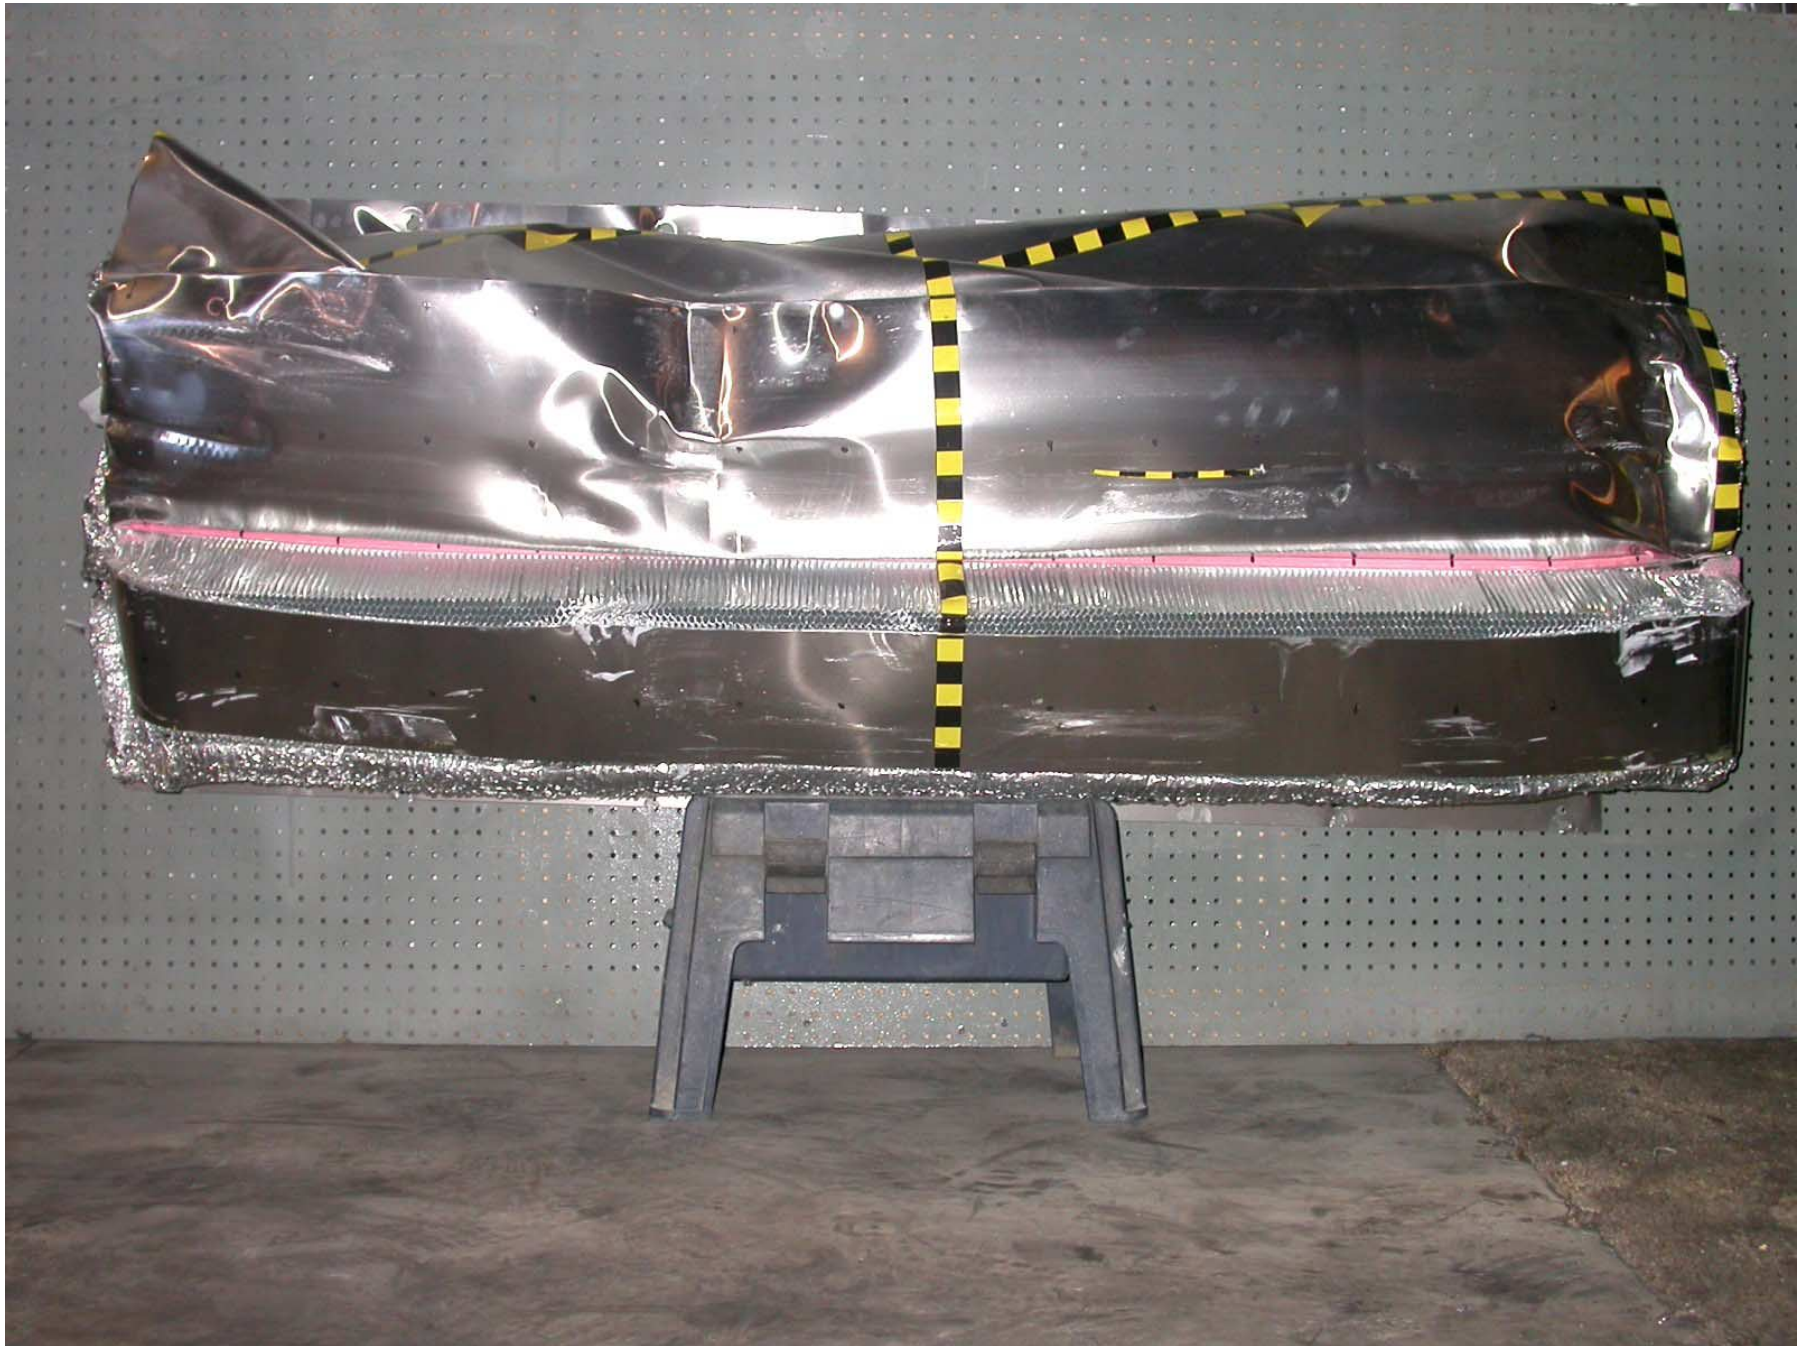
Figure A-54: Front View of Deformable Barrier, Post-Test

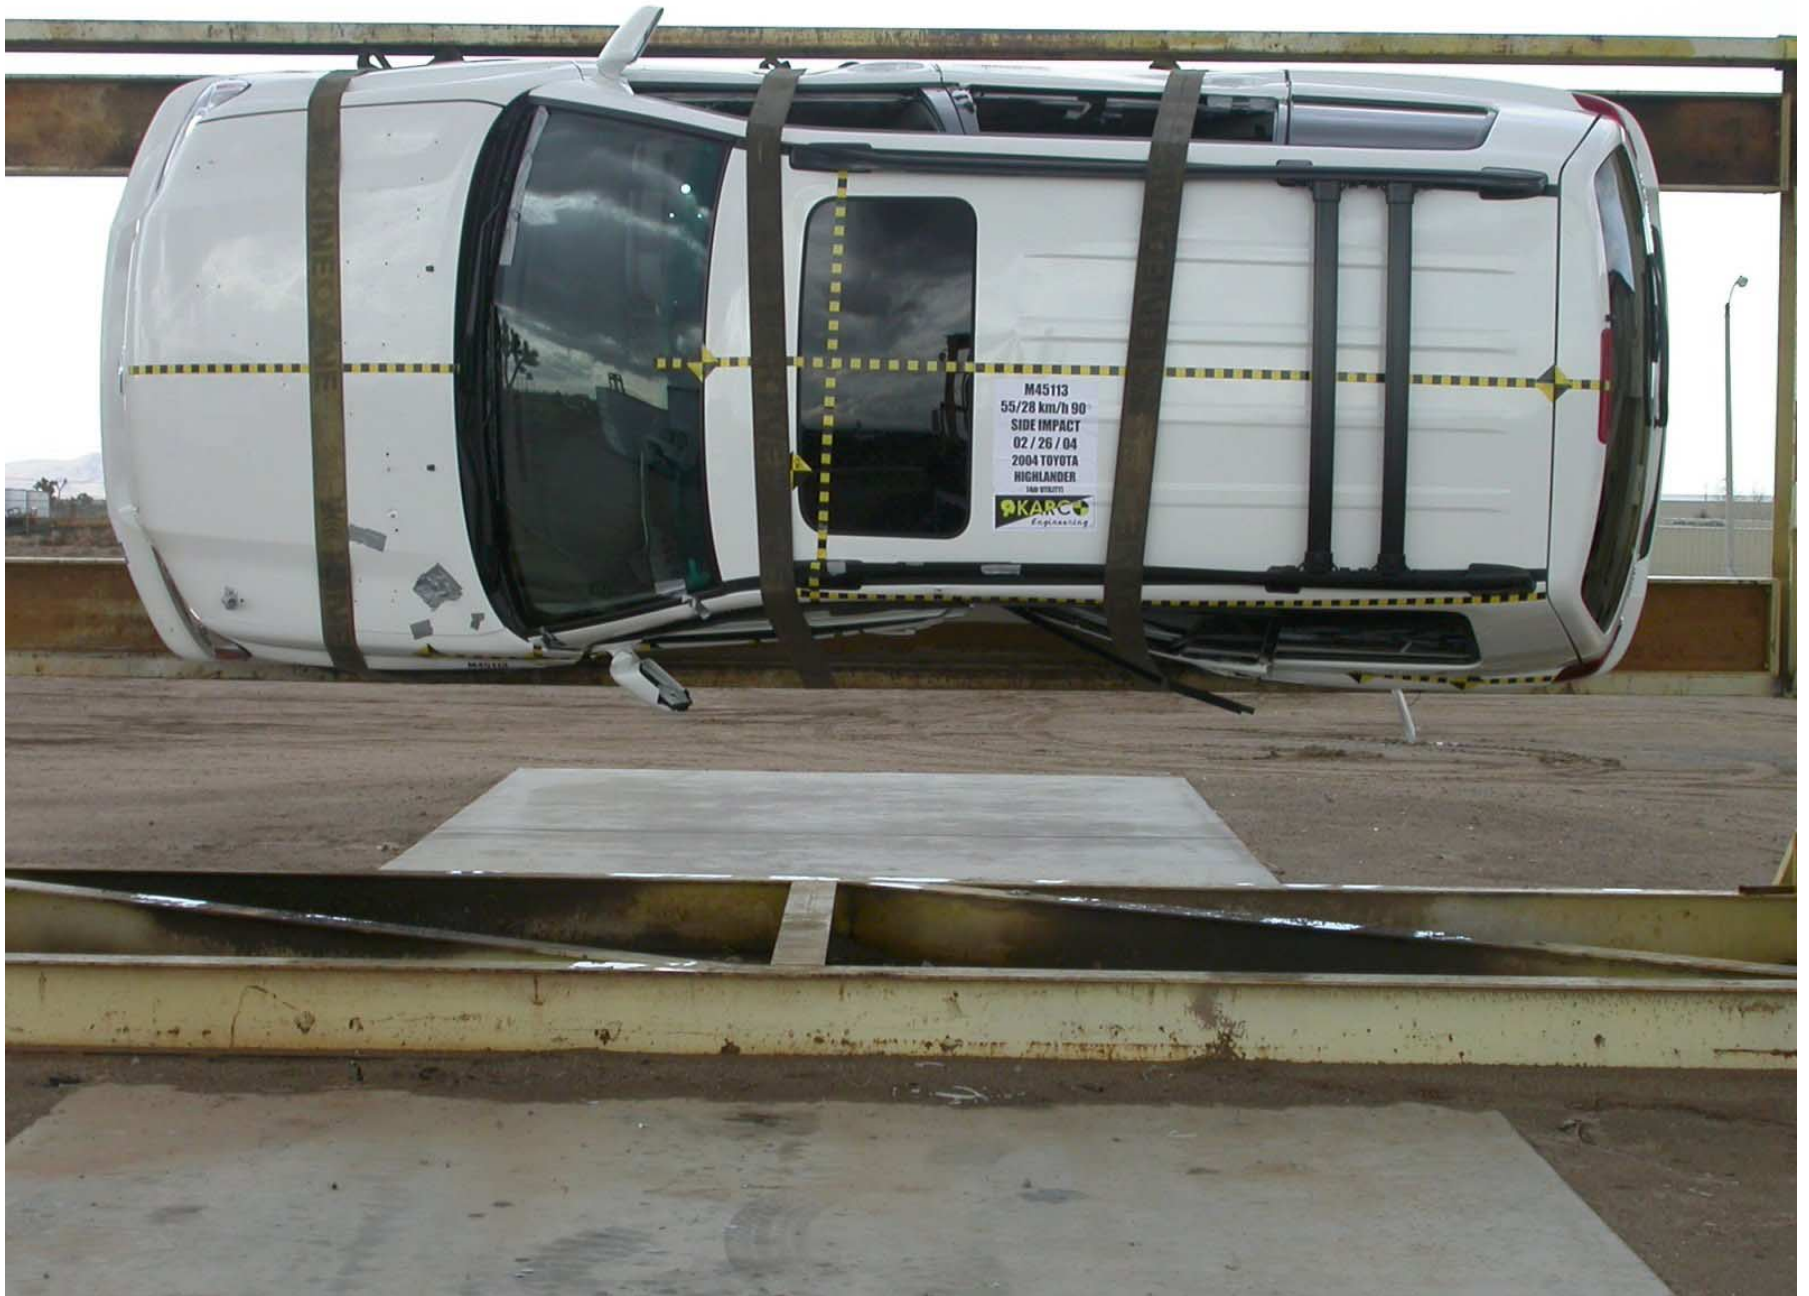
Figure A-62: Vehicle on Rollover Device, 90° View

No solvent leakage occurred during static rollover testing.

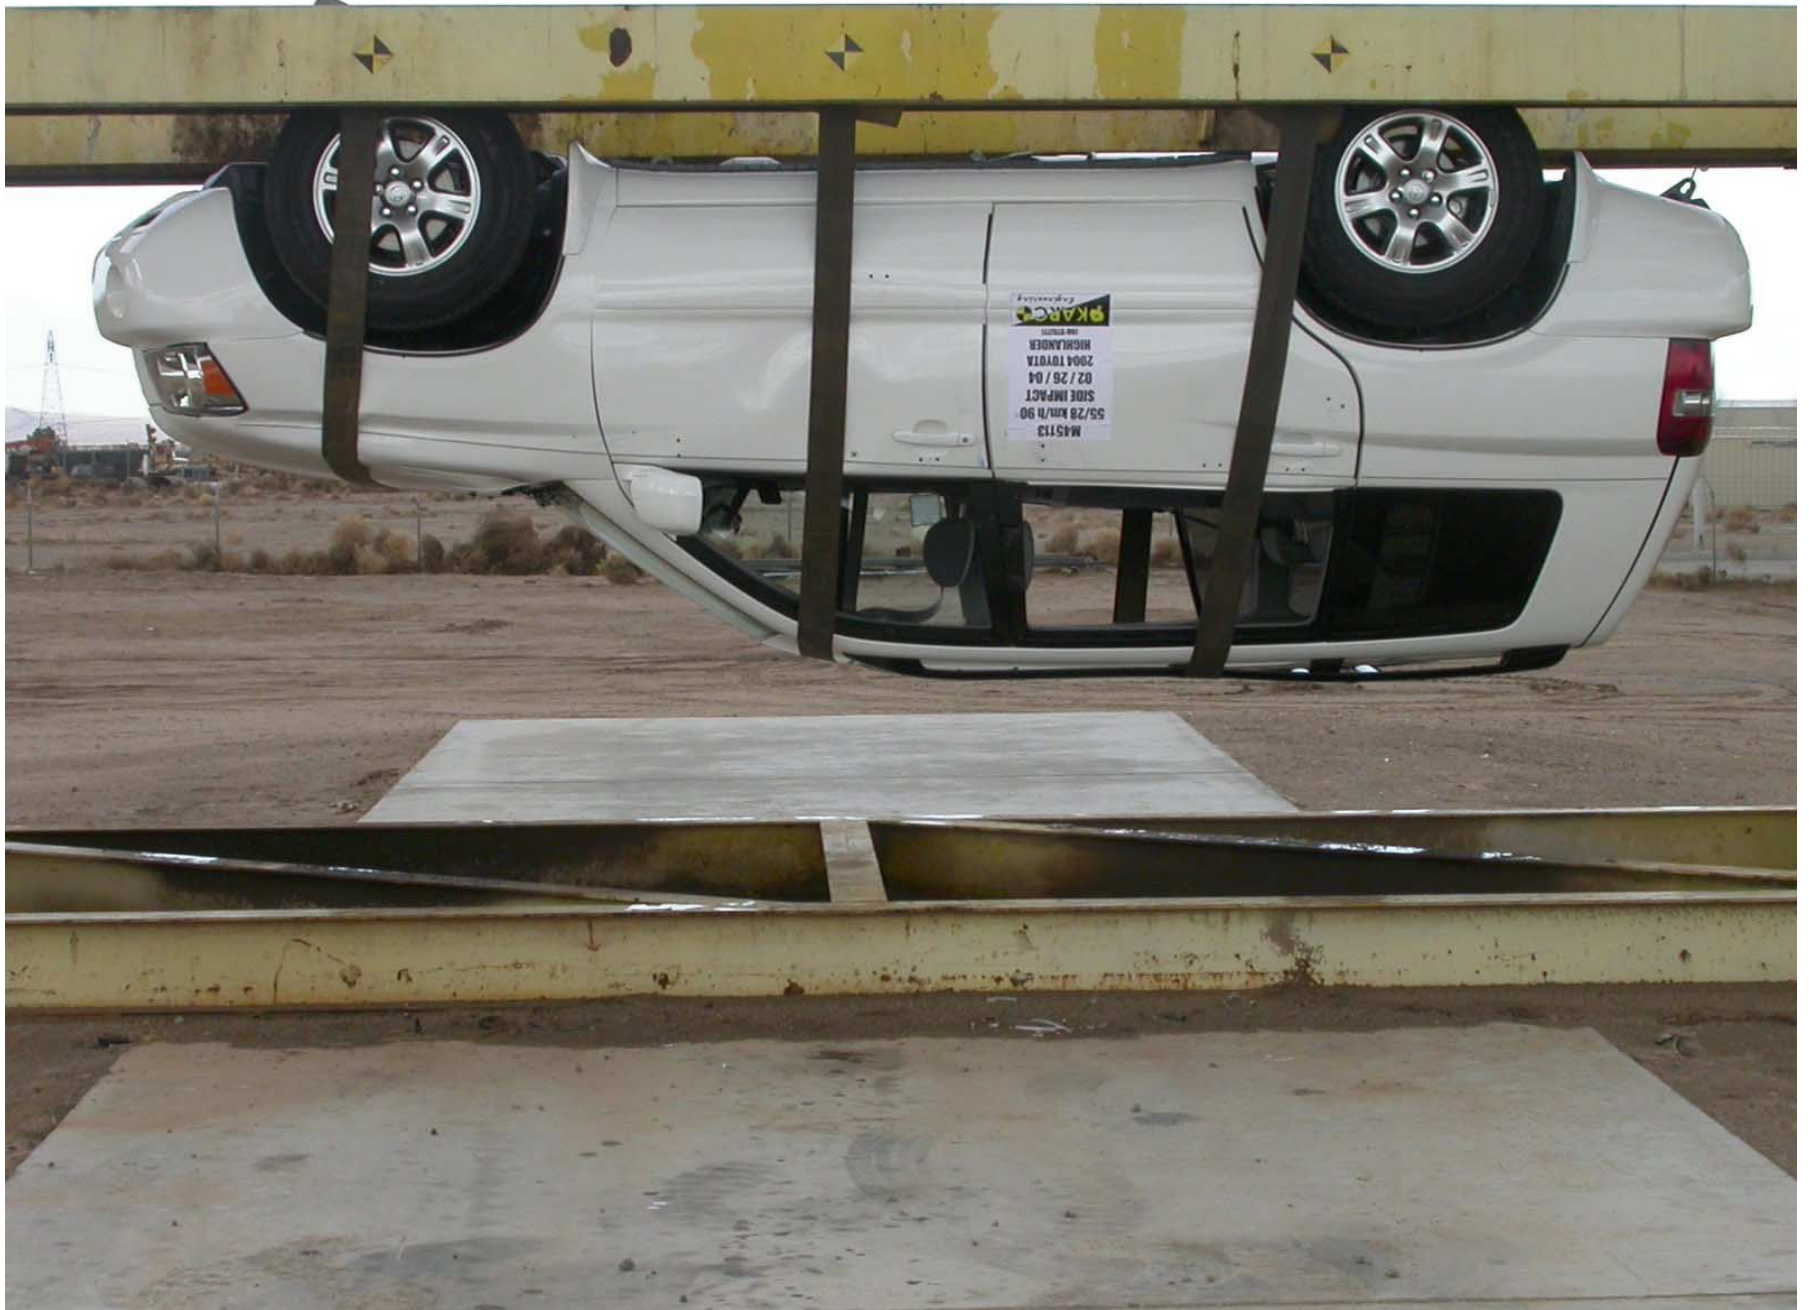
Figure A-63: Vehicle on Rollover Device, 180° View

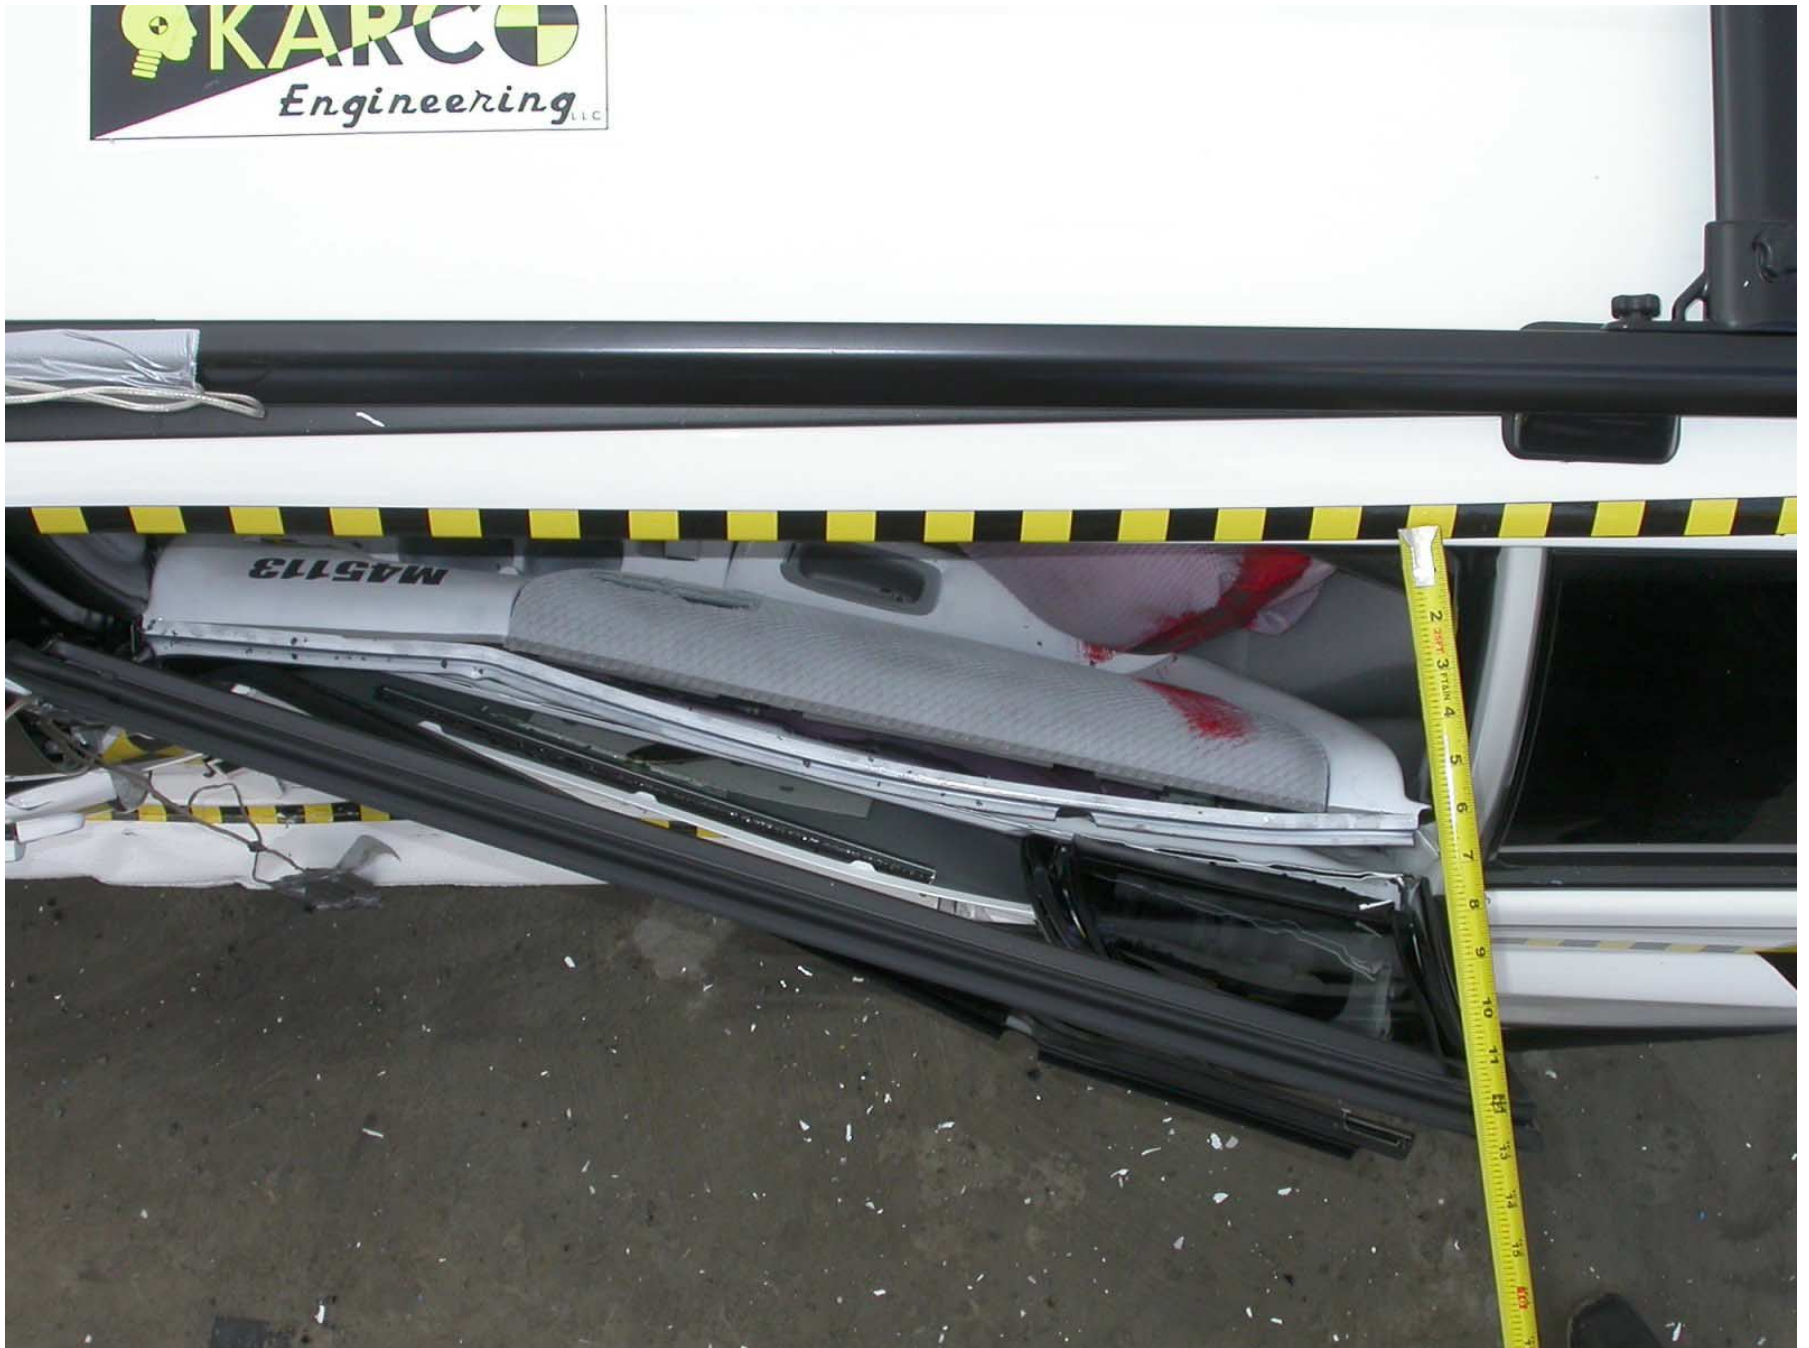
Figure A-66: Left Rear Door Window Separation, Post-Test

| Critical Areas of Performance | Observations and Conclusions |
|---|---|
| Window Damage | Left front window intact, rear left window broke |
