**REPORT NUMBER TR-P24003-04-NC**

**NEW CAR ASSESSMENT PROGRAM  
SIDE IMPACT TEST**

**TOYOTA MOTOR CORPORATION  
2004 TOYOTA HIGHLANDER  
SUV**

**NHTSA NUMBER: M45113**

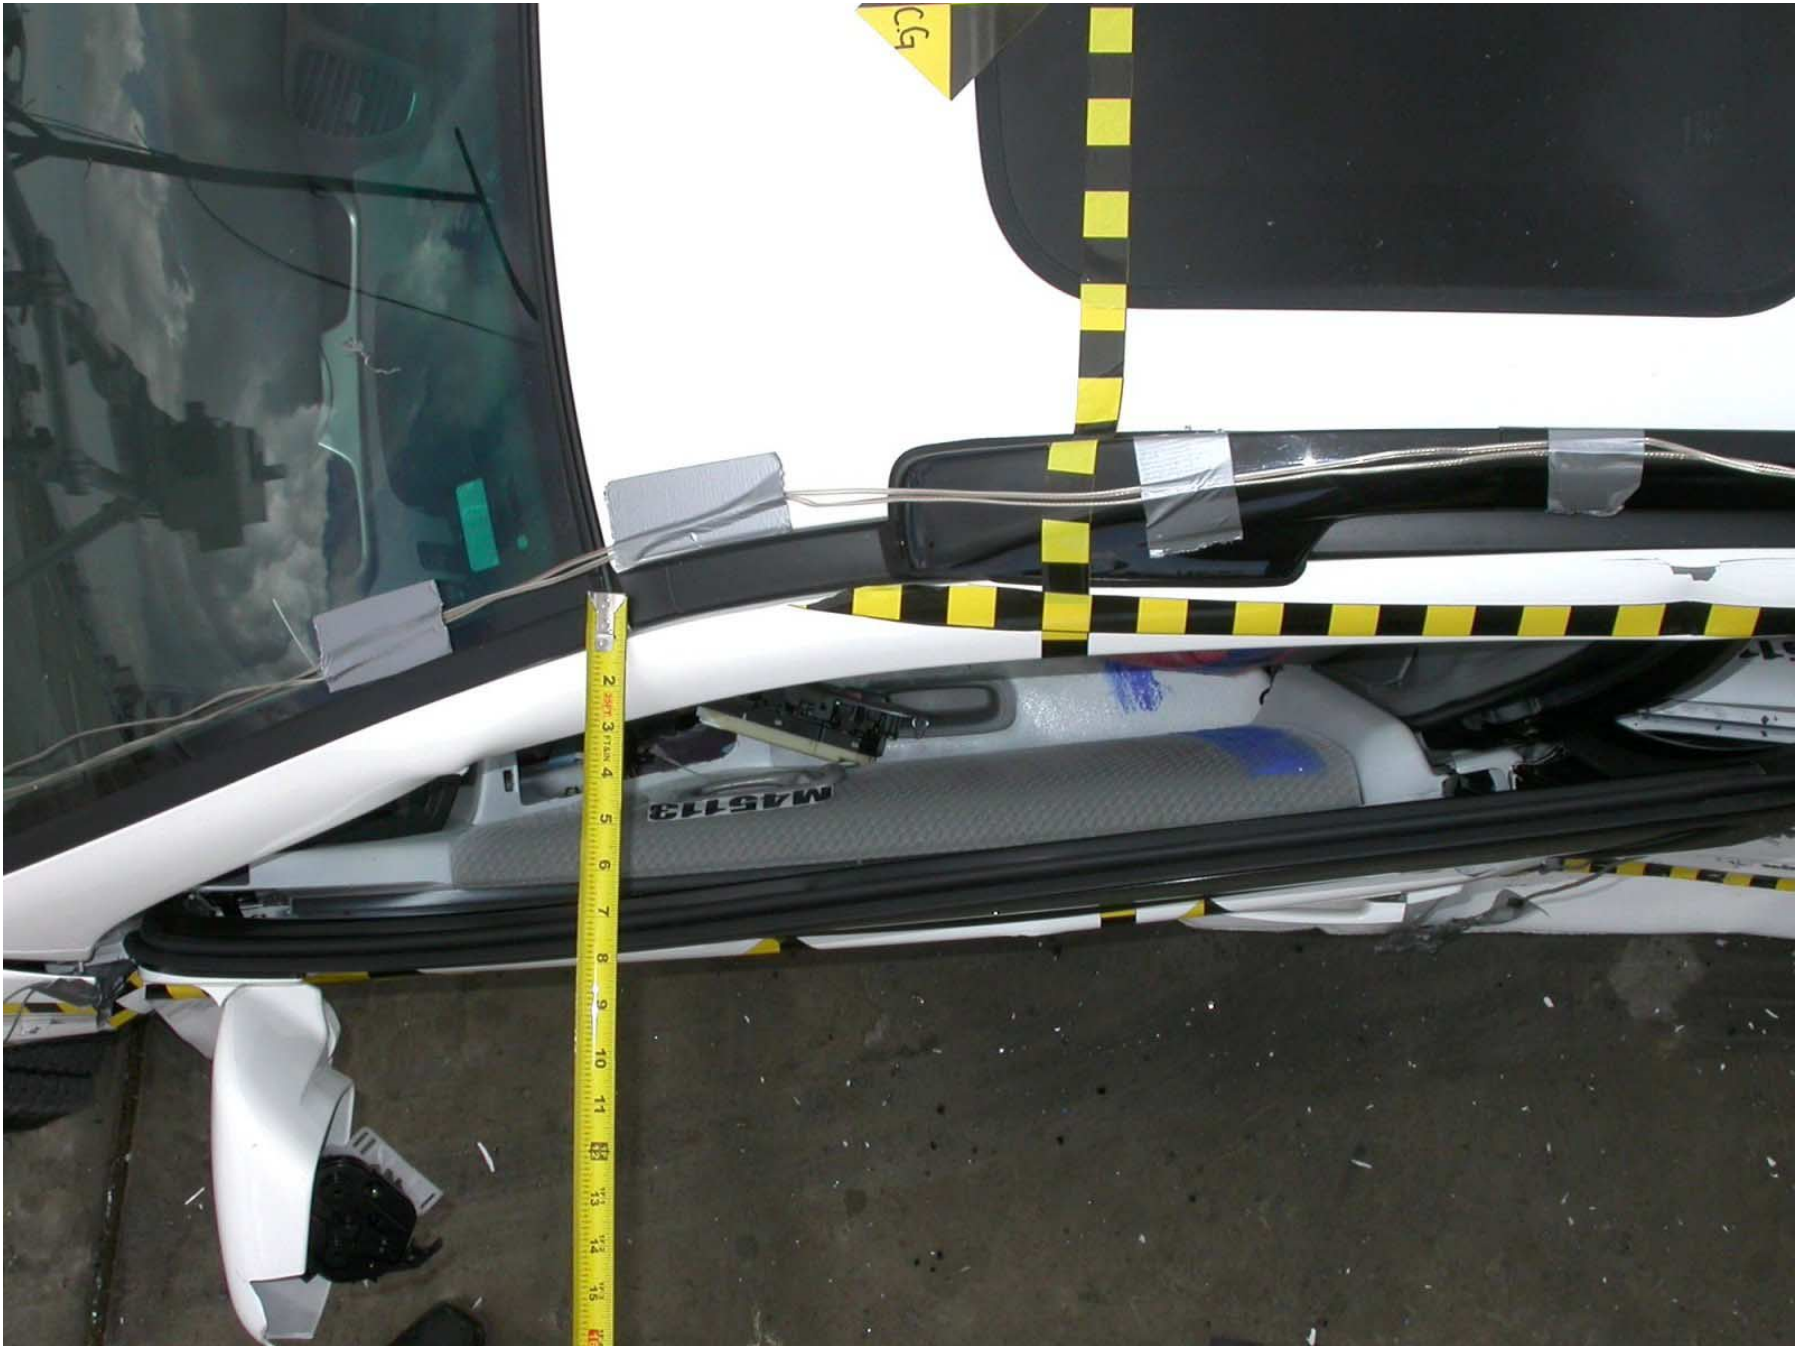
Figure A-67: Left Front Door Window Separation, Post-Test

| Critical Areas of Performance | Observations and Conclusions |
|---|---|
| Pillar Performance | Pillars pushed inward with separation as noted in photos. |
