REPORT NUMBER: TWG-CAL-04-01

**NEW CAR ASSESSMENT PROGRAM (NCAP)
SIDE AIRBAG OUT OF POSITION INJURY TESTING**

2003 NISSAN MURANO

NHTSA NUMBER: C35200TWG3

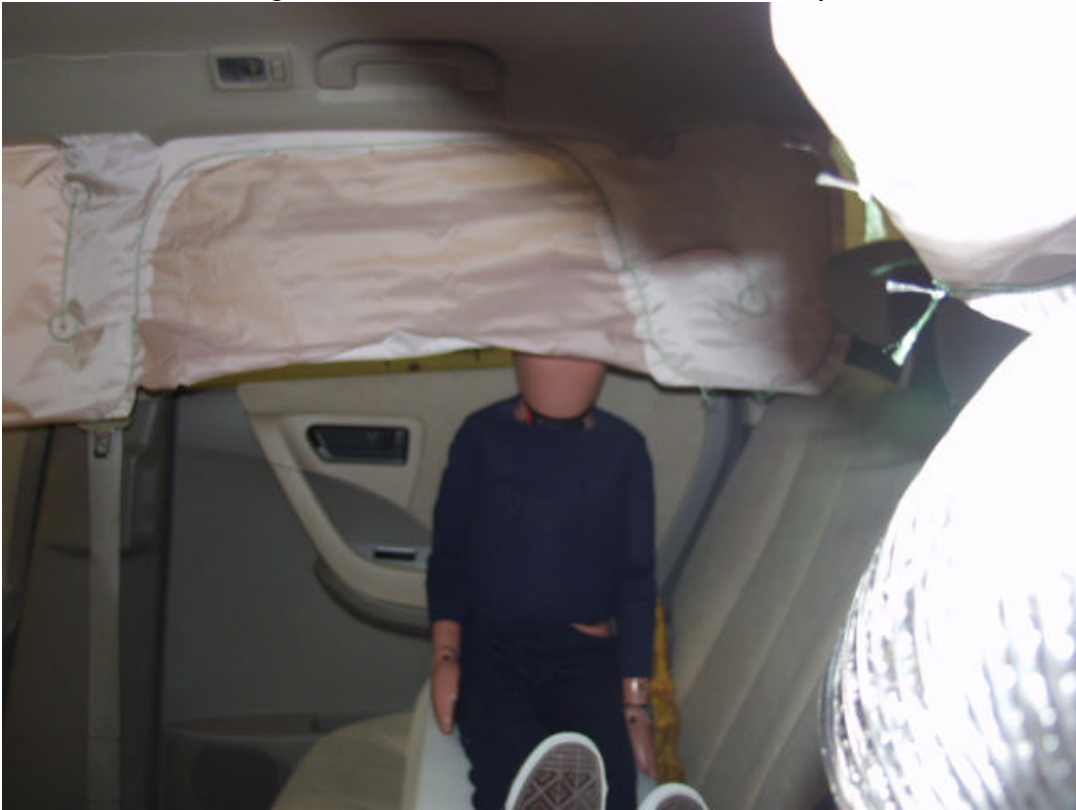
Figure A-6: Post-Test Frontal View of Dummy

Head Contact:	The top of the head was struck by the side curtain.
Upper Torso Contact:	None
Lower Torso Contact:	None
Left Knee Contact:	None
Right Knee Contact:	None
