REPORT NUMBER: TWG-CAL-04-06

**NEW CAR ASSESSMENT PROGRAM (NCAP)**  
SIDE AIRBAG OUT-OF-POSITION INJURY TESTING

2004 HYUNDAI XG350

NHTSA NUMBER: M40503TWG2

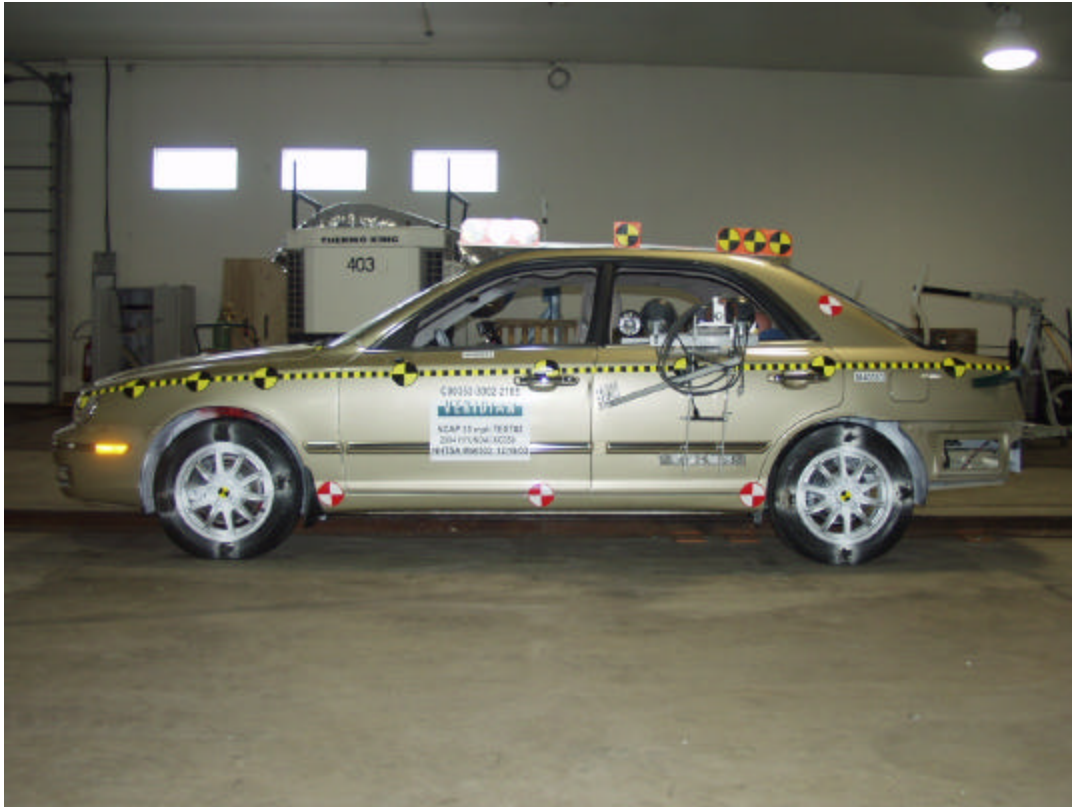
Figure A-1: Pre-Test Vehicle Left Side View

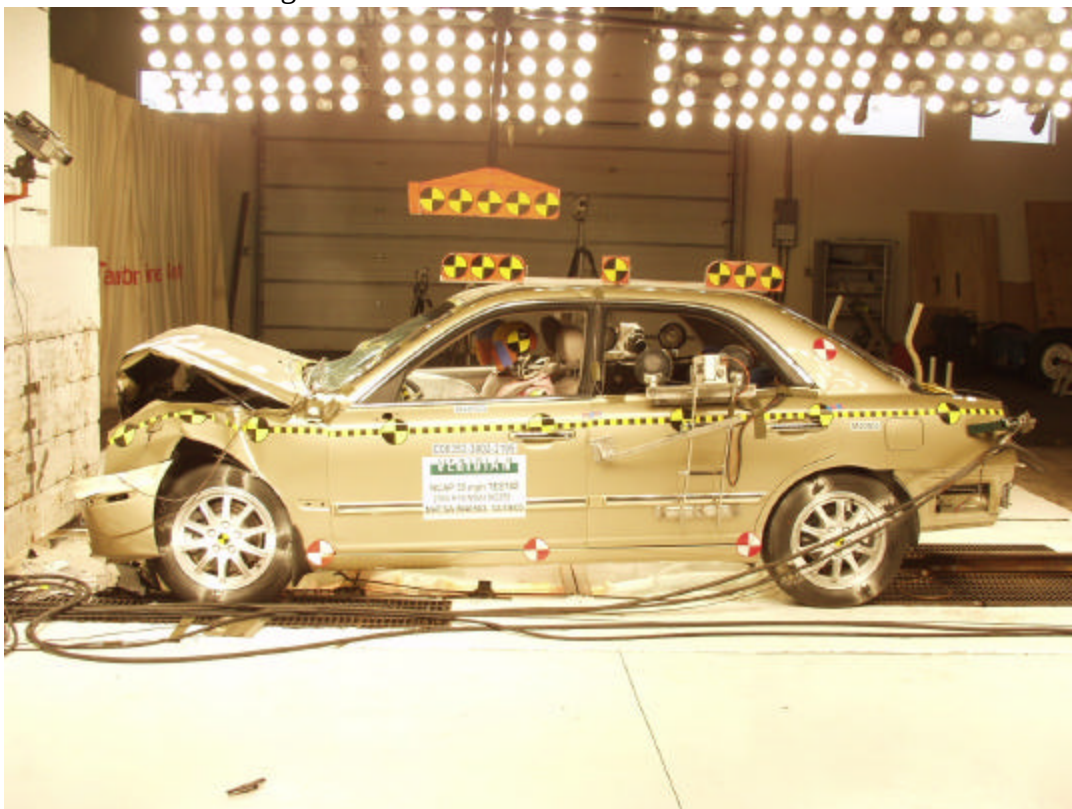
Figure A-2: Post-Test Vehicle Left Side View

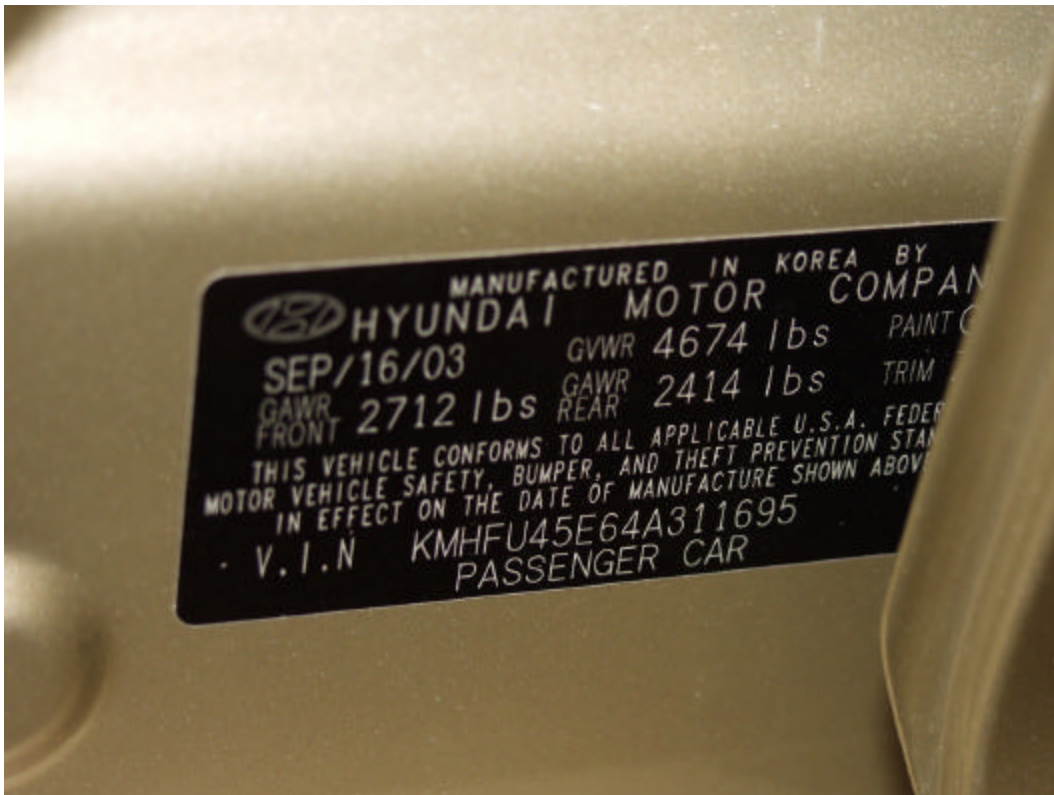
Figure A-3: Vehicle Certification Placard

Vehicle Manufactured by: Hyundai Motor Company

Date of Manufacture SEP/16/03

GVWR: 2120 kg; GAWR: 1230 kg FRONT; 1095 kg REAR

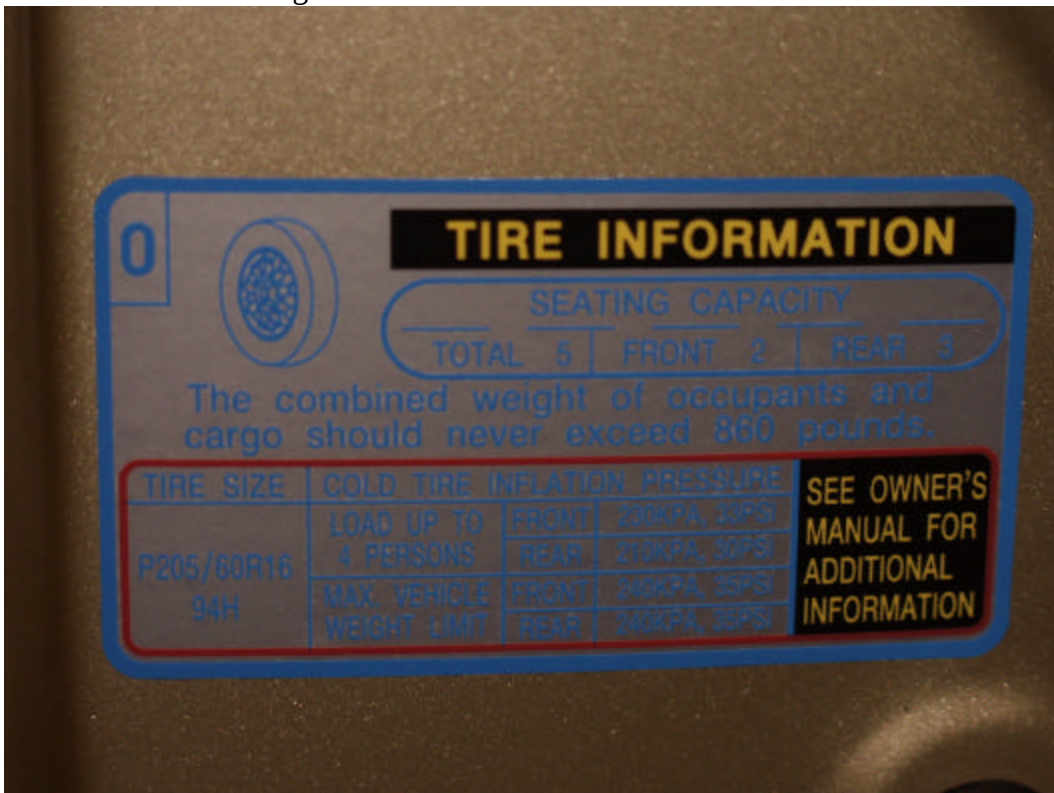
Figure A-4: Vehicle Tire Placard

Recommended Tire Size: P205/60R16

\* Recommended Cold Tire Pressure: 230 kPa FRONT; 210 kPa REAR

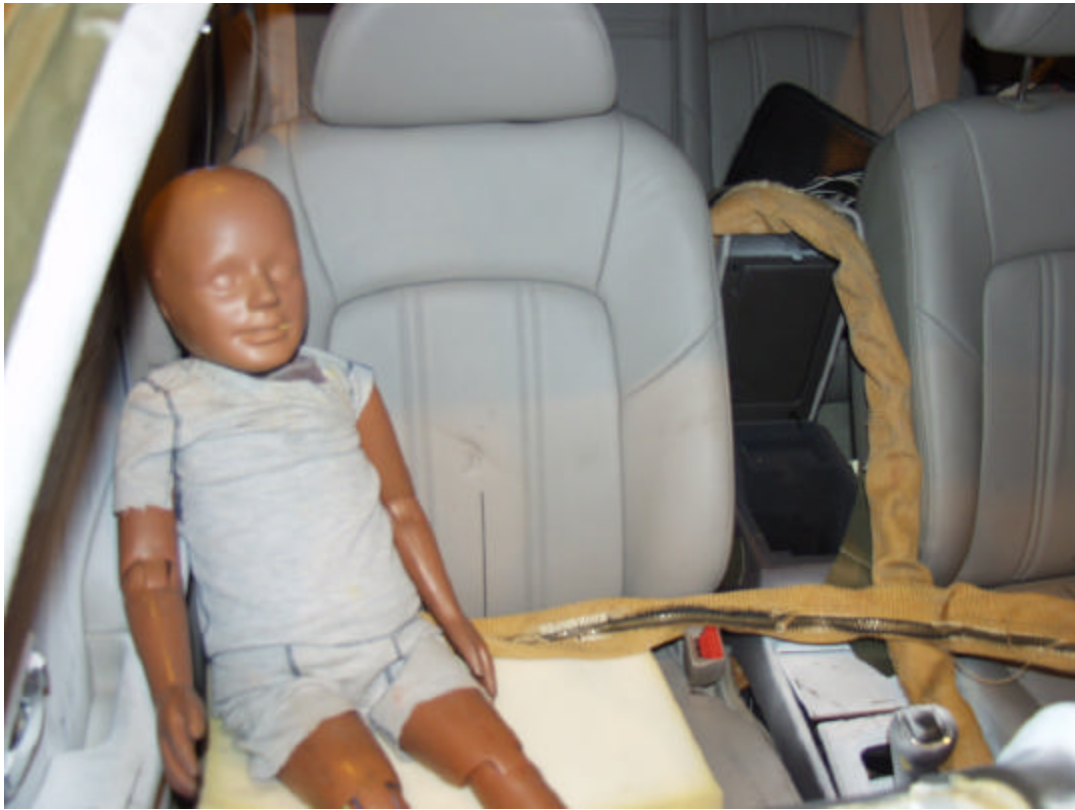
Figure A-5: Pre-Test Frontal View of Dummy

The three-year-old child dummy was placed on a booster block and oriented in the forward facing position on the outboard portion of the seat cushion. The right side window was raised and the seatback was set to the manufacturer's design position for a fiftieth percentile male dummy. The seat was placed in the lowest height position and the seat tracks were set in mid-position because the full rearward position could not be achieved due to the car being previously used in an NCAP 35 mph frontal barrier impact. The dummy's spine was aligned with the leading edge of the seat bolster with the head placed between but not in contact with the seat bolster and the B-Pillar with the neck/torso junction aligned vertically with the top edge of the airbag module. The dummy legs were aligned so that they crossed the heel placement points at a location of 20 to 20 mm from the leading edge of the seat cushion and 75 mm to either side of the seat cushion centerline. The dummy's heels were in line with leading edge of the seat cushion. The dummy's right arm was placed on the arm rest with the forearm and hand aligned along the armrest. The dummy's left arm was in contact with the seatback with the left forearm located such that the fingertips contacted the booster seat. This orientation complies with section 3.3.3.1 of the TWG Recommended Procedures for Evaluating Occupant Injury Risk from Deploying Side Airbags as defined by Lund, et al and the Technical Working Group dated July 2003.

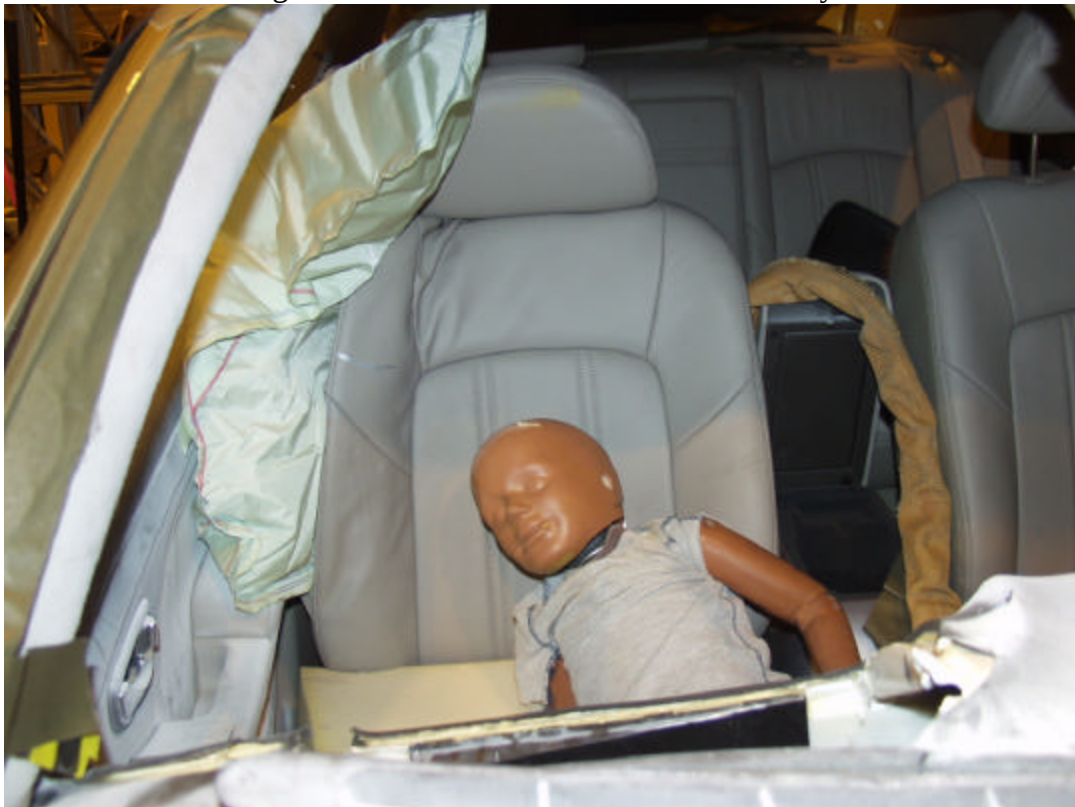
Figure A-6: Post-Test Frontal View of Dummy

The Hybrid III three-year-old child dummy's visible contact points were as follows: The airbag to the back of the head and back of the right side of the torso of the ATD.

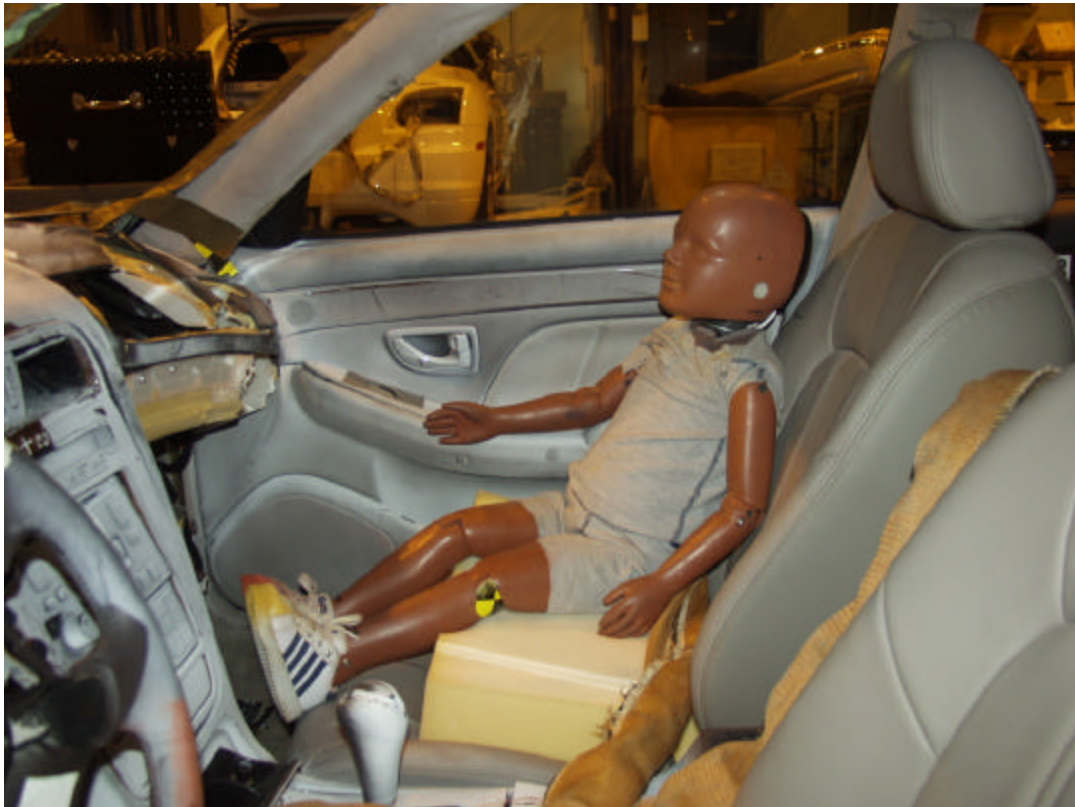
Figure A-7: Pre-Test Left Side View of Dummy

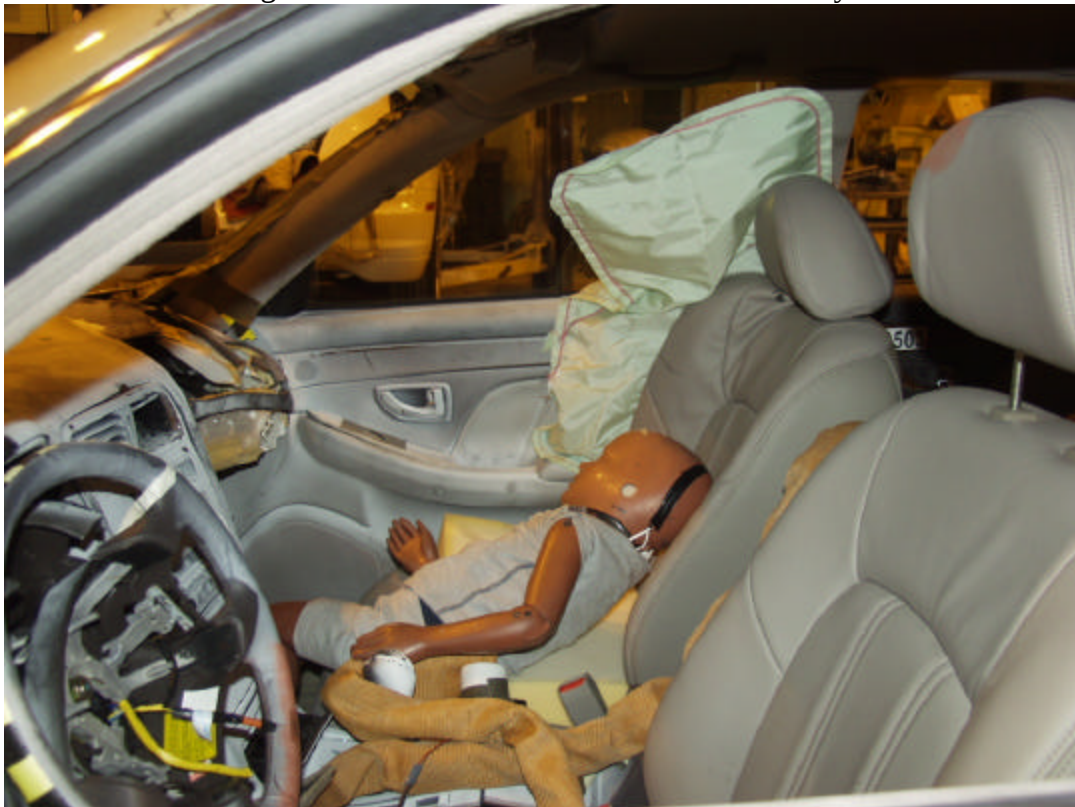
Figure A-8: Post-Test Left Side View of Dummy

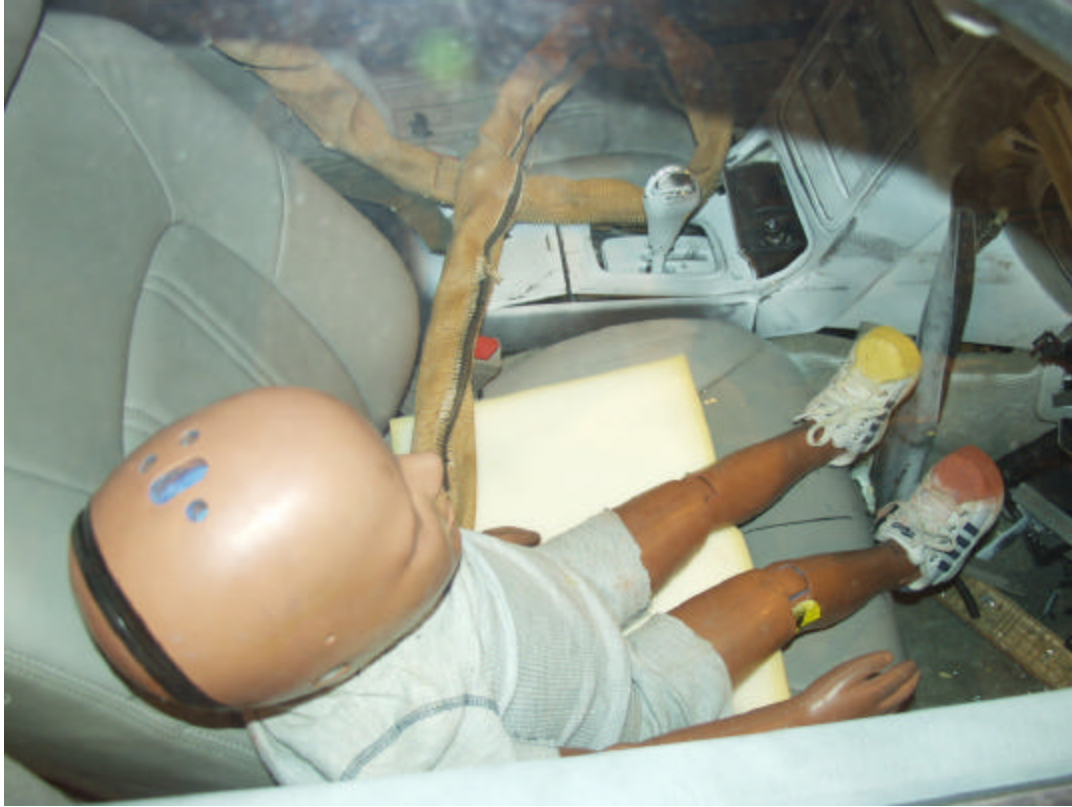
Figure A-9: Pre-Test Right Side View of Dummy

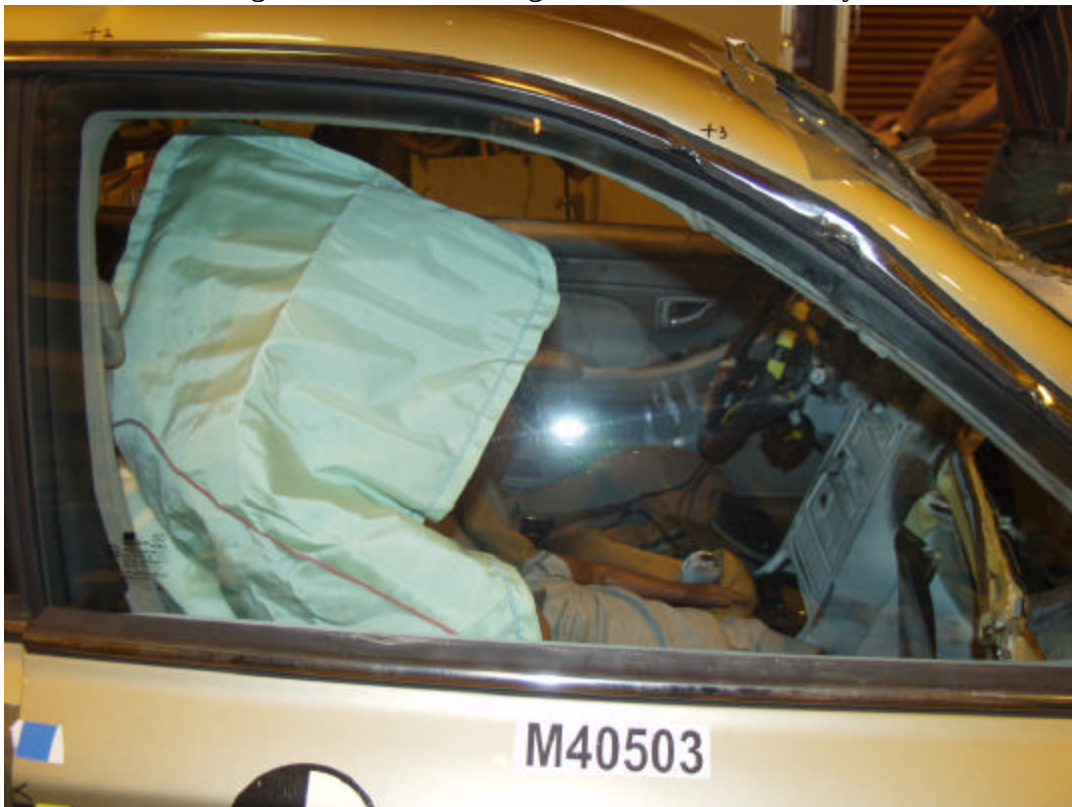
Figure A-9: Post-Test Right Side View of Dummy
