**NEW CAR ASSESSMENT PROGRAM (NCAP)**  
SIDE AIRBAG OUT-OF-POSITION INJURY TESTING

2004 CHRYSLER CROSSFIRE

NHTSA NUMBER: C40305TWG2

**FINAL REPORT**

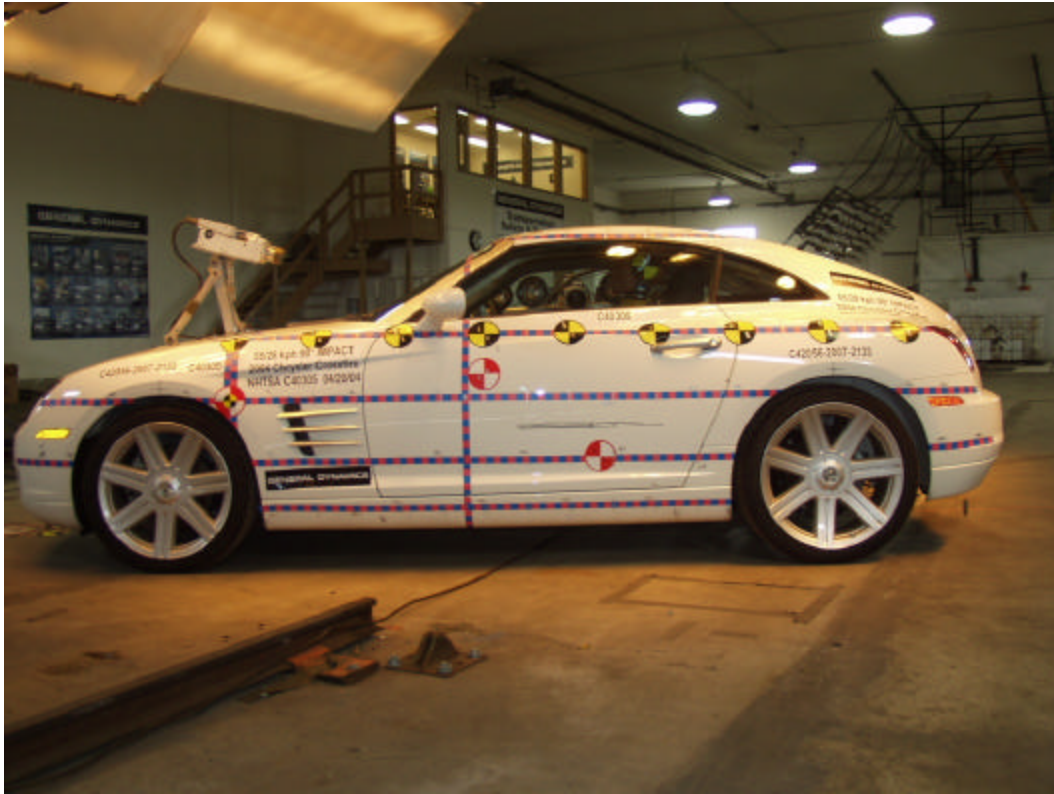
Figure A-1: Pre-Test Vehicle Left Side View

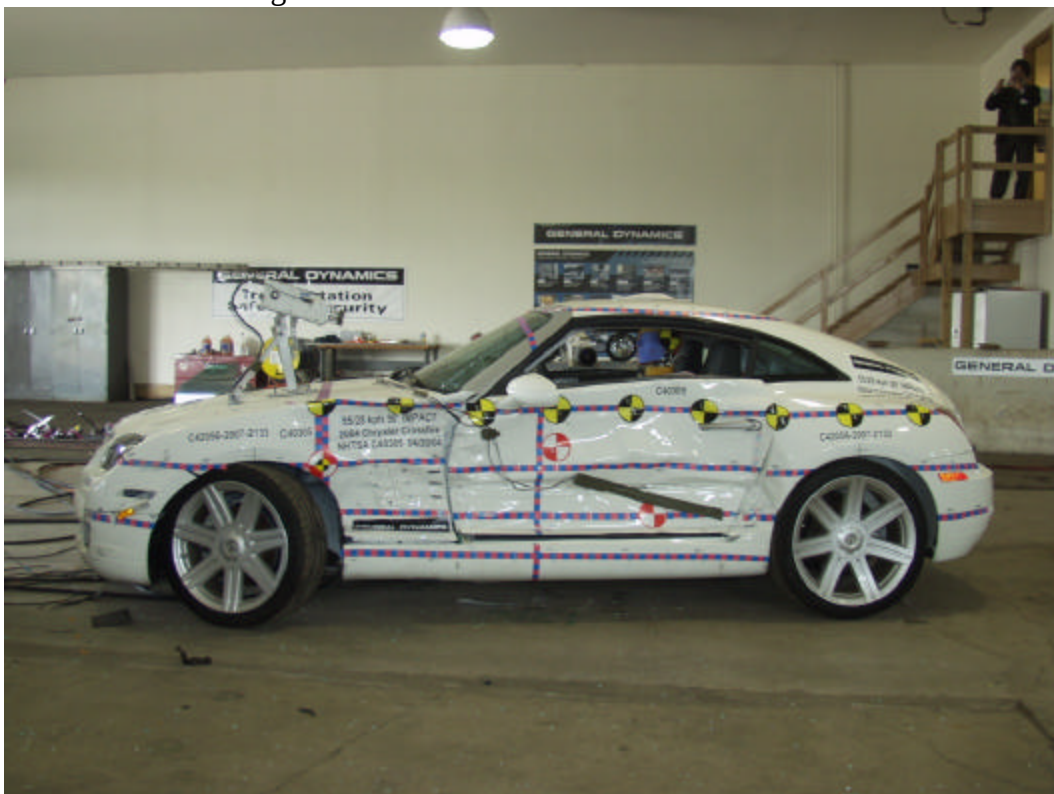
Figure A-2: Post-Test Vehicle Left Side View

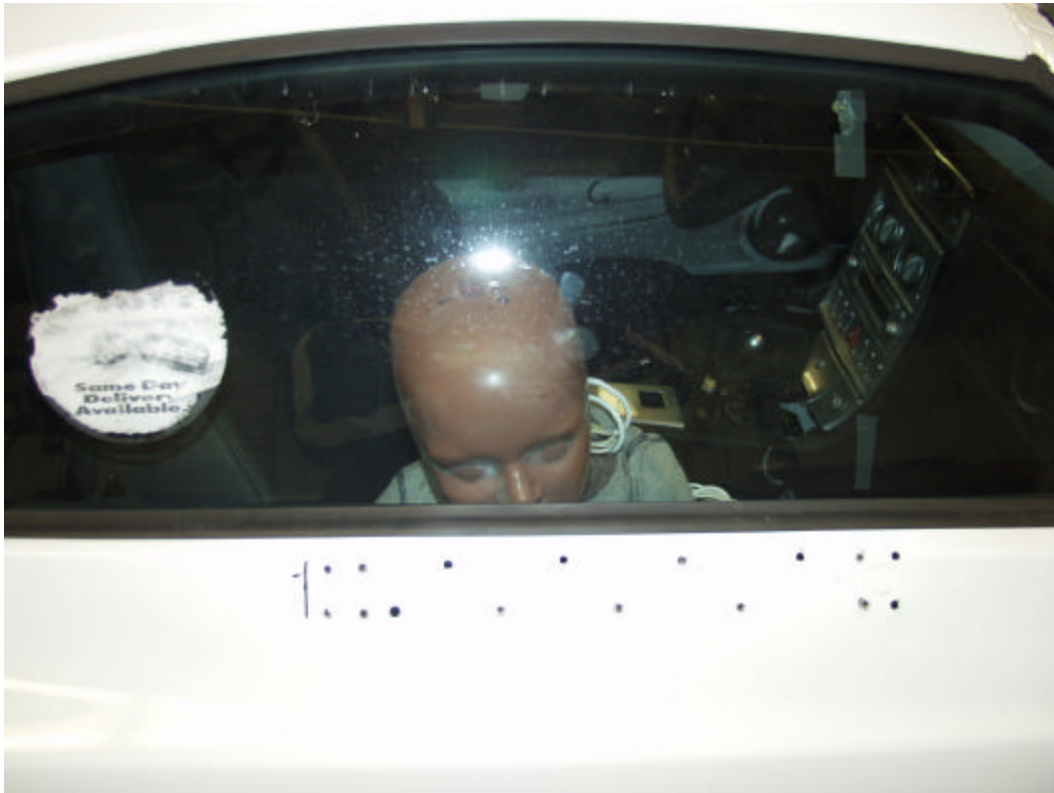
Figure A-5: Pre-Test Frontal View of Dummy

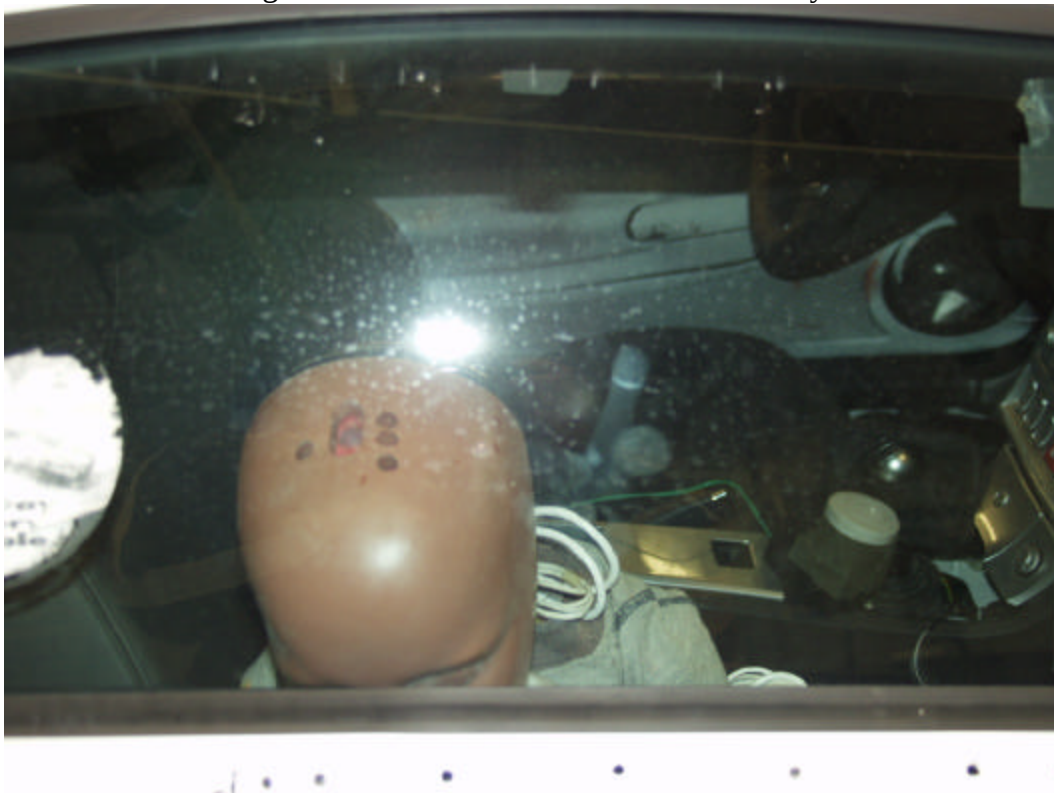
Figure A-6: Post-Test Frontal View of Dummy

The Hybrid III three-year-old child dummy's visible contact points were as follows: The airbag to the chin and the sternum, and abdomen of the ATD.

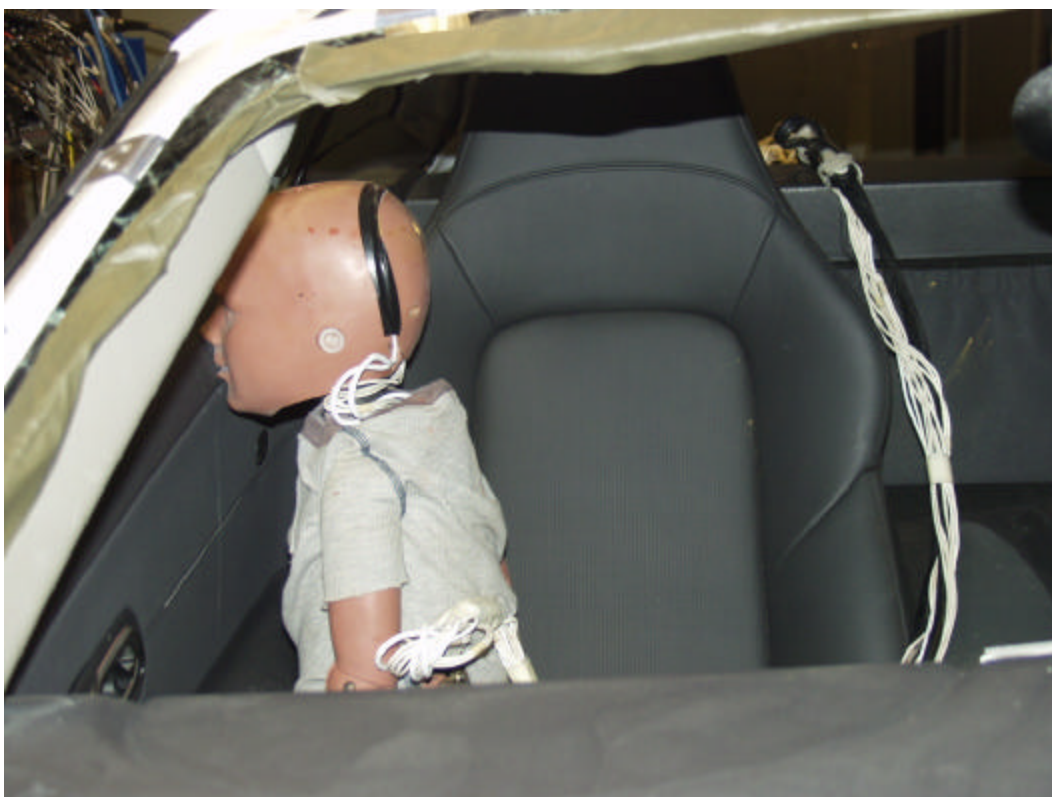
Figure A-7: Pre-Test Left Side View of Dummy

The three-year-old child dummy was placed in the outboard facing position kneeling on the outboard portion of the seat cushion leaning against the seat and door trim panel. The right side window was raised and the seatback was initially set to the manufacturer's design position for a fiftieth percentile male dummy. The seat was placed in the lowest height position and the seat track was set in order to align the vertical centerline of the sternum with the vertical centerline of the airbag module. The dummy's arms and seatback angle were adjusted to stabilize the dummy so that its head remained in a neutral orientation with its sternum and airbag module's vertical centerlines aligned. The dummy was then leaned outboard so that its upper chest contacted the door trim panel. The dummy's knees were then adjusted outboard in order to align the upper ribs with the top of the airbag module while maintaining vertical centerline orientation, neutral head position and chest contact. This orientation complies with section 3.3.4.1 of the TWG Recommended Procedures for Evaluating Occupant Injury Risk from Deploying Side Airbags as defined by Lund, et al and the Technical Working Group dated July 2003.

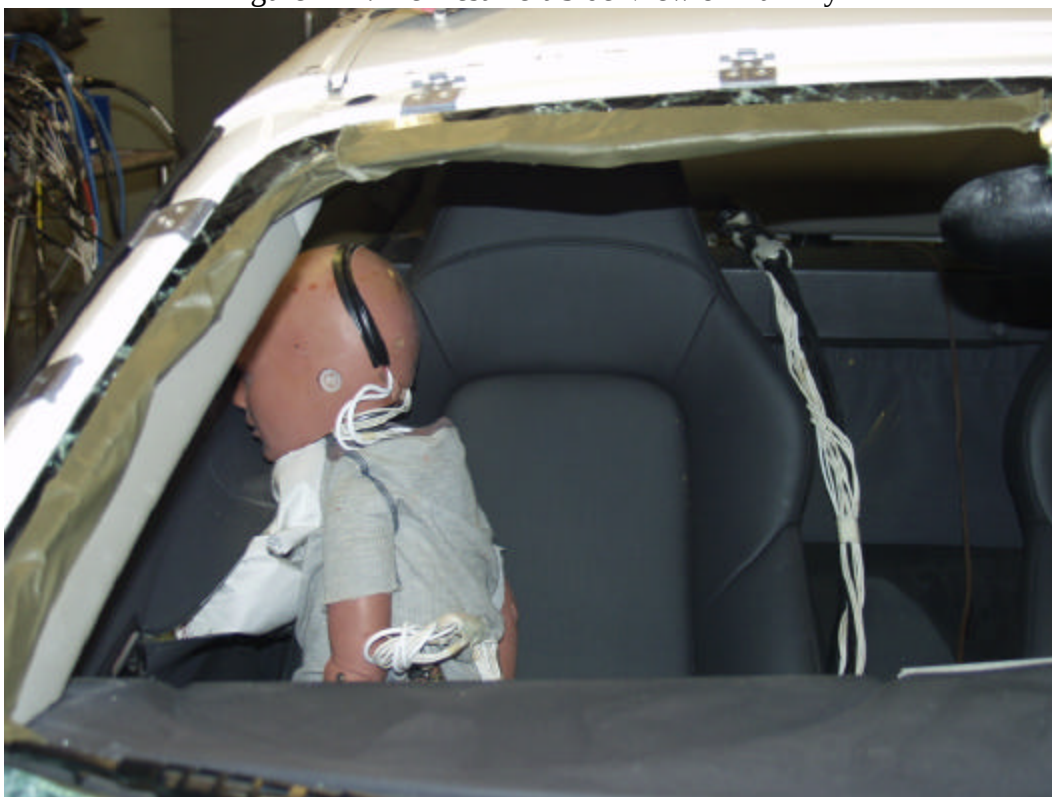
Figure A-8: Post-Test Left Side View of Dummy

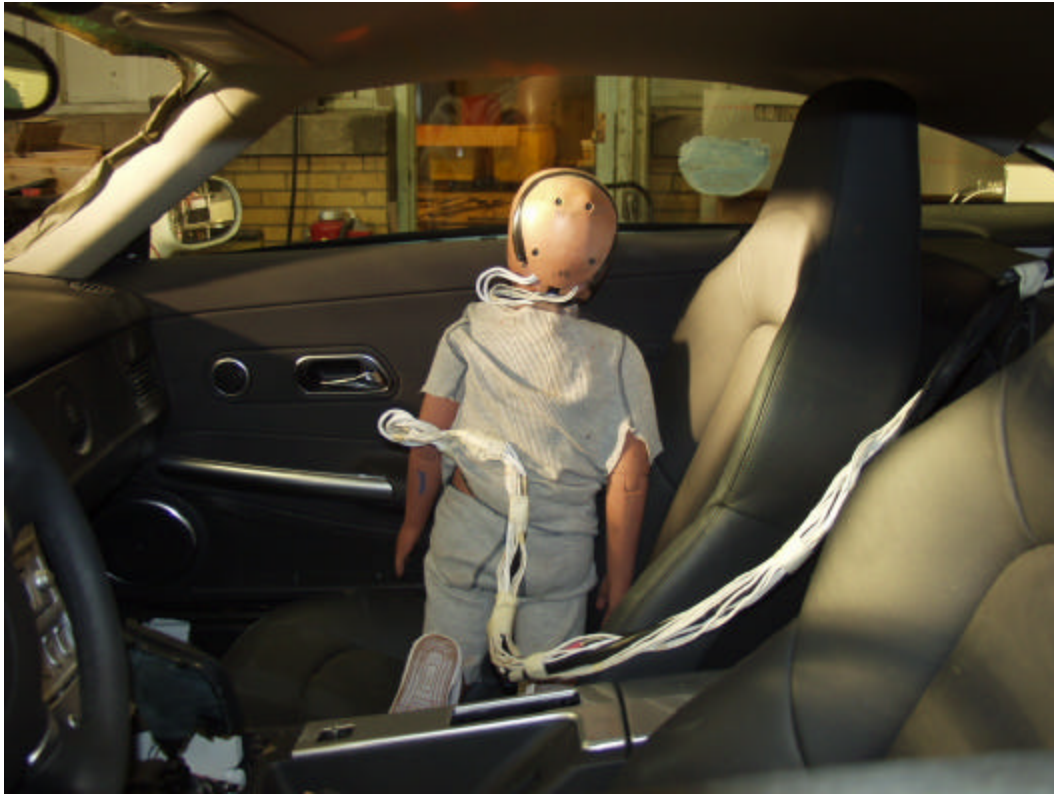
Figure A-9: Pre-Test Rear View of Dummy

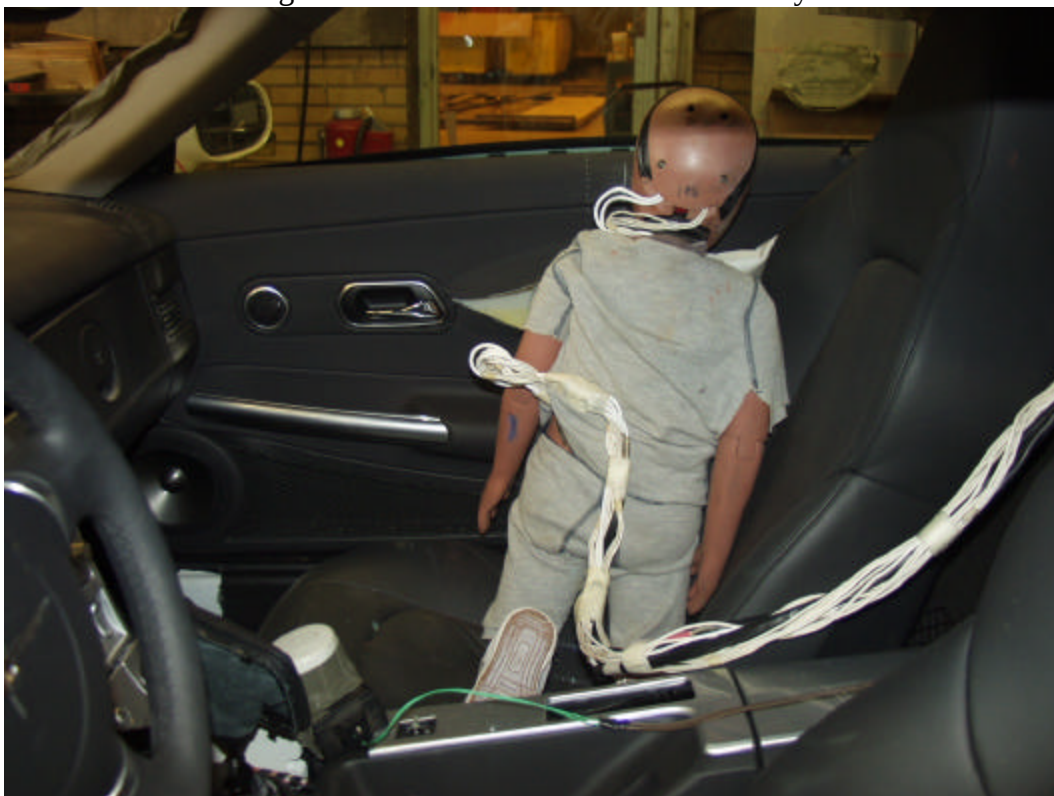
Figure A-9: Post-Test Rear View of Dummy
