**NEW CAR ASSESSMENT PROGRAM (NCAP)**  
SIDE AIRBAG OUT-OF-POSITION INJURY TESTING

2004 VOLKSWAGEN TOUAREG

NHTSA NUMBER: M45800TWG2

**FINAL REPORT**

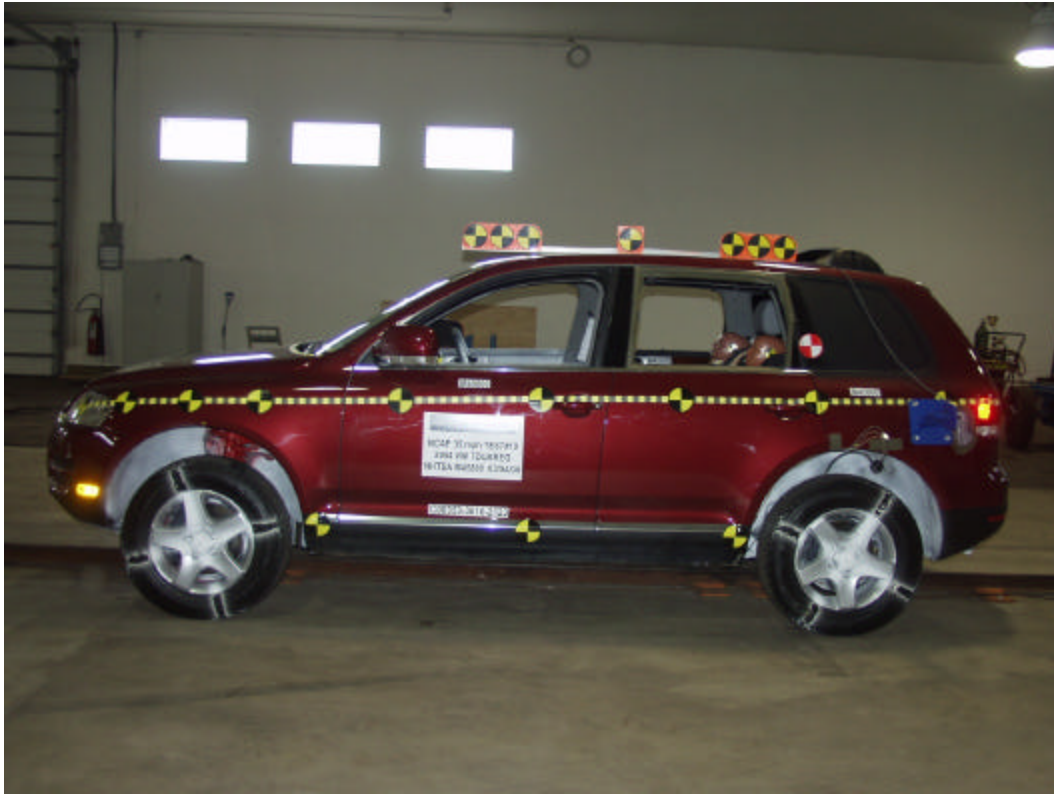
Figure A-1: Pre-Test Vehicle Left Side View

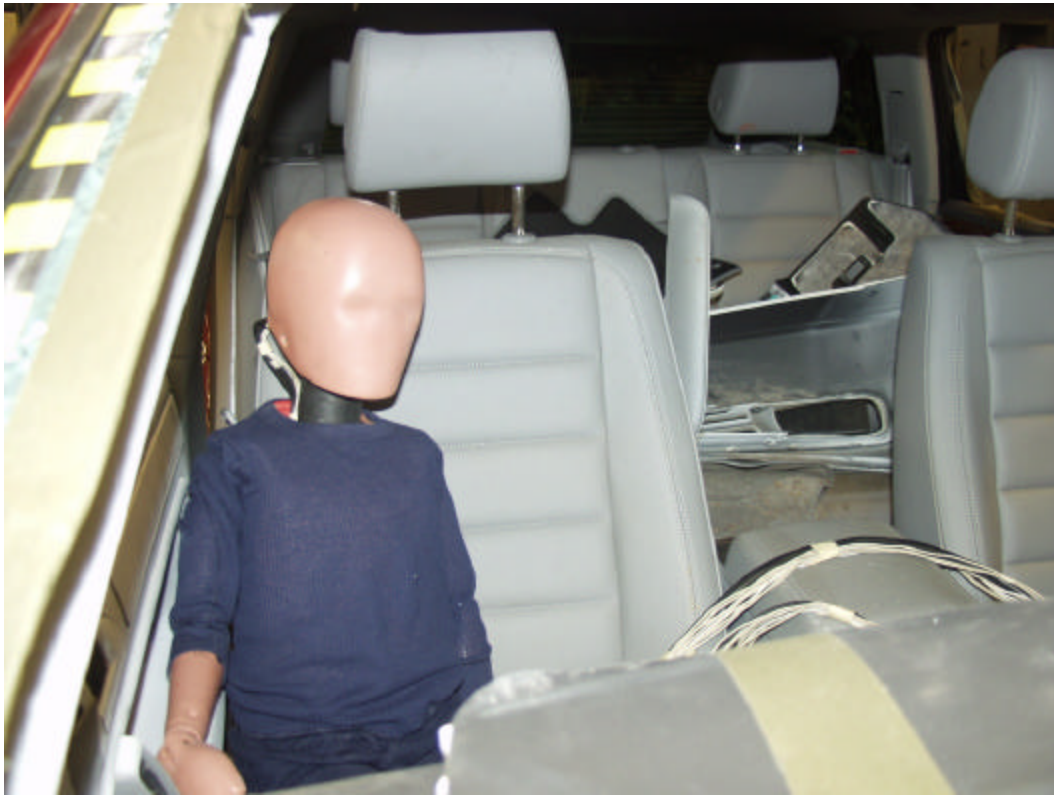
Figure A-5: Pre-Test Frontal View of Dummy

The six-year-old child dummy was placed on a booster block and oriented in the forward facing position on the outboard portion of the seat cushion. The seat was placed in the lowest height position with the seatback placed at the manufacturer's design position for a fiftieth percentile male. Due to the vehicle being previously tested in a 35 mph NCAP frontal impact, the seat tracks were not able to be placed in the rearmost position and the passenger side window was not able to be placed in the closed position. The dummy's spine was aligned with the leading edge of the seat bolster with the head placed between but not in contact with the seat bolster and the B-Pillar with the neck/torso junction aligned vertically with the top edge of the airbag module. The dummy legs were aligned so that they crossed the heel placement points at a location of 50 mm from the leading edge of the seat cushion and 75 mm to either side of the seat cushion centerline. The dummy's heels were ahead of the leading edge of the seat cushion. The dummy's right arm was placed on the arm rest with the forearm and hand aligned along the armrest. The dummy's left arm was in contact with the seatback with the left forearm located such that the fingertips contacted the booster seat. This orientation complies with section 3.3.3.5 of the TWG Recommended Procedures for Evaluating Occupant Injury Risk from Deploying Side Airbags as defined by Lund, et al and the Technical Working Group dated July 2003.

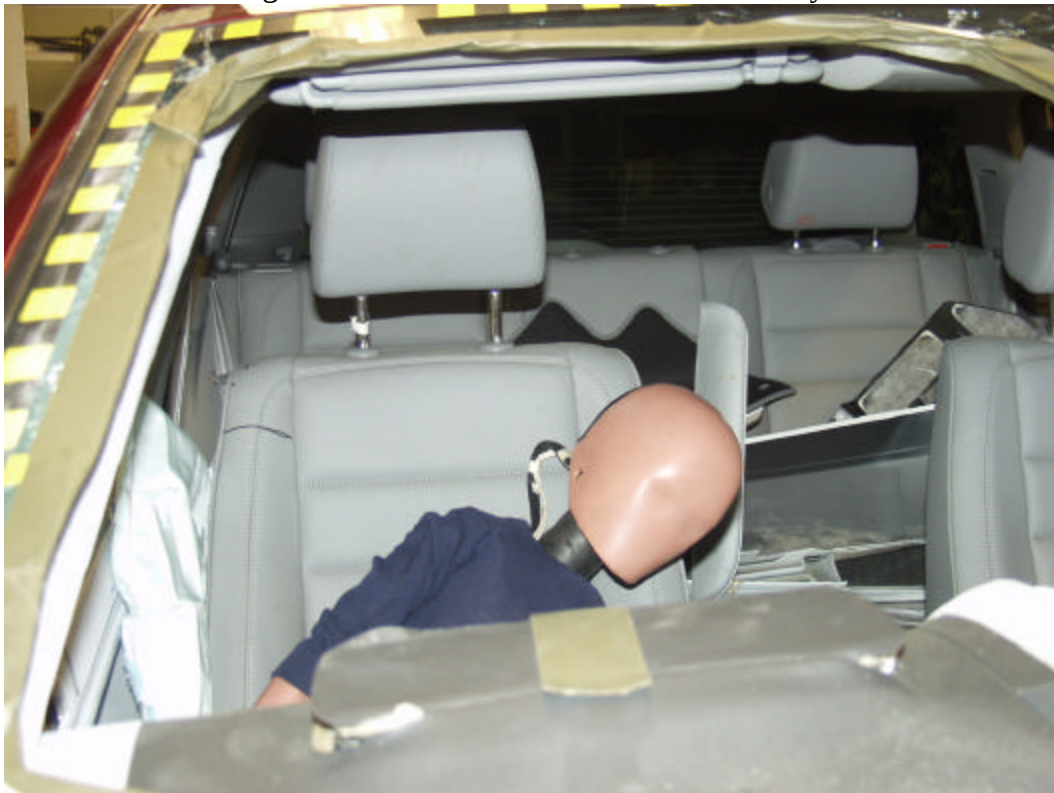
Figure A-6: Post-Test Frontal View of Dummy

The Hybrid III six-year-old child dummy's visible contact points were as follows: The airbag to the back of the head and back of the right side of the torso of the ATD.

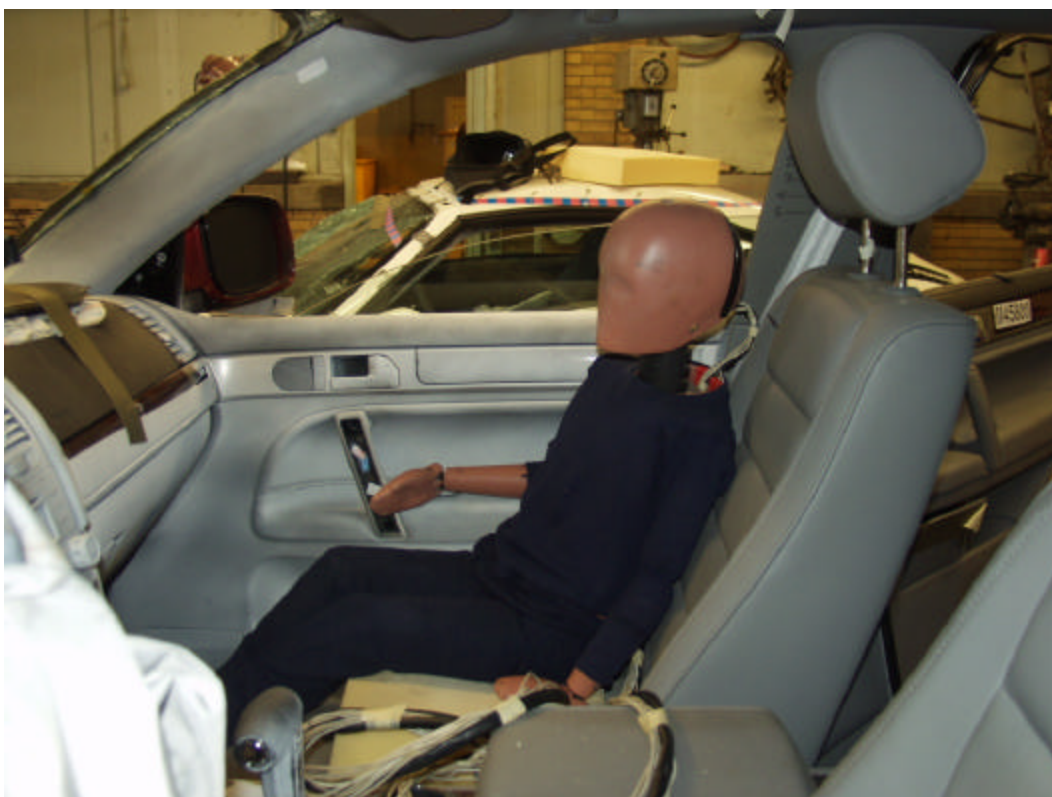
Figure A-7: Pre-Test Left Side View of Dummy

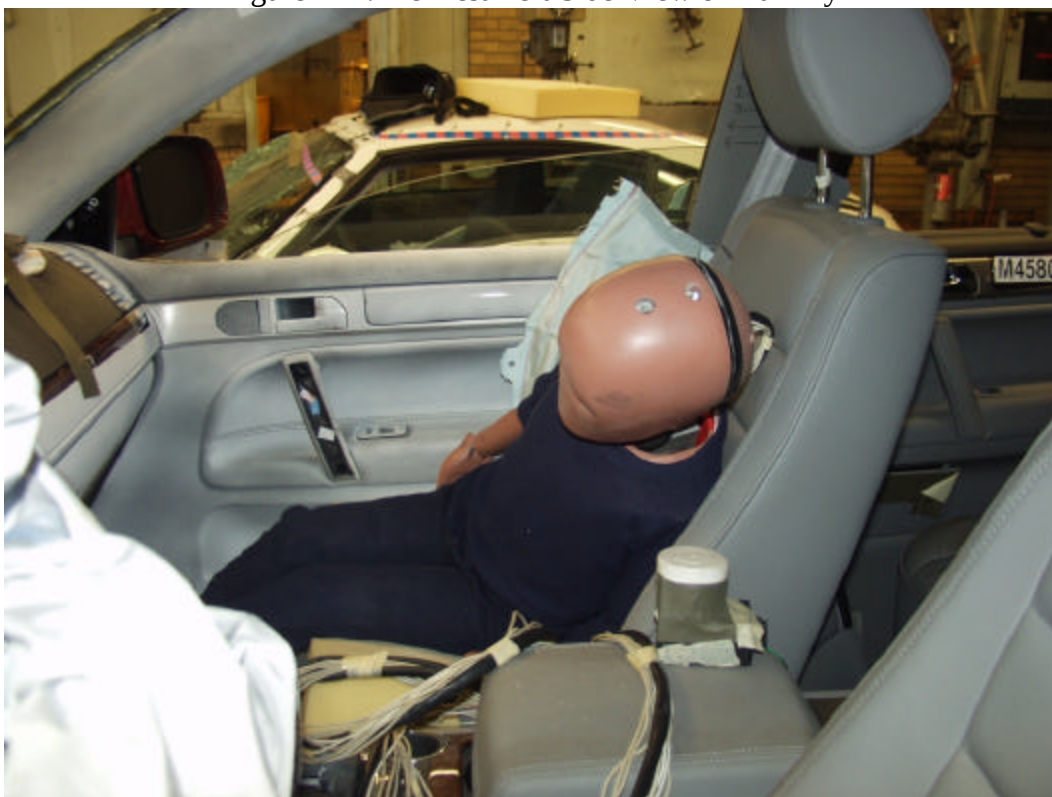
Figure A-8: Post-Test Left Side View of Dummy

| <b>Head Contact:</b> | The back of the head was struck by the airbag during deployment |
| <b>Upper Torso Contact:</b> | The back of the right side of the torso. |
| <b>Lower Torso Contact:</b> | The back of the right side of the torso. |

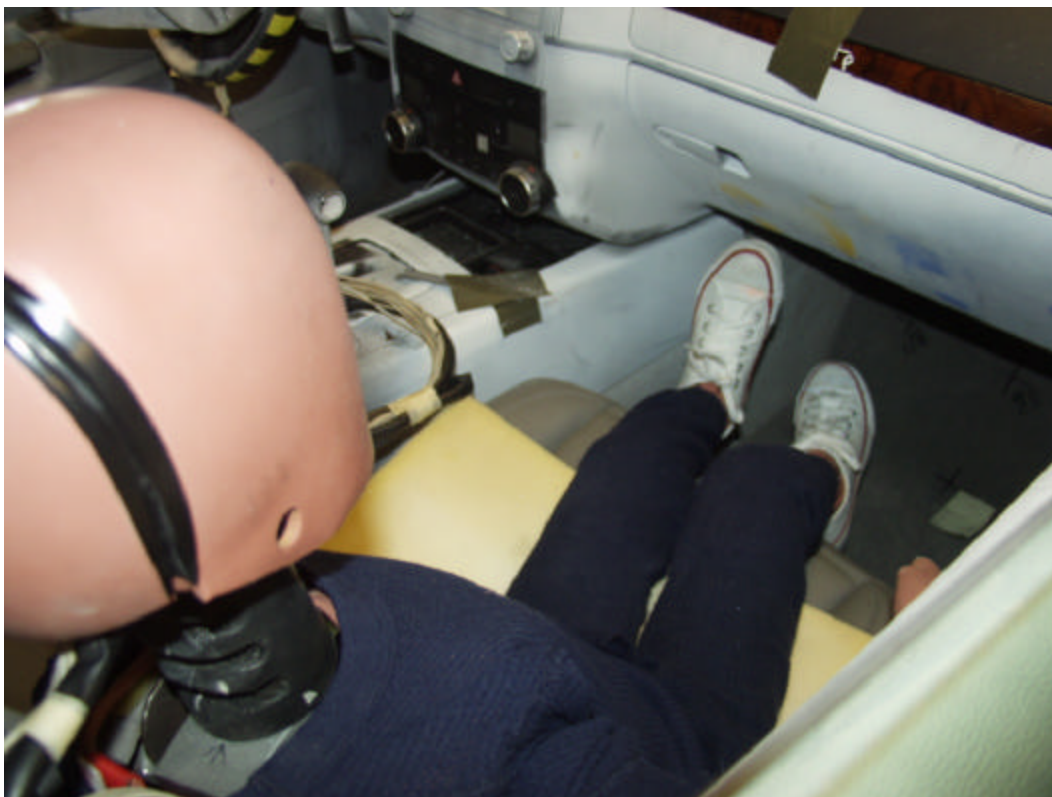
Figure A-9: Pre-Test Right Side View of Dummy

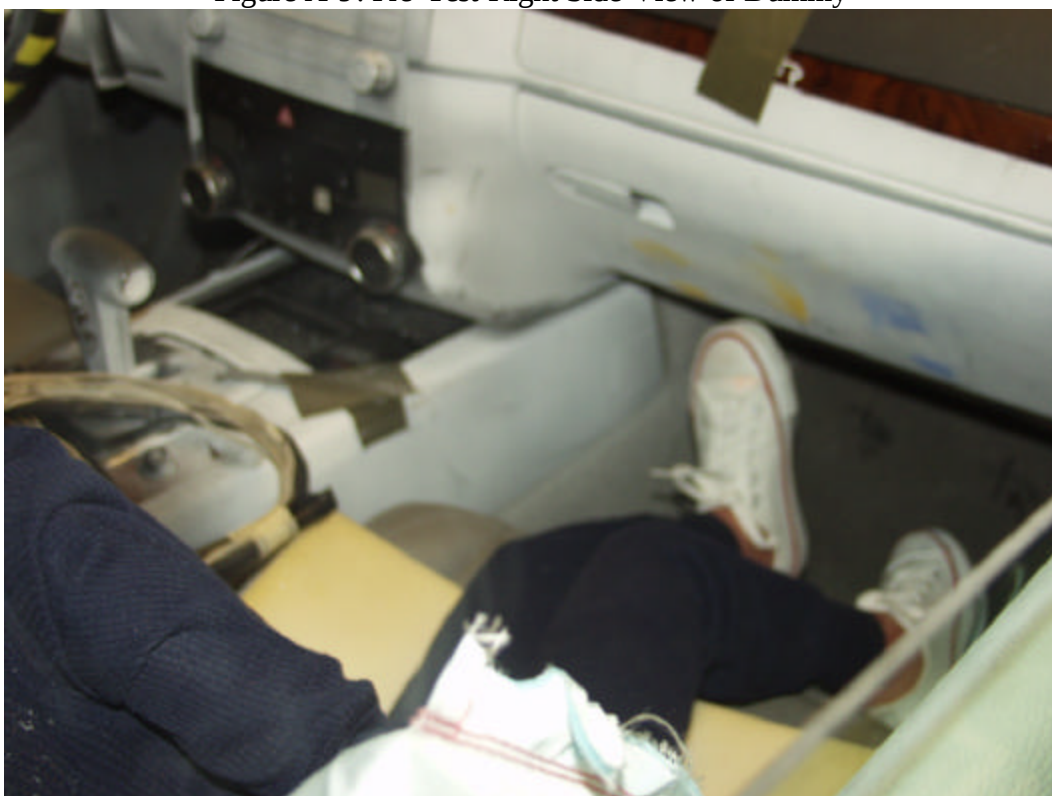
Figure A-9: Post-Test Right Side View of Dummy
