REPORT NUMBER: 301-CAL-04-03

**SAFETY COMPLIANCE TESTING FOR FMVSS 301  
FUEL SYSTEM INTEGRITY**

TOYOTA MOTOR MANUFACTURING INDIANA INC.  
2004 TOYOTA SIENNA  
MINIVAN

NHTSA NUMBER: C45103

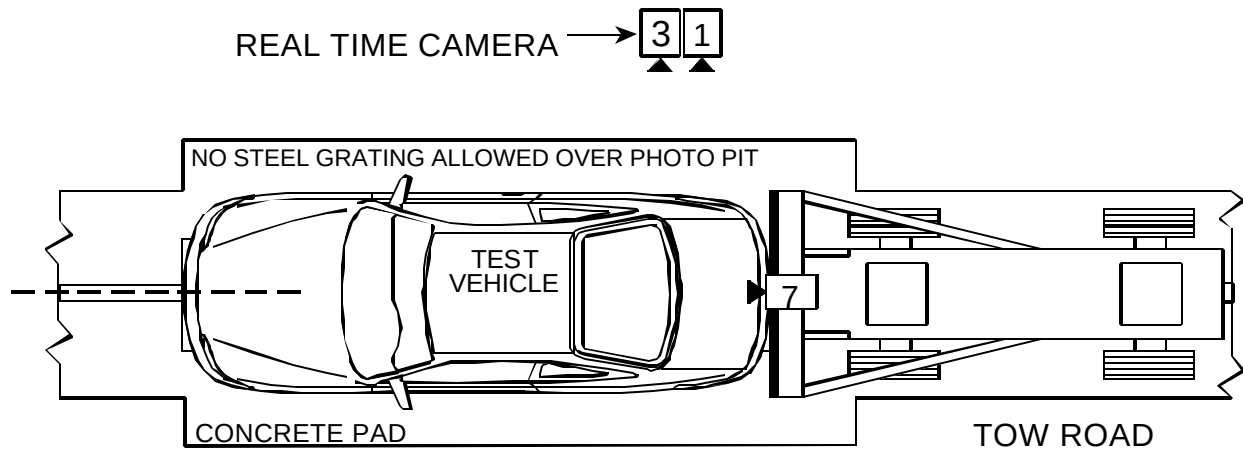
This diagram shows a top-down view of the test vehicle. A camera, indicated by a downward arrow and the number 2, is positioned directly above the vehicle.

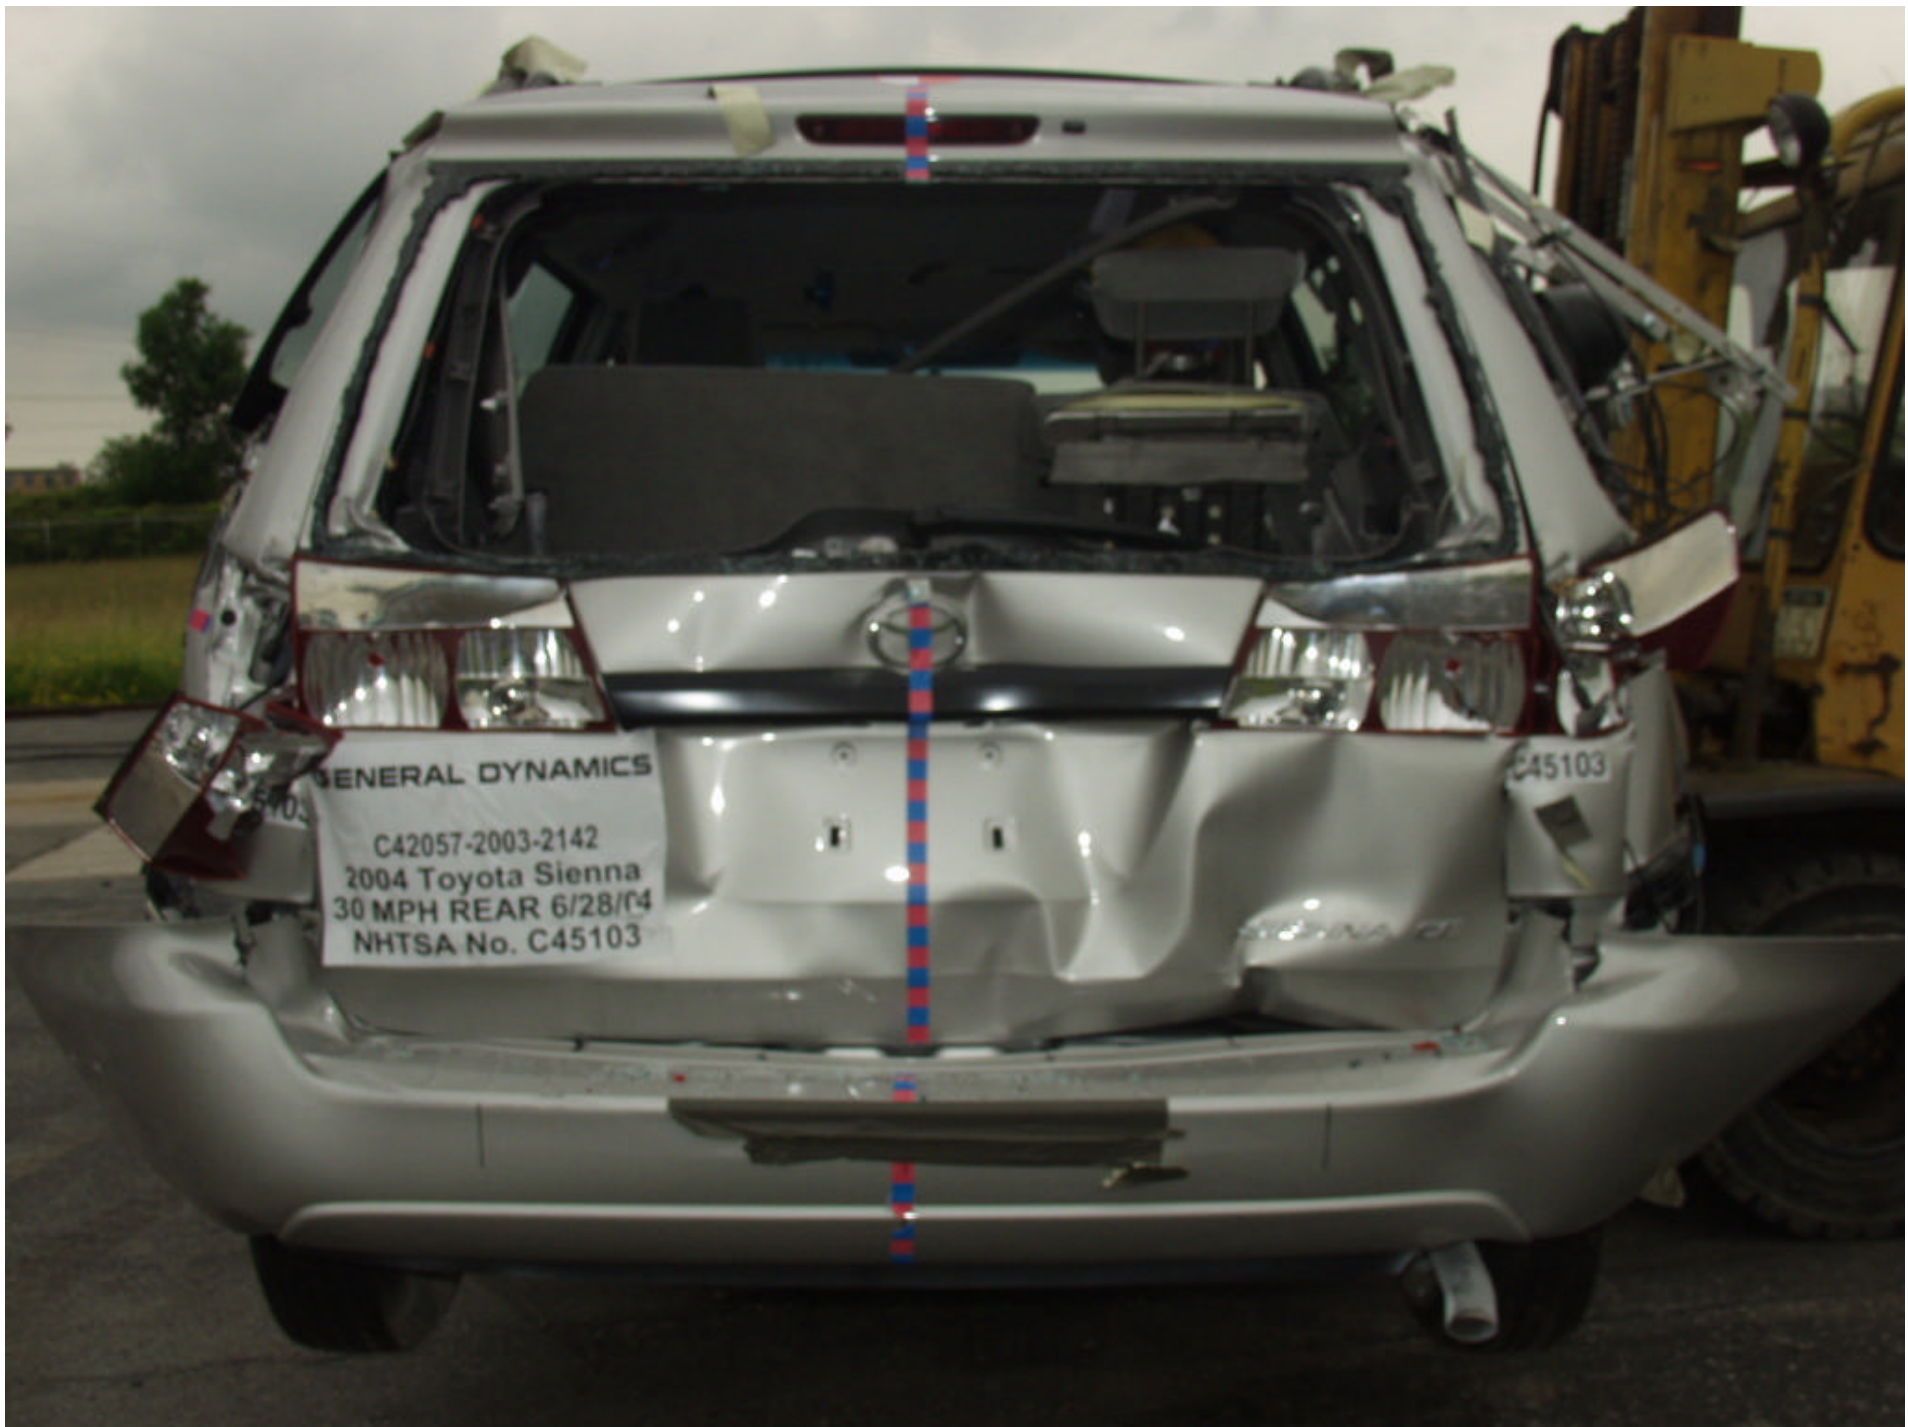
Figure A-8 POST-TEST REAR VIEW

Comments: The rear hatch window glass shattered during the event. The driver's seat cushion base deformed during the event.
