REPORT NUMBER: 301-CAL-04-02

**SAFETY COMPLIANCE TESTING FOR FMVSS 301  
FUEL SYSTEM INTEGRITY**

MAZDA MOTOR CORPORATION  
2004 MAZDA 6  
4-DOOR SEDAN

GDAIS TEST NUMBER: 8655-F301-19

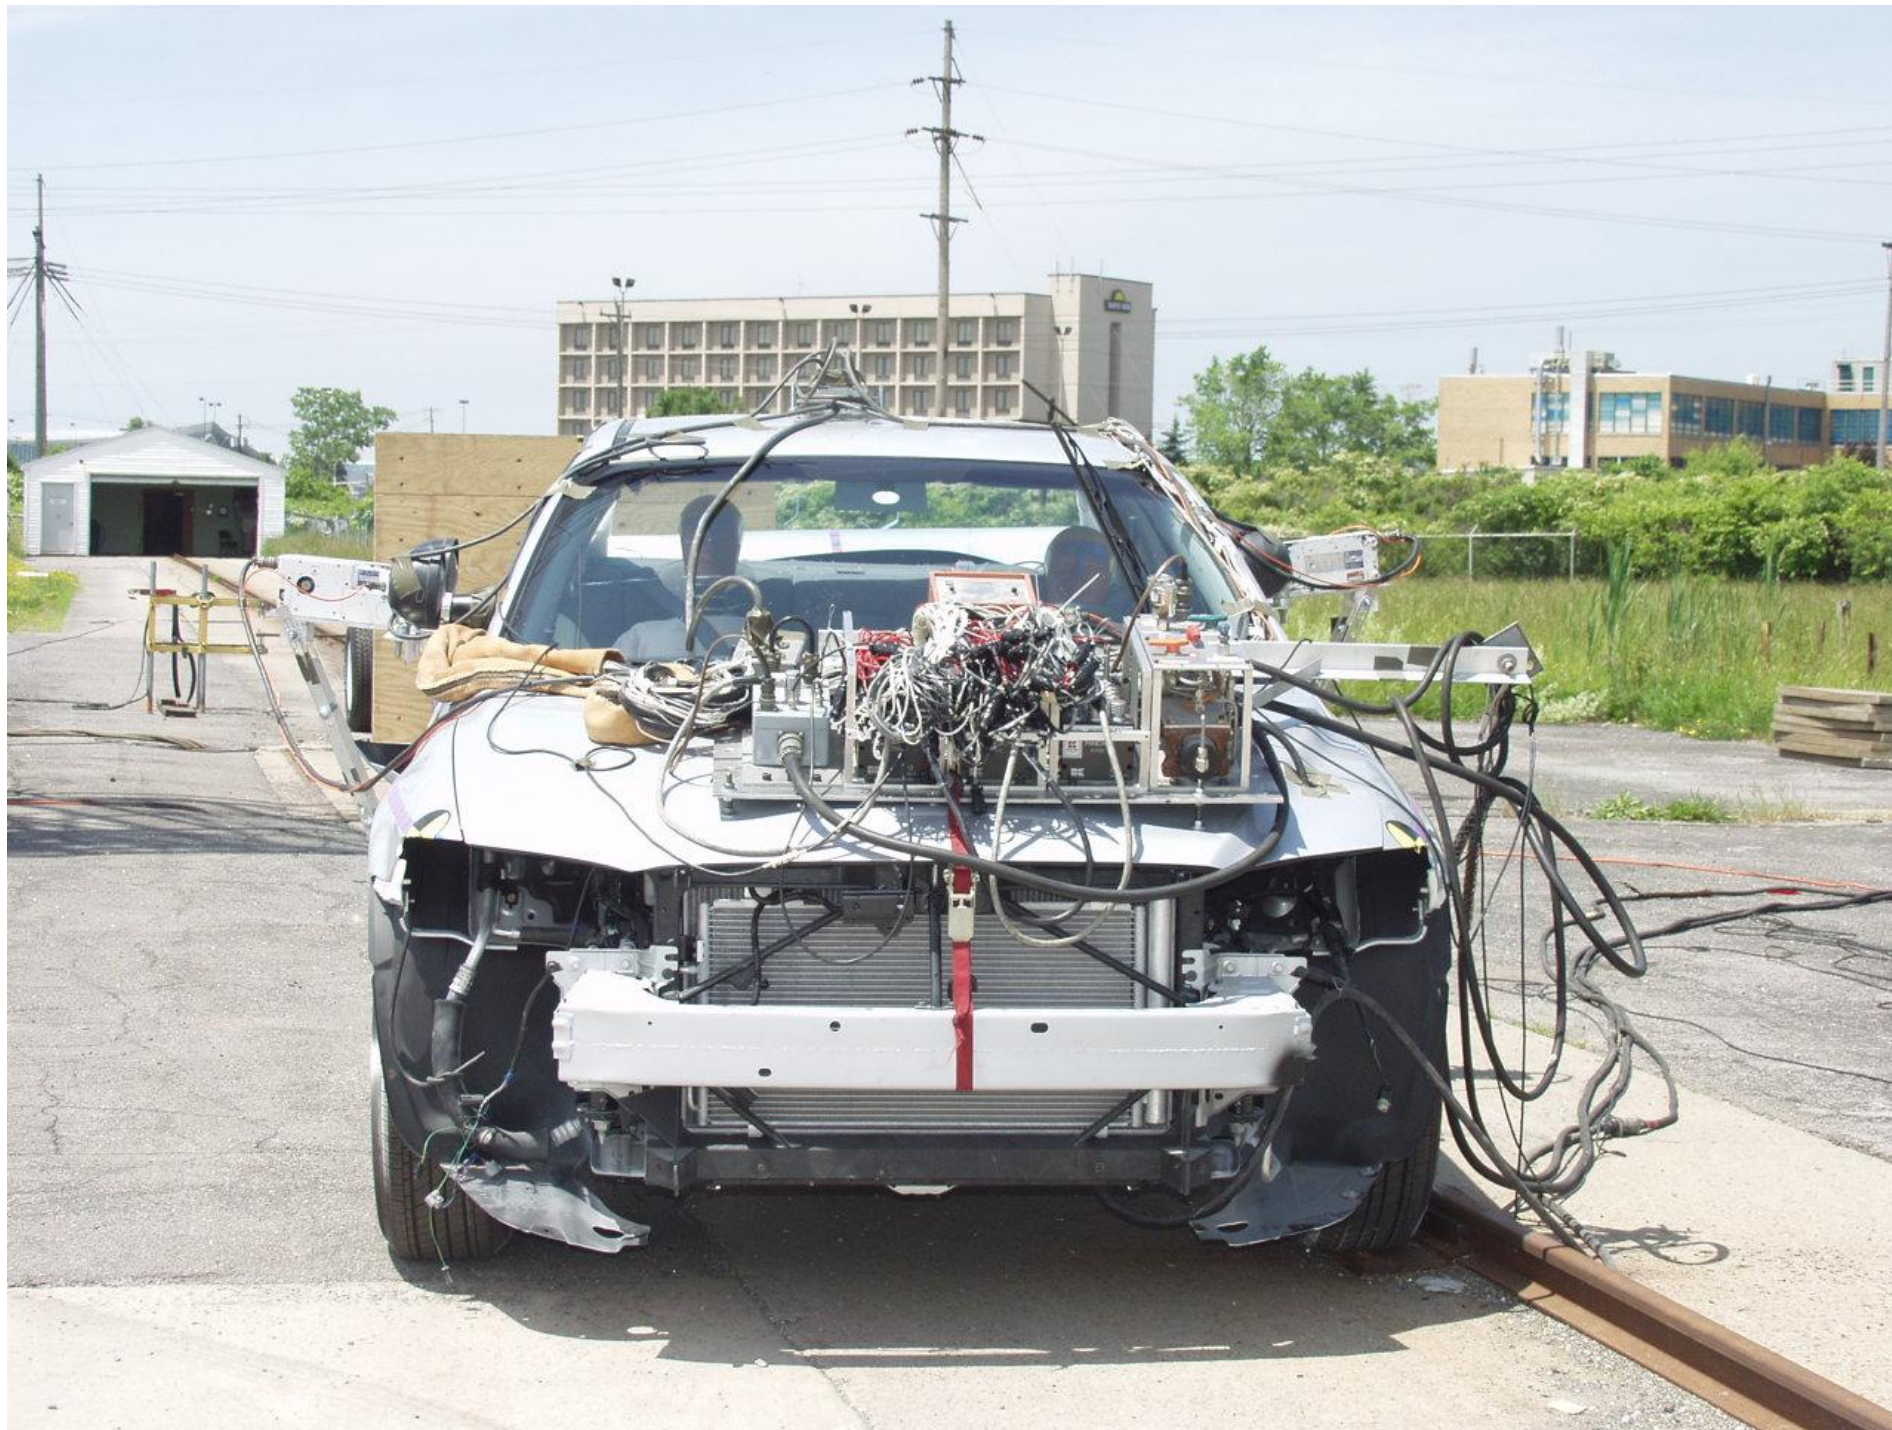
Figure A-2 POST-TEST FRONT VIEW

There was no fuel system fluid spillage following the impact or during any portion of the static rollover test. The average vehicle longitudinal crush was 356 millimeters. The vehicle appeared to comply with all the requirements of FMVSS No. 301 "Fuel System Integrity."

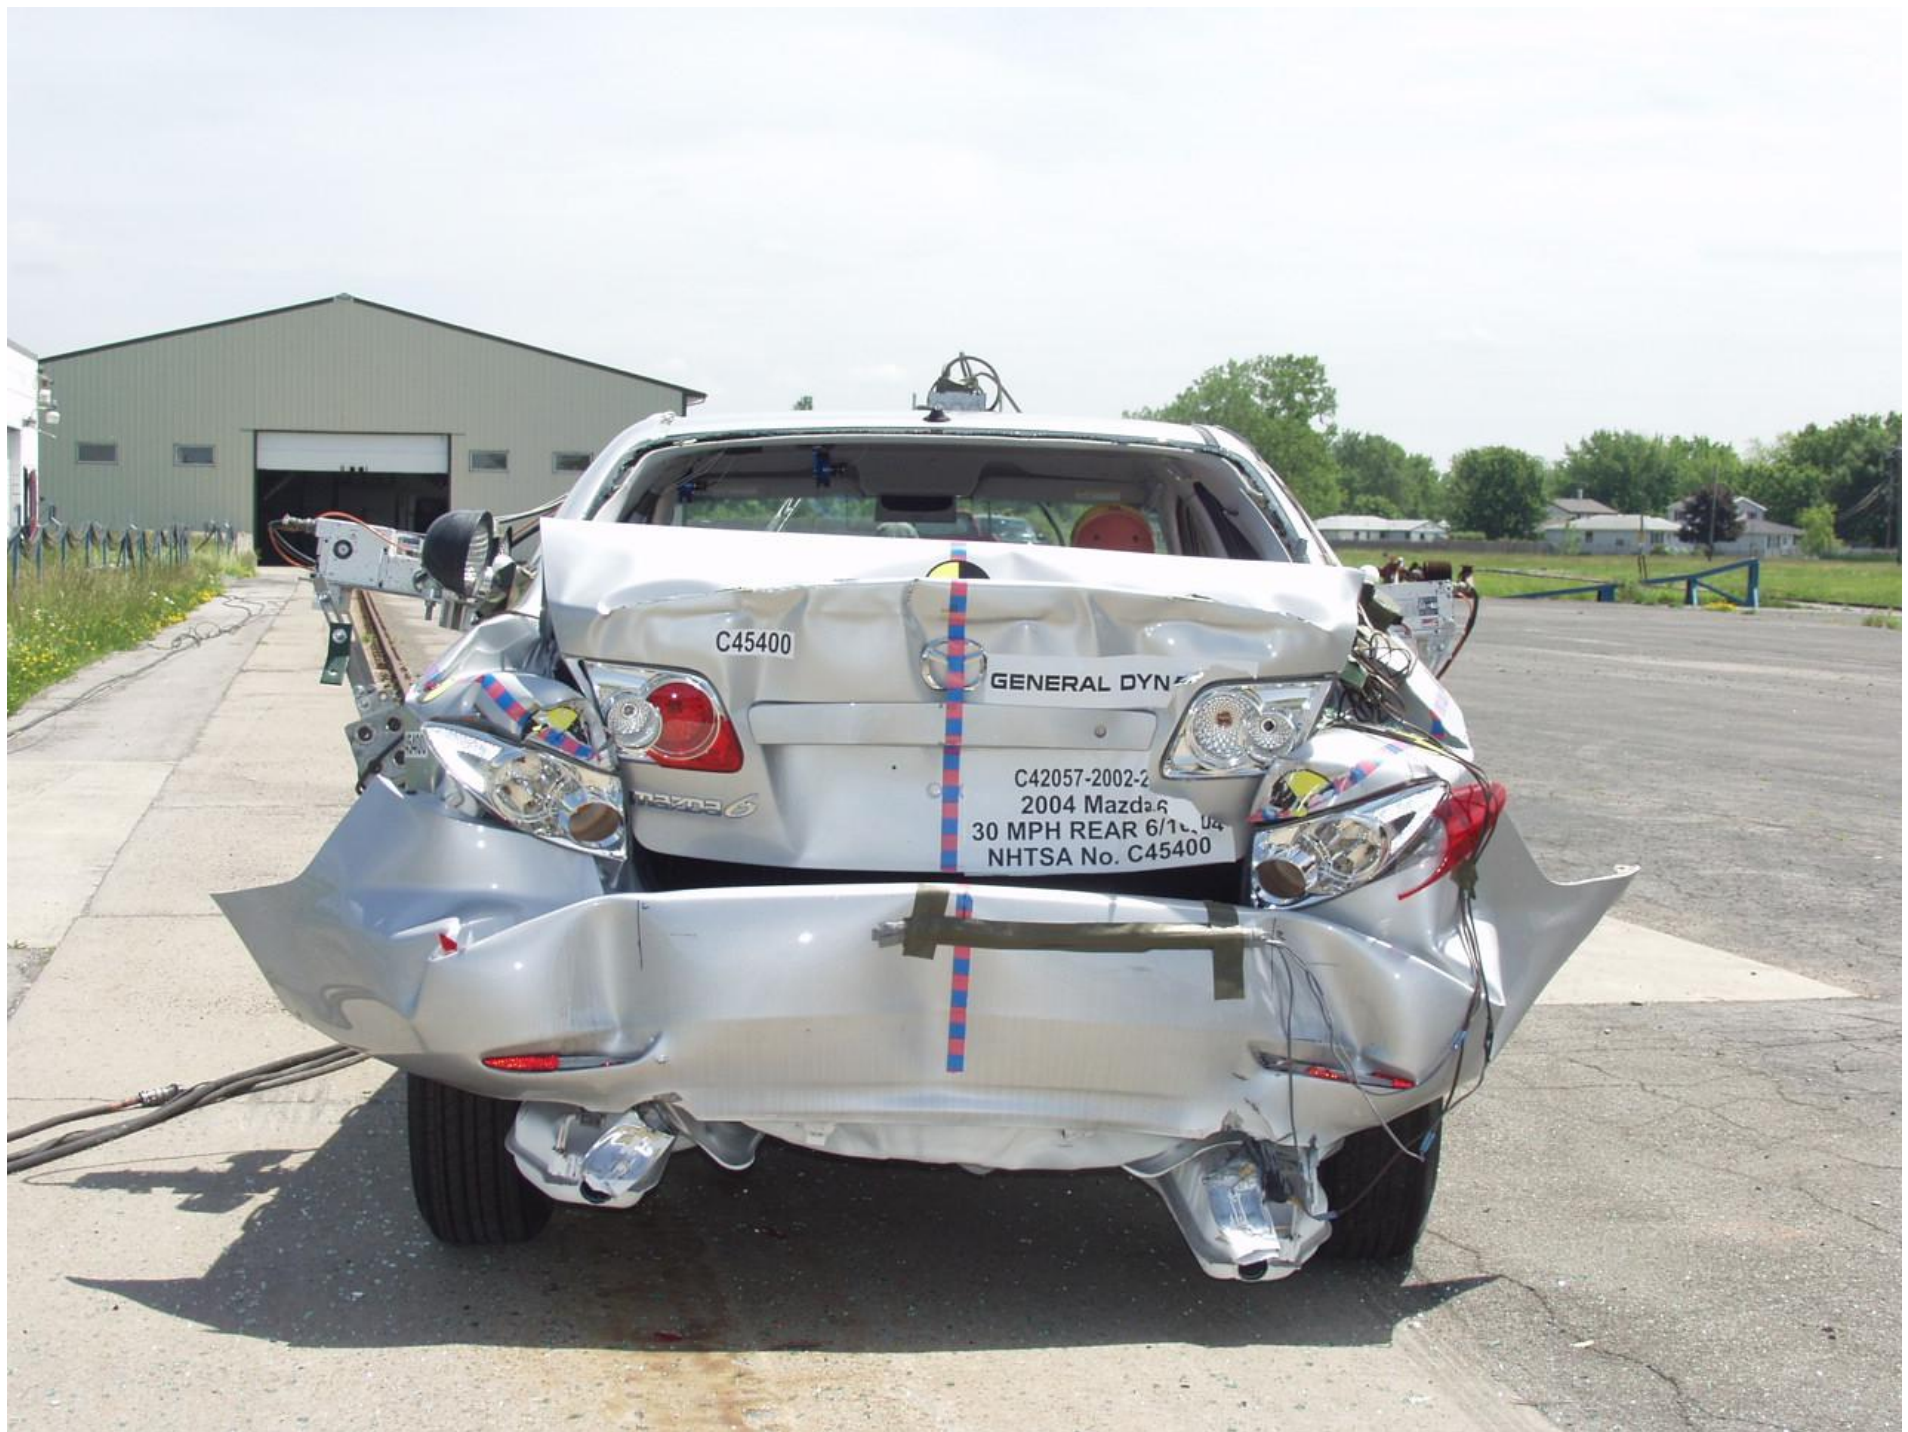
Figure A-8 POST-TEST REAR VIEW

| Post-Test | Left = | <u>4178</u> | ; C/L = | <u>4376</u> | Right = | <u>4252</u> |
| Crush | Left = | <u>377</u> | ; C/L = | <u>388</u> | Right = | <u>303</u> |
| AVERAGE | = | <u>356</u> | millimeters | | | |

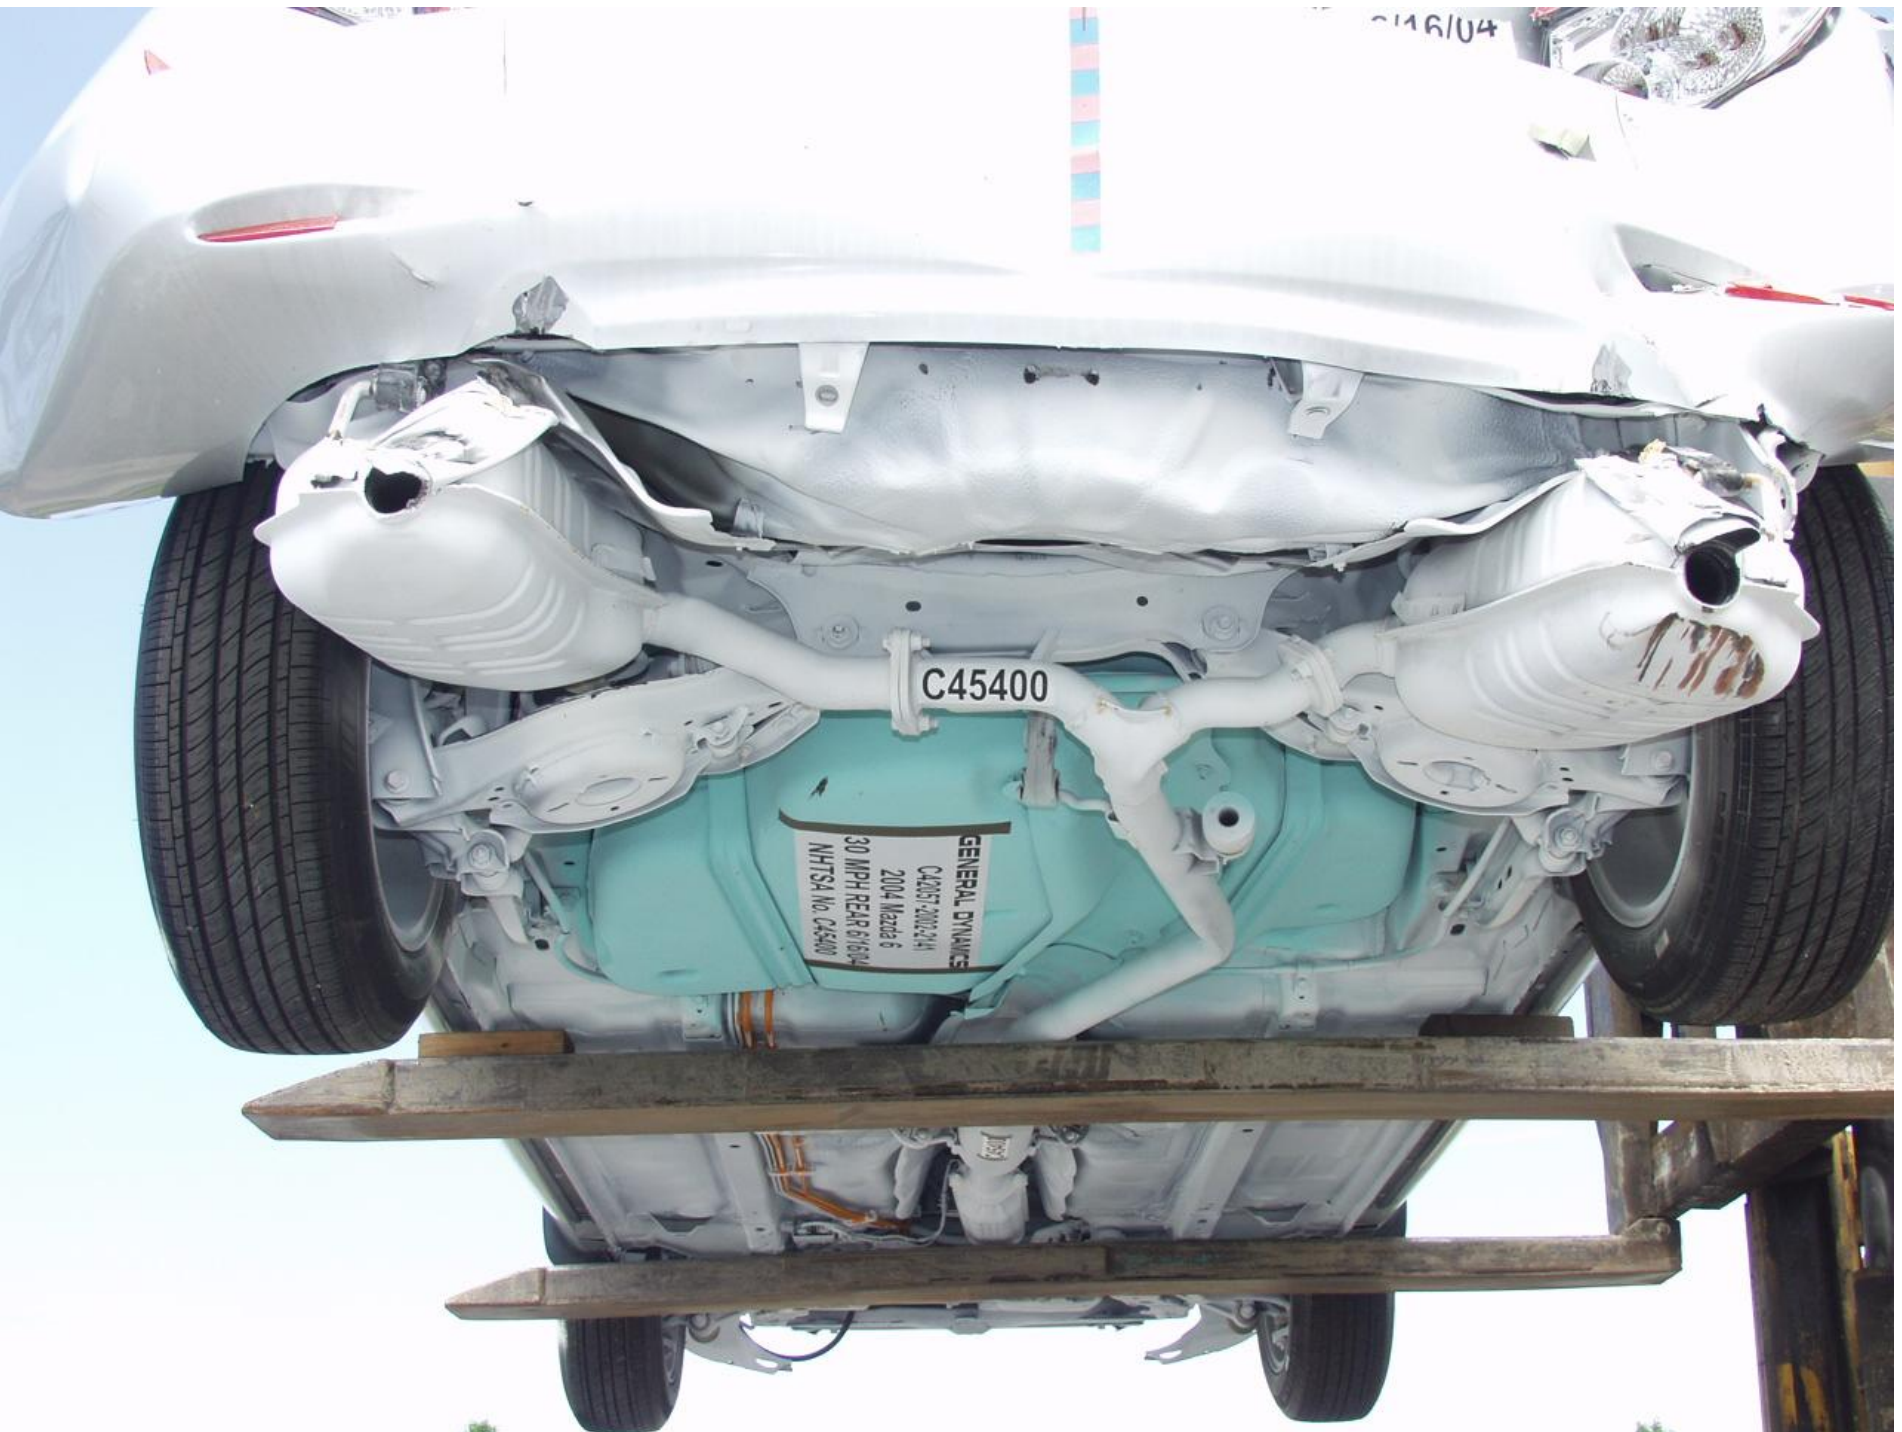
Figure A-16 POST-TEST REAR UNDERBODY VIEW

| Details of Fuel System: Fuel filler is located on the left rear quarter panel aft of the rear axle; Fuel tank is located on the vehicle underbody beneath the rear seat and forward of the rear axle; Fuel lines are routed along the left side of the vehicle underbody. | |

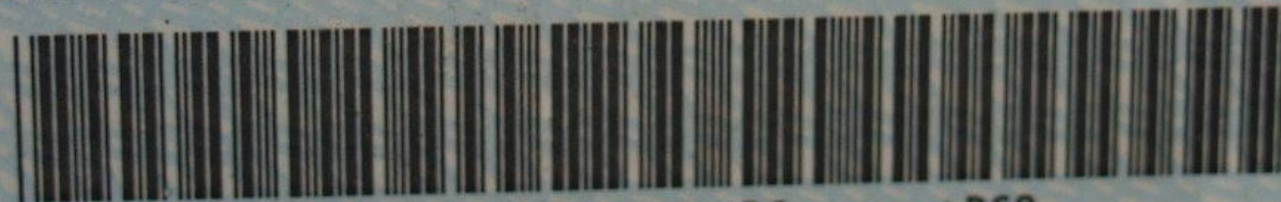
MFD. BY AUTO ALLIANCE INTERNATIONAL, INC.  
FOR **MAZDA MOTOR CORPORATION**  
MADE IN U.S.A.

DATE: 09/03

GVWR: 4317LB/1958KG

FRONT GAWR: 2359LB/1070KG REAR GAWR: 1958LB/888KG

THIS VEHICLE CONFORMS TO ALL APPLICABLE FEDERAL MOTOR  
VEHICLE SAFETY, BUMPER, AND THEFT PREVENTION STANDARDS  
IN EFFECT ON THE DATE OF MANUFACTURE SHOWN ABOVE.

VIN: 1YVFP80C345N22817

TYPE: PASSENGER

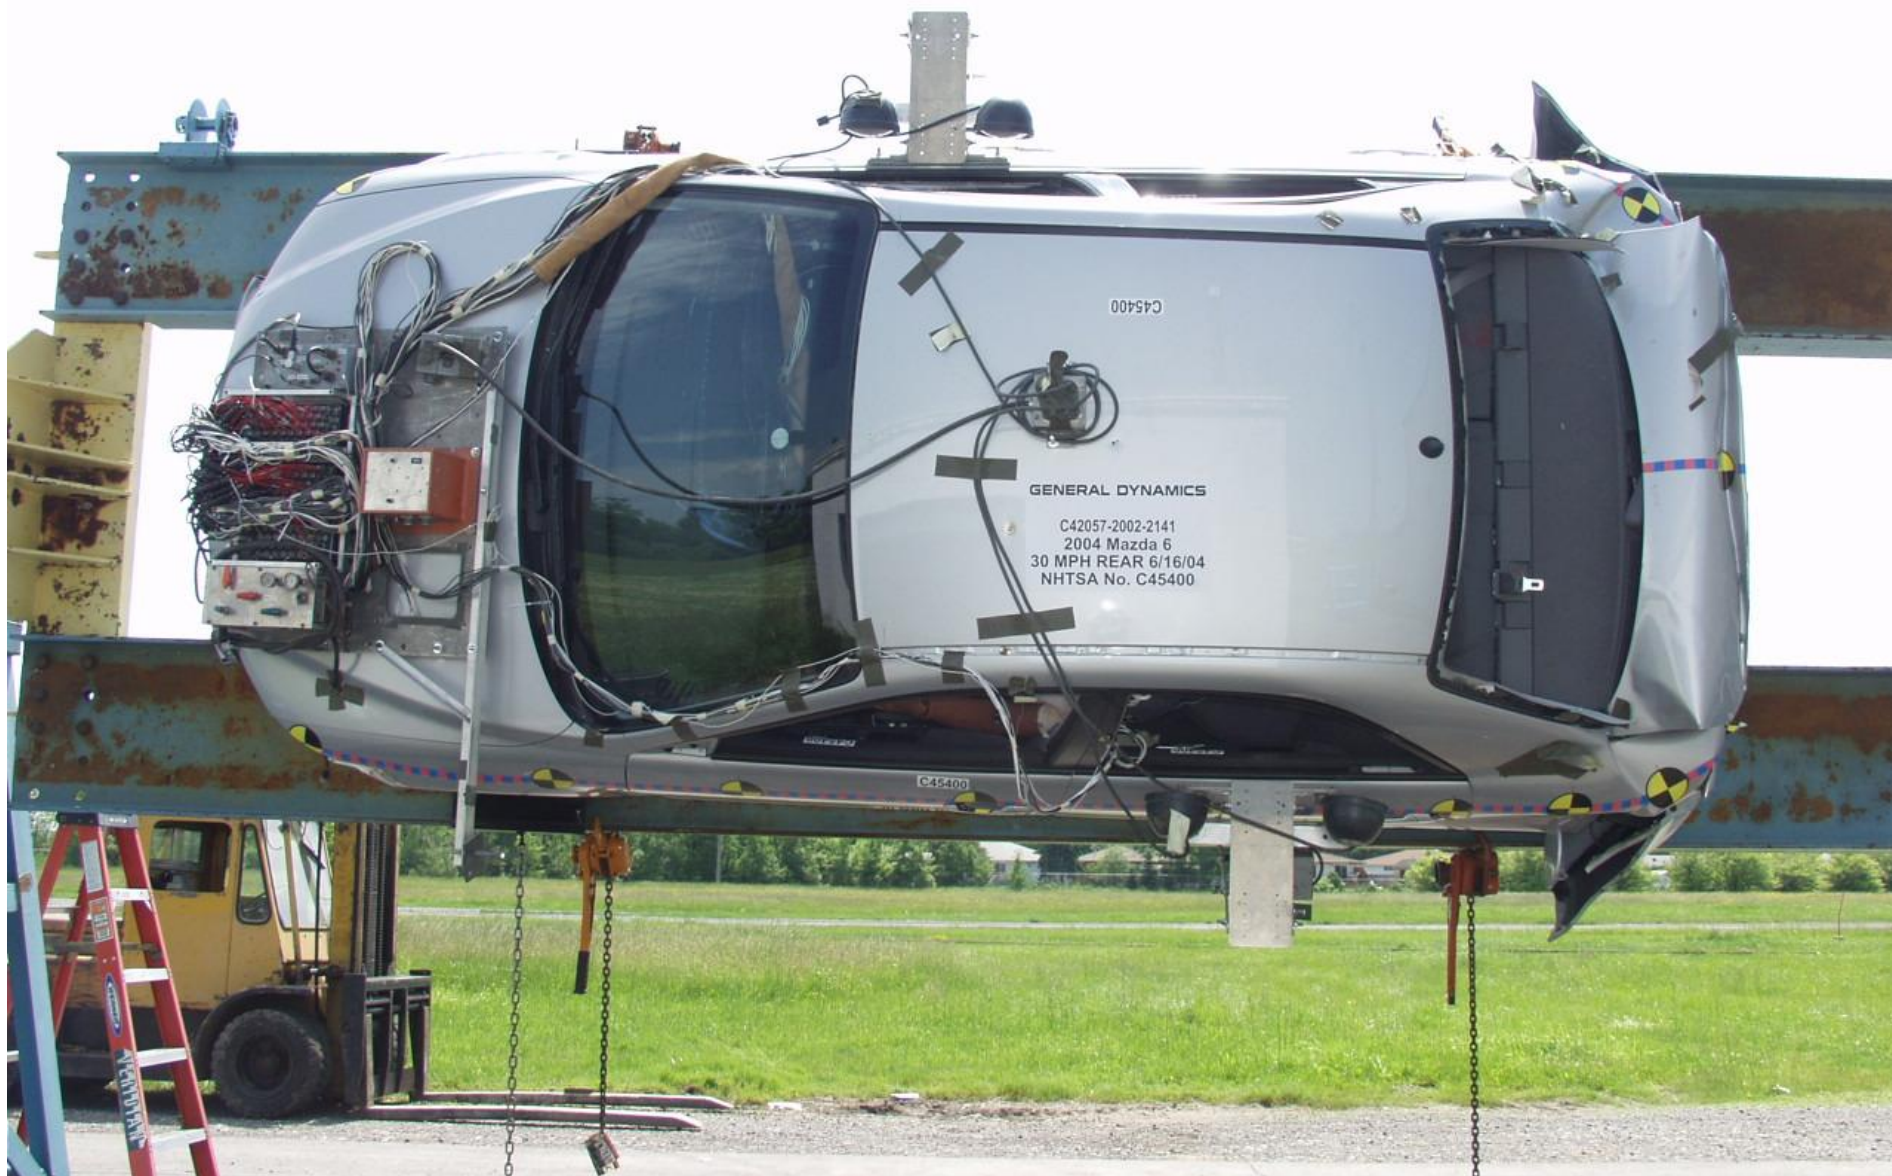
Figure A-19 ROLLOVER 90°

| Rollover Stage | Spillage Location |
|---|---|
| 0° - 90° | None |

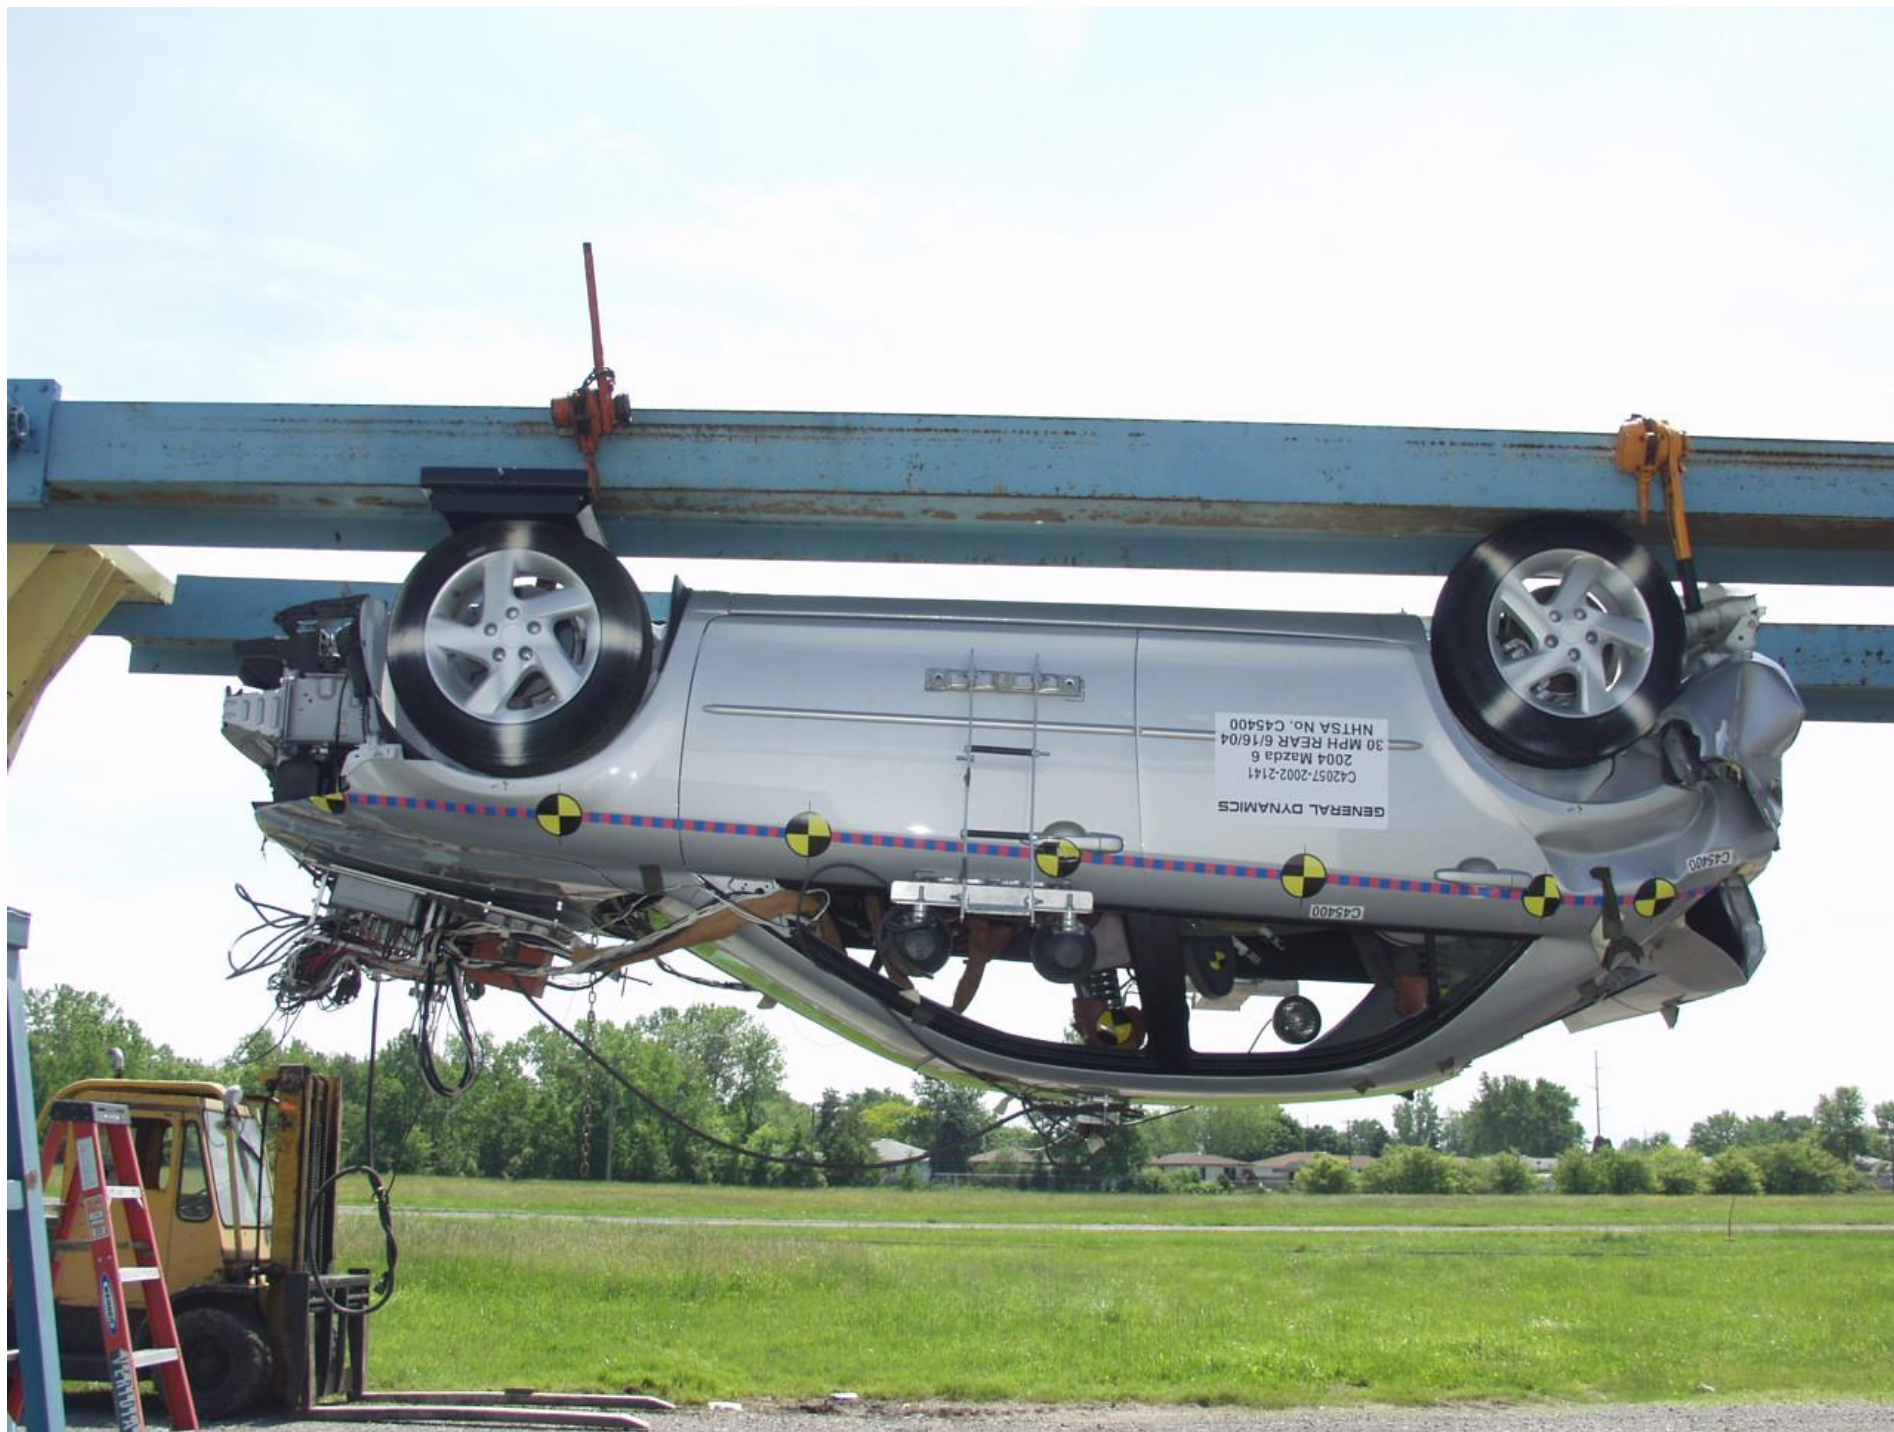
Figure A-20 ROLLOVER 180°

| Rollover Stage | Spillage Location |
|---|---|
| 90° - 180° | None |

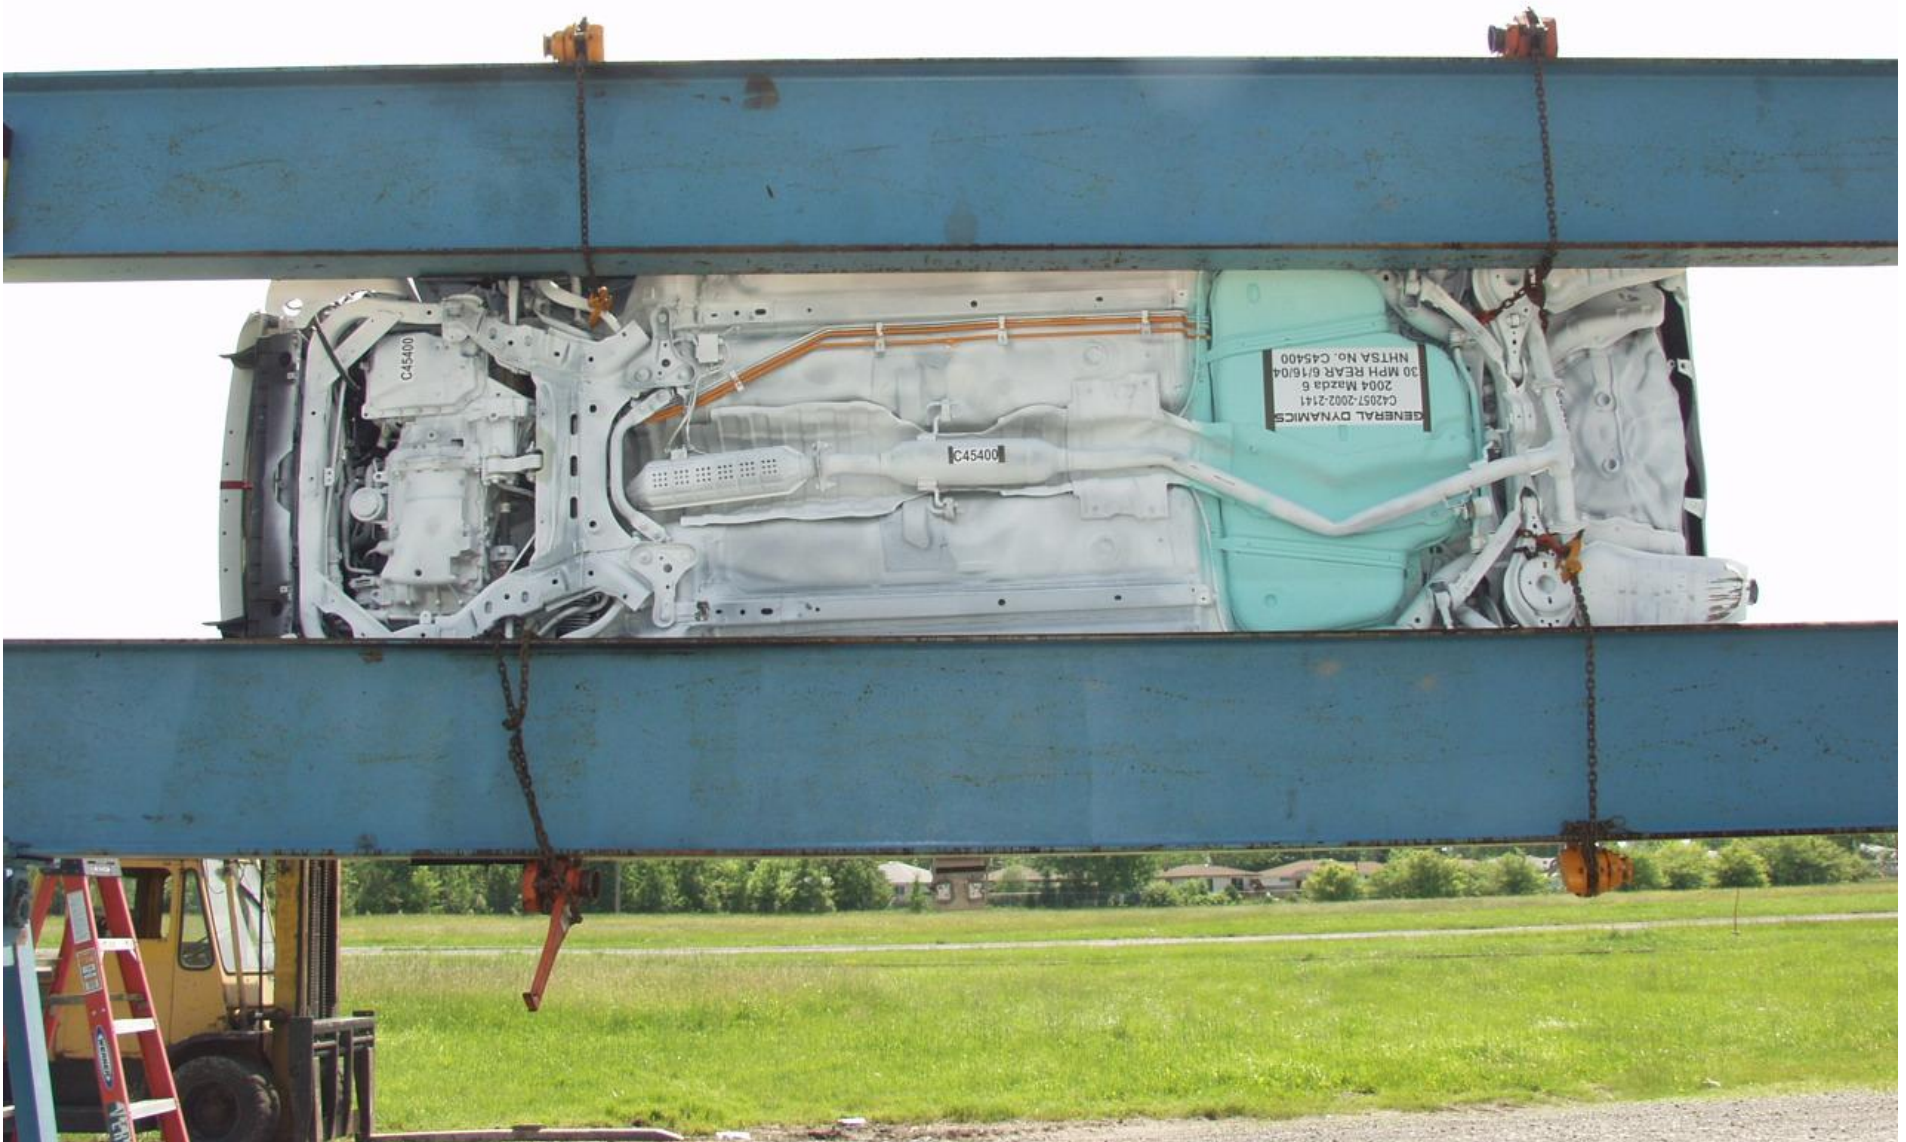
Figure A-21 ROLLOVER 270°

| Rollover Stage | Spillage Location |
|---|---|
| 180°-270° | None |
