**Report Number: TWG-TRC-04-001**

**New Car Assessment Program (NCAP)**  
**Side Airbag Out-Of-Position Injury Testing**

**2004 Mazda RX-8**  
**Hybrid III 6YO Static Air Bag Deploy**  
**Procedure #3.3.5.1**

**TRC Inc. Test Number: S040622**

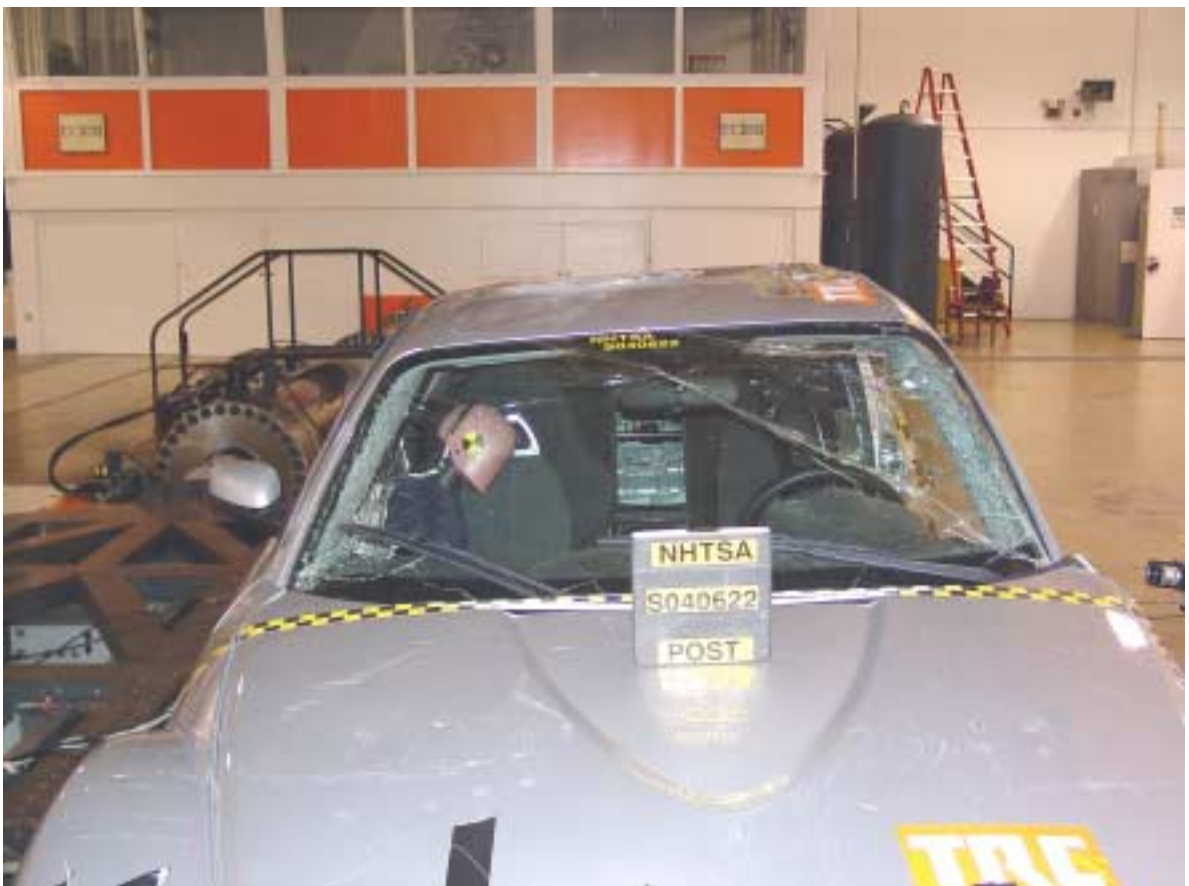
**Figure A-2 Post-Test Vehicle Front View**

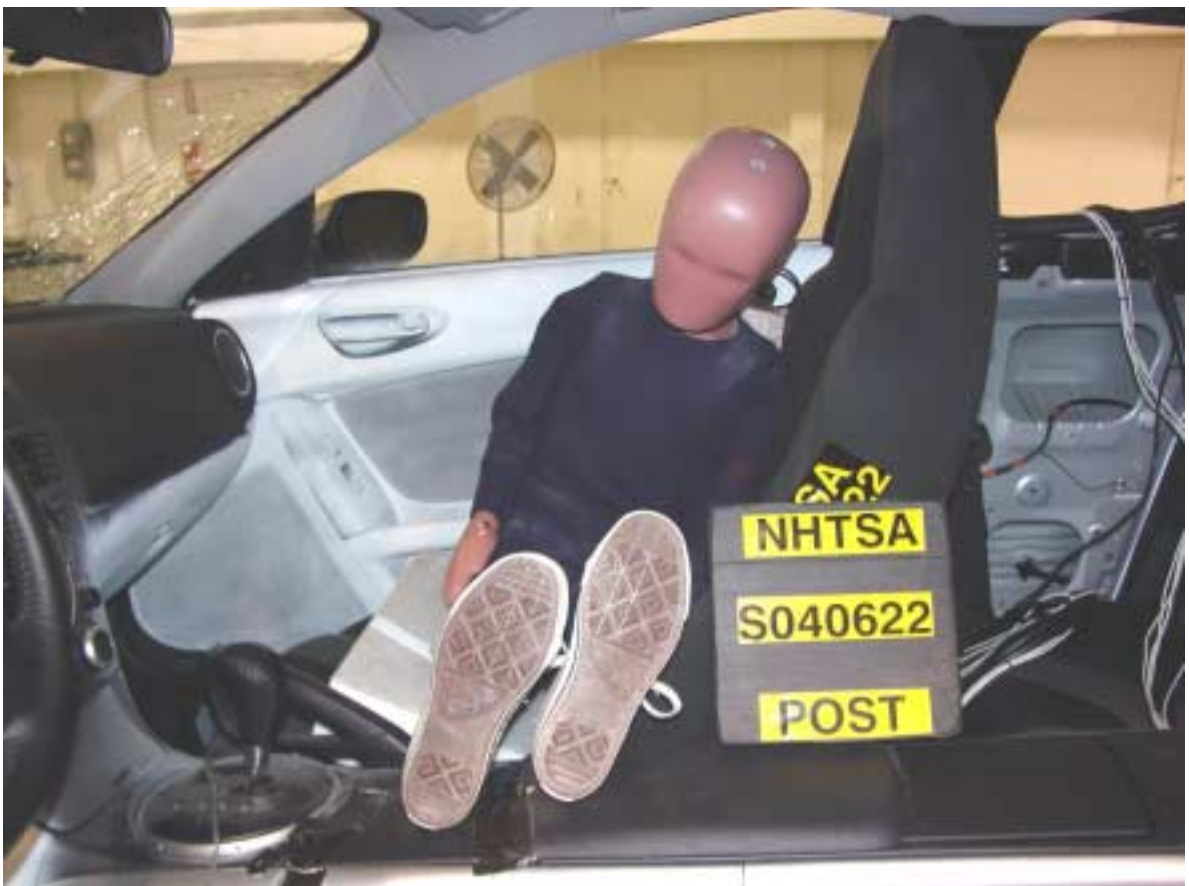
**Figure A-6 Post-Test Left Side View of Dummy**

The Hybrid III six-year-old child dummy's visible contact points were as follows: The airbag to the back of the right side of the torso of the dummy. The dummy's head to the headliner above the passenger door.

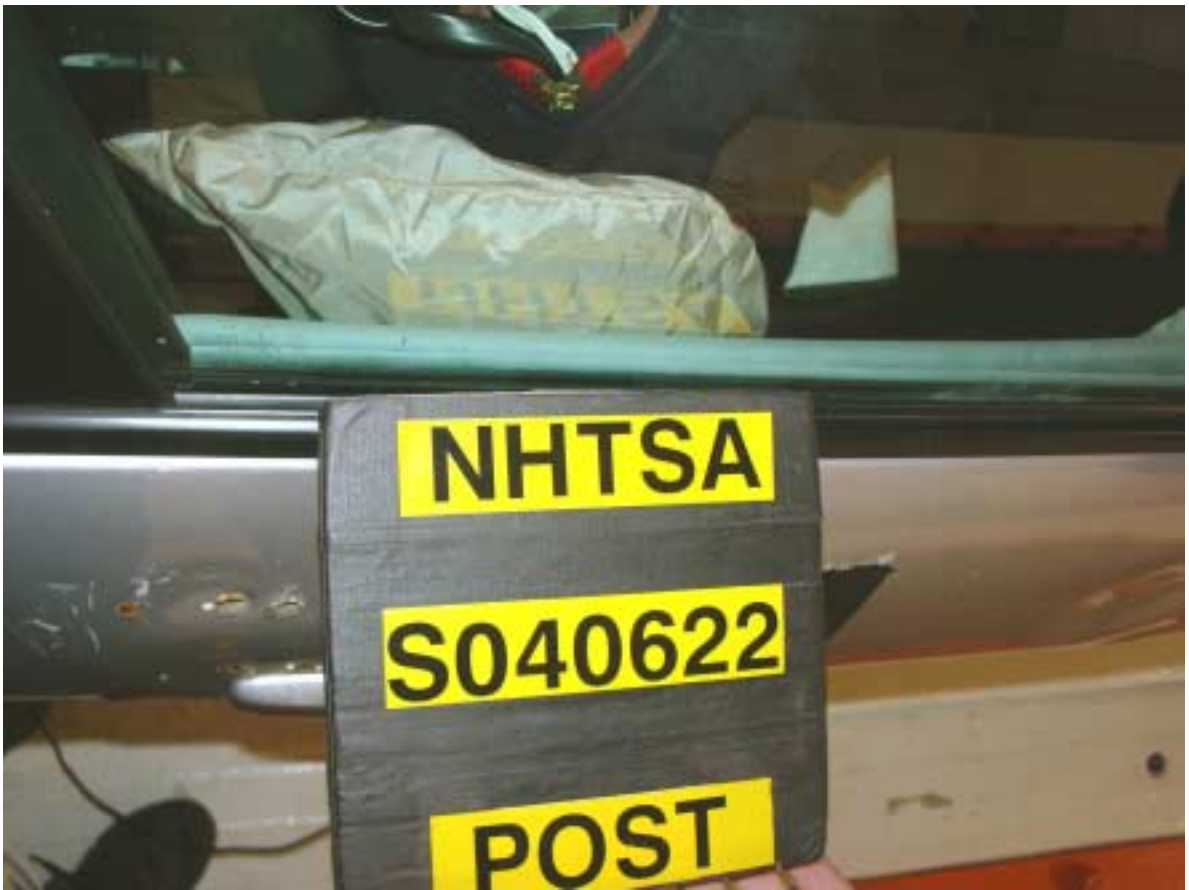
**Figure A-11 Post-Test Side Torso Airbag - View 1**

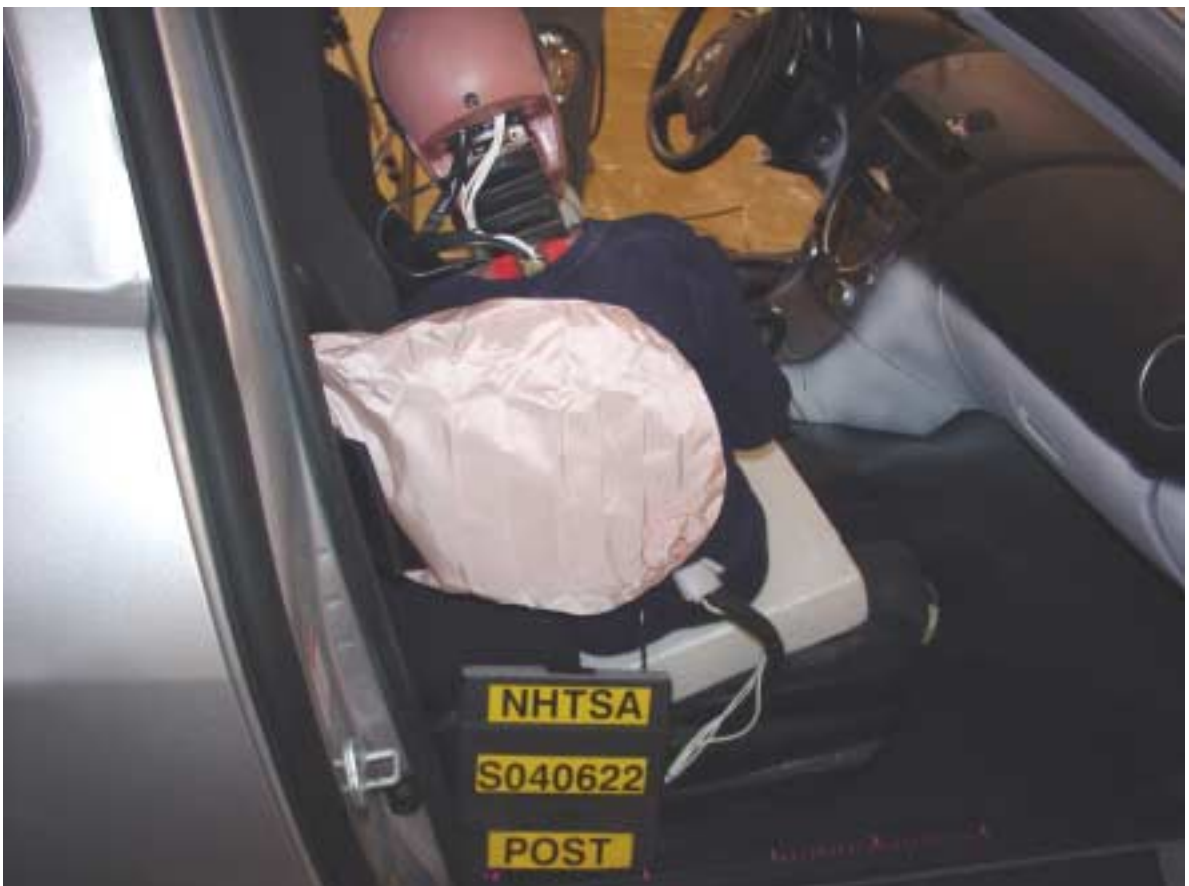
**Figure A-12 Post-Test Side Torso Airbag - View 2**

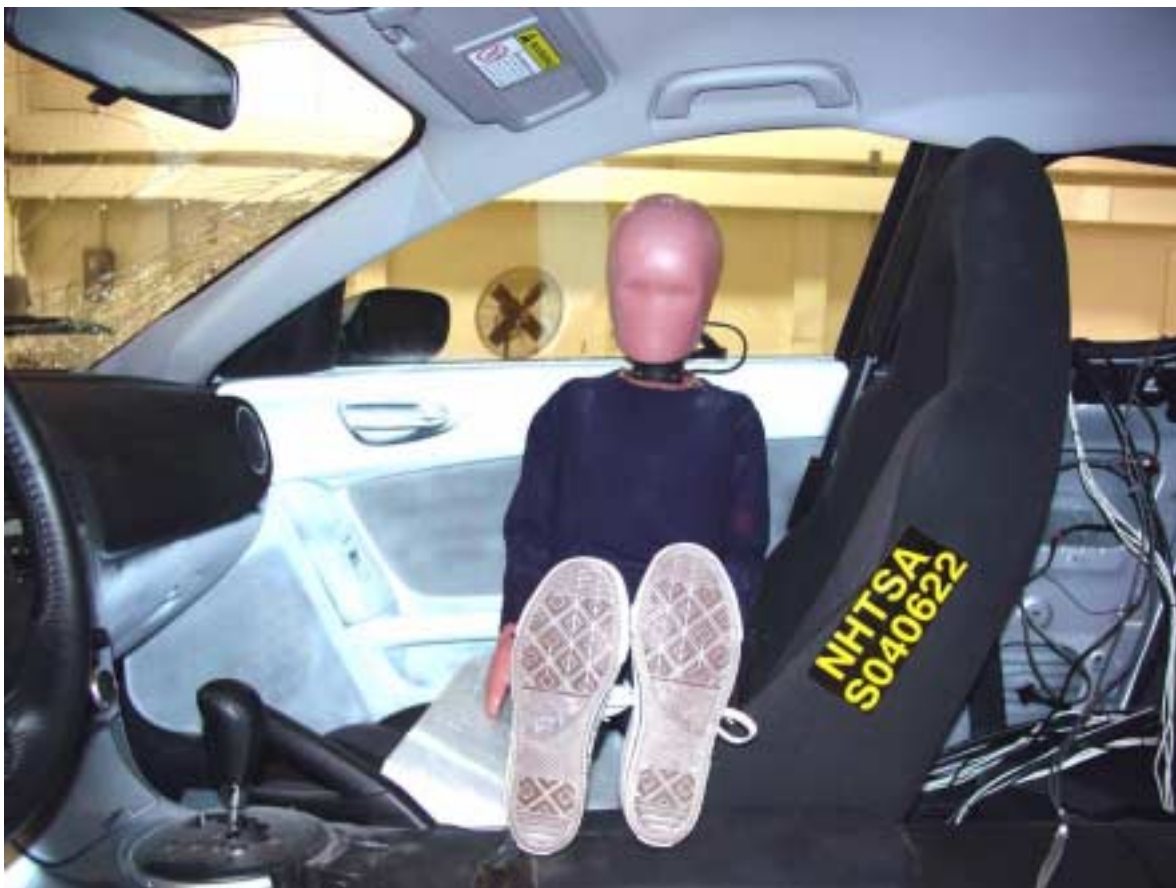
**Figure A-13 Pre-Test Dummy Positioning - View 1**

The six-year-old child dummy was placed on a booster block and oriented in the leftward facing position on the outboard portion of the seat cushion. The seat was placed in the highest height position with the seatback placed at the manufacturer's design position for a fiftieth percentile male. The seat track was positioned forward to minimize the vertical distance between the dummy's head and the roof rail module. The dummy's pelvis was slid outward until contact with the door trim panel and the head was adjusted to align its center of gravity with the edge of the roof header. The dummy's arms were bent at the elbow until the fingers touched the booster seat. This orientation complies with Section 3.3.5.1 of the TWG Recommended Procedures for Evaluating Occupant Injury Risk from Deploying Side Airbags as defined by Lund, et al and the Technical Working Group dated July 2003.

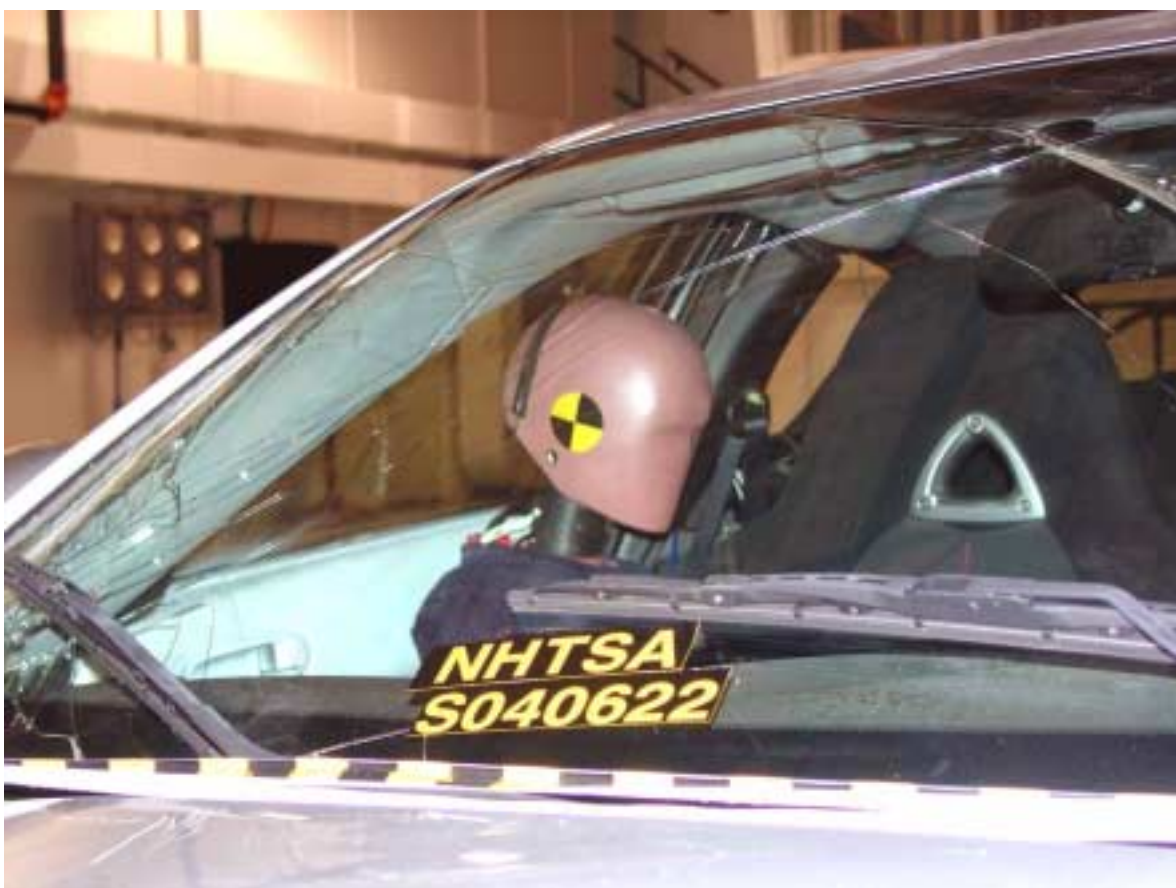
**Figure A-14 Pre-Test Dummy Positioning - View 2**

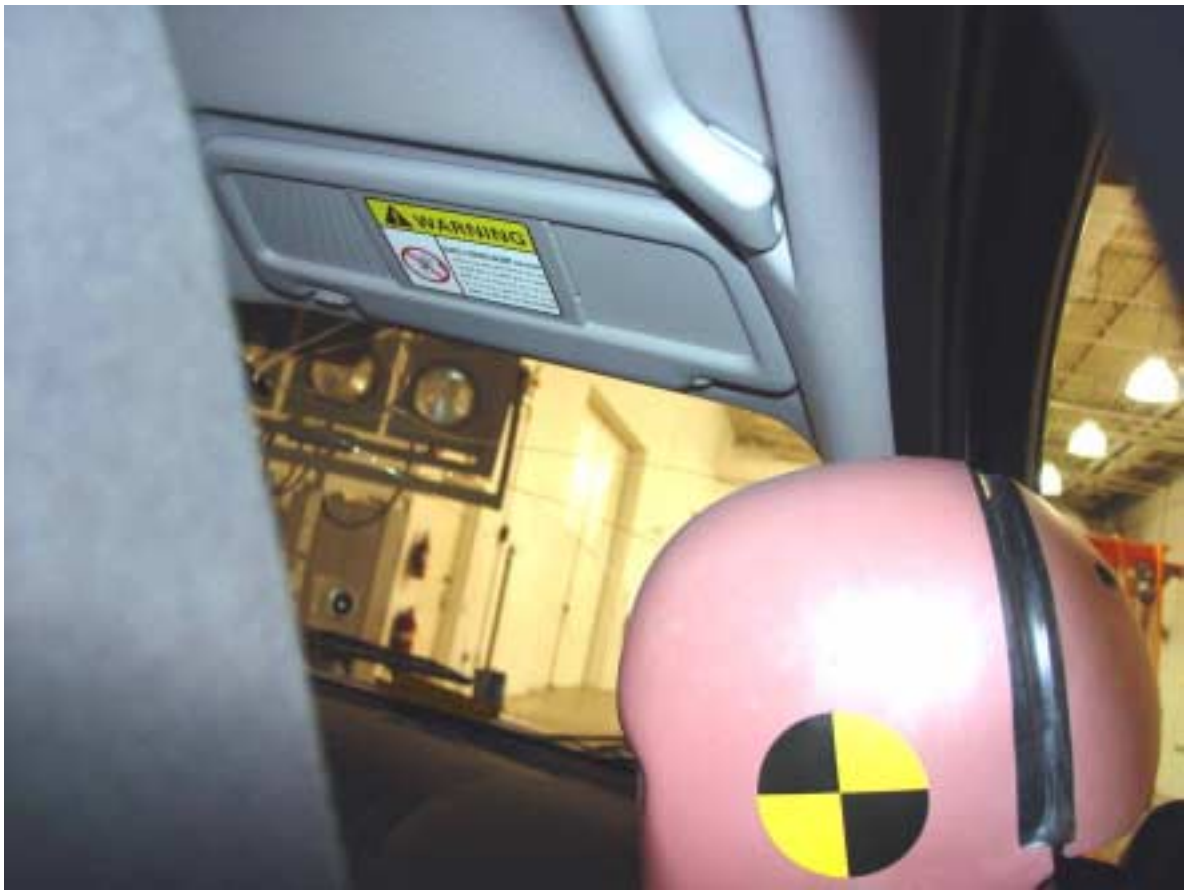
**Figure A-15 Pre-Test Dummy Positioning - View 3**

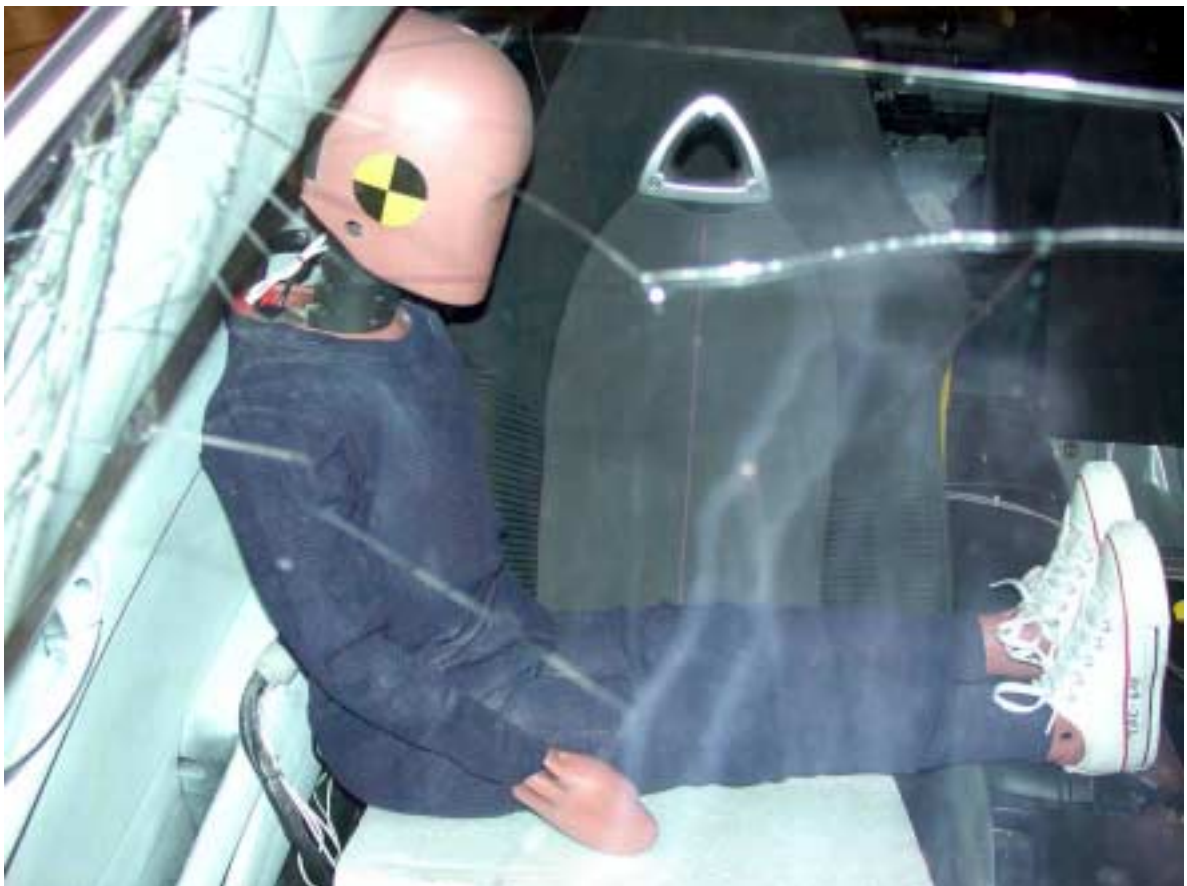
**Figure A-16 Pre-Test Dummy Positioning - View 4**
