**REPORT NUMBER: NCAP-MGA-2005-001**

**NEW CAR ASSESSMENT PROGRAM  
FRONTAL BARRIER IMPACT TEST**

**Daimler Chrysler Corporation  
2005 Chrysler 300  
NHTSA NUMBER: M50300**

**PREPARED BY:  
MGA RESEARCH CORPORATION  
5000 WARREN ROAD  
BURLINGTON, WI 53105**

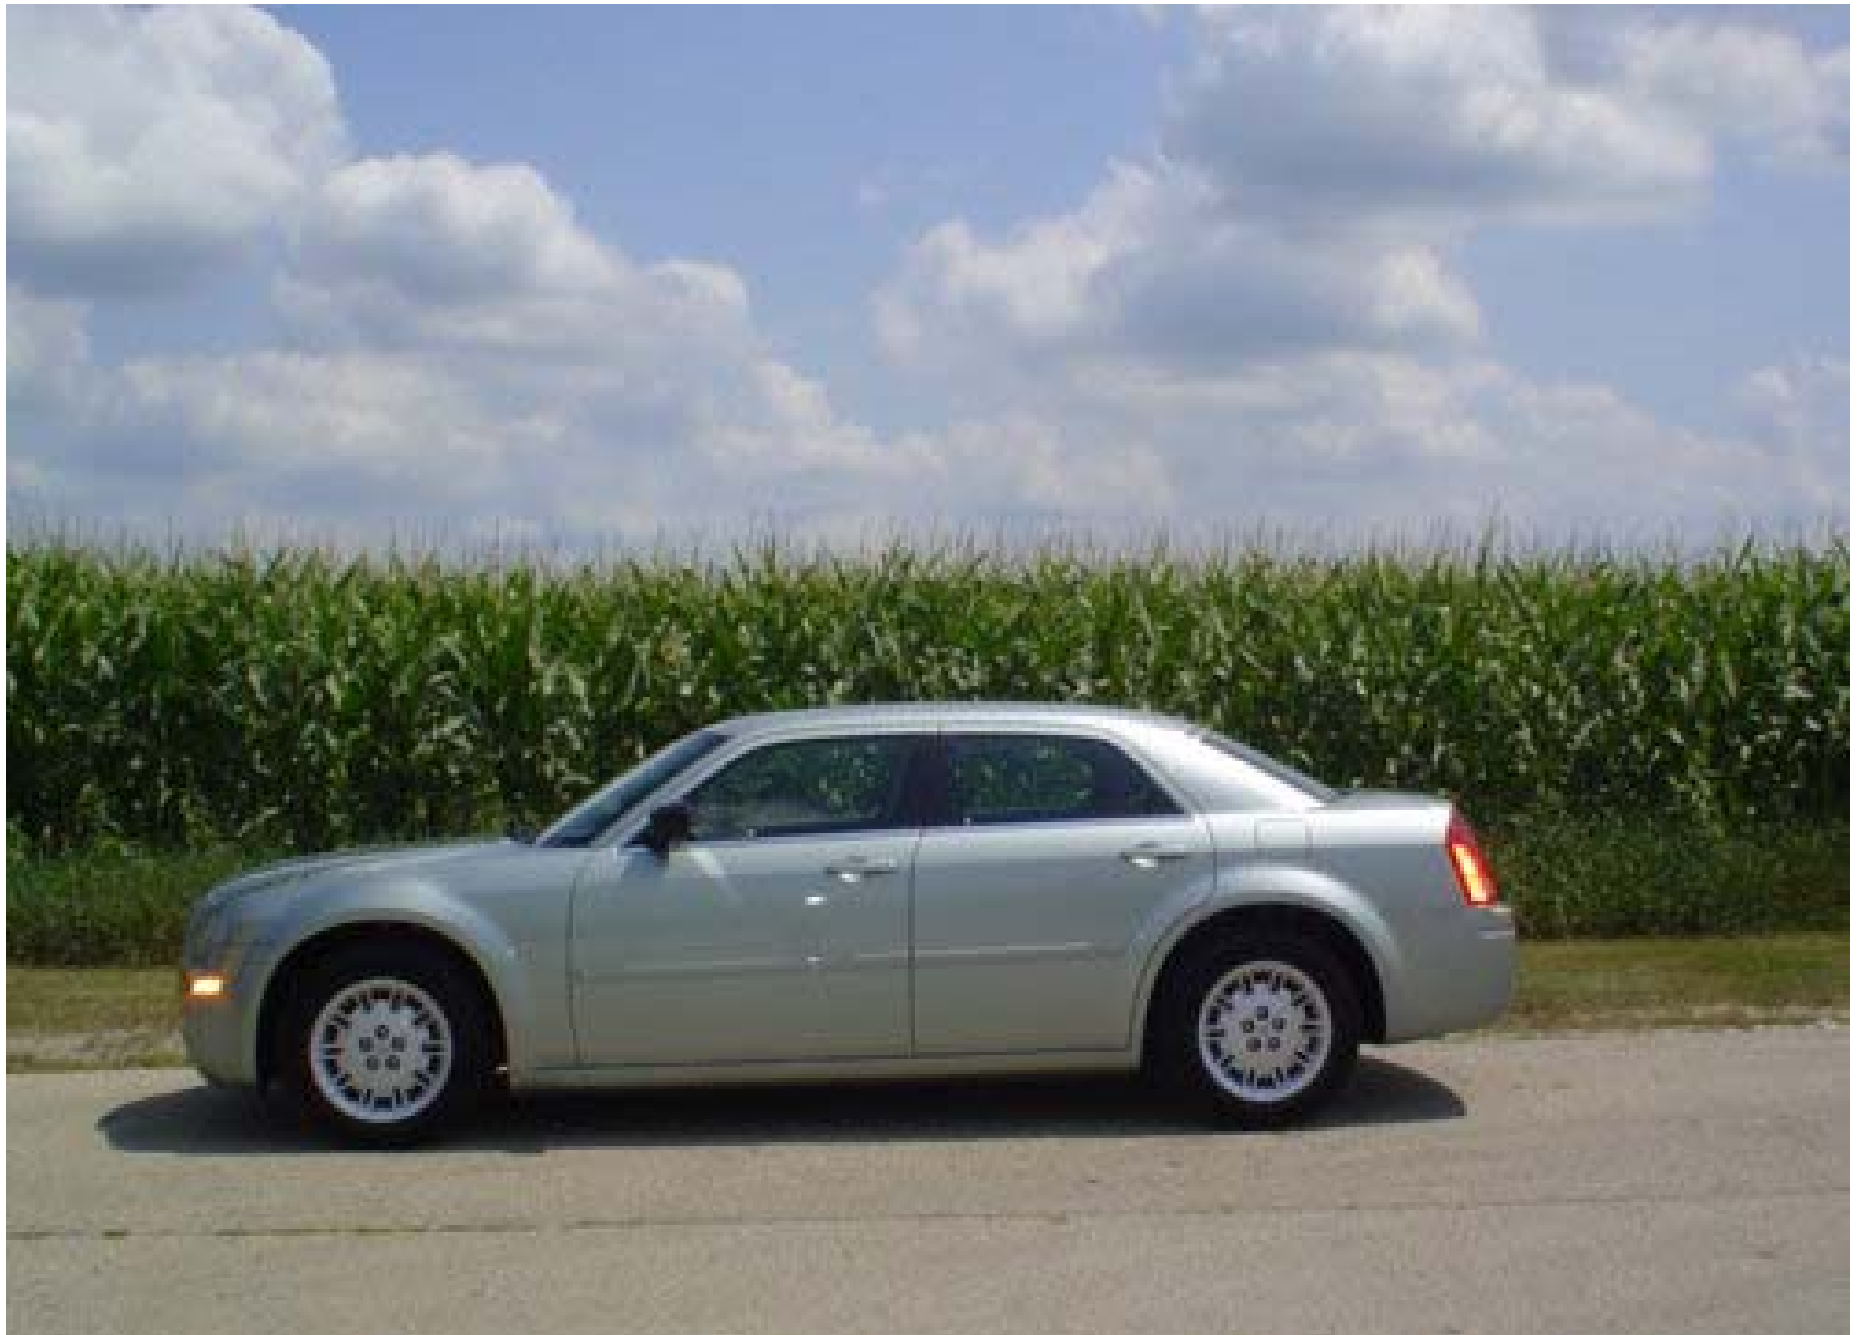
Left Side View of Test Vehicle, as received

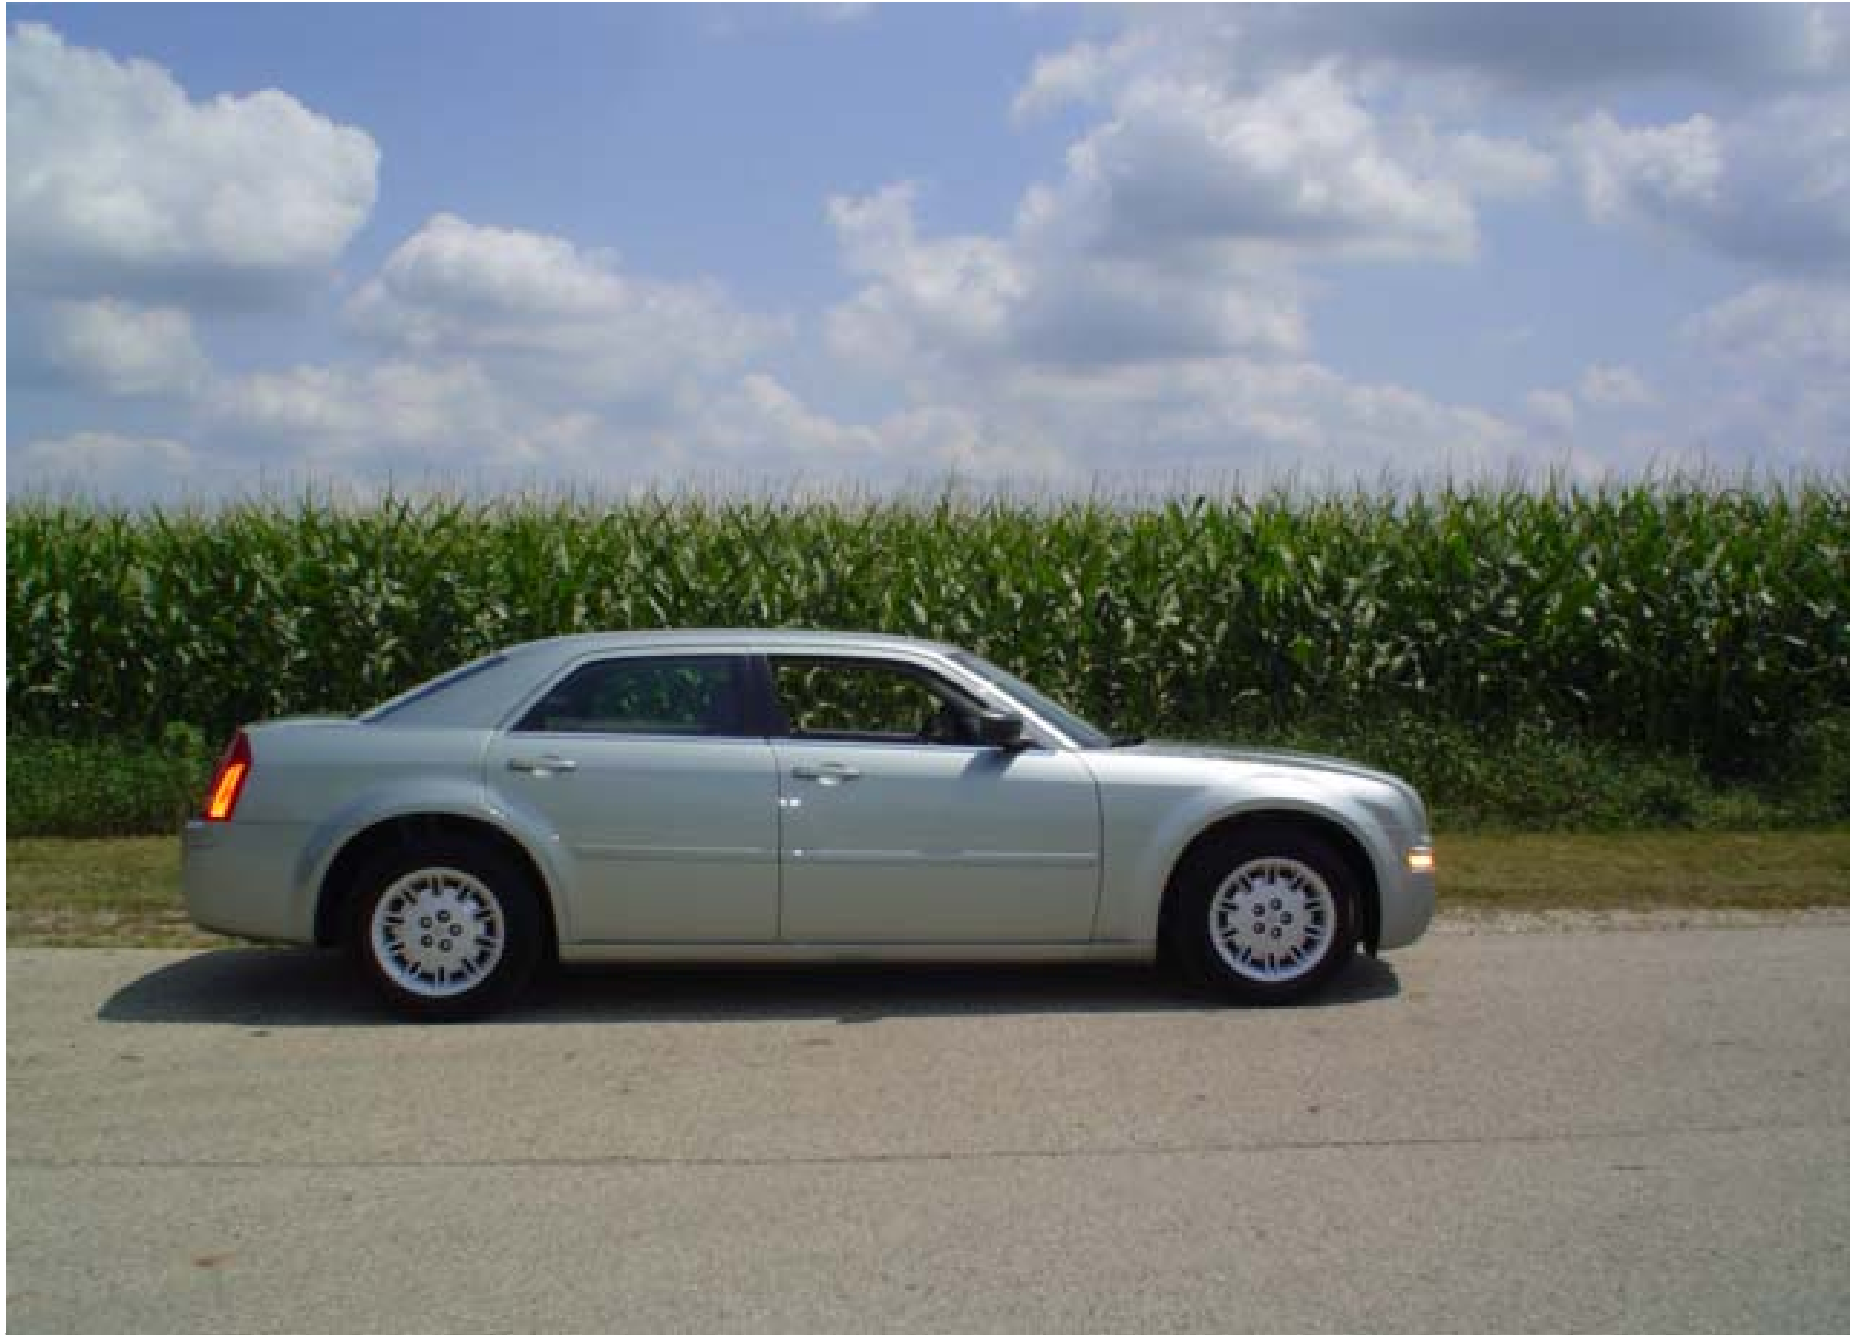
Right Side View of Test Vehicle, as received

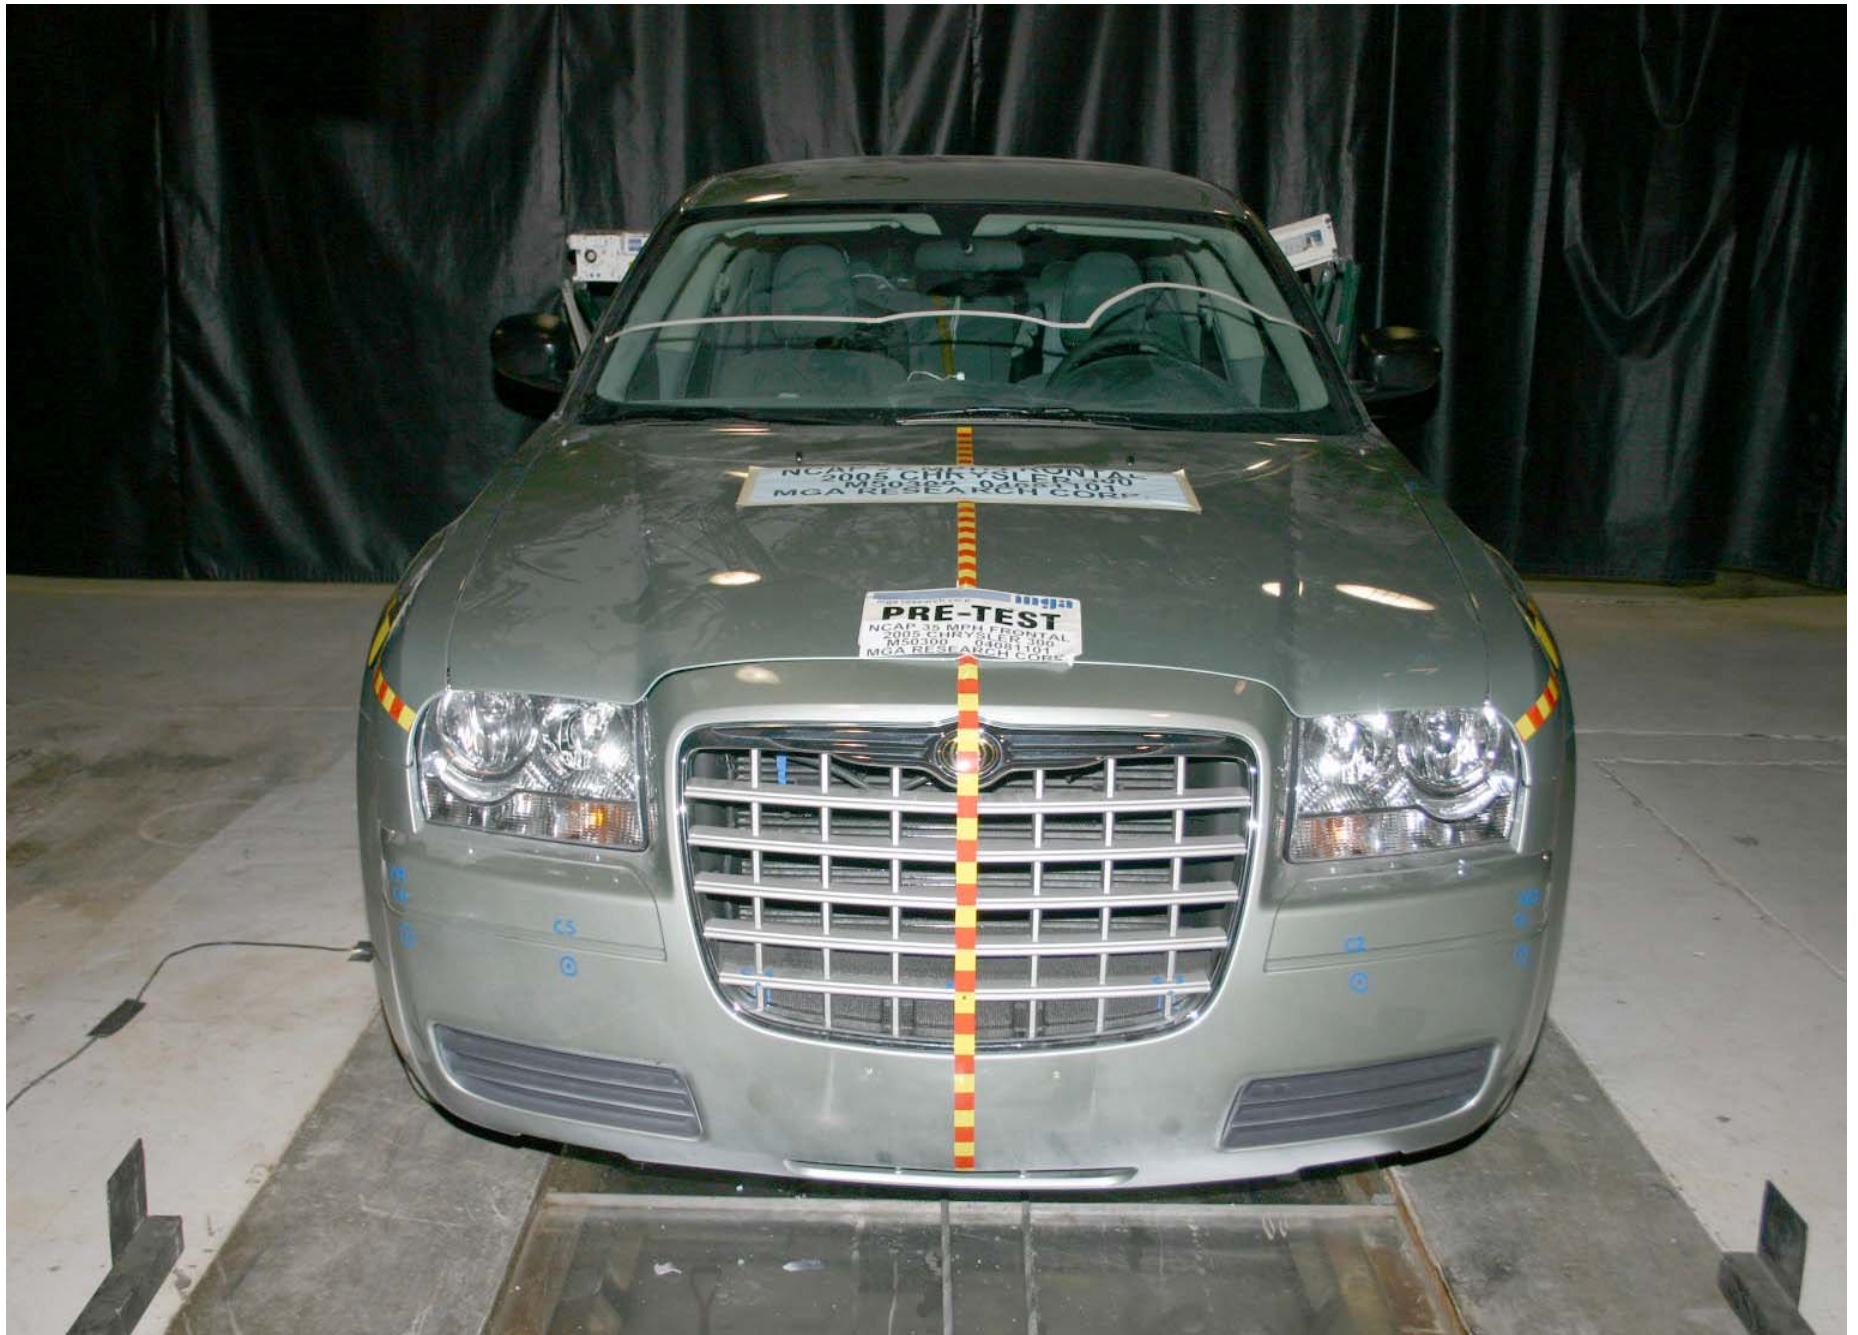
Pre-Test Front View of Test Vehicle

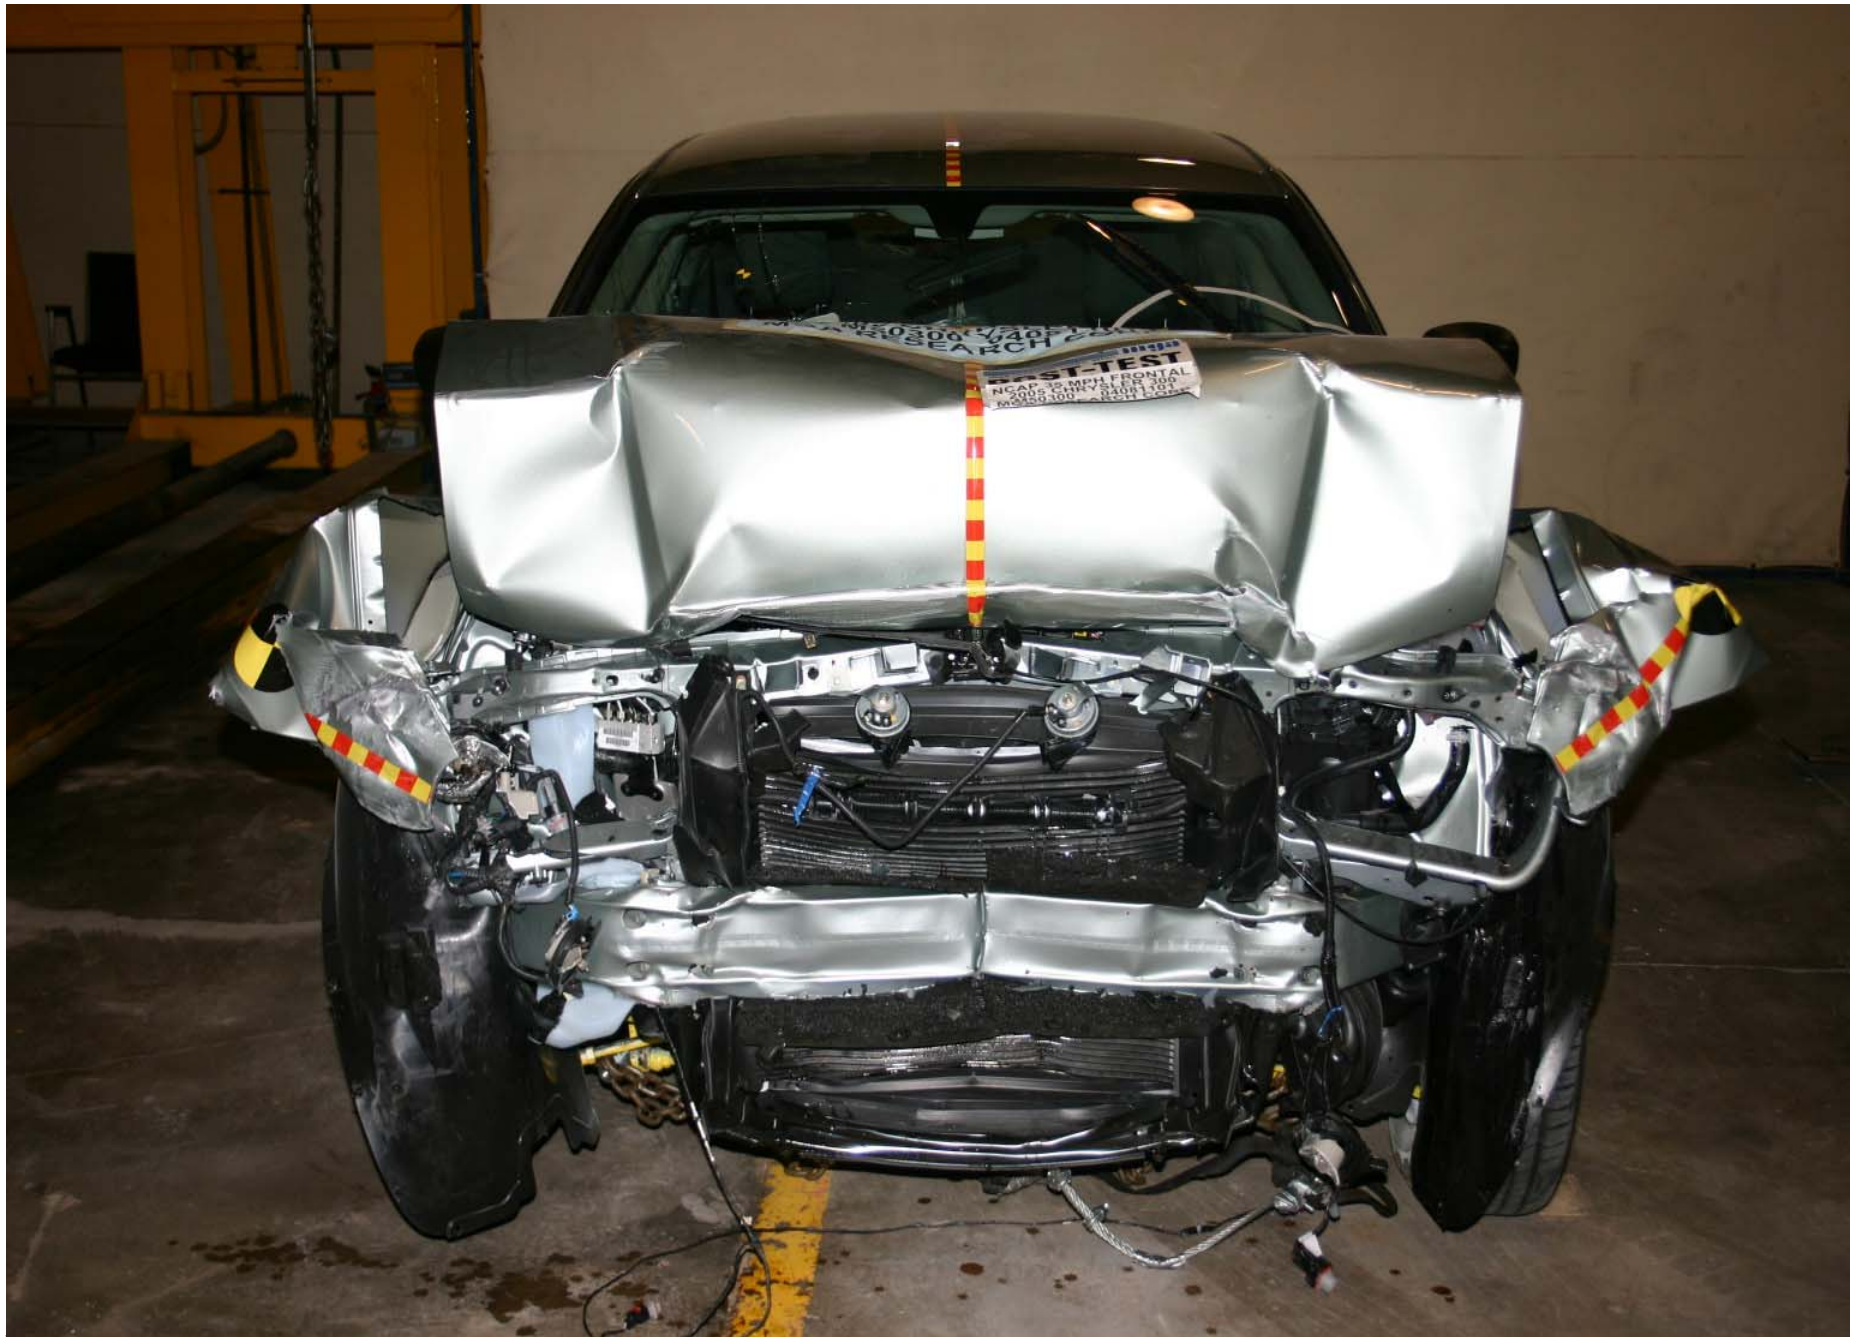
Post-Test Front View of Test Vehicle

The maximum static crush of the vehicle was 679 mm and both the driver and passenger side doors remained closed and latched during the impact event and were operable after the impact.

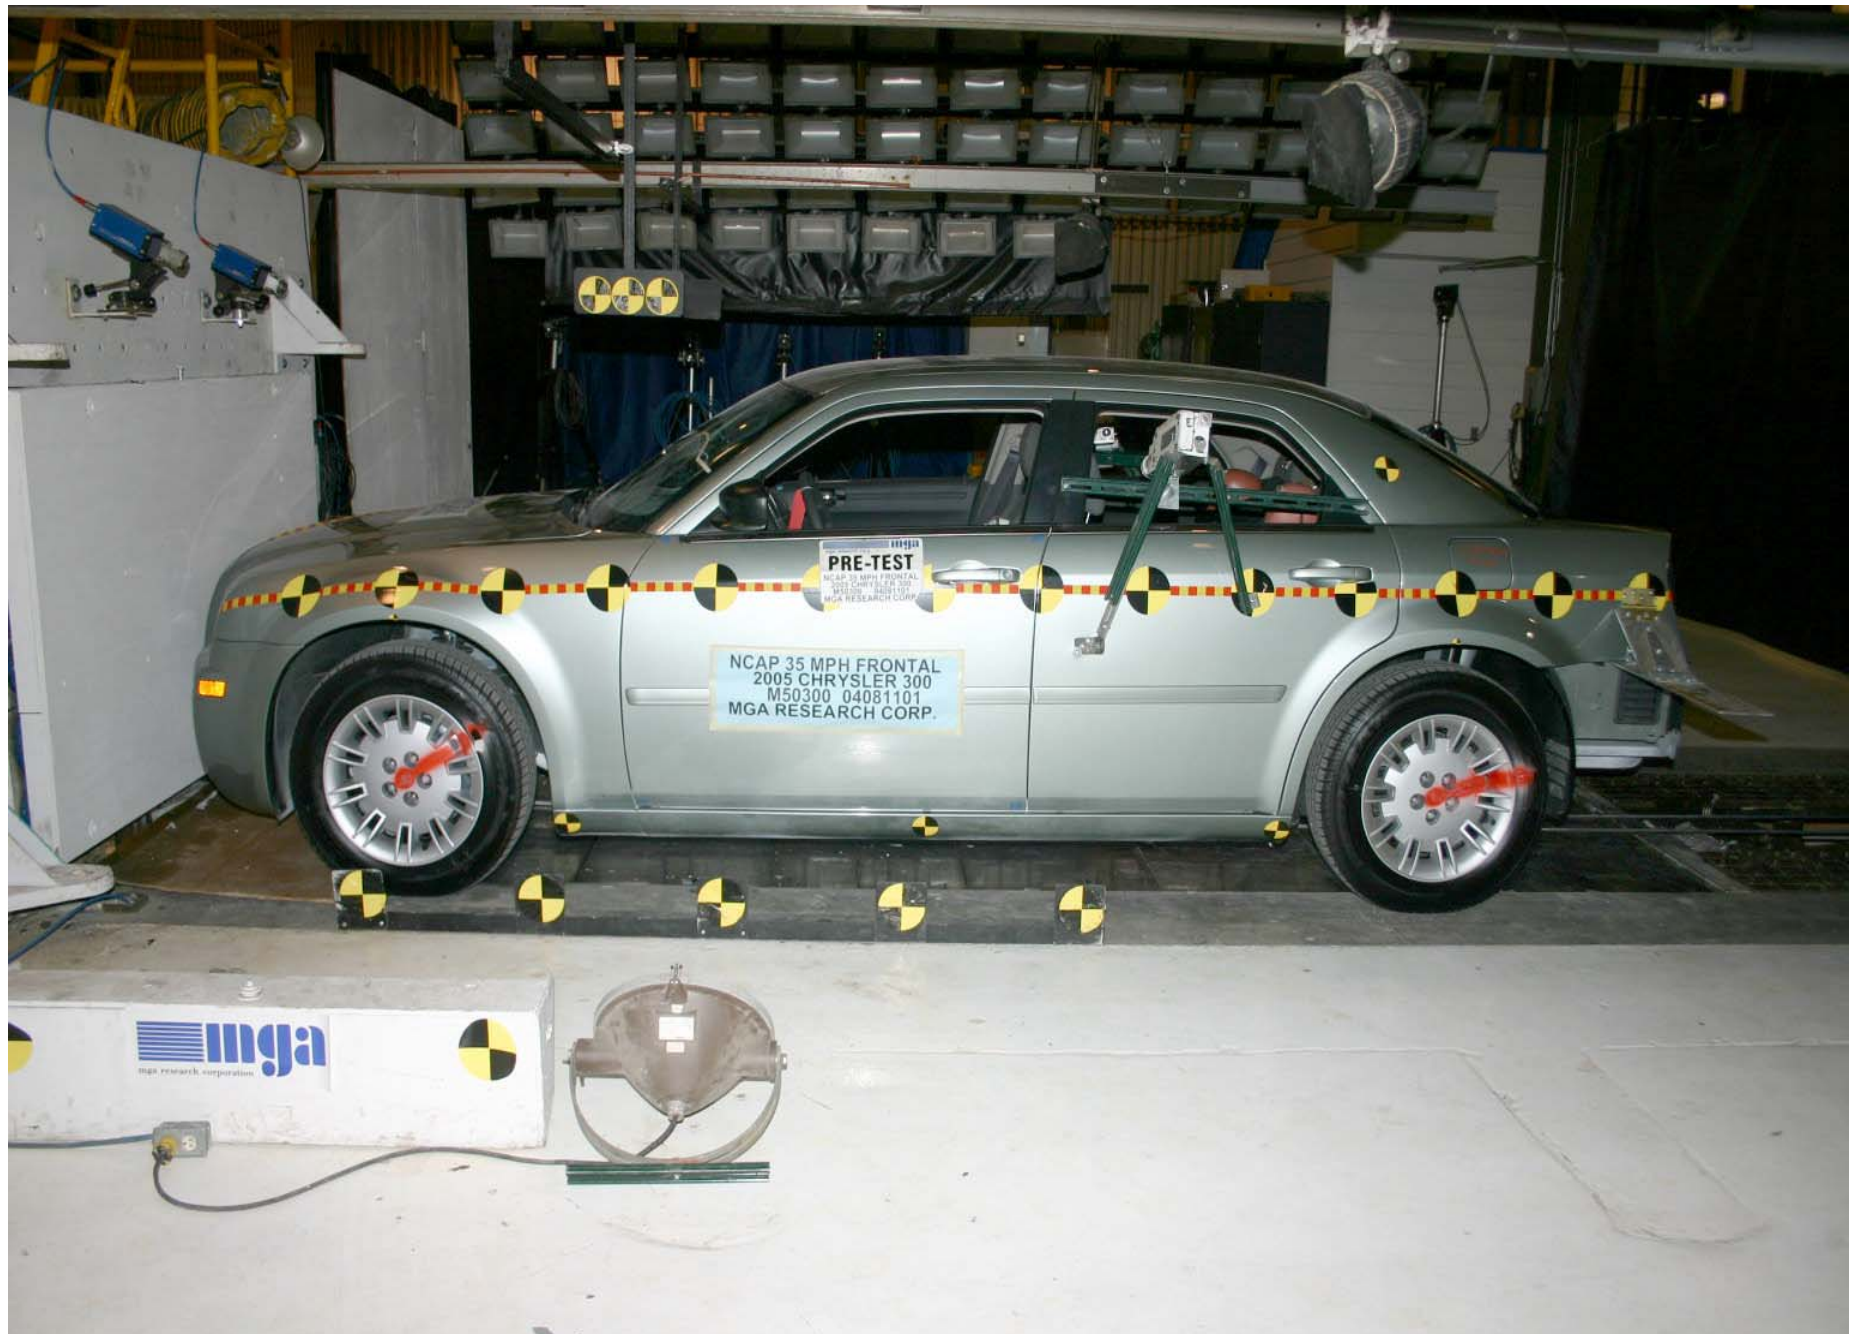
Pre-Test Left Side View of Test Vehicle

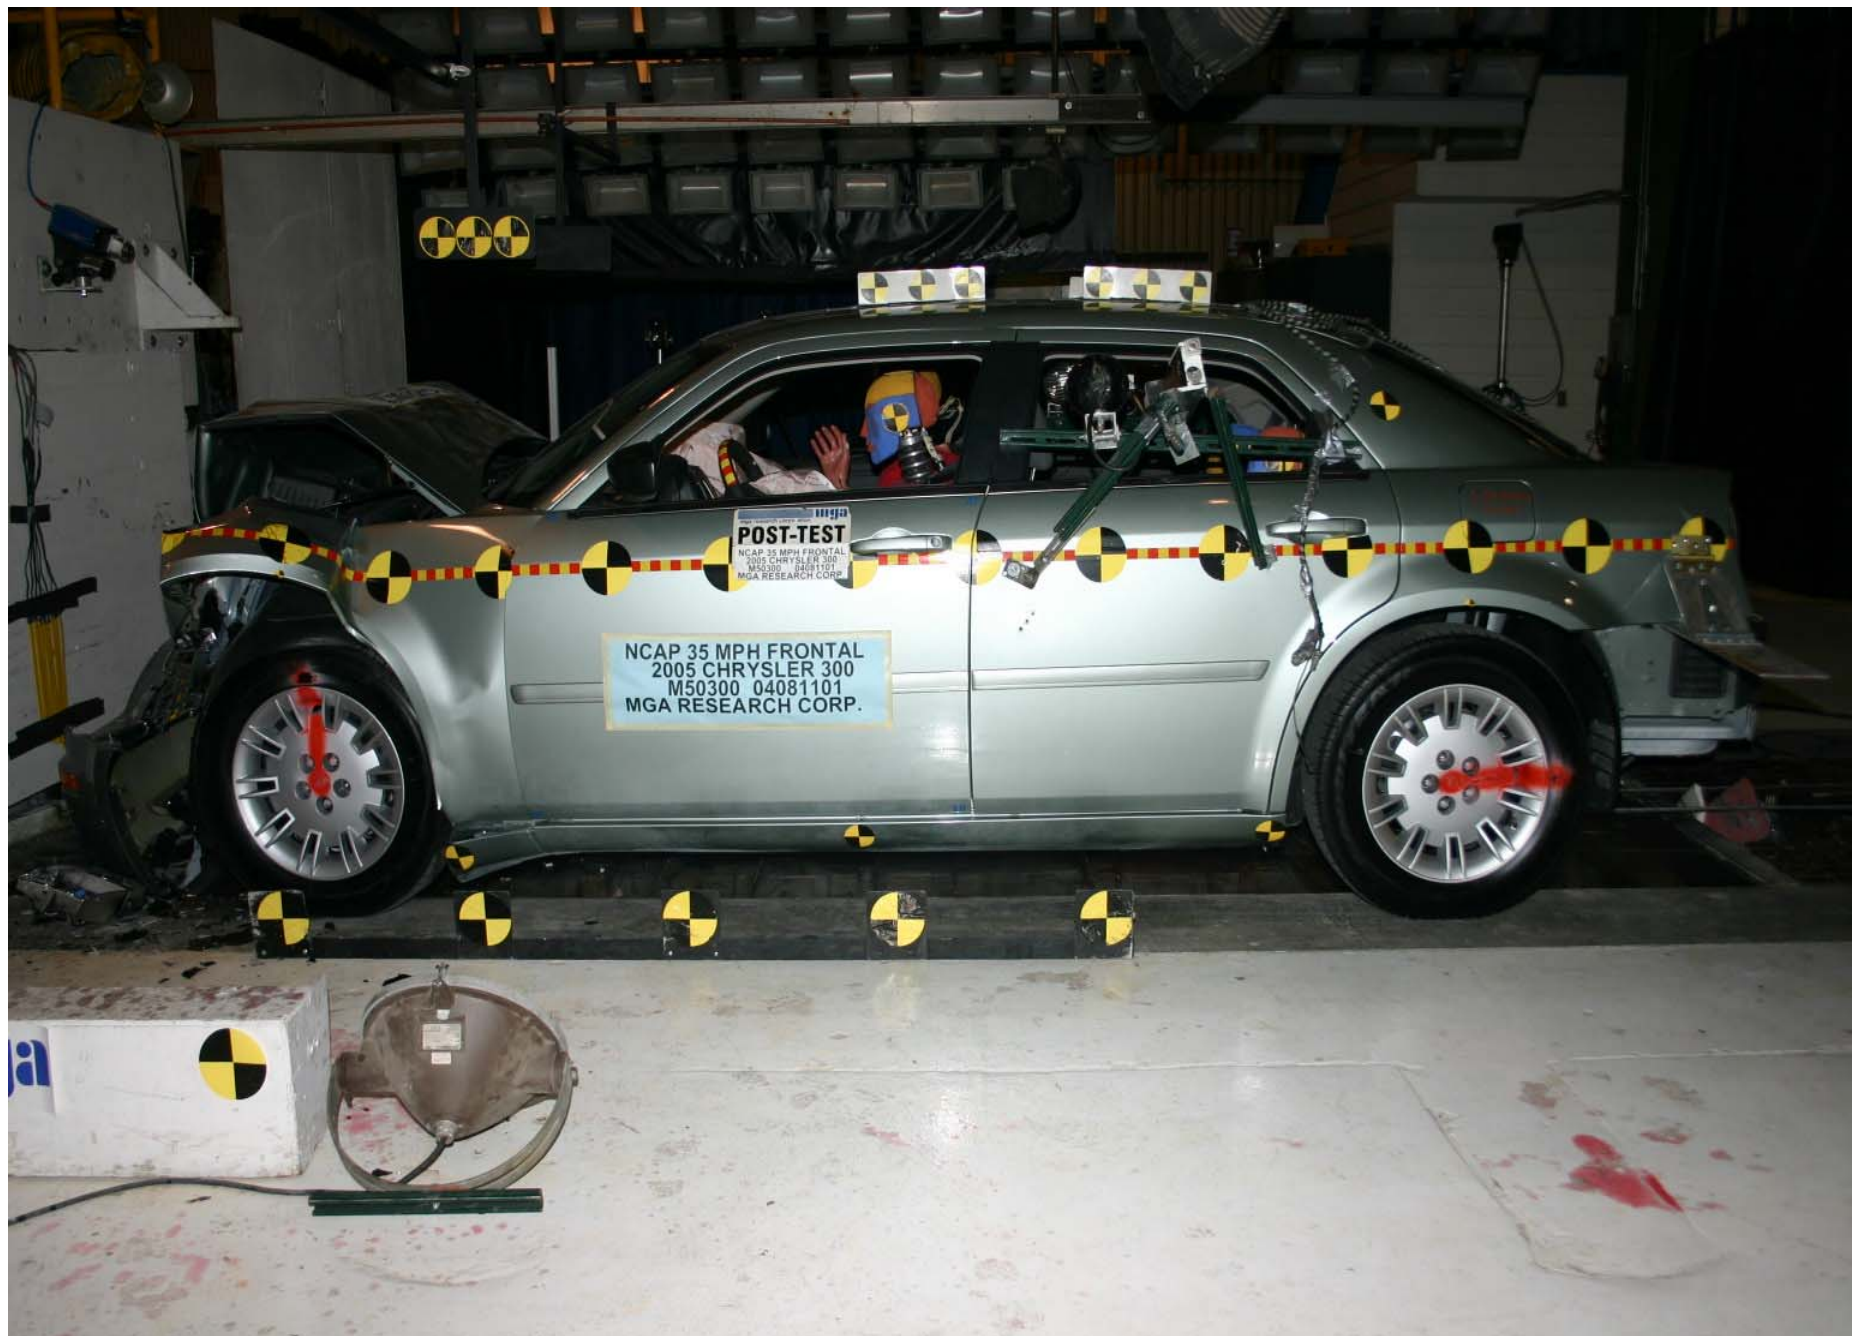
Post-Test Left Side View of Test Vehicle

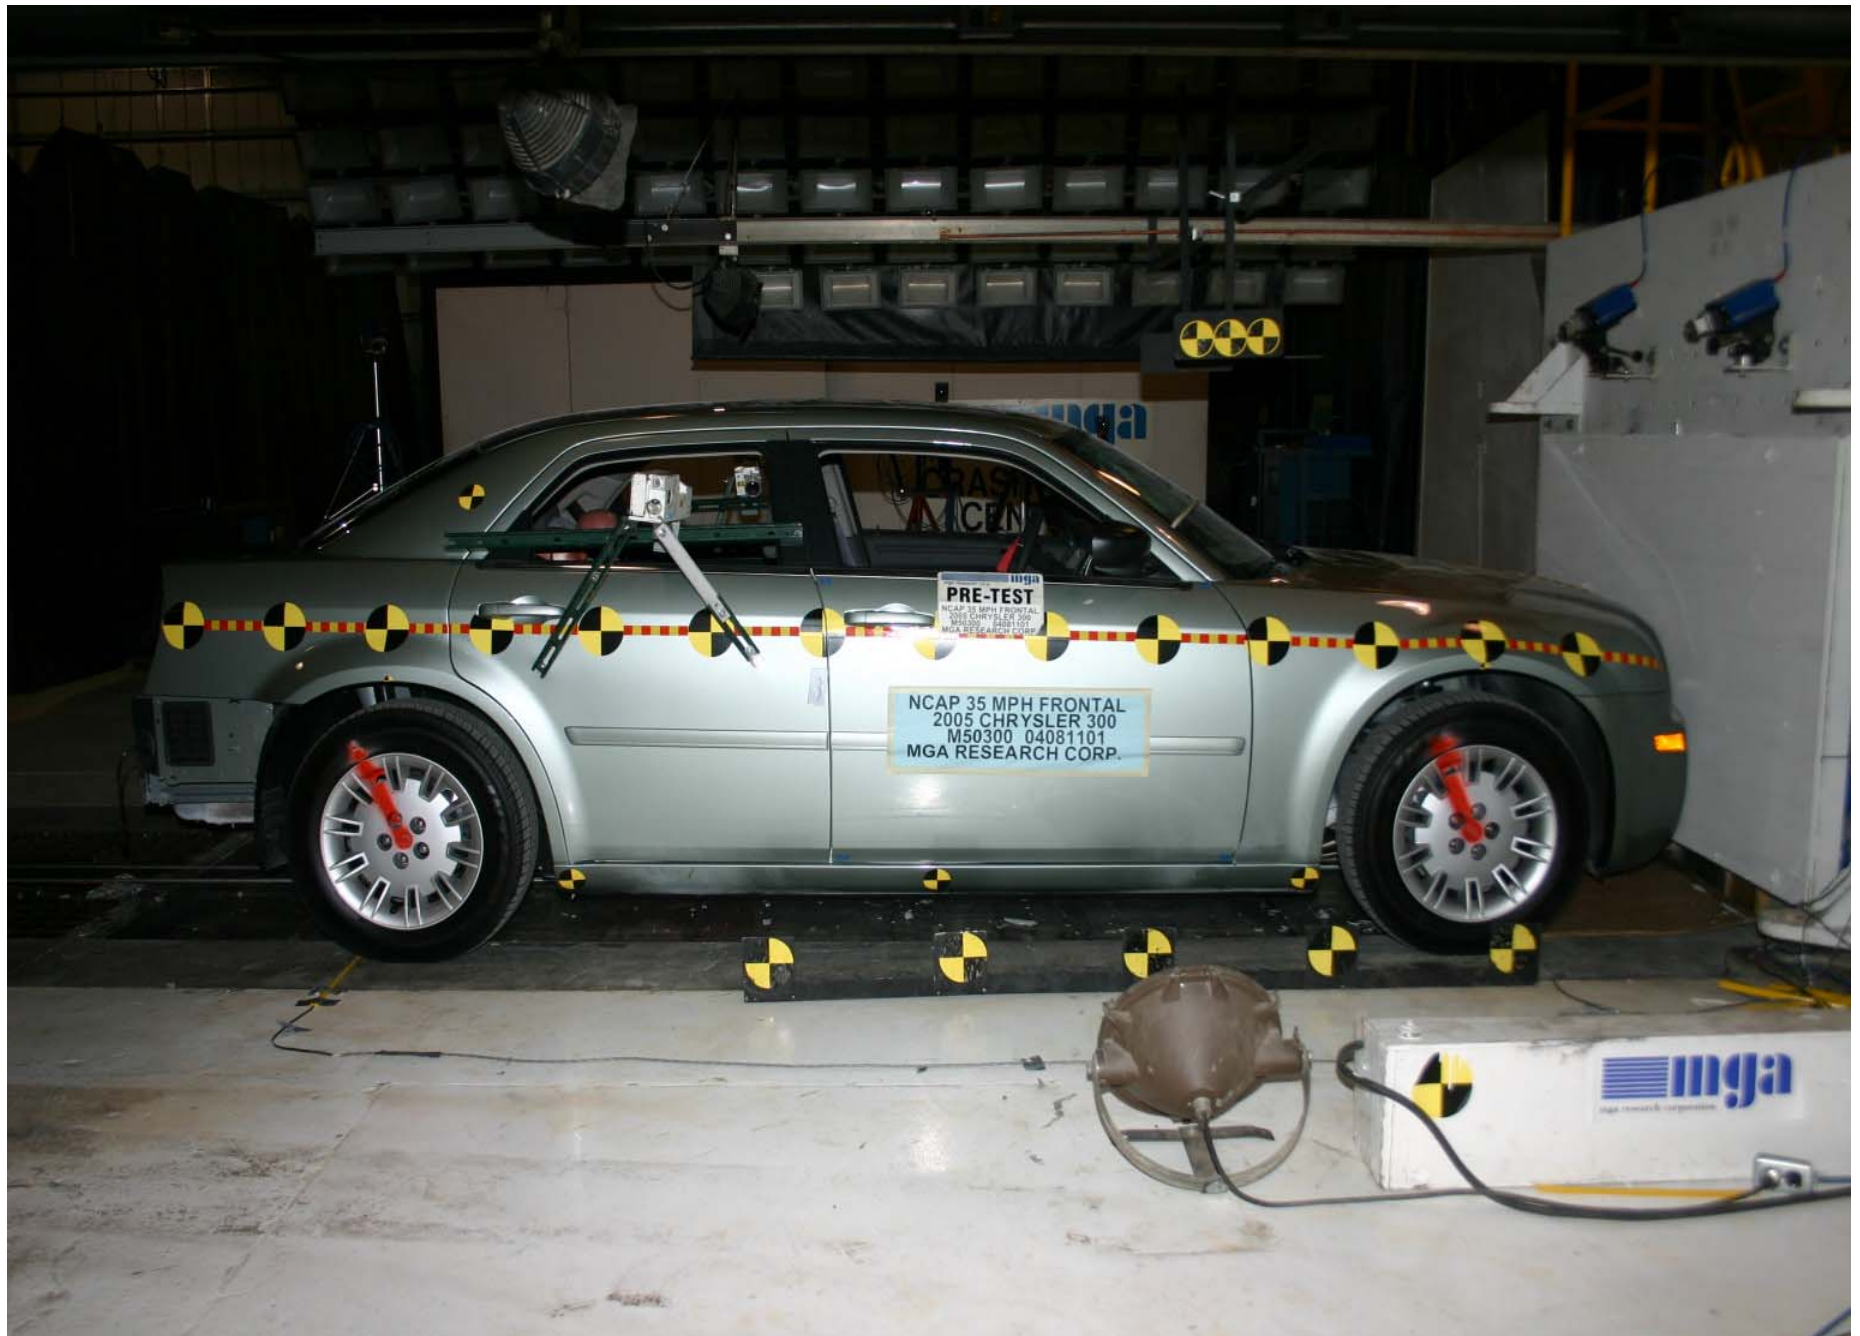
Pre-Test Right Side View of Test Vehicle

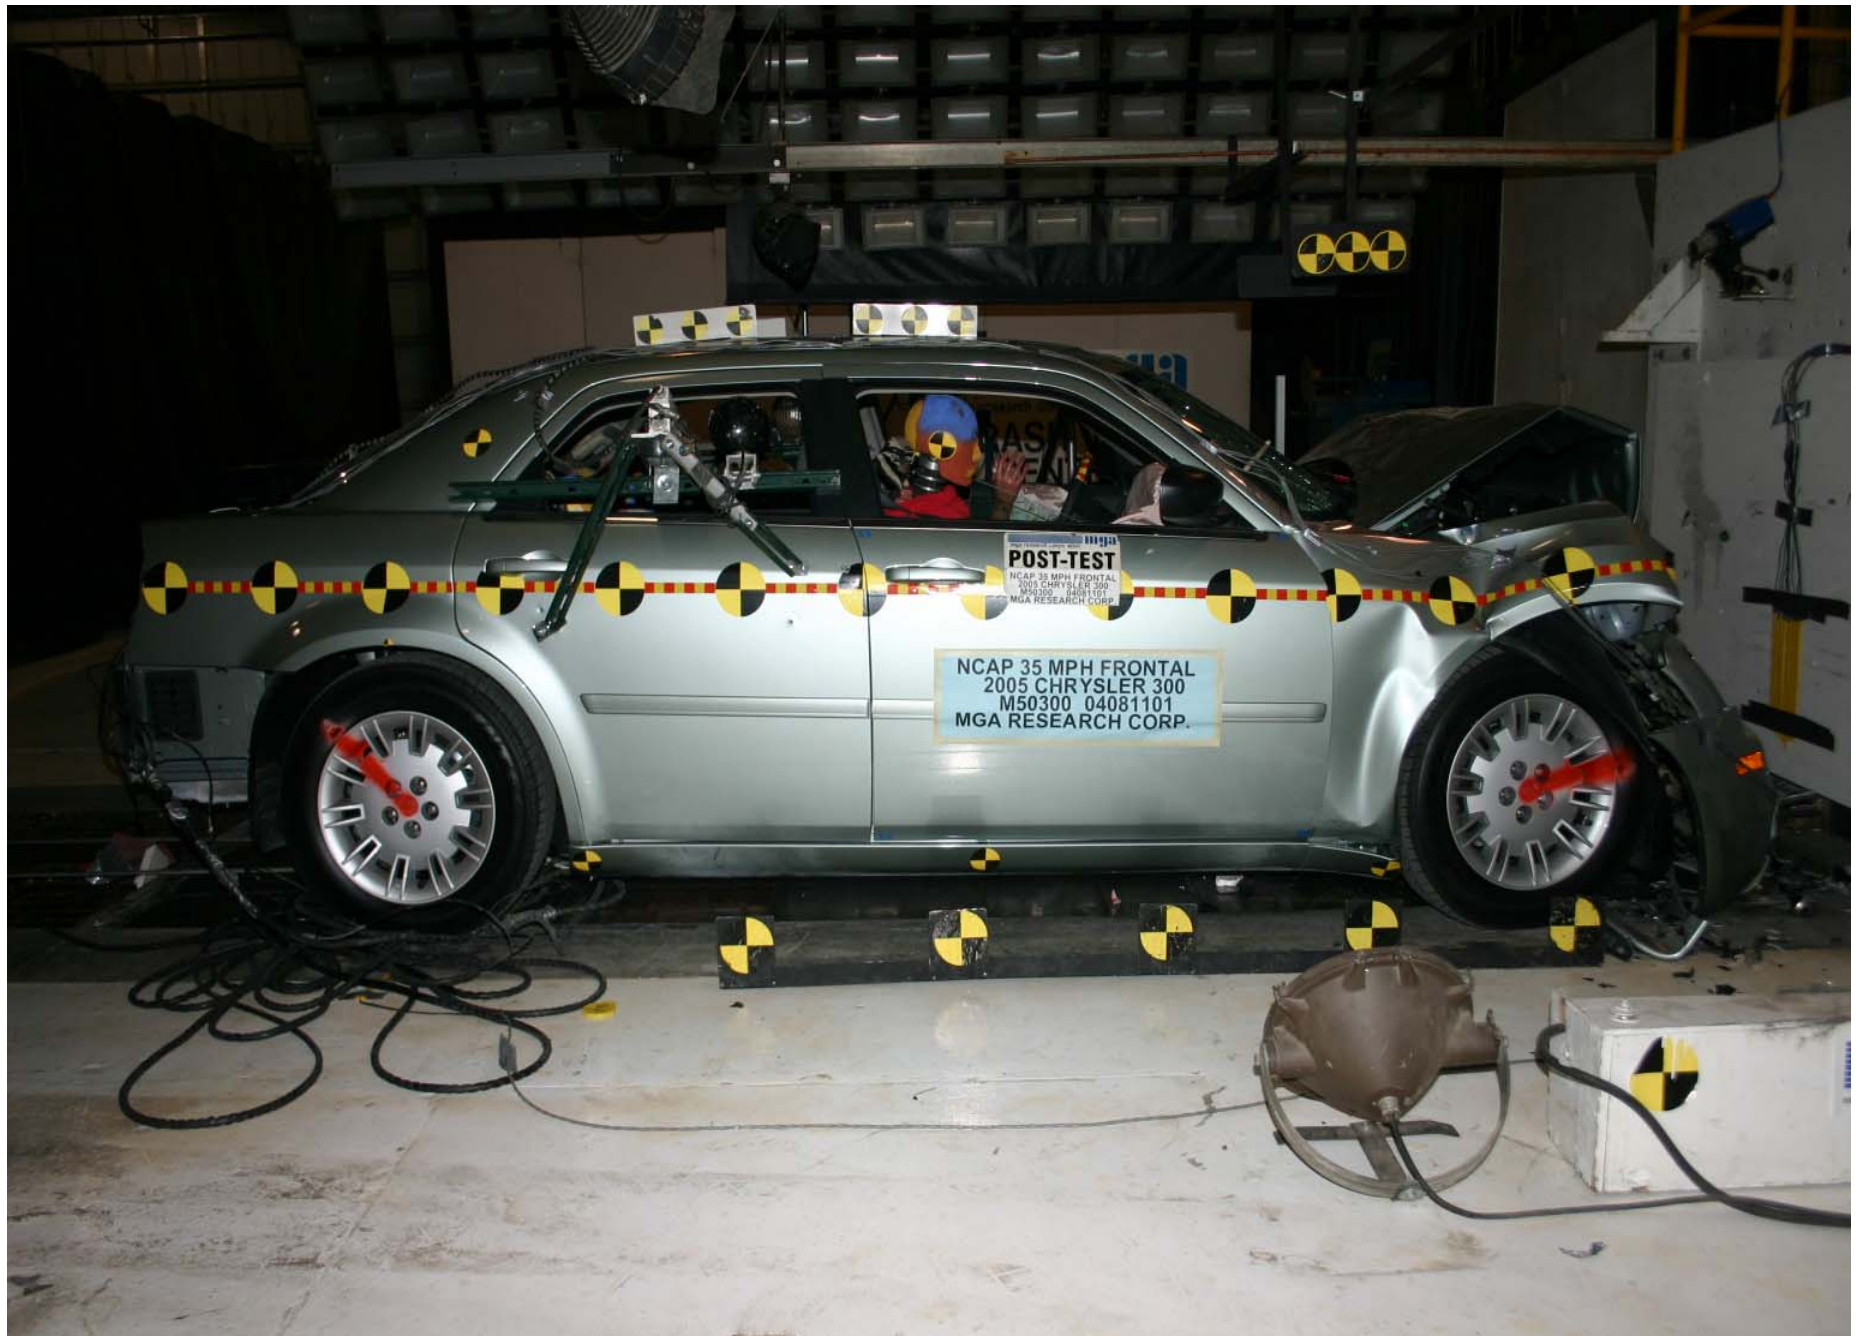
Post-Test Right Side View of Test Vehicle

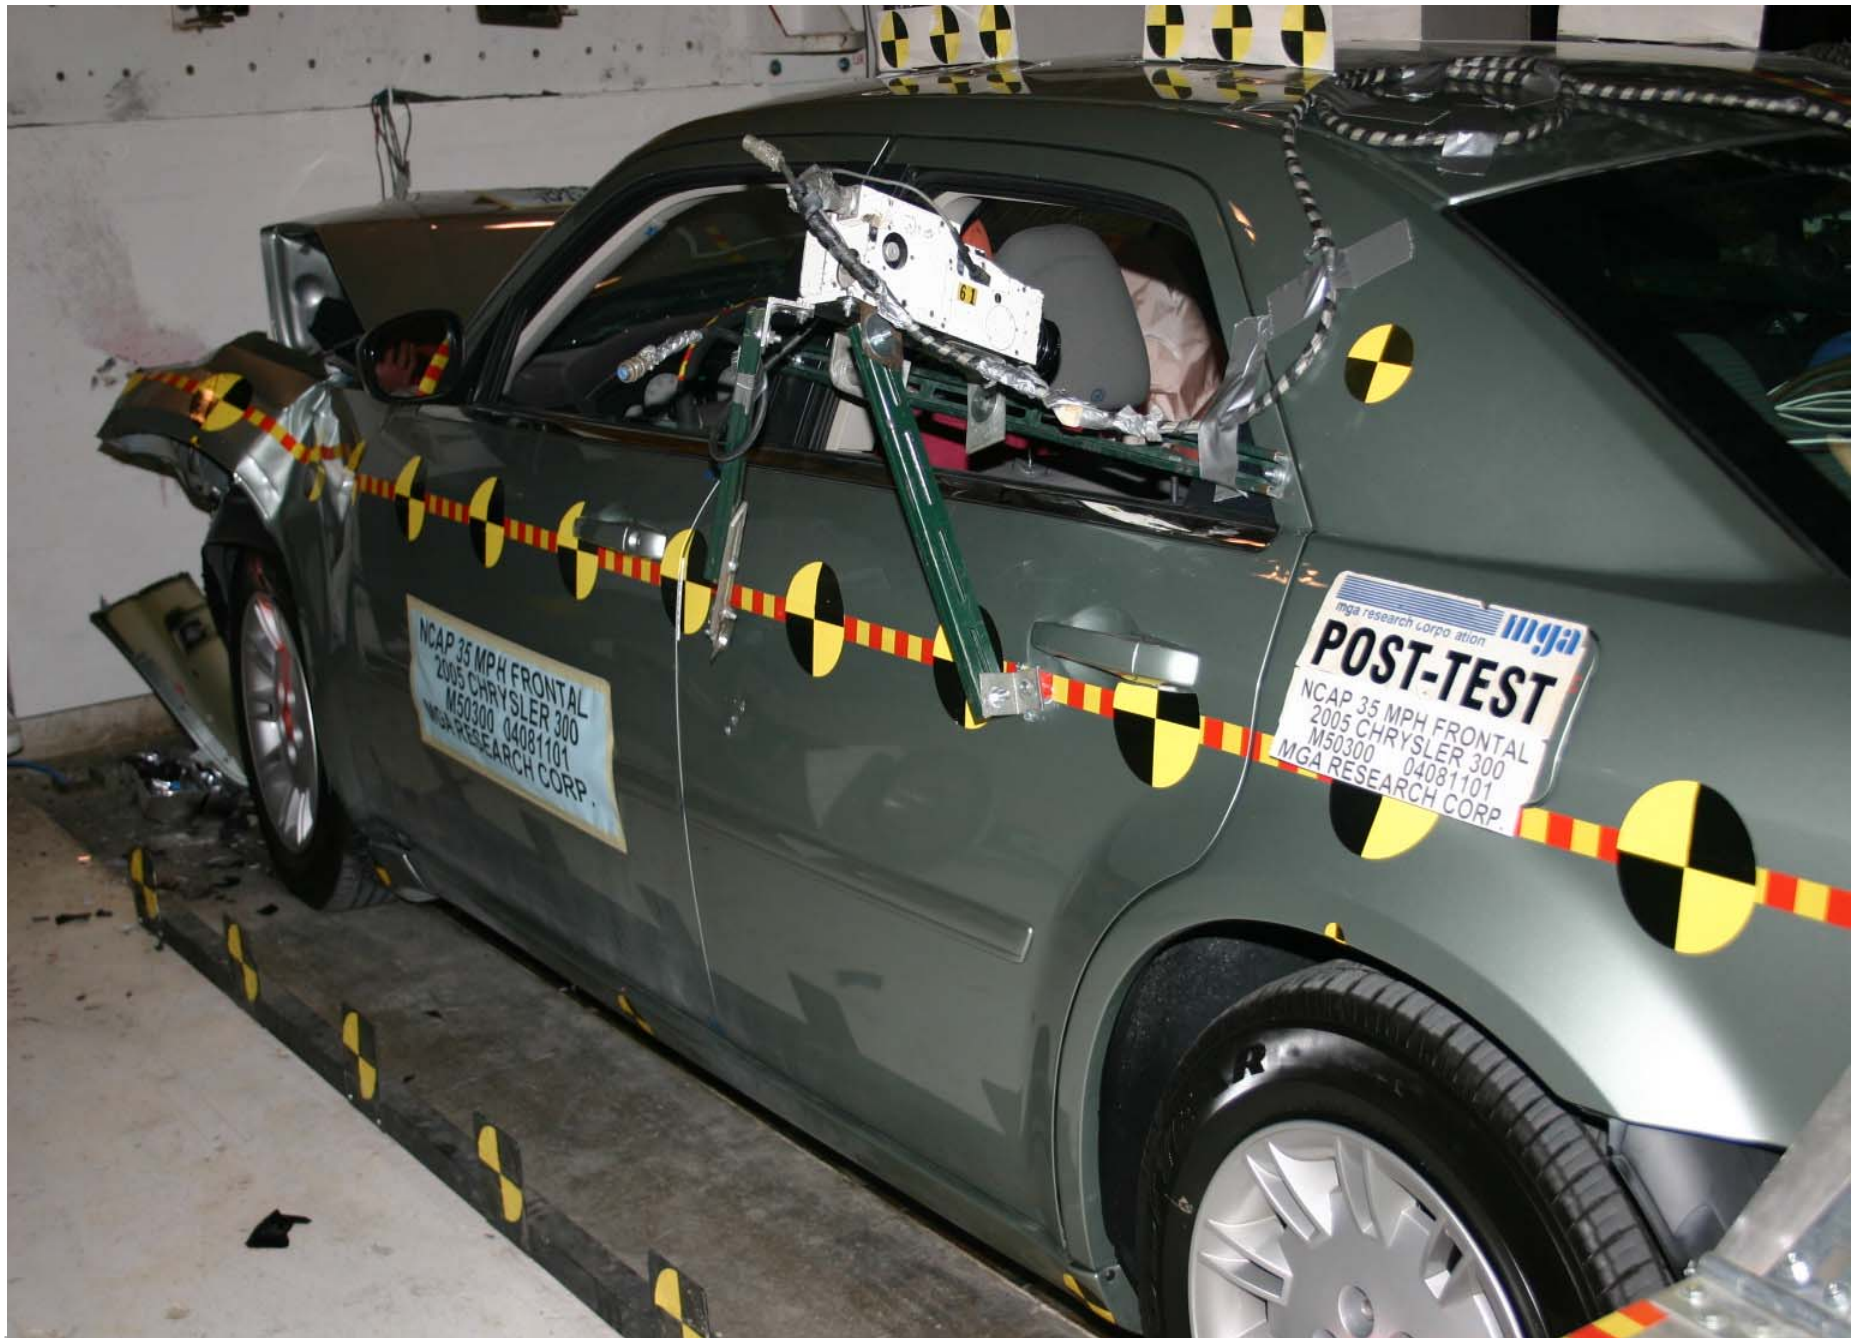
Post-Test Left Side Three-Quarter View of Doors After Impact
