**REPORT NUMBER: NCAP-MGA-2005-001**

**NEW CAR ASSESSMENT PROGRAM  
FRONTAL BARRIER IMPACT TEST**

**Daimler Chrysler Corporation  
2005 Chrysler 300  
NHTSA NUMBER: M50300**

**PREPARED BY:  
MGA RESEARCH CORPORATION  
5000 WARREN ROAD  
BURLINGTON, WI 53105**

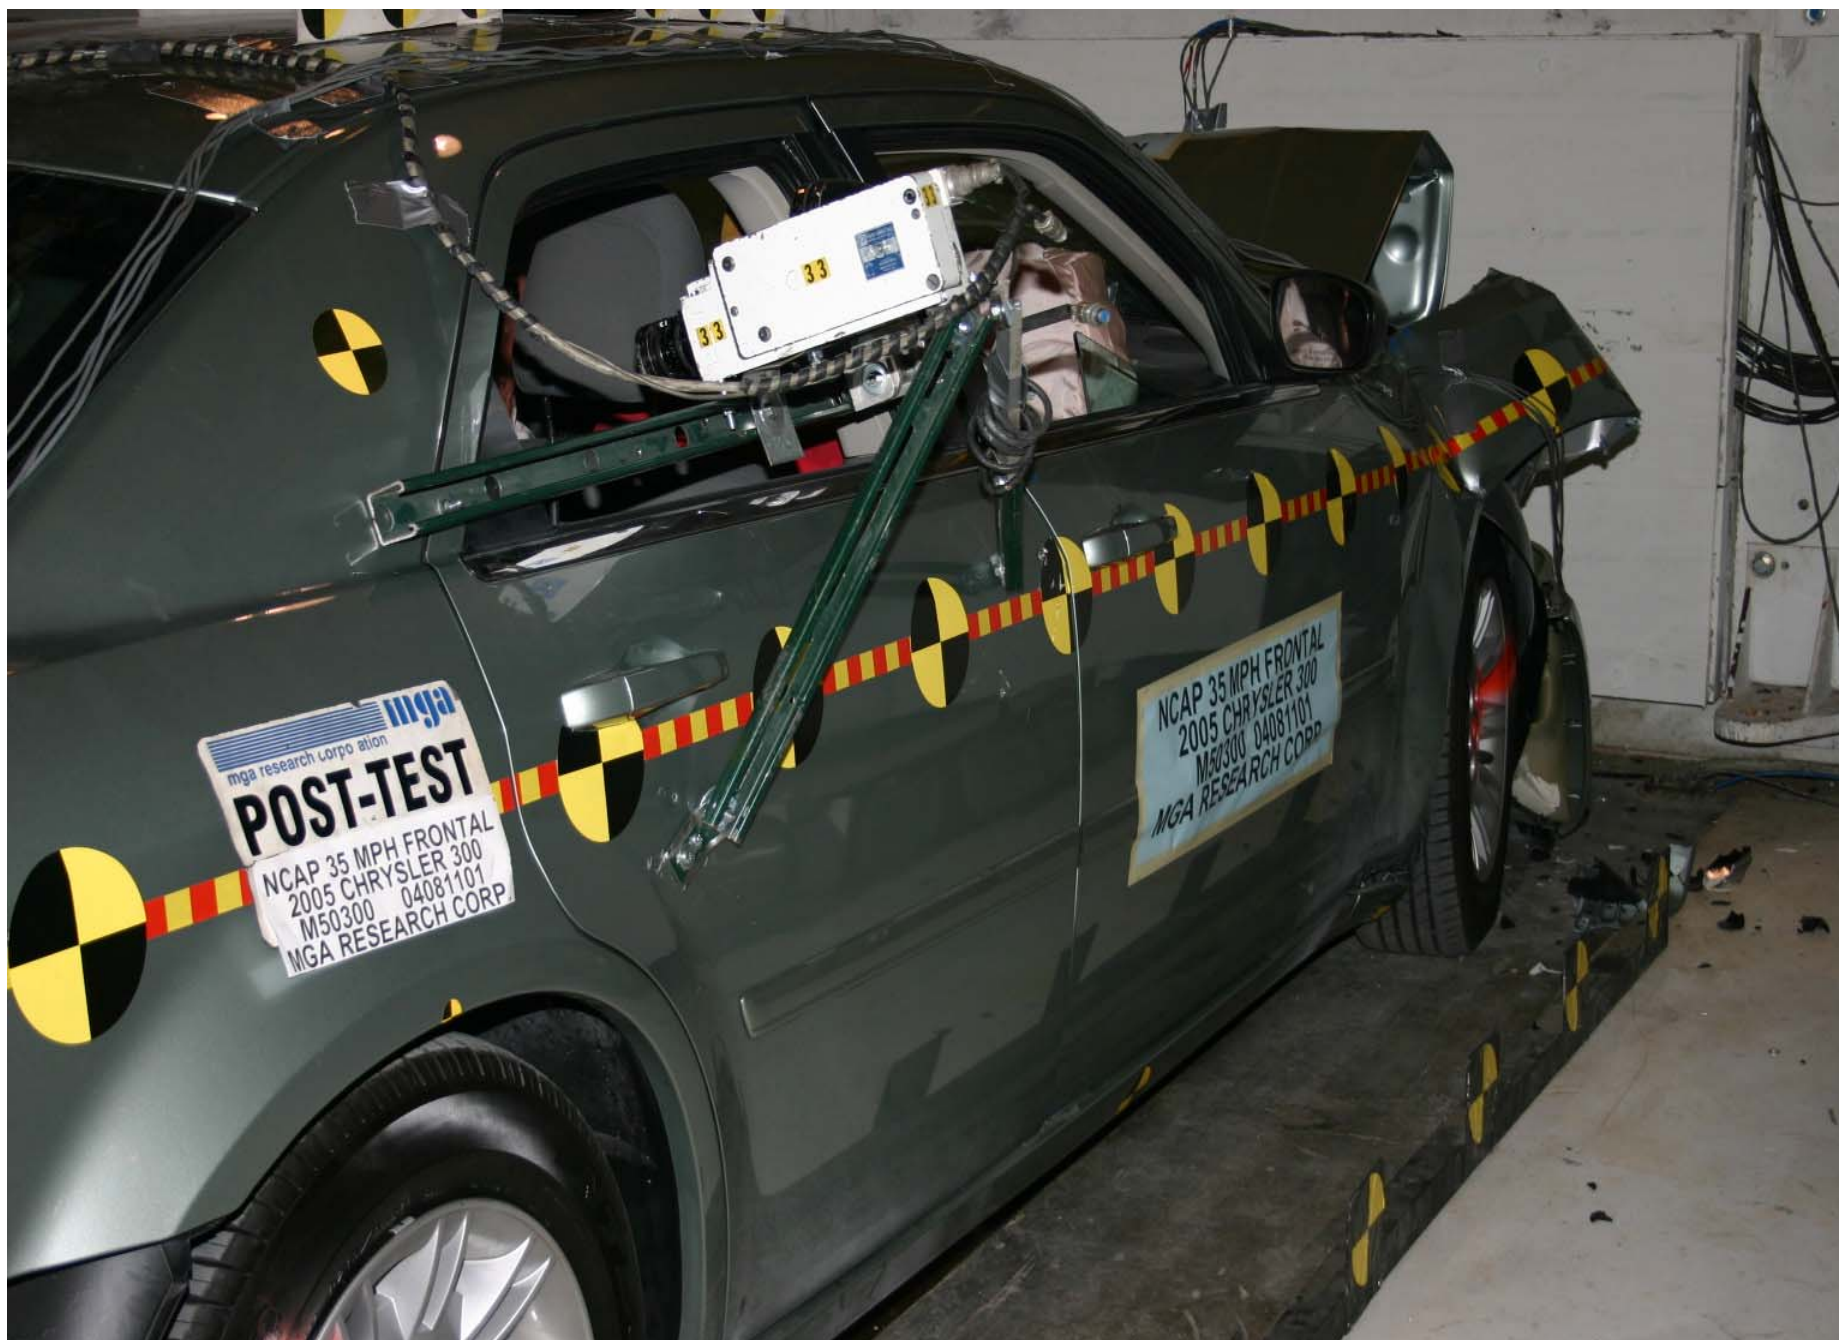
Post-Test Right Side Three-Quarter View of Doors After Impact

The maximum static crush of the vehicle was 679 mm and both the driver and passenger side doors remained closed and latched during the impact event and were operable after the impact.

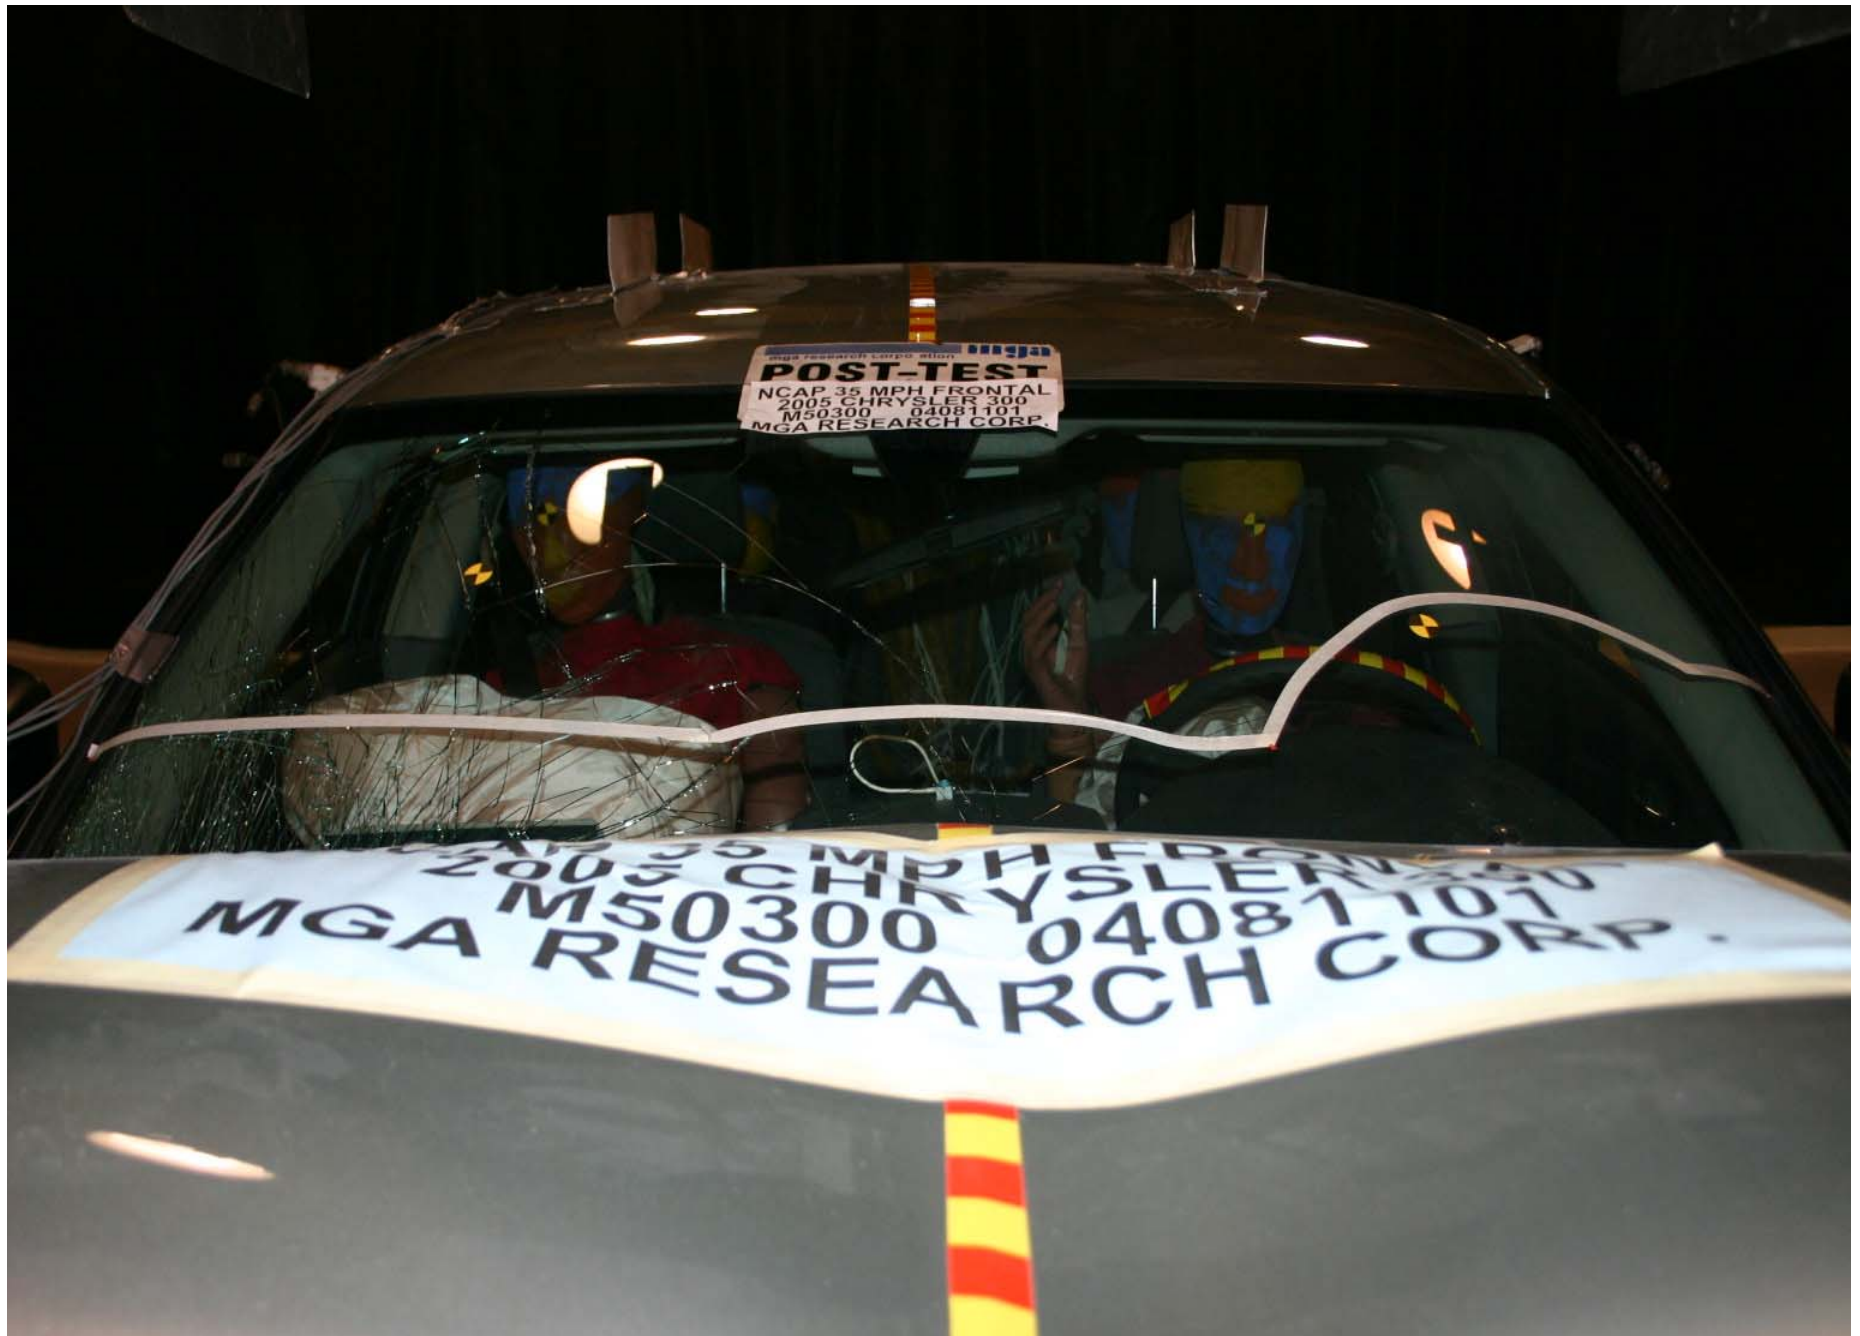
Post-Test Windshield View

There was 100 percent windshield retention and no intrusion into the protected zone of the windshield during the event. There was no Stoddard Solvent leakage after the event or during any phase of the static rollover.

| Description | Driver | Passenger |
|---|---|---|
| Glazing Damage | The windshield cracked. | |

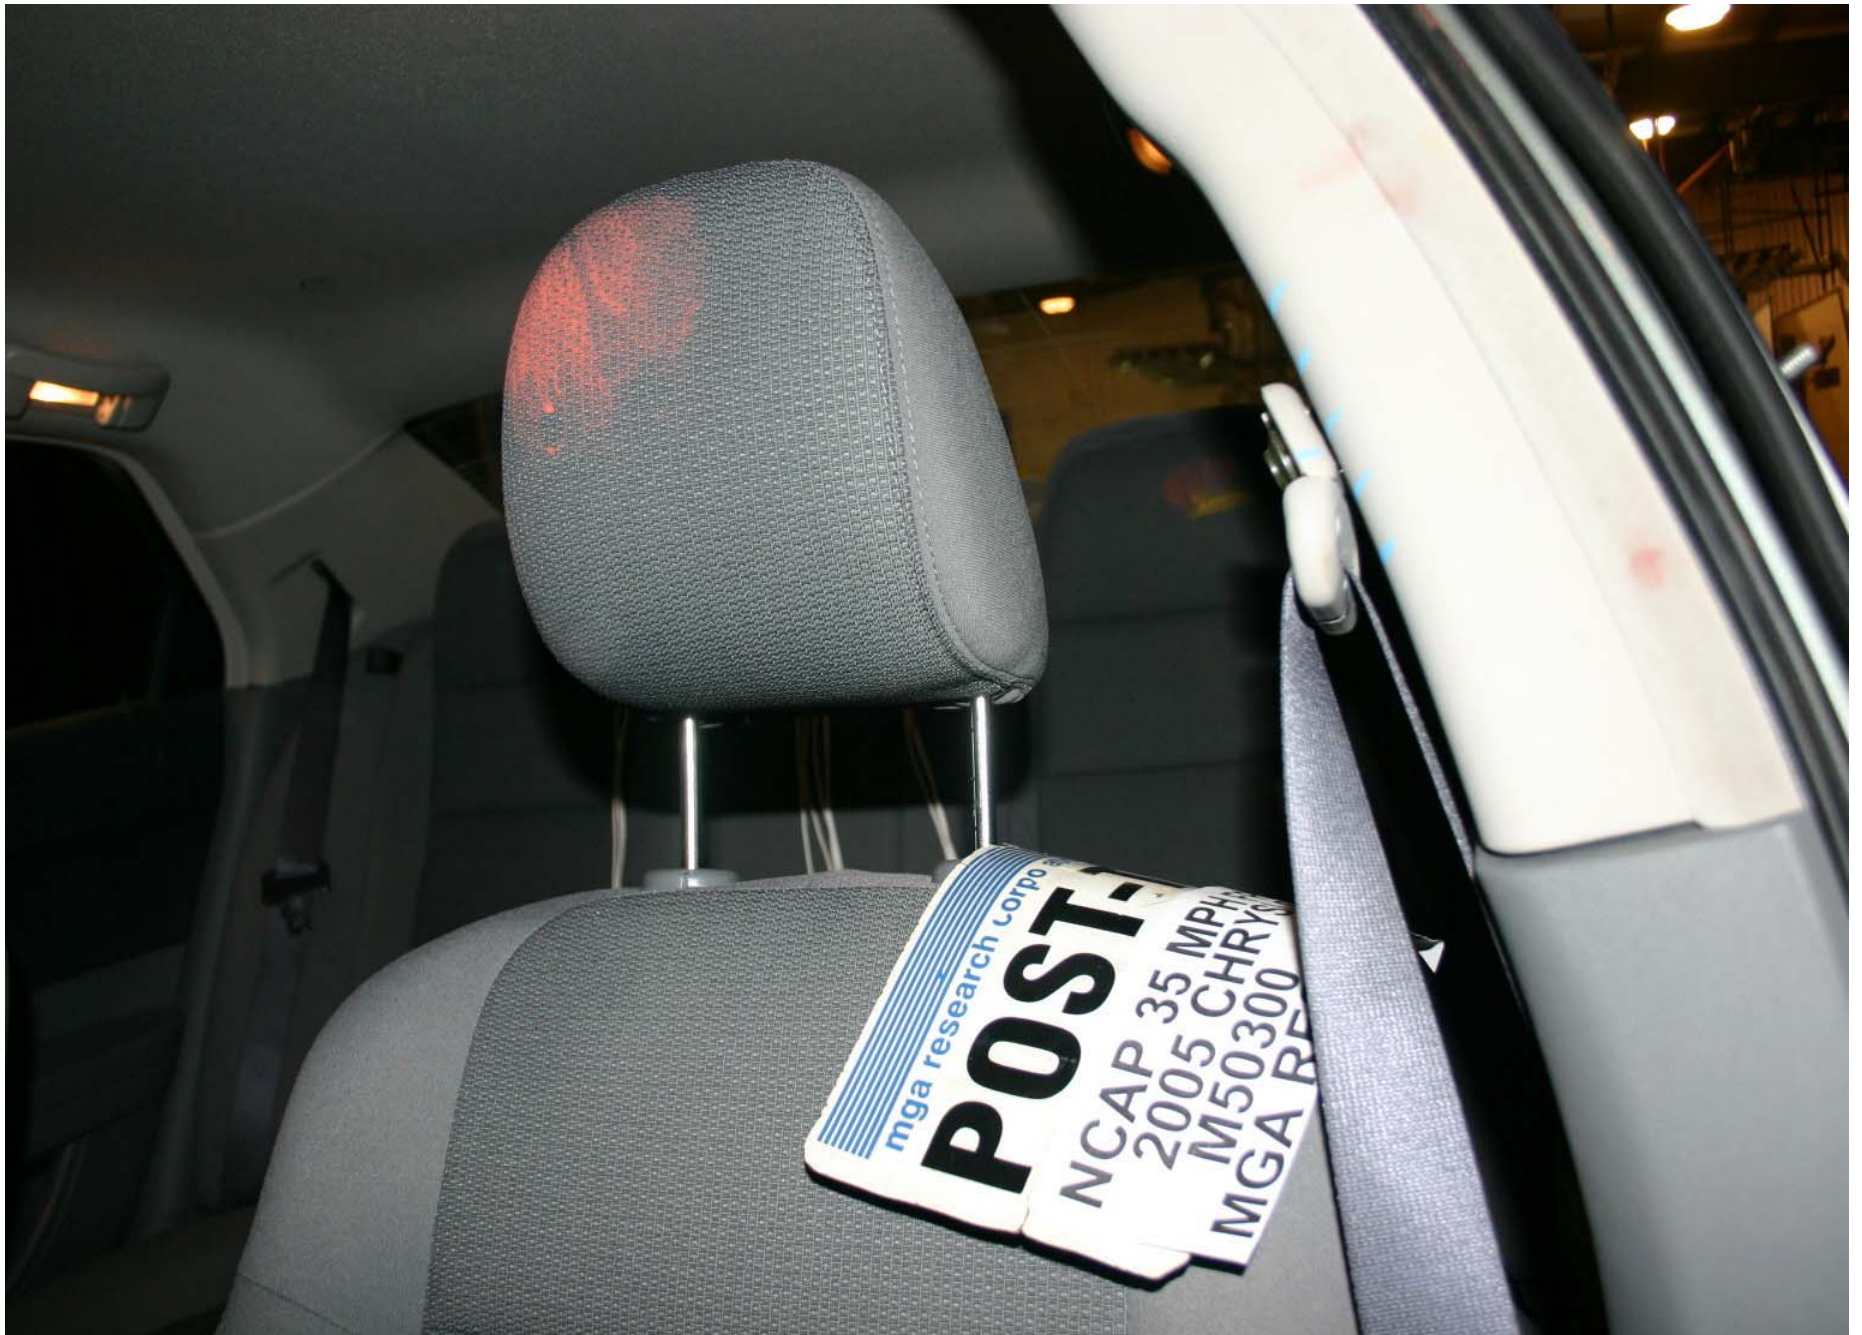
Post-Test Driver Dummy Head Contact

The driver's head, chest, and abdomen contacted the airbag. The driver's head also contacted the headrest. The driver's knees contacted the bolster. The passenger's head, chest and abdomen contacted the airbag. The passenger's head contacted the headrest. The passenger's knees contacted the glove box.

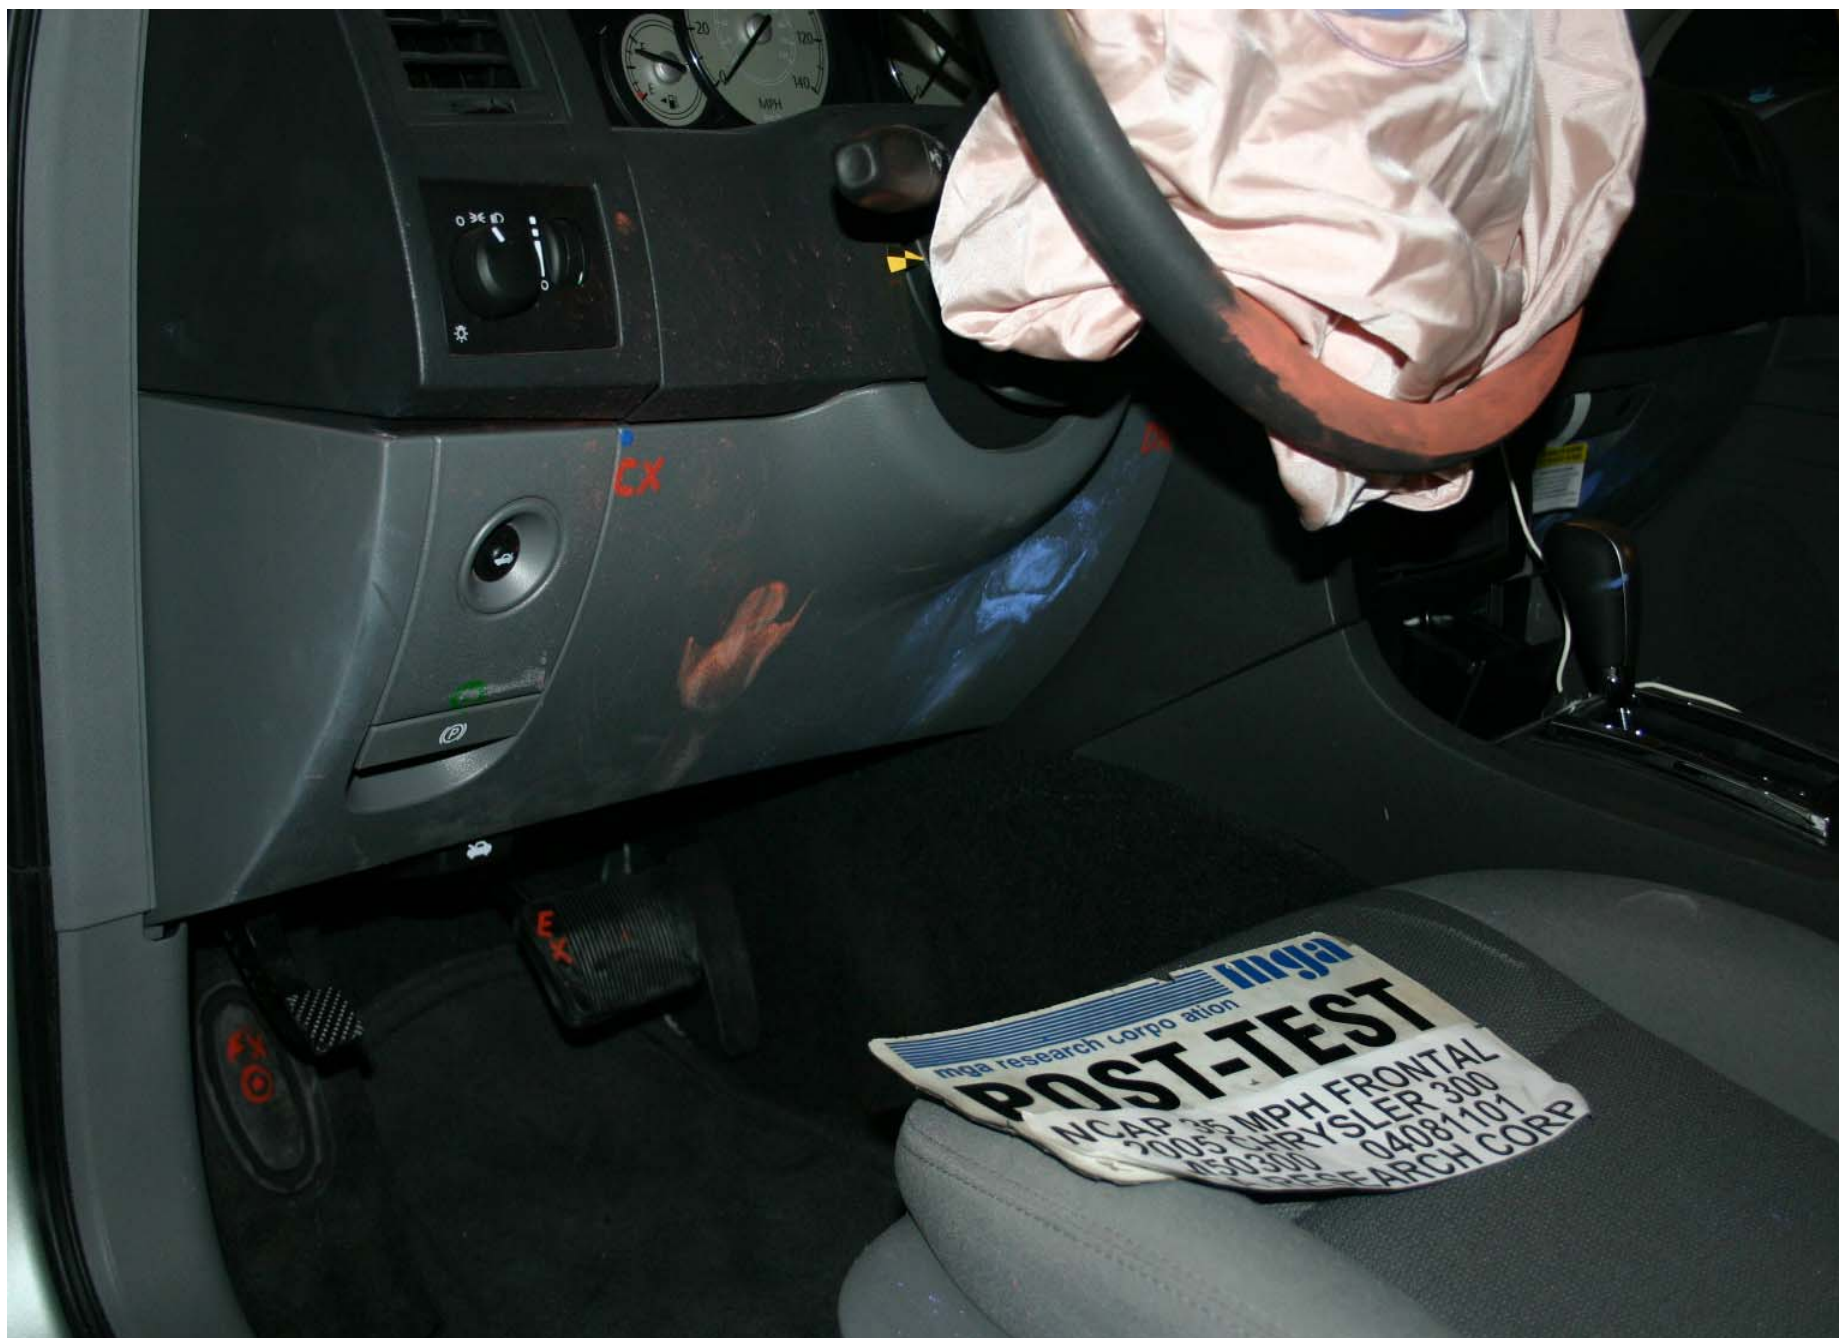
Post-Test Driver Dummy Knee Contact

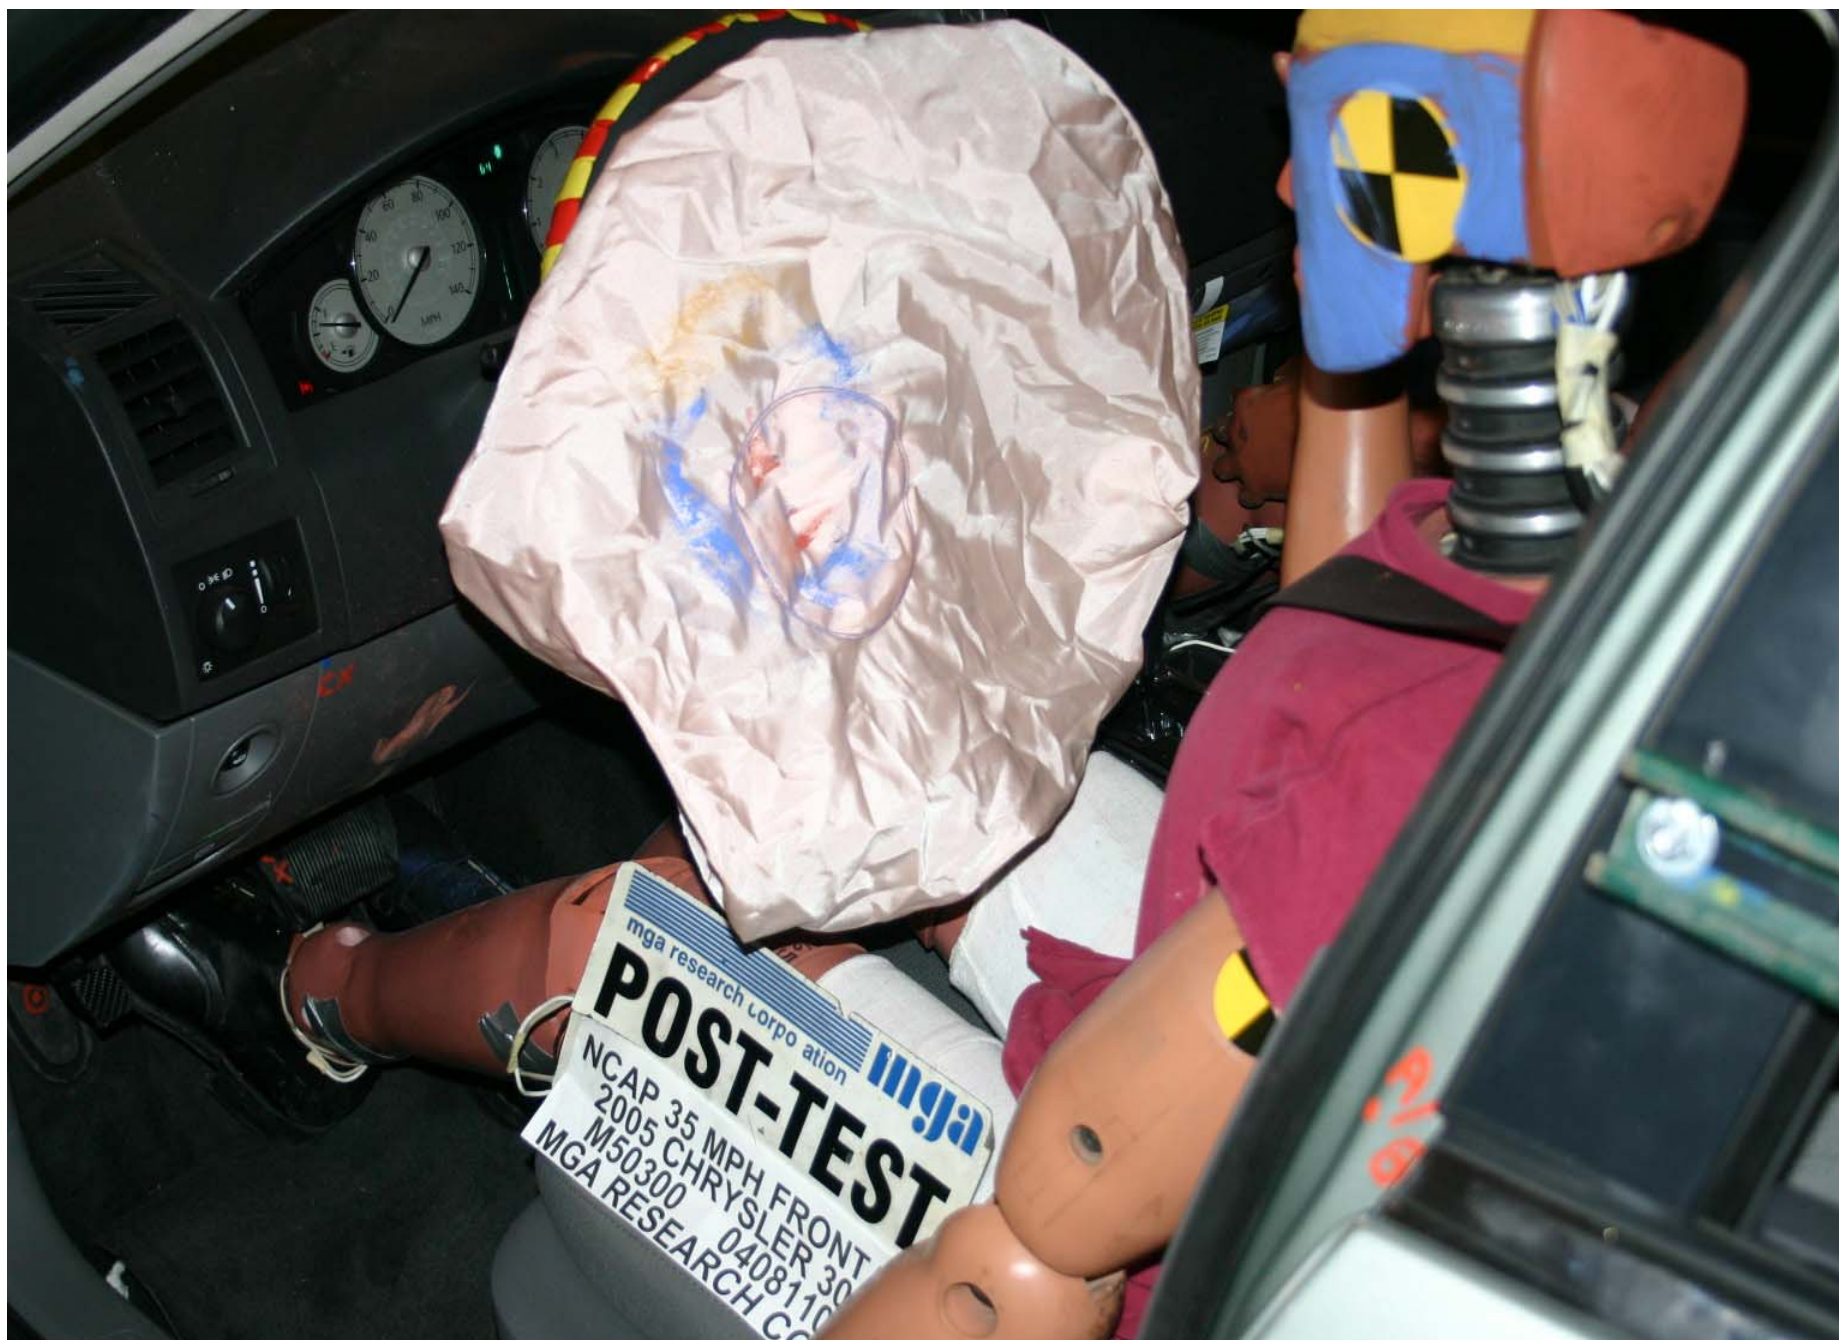
Post-Test Driver Dummy Airbag Contact

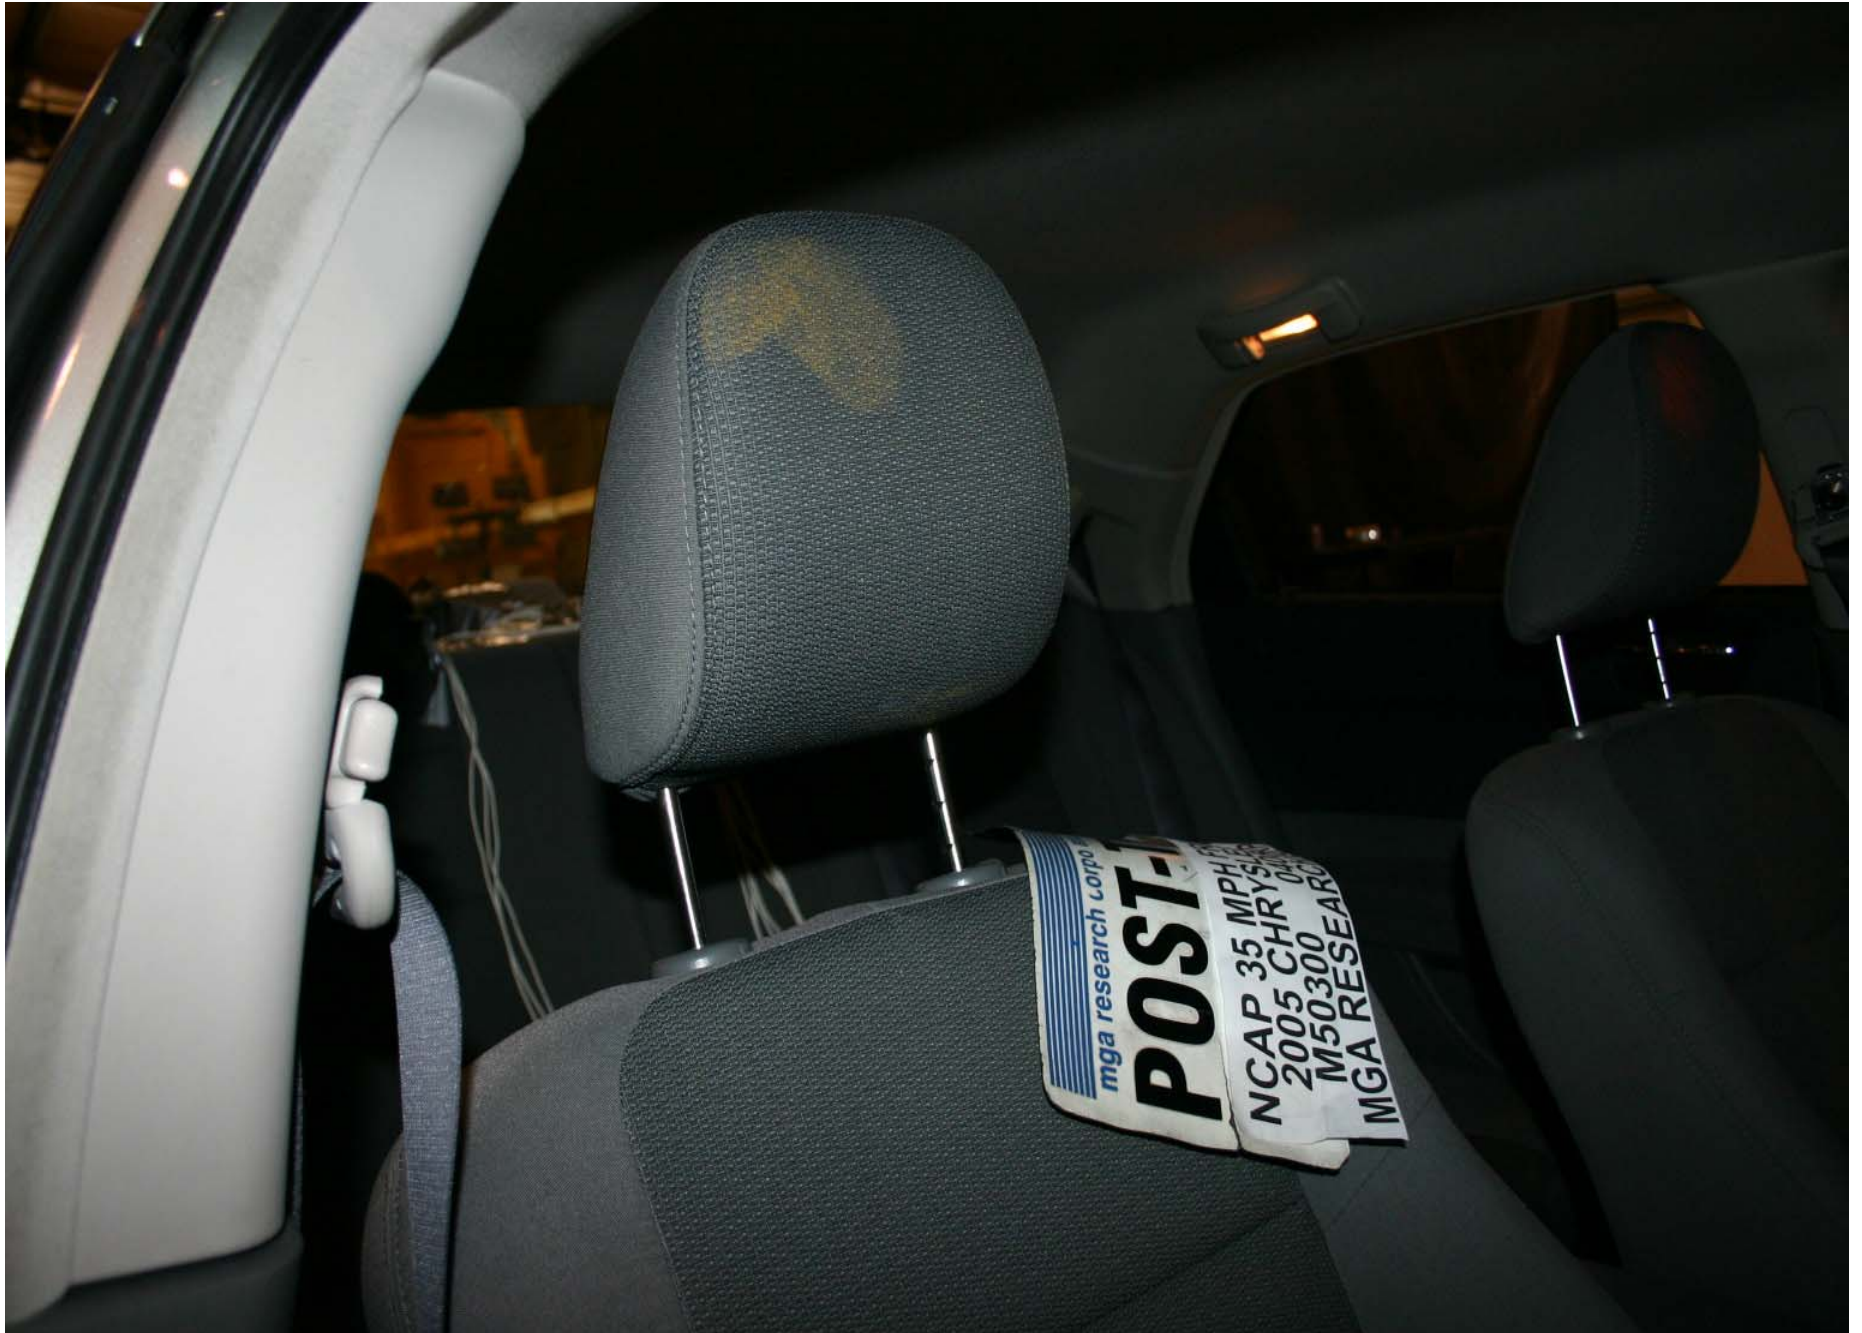
Post-Test Passenger Dummy Head Contact

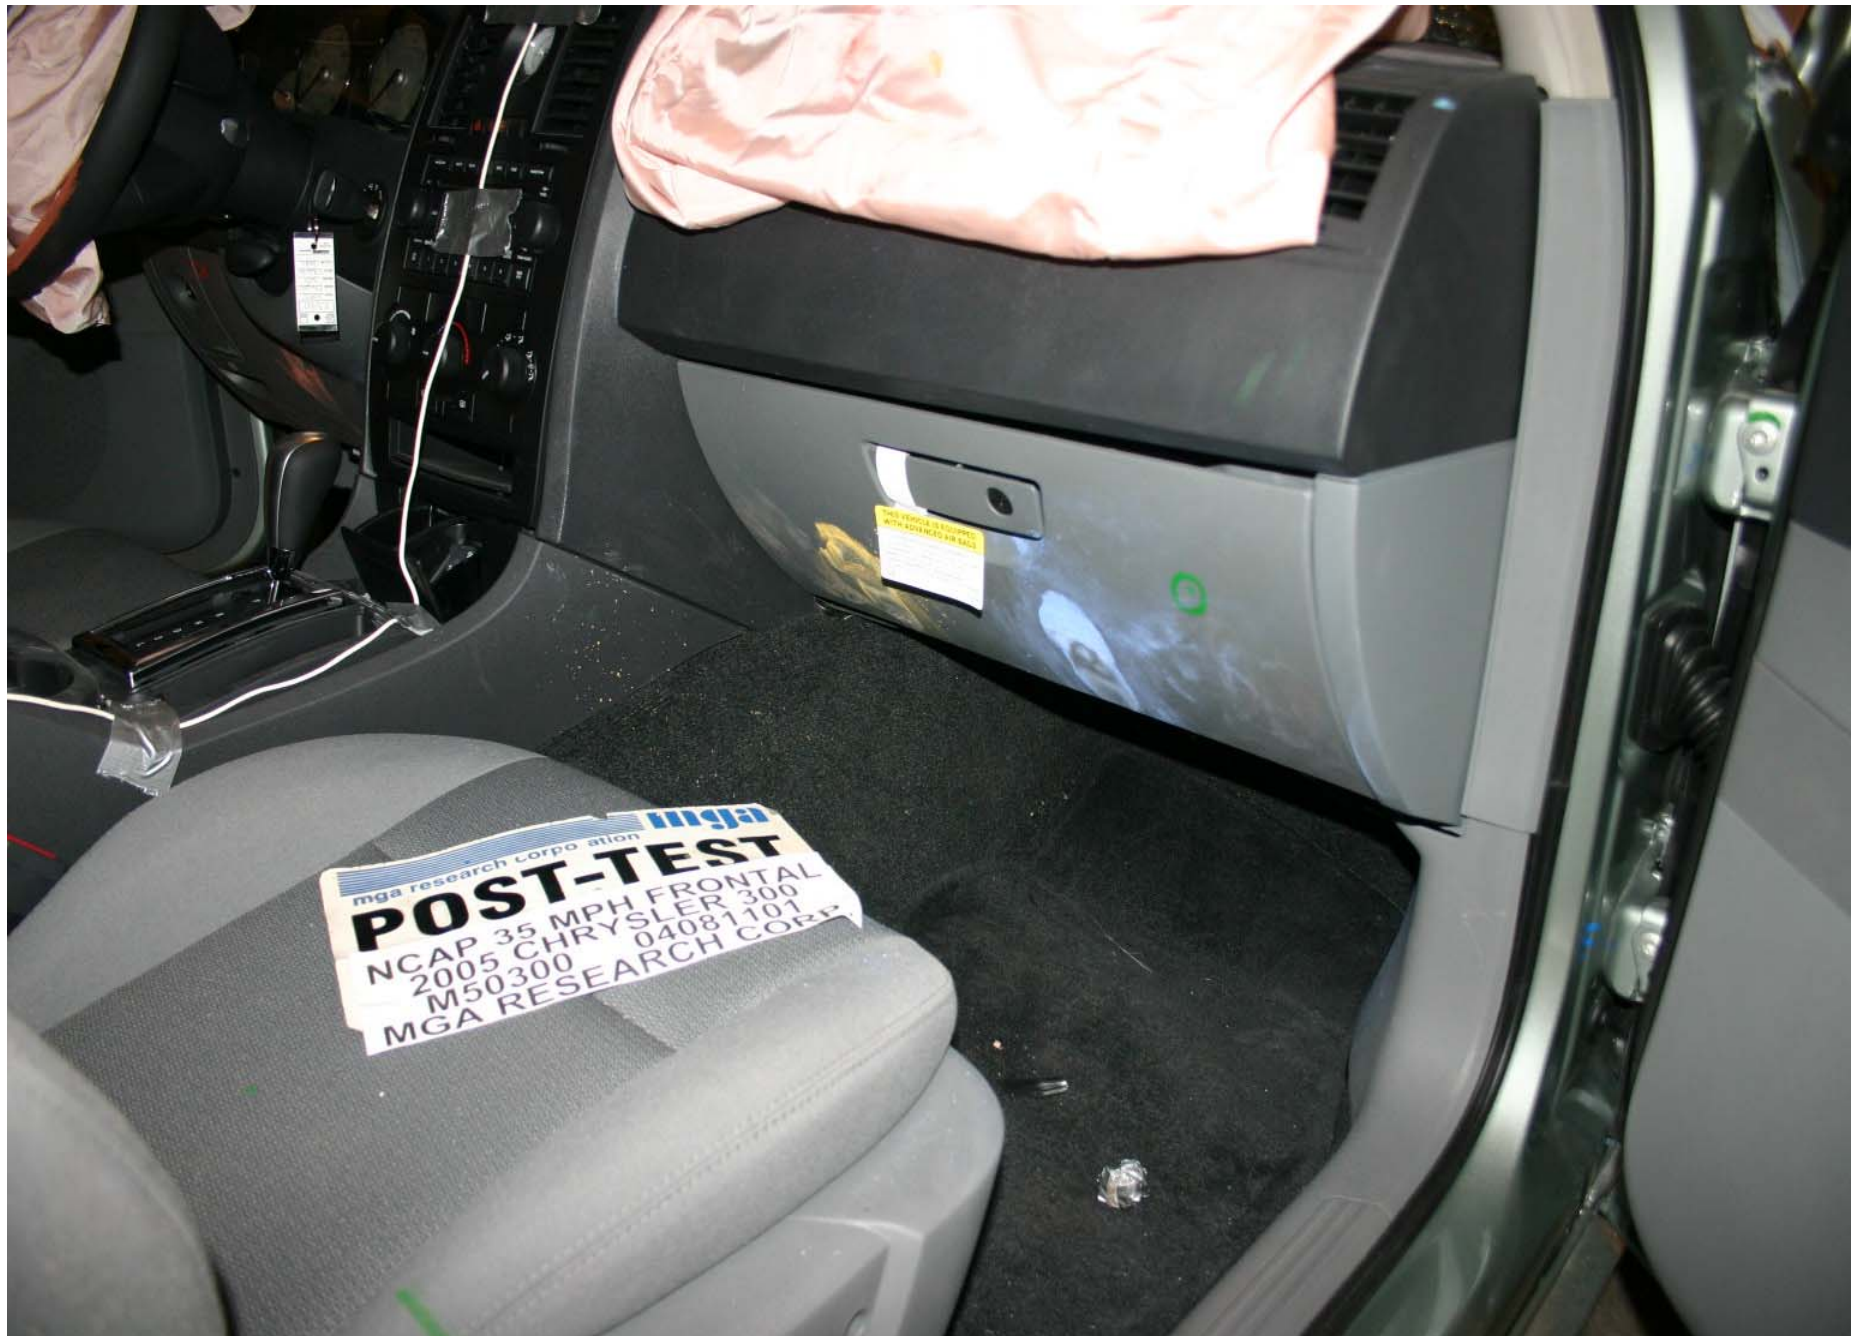
Post-Test Passenger Dummy Knee Contact

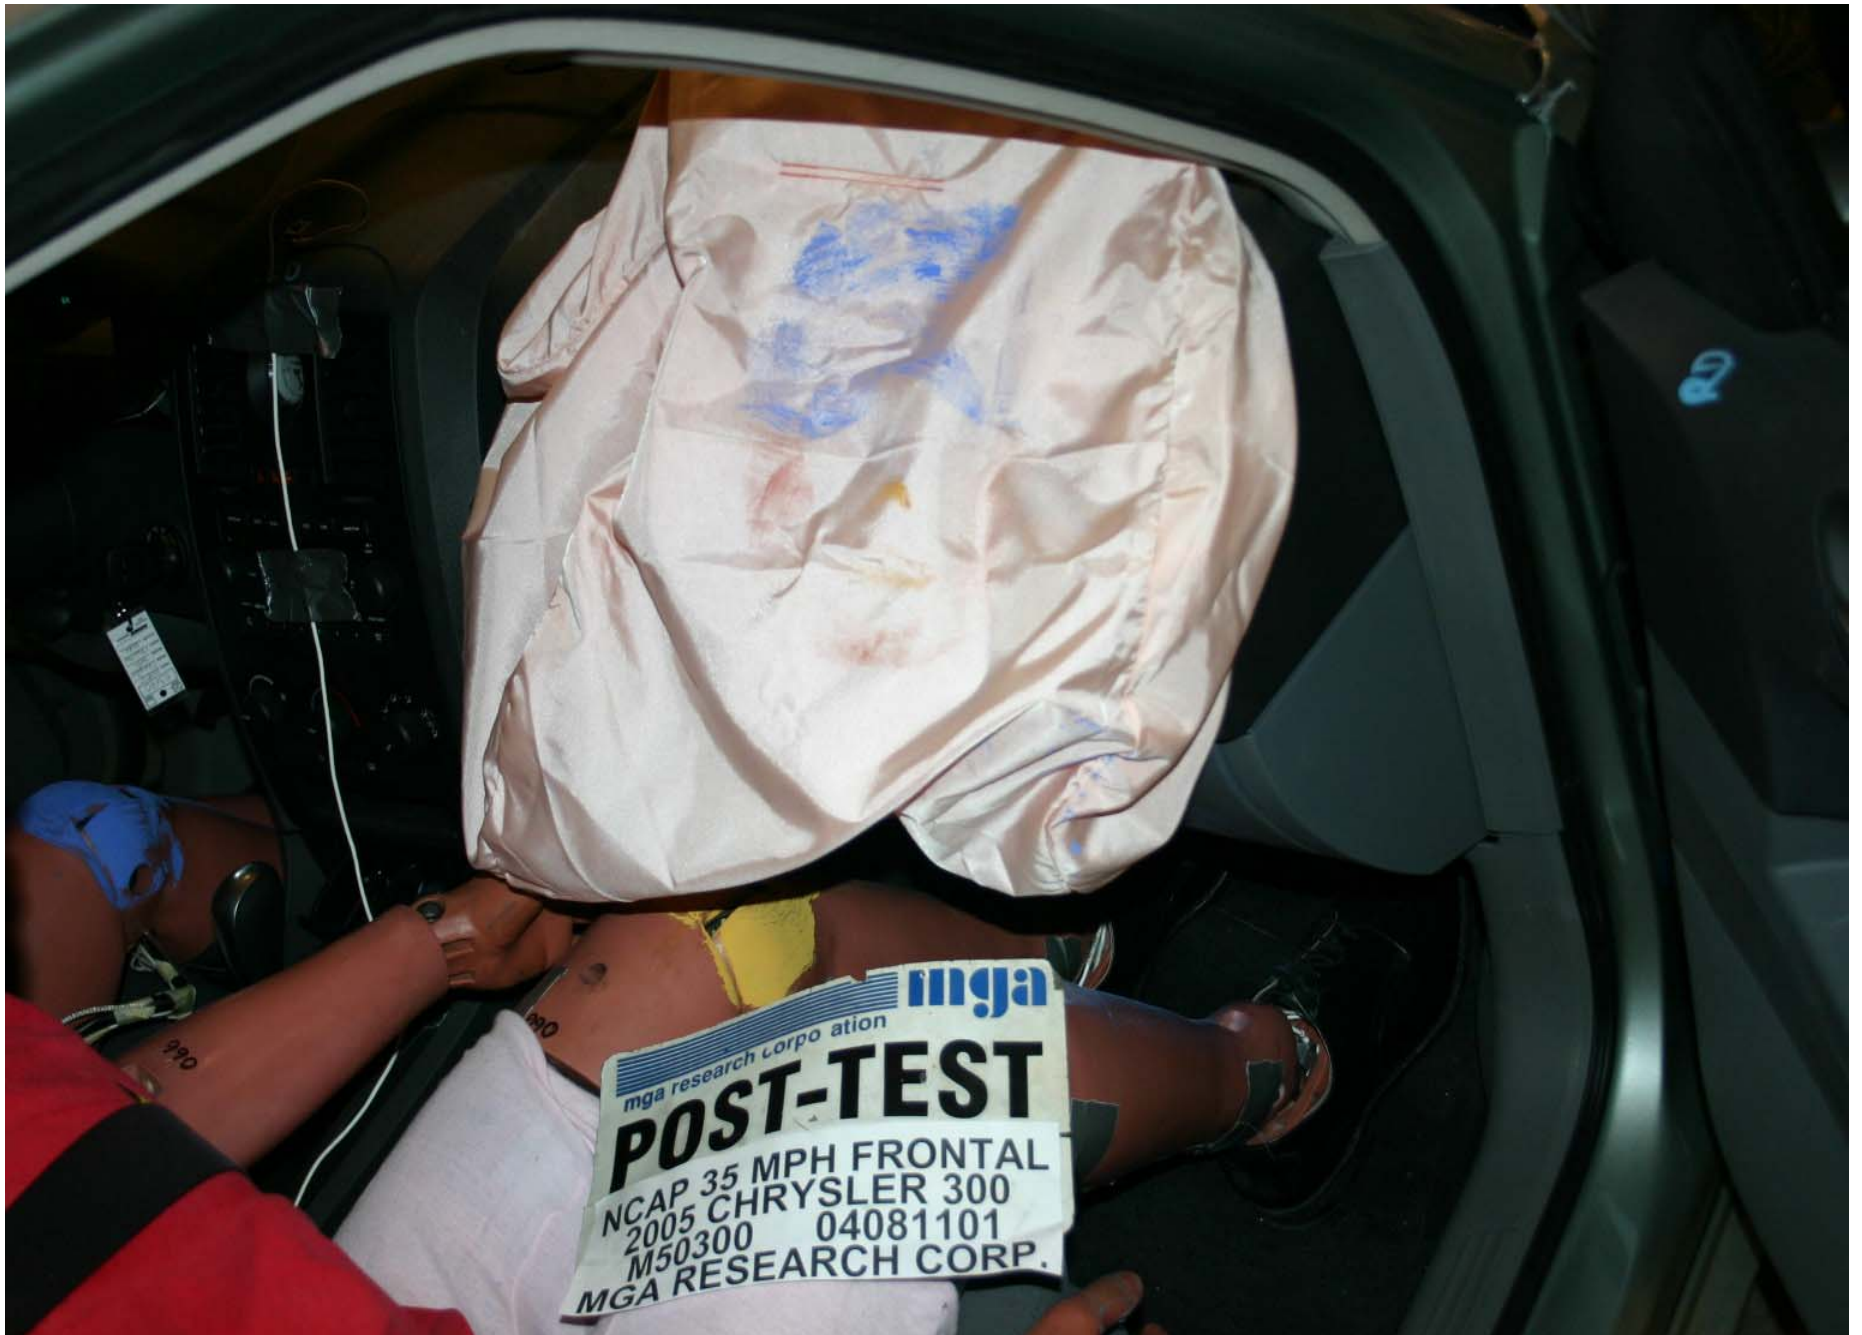
Post-Test Passenger Dummy Airbag Contact

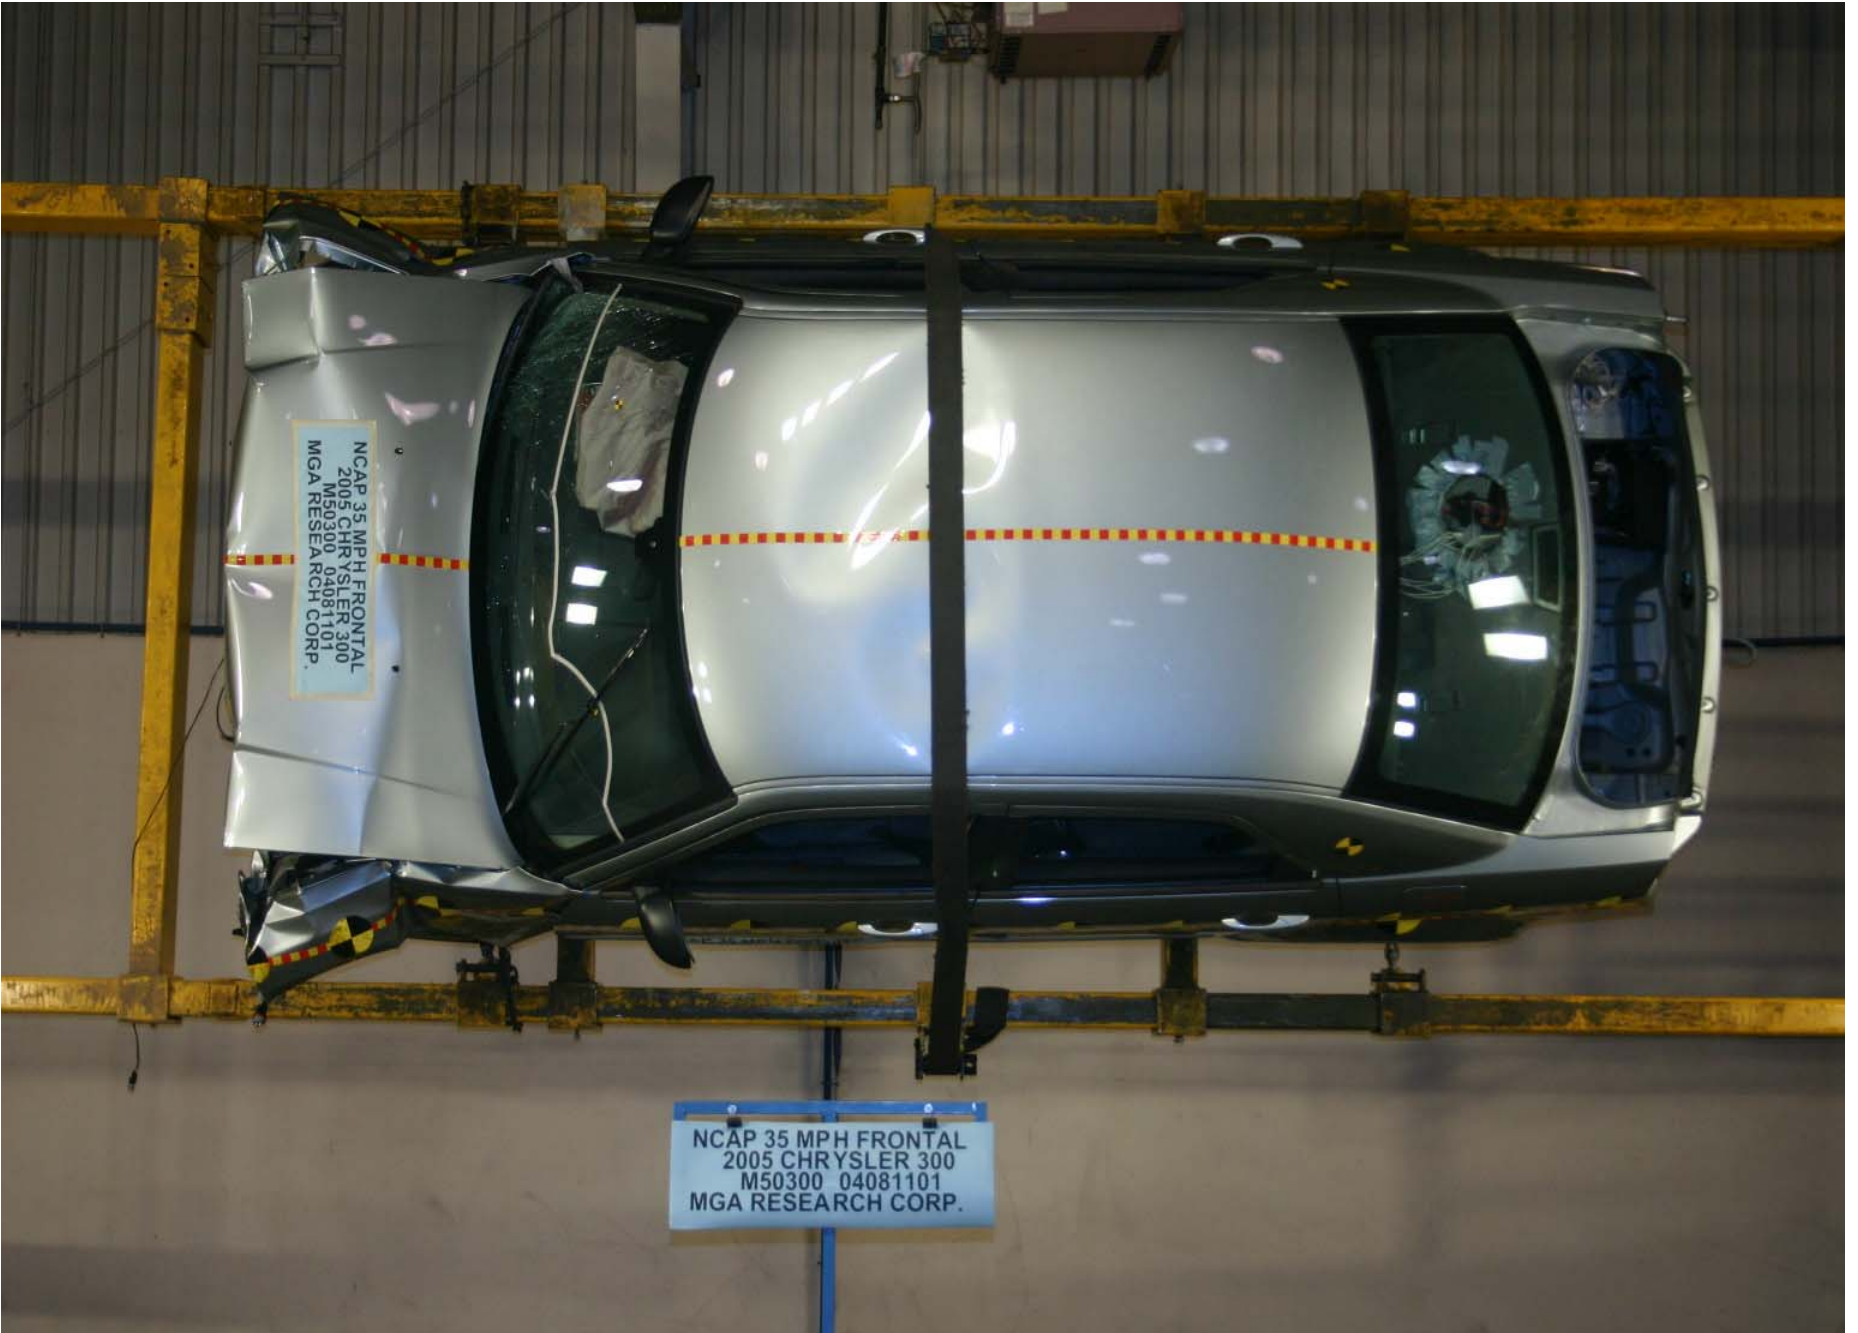
Rollover 90 Degrees
