**REPORT NUMBER: NCAP-MGA-2005-001**

**NEW CAR ASSESSMENT PROGRAM  
FRONTAL BARRIER IMPACT TEST**

**Daimler Chrysler Corporation  
2005 Chrysler 300  
NHTSA NUMBER: M50300**

**PREPARED BY:  
MGA RESEARCH CORPORATION  
5000 WARREN ROAD  
BURLINGTON, WI 53105**

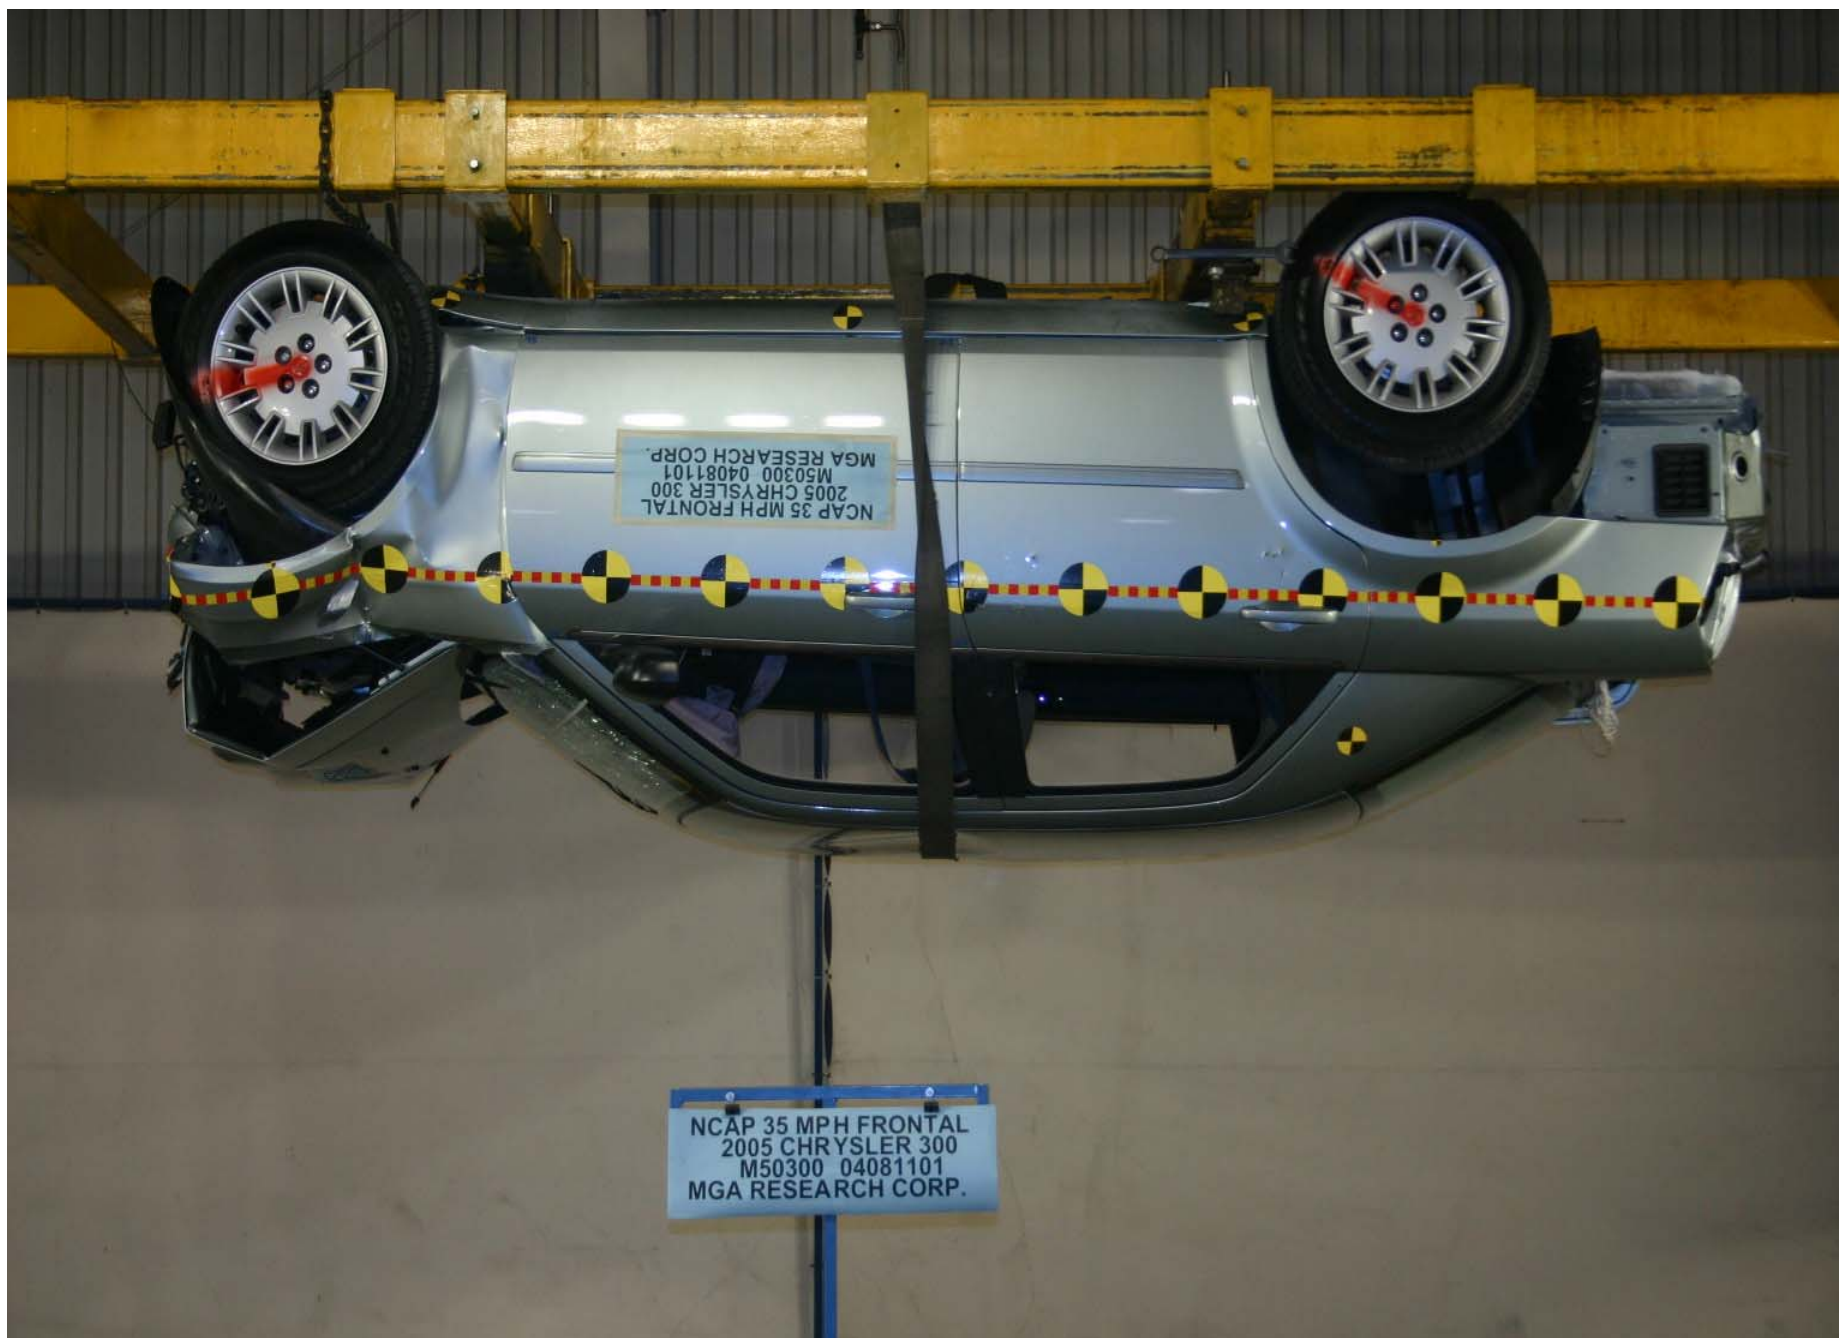
Rollover 180 Degrees

There was 100 percent windshield retention and no intrusion into the protected zone of the windshield during the event. There was no Stoddard Solvent leakage after the event or during any phase of the static rollover.

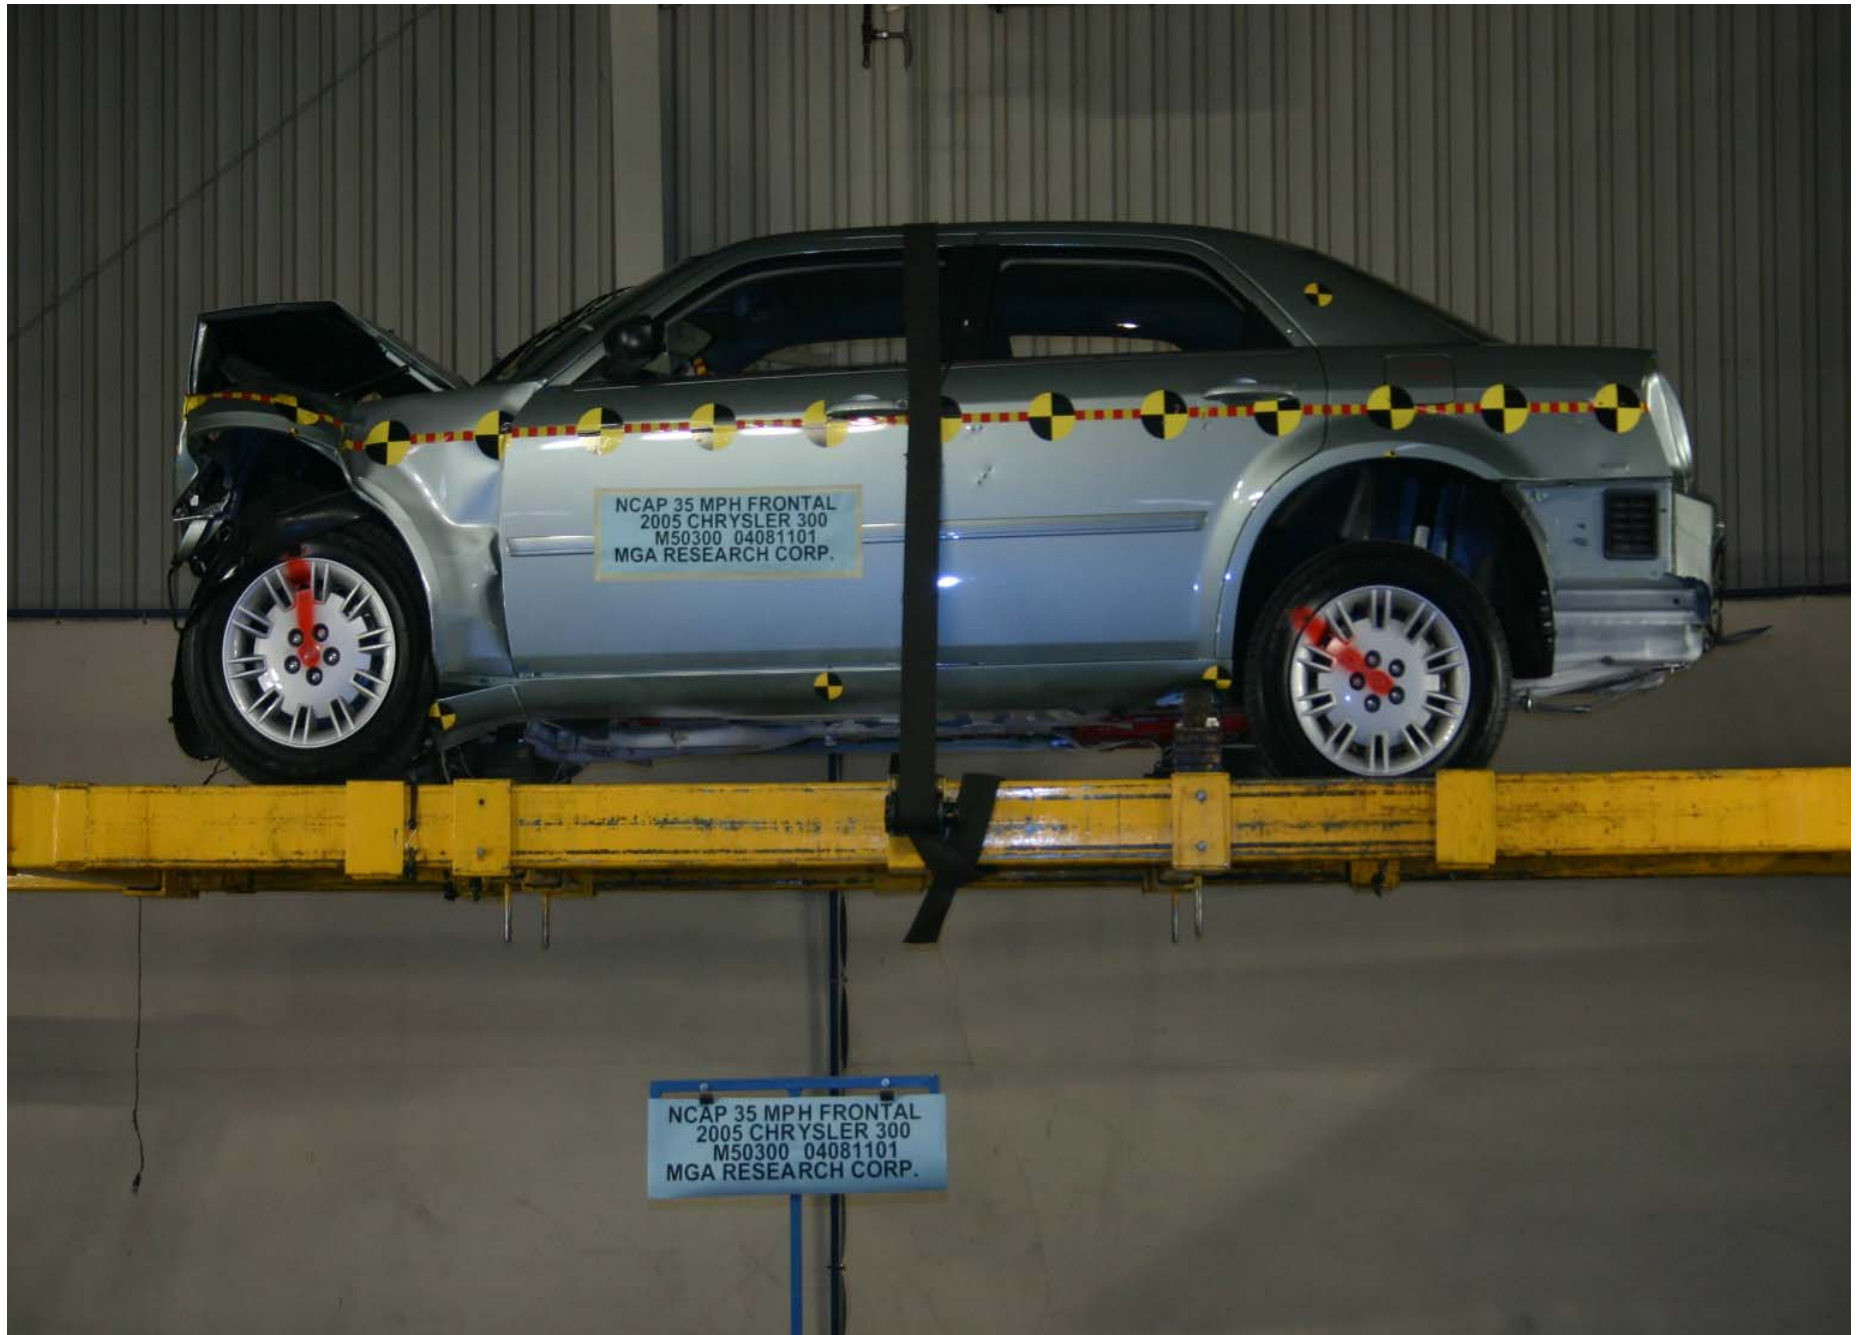
Rollover 360 Degrees

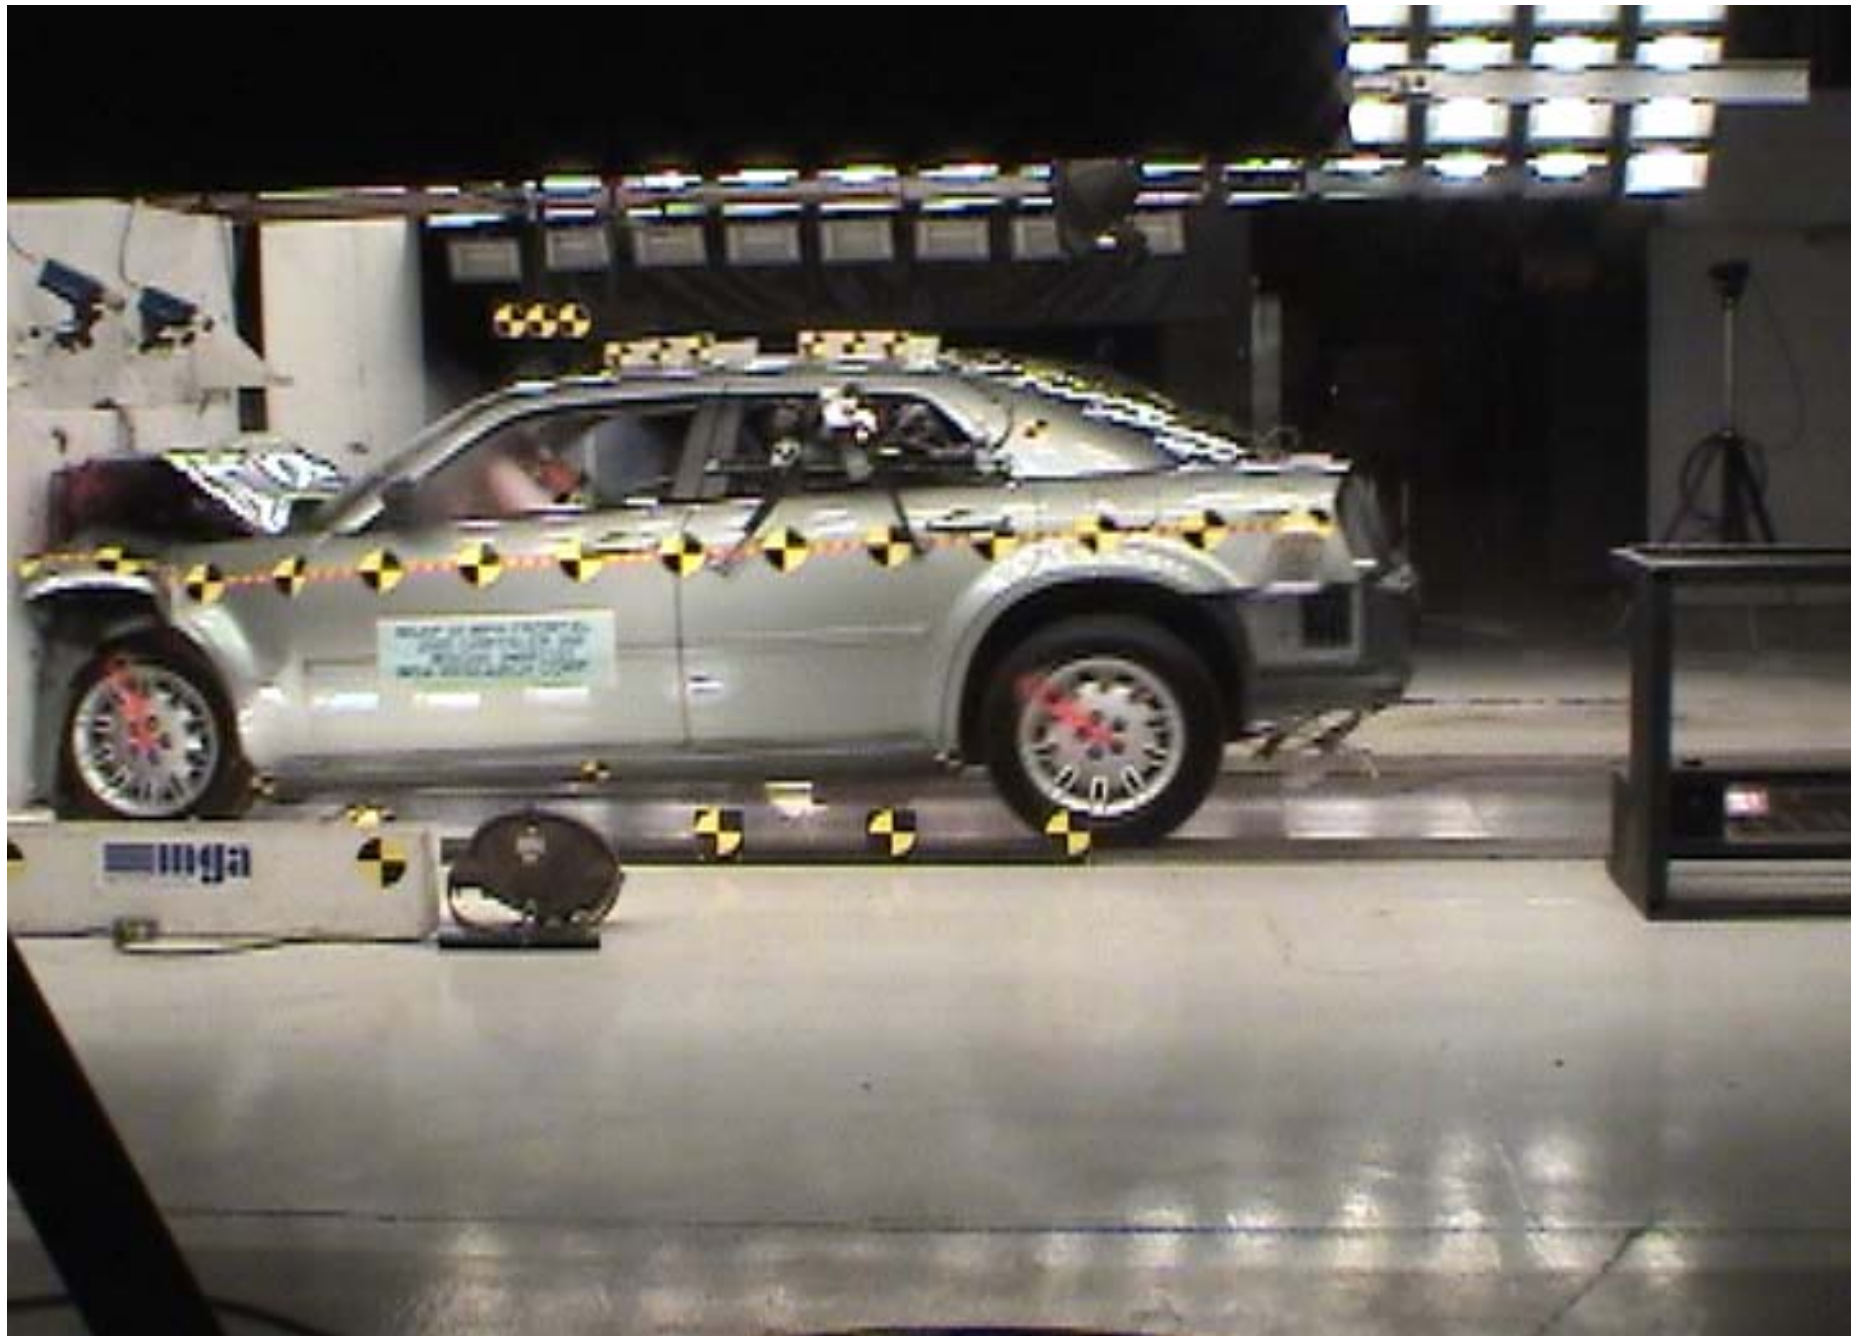
Vehicle Impact

A load cell barrier consisting of 30 load cells was impacted by a 2005 Chrysler 300 at a velocity of 56.5 kph. The test was performed at MGA Research Corporation on August 11, 2004. Pre-and post-test photographs of the vehicle and dummies can be found in Appendix A.
