REPORT NUMBER: NCAPSIDE-MGA-2005-001

**NEW CAR ASSESSMENT PROGRAM
SIDE IMPACT TEST**

**Toyota Motor Corporation
2005 Toyota Corolla
NHTSA NUMBER: M55109**

**PREPARED BY:
MGA RESEARCH CORPORATION
5000 WARREN ROAD
BURLINGTON, WI 53105**

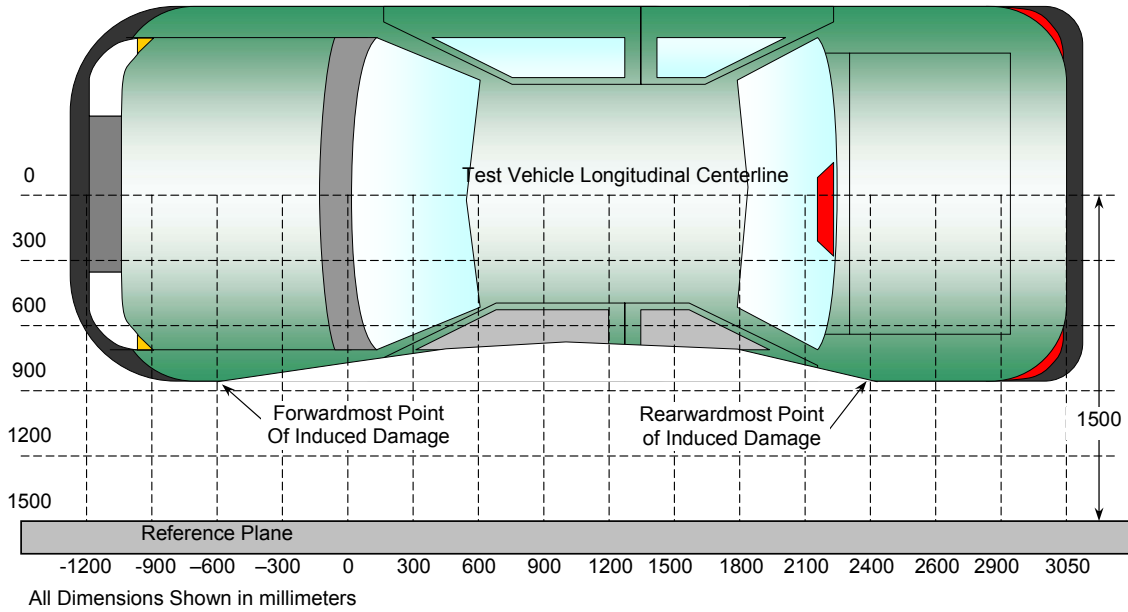
DATA SHEET NO. 13
VEHICLE DAMAGE PROFILE DISTANCES

TOP VIEW

DAMAGE PROFILE DISTANCES

The test vehicle sustained a maximum static crush of 318 mm at level 2, 1200 mm rearward of the left vertical impact point. The driver and passenger SID/HIII's, Serial Nos. 271 and 904 respectively, were calibrated just prior to this test. The SID/HIII's injury criteria are summarized as follows:

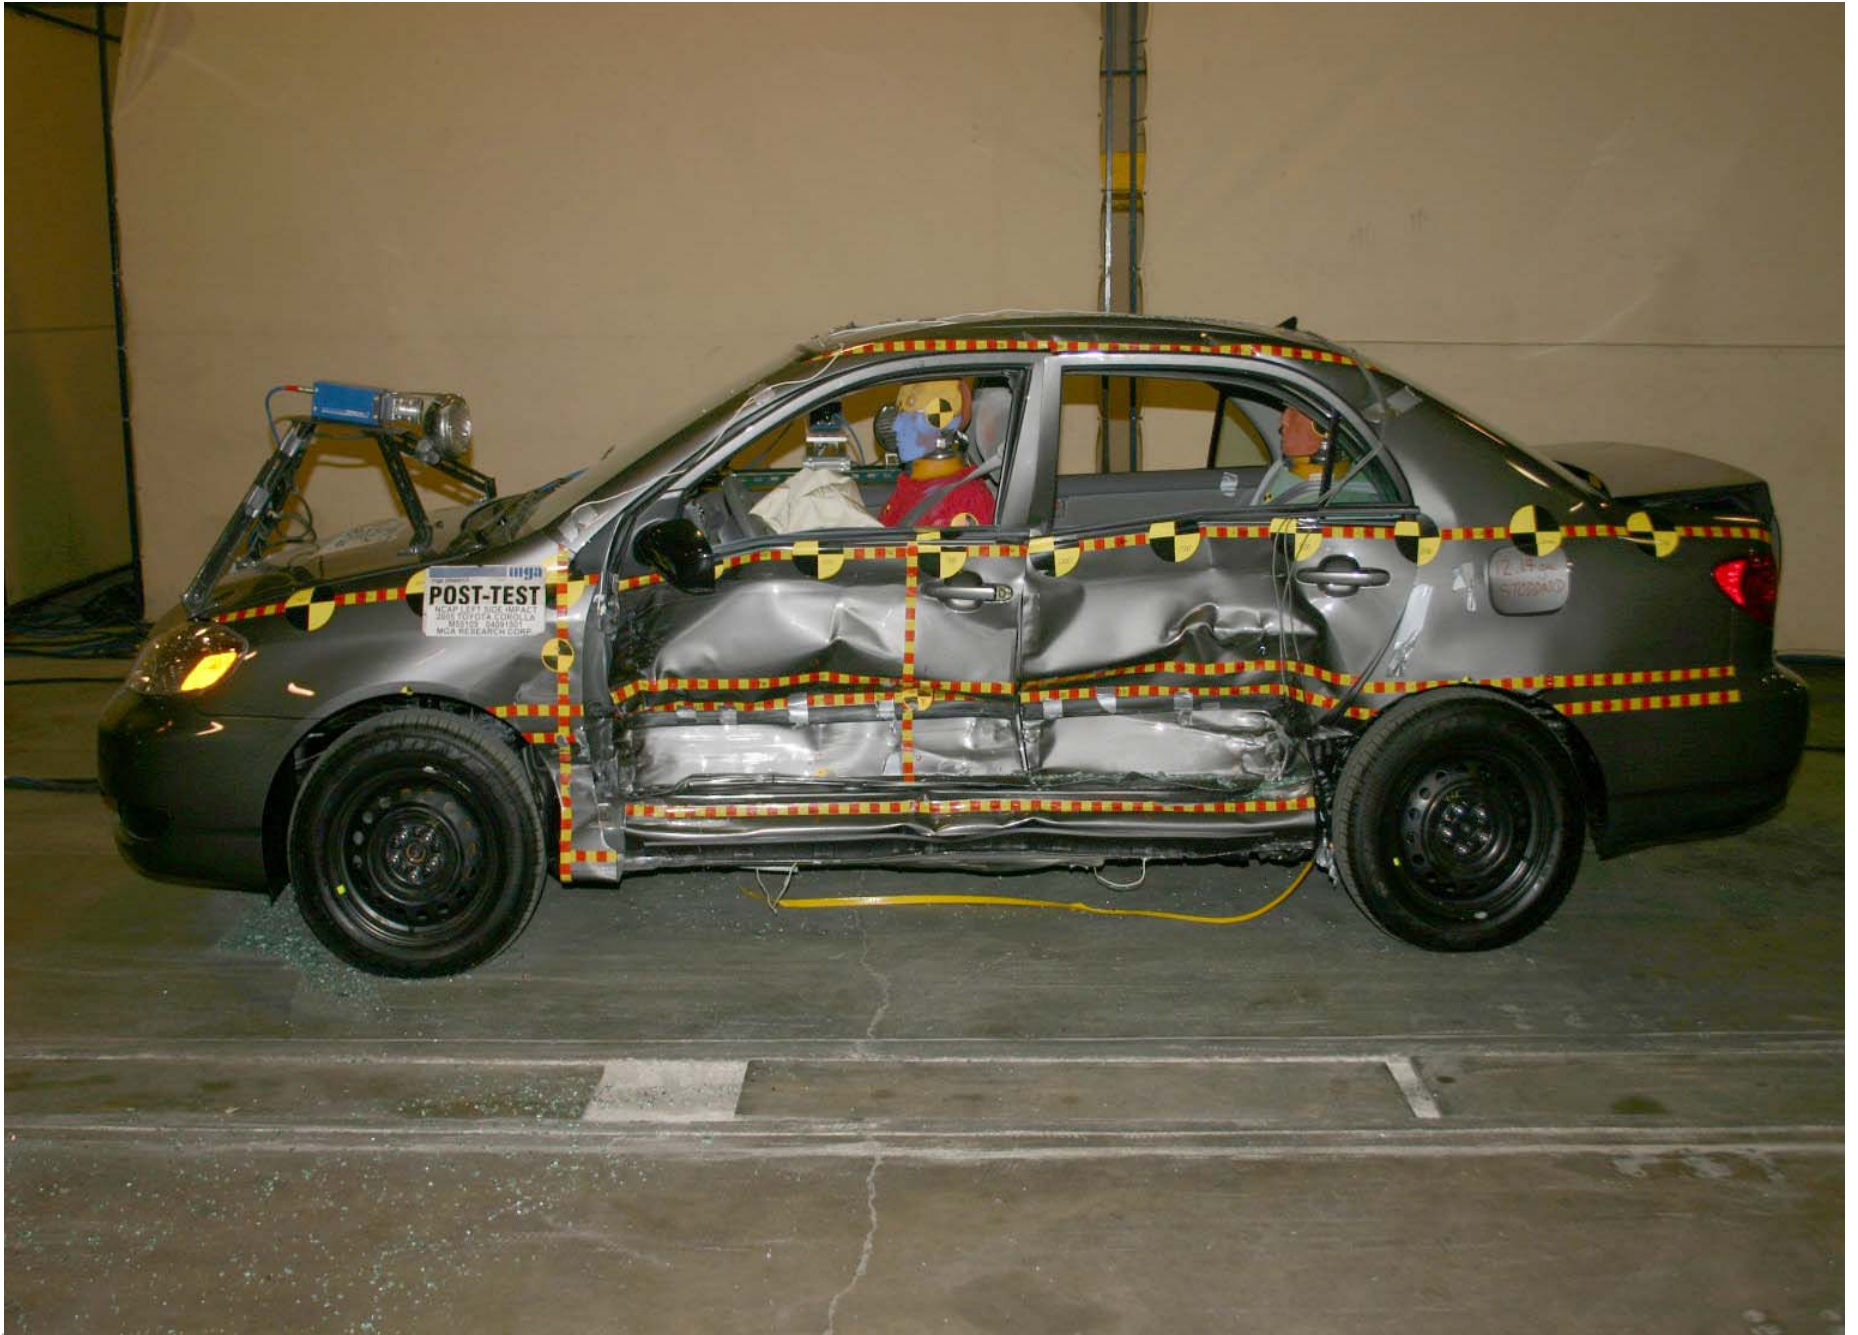
Post-Test Left Side View of Test Vehicle

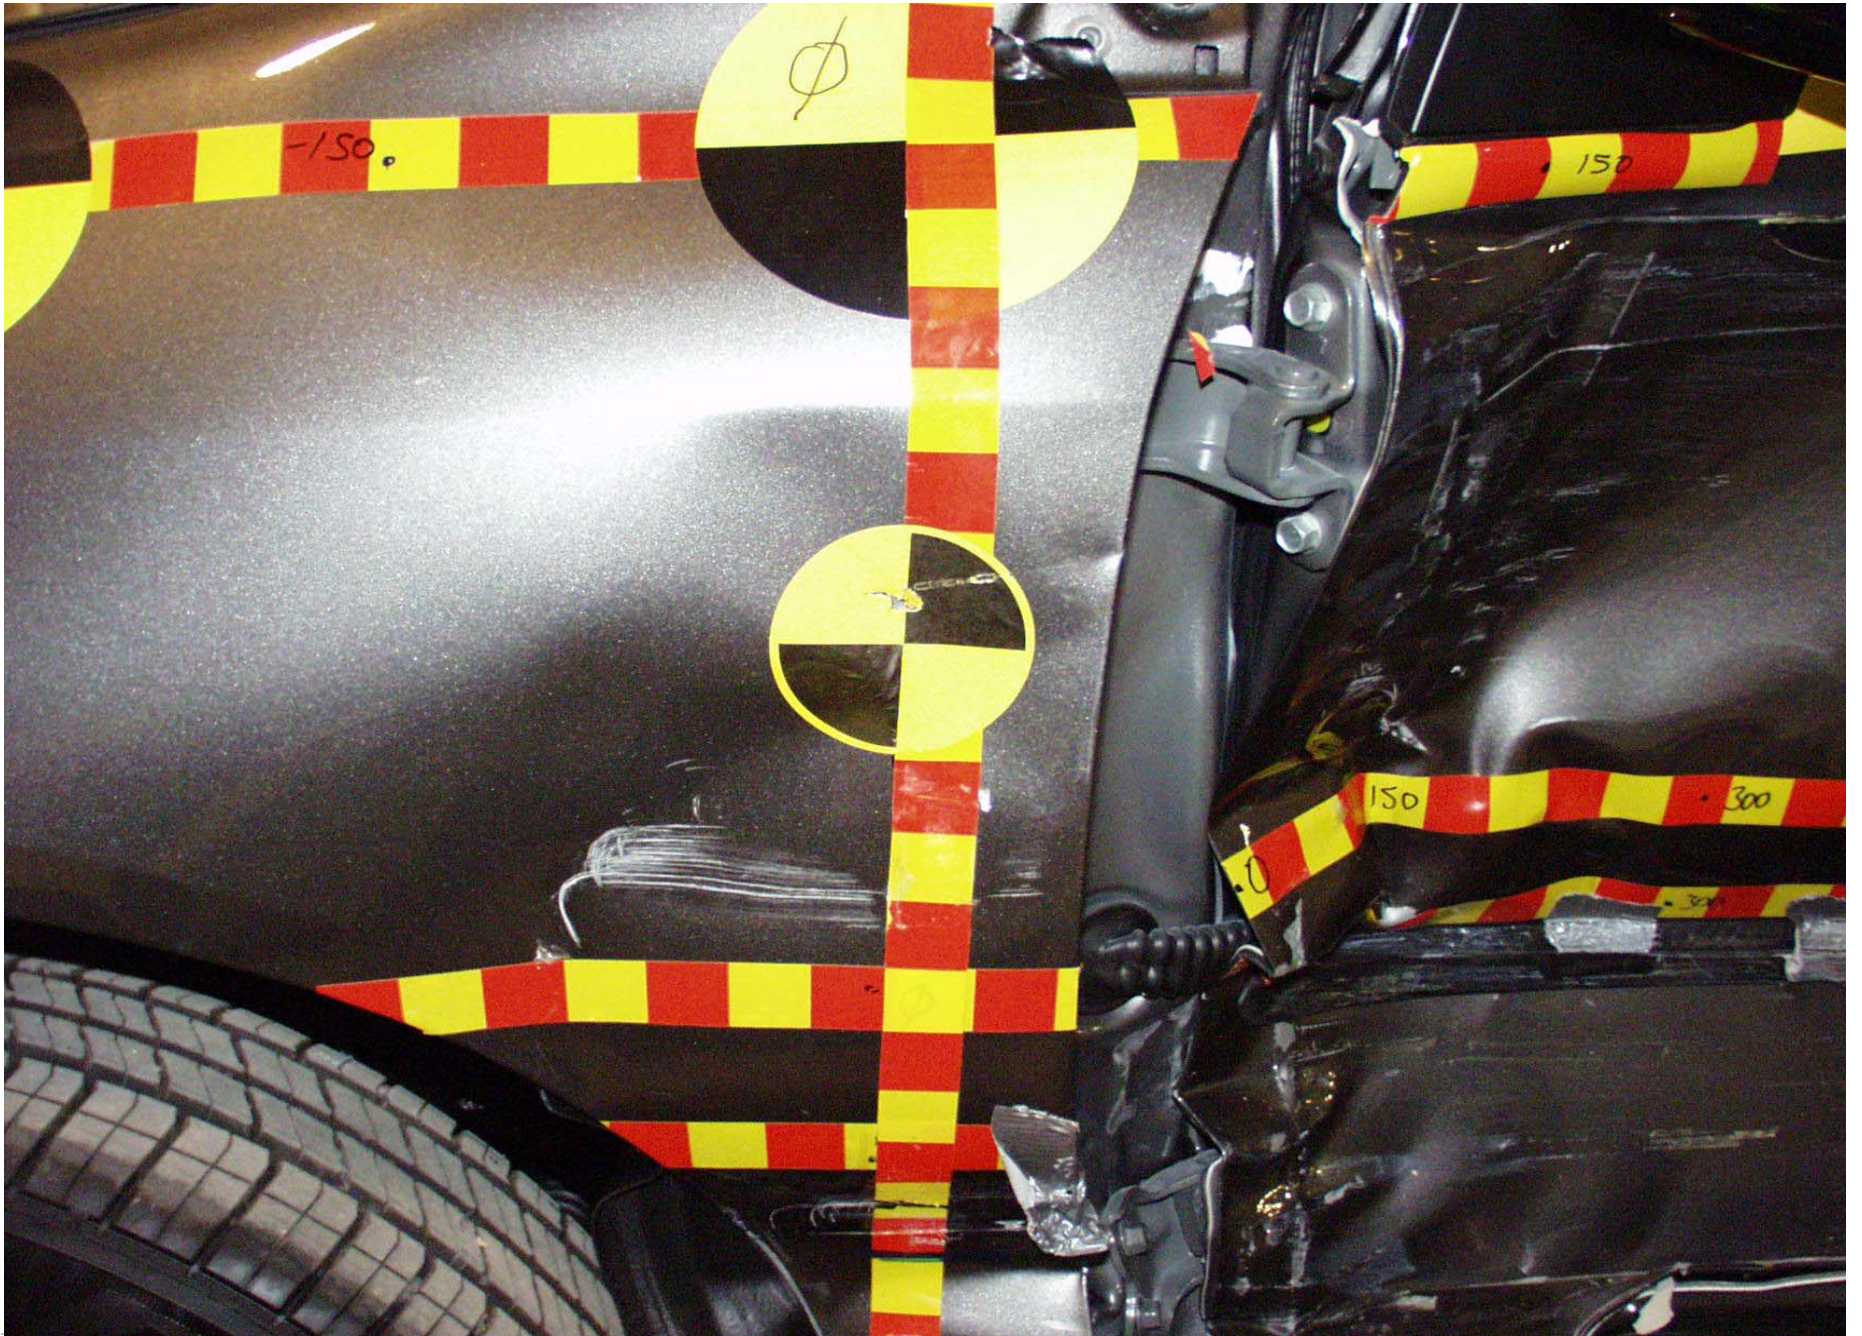
Post-Test Impact Point on Vehicle

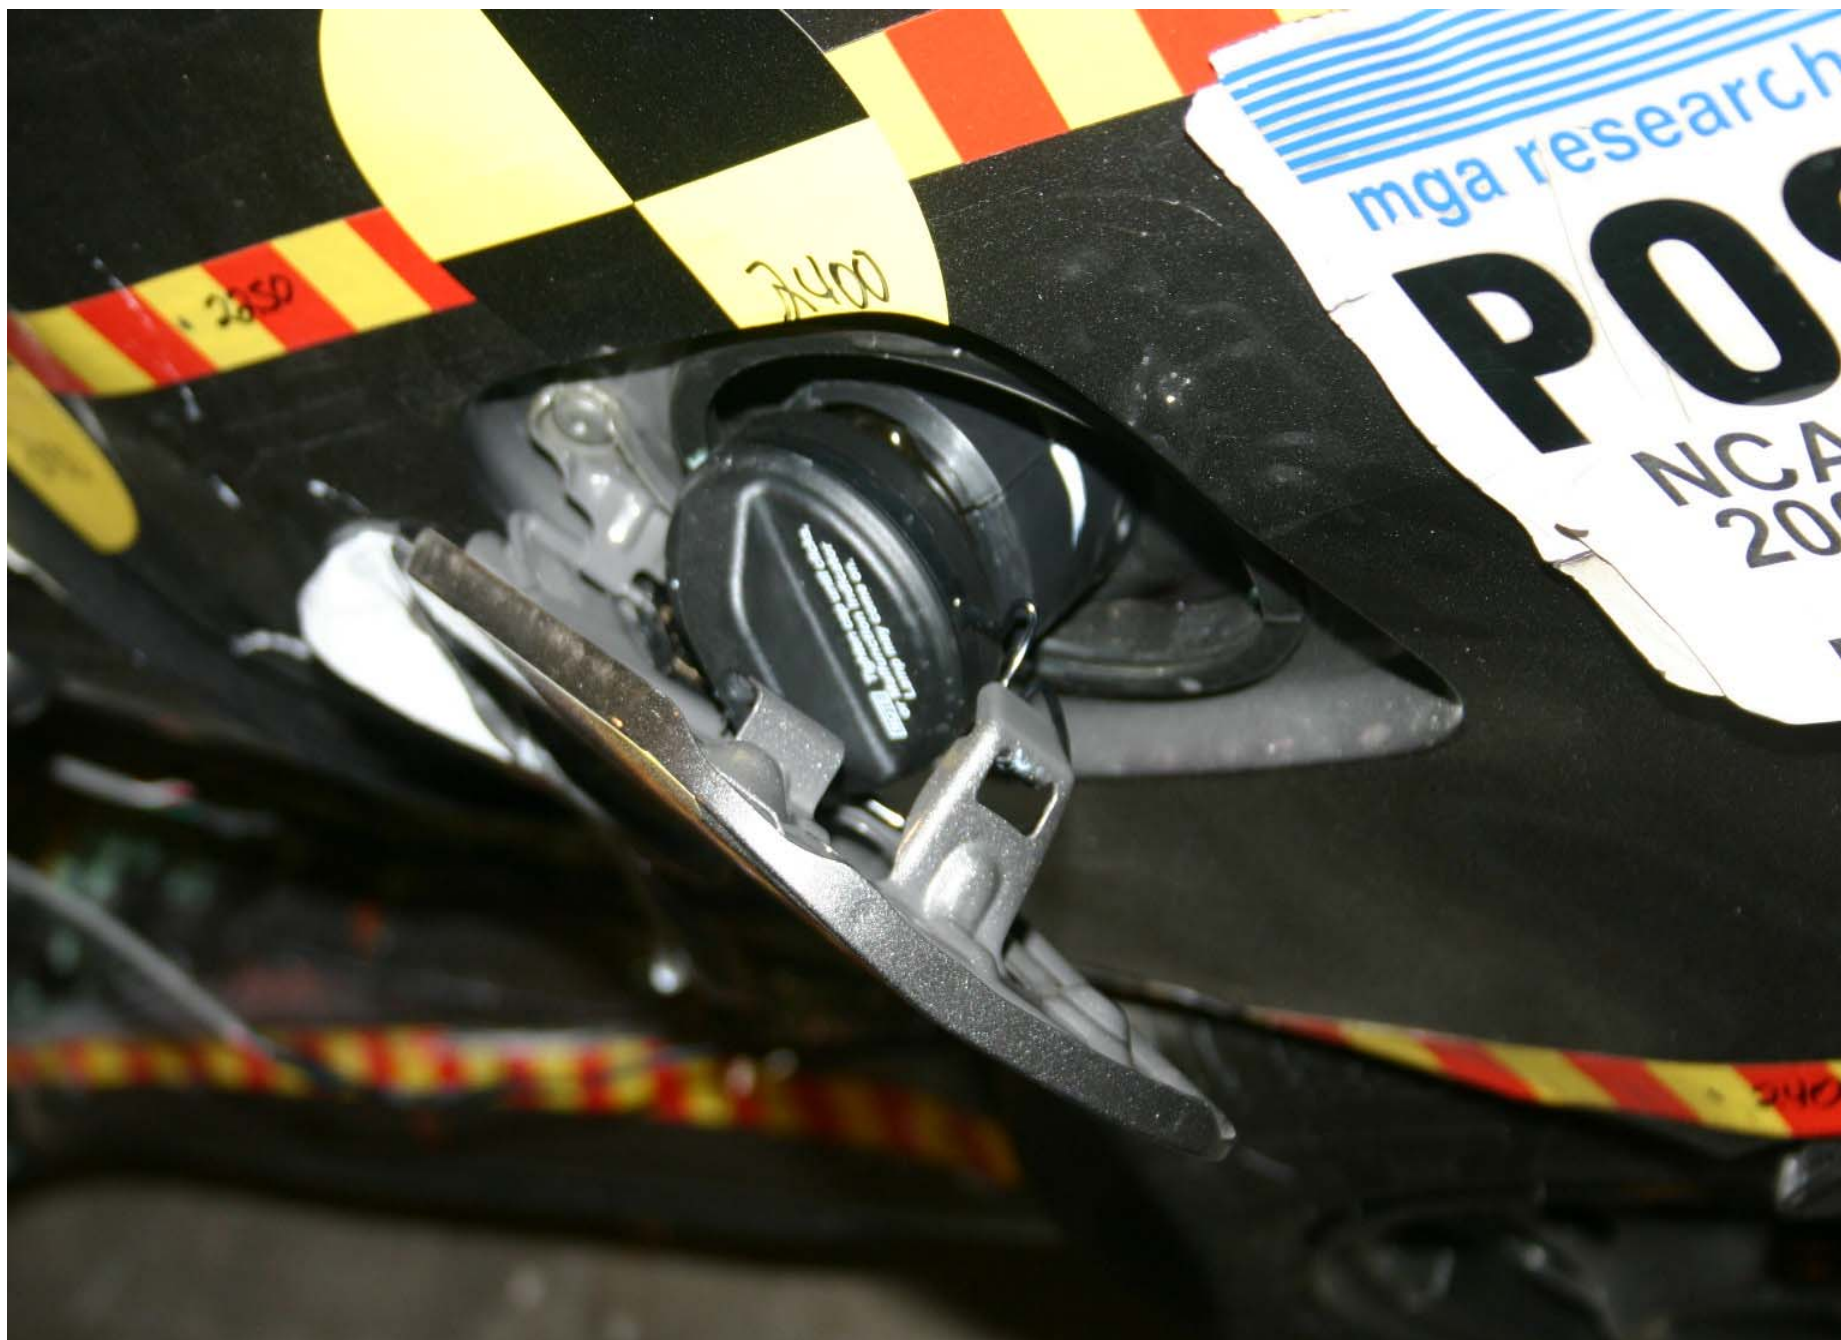
Post-Test Fuel Filler Cap View

The gas cap door opened and filler neck came out. (See Appendix A for photos)

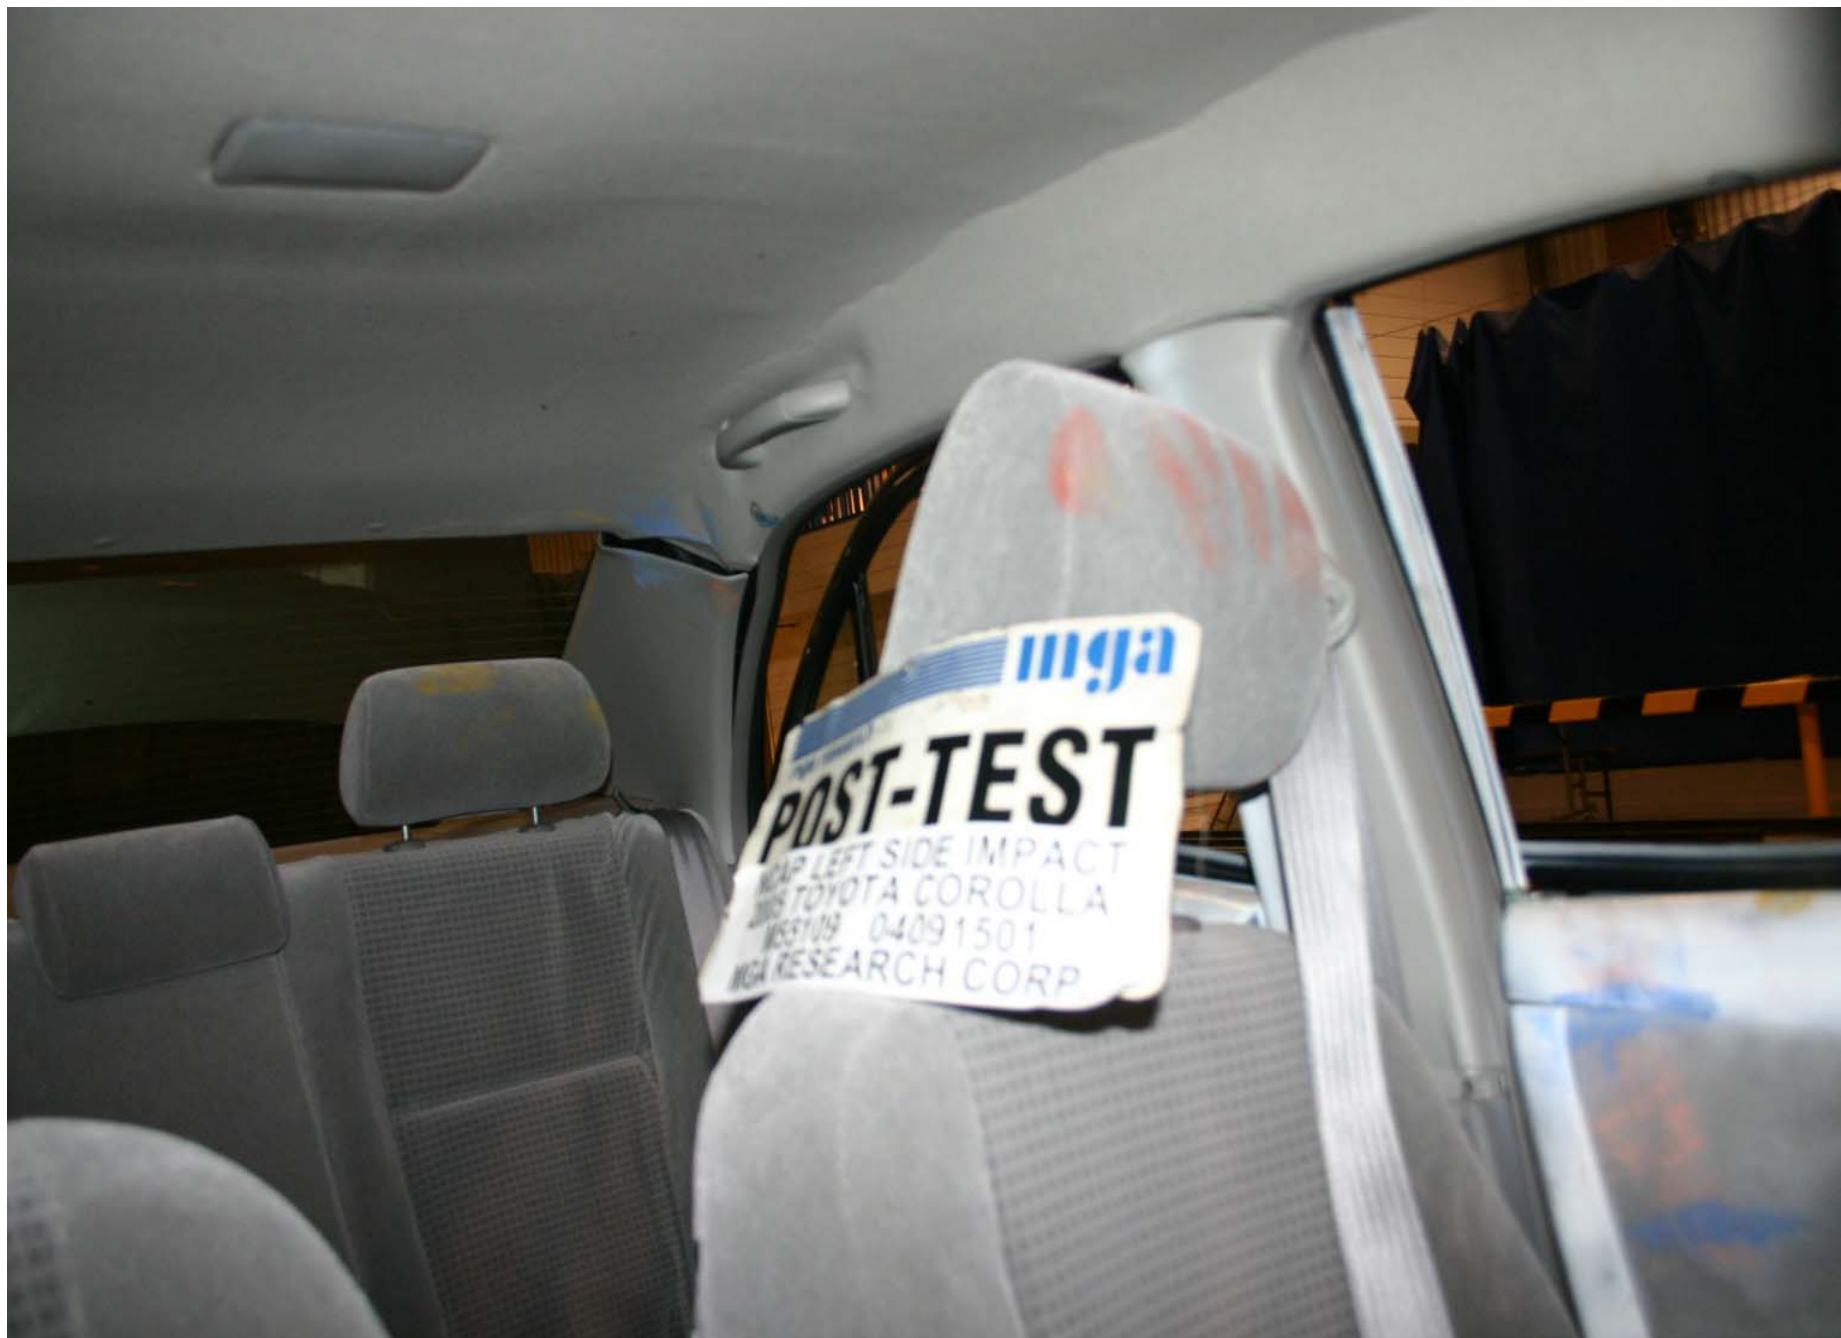
Post-Test Driver Dummy Head Contact

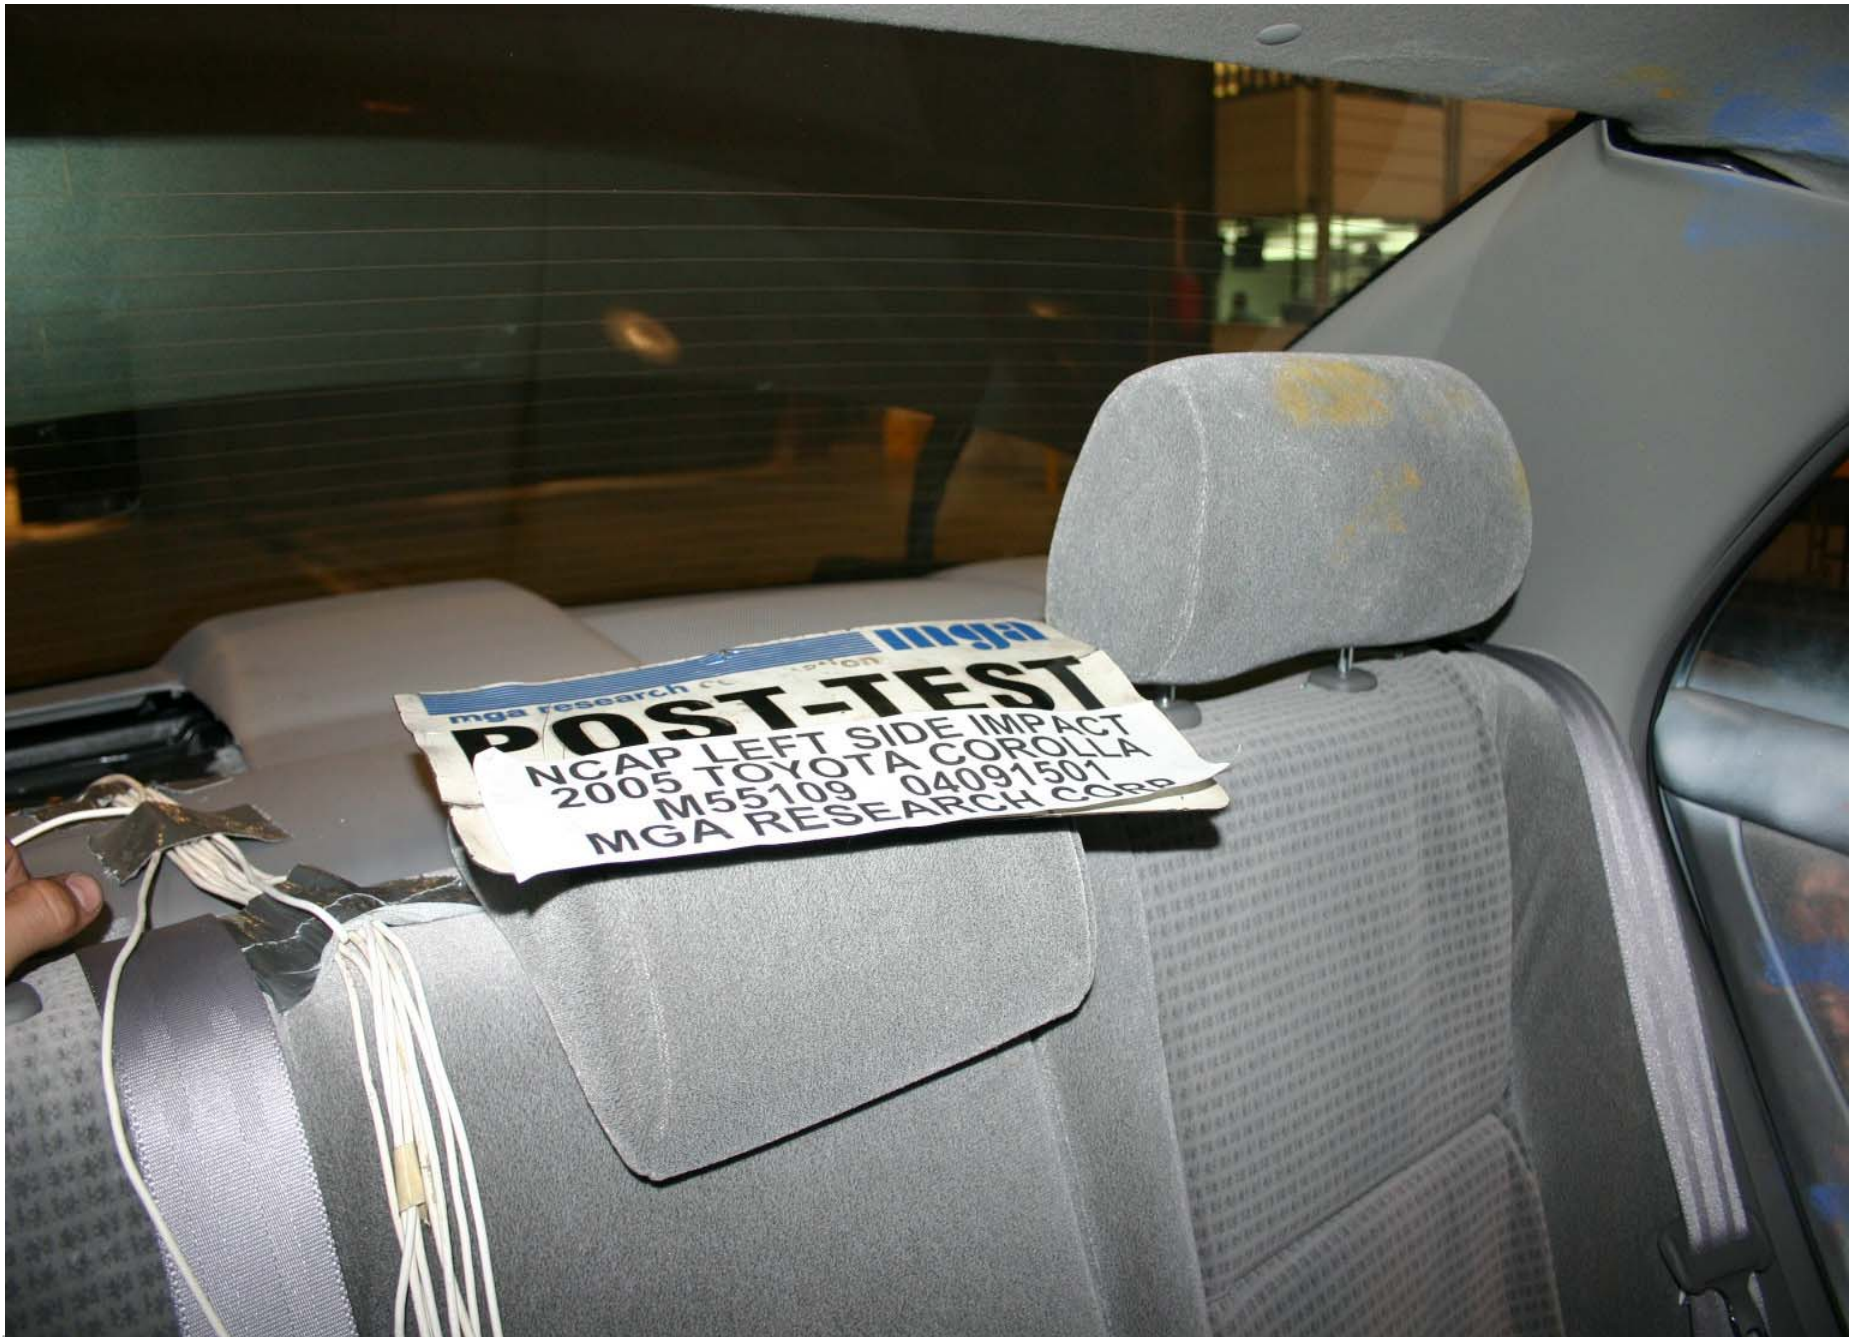
Post-Test Passenger Dummy Head Contact

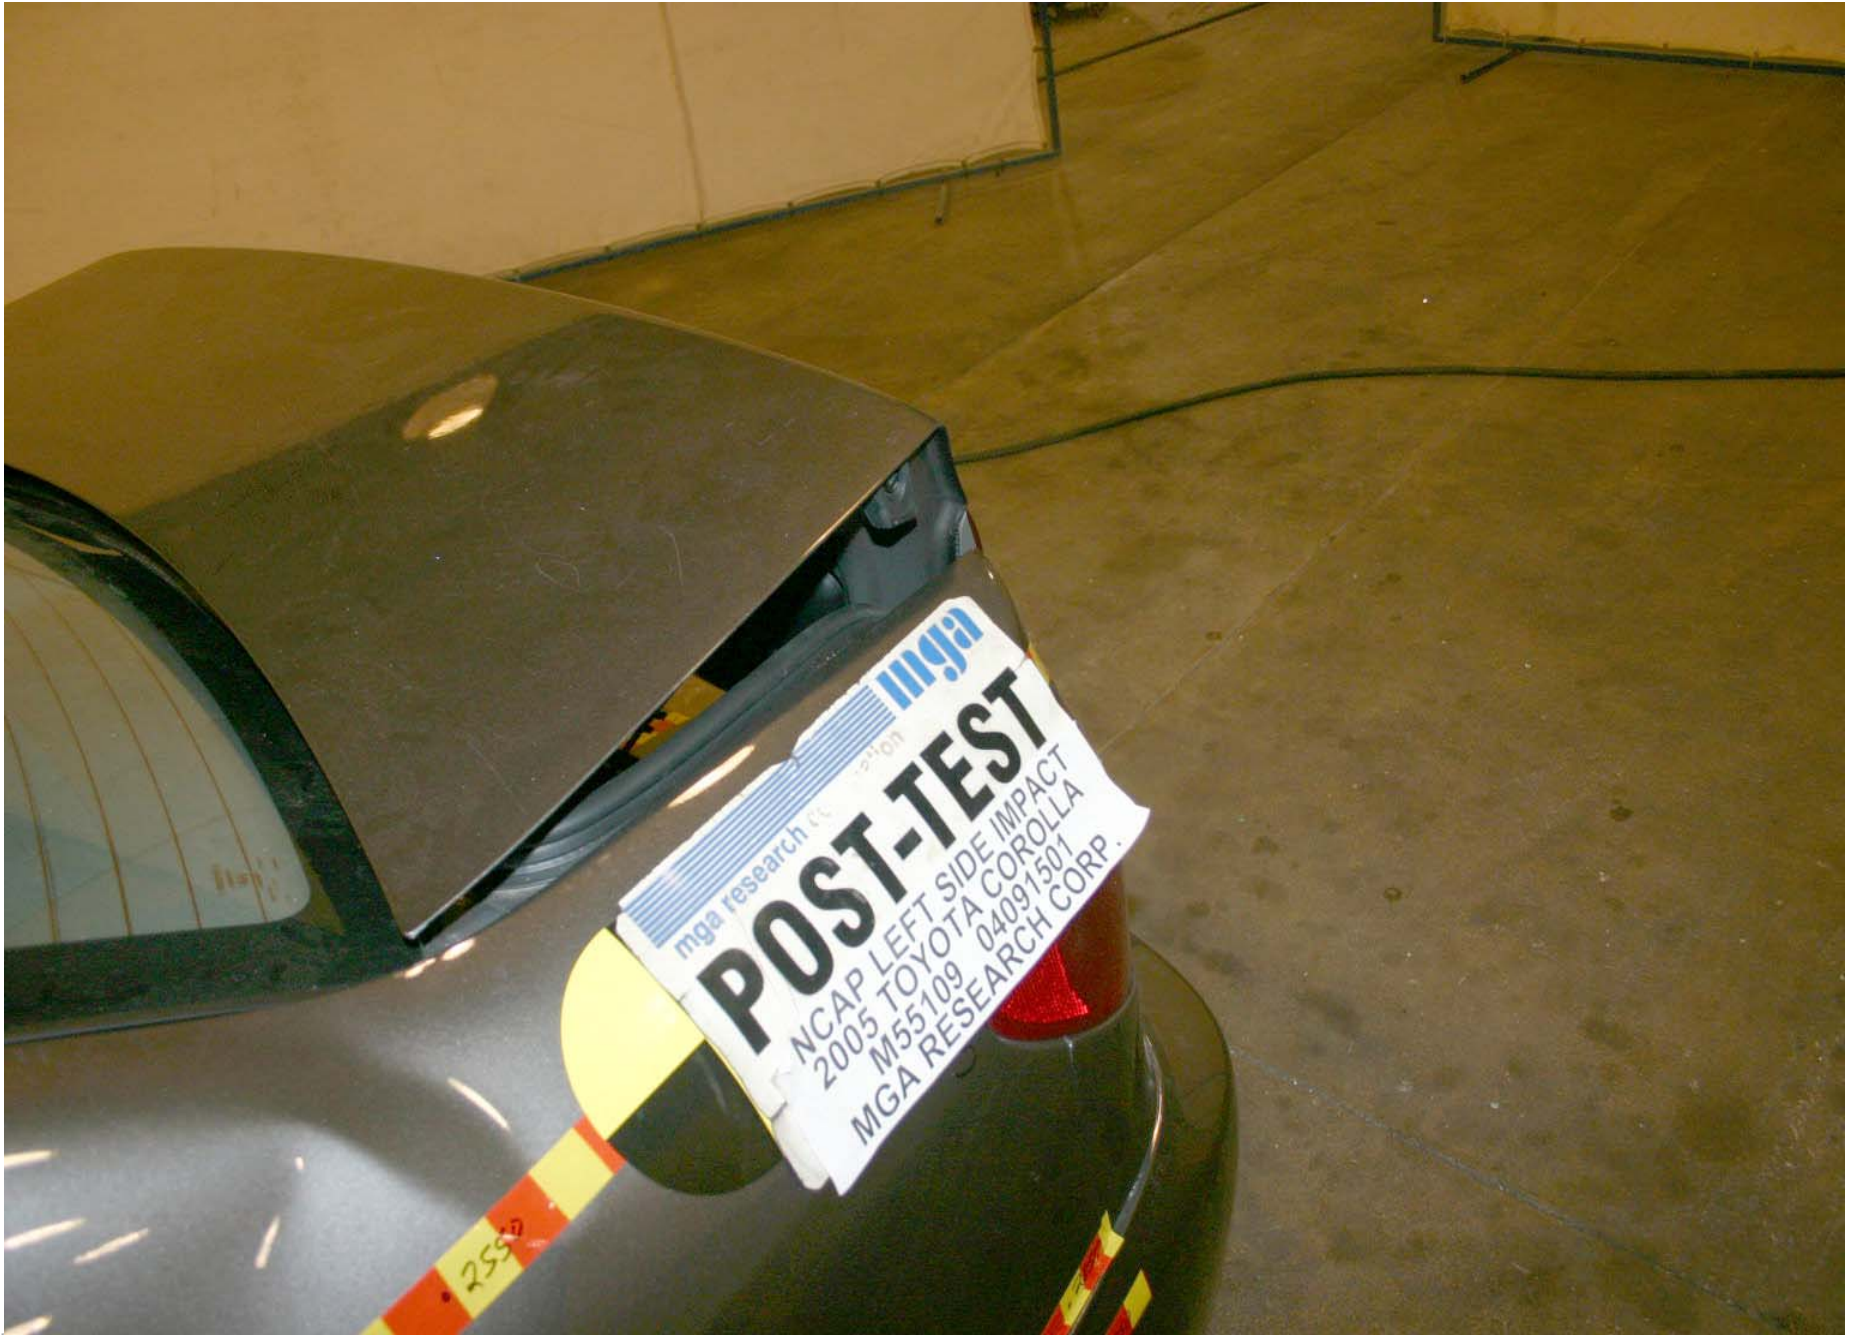
Post-Test Trunk Left Side View

The trunk door opened on impact. (See Appendix A for photos)

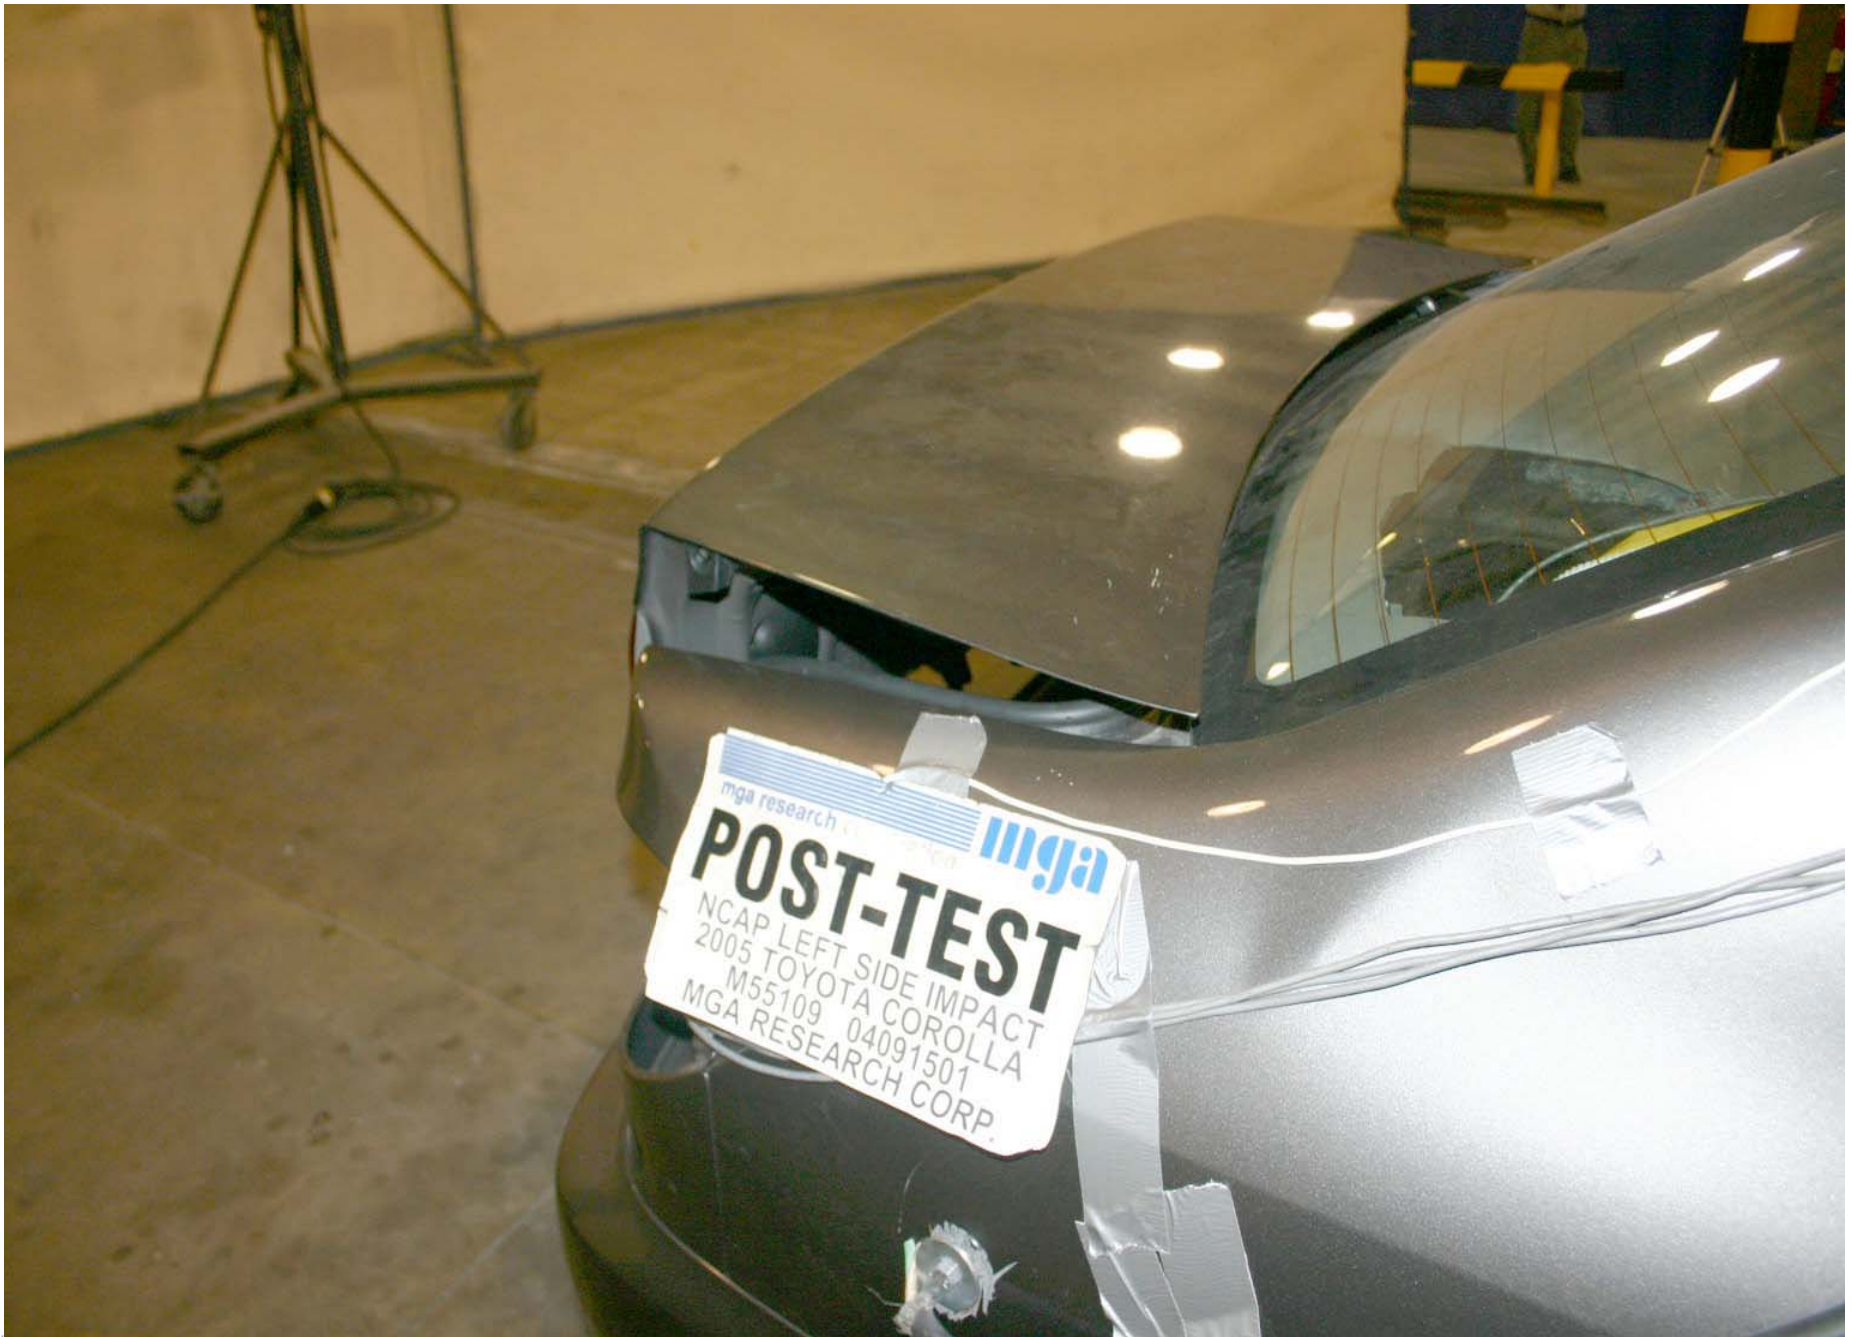
Post-Test Trunk Right Side View

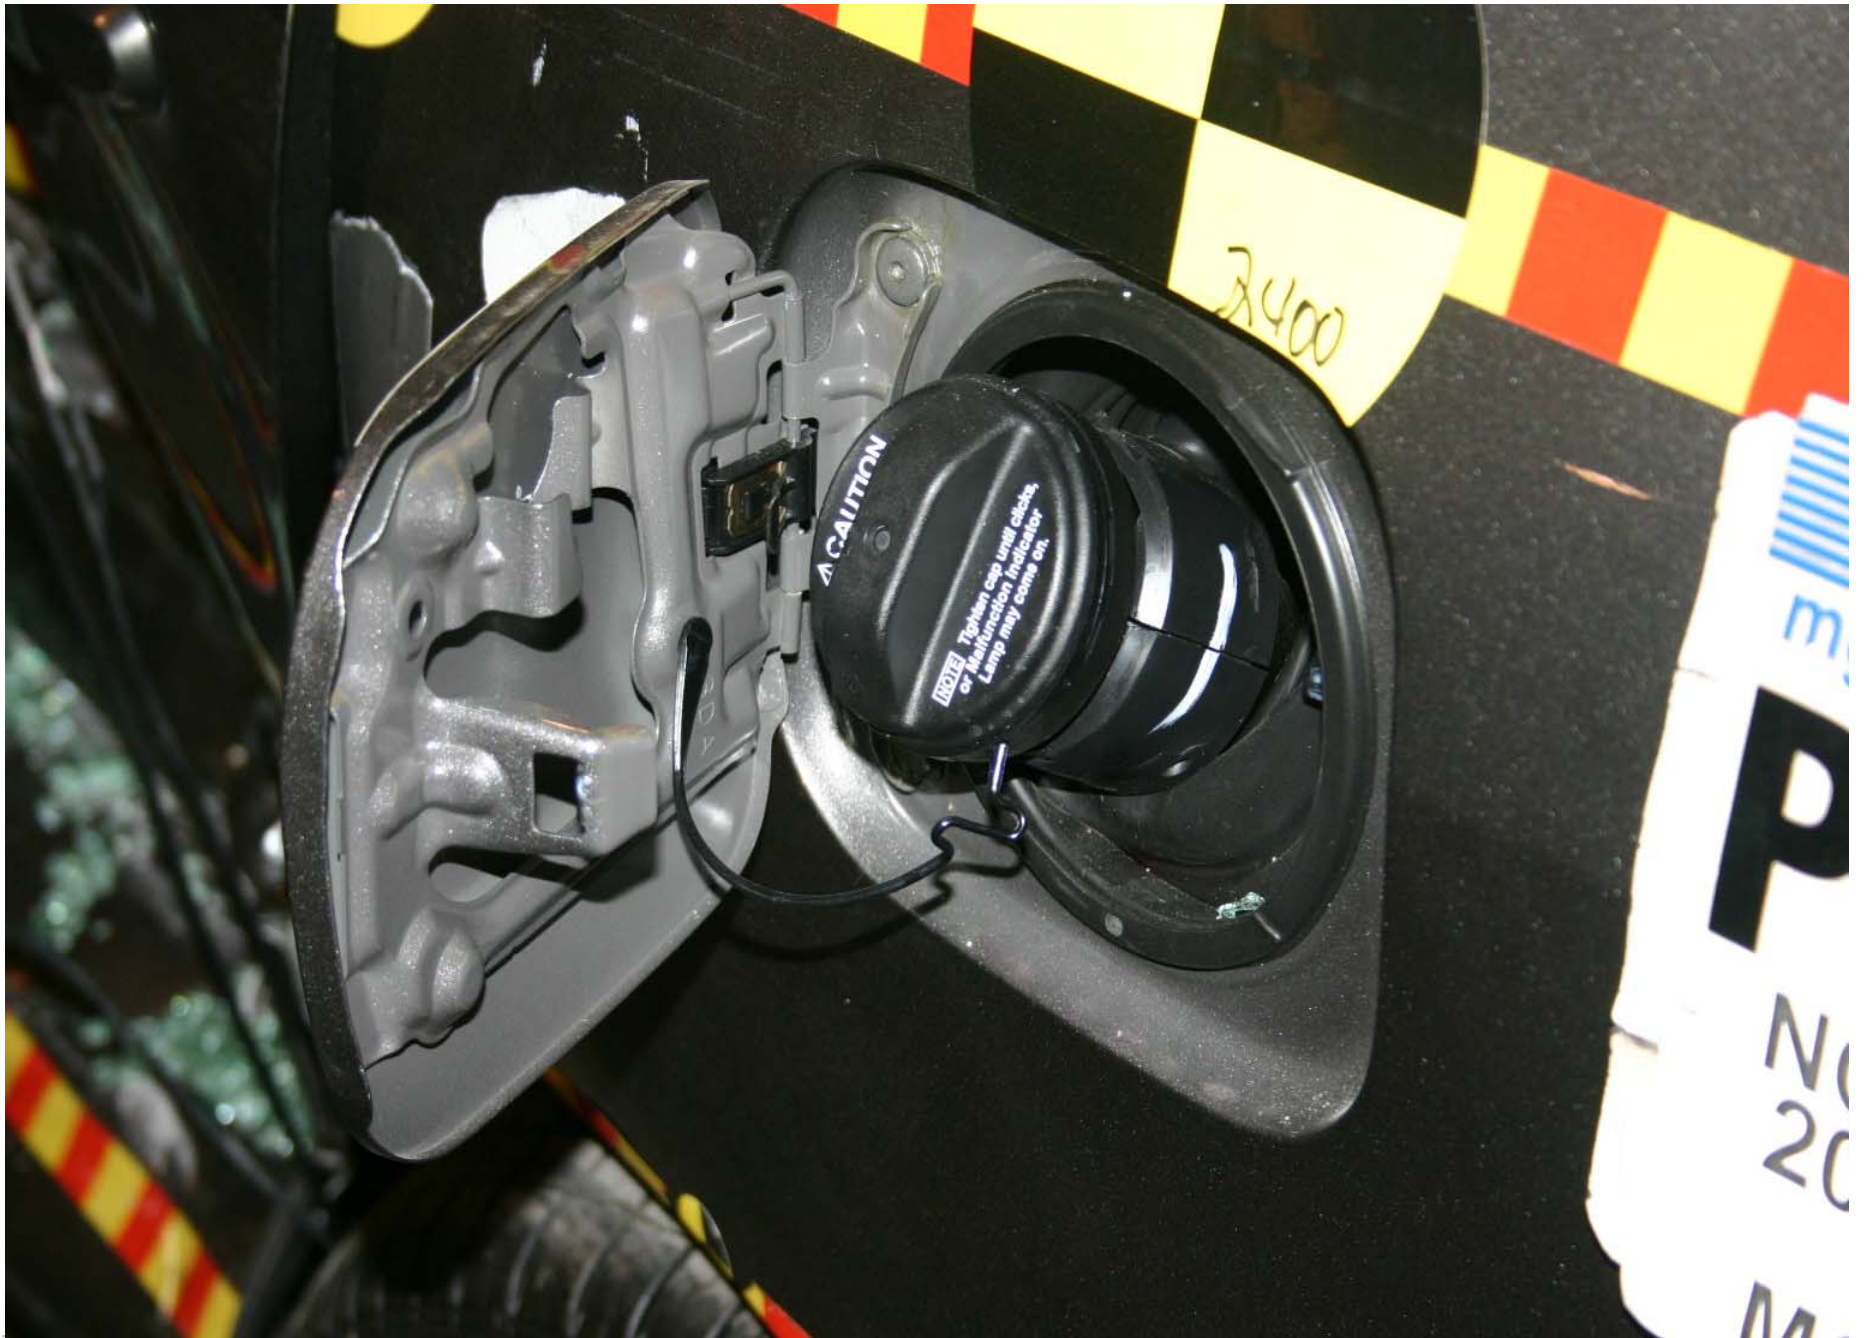
Post-Test Fuel Filler Cap View
