**REPORT NUMBER: NCAP-MGA-2005-002**

**NEW CAR ASSESSMENT PROGRAM  
FRONTAL BARRIER IMPACT TEST**

**TOYOTA MOTOR CORPORATION  
2005 Toyota Corolla  
NHTSA NUMBER: M55108**

**PREPARED BY:  
MGA RESEARCH CORPORATION  
5000 WARREN ROAD  
BURLINGTON, WI 53105**

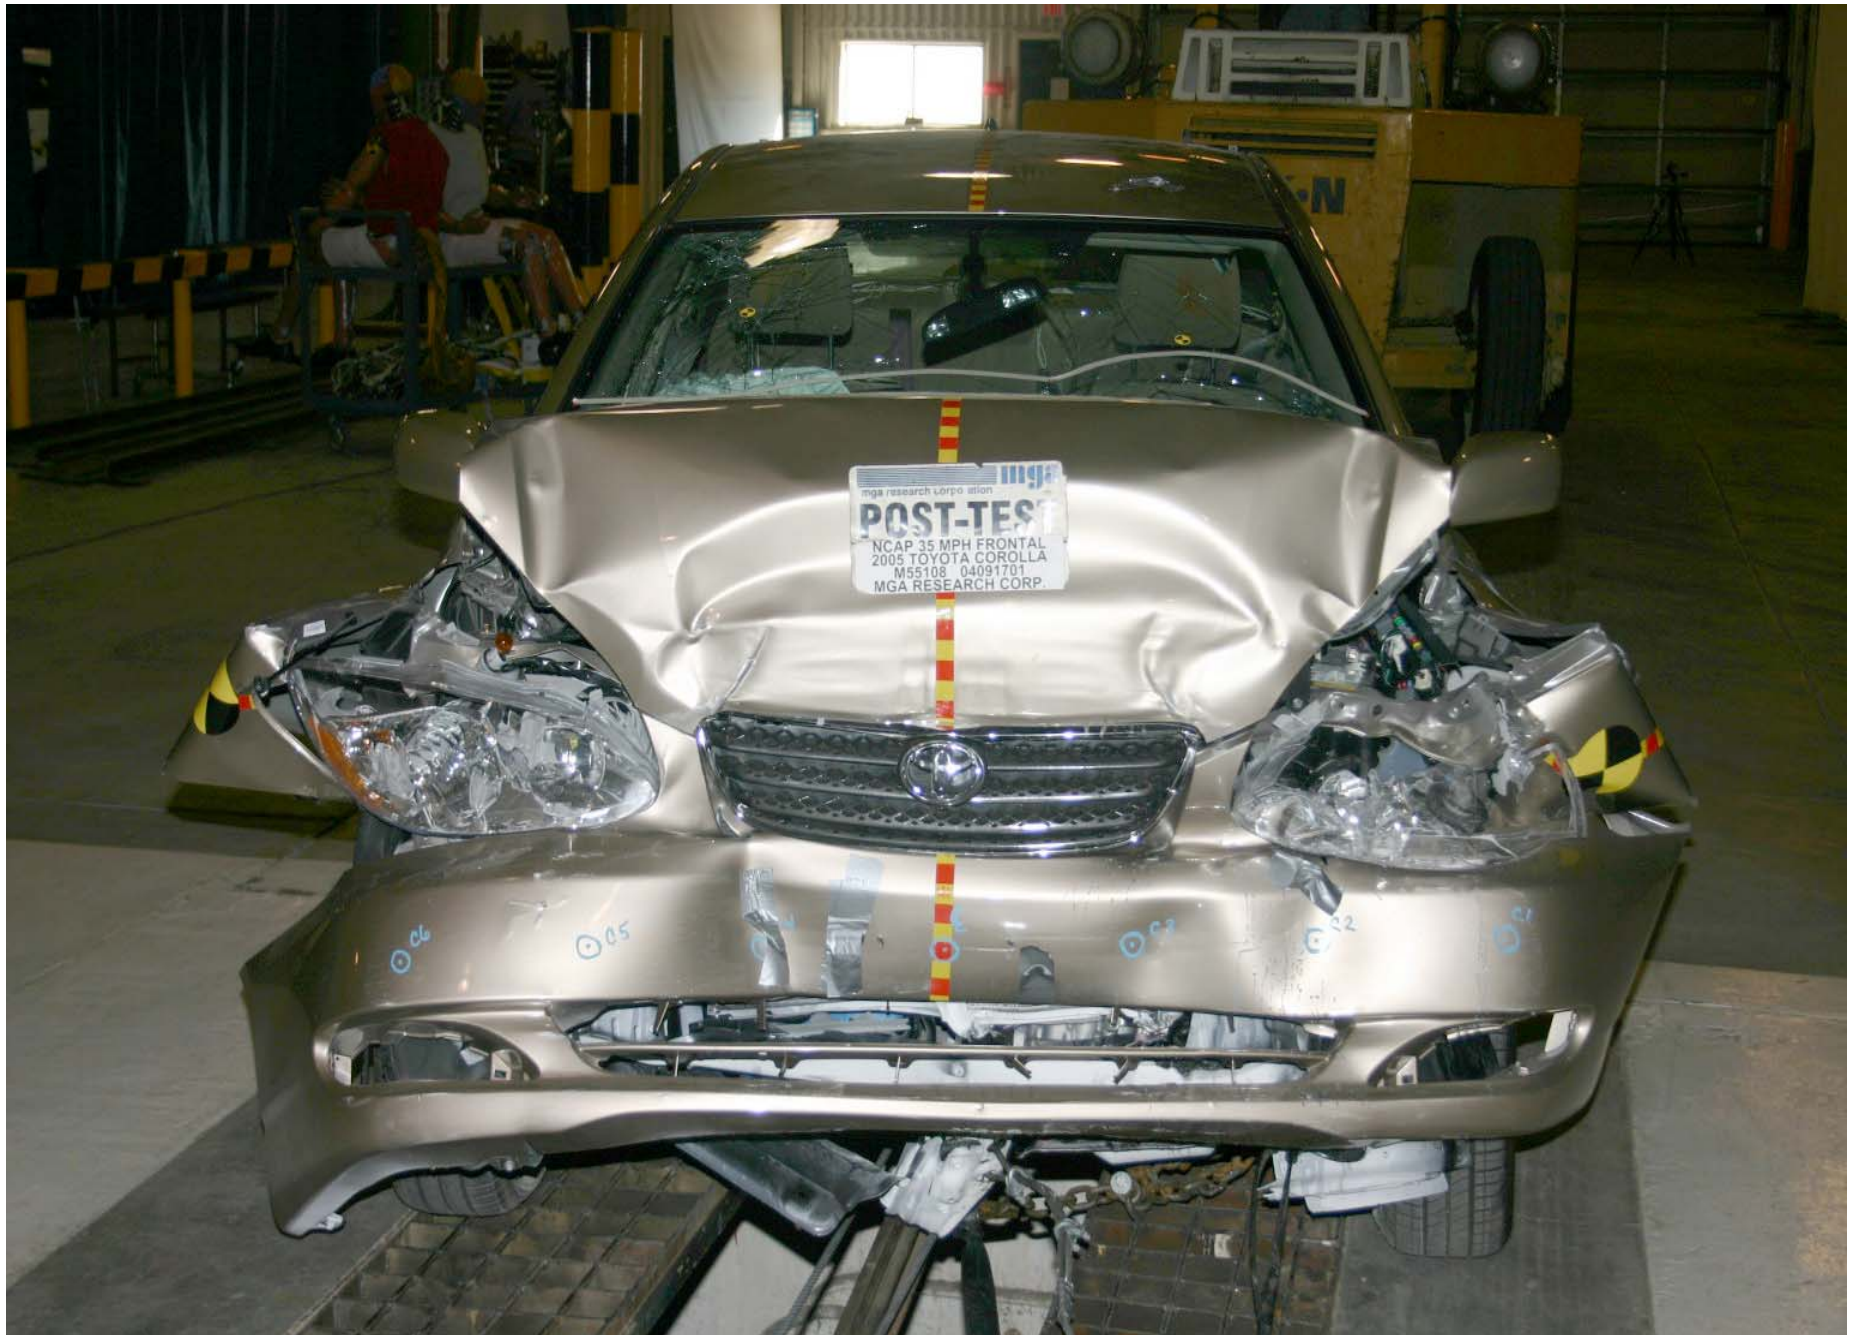
Post-Test Front View of Test Vehicle

The maximum static crush of the vehicle was 603 mm and both the driver and passenger side doors remained closed and latched during the impact event and were operable after the impact.

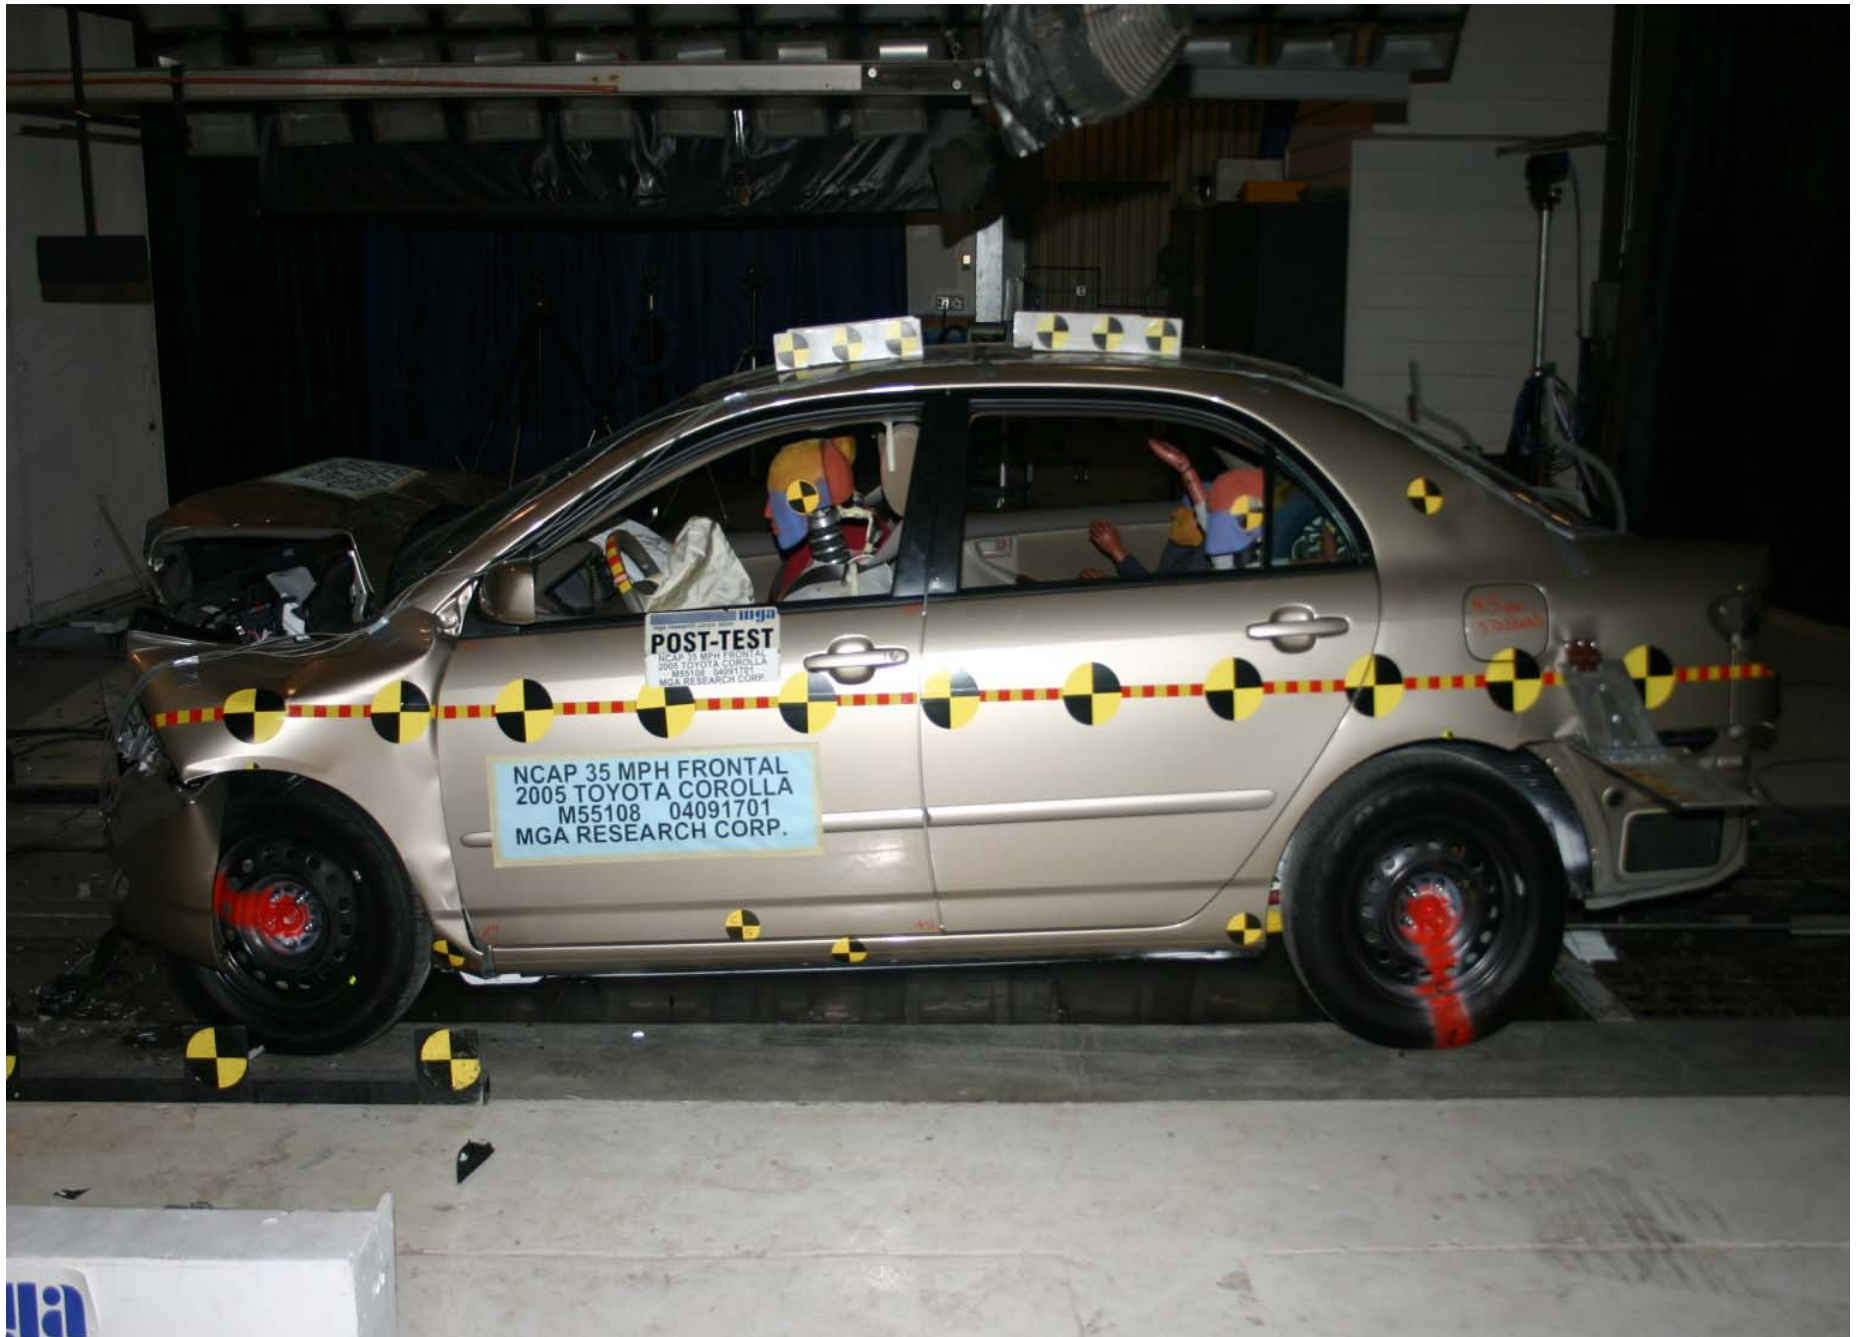
Post-Test Left Side View of Test Vehicle

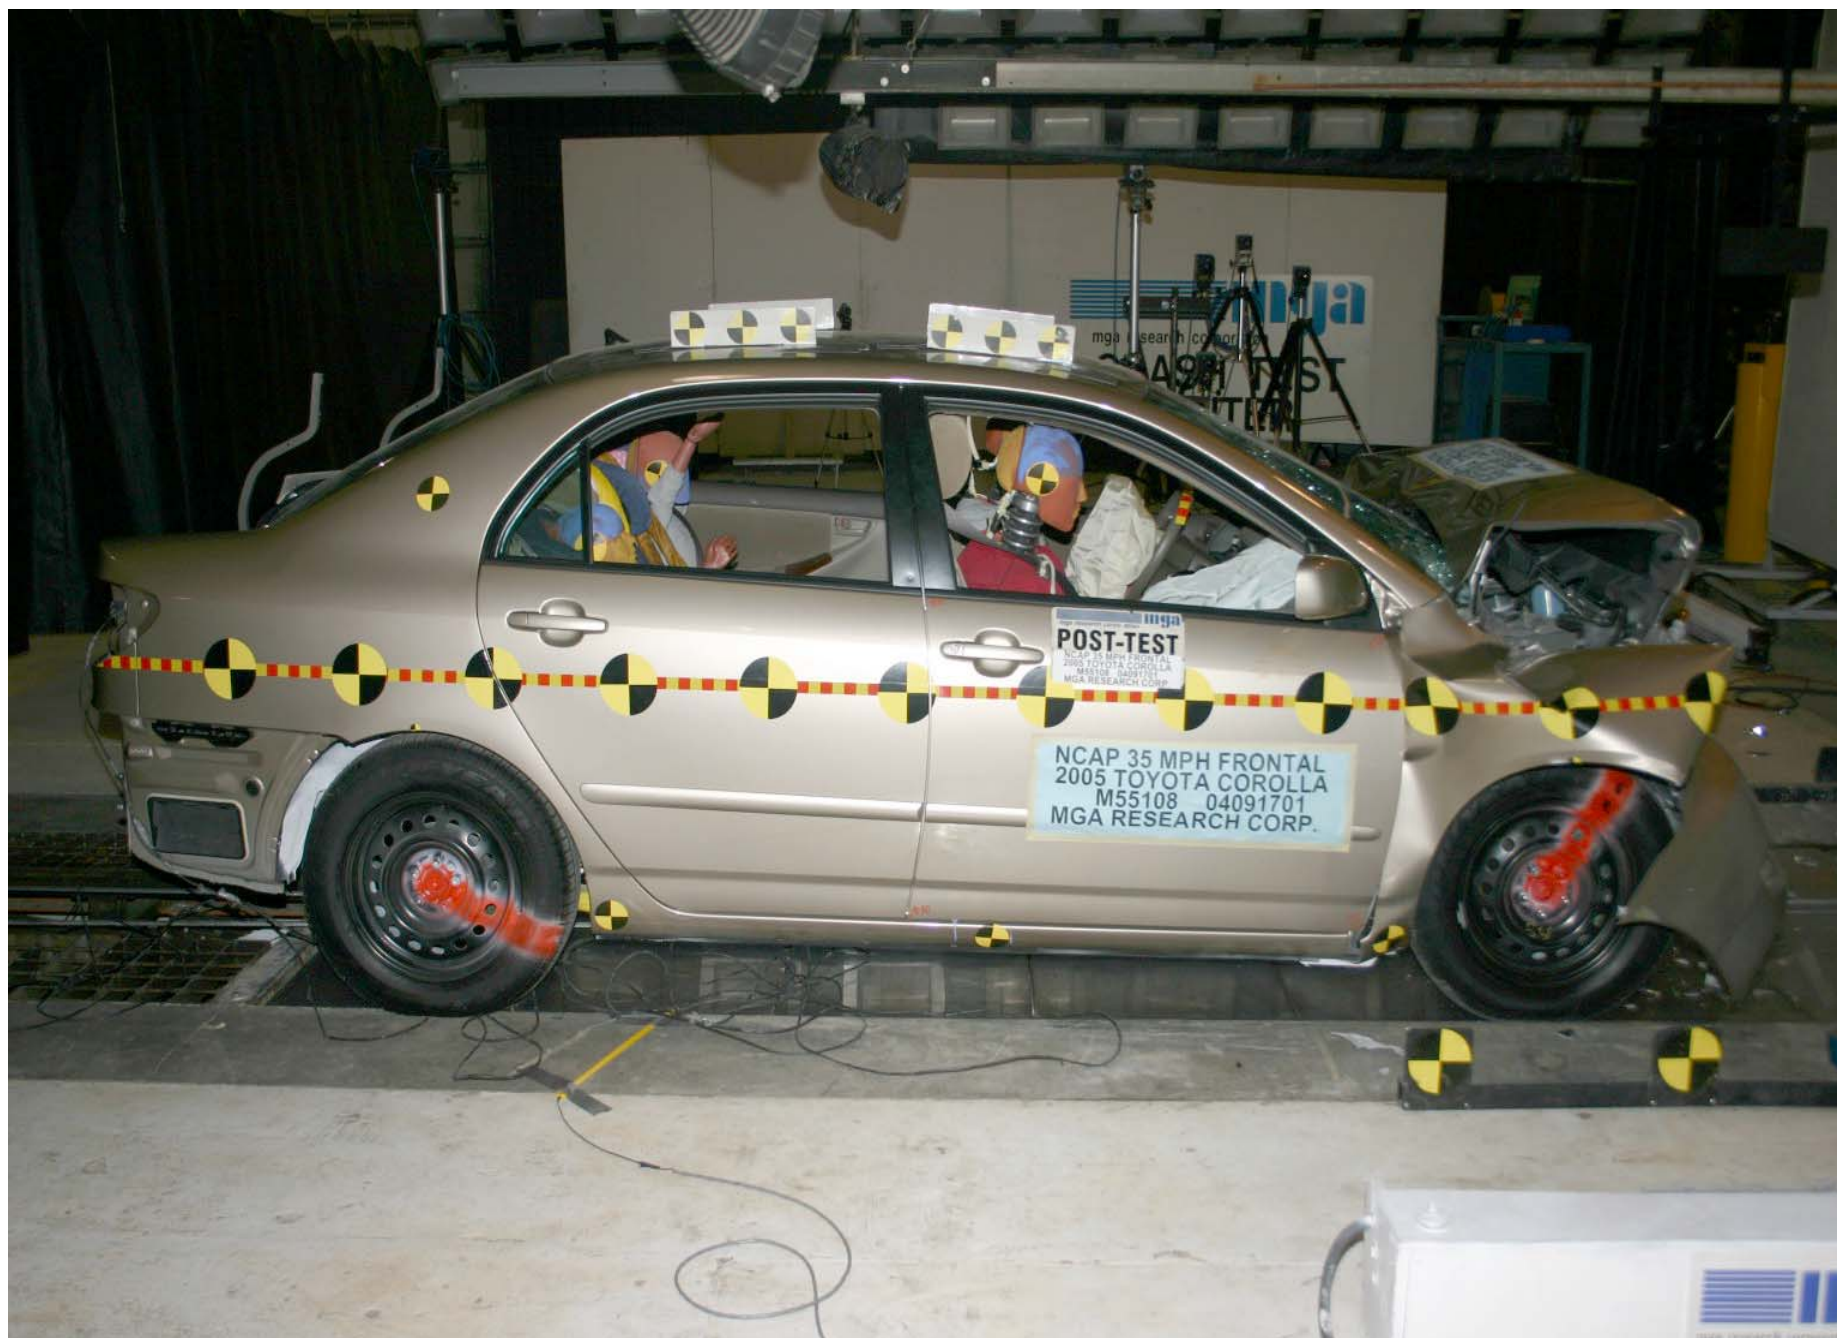
Post-Test Right Side View of Test Vehicle

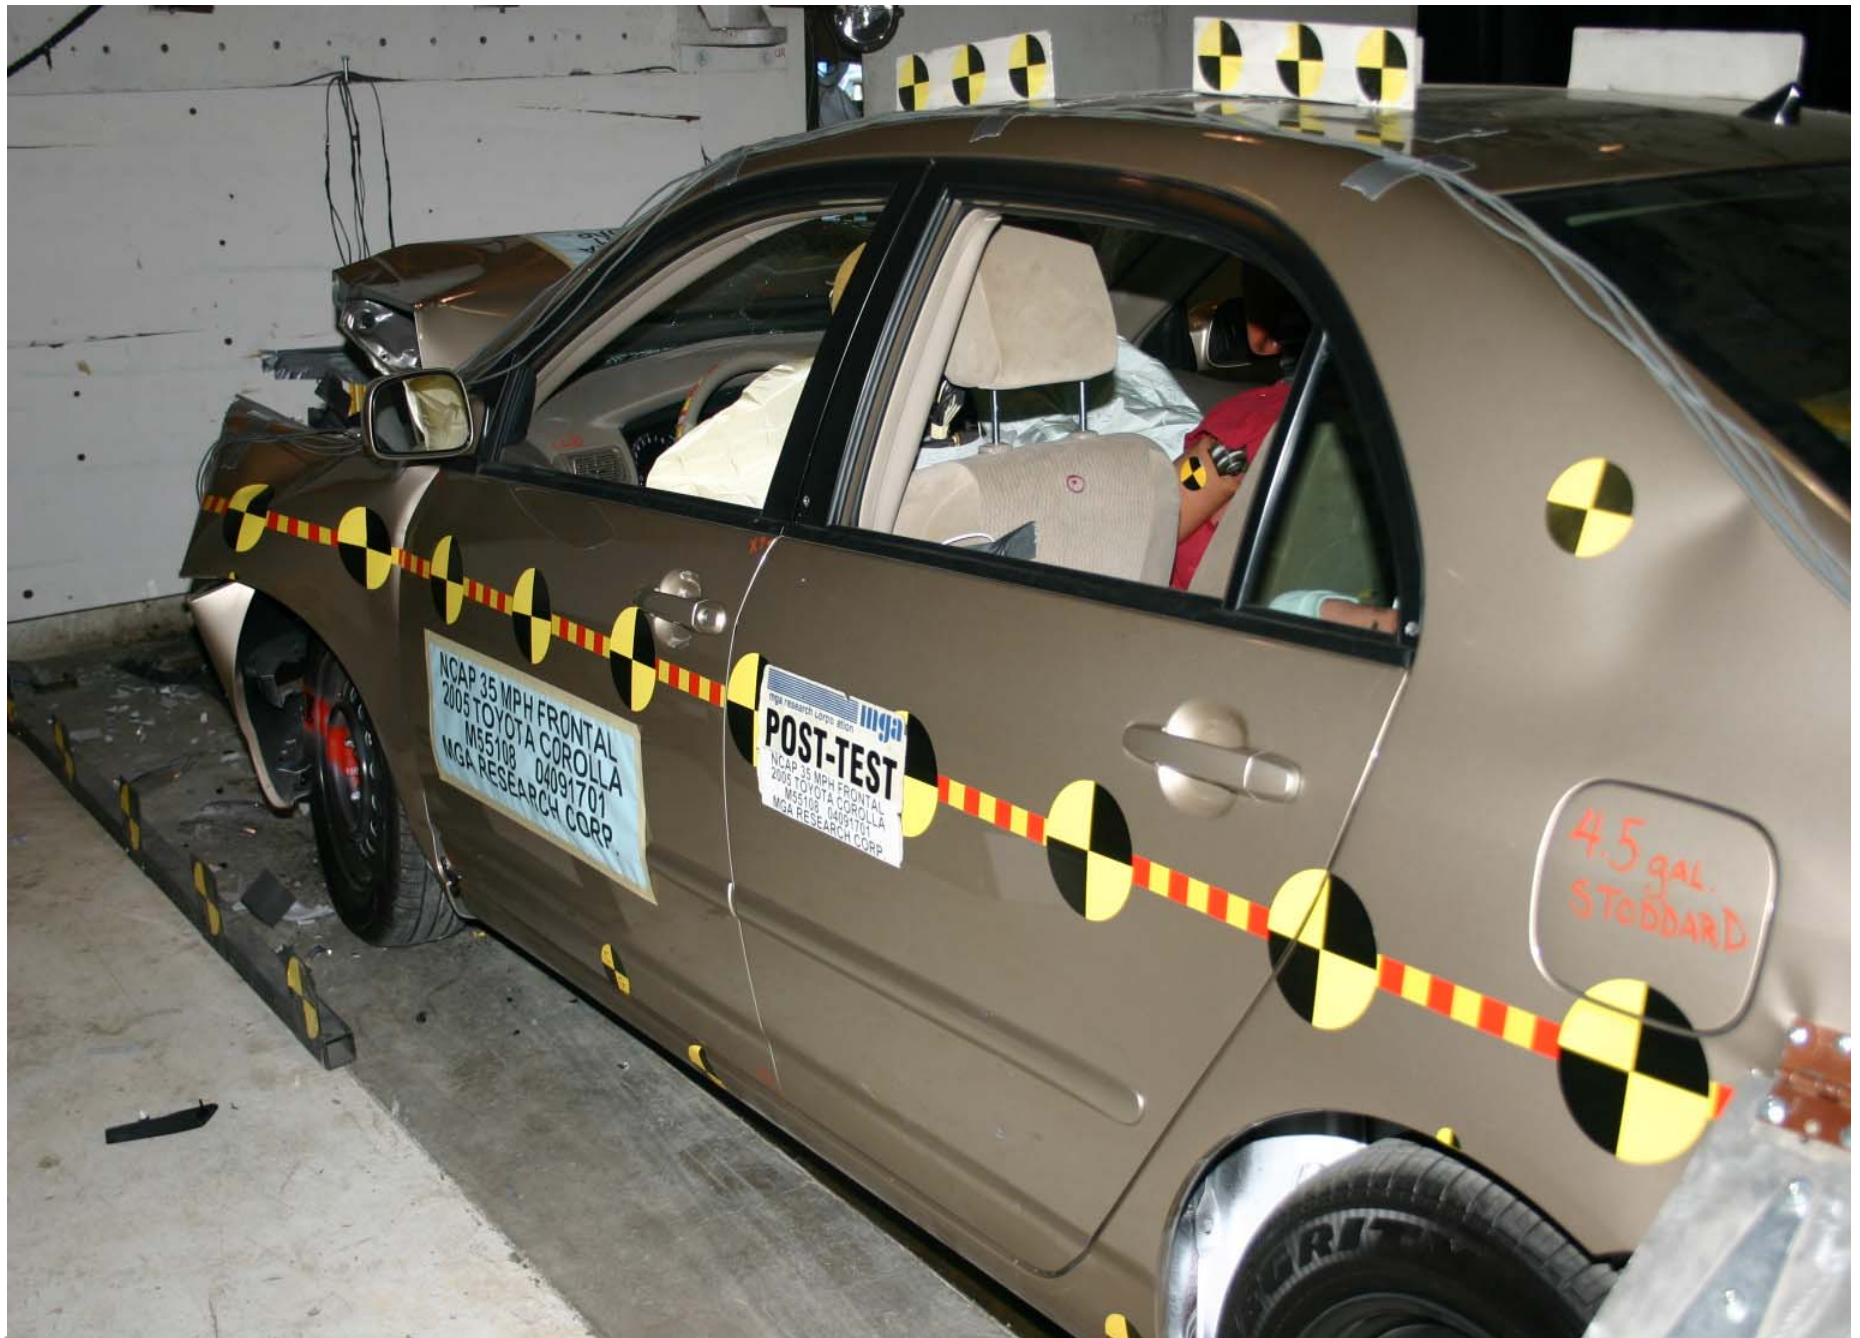
Post-Test Left Side Three-Quarter View of Doors After Impact

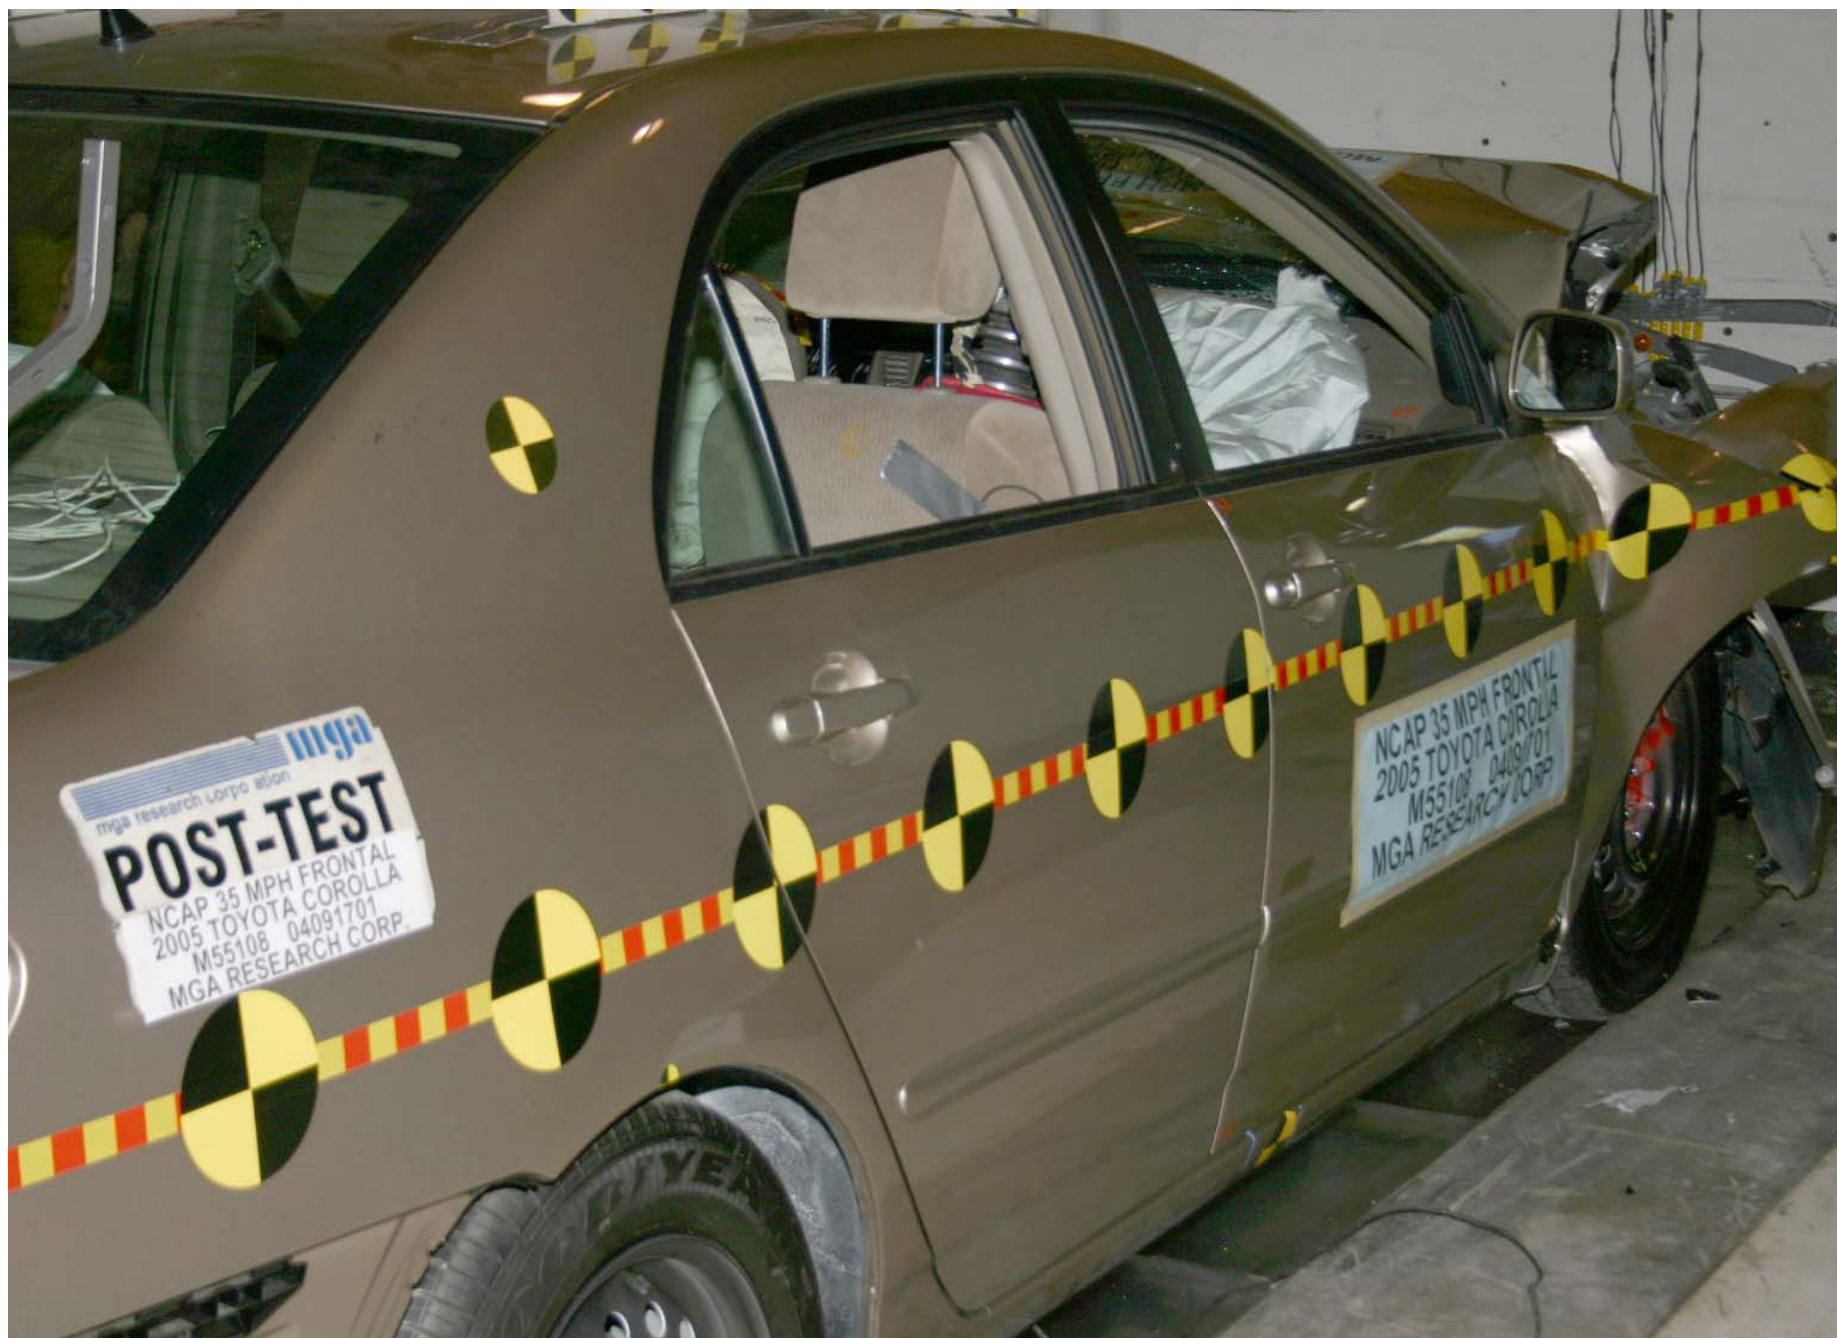
Post-Test Right Side Three-Quarter View of Doors After Impact

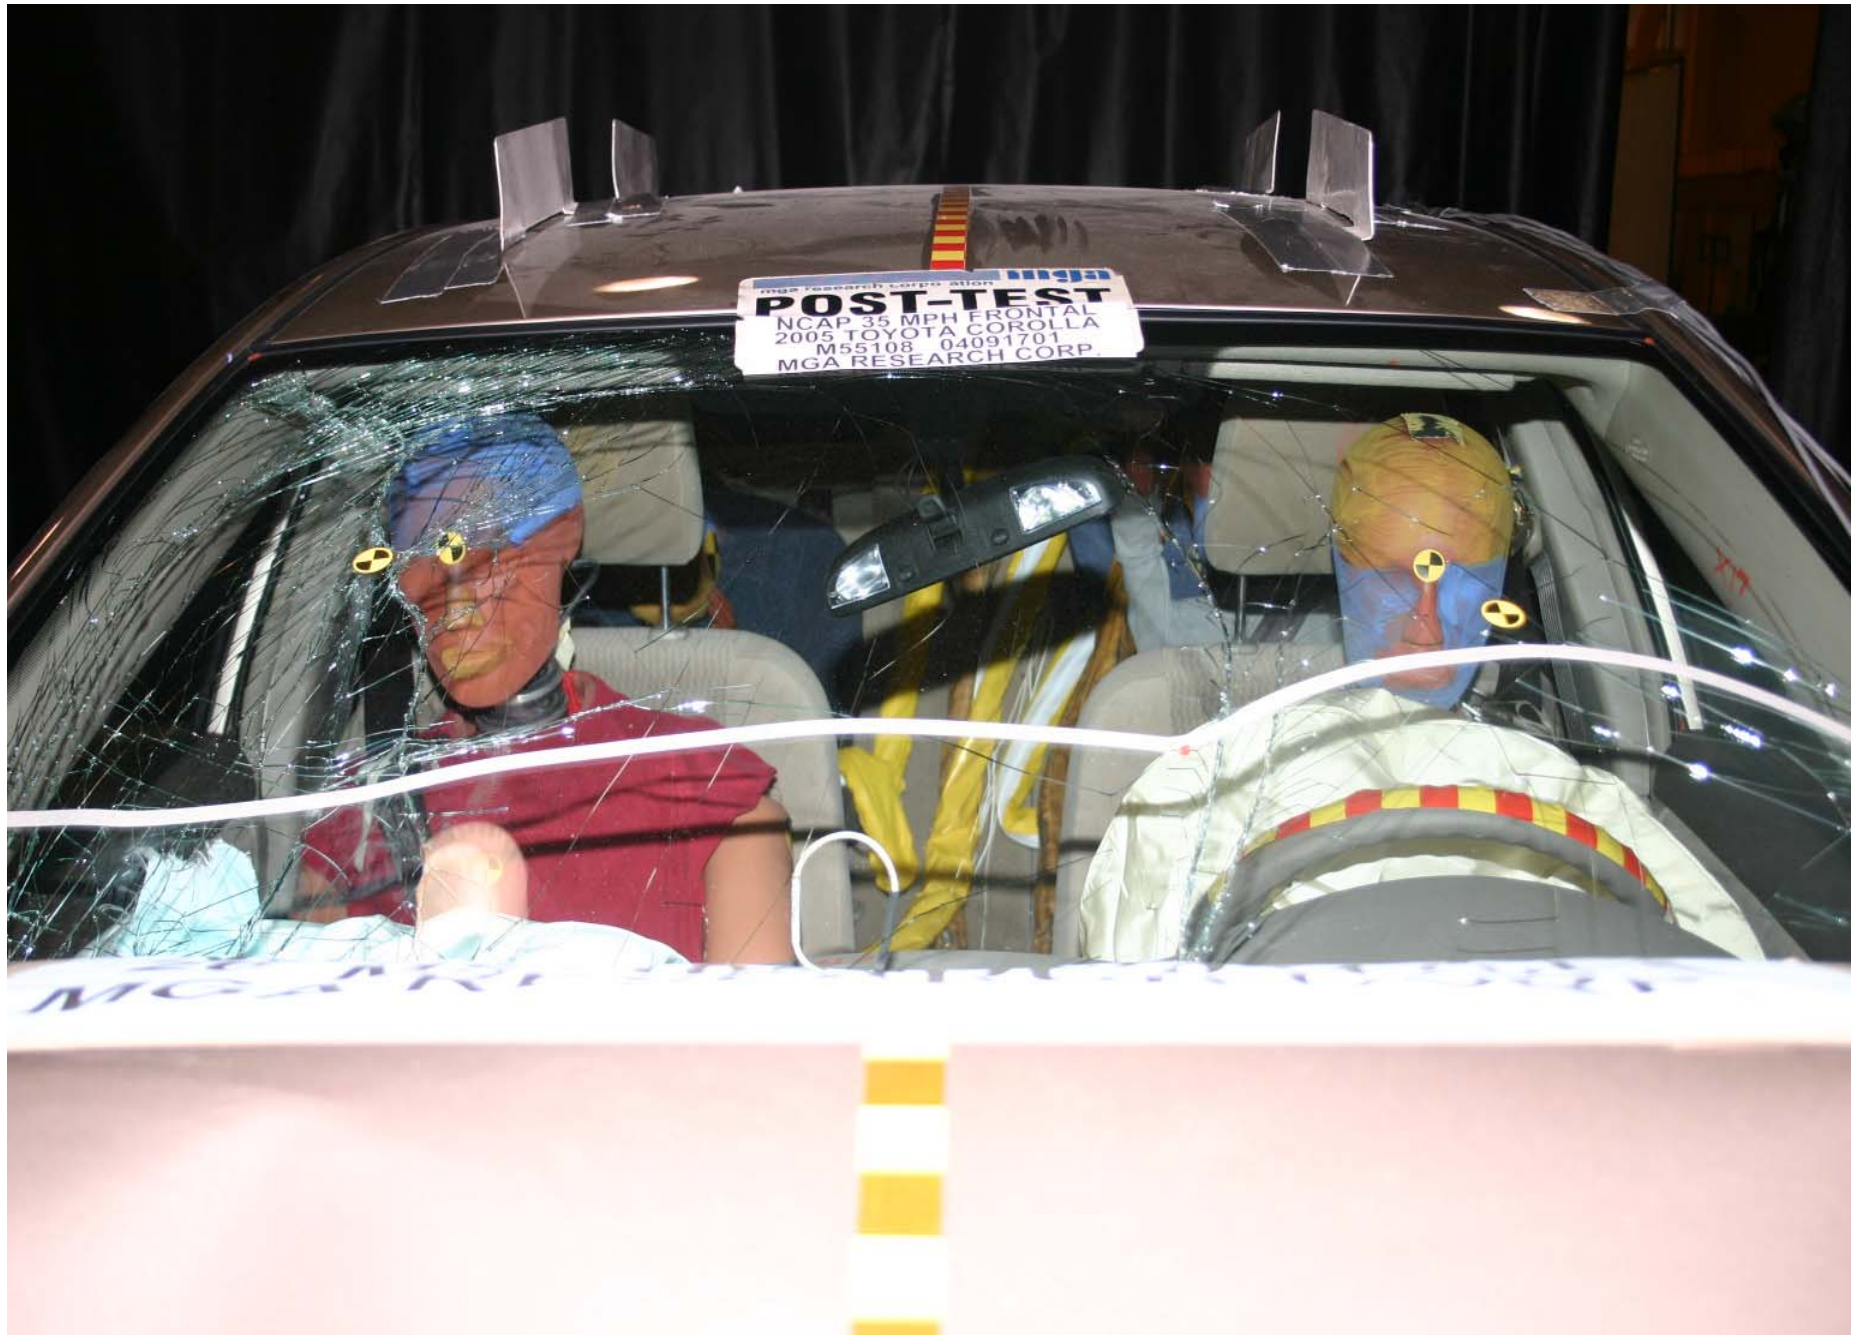
Post-Test Windshield View

There was 100 percent windshield retention and no intrusion into the protected zone of the windshield during the event. There was no Stoddard Solvent leakage after the event or during any phase of the static rollover.

| Description | Driver | Passenger |
|---|---|---|
| Glazing Damage | The windshield cracked. | |

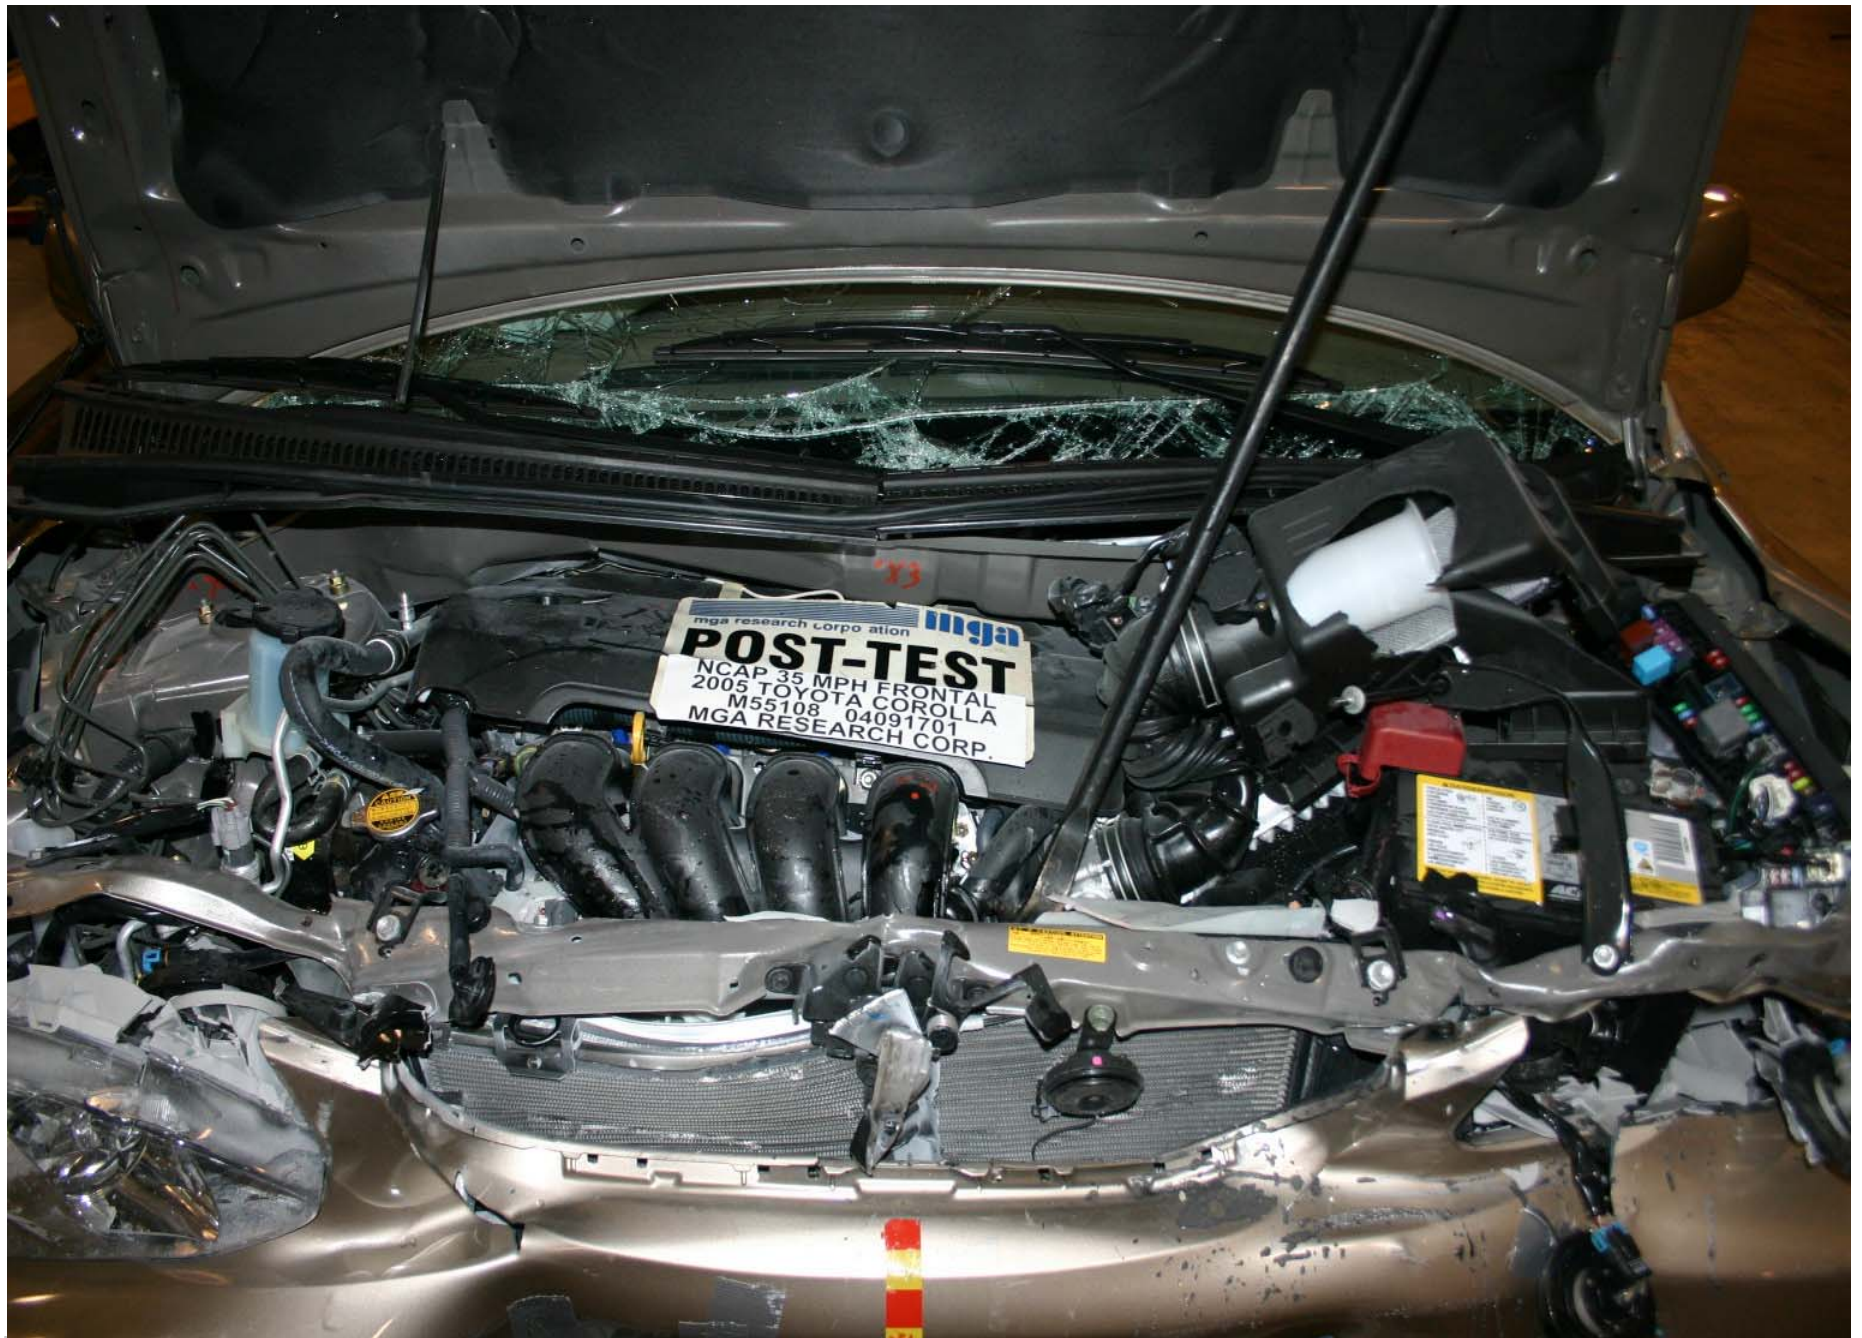
Post-Test Engine Compartment View

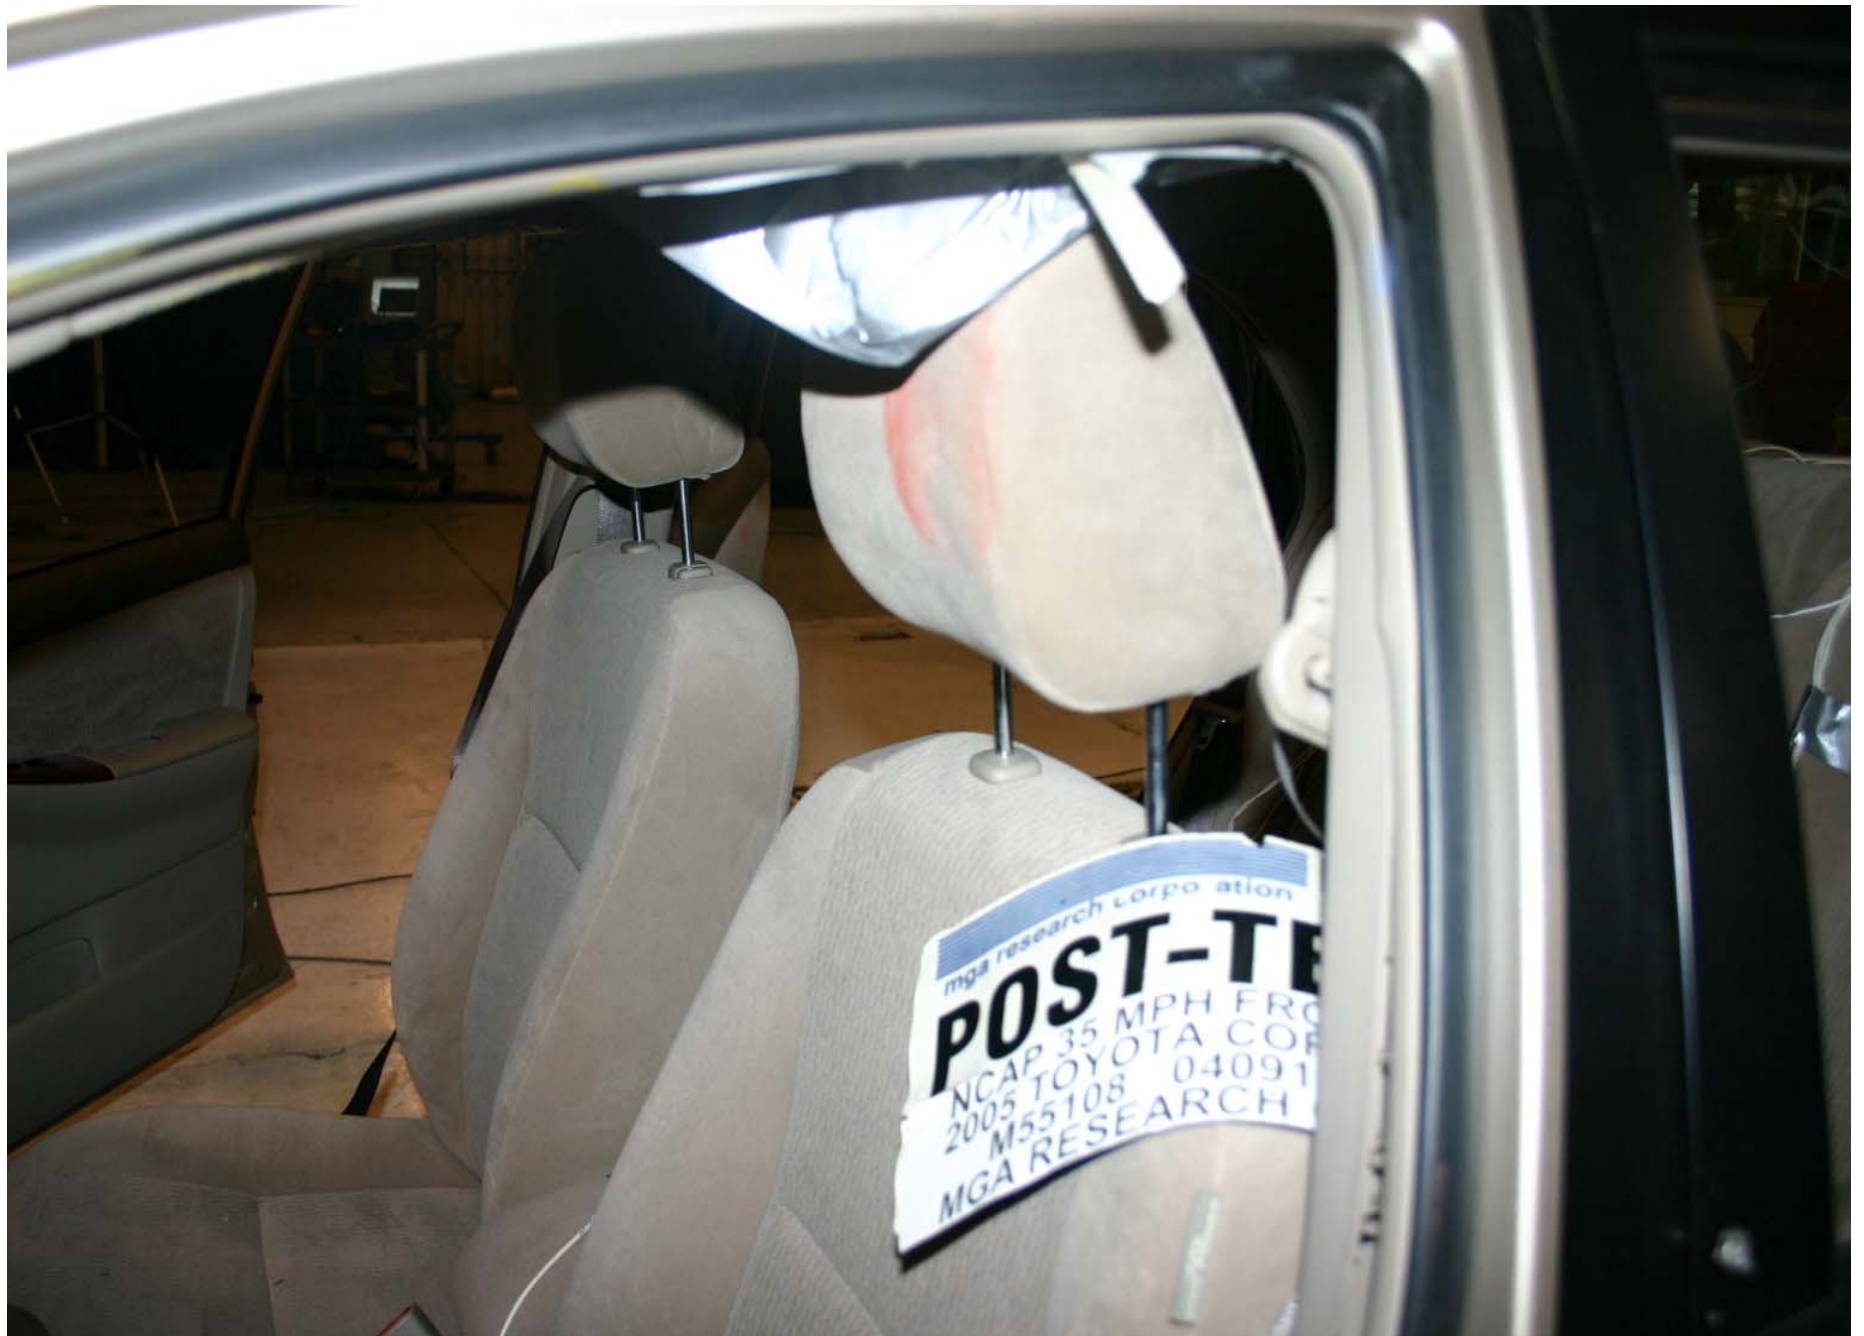
Post-Test Driver Dummy Head Contact

The driver's head, chest, and abdomen contacted the airbag. The driver's head also contacted the headrest. The driver's knees contacted the bolster and the steering column. The passenger's head, chest and abdomen contacted the airbag. The passenger's head contacted the headrest. The passenger's knees contacted the glove box.

| Description | Driver | Passenger |
|---|---|---|
| Head Contact | Airbag, Headrest | Airbag, Headrest |

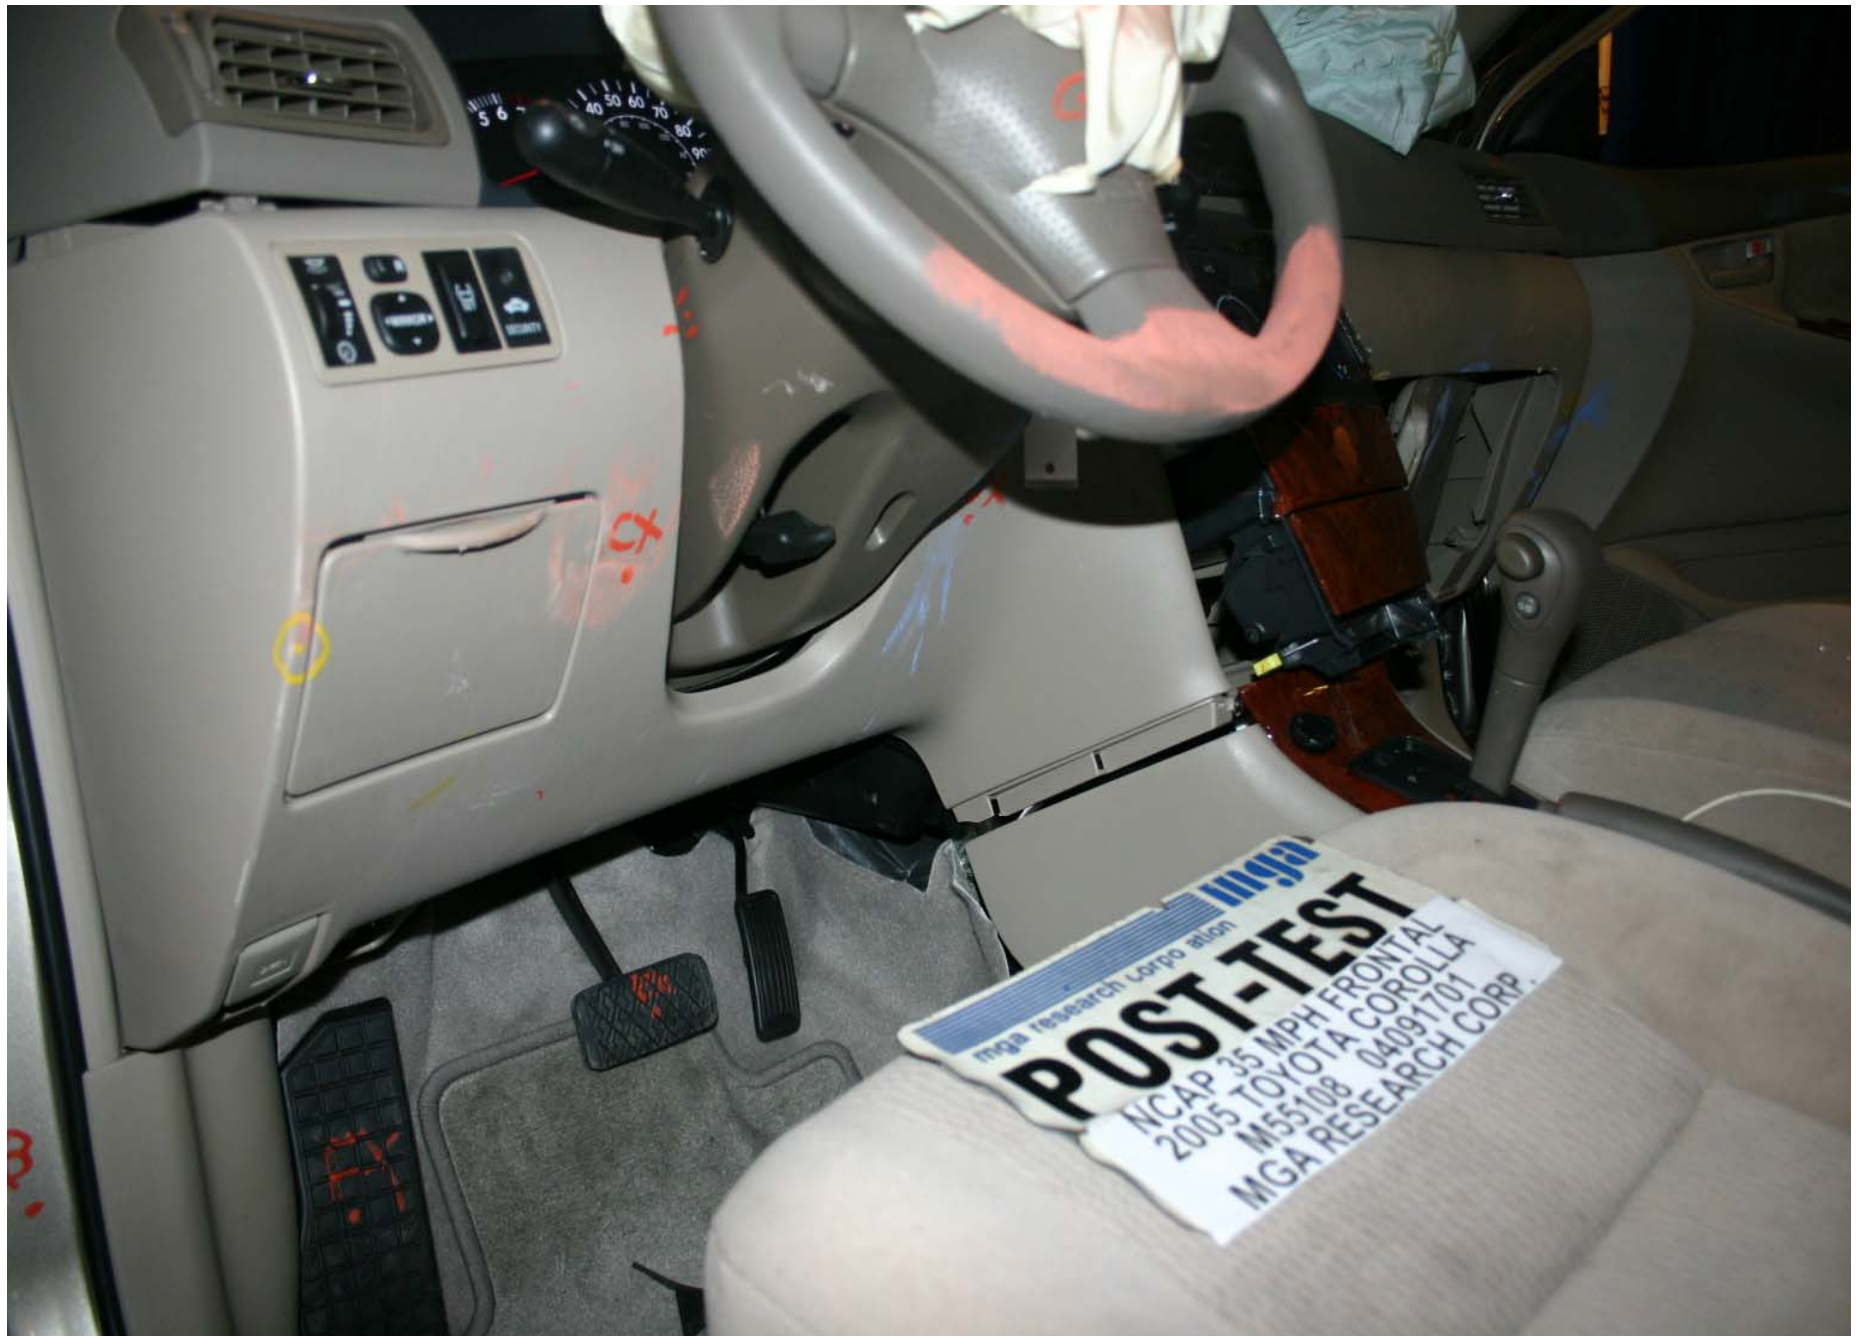
Post-Test Driver Dummy Knee Contact

| Description | Driver | Passenger |
|---|---|---|
| Left Knee Contact | Knee Bolster, Steering Column | Glove Box |
