**REPORT NUMBER: NCAP-MGA-2005-002**

**NEW CAR ASSESSMENT PROGRAM  
FRONTAL BARRIER IMPACT TEST**

**TOYOTA MOTOR CORPORATION  
2005 Toyota Corolla  
NHTSA NUMBER: M55108**

**PREPARED BY:  
MGA RESEARCH CORPORATION  
5000 WARREN ROAD  
BURLINGTON, WI 53105**

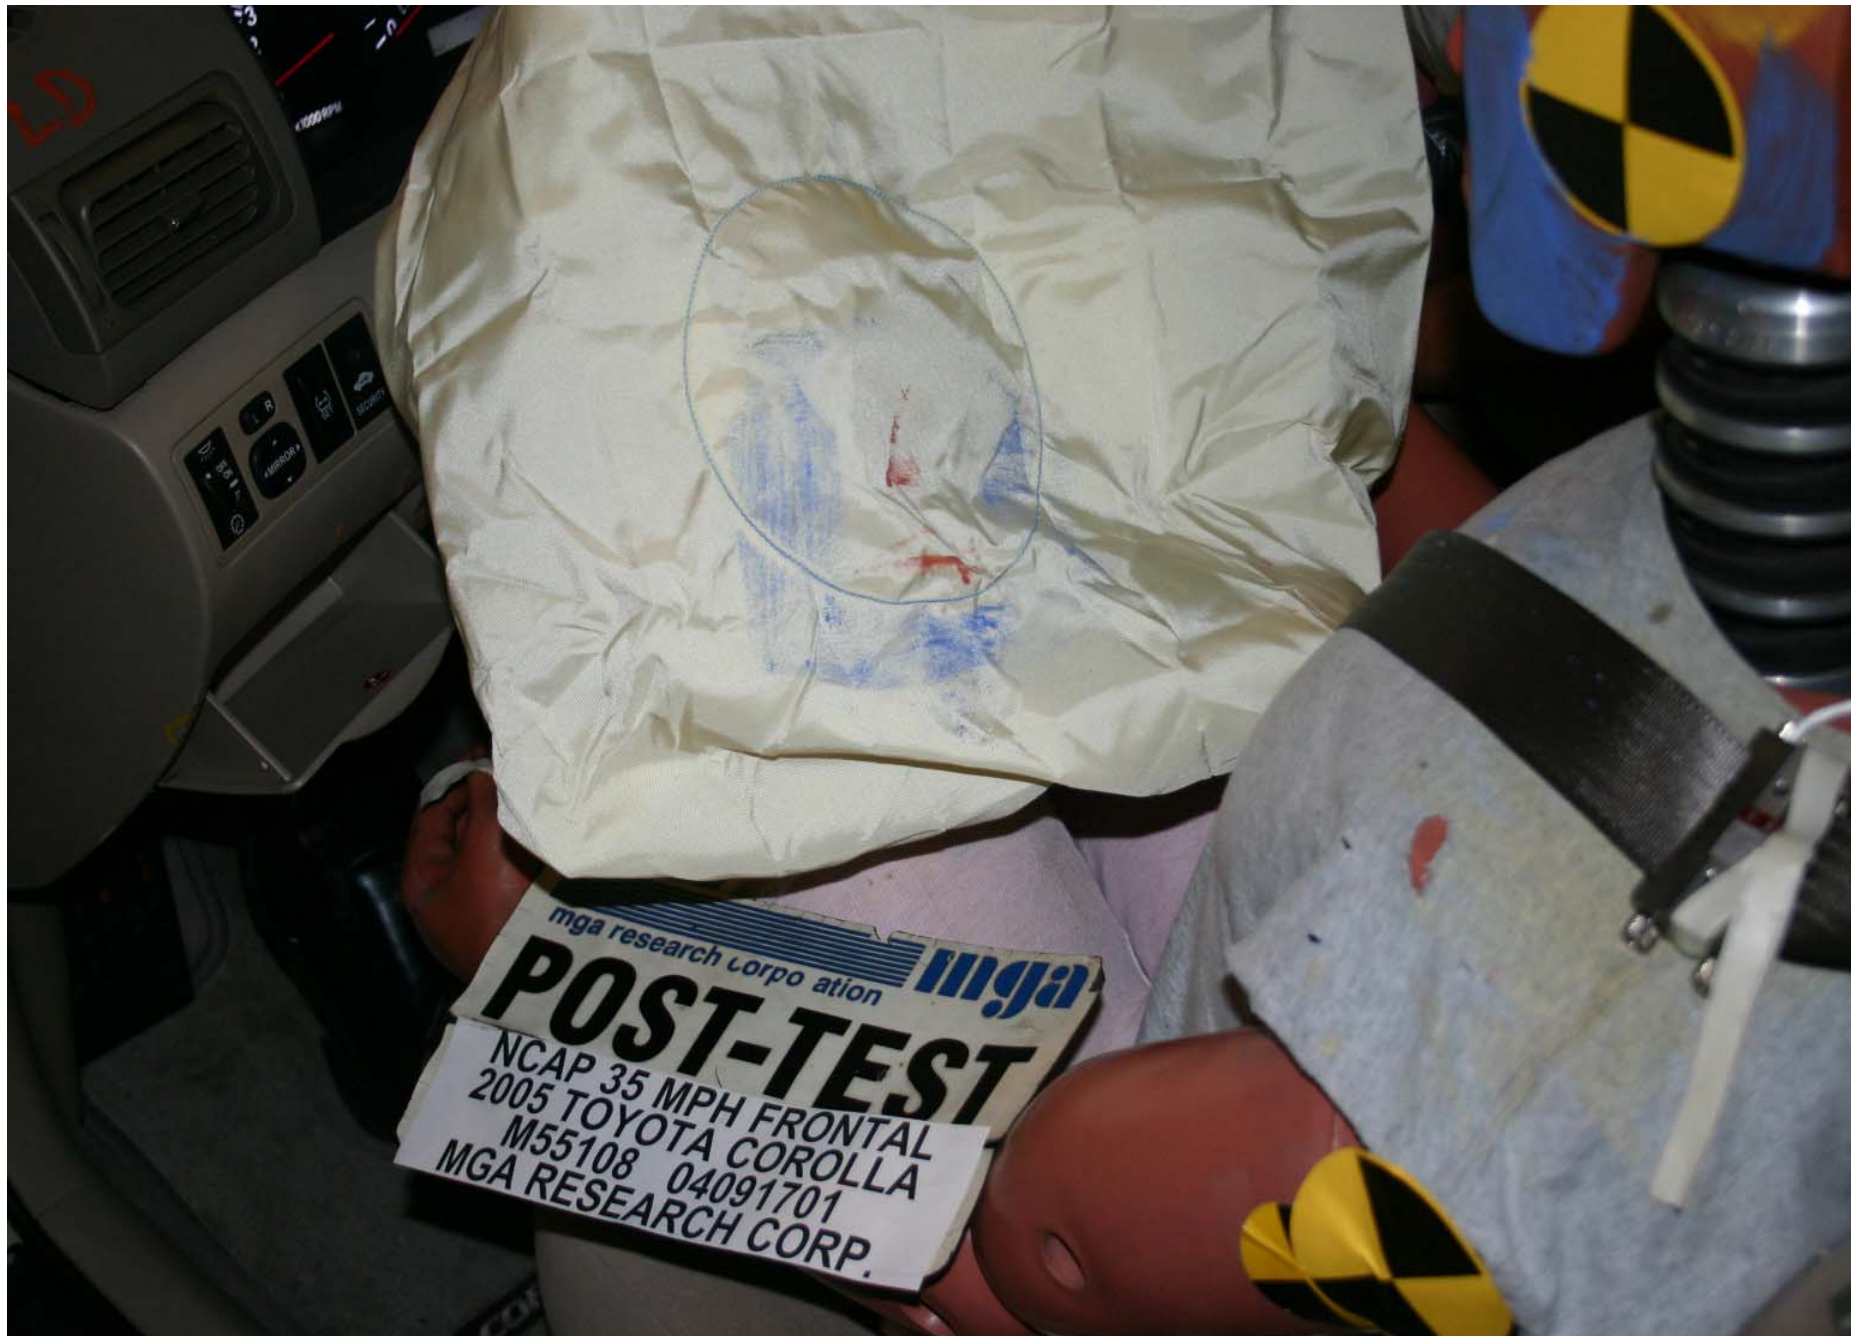
Post-Test Driver Dummy Airbag Contact

The driver's head, chest, and abdomen contacted the airbag. The driver's head also contacted the headrest. The driver's knees contacted the bolster and the steering column. The passenger's head, chest and abdomen contacted the airbag. The passenger's head contacted the headrest. The passenger's knees contacted the glove box.

| Description | Driver | Passenger |
|---|---|---|
| Chest Contact | Airbag | Airbag |

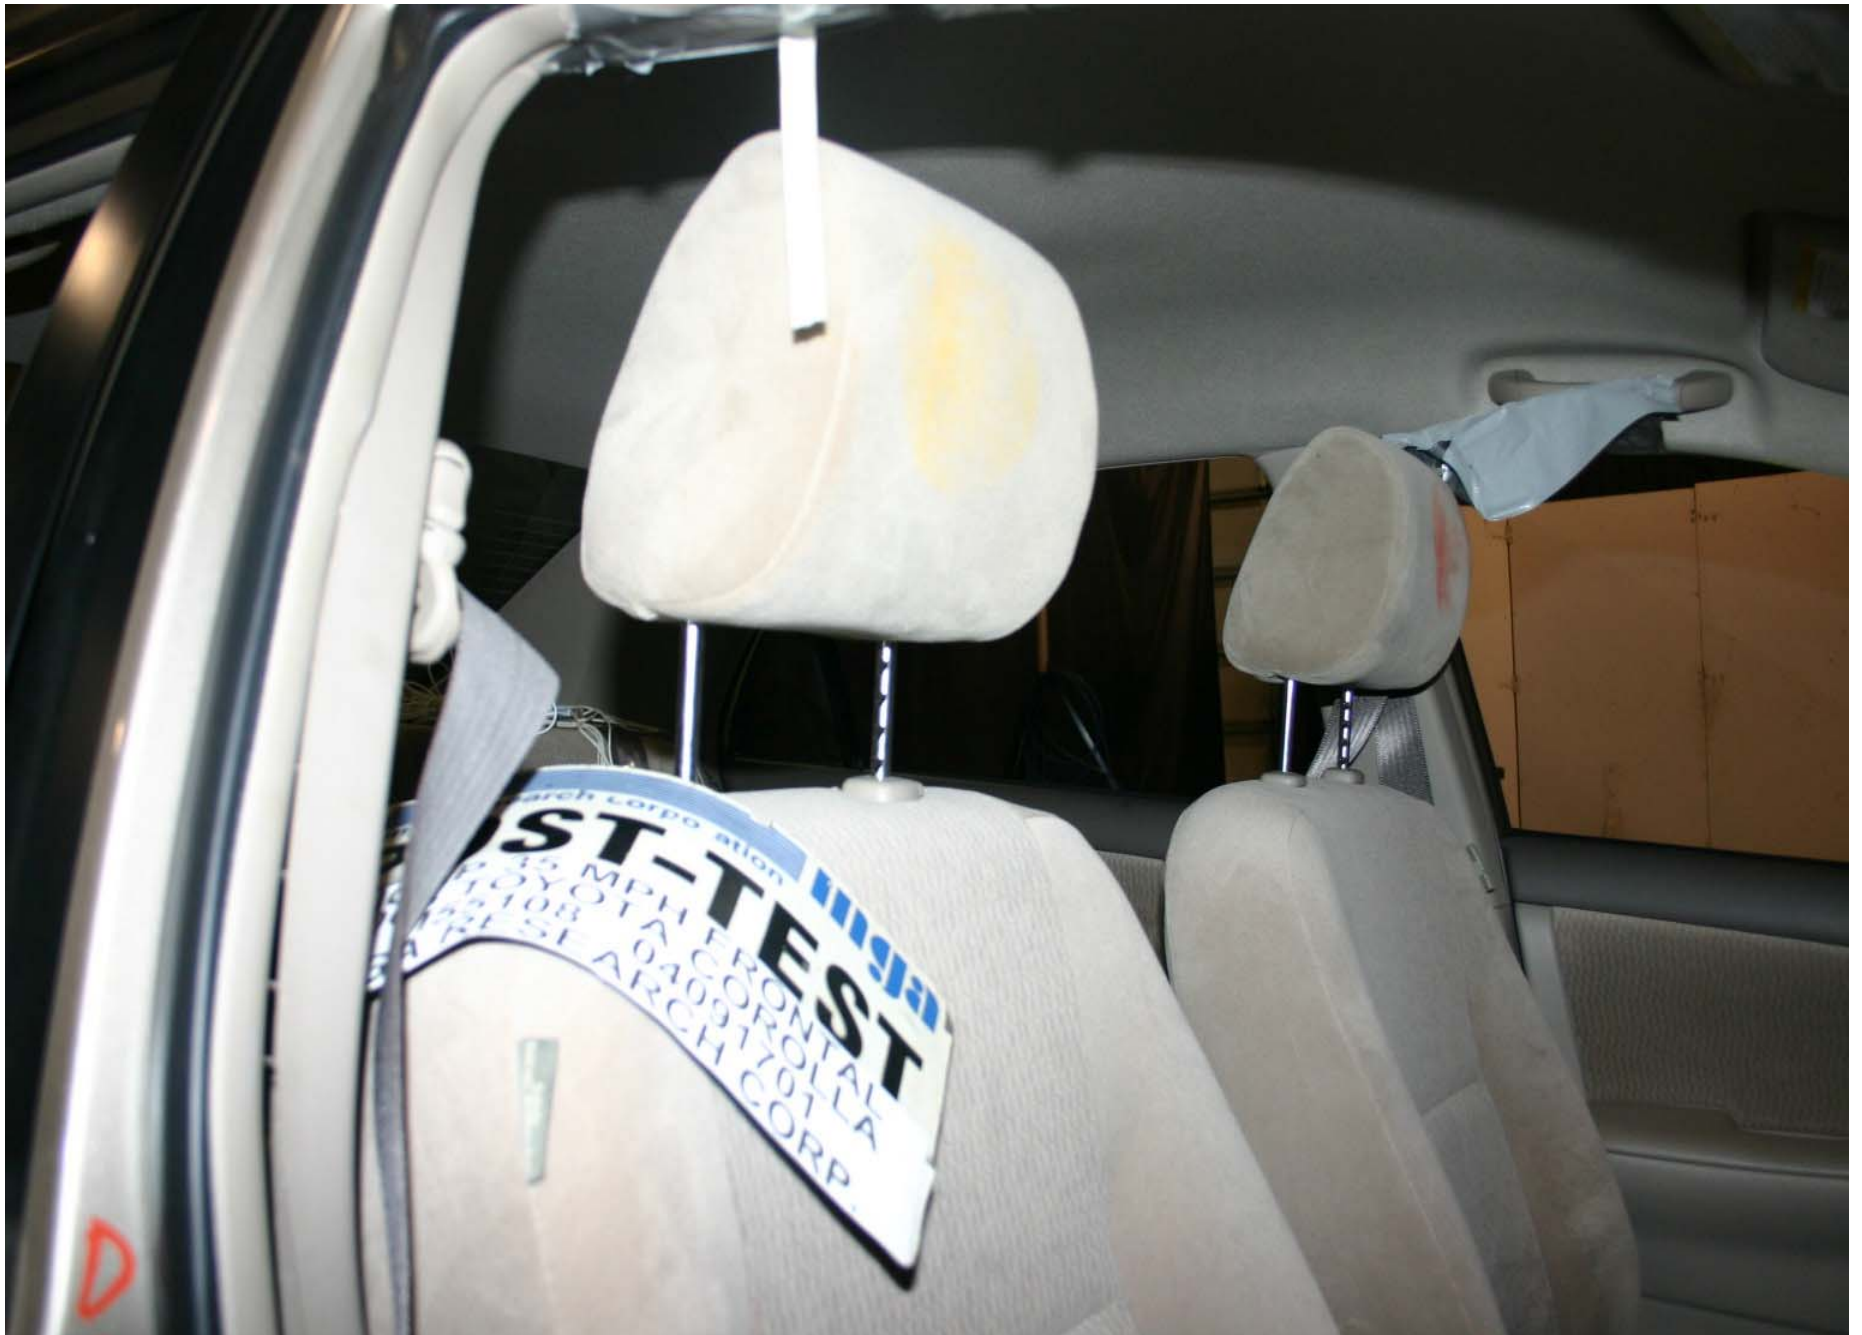
Post-Test Passenger Dummy Head Contact

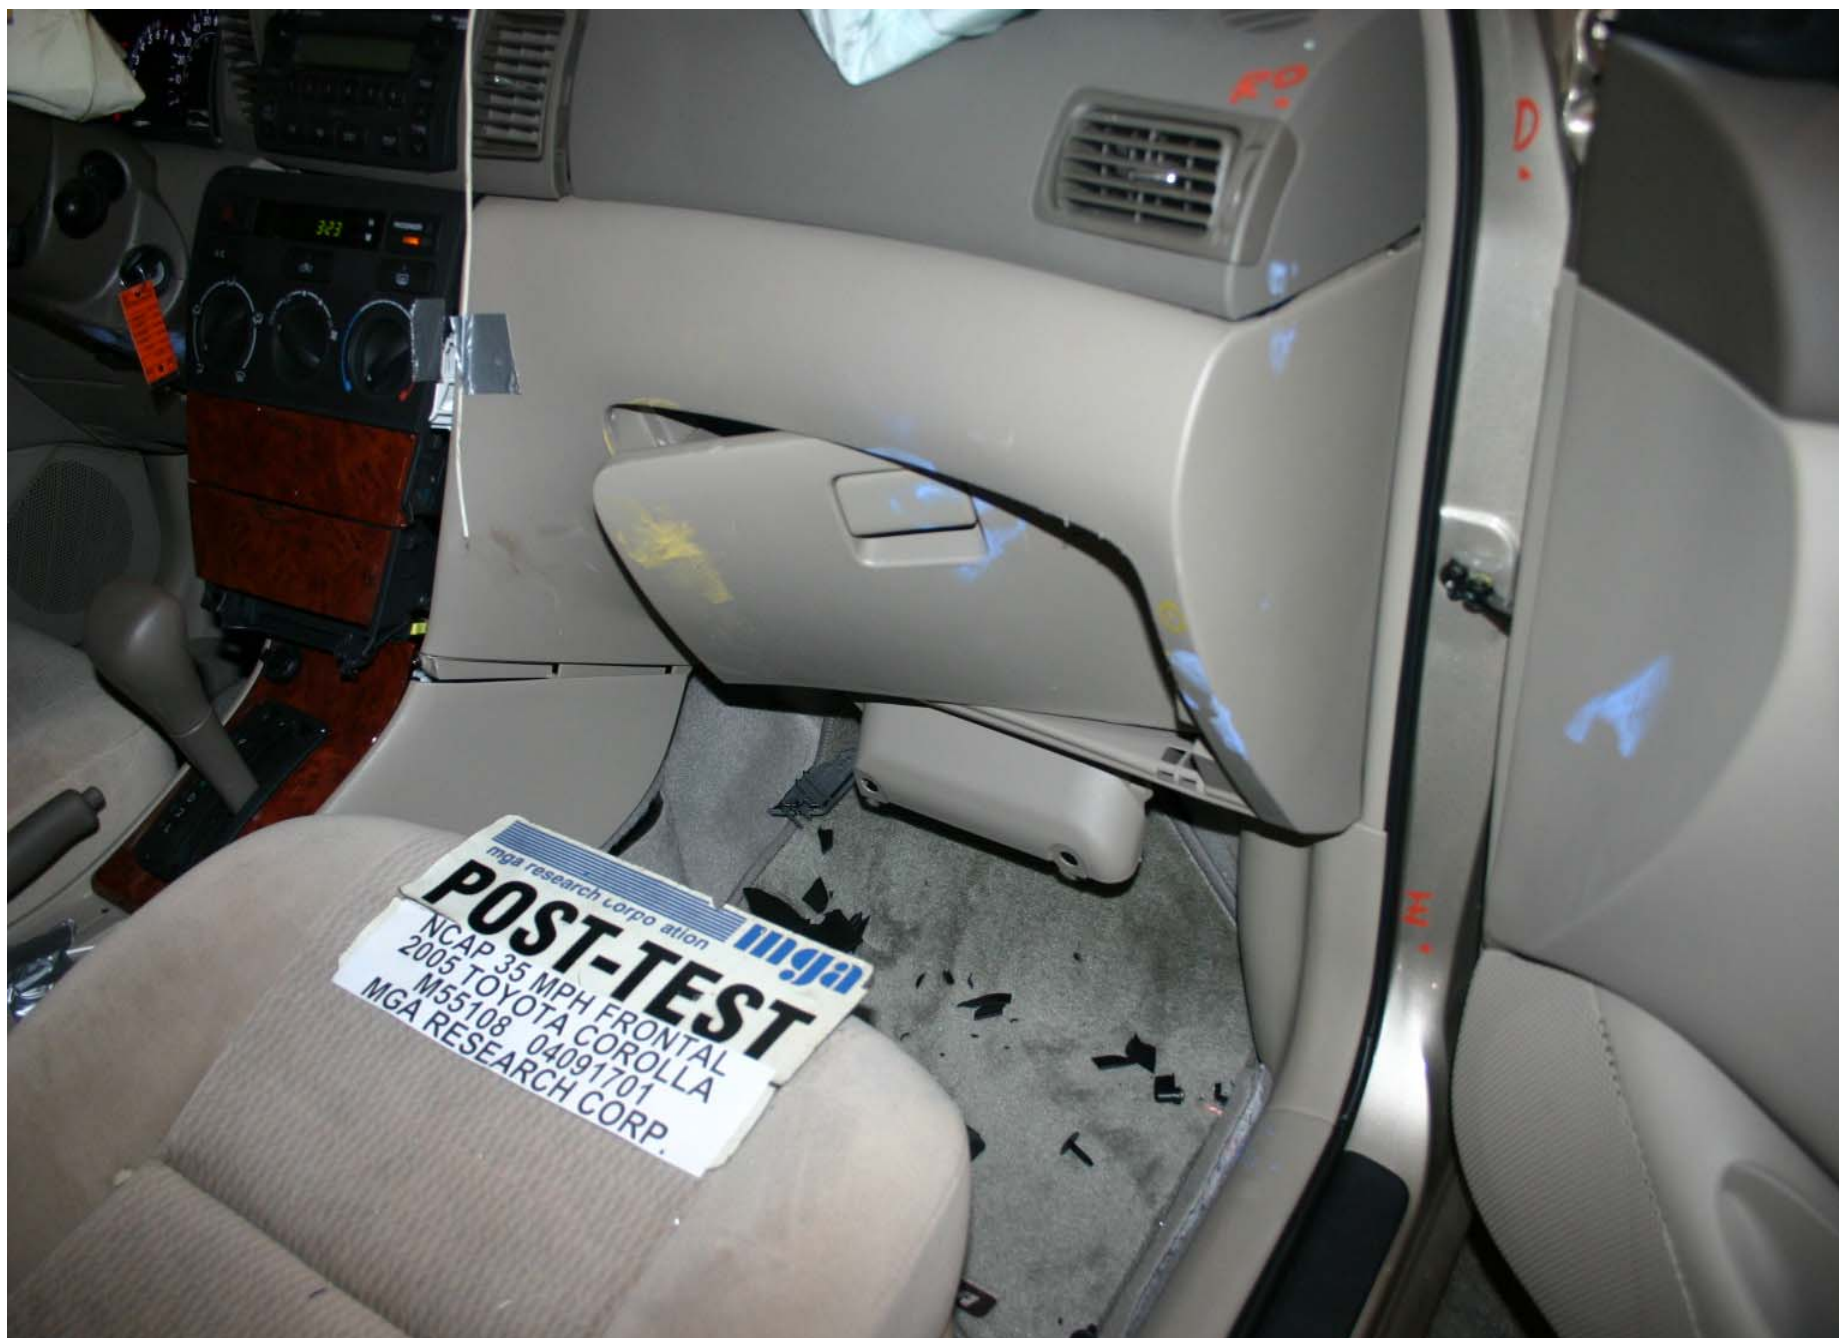
Post-Test Passenger Dummy Knee Contact

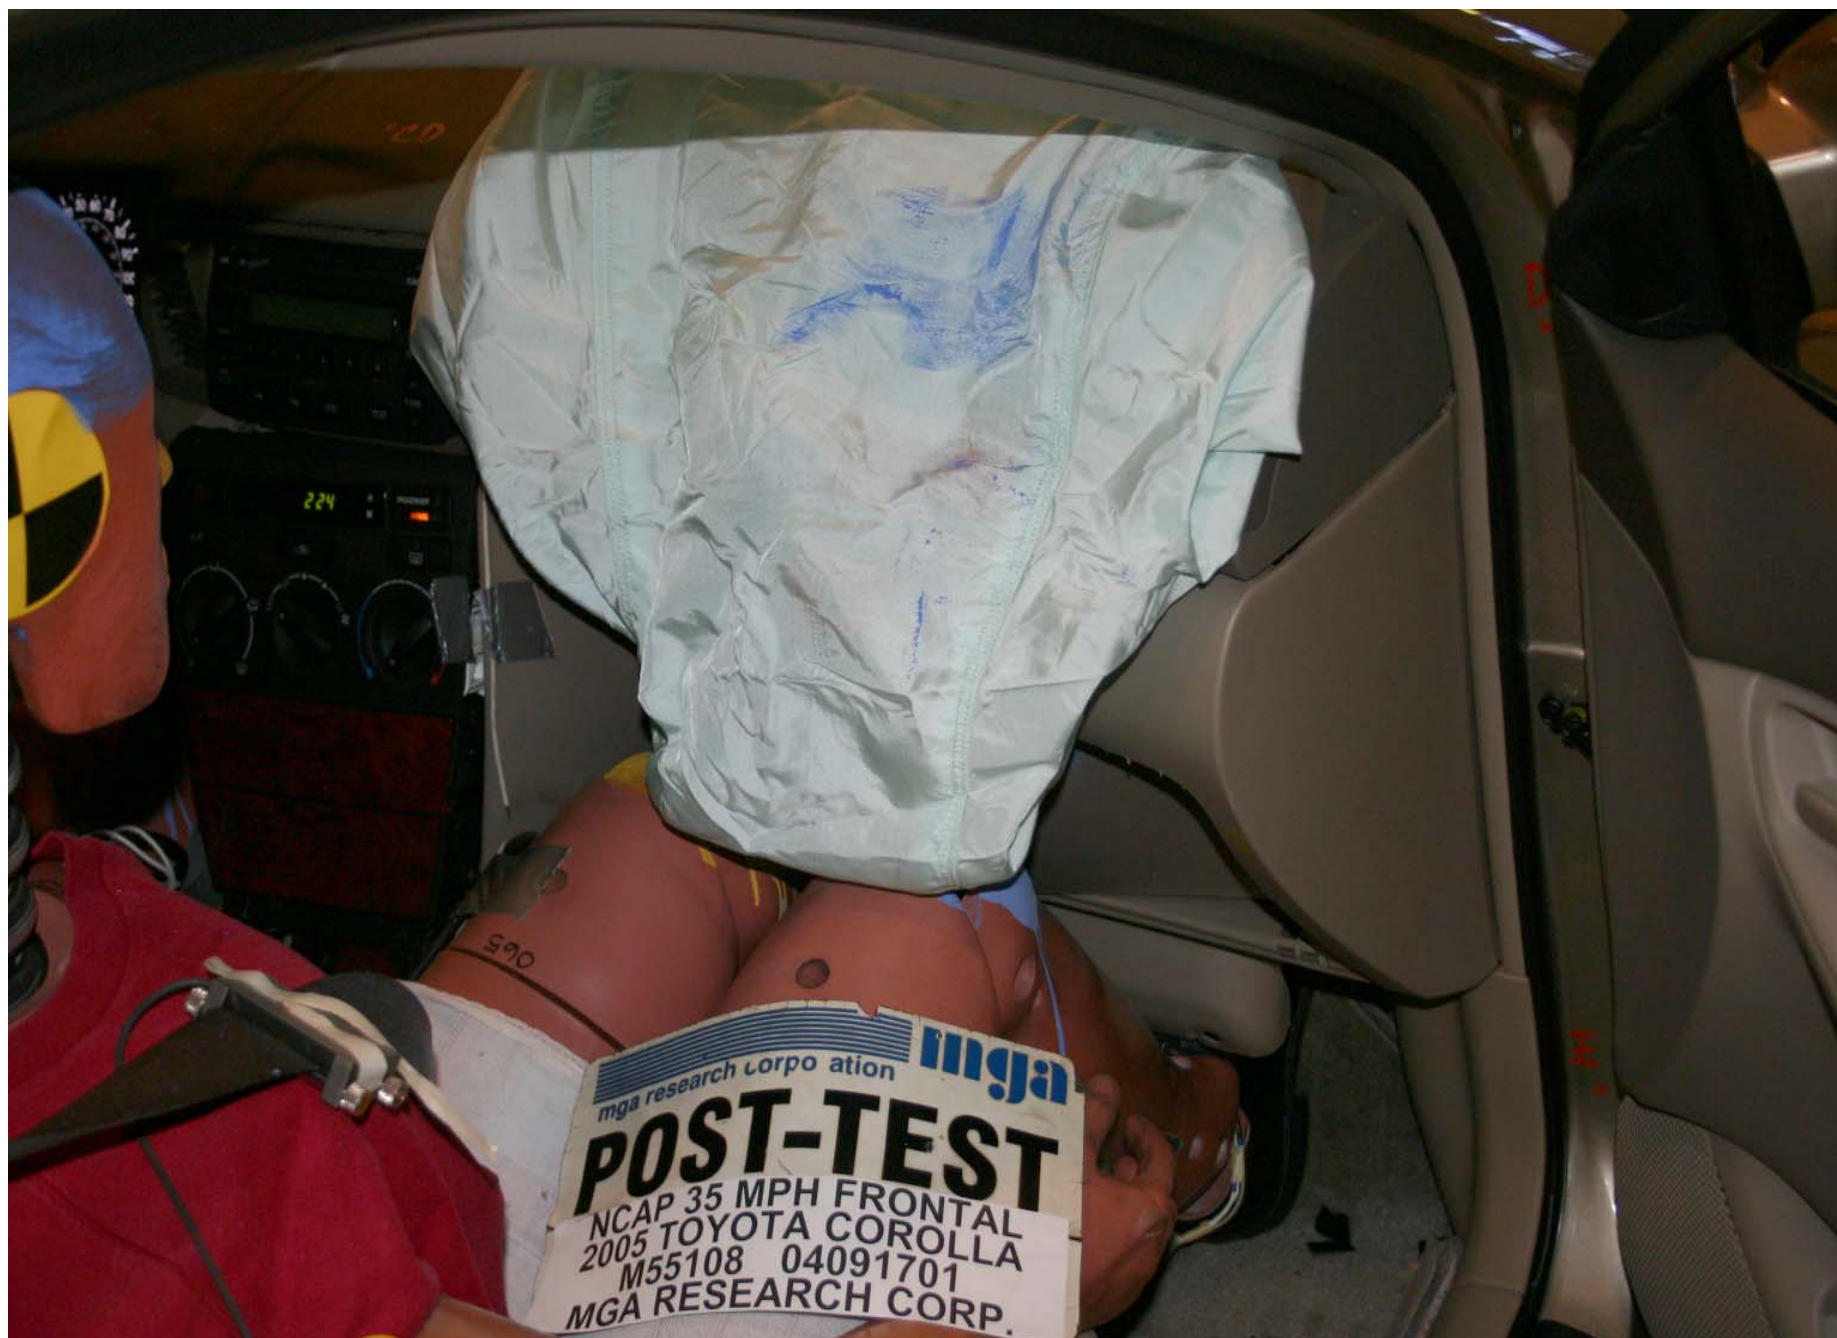
Post-Test Passenger Dummy Airbag Contact

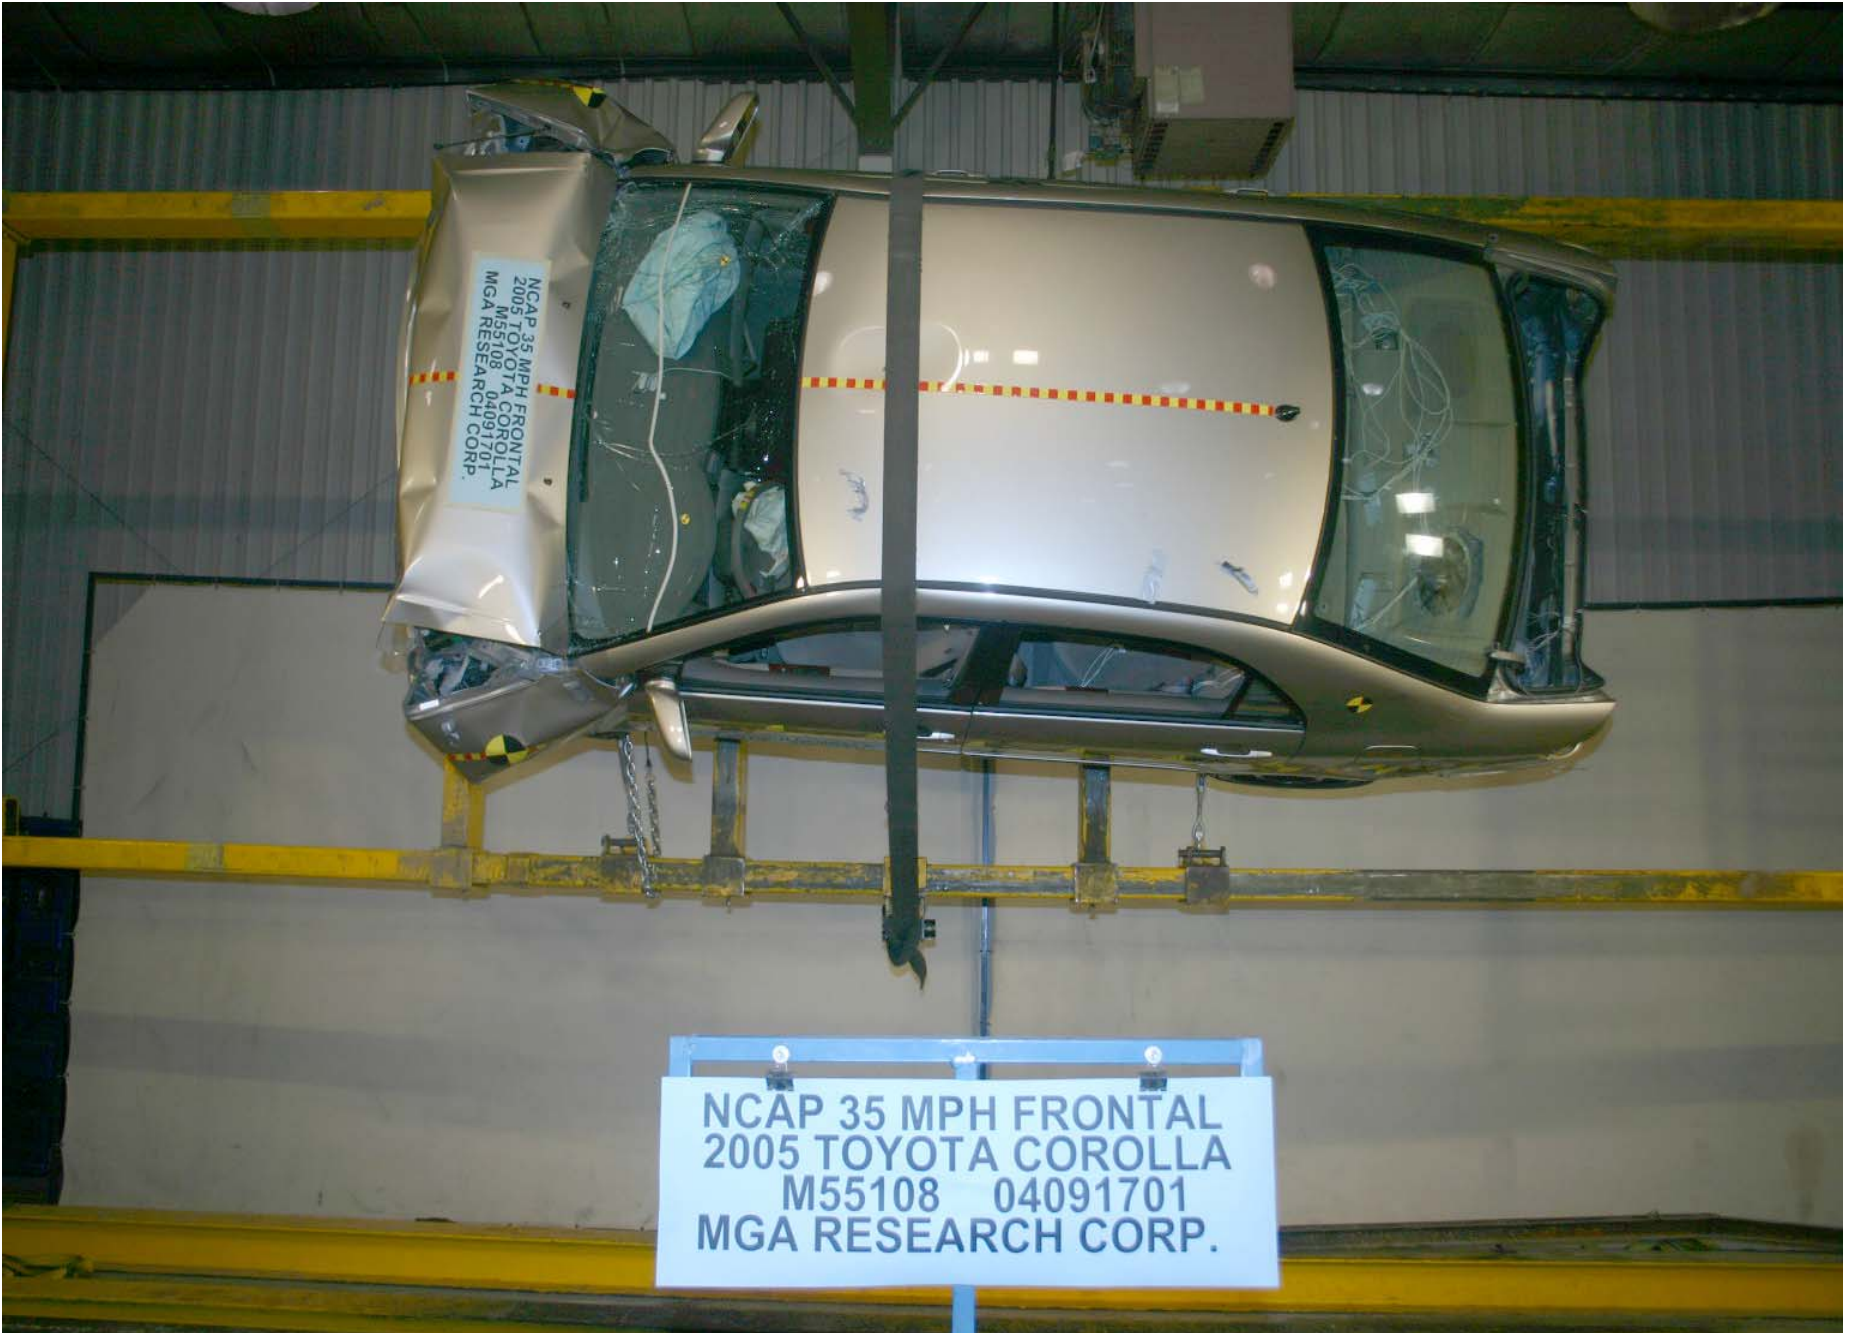
Rollover 90 Degrees

There was 100 percent windshield retention and no intrusion into the protected zone of the windshield during the event. There was no Stoddard Solvent leakage after the event or during any phase of the static rollover.

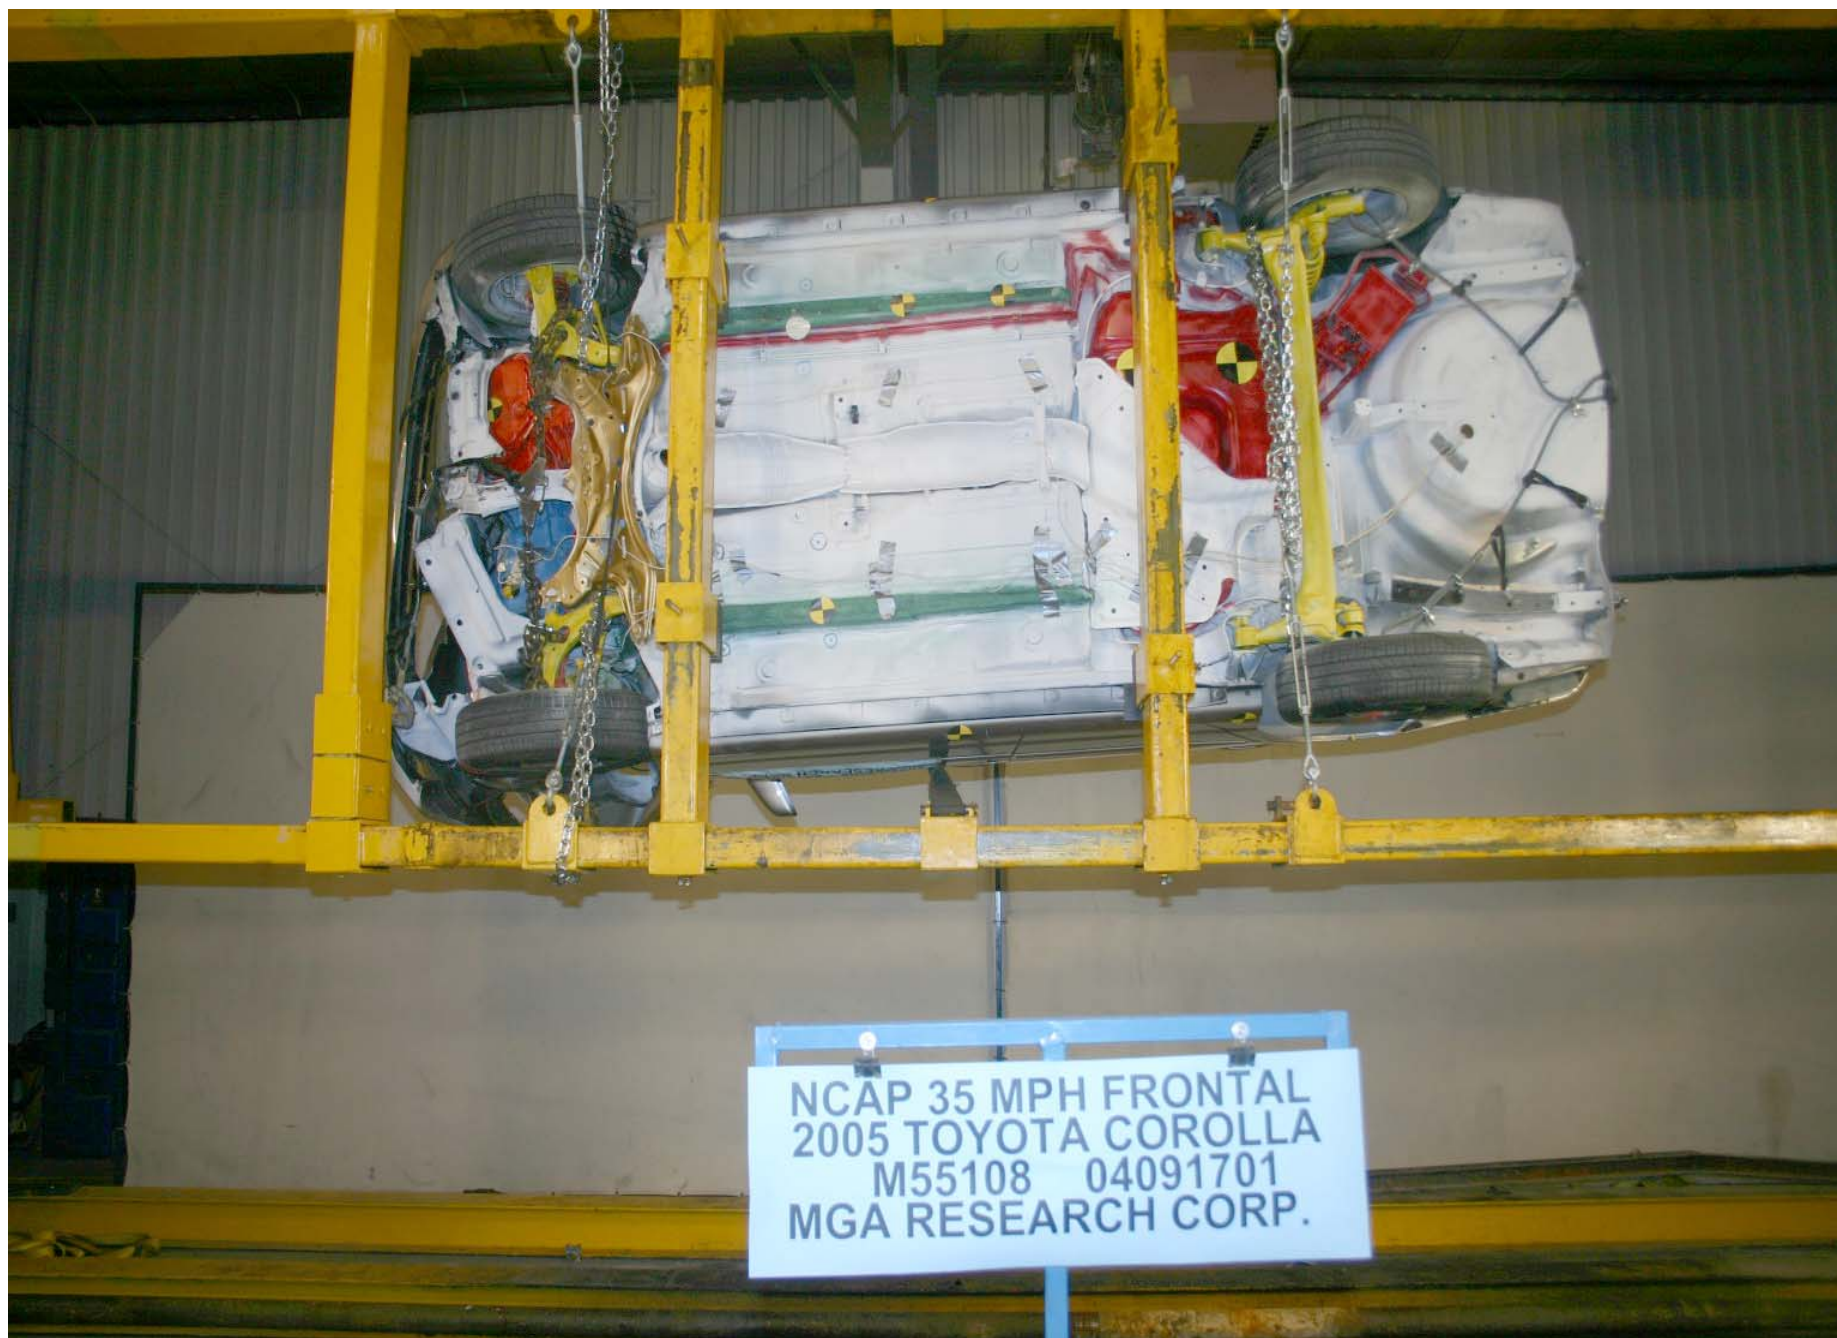
Rollover 270 Degrees

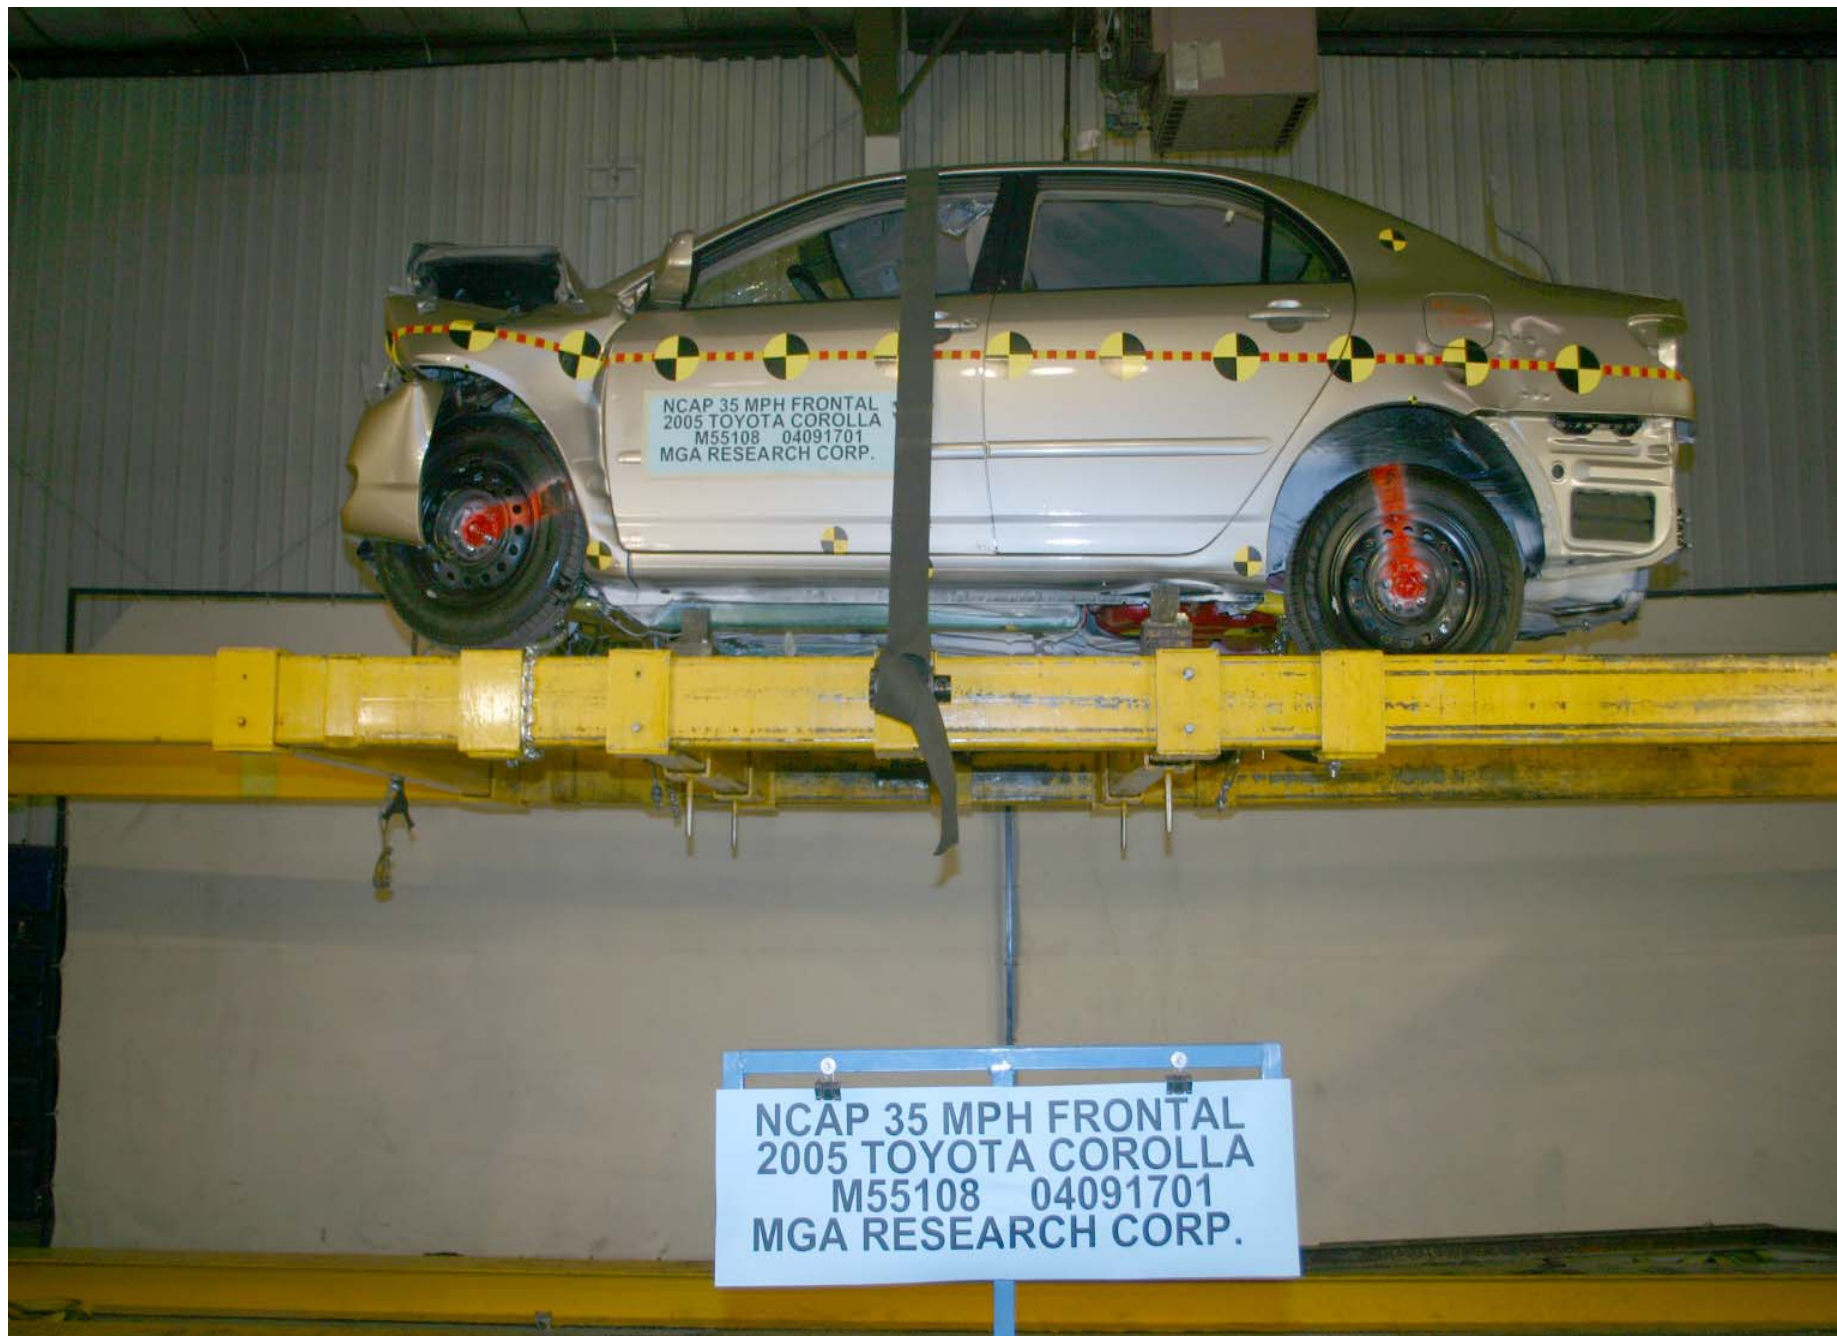
Rollover 360 Degrees
