**NEW CAR ASSESSMENT PROGRAM  
SIDE IMPACT TEST**

**Toyota Motor Manufacturing  
2005 Toyota Corolla Matrix  
NHTSA NUMBER: M55103**

**PREPARED BY:  
MGA RESEARCH CORPORATION  
5000 WARREN ROAD  
BURLINGTON, WI 53105**

**FINAL REPORT**

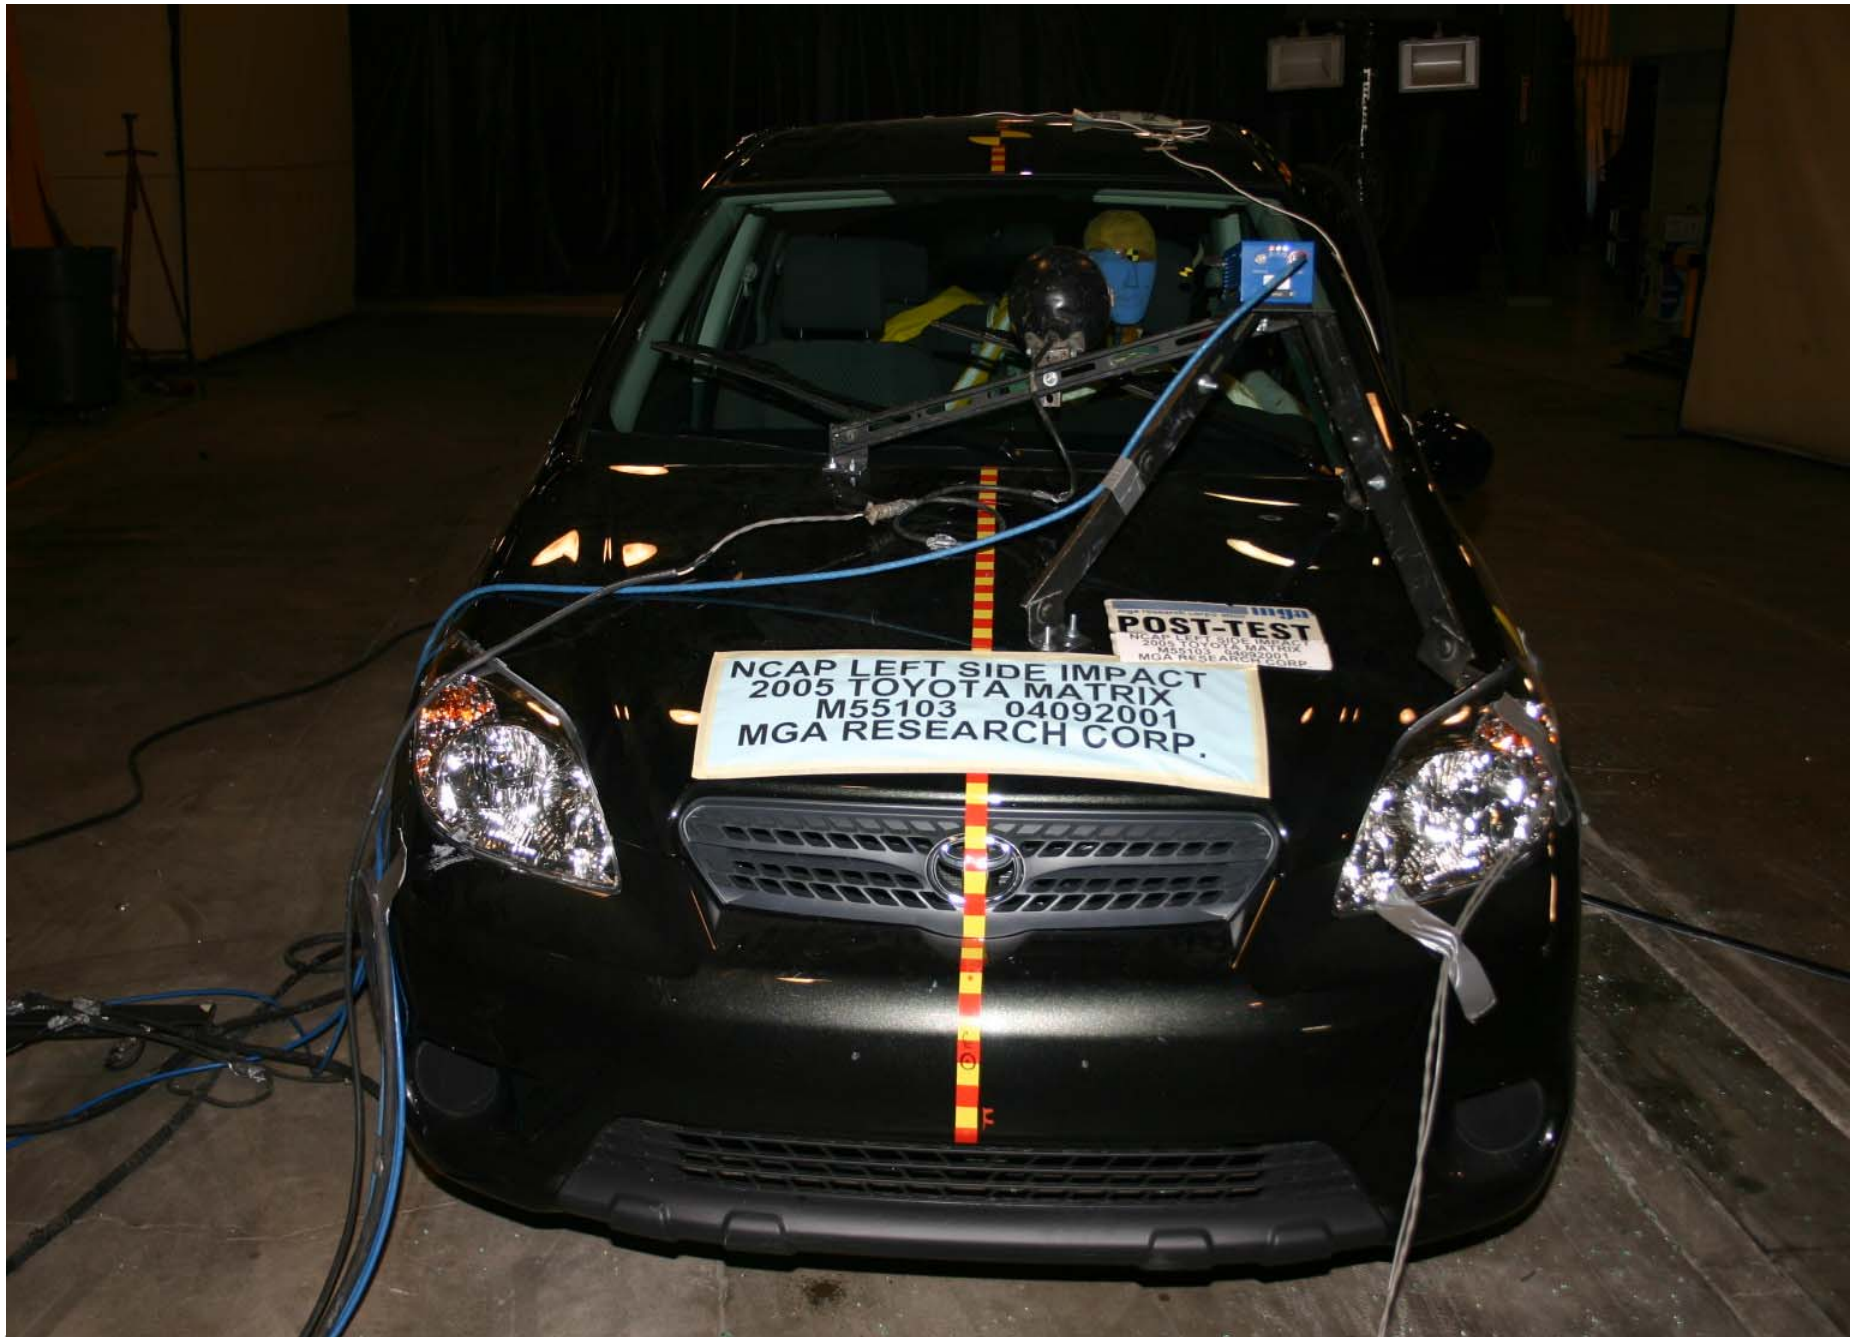
Post-Test Front View of Test Vehicle

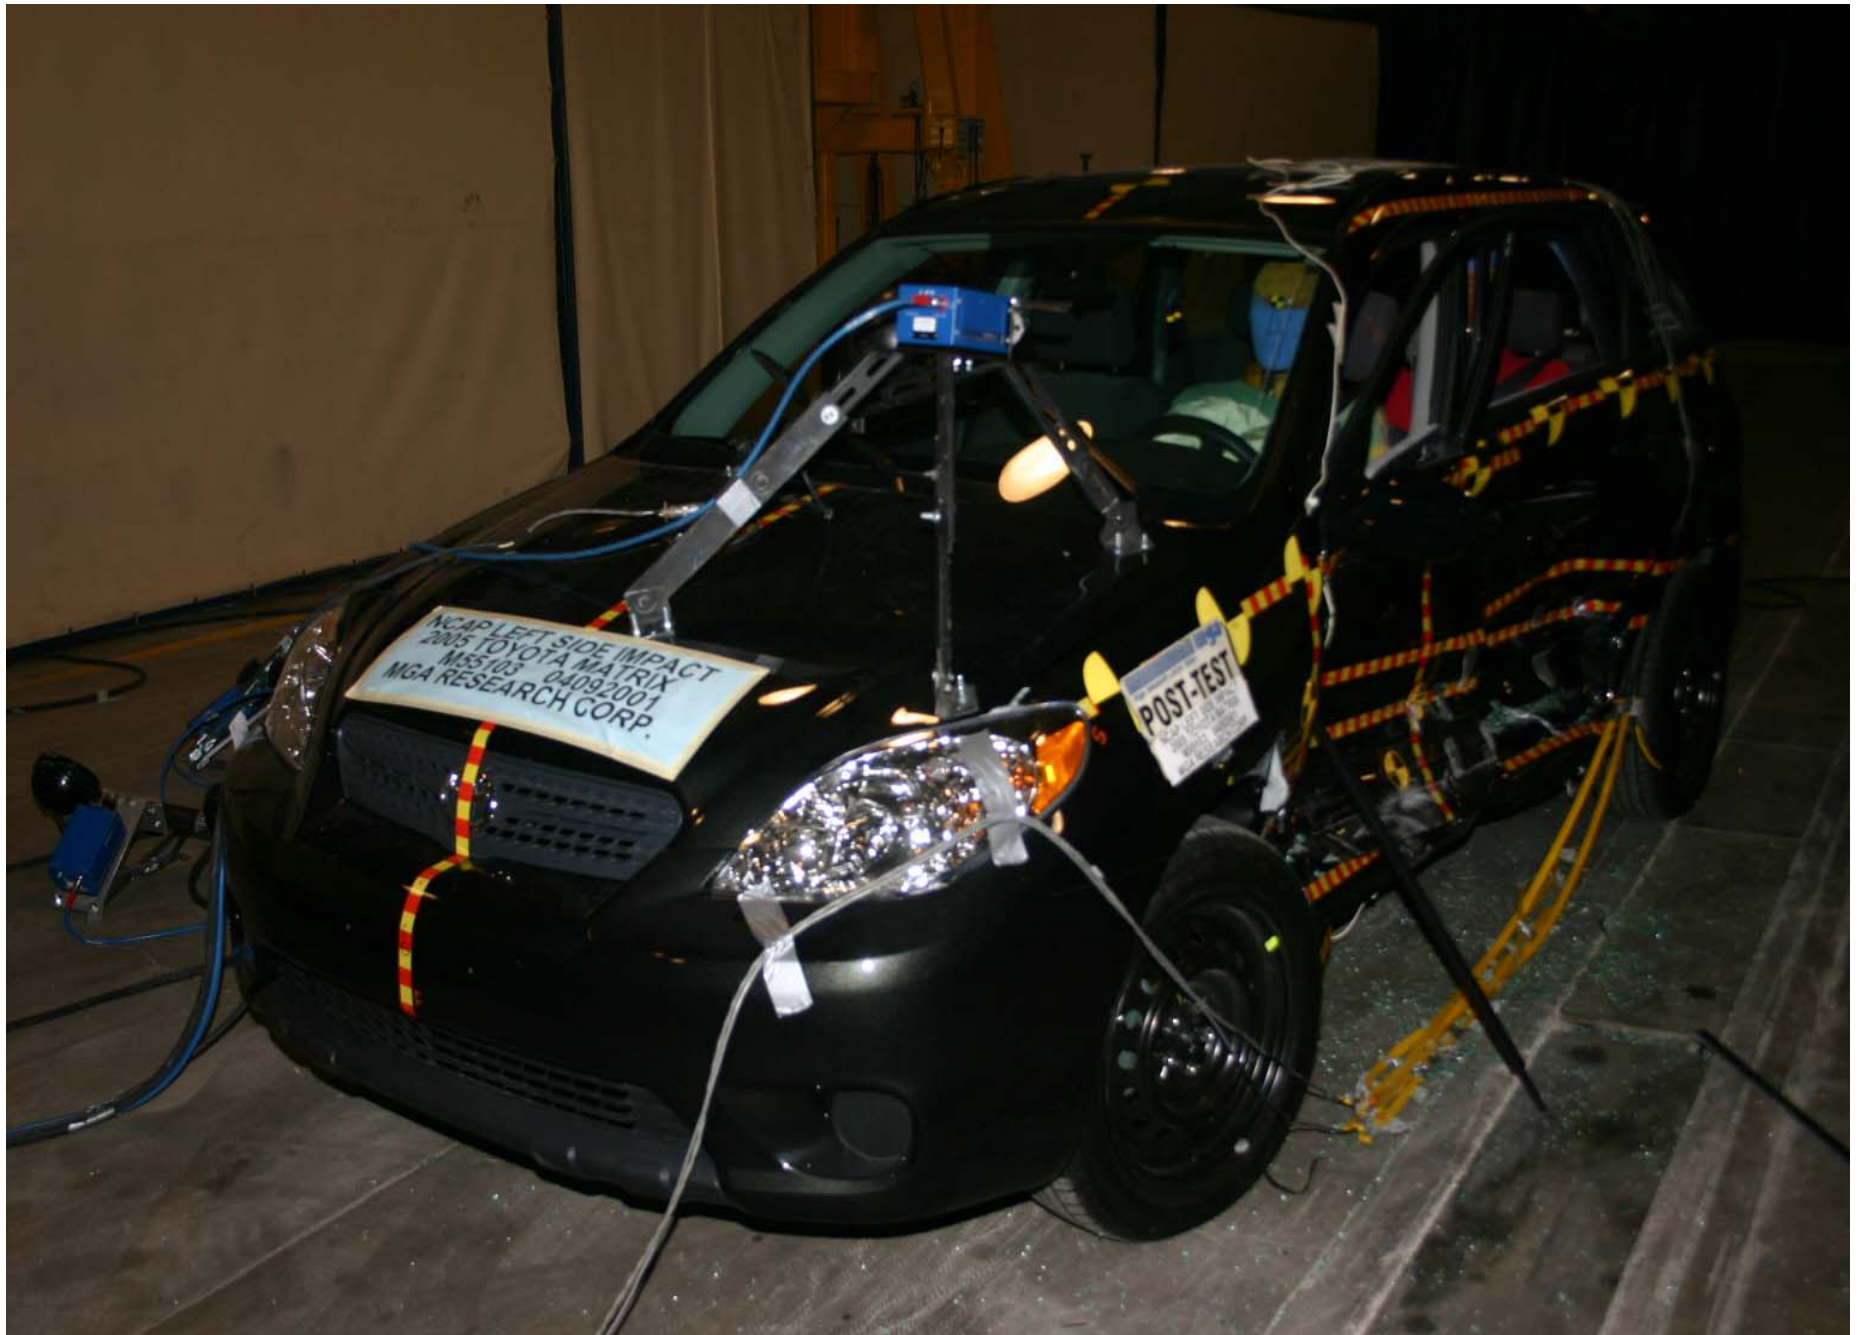
Post-Test Left Front  $\frac{3}{4}$  View of Test Vehicle

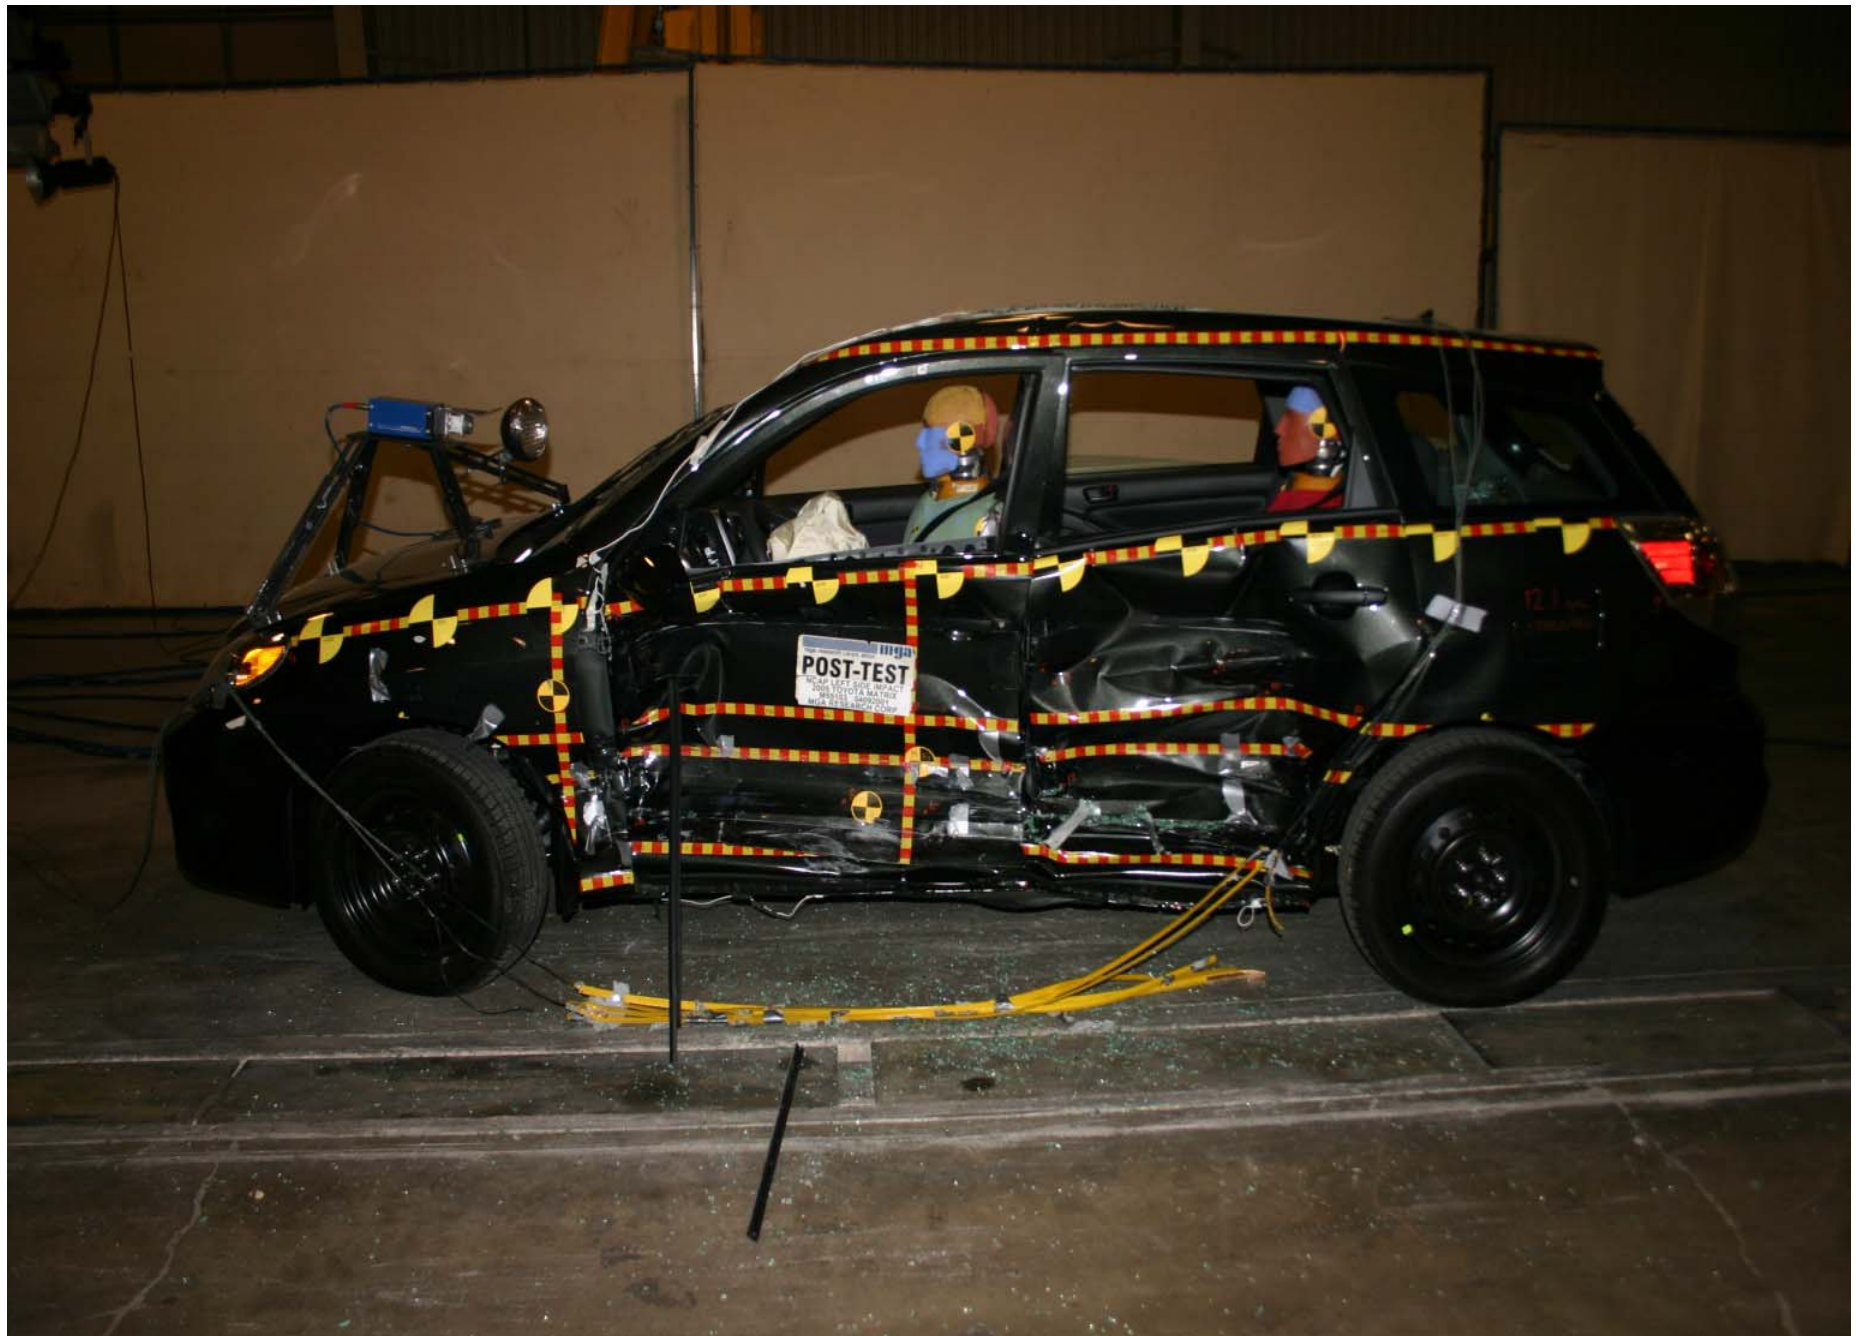
Post-Test Left Side View of Test Vehicle

The test vehicle sustained a maximum static crush of 283 mm at level 2, 1200 mm rearward of the left vertical impact point. The driver and passenger SID/HIII's, Serial Nos. 904 and 271 respectively, were calibrated just prior to this test. The SID/HIII's injury criteria are summarized as follows:

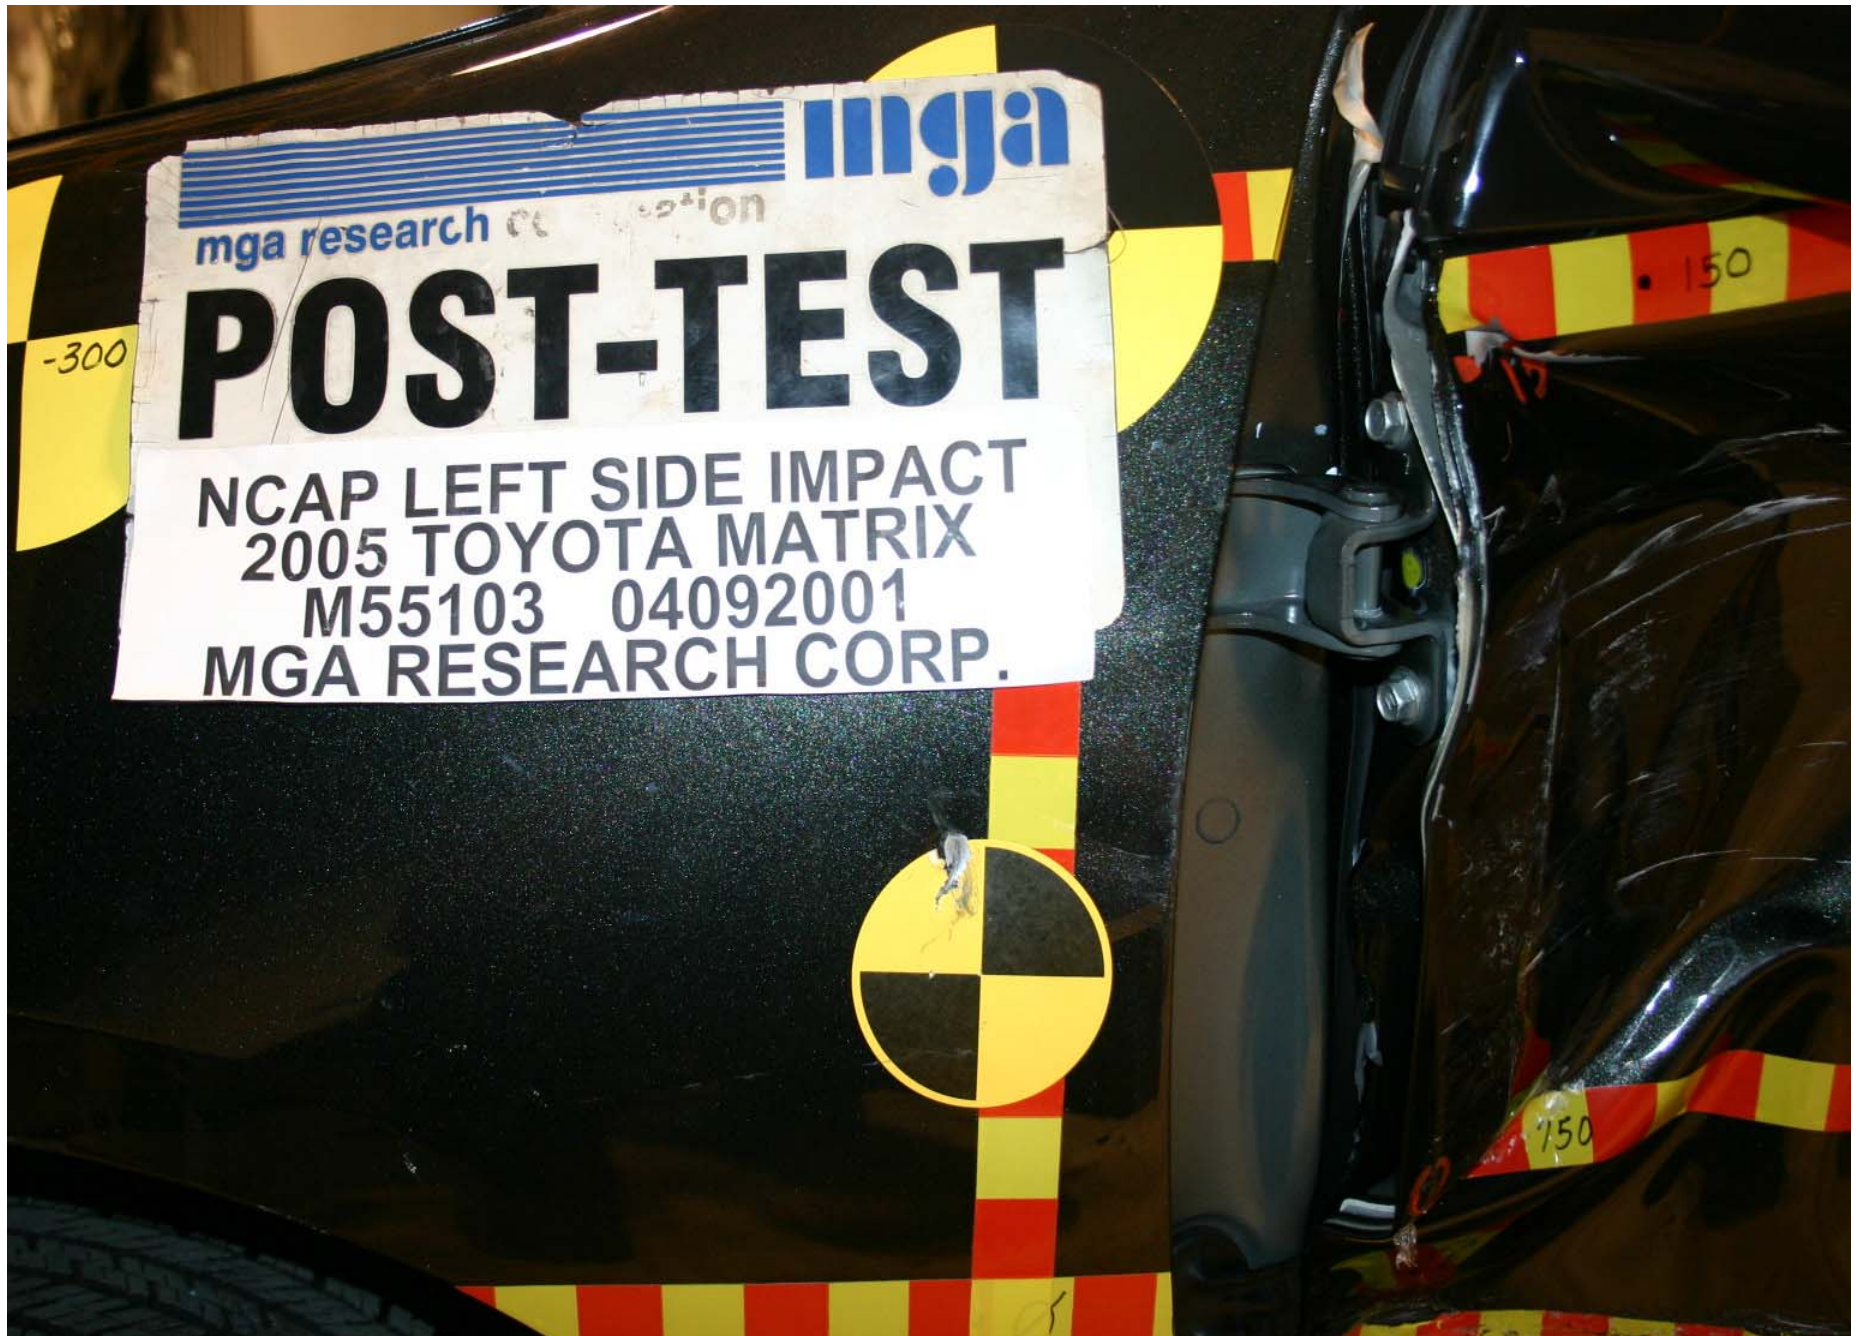
Post-Test Impact Point on Vehicle

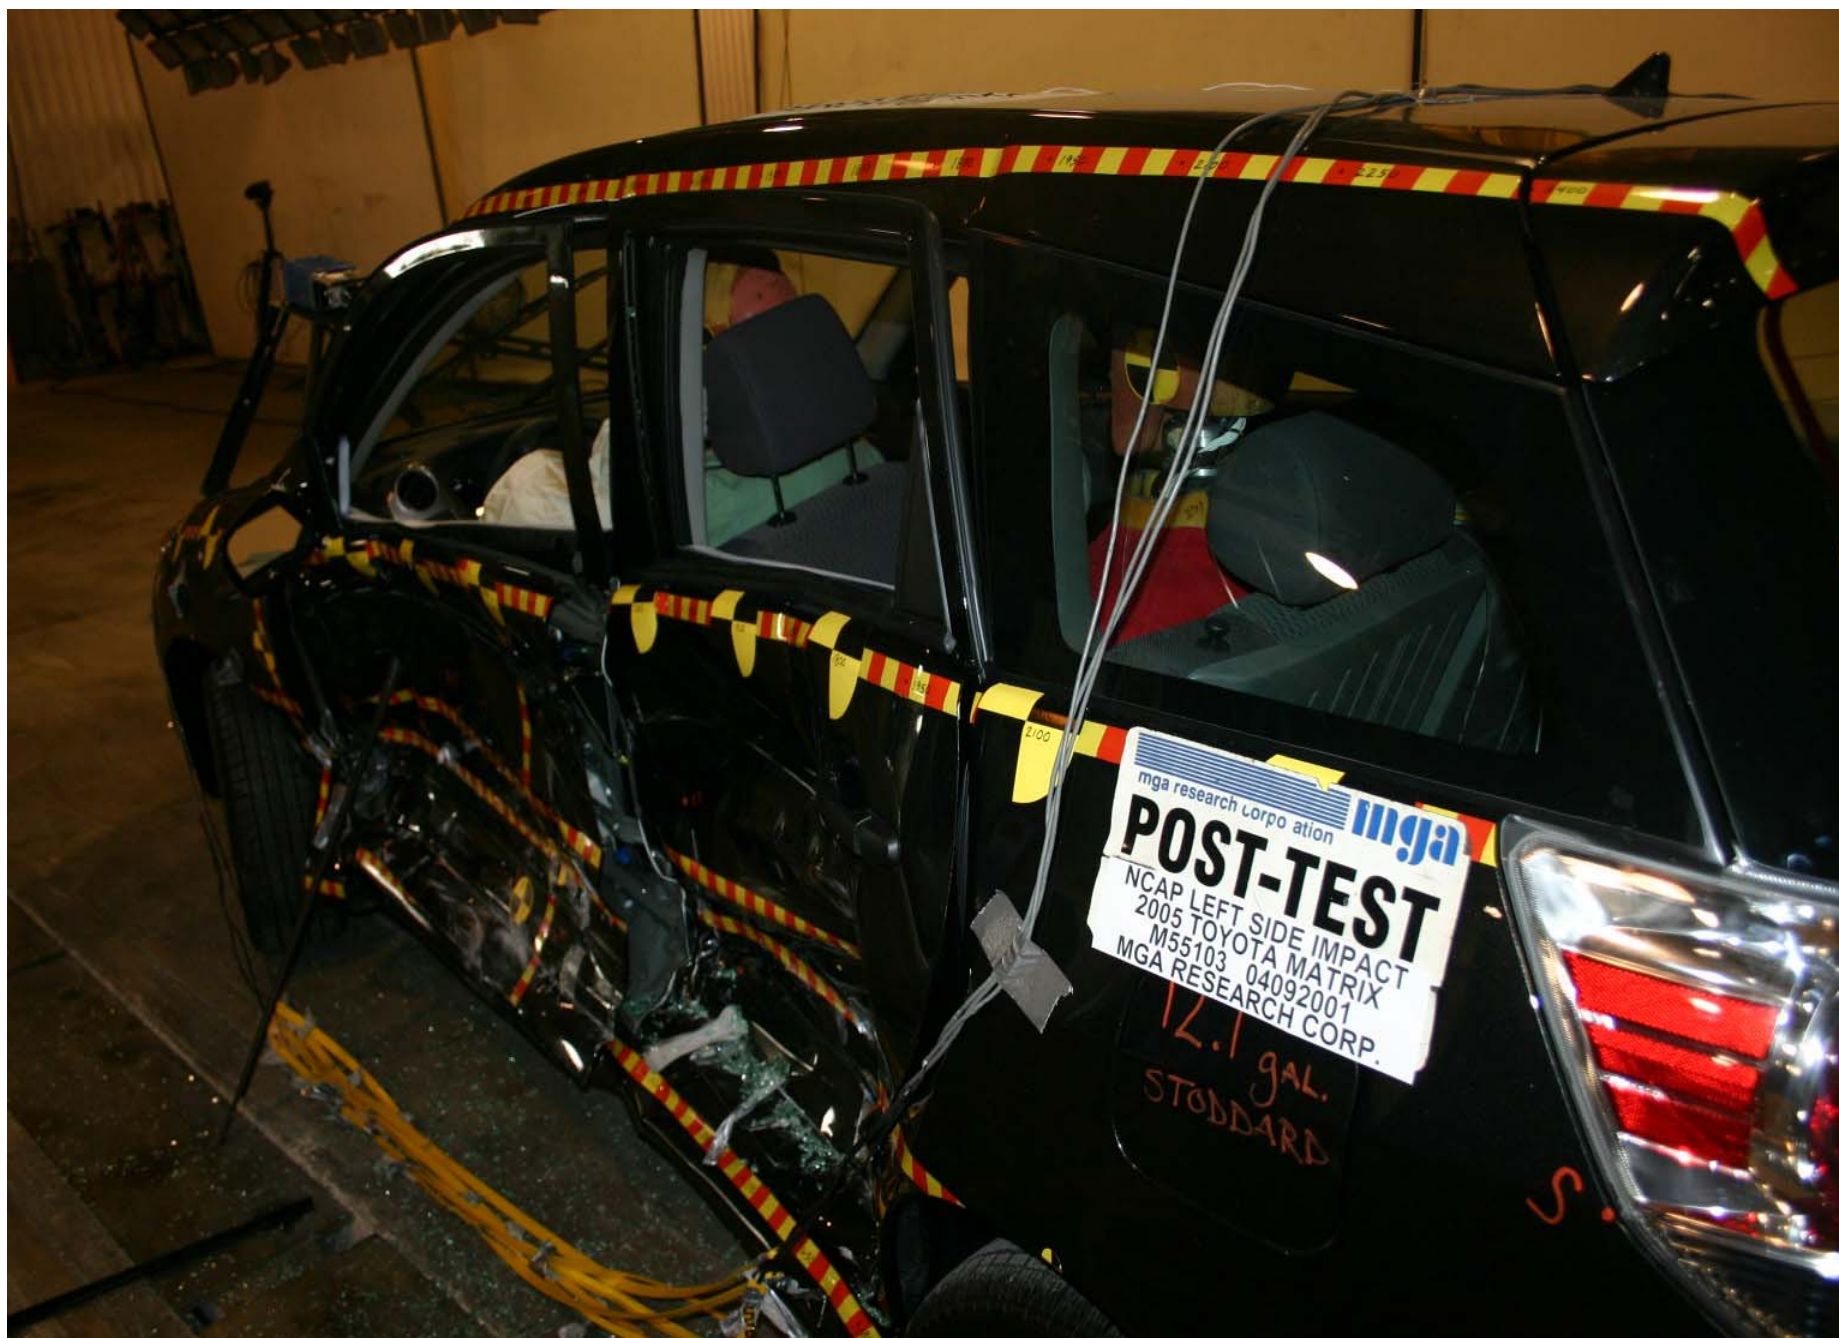
Post-Test Three-Quarter View of Left Side Doors of Test Vehicle

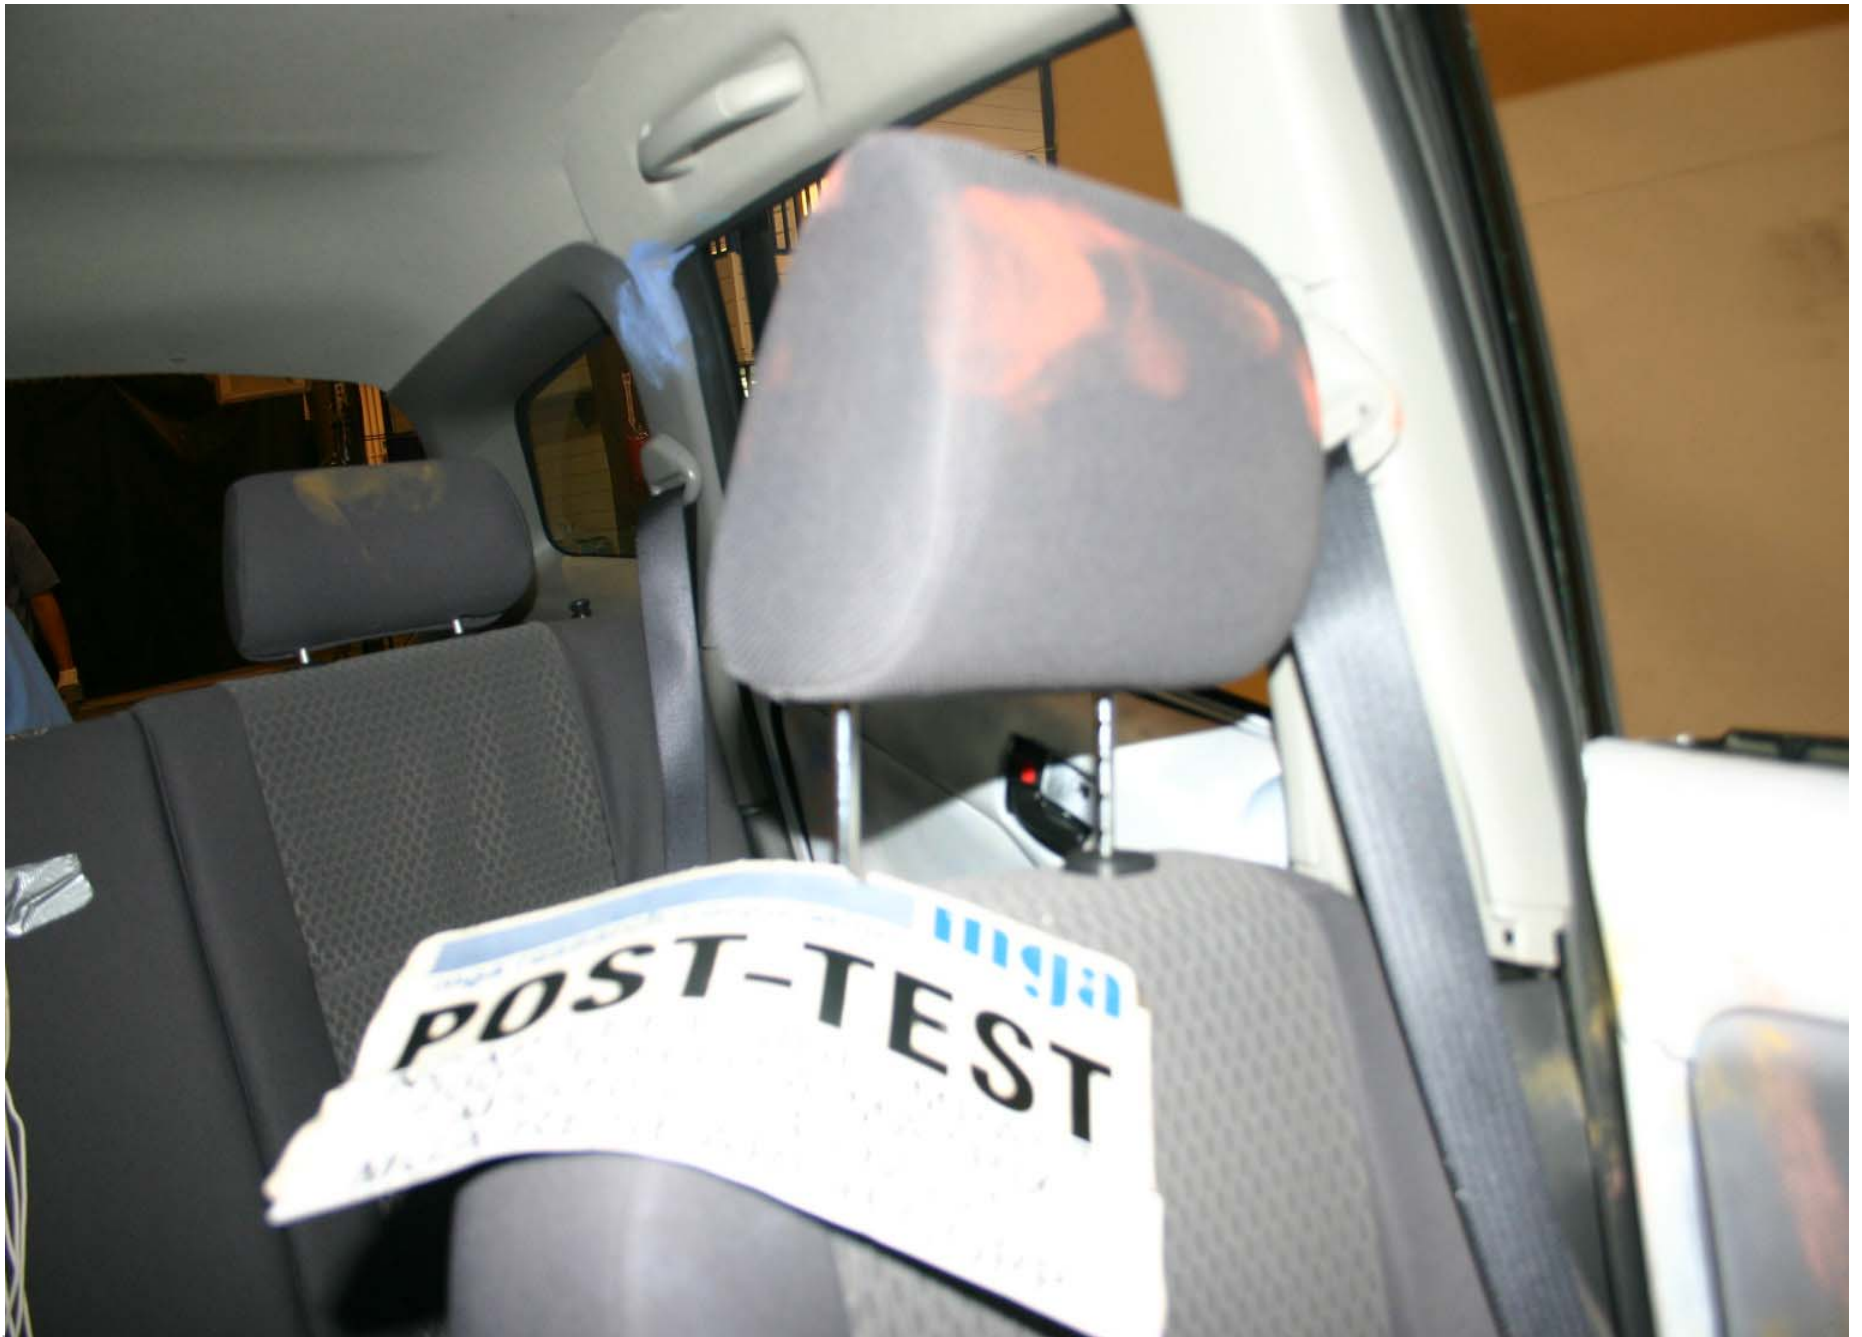
Post-Test Driver Dummy Head Contact

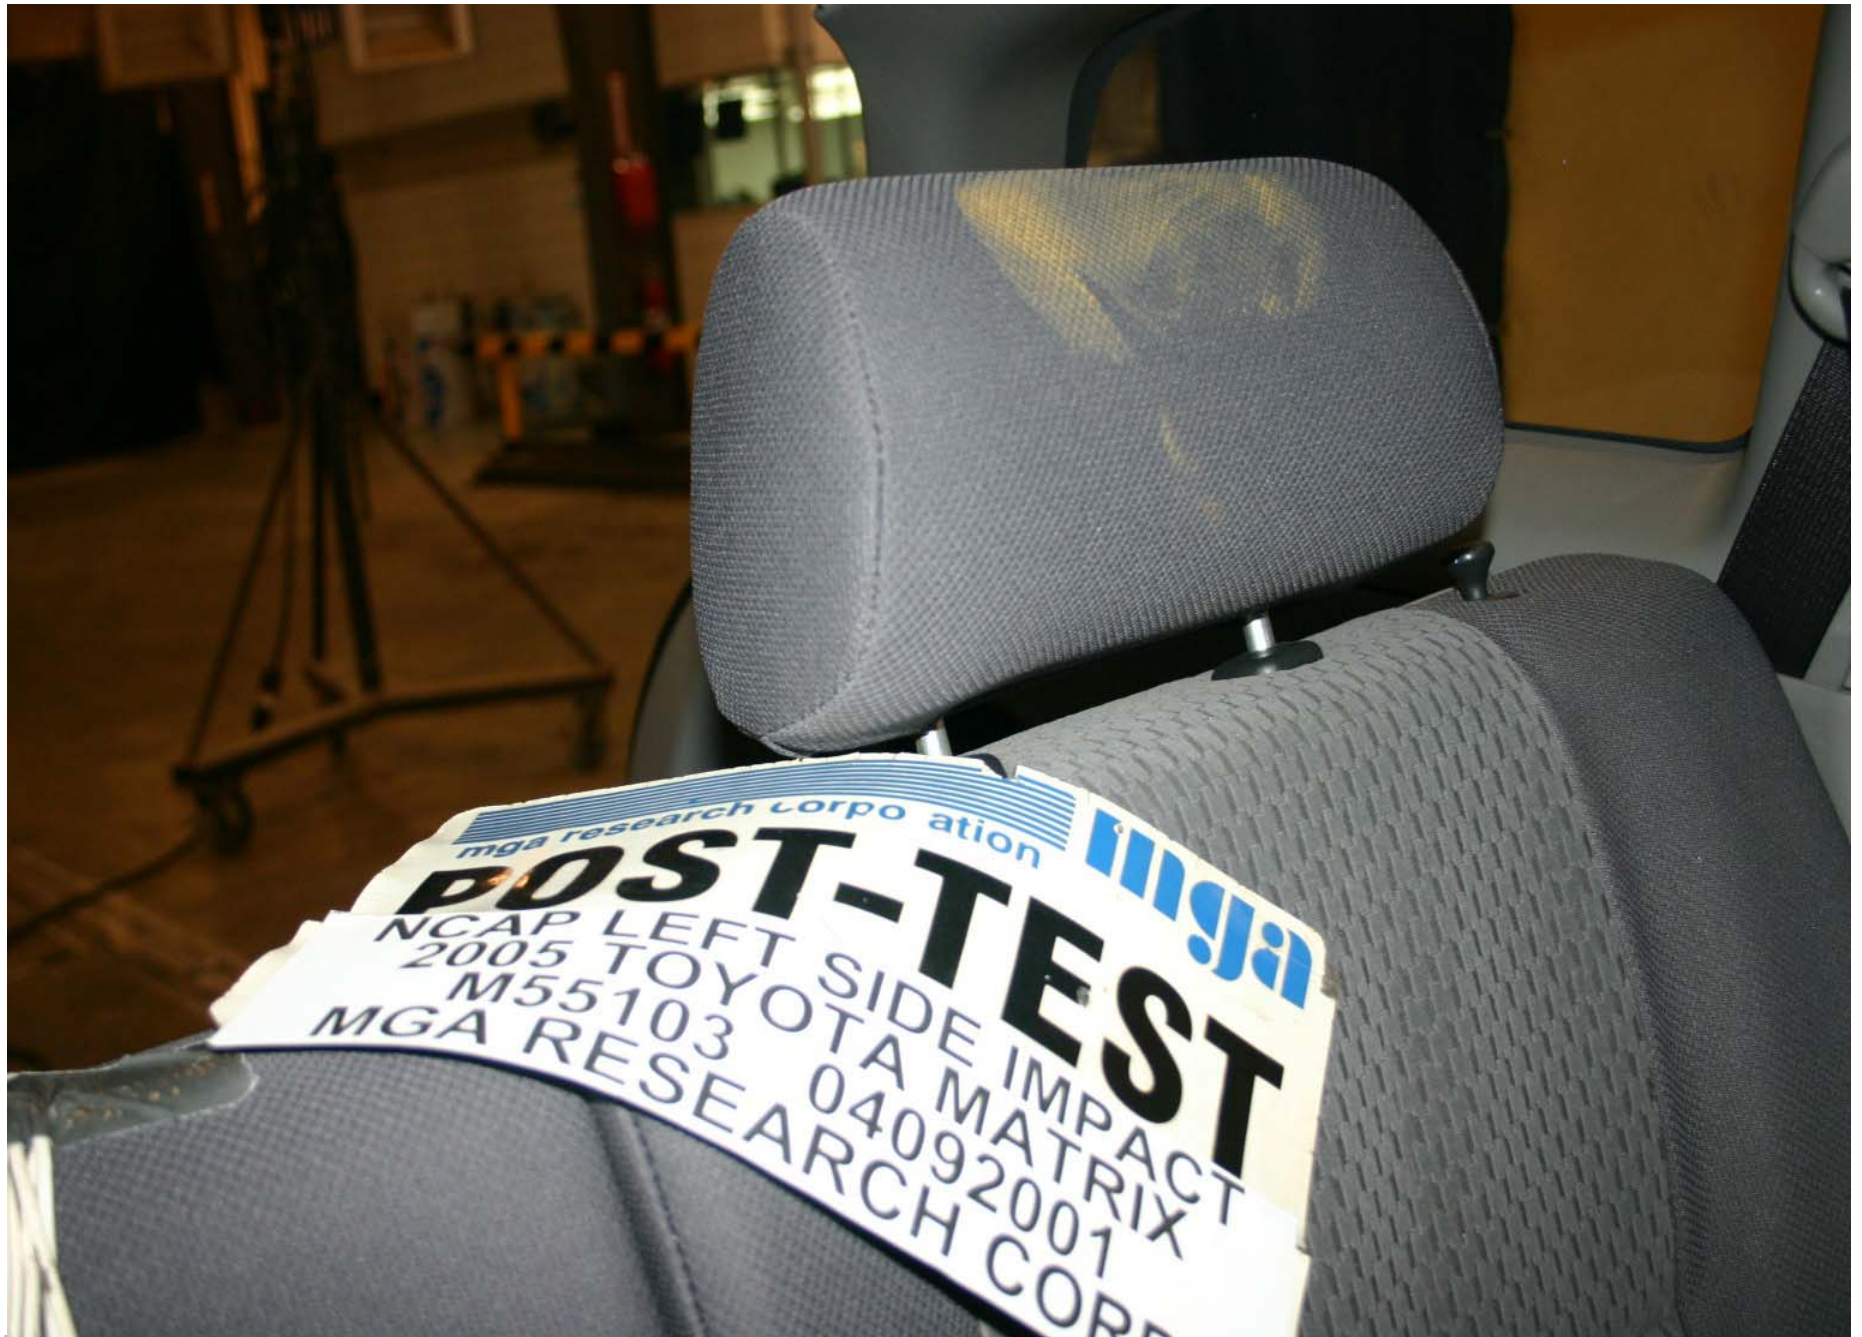
Post-Test Passenger Dummy Head Contact

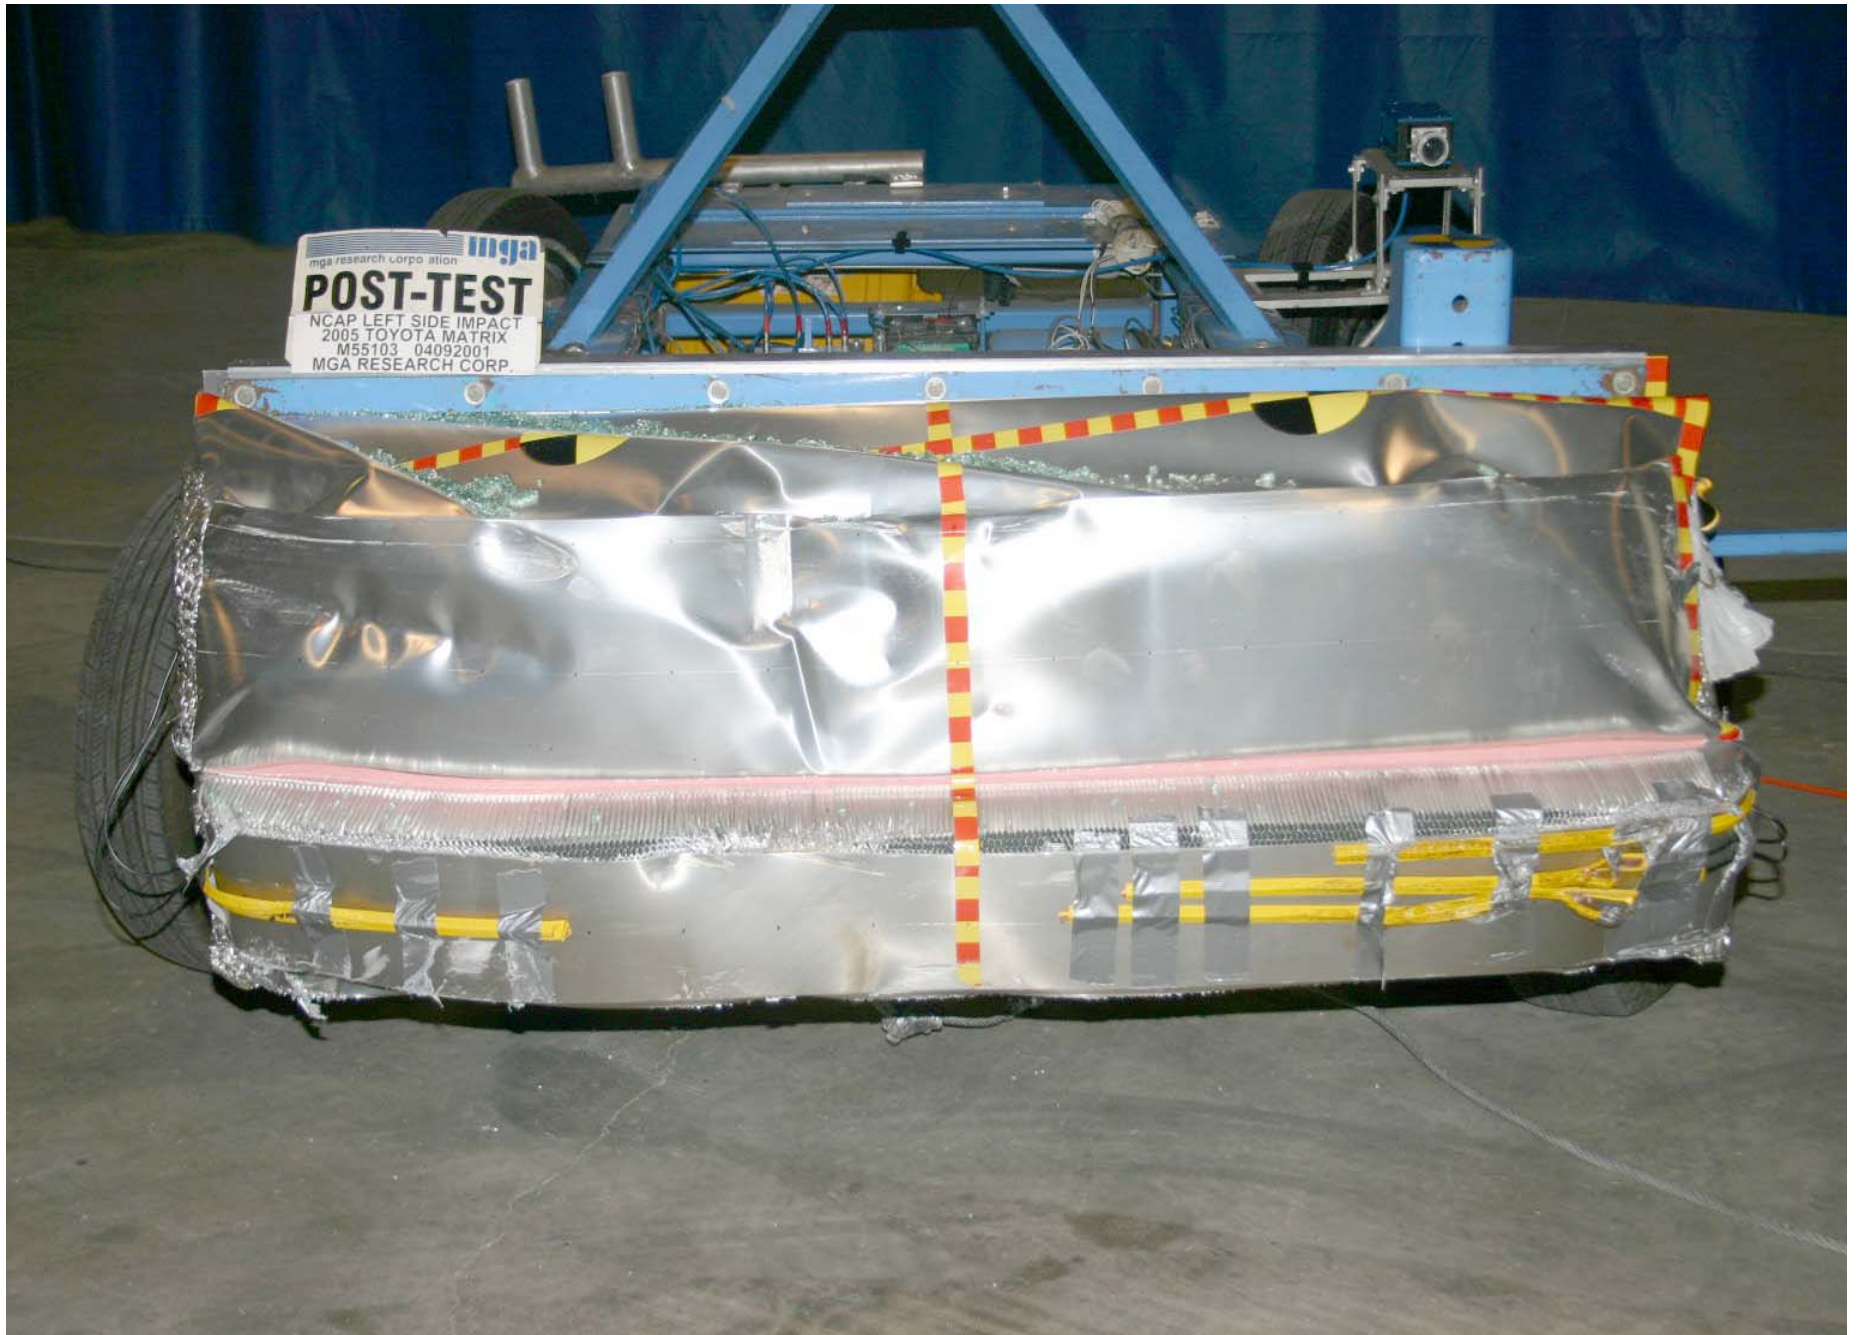
Post-Test MDB Front View

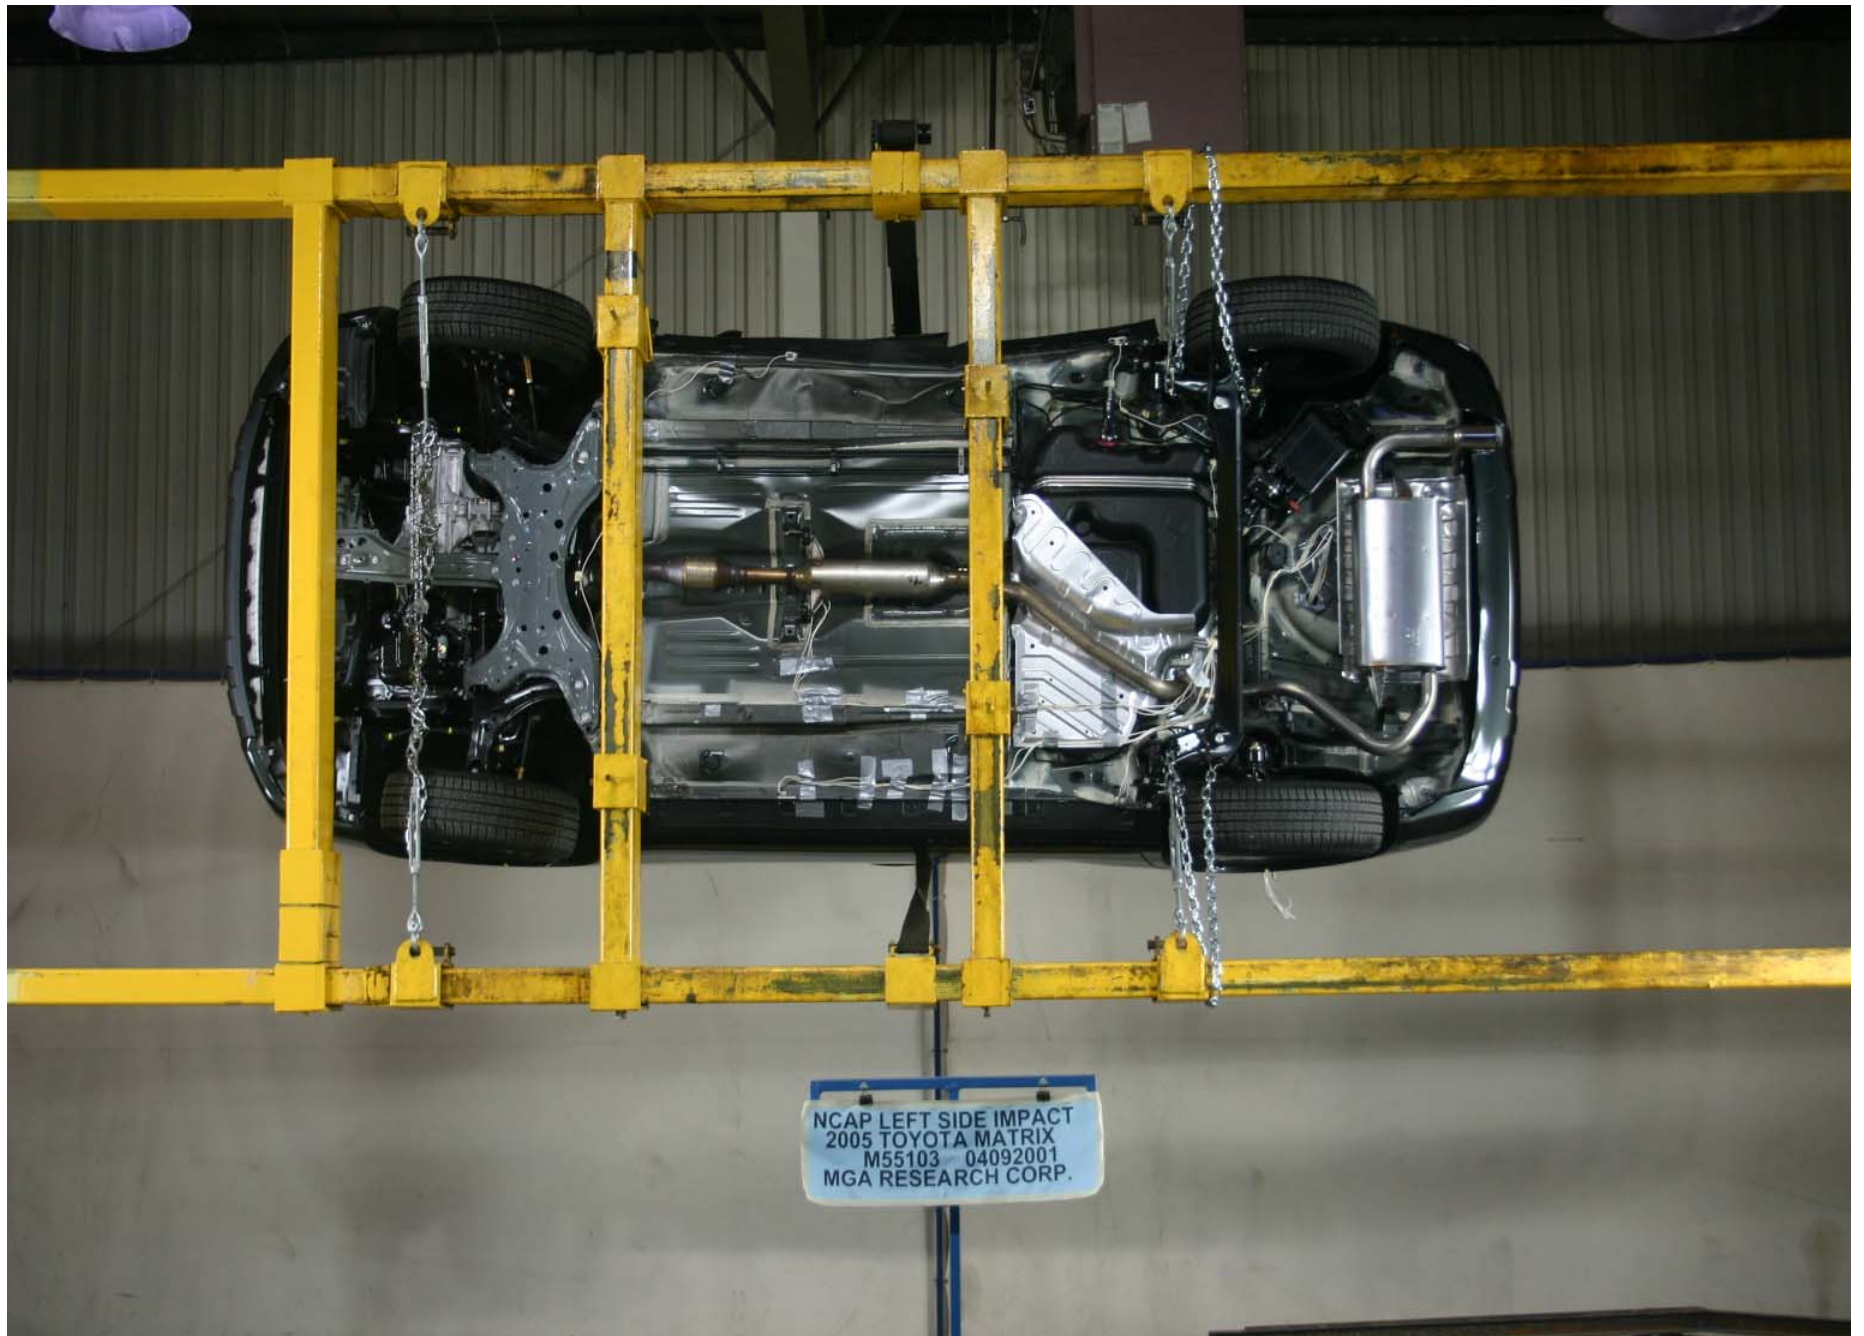
Rollover 90 Degrees
