**NEW CAR ASSESSMENT PROGRAM  
SIDE IMPACT TEST**

**Toyota Motor Manufacturing  
2005 Toyota Corolla Matrix  
NHTSA NUMBER: M55103**

**PREPARED BY:  
MGA RESEARCH CORPORATION  
5000 WARREN ROAD  
BURLINGTON, WI 53105**

**FINAL REPORT**

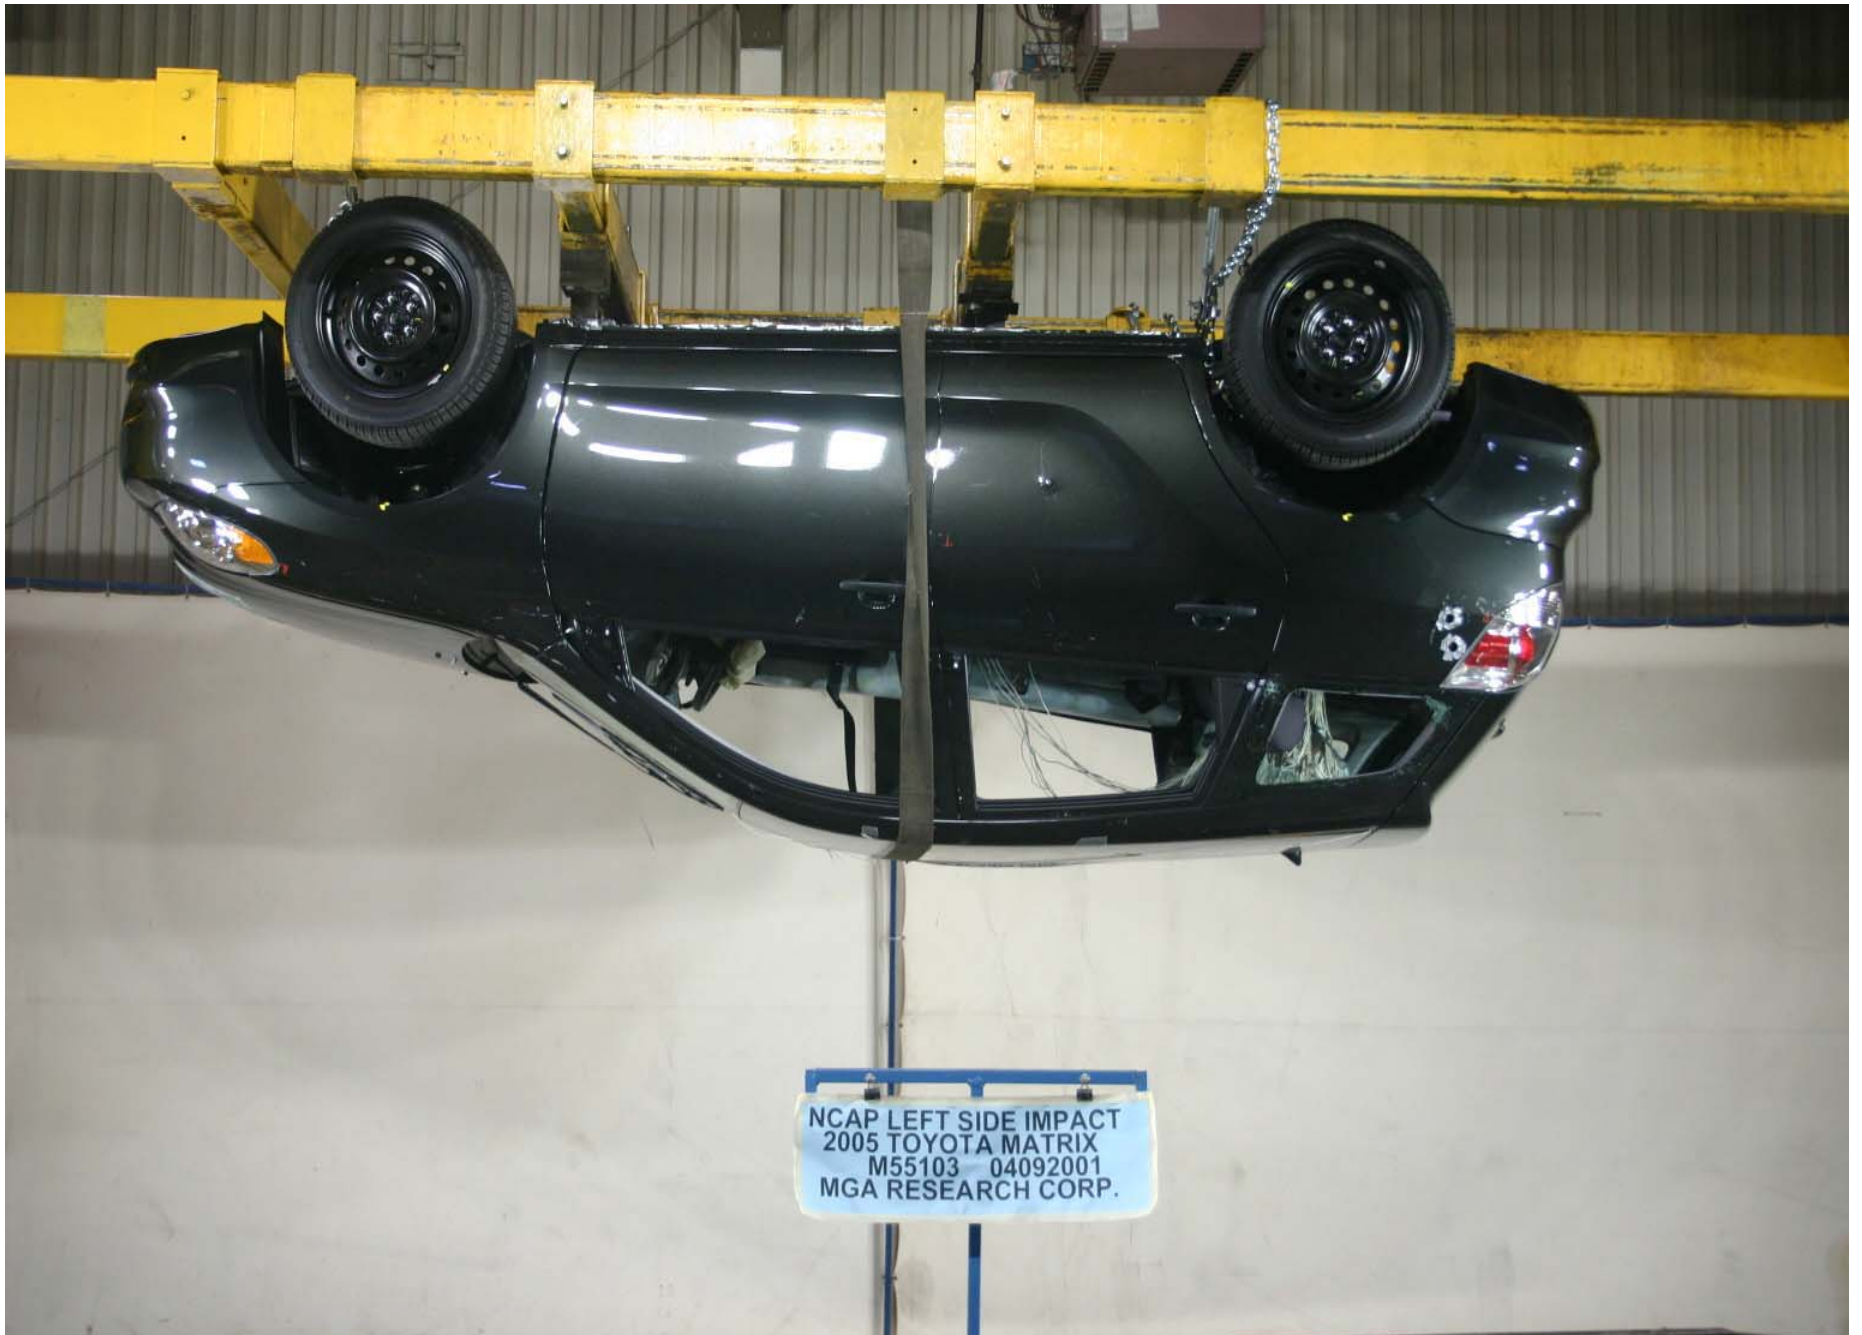
Rollover 180 Degrees
