**Vehicle Research and Test Center  
2004 Chevrolet Avalanche  
into Flat Frontal Barrier  
TRC Inc. Test Number: 040812**

**Prepared By:  
Transportation Research Center Inc.  
10820 State Route 347  
East Liberty, OH 43319**

**Final Report  
August - September 2004**

**Prepared For:  
Vehicle Research and Test Center  
P. O. Box 37  
East Liberty, OH 43319**

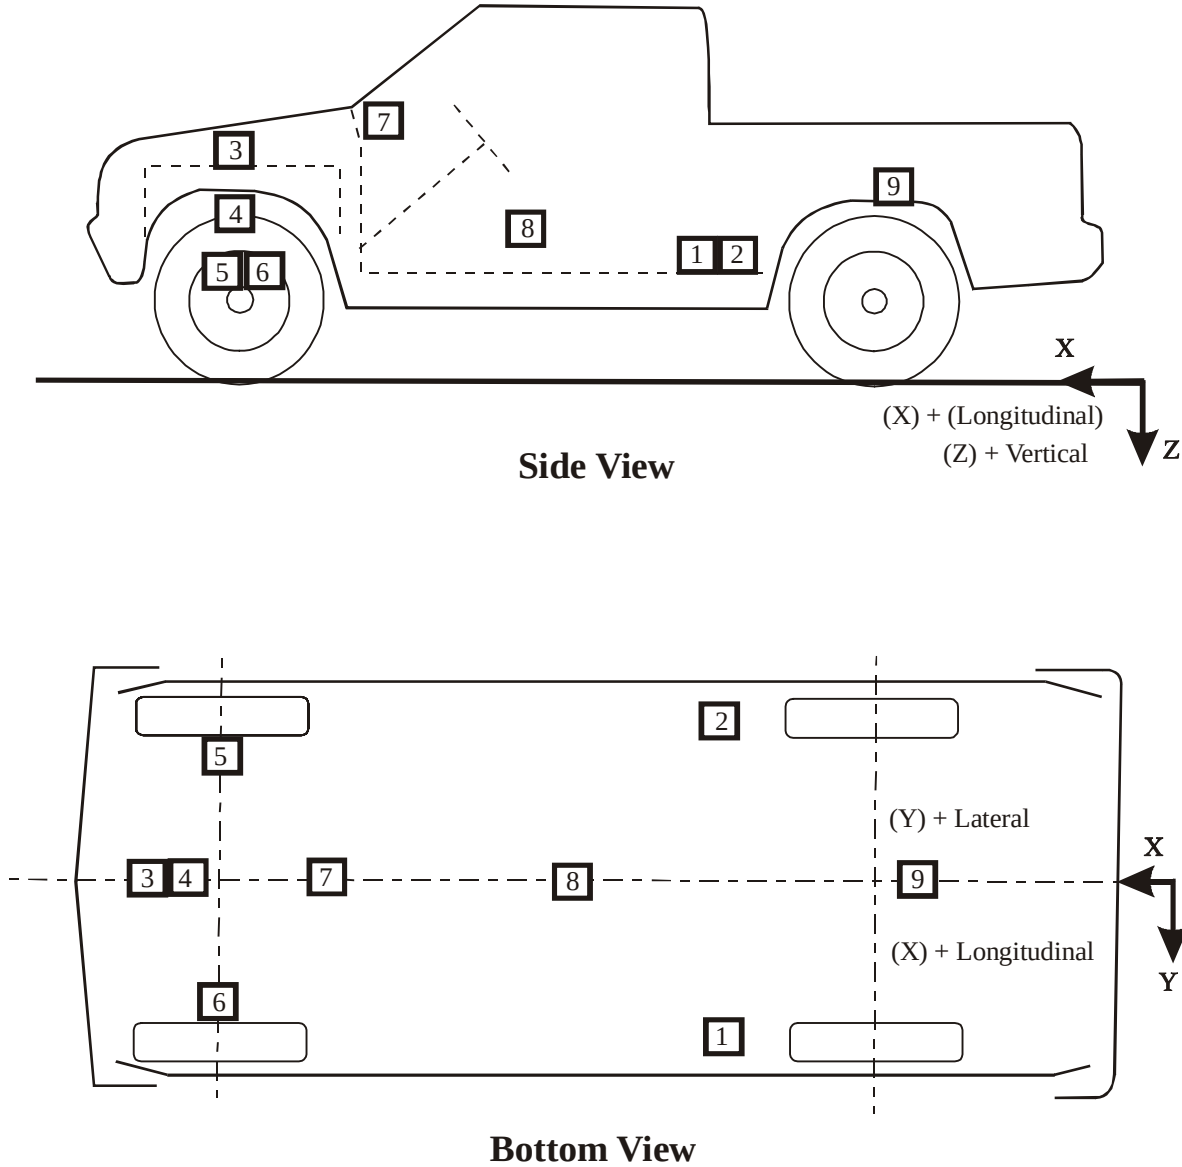
Figure 3 Vehicle Accelerometer Placement

The test vehicle was instrumented with nine (9) accelerometers to measure longitudinal axis accelerations; two (2) accelerometers to measure lateral axis accelerations; two (2) accelerometers to measure vertical axis accelerations, and two (2) airbag event data channels. The vehicle's specified impact velocity range was 55.5 to 57.1 km/h. The vehicle impacted a flat frontal barrier equipped with one hundred thirty-four (134) load cells.
