**REPORT NUMBER: NCAPSIDE-MGA-2005-003**

**NEW CAR ASSESSMENT PROGRAM  
SIDE IMPACT TEST**

**VOLVO GOTHENBURG SWEDEN  
2005 Volvo V70 Station Wagon  
NHTSA NUMBER: M55901**

**FINAL REPORT**

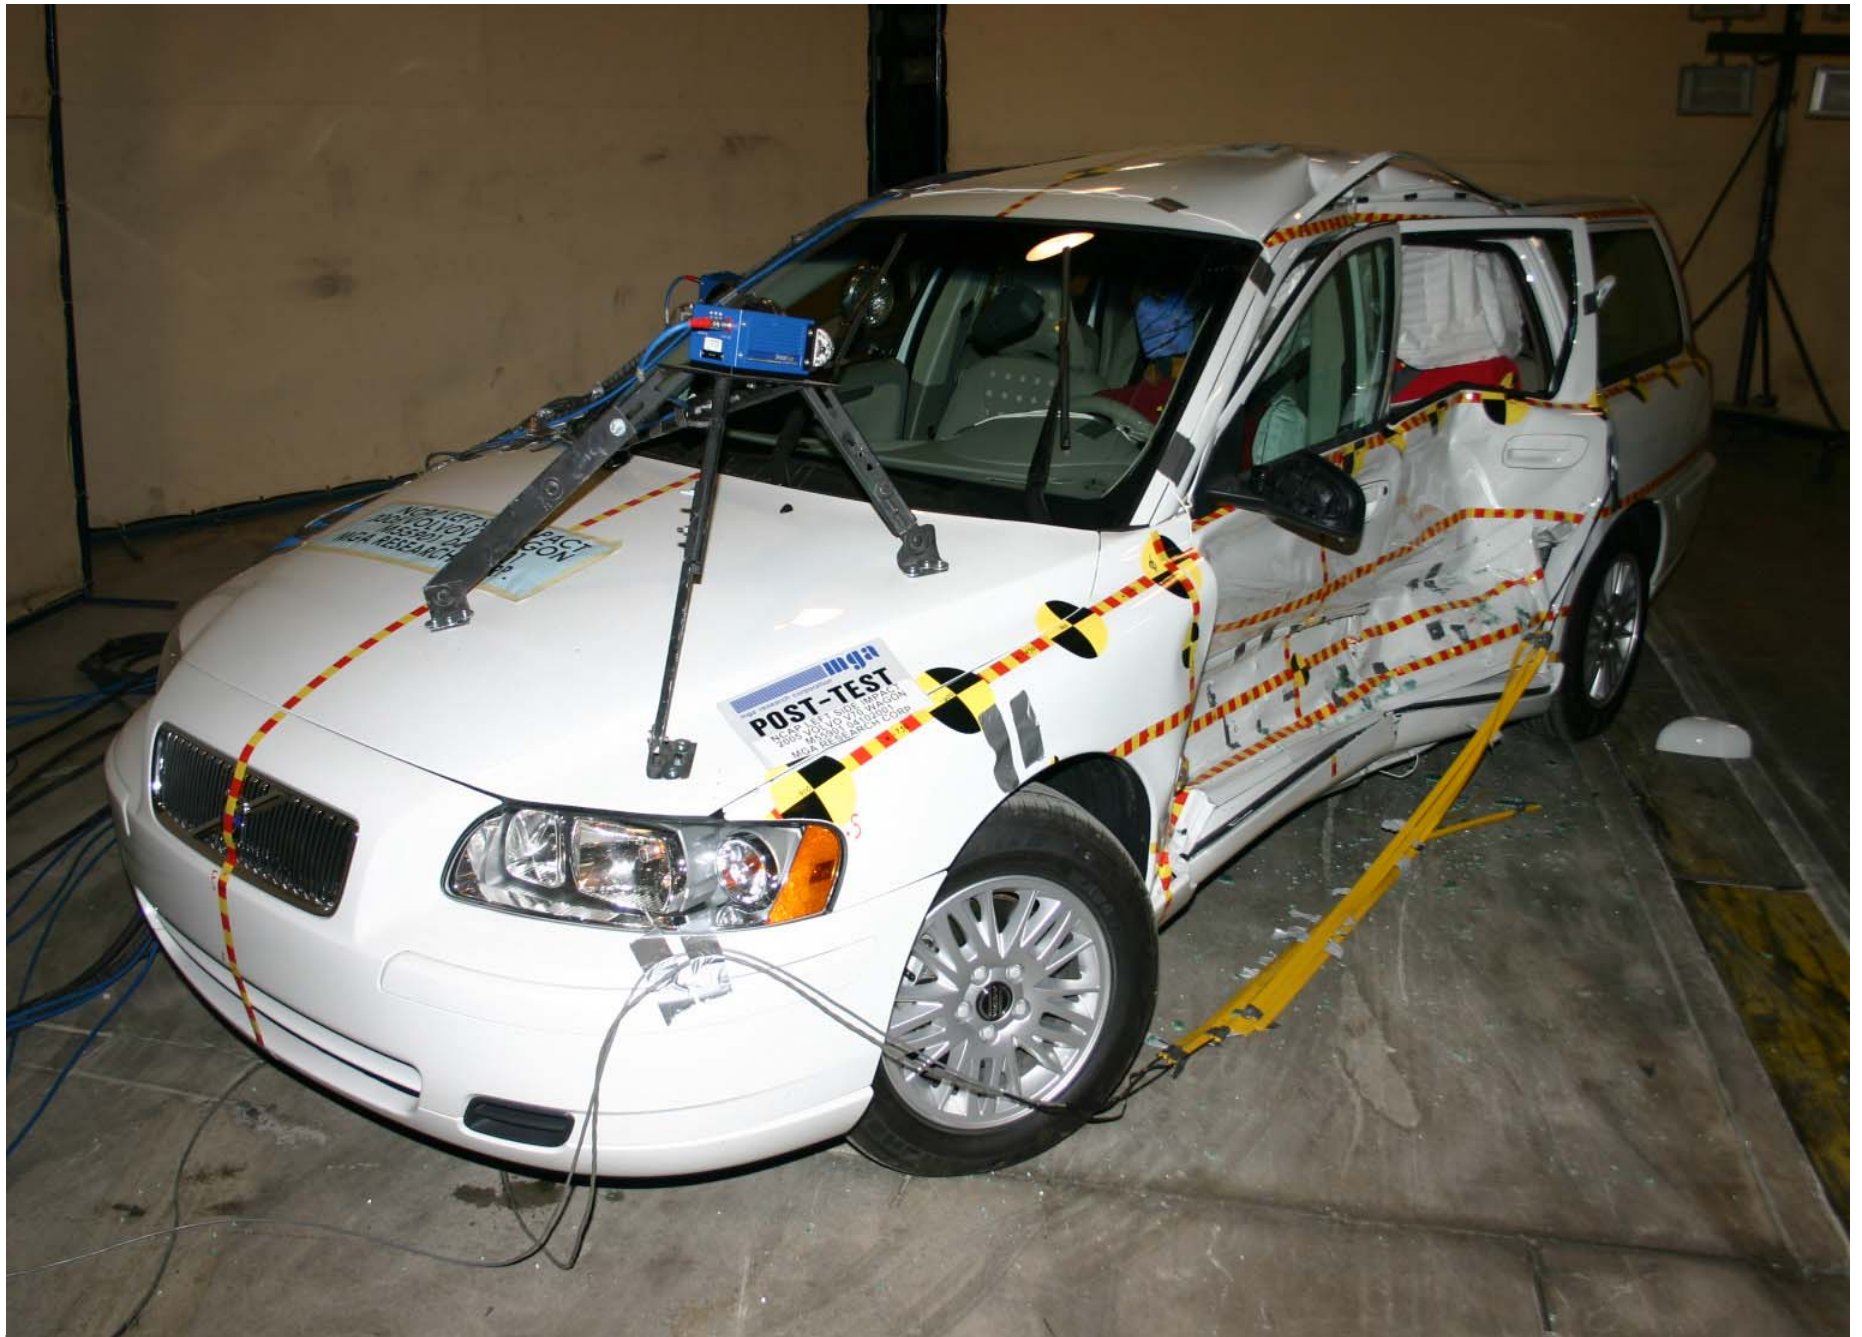
A-8.

Post-Test Left Front  $\frac{3}{4}$  View of Test Vehicle

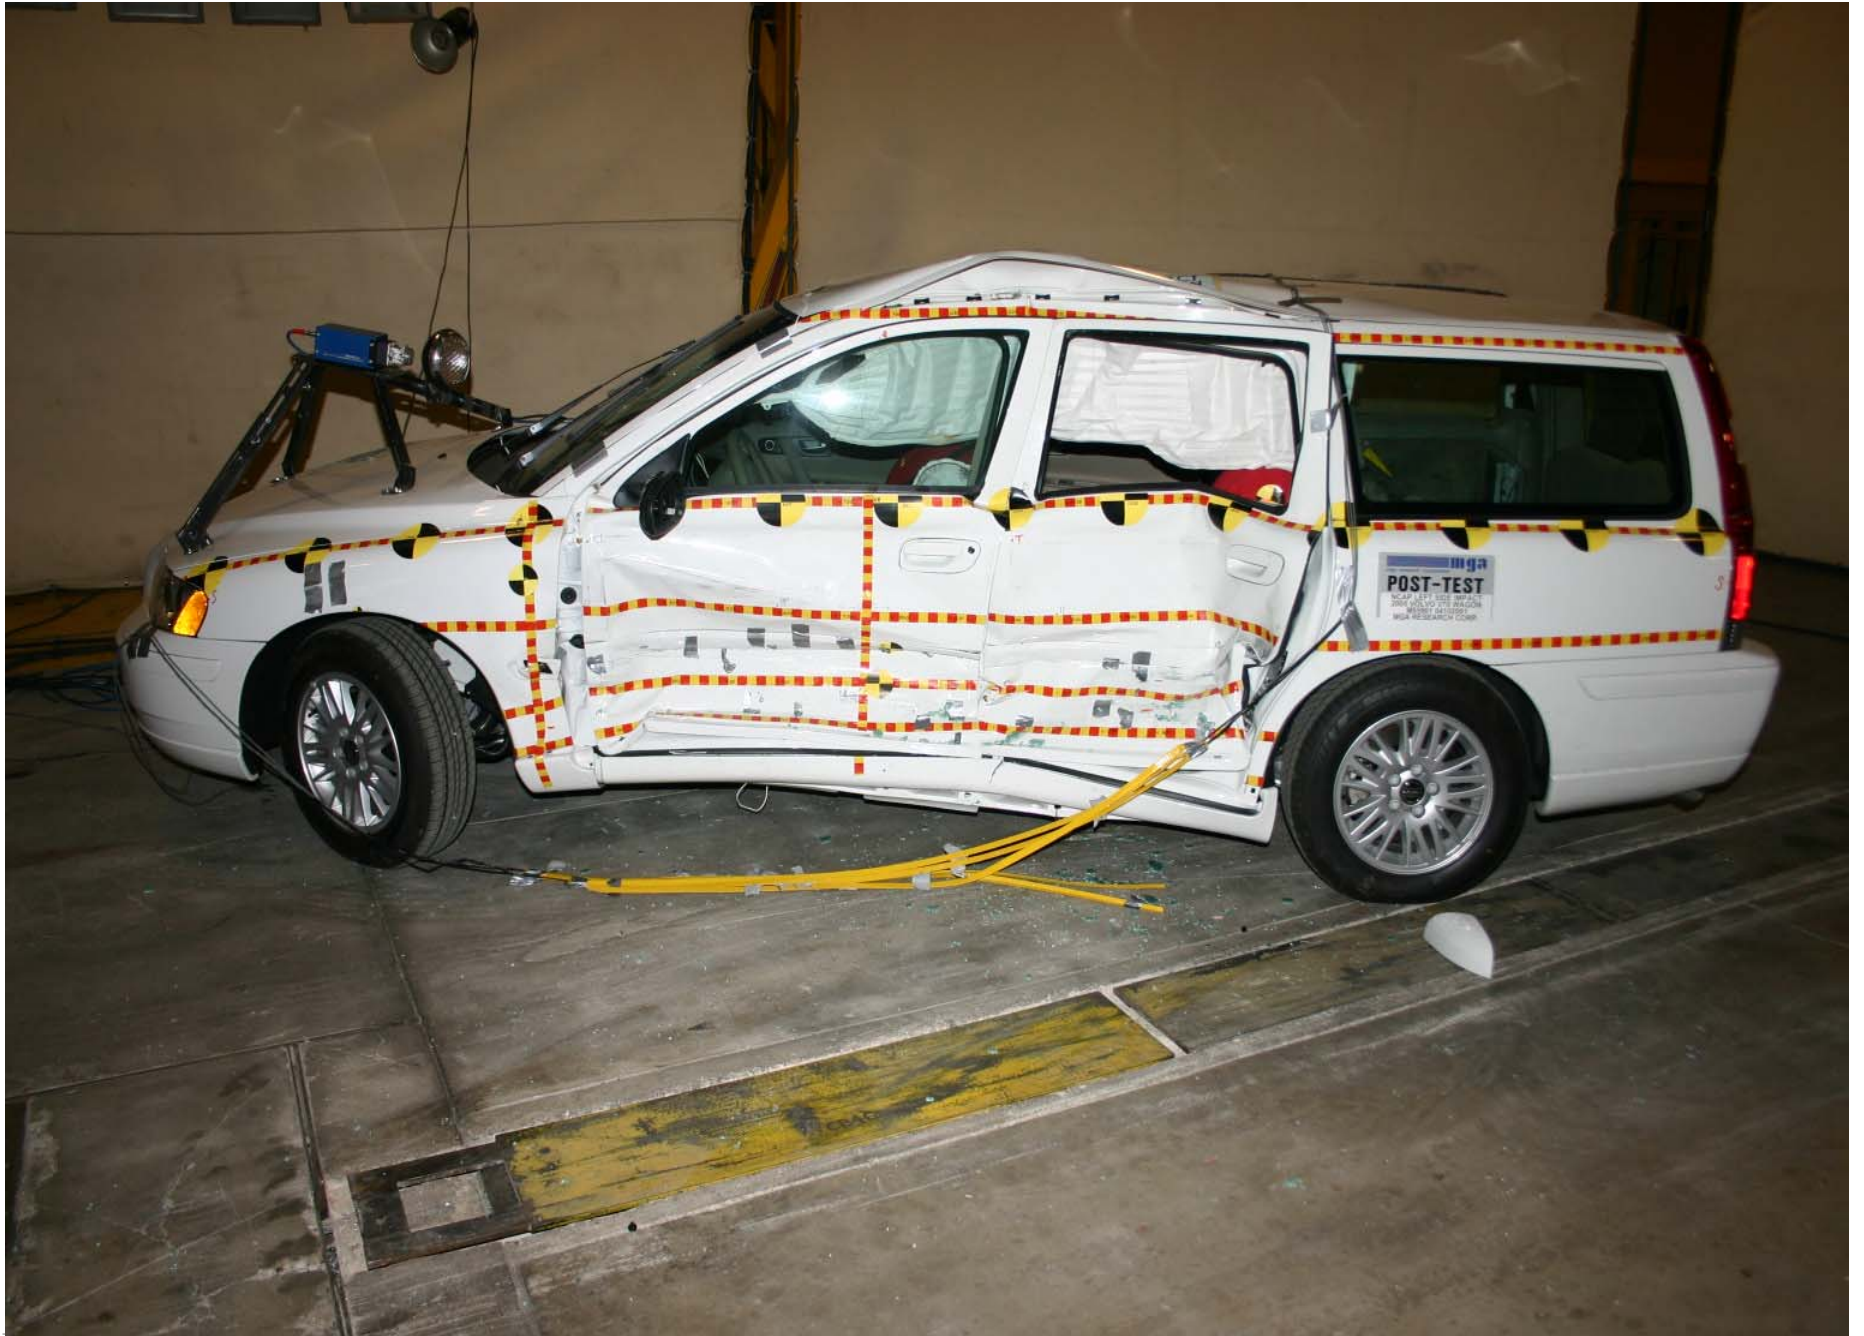
A-10.

Post-Test Left Side View of Test Vehicle

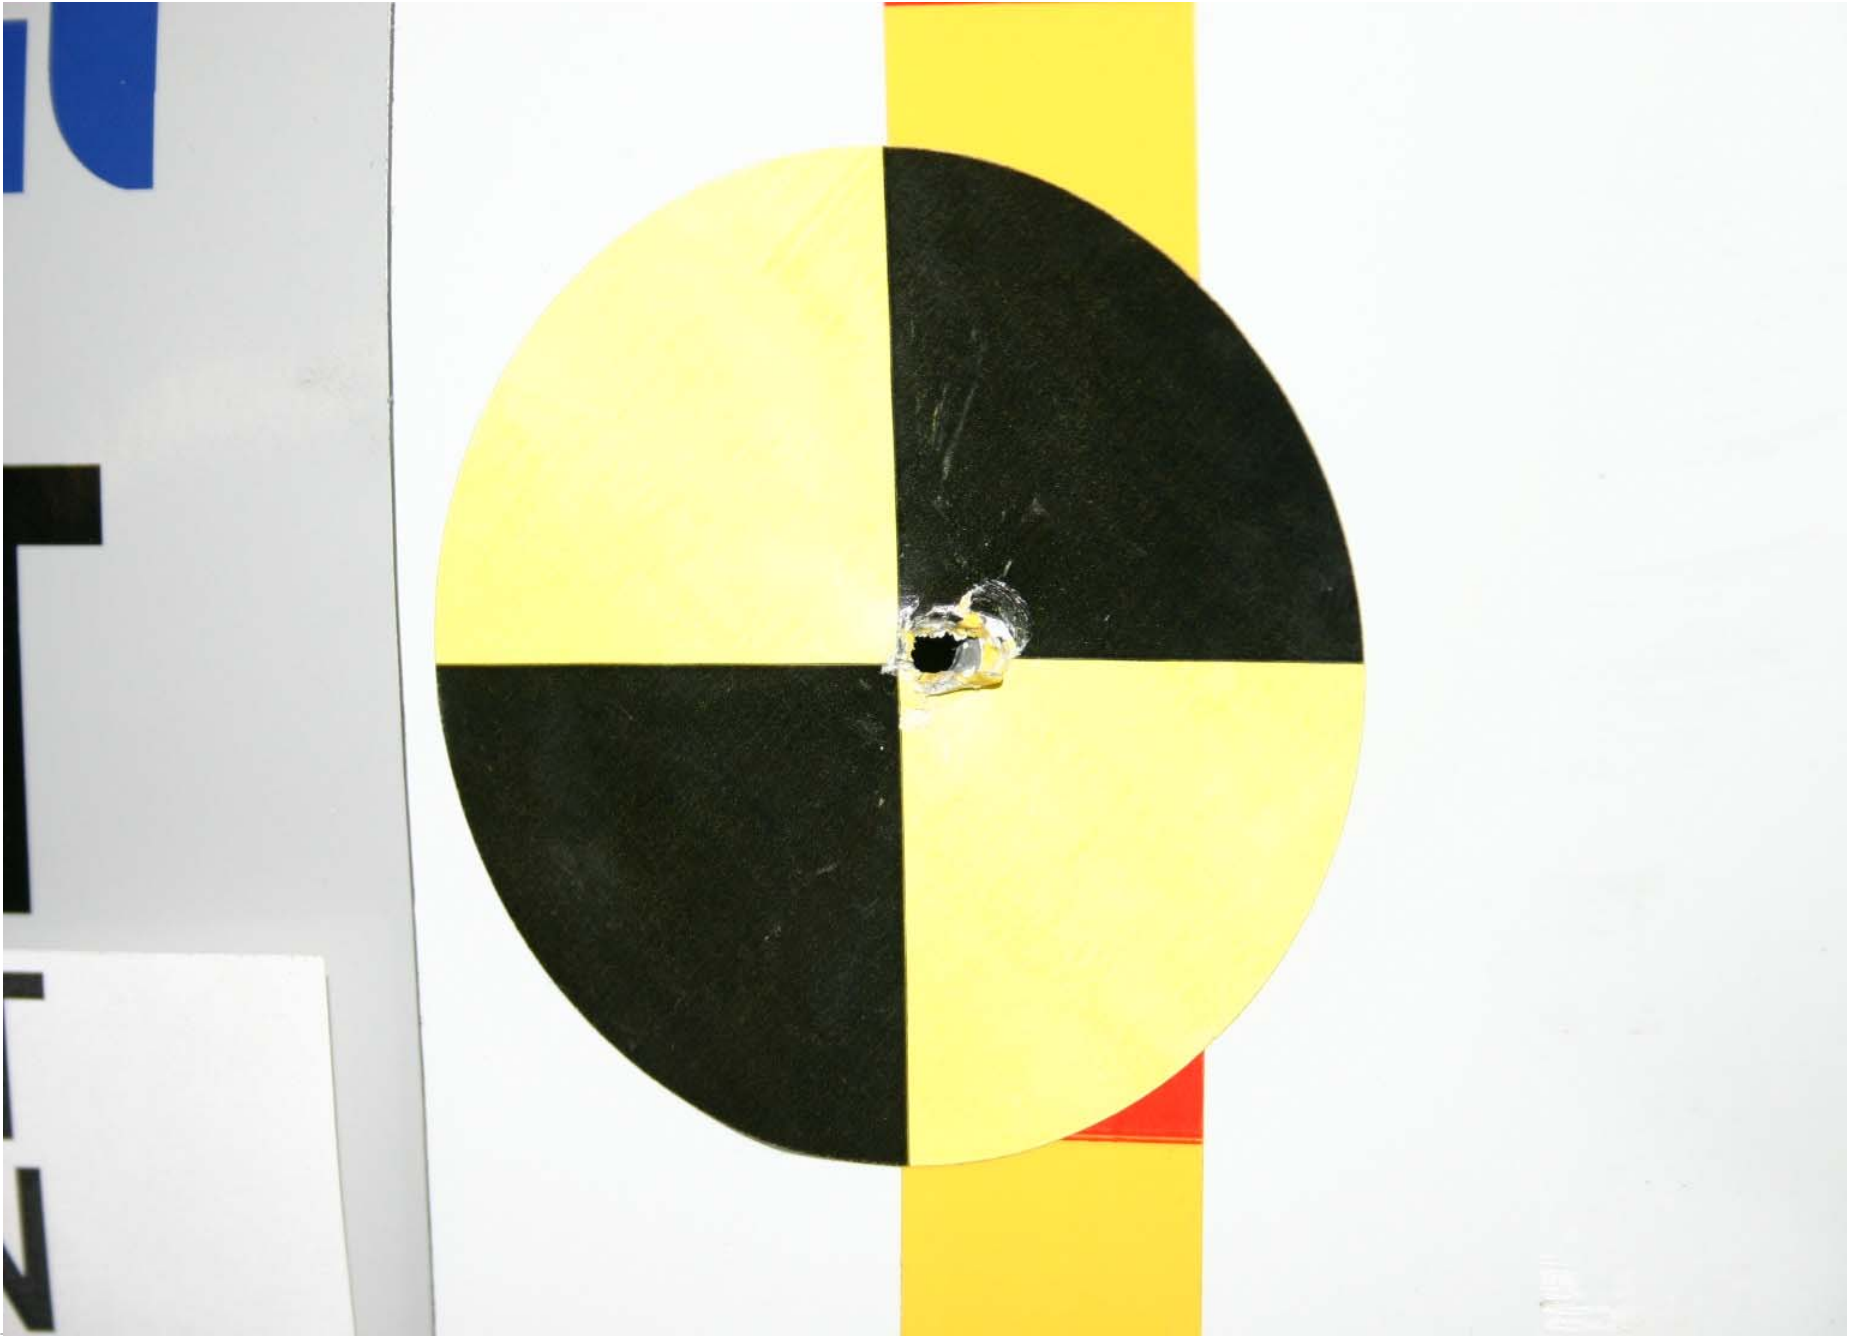
Post-Test Impact Point on Vehicle

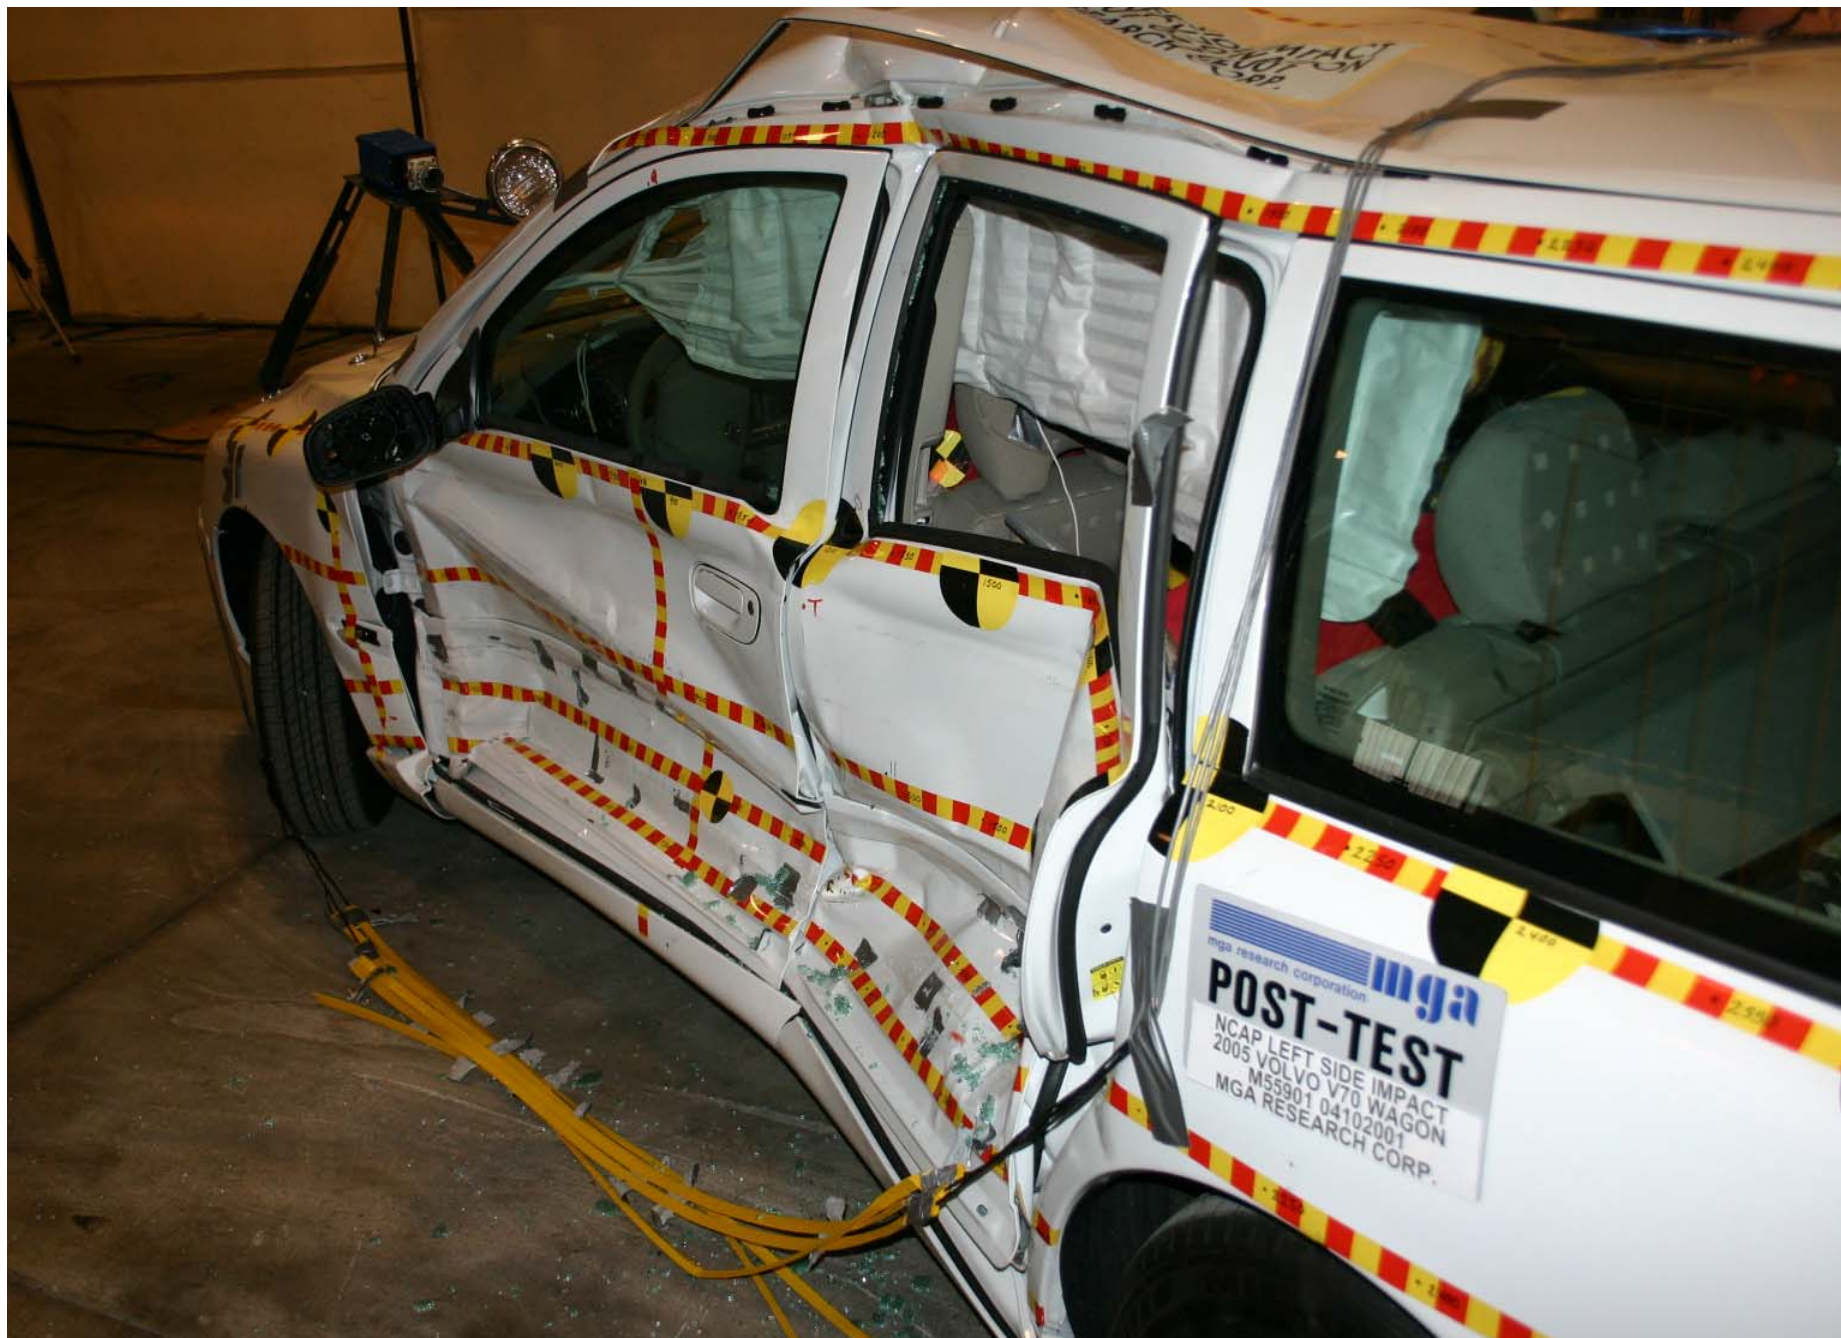
Post-Test Three-Quarter View of Left Side Doors of Test Vehicle

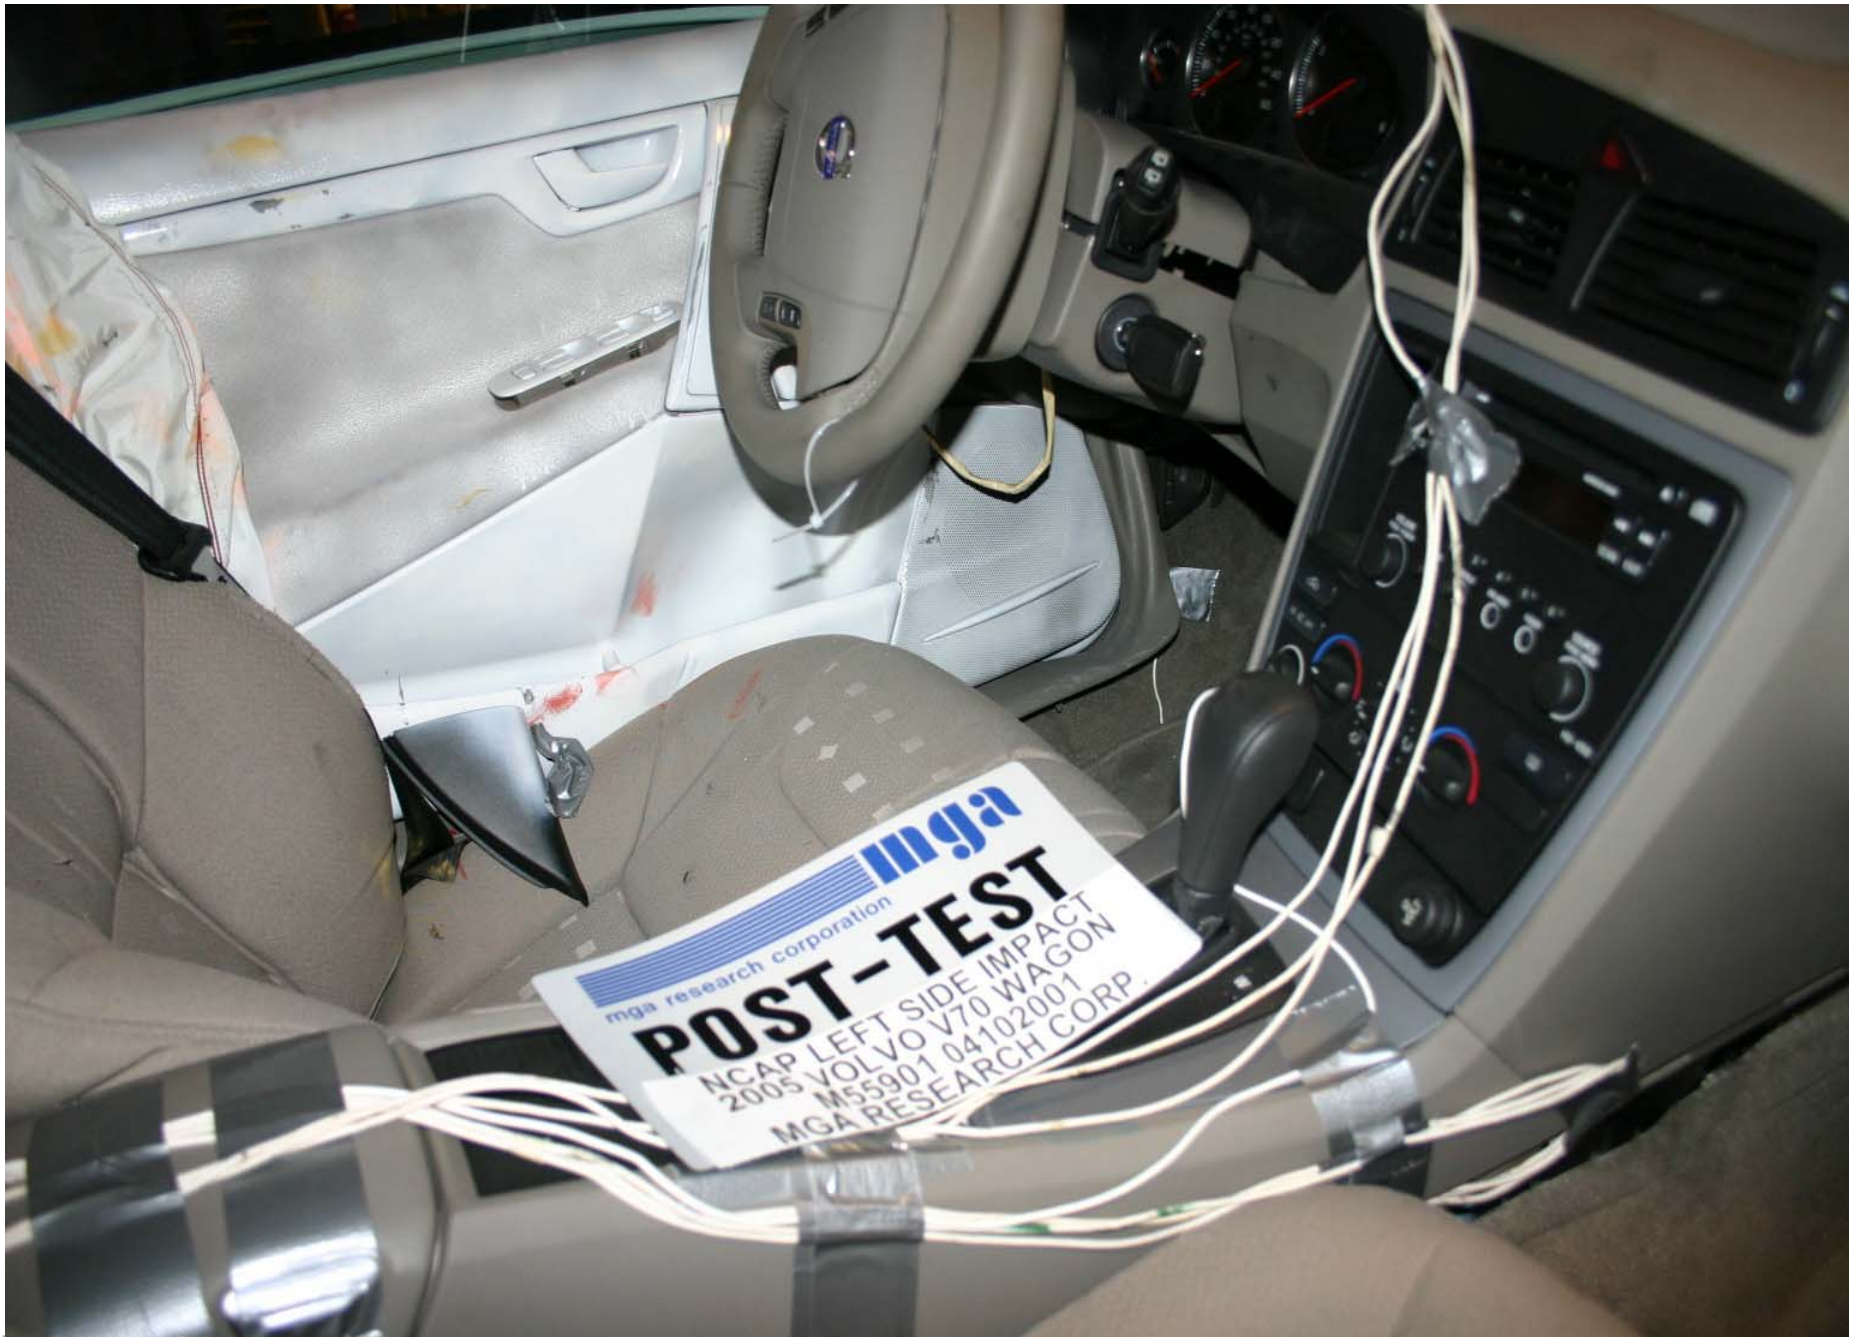
Post-Test Driver Dummy Contact

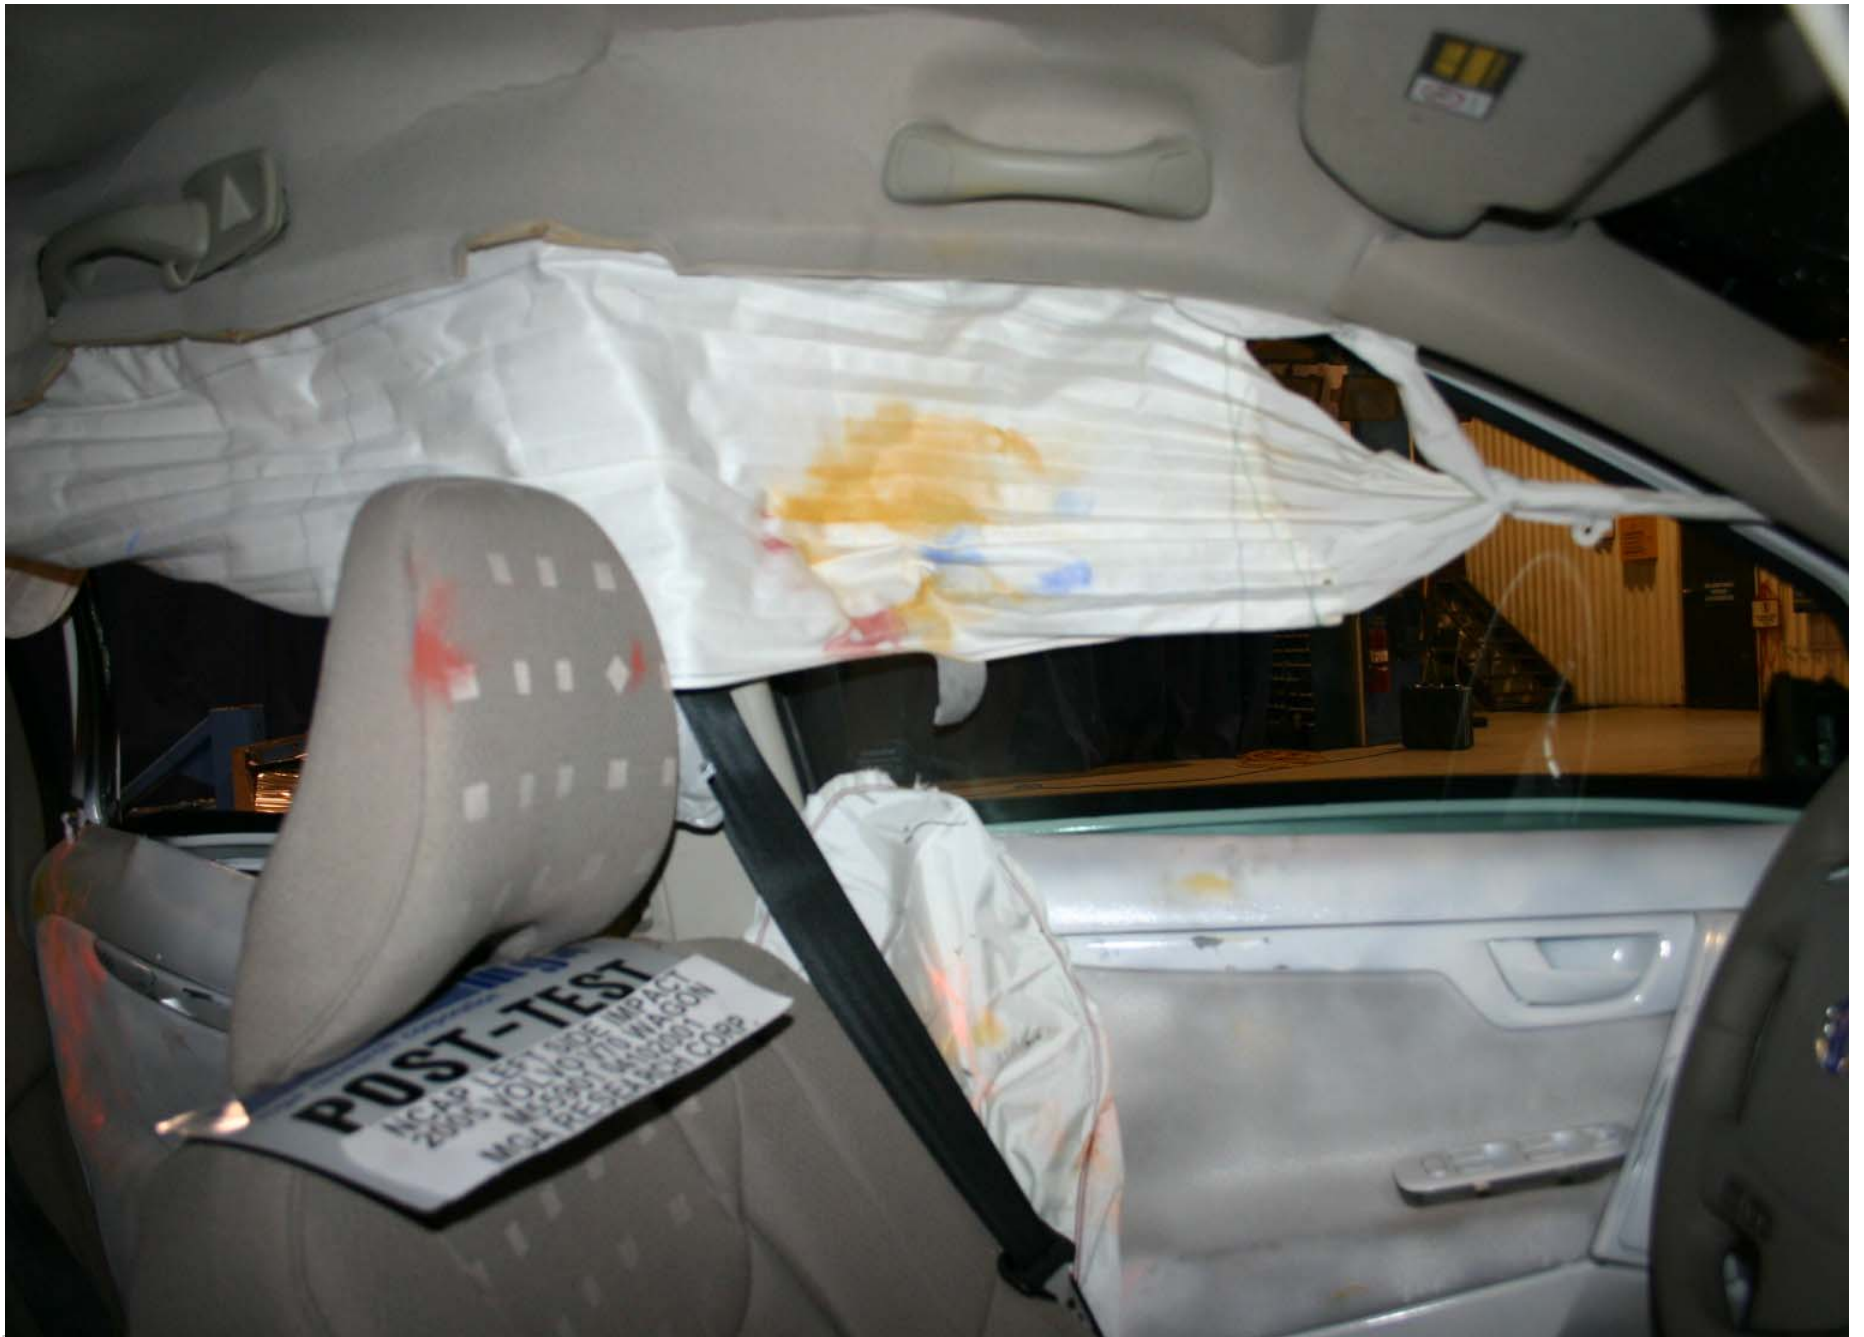
A-37.

Post-Test Driver Dummy Head Contact

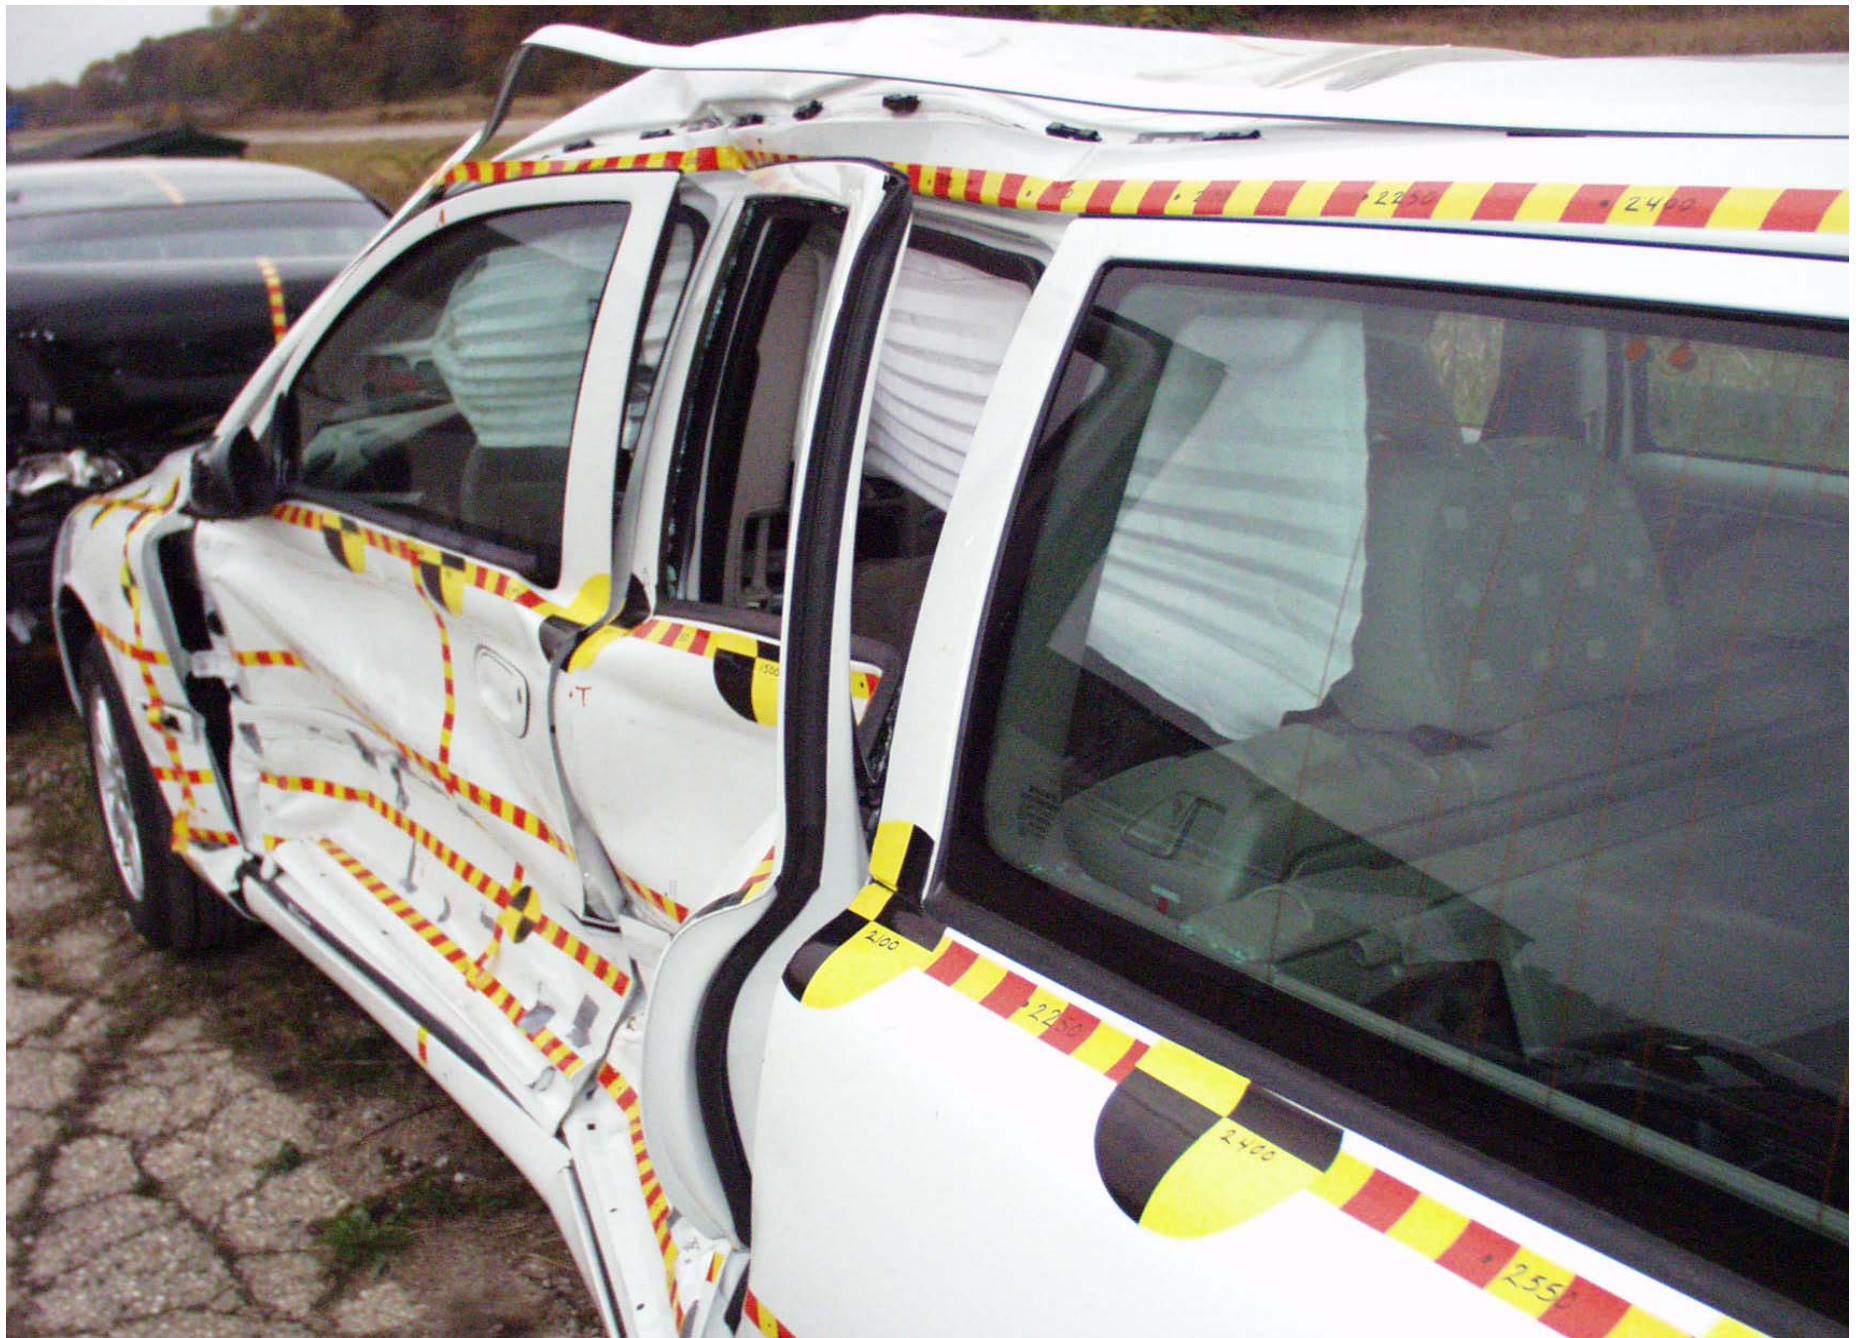
Post-Test Left Rear Door Opening

The left rear door had approximately 120 mm opening at the top of the vehicle (See Appendix A for photo.)

Critical Areas of Performance	Observations and Conclusions
Pillar Performance	No Separation
Sill Separation	None
Windshield Damage	Windshield broke
Window Damage	Left Front and Rear Broke
Other Notable Effects	The left rear door opened at the top about 120mm.
