**REPORT NUMBER: NCAP-MGA-2005-004**

**NEW CAR ASSESSMENT PROGRAM  
FRONTAL BARRIER IMPACT TEST**

**VOLVO GOTHENBURG SWEDEN  
2005 Volvo V70 Station Wagon  
NHTSA NUMBER: M55900**

**FINAL REPORT**

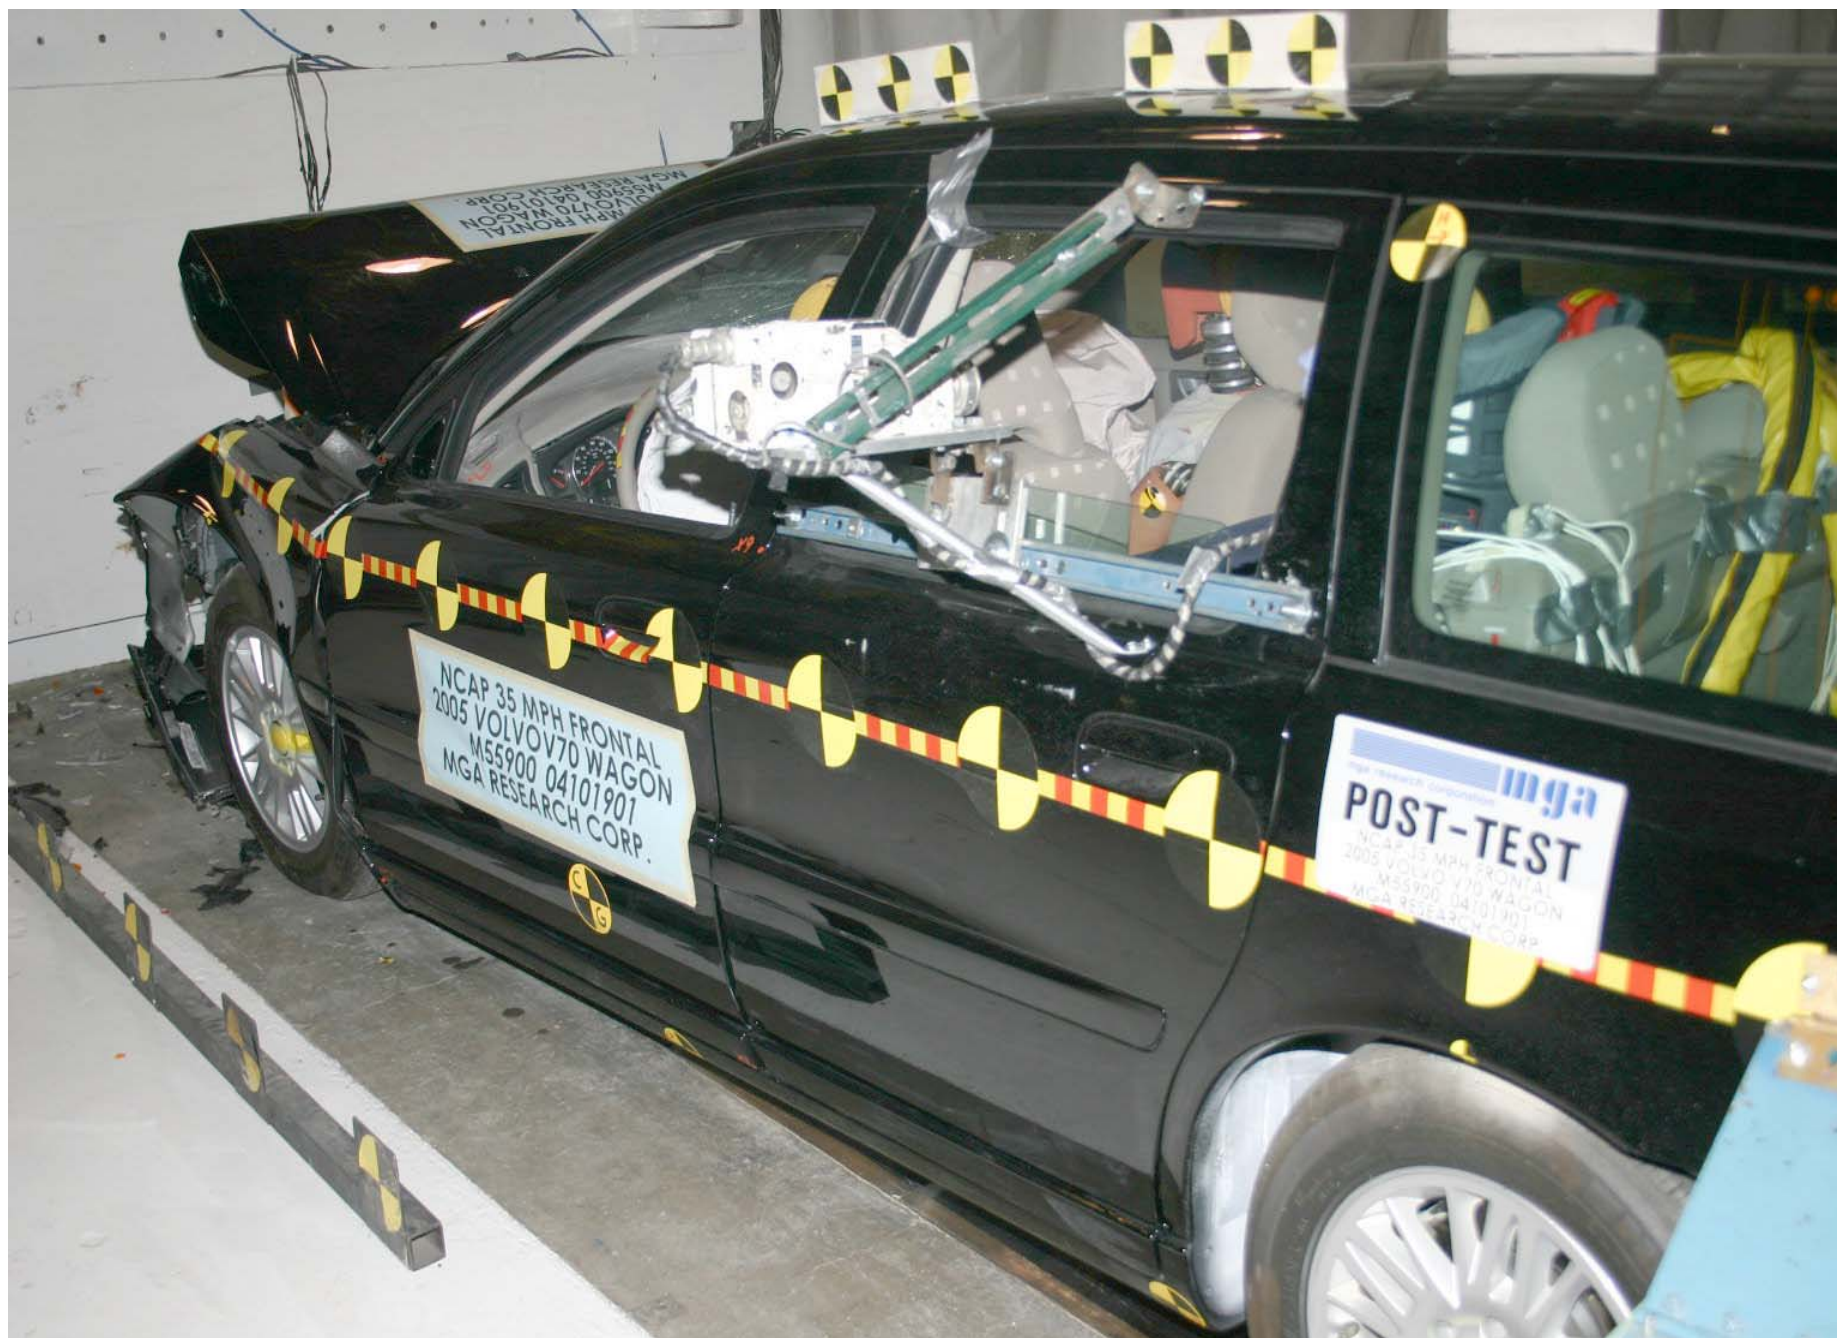
Post-Test Left Side Three-Quarter View of Doors After Impact

| Description | Driver | Passenger |
|---|---|---|
| Front Door Opening | Door remained closed and latched;<br>Door opened without tools | Door remained closed and latched;<br>Door opened without tools |

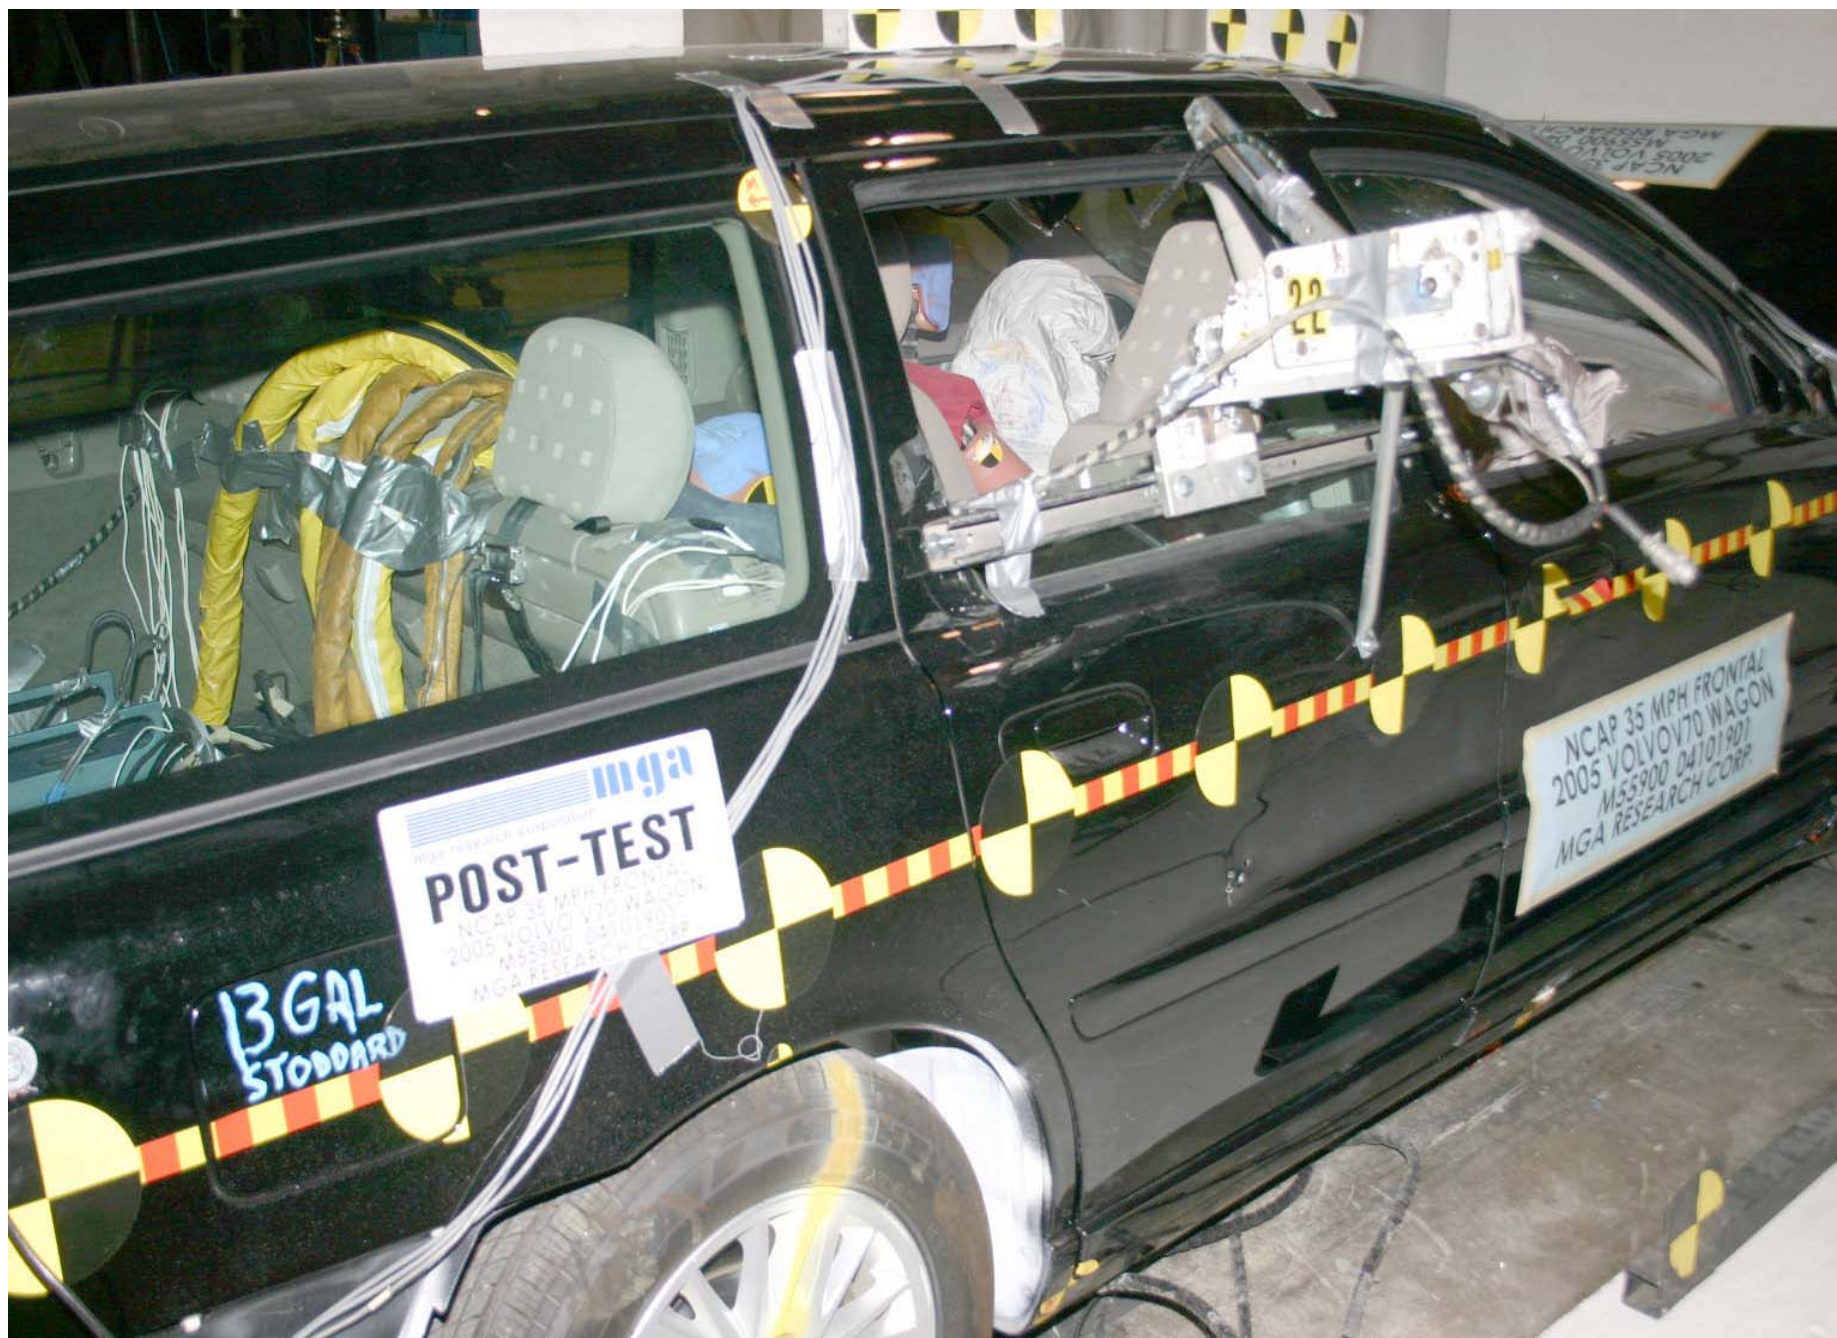
Post-Test Right Side Three-Quarter View of Doors After Impact

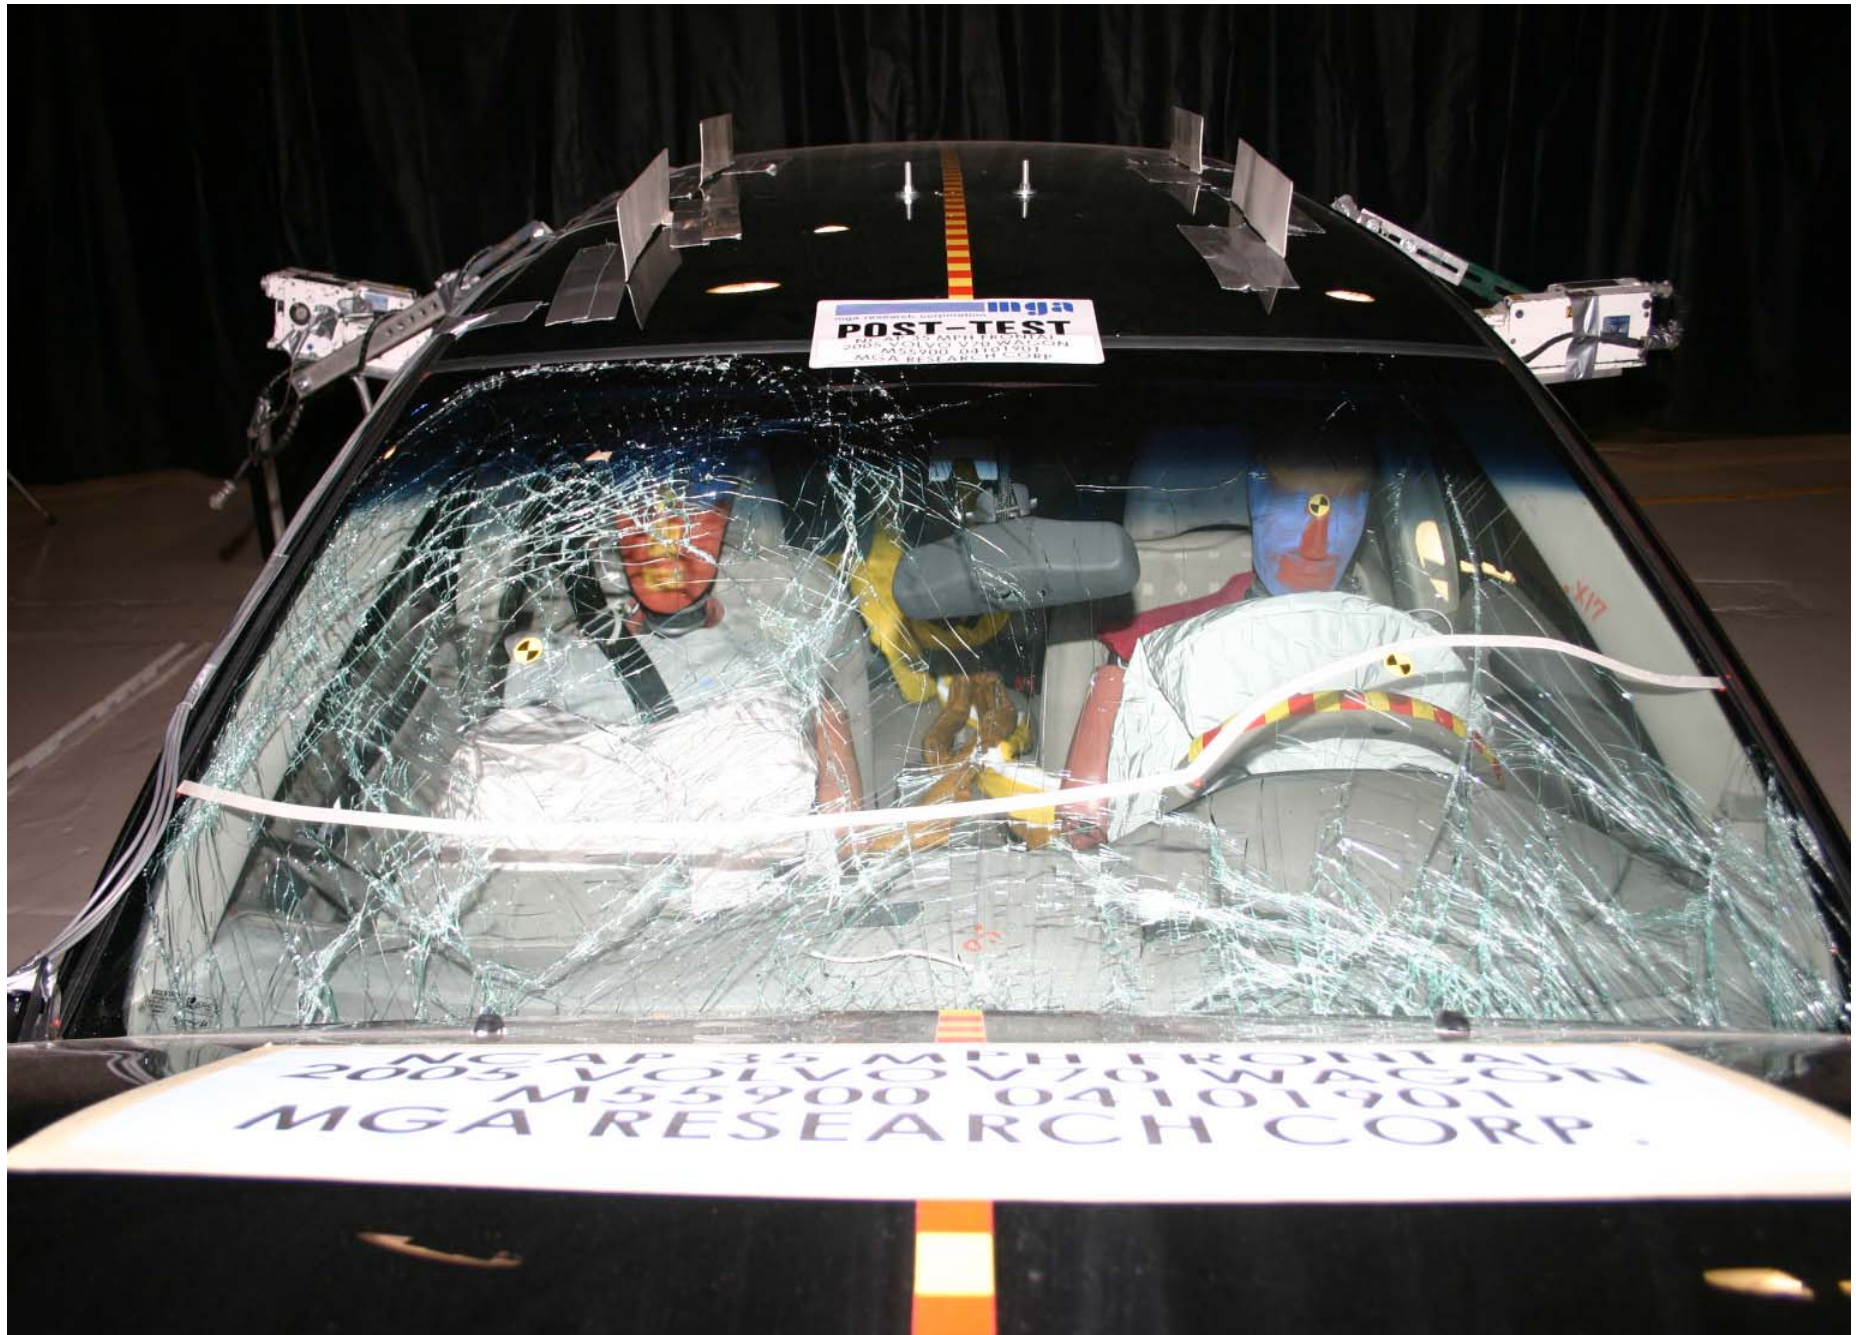
Post-Test Windshield View

There was 100 percent windshield retention and no intrusion into the protected zone of the windshield during the event. There was no Stoddard Solvent leakage after the event or during any phase of the static rollover.

| Description | Driver | Passenger |
|---|---|---|
| Glazing Damage | The windshield cracked. | |

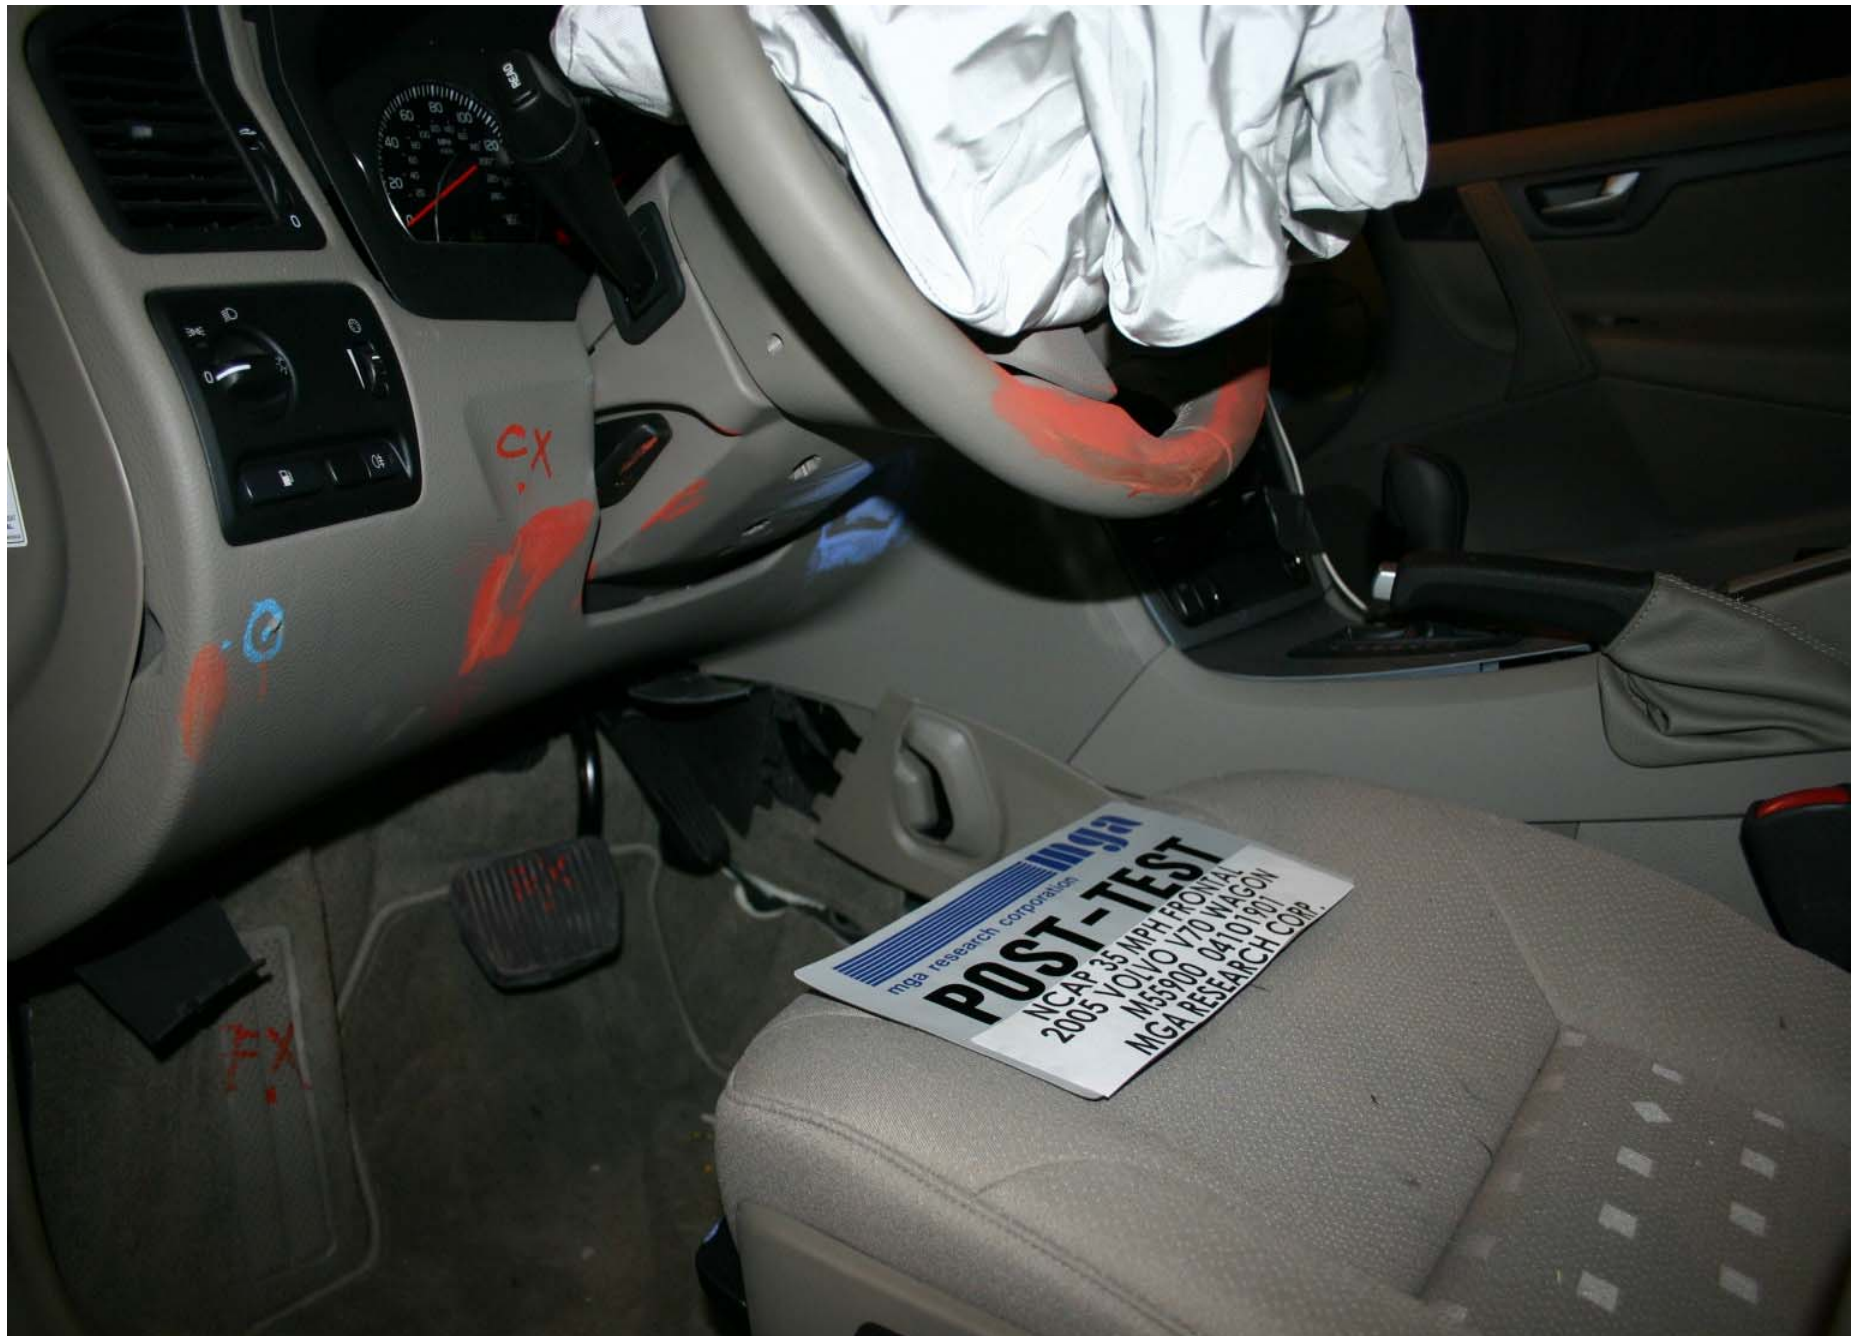
Post-Test Driver Dummy Knee Contact

| Description | Driver | Passenger |
|---|---|---|
| Left Knee Contact | Knee Bolster, Steering Column | Glove Box |
| Right Knee Contact | Knee Bolster, Steering Column | Glove Box |

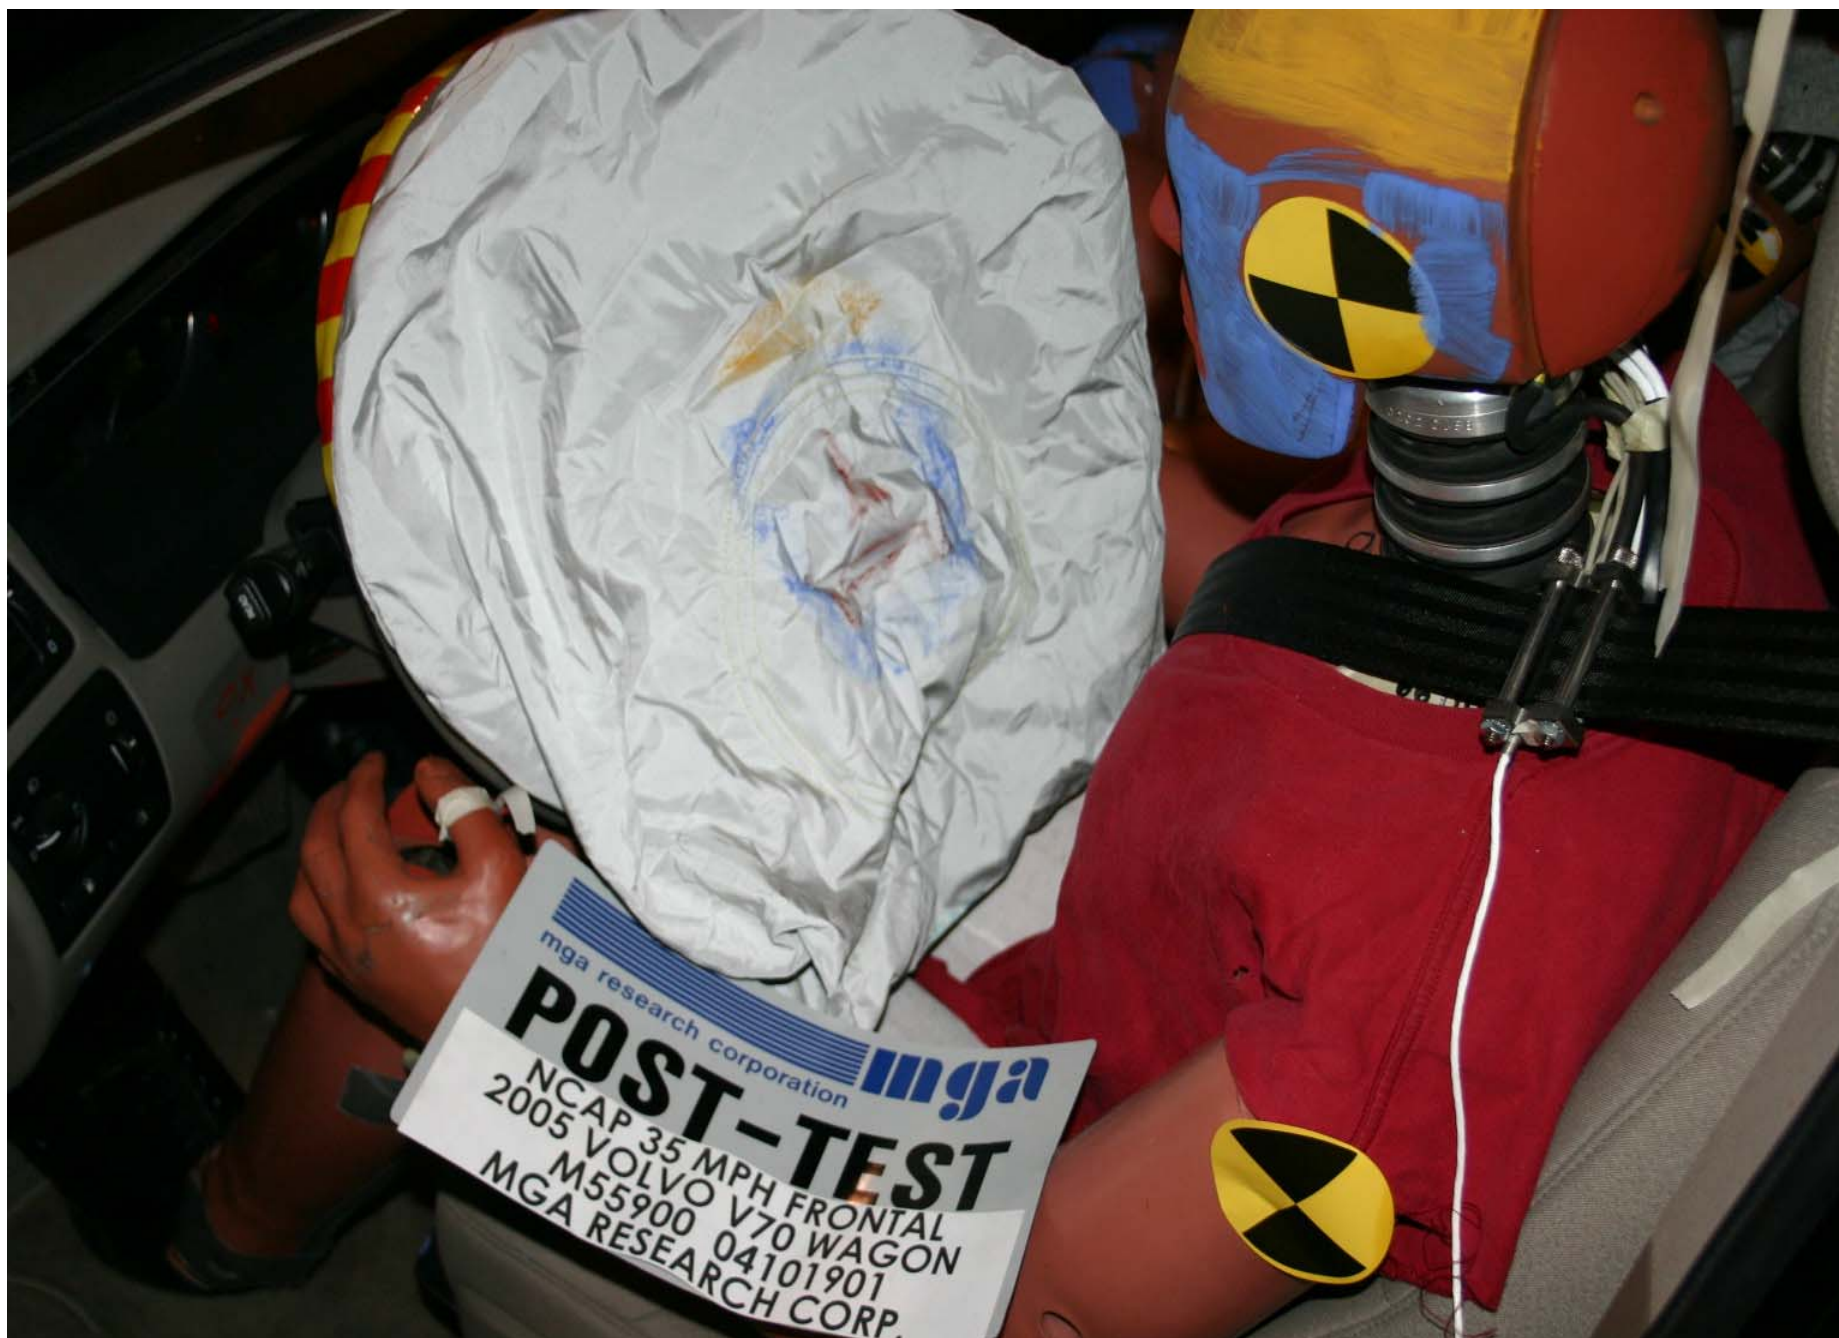
Post-Test Driver Dummy Airbag Contact

| Description | Driver | Passenger |
|---|---|---|
| Chest Contact | Airbag | Airbag |
| Abdomen Contact | Airbag | Airbag |

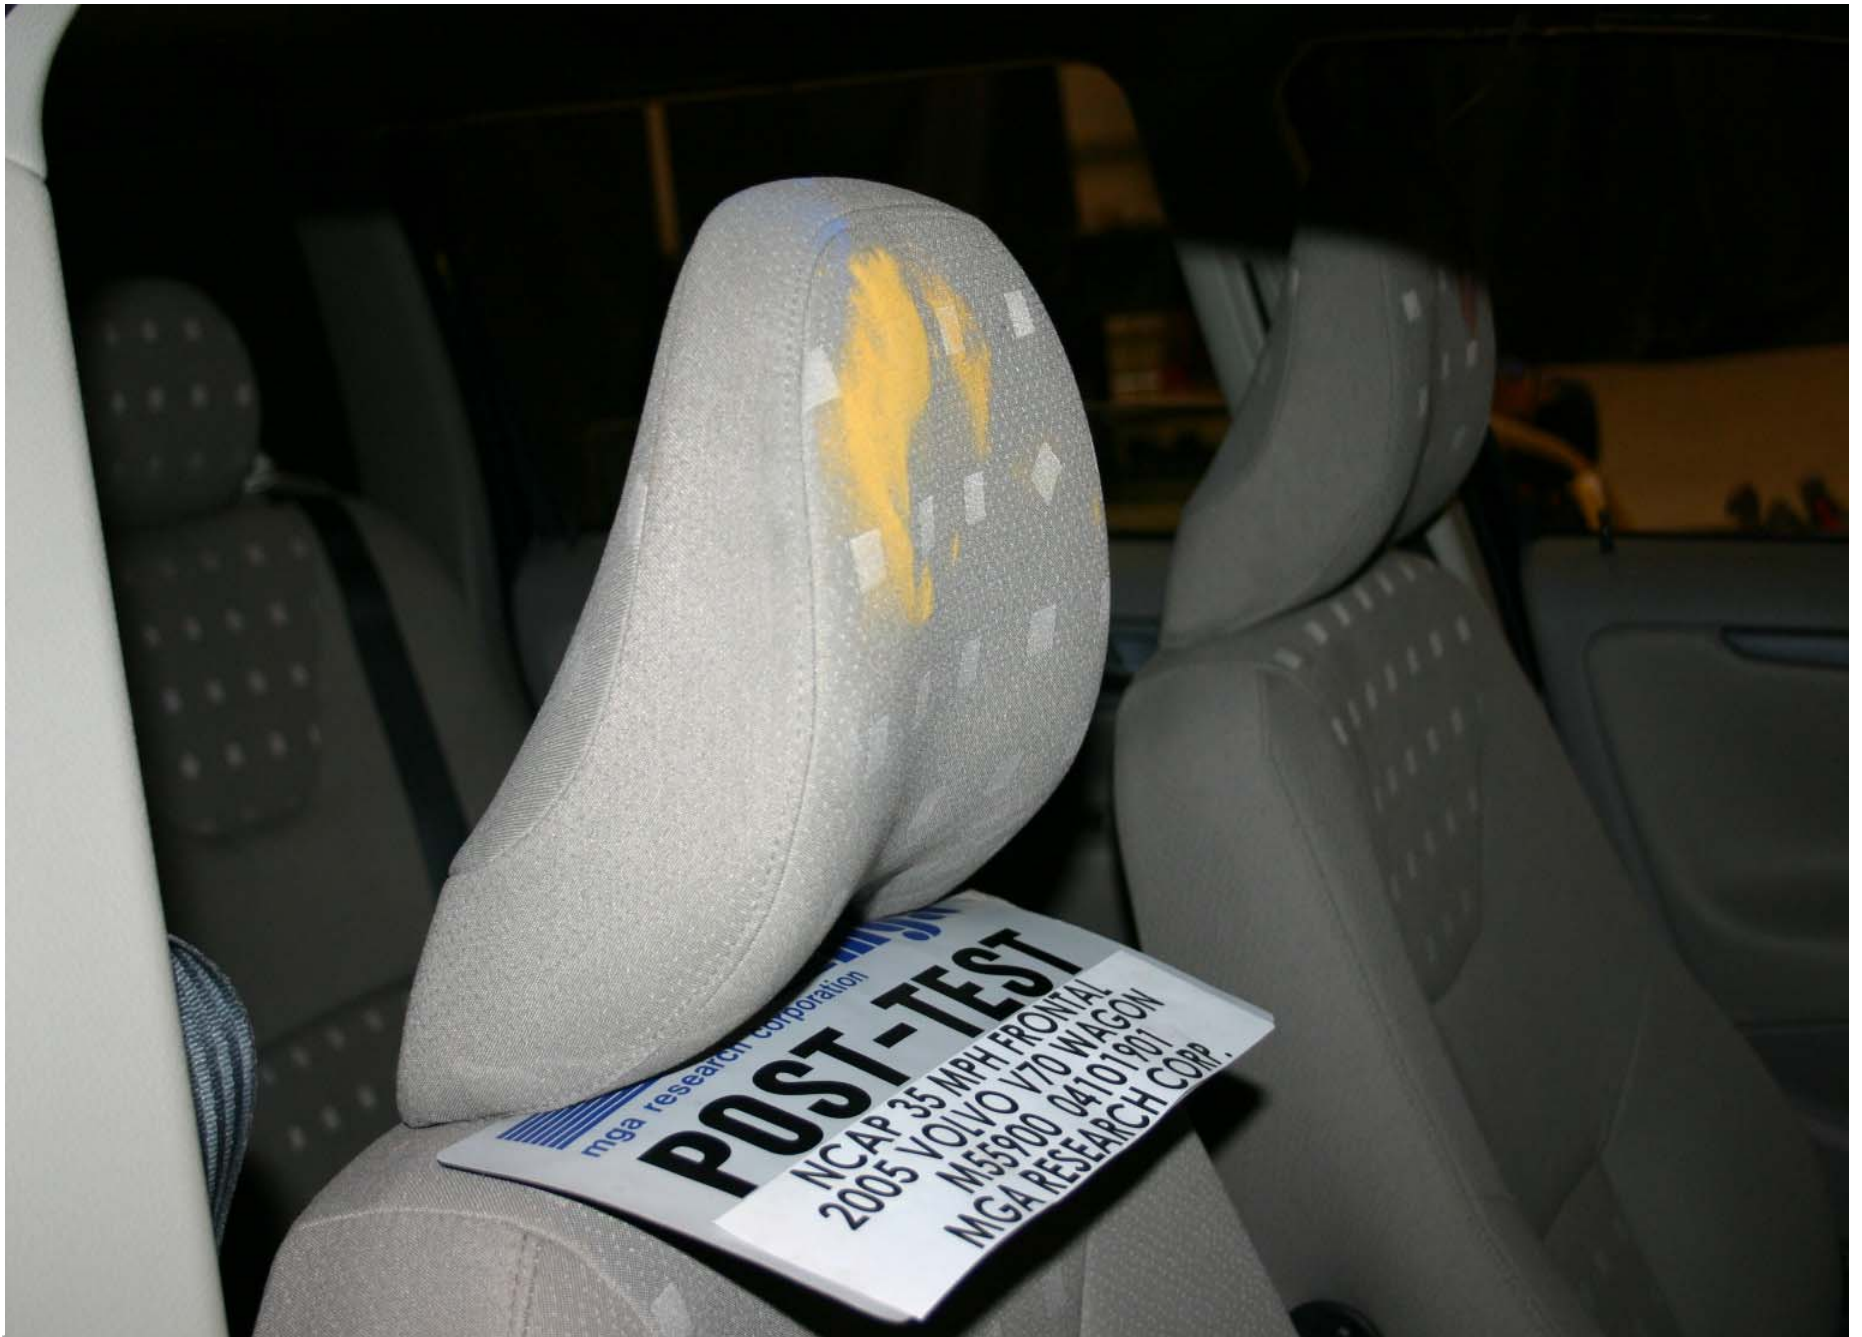
Post-Test Passenger Dummy Head Contact

| Description | Driver | Passenger |
|---|---|---|
| Head Contact | Airbag, Headrest | Airbag, Headrest |

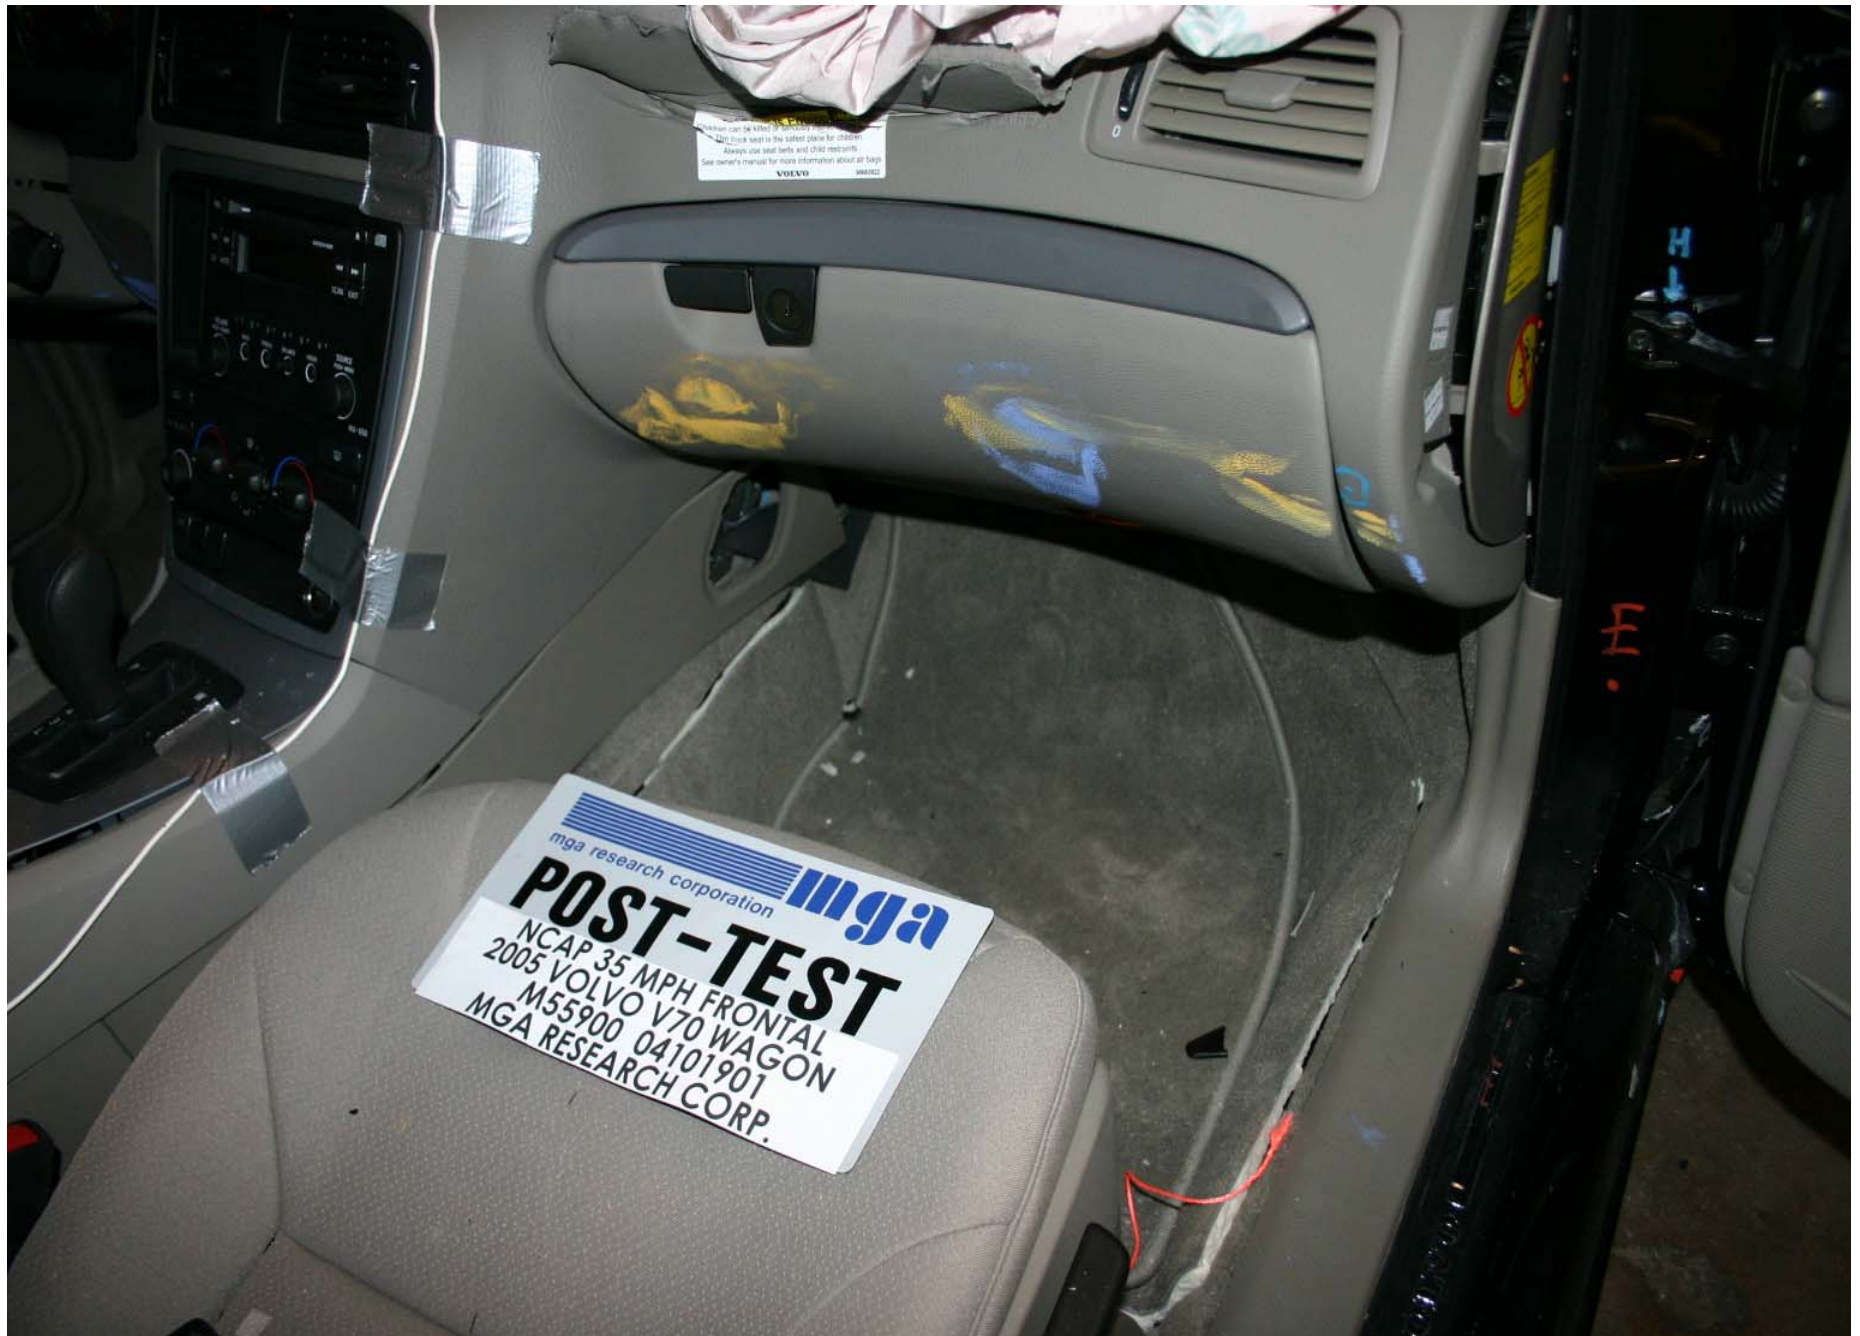
Post-Test Passenger Dummy Knee Contact
