**REPORT NUMBER: NCAP-MGA-2005-004**

**NEW CAR ASSESSMENT PROGRAM  
FRONTAL BARRIER IMPACT TEST**

**VOLVO GOTHENBURG SWEDEN  
2005 Volvo V70 Station Wagon  
NHTSA NUMBER: M55900**

**FINAL REPORT**

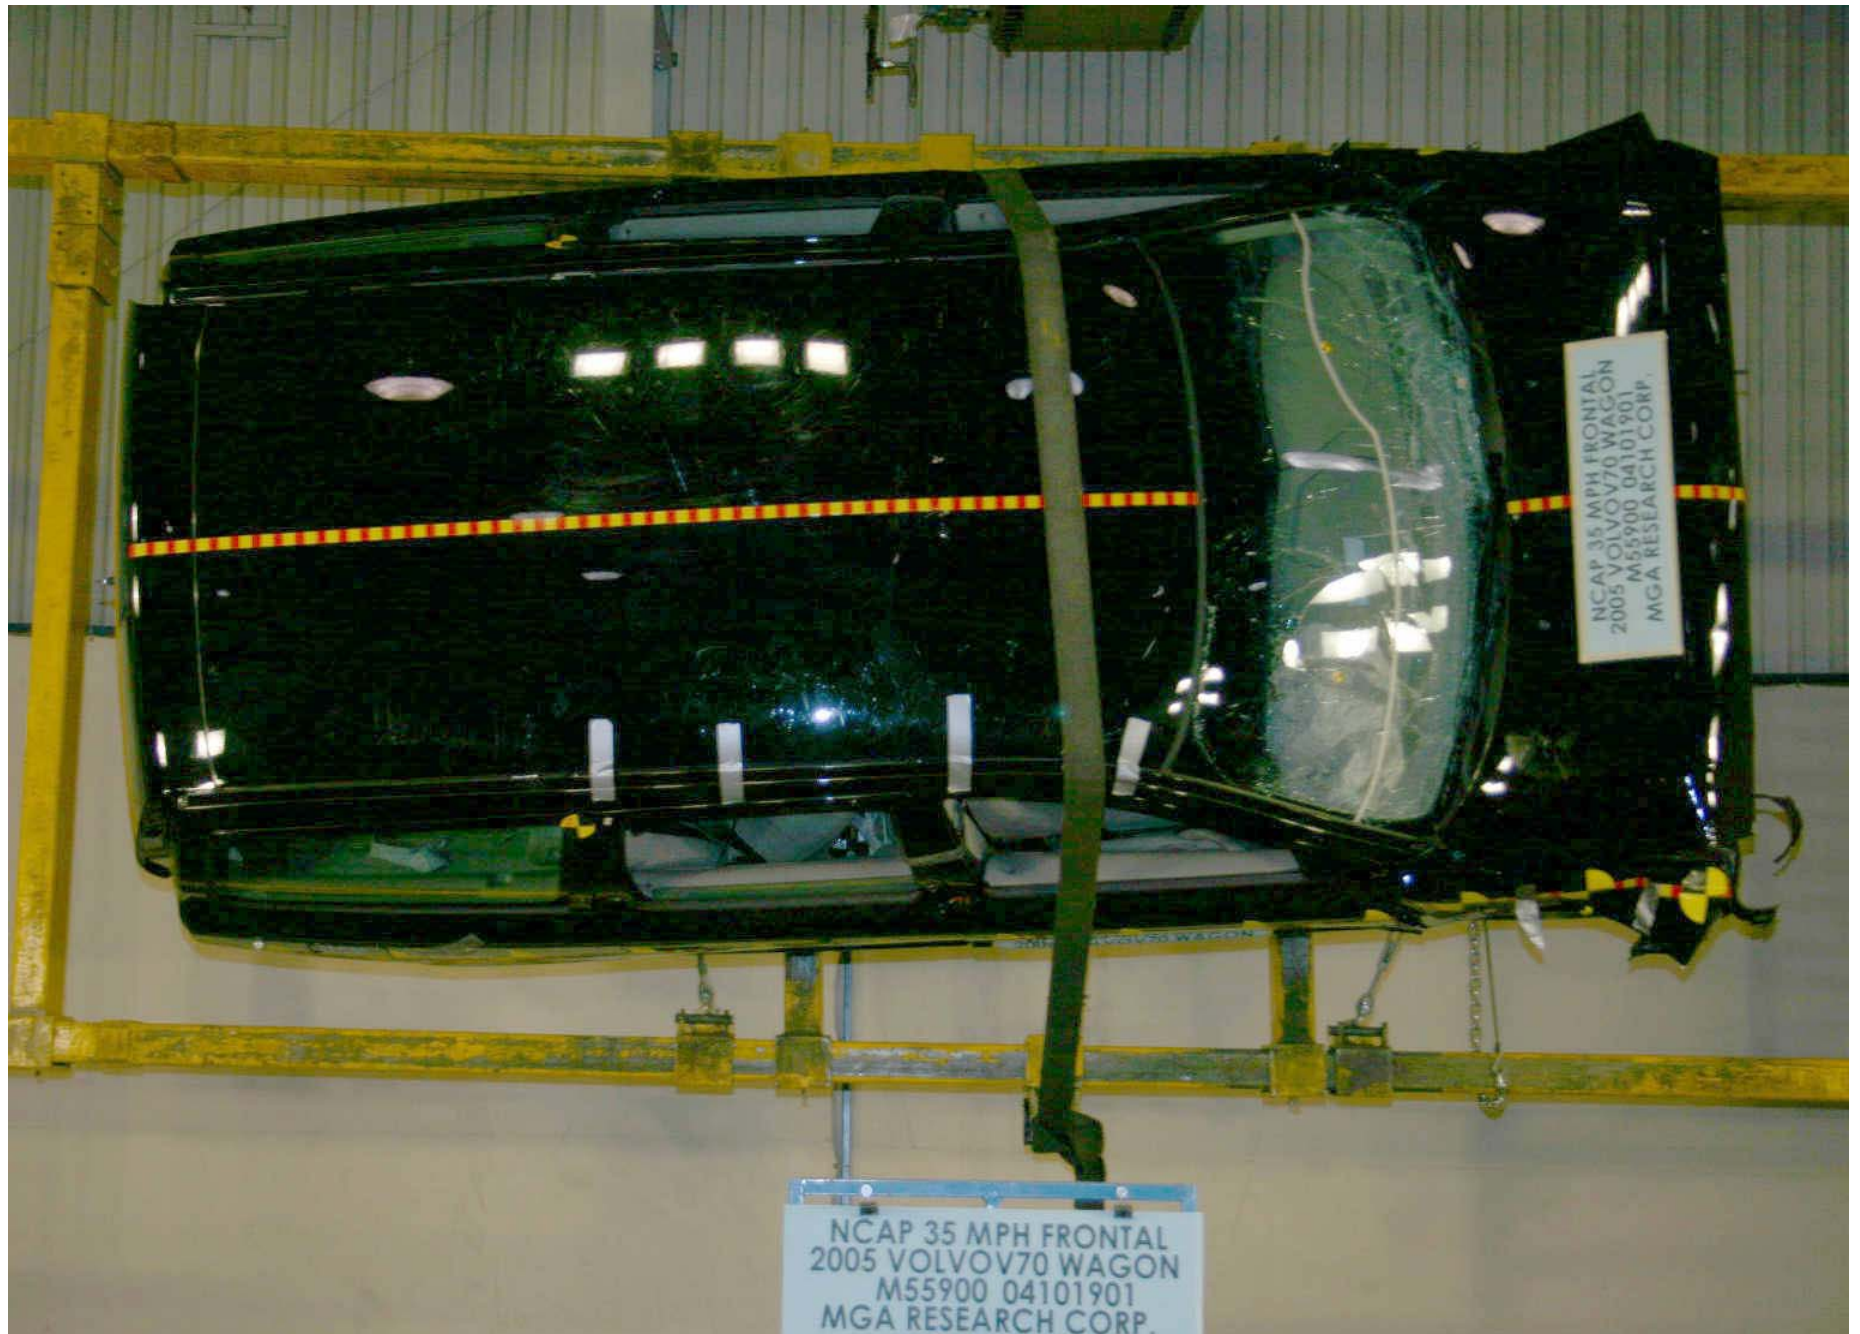
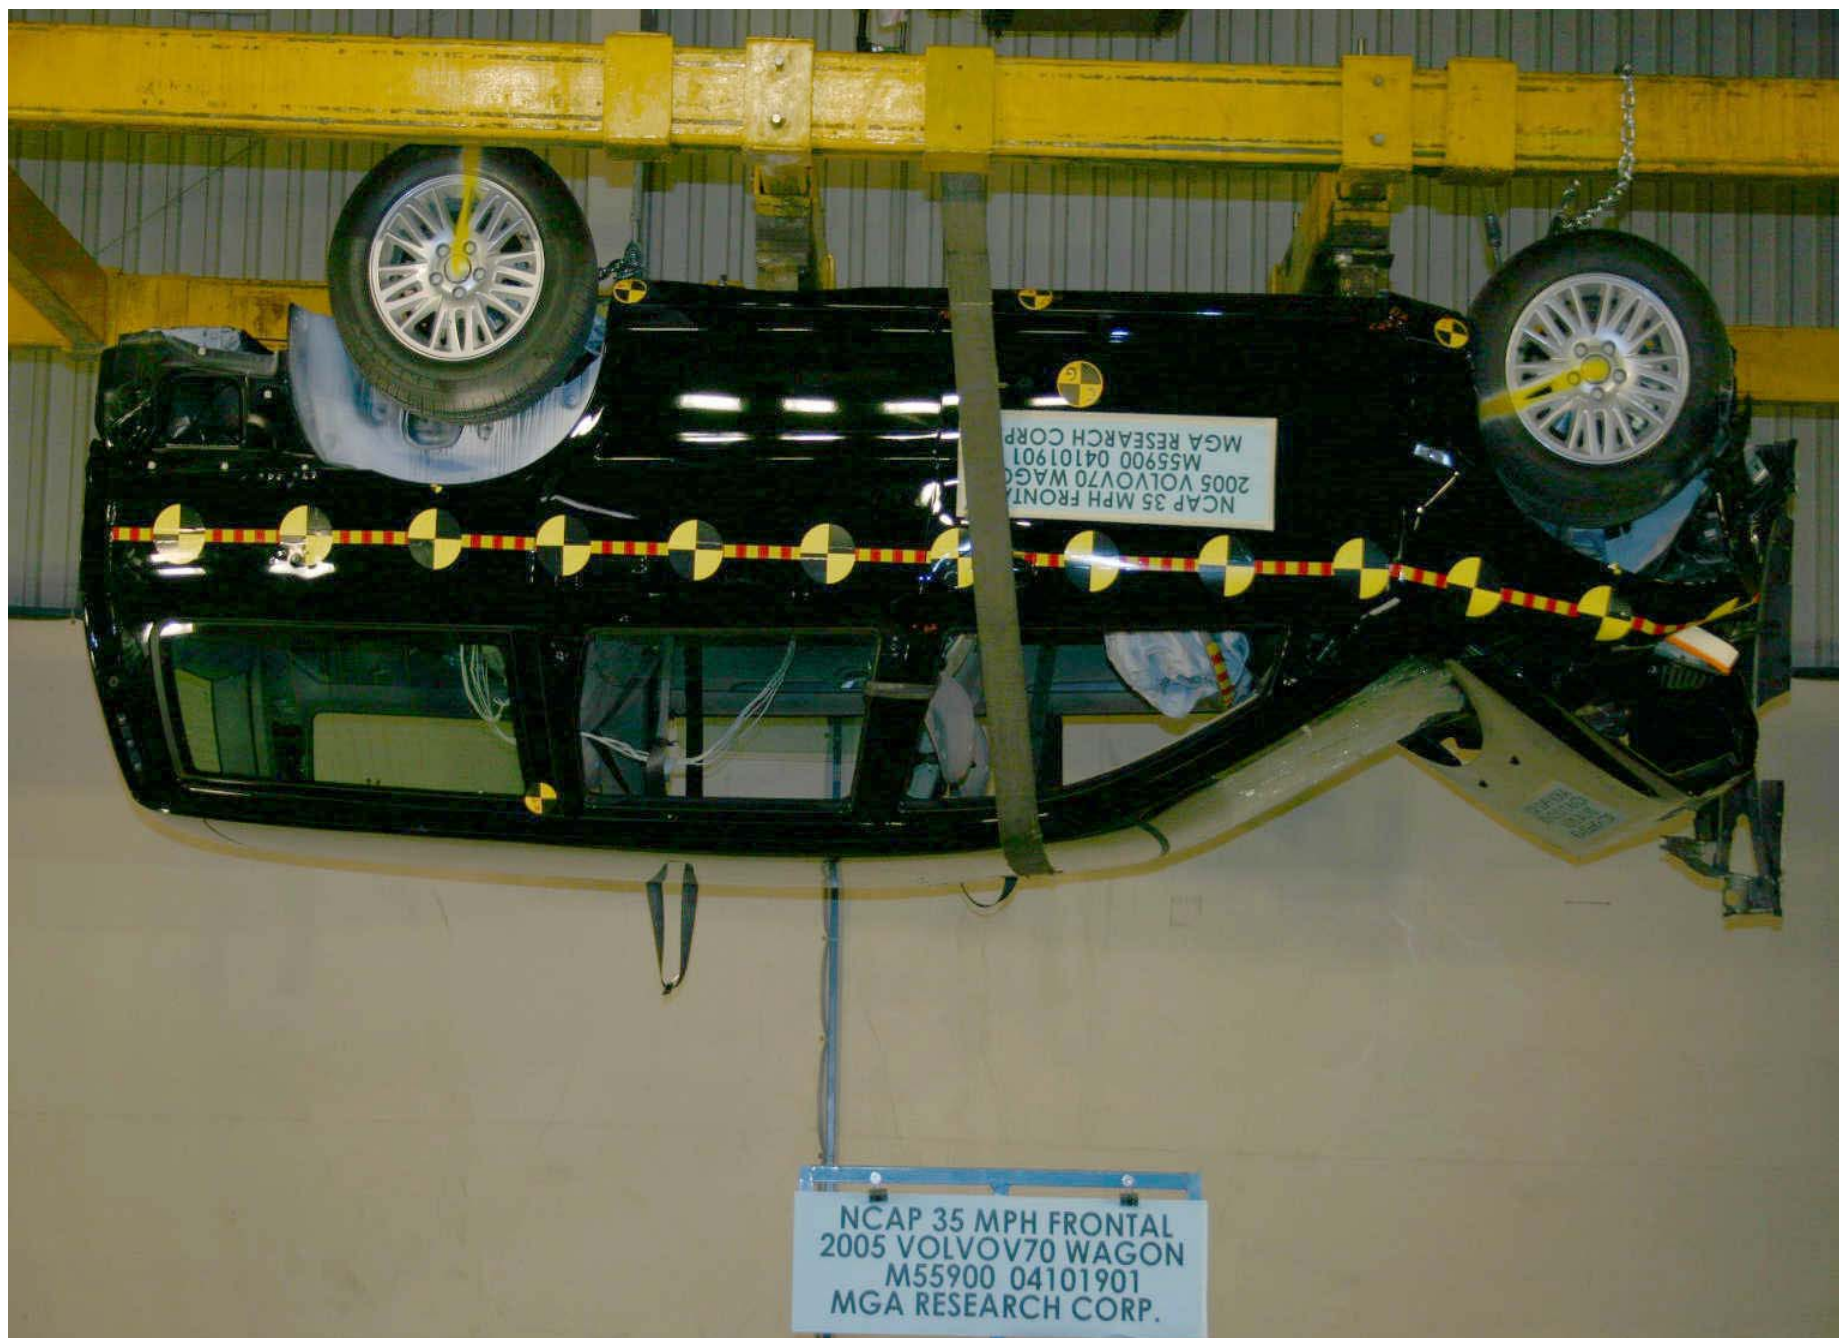
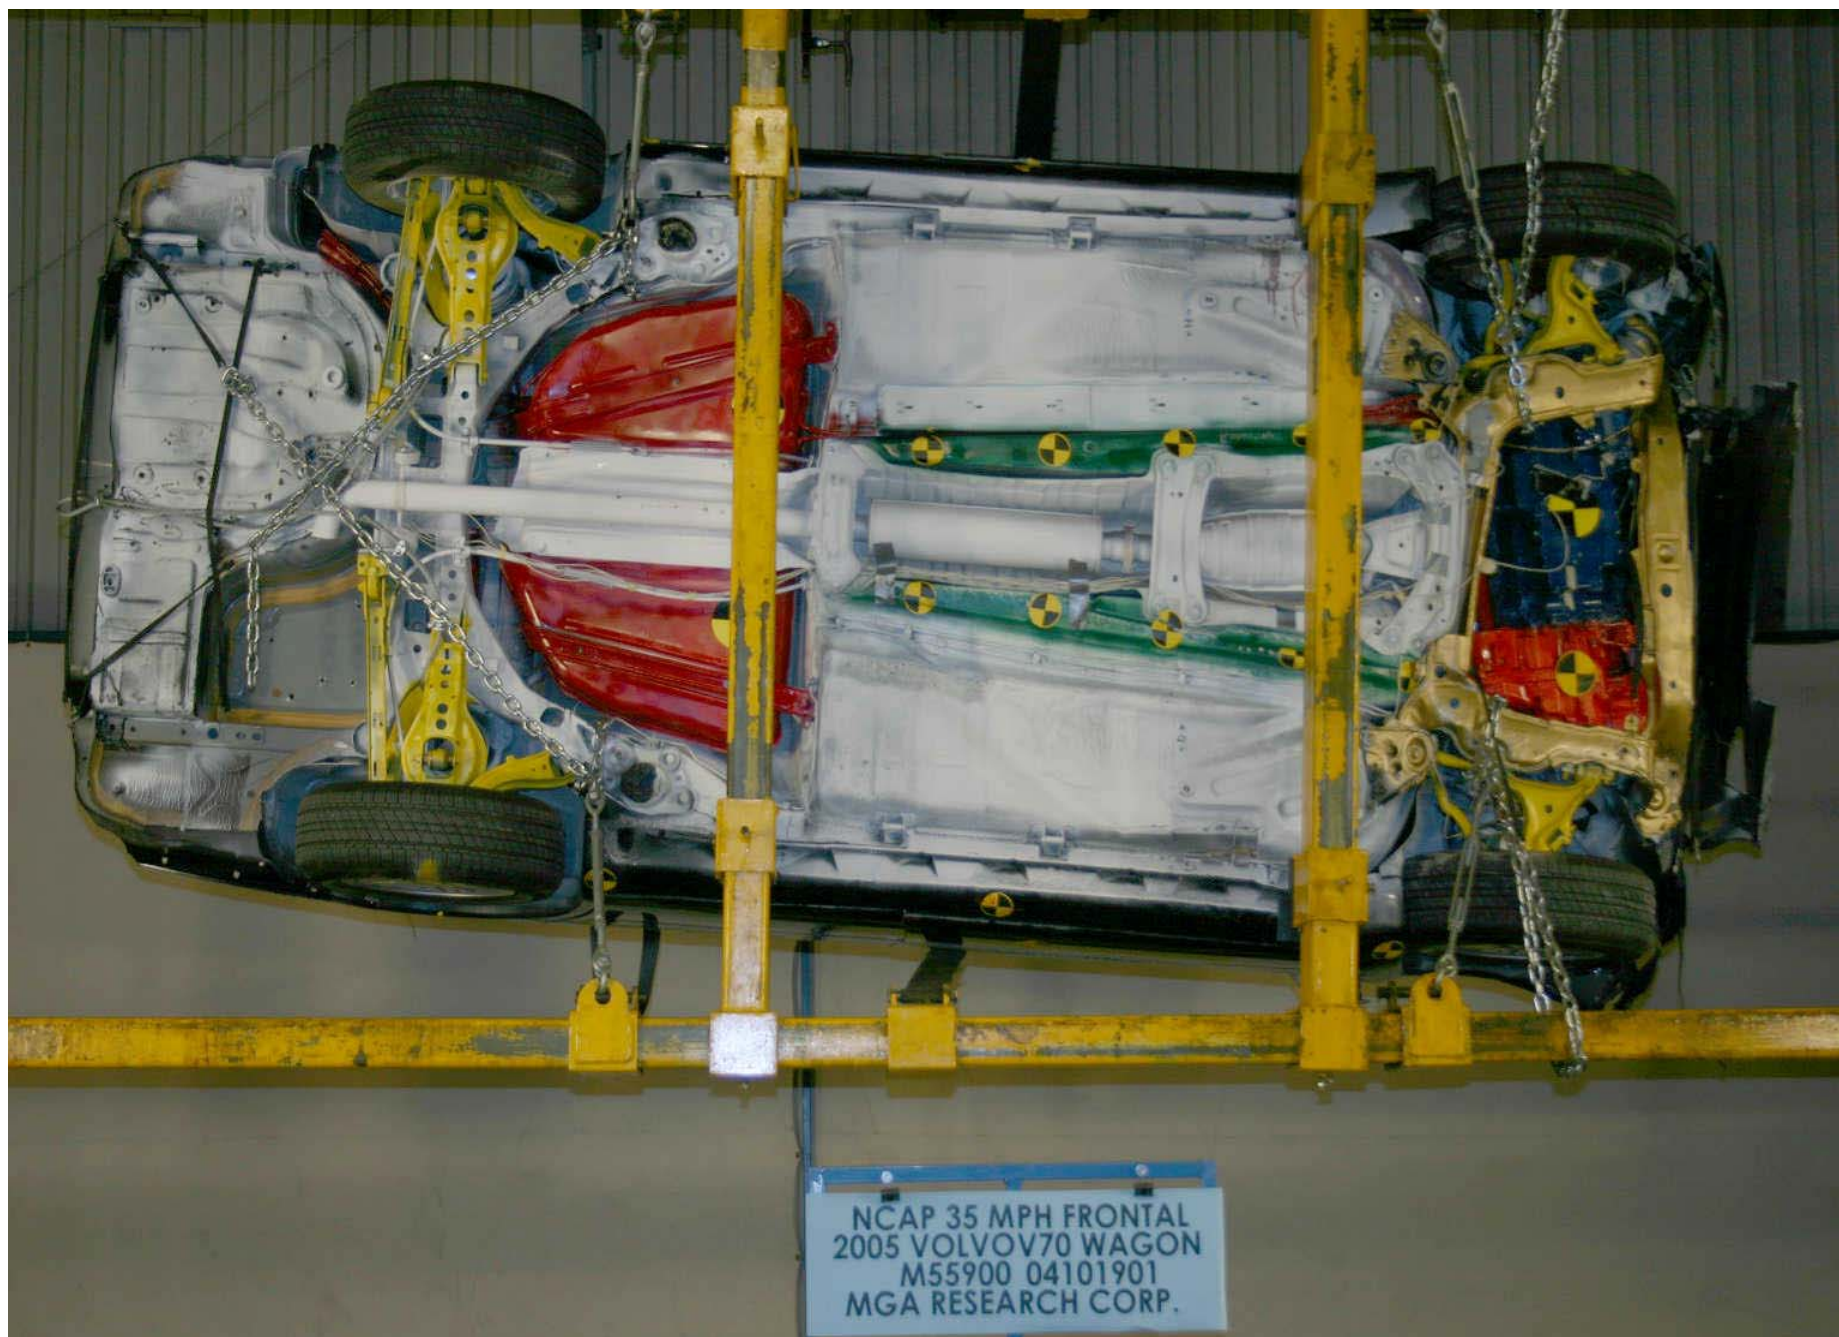
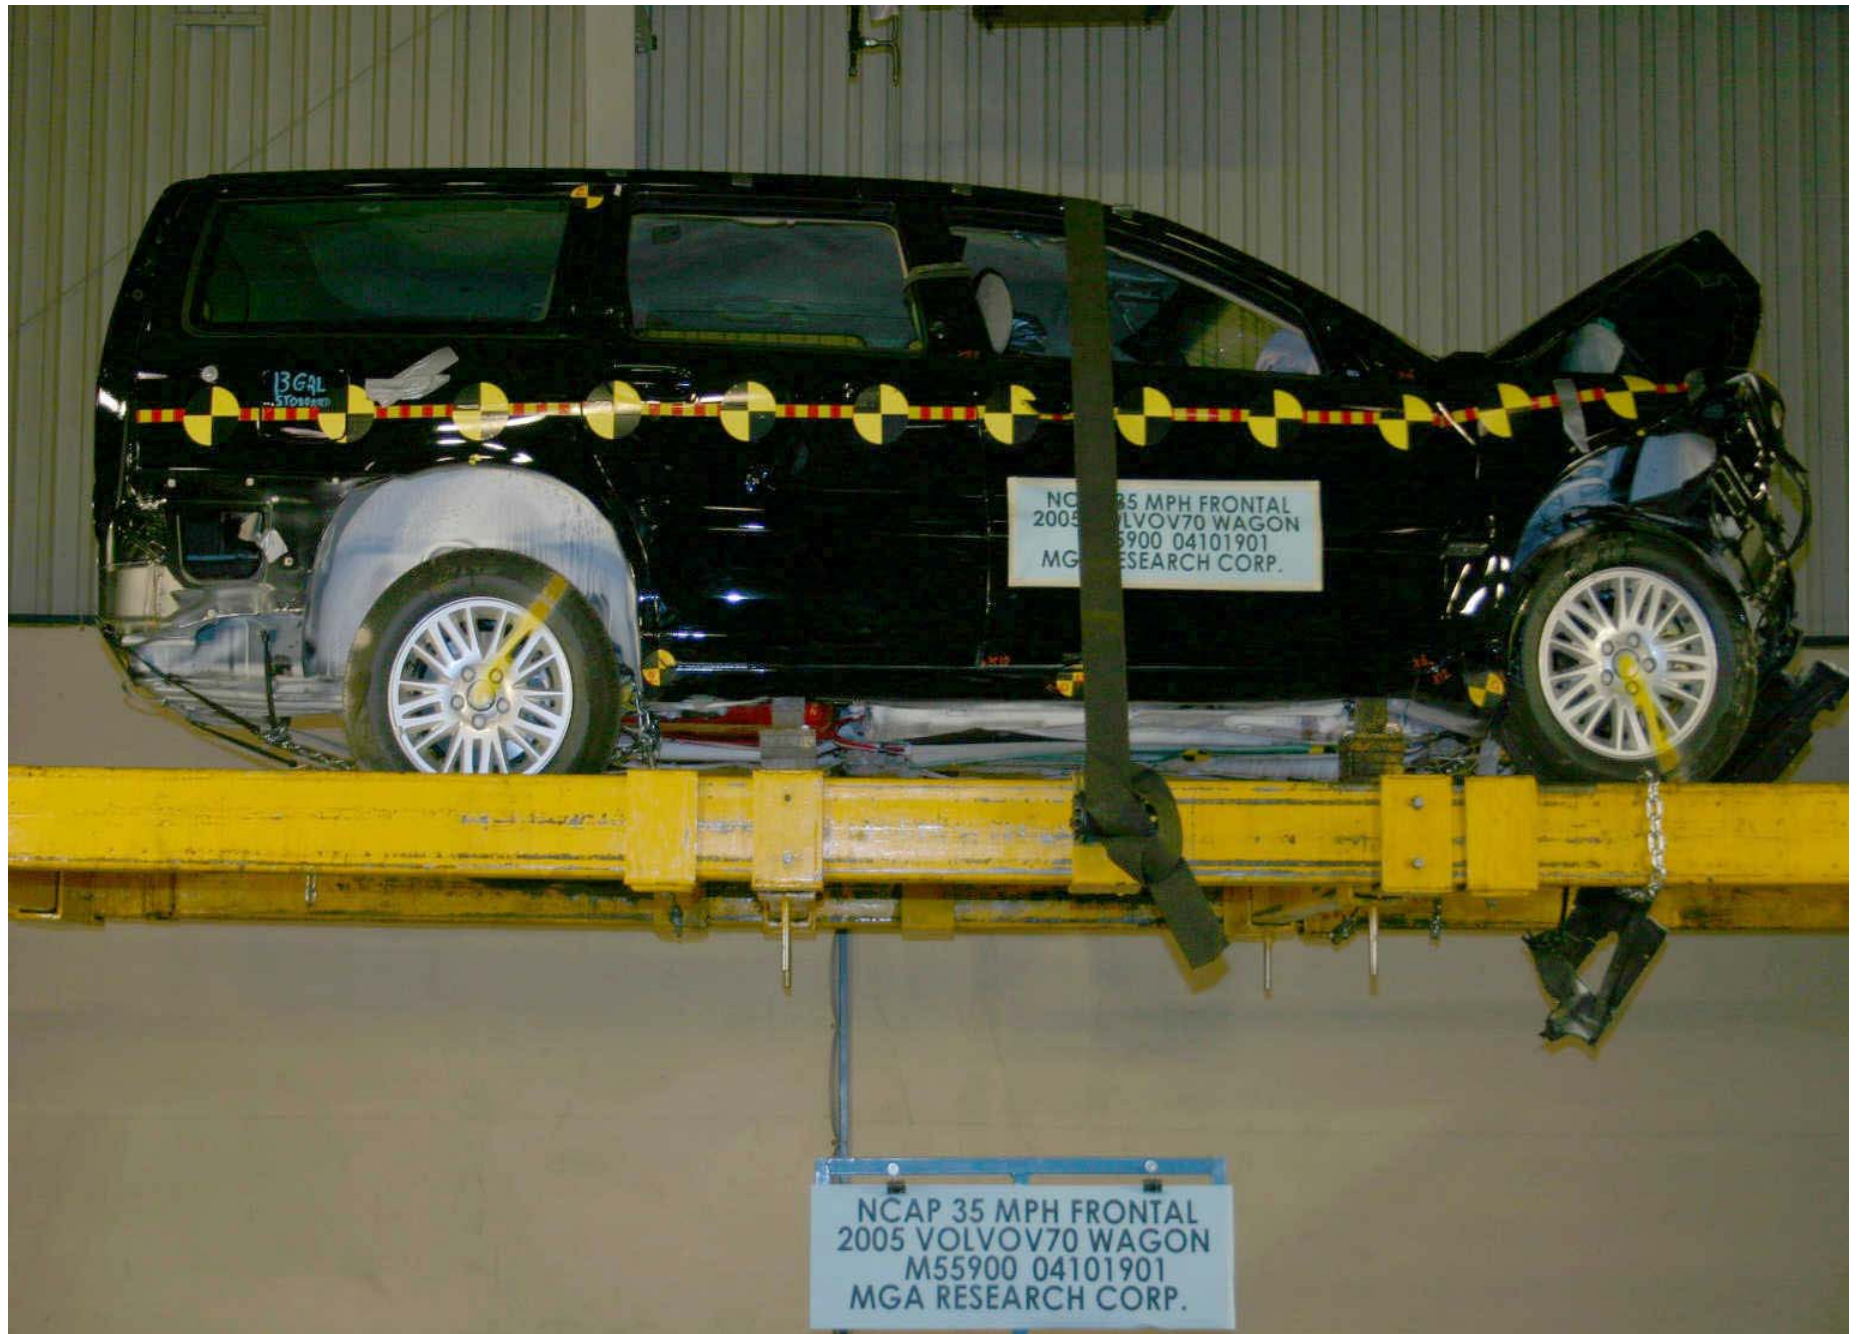
Rollover 90 Degrees

Rollover 180 Degrees

Rollover 270 Degrees

Rollover 360 Degrees

There was 100 percent windshield retention and no intrusion into the protected zone of the windshield during the event. There was no Stoddard Solvent leakage after the event or during any phase of the static rollover.
