**REPORT NUMBER TR-P24145-01-NC**

**NEW CAR ASSESSMENT PROGRAM  
SIDE IMPACT TEST**

**HONDA MOTOR CORPORATION  
2005 ACURA RL  
4-DOOR SEDAN**

**NHTSA NUMBER: H55301**

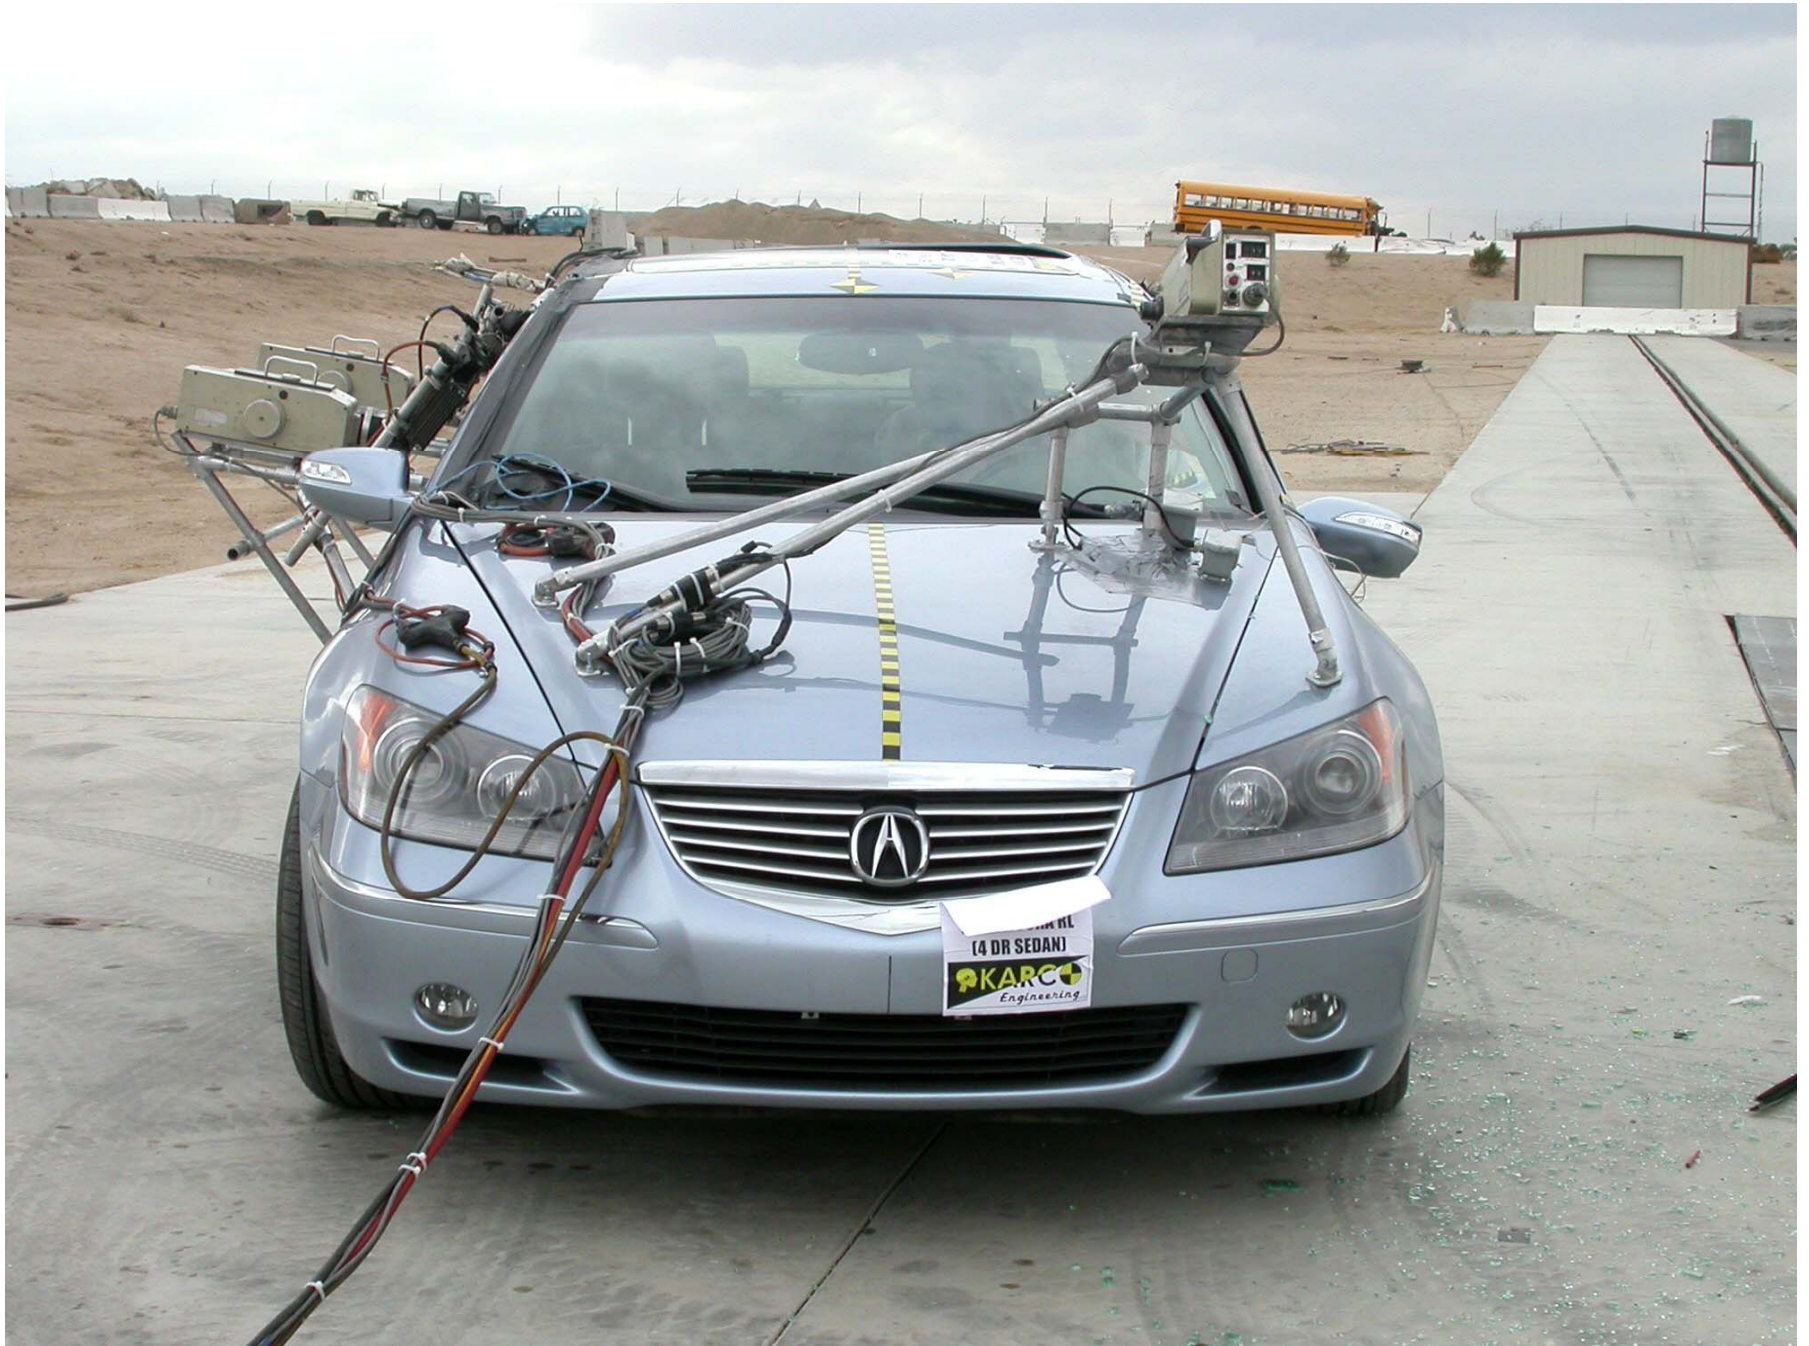
Figure A-6: Front View, Post-Test

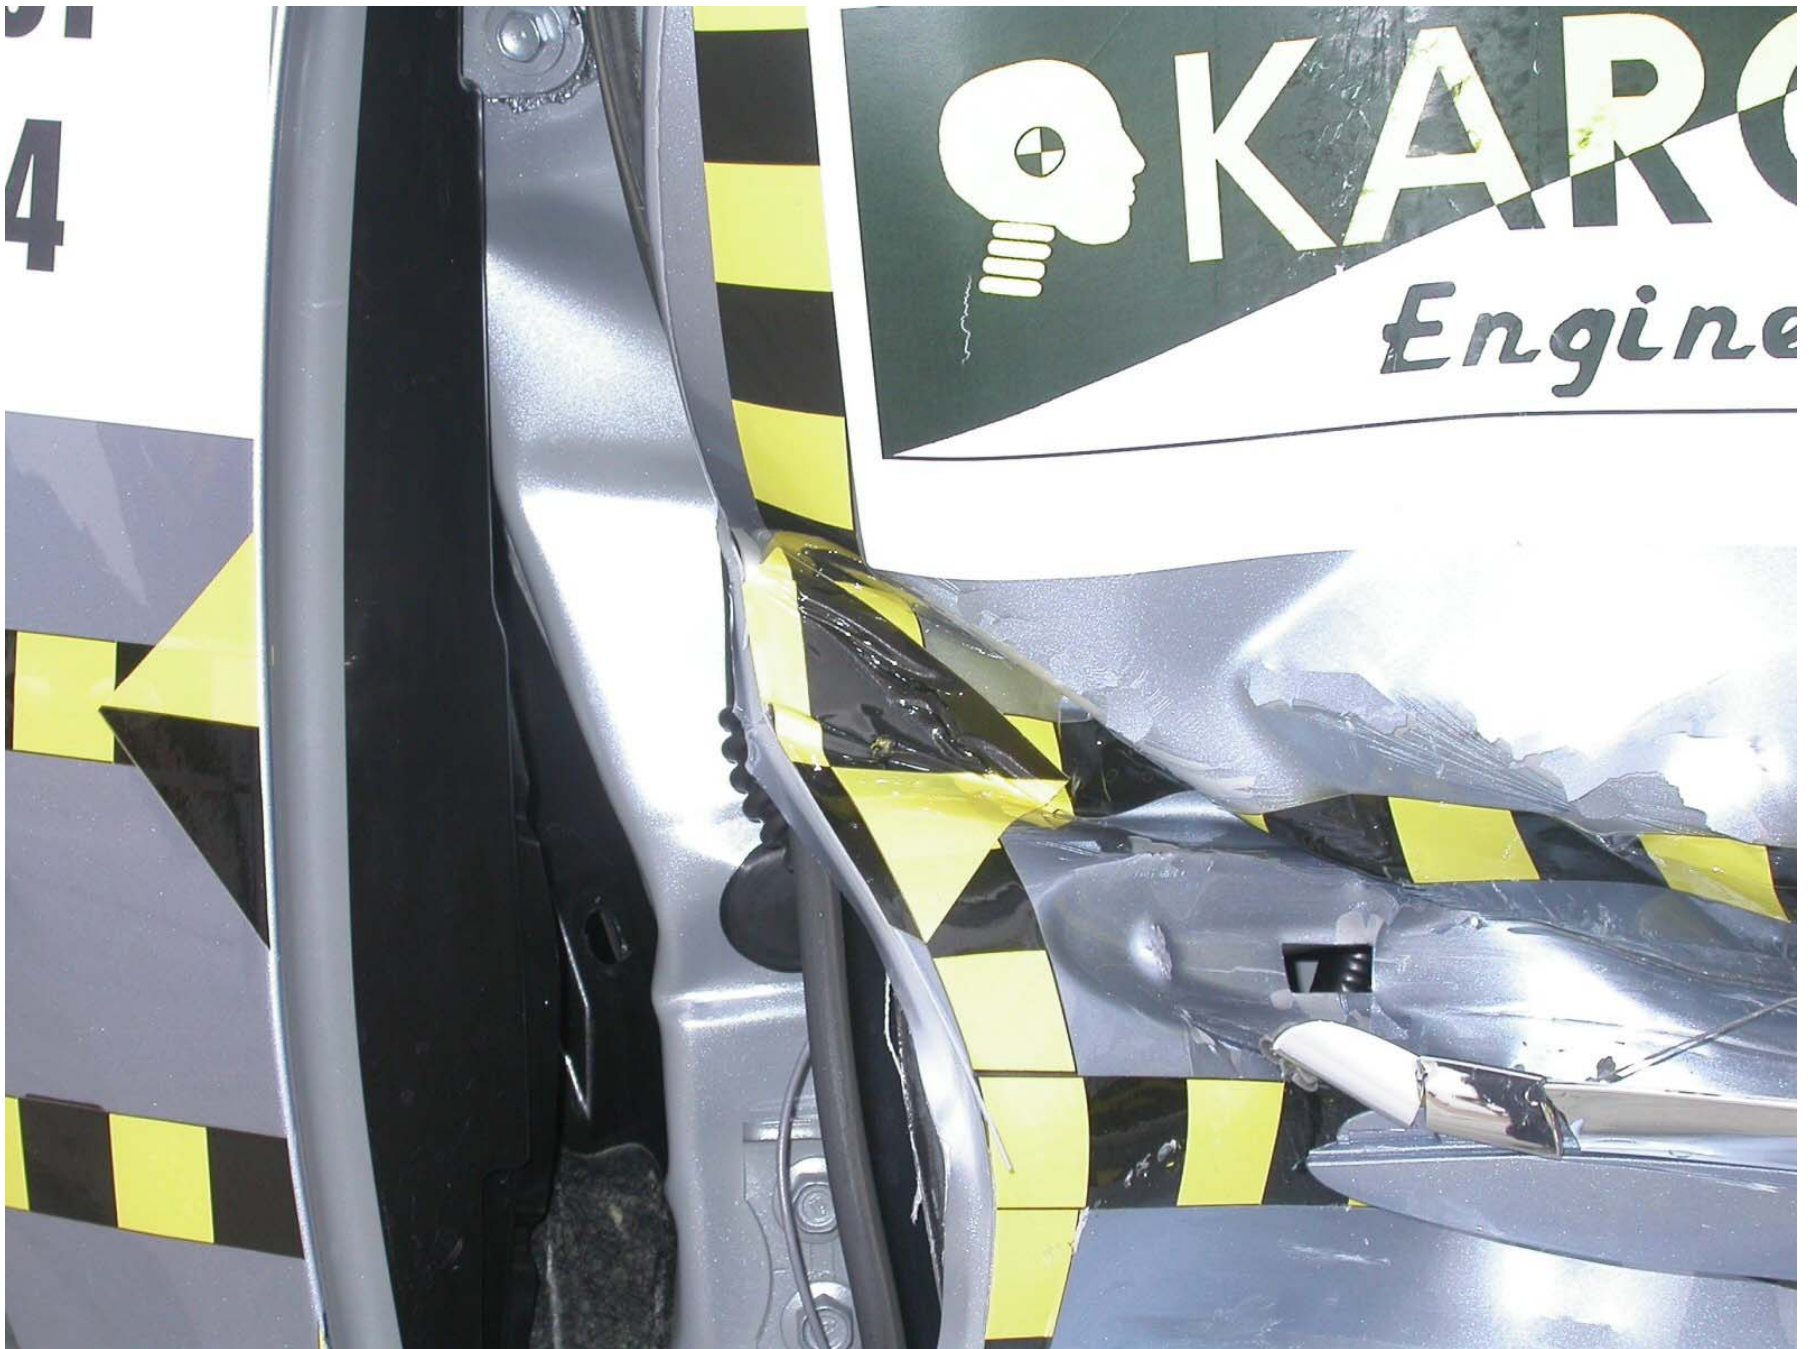
Figure A-26: Impact Point, Post-Test

The test vehicle sustained a maximum static crush of 224 mm at level 4, 1350 mm rearward of the left vertical impact point. The driver SID/Hybrid III, Serial No. 274 and the passenger SID/Hybrid III, Serial No. 275 were calibrated just prior to this test. The SID/Hybrid III injury criteria is summarized as follows:

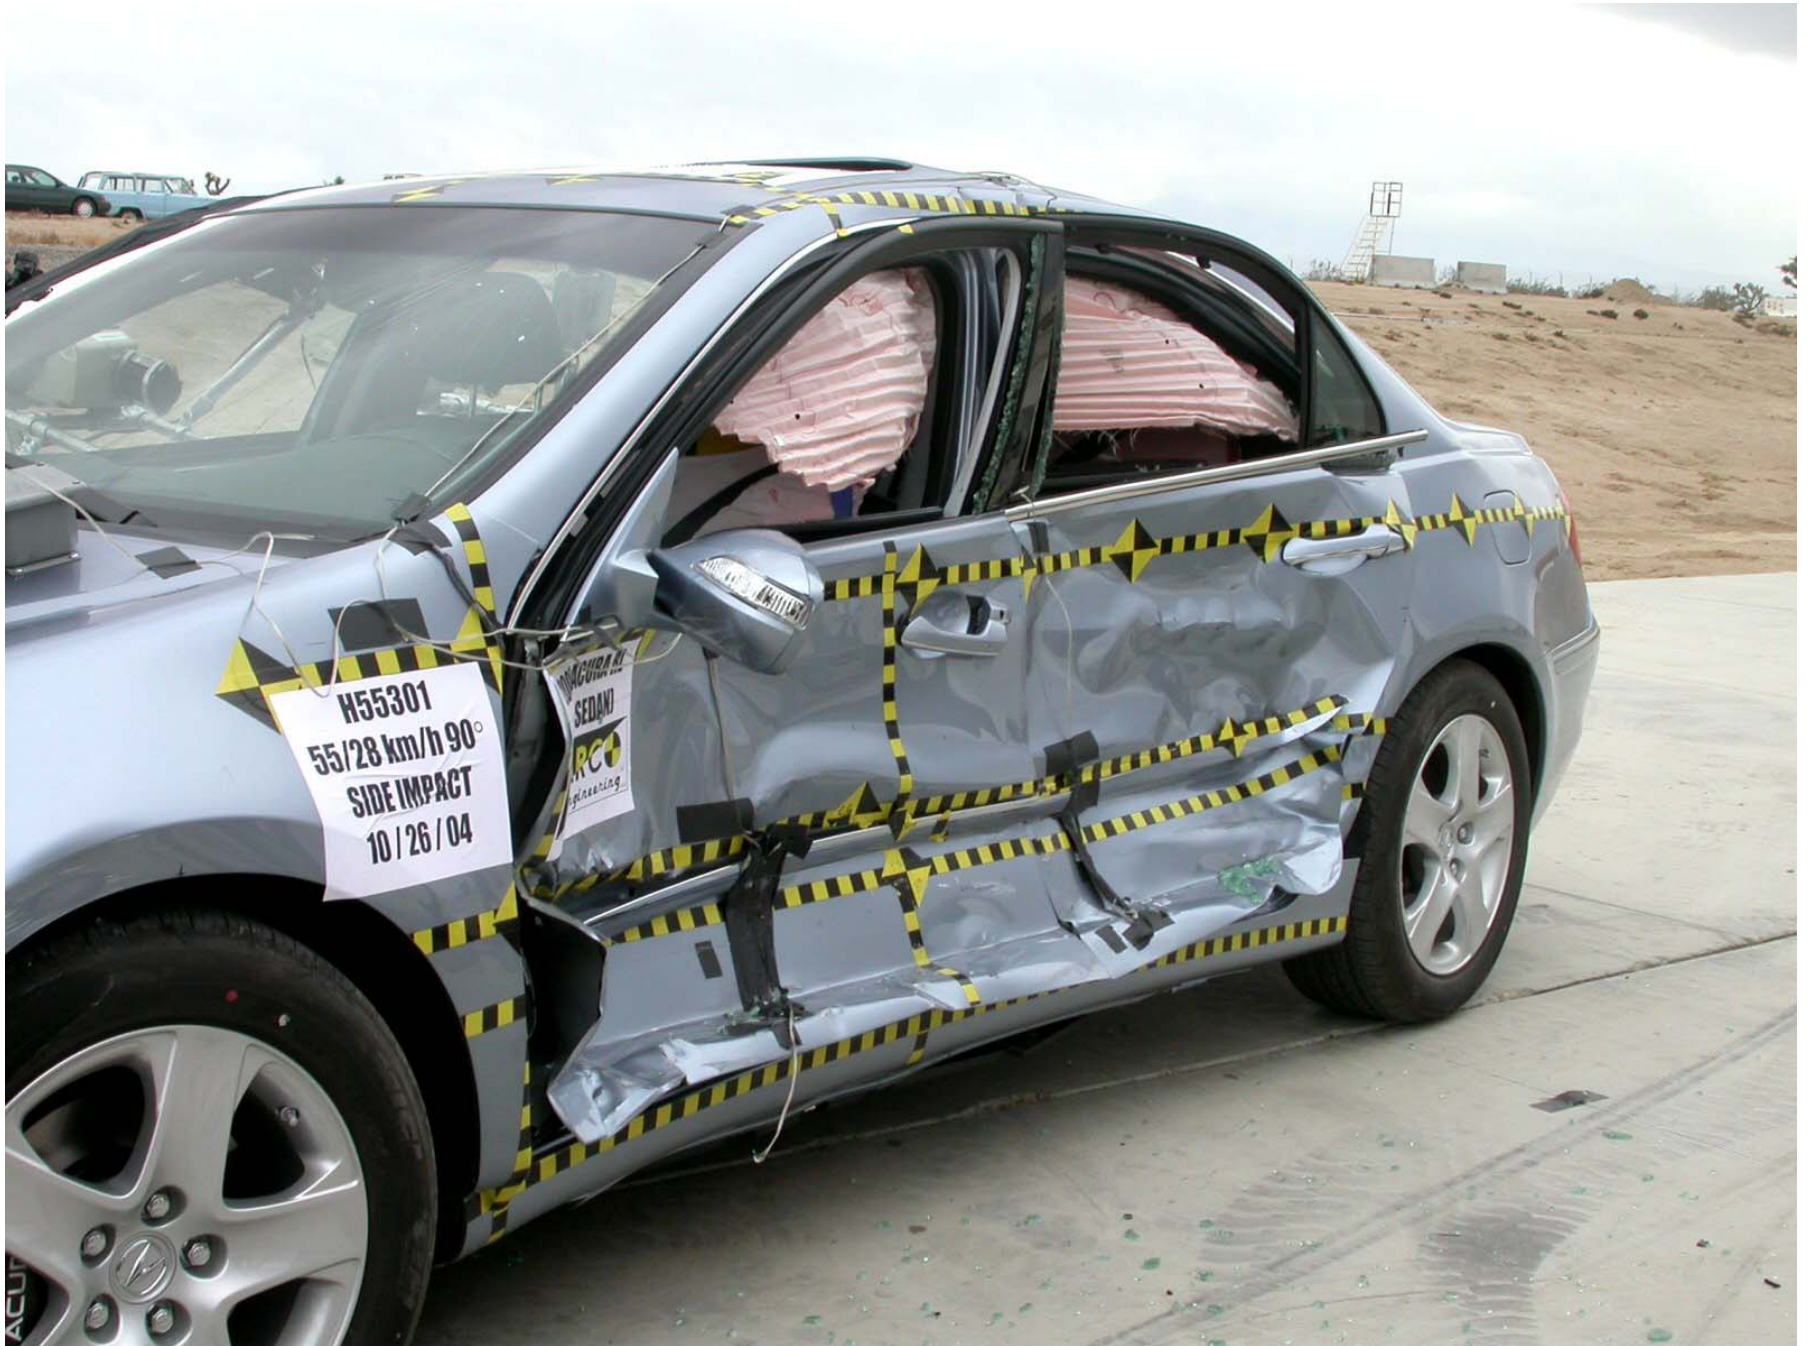
Figure A-28: Front  $\frac{3}{4}$  View of Left Side Doors, Post-Test

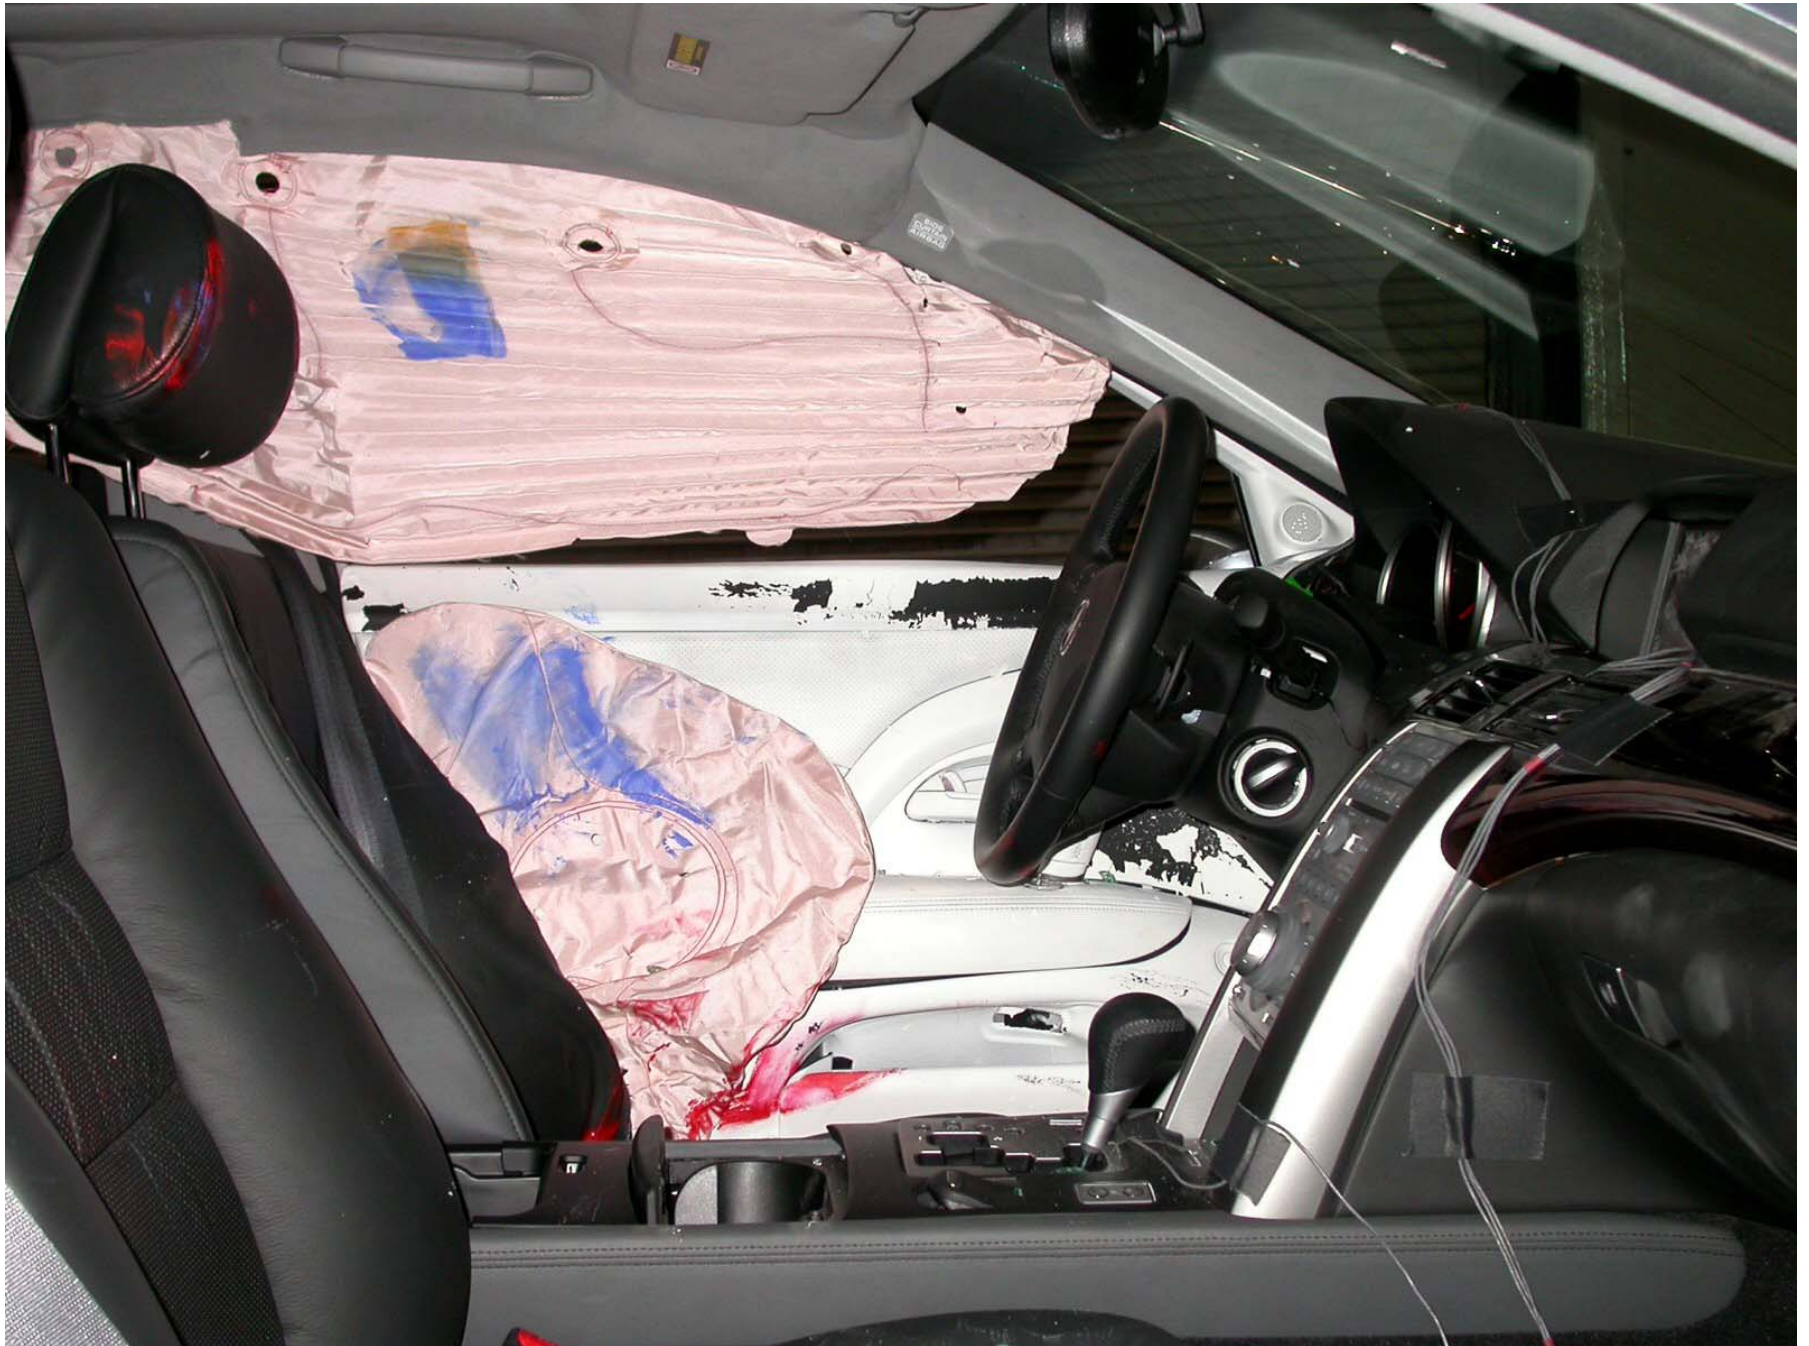
Figure A-43: Driver Dummy Contact Points, Post-Test (Vehicle Moved)

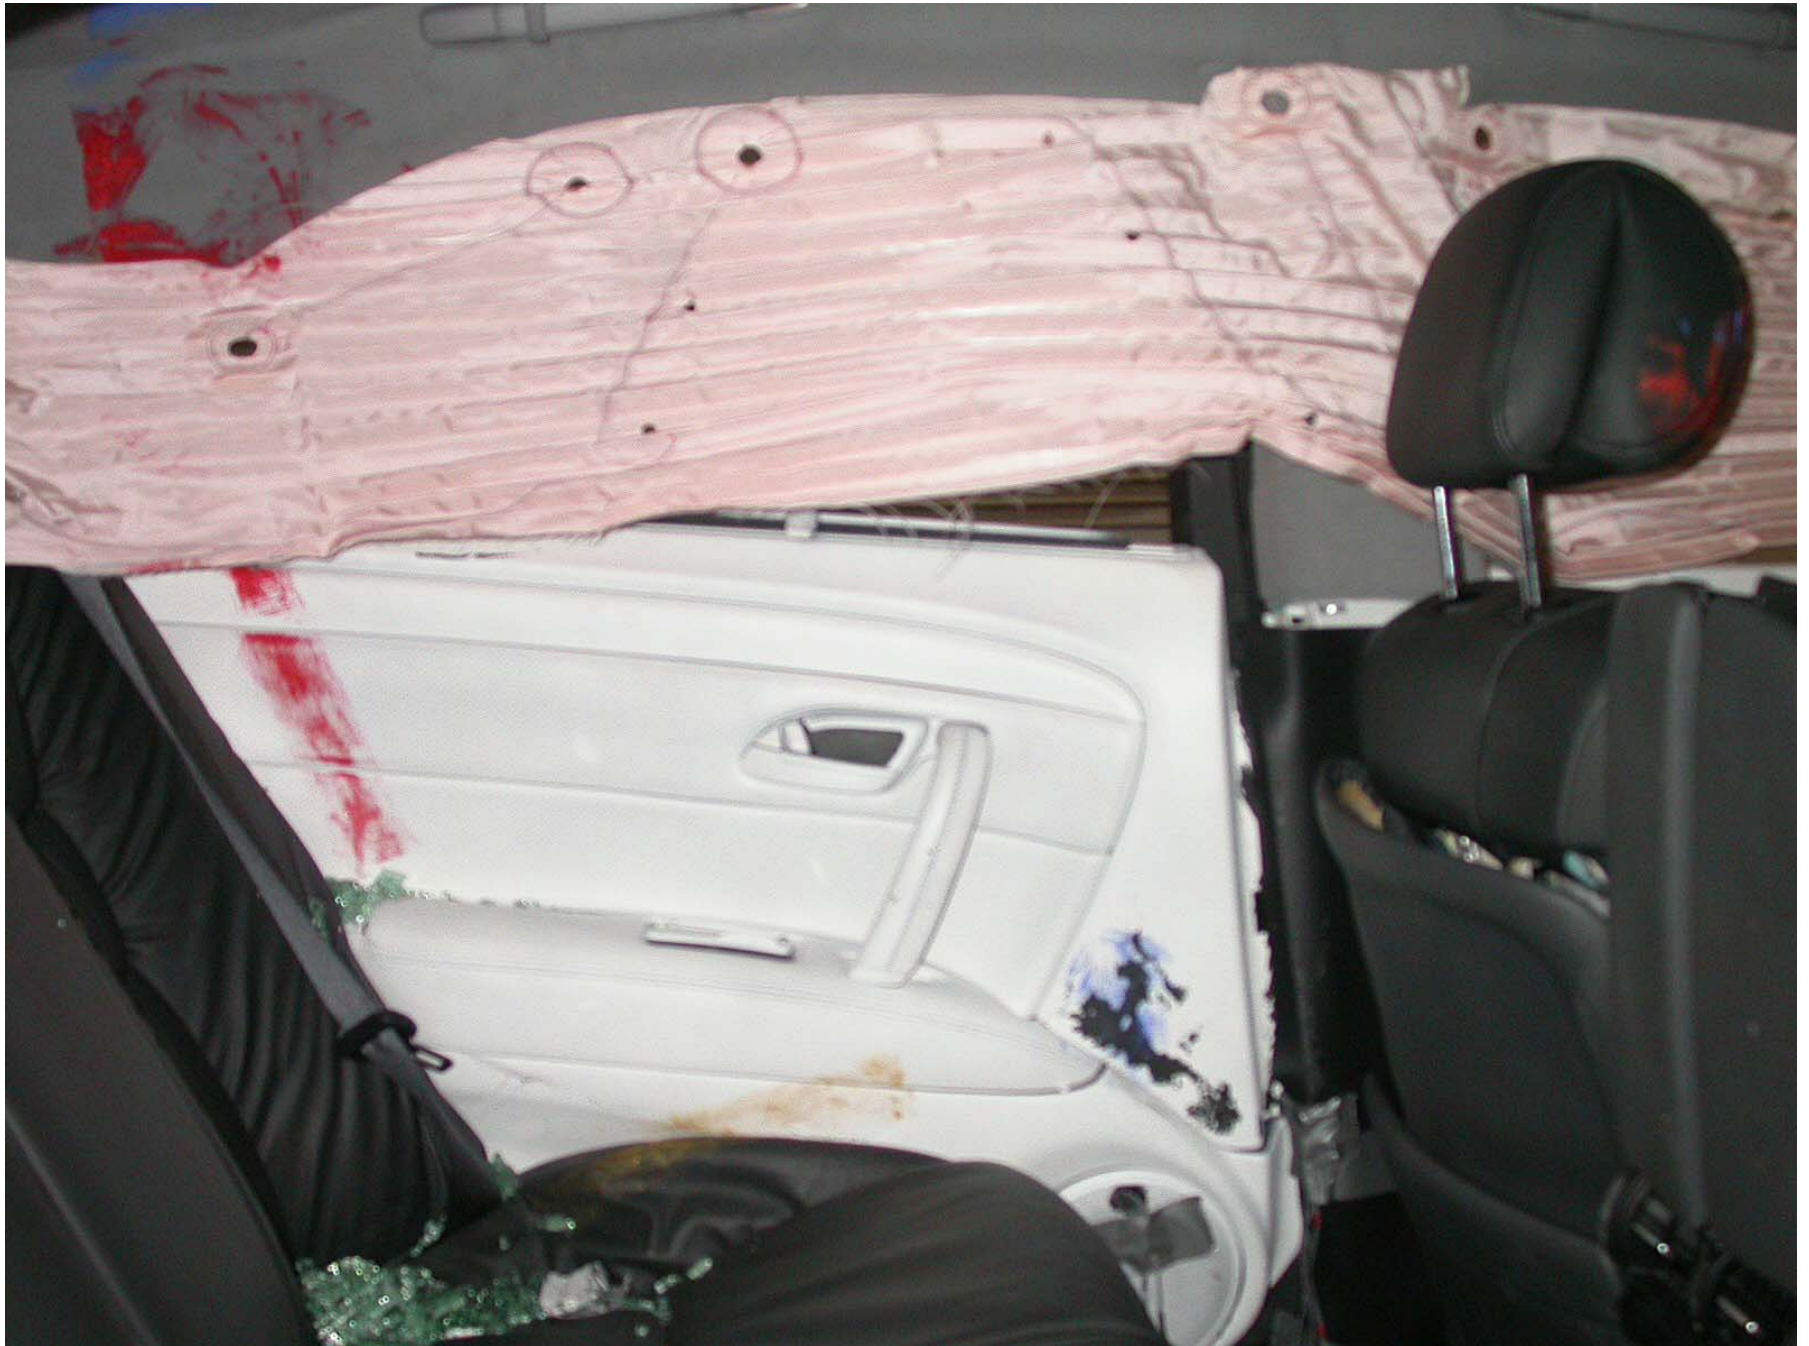
Figure A-52: Passenger Dummy Contact Points, Post-Test (Vehicle Moved)

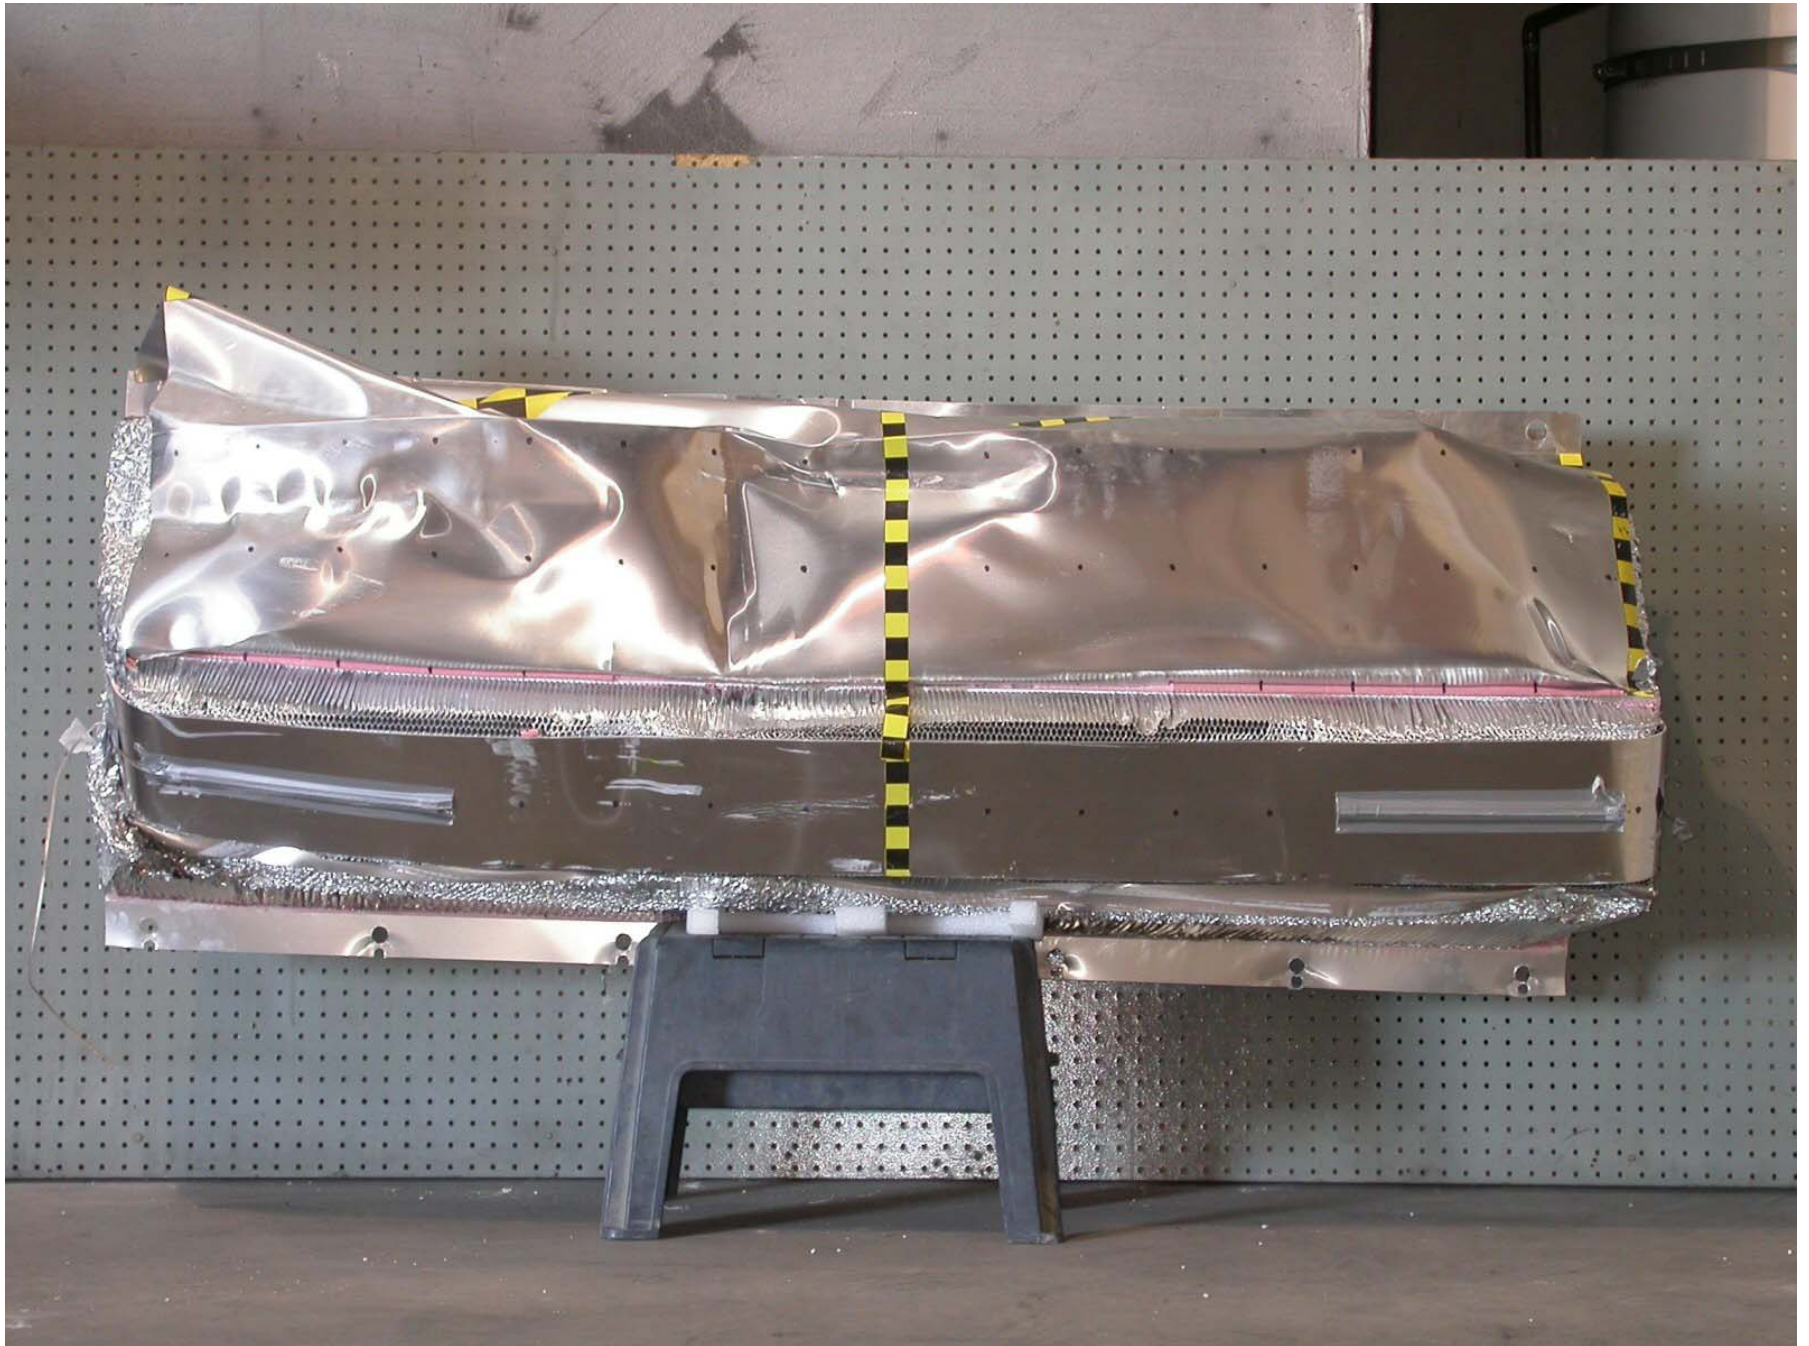
Figure A-54: Front View of Deformable Barrier, Post-Test
