Report Number: 214-TRC-04-004

Safety Compliance Testing For FMVSS 214

Side Impact Protection

2005 Scion TC 2-door

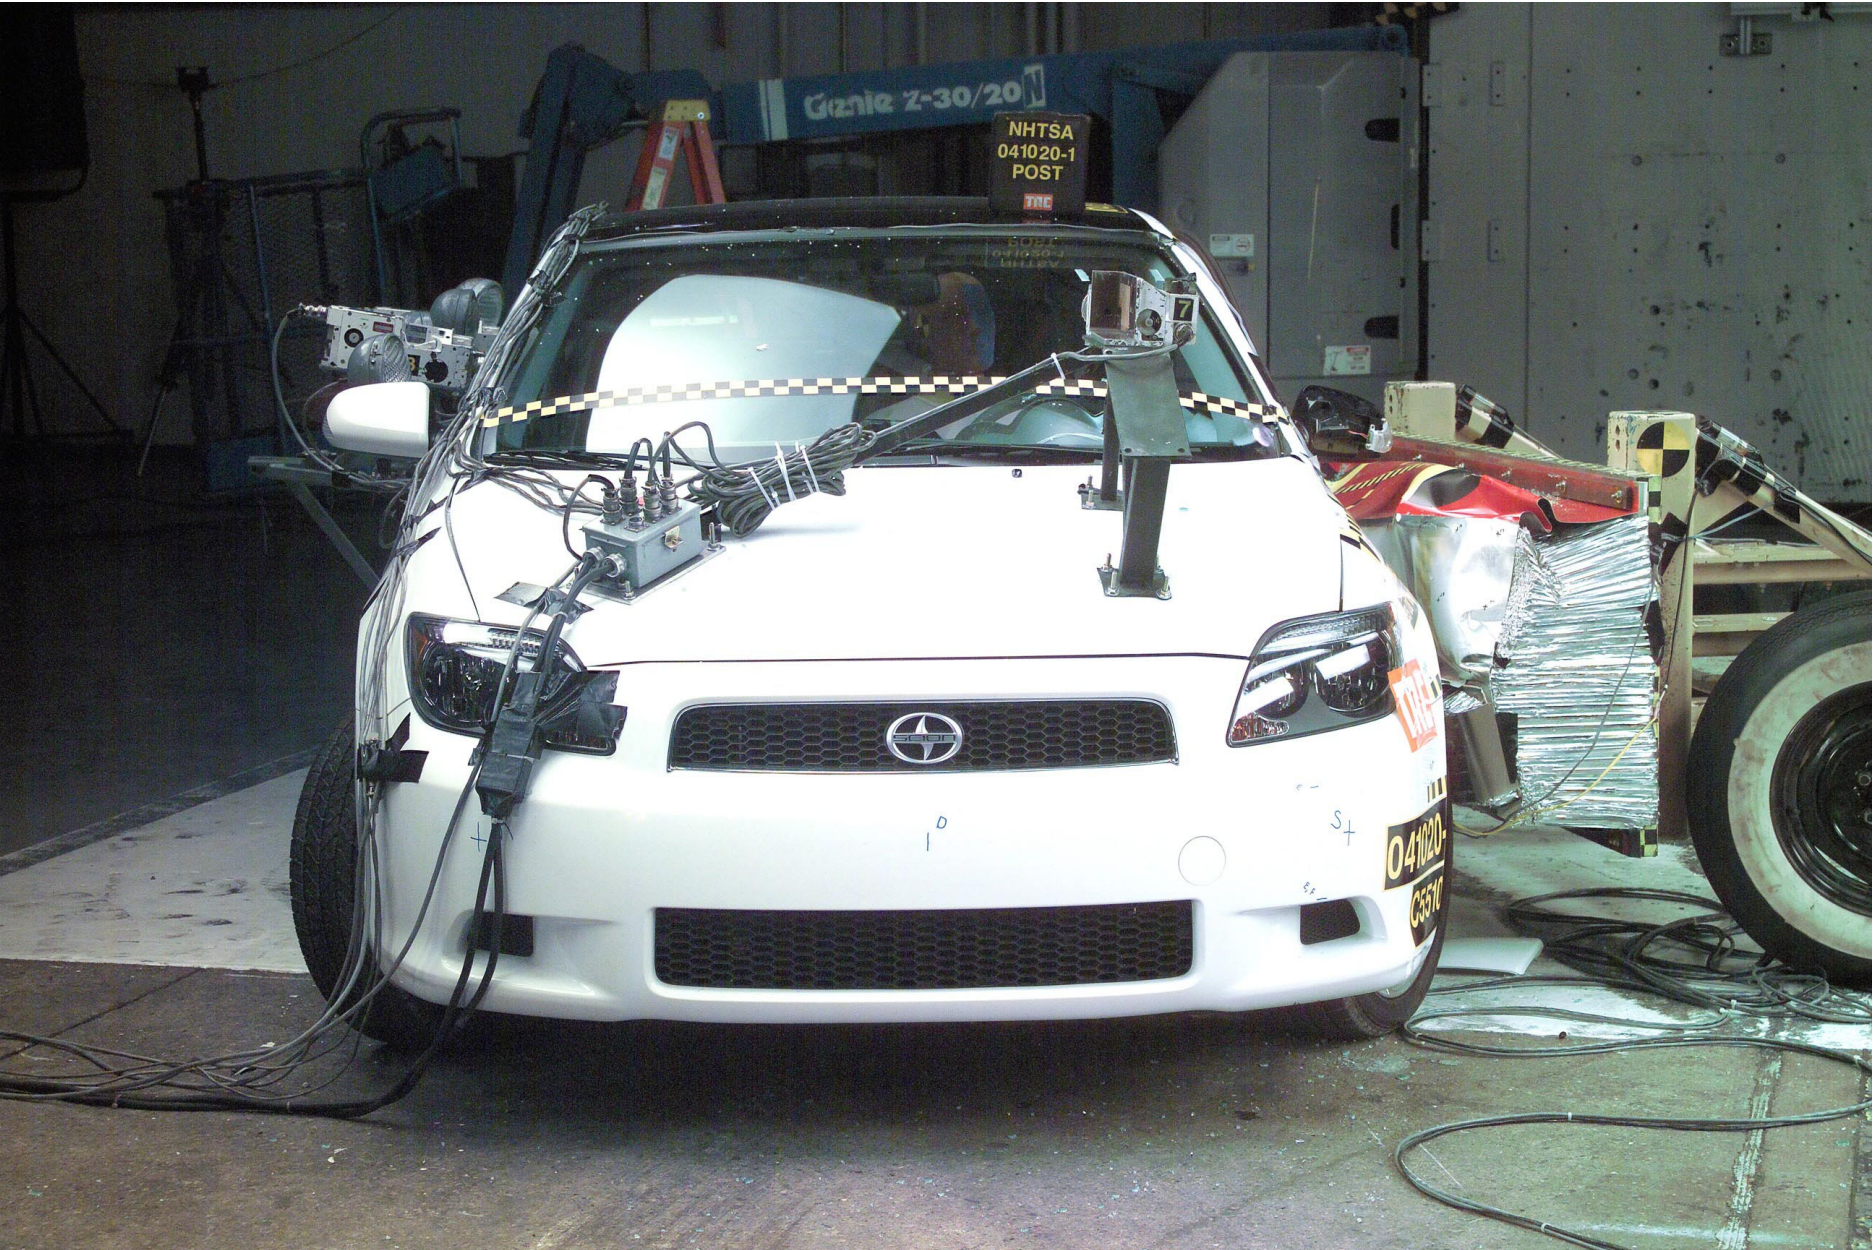
Figure A-2 Post-Test Front View of Test Vehicle

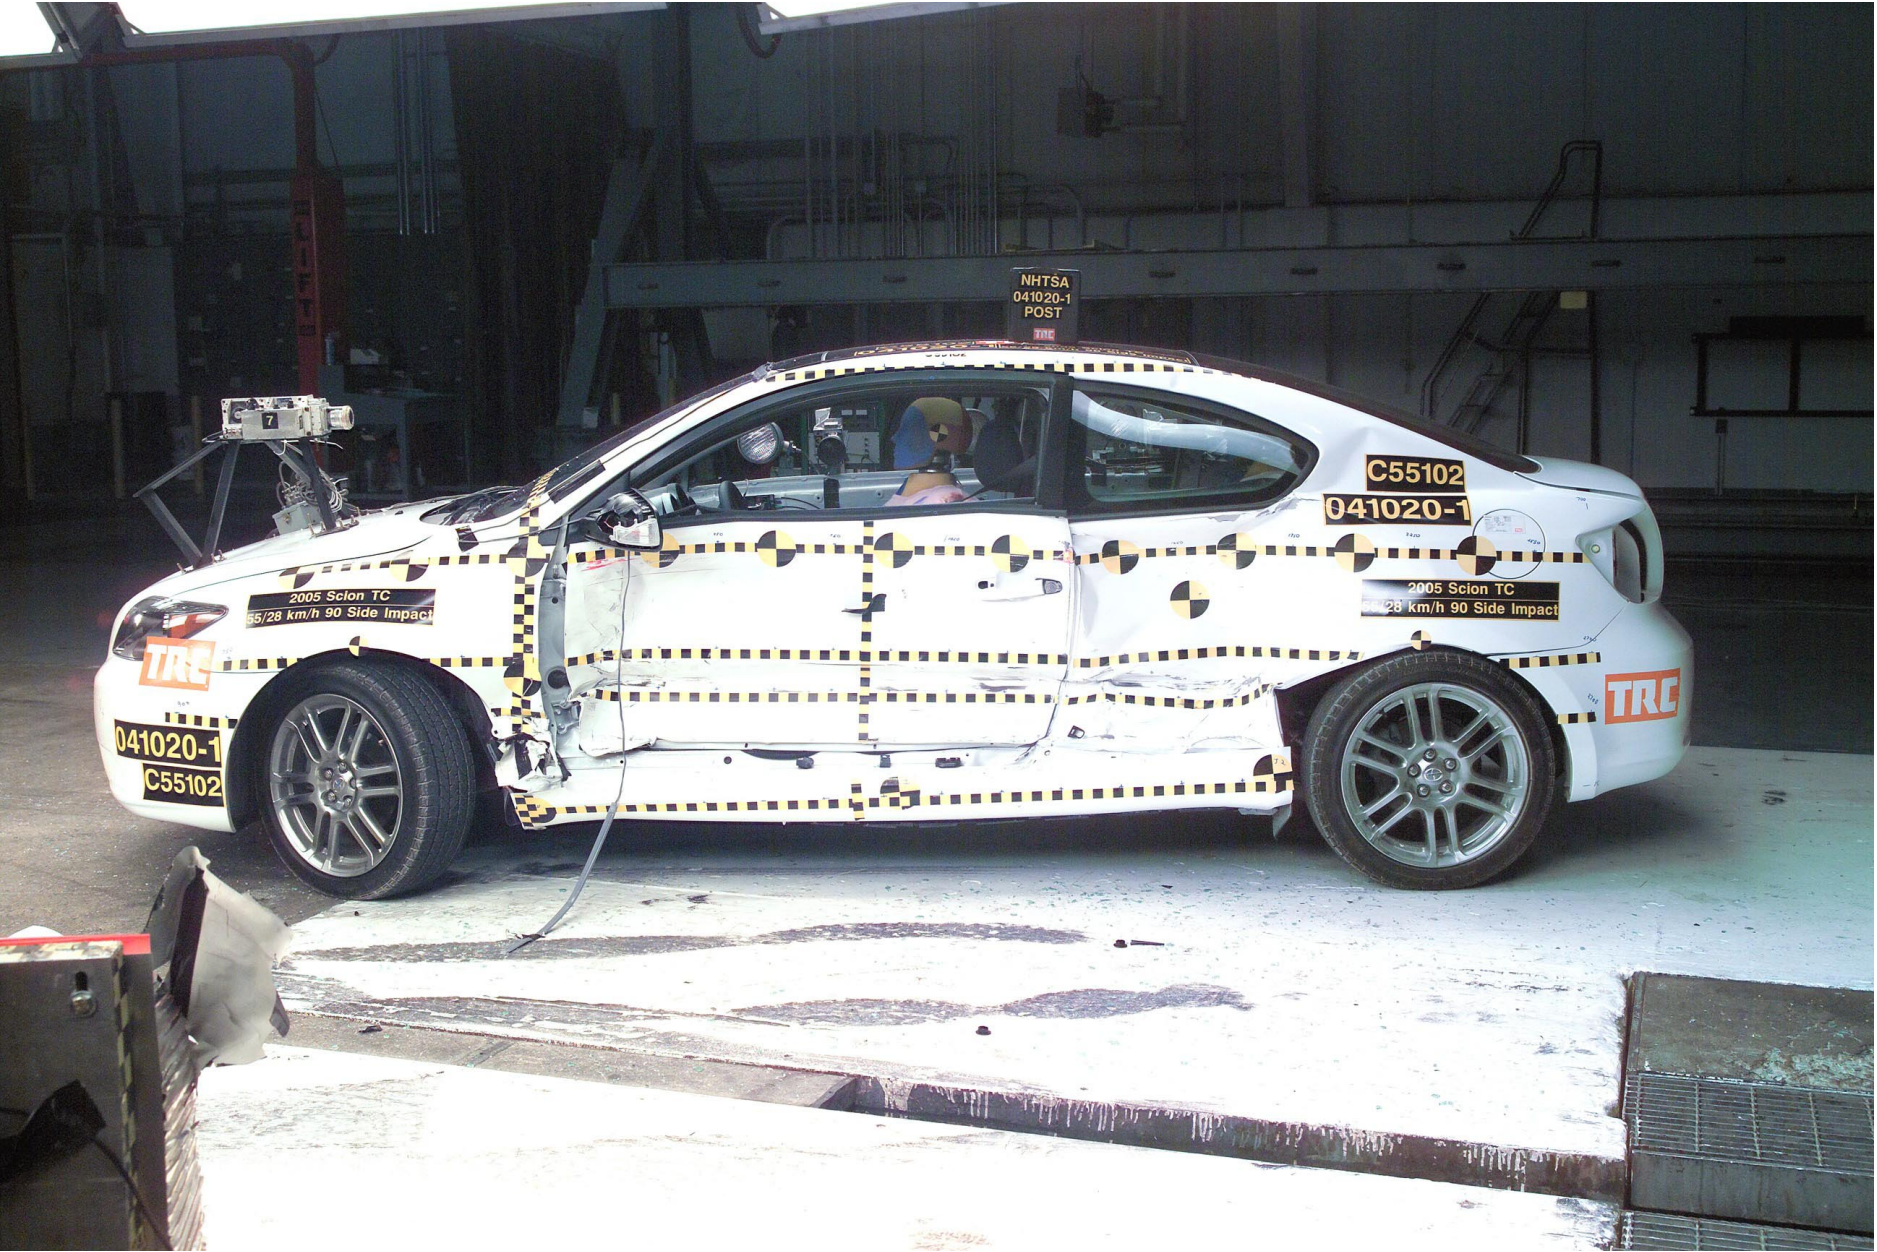
Figure A-4 Post-Test Impacted Side View of Test Vehicle
A-8

Vehicle Damage Profile Distances

Full length of induced damage was 2250 mm.

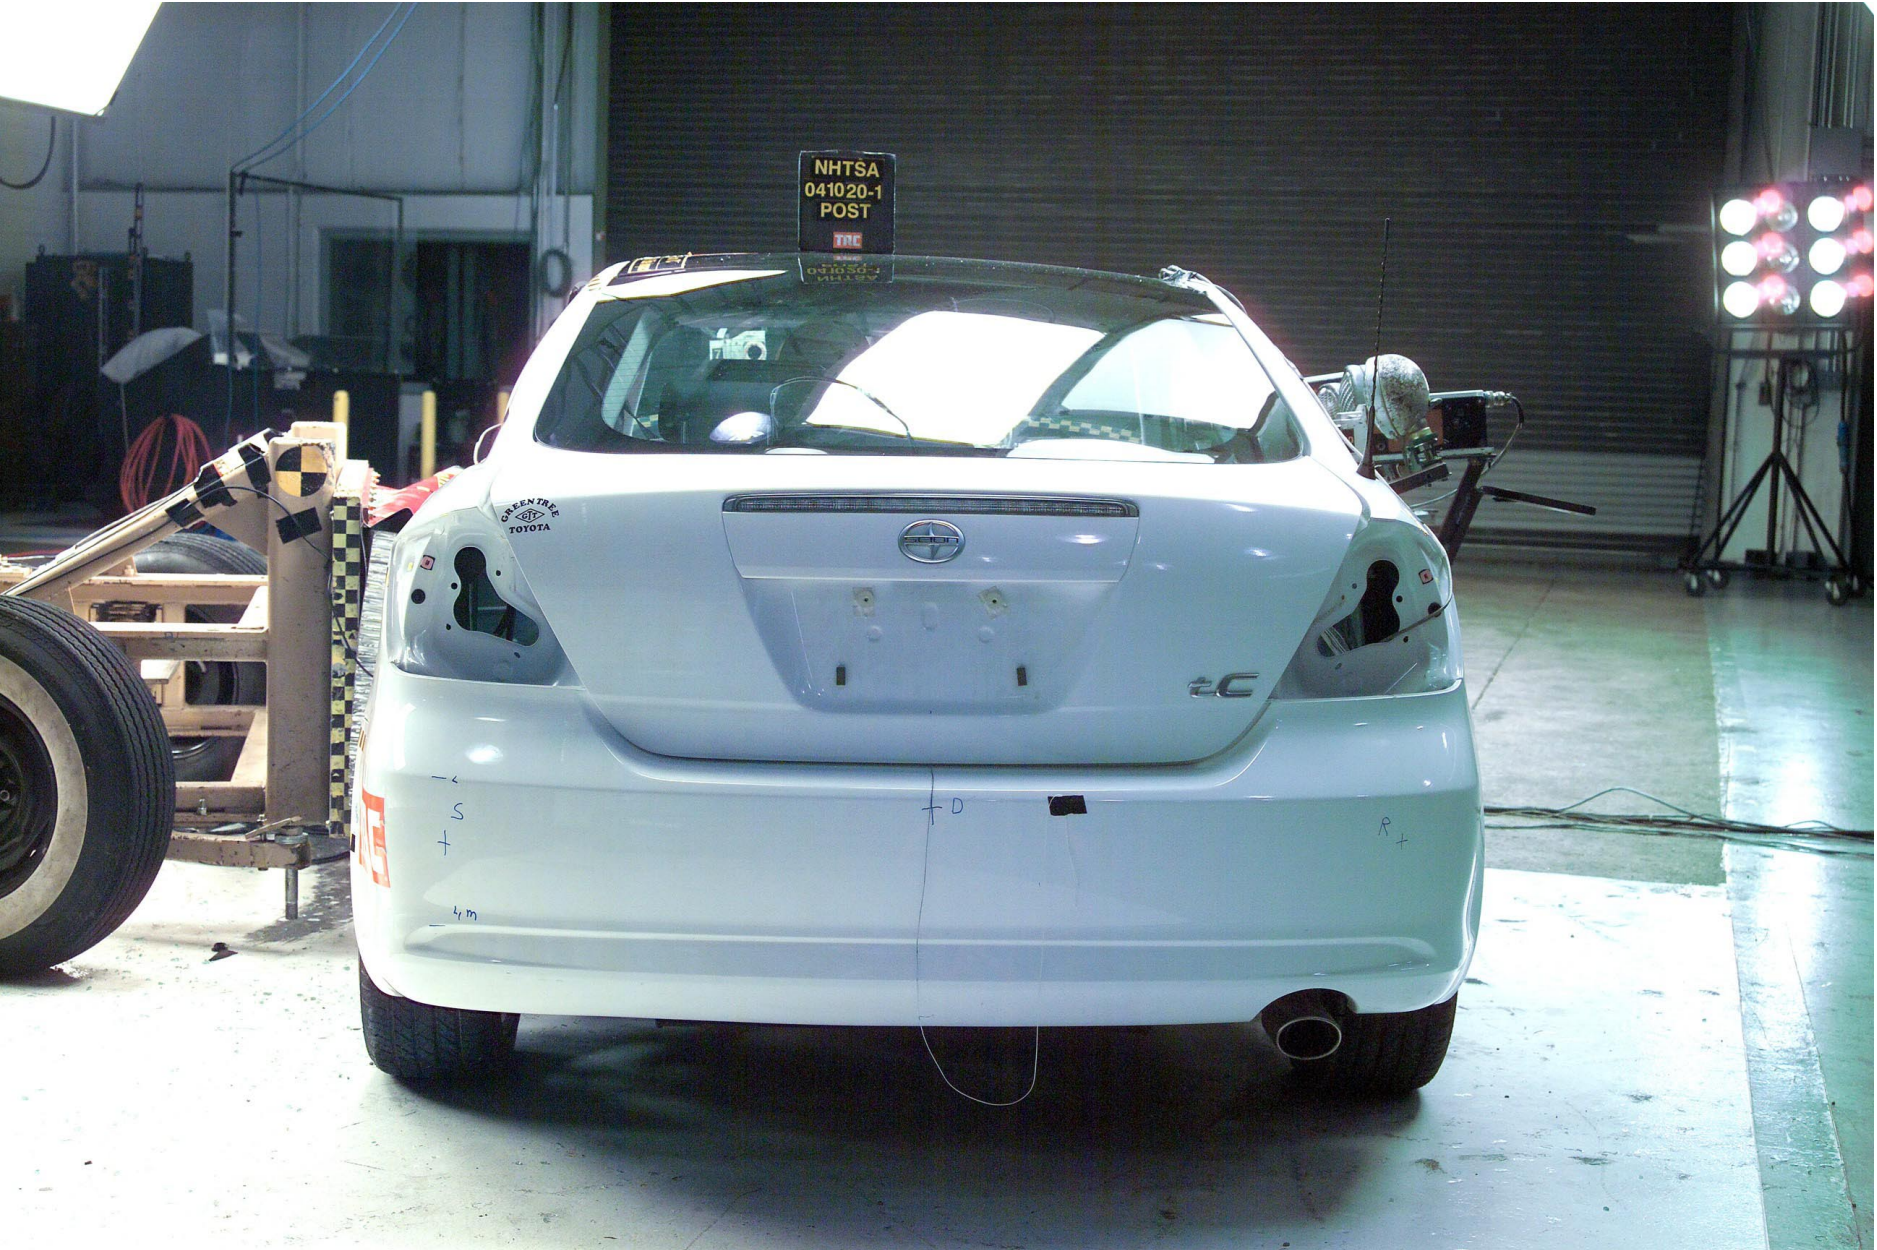
Figure A-6 Post-Test Rear View of Test Vehicle
A-10

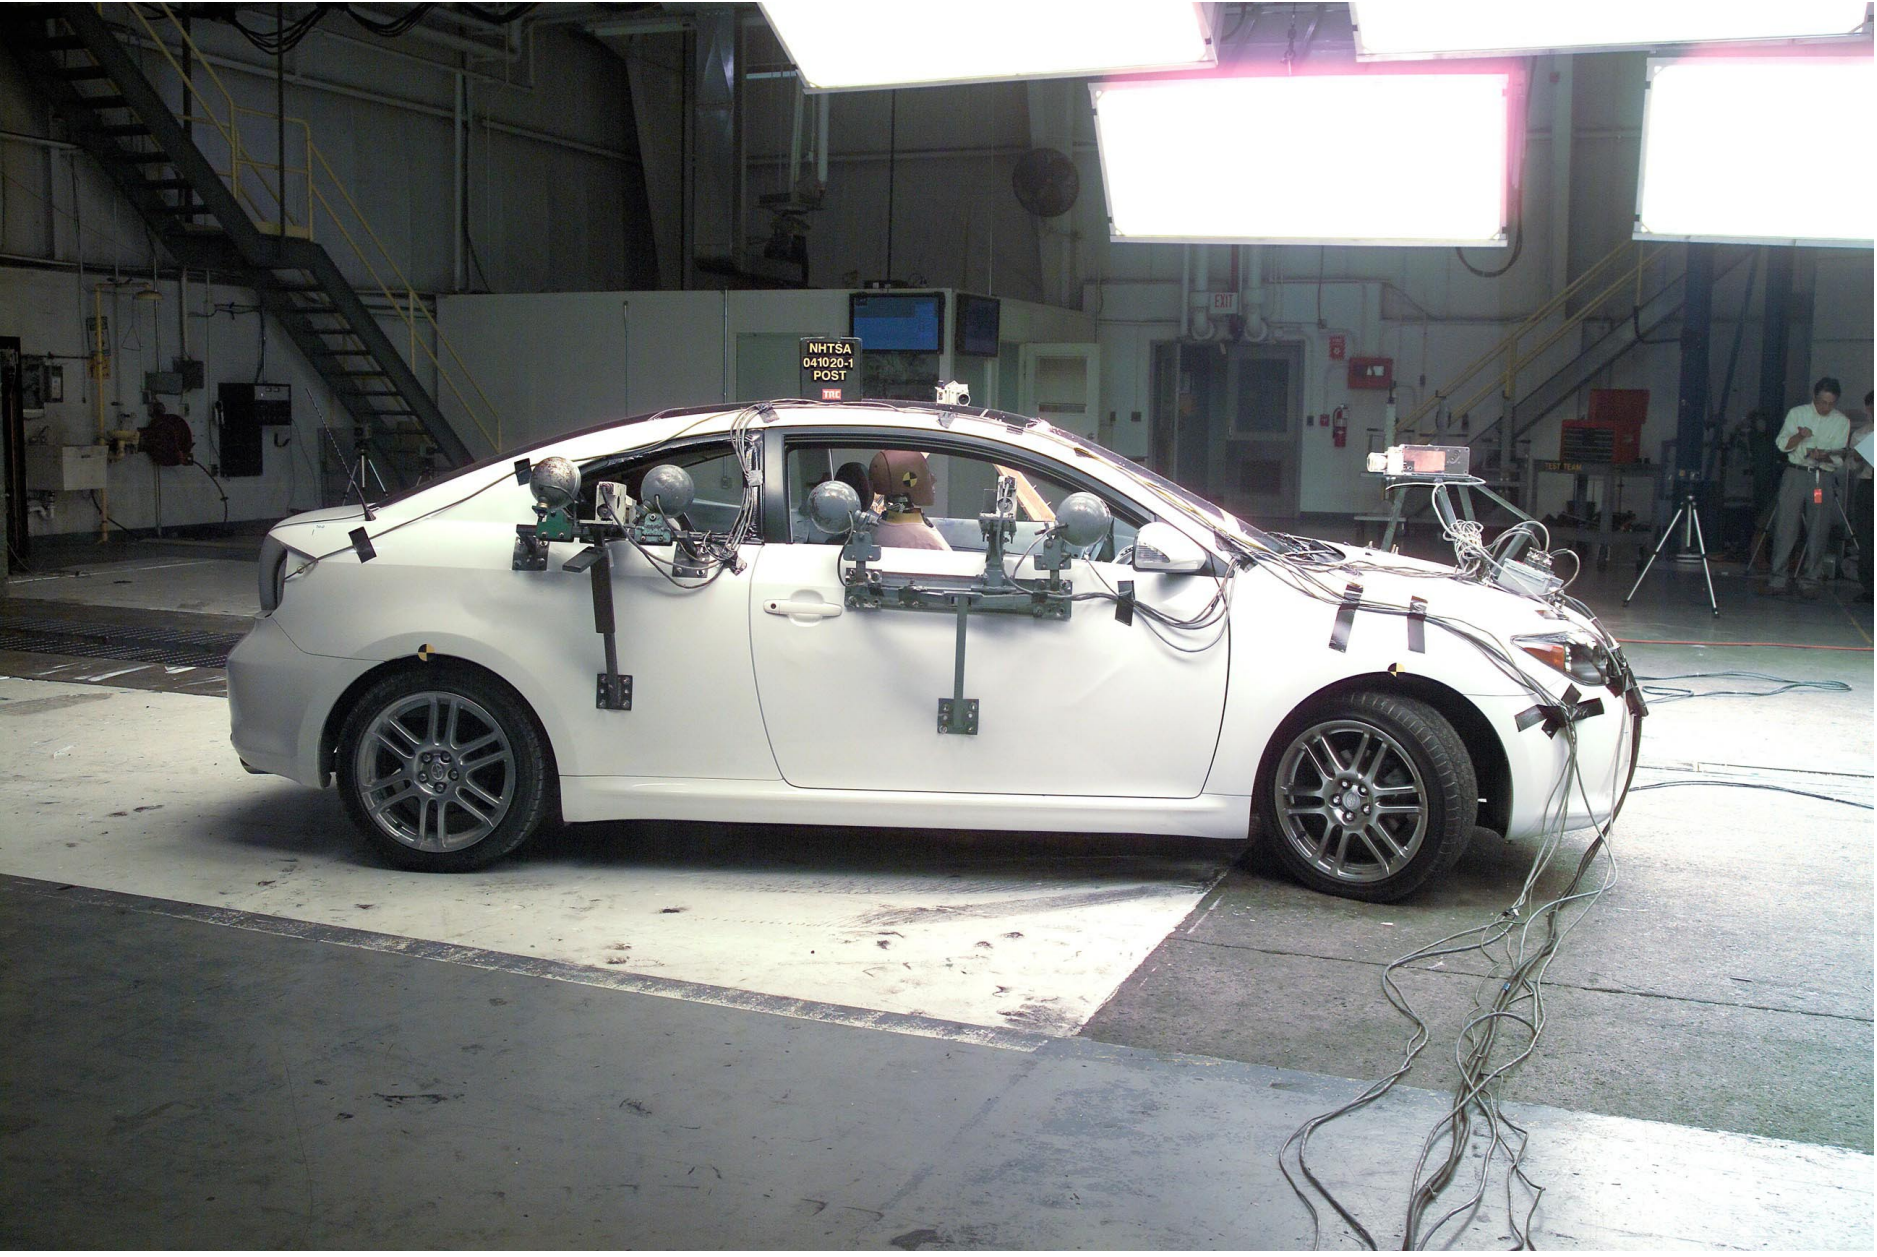
Figure A-8 Post-Test Non-Struck Side View of Test Vehicle
A-12

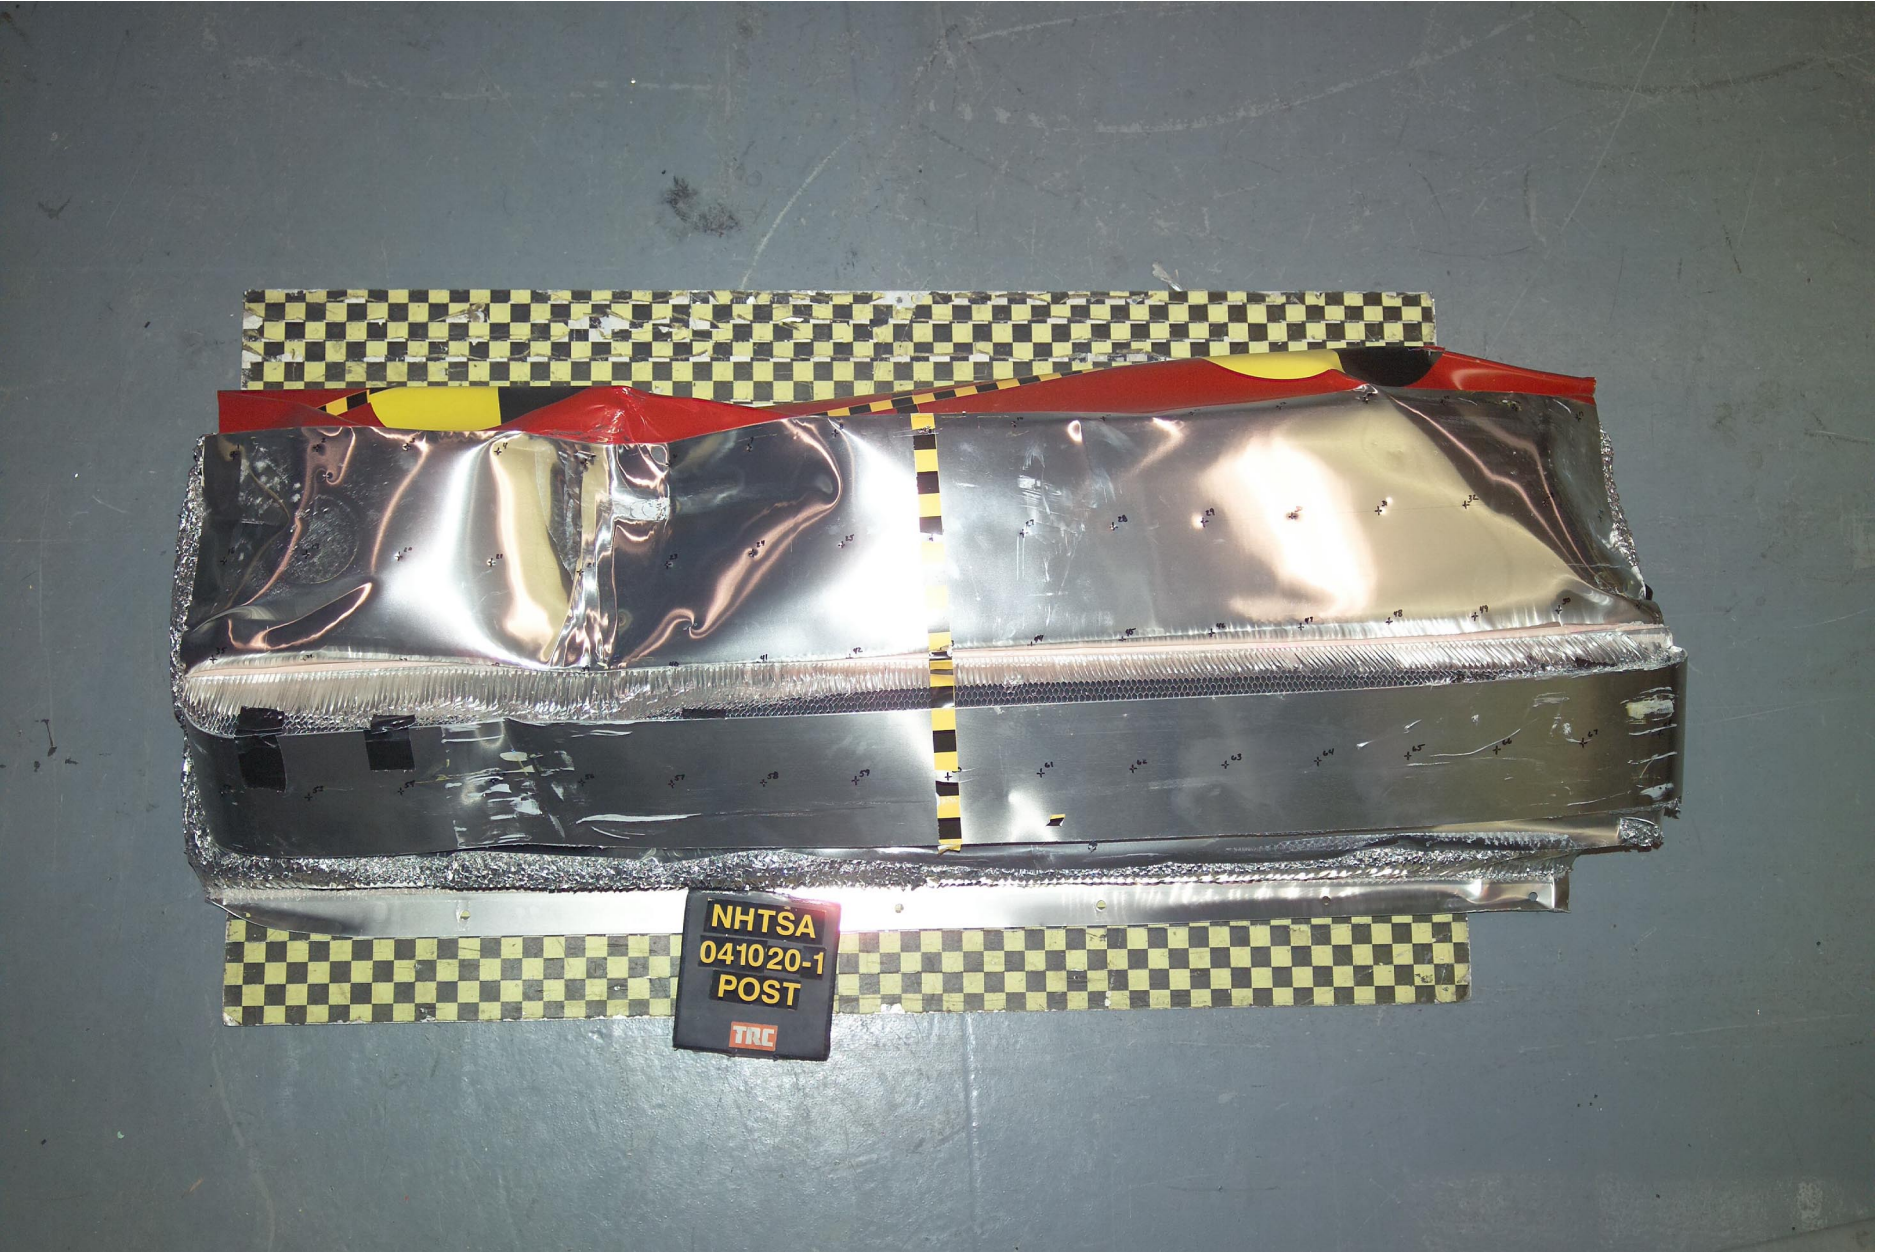
Figure A-10 Post-Test Frontal View of Impactor Face
A-14

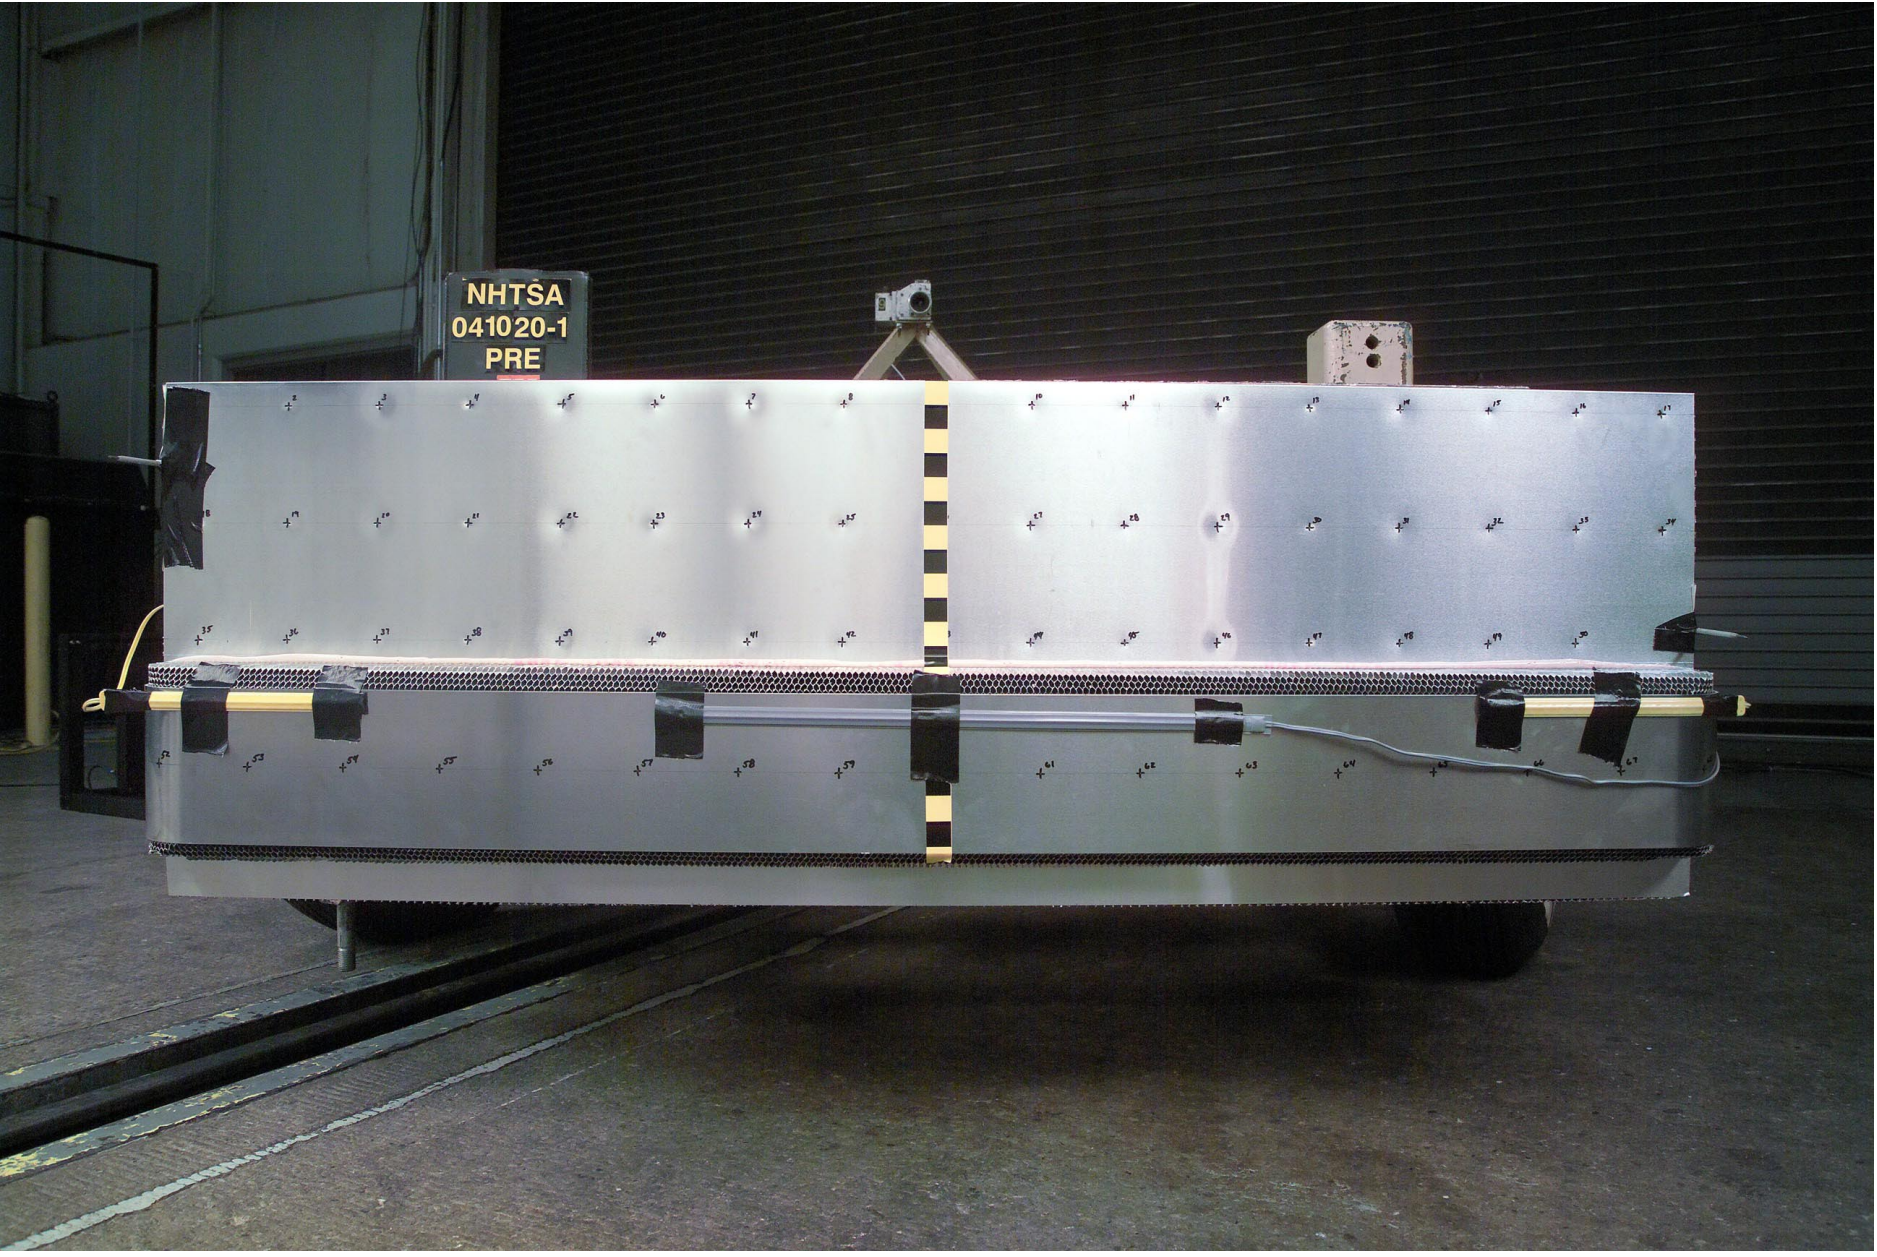
Figure A-17 Pre-Test View of MDB Showing Contact Switches in Place
A-21

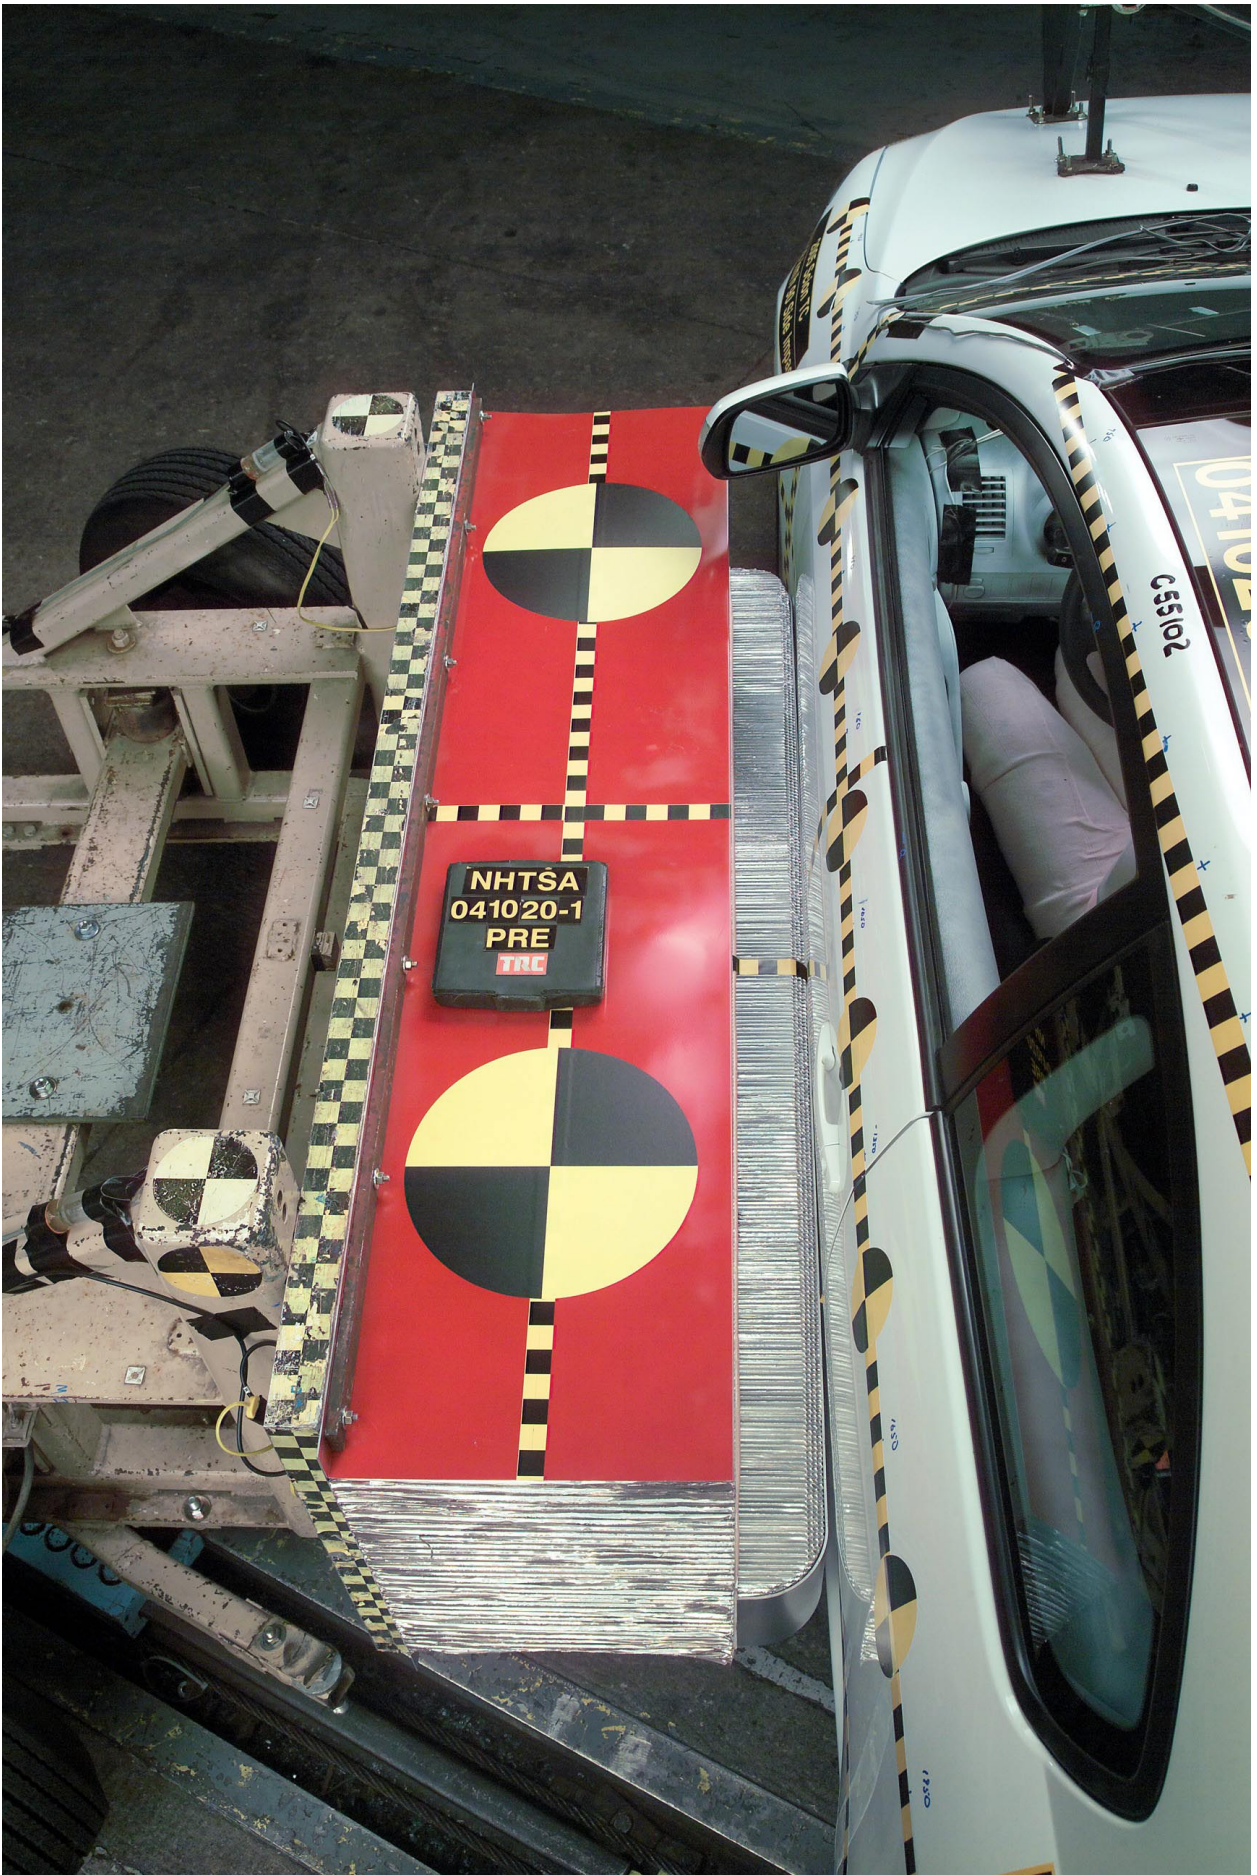
Figure A-19 Pre-Test Overhead View of MDB Aligned with Vehicle

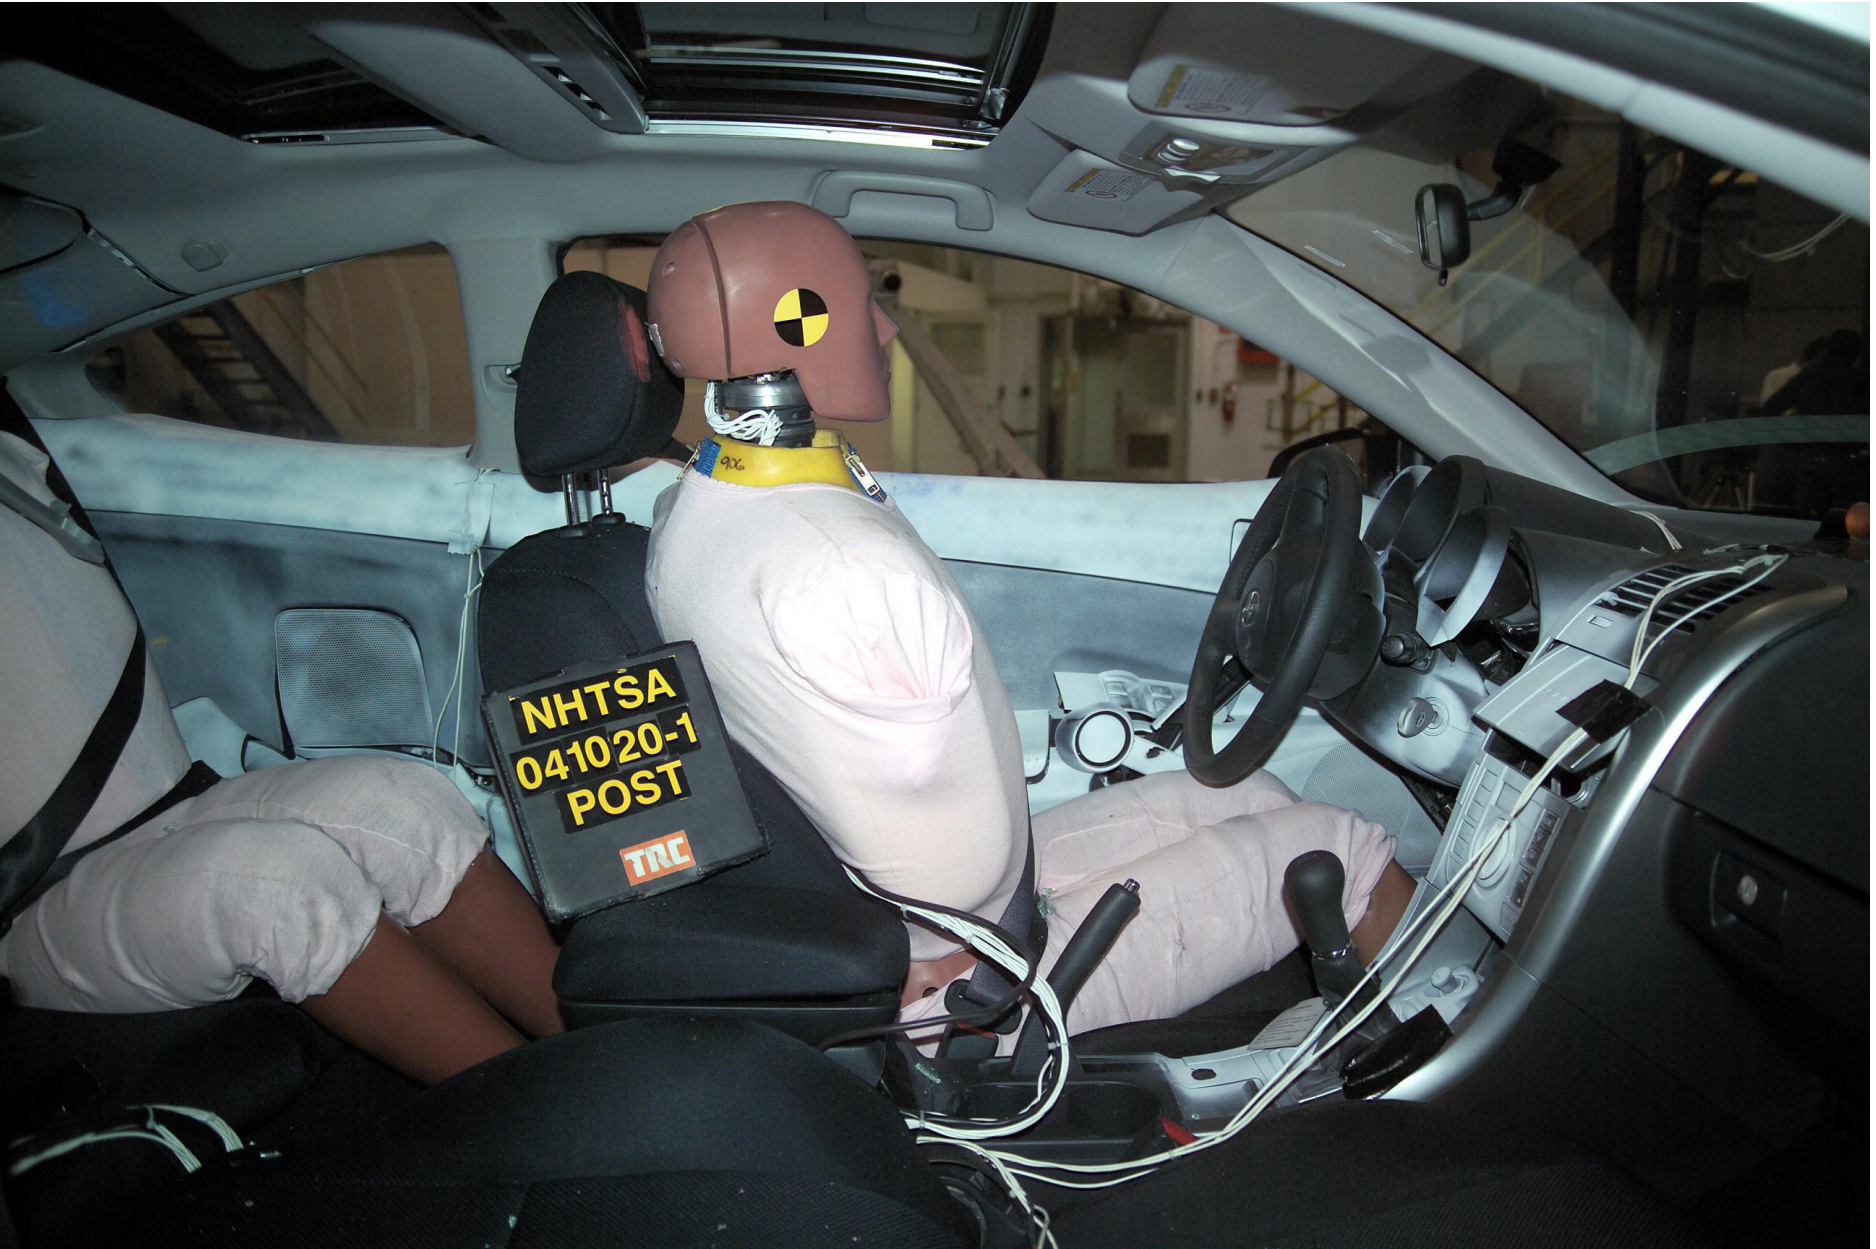
Figure A-22 Post-Test Right Occupant Compartment View of Front SID HIII

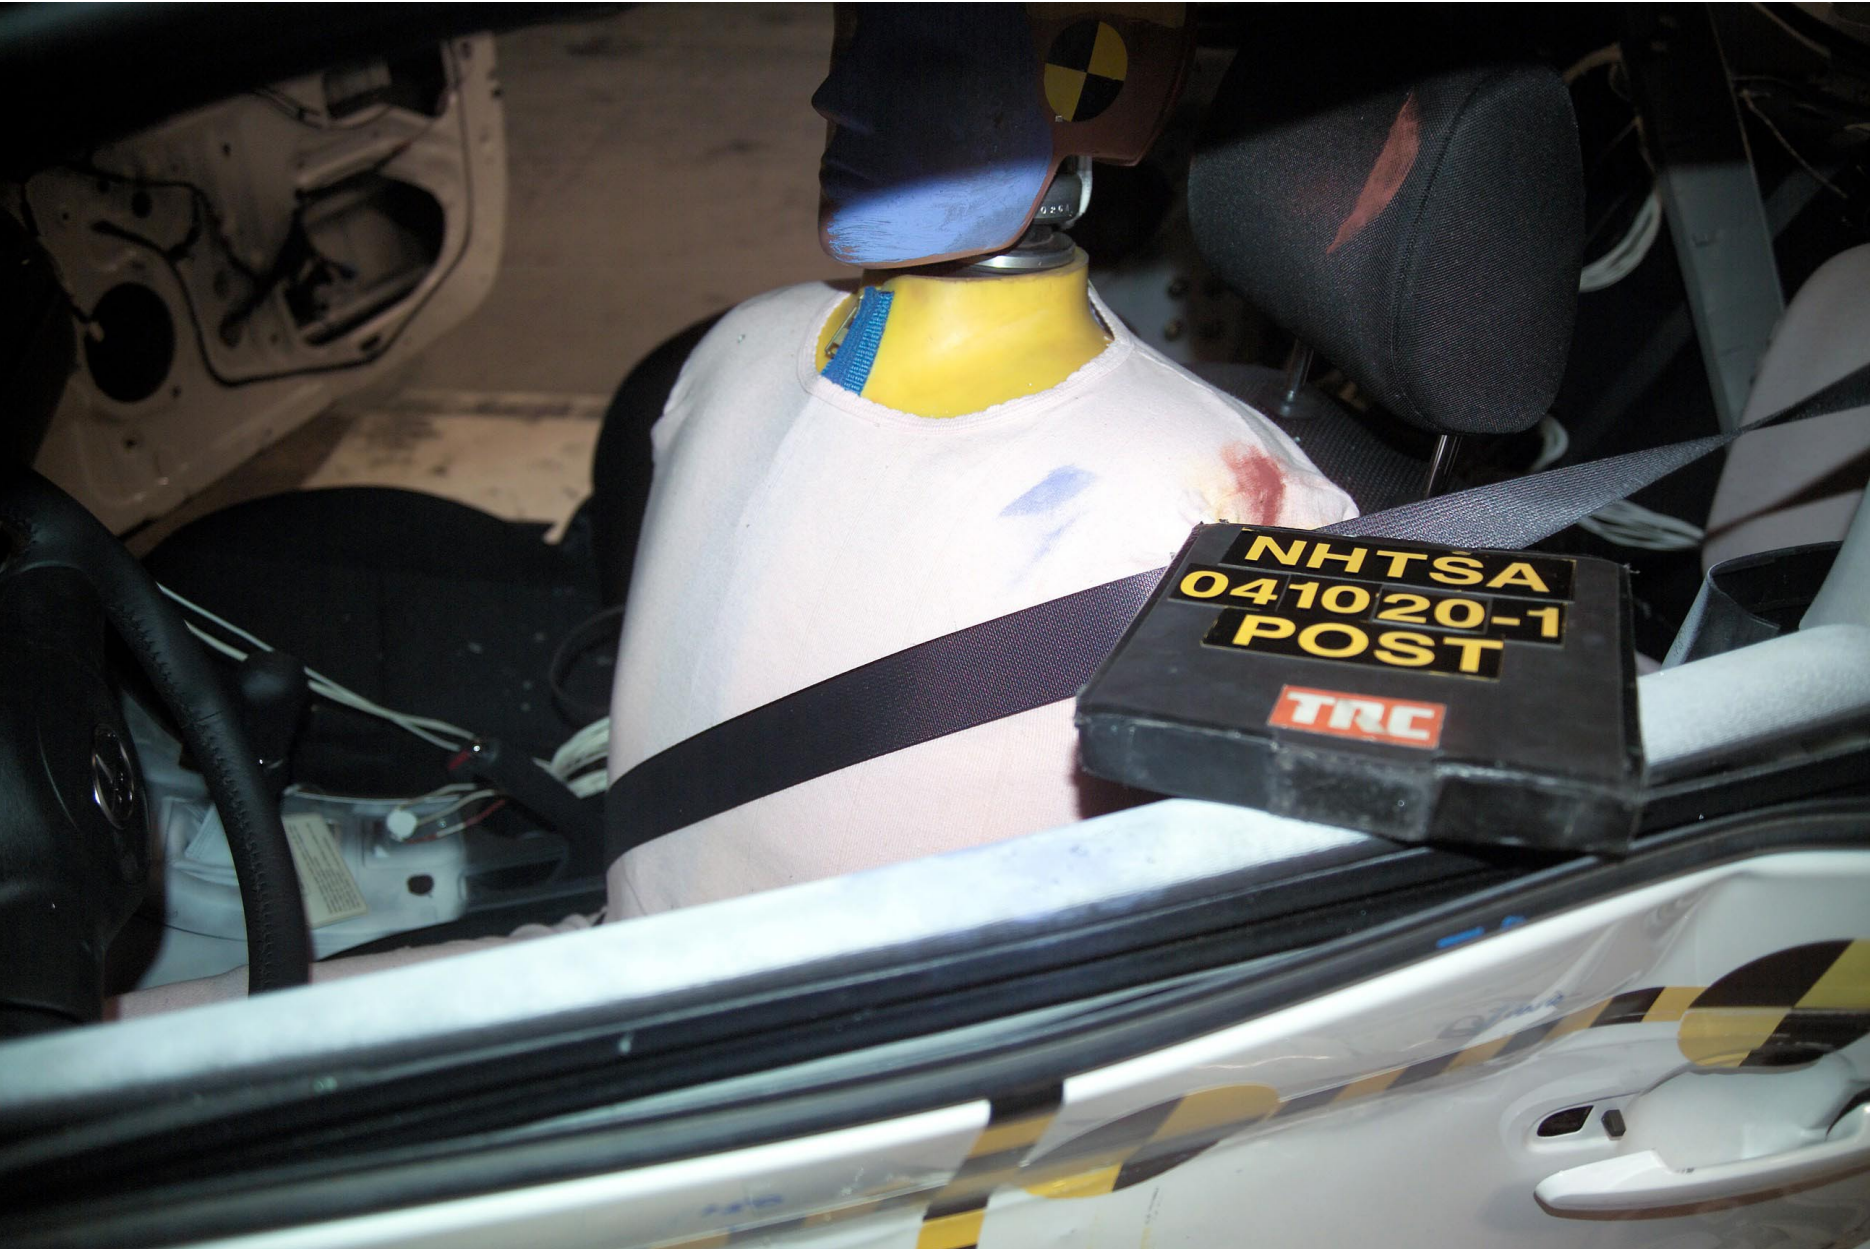
Figure A-28 Post-Test Left View of Front SID HIII and Belt Position
