Report Number: 214-TRC-04-004

Safety Compliance Testing For FMVSS 214

Side Impact Protection

2005 Scion TC 2-door

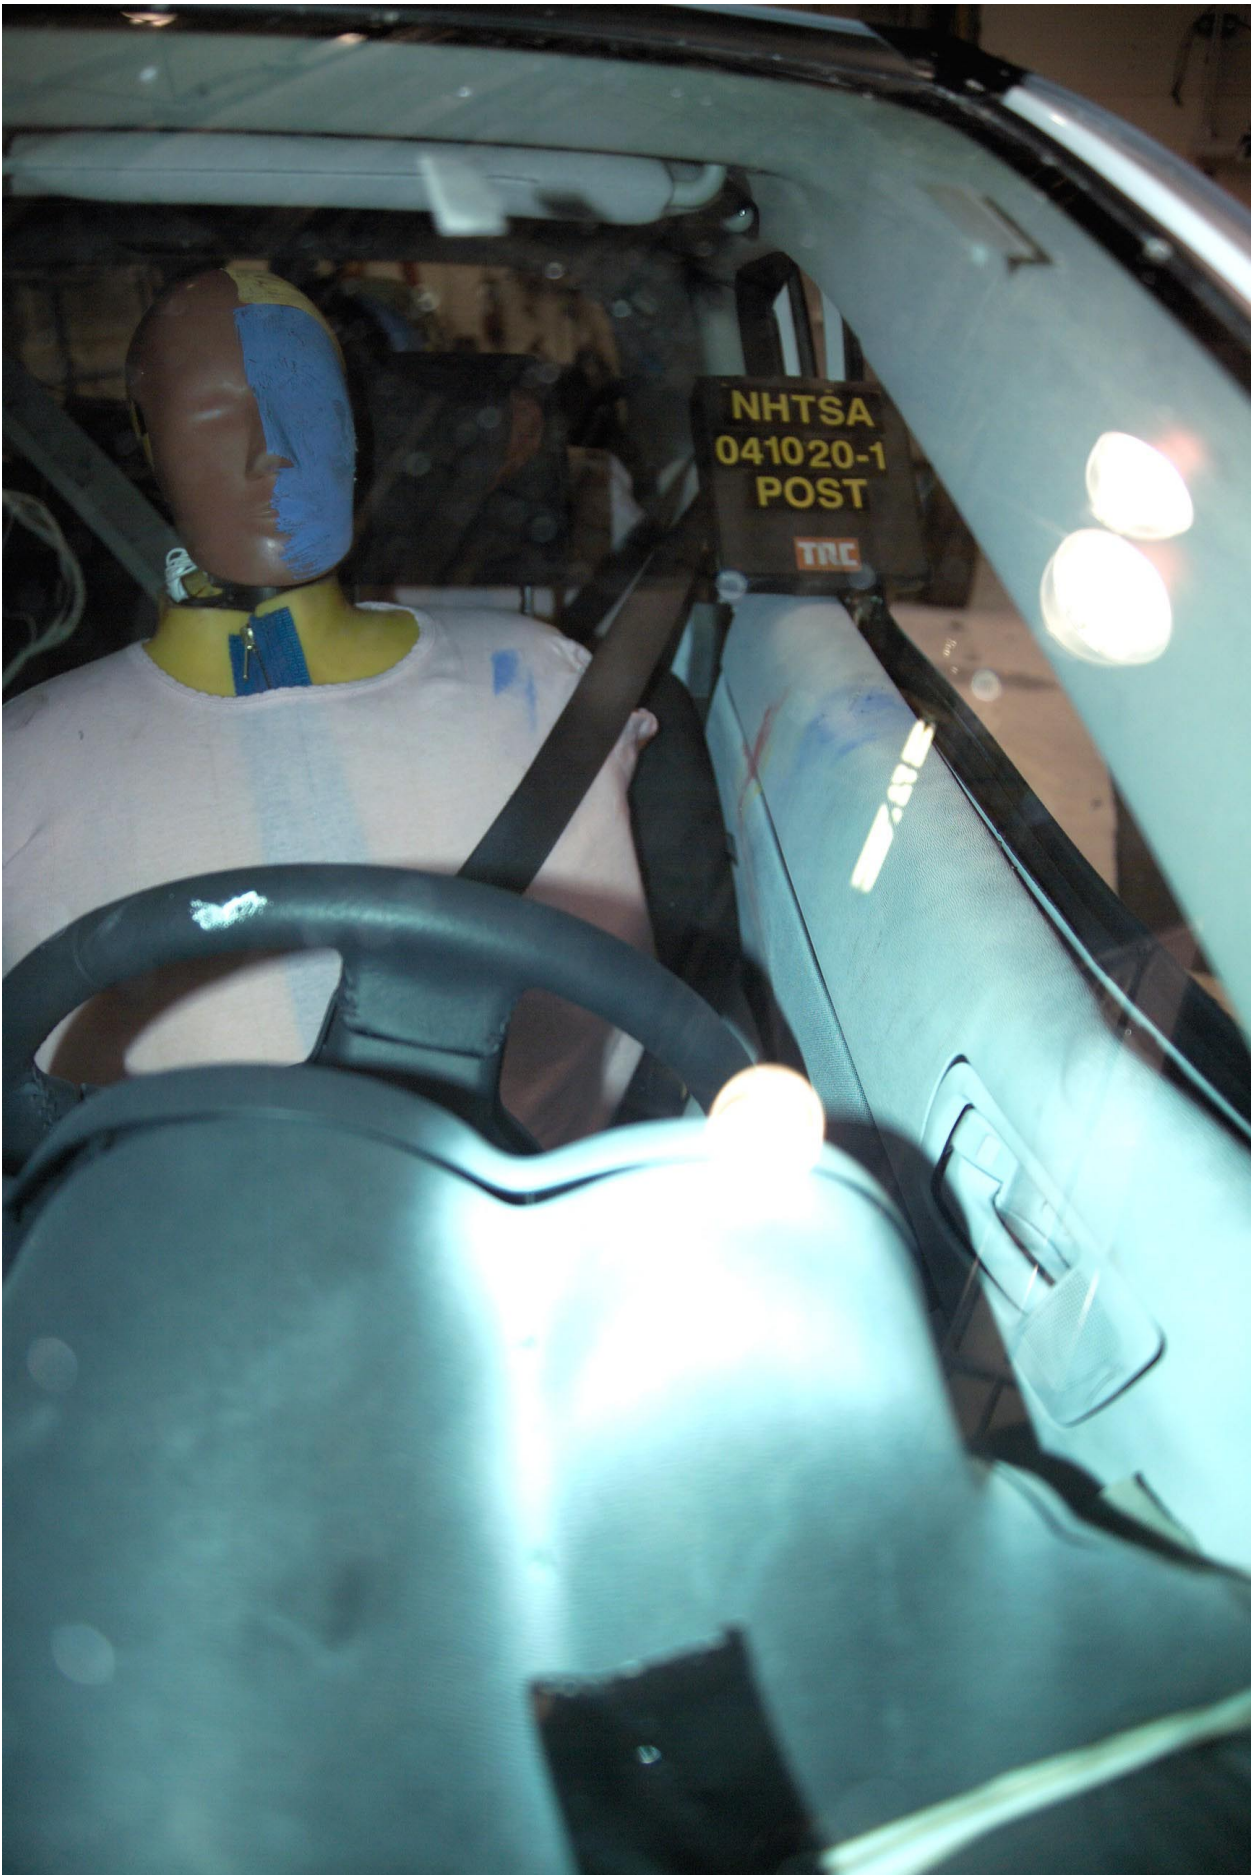
Figure A-30 Post-Test View of Front SID HIII and Door Clearance

<p>The door on the struck side of the vehicle did not separate from the body at the hinge or latch and the opposite door did not open during side impact event.</p>					<u>Front SID HIII</u>		<u>Rear SID HIII</u>	Left Upper Rib Acceleration:	<u>55.7</u>	g's	<u>52.0</u>	Left Lower Rib Acceleration:	<u>56.8</u>	g's	<u>67.6</u>	Lower Spine Acceleration:	<u>67.4</u>	g's	<u>56.4</u>	Thoracic Trauma Index, (TTI):	<u>62.1</u>	g's	<u>62.0</u>	Pelvis Acceleration (PEV):	<u>54.1</u>	g's	<u>42.8</u>
	<u>Front SID HIII</u>		<u>Rear SID HIII</u>																								
Left Upper Rib Acceleration:	<u>55.7</u>	g's	<u>52.0</u>																								
Left Lower Rib Acceleration:	<u>56.8</u>	g's	<u>67.6</u>																								
Lower Spine Acceleration:	<u>67.4</u>	g's	<u>56.4</u>																								
Thoracic Trauma Index, (TTI):	<u>62.1</u>	g's	<u>62.0</u>																								
Pelvis Acceleration (PEV):	<u>54.1</u>	g's	<u>42.8</u>																								
17. Key Words Compliance Testing Side Impact Protection FMVSS 214 Side Impact Dummy (SID HIII)		18. Distribution Statement <u>Copies of this report are available from:</u> NHTSA Technical Information Services (TIS) Room 5108 (NPO-230), 400 Seventh Street, S.W. Washington, DC 20590 Telephone No. (202) 366-4946 Attn: Robert Hornicle																									
19. Security Classification (of this report) Unclassified	20. Security Classification (of this page) Unclassified	21. Number of Pages 367	22. Price

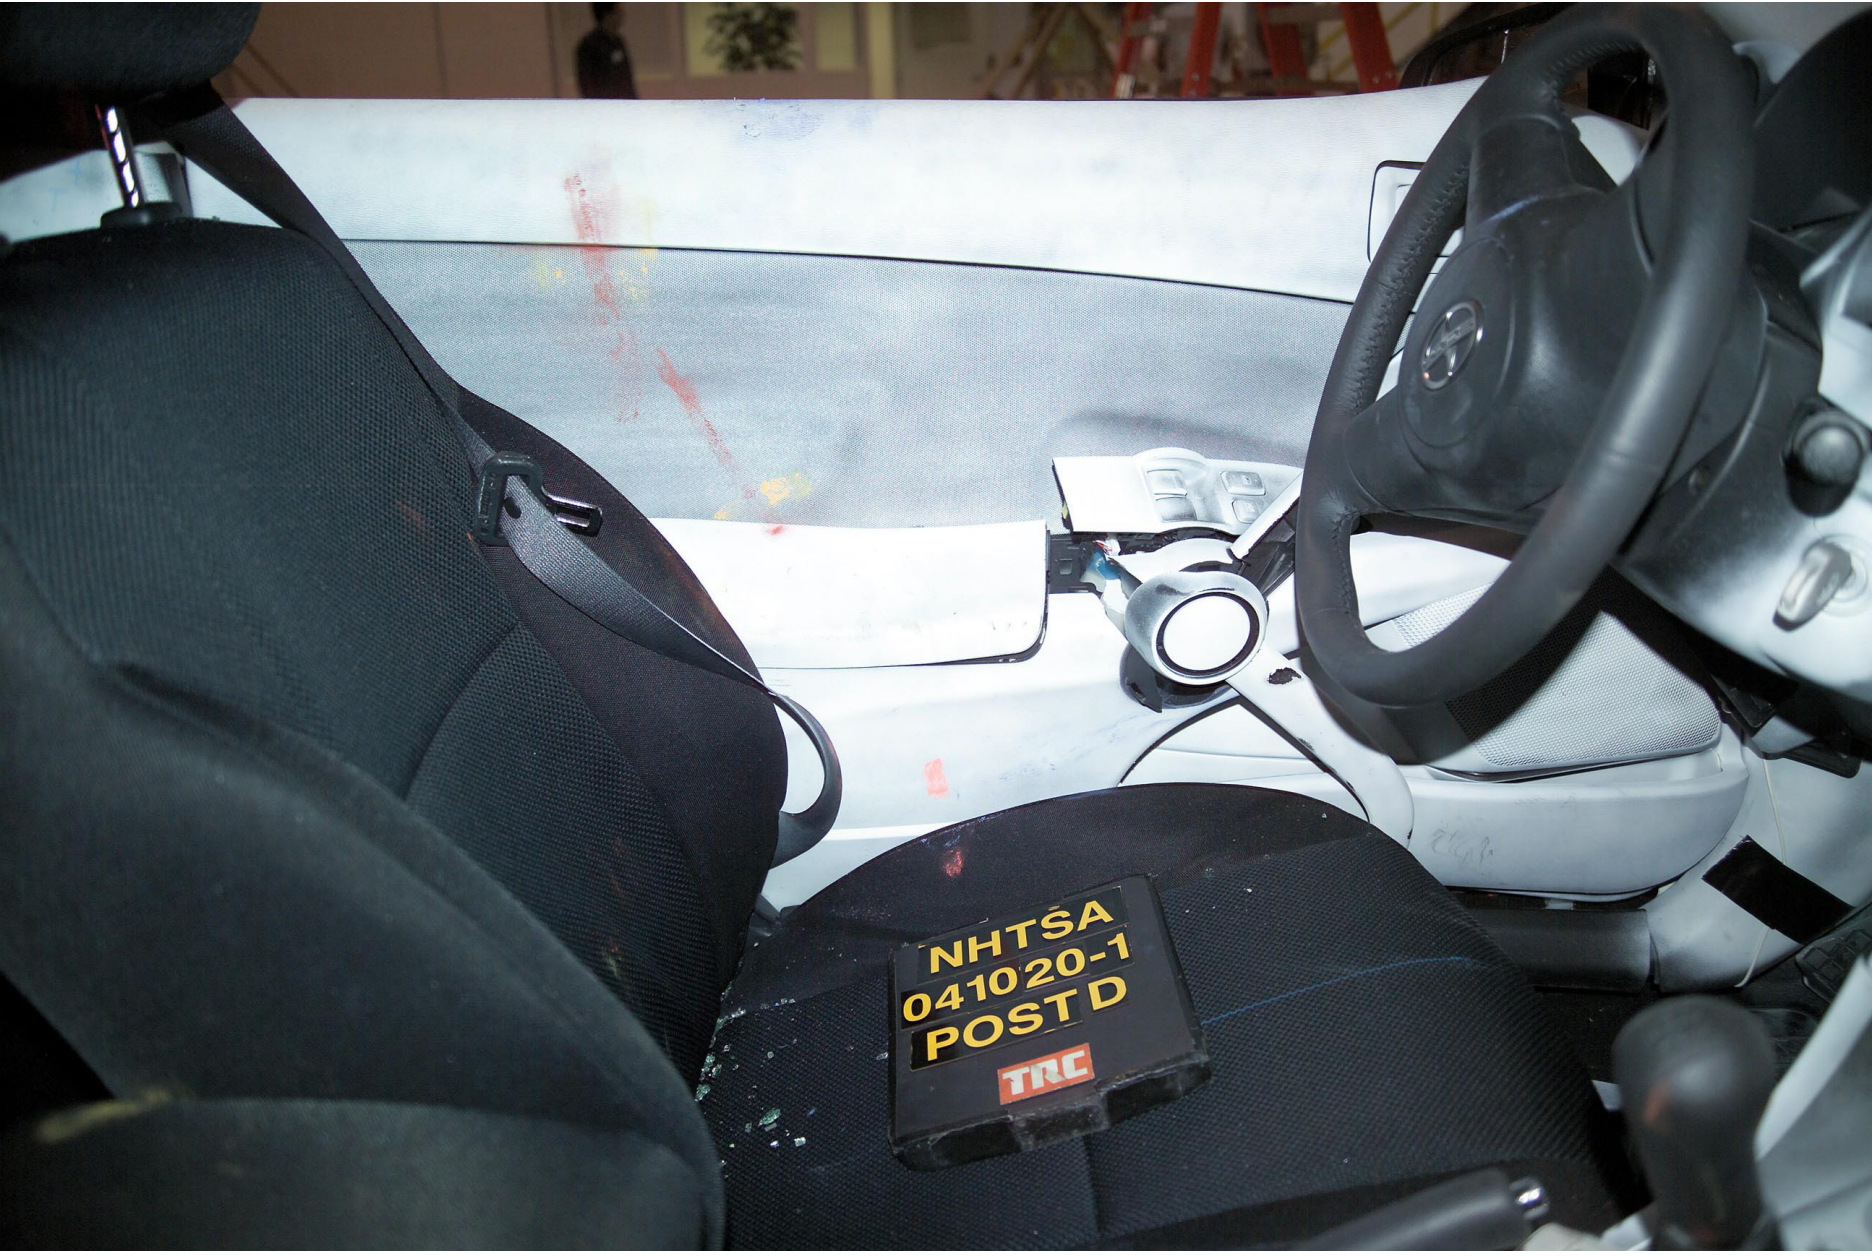
Figure A-36 Post-Test Interior of Front Door Showing SID HIII Impact Locations
A-40

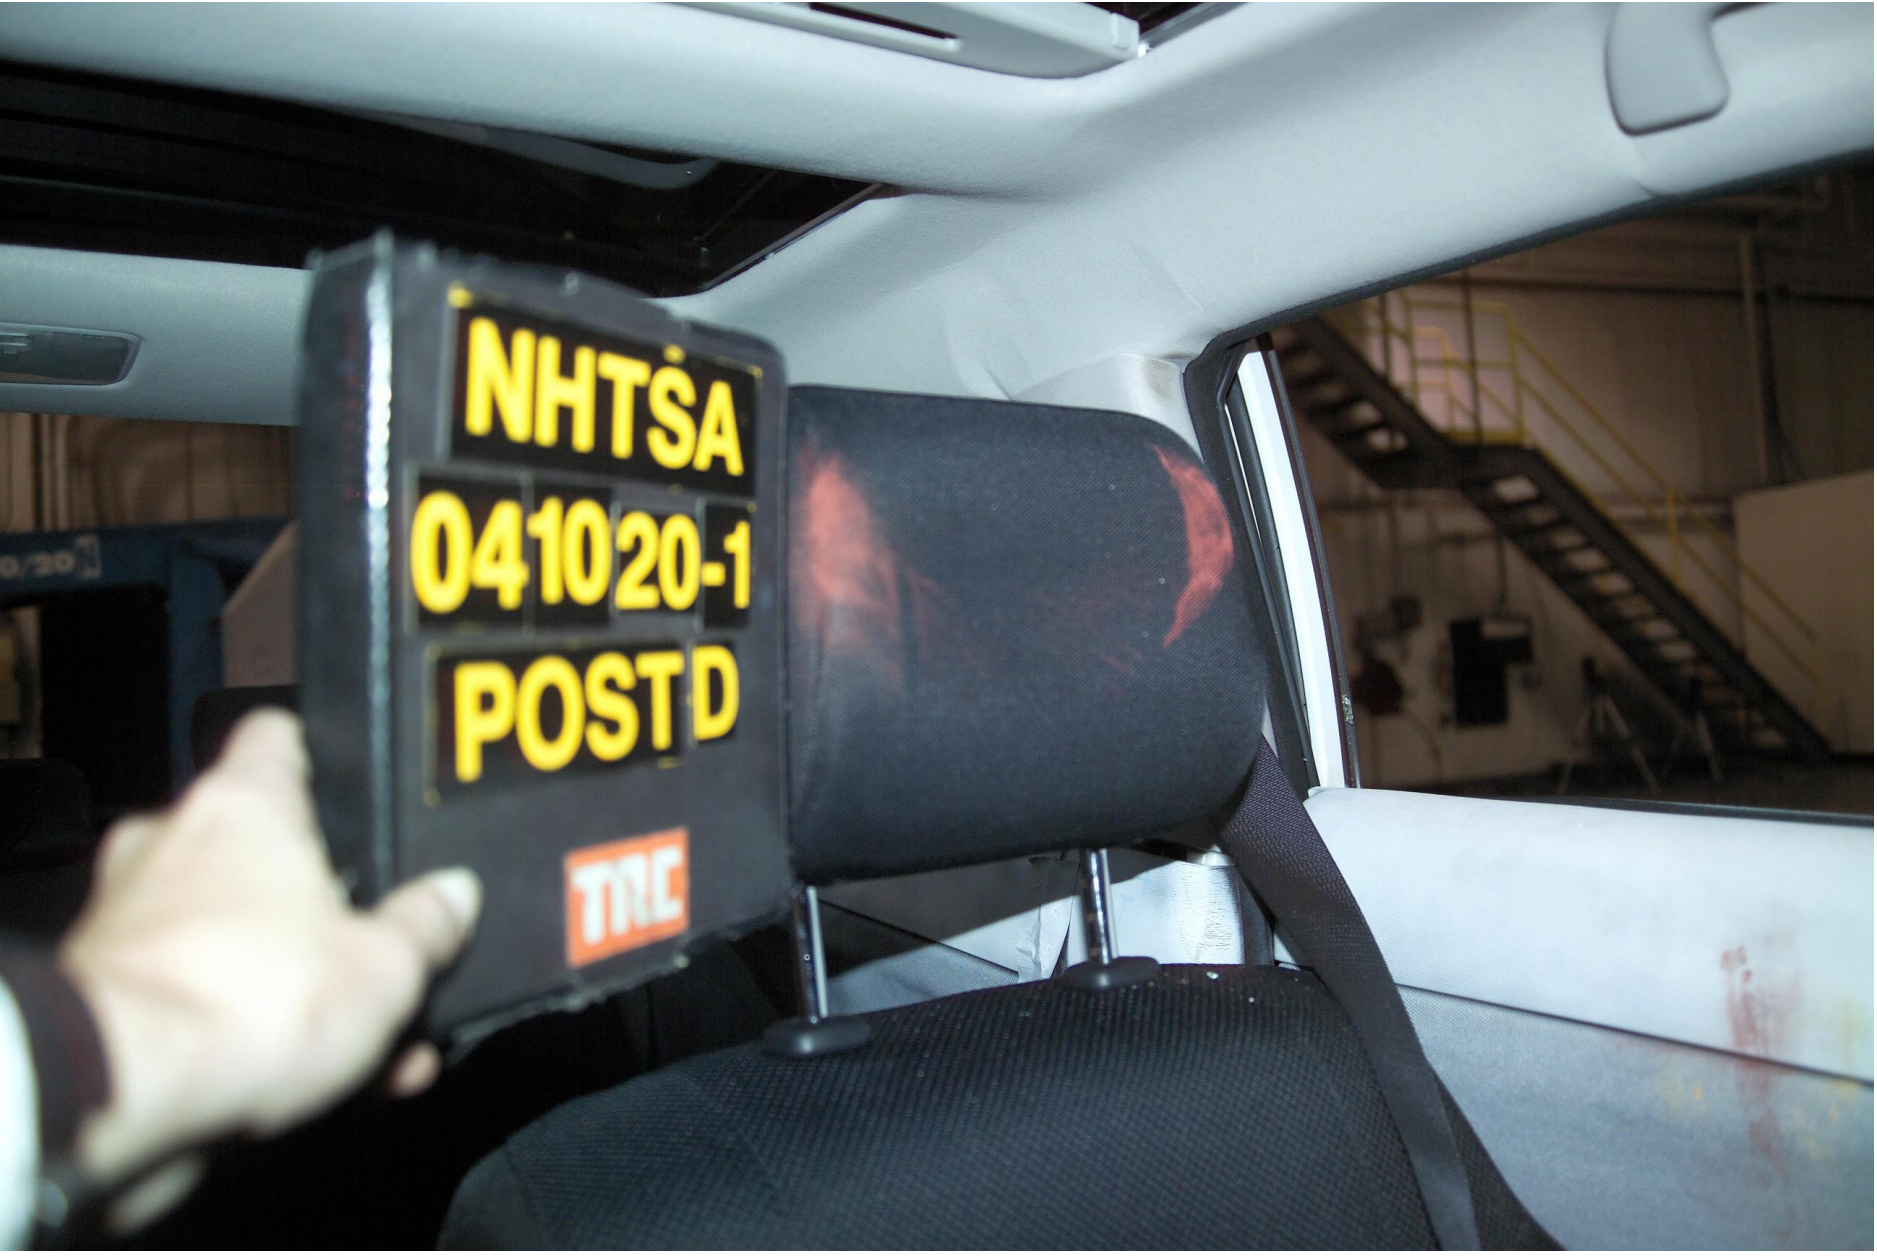
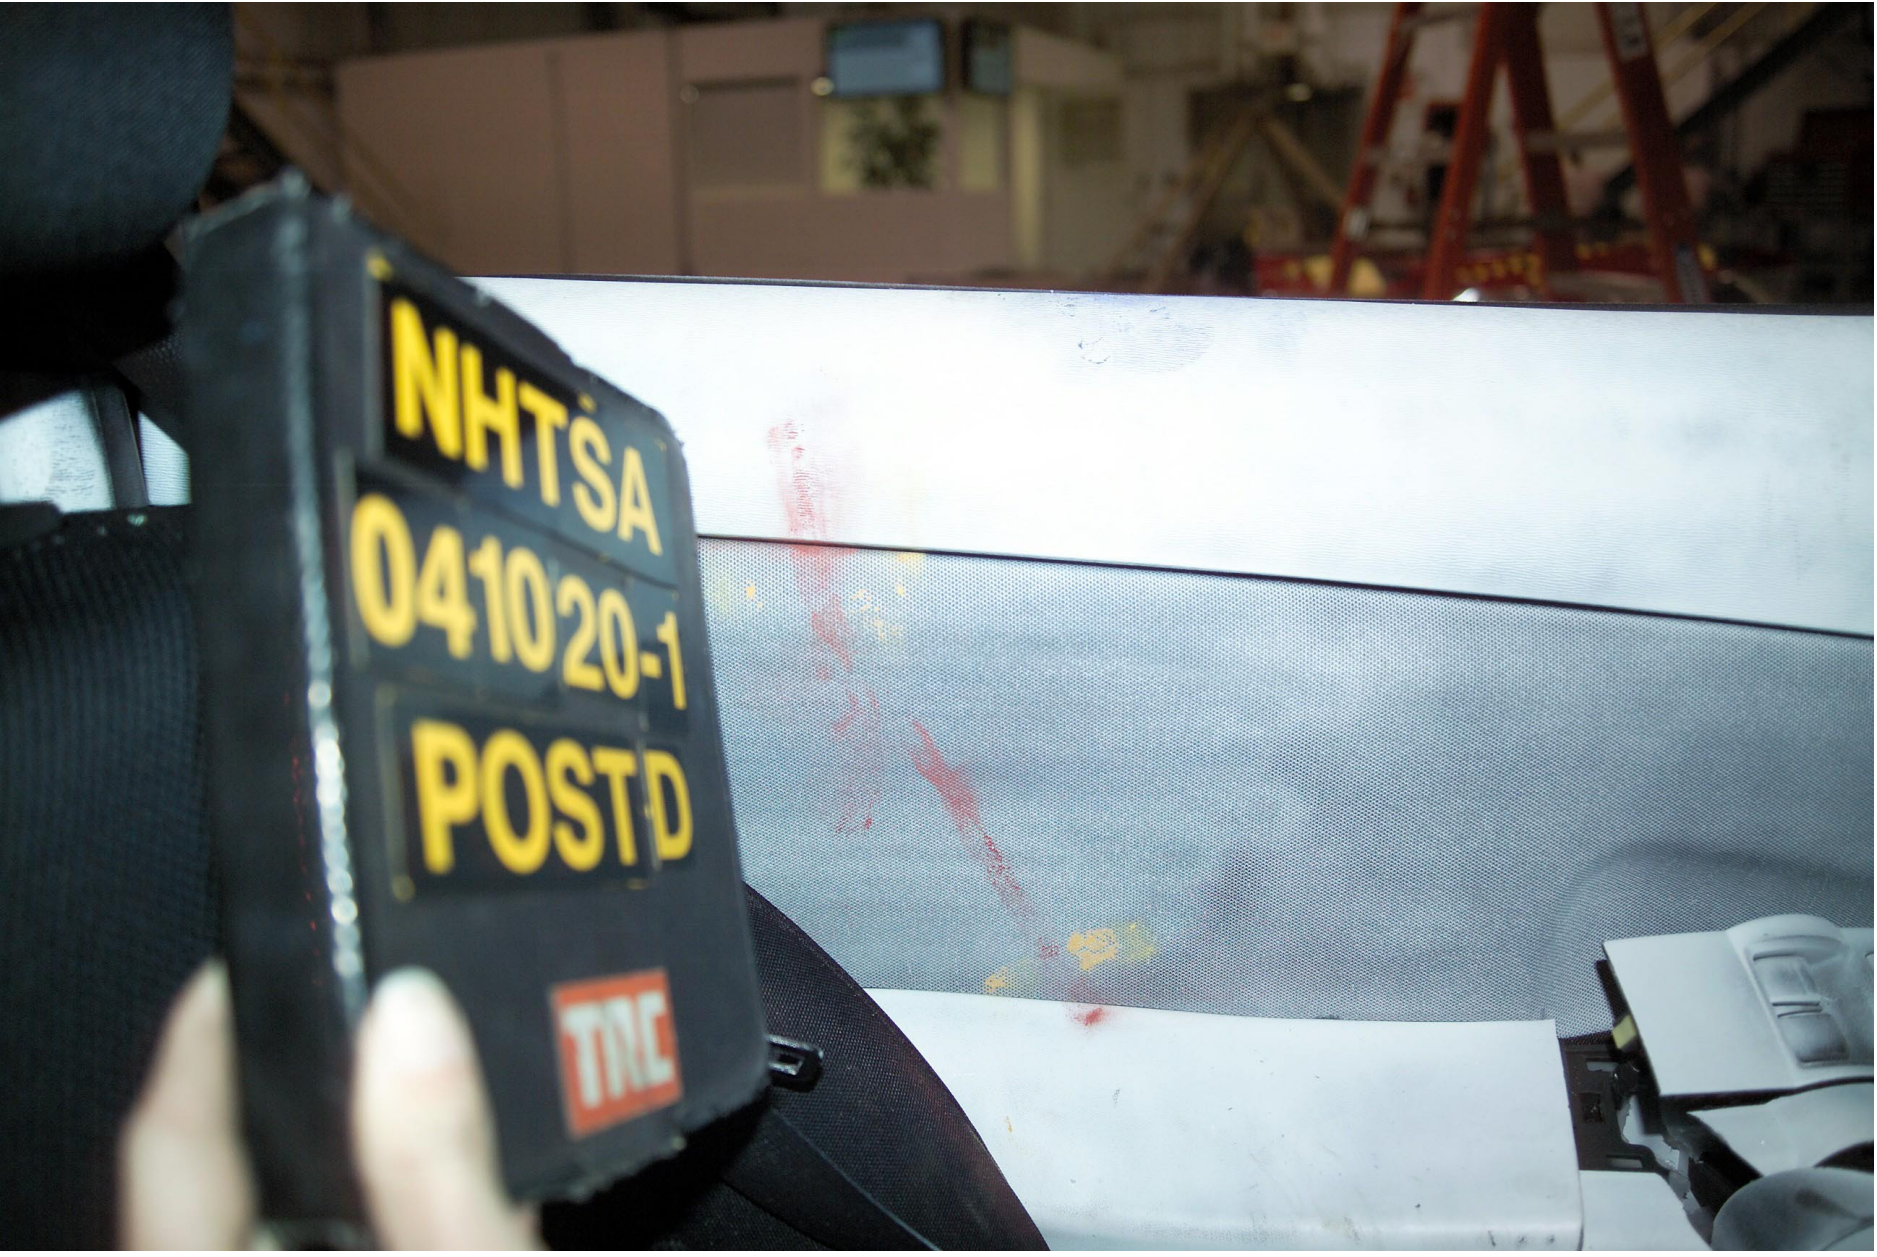
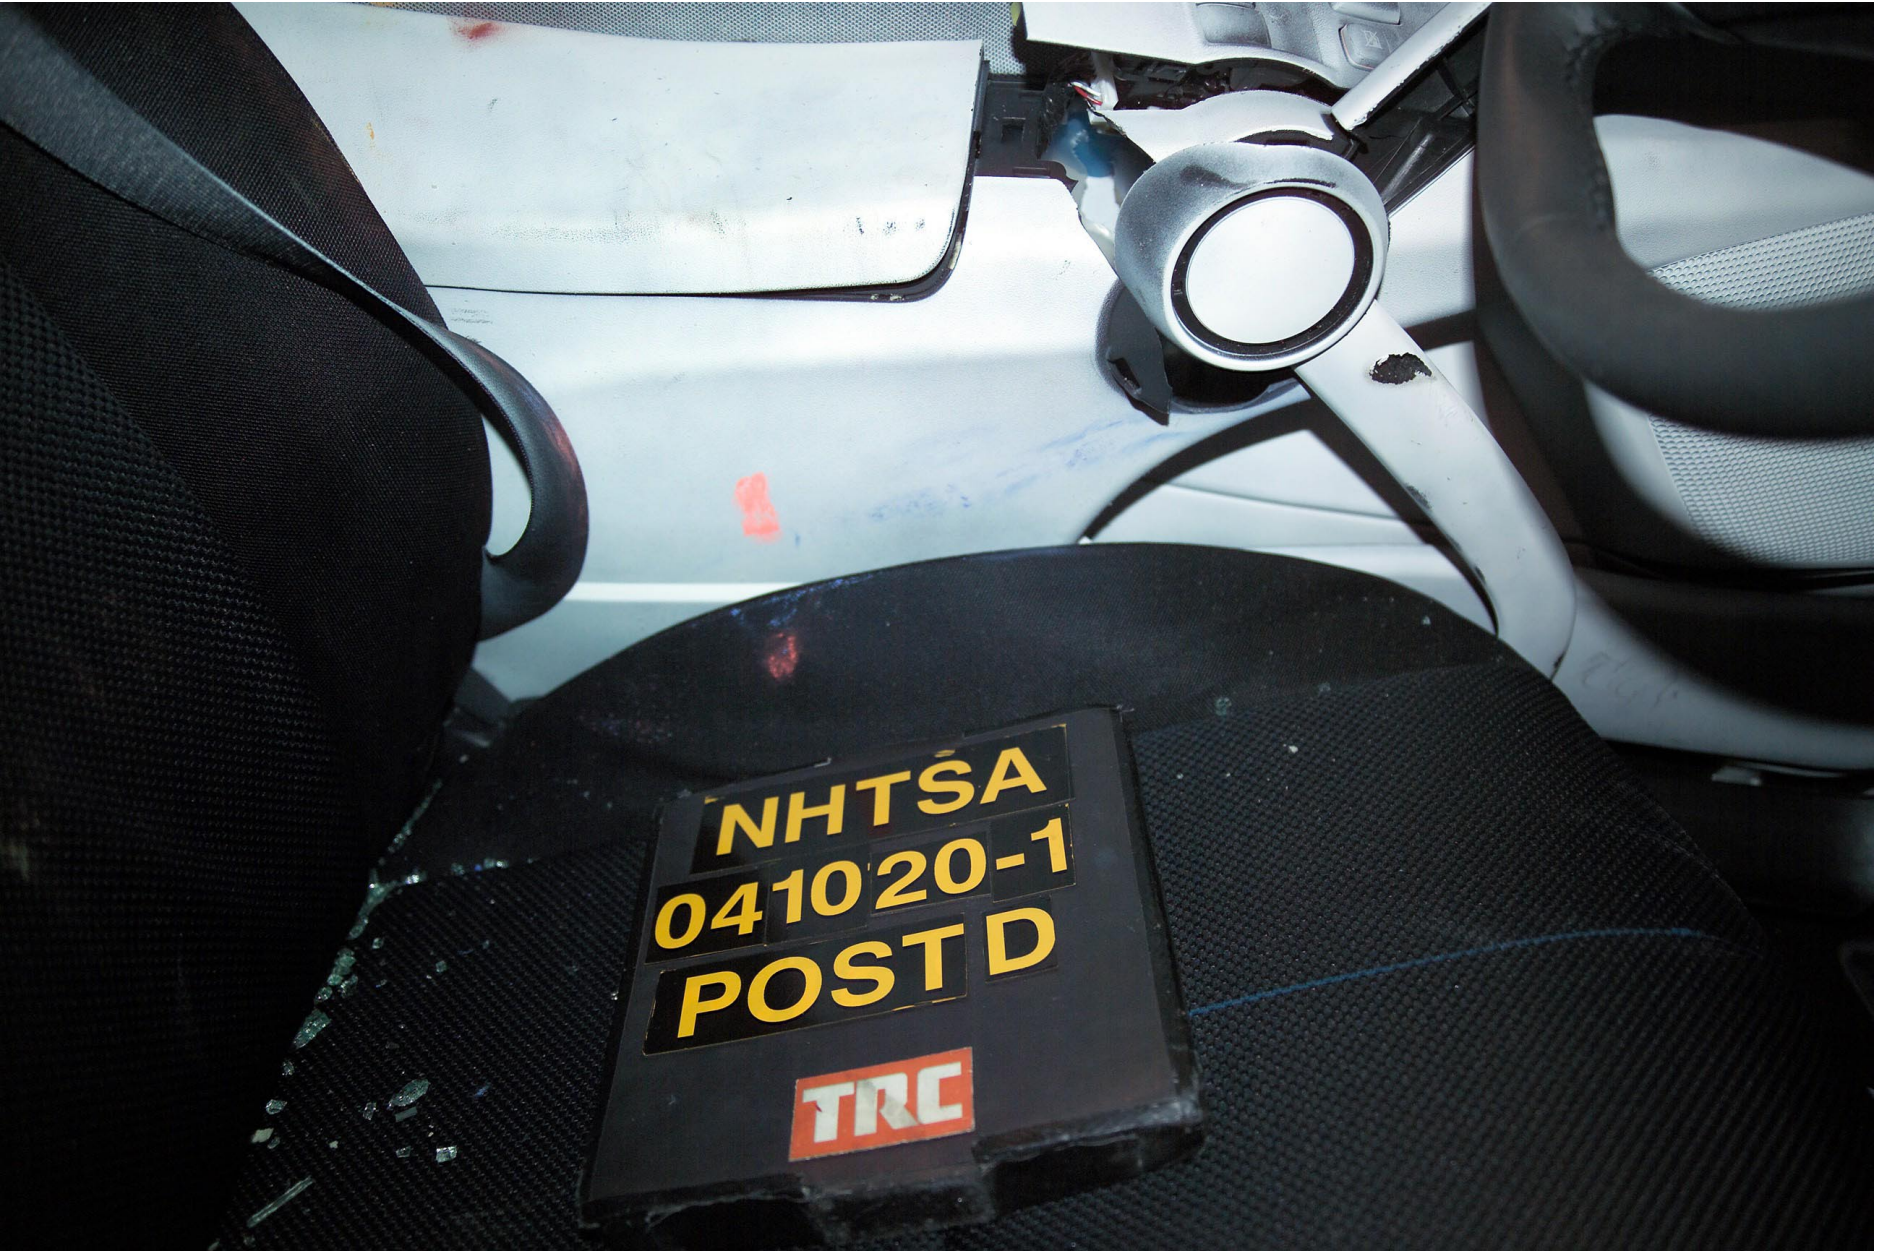
Figure A-37 Post-Test Front SID HIII Contact - View 1
A-41

Figure A-38 Post-Test Front SID HIII Contact - View 2

Figure A-39 Post-Test Front SID HIII Contact - View 3

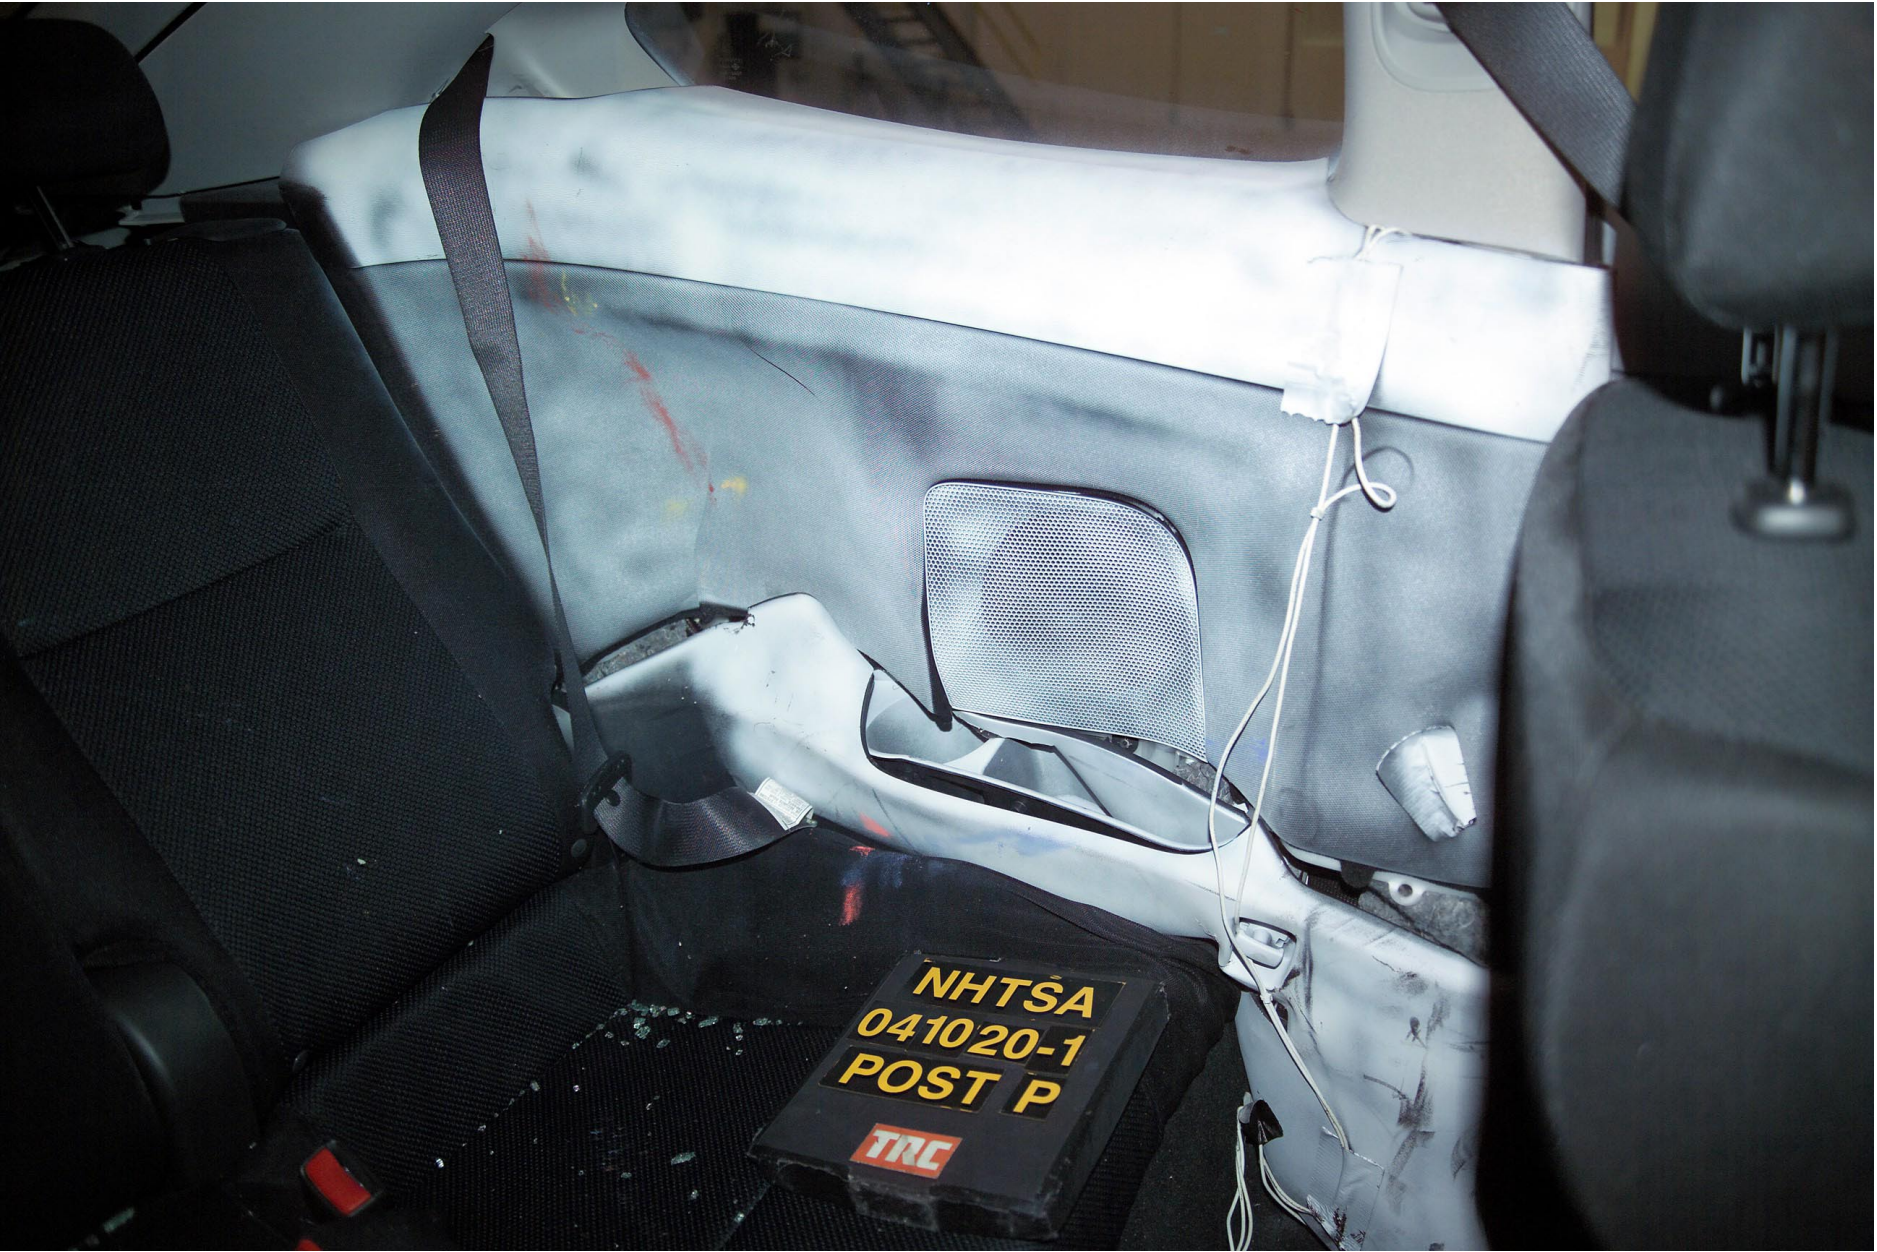
Figure A-40 Post-Test Interior of Rear Panel Showing SID HIII Impact Locations
